MASH TL-3 EVALUATION OF TXDOT EXTRA-LARGE MAILBOXES

Test Report 0-6968-R9

**TEXAS A&M TRANSPORTATION INSTITUTE
COLLEGE STATION, TEXAS**

TEXAS DEPARTMENT OF TRANSPORTATION

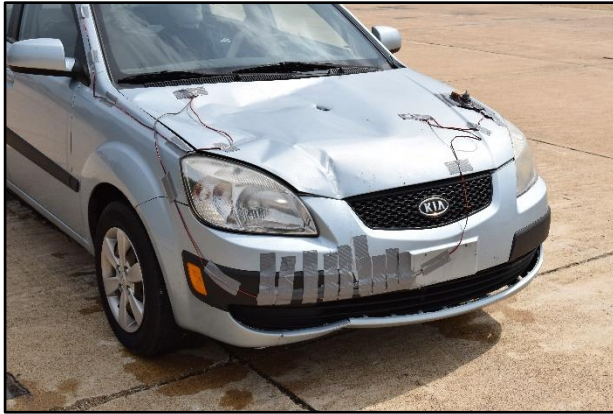
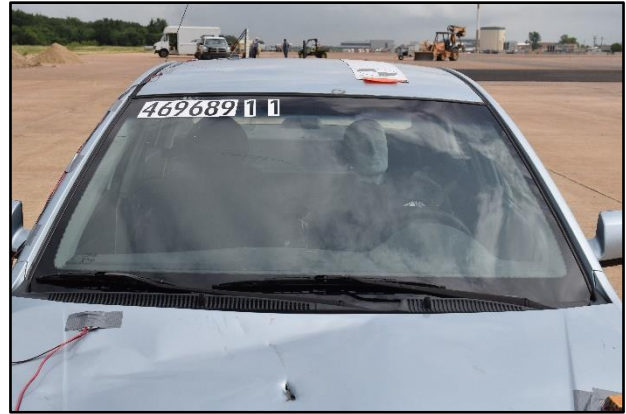
Figure 4.7. Test Vehicle after Test No. 469689-1-1.

Figure 4.7 shows the damage sustained by the vehicle. There was a 2-inch dent in the front bumper at the right quarter point. The hood received a 33-inch × 23-inch dent in the right side of the hood with a 0.5-inch × 3-inch cut and a 0.5-inch × 1.5-inch cut. The right upper windshield sustained a 1-inch × 1-inch break near the roof line. Maximum exterior crush to the vehicle was 2.0 inches in the front plane at the right quarter point at bumper height. No occupant compartment deformation or intrusion was observed. Figure 4.8 shows the interior of the vehicle. Tables A.2 and A.3 in Appendix A.2 provide exterior crush and occupant compartment measurements.

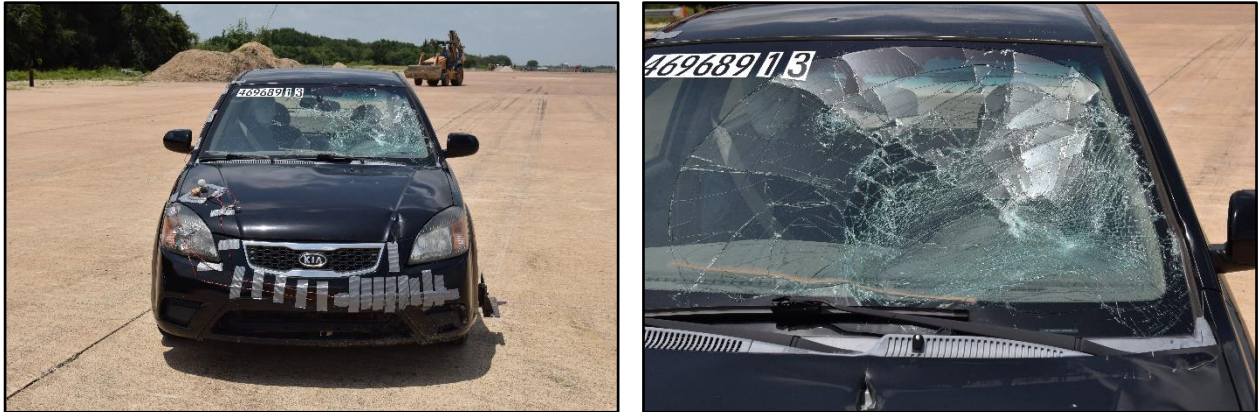
Figure 6.7. Test Vehicle after Test No. 469689-1-3.

Figure 6.7 shows the damage sustained by the vehicle. The left quarter point of the front bumper sustained a 3.0-inch deep dent, and the left side of the hood was deformed with a 1.0-inch × 3-inch long cut. The windshield was shattered over an area of 36 inches × 33 inches with 4.6 inches of deformation into the occupant compartment. The windshield laminate was also torn. Maximum exterior crush to the vehicle was 3.0 inches in the front plane at the left quarter point at bumper height. Maximum occupant compartment deformation was 4.6 inches in the windshield area. Figure 6.8 shows the interior of the vehicle. Tables C.2 and C.3 in Appendix C.2 provide exterior crush and occupant compartment measurements.

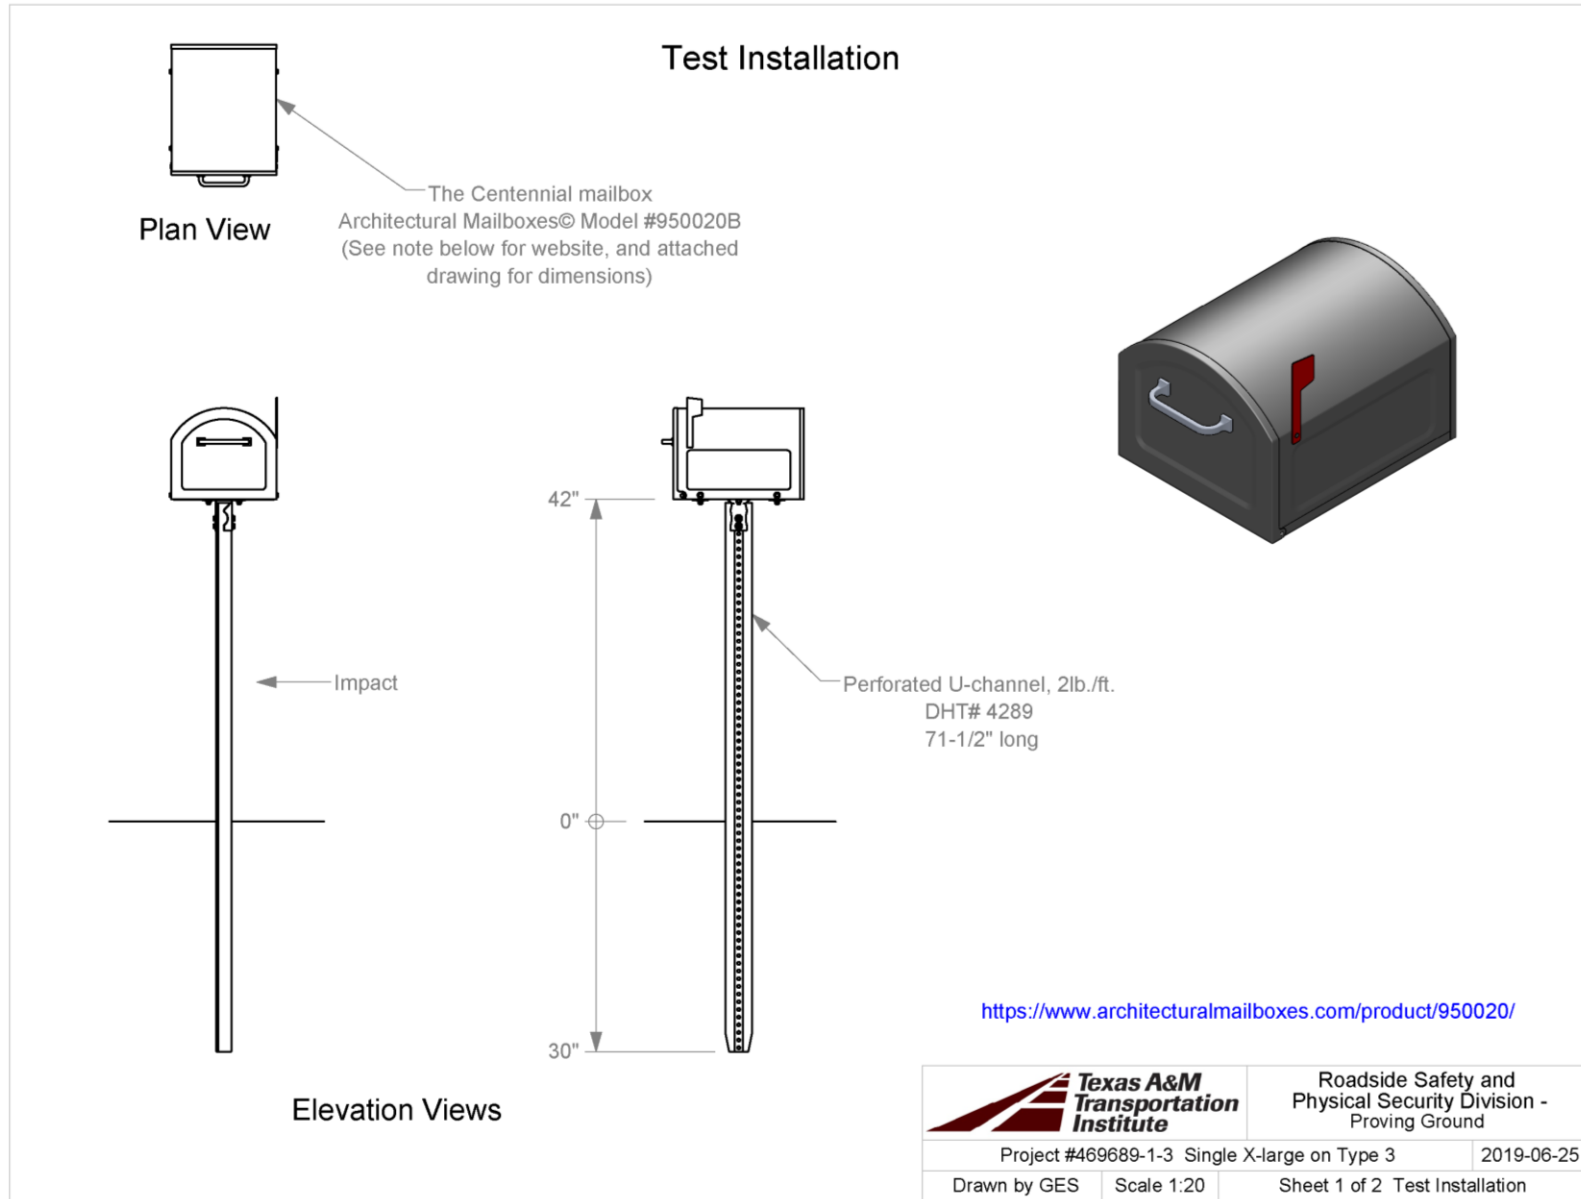
Figure 7.1. Overall Details of Centennial Model Extra-Large Mailbox on Type 3 Support.

Test No. 469689-1-4 was a repeat of testing installation and impact conditions from Test No. 469689-1-3. The only design modification applied for Test No. 469689-1-4 was the inclusion of an additional connection bracket between the extra-large mailbox and the support. The connection bracket design previously tested under Test Nos. 469689-1-1 and 469689-1-3 specifically connected the extra-large mailbox floor to the mailbox support structure. For both Test Nos. 469689-1-1 and -1-3, the extra-large mailbox body fractured as a result of the high-speed vehicle impact, resulting in a separation between the mailbox floor and the mailbox sides was noted. After separation, the mailbox side became test article debris projected against the vehicle body and impacted the windshield. While in Test No. 469689-1-1 the contact between the mailbox side and the windshield did not affect the system crashworthiness, in Test No. 469689-1-3 the mailbox side caused a windshield deformation greater than the maximum allowed in *MASH*.

It became clear that a bracket that would connect the support, the mailbox floor, and the mailbox side was a possible solution to avoid separation of the mailbox floor from the rest of the mailbox body. Thus, four L brackets were integrated into the mailbox support assembly as described above. Figures 7.1 through 7.4 show the details of these brackets.

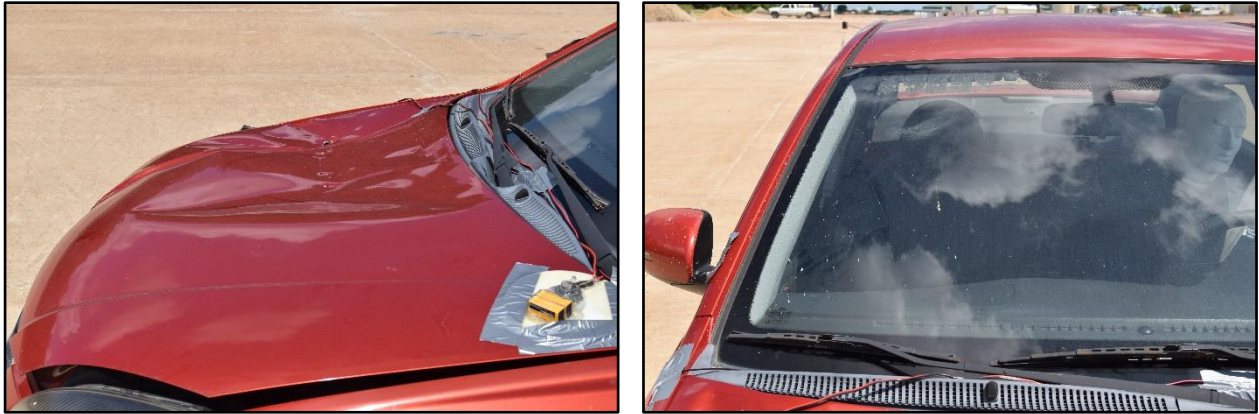
Figure 7.8. Test Vehicle after Test No. 469689-1-4.

Figure 7.8 shows the damage sustained by the vehicle. The front bumper sustained a small indentation 14 inches to the right of centerline, and the hood was deformed over an area 35 inches \times 25 inches and 1.5 inches deep. Maximum exterior crush to the vehicle was 1.5 inches in the hood. No occupant compartment deformation or intrusion was observed. Figure 7.9 shows the interior of the vehicle. Tables D.2 and D.3 in Appendix D.2 provide exterior crush and occupant compartment measurements.

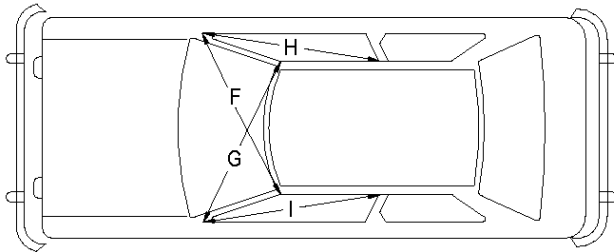
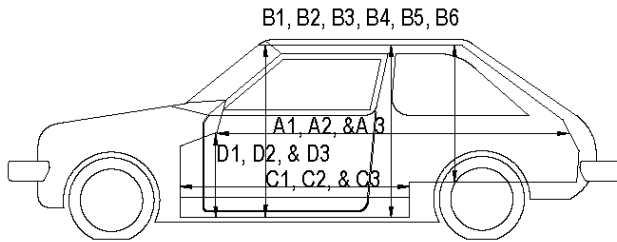
Table C.3. Occupant Compartment Measurements of Vehicle for Test No. 469689-1-3.

During *MASH* Test 3-61 on the single Centennial model extra-large mailbox on Type 3 support, the windshield of the test vehicle deformed 4.6 inches into the occupant compartment, and the laminate was torn. The installation failed criterion D of *MASH*.

Specific Impact Number	Plane* of C-Measurements	Direct Damage		Field L**	C ₁	C ₂	C ₃	C ₄	C ₅	C ₆	±D
		Width*** (CDC)	Max**** Crush								
	Front Plane at bumper ht		3								
	Windshield		4.6								
	Measurements recorded										
	<input checked="" type="checkbox"/> inches or <input type="checkbox"/> mm
