Development of Guidelines for Inspection, Repair, and Use of Portable Concrete Barriers—Volume 1: Technical Report

Technical Report 0-7059-R1-Vol1

TEXAS A&M TRANSPORTATION INSTITUTE
COLLEGE STATION, TEXAS

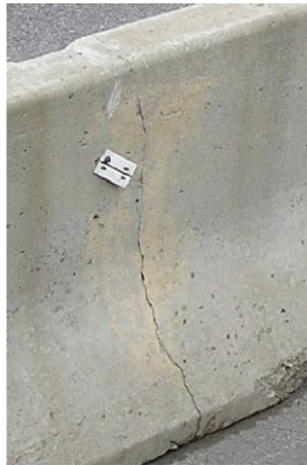
Defects	Unacceptable
Cracks	<ul style="list-style-type: none"> • A PCB piece has more than one transverse crack through the section, it is not acceptable (Figure 2.12). • A PCB piece has an open crack running more than 4 ft longitudinally, it is not acceptable (Figure 2.13). • A single crack exhibits evidence that the reinforcing bar is rusting, the piece is not acceptable.
Concrete Spalling	<ul style="list-style-type: none"> • If spalled areas exceeding 12 inches in any direction, it is not acceptable. • A corner of PCB has the depth of the spalling is 3 or more inches, it is not acceptable (Figure 2.14).
Snag Risk	<ul style="list-style-type: none"> • A PCB has a surface that projects towards traffic by more than 30 degrees and that is exposed to a depth of greater than 1.75 inches for traffic approaching the barrier at a 25-degree angle, it is not acceptable (Figure 2.15 and Figure 2.16).

Figure 2.12. Transverse Cracks—NYSDOT (27).

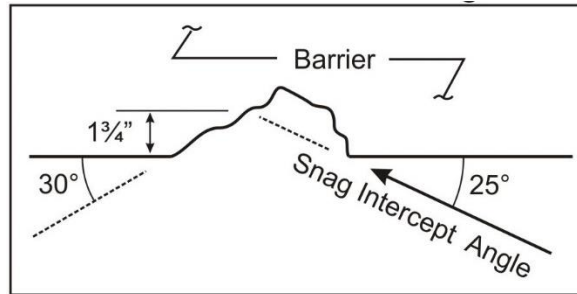
Figure 2.15. Threshold Criteria for Snag Point—NYSDOT (27).

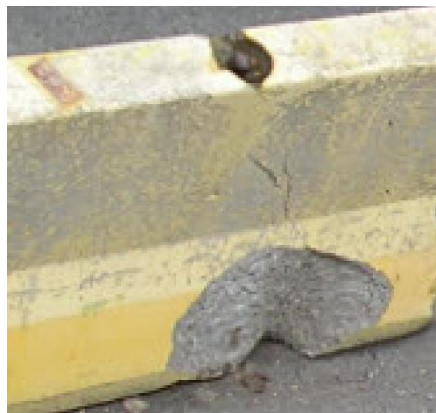
Figure 2.16. Unacceptable Barrier Due to Snag Risk—NYSDOT (27).

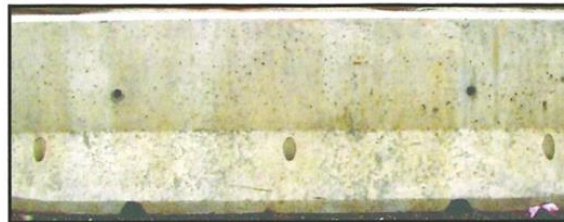
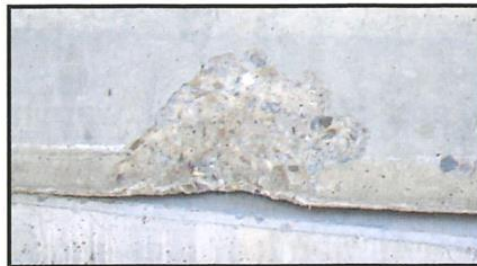
Figure 2.18. Barrier Examples—ATSSA (29).

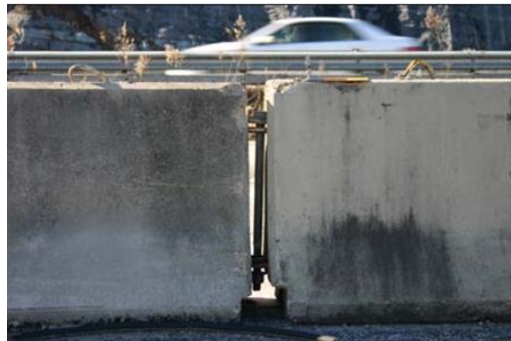
Figure 3.1. Examples of Connection Systems—ALDOT (33).

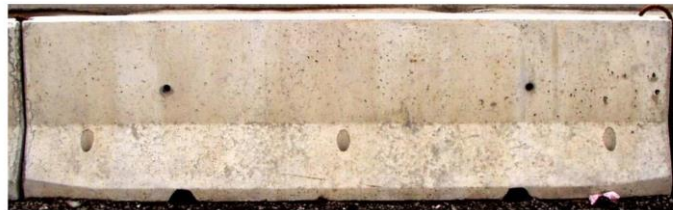
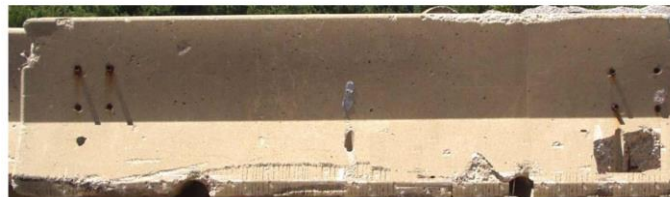
Figure 3.3. Examples of Barrier Conditions—ODOT (38).

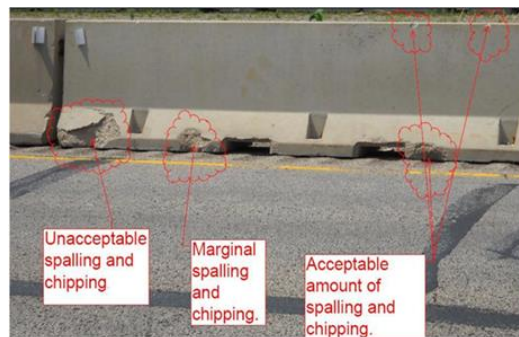
Figure 3.4. Spalling and Chipping—WisDOT (43).

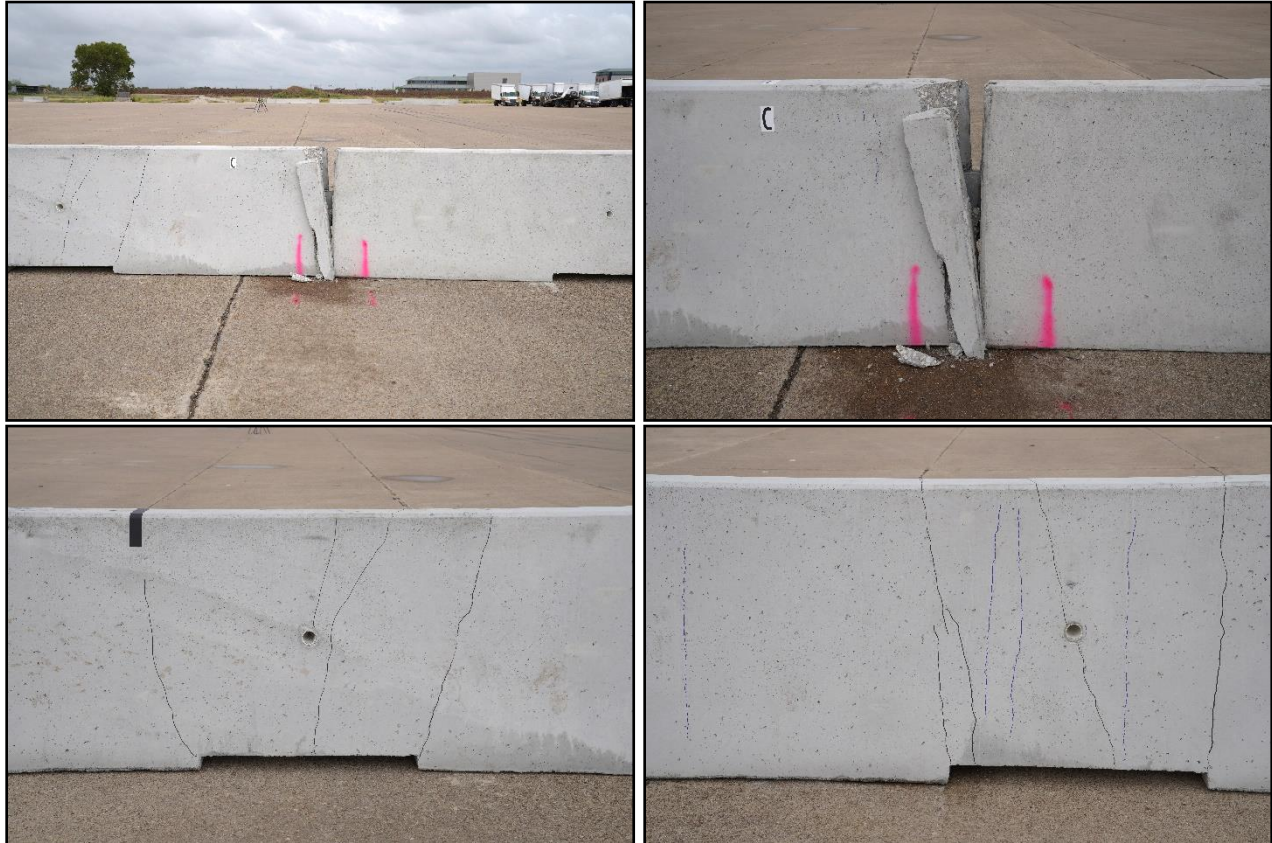
Figure 5.4. Single-Slope Barrier after Test No. 440590-01-B1.

Figure 5.4 shows damage to the barrier. The blue lines indicate existing cracks, and the black lines indicate the cracks post impact. The larger, more visible cracks were not marked. The left end of barrier A moved 2 inches back, and the joint at barriers A and B moved forward by 3 inches. The joint at barriers B and C moved 1 ft back, and the joint at barriers C and D moved 13 inches back. The joint at barriers D and E moved 3 inches forward, and the right end of barrier E moved 1 inch back. Measured from the top of the joints, the gaps between the barriers were as follows: the joint of barriers A and B was 2¼ inches at the front and 2 inches at the back; the joint of barriers B and C was 2 inches at the front and 2¼ inches at the back; the joint of barriers C and D was not measurable at the front and 2½ inches at the back; and the joint of

barriers D and E was 2¼ inches at the front and 1¾ inches at the back. There was some cracking at the top of the right end of barrier B. Barrier C had cracks all along the front and back side of the barrier and had some spalling on the backside of the barrier near the bottom. Barrier D had some spalling of the concrete at the right scupper. There was a crack on the bottom of barrier D near the joint of barriers C and D. Maximum dynamic deflection during the test was 16.4 inches, and maximum permanent deformation was 13.0 inches.

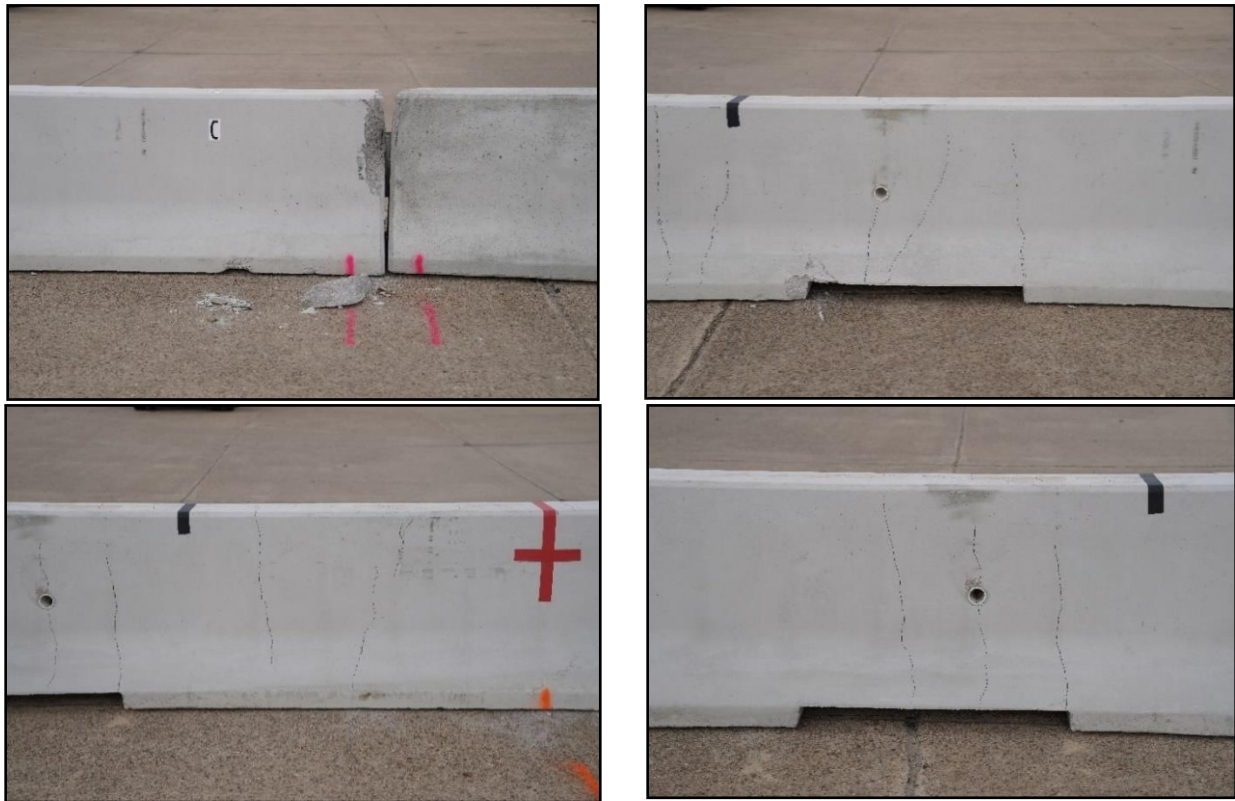
Figure 5.28. F-Shape Barrier after Test No. 440590-01-B3.

Figure 5.28 shows damage to the barrier. The red lines indicate existing cracks, and the black lines indicate the cracks post impact. The larger, more visible cracks were not marked. No movement was noted on either the far left or far right ends of the installation. The joint at barriers A and B moved 2½ inches forward, and the joint at barriers B and C moved 12½ inches back. The joint at barriers C and D moved 14 inches back, and the joint at barriers D and E moved 1 inch forward. Measured from the top of the joints, the gaps between the barriers were as follows: the joint of barriers A and B was 2¼ inches at the front and 2 inches at the back; the joint of barriers B and C was 2 inches at the front and 2½ inches at the back; the joint of barriers C and D was 2 inches at the front, and the back was not measurable due to spalling; and the joint of barriers D and E was 2½ inches at the front and 2 inches at the back. There were cracks at the scuppers of all the barriers. There was exposed rebar on the backside of barrier D at the joint of barriers C and D, and barrier C had some spalled concrete at this joint as well. Barrier D also had major cracking on its base at the middle of the barrier. There was some spalling at the base of barrier E at the joint of barriers D and E. Barrier C had some spalling at various locations along the backside of the barrier, and there was also a ¼-inch crack starting from the inner corner of the right scupper on the backside of the barrier. There was some spalling at the base of barrier B, as well as at the end and left corner of barrier A. Maximum dynamic deflection during the test was 20.2 inches, and maximum permanent deformation was 14.0 inches.

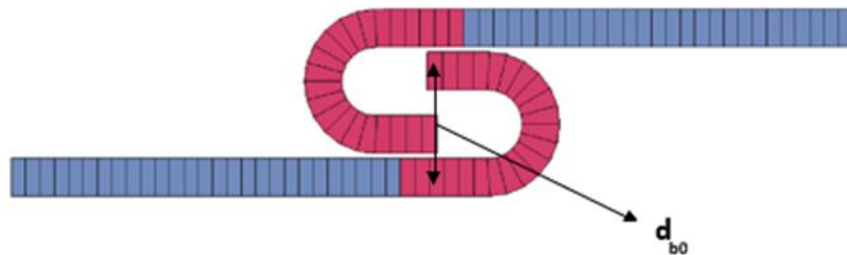
Figure 7.15. Undeformed JJ Hook Connectors with $d_{b0} = 28$ mm.

This series of simulations was carried out to assess the crashworthiness of the F-shape barrier system with pre-deformed JJ hooks and associated changes in the vehicle stability. JJ hook connectors were deformed in the model by making changes in the original geometry. Figure 7.15 shows a pair of undeformed hooks (diameter = 28 mm), and Figure 7.16 shows a pair of JJ hook connectors, where each hook is opened to 35.8 mm from the original diameter of 28 mm.

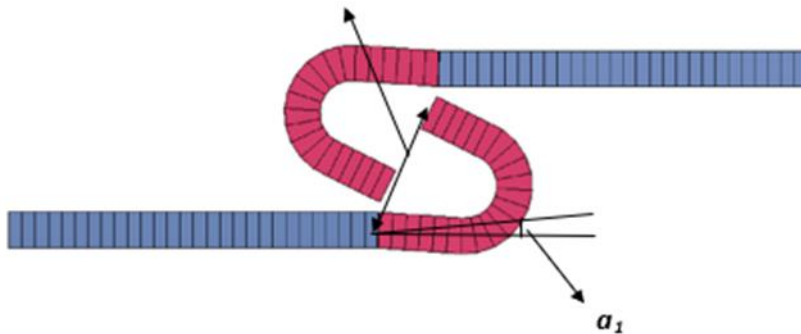
Figure 7.16. Pre-deformed JJ Hook Connectors with $d_{b1} = 35.8$ mm and Rotation Angle (α_1) = 4 deg.

This deformation was comparable to the maximum JJ hook deformation recorded at the end of the predictive FEA simulation replicating *MASH* Test 3-11. A second predictive FEA simulation was conducted to replicate *MASH* Test 3-11 with inclusion of the above recorded JJ hook deformation. The critical impact point was chosen as suggested by *MASH* (4.3 ft upstream of the joint). Results of the second predictive FEA simulation showed that JJ hook connectors increased their deformation as expected (Figure 7.17). The pre-impact distance, d_{b1} , increased from 35.8 mm to 39 mm.

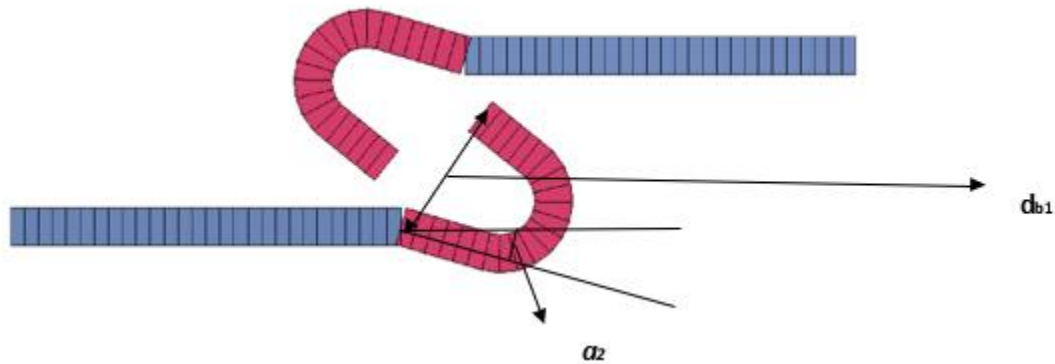
Figure 7.18. Pre-deformed JJ Hook Connectors with $d_{b1} = 35.8$ mm and Rotation Angle (a_2) = 16.4 deg.

Further, the deformation in JJ hook connectors was increased by complementing the opening of the hook with maximum hook rotation. Figure 7.18 illustrates the next deformation level that was introduced in the JJ hook connectors.

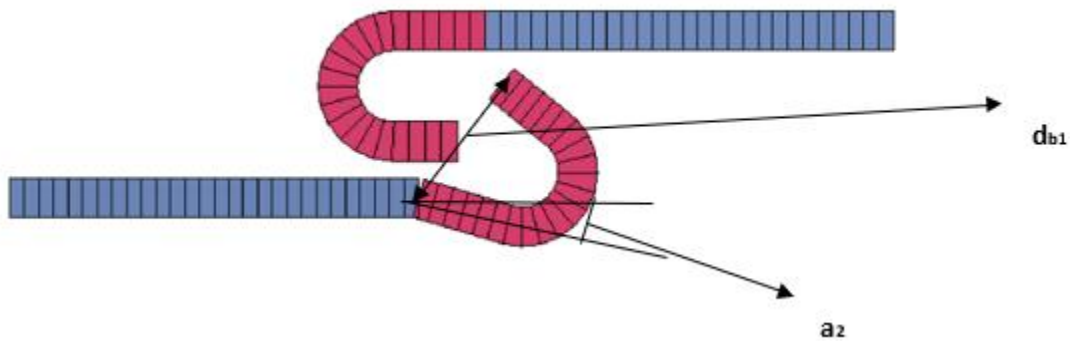
Figure 7.20. Pair of Undeformed and Pre-deformed JJ Hook Connectors: $d_{b1} = 35.8$ mm, $a_2 = 16.4$ deg.

JJ hook and another rotated JJ hook. Figure 7.20 shows the JJ connector pair with an undeformed hook and a deformed hook.

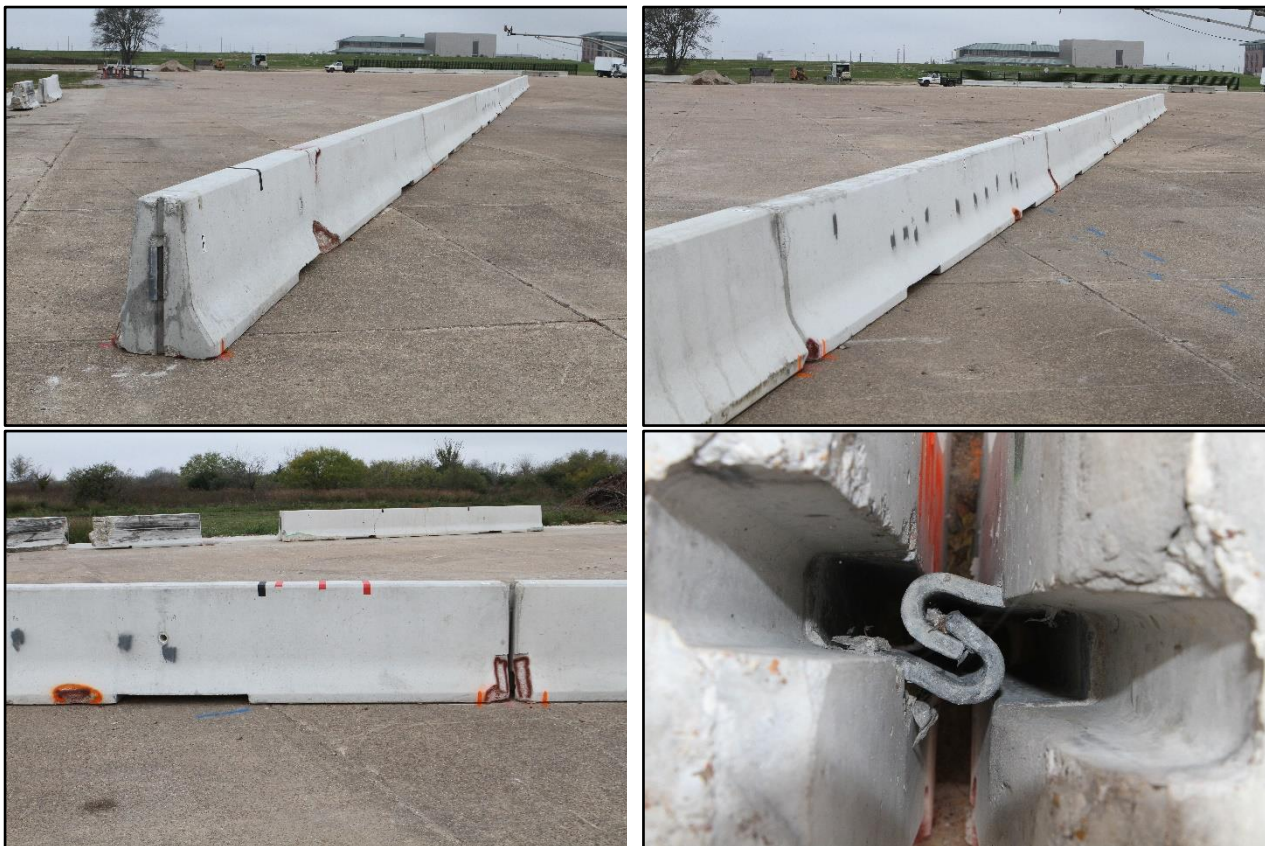
Figure 8.2. Damaged Portable Concrete Barrier before Test No. 440592-2.

For the Test No. 440592-2 test installation, spalling was manufactured by TTI personnel on the traffic side toe of barriers 3 and 4 at their joint. Each had a spall measuring approximately 3¾ inches wide by 13 inches high by 2 inches deep. At the same joint on the field side, the toe of barrier 4 was intentionally spalled and measured approximately 24 inches wide by 5 inches high by 2 inches deep. The JJ hooks at the joint of barriers 2 and 3 were not damaged. The downstream JJ hook on barrier 3 was bent 19 degrees, and the upstream JJ hook of barrier 4 was bent 15 degrees.
