Test Report No. 440822-01

**EVALUATION OF ATTACHMENTS TO CONCRETE BARRIER
SYSTEMS TO DETER PEDESTRIANS**

Texas Department of Transportation
<https://tti.tamu.edu/documents/0-7082-R1-Vol2.pdf>

1. Report No. FHWA/TX-23/0-7082-R1-Vol2		2. Government Accession No.		3. Recipient's Catalog No.	
4. Title and Subtitle EVALUATION OF ATTACHMENTS TO CONCRETE BARRIER SYSTEMS TO DETER PEDESTRIANS—VOLUME 2: CRASH REPORT				5. Report Date Published: August 2023

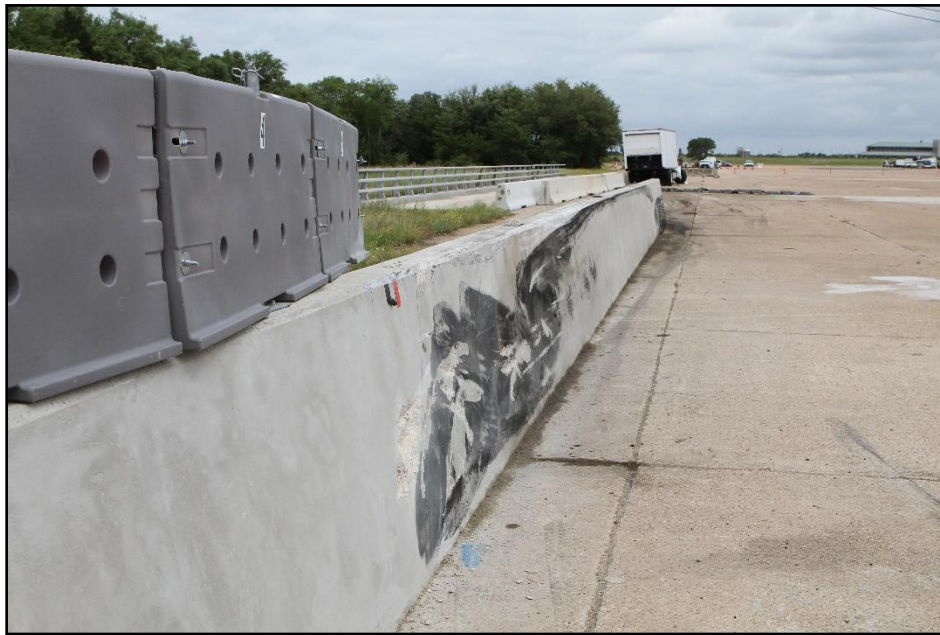
Table 5.6 describes the damage to the Armorcast[®] gawk screen on the single-slope barrier. Figure 5.6 and Figure 5.7 show the damage to the Armorcast[®] gawk screen on the single-slope barrier.

Test Parameter	Measured
Permanent Deflection/Location	0 inches at the concrete barrier
Dynamic Deflection	0 inches at the concrete barrier (screen released from barrier)
Working Width ^a and Height	Dislodged Screen panels at 129.9 inches, at a height of 27.7 inches

Figure 5.6. Armorcast® Gawk Screen on Single-Slope Barrier after Test at Impact Location, Test 440822-01-1.

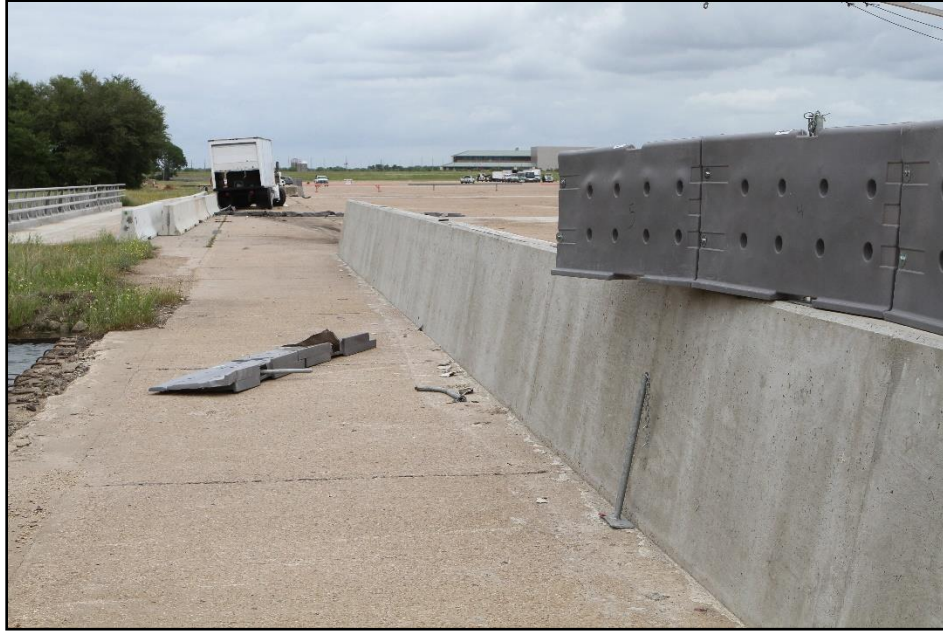
Figure 5.7. Rear View of the Armorcast® Gawk Screen on Single-Slope Barrier Post Impact, Test 440822-01-1.

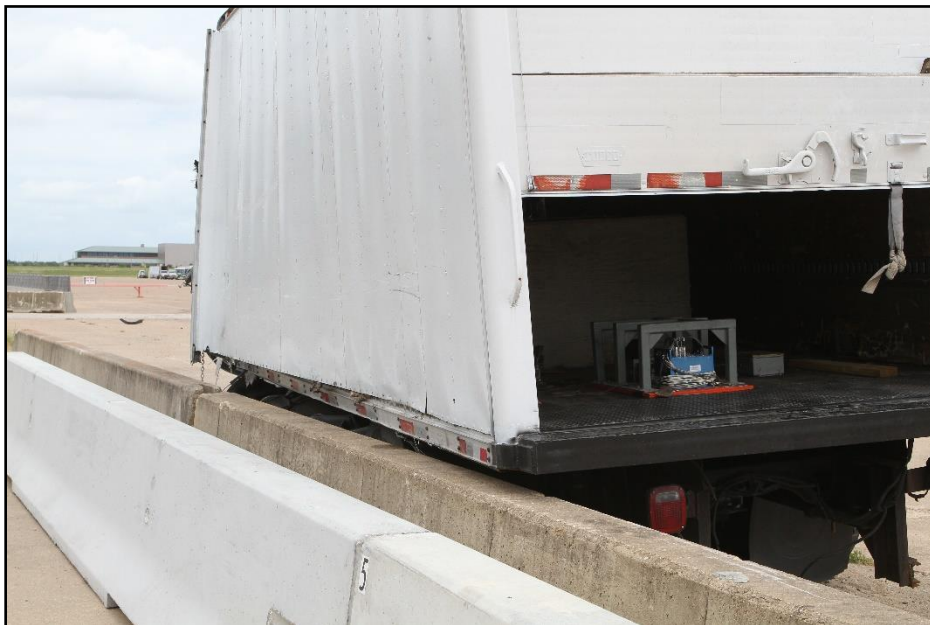
Figure 5.9 and Figure 5.10 show the damage sustained by the vehicle. Figure 5.11 and Figure 5.12 show the interior of the test vehicle. Table 5.7 and Table 5.8 provide details on the occupant compartment deformation and exterior vehicle damage.

Figure 5.10. Rear Impact Side of Test Vehicle after Test 440822-01-1.

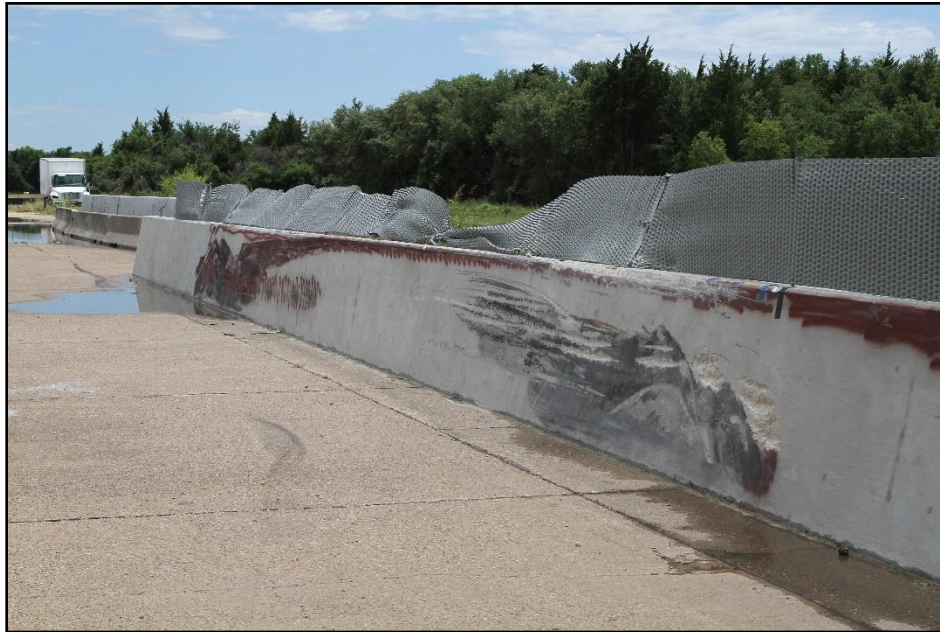
Table 6.6 describes the damage to the Screen-Safe[®] glare screen on the single-slope barrier. Figure 6.6 and Figure 6.7 show the damage to the Screen-Safe[®] glare screen on the single-slope barrier.

Test Parameter	Measured
Permanent Deflection/Location	The fence at 20.5 inches toward field side, 20 inches downstream of post 9
Dynamic Deflection	Not measurable (view obscured by box truck)
Working Width ^a and Height	The box truck at 69 inches, at a height of 136.6 inches

Figure 6.6. Screen-Safe® Glare Screen on Single-Slope Barrier after Test at Impact Location, Test 440822-01-2.

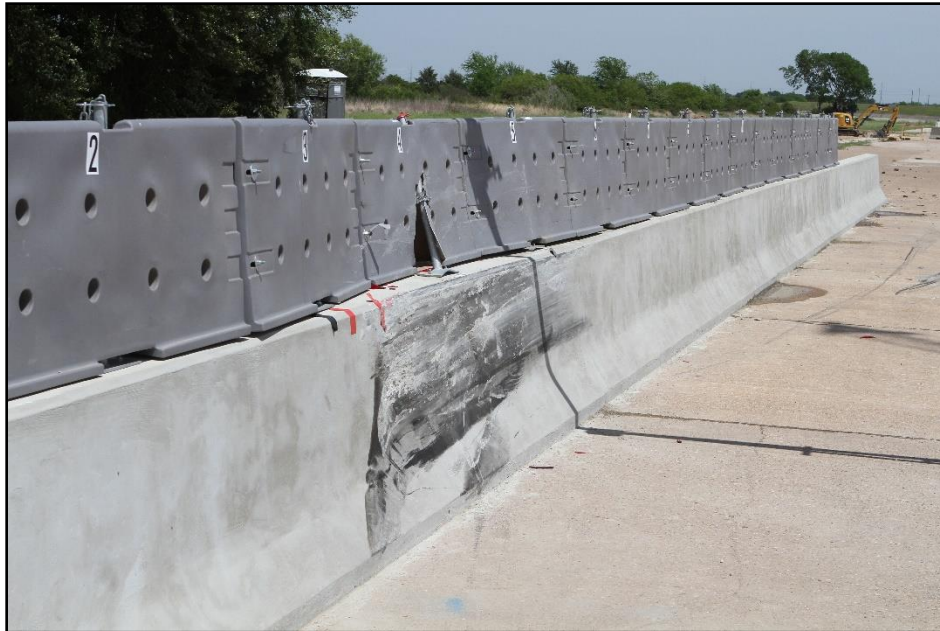
Figure 7.6. Armorcast® Gawk Screen on F-Shape Barrier after Test at Impact Location, Test 440822-01-3.

There was some scuffing and gouging at impact on the concrete barrier. Screen 4 was damaged and had a vertical tear at its post. The posts and baseplates of screens 3, 4, and 5 were all bent.

Table 7.6 describes the damage to the Armorcast® gawk screen on the F-shape barrier. Figure 7.6 and Figure 7.7 show the damage to the Armorcast® gawk screen on the F-shape barrier.

Test Parameter	Measured
Permanent Deflection/Location	The screen at 8.5 inches toward field side, 5 inches upstream of post 4
Dynamic Deflection	The screen at 16.5 inches toward field side
Working Width ^a and Height	29.5 inches, at a height of 56 inches (barrier attachment)

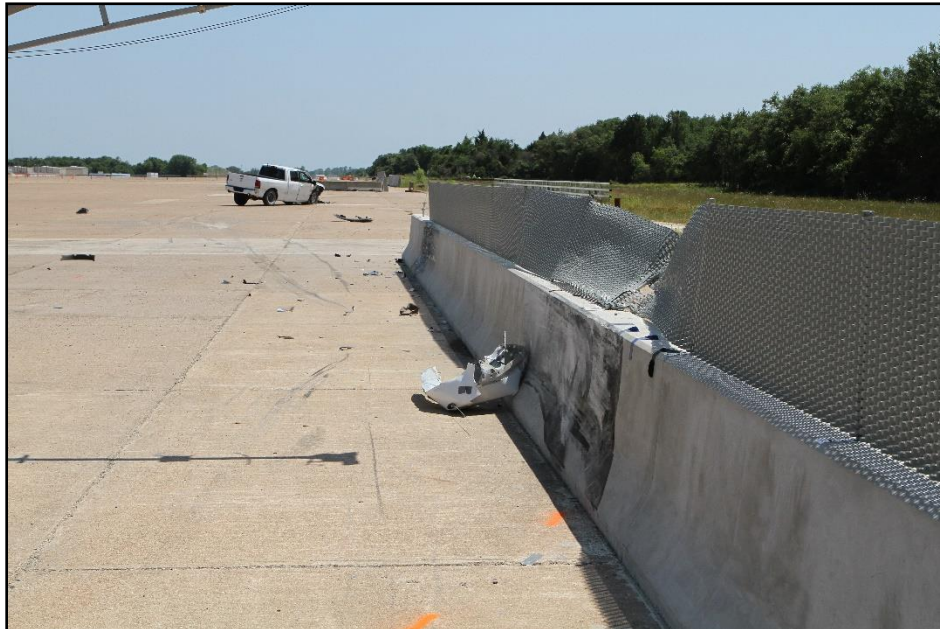
Figure 8.6. Screen-Safe[®] Glare Screen on F-Shape Barrier after Test at Impact Location, Test 440822-01-4.

Table 8.6 describes the damage to the Screen-Safe[®] glare screen on the F-shape barrier. Figure 8.6 and Figure 8.7 show the damage to the Screen-Safe[®] glare screen on the F-shape barrier.

Test Parameter	Measured
Permanent Deflection/Location	The screen at 21 inches toward field side at the joint of posts 6 and 7
Dynamic Deflection	The screen at 24 inches toward field side
Working Width ^a and Height	36 inches, at a height of 56 inches (barrier attachment)

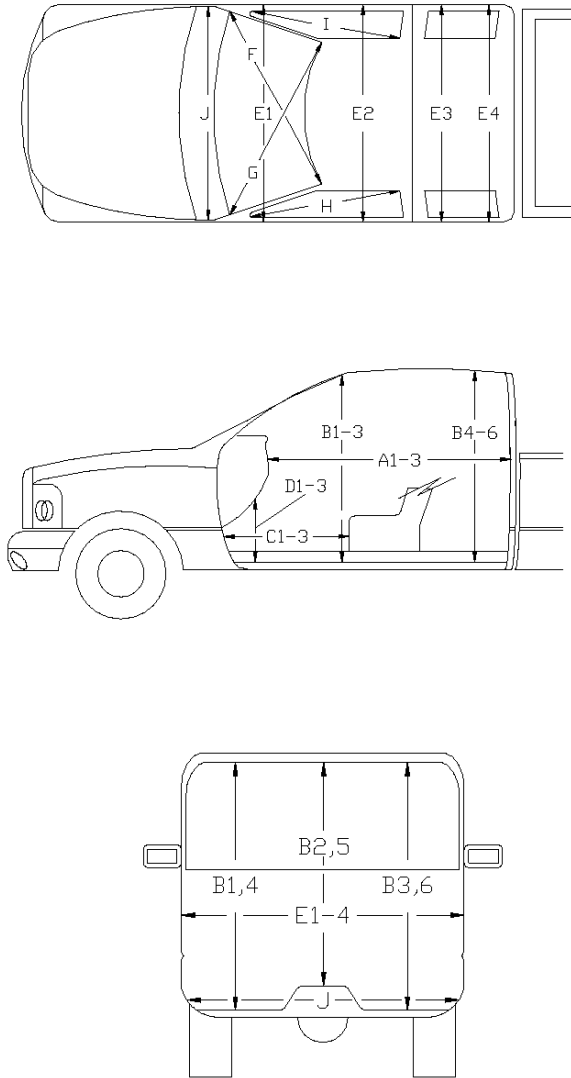
Figure C.3. Occupant Compartment Measurements for Test No. 440822-01-3.

Before	After (inches)	Differ.
A1	65.00	65.00	0.00
A2	63.00	63.00	0.00
A3	65.50	65.50	0.00
B1	45.00	45.00	0.00
B2	38.00	38.00	0.00
B3	45.00	45.00	0.00
B4	39.50	39.50	0.00
B5	43.00	43.00	0.00
B6	39.50	39.50	0.00
C1	26.00	24.00	-2.00
C2	0.00	0.00	0.00
C3	26.00	26.00	0.00
D1	11.00	11.00	0.00
D2	0.00	0.00	0.00
D3	11.50	11.50	0.00
E1	58.50	58.50	0.00
E2	63.50	63.50	0.00
E3	63.50	63.50	0.00
E4	63.50	63.50	0.00
F	59.00	59.00	0.00
G	59.00	59.00	0.00
H	37.50	37.50	0.00
I	37.50	37.50	0.00
J*	25.00	24.00	-1.00
