MASH TEST 4-12 ON T2P RETROFIT BRIDGE RAIL

Test Report 0-7086-R5

TEXAS DEPARTMENT OF TRANSPORTATION

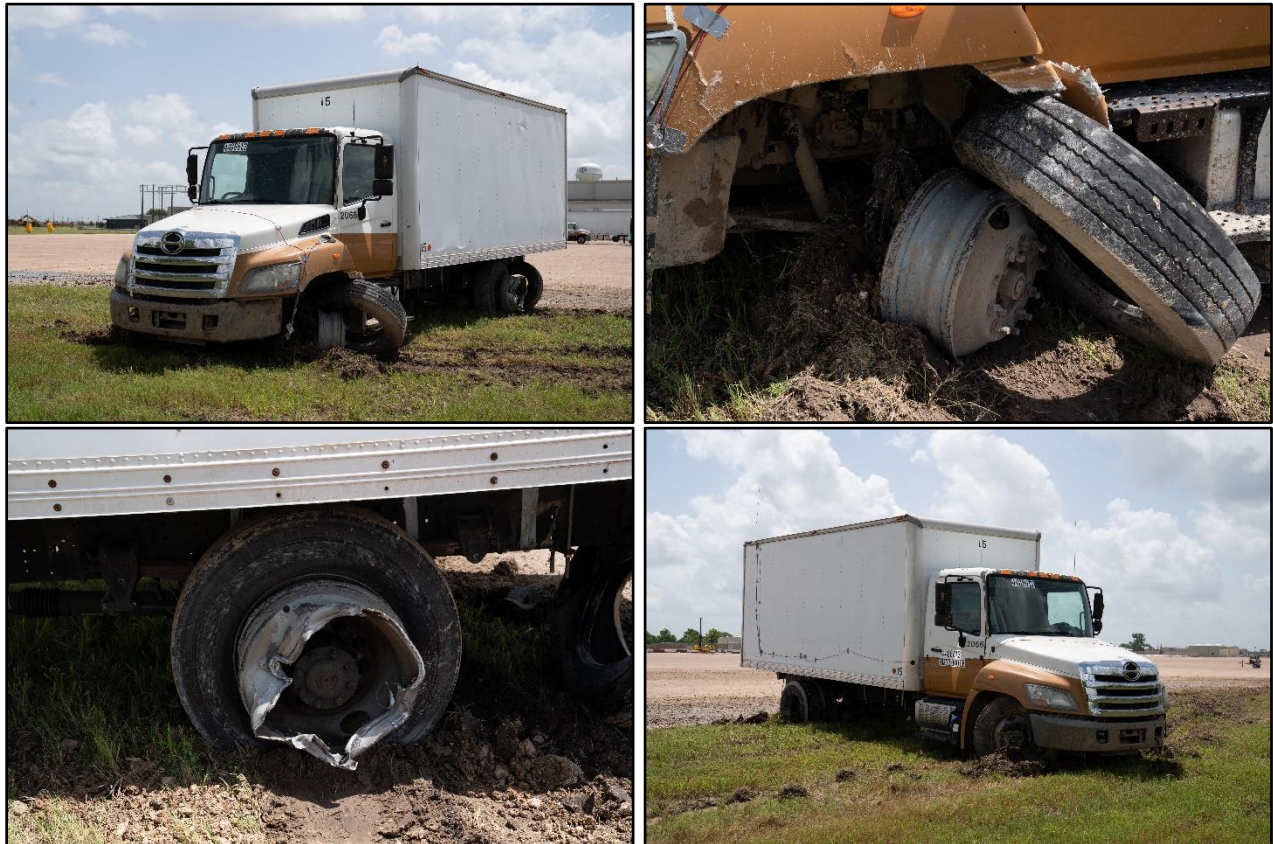
Figure 5.5. Test Vehicle after Test No. 440861-2.

Figure 5.5 shows the damage sustained by the vehicle. The front bumper, hood, left front tire and rim, left front U-bolts, left rear outer tire and rim, and left rear corner of the cargo box were damaged. No damage to the fuel tank was observed. Maximum exterior crush to the vehicle was 10.0 inches in the front plane at the left front corner at bumper height. No occupant compartment deformation or intrusion was noted. Figure 5.6 shows the interior of the vehicle.
