CONCRETE RESURFACING OVERLAYS

TWO BRIDGE DECKS

Research Report No. 130-8  
A Study of Reinforced Concrete Bridge Deck Deterioration:  
Diagnosis, Treatment and Repair  
Research Study 2-18-68-130

August, 1972

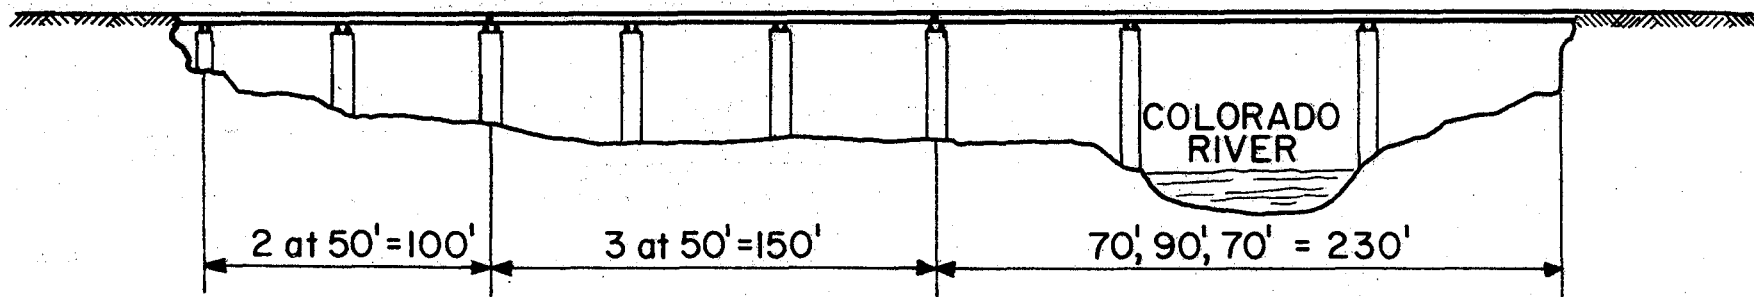
FIG. 1 BRIDGE ON TEXAS STATE ROUTE 208 IN COKE COUNTY, TEXAS SHOWING SEQUENCE OF PLACEMENT OF P.C. OVERLAY IN OCTOBER, 1970.

This AASHO H-20 bridge is located on State Route 208. It crosses the Colorado River at Robert Lee, Coke County, Texas. Two traffic lanes are carried on three continuous units, Fig. 1, over a total length of 480 ft. The 13,440 sq ft deck area, Fig. 2, had shallow surface scaling in spots, Fig. 3, and extensive isolated areas of spalling which extended below the top mat of steel in some spots, Figs. 4 and 5. Repair patches of concrete and mortar made with quick-setting cements and epoxy resins had been made from time to time, and the surface was rough. Cracking extended through the deck in some areas. The cracks were predominantly transverse, but they showed up in square patterns between beams in some locations on the bottom of the slab. Only a few longitudinal cracks were located, being difficult to see on the top surface. Those that were found were over beams.

were capable of carrying a 1 5/8 in. thick overlay without shoring during placement. A portland cement concrete resurfacing overlay was designed to provide a smooth riding surface, to seal some of the major cracks, and to add stiffness to the longer spans. Spalled areas and pot holes were to be patched prior to overlaying. The work was performed by THD District 7 personnel; TTI provided technical assistance in producing job specifications, Appendix B, furnishing advice on the job about installation procedures, and made inspections after the overlay was put into service.

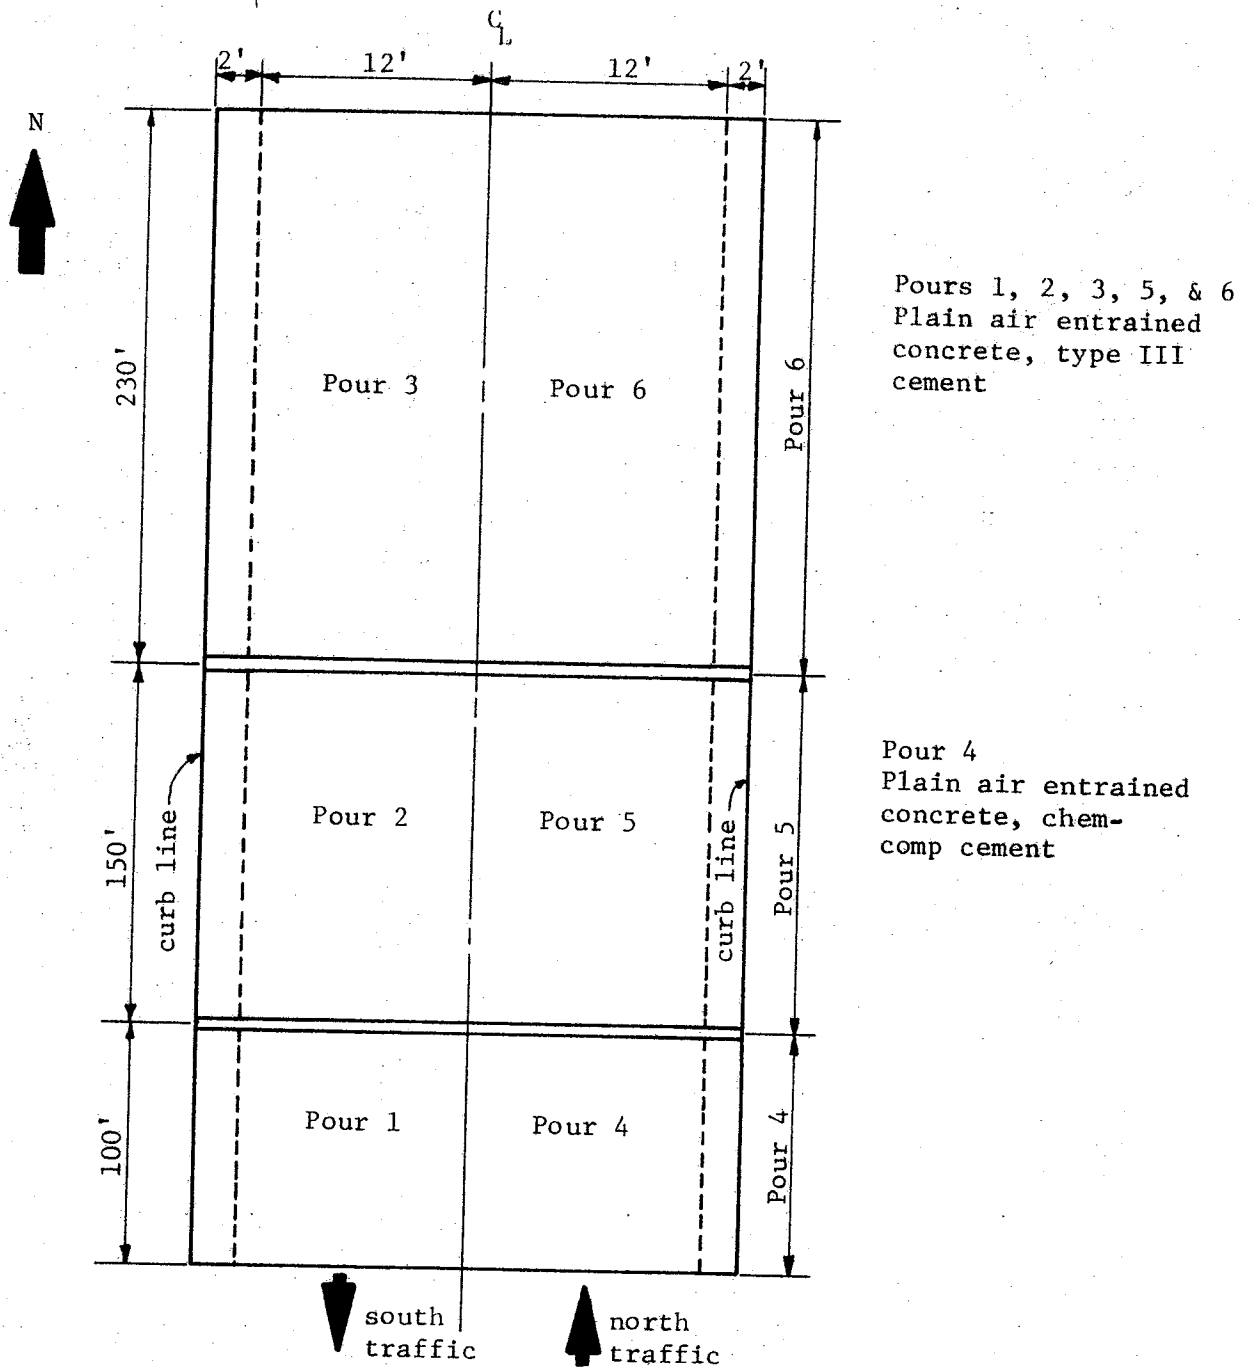
Figure 9. Schedule of Pours - Spur 179 Bridge at Robert Lee, Texas

Plastic shrinkage cracking developed over a portion, about 100 sq ft of pour 1 before curing mats were placed. Two months after the overlay was opened to traffic, an inspection of the surface revealed transverse reflective cracking over some supports, but the cracks were narrow. At that time there was no cracking found in the shrinkage compensating cement, Chem Comp, concrete, pour 4.

At four months age a check for delamination was made with the TTI delamination detector (11). One area about 12 ft square in pour 2, N-W corner by the curb line, gave signals which indicated that there were three or four small spots of delamination. That particular area was troublesome during grouting because water from the fog spray nozzles was blown to the deck by gusting winds. In a later inspection when cores were taken, the overlay in that area readily parted from the base slab revealing either no grout or a powdery material which presumably was extremely wet grout at placement.

The mix design for the overlay concrete is shown in Appendix A. Type III cement was used everywhere except for pour 4, Fig. 9, which used shrinkage compensating cement. The aggregates were from a local pit. Properties of the material are given in Table I. Mixing was done on the job site and the concrete was delivered in a front end loader. Only the vibrating screed, Fig. 10, was used for compaction. The screed was followed by wood float finishing.

Pours 1, 2, 3, and 6 were cured 7 days under wet cotton mats, and pours 4 and 5 were cured 7 days under polyethylene sheeting. The Chem Comp cement concrete, pour 4, was flushed with water beneath the membrane to provide added moisture for curing. The bridge was opened to traffic immediately after curing mats were removed. Two coats of a mixture of equal volumes of boiled linseed oil and kerosene were sprayed on the deck after it had dried four days.

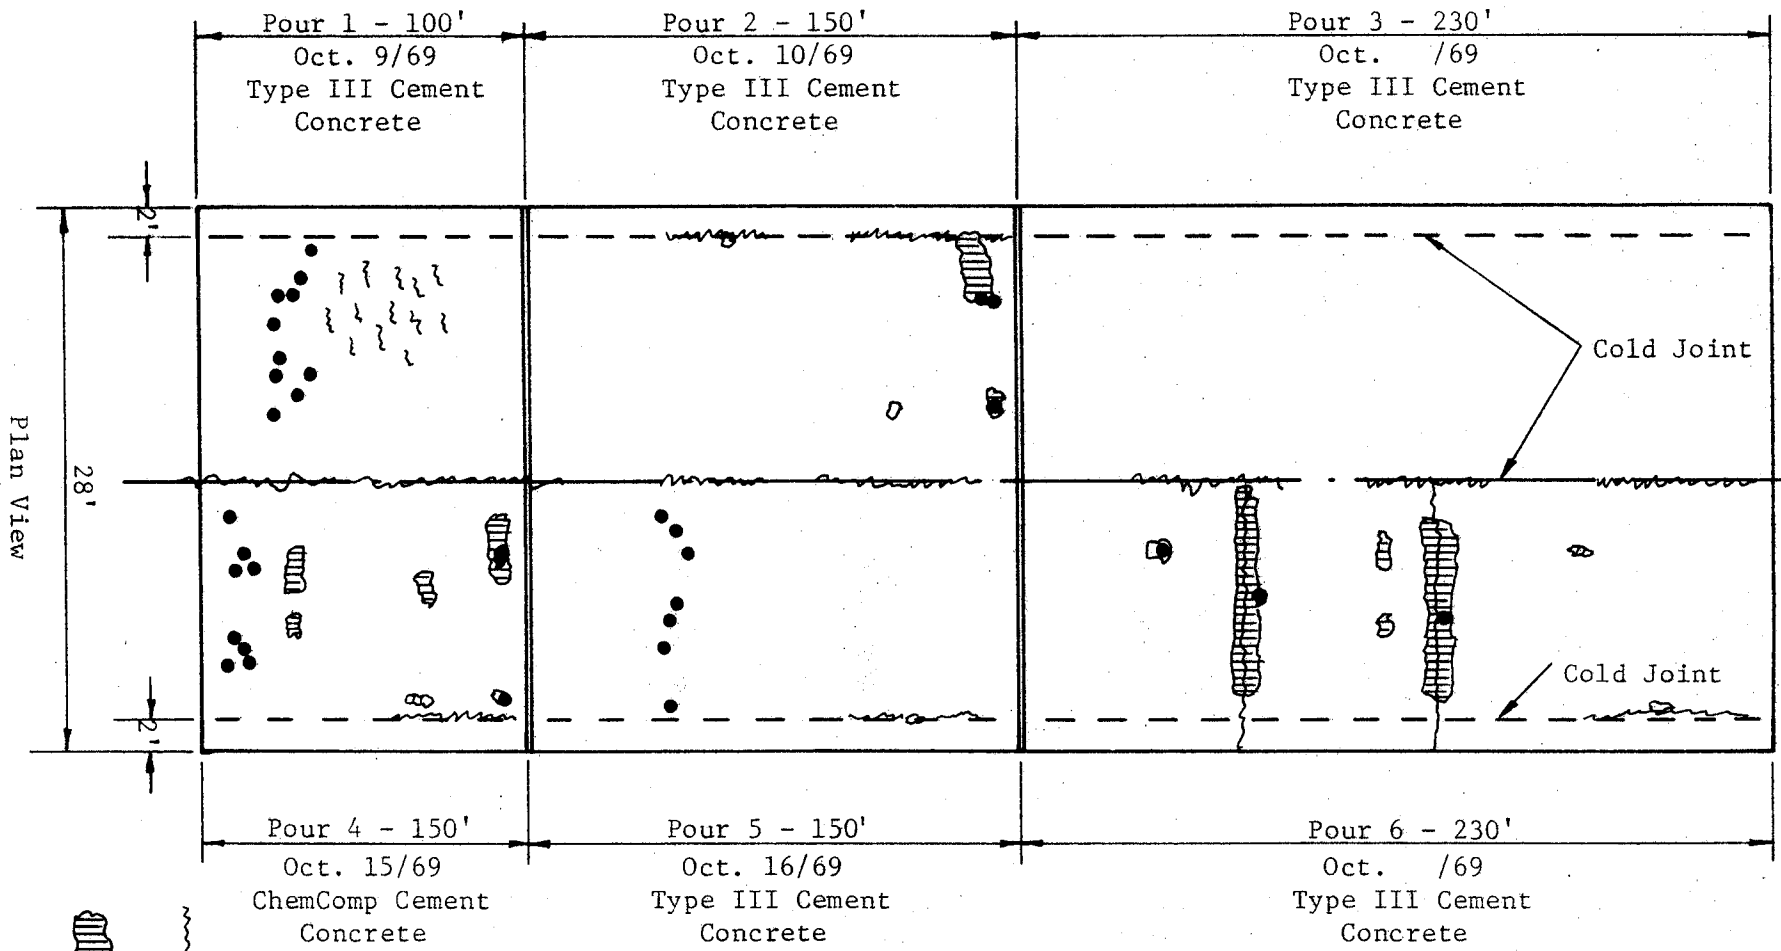
After 19 months in service, the overlay was again inspected. That inspection consisted of making a record of delamination found by the TTI delamination detector (11), visual inspection for cracks, coring to determine the condition of the overlay and base material, and pipe cap tests, Fig. 11, to determine the tensile strength of the bond between the overlay and the base material. A two-in. diameter coring bit was used for the cores and the pipe-cap tests. Fig. 12 gives general locations of cracks, delaminations, and cores.

A number of very narrow areas one ft. long were delaminated at longitudinal cold joints along the center of the roadway and two ft. from each curb. Two delaminated areas about 3 in. to 6 in. wide extended almost the full width of the 12 ft wide pour number 6. Both lay along transverse cracks in the overlay, one being reflected from a construction joint in the deck, and the other from a full depth crack. The delaminated area in pour 2, found in the earlier inspection, appeared to be about the same size as it was when discovered. Six small

areas of delamination were found in pour 4, the first trouble that had been found in the shrinkage compensating cement material.

Aside from the plastic shrinkage cracking in pour 2, referred to earlier, most of the cracks were reflected from old deck cracking or they occurred along cold joints. About the same pattern of cracking was found during this 19 month survey as was found about 3 months after the overlay was placed. There were more visible cracks in areas where cracks were evident in the bottom of the slab and cracks at cold joints were wider.

Eight cores were taken to determine the condition of the original deck and the overlay concrete. All were taken from areas where delamination was indicated by the detector or from an area over cracked concrete. All of these cores, except one, broke at the bond line.

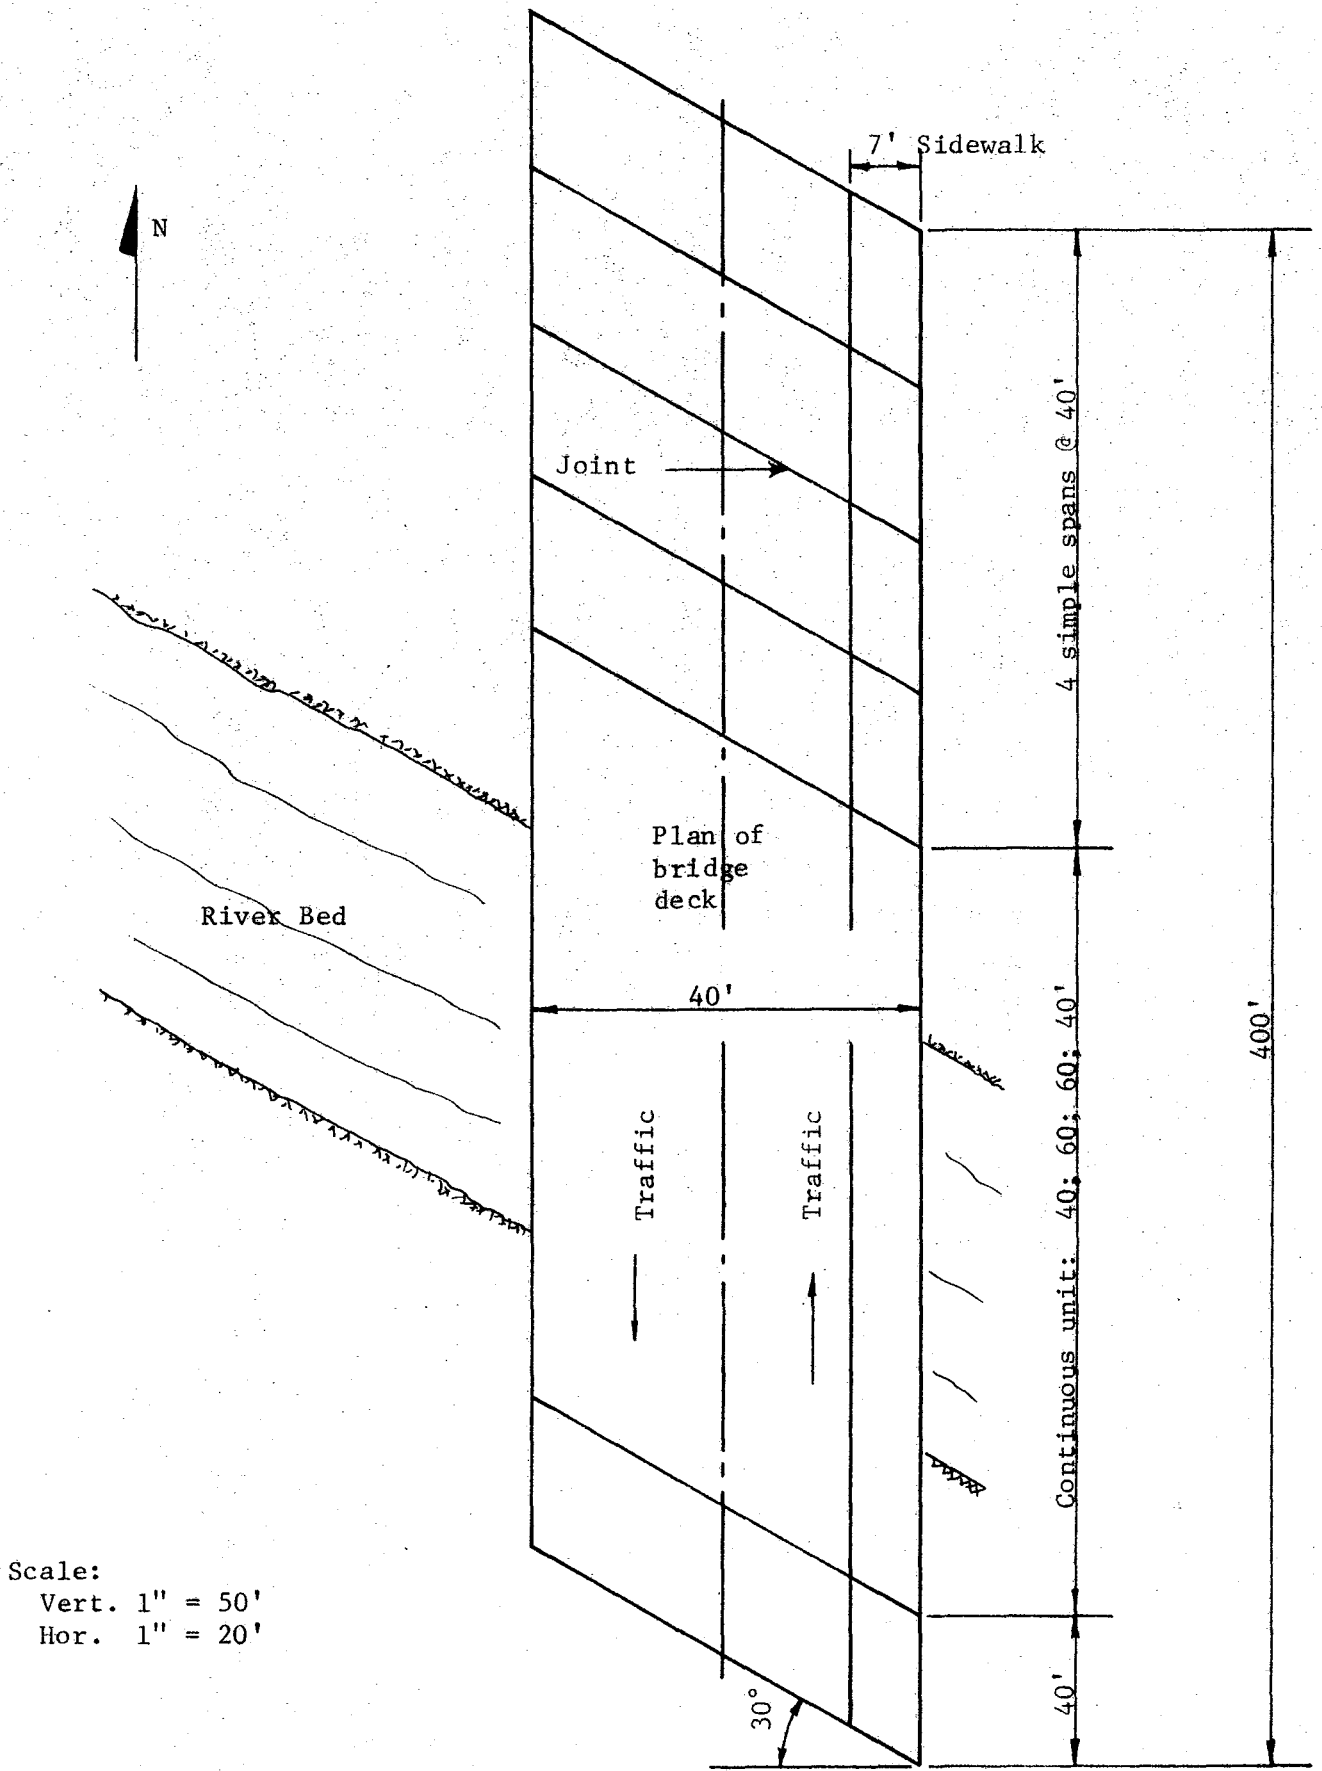
Figure 13. Bosque River bridge, Spur 179, Stephenville, Texas.

This 23-year-old AASHO 20-44 bridge is located at Stephenville, Texas in Erath County. It carries spur 179 across the Bosque River on the outskirts of Stephenville. The bridge is 400 ft long and 40 ft wide with two traffic lanes and a sidewalk. There are five simple I-beam spans 40 ft long and one continuous I-beam unit with 4 spans of 40, 60, 60, and 40 ft. The plan is shown in Fig. 13. In addition to busy passenger vehicle traffic, it carries trucks with farm and ranch supplies and produce as well as local business freight.

Isolated spalls, Fig. 14, have been patched from time to time, and two full depth deck replacement patches of Fast-Fix<sup>1</sup> concrete were made just prior to the overlay repair. Transverse cracks extending through the deck were present in a number of places. Two areas of checkerboard cracks were visible on the bottom of the deck between the steel I-beams, but this cracking was not considered to be serious enough to replace that part of the deck.

maintenance personnel to provide stiffness over cracked portions, to fill in spalled areas, and to provide a smooth riding surface. The deck was prepared and the grout was placed by THD District 2 personnel, the overlay was placed and finished by contract and it was cured by THD personnel. TTI provided technical assistance in preparing specifications, Appendix C, and in periodic inspections of the finished overlay.

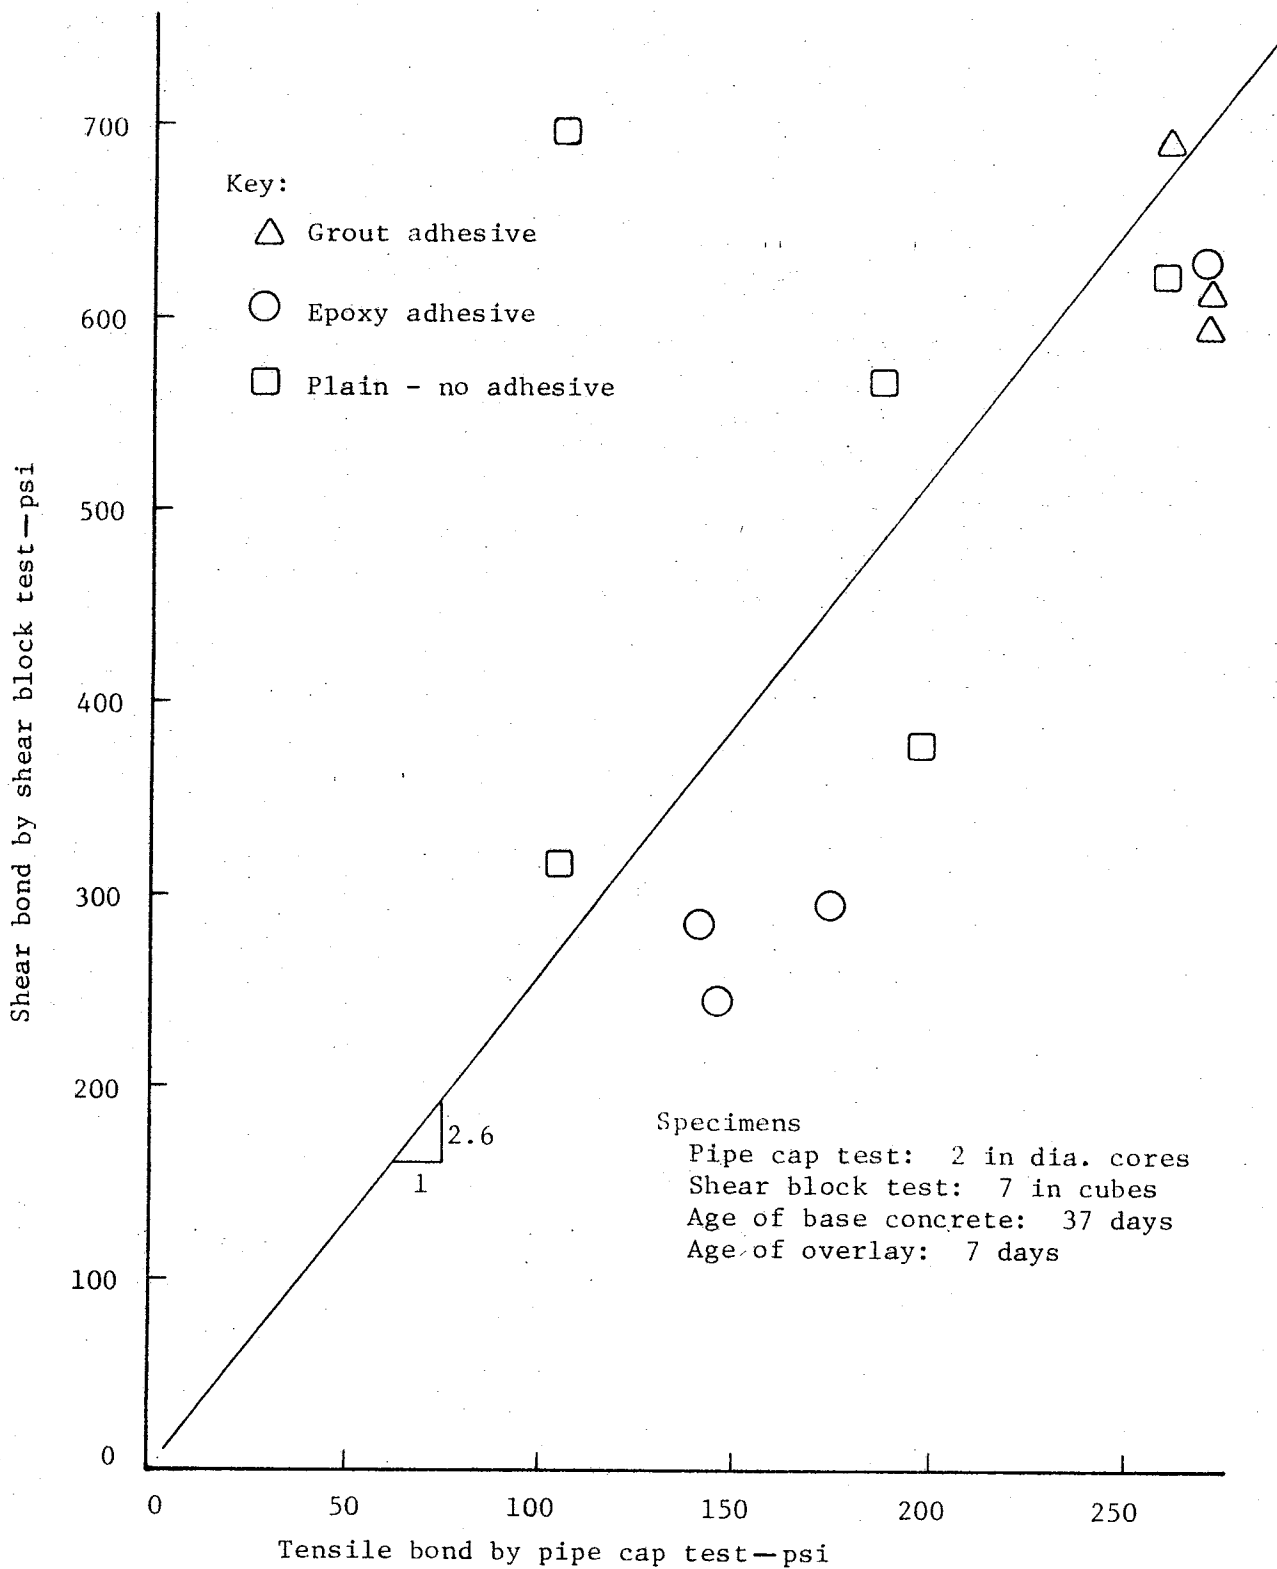
Figure 20. Relationship between tensile bond (pipe cap test) and shear bond (shear block test) for overlays bonded to laboratory specimens.

In order to get information with which shear bond and tensile bond could be compared, tests were made on laboratory specimens. Identical cubes, 7 in. on a side, were prepared by sand-blasting the top surface. Six of these were grouted and overlaid with concrete, another set of 6 were overlaid with concrete without grout, and the third set of 6 specimens were overlaid with concrete applied to epoxy adhesive. At 7-day age two in. pipe cap tensile bond tests were made on 3 of each set and shear bond tests (13) were made on 3 of each set. The bond strength of each specimen is given in Table VI and a plot of the values is shown in Fig. 20. The linear curve through the plotted points shows that the shear bond strength is about 2.5 times the tensile bond strength for these particular specimens. This particular ratio would not be valid for all bonded overlays, but it gives a rough idea of relative values. From it one can see that a tensile bond at about 75 psi is roughly equivalent to a shear bond strength of 200 psi in these specimens. A tensile bond of approximately 25 psi will be adequate to develop the nominal 64 psi required (10) for traffic induced shear.
