1. Report No. TX-92/1313-1F		2. Government Accession No.		3. Recipient's Catalog No.	
4. Title and Subtitle Evaluation and Repair of Fatigue Damage to Midland County Bridges				5. Report Date October, 1992

Evaluation and Repair  
of  
Fatigue Damage  
to  
Midland County Bridges

Final Report

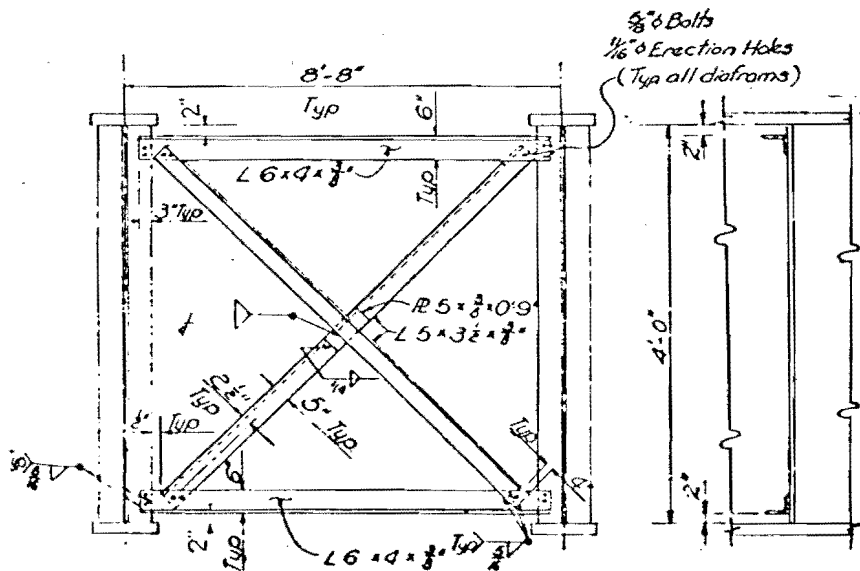
Figure 1-5: Type B diaphragm detail.

Examination of Figs. 1-5 and 1-6 show that the ends of the diaphragm diagonal members are welded to either the upper or lower struts. This type of connection provided a convenient means of attaching the diagonals without the use of a gusset plate. However, this resulted in diagonal member forces no longer being concentric and is the primary reason for the growth of fatigue cracks in the diaphragm members.

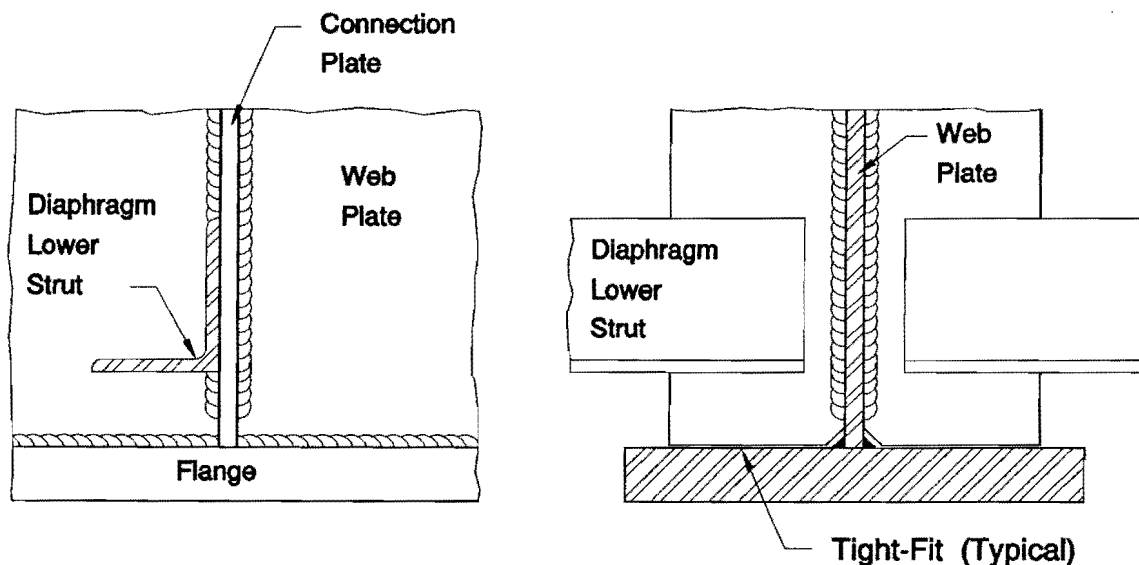
Figure 1-7: Connection plate detail (tight-fit) for original construction.

As was a common practice during the 1960s, the ends of the connection plates were not rigidly attached to the girder tension flanges. Instead, a tight fit detail was called for in the original design drawings and is shown schematically in Fig. 1-7. This provided an unstiffened web gap susceptible to distortion-induced fatigue [3]. The ends of the connection plates were welded to the girder compression flanges.

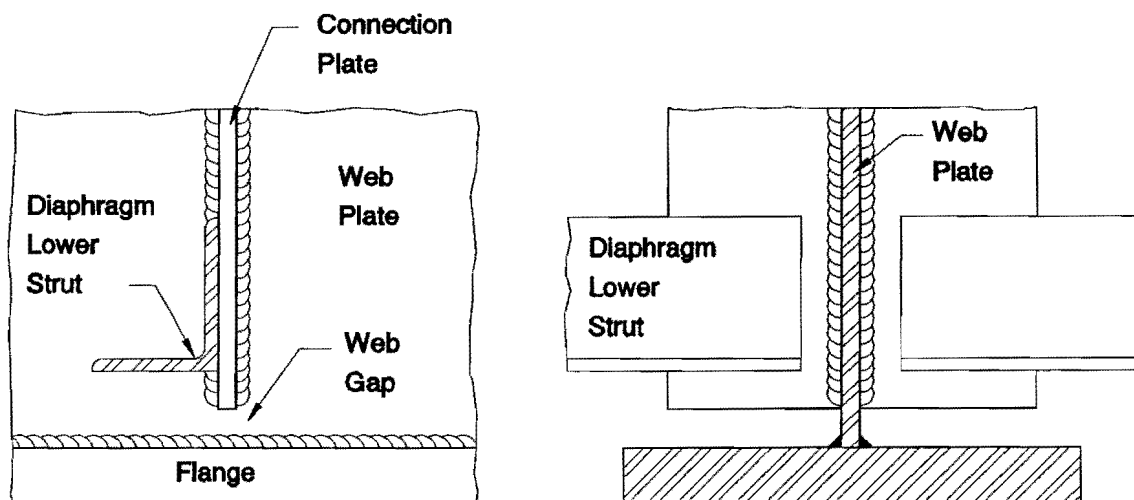
Figure 1-9: Connection plate detail for new construction.

Similar to the original design, the ends of the connection plates were not rigidly attached to the tension flanges. However, the new construction utilized a one-inch web gap instead of the tight-fit detail as shown in Fig. 1-9.

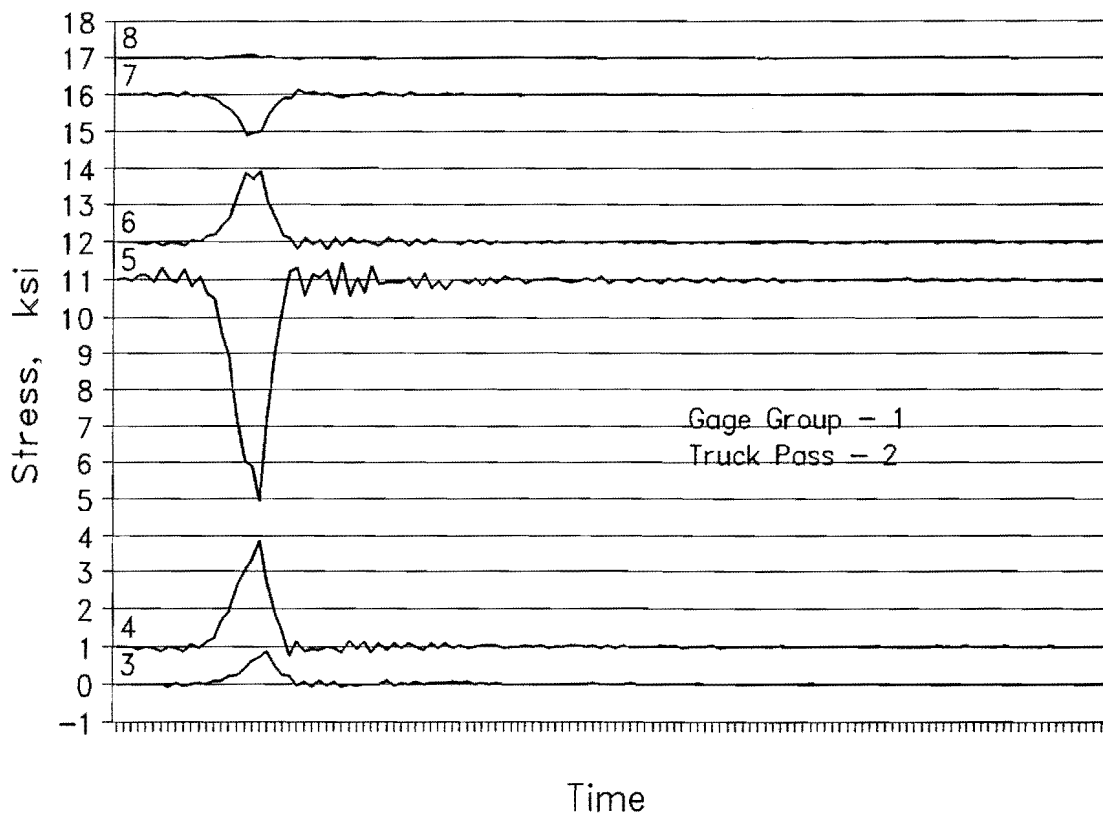
Figure 3-6: Diaphragm D-40 member stress histories for Gage Group 1, Truck Pass 2 (test truck centered in driving lane).

stresses obtained for Gage Nos. 4 and 5 which show the effect of the eccentric connection between the diagonal and lower strut. A measured diagonal force of 6.4 kips resulted in a bending stress range of 6.6 ksi. near the top of the lower strut. The vertical fillet weld that attaches the strut to the connection plate can be classified as an AASHTO Category D detail with a corresponding fatigue limit of 7 ksi. Therefore, any truck weight above that of the test truck (greater than 43 kips) is likely to initiate fatigue crack propagation. A truck loaded to the legal weight limit would result in a stress range approximately double that of the test truck.

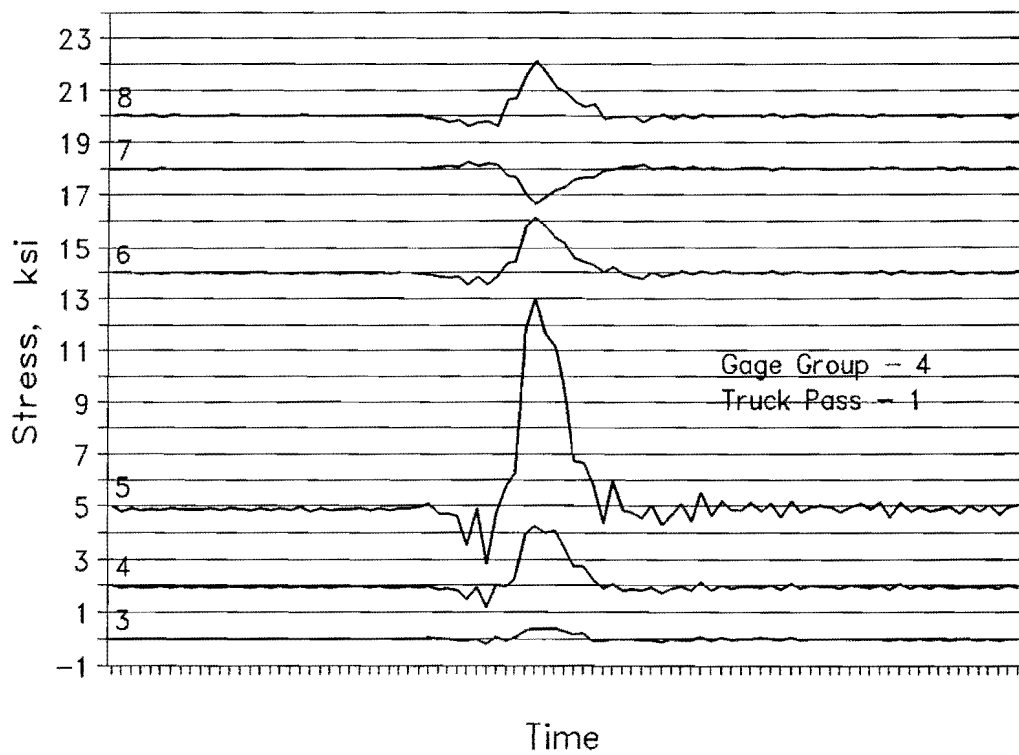
Figure 3-12: Diaphragm D-43 member stress histories for Gage Group 4, Truck Pass 1 (test truck centered in driving lane).

Gage Numbers 4 and 5 of Gage Group 4 were placed on the lower strut between the diagonal and connection plate to measure the bending stress caused by the eccentric diagonal connection. For a 7.9 kip tensile axial force in the diagonal, a maximum bending stress range of 10.2 ksi was measured. as shown in Fig. 3-12. Higher stresses were recorded for other truck positions. For example, when the test truck was positioned in the right shoulder lane, a stress range of 12 ksi was measured. The truck position places the truck directly above the instrumented diaphragm in Bay D. (See Figs. B-23 through B-27 for stress histories of other test truck positions.)

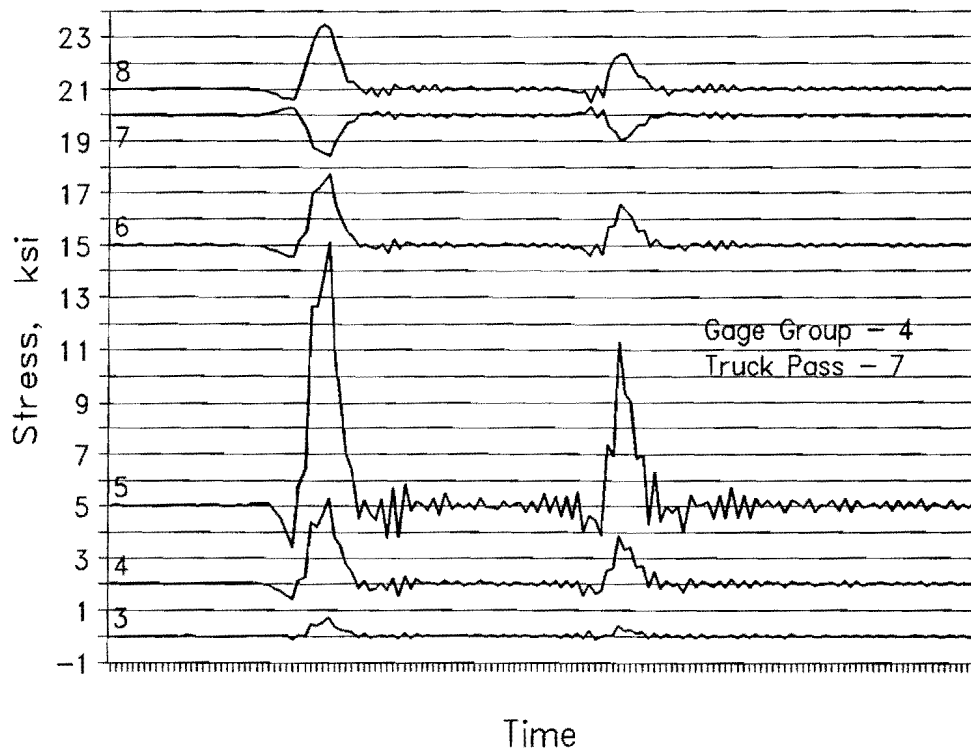
**Figure 3-13:** Diaphragm D-43 member stress histories for Gage Group 4, Truck Pass 7 (two tractor trailer trucks centered in driving lane).

Stress histories were measured for two tractor trailer trucks in the driving lane of unknown weights with this gage group as shown in Fig. 3-13. A maximum stress range of 11.7 ksi was measured for Gage No. 5.

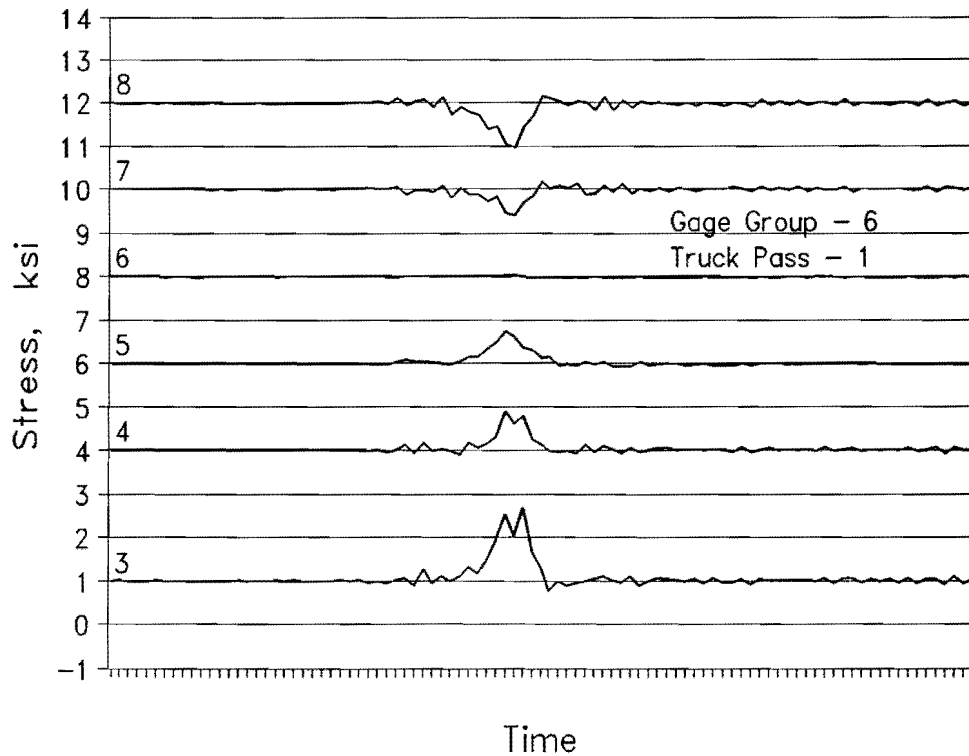
**Figure 3-15:** Diaphragm C-39 member stress histories for Gage Group 6, Truck Pass 1 (test truck centered in driving lane).

Similar to the Type C diaphragm located in the negative moment region, no stress was recorded in the upper strut (see Fig. 3-15). While the maximum bending stress of the eccentric diagonal connection was relatively low (1.2 ksi), the finite element analysis indicated that higher diaphragm member forces occurred at other diaphragm locations. (See Figs. B-35 through B-39 for other truck positions.)

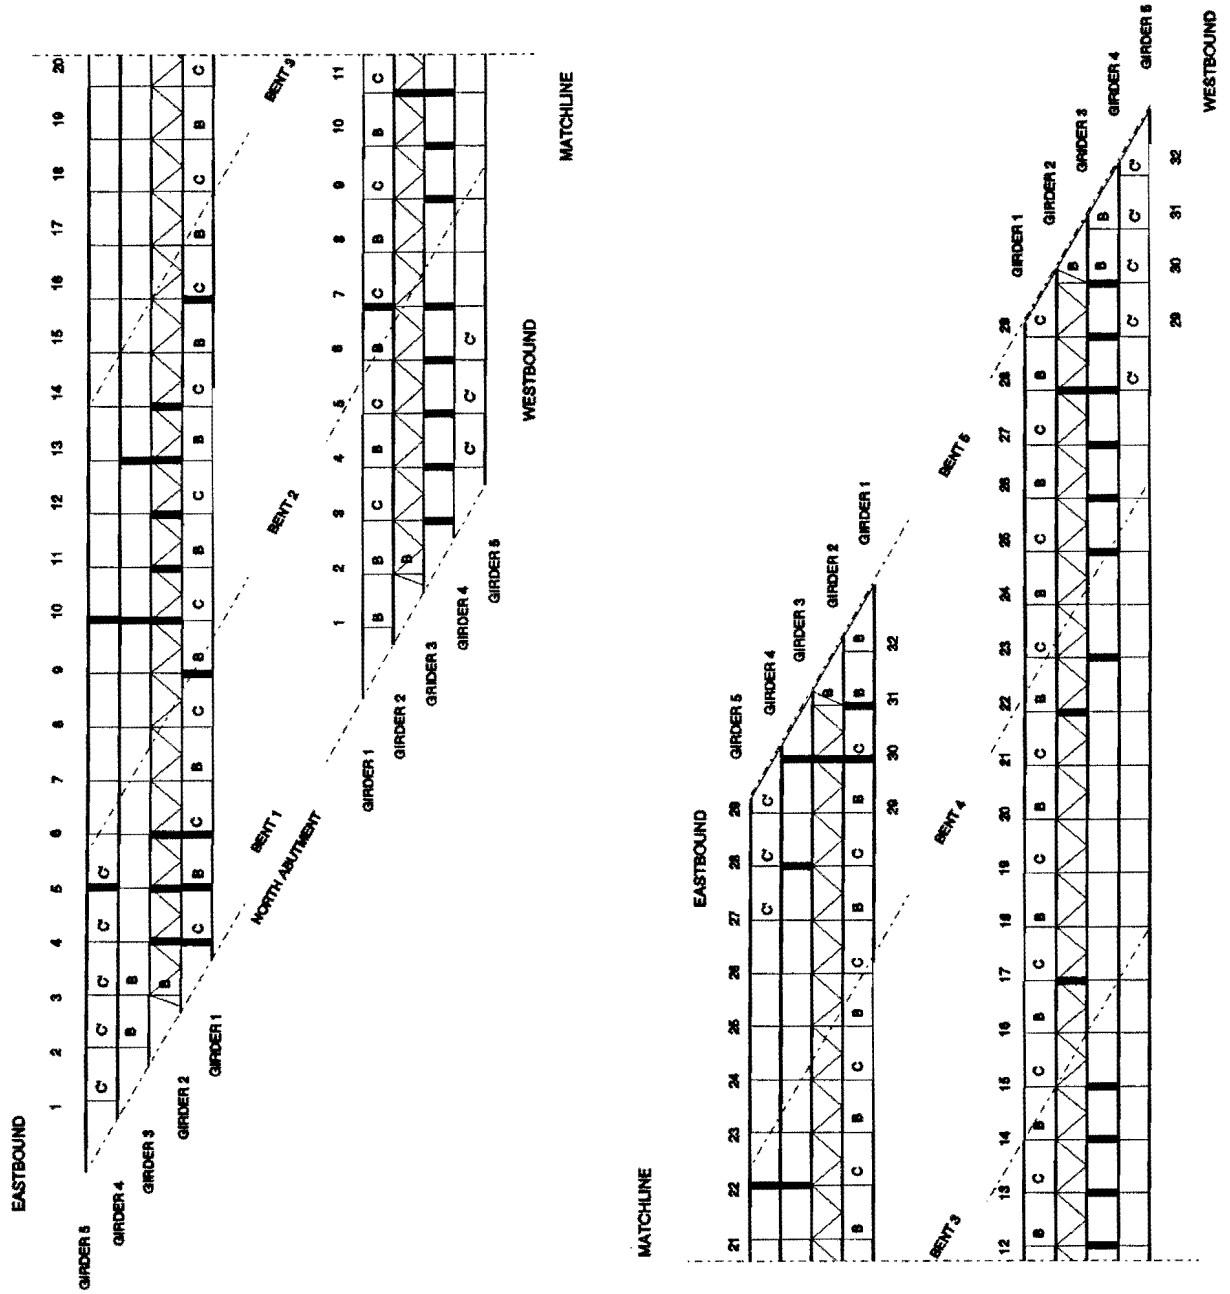
Figure A-11: All diaphragm member cracking, North Structures.

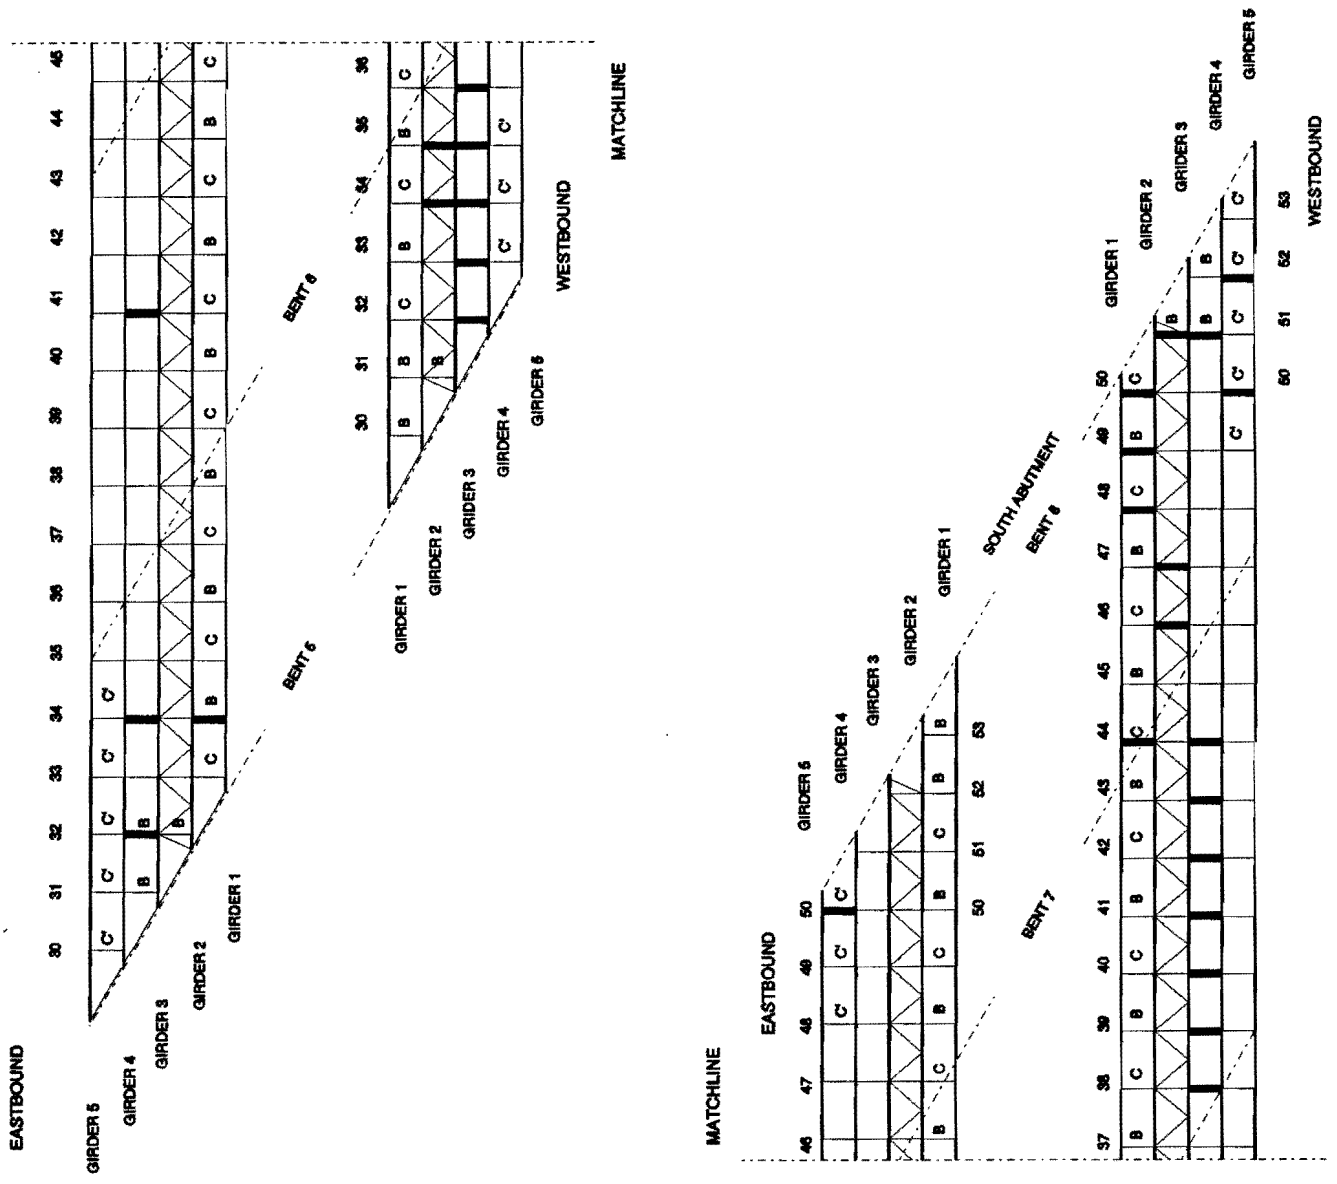
Figure A-12: All diaphragm member cracking, South Structures.

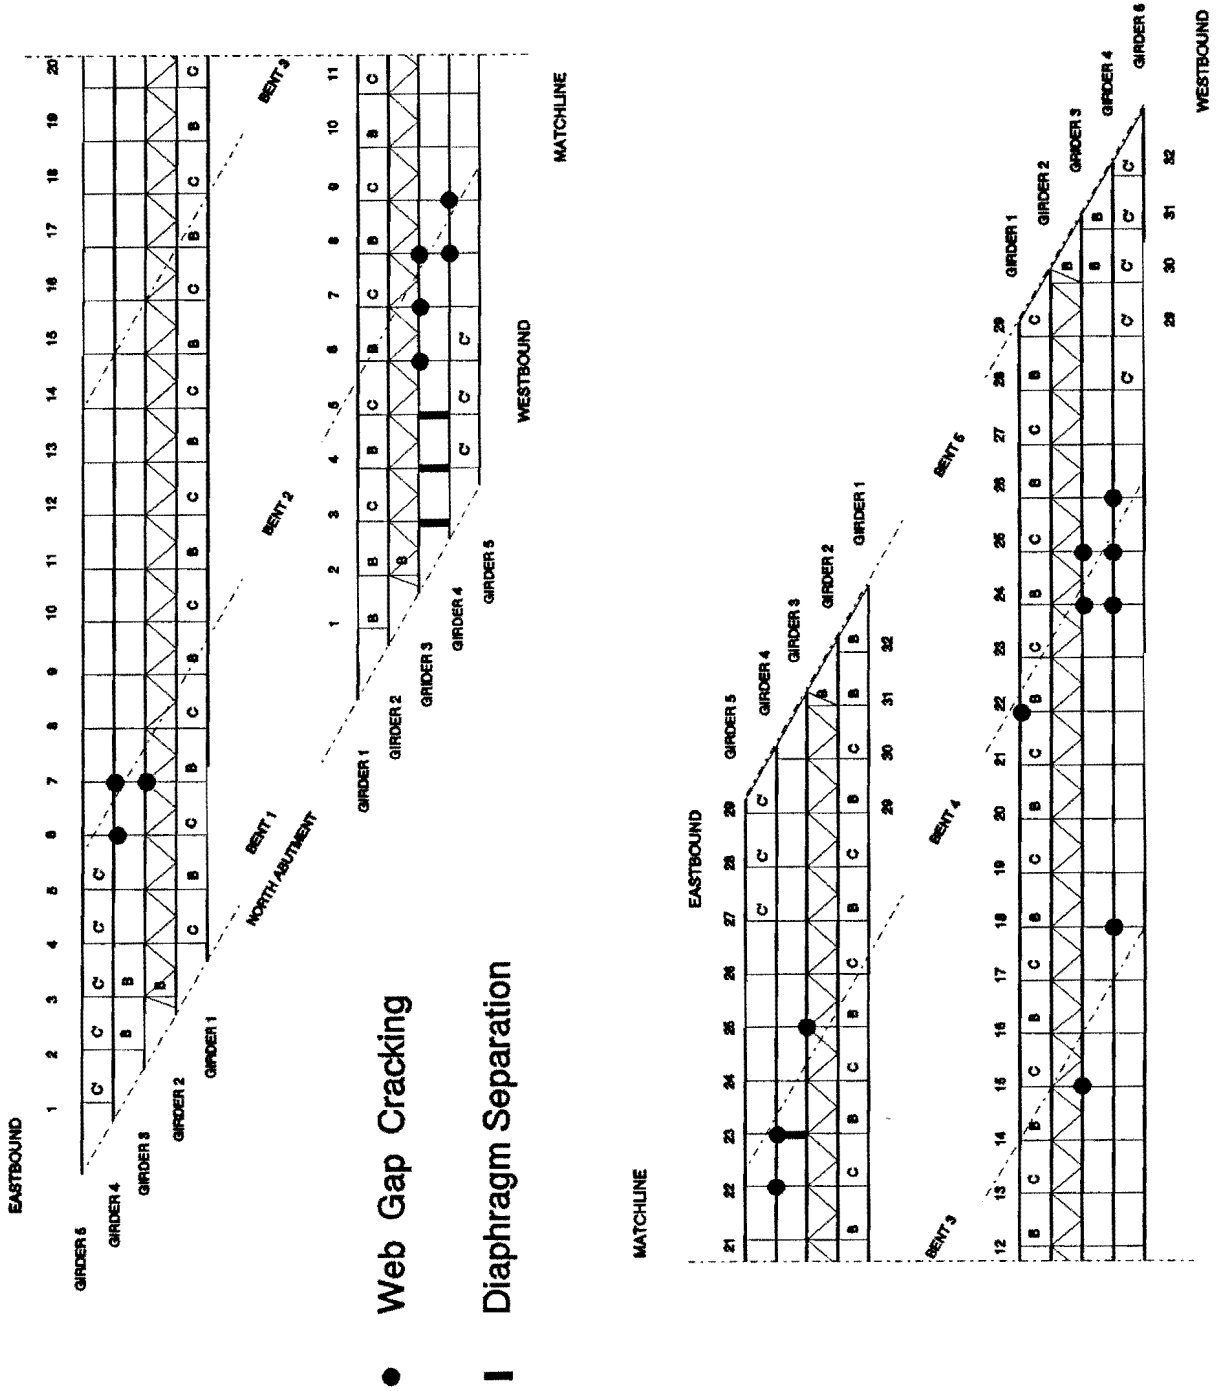
Figure A-13: 1983 repair locations, North Structures.

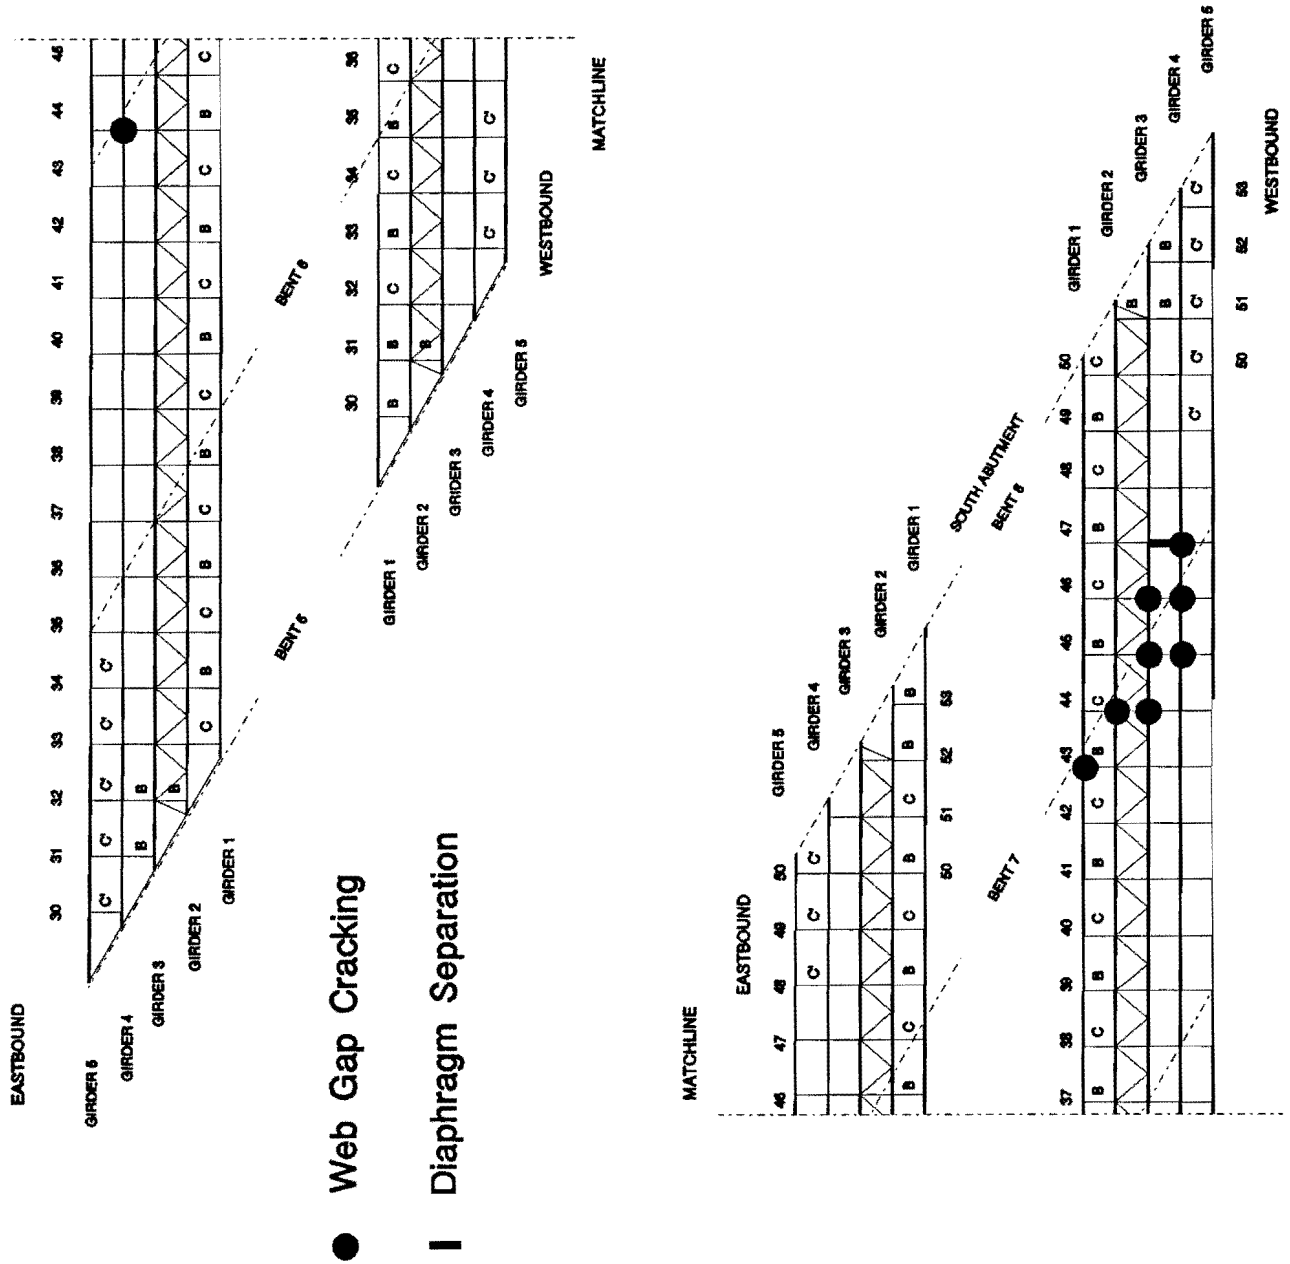
Figure A-14: 1983 repair locations, South Structures.

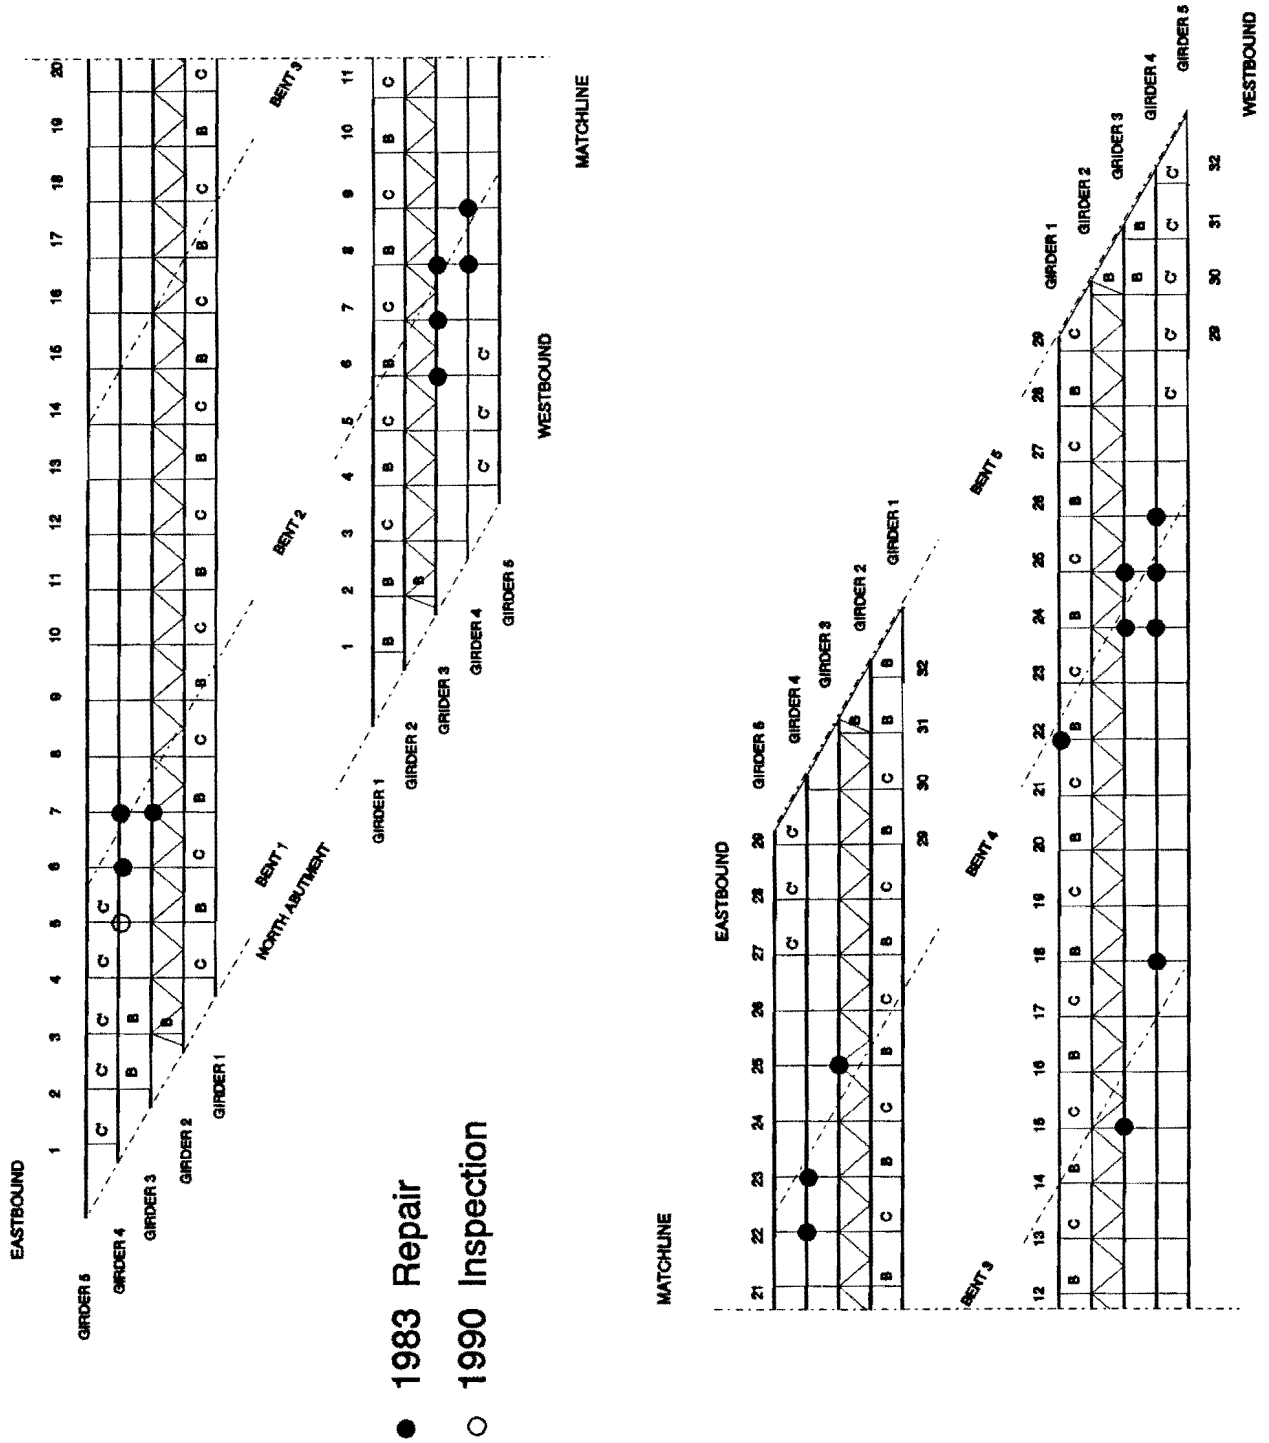
Figure A-15: All Type A2 cracking, North Structures.

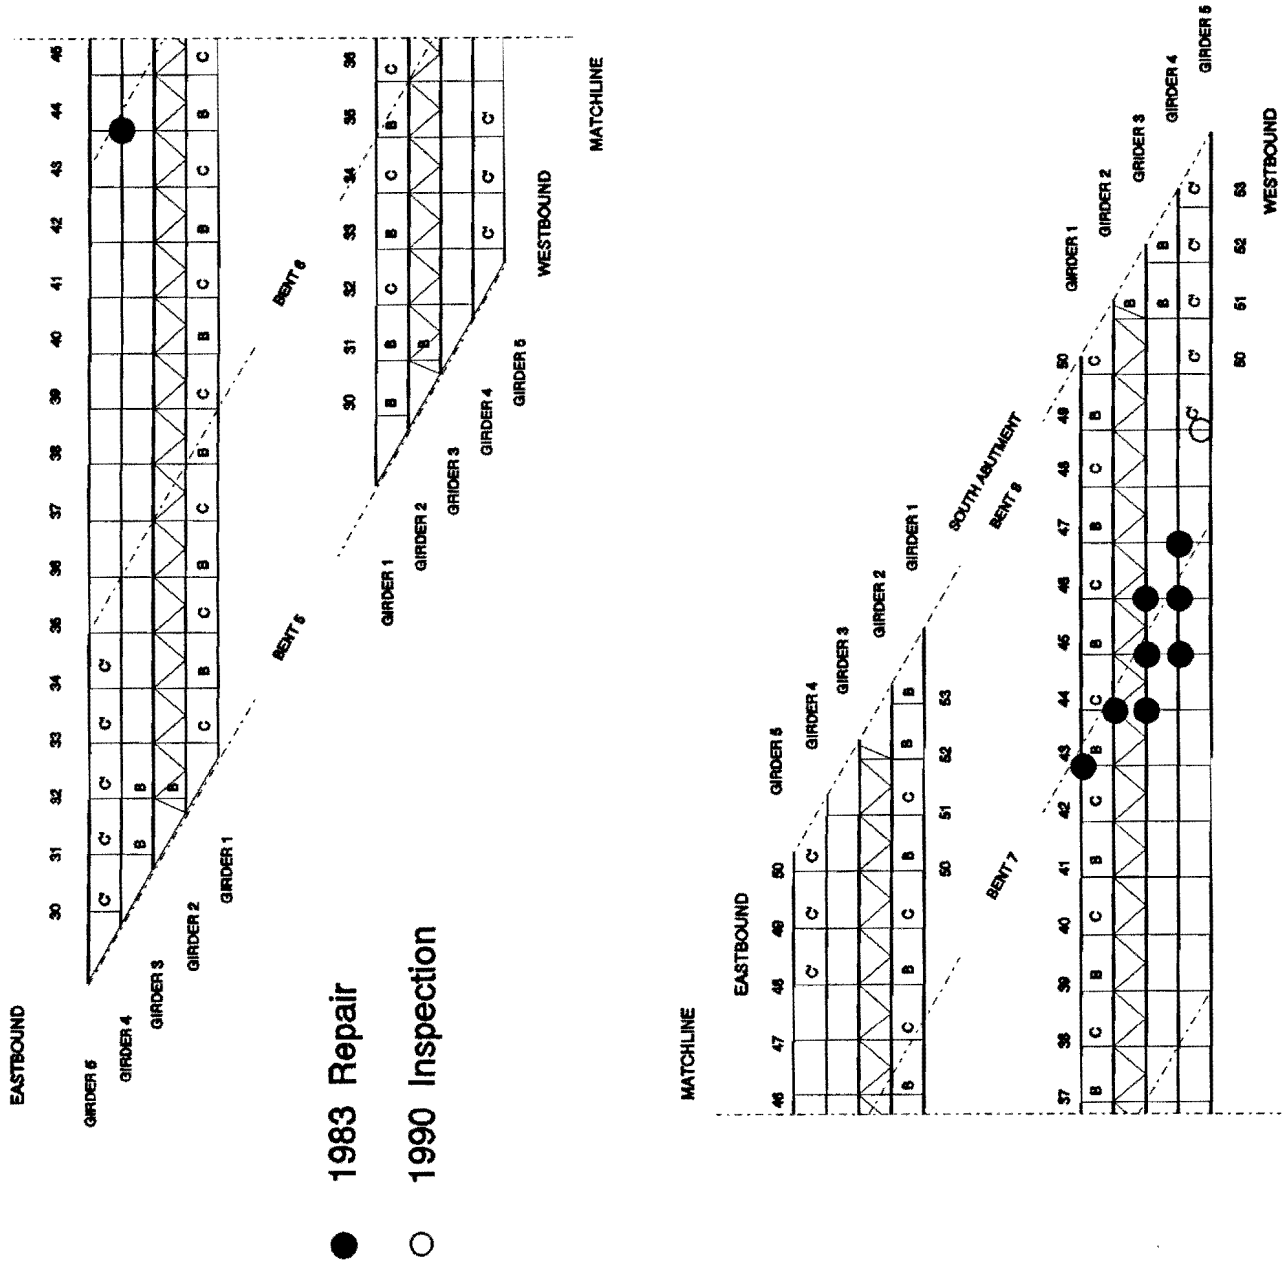
Figure A-16: All Type A2 cracking, South Structures.

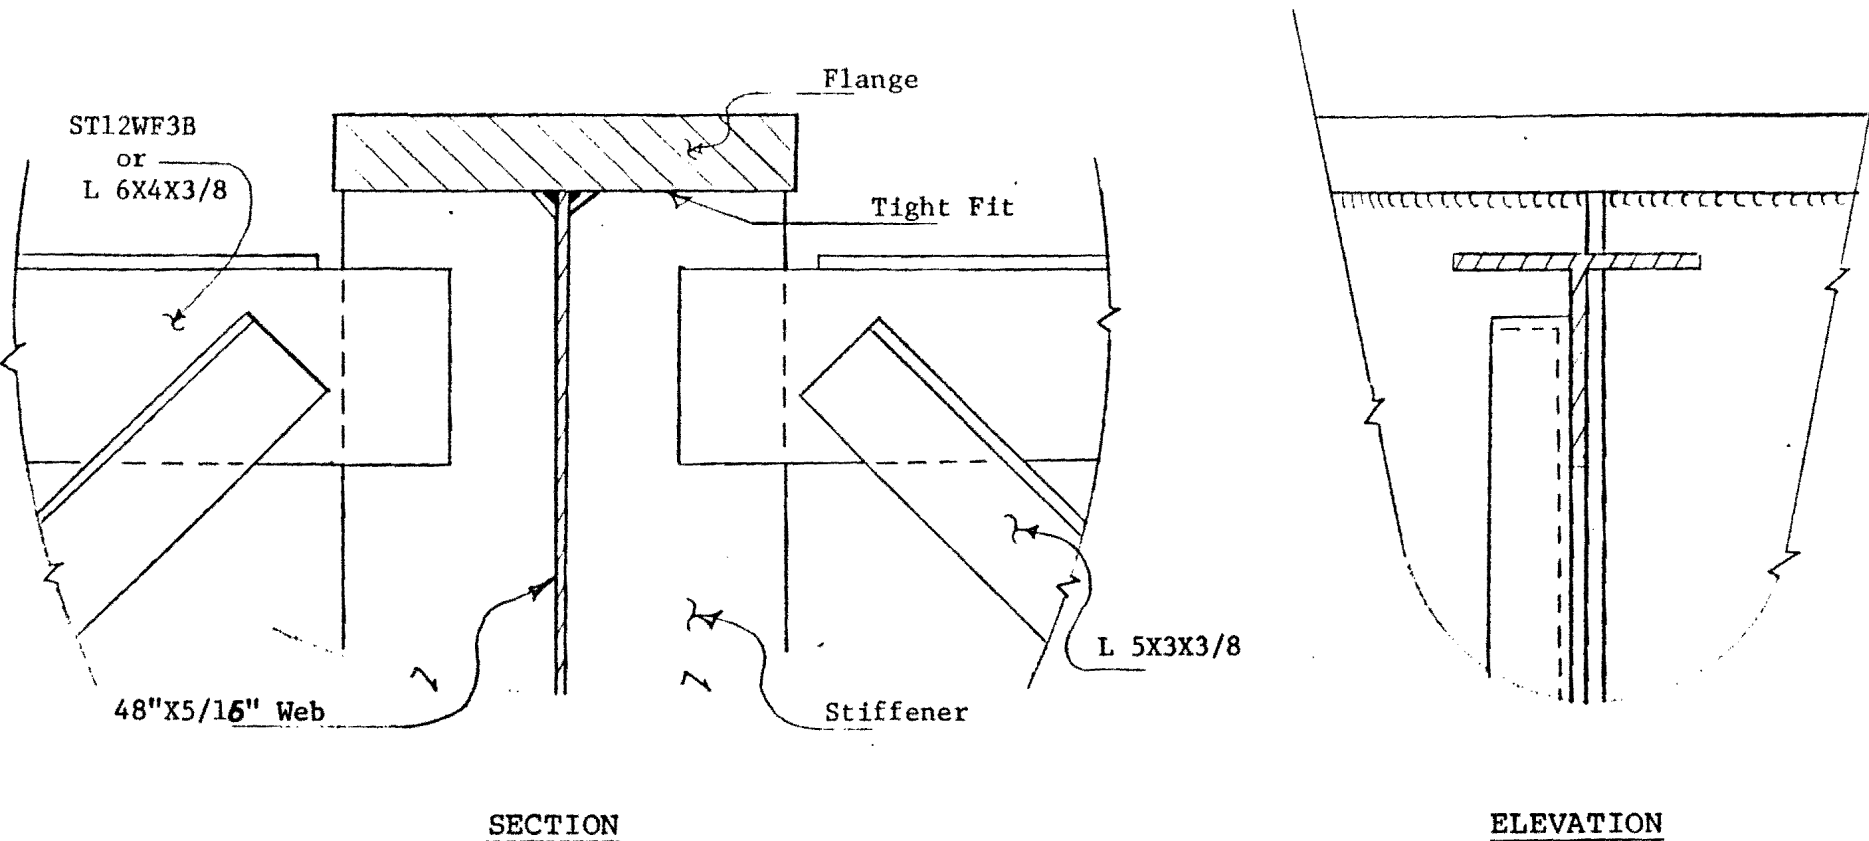
SKETCH OF TYPICAL STIFFENER AND DIAFRAM CONNECTION

The concentration of the cracking problem adjacent to the skewed bents, the rigid diafram design, welding details for stiffeners, and crack location above the stiffeners all suggested that out of plane bending was the major cause of the cracking.

REPAIR PROCEDURES:

1. Drill 3/4" diameter holes through web and fillet weld beyond end of crack.
2. Gouge out crack in one side of web and fill with low hydrogen filler metal and grind smooth.
3. Weld web stiffener to top flange.
4. Repeat Steps 2 and 3 on opposite side.
5. If no crack is noted, weld web stiffeners to top flange of diaframs that are within 20' of the interior bearings.
6. Preheat to above 70°F and maintain while welding.
7. Paint steel at repair areas with System I-Aluminum.

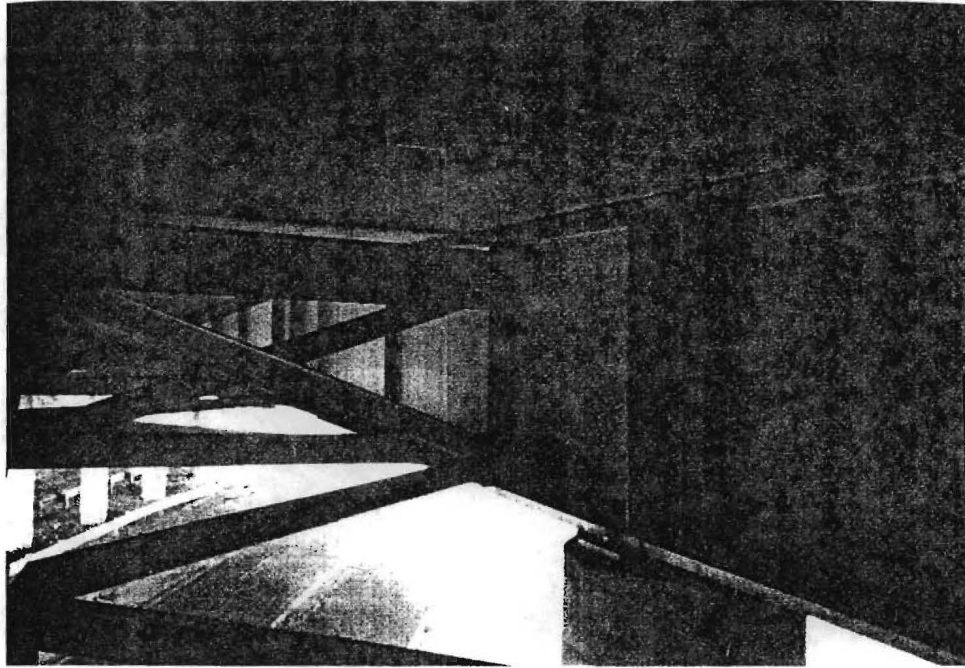
TYPICAL DIAFRAMS AND STIFFENERS

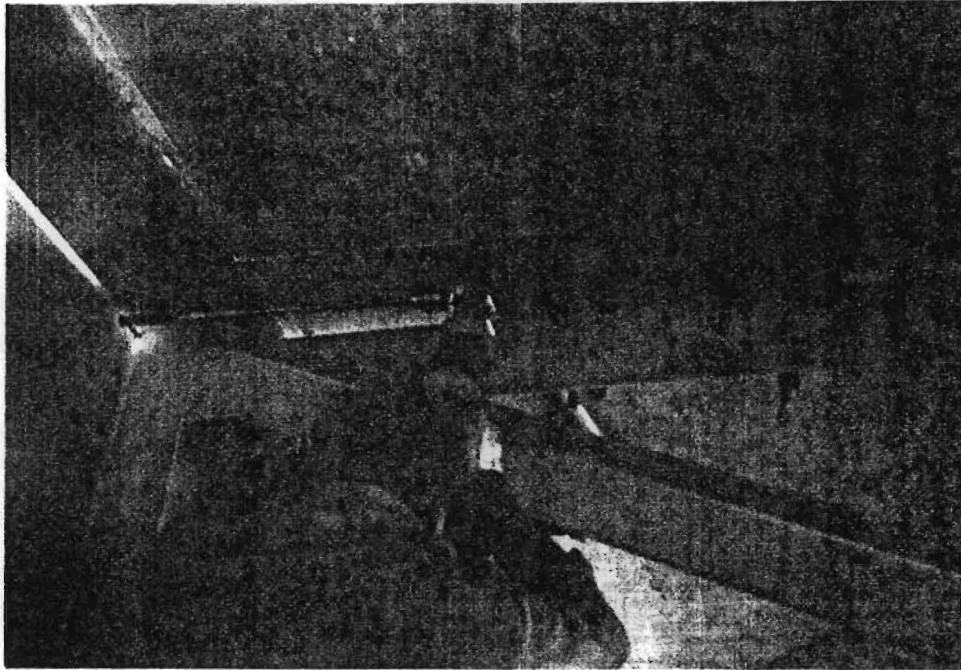
DRILL OPERATION USING RIGHT ANGLE DRILL

After trying several pieces of drilling equipment, the crew selected a right angle drill and bit extension as the best combination to allow proper placement of the bit. Drilling pressure was supplied by a wooden lever system blocked off of the diafram. Finished holes were given a close visual inspection to assure that the crack tip was removed.

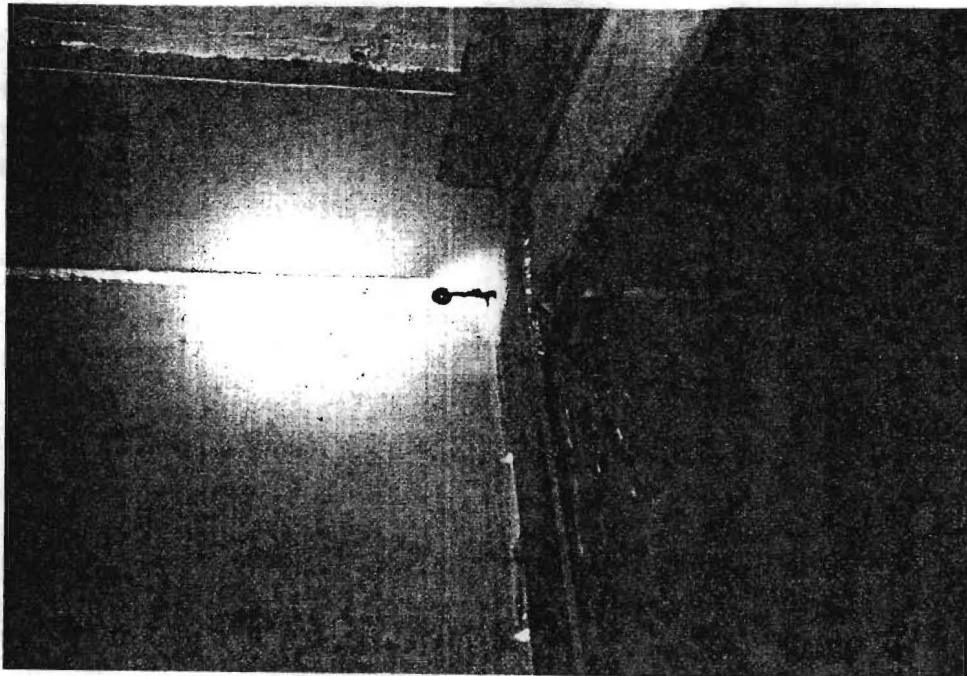
COMPLETED 3/4" HOLE

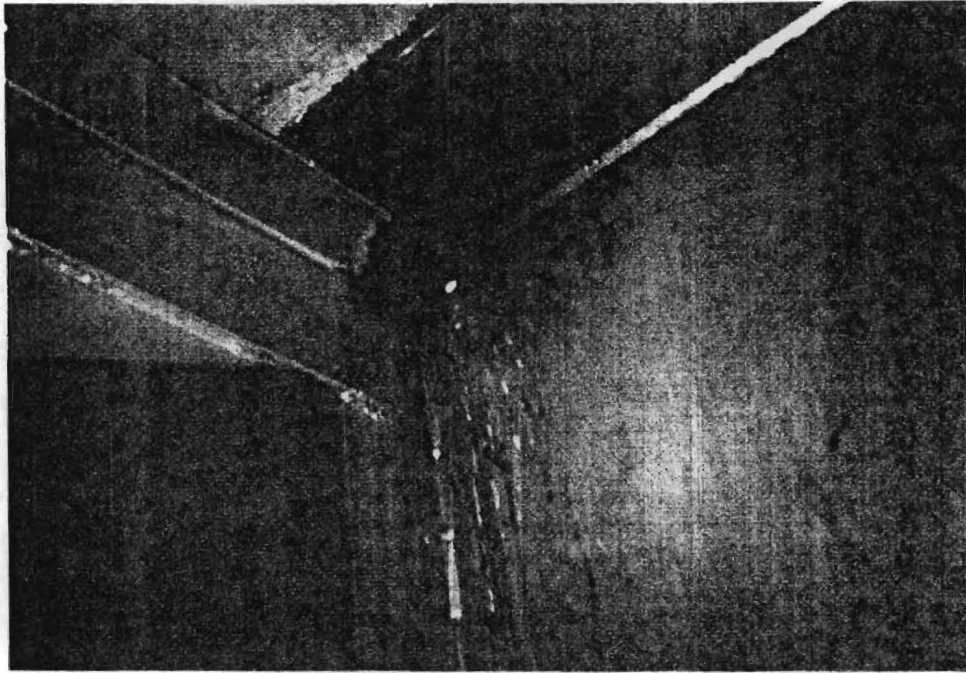
CLIPPED CORNER OF DIAFRAM ANGLE TO  
ALLOW ACCESS FOR WELDING

With the crack stopped and bounded by holes, the repair and retrofit could begin. Next, corners from the top horizontal member of the diafram were flame cut to improve working room, the crack was back gouged, the groove welded between holes, stiffeners were welded to the top flange, and, finally, the area was cleaned and painted.
