1. Report No. FHWA/TX-97/1360-1		2. Government Accession No.		3. Recipient's Catalog No.	
4. Title and Subtitle EVALUATION OF REPAIR PROCEDURES FOR WEB GAP FATIGUE DAMAGE				5. Report Date September 1996

EVALUATION OF REPAIR PROCEDURES FOR WEB GAP FATIGUE DAMAGE

Research Report 1360-1
Research Study Number 0-1360
Research Study Title: Repair Procedures for Fatigue Damage in
Steel Highway Bridges

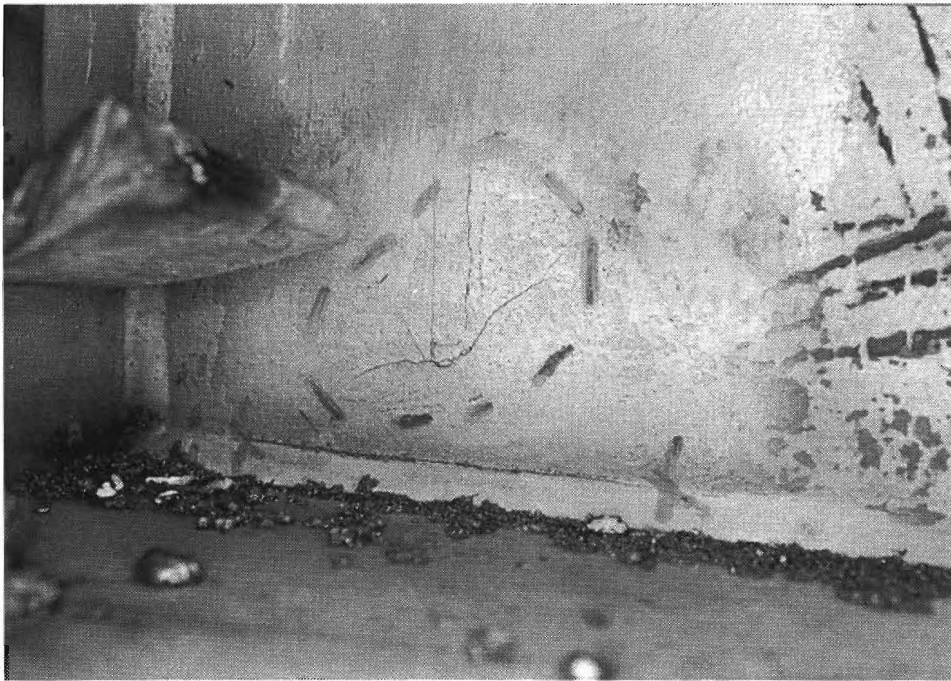
Figure 2-9: Location and marking of the cracked area.

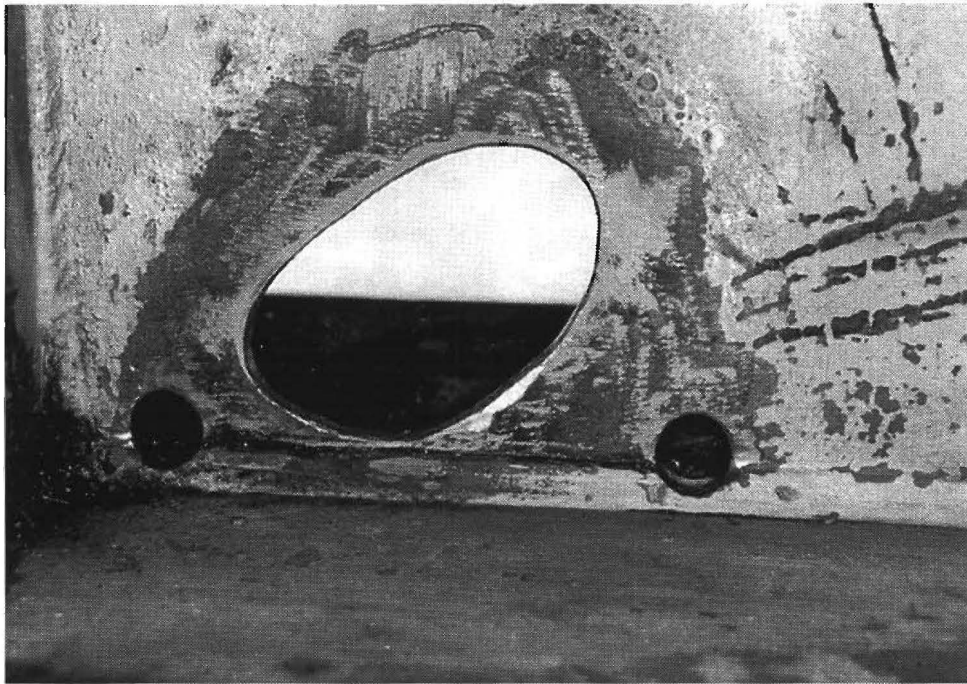
Figure 2-12: Web after initial repairs.

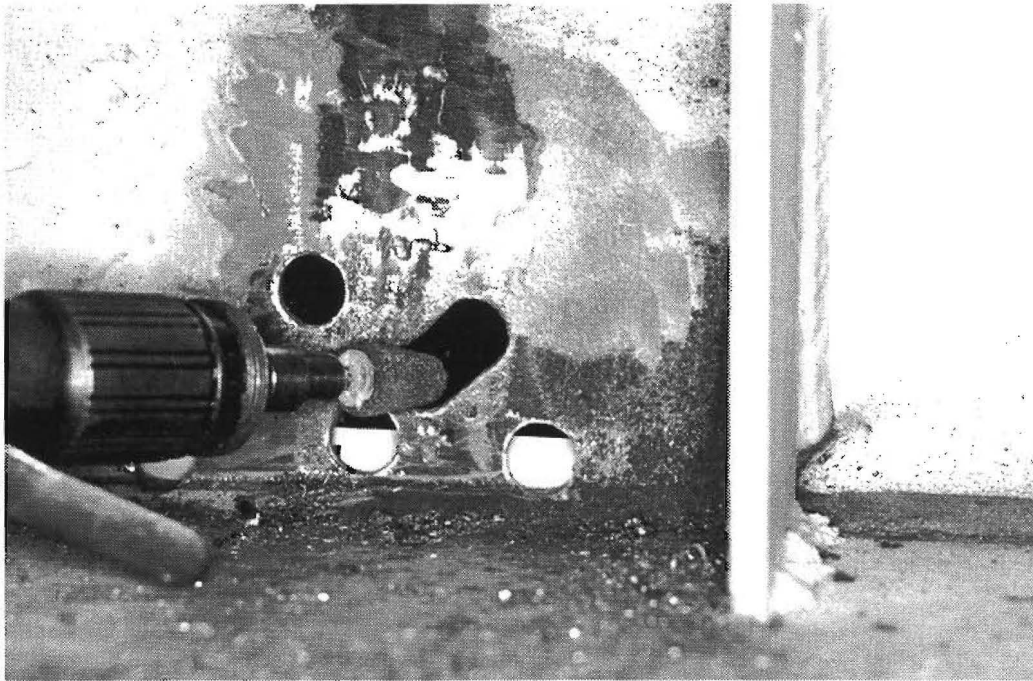
Figure 2-20: Repaired web section after hole-slotted.

Once all holes are drilled to their final diameter, both sides of the web plate should be ground smooth using a rotary grinder to remove any burrs from the drilling operation. Each hole should then be ground smooth using a die or rotary burr grinder, one of which is shown in Fig. 2-20. Once all the grinding is complete, a final dye penetrant inspection should be performed to insure that all cracks have been arrested.

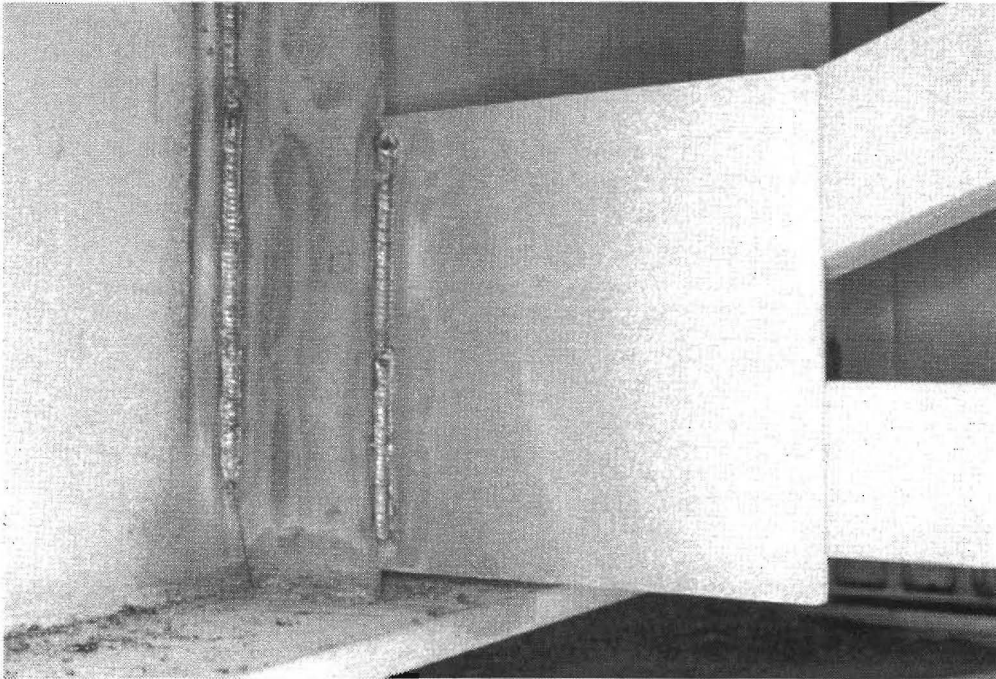
Figure 2-24: View of replacement cross-frame diaphragm with welded connection plate.

In addition to the web-gap fatigue crack repairs, additional repair methods were used during the contract that could influence the fatigue life of the structure. This involved the field welding of the existing connection plates to the flange. This operation was performed at locations where new cross-frame diaphragms were re-installed. Figure 2-24 shows a replacement cross frame and connection plate. Again, concern is with the quality of the field welding. Since the connection plate was not originally attached to avoid a tension flange weldment, welding it now would result in a fatigue-sensitive detail. If the connection plate end termination was a tight-fit detail, it would not be possible to thoroughly clean the gap between the end of the connection and the flange surface. Any impurity could affect weld metal quality. If the connection plate end was a cut-short detail, some type of plate extension will be required to make the rigid attachment. While adequate cleaning could be performed prior to welding, concern again is with the field welding.

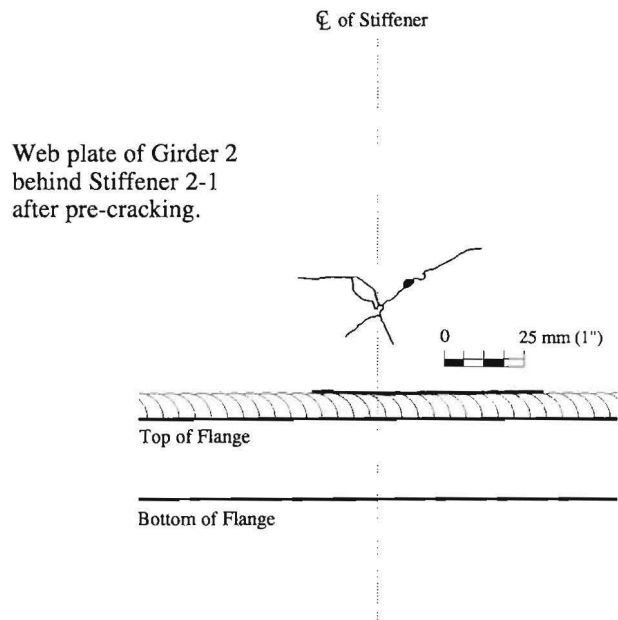
Figures 3-9 through 3-20 show the fatigue cracking in the web plate around each stiffener. Each pair of figures (Figs. 3-9 and 3-10 for example) provides a schematic drawing of the mapped cracking pattern for one side of the web plate and the corresponding view photographed after dye penetrant inspection was performed. The crack patterns that developed were similar to those commonly found on in-service highway bridges suffering from distortion induced fatigue. Fatigue cracks developed in the toe of the web-to-flange fillet weld, as well as around the end of the connection plate.

Figure 3-9: Pre-cracking in web plate of Girder 2 behind Stiffener 1.

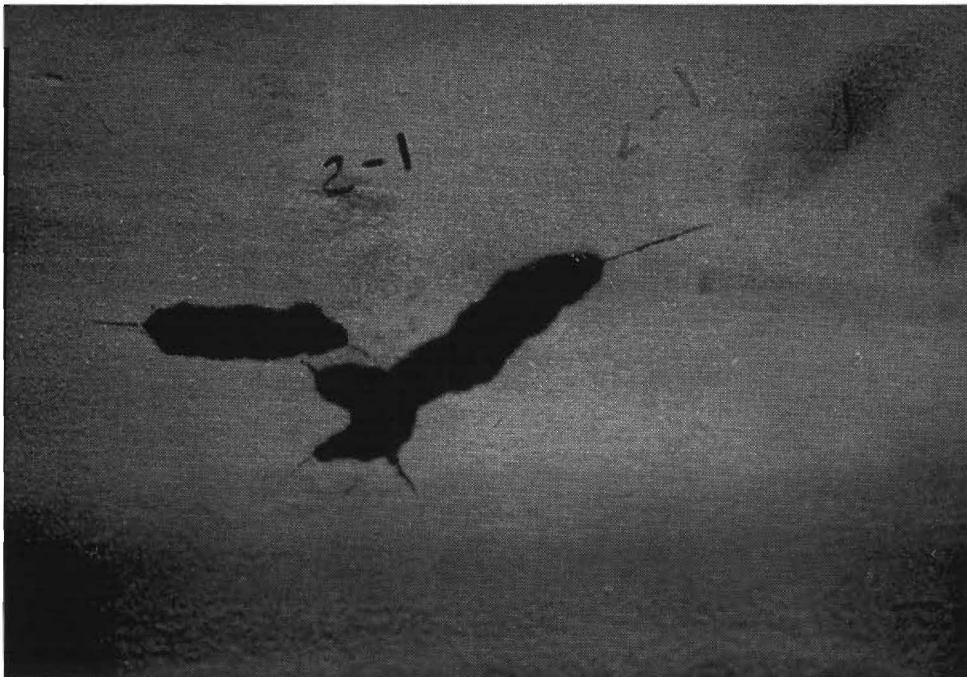
Figure 3-10: Examination of crack using dye penetrant.

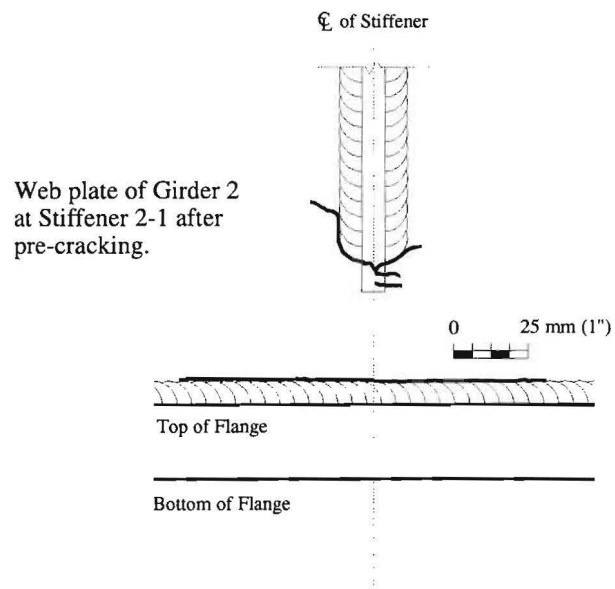
Figure 3-11: Pre-cracking in web plate of Girder 2 at weld toe of Stiffener 1.

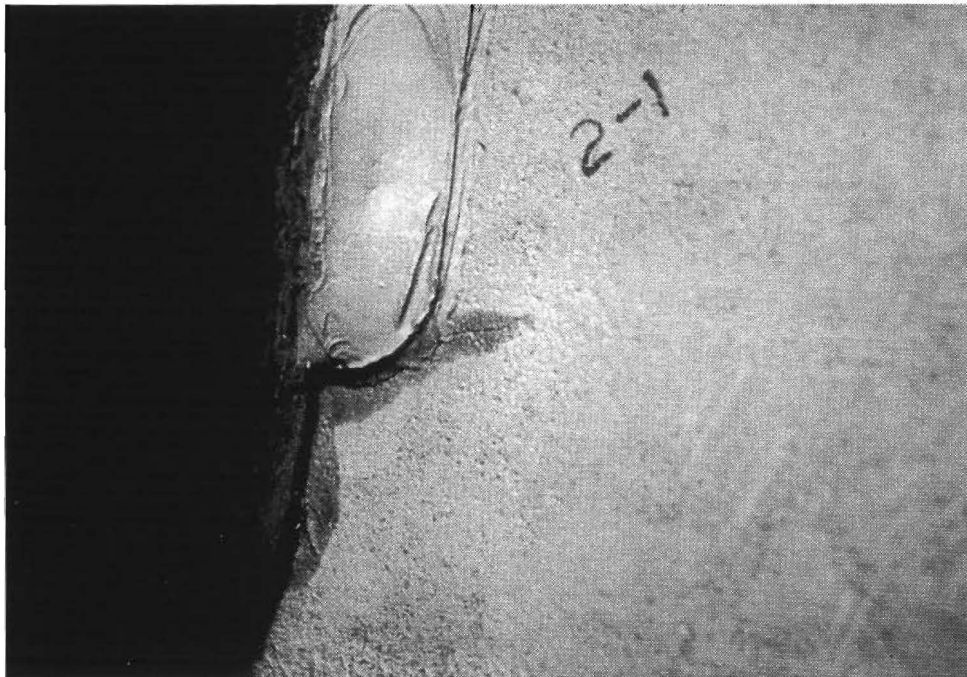
Figure 3-12: Examination of crack using dye penetrant.

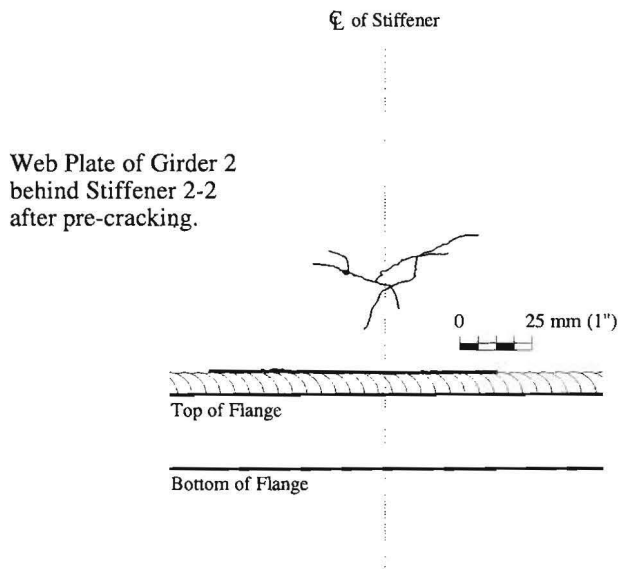
Figure 3-13: Pre-cracking in web plate of Girder 2 behind Stiffener 2.

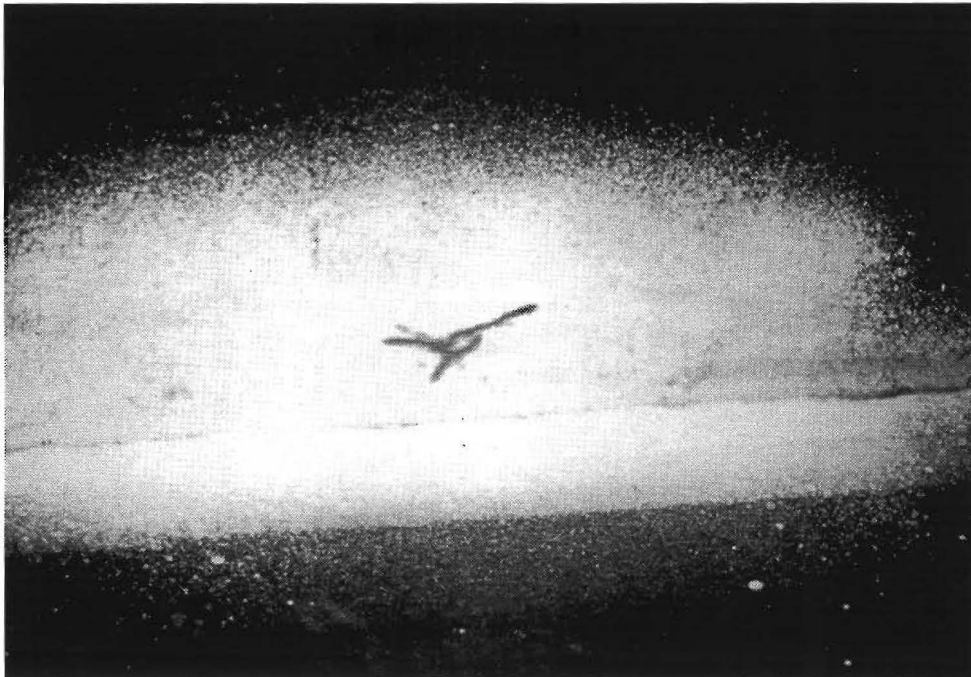
Figure 3-14: Examination of crack using dye penetrant.

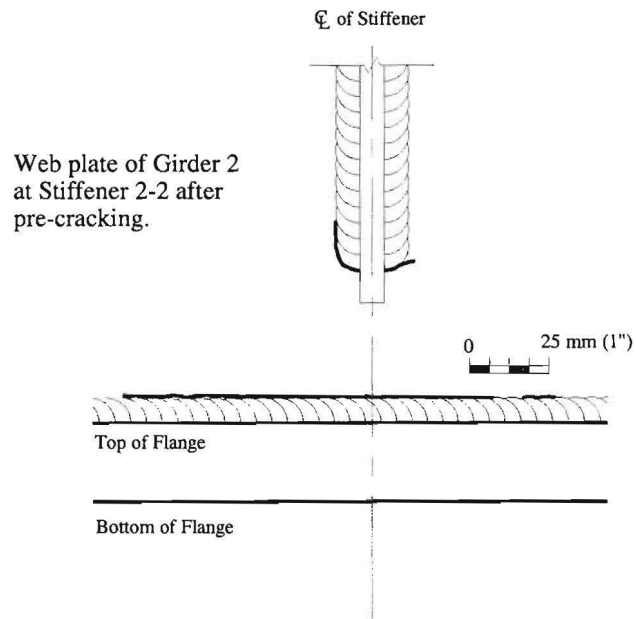
Figure 3-15: Pre-cracking in web plate of Girder 2 at weld toe of Stiffener 2.

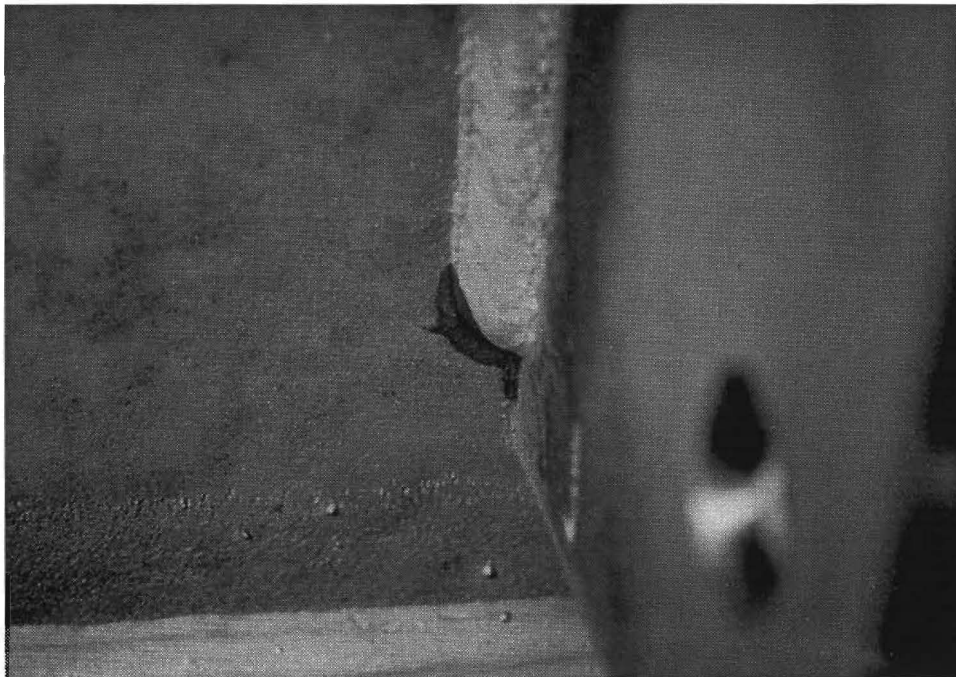
Figure 3-16: Examination of crack using dye penetrant.

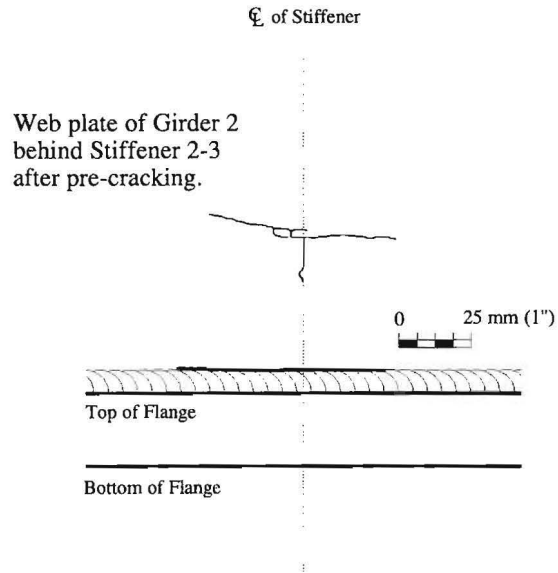
Figure 3-17: Pre-cracking in web plate of Girder 2 behind Stiffener 3.

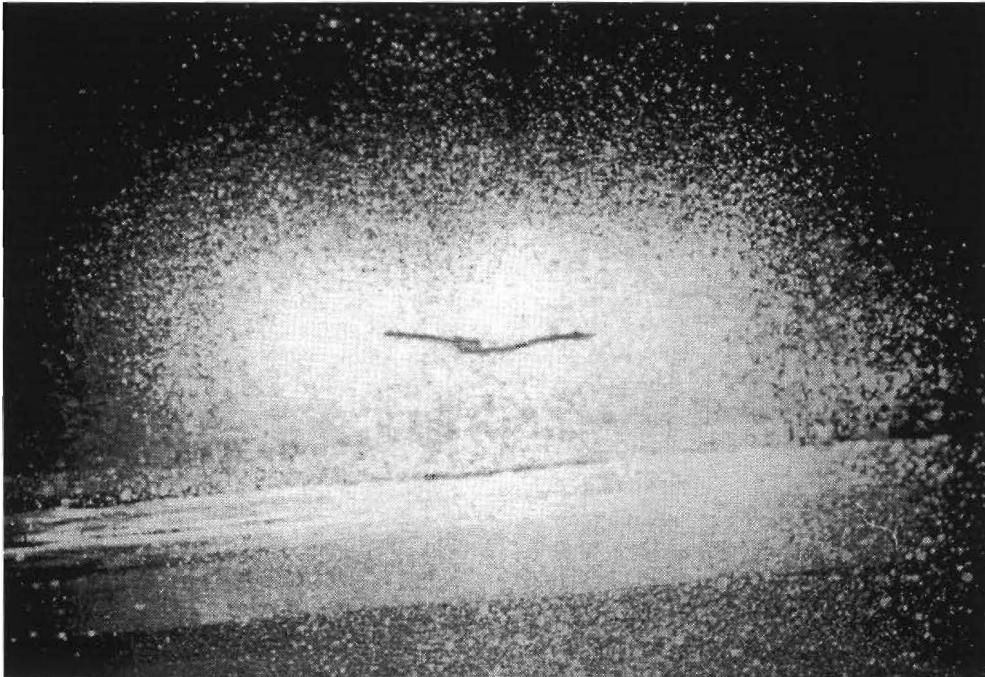
Figure 3-18: Examination of crack using dye penetrant.

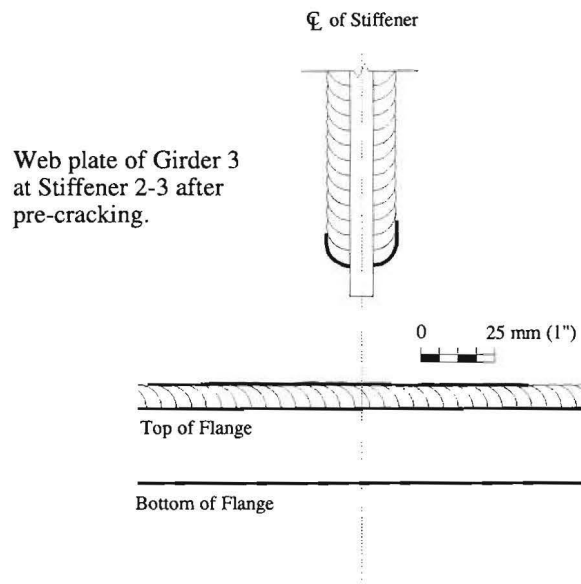
Figure 3-19: Pre-cracking in web plate of Girder 2 at weld toe of Stiffener 3.

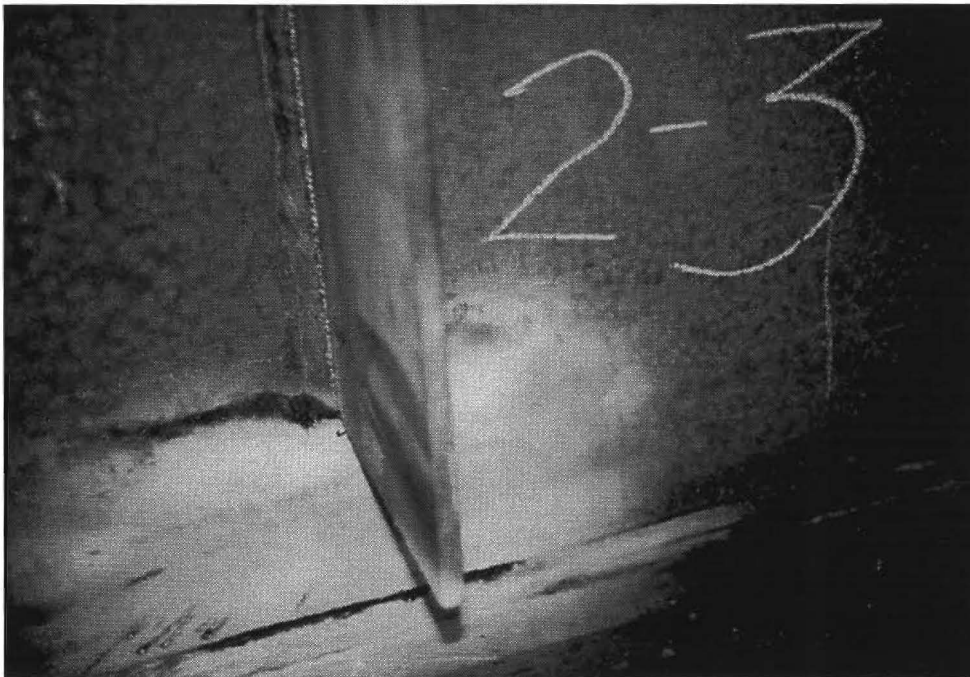
Figure 3-20: Examination of crack using dye penetrant.

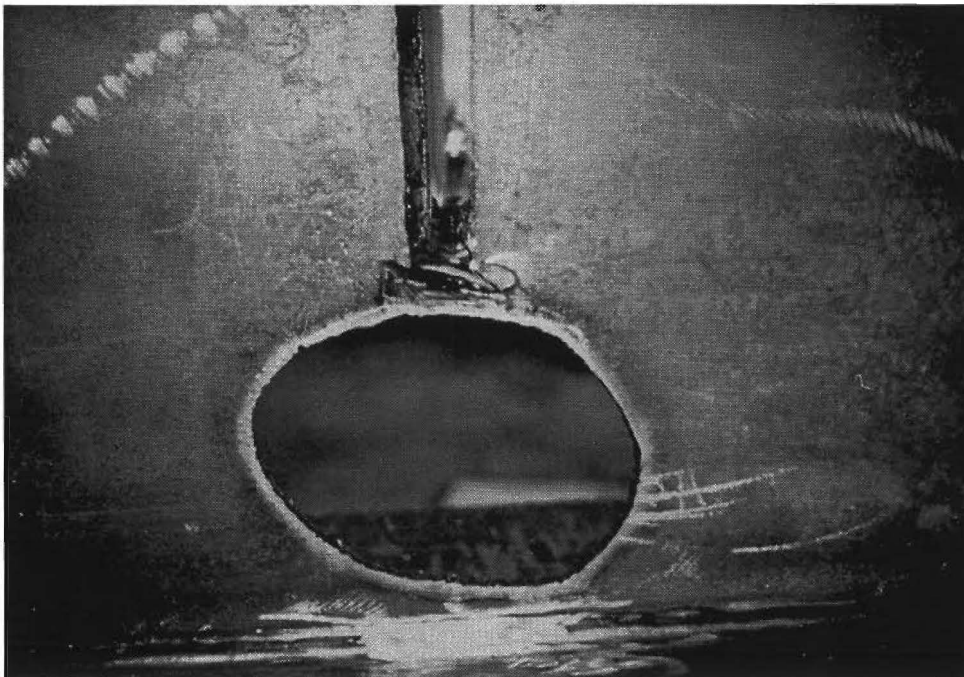
Figure 3-26: Flame-cut hole in web plate at Stiffener 1-1.

Figures 3-25 through 3-27 show the size and shape of each torched hole. The holes at Stiffeners 1-1 and 1-2 are very similar to those used on the Midland County bridges. In the case of the hole near Stiffener 1-2, notches were ground into the edges of the hole to simulate removal of any crack tips that may remain after flame-cutting, and to determine if the notches would have any adverse effects on the fatigue life of the girder. Finally, all torched surfaces on the stiffeners and around the holes were ground to a smoothness of 0.050 mm (2000 μ m.) or less. As will be discussed later, it is extremely important to obtain this finish to eliminate any surface discontinuities which might be a site of additional crack initiation and propagation.

Girder 1: Drilling holes at the tip of a crack is the most common means of arresting a crack's growth. In some cases, however, crack density is so severe that drilling holes to arrest all of the cracks is not feasible. As a result, complete removal of the cracked material may be necessary. The repairs to Girder 1 simulate this type of repair. Since this repair involved complete removal of cracked material, pre-cracking was not necessary. First, the stiffeners were shortened to provide access to the "cracked" web area. This was done with a cutting torch, as shown in Figure 3-21. Three different cutting details, shown in Figures 3-22 through 3-24, were used to determine if this had any effect on the fatigue behavior of the repair. Again, a torch was used to remove the "cracked" material near the toe of each stiffener.

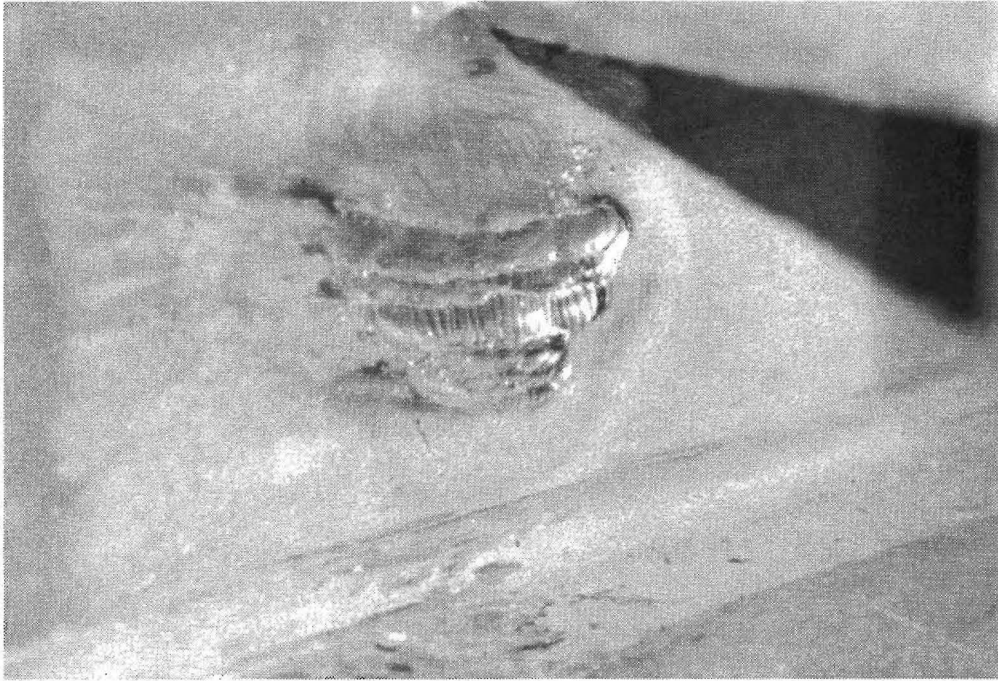
Figure 3-30: View of back gouged fatigue crack lines.

Two significant events occurred during the repair of Girder 2. At Stiffener 2-2, the web was inadvertently burned through during the air gouging process. The welder (inspector) was able to replace the material with weld metal. However, this requires a highly skilled welder and greatly increases the time and cost of the repair. At Stiffener 2-3, the repair was completed on one side of the web. During the gouging process on the other side of the web, the remaining crack propagated back into the newly-repaired region. Consequently, the repair had to be repeated in the area of the new crack. After the gouging and re-welding was completed, all repaired web surfaces were ground smooth using a disc grinder. Additional dye penetrant tests were performed to ensure that no other heat-driven cracks had propagated.

Girder 2: The "back-gouge and re-weld" technique was used to repair the cracking at all three stiffeners in Girder 2. First, the fatigue damaged areas on both sides of the web were sand-blasted clean. The stiffeners were then shortened with a cutting torch, creating a gap of approximately 100 mm (4 in.) between the end of the stiffener and top of the flange plate, as shown in Fig. 3-29. An air gouger was then used to remove the material on one side of the web plate along the crack lines (see Fig. 3-30). The depth of the gouge was a little more than one-half of the web plate thickness. Care was taken to avoid burning all the way through the plate. A burn- or blow-through of the web plate would increase the subsequent re-welding difficulty. The removed material was then replaced by arc welding using the shielded metal (SMAW) process with E70XX electrodes (see Fig. 3-31). The same procedure was then performed on all crack lines on the other side of the web. After the newly placed weld metal cooled, it was ground smooth using a standard hand-held grinder to an ANSI finish of 500.

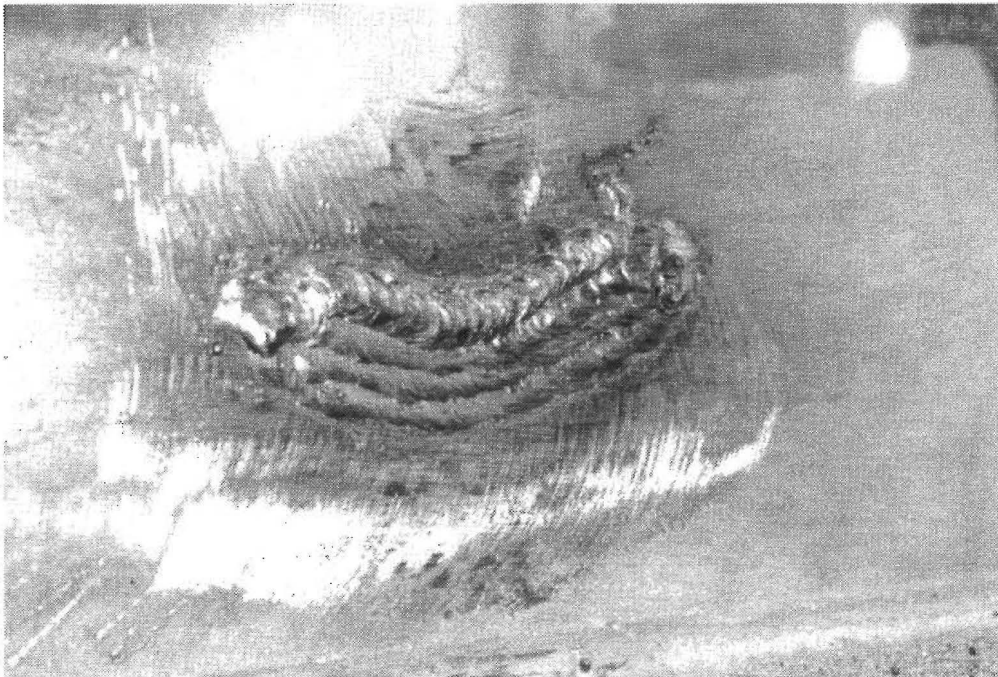
Figure 3-31: View of re-welded fatigue crack lines.

The longitudinal cracks in the web-to-flange plate fillet weld were not repaired. Since these cracks were oriented in the direction of bending stress, it was assumed that these cracks would not propagate further under cyclic loading. As will be discussed later in this chapter, these cracks did propagate under cyclic loading but did not effect the final results of the test.

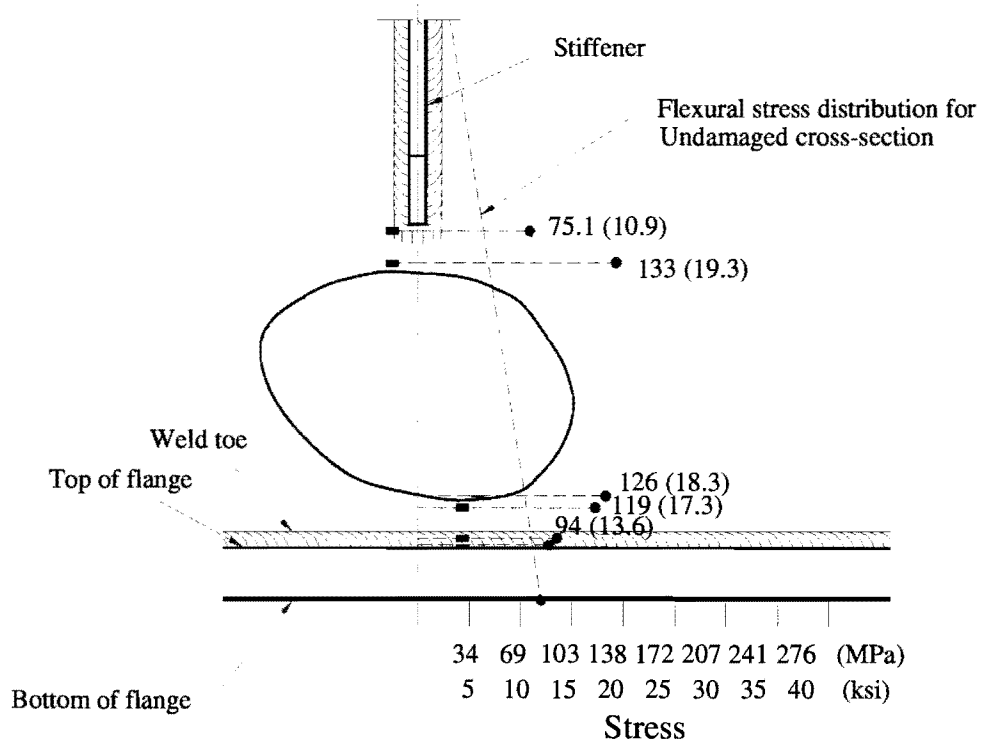
Figures 3-37 through 3-39 show the measured stresses from Static Tests 1 and 2 on Girder 1. As can be seen in these figures, the weld repairs produced significant stress concentrations. These measured stresses are consistent with the analytical results presented in Chapter Five.

Figure 3-37: Stress distribution at Stiffener 1-1 derived from strain gage data.

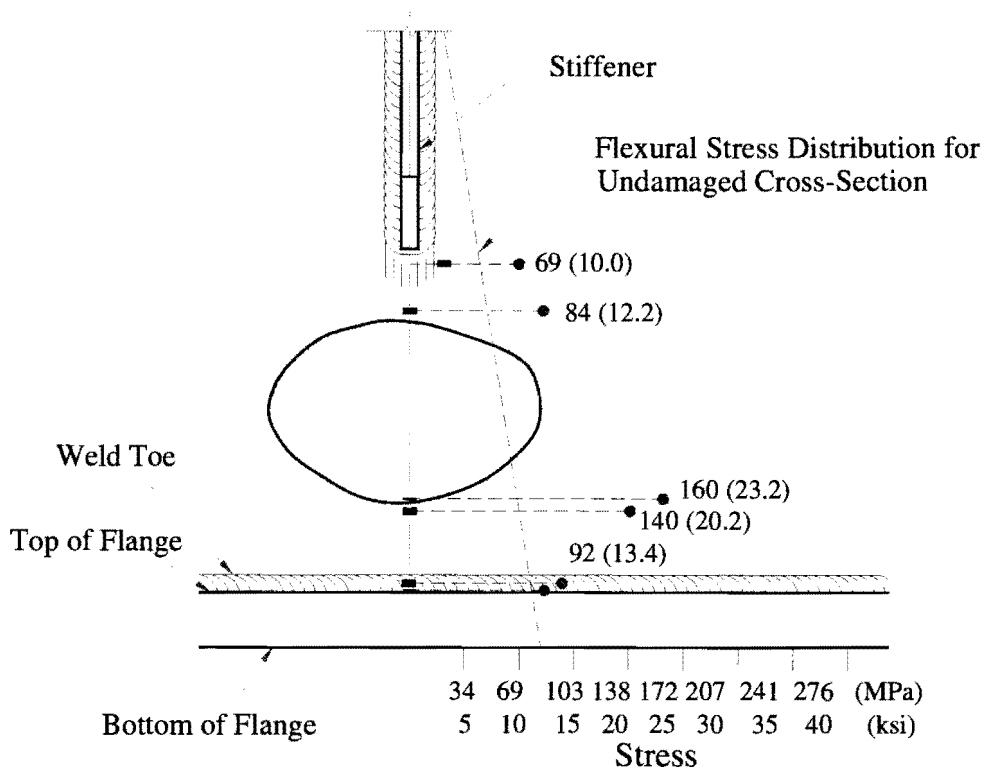
Figure 3-38: Stress distribution at Stiffener 1-2 derived from strain gage data.

As discussed in Chapter Three, a lack of thorough grinding during the initial repair process left a small surface flaw on the top edge of the flame-cut hole at Stiffener 1, as shown in Fig. 3-38. At approximately 1.8 million cycles, a fatigue crack 10 mm (0.40 in.) long was found propagating upward through the web plate from the surface flaw. Fig. 3-39 shows a photograph of the fatigue crack. A repair of the crack was made by grinding out the cracked material. Care was taken to provide smooth surfaces and transitions, and to avoid introducing additional stress concentrations. Fig. 4-22 shows the repaired hole.

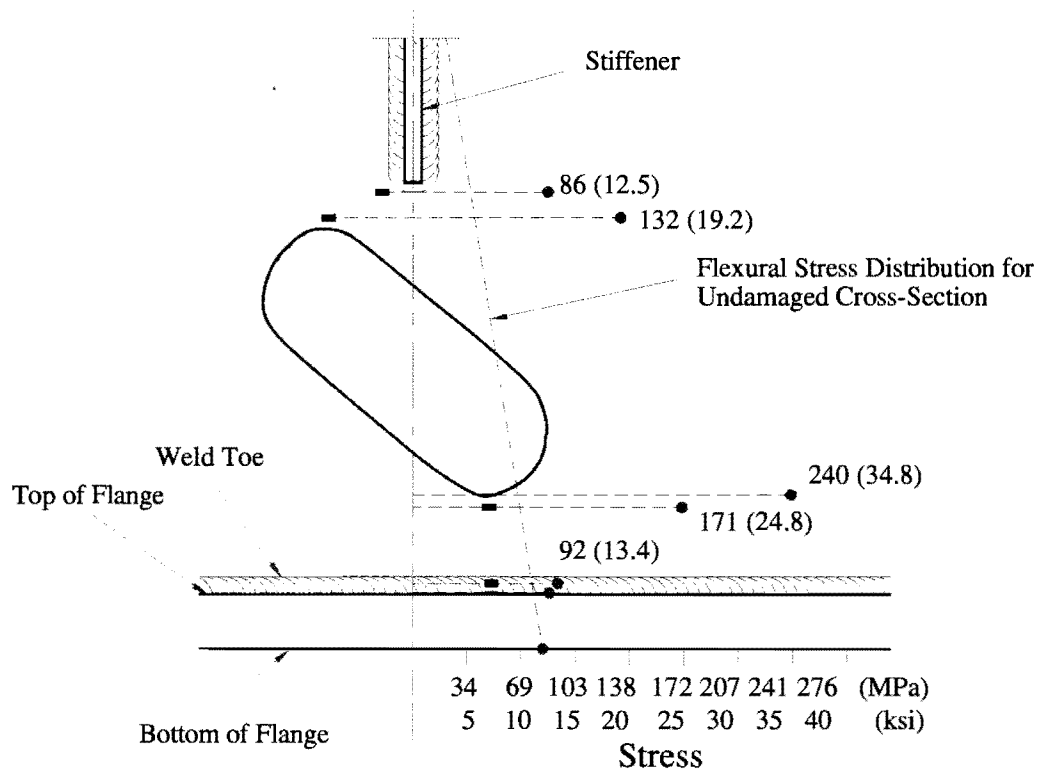
Figure 3-39: Stress distribution at Stiffener 1-3 derived from strain gage data.

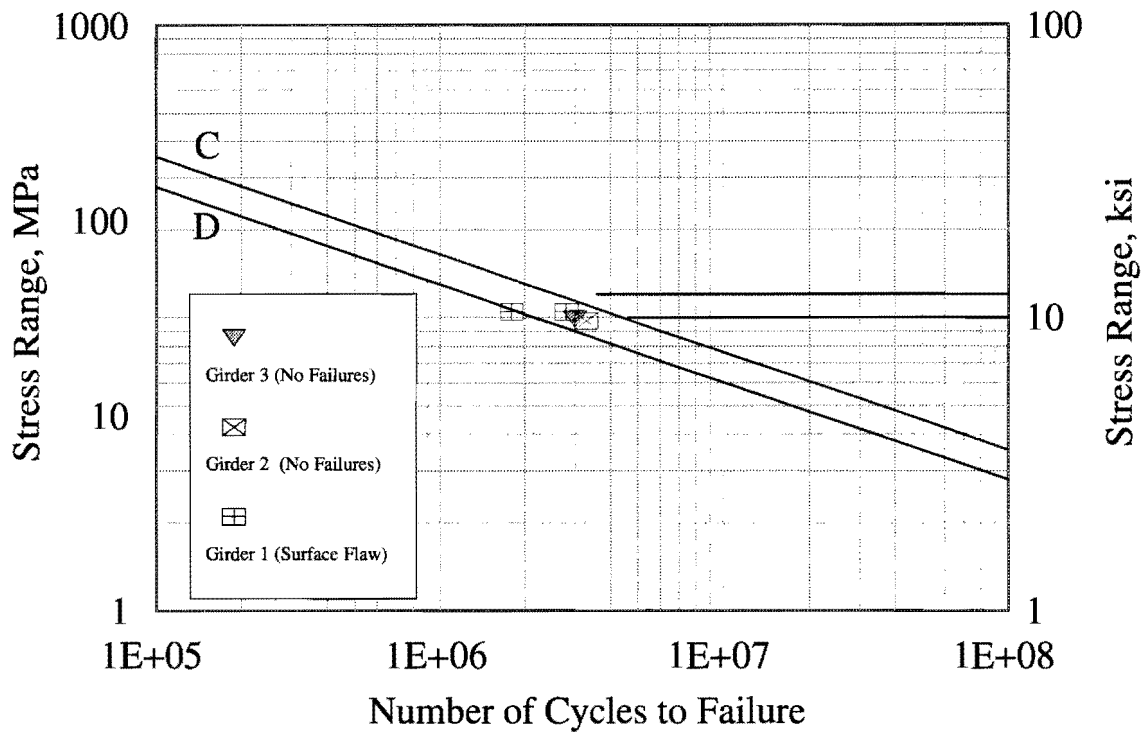
The fatigue data obtained from testing Girder 1 are plotted in Fig. 3-42 with the AASHTO Fatigue Design Categories. As indicated by the plot, the hole with the surface flaw failed at Category D. Upon completion of the testing, the inspection of the other two flame-cut holes did not indicate any fatigue cracking. Since no additional cracks formed at the edges, significant fatigue life remains. However, in the absence of further data, the flame-cut holes cannot be categorized as Category C with any certainty, and without further testing. As previously mentioned, the fatigue testing of Girder 2 was halted prematurely due to unrelated problems.

Figure 3-41: S-N plot of fatigue data for Girder 1 with AASHTO curves.

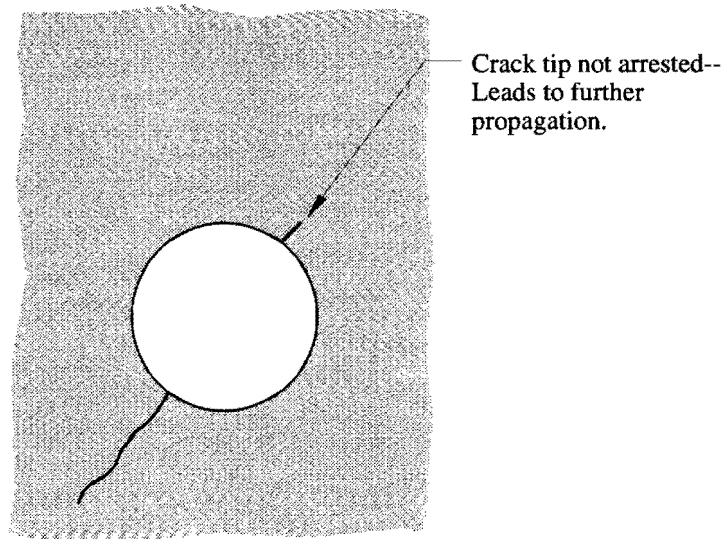
Figure 4-16: Propagation of crack tip not contained by drilled hole.

Drilled Hole Spacing Based on the data presented in Table 4-2, when drilling holes to arrest tips of the same crack spacing should be kept to a minimum. This can be accomplished by moving the holes as close together as possible and still containing the crack tips within the holes, as shown in Fig. 4-15. After drilling the holes, dye penetrant testing should be performed to verify that the tips of the cracks are contained in the holes. Containing the crack tips in the holes is of paramount importance since any cracks not contained would propagate in a higher stress field than if the repair had not been performed and render the repair useless, as shown in Fig. 4-16.

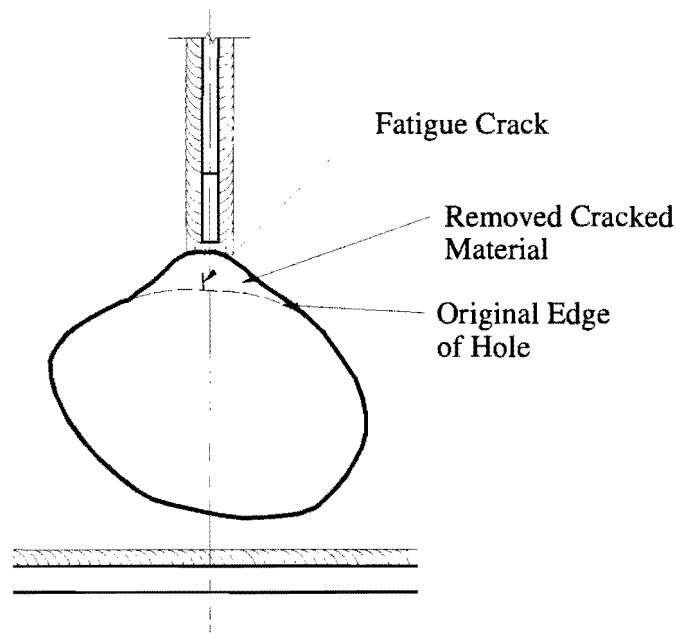
Figure 4-22: Flame-cut hole after repair of fatigue crack

The fact that a crack initiated and propagated from the surface flaw on one of the holes illustrates the importance of providing a smooth surface on the inside edges of both drilled and flame-cut holes. Edges should be ground as smooth as possible and, upon completion of a repair, all edges of every hole should be rechecked with dye penetrant for surface flaws. The smallest flaw could produce a fatigue crack.

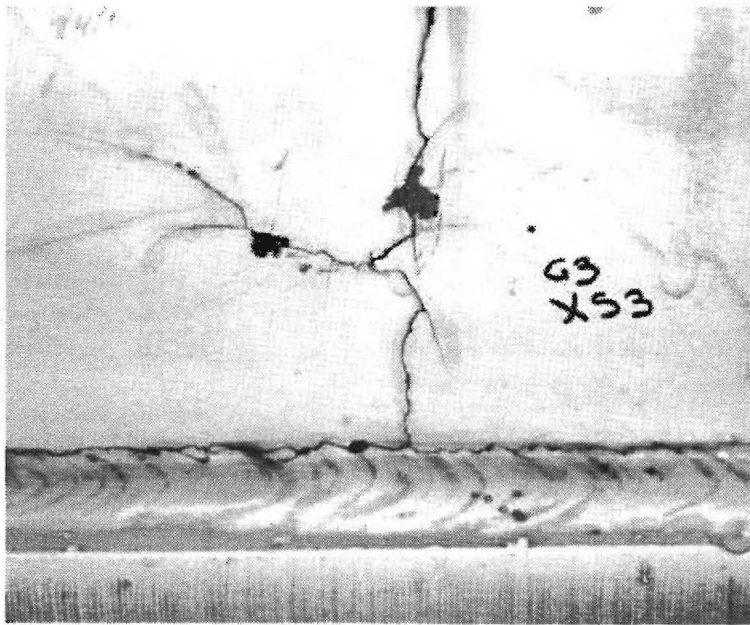
Figure 5-6: View of irregular web-to-flange fillet weld toe.

The crack interface of web-to-flange welds should be examined for possible crack growth into the flange. Typical, the fatigue crack surface is smooth, thus eliminating any possibility of crack initiation perpendicular to its plane from the in-plane bending stress. However, the crack line on either side of the web plate should be inspected for irregularities that might serve as a crack initiation site. For example, as an extreme case, the fillet weld shown in Fig. 5-6 was welded manually. (Note, detail shown in Fig. 5-6 is not from a bridge located in Texas.)

If an uneven crack surface forms along the toe of the web-to-flange fillet weld, the entire crack should be removed from the structure when adjacent to a tension flange. A crack could develop perpendicular to this surface and propagate into the flange. In addition to drilling holes at the crack tips, a slot should be made with the edge of a rotary grinder along the toe of the fillet weld (see Fig. 5-7) such that the entire crack surface is removed from both the flange and the web plate (the flange being more critical of the two). Procedures for retrofitting the fatigue cracks along the web-to-flange fillet weld should include the following steps:

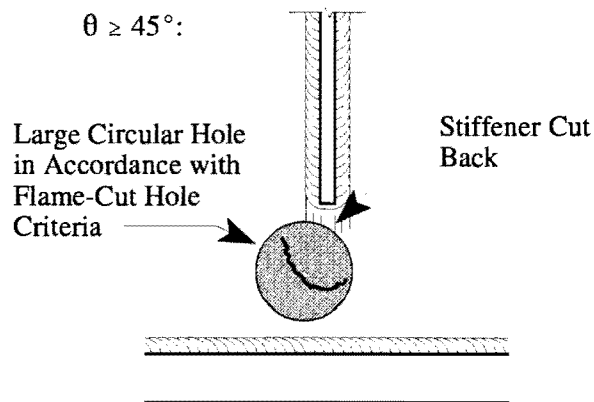
Figure 5-8: Large hole repair technique for web crack.

Large circular holes have been used when the crack length is relatively short so that the entire crack can be removed by the hole. Figure 5-8 shows a crack that originated in the weld toe at the end of the connection plate. Note that the end of the connection plate needs to be cut back.

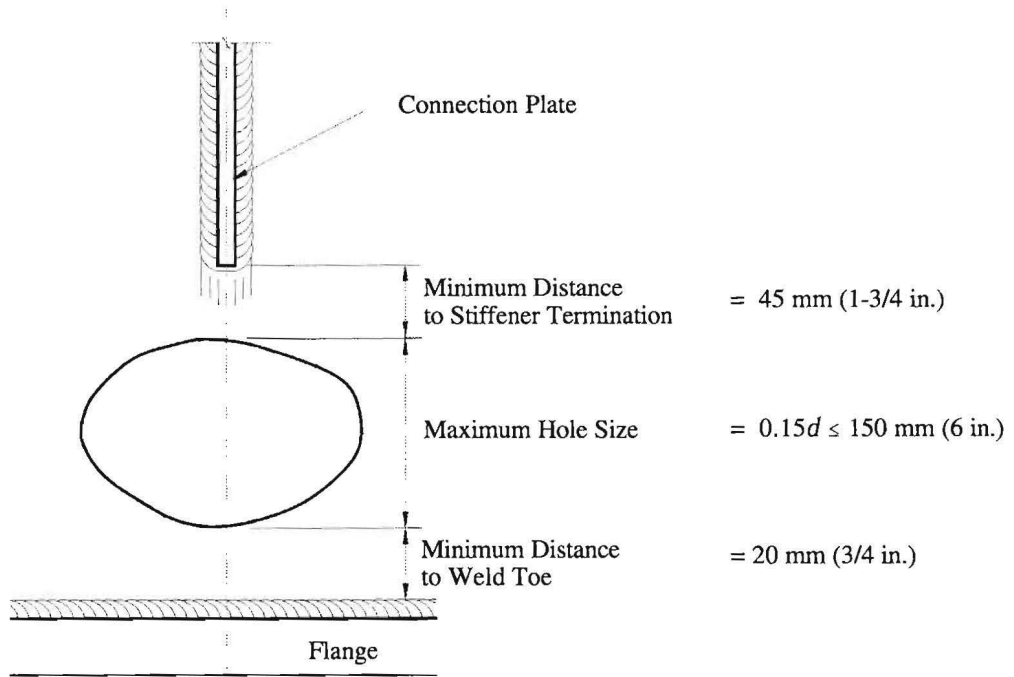
1. The distance from the toe of the transverse stiffener to the top of the hole should be at least 45 mm (1-3/4 in.).
2. The height of a flame-cut hole should not exceed the lesser of $0.15d$ or 150 mm (6 in.), where d is the depth of the girder to be repaired.
3. The minimum distance from the bottom of the flame-cut hole to the top of the longitudinal fillet weld should not be less than 20 mm (3/4 in.).

Figure 5-9: Guidelines for the use of flame-cut holes.

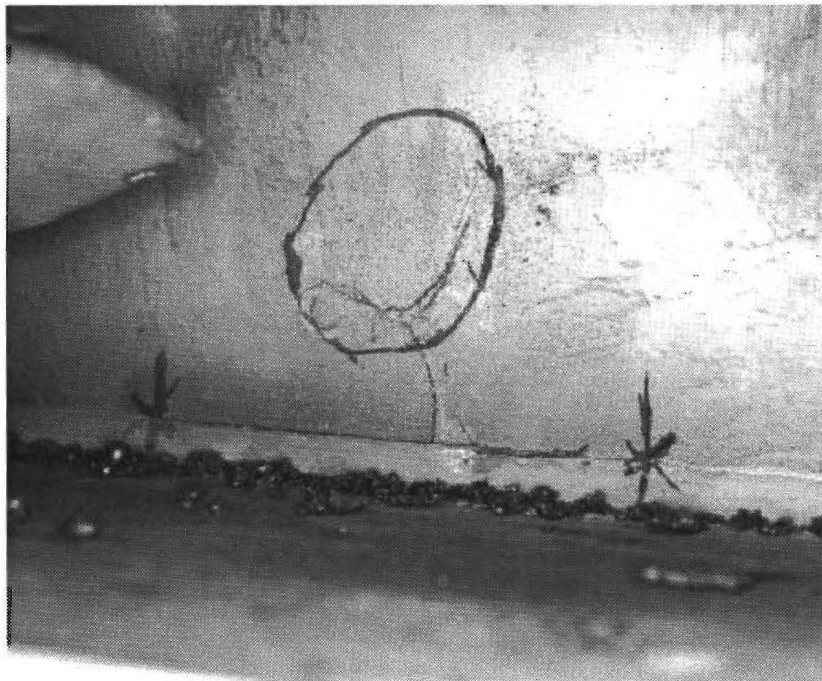
The flame-cut hole perimeter must be properly located. While the area of the hole should be minimized to reduce the web section loss, not removing the crack tip(s) will lead to continued crack propagation. Figure 5-10 shows the marked outline for a flame-cut hole. Note the proximity of the outline to the fatigue crack tip at the lower-left side. After flame-cutting and grinding, dye penetrant inspection indicated a crack at that location. A small rotary grinder was necessary to remove the crack tip, as well as at other locations (see Fig. 5-10).

Figure 5-10: View of outlined hole for flame-cutting.

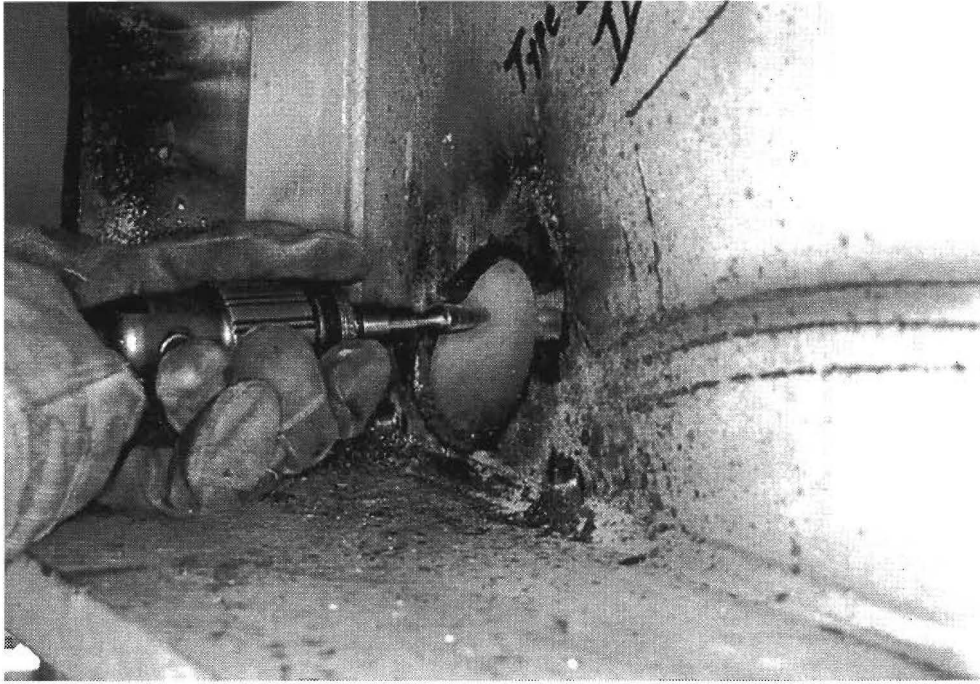
Ideally, the fatigue strength of the flame-cut hole should be AASHTO Category C. This matches the fatigue strength of the original detail and would, therefore, not increase the overall susceptibility of the structure to fatigue damage. As with drilled holes, proper finishing of the flame-cut surface is required for the Category C classification. Flame-cut holes require a higher degree of finishing due to the rough surface that remains from the actual cutting operation, as compared to that from drilling. Figure 5-12 shows a view of a grinder used to finish a flame-cut hole on the Midland County bridge.

Figure 5-12: View of die grinder used to finish holes.

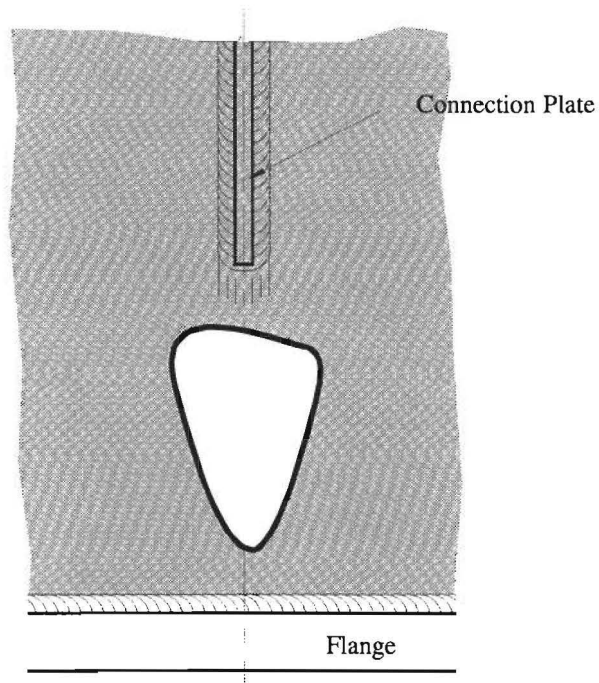
Care should also be taken to avoid a small radius of curvature of the hole nearest to the web-to-flange weld. This will result in a higher localized stress concentration at a critical location. Figure 5-13 provides an example of an undesirable curvature of the flame-cut hole. As previously mentioned, the presence of a retrofitted fatigue crack in the web-to-flange weld will act as insurance against crack propagation into the flange.

Figure 5-13: Example of undesirable curvature near web-to-flange weld.
