1. Report No. FHWA/TX-95/1442-1F		2. Government Accession No.		3. Recipient's Catalog No.	
4. Title and Subtitle  SHORT-RADIUS THRIE BEAM TREATMENT FOR INTERSECTING STREETS AND DRIVES				5. Report Date November 1994

6. Performing Organization Code	
7. Author(s) Roger P. Bligh, Hayes E. Ross, Jr., and Dean C. Alberson				8. Performing Organization Report No. Research Report 1442-1F

**SHORT-RADIUS THRIE BEAM TREATMENT FOR  
INTERSECTING STREETS AND DRIVES**

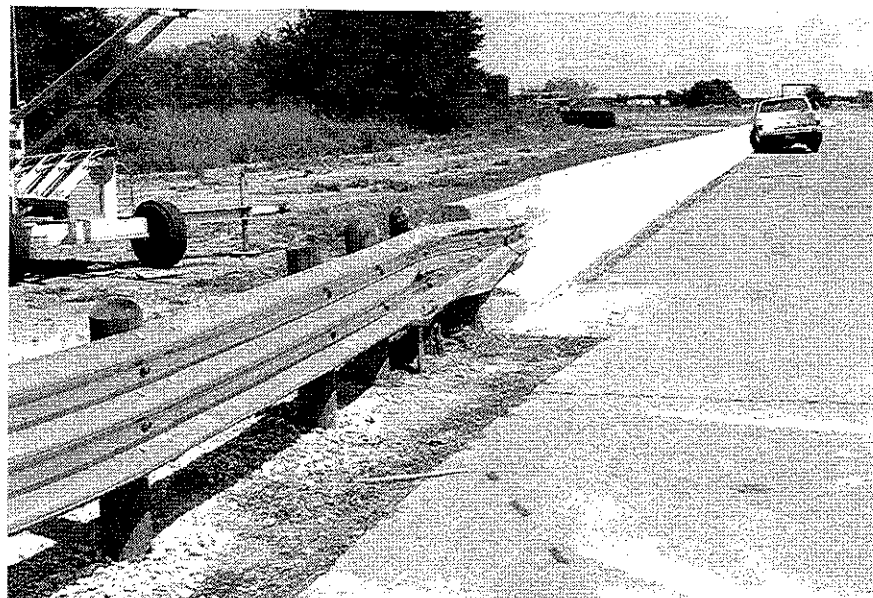
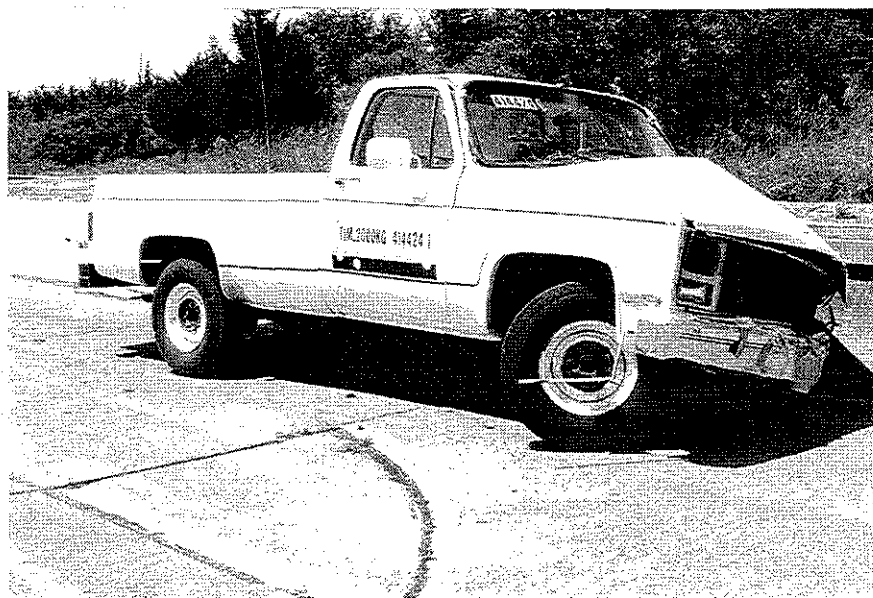
Figure 11. After impact trajectory, test 414424-1.

Shortly after impact, the front wheels were pulled hard to the left, apparently as a result of contact with the concrete parapet. As the vehicle continued to be redirected, the front end became airborne. After being in contact with the barrier for a distance of 4.78 m (15.7 ft), the vehicle safely exited the test installation traveling at a speed of 66.8 km/h (41.5 mph) and an exit angle of 2.5 degrees. The vehicle came to rest 41.1 m (135 ft) downstream from the point of impact adjacent to the concrete barrier as shown in Figure 11. A summary of the test data is presented in Figure 12.

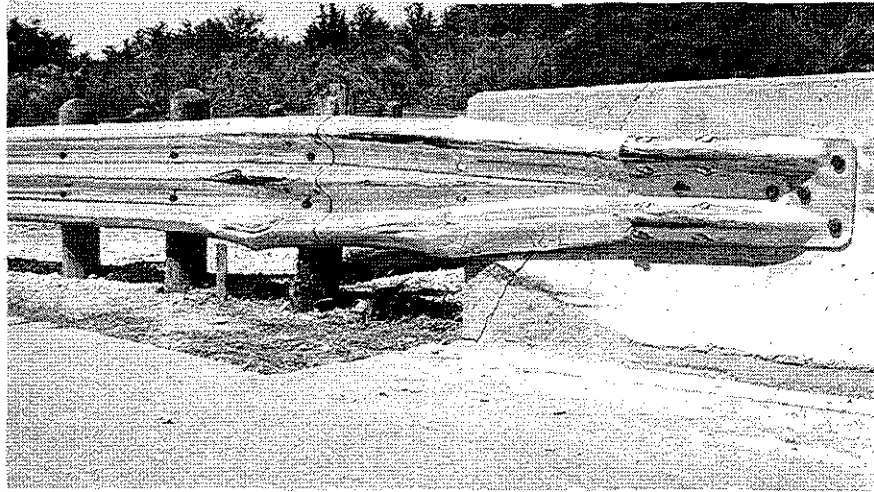
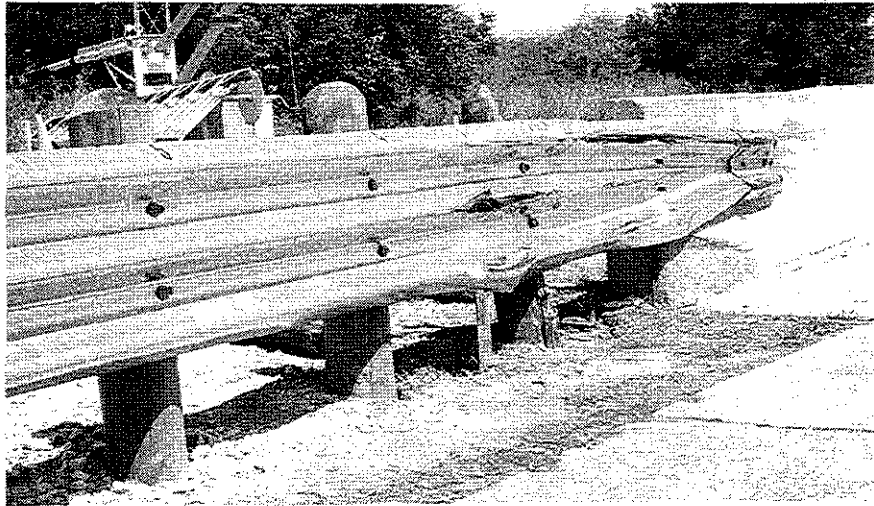
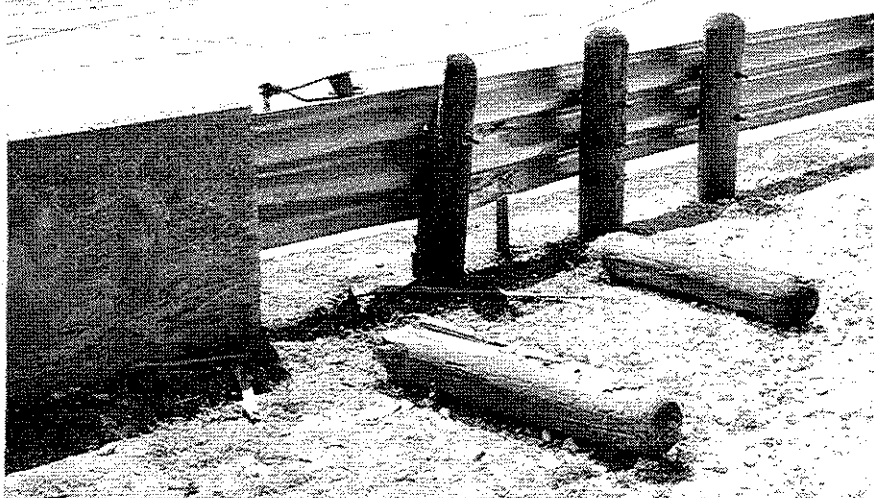
Figure 13. Installation after test 414424-1.

Damage to the test installation is shown in Figure 13. The first three posts adjacent to the bridge end were fractured at ground level, and post 4 was deflected laterally approximately 57 mm (2.25 in.). Although the end of the safety-shaped barrier was cracked, there was no visible evidence of wheel contact on the end of the barrier. The maximum residual deformation was measured to be 127 mm (5.0 in.). The maximum dynamic deflection was not obtained.

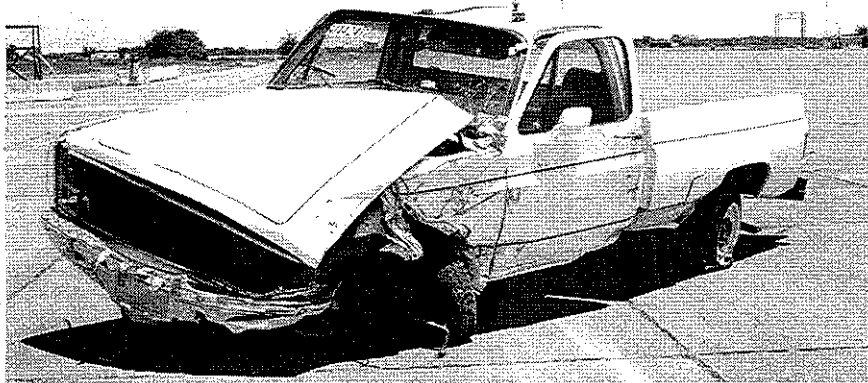
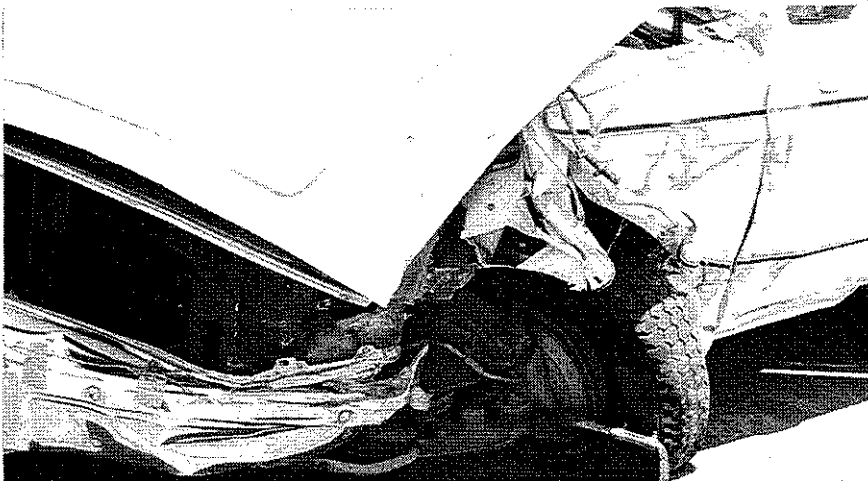
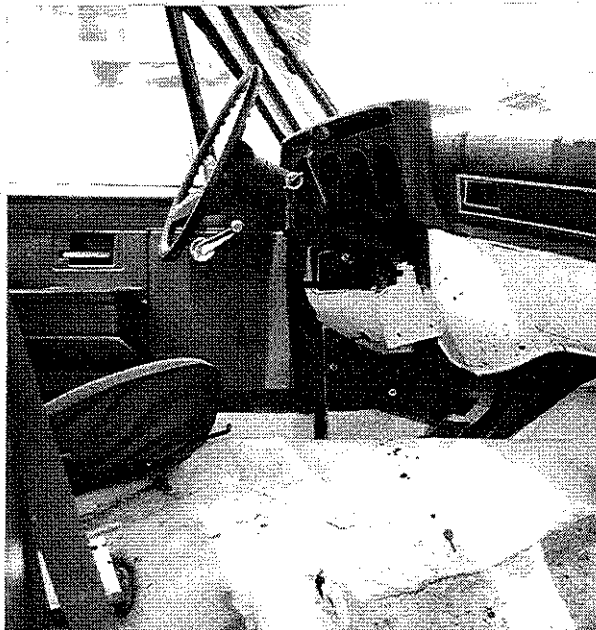
Figure 14. Vehicle after test 414424-1.

Figure 14 shows the damage sustained by the test vehicle. The maximum crush was measured to be 580 mm (22.8 in.) at the left front corner of the vehicle at bumper height. The driver side door was deformed outward 160 mm (6.3 in.), and the floorpan was pushed inward toward the occupant compartment 95 mm (3.75 in.). The wheelbase was measured to be 2980 mm (117.3 in.) and 3320 mm (130.7 in.) on the driver and passenger sides, respectively.

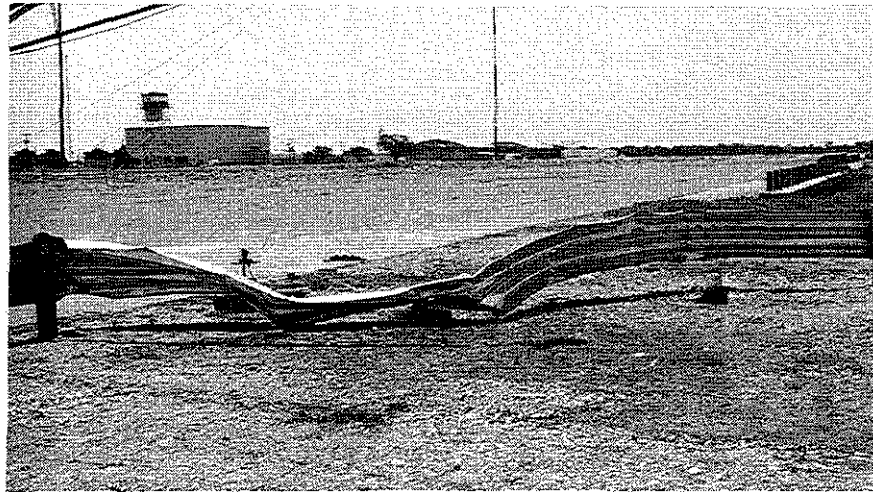
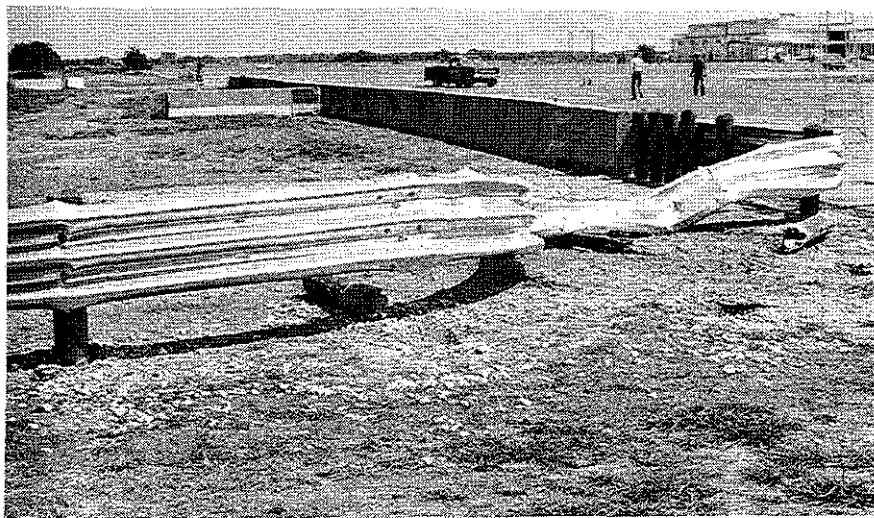
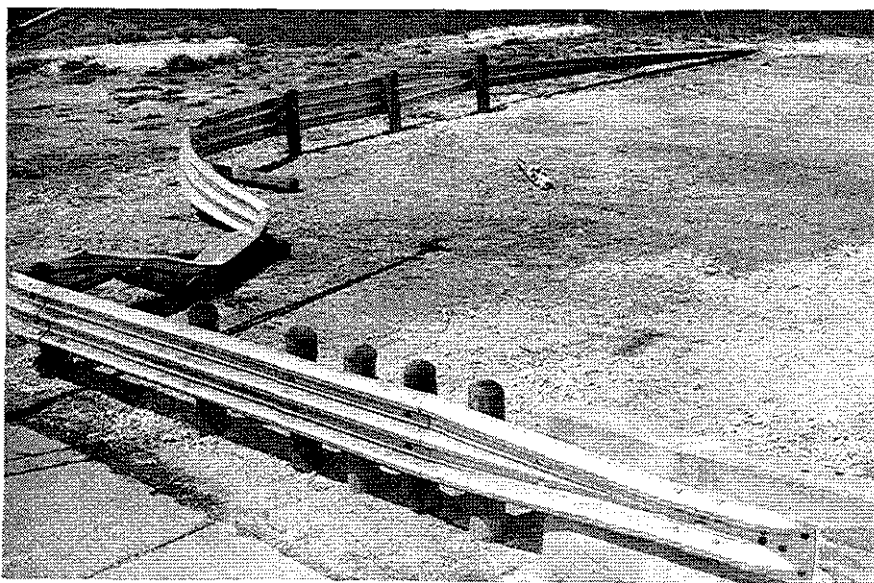
Figure 20. Installation after test 414424-2.

Damage to the test installation is shown in Figure 20. Posts 7, 8, 9, 10 in the curved section of rail all broke at ground level. Maximum dynamic deflection was 3.05 m (10.0 ft), and the maximum residual deformation was 2.84 m (9.3 ft) at post 8. As shown in Figure 21, damage sustained by the vehicle was relatively minor. The maximum crush was recorded to be 280 mm (11.0 in.) at the left front corner at bumper height.

This test was judged to be a failure since it failed to contain the test vehicle. Analysis of the high-speed film appeared to indicate that the posts in the impact region were at least partially responsible for the observed twisting and dropping behavior of the rail. It was theorized that the posts were rotating in the soil and initiating the rotation of the three beam before they had sufficient time to release from the rail and/or fracture at the ground line. The short-radius treatment was subsequently modified in an attempt to minimize this behavior. The modification consisted of removing the post bolts from posts 7, 8, and 9 in the curved section of rail. A 3/8-in diameter lag screw was used to provide vertical support to the rail at these locations. The modified system was then retested as described below.

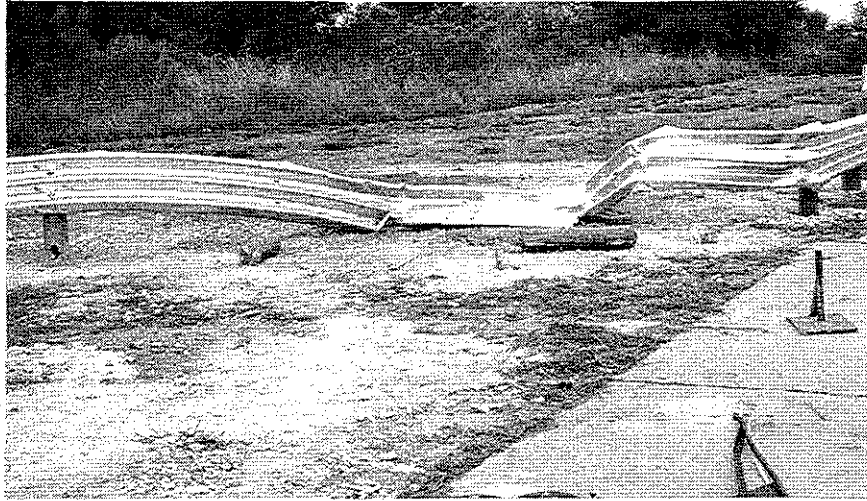
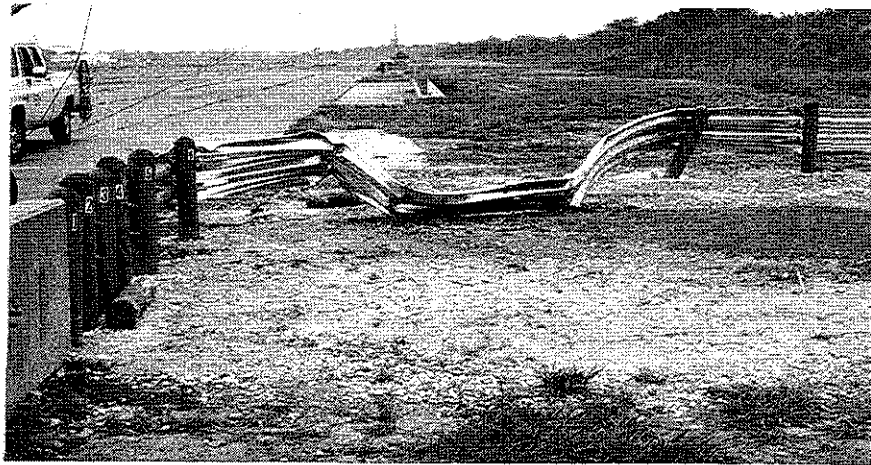
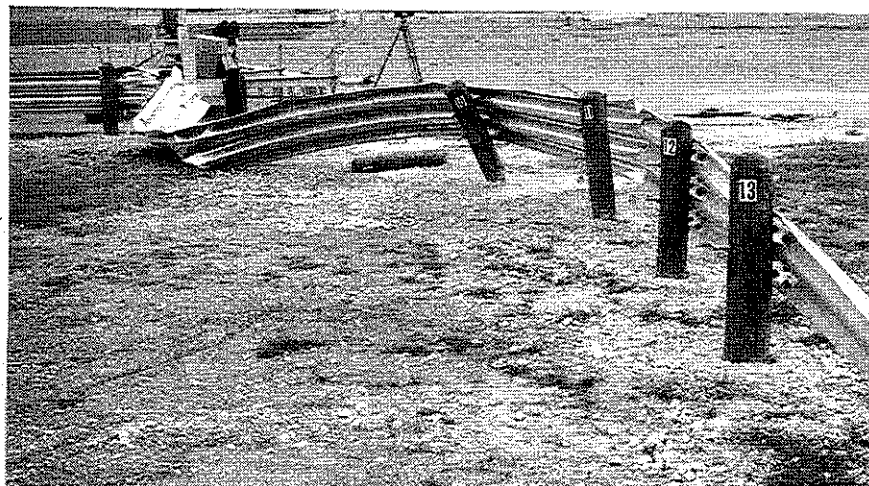
Figure 27. Installation after test 414424-3.

Damage to the test installation is shown in Figure 27. As in the previous test, posts 7, 8, 9, 10 in the curved section of rail all broke at ground level. Maximum dynamic deflection was 3.27 m (10.7 ft), and the maximum residual deformation was 2.90 m (9.5 ft) at post 8. Damage to the test vehicle is shown in Figure 28. Most of the damage was sustained in the secondary impact with a tree after the vehicle vaulted the test installation.

As with the previous test, the test installation failed to contain the 3/4-ton pickup truck and, therefore, the test was judged to be a failure. After close examination of the test results, it was concluded that the rotation of the rail was attributable to a combination of the low torsional stiffness of the open thrie-beam section and the eccentric loading applied by the bumper of the vehicle on the upper portion of the rail. Based on this analysis, it became evident that any potential solutions to this problem would require substantial modifications to the short-radius system along with some level of developmental testing. After consultation with TxDOT personnel, it was mutually decided that the best use of the remaining project resources would be to certify the short-radius thrie-beam design under *NCHRP Report 230 (3)*. This approach would provide TxDOT with a crashworthy short-radius treatment that could be implemented until such time that a treatment meeting the requirements of *NCHRP Report 350* can be developed. Since

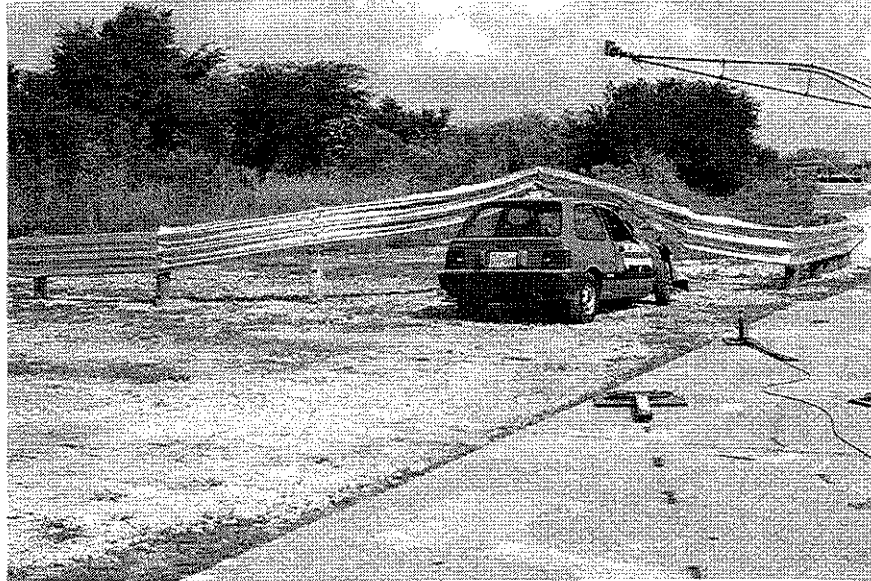
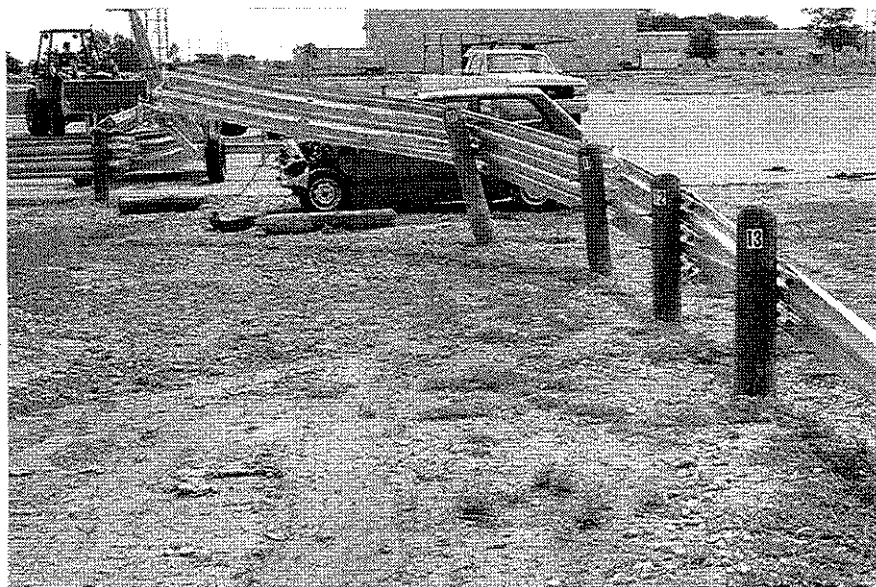
Figure 33. After impact trajectory, test 414424-4.

Upon impact, the weakened wood posts fractured as designed and the thrie beam began to deform around the front of the vehicle. However, as the vehicle continued forward into the installation, the top of the rail started rotating toward the vehicle and the thrie beam began to override the hood. At a point when most of the vehicular kinetic energy had been dissipated, the thrie beam contacted the A-pillar. The vehicle finally came to rest 4.0 m (13.1 ft) downstream and 2.1 m (7.0 ft) behind the point of impact as shown in Figure 33.

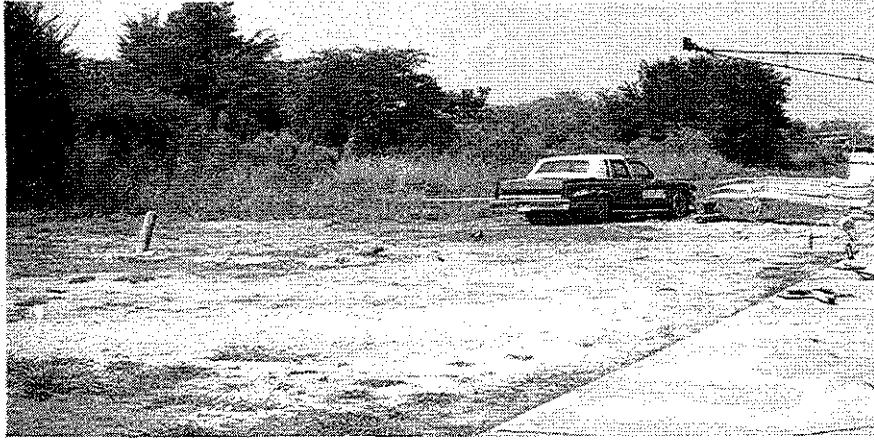
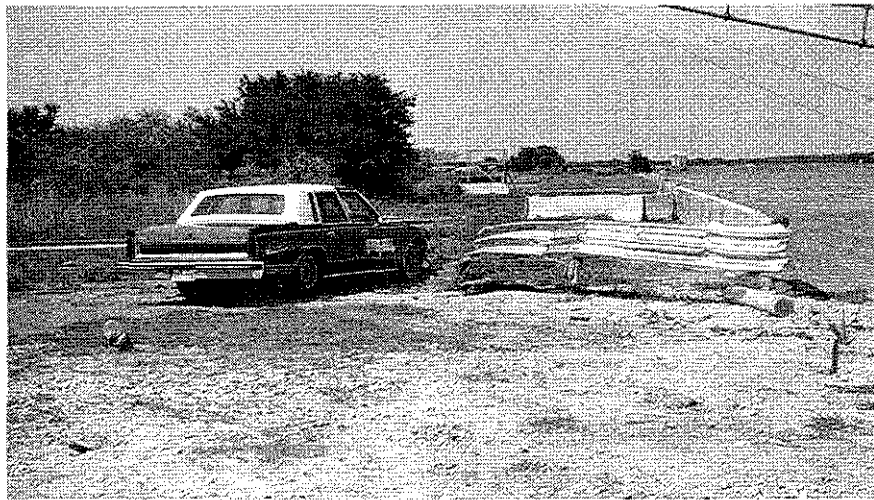
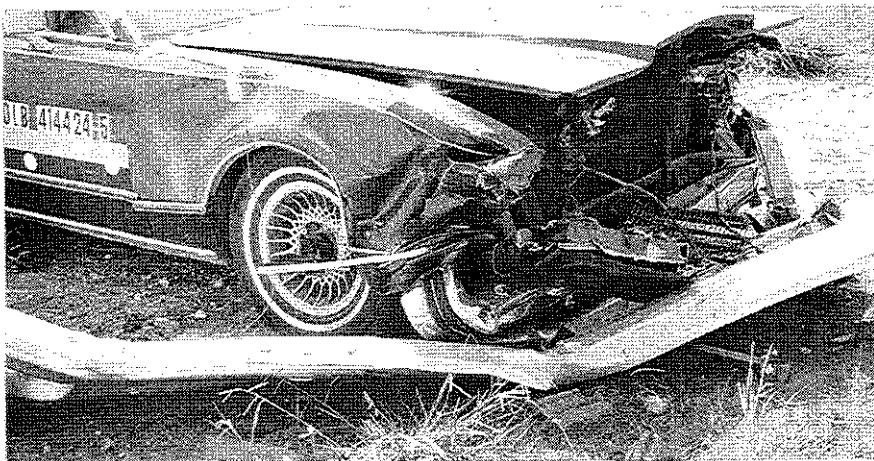
Figure 41. After impact trajectory, test 414424-5.

Upon impact, the posts in the impact area fractured as intended and the rail deformed around the front end of the test vehicle. The forward velocity of the vehicle was nearly stopped when the four bolts connecting the W-beam terminal connector to the turndown anchor failed in shear, permitting the rail to swing out in front of the vehicle. As shown in Figure 41, the vehicle rolled to a stop 12.5 m (41.0 ft) downstream and 6.5 m (21.3 ft) behind the point of impact without the brakes being applied. A summary of the test information is presented in Figure 42.

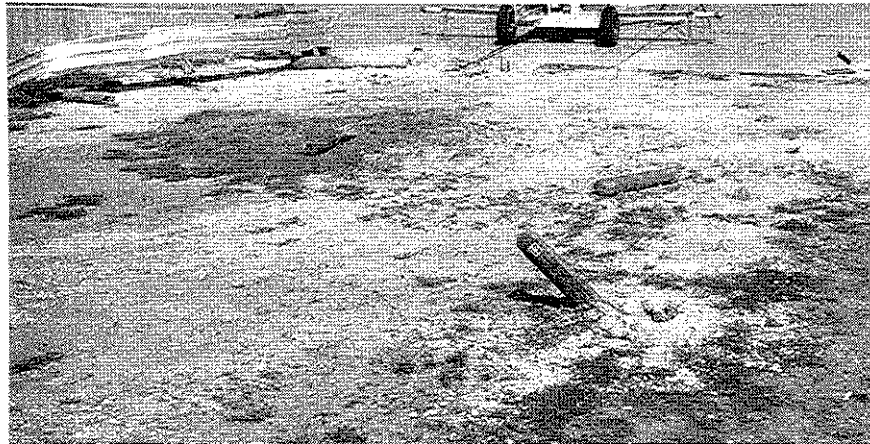
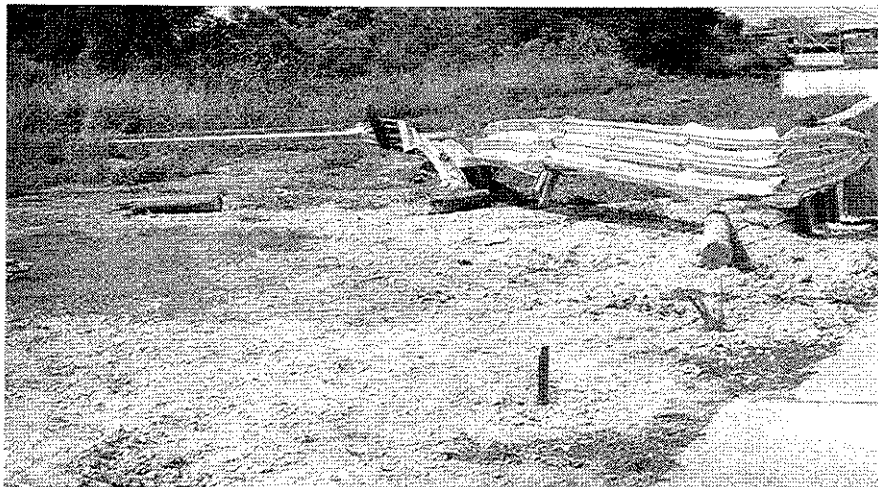
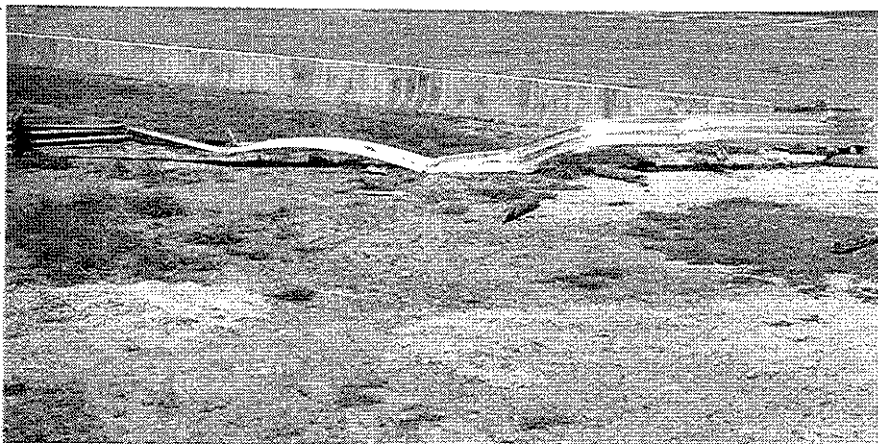
Figure 43. Installation after test 414424-5.

Damage to the test installation is shown in Figure 43. All of the weakened CRT posts (posts 6-12) fractured at or below ground level as intended. Post 5 was pulled from the ground, and post 13 was knocked over in the soil. Maximum dynamic rail deflection was 13.2 m (43.2 ft), and the maximum residual deformation was 11.3 m (37.2 ft). Investigation of the turndown anchorage failure revealed that 5/8-in. diameter bolts were incorrectly substituted for the standard 7/8-in. diameter bolts typically used with the end-shoe type turndown anchor. Analysis shows that a 7/8-in. diameter bolt has approximately twice the shear capacity of a 5/8-in. diameter bolt of similar grade. Since the test vehicle was almost stopped prior to the shear failure of the four 5/8-in. diameter bolts, it is the opinion of the researchers that, had the correct size bolts been installed, this failure would not have occurred. Analysis of the high-speed film indicated that the vehicle traveled approximately 2.4 m (8 ft) after the failure of the turndown anchorage connection. It is, therefore, reasonable to assume that, in the absence of the connection failure, the maximum dynamic rail deflection would be approximately 10.1 m (33 ft) for the given impact conditions.

In summary, this test was judged to be a success. Although the turndown anchorage connection failed prior to the test vehicle coming to a complete stop, the failure was a result of using incorrect bolt sizes. When properly installed, the system can be expected to bring the vehicle to a smooth, controlled stop over a distance of approximately 9.5 m (31 ft). Furthermore, although not required in the evaluation of a strength test, the occupant risk indices were all well within the recommended limits of *NCHRP Report 230*. In addition, the vehicle remained upright

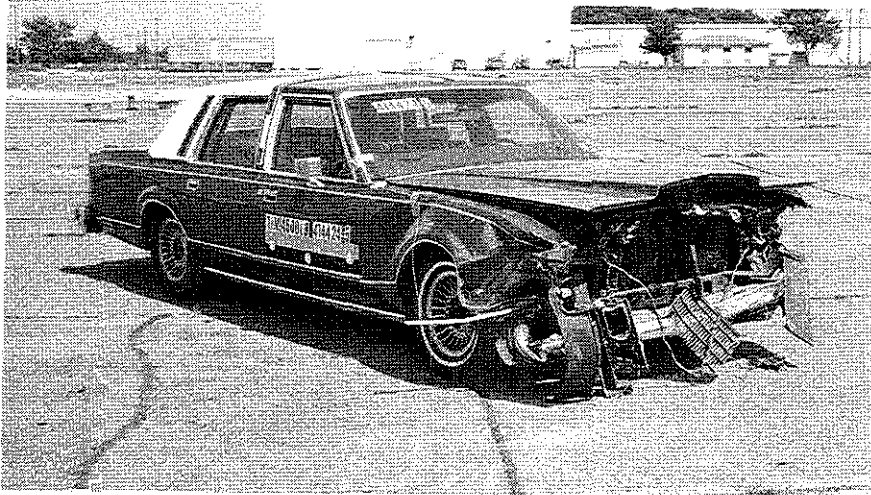
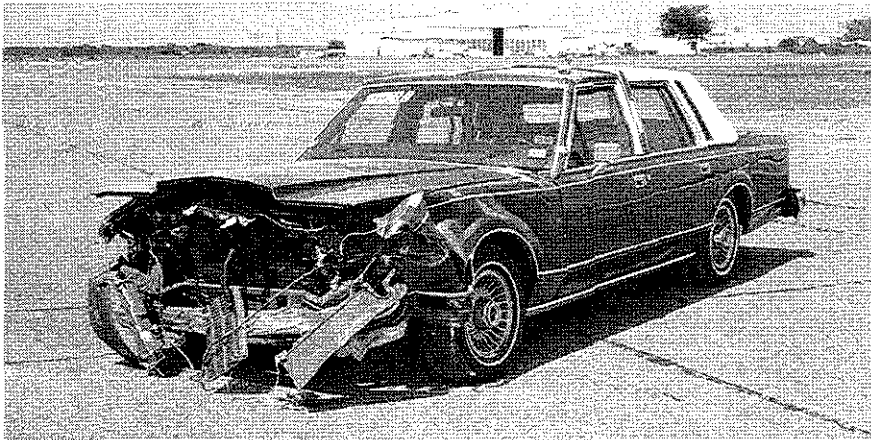
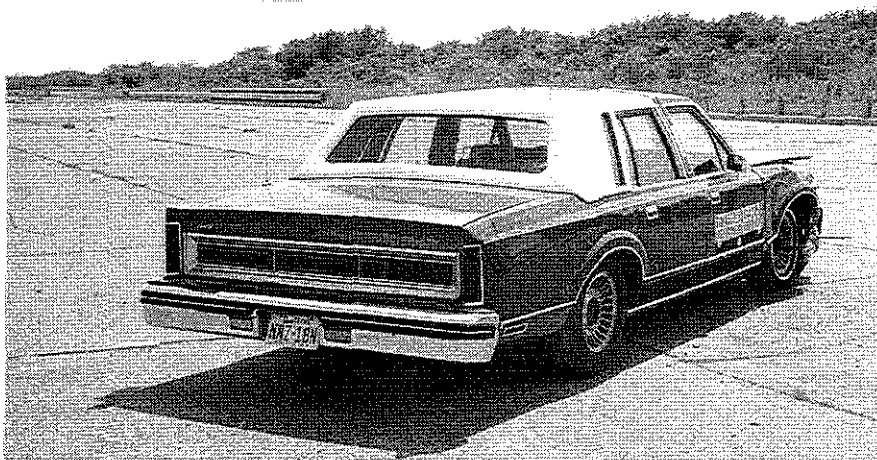
Figure 44. Vehicle after test 414424-5.

As shown in Figure 44, damage sustained by the test vehicle was minor for a test of this severity. The maximum crush was measured to be 460 mm (18.1 in.) at the left front corner of the vehicle at bumper height. Damaged areas included the bumper, grill, hood, front fenders, and doors.
