STUDY OF IN-SERVICE BRIDGES CONSTRUCTED  
WITH PRESTRESSED PANEL SUB-DECKS

Research Report 145-1

A Study of Prestressed Panels and Composite Action in  
Concrete Bridges Made of Prestressed Beams, Prestressed  
Sub-deck Panels, and Cast-in-place Deck

Research Project No. 2-5-70-145

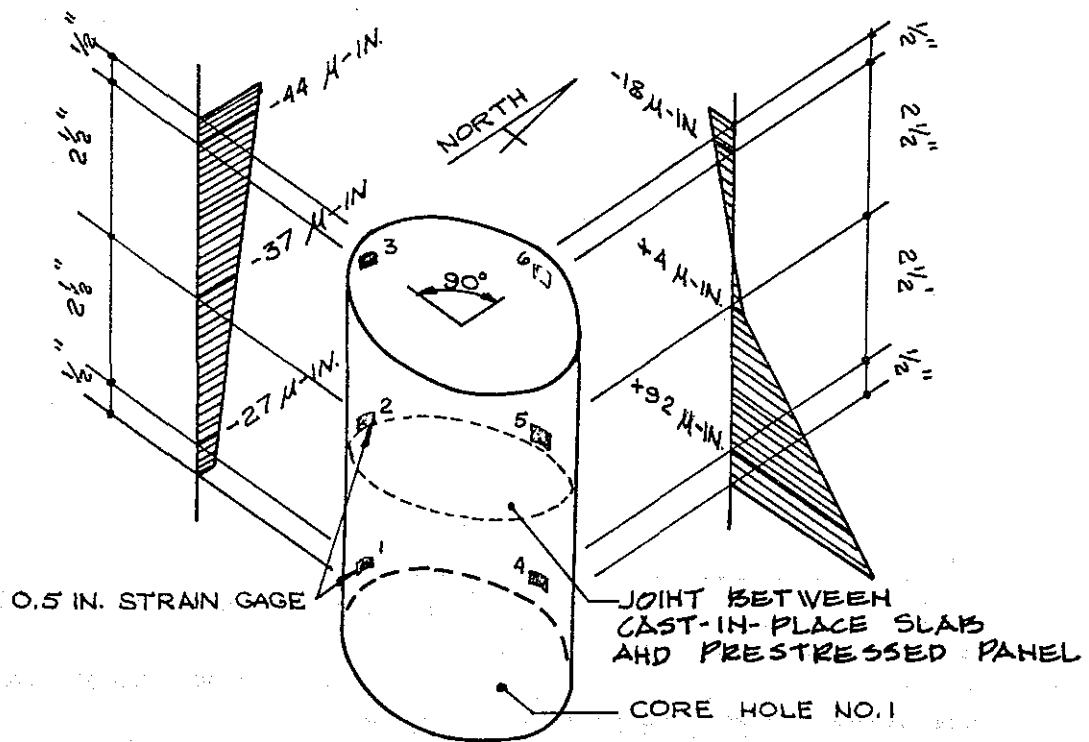
Figure 20. Location of Strain Gages and Strain Readings in Core Hole No. 1.

The six gages mounted in core hole No. 1 provided strain profiles through the slab and panel, in both the transverse and longitudinal directions. As expected, the strains in the longitudinal direction were all compressive, with the largest value occurring at the top of the cast-in-place slab and decreasing almost linearly with depth. The strains in the transverse direction varied from compressive in the top of the slab to tension at the bottom of the panel, with approximately zero at mid-depth.

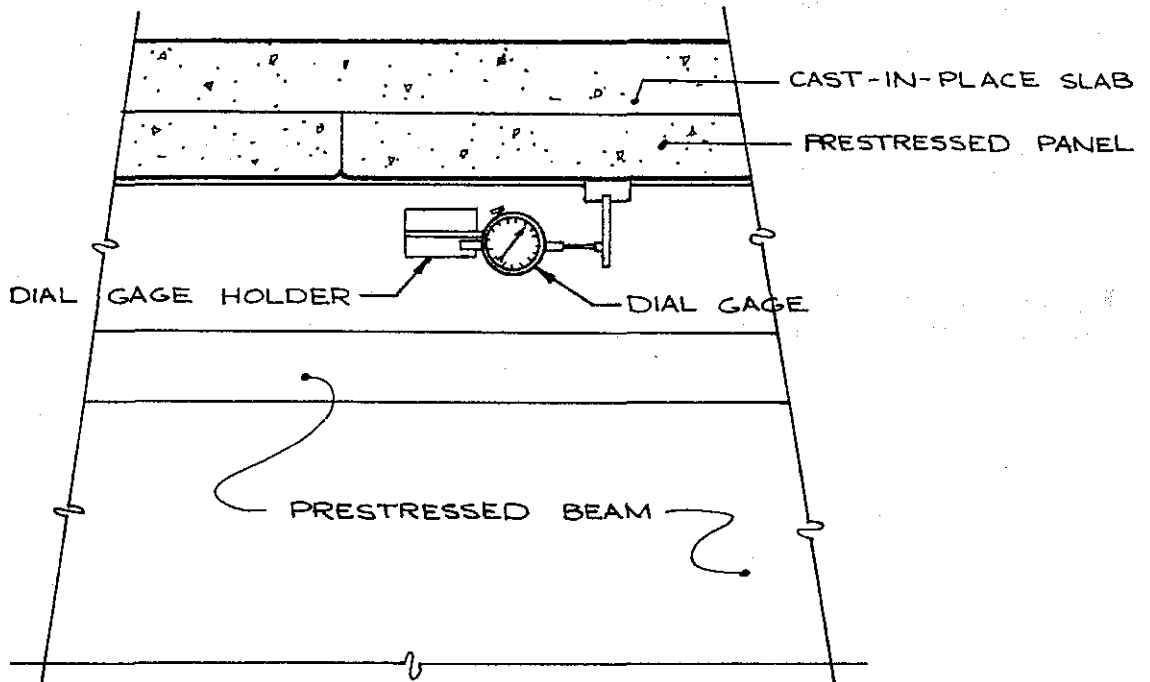
Figure 21. Dial Gage Installation to Detect Slippage Between Prestressed Beam and Panel.

slip between prestressed panel and beam, and that shown in Fig. 22 was used to measure relative vertical movement between two adjacent prestressed panels.
