1. Report No. FHWA/TX-01/1458-3		2. Government Accession No.		3. Recipient's Catalog No.	
4. Title and Subtitle TESTING AND EVALUATION OF RECYCLED MATERIALS IN ROADSIDE SAFETY DEVICES				5. Report Date October 2000 Resubmitted: April 2001

9. Performing Organization Name and Address Texas Transportation Institute The Texas A&M University System College Station, Texas 77843-3135				10. Work Unit No. (TRAIS)

# **TESTING AND EVALUATION OF RECYCLED MATERIALS IN ROADSIDE SAFETY DEVICES**

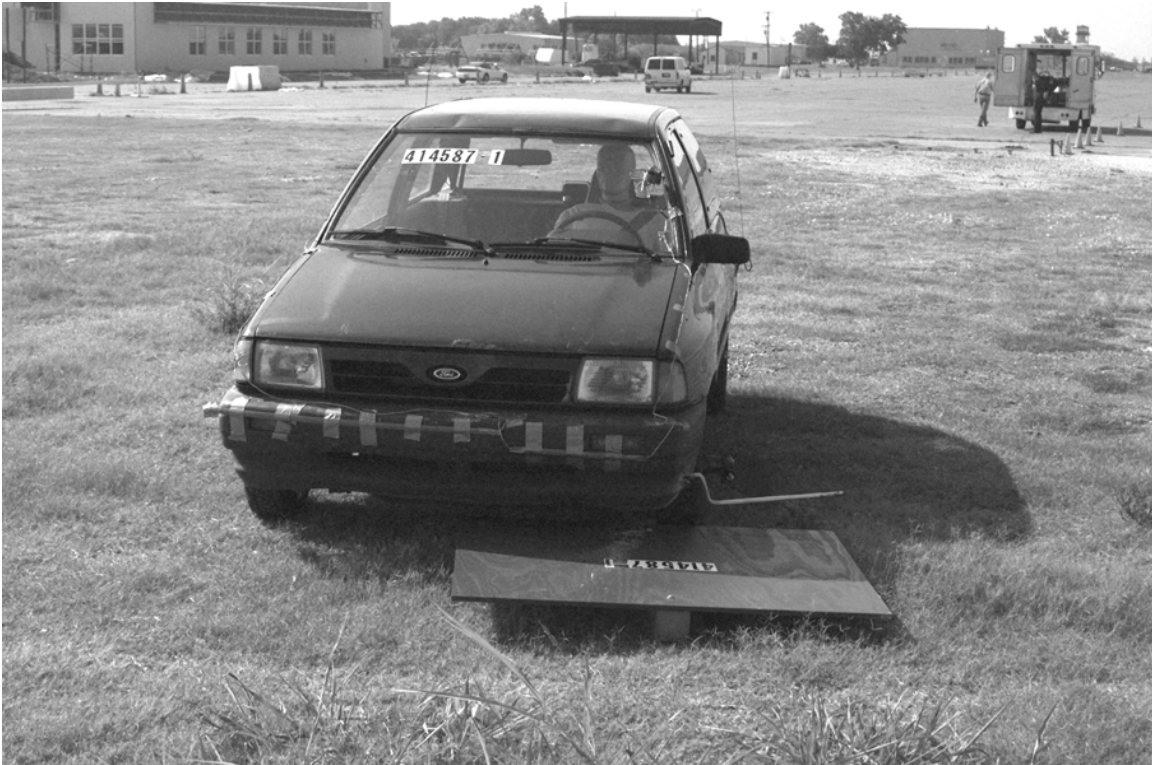
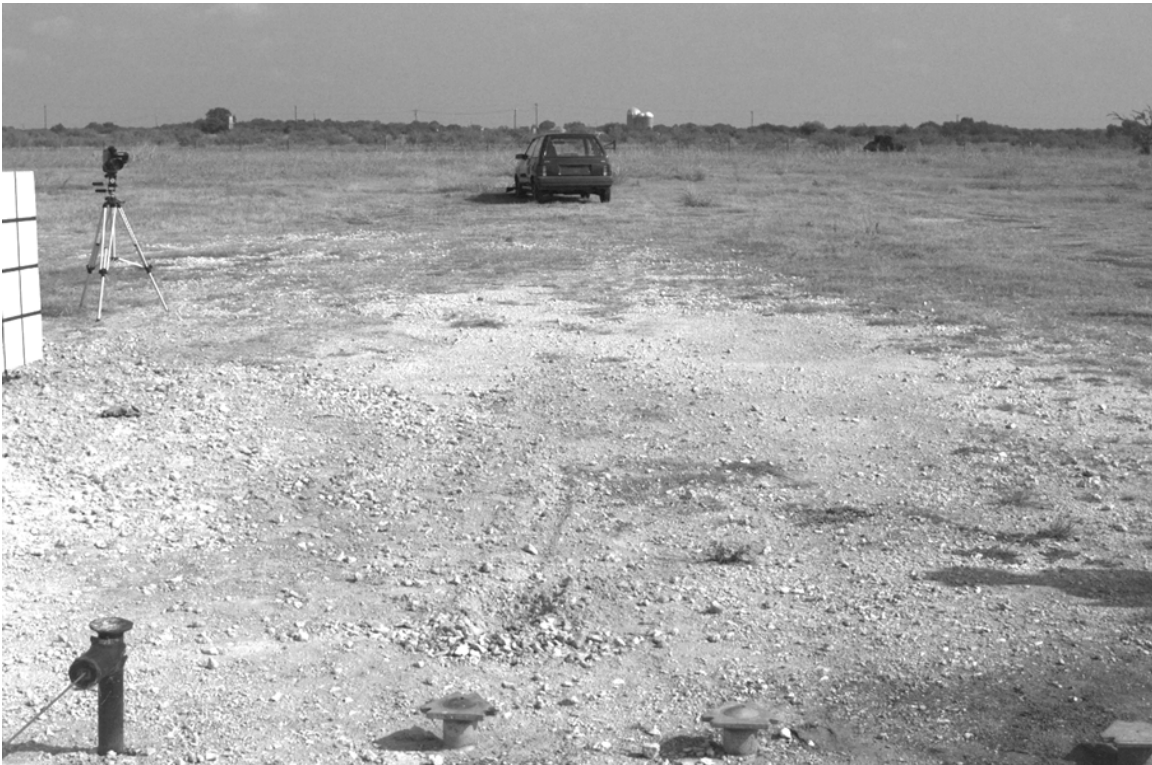
**Figure 7. After Impact Trajectory for Test 414587-1.**

The sign support fractured 203 mm below ground level. The support and sign were dragged under the vehicle until the vehicle came to a stop. The sign support was not reusable. Damage to the sign installation is shown in [figures 7 and 8](#).

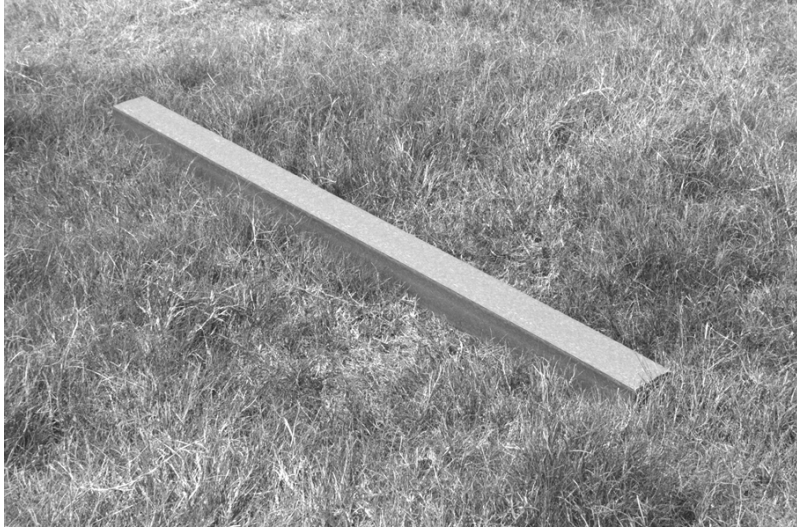
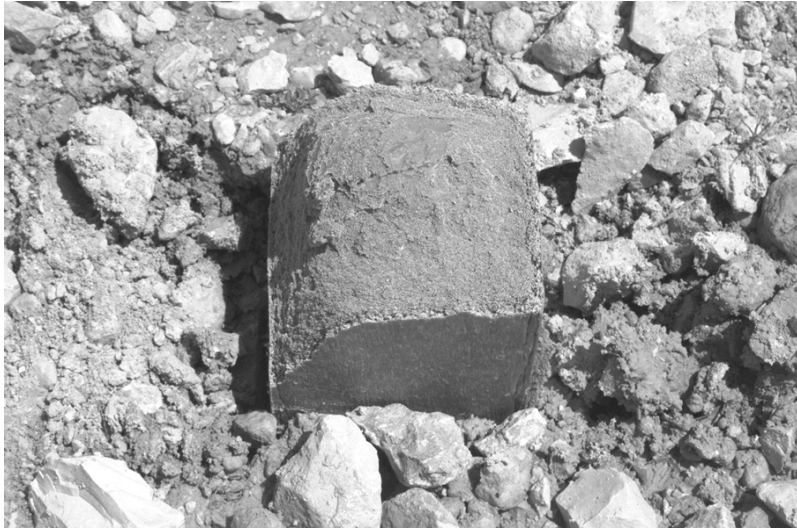
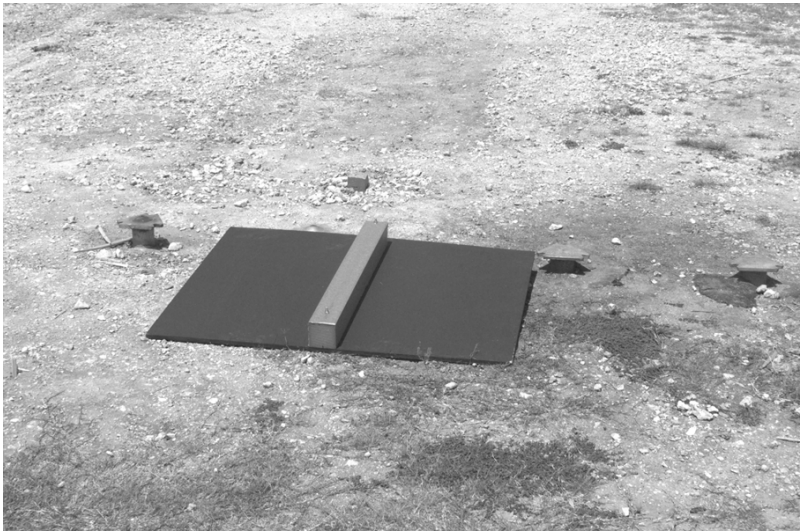
**Figure 15. Support After Test 414587-2.**

The sign support fractured near ground level, as shown in figures 14 and 15, and then into three sections. The base of the support fractured at 10 mm (impact side) and 45 mm (rear side) above ground level. The sign panel and a piece of the support separated during initial impact and came to rest near the impact point. One section of the support was 0.3 to 0.6 m long, and the other was 1.8 m long. The soil around the support was only disturbed. The support was not reusable.

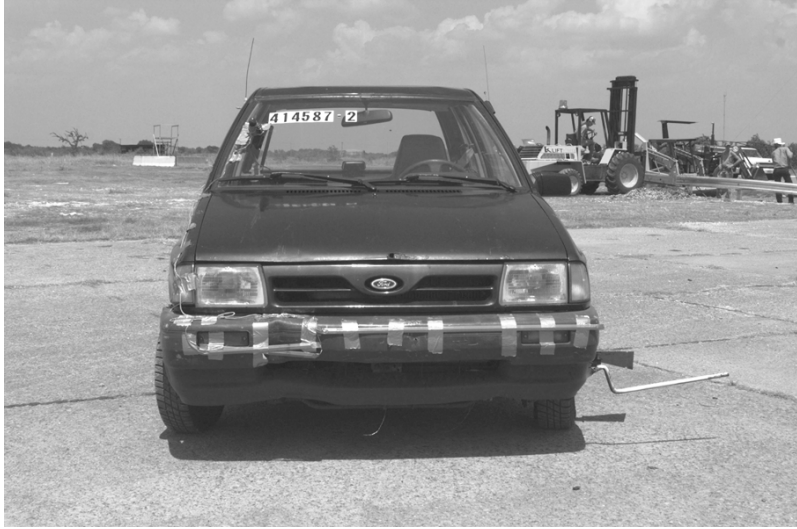
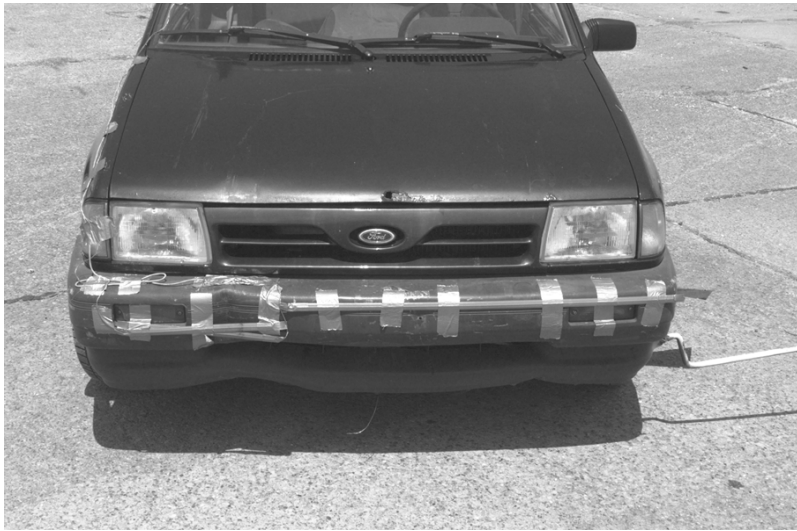
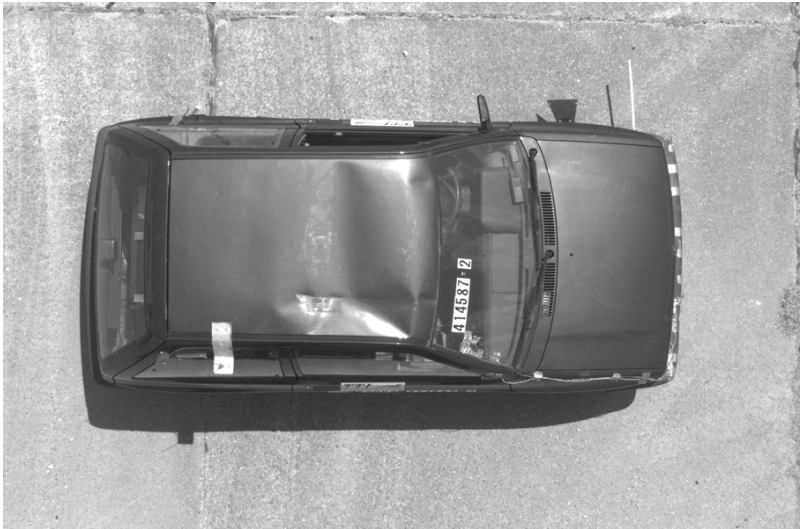
**Figure 16. Vehicle After Test 414587-2.**

Minor damage was done to the vehicle, as shown in figure 16. The right front bumper was dented in 15 mm. The roof was dented 25 mm deep in an area 700 mm in length by 900 mm wide. A scuff mark from contact with the panel was noted within the roof indentation. Maximum occupant compartment deformation was 7 mm in the rear occupant roof area.

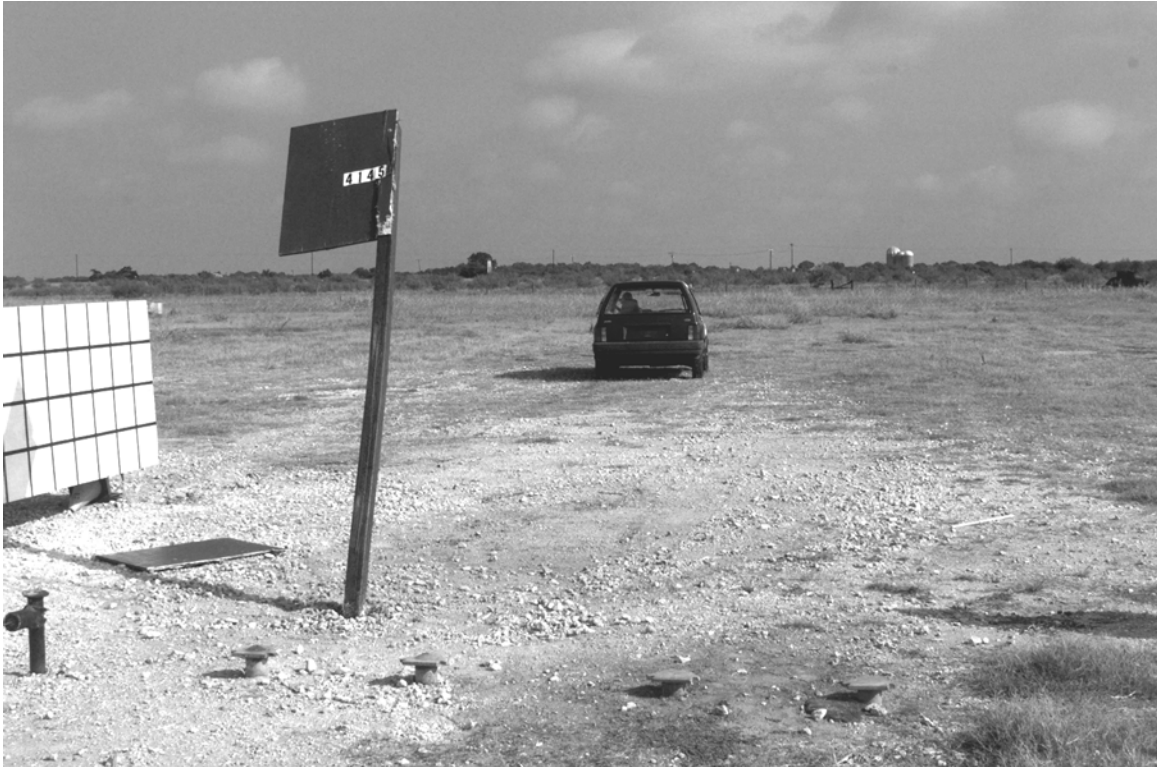
**Figure 21. After Impact Trajectory for Test 414587-3.**

Damage to the sign support is shown in [figures 21](#) and [22](#). The support had been pushed back 185 mm during the test (measured at ground level) and had a permanent displacement of

75 mm after the test (measured at ground level). The support did not rotate in the soil, but was leaning back at about a 60 degree angle. The plywood sign panel was split with one half remaining attached to the support and the other half coming to rest near the impact point.

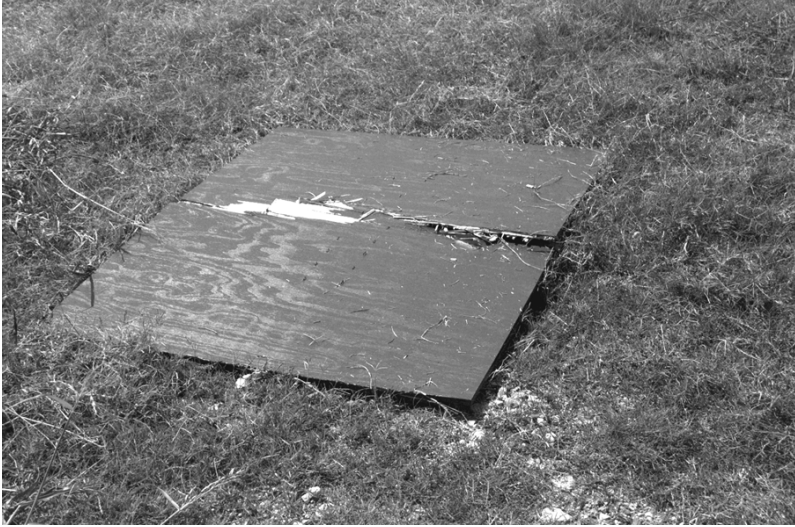
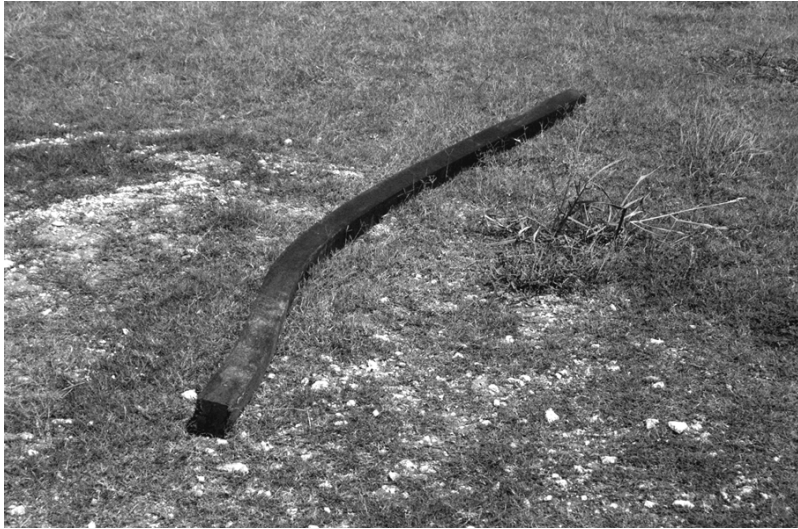
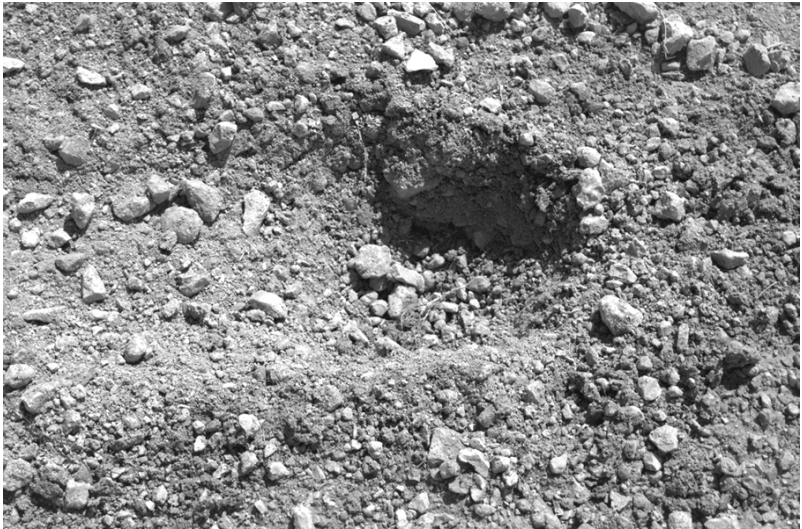
**Figure 29. Support After Test 414587-4.**

As can be seen in figures 28 and 29, the support pulled out of the ground without fracturing. The support was deformed from ground level to just above bumper height. The sign panel was split and separated from the support.

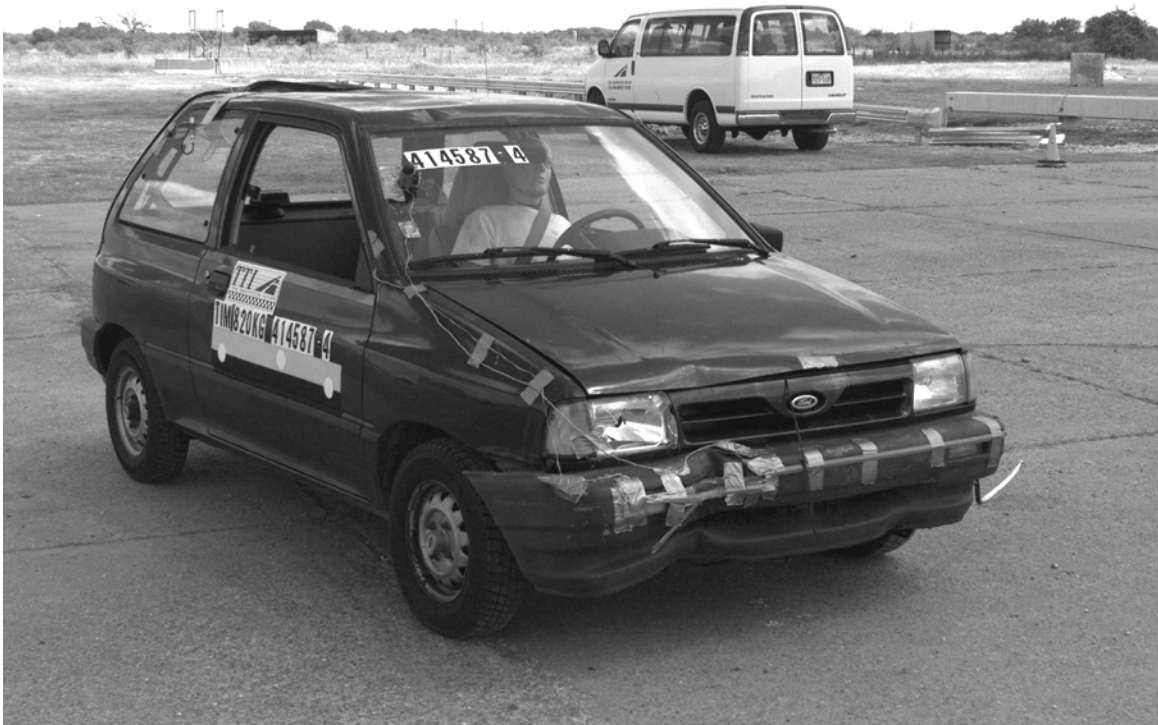
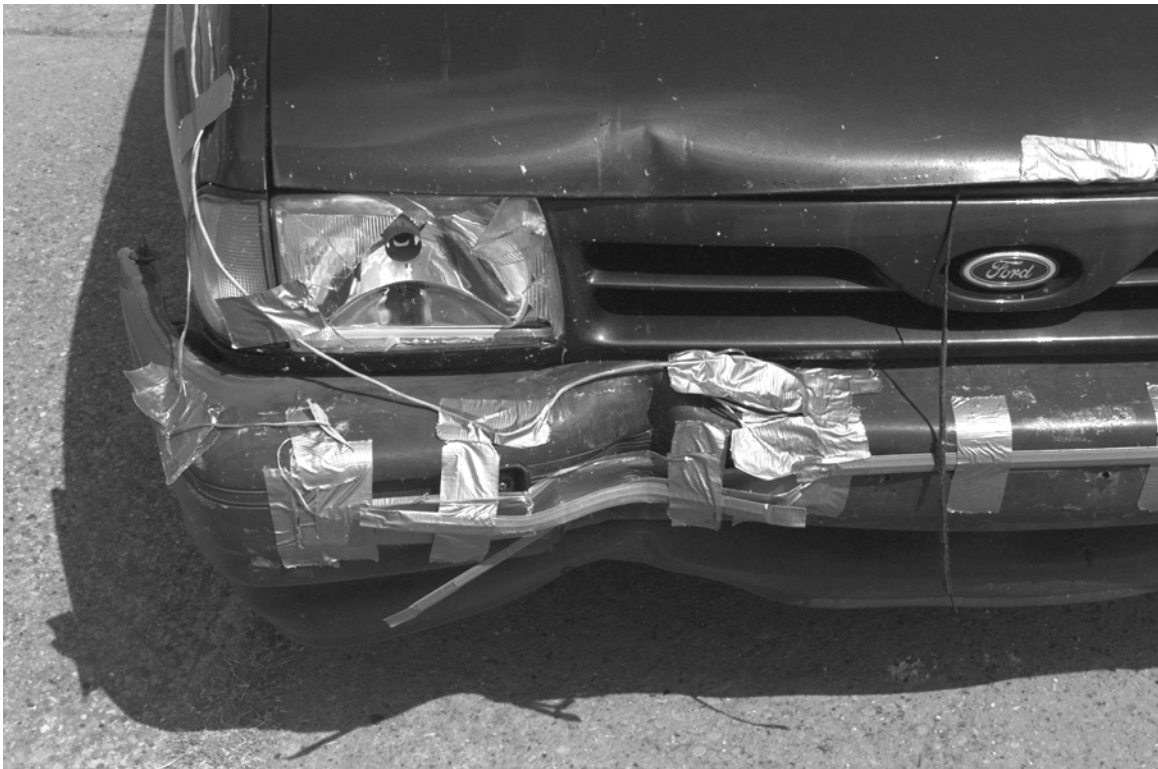
**Figure 30. Vehicle After Test 414587-4.**

Figure 30 shows the moderate damage sustained by the vehicle. The right front bumper was dented 30 mm, and the right front headlight was broken. The hood was slightly dented. A dent in the roof measuring 960 mm long by 960 mm wide by 17 mm deep was noted. The rear hatch was damaged on the right side with a gap between the body and the hatch of 120 mm. Maximum exterior crush to the right side of the vehicle was 30 mm at the bumper. Maximum occupant compartment deformation was 37 mm in the roof toward the rear of the occupant compartment. Exterior crush and occupant compartment measurements are shown in appendix B, tables 11 and 12.

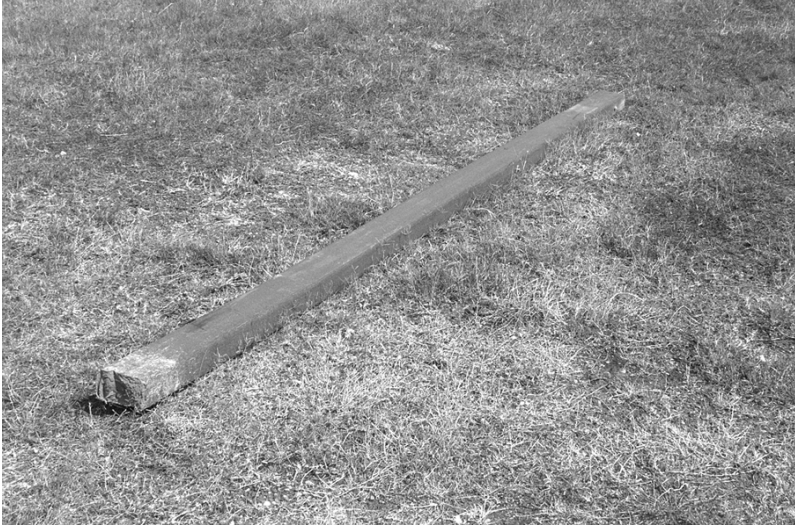
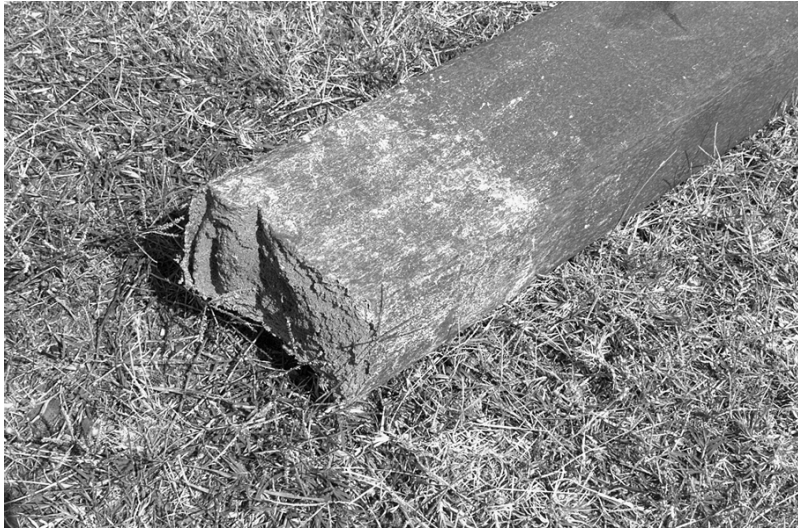
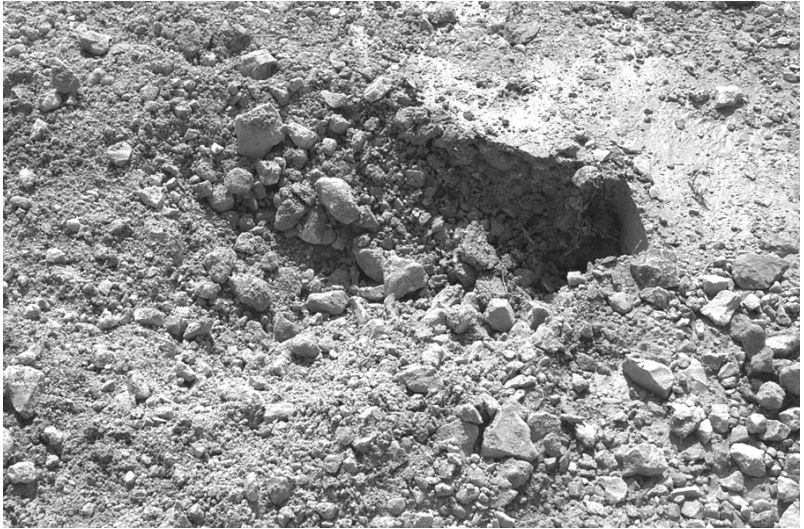
**Figure 36. Support After Test 414588-2.**

As can be seen in figures 35 and 36, the support fractured just below ground level leaving 788 mm below the ground. The sign panel was separated from the support.

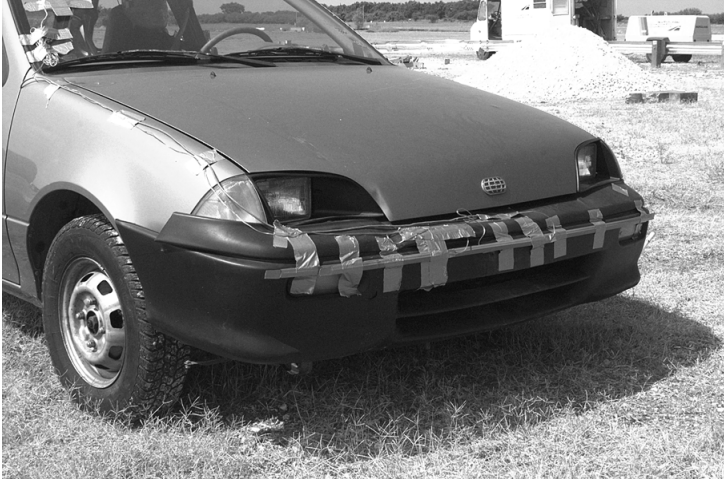
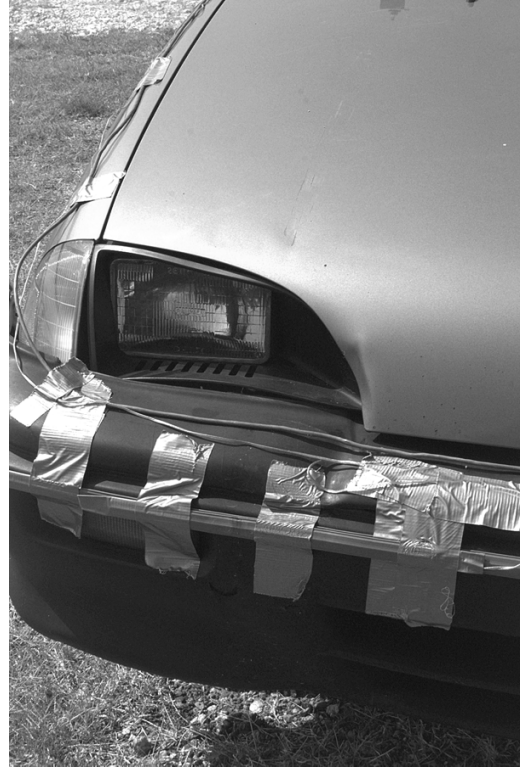
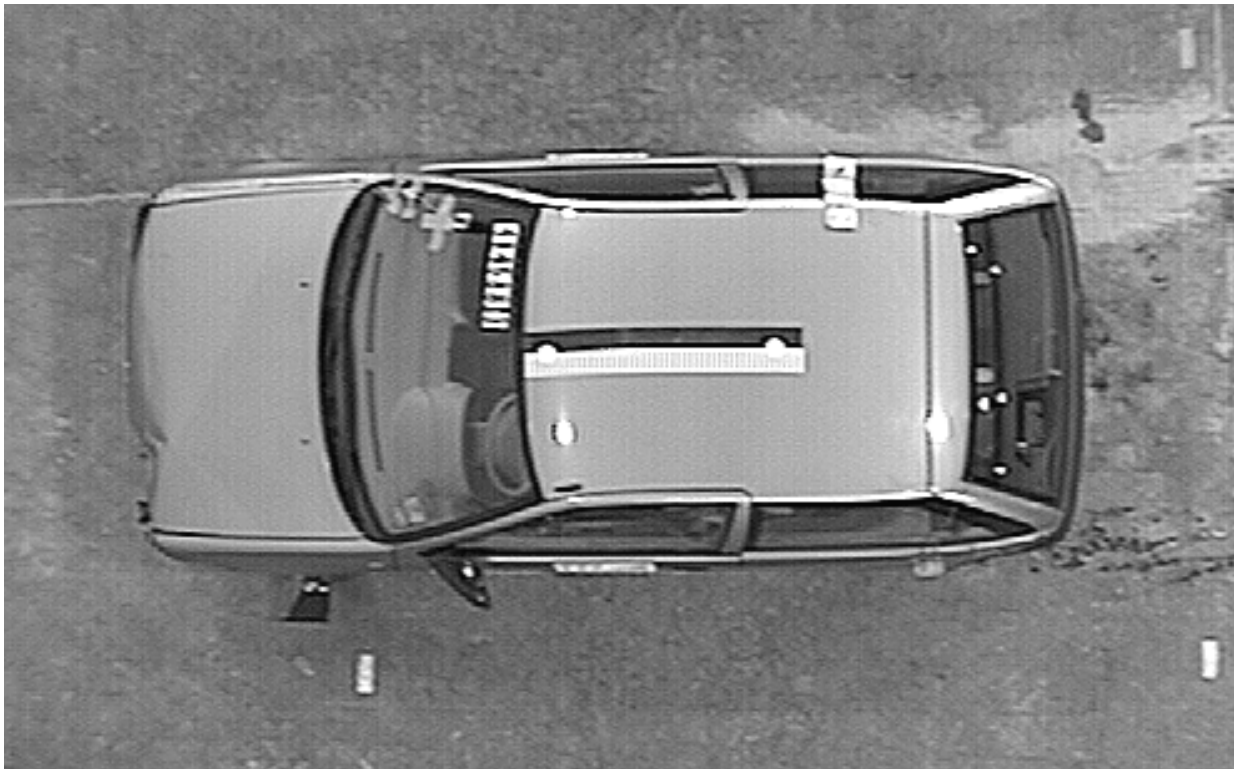
**Figure 37. Vehicle After Test 414588-2.**

As can be seen in figure 37, minimal damage was received by the vehicle. There was a small indentation in the bumper, and the hood, windshield, and passenger door were scuffed. No measurable crush occurred to the exterior of the vehicle, and no deformation of the occupant compartment occurred. Occupant compartment measurements are shown in appendix B, table 13.

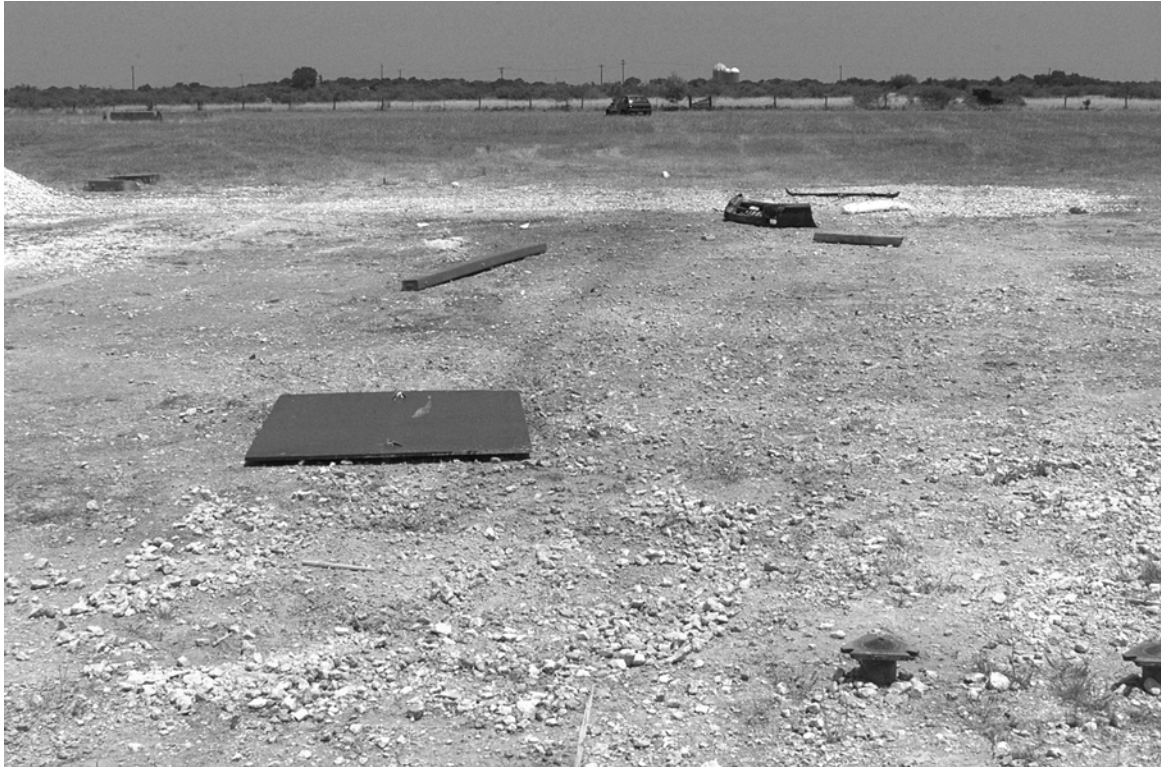
**Figure 42. After Impact Trajectory for Test 414588-3.**

As can be seen in figures 42 and 43, the support fractured into three pieces. A piece 680 mm long remained below ground. The other fragments were 920 mm long and 2920 mm long. The sign panel was separated from the support.

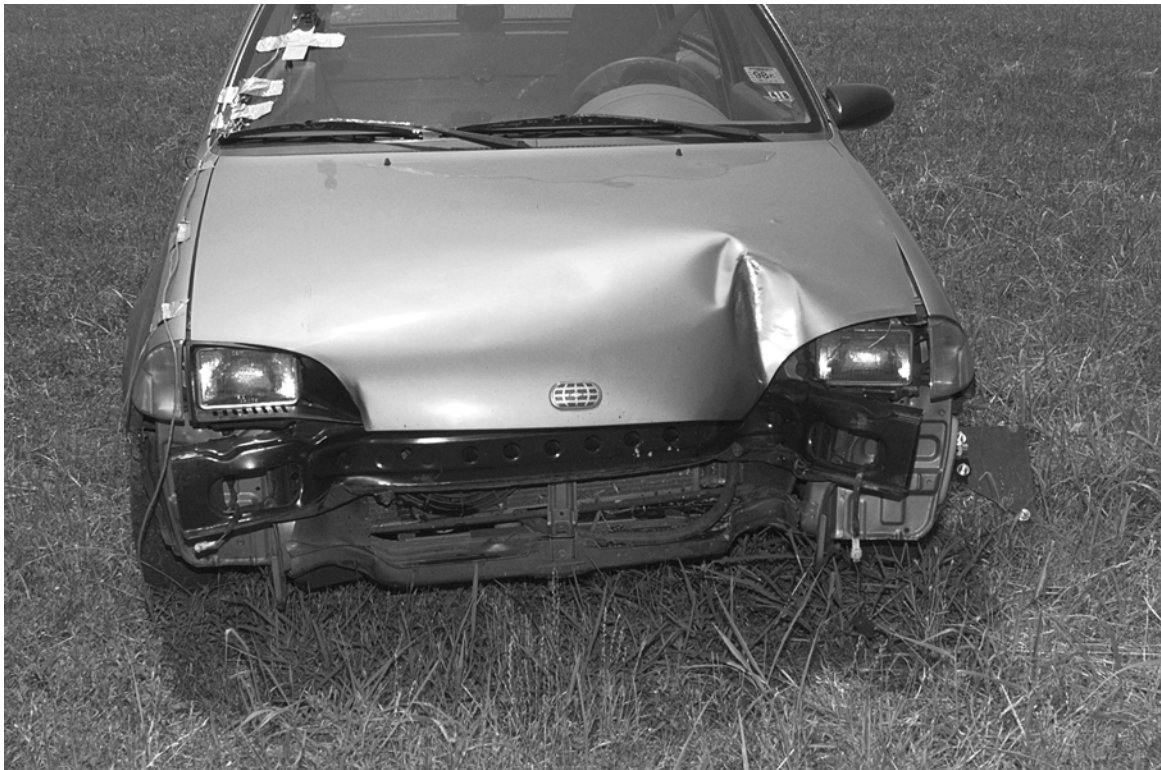
**Figure 44. Vehicle After Test 414588-3.**

As can be seen in figure 44, minimal damage was received by the vehicle. The front bumper, inner bumper, hood, and radiator support were deformed. Maximum exterior crush to the vehicle was 120 mm occurring at the left quarter point at bumper height. No deformation or intrusion of the occupant compartment occurred. Exterior crush measurements are shown in table 15.

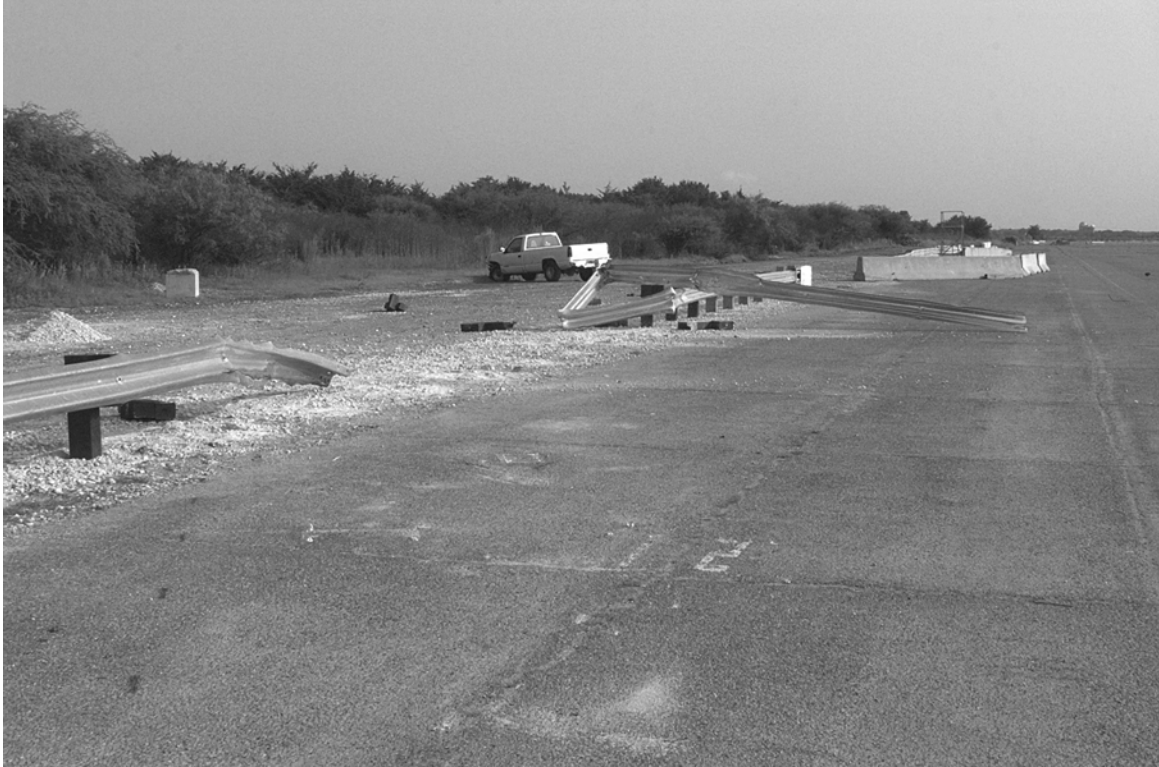
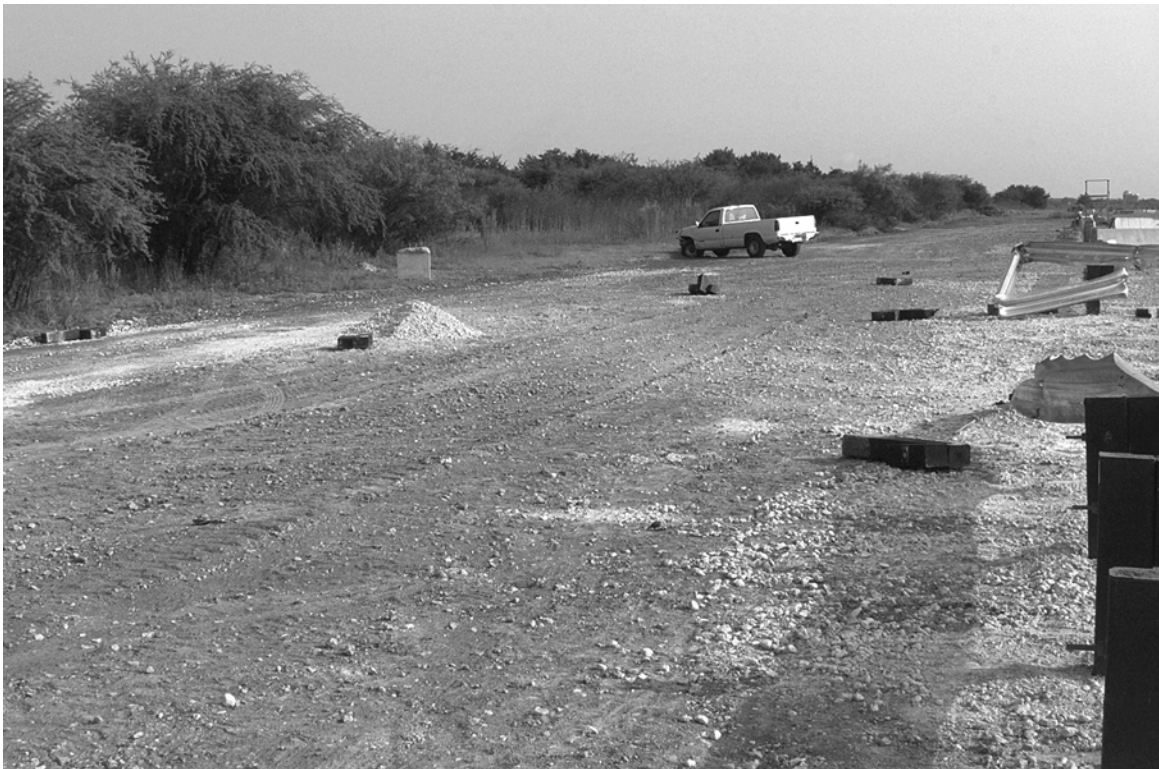
**Figure 51. After Impact Trajectory for Test 414588-1.**

The W-beam guardrail with plastic posts and blockouts sustained substantial damage as shown in figures 51 and 52. The W-beam rail element ruptured at the lower bolt holes of the connection splice at post 15. Posts 1 through 6 were disturbed, post 7 was pulled laterally 5 mm, and posts 8 through 10 were disturbed. Post 11 was displaced 10 mm in both the lateral and longitudinal directions and post 12 was displaced 20 mm longitudinally. Posts 13 through 20 were fractured. Post 21 was pulled laterally 20 mm, post 22 was pulled back 15 mm, and the blockout was rotated. The post to rail connection bolt was pulled from the rail at posts 21 and 22. Posts 23 through 29 were disturbed, and the end anchors were each pulled inward 5 mm.

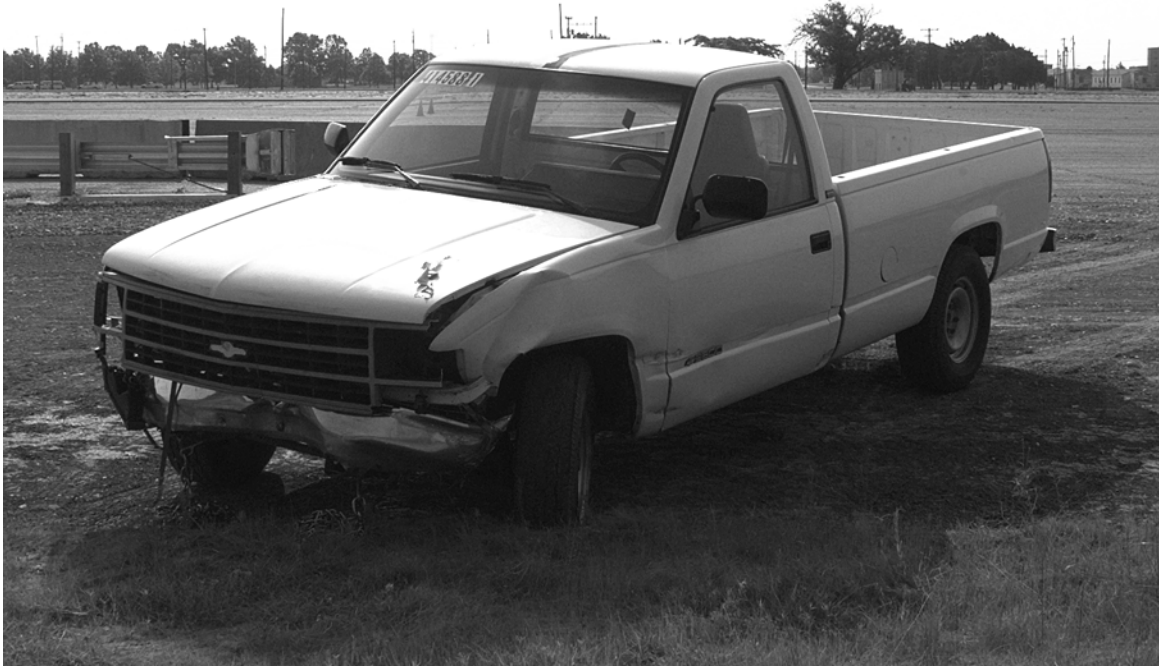
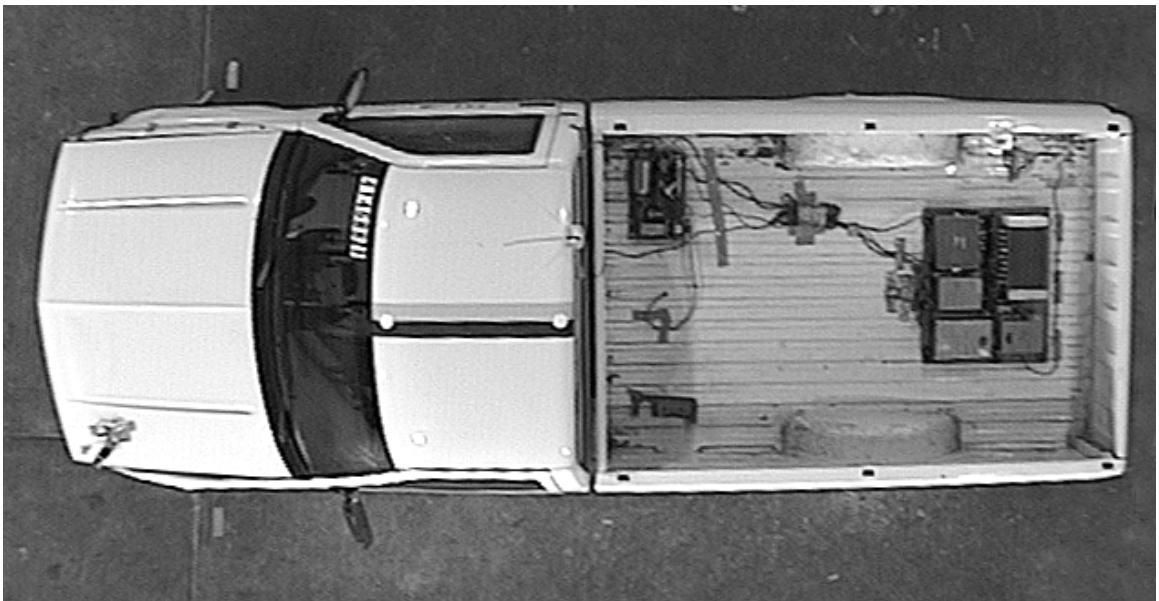
**Figure 53. Vehicle After Test 414588-1.**

The vehicle sustained moderate damage as shown in figure 53. Structural damage included the left outer tie rod and left lower A-arm. The left front tire was flat and the rim bent. The left and right front quarter panels, grill, and bumper were damaged. A dent was noted in the left corner of the cab. Scuff marks and dents were found on the left door. Maximum crush to the vehicle was 360 mm at the left front corner of the front bumper. No intrusion into the occupant compartment occurred, as shown in figure 54. Details of the vehicle damage are given in tables 16 and 17 of appendix B.

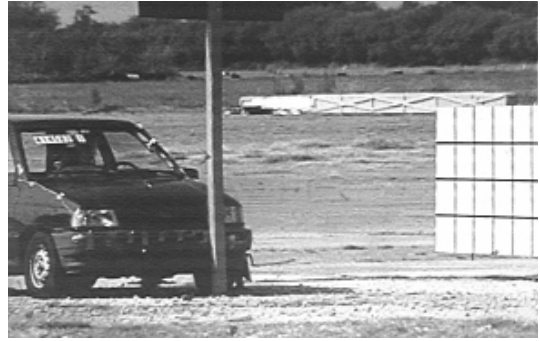
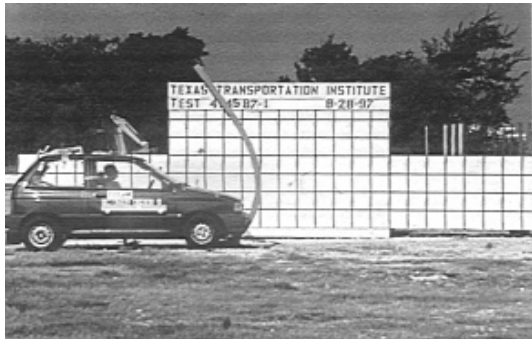
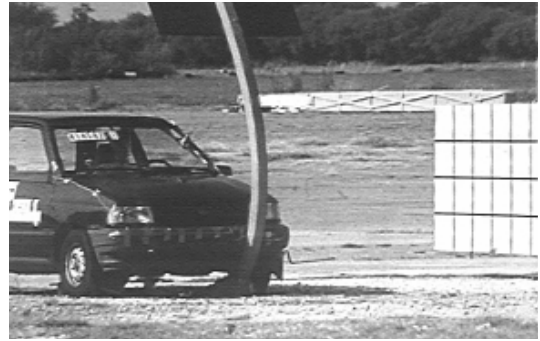
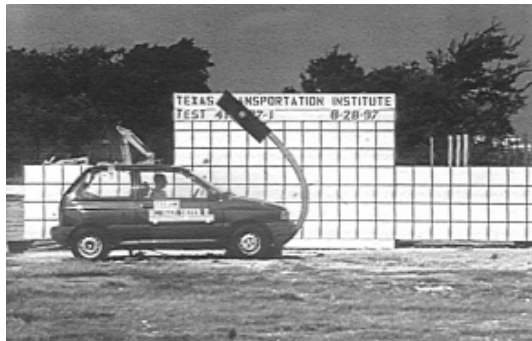
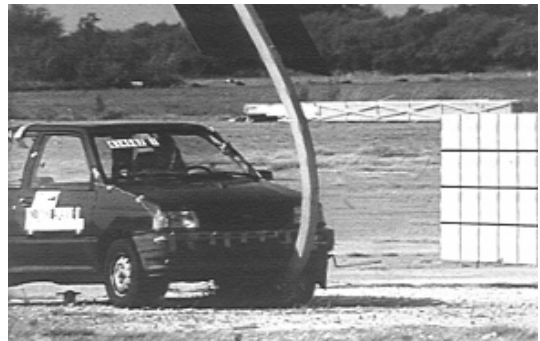
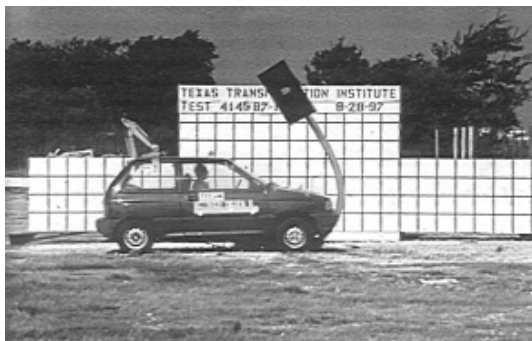
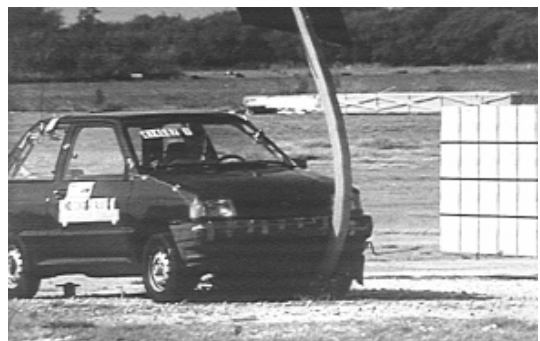
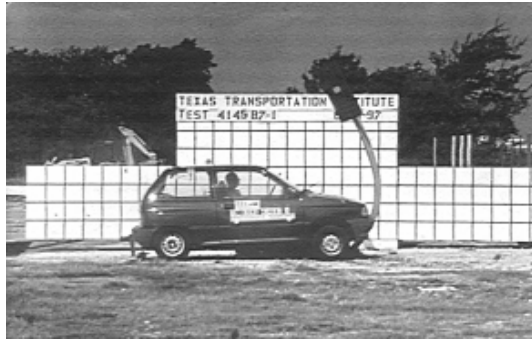
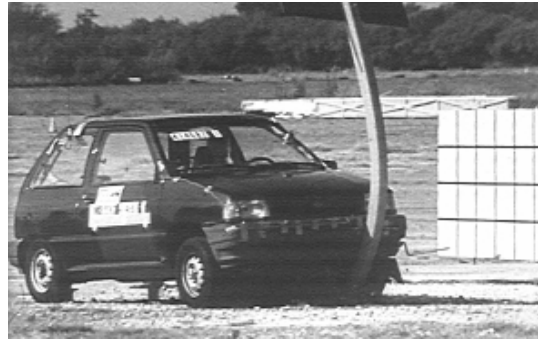
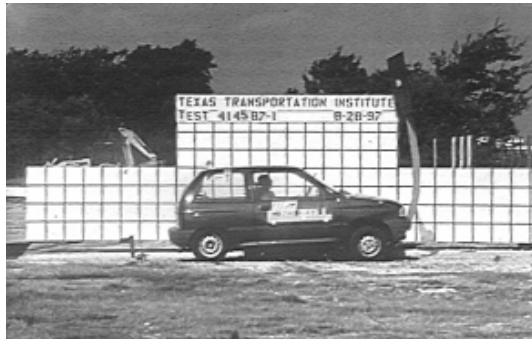
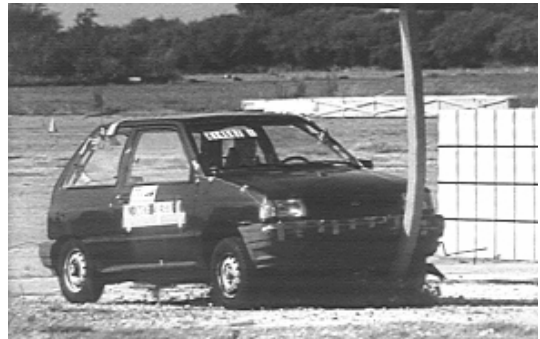
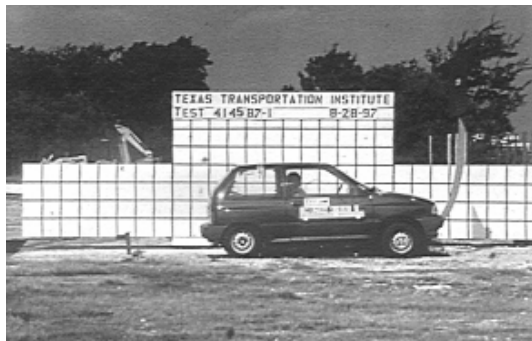
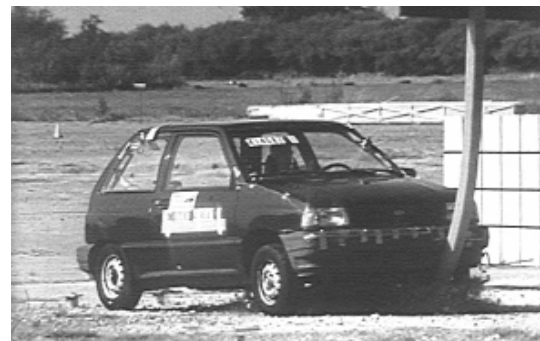
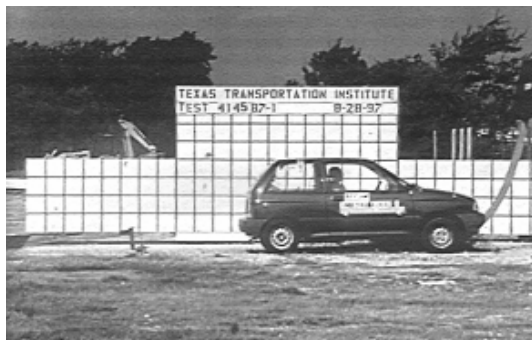
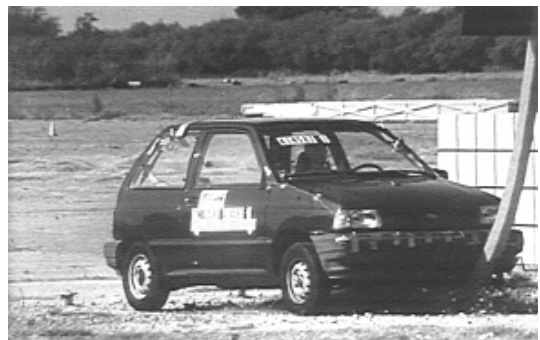
**Figure 59. Sequential Photographs for Test 414587-1 (Perpendicular and Oblique Views).**

The vehicle, traveling at 33.9 km/h, impacted the sign support at a zero degree angle, with the left quarter point of the vehicle aligned with the centerline of the support. At 0.004 s after impact, the support began to flex, and at 0.034 s the support had pulled out of the ground. At 0.119 s the post was bowed around the bumper of the vehicle in a C-shape with the ends of the support post each bent at a 45-degree angle from vertical toward the vehicle. Post-test examination of the support post showed that it had fractured 203 mm below ground. At 0.243 s the vehicle had slowed to 28.0 km/h. The support, with attached panel, was dragged along as the vehicle continued to travel forward. Brakes on the vehicle were applied at 5.3 s, bringing it to a safe and controlled stop 13.7 m downstream and 1.5 m to the left of the point of impact. The sign support came to rest under the vehicle. Sequential photographs of the impact event are presented in appendix C, [figure 59](#).
