1. Report No. FHWA/TX-01/1458-3		2. Government Accession No.		3. Recipient's Catalog No.	
4. Title and Subtitle TESTING AND EVALUATION OF RECYCLED MATERIALS IN ROADSIDE SAFETY DEVICES				5. Report Date October 2000 Resubmitted: April 2001

9. Performing Organization Name and Address Texas Transportation Institute The Texas A&M University System College Station, Texas 77843-3135				10. Work Unit No. (TRAIS)

# **TESTING AND EVALUATION OF RECYCLED MATERIALS IN ROADSIDE SAFETY DEVICES**

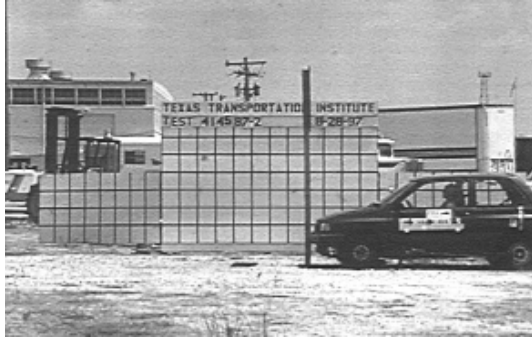
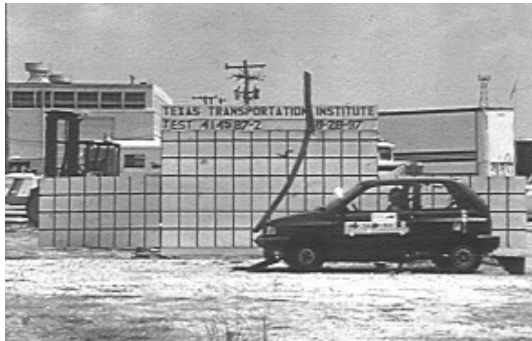
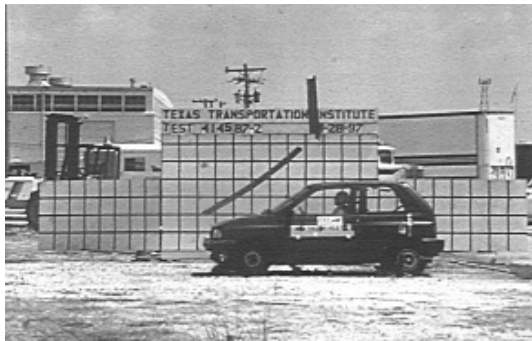
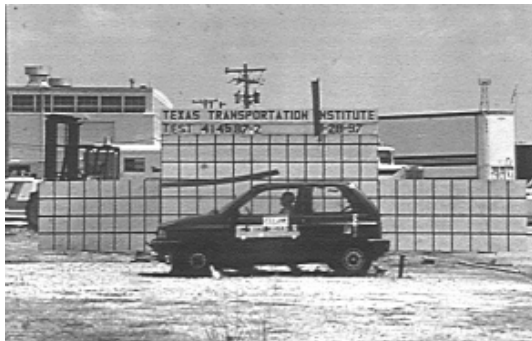
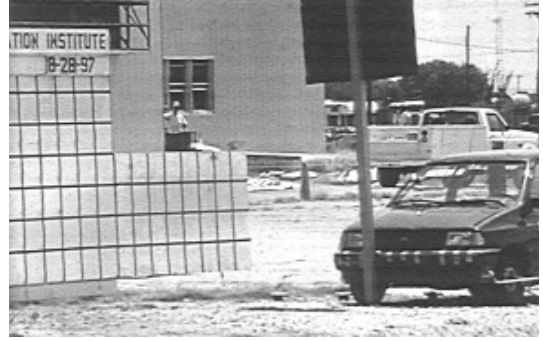
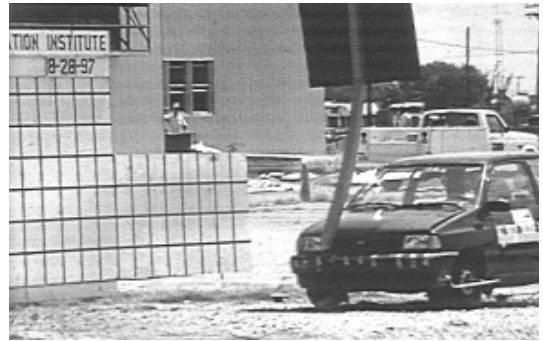
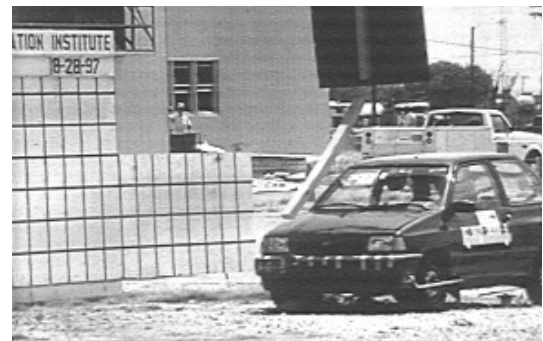
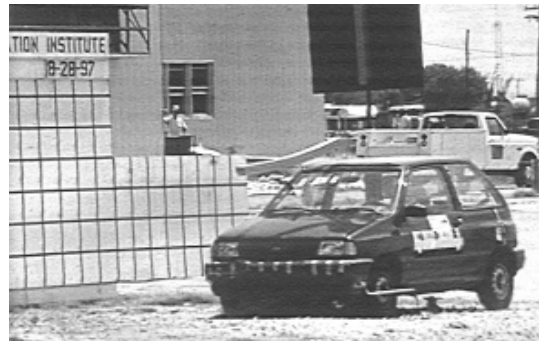
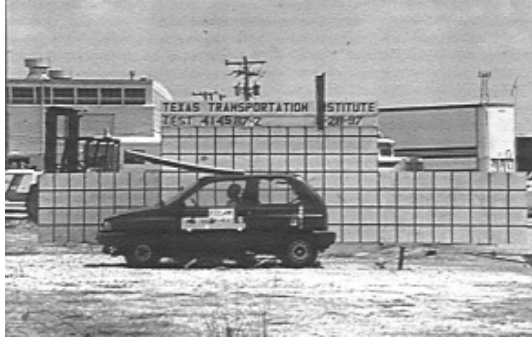
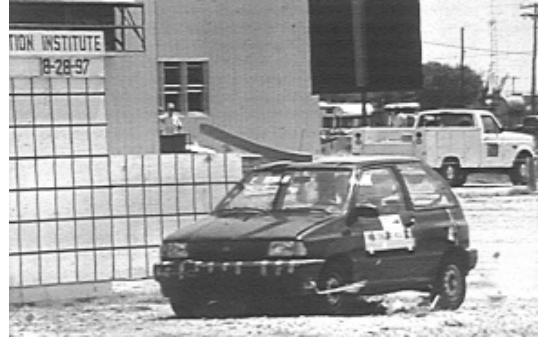
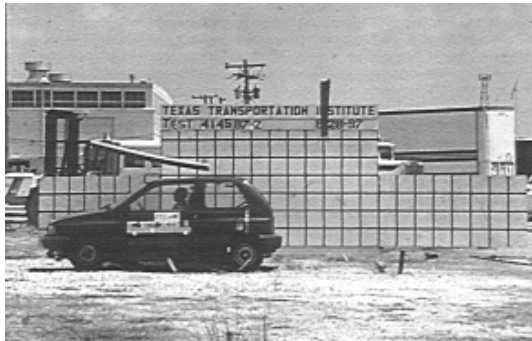
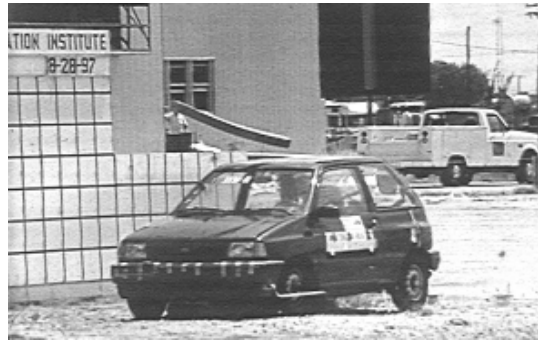
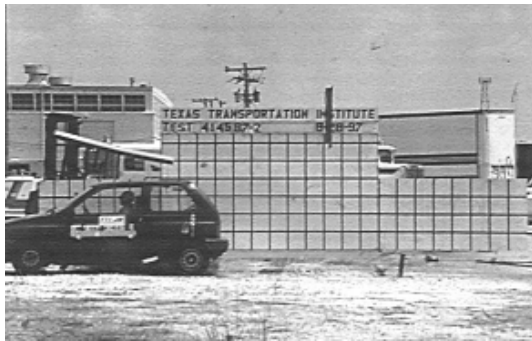
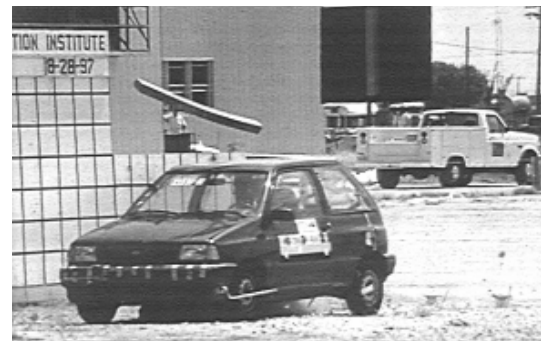
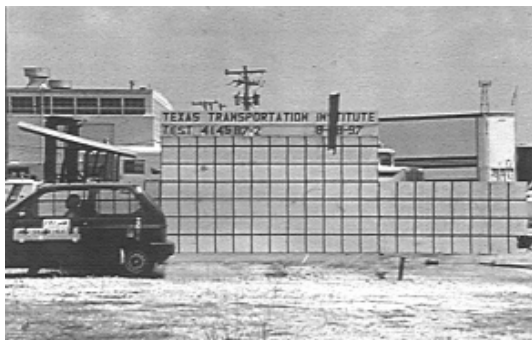
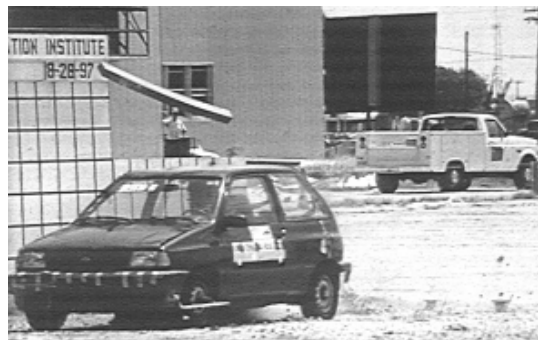
**Figure 60. Sequential Photographs for Test 414587-2 (Perpendicular and Oblique Views).**

The vehicle, traveling at 99.9 km/h, impacted the recycled plastic sign support at a zero degree angle with the right quarter point of the vehicle aligned with the centerline of the support. Shortly following impact, the support moved and began to fracture at bumper height. At 0.009 s the support simultaneously fractured into three pieces. The support began to separate from the bottom portion of the sign panel at 0.029 s and became completely detached at 0.031 s. The detached sign panel was suspended in midair momentarily before it came to rest to the right of the point of impact. By 0.044 s, the lower end of the middle section of the support, which measured 1.8 m, was impacted by the vehicle's hood and grill, causing it to rotate above the vehicle. Vehicle speed at this time was 98.7 km/h. The lower section of the support, measuring 0.3–0.6 m, became caught underneath the vehicle and traveled with the vehicle a distance of 15.2 m. At 0.095 s the upper end of the middle section of the support contacted the front section of the vehicle's roof, rebounded off at 0.132 s, and came to rest 33 m downstream from and 1.5 m to the right of the initial point of impact. The vehicle at this time was traveling at 98.0 km/h. Brakes on the vehicle were applied at 1.5 s, bringing it to a safe and controlled stop 98 m downstream from and 3.6 m to the left of the point of impact. Sequential photographs of the test period are presented in appendix C, [figure 60](#).

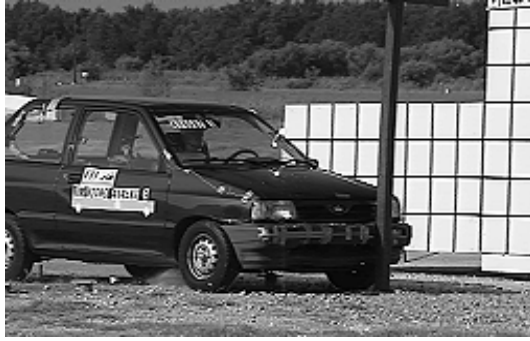
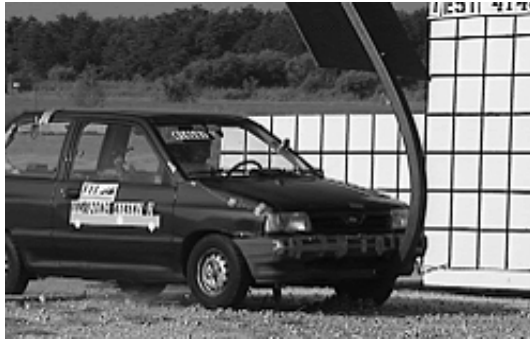
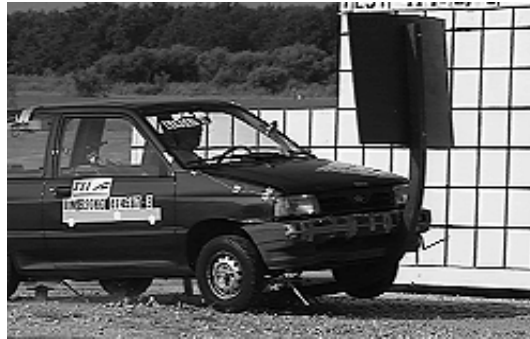
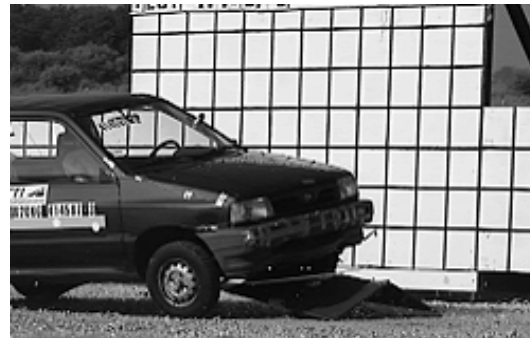
**Figure 61. Sequential Photographs for Test 414587-3 (Oblique View).**

The vehicle, traveling at 34.7 km/h, impacted the recycled plastic sign support at a zero degree angle, with the left quarter point of the vehicle aligned with the centerline of the support. Shortly after impact, the support began to deform back without fracturing at the ground. As the vehicle continued forward it rode up the deflecting sign support causing the left tire to leave the ground at 0.150 s, followed by the right tire at 0.283 s. The sign support continued to deform back without fracturing and impacted the ground at 0.300 s. The vehicle traveled over the sign panel and fractured the plywood panel in half from top to bottom. The fractured panel came to rest 0.9 m down from point of impact. The vehicle's right front tire returned to the ground at 0.350 s, followed by the left tire at 0.433 s. The support, with half of the panel still attached, returned to a near upright position. Brakes were applied at 3.35 s, bringing the vehicle to a safe and controlled stop 20.4 m down from and 0.9 m to the left of the point of impact. High speed film was not available, but sequential photographs of the test period taken from video are presented in appendix C, [figure 61](#).

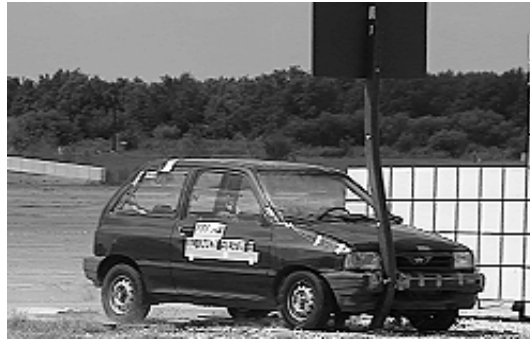
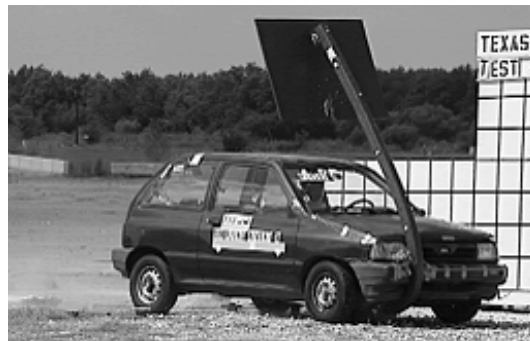
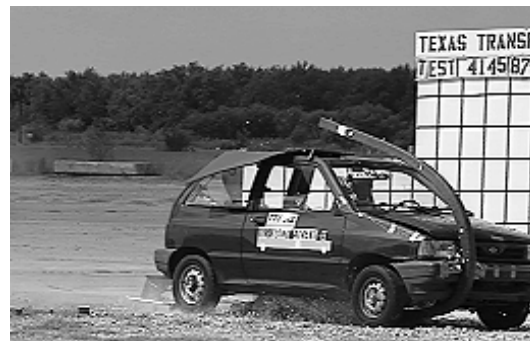
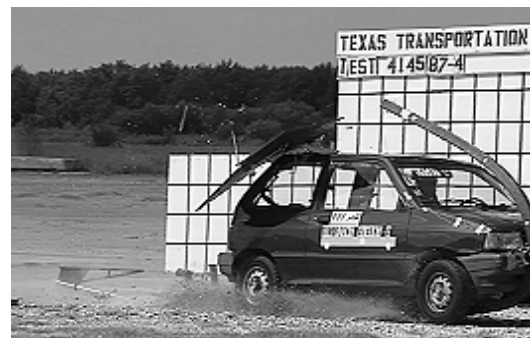
**Figure 62. Sequential Photographs for Test 414587-4 (Oblique View).**

The vehicle, traveling at 100.2 km/h, impacted the sign support at zero degrees, with the right quarter point of the vehicle aligned with the centerline of the support. Shortly following impact, the support began to deform at bumper height. At 0.017 s the support began to pull out of the ground and was clear of the ground at 0.033 s. The sign panel separated from the support at 0.050 s. At 0.066 s the bottom of the sign panel contacted the front section of the vehicle's roof approximately 25–50 mm from the top of the windshield. The sign panel was flat on top of the roof at 0.083 s and snagged the hinges of the hatchback door, causing damage to that area of the vehicle. As the panel tore free, it rotated parallel to the ground and came to rest 22.8 m down from and 6 m to the right of point of impact. By 0.117 s the upper section of plastic support that was connected to the sign panel lost contact with the vehicle. The support itself did not come in contact with the vehicle's roof or windshield and came to rest 42 m down from and 1.5 m to the right of the point of impact. At 2.0 s, brakes on the vehicle were applied, bringing it to a safe and controlled stop 64.8 m down from the point of impact. High speed film was not available, but sequential photographs of the test period taken from video are presented in appendix C, figure 62.

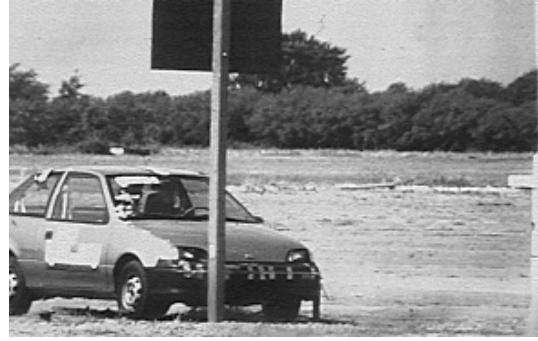
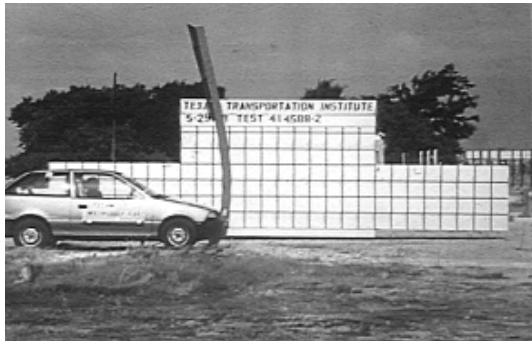
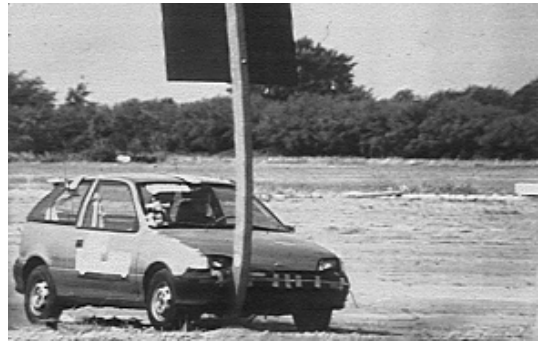
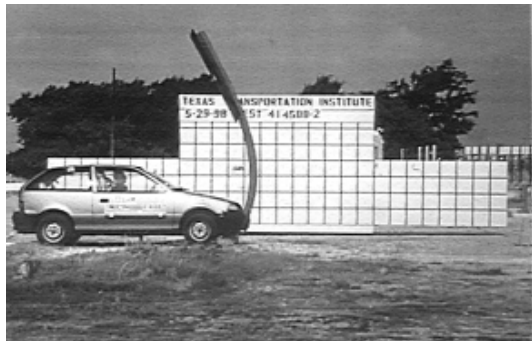
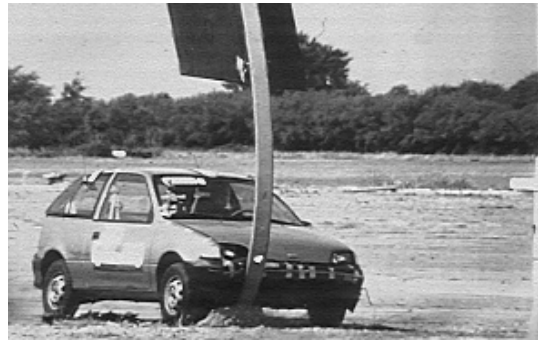
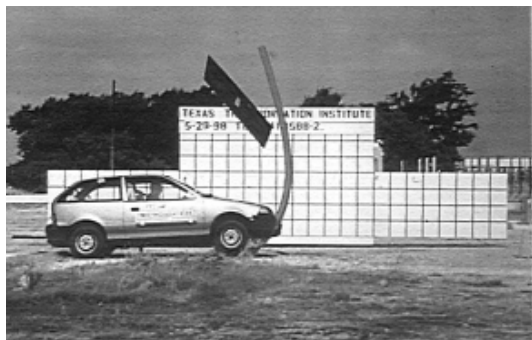
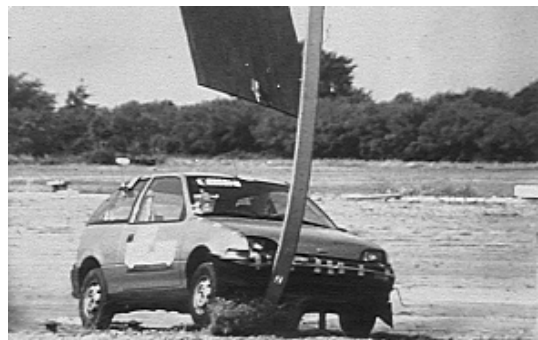
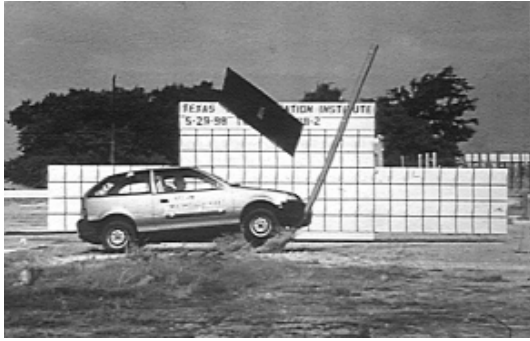
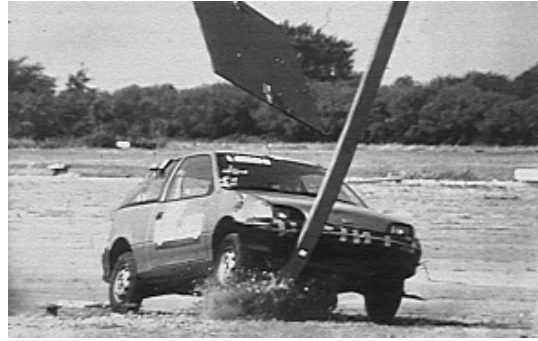
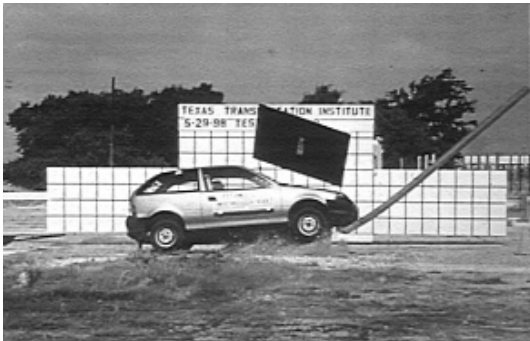
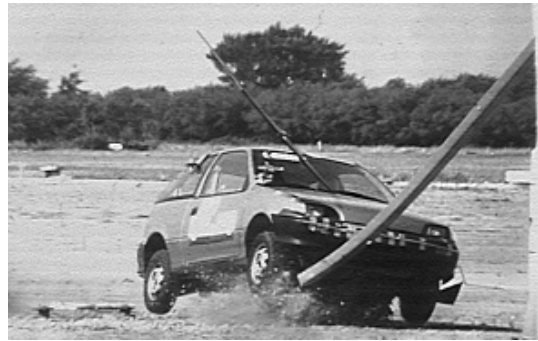
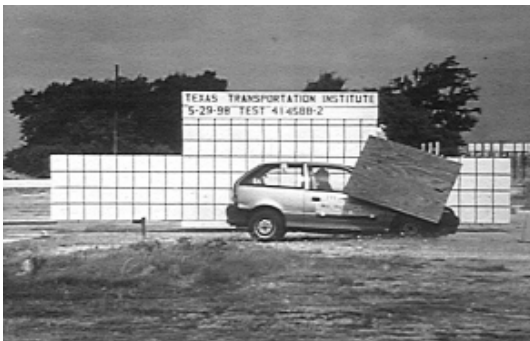
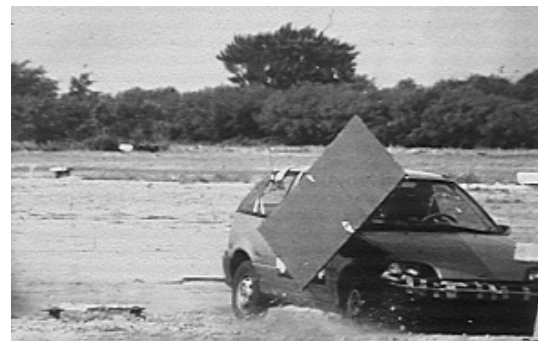
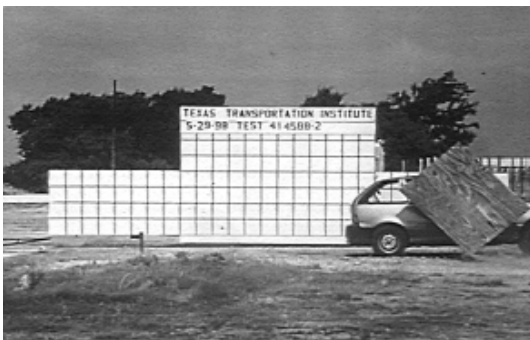
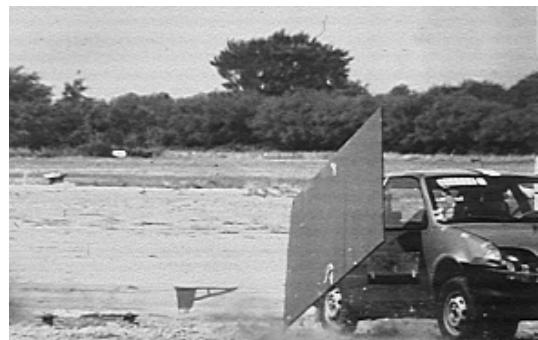
**Figure 63. Sequential Photographs for Test 414588-2  
(Perpendicular and Oblique Views).**

The vehicle, traveling at 34.7 km/h, impacted the recycled plastic support with the right quarter point at zero degree. At 0.041 s the support fractured just below ground level and began to rotate toward the vehicle. The top and bottom brackets on the sign panel sheared at 0.080 s and 0.082 s, respectively, releasing the sign panel from the support. At 0.156 s the vehicle began to ride up the support, and the left front wheel momentarily left the ground followed by the right. The vehicle lost contact with the support at 0.329 s while traveling at a speed of 22.9 km/h. As the vehicle continued forward, the corner of the plywood sign panel contacted the hood at 0.388 s and then the windshield at 0.393 s. The sign panel bounced off the vehicle at 0.440 s. At 0.536 s the left front wheel returned to the ground. At 0.704 s the sign panel lightly grazed the vehicle on the passenger door as it fell to the ground 3.6 m down from and 2.6 m to the right of the point of impact. The support traveled along with the vehicle and came to rest in front of the vehicle 30.0 m down from the point of impact. Brakes on the vehicle were not applied. The vehicle came to a safe and controlled stop on its own 26.0 m down from the point of impact. Sequential photographs of the test period are shown in appendix C, [figure 63](#).

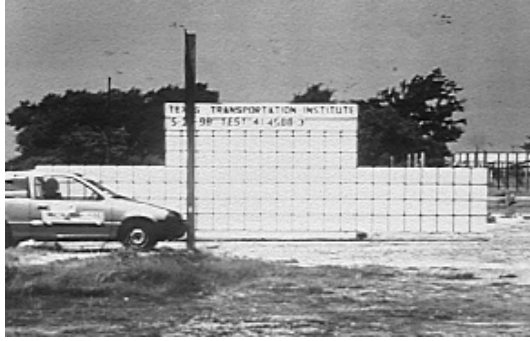
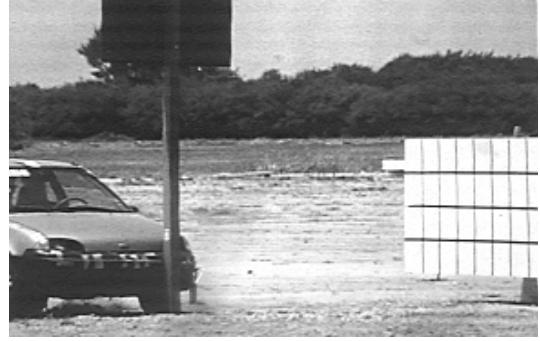
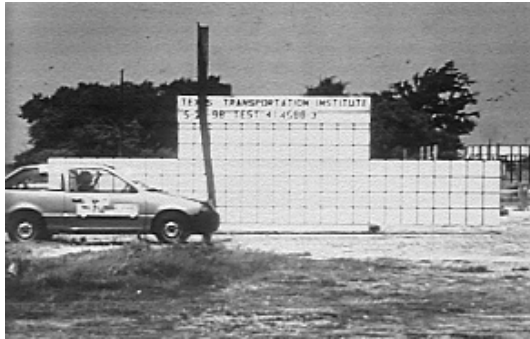
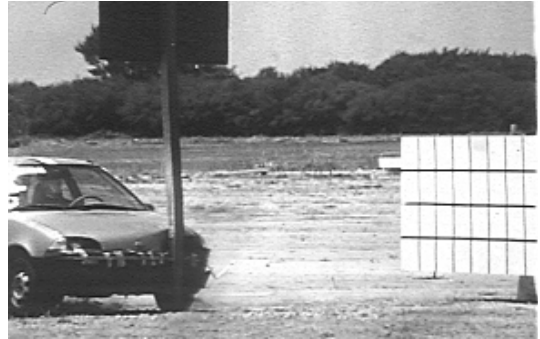
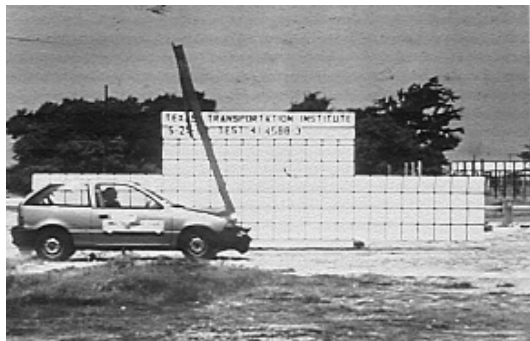
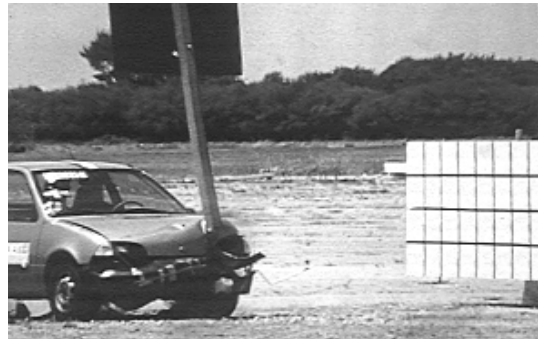
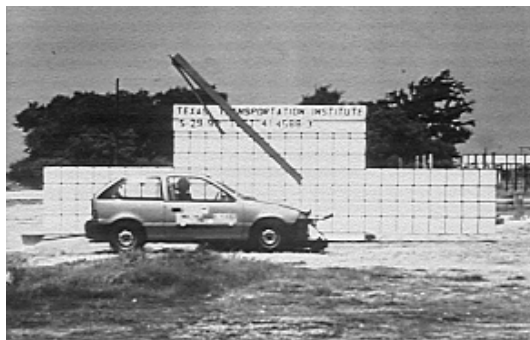
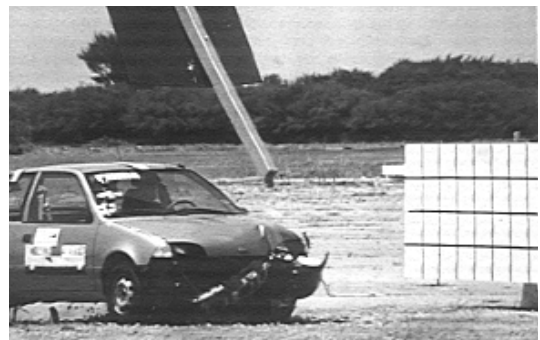
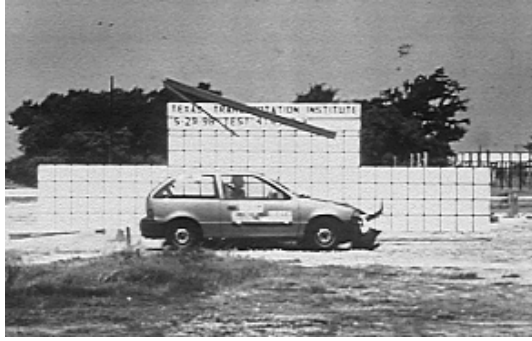
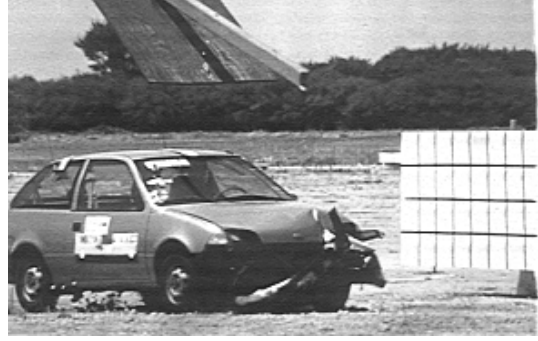
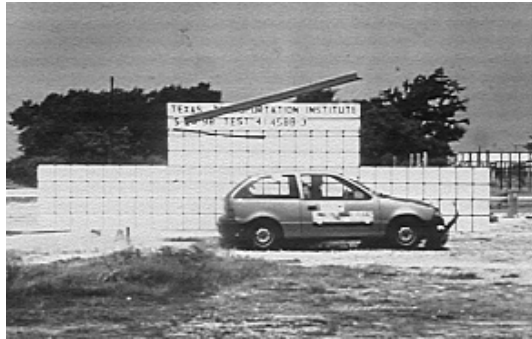
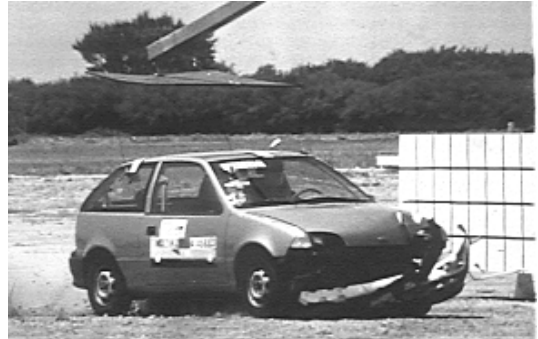
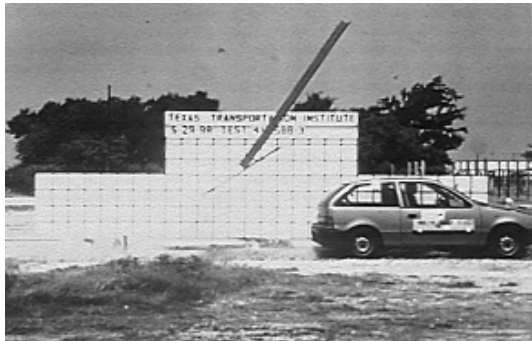
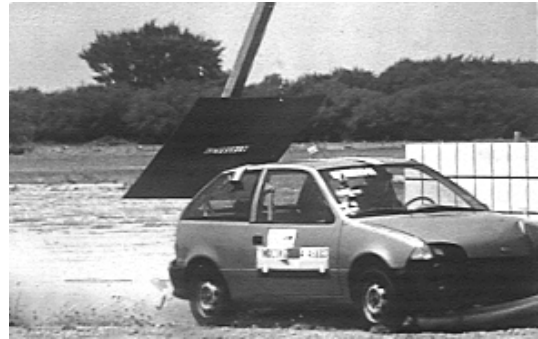
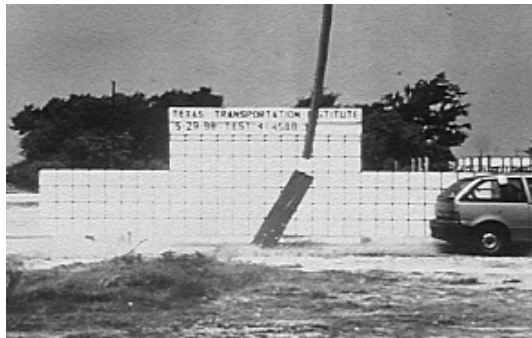
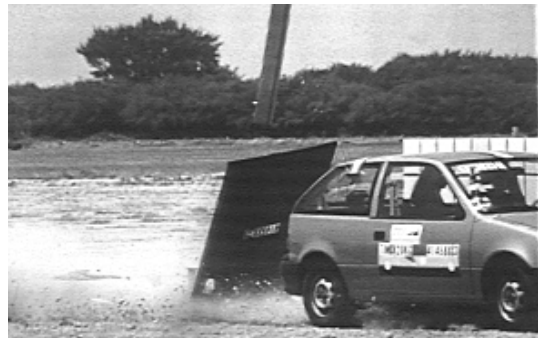
**Figure 64. Sequential Photographs for Test 414588-3  
(Perpendicular and Oblique Views).**

The vehicle, traveling at 102.3 km/h, impacted the recycled plastic support with the left quarter point at zero degree. Immediately upon impact the support moved, and by 0.019 s the support had pushed through the soil at ground level. At 0.024 s the support fractured near hood height of the vehicle, and the lower bracket attaching the sign panel to the support failed. The support fractured at a second location below ground level at 0.032 s. At 0.046 s the lower segment of the fractured post, which was 920 mm long, contacted the ground and bounced in front of the vehicle. The vehicle lost contact with the support while traveling at a speed of 95.5 km/h. At 0.112 s the upper bracket of the sign panel failed, causing the plywood panel to separate from the support. The upper fragment of the support was parallel over the roof of the vehicle at 0.136 s. This fragment was 2920 mm long and eventually came to rest 10.5 m down from and 2.2 m to the left of the point of impact. The smaller fragment traveled along with the vehicle and came to rest 13.0 m down from and 1.7 m to the right of the point of impact. Brakes on the vehicle were applied at 1.75 s after impact as the vehicle exited the test site. The vehicle subsequently came to a safe, controlled stop 86.5 m down from and 7.0 m to the left of the point of impact. Sequential photographs of the test period are shown in appendix C, [figure 64](#).

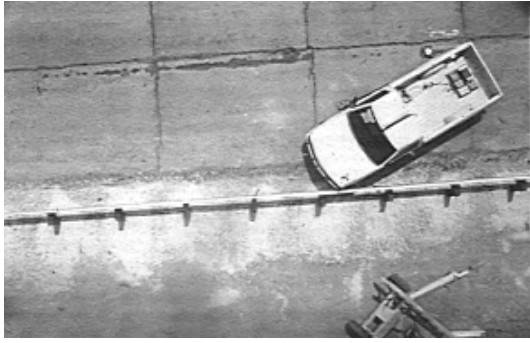
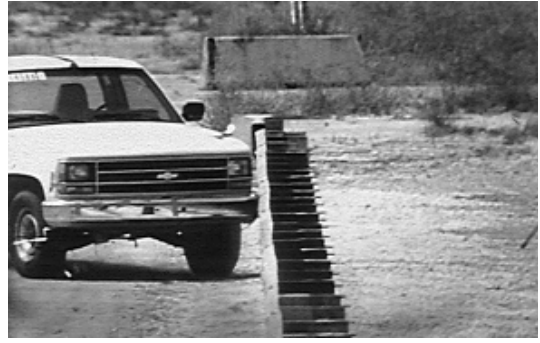
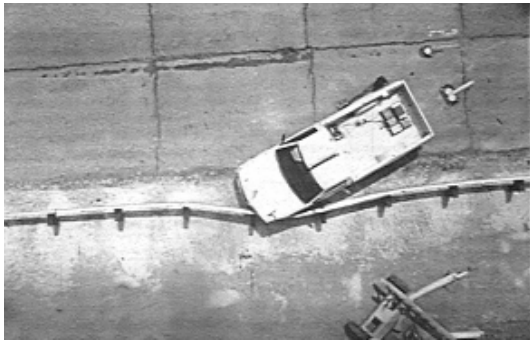
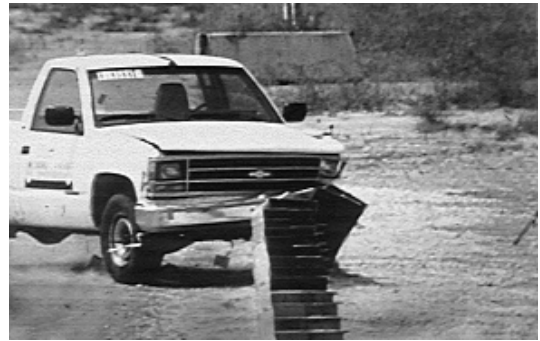
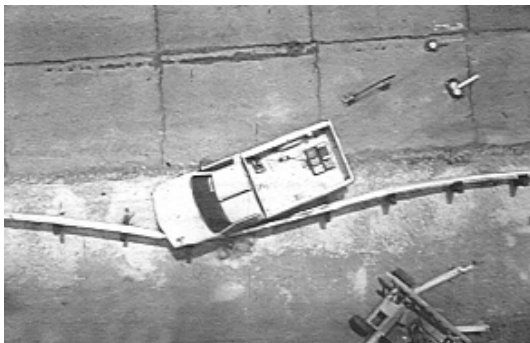
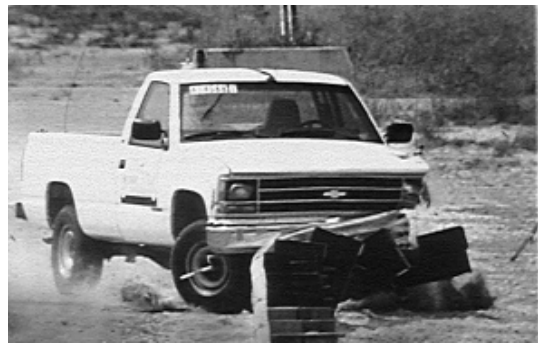
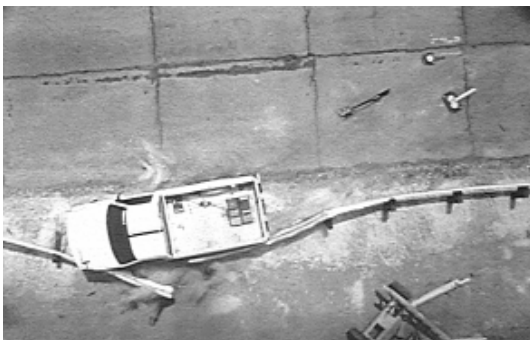
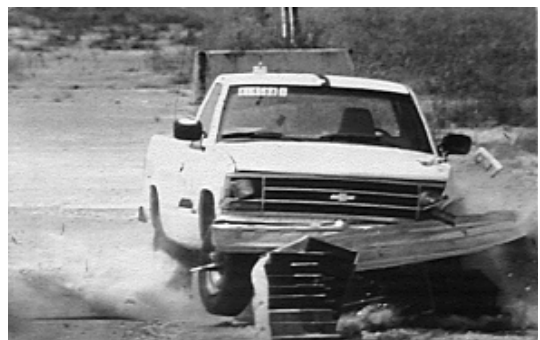
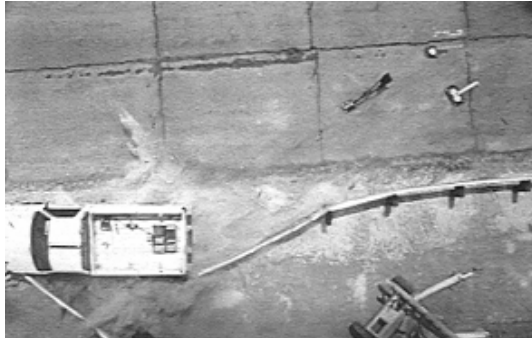
**Figure 65. Sequential Photographs for Test 414588-1 (Overhead and Frontal Views).**

The vehicle, traveling at 100.6 km/h, impacted the guardrail at 26.5 degrees. Initial contact was 330 mm upstream of post 13. Upon impact the rail element moved as posts 12 and 13 began to deflect. At 0.020 s the front of the vehicle contacted and fractured post 13. The vehicle began to redirect at 0.047 s. At 0.079 s post 14 fractured in advance of the vehicle. Post 15 and post 16 both fractured in advance of the vehicle at 0.114 s and 0.143 s, respectively. Post 17 fractured at 0.177 s. At 0.206 s the rail ruptured at a splice at the location of post 15. Post 18 fractured 940 mm from the top about its strong axis but remained upright, supported by the rail. At 0.288 s an elbow formed as the ruptured rail bent around post 18. At 0.539 s the ruptured rail and the vehicle contacted post 19 and fractured the post about its weak axis. The vehicle contacted post 20 at 0.692 s, causing the post to fracture about its weak axis. At 0.866 s the separated rail section swung over the posts. The vehicle continued traveling through the guardrail system behind the test installation. Brakes on the impacting vehicle were applied at 5.4 s. The vehicle remained upright and subsequently came to rest 45.7 m down from impact and 13.7 m behind the installation. Sequential photographs of the test period are shown in appendix C, figures 65 and 66.
