EVALUATION OF BREAKAWAY LIGHTPOLES
FOR USE IN HIGHWAY MEDIANS

Research Report 146-5

A Joint Report From
Research Study Number 2-8-68-146
Studies of Field Adaptation
of Impact Attenuation Systems
and
Research Study Number 2-8-69-137
Roadway Illumination Systems

May, 1972

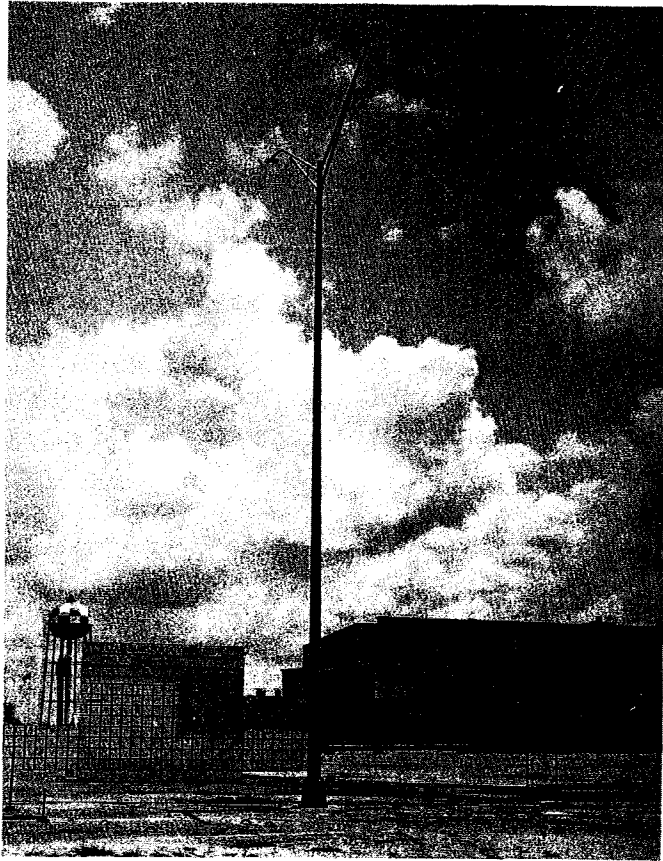
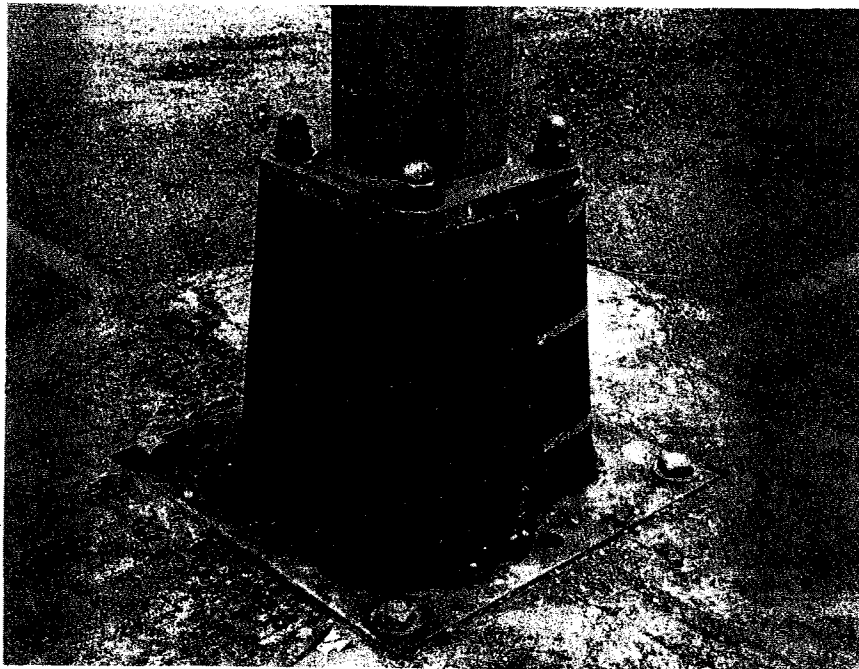
FIGURE 1, LUMINAIRE SUPPORT AND BASE BEFORE TEST LS-1.

This test simulated a relatively lightweight vehicle striking the support at 45 mph and 20 degrees to the direction of the roadway. The octagonal galvanized pole was mounted on a frangible aluminum transformer base as shown in Figure 1.

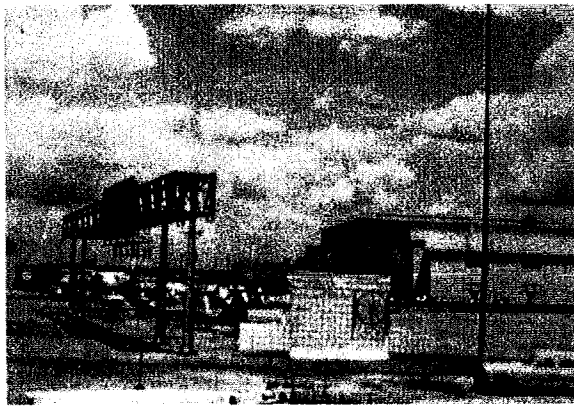
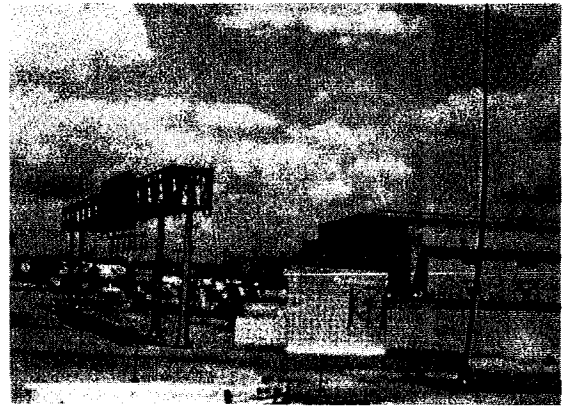
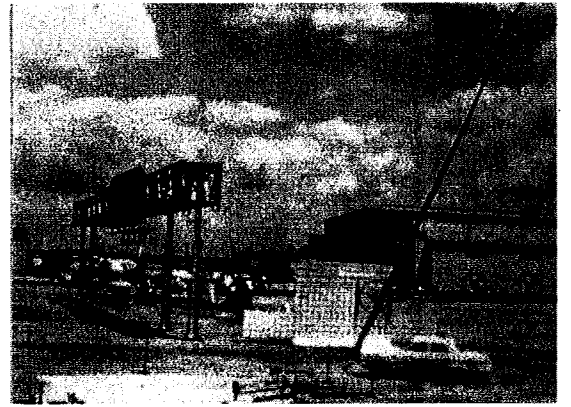
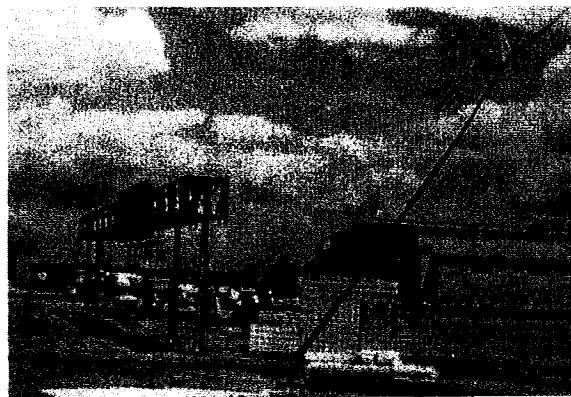
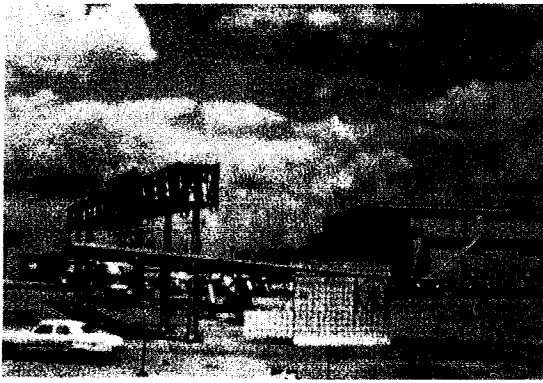
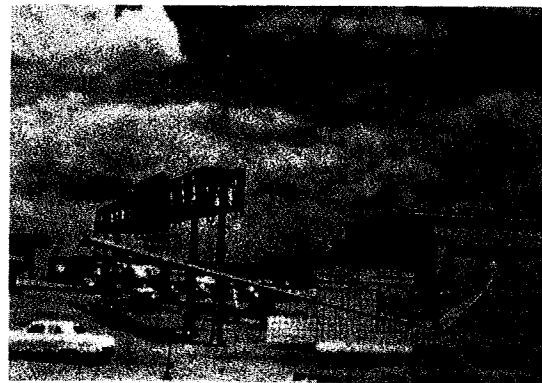
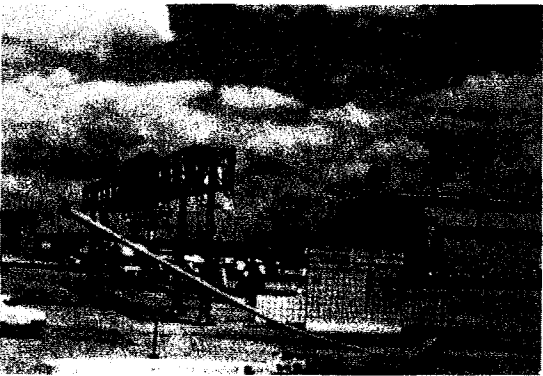
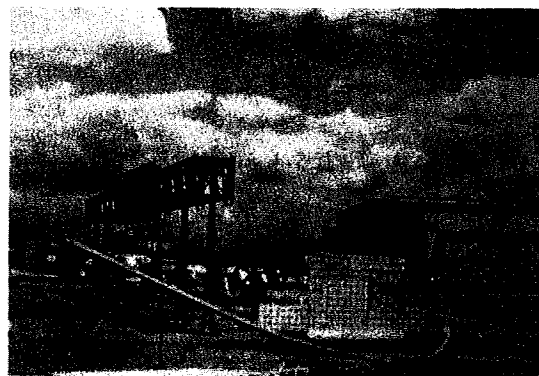
FIGURE 2, SEQUENTIAL PHOTOGRAPHS OF TEST LS-1 (Continued).

The vehicle contacted the pole 18 inches to the right of the vehicle's centerline, but the base shattered, allowing the support to rotate up and clear the vehicle as intended. Sequential photographs of the test are shown in Figure 2. Figure 3 shows the fragmented base after the test. The front of the vehicle before and after the impact is shown in Figure 4. The vehicle sustained a residual deformation to the right front of 0.6 ft.

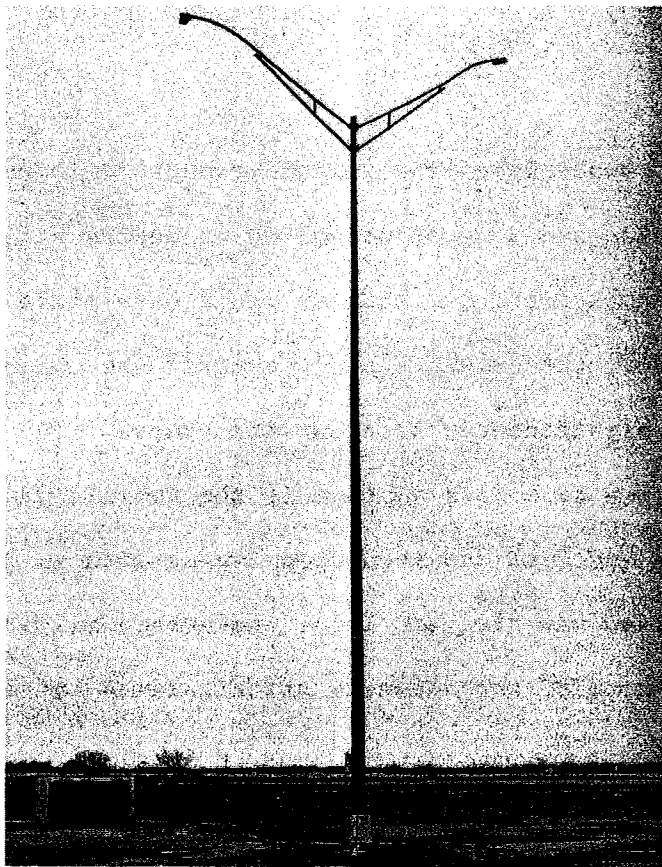
FIGURE 6, LUMINAIRE SUPPORT AND BASE BEFORE TEST LS-2.

The cast aluminum transformer base, shown in Figures 6 and 7, shattered as expected and the pole rotated up and cleared the vehicle as the vehicle continued on its course. Sequential photographs of the test are shown in Figure 8.

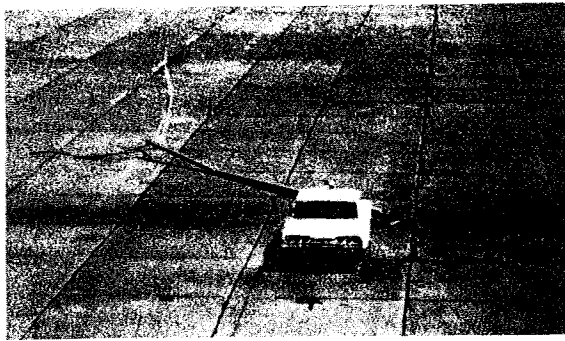
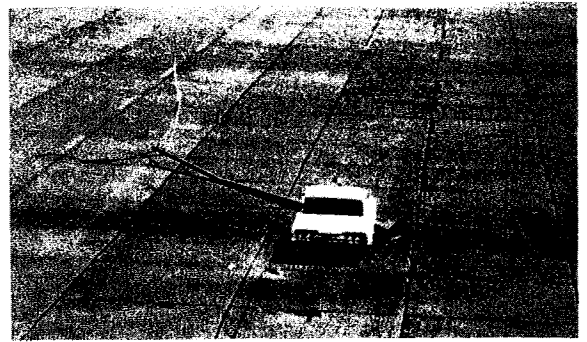
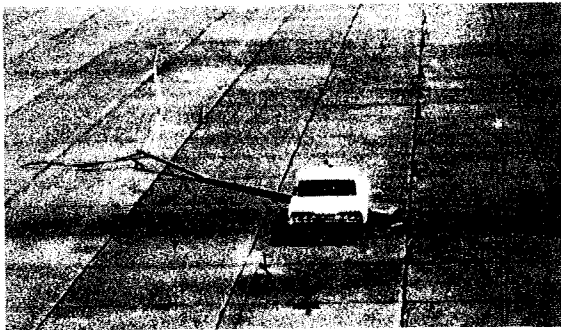
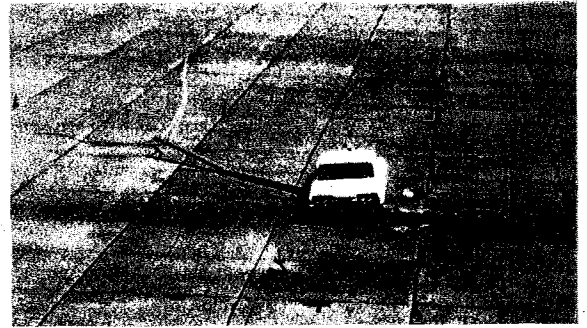
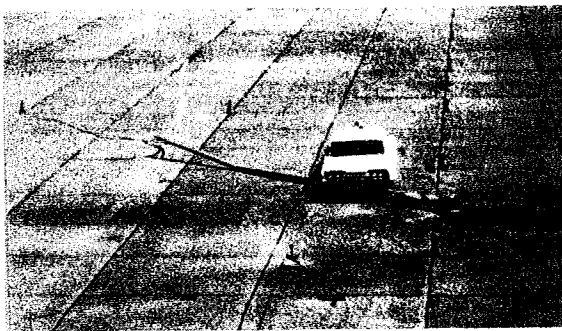
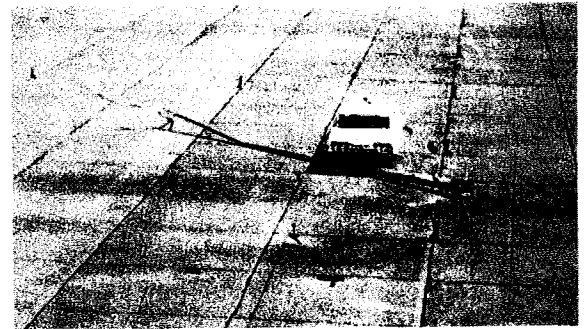
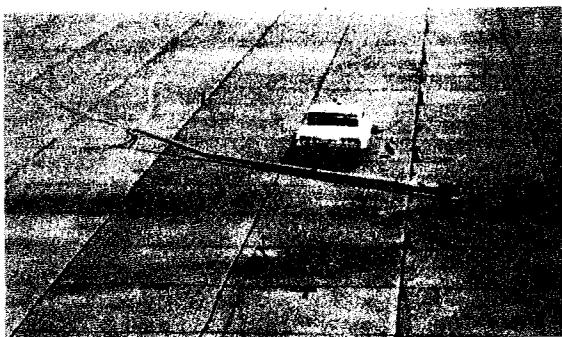
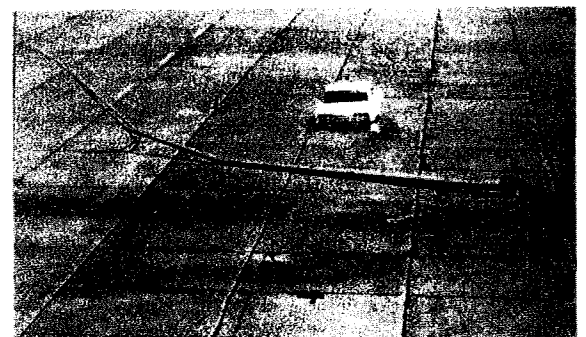
FIGURE 13, SEQUENTIAL PHOTOGRAPHS OF TEST LS-3.

The luminaire support was pushed around to an angle of 85 degrees to the roadway, and extended 25 feet into the traffic lanes after the test. Note in Figure 13 that the vehicle did not contact the fragmented base, but ran over the shaft only.

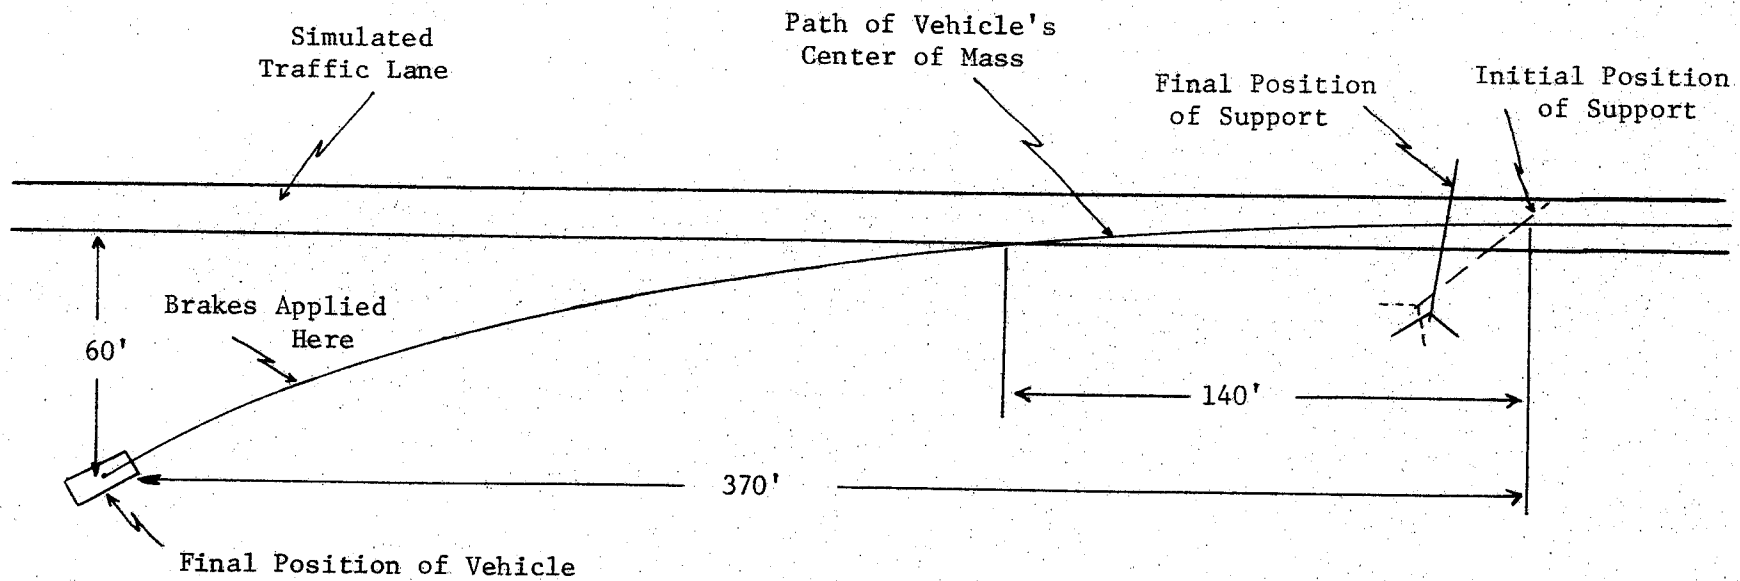
FIGURE 16, PATH OF VEHICLE IN TEST LS-3.

If a medium size vehicle encounters a support in its traffic lane and strikes it with all wheels on the pole shaft (not straddle the base and not attempt to maneuver) at 60 mph, it may be able to continue straight ahead until control is regained. However, no firm conclusions can be drawn from one test. The support struck in such a manner would possibly be shifted into the adjacent traffic lane and thereby furnish a further hazard to other traffic.
