1. Report No. FHWA/TX-01/1792-2		2. Government Accession No.		3. Recipient's Catalog No.	
4. Title and Subtitle IMPACT PERFORMANCE EVALUATION OF WORK ZONE TRAFFIC CONTROL DEVICES				5. Report Date December 2000

6. Performing Organization Code	
7. Author(s) Roger P. Bligh, D. Lance Bullard, Wanda L. Menges, and Sandra K. Schoeneman				8. Performing Organization Report No. Report 1792-2

IMPACT PERFORMANCE EVALUATION OF WORK ZONE TRAFFIC CONTROL DEVICES

December 2000

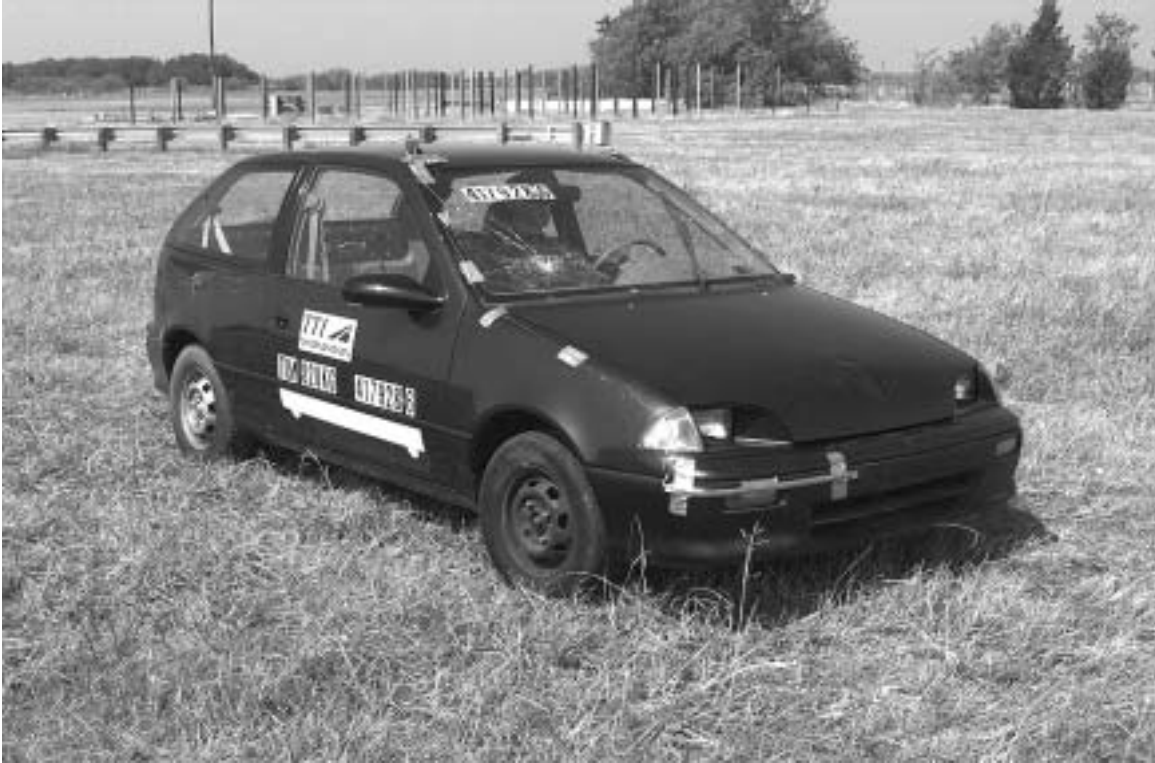
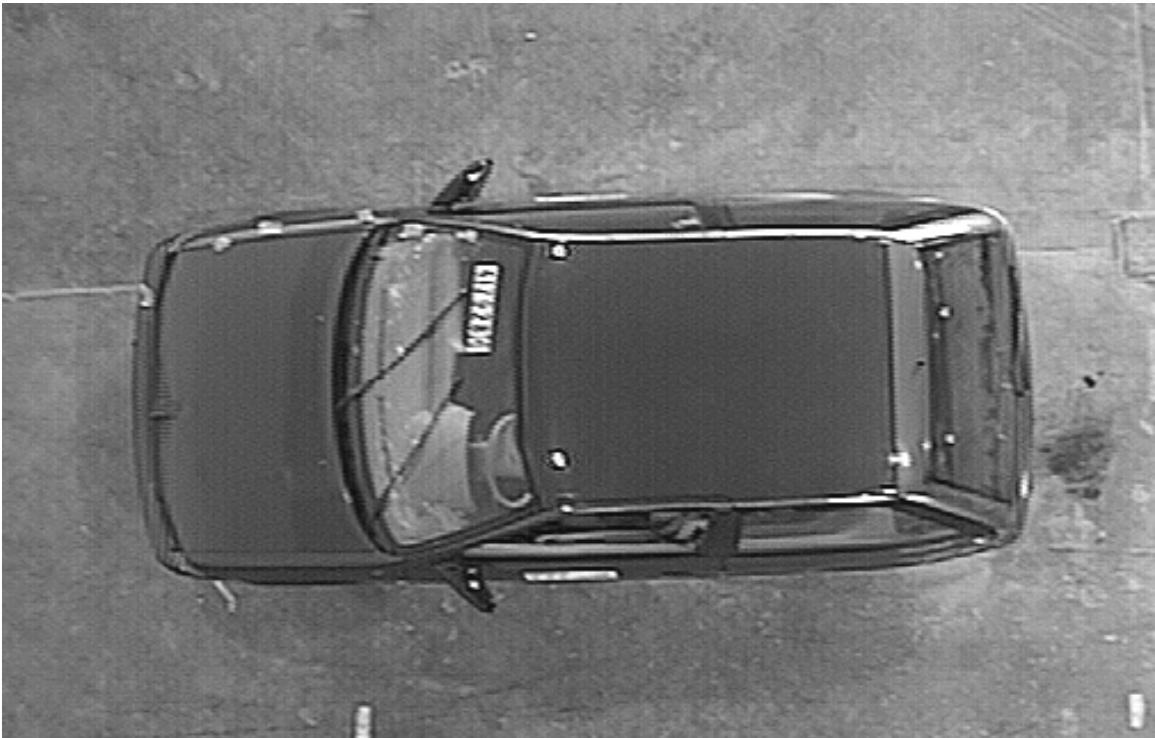
Figure 29. Vehicle after Test 417928-6.

The vehicle received damage to the front, as shown in [Figure 29](#). The windshield was shattered on the passenger side from contact with the panel. However, the hollow profile PVC panel did not have sufficient mass to cause penetration into the occupant compartment of the vehicle. The interior of the vehicle is shown in [Figure 30](#).

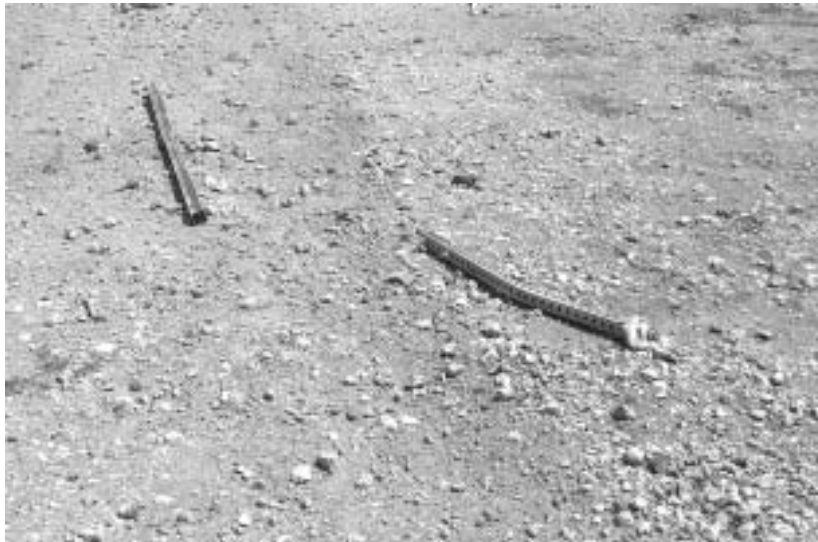
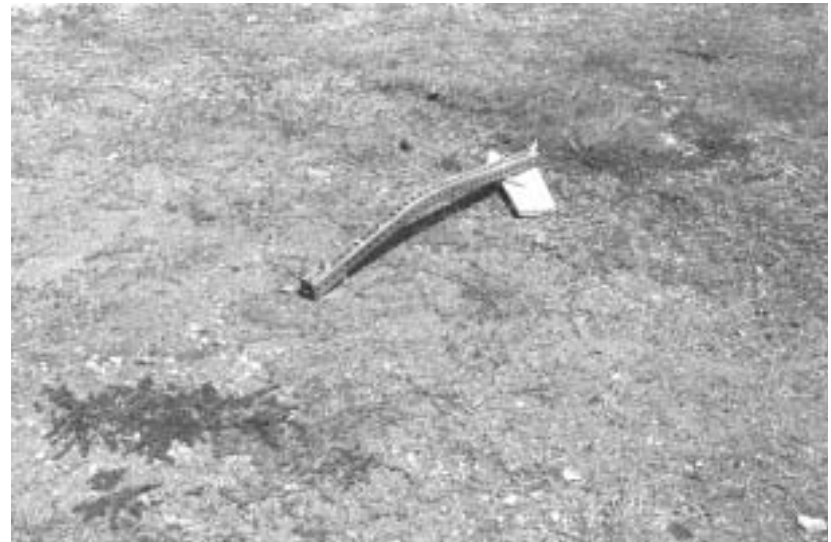
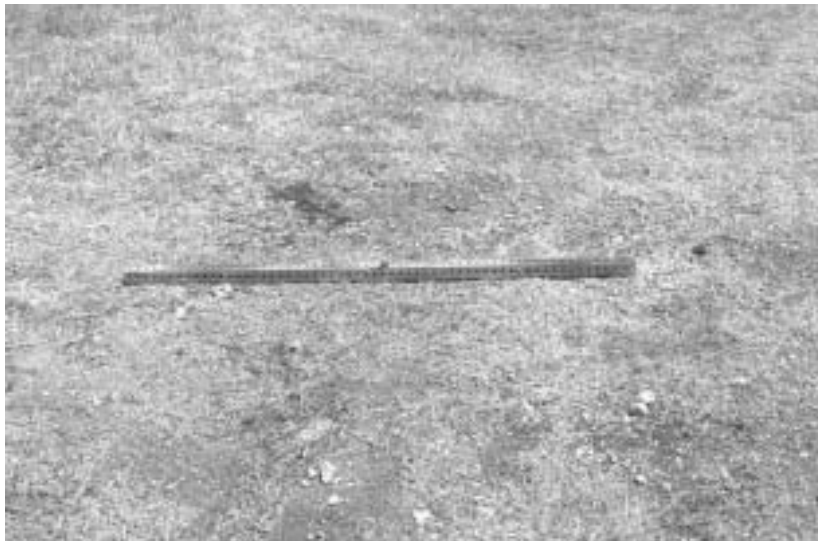
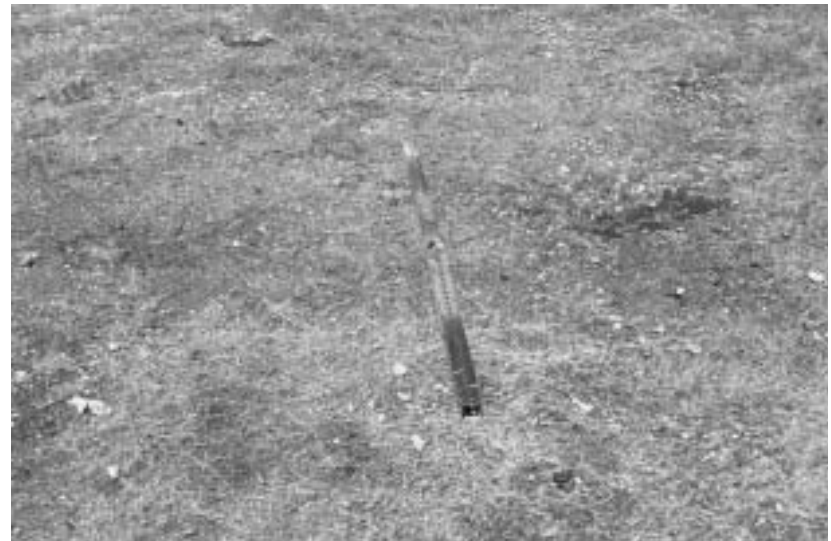
Figure 36. Installation after Test 417928-7.

The barricade separated into multiple pieces, as shown in [Figures 35 and 36](#). The debris extended 26.7 m (87.6 ft) down, 3.8 m (12.5 ft) to the left, and 6.1 m (20.0 ft) to the right of the impact point.

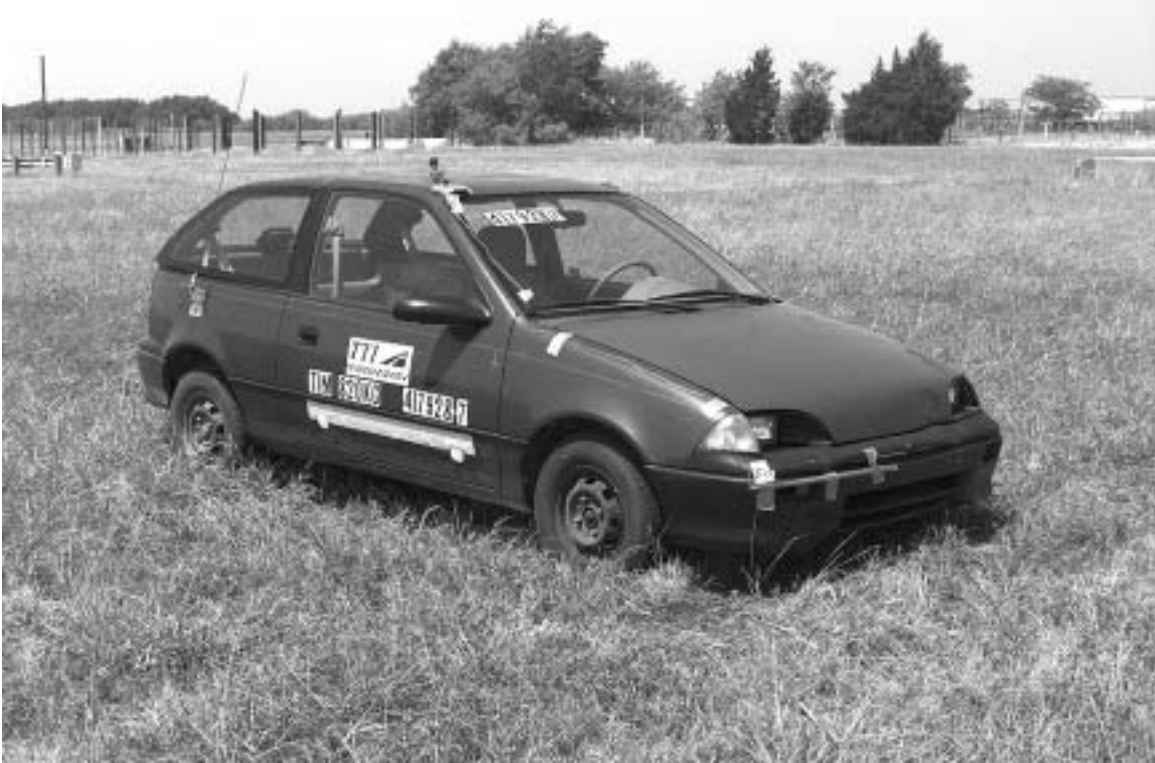
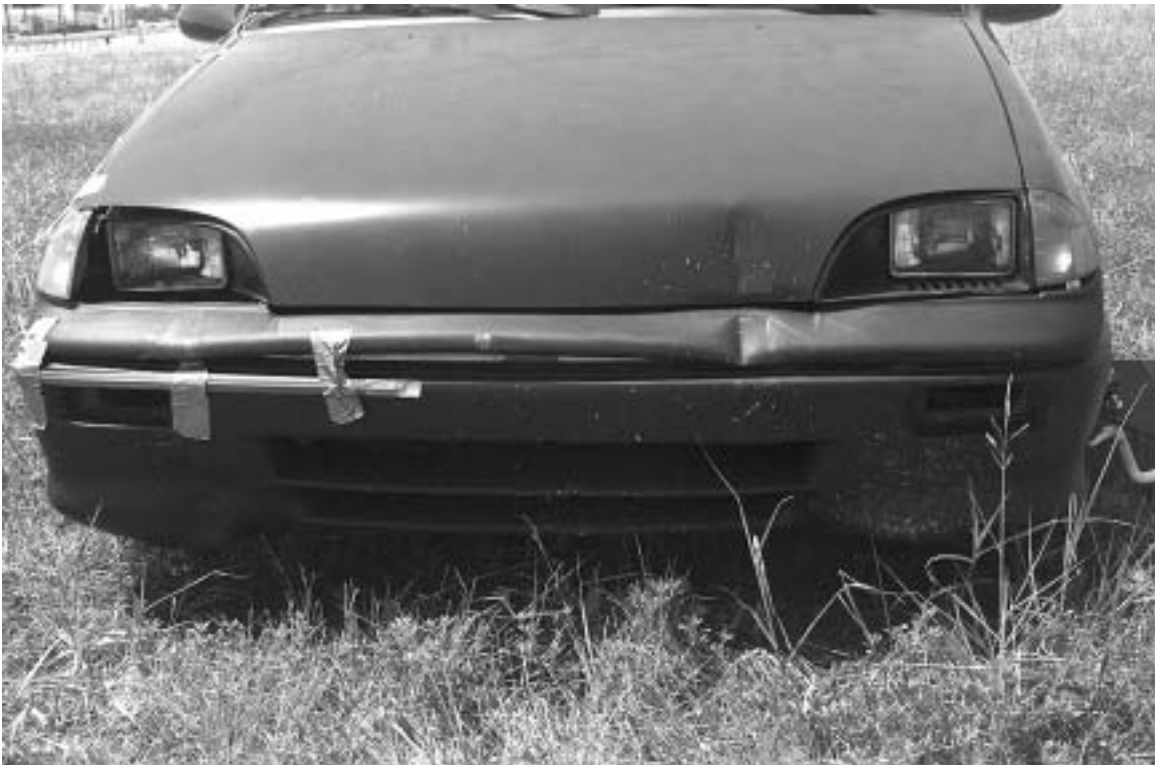
Figure 37. Vehicle after Test 417928-7.

The 914 mm (36 inch) rail height permitted the vehicle to ride down the barricade without any windshield damage. The only damage the vehicle received was a small dent in the hood and bumper, as shown in [Figure 37](#). The interior of the vehicle is shown in [Figure 38](#).

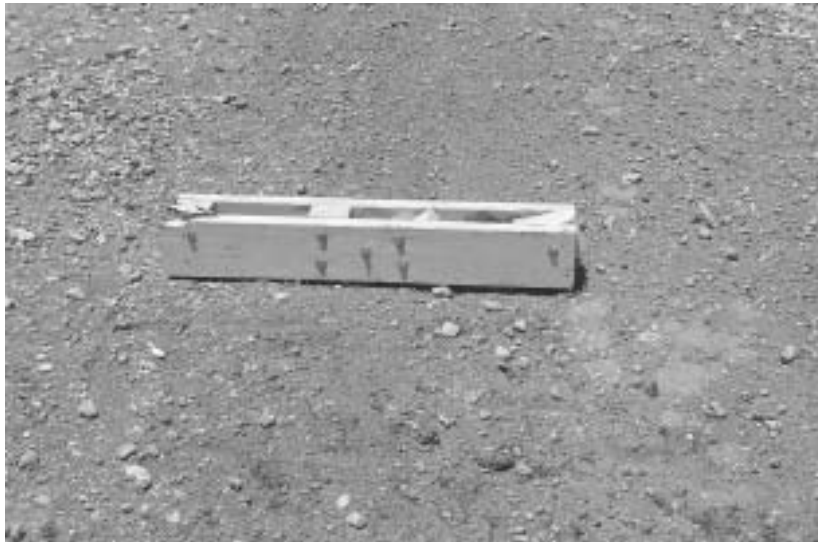
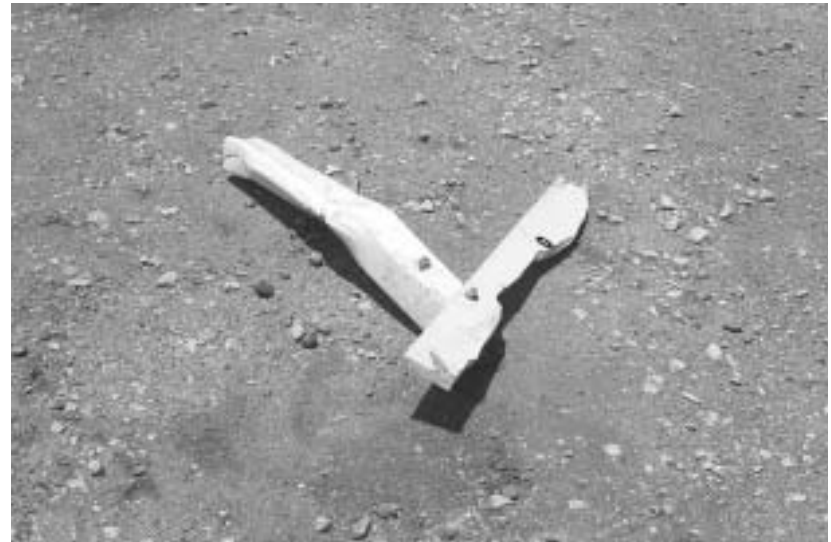
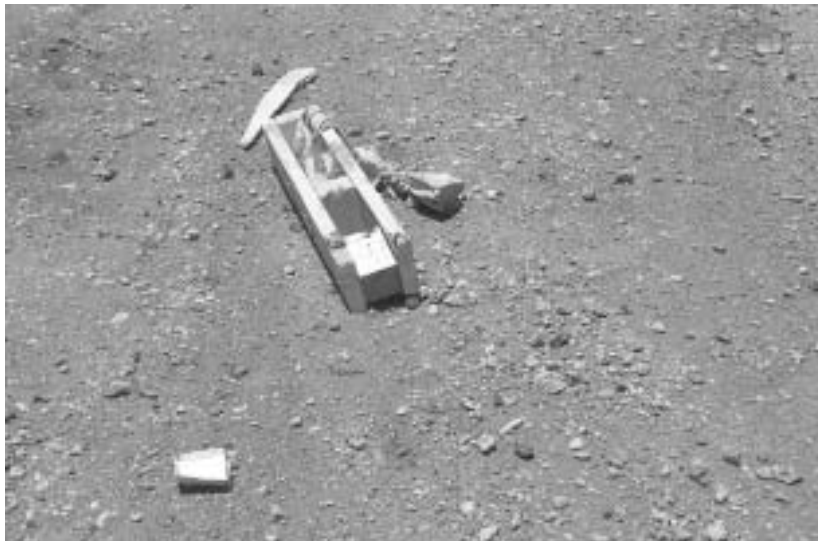
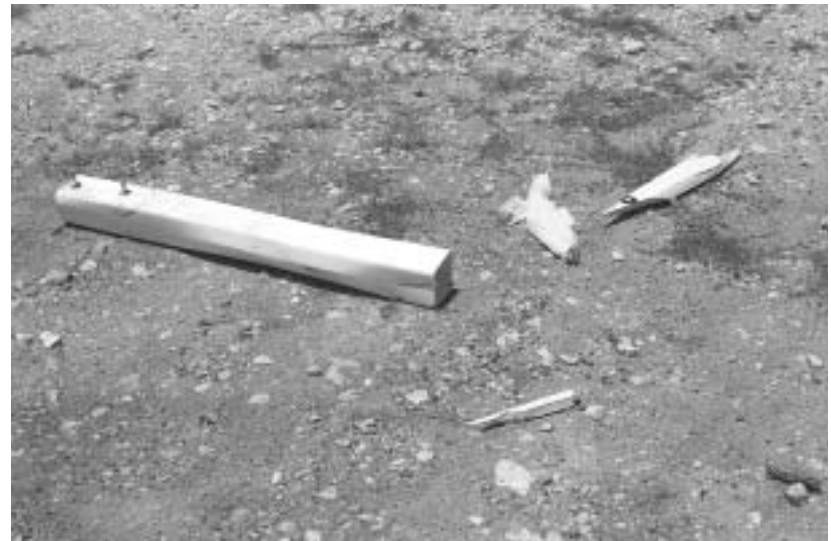
Figure 44. Installation after Test 417928-8.

The barricade separated into multiple pieces, as shown in [Figures 43 and 44](#). The debris extended 26.7 m (87.6 ft) down, 6.1 m (20.0 ft) to the left, and 1.2 m (4.0 ft) to the right of impact point.

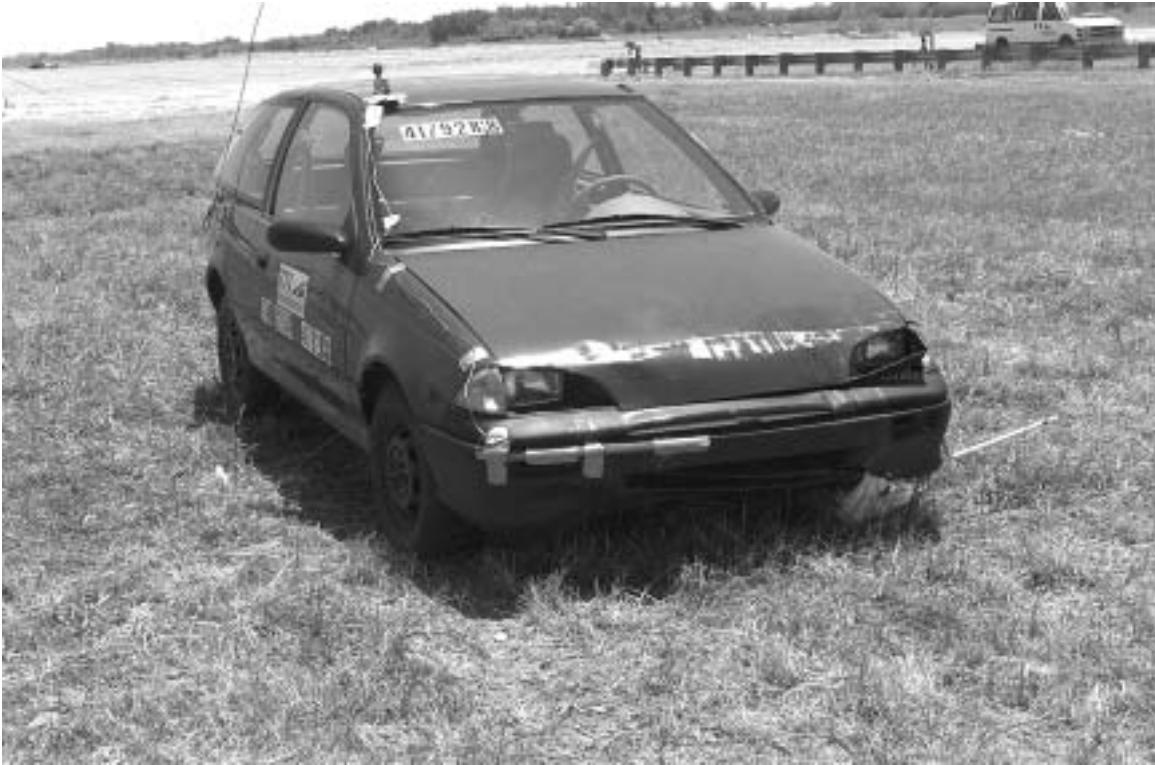
Figure 45. Vehicle after Test 417928-8.

As with the perforated steel tube design, the vehicle was able to ride down the 914 mm (36 in) tall barricade without any windshield contact. The minor damage sustained by the vehicle is shown in [Figure 45](#). There was a dent across the hood (not measurable), small dents in the bumper, and the radiator support was deformed. [Figure 46](#) shows the interior of the vehicle

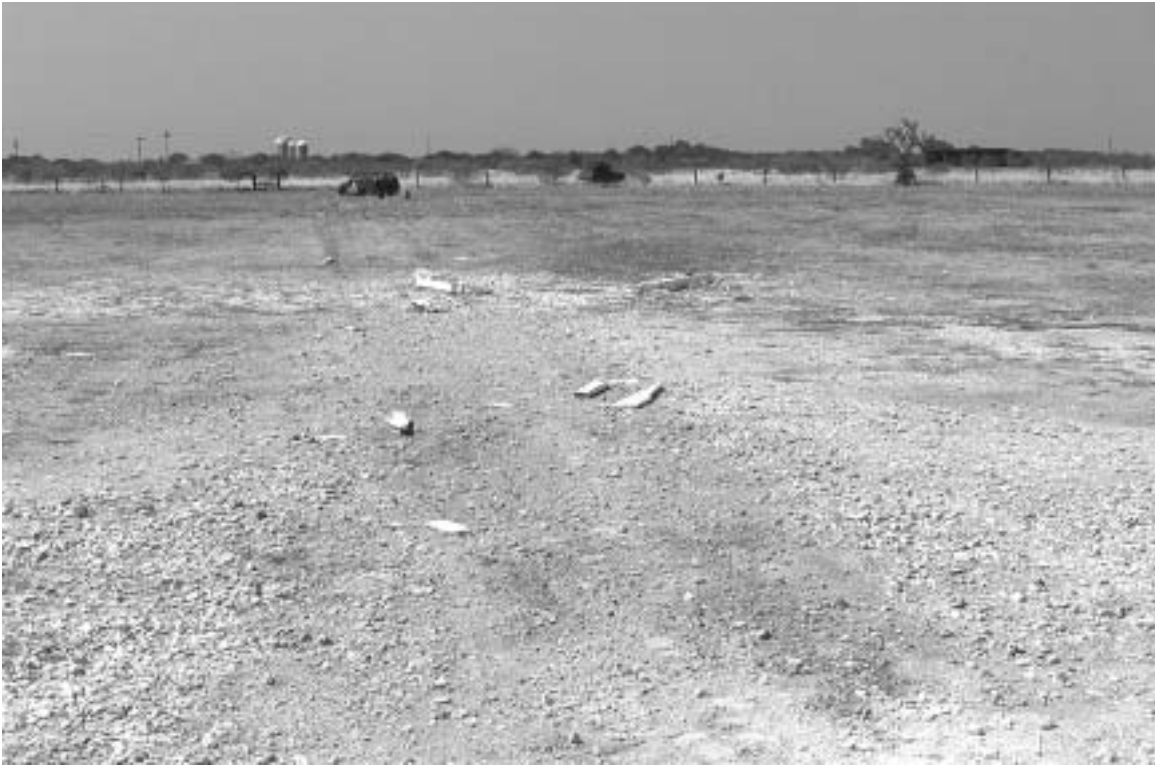
Figure 51. After Impact Trajectory for Test 417928-9.

The folding barricade separated into multiple pieces, as shown in Figures 51 and 52. The debris extended 82.3 m (264.0 ft) down and 1.8 m (5.9 ft) to the right of the impact point.

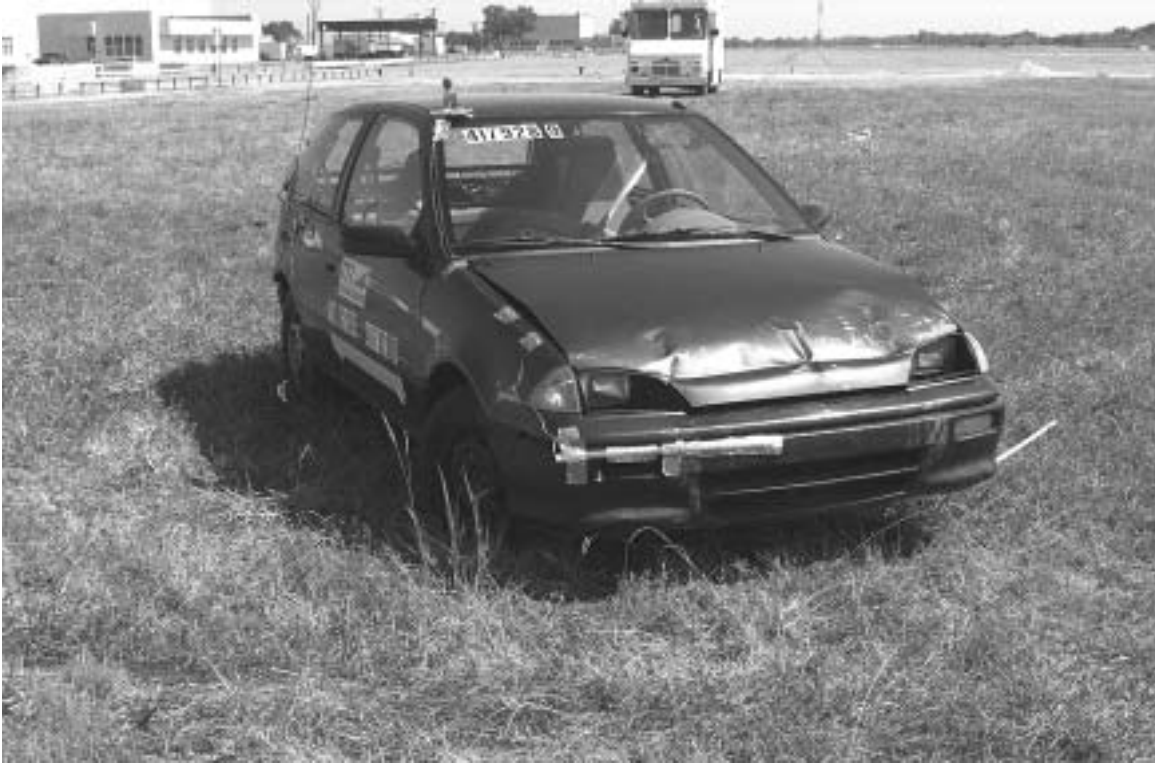
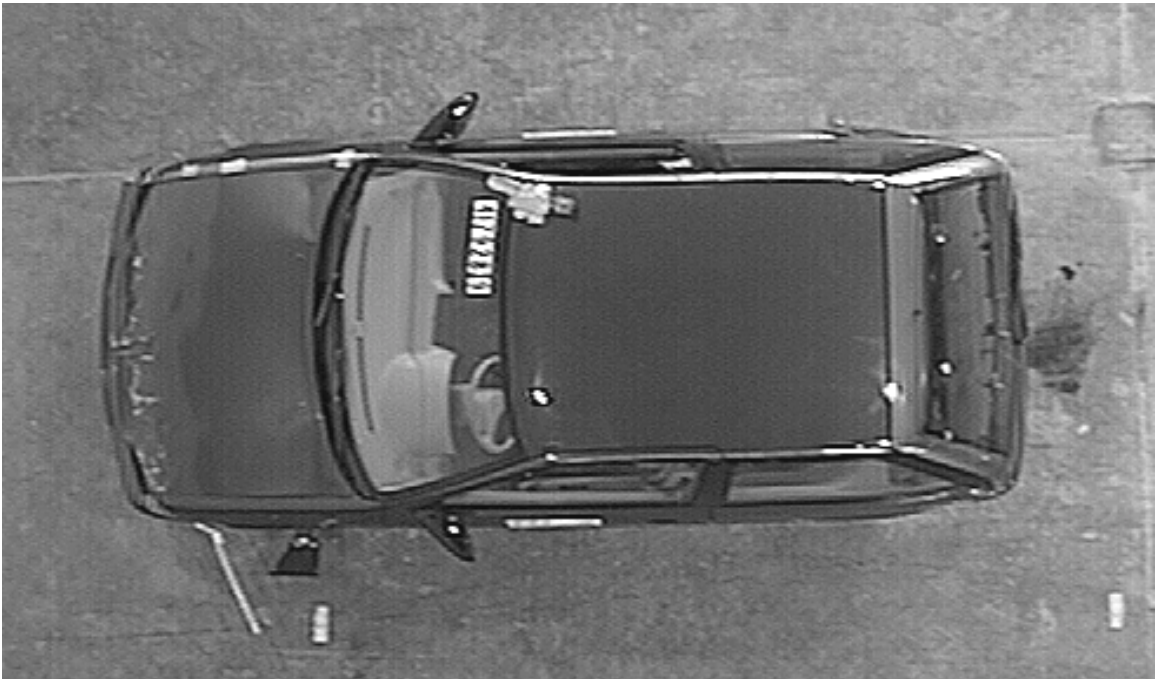
Figure 53. Vehicle after Test 417928-9.

The vehicle rode down the 914 mm (36 inch) tall folding A-frame barricade without any windshield contact. Figure 53 shows the damage sustained. There was a dent across the hood (not measurable) and small dents in the bumper. The interior of the vehicle is shown in Figure 54.

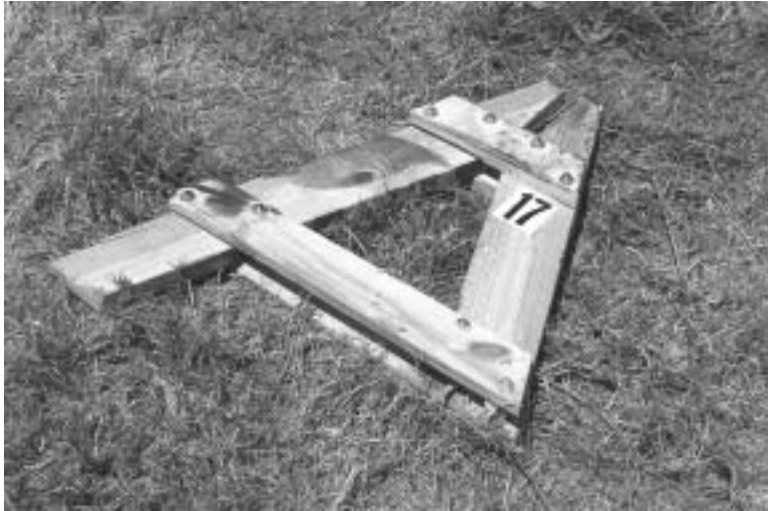
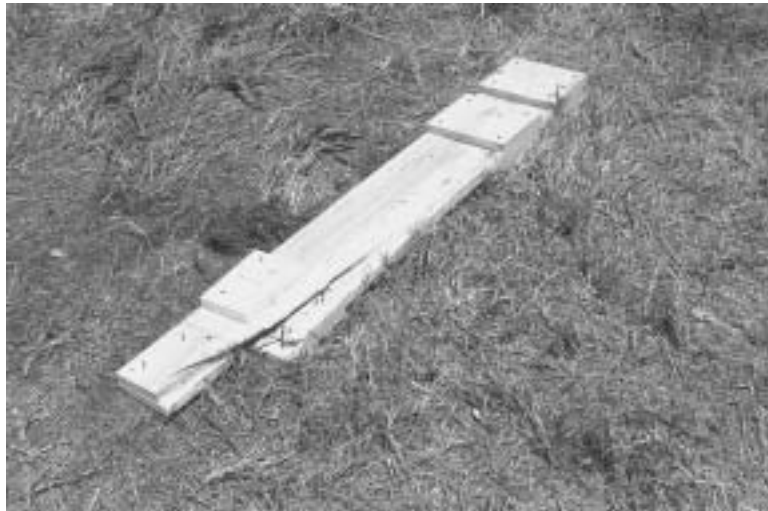
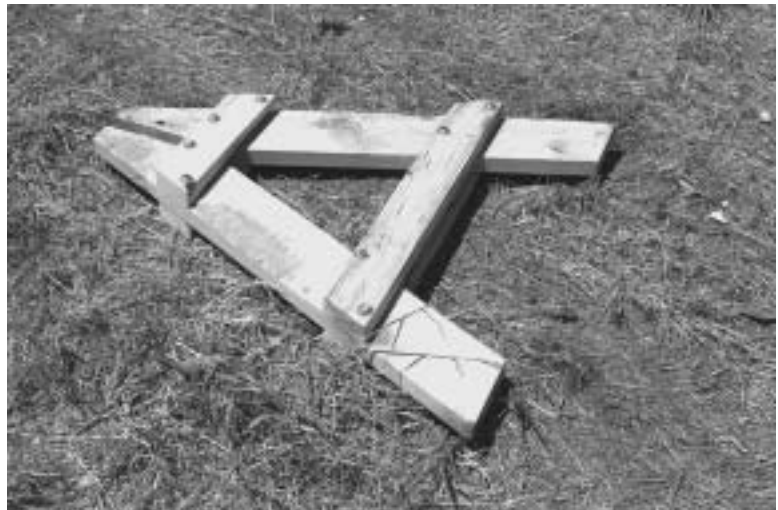
Figure 60. Installation after Test 417928-17.

The A-frame barricade separated into a few pieces, as shown in Figures 59 and 60. The debris extended 61.7 m (202.4 ft) down, 4.6 m (15.1 ft) to the right, and 4.0 m (13.1 ft) to the left of the impact point.

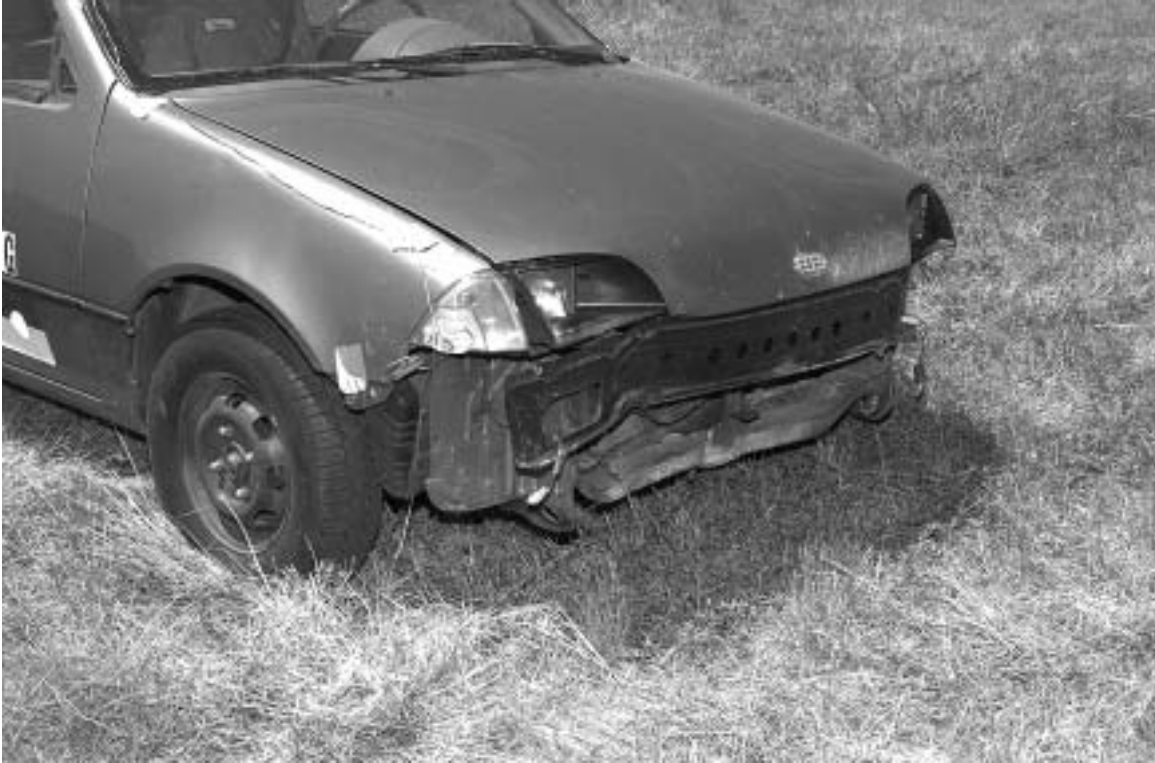
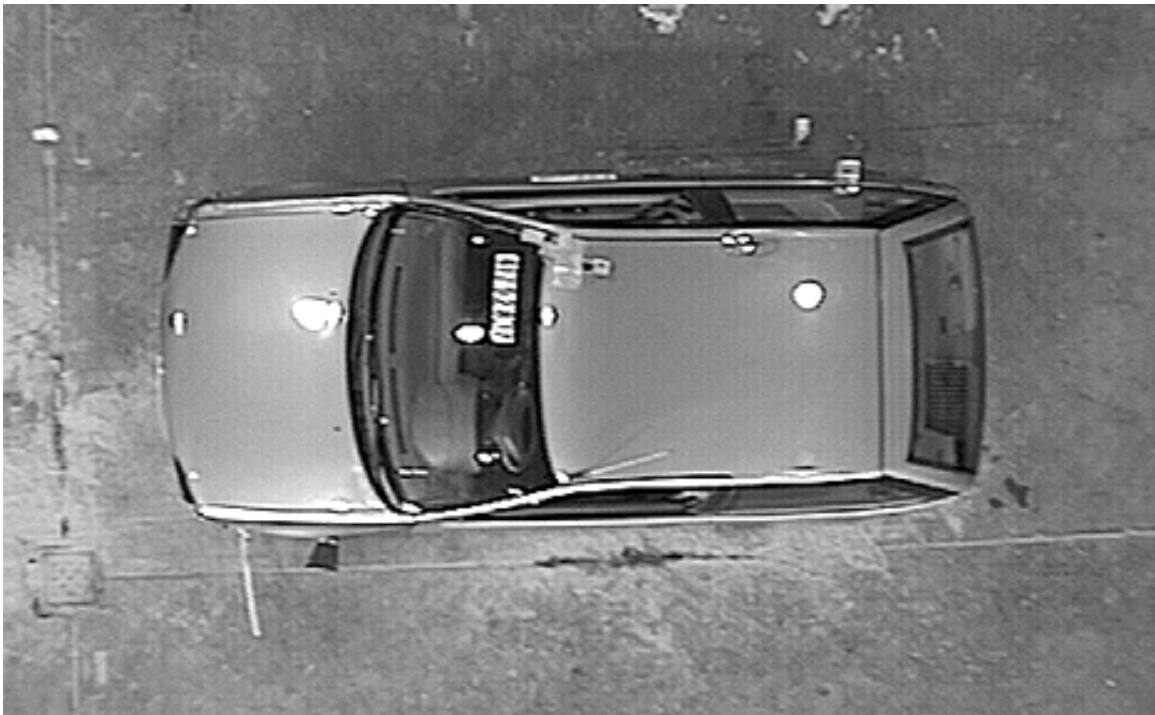
Figure 61. Vehicle after Test 417928-17.

There was no windshield contact during the test. The front bumper and radiator supports received minimal damage, as shown in Figure 61. Figure 62 shows the interior of the vehicle.

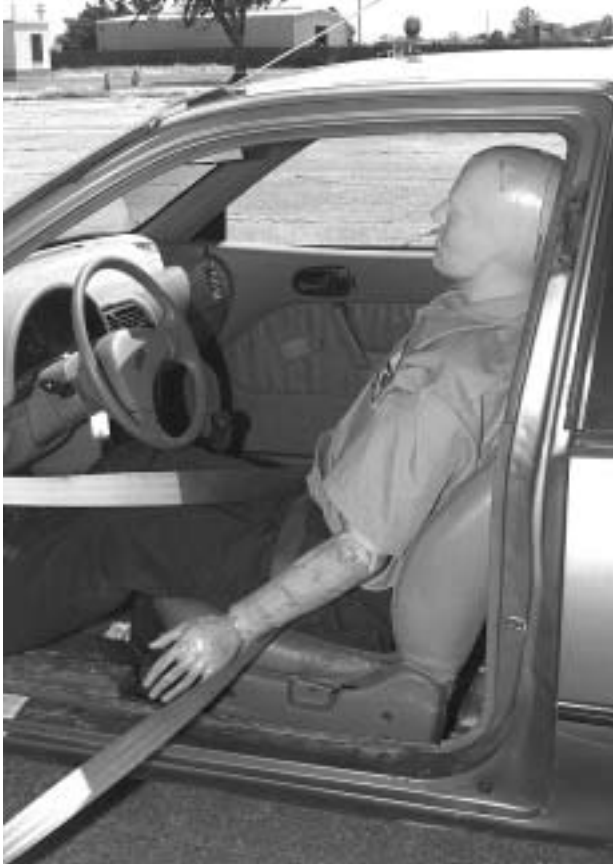
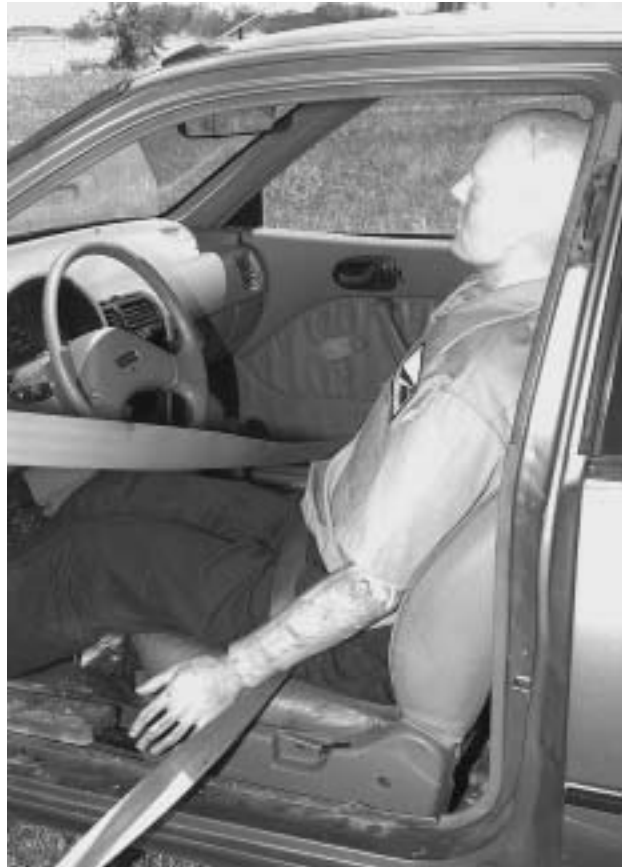
Figure 62. Interior of Vehicle for Test 417928-17.

The barricade traveled with the vehicle but did not penetrate or show potential to penetrate the occupant compartment, or present undue hazard to others in the area. No deformation or intrusion of the occupant compartment occurred.

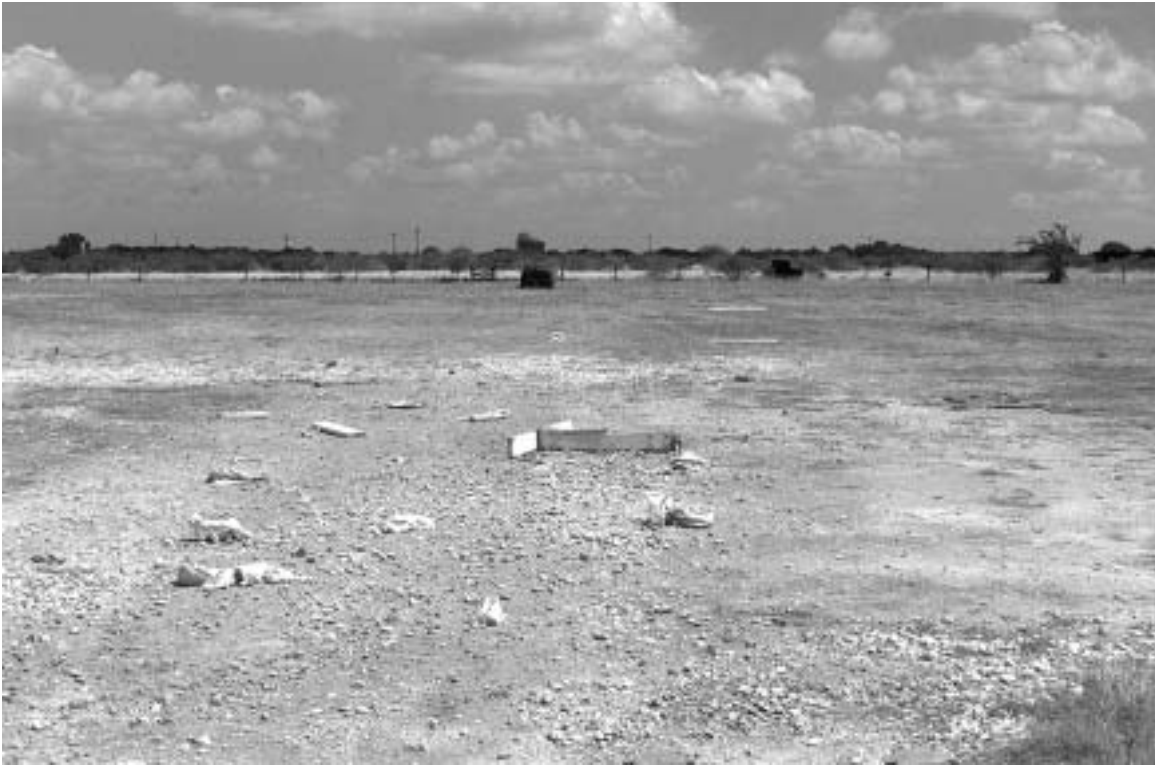
Figure 67. After Impact Trajectory for Test 417928-2.

The upper supports and the base of the barricade shattered into multiple pieces, as shown in [Figures 67 and 68](#). The debris extended 93.6 m (307.1 ft) down, 1.5 m (5.0 ft) to the left, and 7.6 m (25.0 ft) to the right of the impact point.

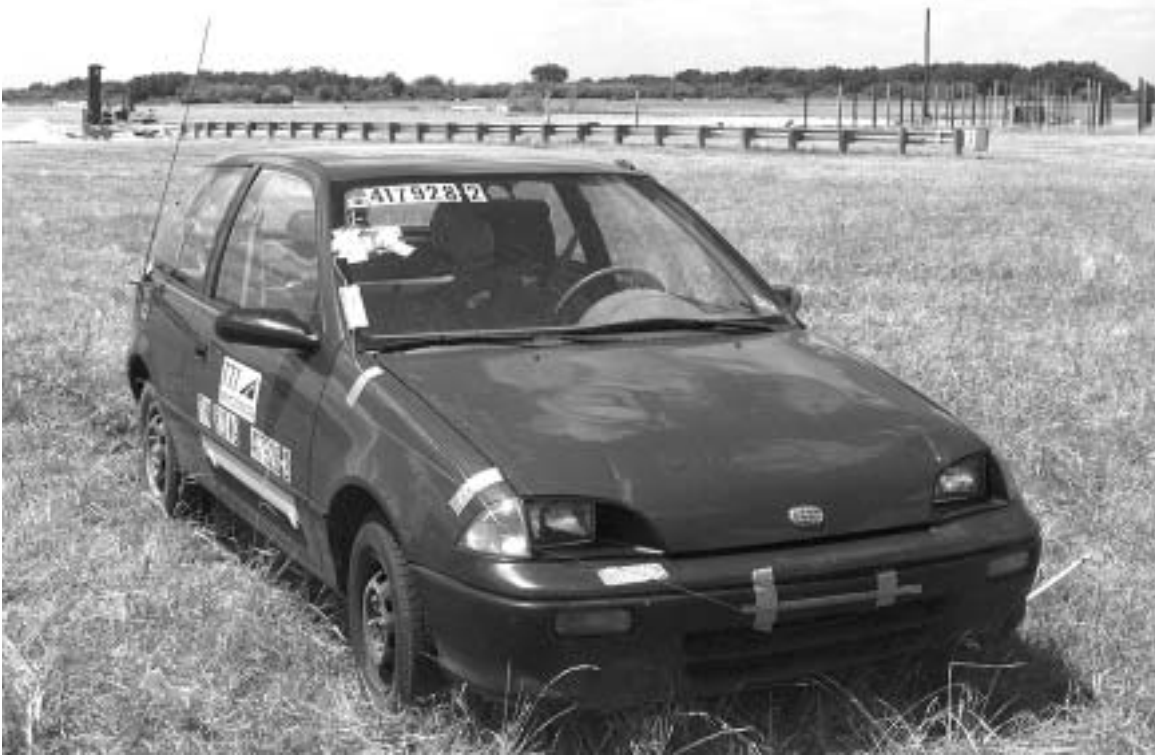
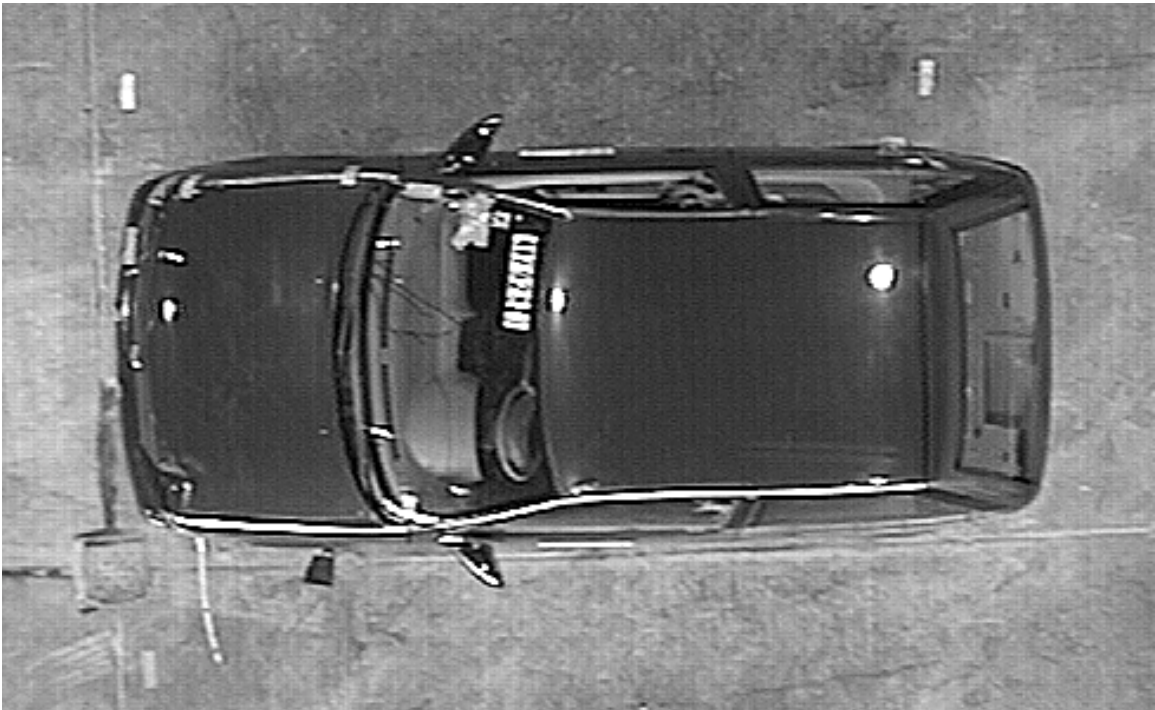
Figure 69. Vehicle after Test 417928-2.

Damage sustained by the front of the vehicle is shown in [Figure 69](#). The vehicle received minor scrapes to the hood, the windshield, and the left rear wheel rim. The interior of the vehicle is shown in [Figure 70](#).

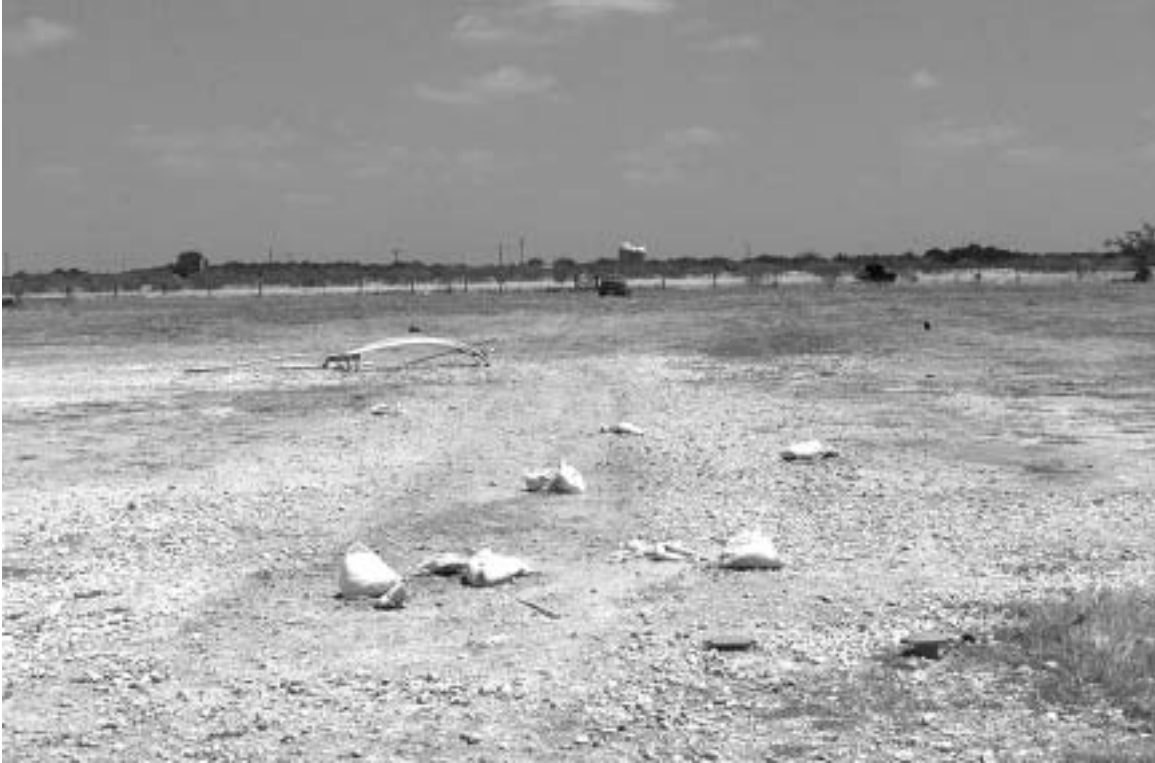
Figure 75. After Impact Trajectory for Test 417928-14.

The barricade remained in one piece, as shown in [Figures 75 and 76](#). The debris extended 20.6 m (67.6 ft) down, and 3.0 m (9.8 ft) to the left of the impact point.

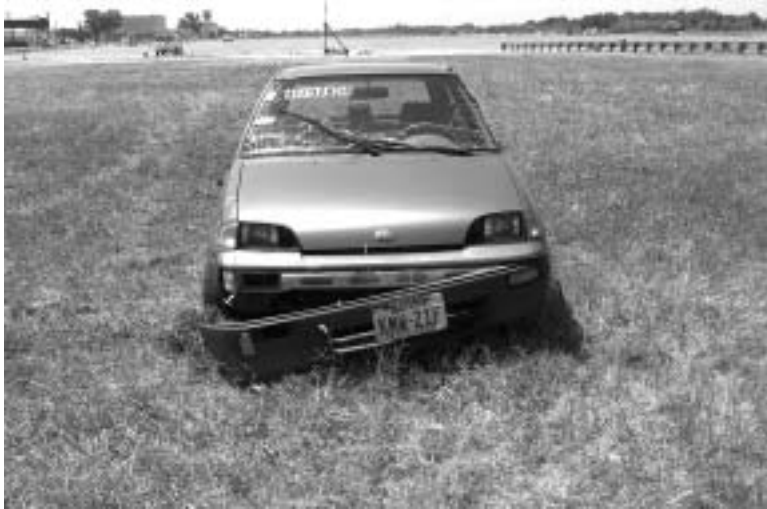
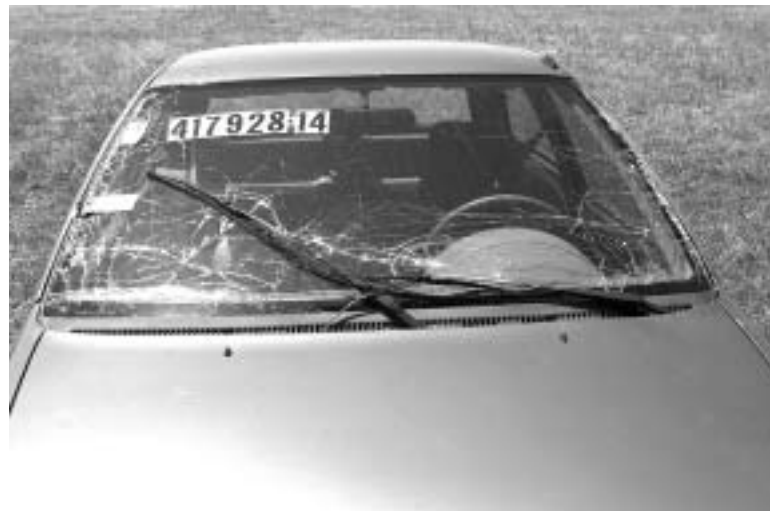
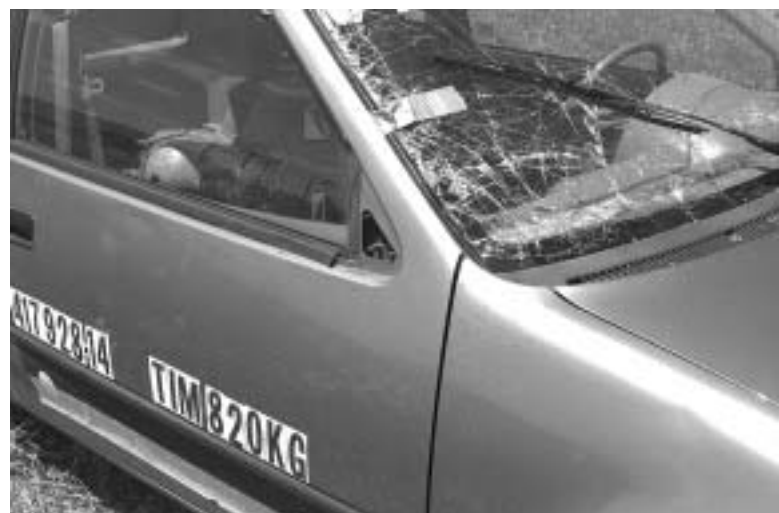
Figure 77. Vehicle after Test 417928-14.

The vehicle received damage to the front, as shown in [Figure 77](#). The vehicle received minor scrapes to the roof and a dent in the front bumper. The left rear tire was deflated, and the windshield was shattered on the passenger's side. A dent on the right lower front fender was measured at 120 mm × 30 mm (4.7 inch × 1.2 inch). The interior of the vehicle is shown in [Figure 78](#).

The center plastic panel of the steel barricade shattered the bottom of the windshield, but it did not penetrate or show potential to penetrate the occupant compartment, or present undue hazard to others in the area. No deformation or intrusion of the occupant compartment occurred.

The steel supports for the panels broke off the side mirrors from the vehicle, but none of the detached elements or vehicle damage would block the driver's vision or cause the driver to lose control of the vehicle.

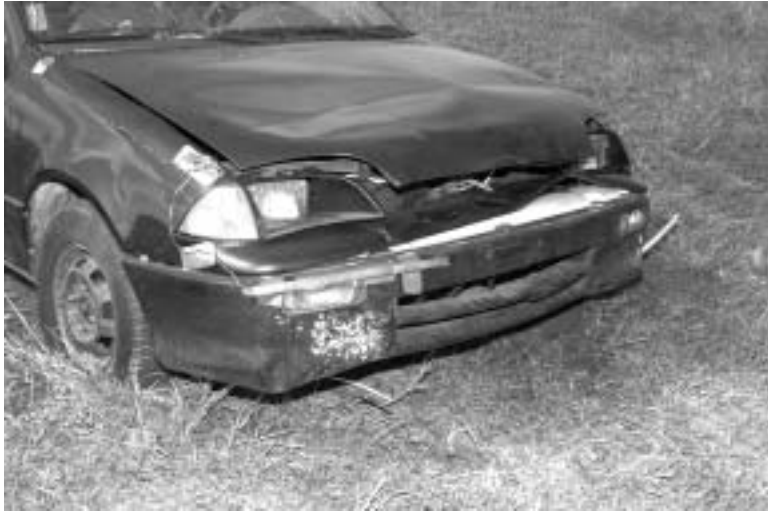
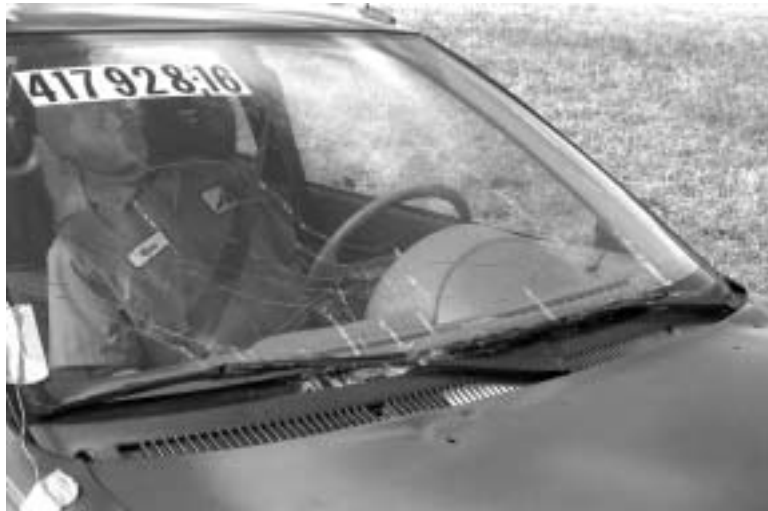
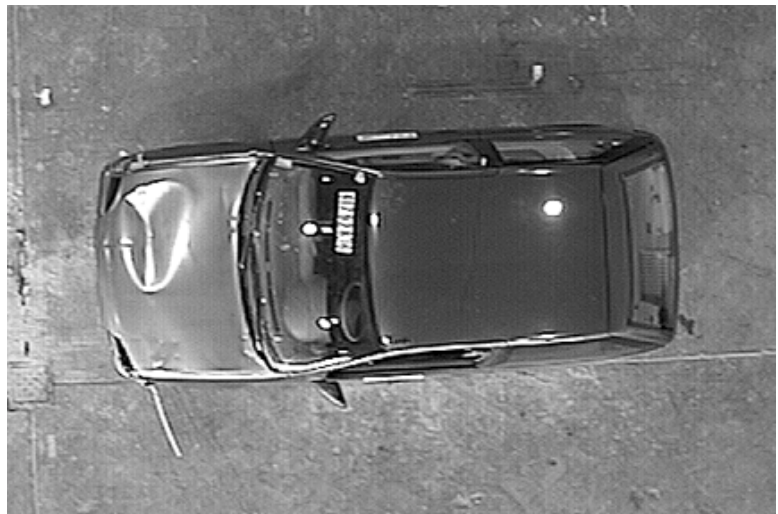
Figure 85. Vehicle after Test 417928-16.

The vehicle received damage to the bumper, hood, and grill, as shown in [Figure 85](#). The windshield was shattered on the passenger's side, and the radiator support was deformed. The interior of the vehicle is shown in [Figure 86](#).

The barricade contacted the hood and cracked the base of the windshield, but it did not penetrate or show potential to penetrate the occupant compartment, or present undue hazard to others in the area. No deformation or intrusion of the occupant compartment occurred.

The steel supports for the panels broke off the side mirrors from the vehicle, but none of the detached elements or vehicle damage would block the driver's vision or cause the driver to lose control of the vehicle.

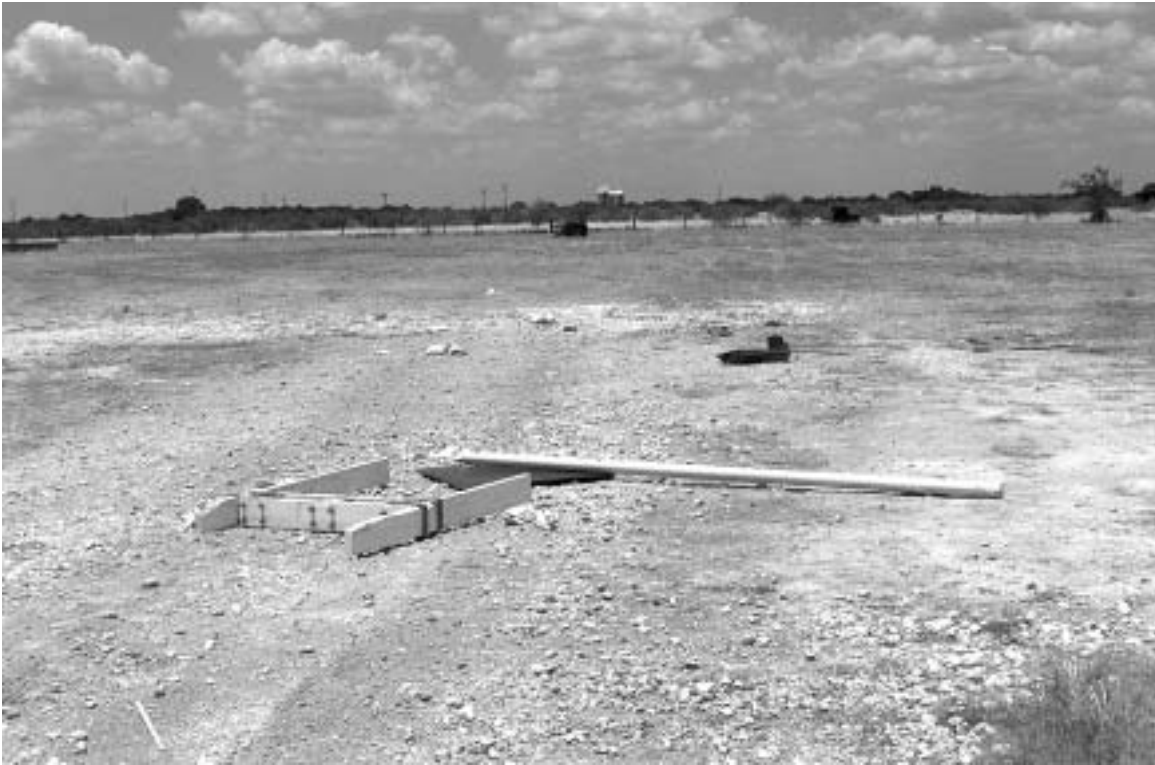
Figure 91. After Impact Trajectory for Test 417928-3.

All of the debris remained near the impact point, as shown in [Figures 91 and 92](#). The sign and base were located 7.3 m (24.0 ft) downstream from the impact point.
