1. Report No. FHWA/TX-01/1792-2		2. Government Accession No.		3. Recipient's Catalog No.	
4. Title and Subtitle IMPACT PERFORMANCE EVALUATION OF WORK ZONE TRAFFIC CONTROL DEVICES				5. Report Date December 2000

6. Performing Organization Code	
7. Author(s) Roger P. Bligh, D. Lance Bullard, Wanda L. Menges, and Sandra K. Schoeneman				8. Performing Organization Report No. Report 1792-2

IMPACT PERFORMANCE EVALUATION OF WORK ZONE TRAFFIC CONTROL DEVICES

December 2000

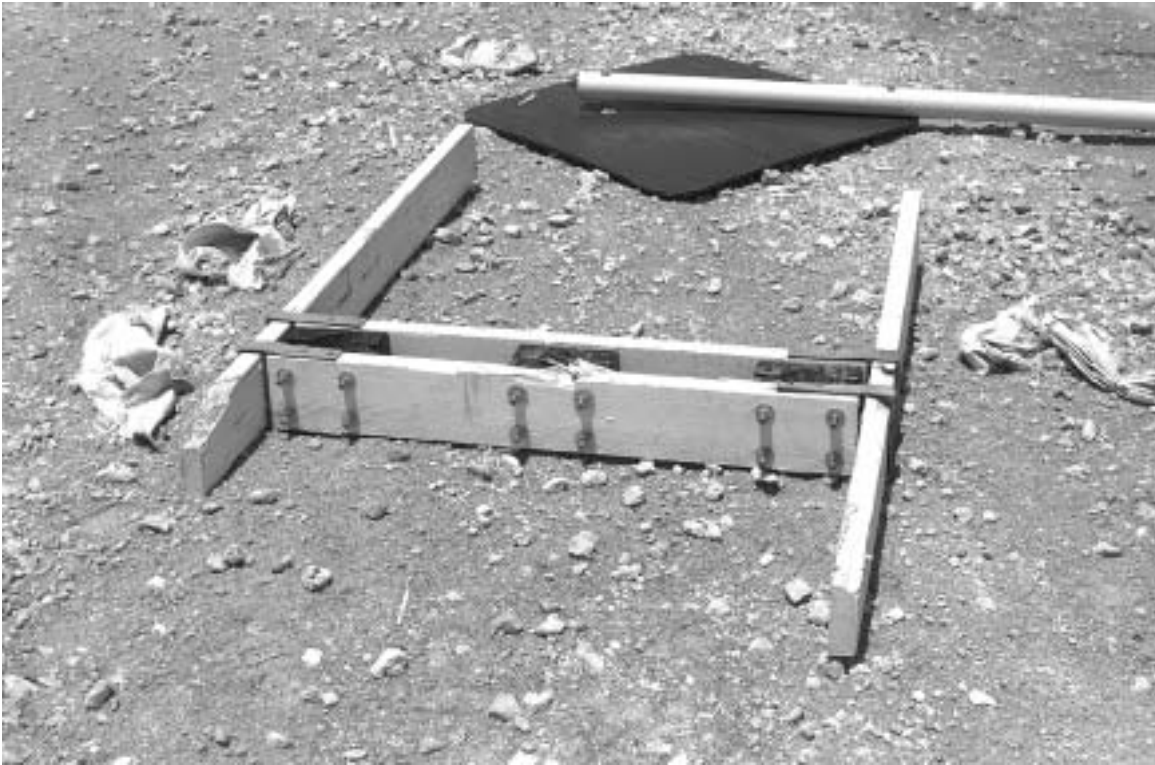
Figure 92. Installation after Test 417928-3.

All of the debris remained near the impact point, as shown in [Figures 91 and 92](#). The sign and base were located 7.3 m (24.0 ft) downstream from the impact point.

The single fiber reinforced plastic sign support pulled out of the dual-purpose base and thereby met the requirements for structural adequacy by yielding to the vehicle.

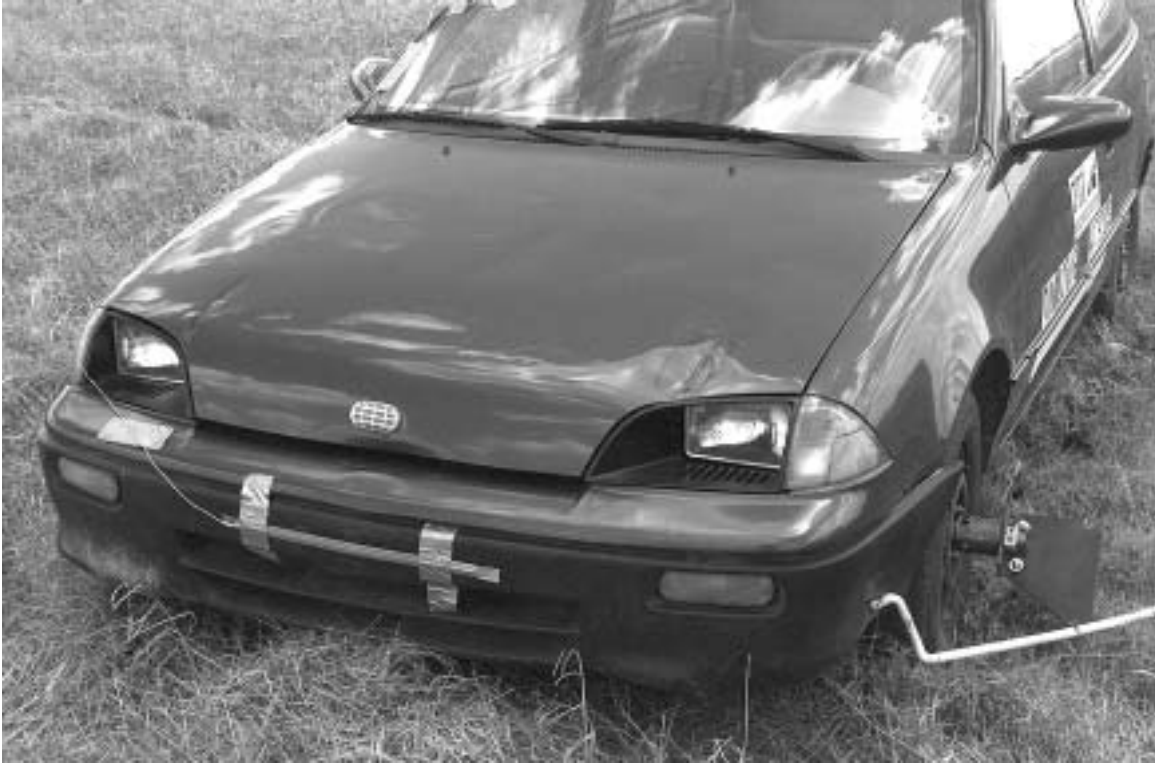
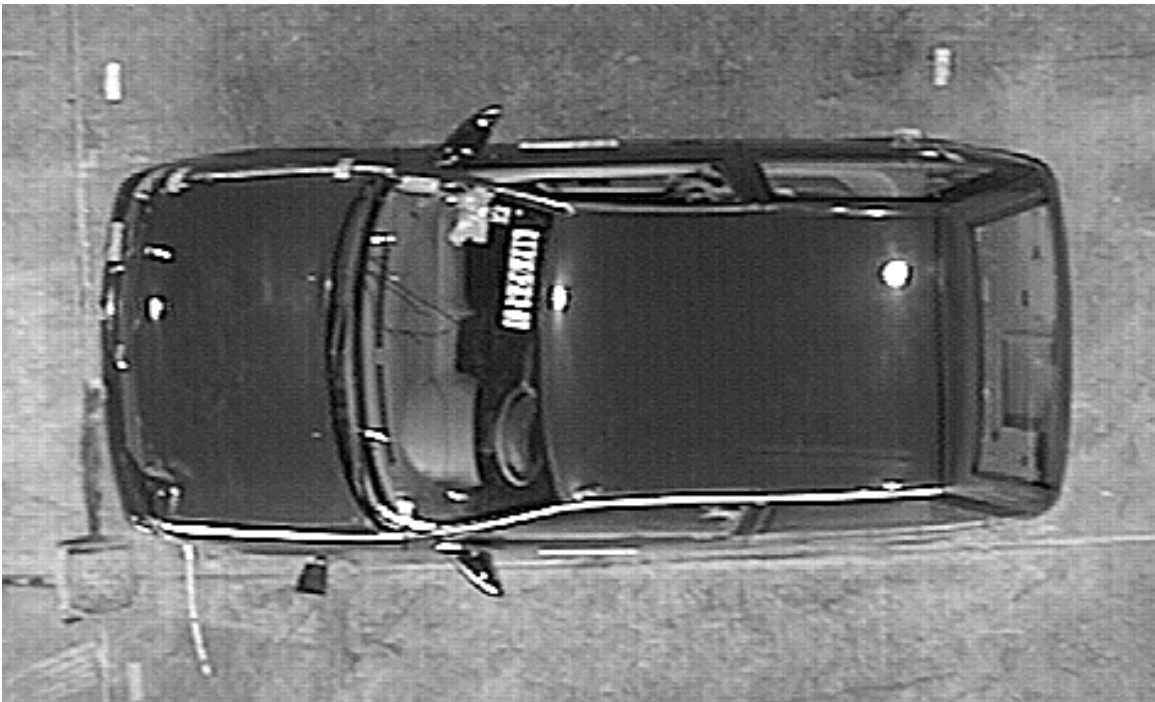
Figure 93. Vehicle after Test 417928-3.

The vehicle received minor scrapes on the front bumper and hood, as shown in [Figure 93](#). The interior of the vehicle is shown in [Figure 94](#).

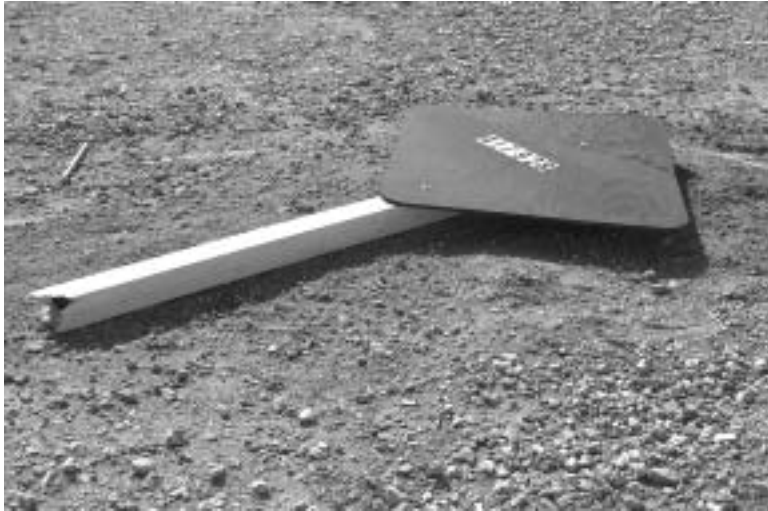
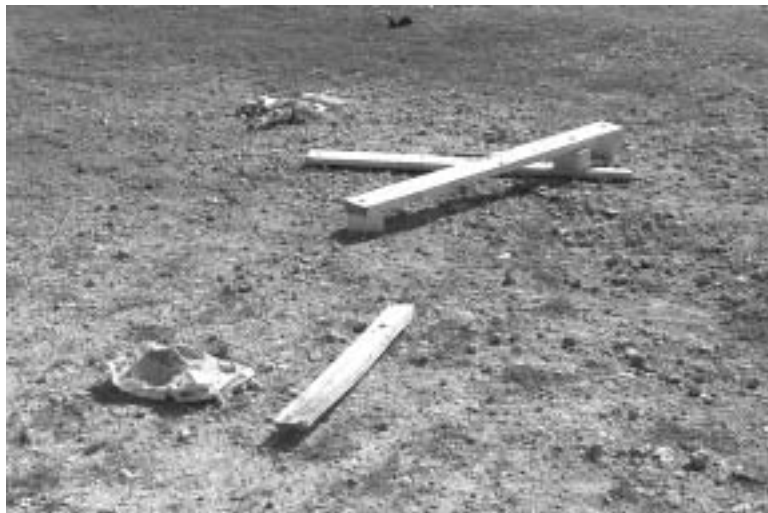
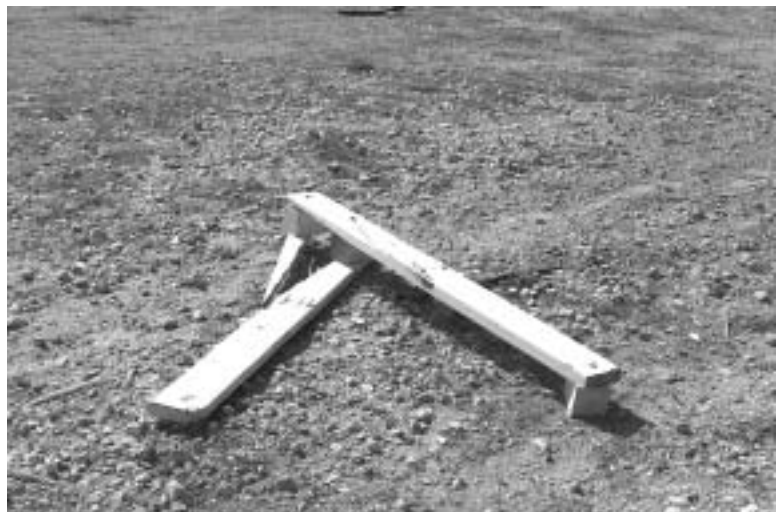
Figure 100. Installation after Test 417928-10.

The sign support separated into multiple pieces, as shown in [Figures 99 and 100](#). The upper portion and a portion of the base came to rest within 5.3 m (17.4 ft) from impact, while the rest of the debris extended 19.8 m (65.0 ft) further down, 0.8 m (2.6 ft) to the left, and 0.9 m (3.0 ft) to the right of impact point.

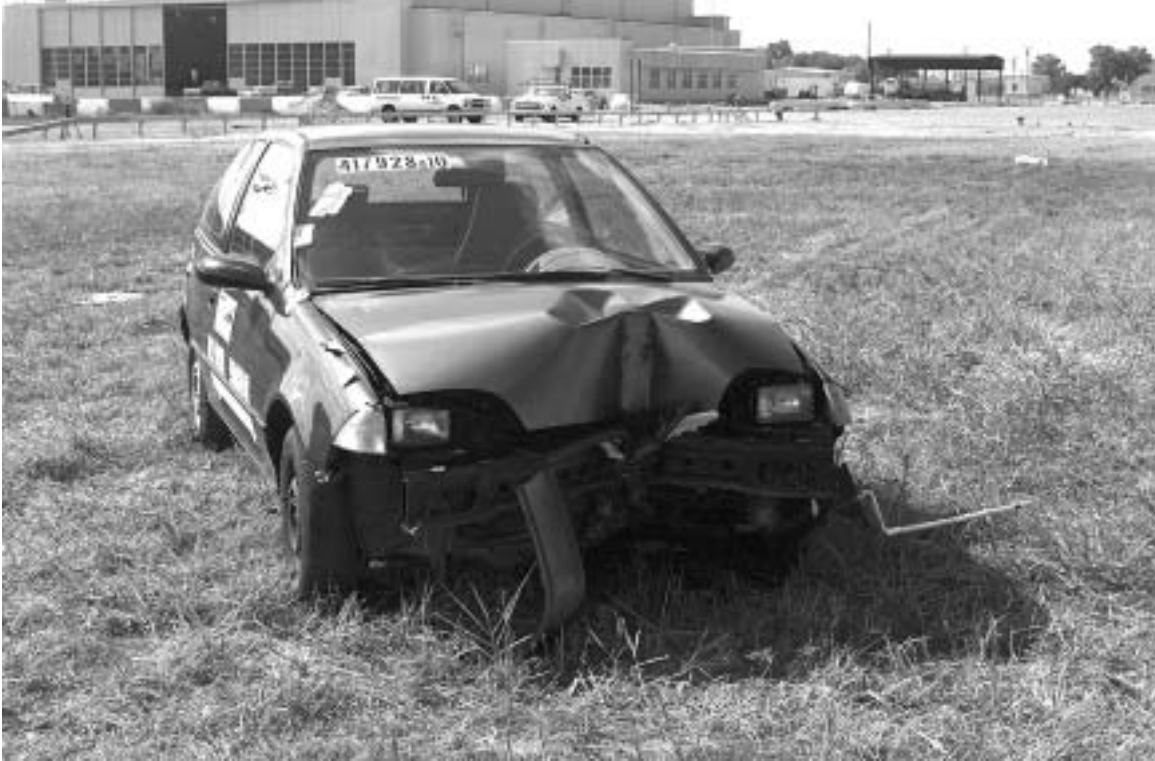
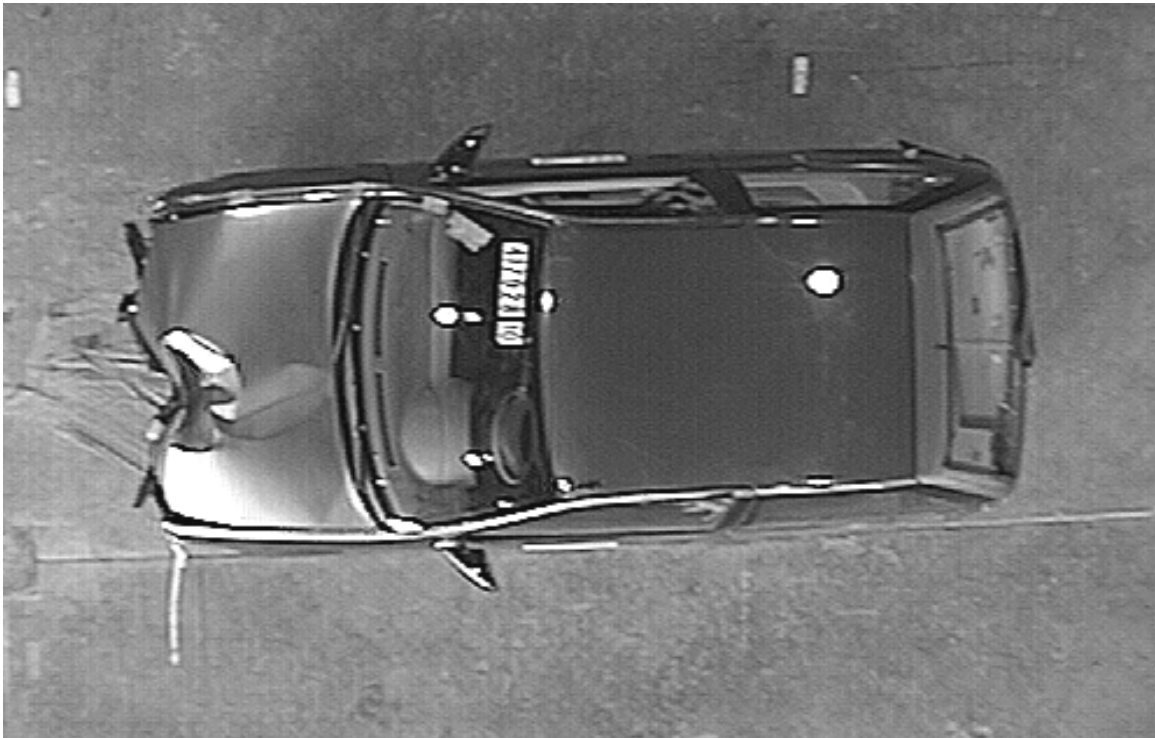
Figure 101. Vehicle after Test 417928-10.

The hood and grill received damage, as shown in [Figure 101](#). Maximum exterior crush to the center of the front bumper was 330 mm (13 inch). The fan, radiator, and radiator support were also damaged. The interior of the vehicle is shown in [Figure 102](#).

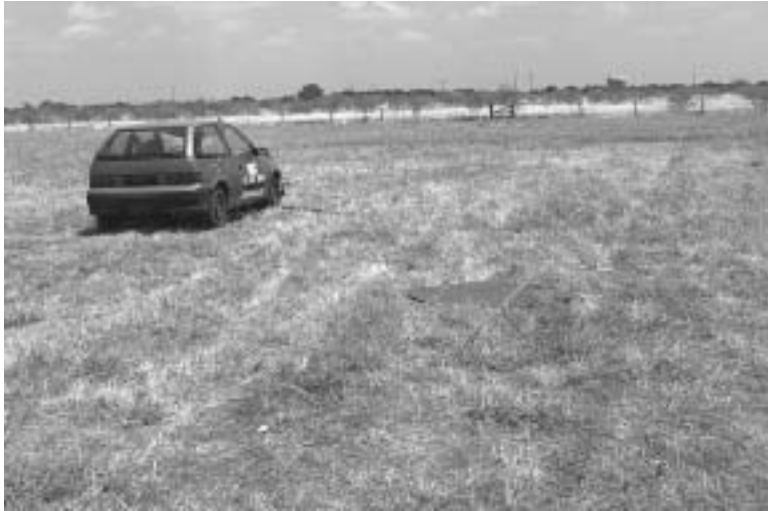
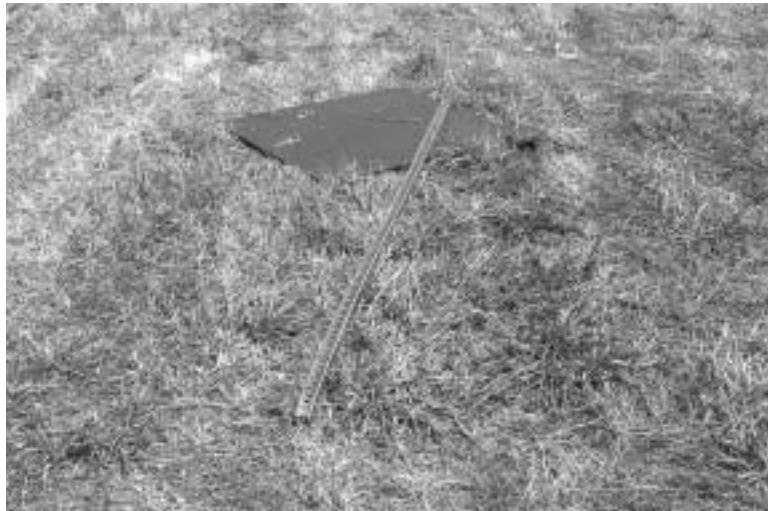
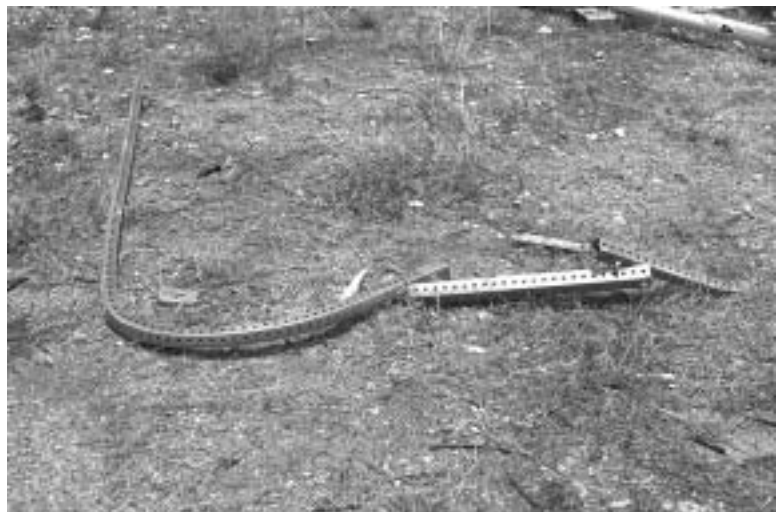
Figure 108. Installation after Test 417928-11.

The upper portion of the barricade and left steel post remained in one piece and came to rest 59.4 m (194.9 ft) down and 3.8 m (12.5 ft) to the right of impact. The right steel post rode along with the vehicle, as shown in Figures 107 and 108. The bases and braces separated from the upright and were scattered along the path of the vehicle.

After removing from under vehicle

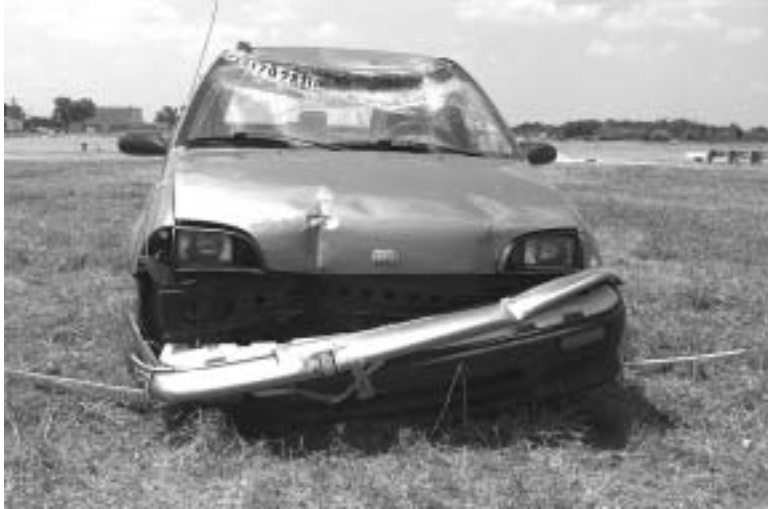
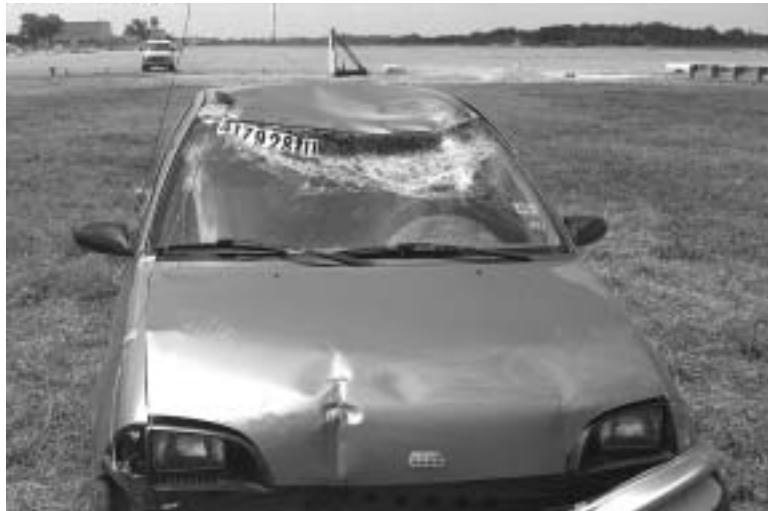
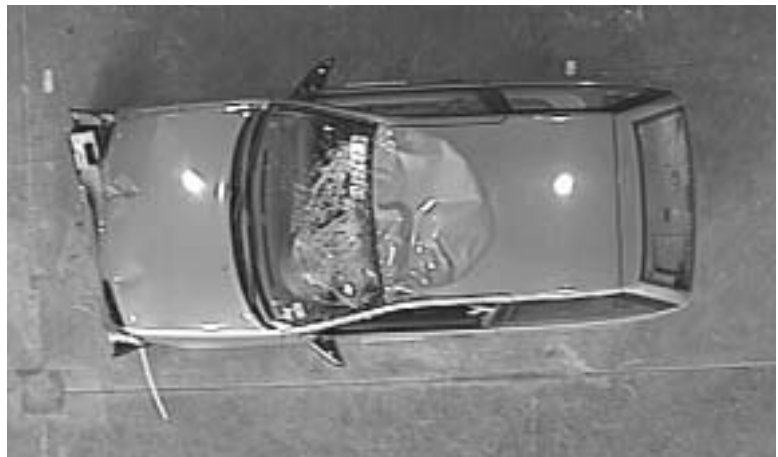
Figure 109. Vehicle after Test 417928-11.

As shown in Figure 109, the vehicle received major damage. The bumper, roof, hood, and grill were dented (not measurable), and the windshield was shattered on the driver's side. The radiator support was also deformed. Maximum deformation into the occupant compartment was 99 mm (3.9 inch) (11 percent reduction of space) measured between the roof of the vehicle and floor pan at the transmission tunnel. The interior of the vehicle is shown in Figure 110. Occupant compartment measurements are shown in Appendix B, Table 3.

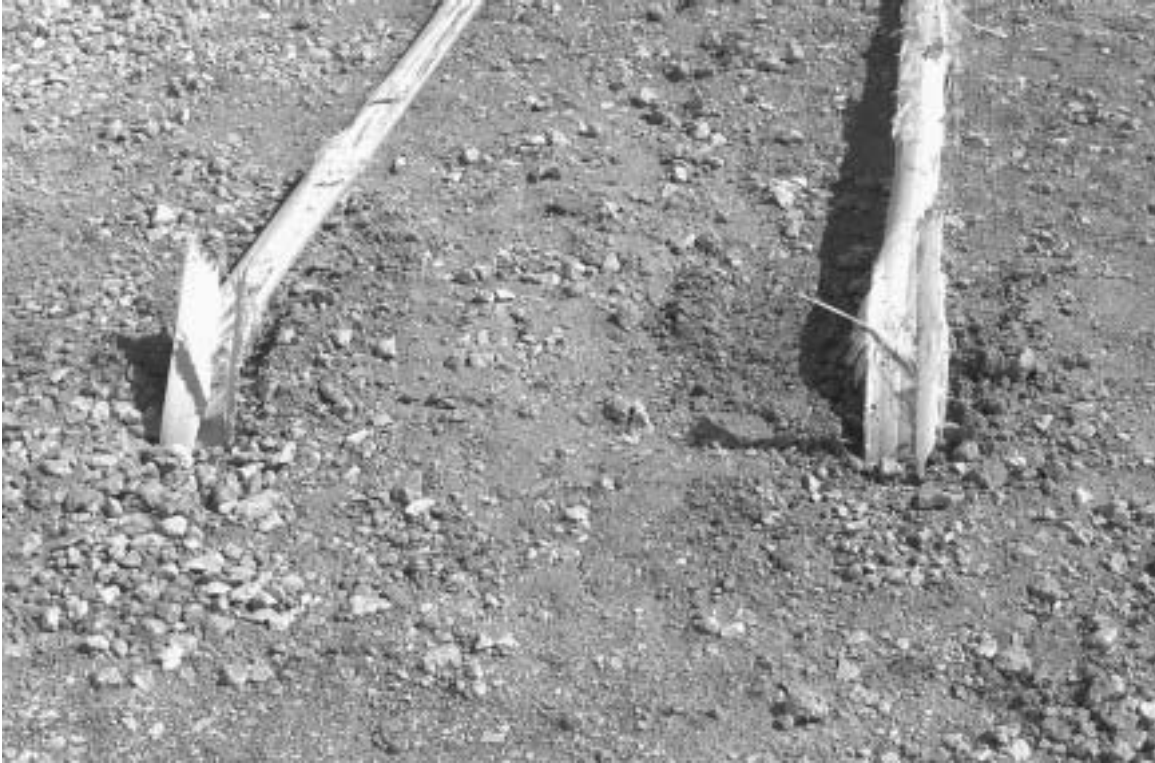
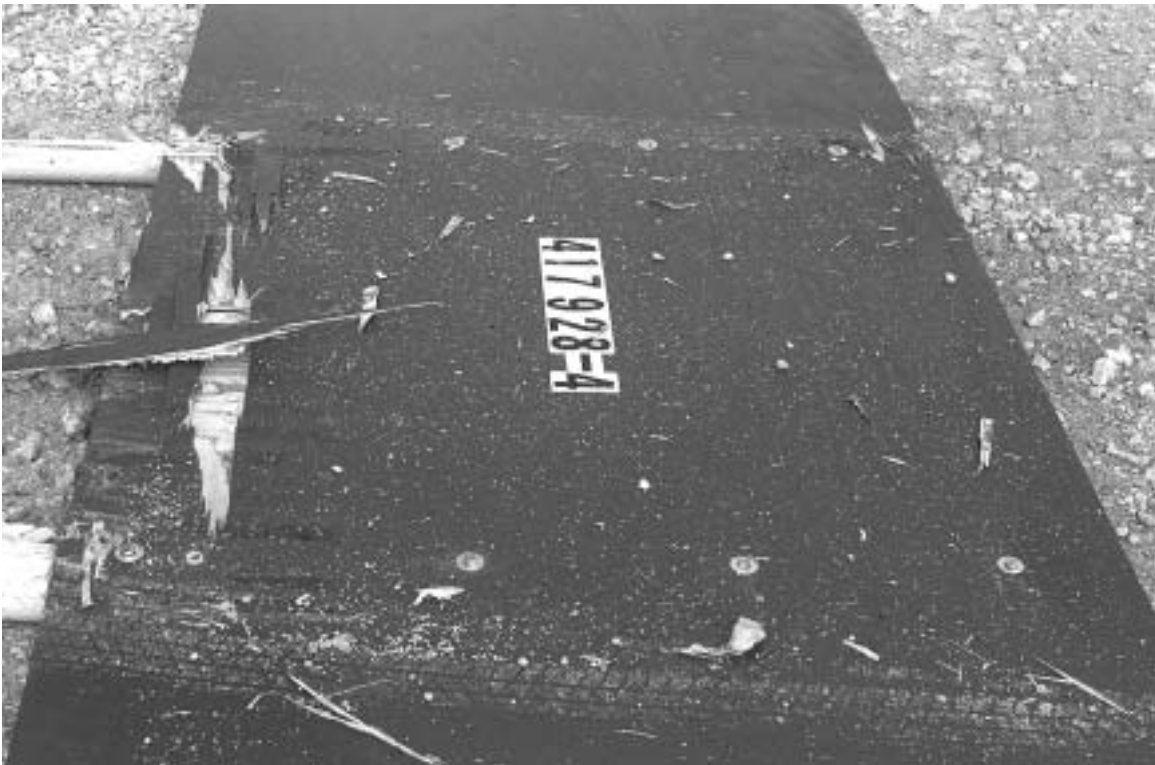
Figure 116. Installation after Test 417928-4.

The sign support and panel remained at their original location and were lying flat against the ground, as shown in [Figures 115 and 116](#).

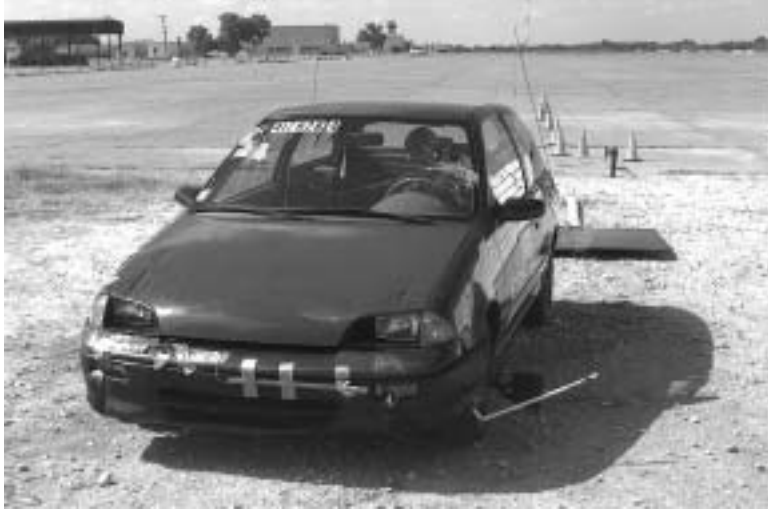
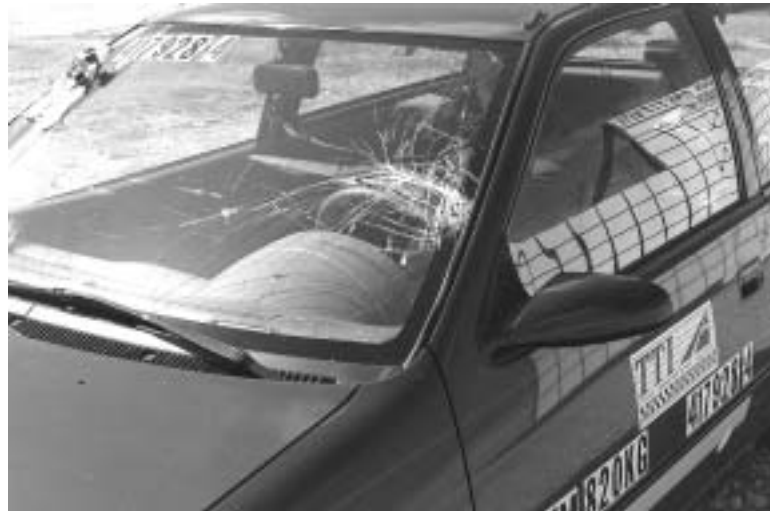
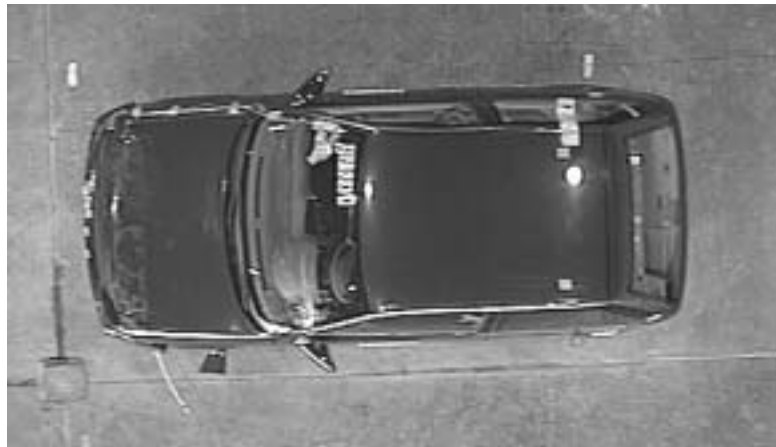
Figure 117. Vehicle after Test 417928-4.

The vehicle received damage to the front, as shown in [Figure 117](#). The hood received two scrapes, and there was minor damage to the bumper cover. The windshield of the vehicle was shattered on the driver's side from contact with the sign panel. The interior of the vehicle is shown in [Figure 118](#).

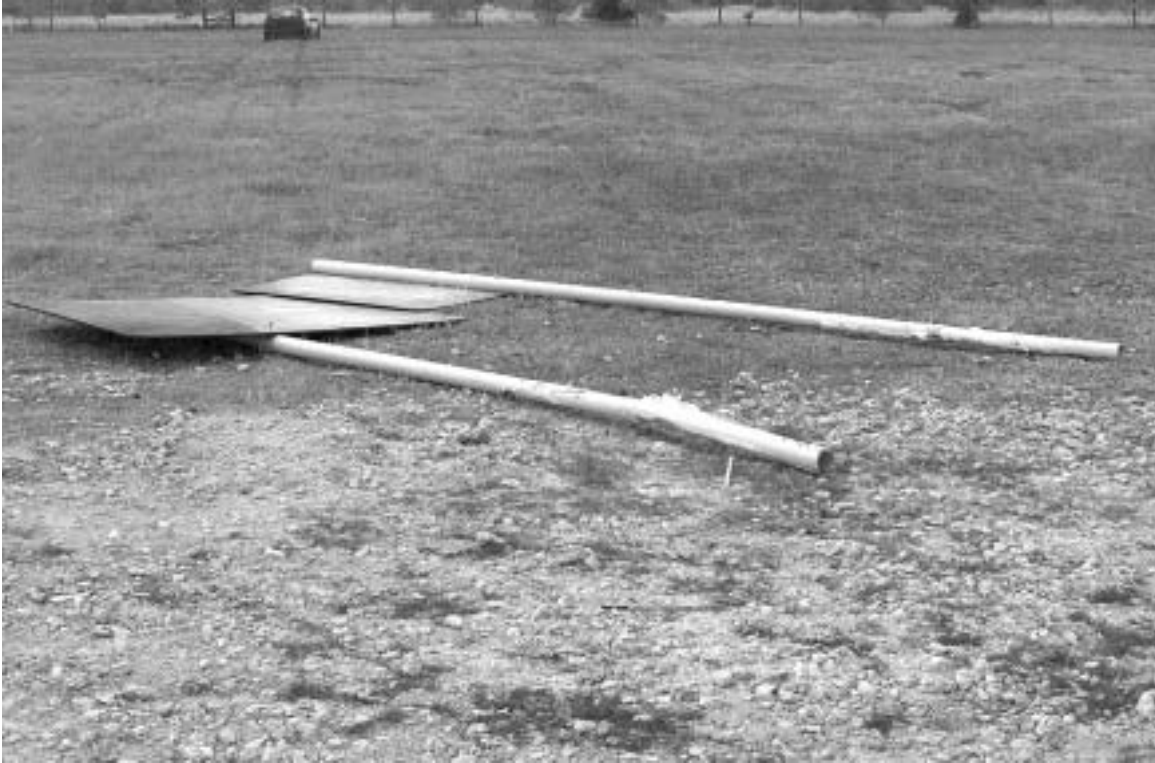
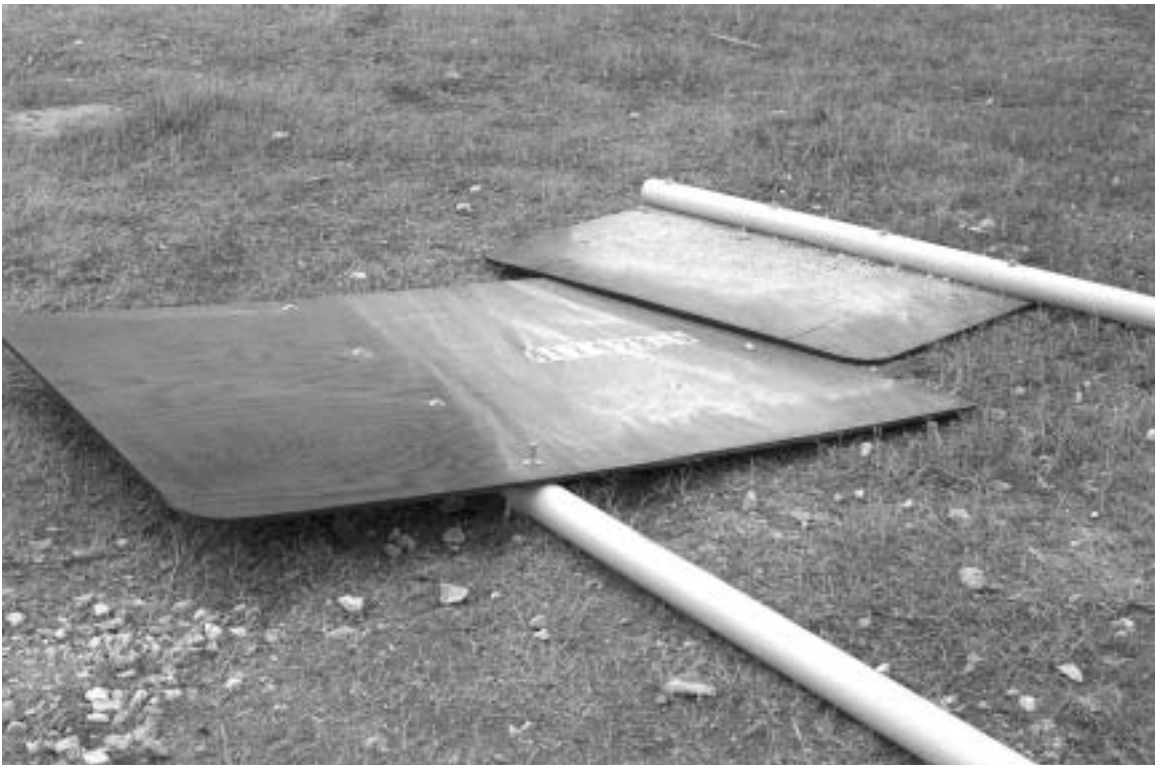
Figure 124. Installation after Test 417928-5.

The sign panel separated into two pieces, as shown in Figures 123 and 124. The two pieces of the sign and the posts came to rest 25.0 m (82.0 ft) from impact and 0.9 m (3.0 ft) to the right of impact.

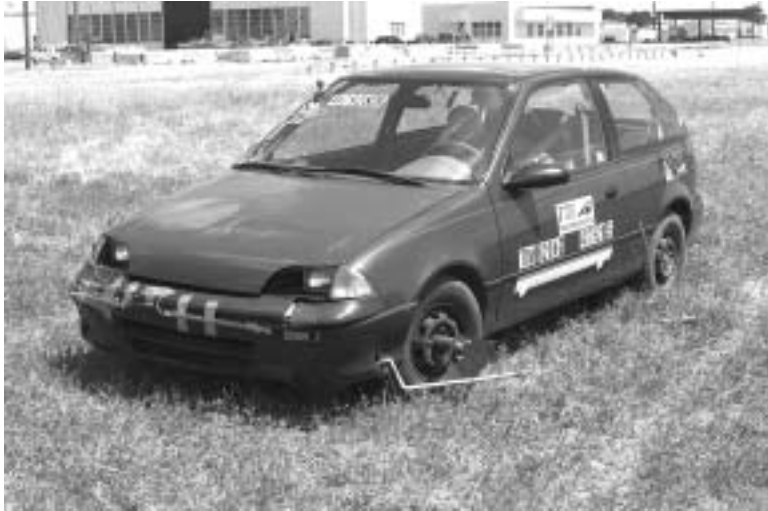
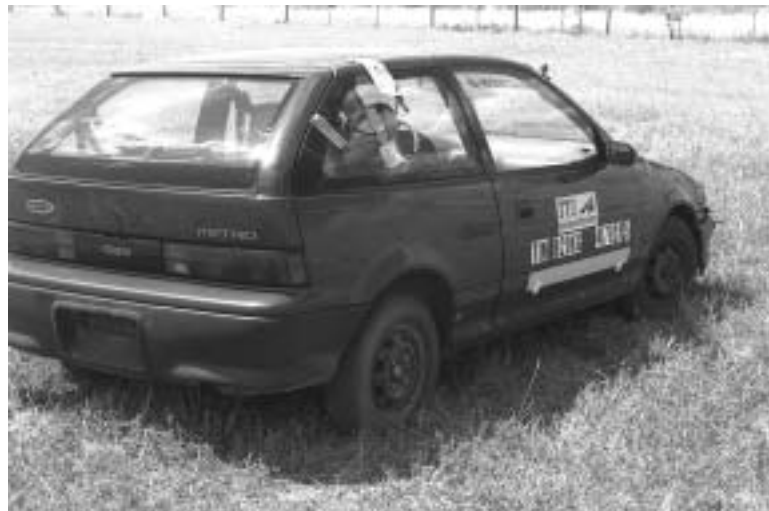
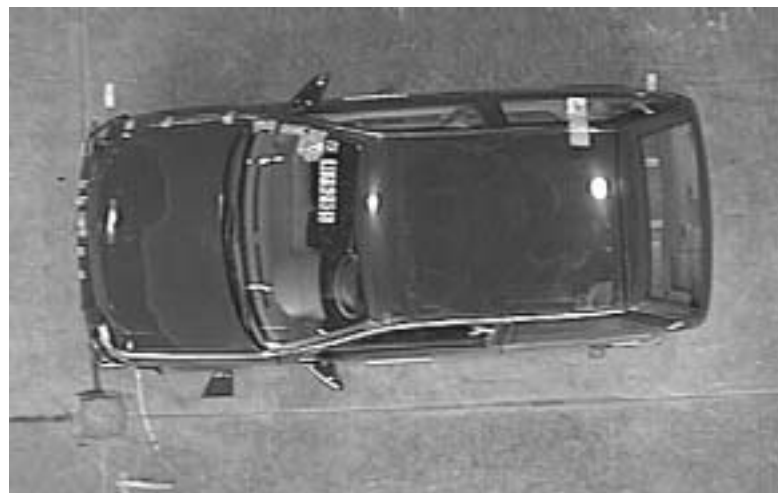
Figure 125. Vehicle after Test 417928-5.

The vehicle received damage to the front, as shown in Figure 125. The vehicle received minor scrapes on the roof, dents in the bumper (not measurable), and shattered the windshield near the driver's side from contact with the sign panel. The interior of the vehicle is shown in Figure 126.

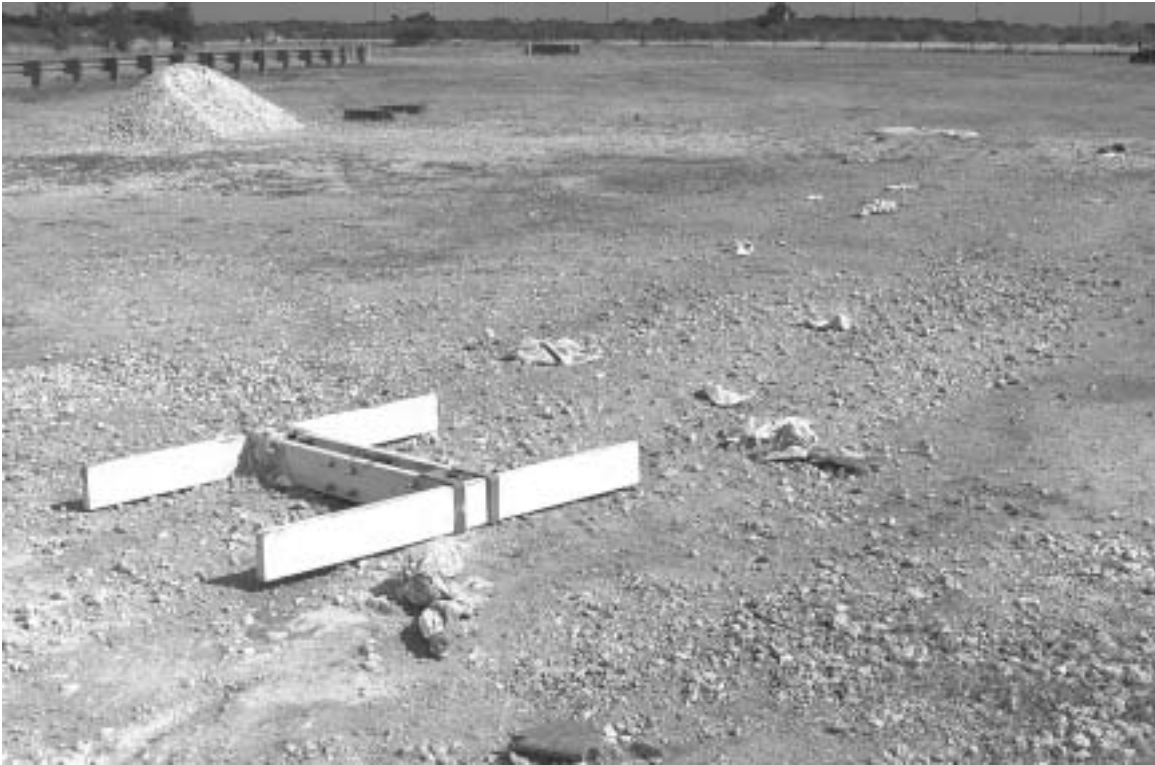
Figure 131. After Impact Trajectory for Test 417928-1.

The roll-up vinyl sign panel and the upper tube separated from the dual-purpose base, as shown in [Figures 131 and 132](#). The roll-up vinyl sign panel came to rest 25.3 m (83.0 ft) from impact and 1.8 m (5.9 ft) to the left of impact, while the support post came to rest 35.7 m (117.1 ft) further down and 4.6 m (15.1 ft) to the left of impact. The base was located 3.0 m (9.8 ft) downstream from impact.

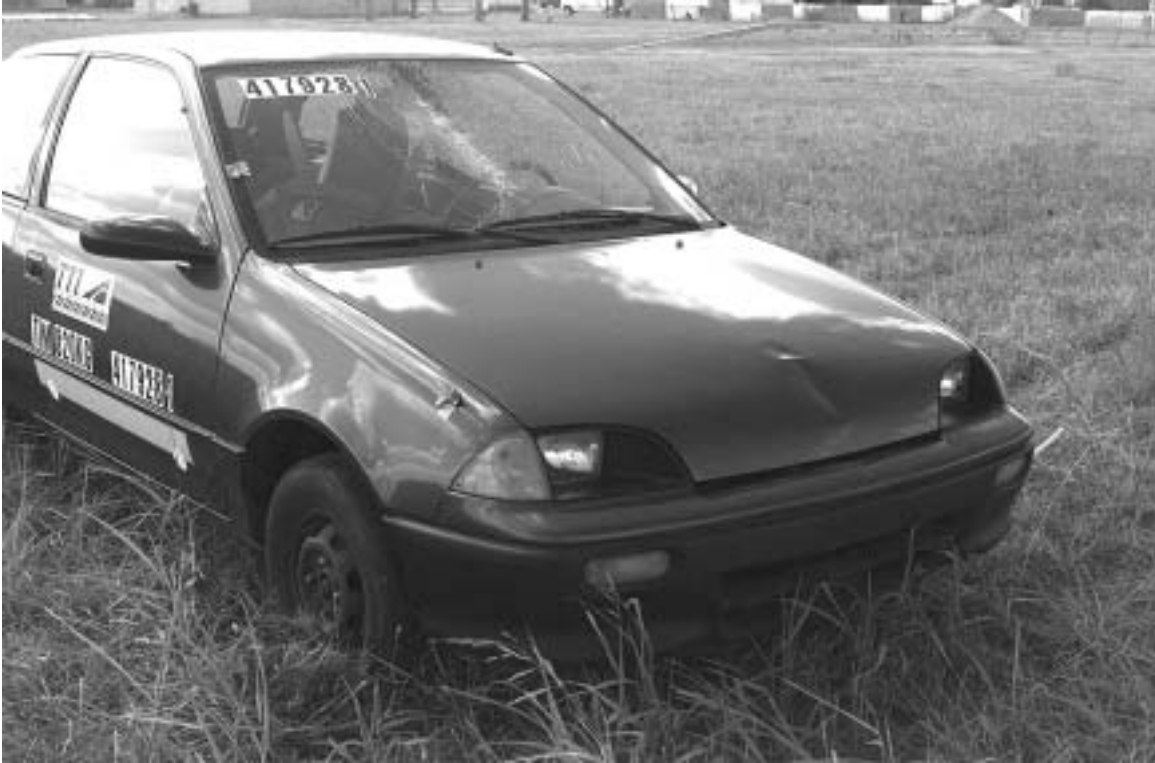
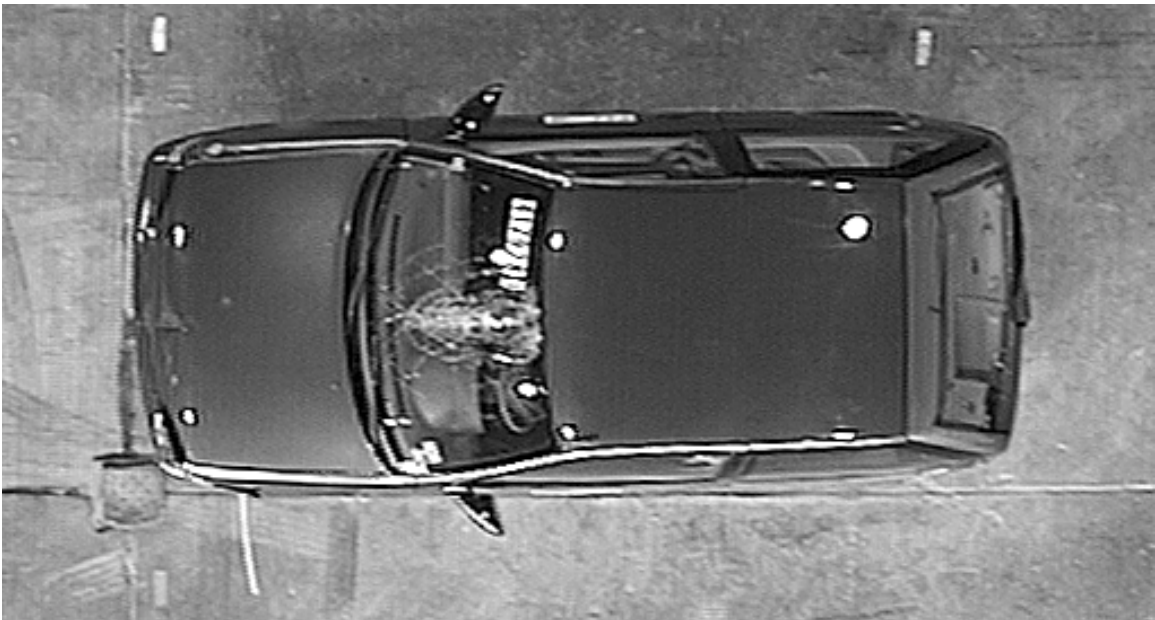
Figure 133. Vehicle after Test 417928-1.

The vehicle received damage to the front as shown in [Figure 133](#). The hood was deformed 30 mm × 190 mm × 5 mm (1.2 inch × 7.5 inch × 0.2 inch) deep, and the left rear rim of the tire was damaged. The windshield was shattered by the FRP post near the roof edge at the center. The interior of the vehicle is shown in [Figure 134](#).

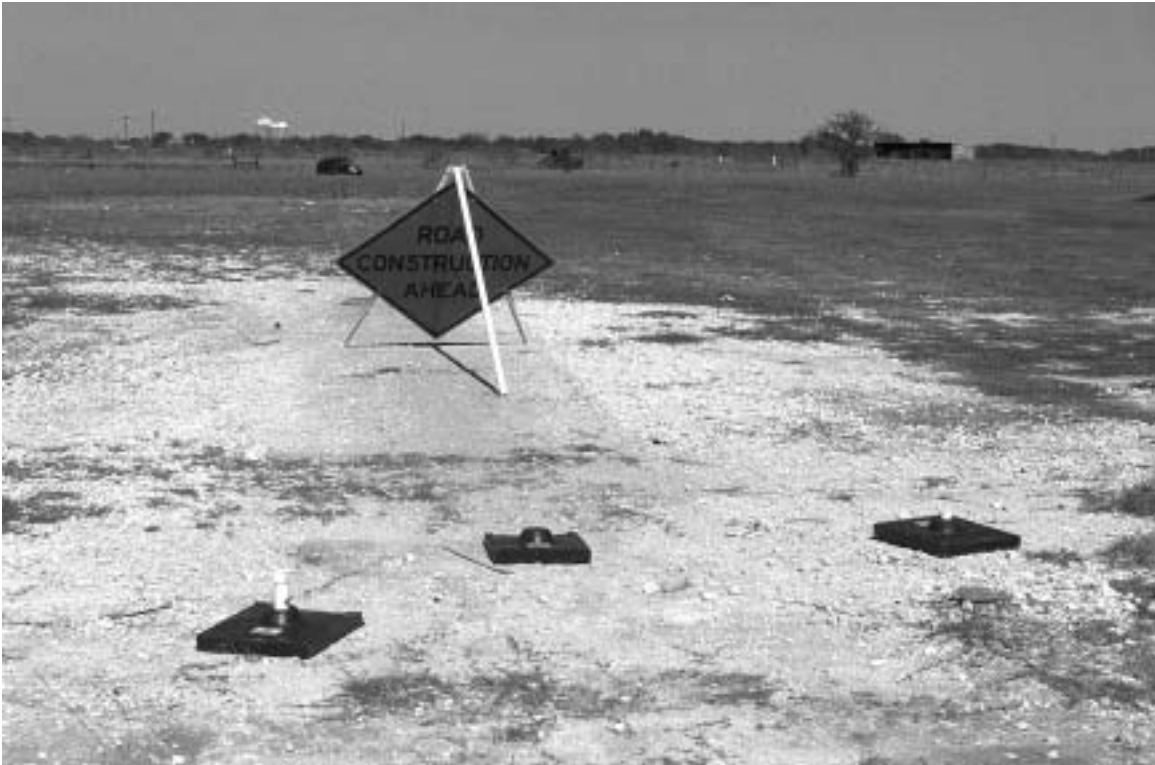
Figure 139. After Impact Trajectory for Test 417929-2.

The upright portion of the barricade remained in one piece and came to rest 9.1 m (30.0 ft) from impact as shown, in Figures 139 and 140. The PVC tube broke off from the front two rubber bases; the base on the left had a stub that measured 128 mm (5.0 inch), and the one on the right measured 45 mm (1.8 inch), while the rear fitting was totally extracted from the base.

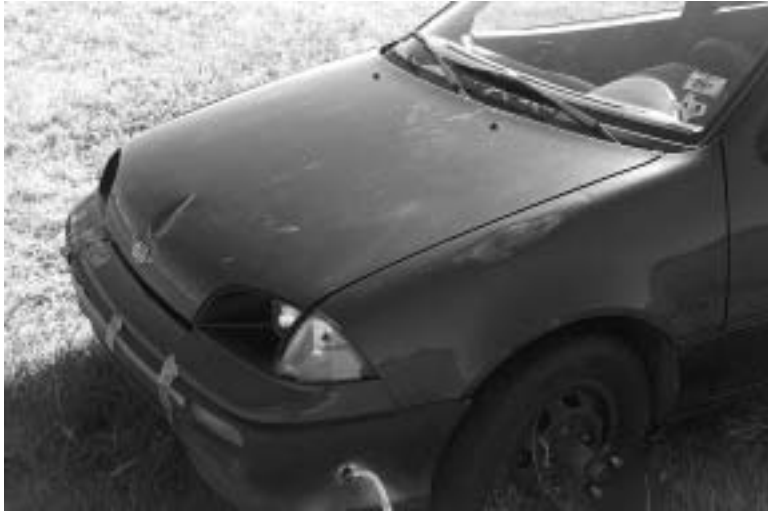
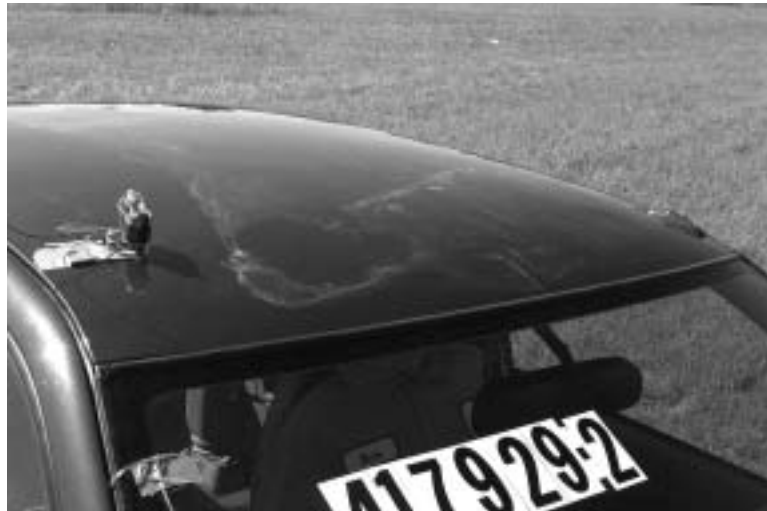
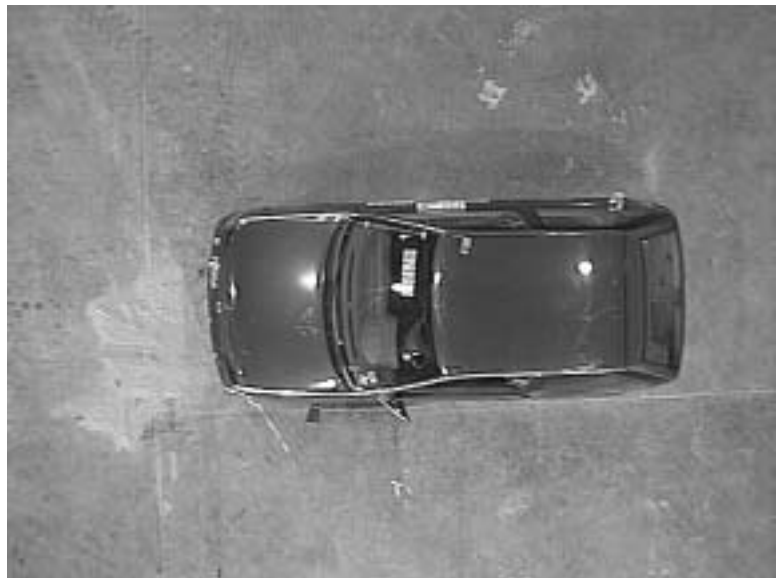
Figure 141. Vehicle after Test 417929-2.

The front of the vehicle received damage, as shown in [Figure 141](#). There was a small dent in the hood (not measurable) and scuff marks on the hood and roof of the vehicle. The interior of the vehicle is shown in [Figure 142](#).

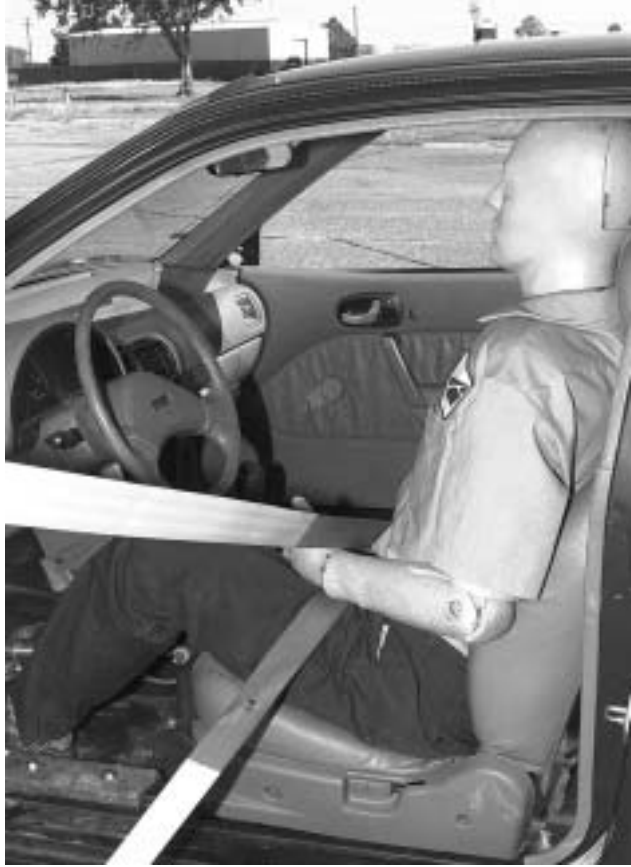
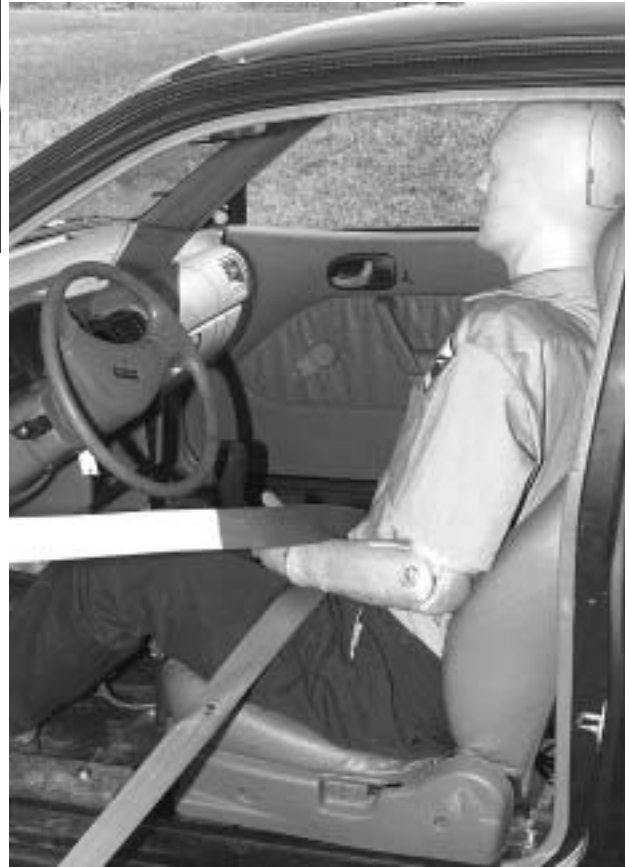
Figure 142. Interior of Vehicle for Test 417929-2.

The sign support did not penetrate or show potential to penetrate the occupant compartment, or present undue hazard to others in the area. No deformation or intrusion of the occupant compartment occurred.

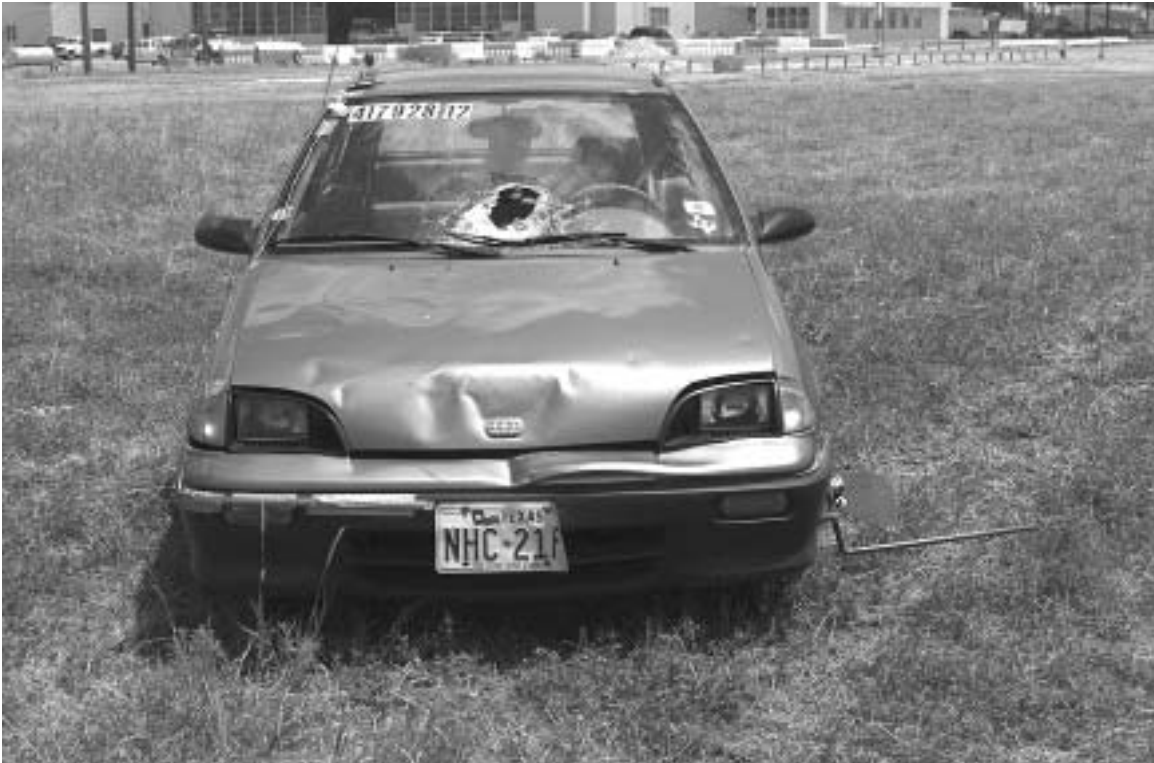
Figure 149. Vehicle after Test 417928-12.

The windshield of the vehicle shattered from the impact of the post, as shown in [Figure 149](#). The hood, bumper, and radiator support were also damaged. The interior of the vehicle is shown in [Figure 150](#).

The vehicle damage would not block the driver's vision but may cause the driver to lose control of the vehicle.

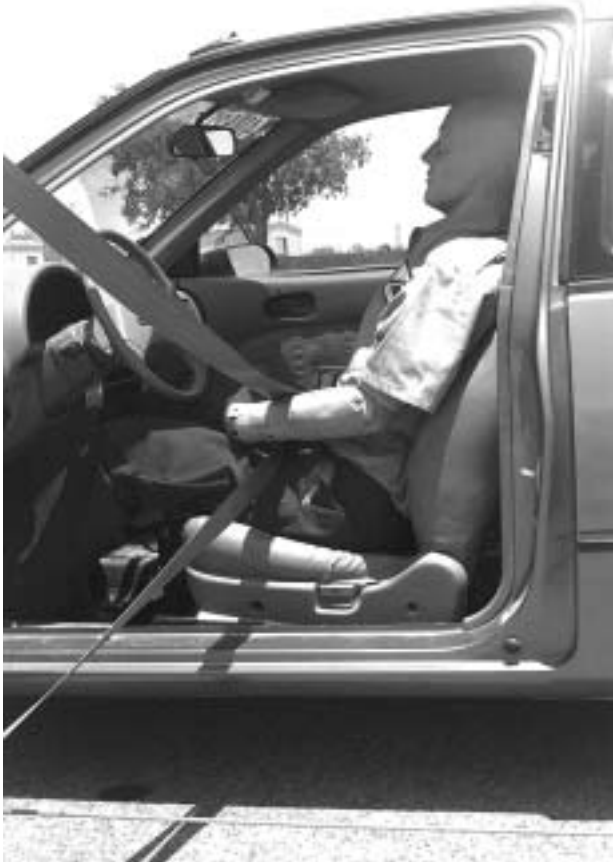
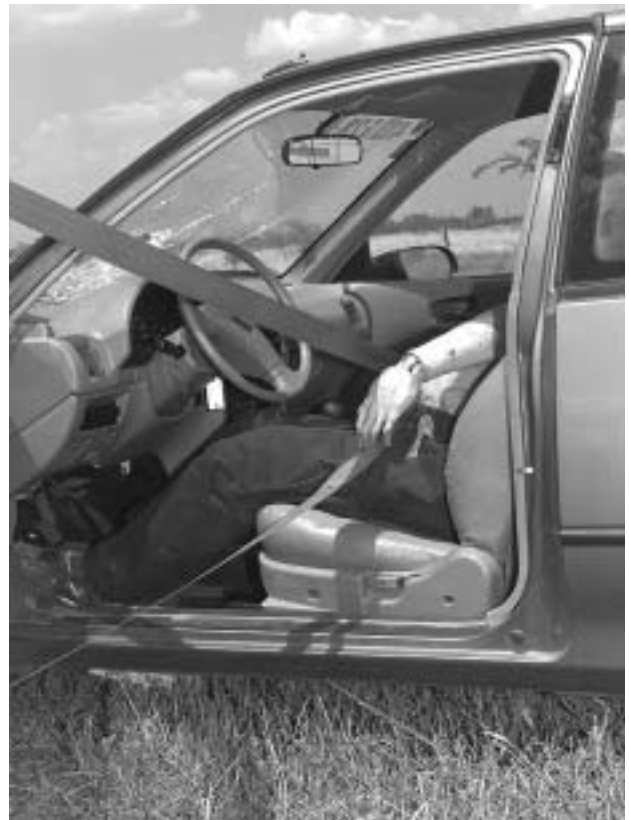
Figure 150. Interior of Vehicle for Test 417928-12.

The temporary wooden sign support with 914 mm × 914 mm (36 inch × 36 inch) plywood sign panel failed to meet *NCHRP Report 350* evaluation criterion D, and is thus considered to be unacceptable.
