1. Report No. FHWA/TX-01/1792-2		2. Government Accession No.		3. Recipient's Catalog No.	
4. Title and Subtitle IMPACT PERFORMANCE EVALUATION OF WORK ZONE TRAFFIC CONTROL DEVICES				5. Report Date December 2000

6. Performing Organization Code	
7. Author(s) Roger P. Bligh, D. Lance Bullard, Wanda L. Menges, and Sandra K. Schoeneman				8. Performing Organization Report No. Report 1792-2

IMPACT PERFORMANCE EVALUATION OF WORK ZONE TRAFFIC CONTROL DEVICES

December 2000

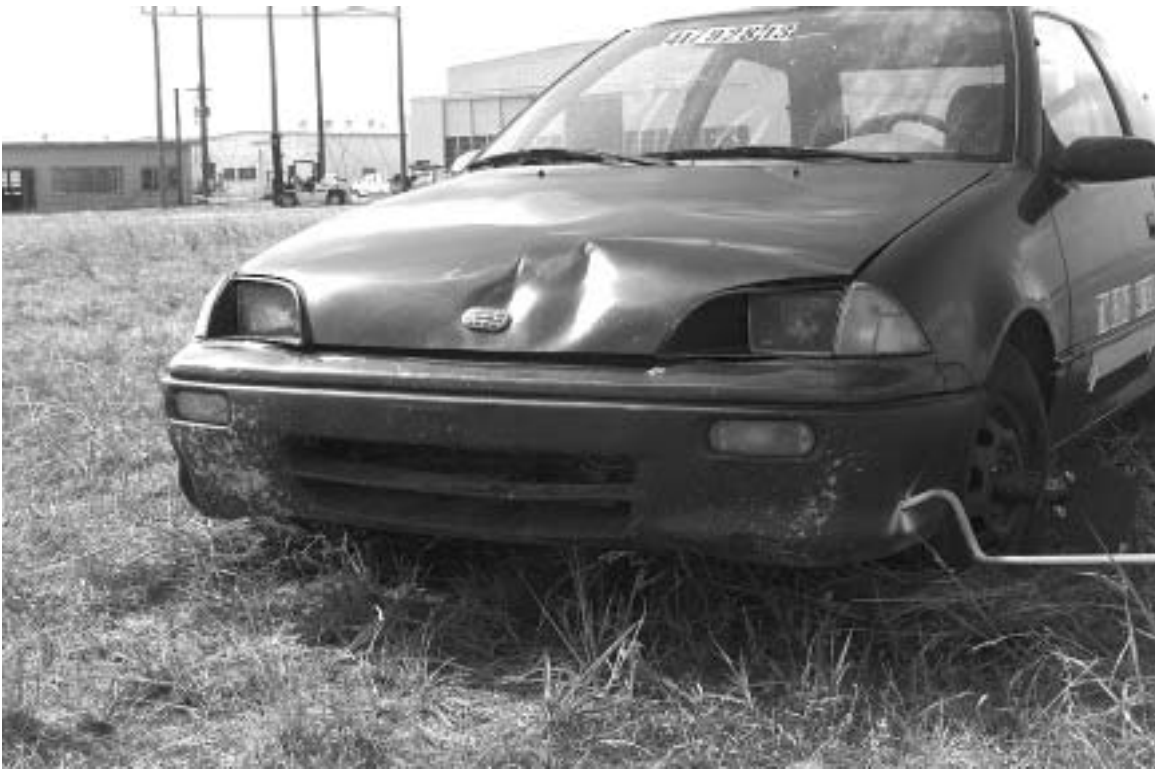
Figure 157. Vehicle after Test 417928-13.

The vehicle received damage to the hood and bumper, as shown in [Figure 157](#). The windshield was shattered, and the radiator support was damaged. The interior of the vehicle is shown in [Figure 158](#).

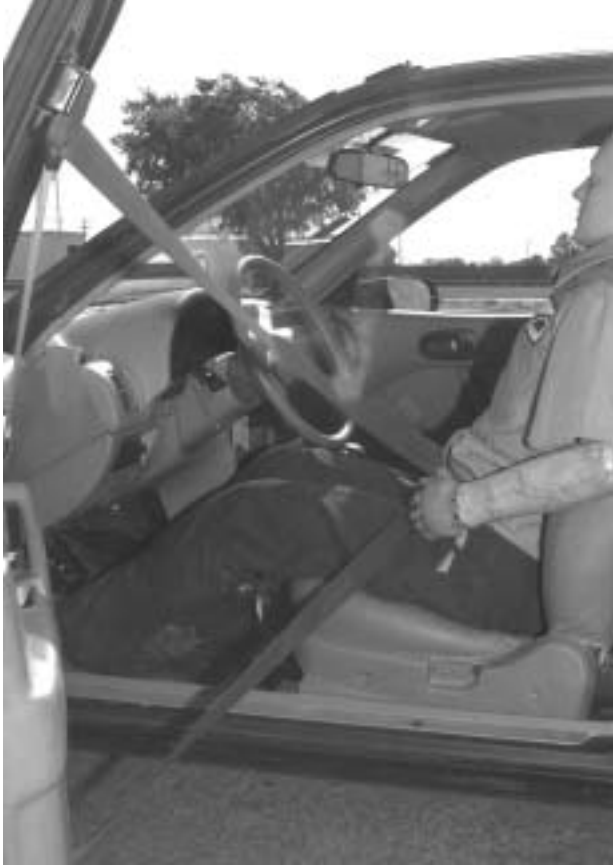
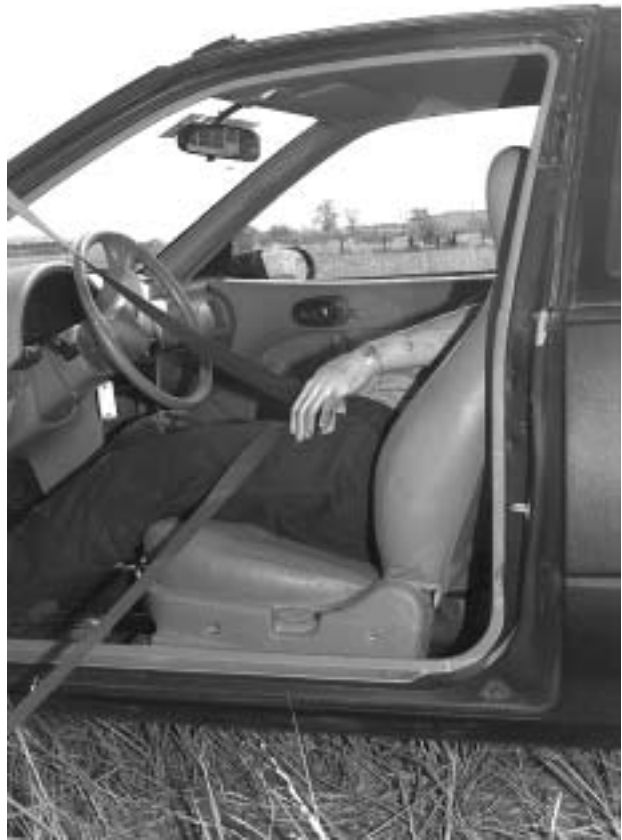
Figure 158. Interior of Vehicle for Test 417928-13.

The hollow profile plastic sign support with wooden sign panel contacted the hood of the vehicle and cracked the base of the windshield, but did not penetrate or show potential to penetrate the occupant compartment, or present undue hazard to others in the area. No deformation or intrusion of the occupant compartment occurred.

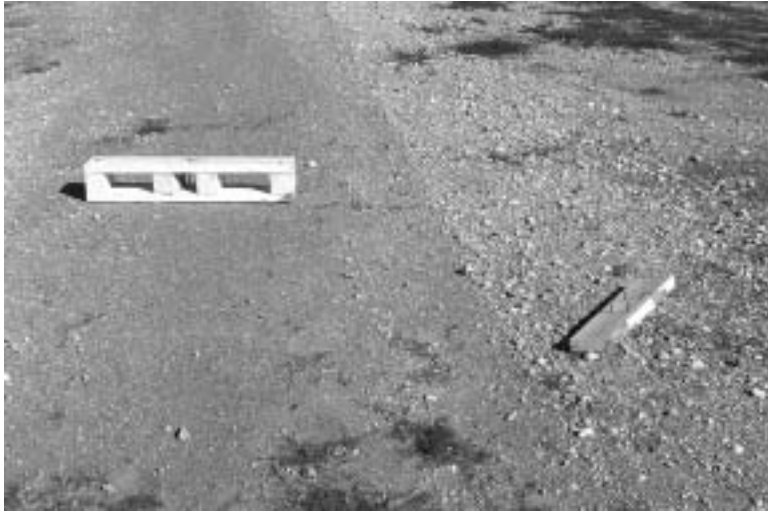
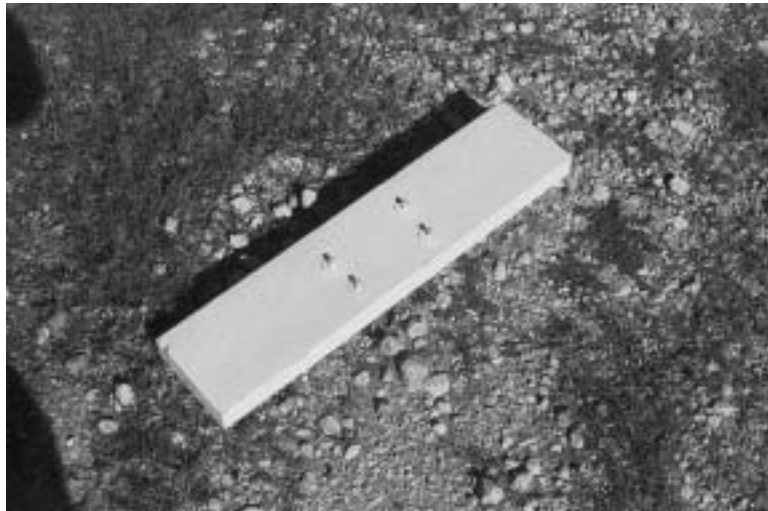
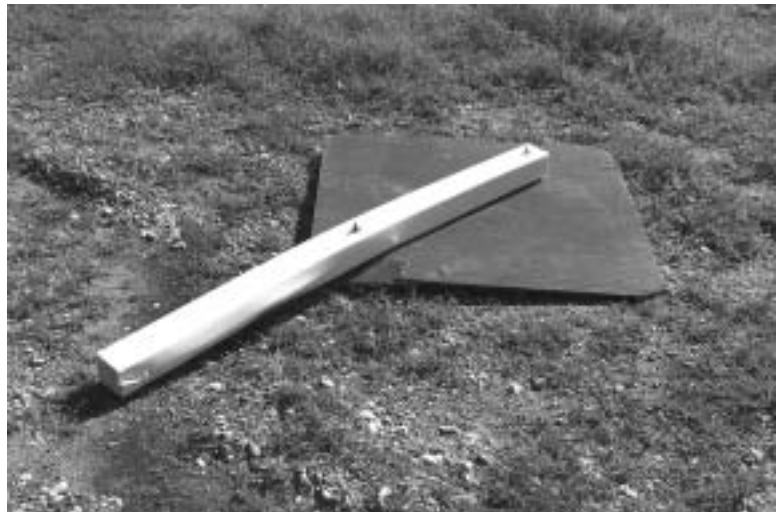
Figure 164. Installation after Test 417929-1.

The barricade separated into a few pieces as shown in [Figures 163 and 164](#). An end piece of the base came to rest 6.9 m (22.6 ft) from impact and 1.5 m (5.0 ft) to the right, while the rest of the debris extended 25.9 m (85.0 ft) further down, 3.1 m (10.2 ft) further to the right, and 9.1 m (30.0 ft) to the left of the impact point.

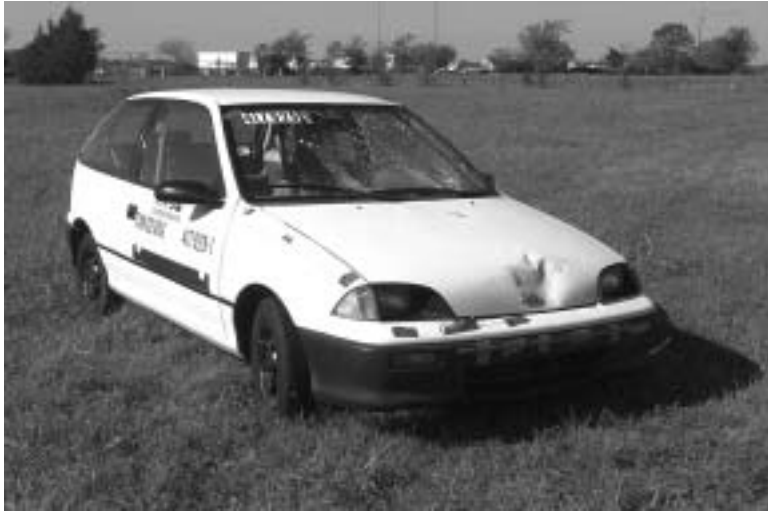
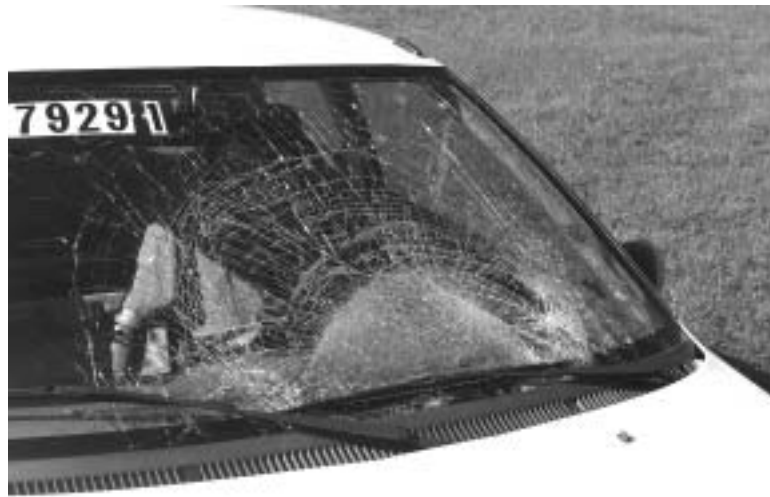
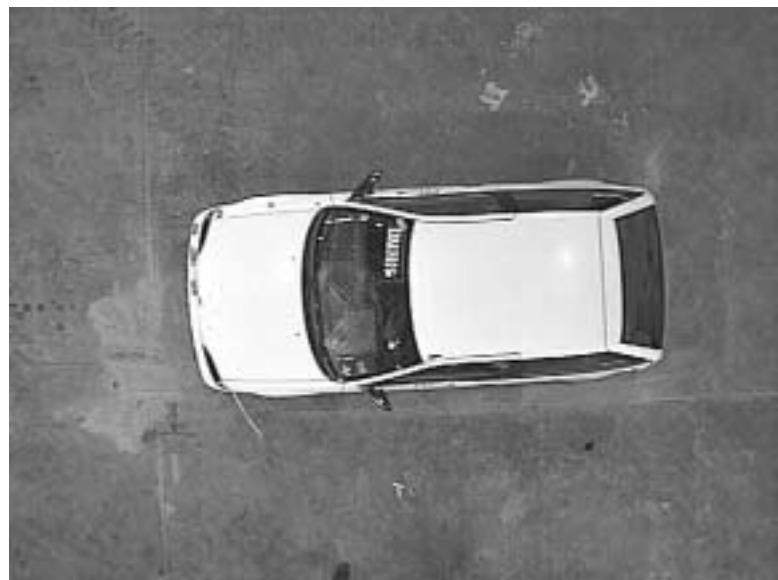
Figure 165. Vehicle after Test 417929-1.

The front of the vehicle received damage, as shown in [Figure 165](#). The windshield was shattered. Maximum exterior crush to the center front of the hood was 25 mm (1 inch). The fan, radiator, and radiator support were also damaged. Exterior vehicle crush measurements are shown in [Appendix B, Table 2](#). The interior of the vehicle is shown in [Figure 166](#).

The resulting windshield damage could potentially block the driver's vision or cause the driver to lose control of the vehicle.

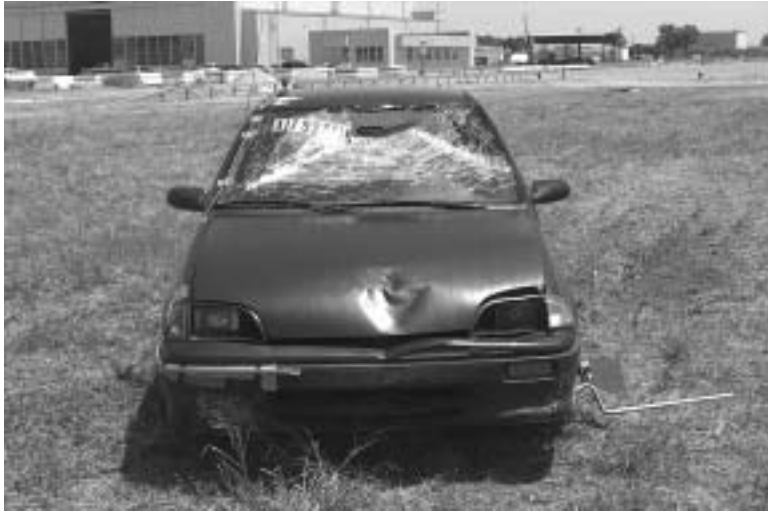
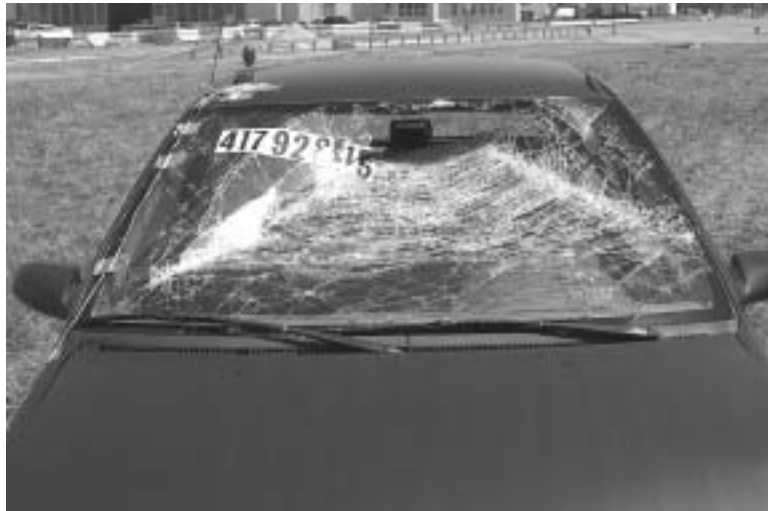
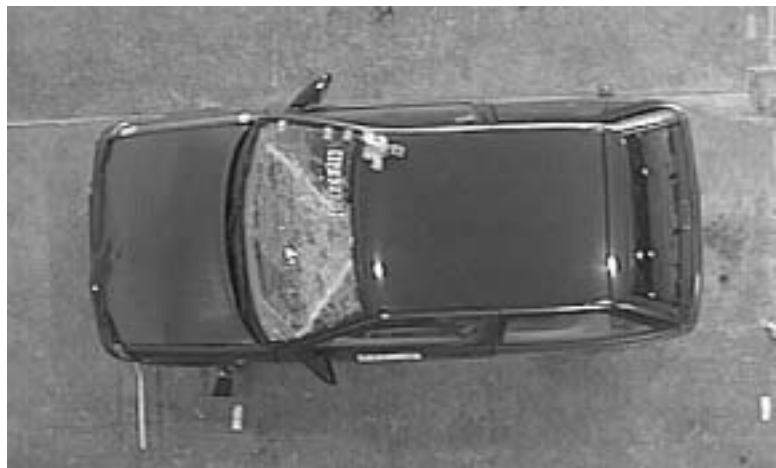
Figure 173. Vehicle after Test 417928-15.

The vehicle received damage to the front, as shown in [Figure 173](#). The hood and bumper received dents (not measurable), and the windshield was shattered from the impact of the sign panel. The interior of the vehicle is shown in [Figure 174](#).

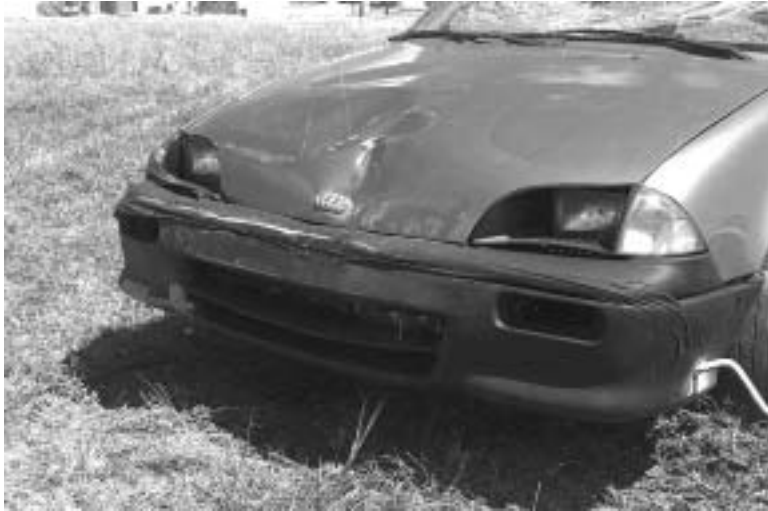
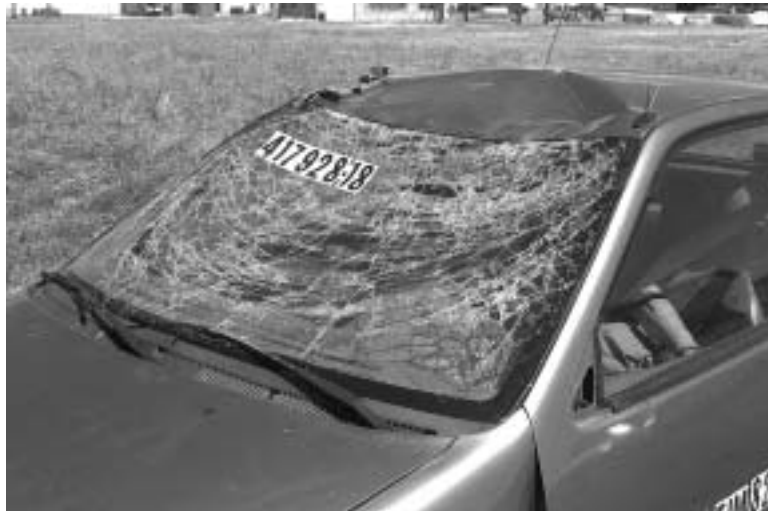
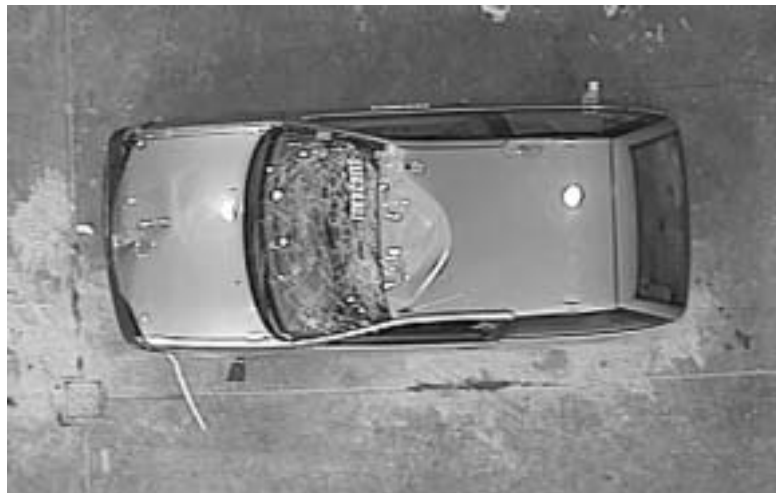
Figure 181. Vehicle after Test 417928-18.

The windshield of the vehicle shattered and pushed inward from the impact of the wooden sign panel, as shown in [Figure 181](#). The roof and hood were also damaged. Maximum deformation into the occupant compartment was 61 mm (2.4 inch) (7 percent reduction in space) in the floor pan area. The interior of the vehicle is shown in [Figure 182](#). Occupant compartment measurements are shown in [Appendix B, Table 4](#).

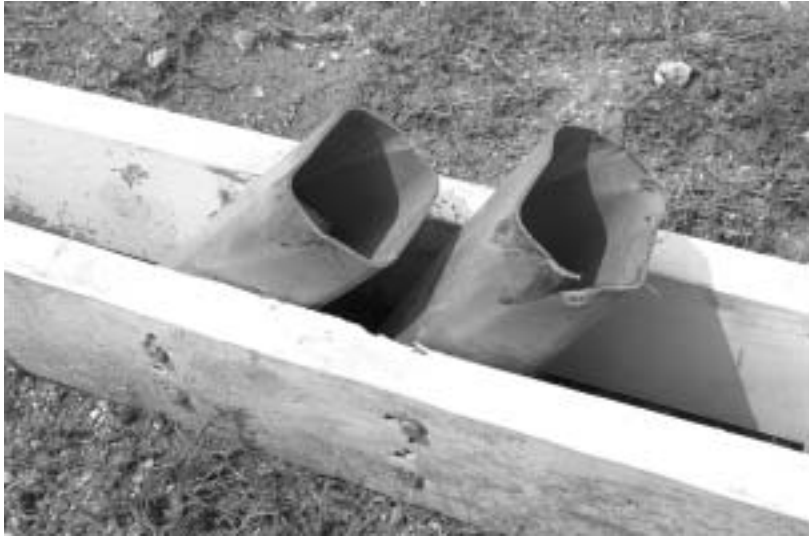
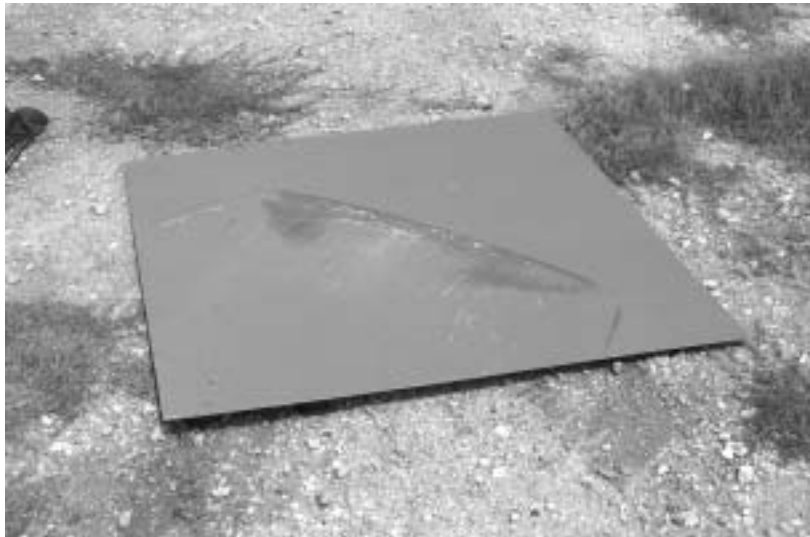
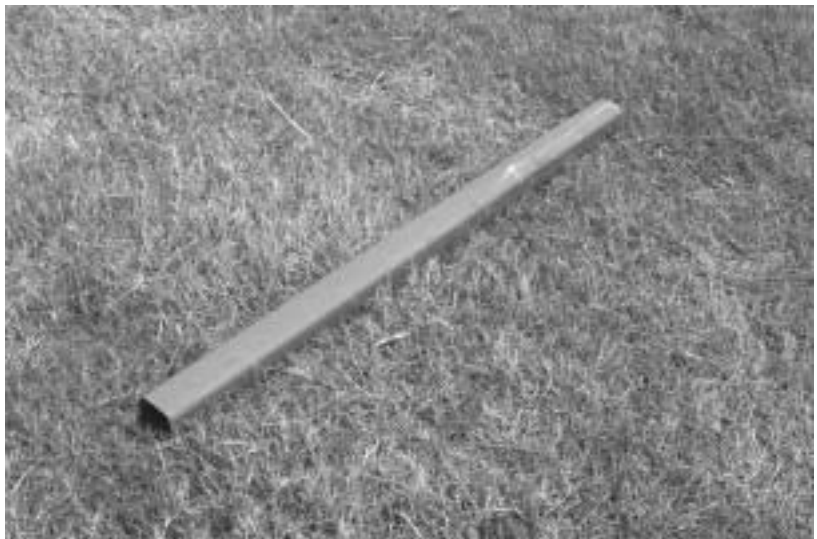
Figure 188. Installation after Test 417929-11.

The barricade separated into multiple pieces, as shown in Figures 187 and 188. The base of the unit moved 3.0 m (9.8 ft) from impact, and the remaining debris extended 40.4 m (132.5 ft) down from the impact point.

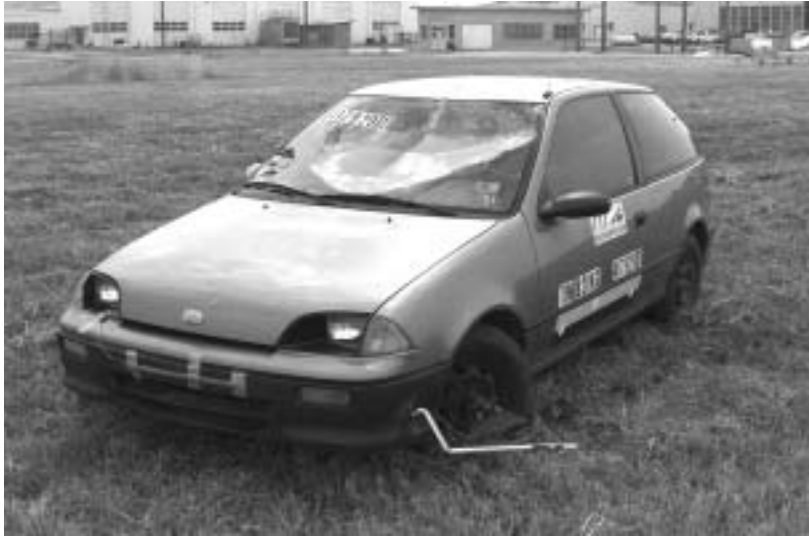
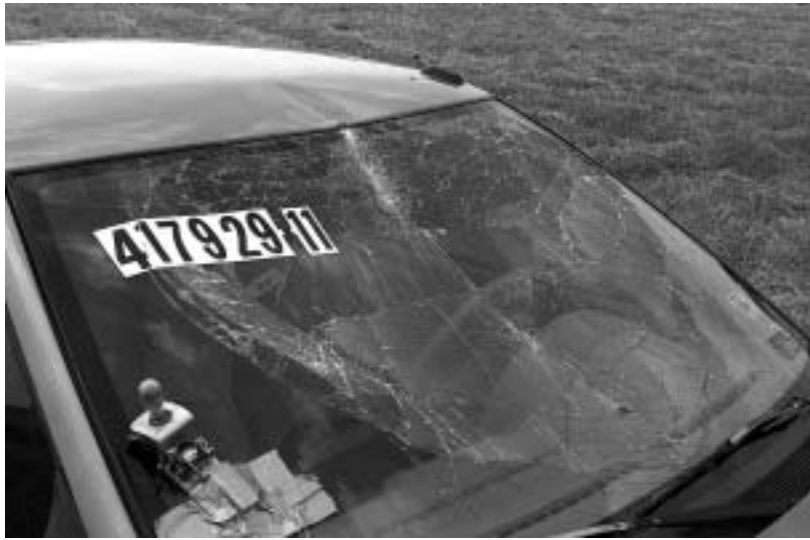
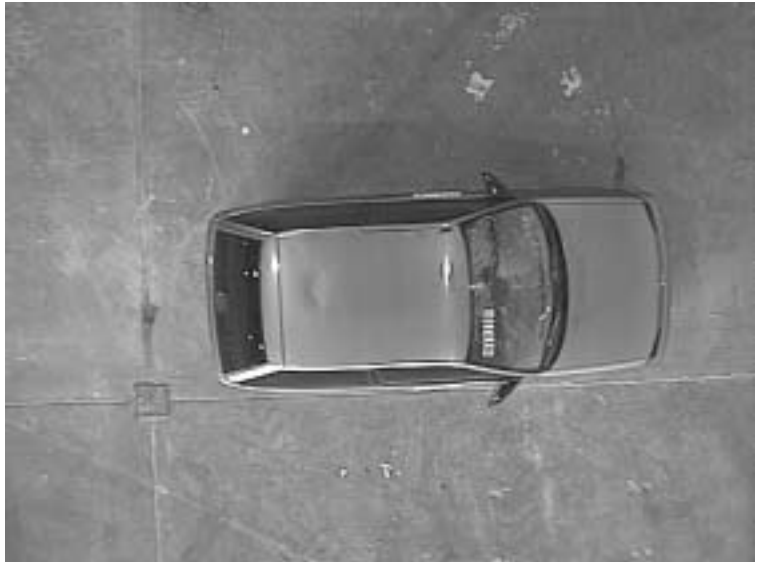
Figure 189. Vehicle after Test 417929-11.

The vehicle received damage to the hood, as shown in Figure 189. The windshield shattered and at the center of the roof, there was a dent that measured 60 mm × 120 mm × 10 mm (2 inch × 5 inch × 0.4 inch). There were also scrapes under the body of the vehicle. Deformation of the occupant compartment of 10 mm (0.4 inch) occurred in the windshield area. The interior of the vehicle is shown in Figure 190.

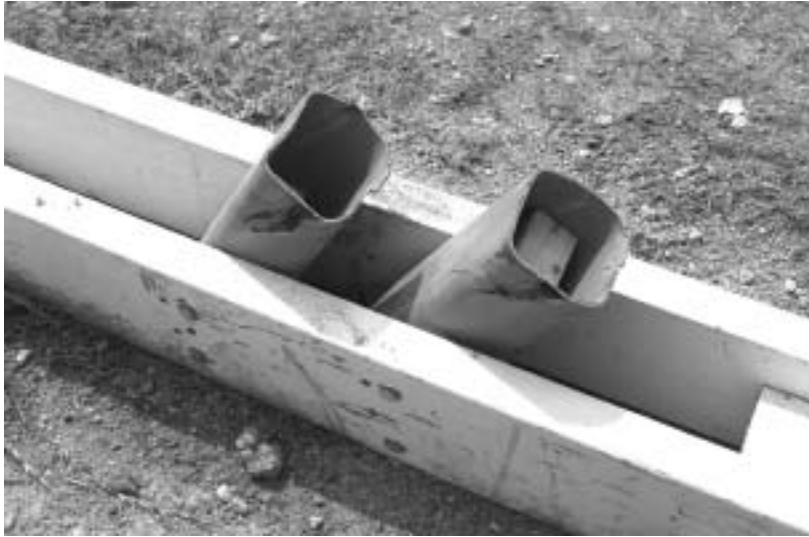
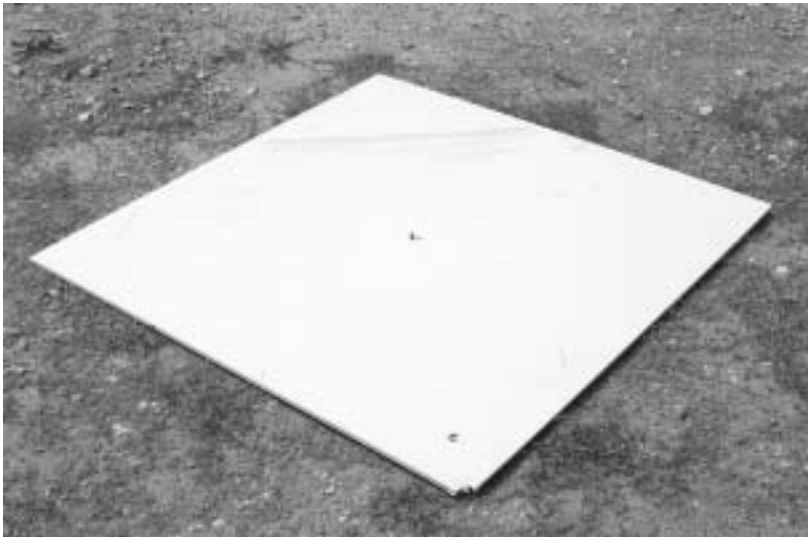
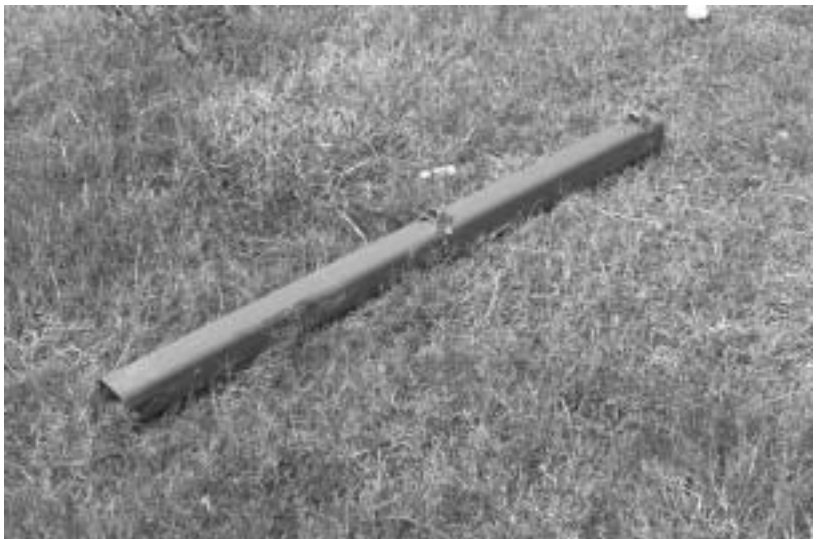
Figure 196. Installation after Test 417929-12.

The barricade separated into multiple pieces, as shown in Figures 195 and 196. The base of the unit moved 0.76 m (2.5 ft) from impact, and the remaining debris extended 38.9 m (127.6 ft) down and 7.6 m (25.0 ft) to the left of the impact point.

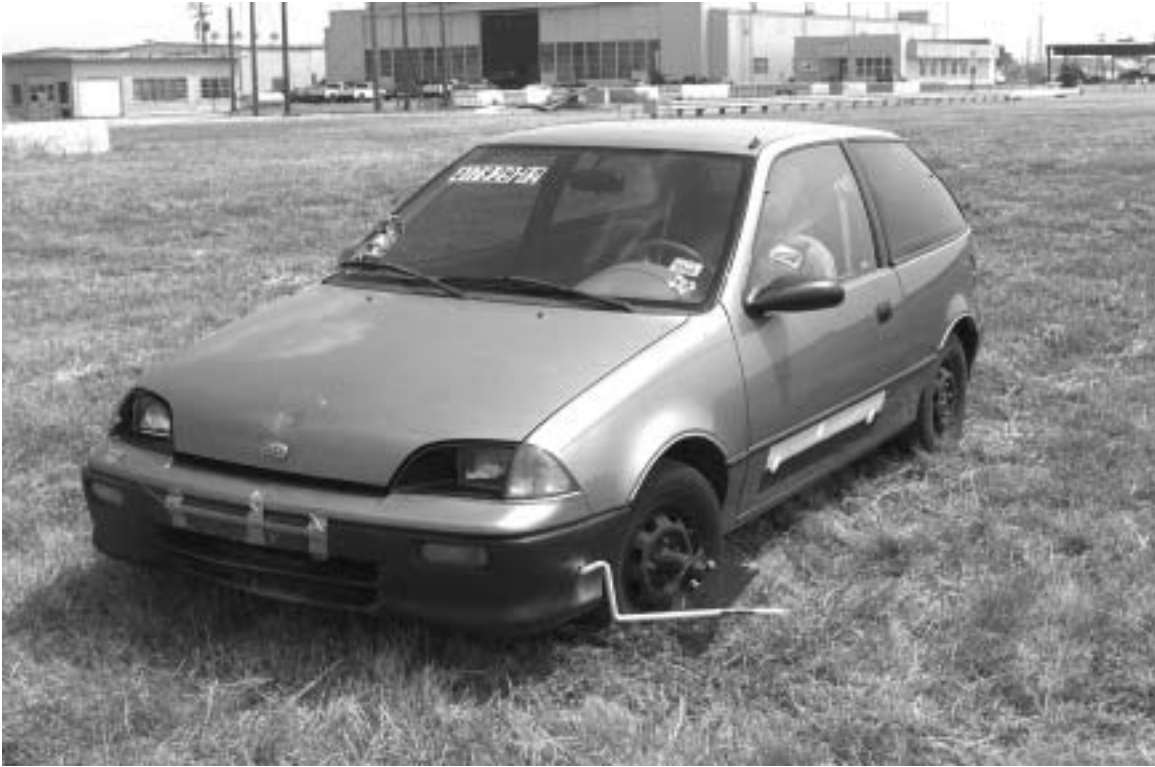
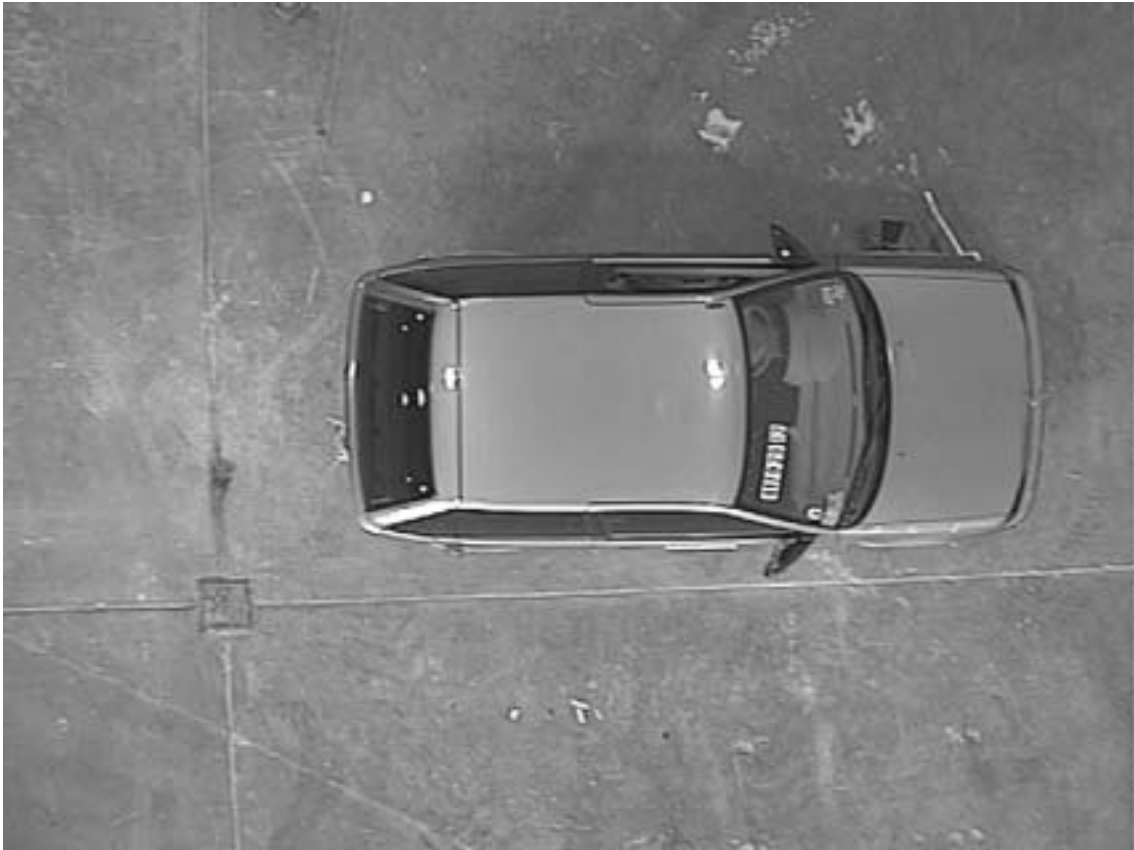
Figure 197. Vehicle after Test 417929-12.

The vehicle received damage, as shown in Figure 197. The hood, roof, and radiator support were damaged. The windshield was cracked at the top in the center. There were scrapes under the body, and the fuel tank was dented. No deformation or intrusion of the occupant compartment occurred. The interior of the vehicle is shown in Figure 198.

The support cracked the windshield at the roof line in the center, but it did not penetrate or show potential to penetrate the occupant compartment, or present undue hazard to others in the area. No deformation or intrusion of the occupant compartment occurred.

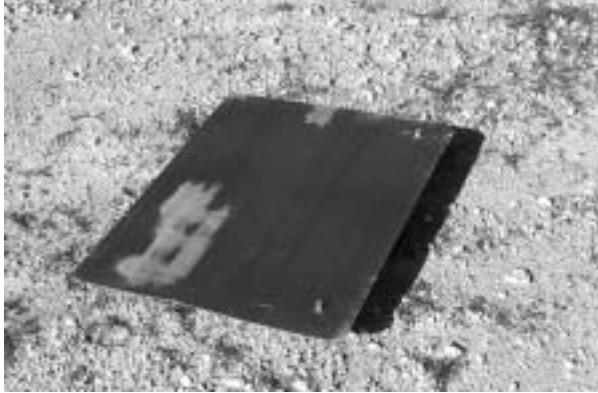
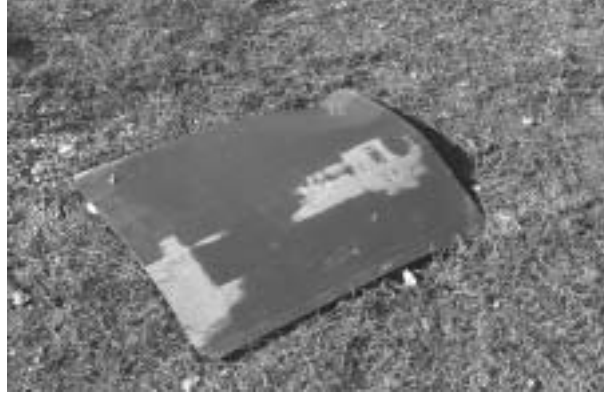
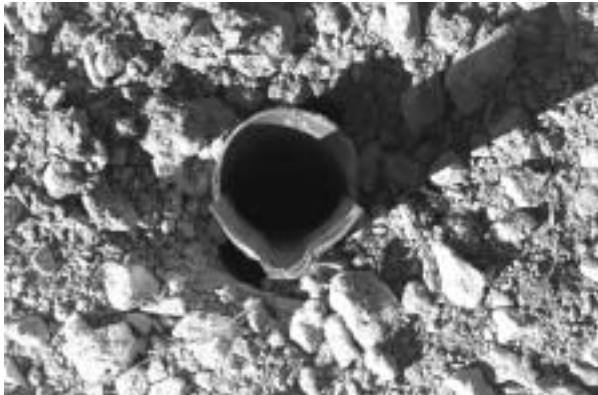
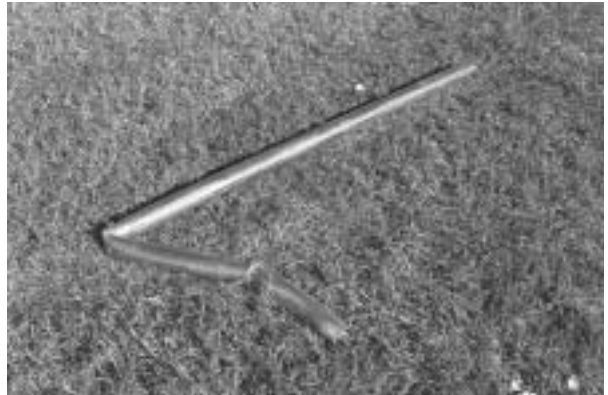
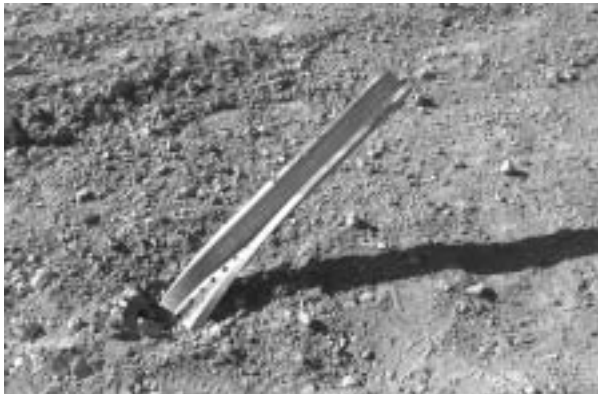
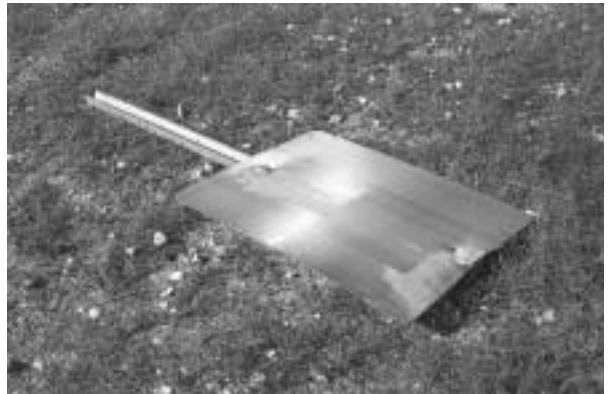
Figure 204. Installation after Test 417929-3.

The sign supports separated into multiple pieces, as shown in Figures 203 and 204. The U-channel post came to rest 28.2 m (92.5 ft) from impact and 0.76 m (2.5 ft) to the right of impact. One of the panels from the tube post sign came to rest 21.3 m (70.0 ft) down and 8.4 m (27.6 ft) to the left of impact, and the other sign panel came to rest 35.1 m (115.2 ft) down and 3.0 m (9.8 ft) to the left of impact. The tube post was 48.0 m (157.5 ft) downstream and 3.0 m (9.8 ft) to the left of impact.

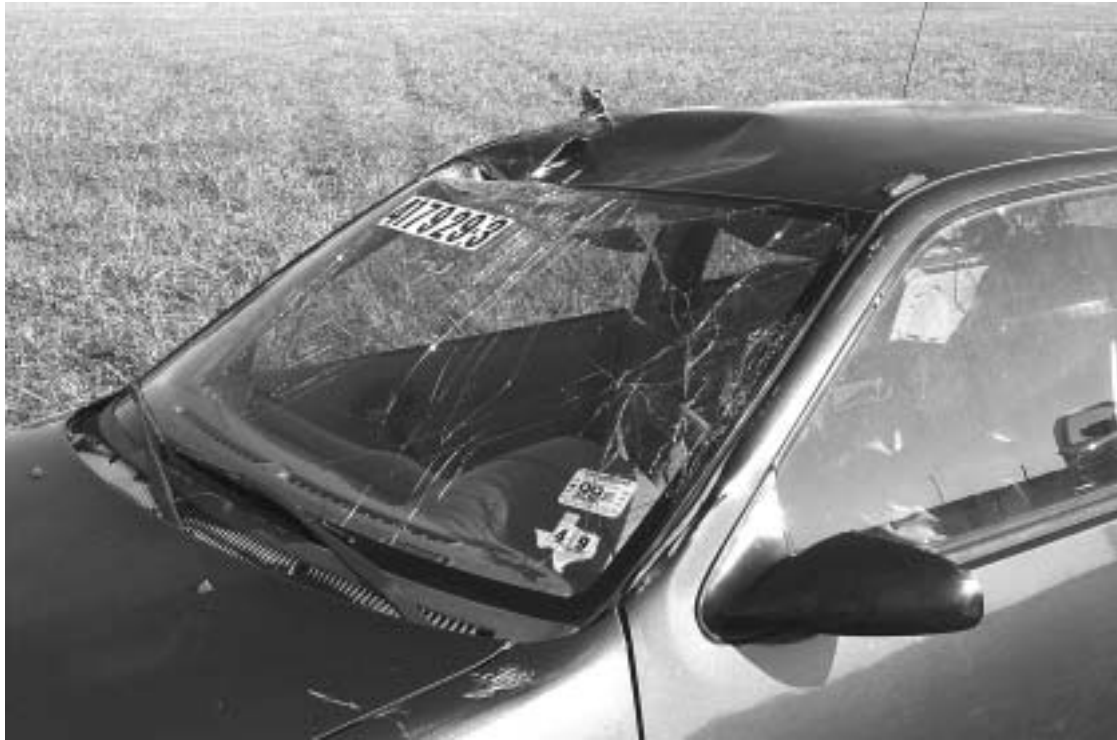
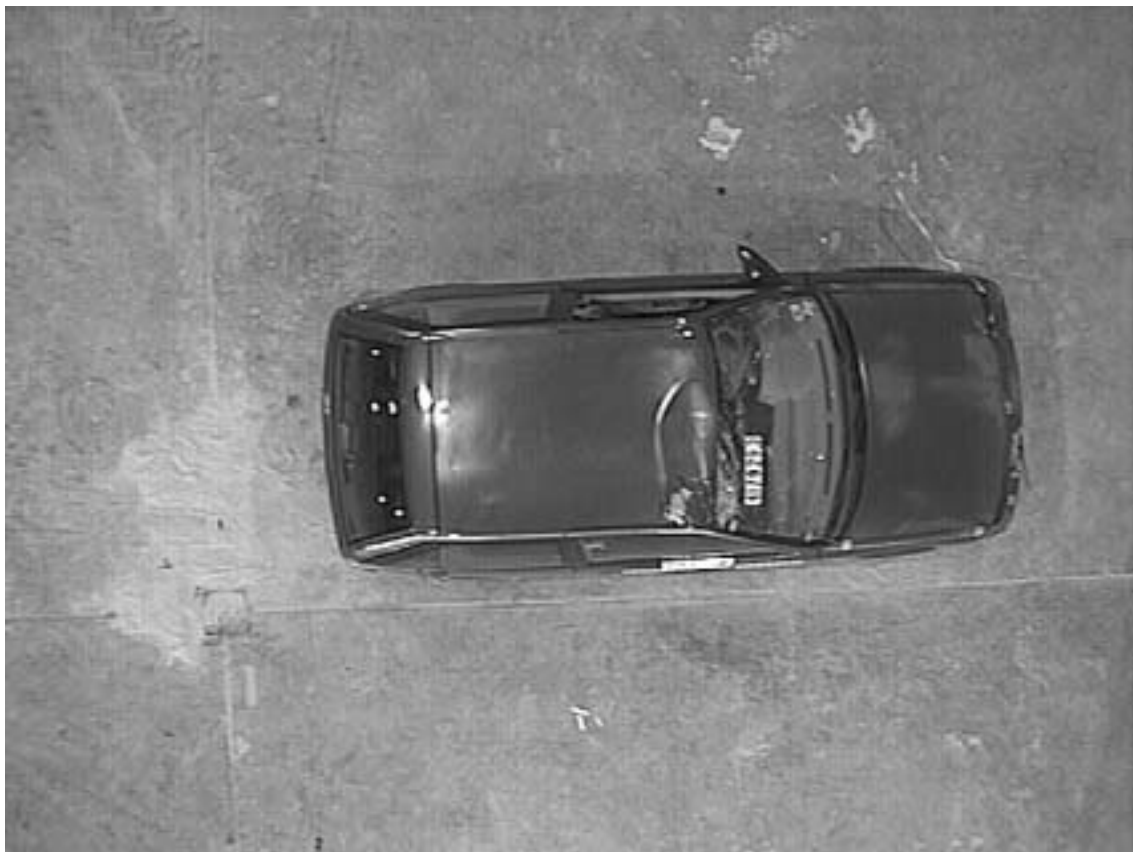
Figure 205. Vehicle after Test 417929-3.

The front of the vehicle received damage, as shown in [Figure 205](#). The hood and bumper of the vehicle were dented. The left door post was dented from contact with the sign. The windshield was shattered. Maximum deformation into the occupant compartment was 75 mm (3.0 inch) (8 percent reduction in space) to the roof of the vehicle. A cut, 110 mm (4.3 inch) in length, was in the deformed section of the roof. The interior of the vehicle is shown in [Figure 206](#). Exterior vehicle crush and occupant compartment measurements are shown in [Appendix B](#), Tables 5 and 6.

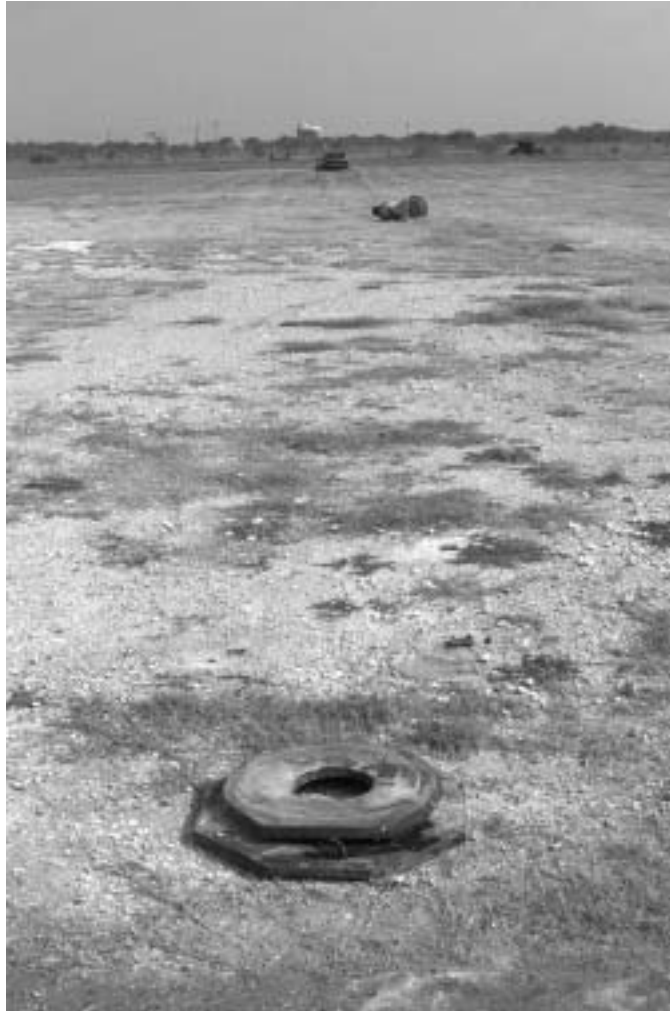
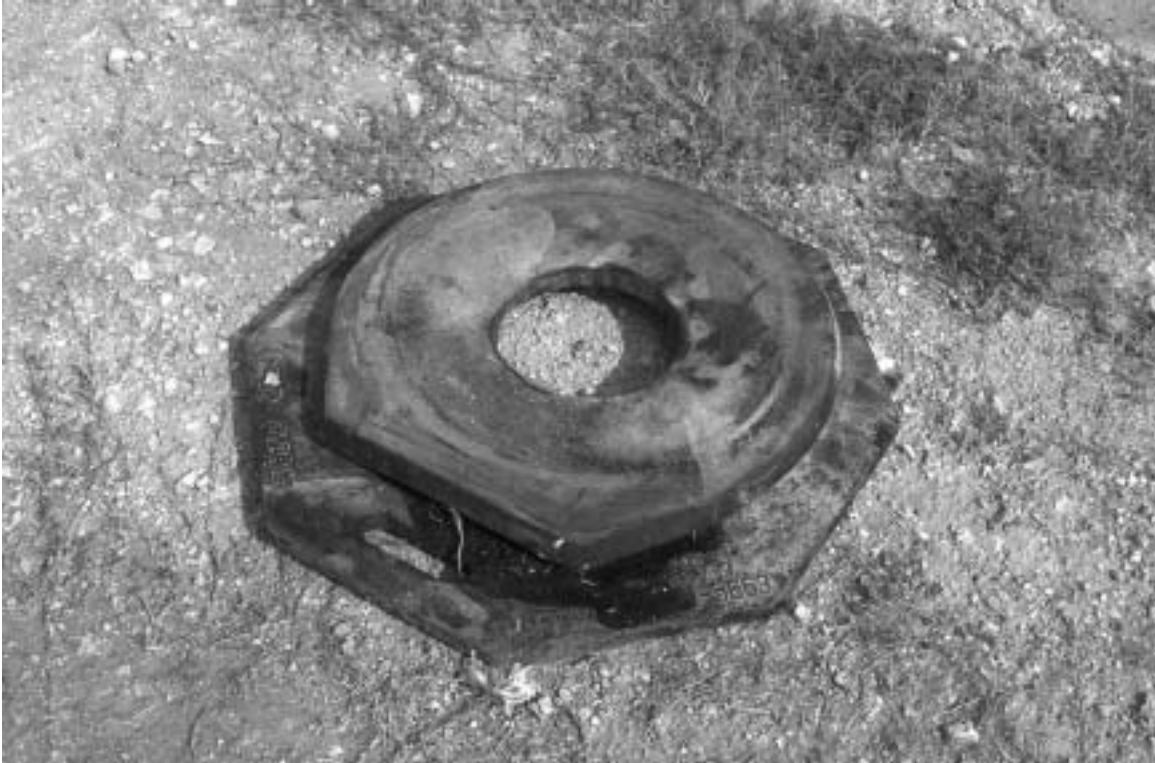
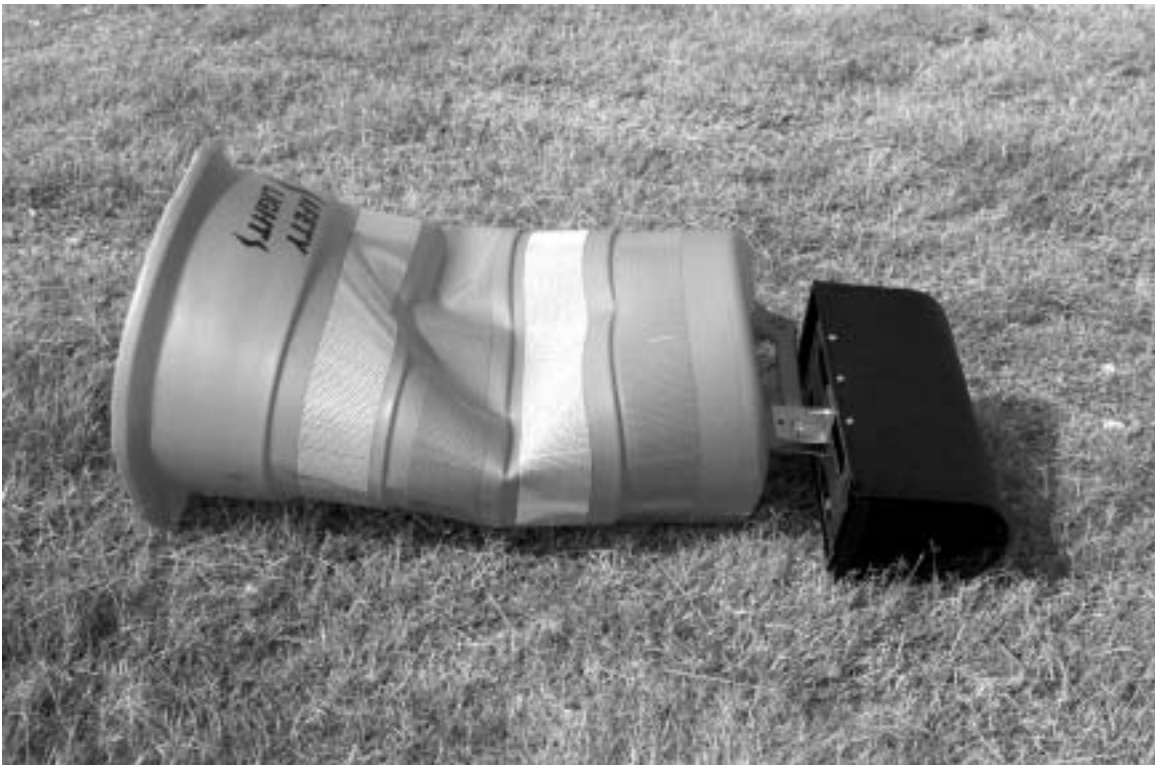
Figure 212. Installation after Test 417929-10.

The drum remained in one piece, as shown in Figures 211 and 212. The base of the unit moved 19 mm (0.8 inch), and debris extended 28.2 m (92.5 ft) down and 4.6 m (15.1 ft) to the left of the impact point.

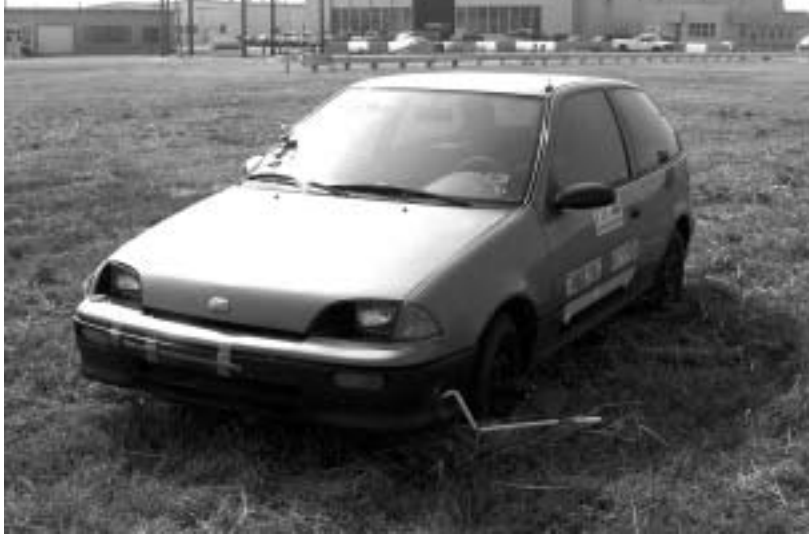
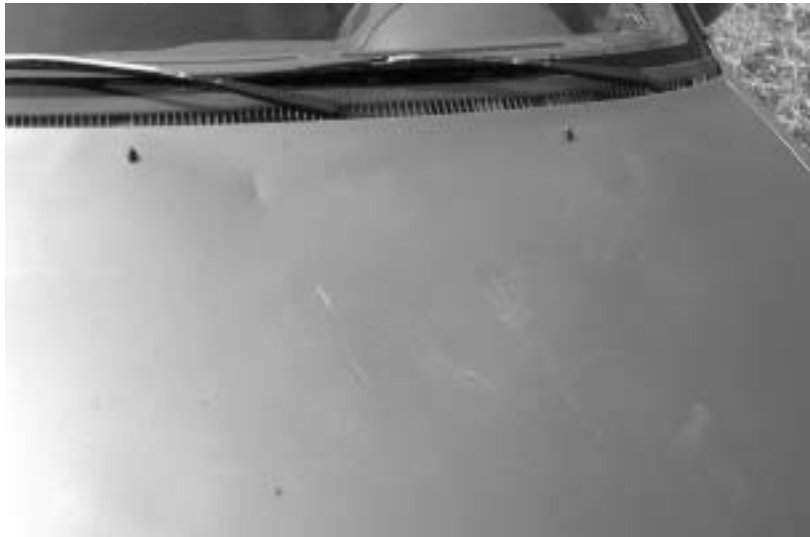
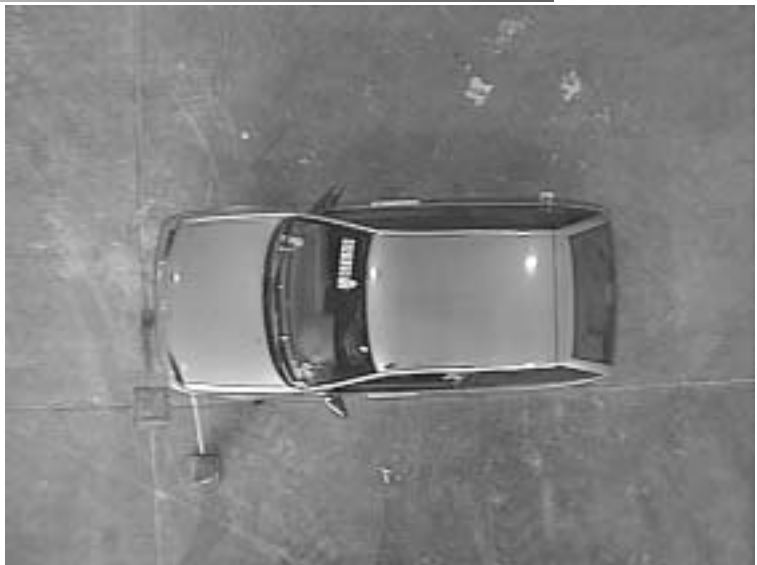
Figure 213. Vehicle after Test 417929-10.

The vehicle received minor damage to the hood as shown in Figure 213. No deformation or intrusion of the occupant compartment occurred. The interior of the vehicle is shown in Figure 214.

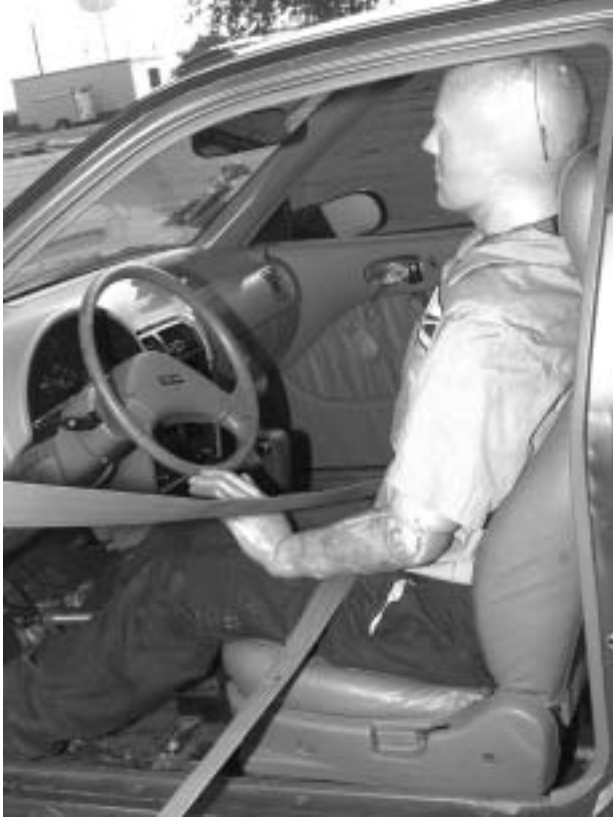
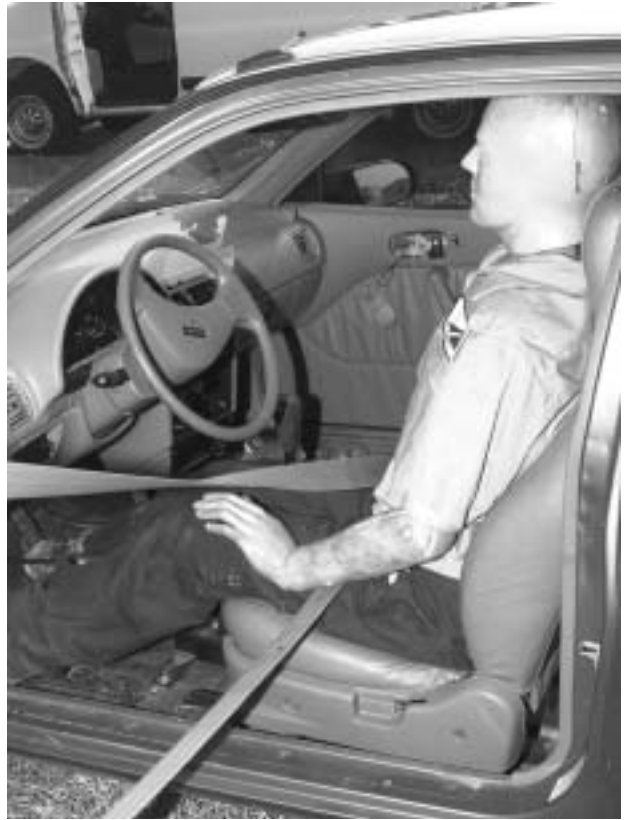
Figure 214. Interior of Vehicle for Test 417929-10.

The mailbox on plastic drum did not penetrate or show potential to penetrate the occupant compartment, or present undue hazard to others in the area. No deformation or intrusion of the occupant compartment occurred.
