1. Report No. FHWA/TX-01/1792-2		2. Government Accession No.		3. Recipient's Catalog No.	
4. Title and Subtitle IMPACT PERFORMANCE EVALUATION OF WORK ZONE TRAFFIC CONTROL DEVICES				5. Report Date December 2000

6. Performing Organization Code	
7. Author(s) Roger P. Bligh, D. Lance Bullard, Wanda L. Menges, and Sandra K. Schoeneman				8. Performing Organization Report No. Report 1792-2

IMPACT PERFORMANCE EVALUATION OF WORK ZONE TRAFFIC CONTROL DEVICES

December 2000

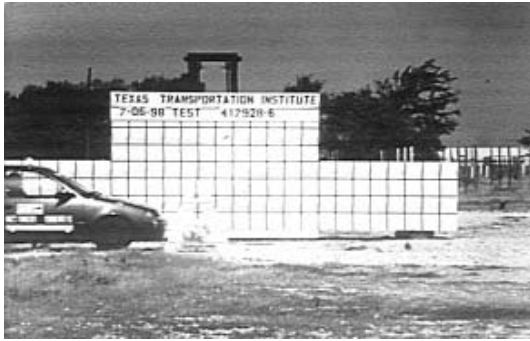
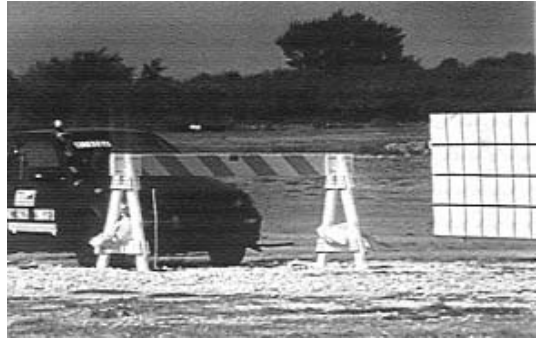
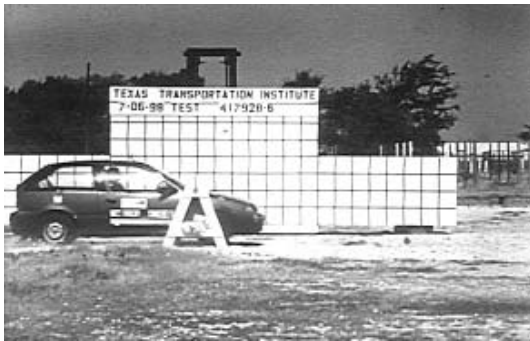
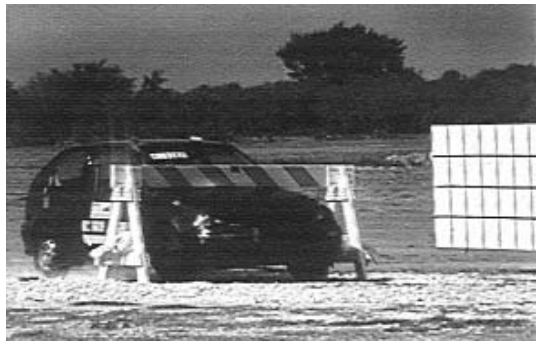
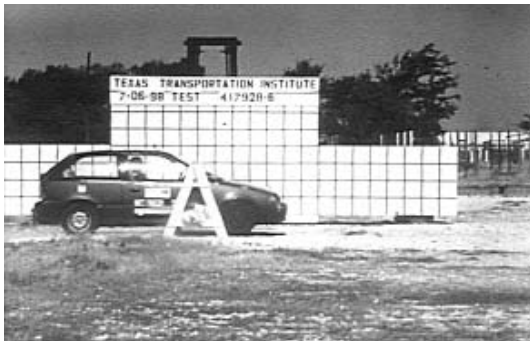
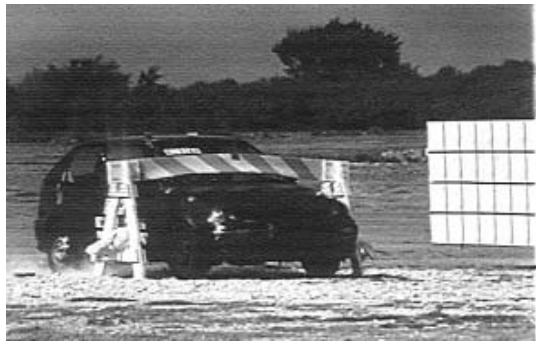
**Figure 226. Sequential Photographs for Test 417928-6
(Perpendicular and Oblique Views).**

pulled out of the left and right legs of the barricade. The panel completely separated from the right leg and left leg at 0.089 s and 0.094 s, respectively. At 0.099 s, the panel lost contact with the vehicle, and at 0.121 s, the vehicle's antenna on the right side contacted a barricade leg. As the vehicle lost contact with the A-Frame, at 0.171 s, the vehicle was traveling at 98.1 km/h (61.0 mi/h). Brakes on the vehicle were applied as the vehicle exited the test site, and the vehicle came to rest 75.0 m (246.1 ft) down from the impact point. Sequential photographs of the test can be found in [Appendix C, Figure 226](#).

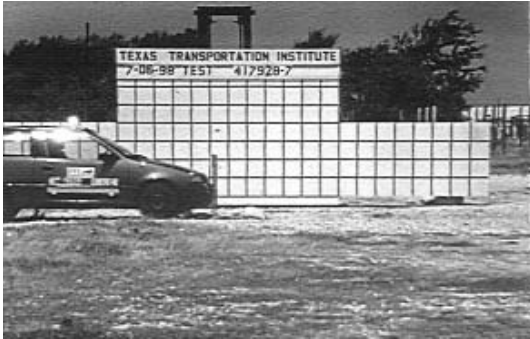
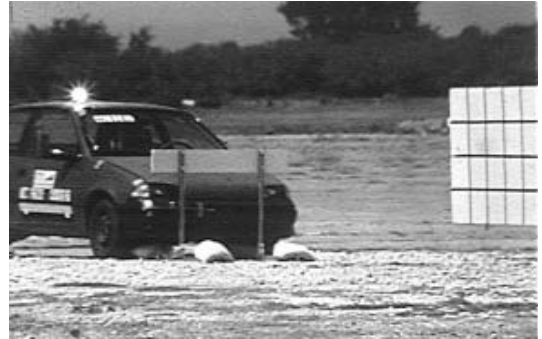
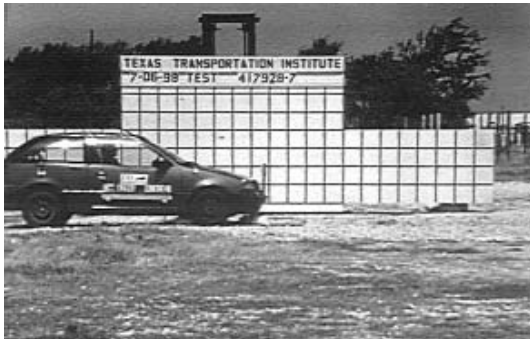
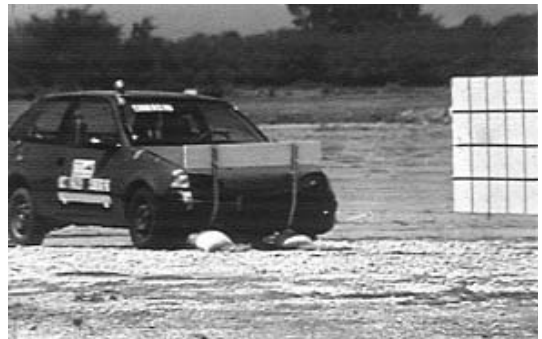
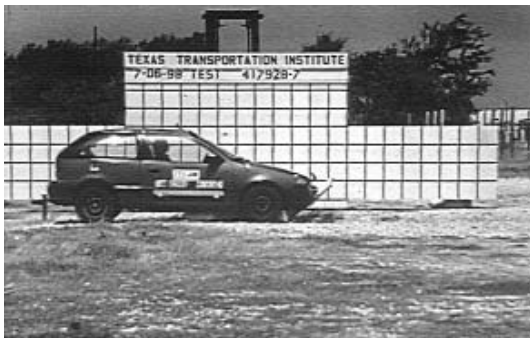
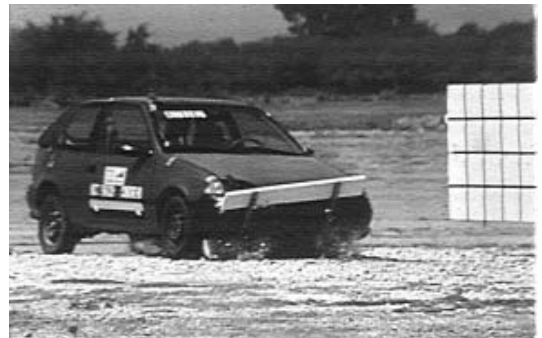
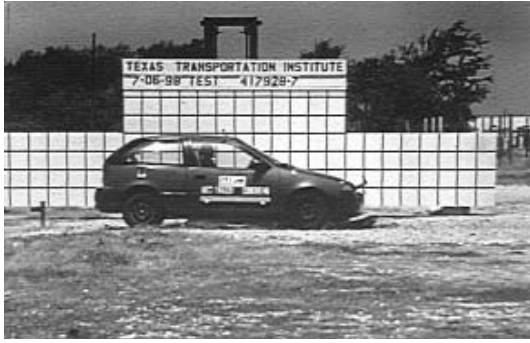
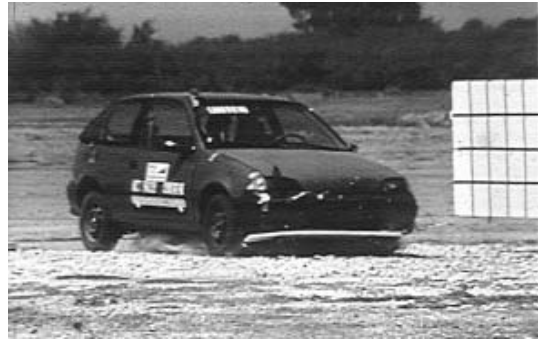
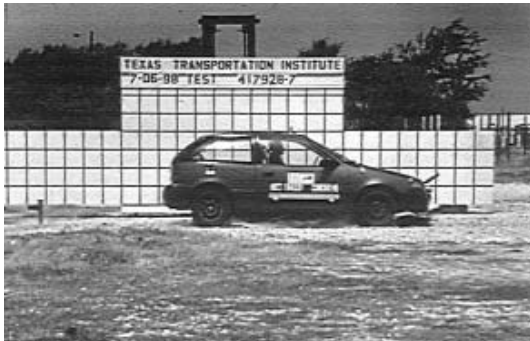
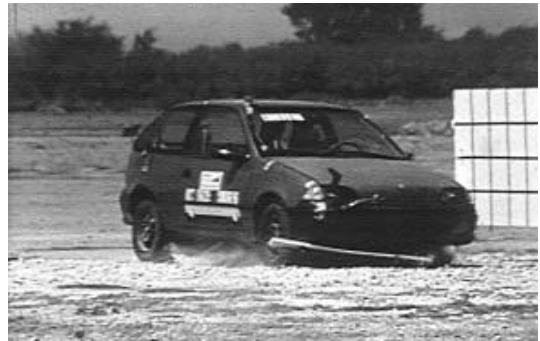
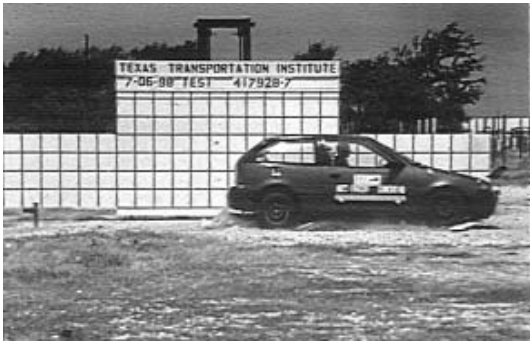
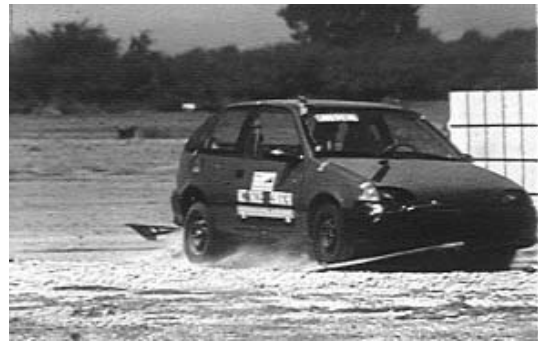
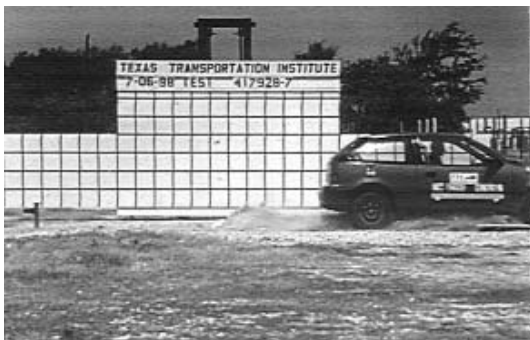
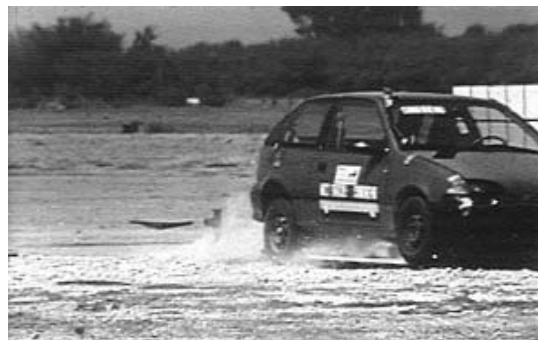
**Figure 227. Sequential Photographs for Test 417928-7
(Perpendicular and Oblique Views).**

Brakes on the vehicle were applied as it exited the test site, and the vehicle came to rest 97.5 m (320.0 ft) down and 1.8 m (5.9 ft) to the right of the impact point. Sequential photographs of the test can be found in [Appendix C, Figure 227](#).

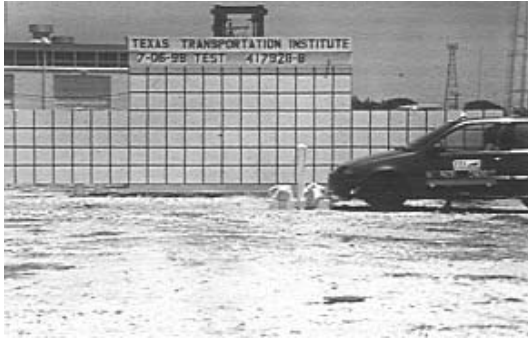
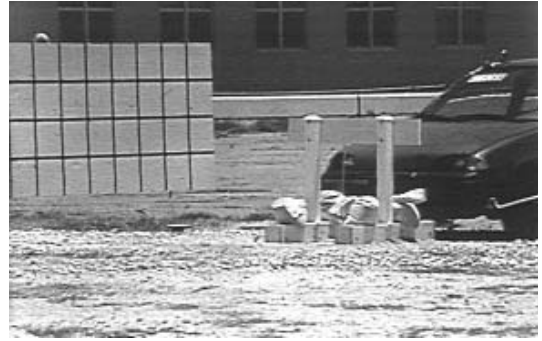
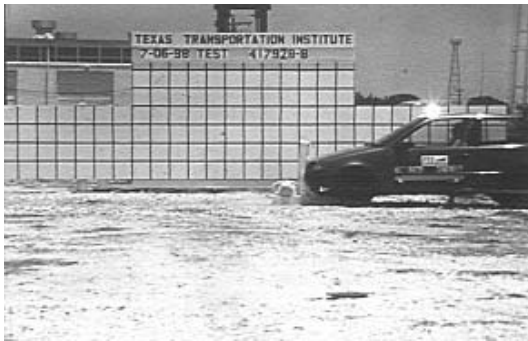
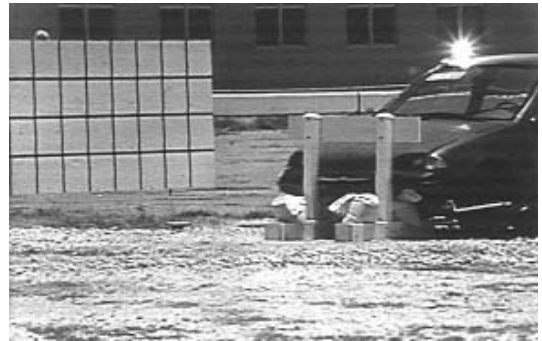
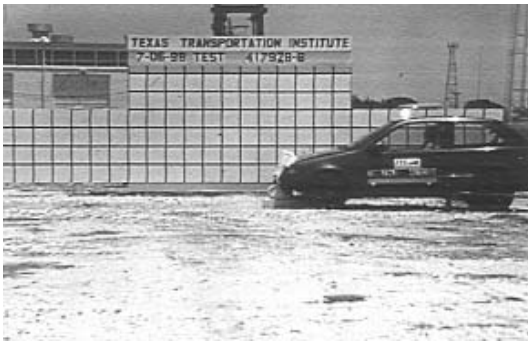
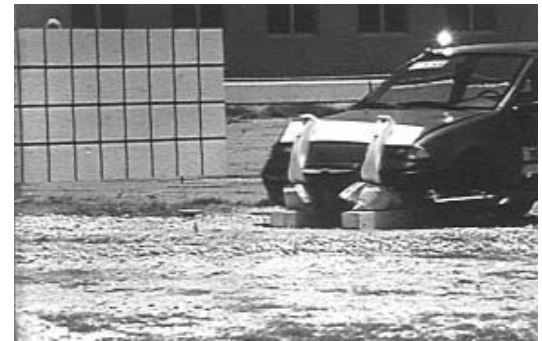
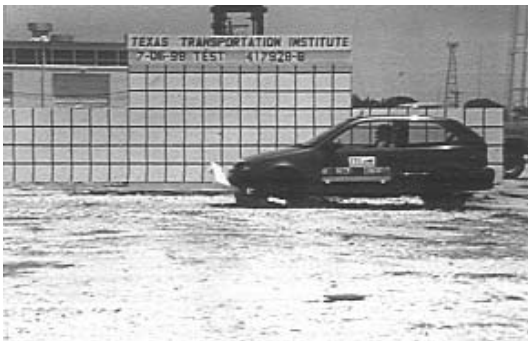
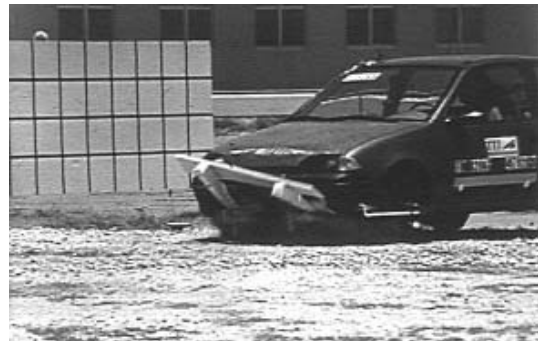
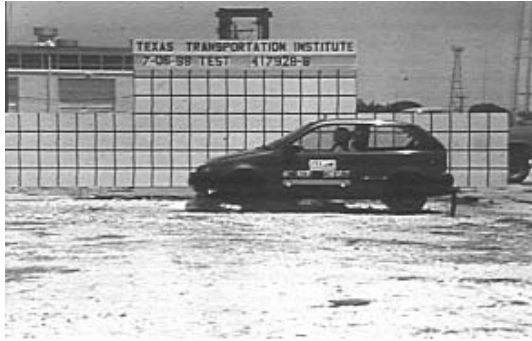
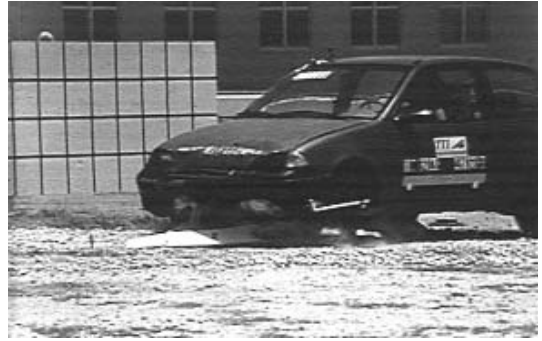
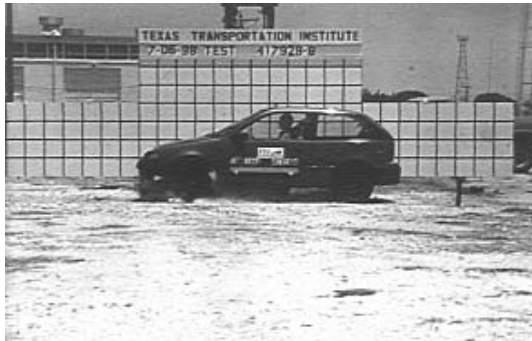
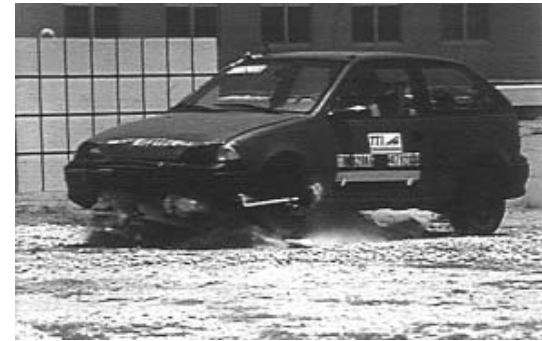
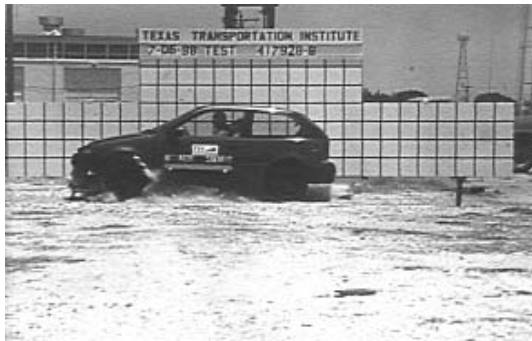
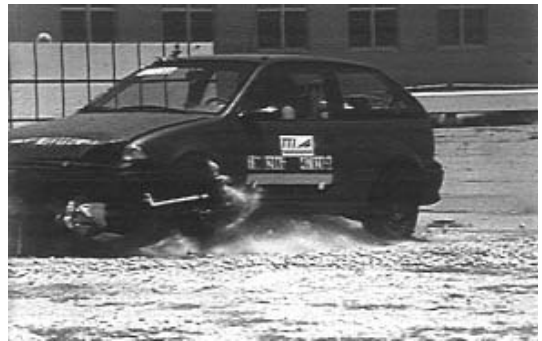
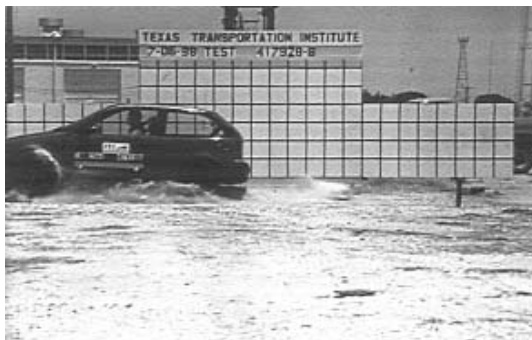
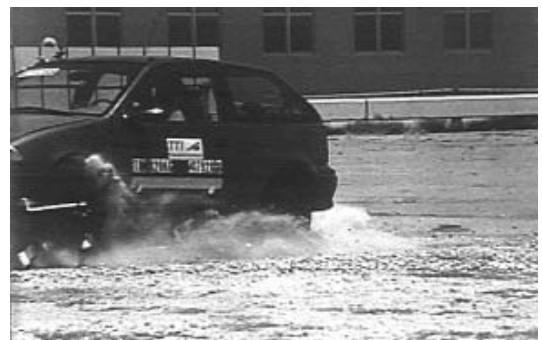
**Figure 228. Sequential Photographs for Test 417928-8
(Perpendicular and Oblique Views).**

the vehicle was traveling at 88.8 km/h (55.2 mi/h) with the barricade still in contact with the vehicle, as the vehicle exited the test site. Brakes on the vehicle were applied as it exited the test site and the vehicle came to rest 79.2 m (259.8 ft) down from impact. Sequential photographs of the test can be found in [Appendix C, Figure 228](#).

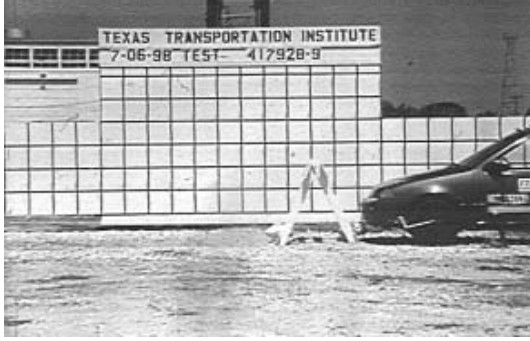
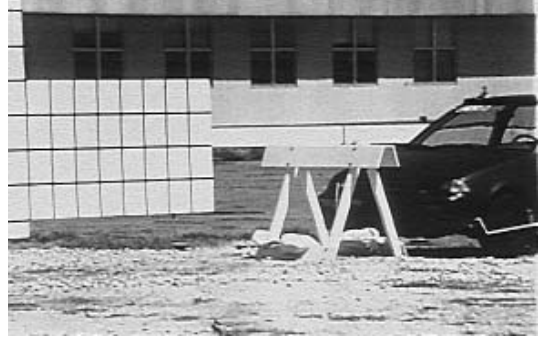
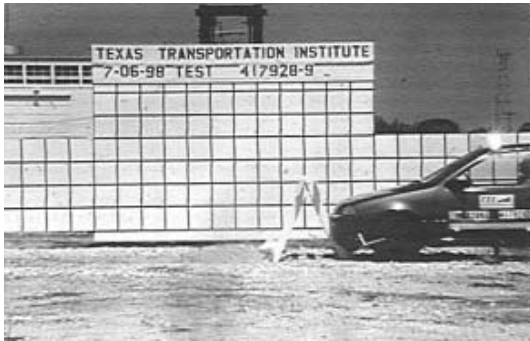
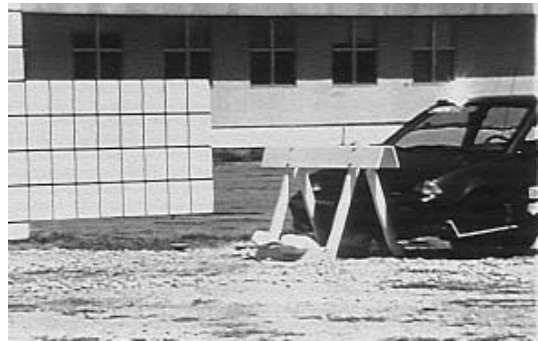
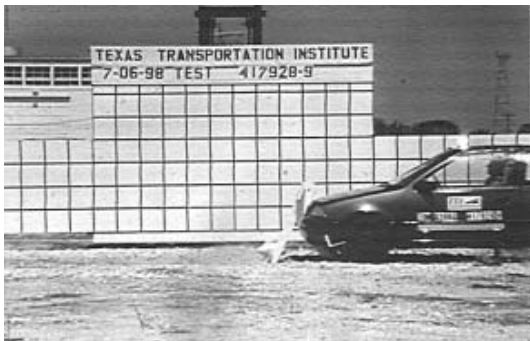
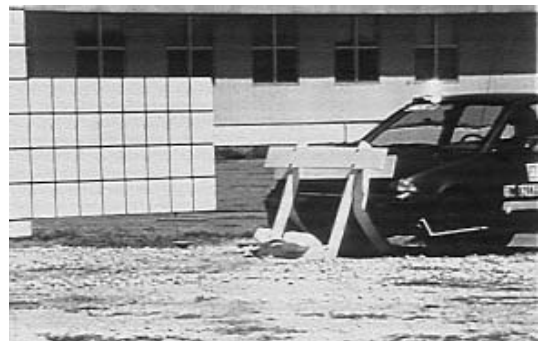
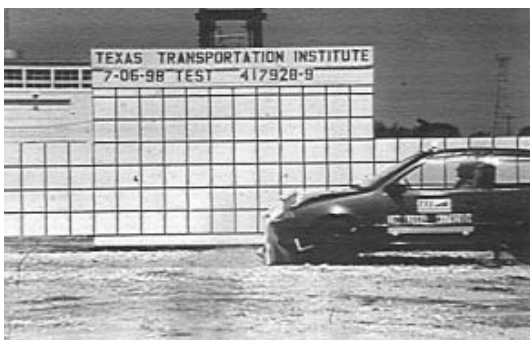
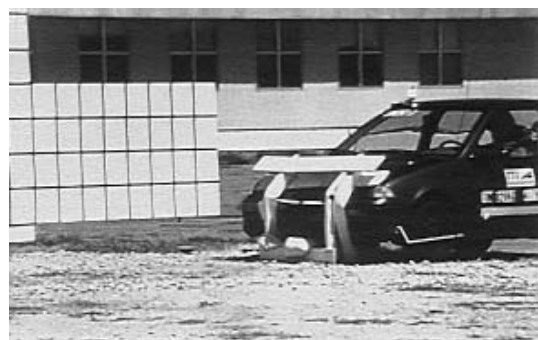
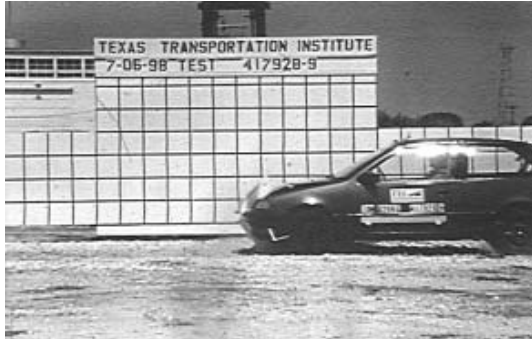
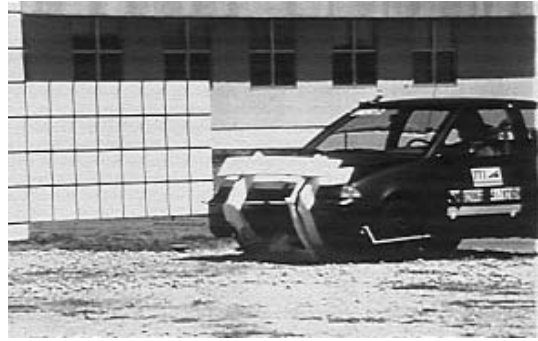
**Figure 229. Sequential Photographs for Test 417928-9
(Perpendicular and Oblique Views).**

ground. The vehicle was traveling at 94.0 km/h (58.4 mi/h) with the barricade still in contact with the vehicle as it exited the test site at 0.154 s. Brakes on the vehicle were applied as it exited the test site, and the vehicle came to rest 93.9 m (308.1 ft) down from impact. Sequential photographs of the test can be found in [Appendix C, Figure 229](#).

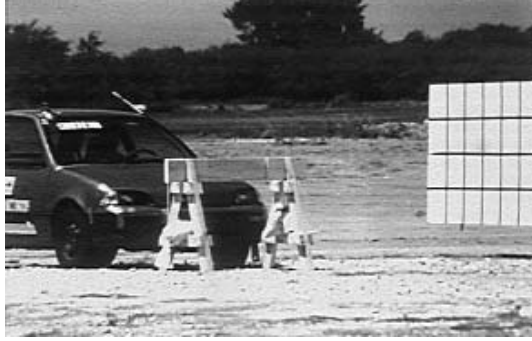
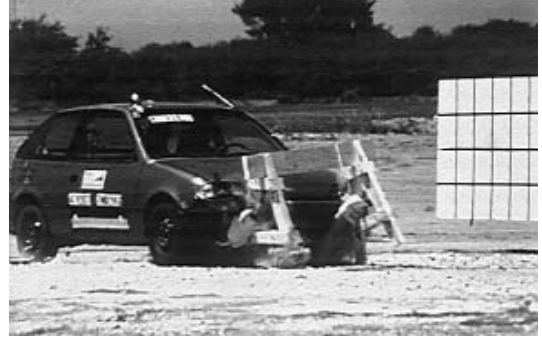
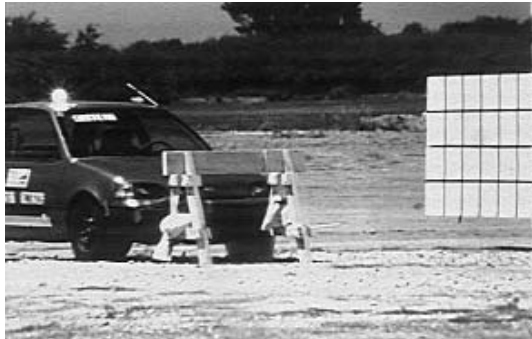
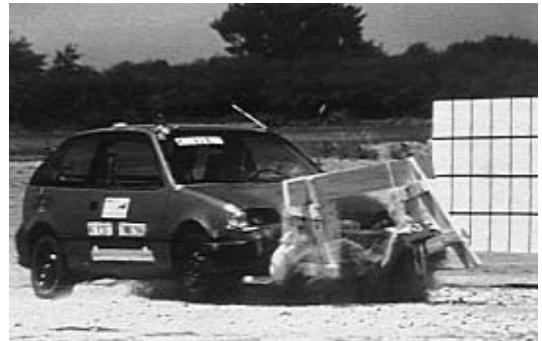
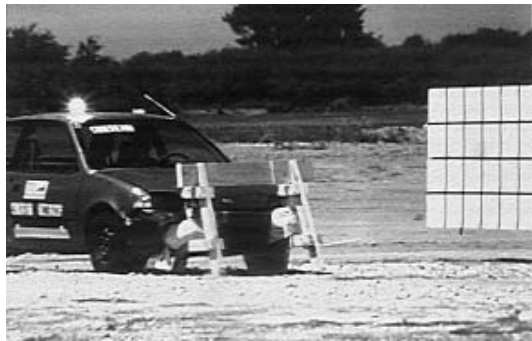
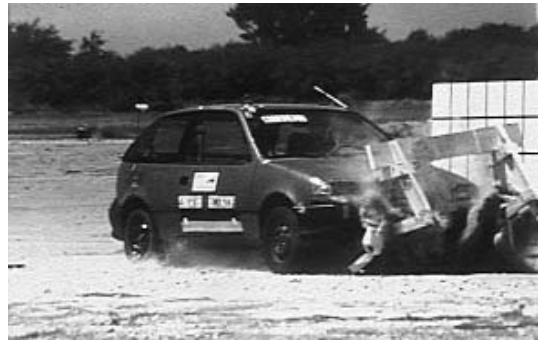
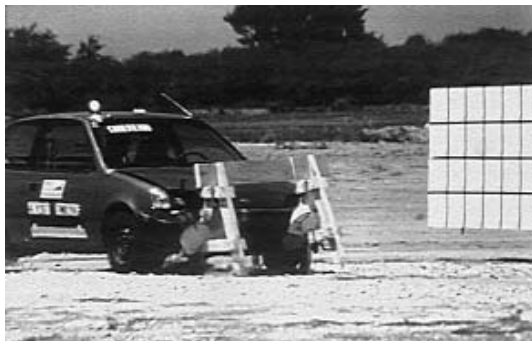
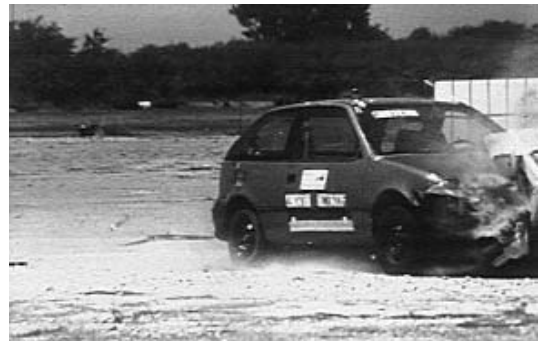
Figure 230. Sequential Photographs for Test 417928-17 (Oblique View).

The vehicle impacted the barricade head-on at a speed of 100.0 km/h (62.1 mi/h). At 0.011 s, the barricade moved; at 0.222 s, the vehicle exited the test site with the barricade. After exiting the test site, the barricade separated into several pieces. Brakes on the vehicle were applied as the vehicle exited the test site, and the vehicle came to rest 96.8 m (317.6 ft) down from impact, with the test article scattered along its path. Sequential photographs of the test can be found in [Appendix C, Figure 230](#).

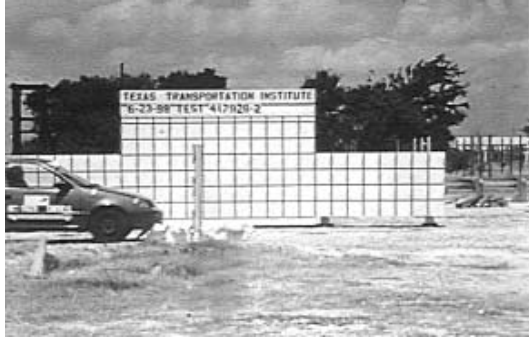
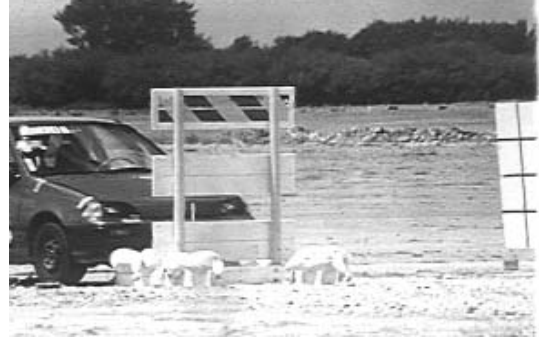
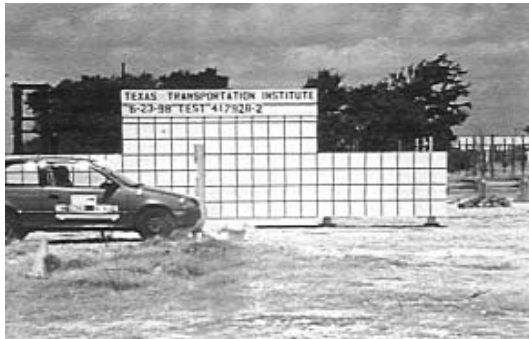
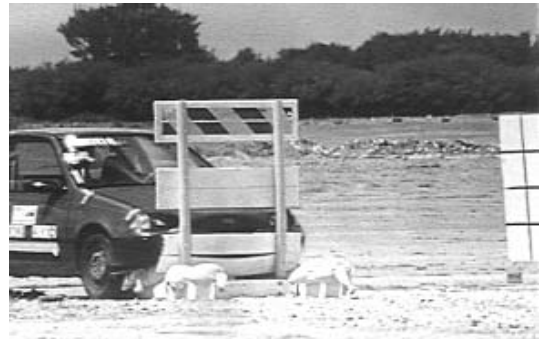
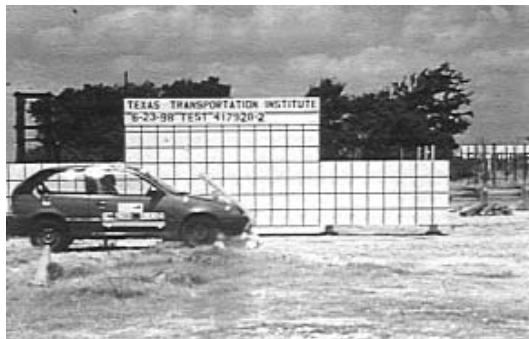
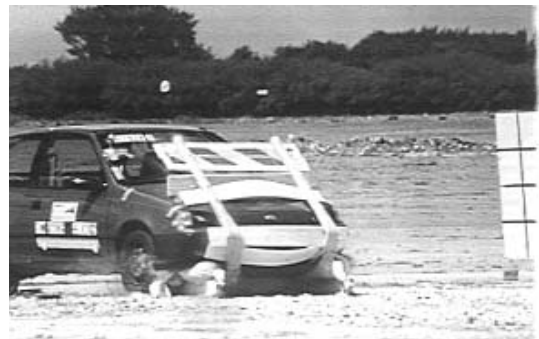
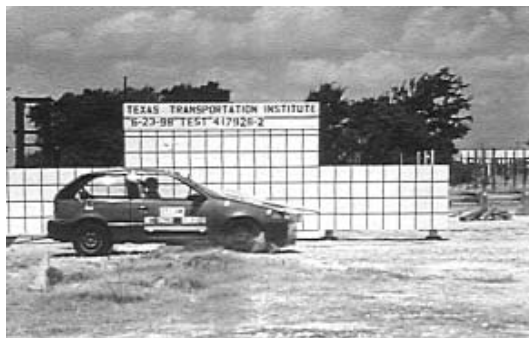
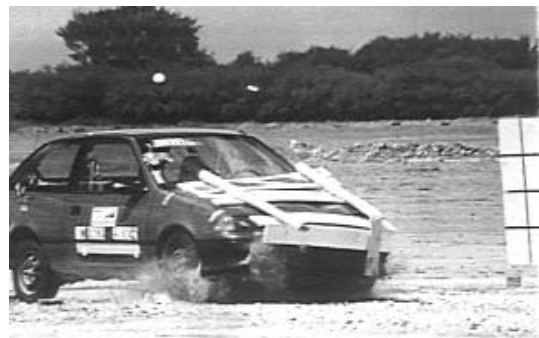
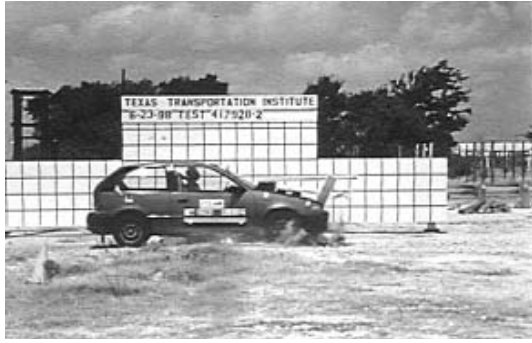
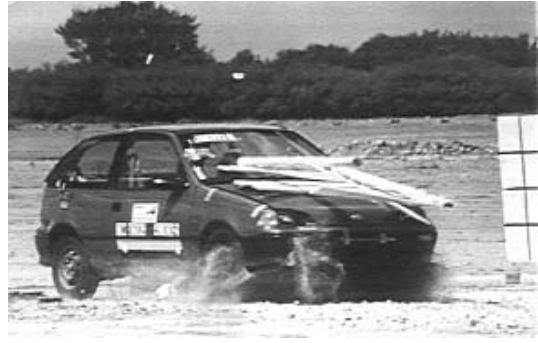
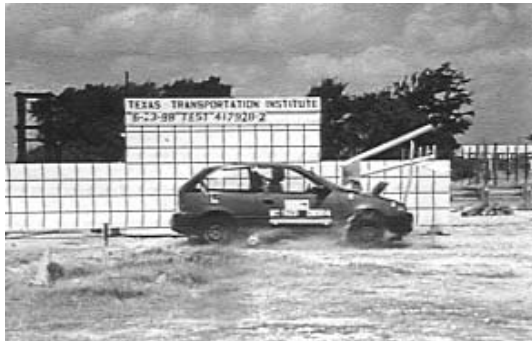
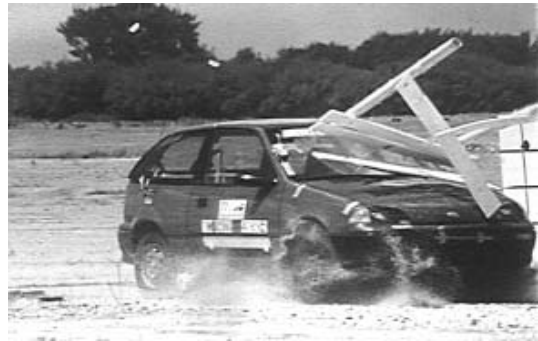
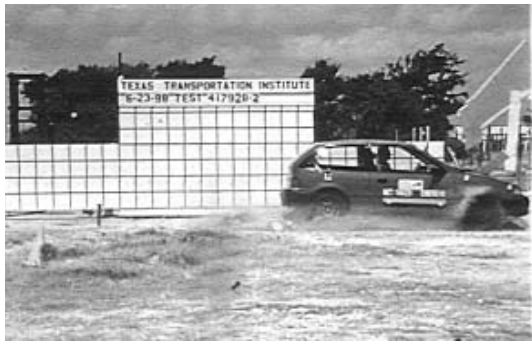
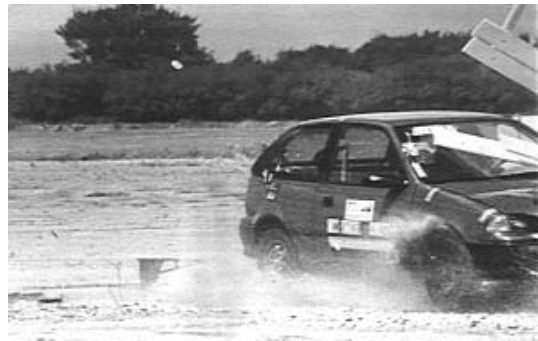
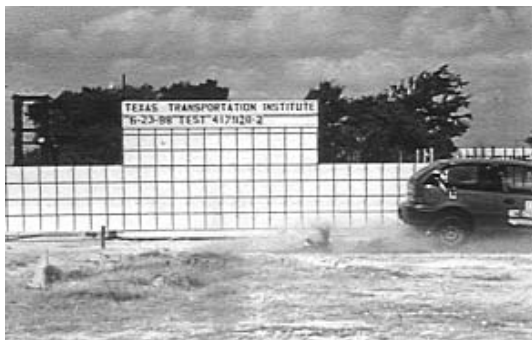
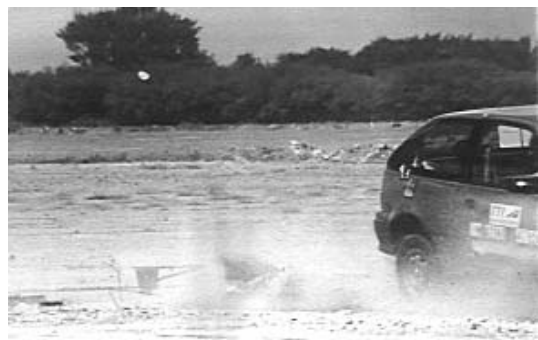
**Figure 231. Sequential Photographs for Test 417928-2
(Perpendicular and Oblique Views).**

windshield near the wiper blades and moved upward on the windshield before loss of contact. The upper panel and posts bounced off the vehicle at 0.141 s. At 0.280 s, the vehicle was traveling at 86.3 km/h (53.6 mi/h) while the pieces were still in contact with the vehicle as it exited the test site. Brakes on the vehicle were applied as it exited the test site, and the vehicle came to rest 100.0 m (328.1 ft) downstream and 0.9 m (3.0 ft) to the right of the impact point. Sequential photographs of the test can be found in [Appendix C, Figure 231](#).

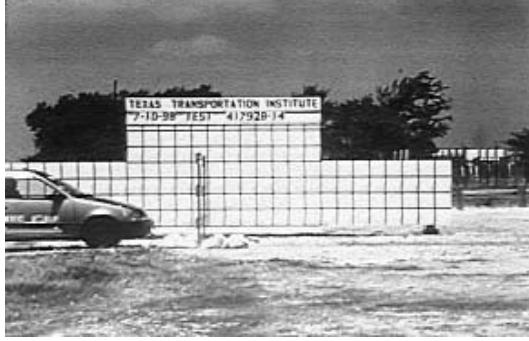
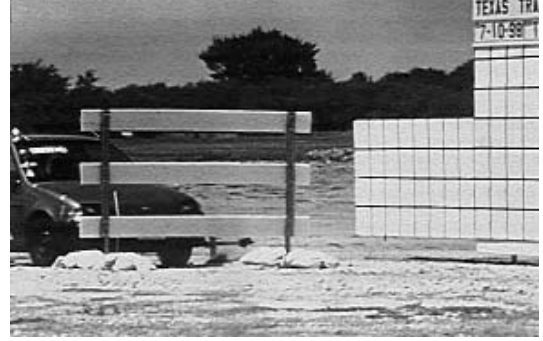
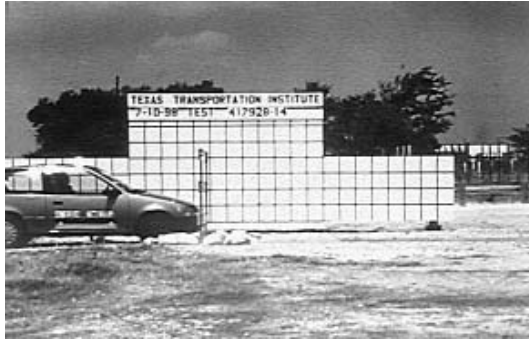
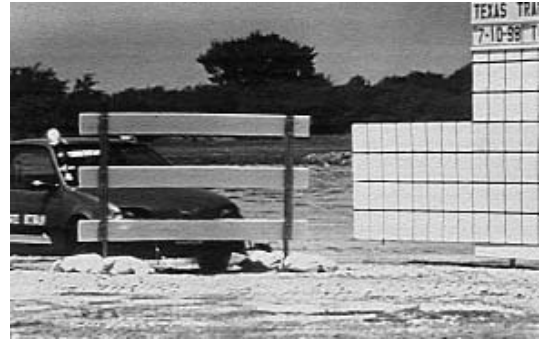
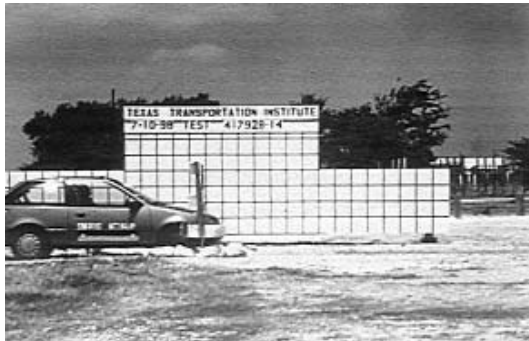
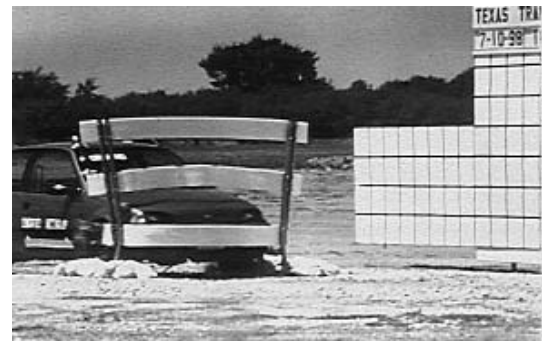
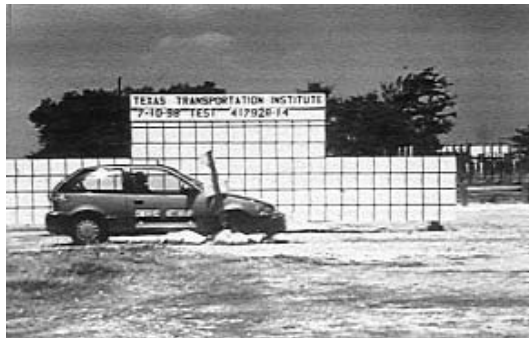
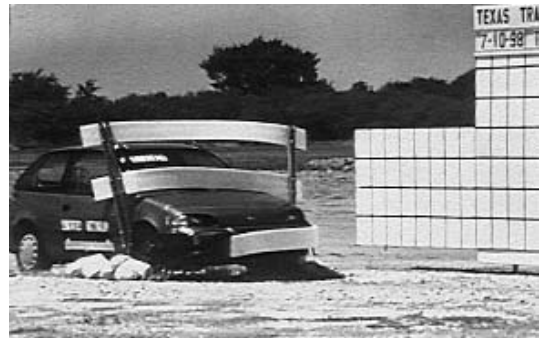
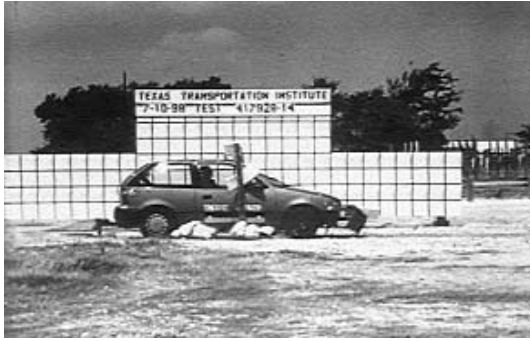
**Figure 232. Sequential Photographs for Test 417928-14
(Perpendicular and Oblique Views).**

The barricade lost contact with the ground surface at 0.085 s. At 0.086 s, the windshield shattered in the lower corners, and at 0.276 s, the vehicle lost contact with the center barricade panel. At 0.346 s, the vehicle was traveling at 94.2 km/h (58.5 mi/h) as the barricade lost contact with the vehicle. Brakes on the vehicle were applied as the vehicle exited the test site, and the vehicle came to rest 102.9 m (337.6 ft) down and 4.6 m (15.1 ft) to the left of the impact point. Sequential photographs of the test can be found in [Appendix C, Figure 232](#).

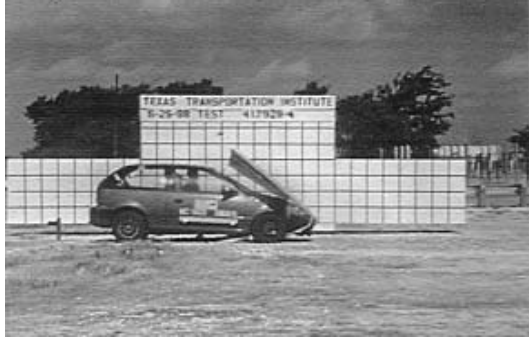
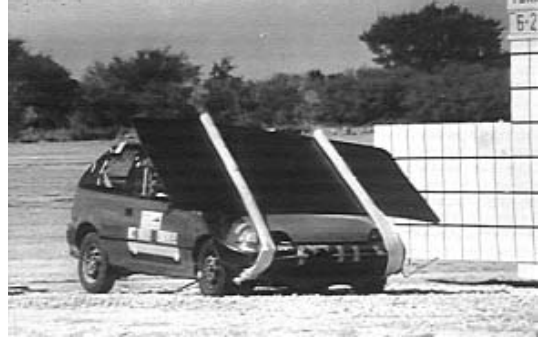
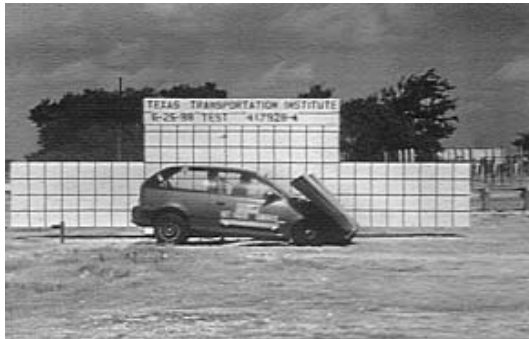
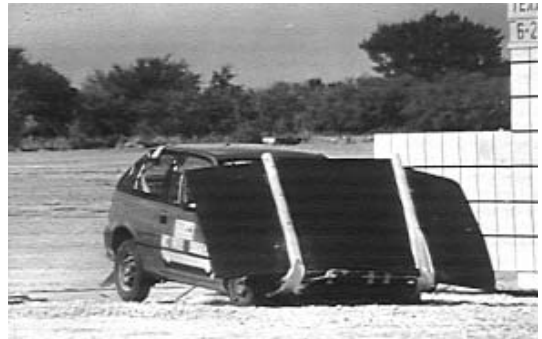
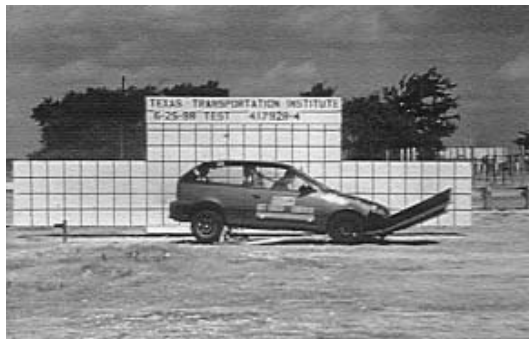
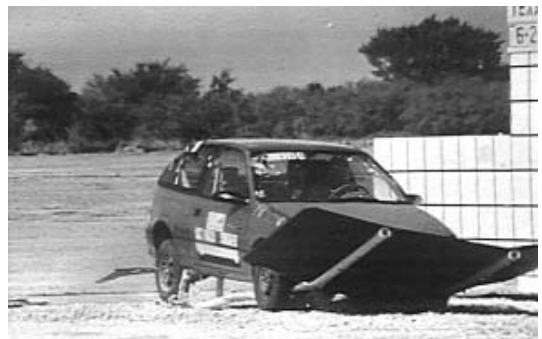
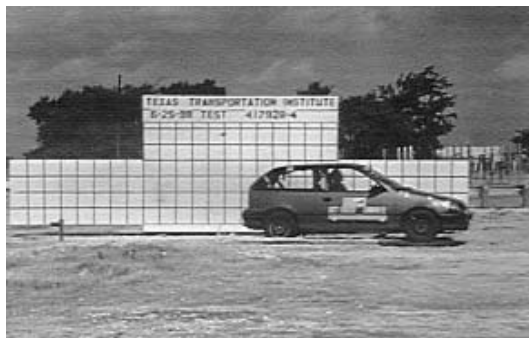
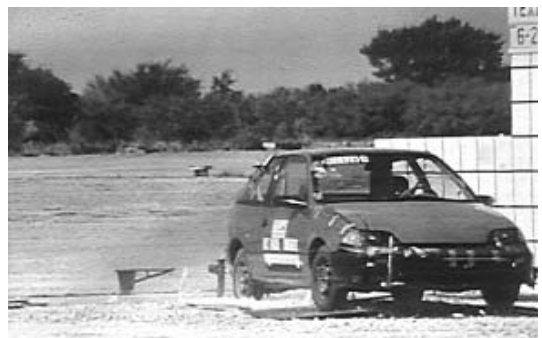
Figure 237. Sequential Photographs for Test 417928-4 (Perpendicular and Oblique Views) (continued).

down from the impact point. Sequential photographs of the test can be found in [Appendix C, Figure 237](#).

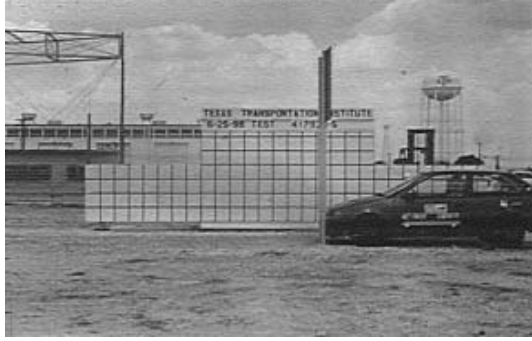
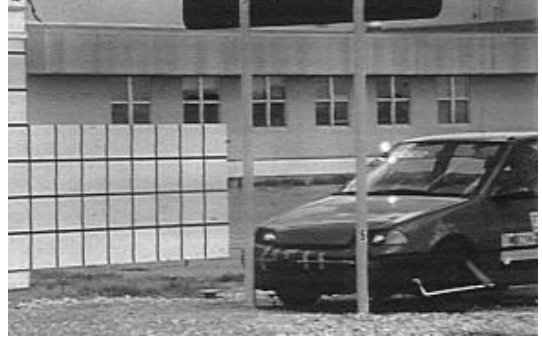
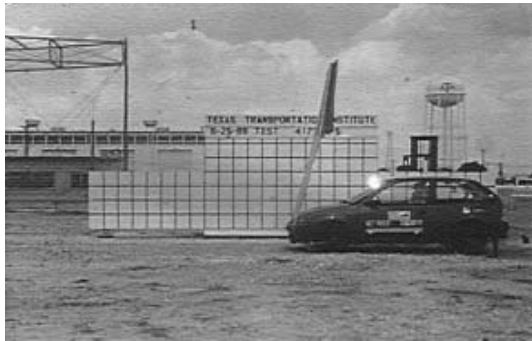
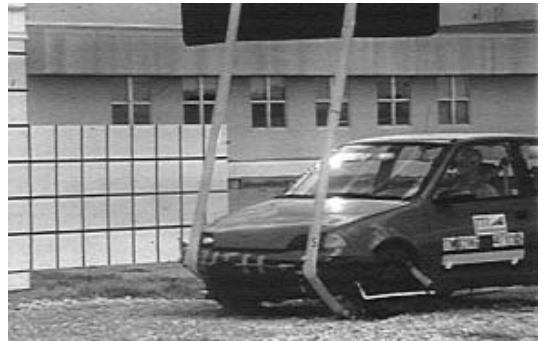
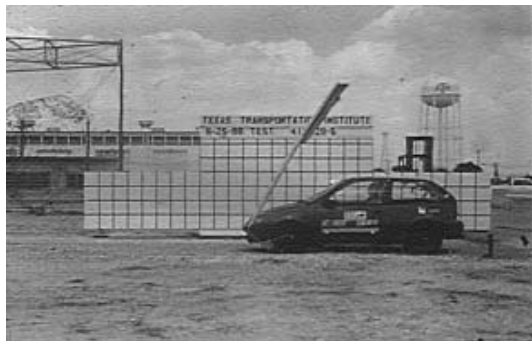
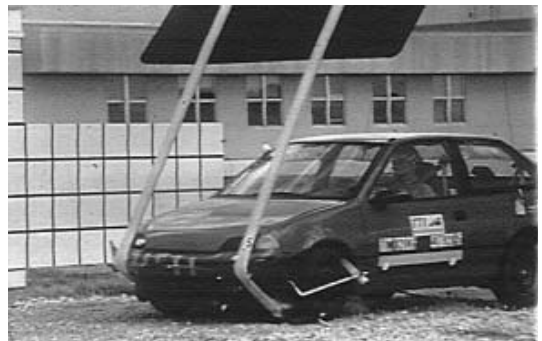
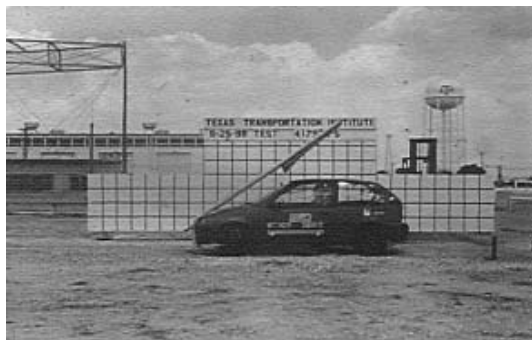
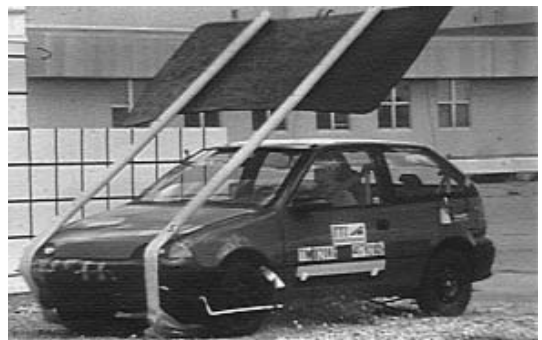
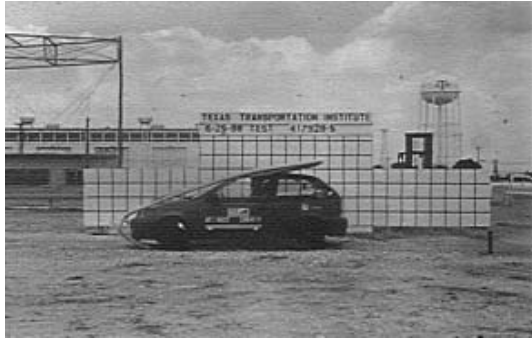
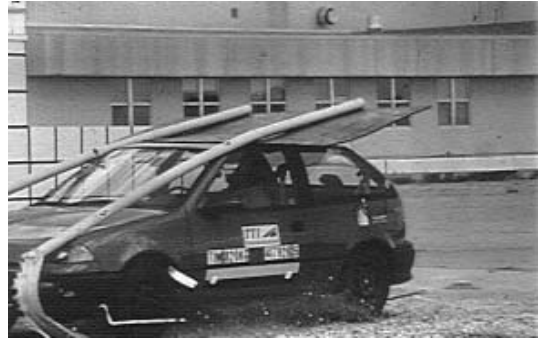
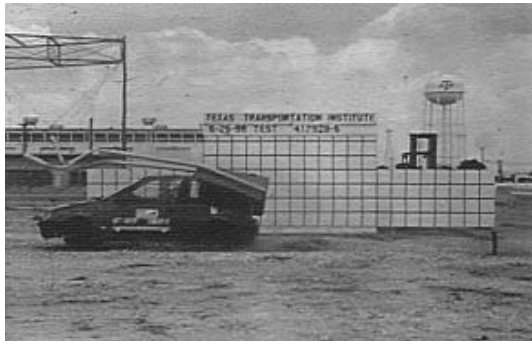
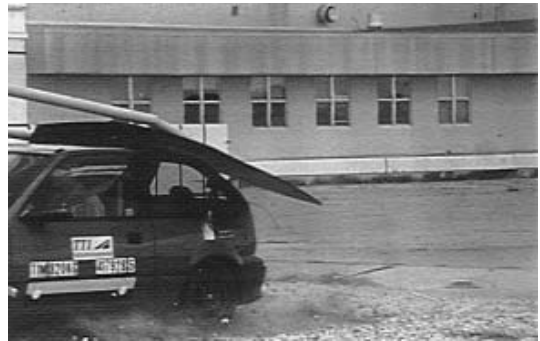
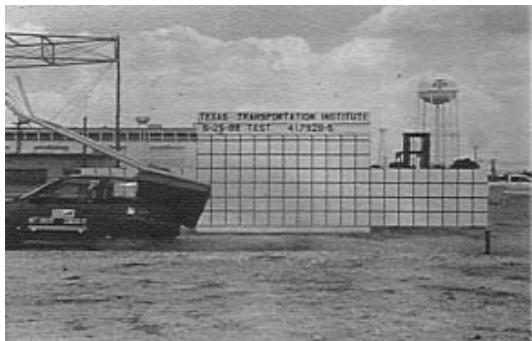
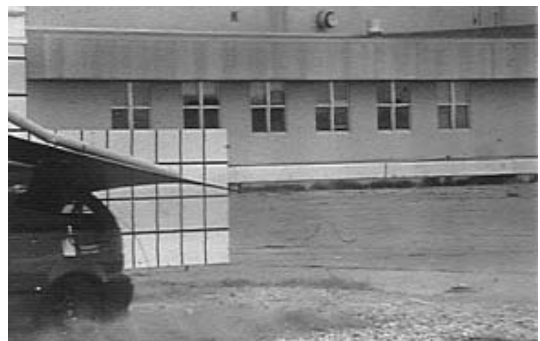
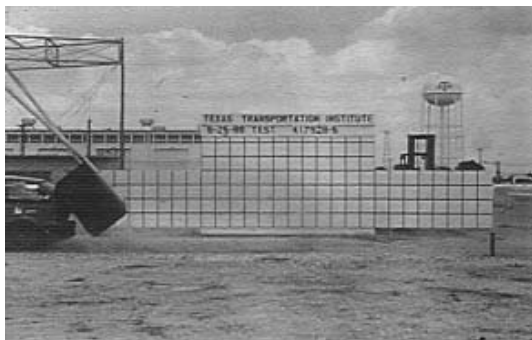
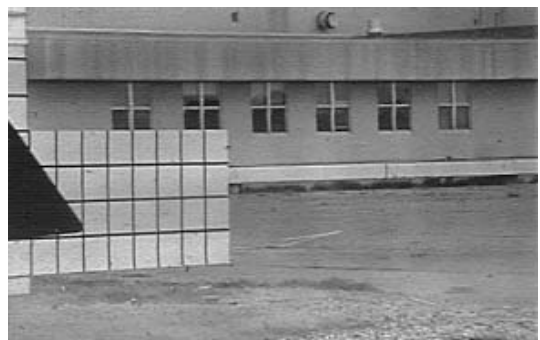
Figure 238. Sequential Photographs for Test 417928-5 (Perpendicular and Oblique Views).

The vehicle impacted the sign support head-on at a speed of 98.6 km/h (61.3 mi/h). At 0.007 s, the sign posts deformed around the front of the bumper, and at 0.034 s, the sign posts were pulled out of the ground. By 0.112 s, the plywood sign panel contacted the roof of the vehicle, and by 0.142 s, the plywood sign panel was parallel above the vehicle. The vehicle was traveling at 97.4 km/h (60.5 mi/h) with the sign panel still in contact, as the vehicle exited the test site. The brakes on the vehicle were applied at 1.6 s, and the vehicle came to rest 29.9 m (98.1 ft) down and 0.6 m (2.0 ft) to the right of the impact point. Sequential photographs of the test can be found in [Appendix C, Figure 238](#).
