1. Report No. FHWA/TX-01/1792-2		2. Government Accession No.		3. Recipient's Catalog No.	
4. Title and Subtitle IMPACT PERFORMANCE EVALUATION OF WORK ZONE TRAFFIC CONTROL DEVICES				5. Report Date December 2000

6. Performing Organization Code	
7. Author(s) Roger P. Bligh, D. Lance Bullard, Wanda L. Menges, and Sandra K. Schoeneman				8. Performing Organization Report No. Report 1792-2

IMPACT PERFORMANCE EVALUATION OF WORK ZONE TRAFFIC CONTROL DEVICES

December 2000

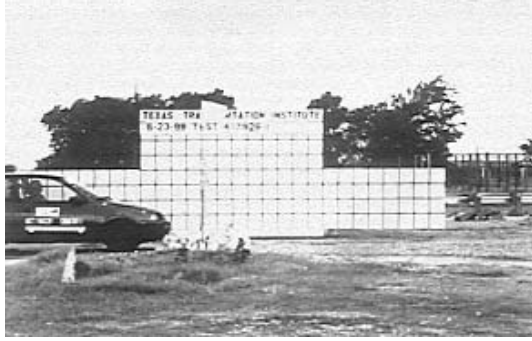
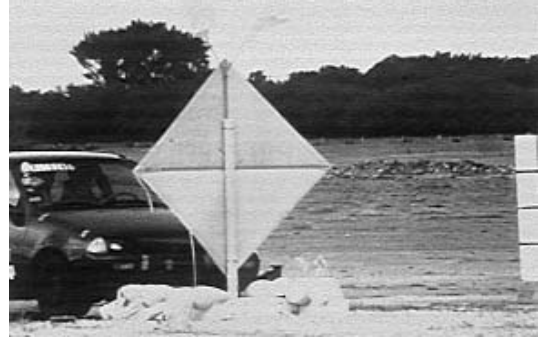
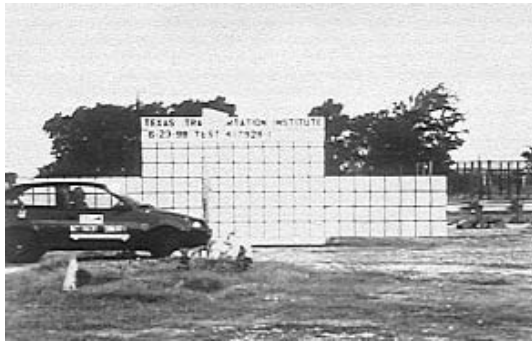
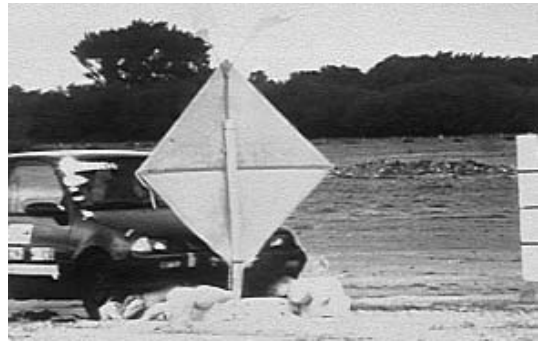
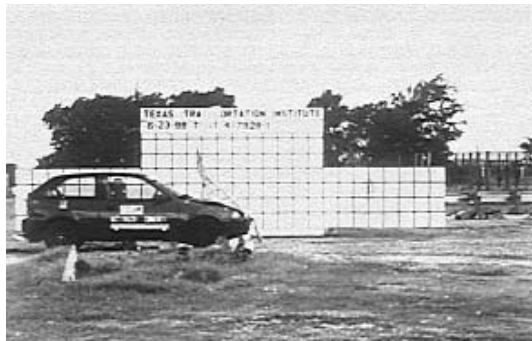
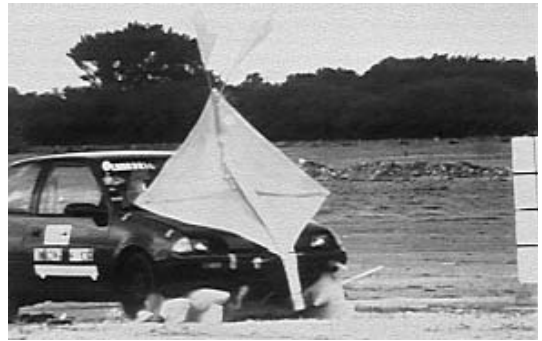
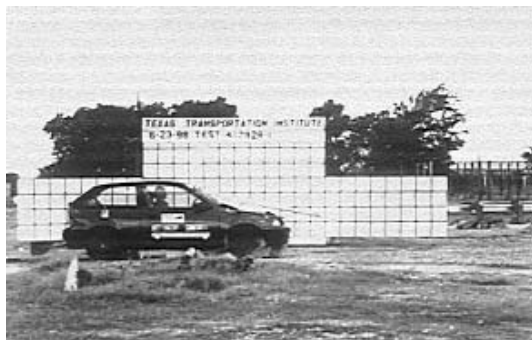
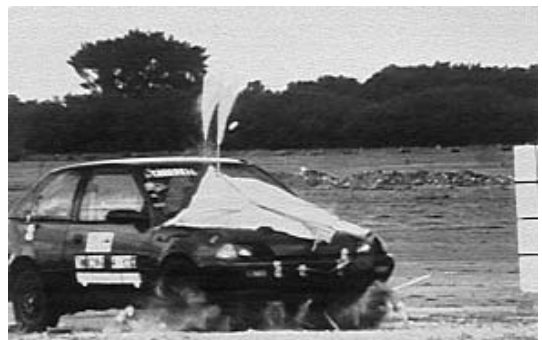
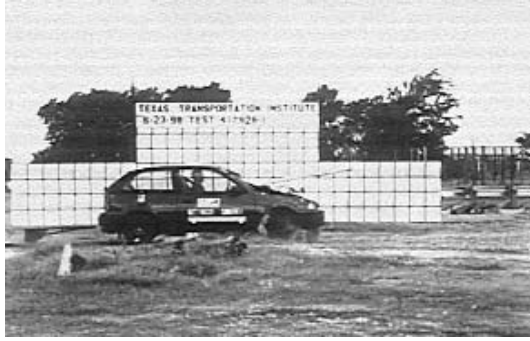
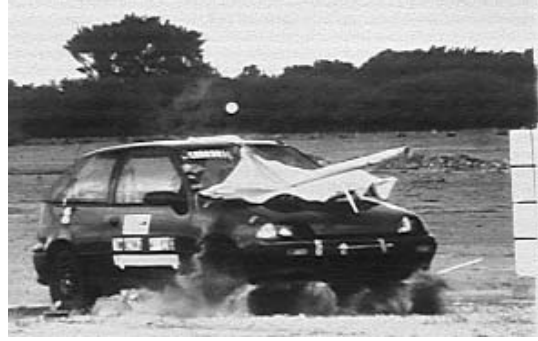
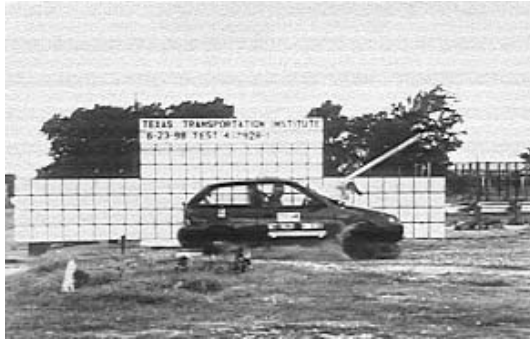
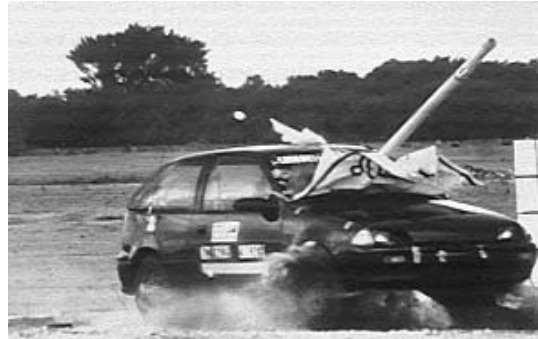
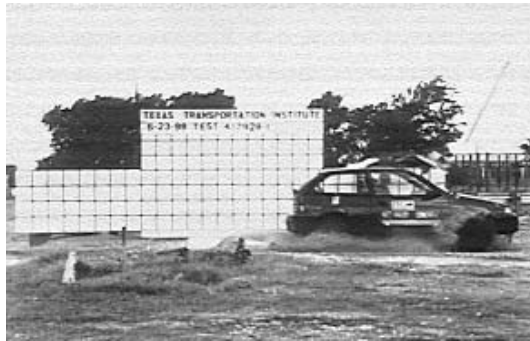
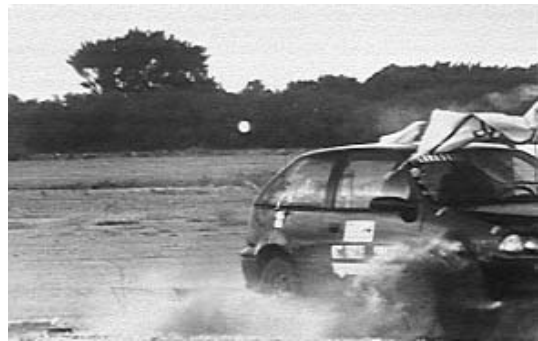
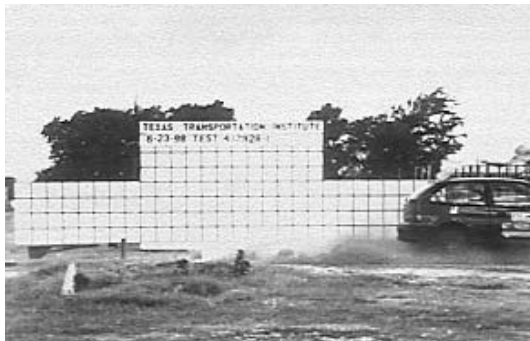
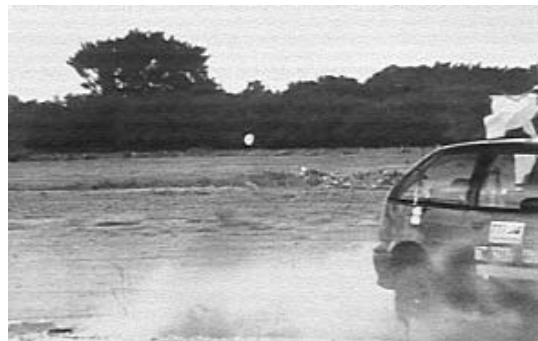
**Figure 239. Sequential Photographs for Test 417928-1
(Perpendicular and Oblique Views).**

0.084 s. At 0.092 s, the plastic sign post lost contact with the vehicle, and at 0.144 s, the fiberglass stays lost contact with the vehicle. The vehicle lost contact with the dual-purpose base at 0.221 s. At 0.304 s, the vehicle was traveling at 89.7 km/h (55.7 mi/h) as it lost contact with the barricade. Brakes on the vehicle were applied as it exited the test site, and the vehicle came to rest 87.5 m (287.1 ft) down and 2.7 m (8.9 ft) to the left of the impact point. Sequential photographs of the test can be found in [Appendix C, Figure 239](#).

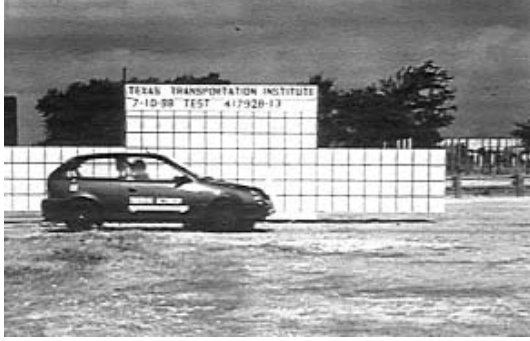
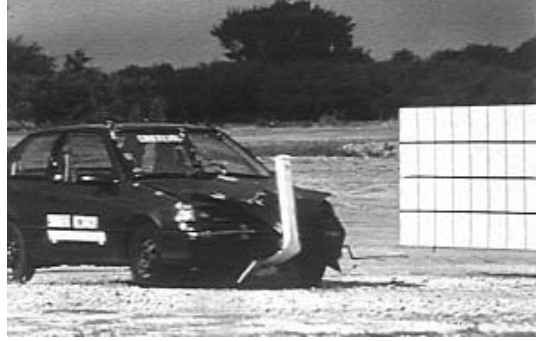
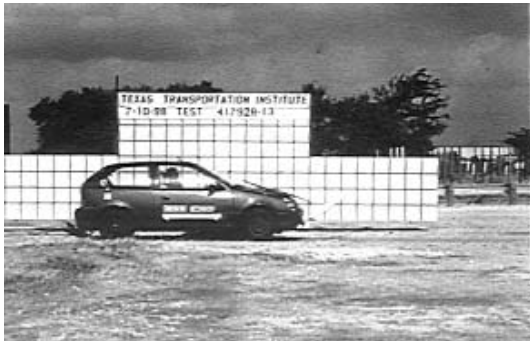
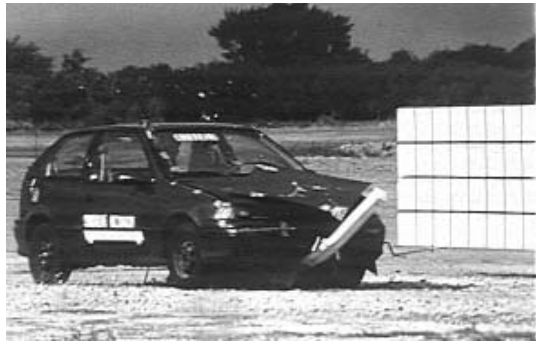
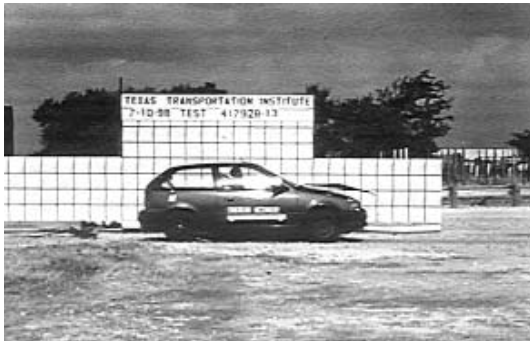
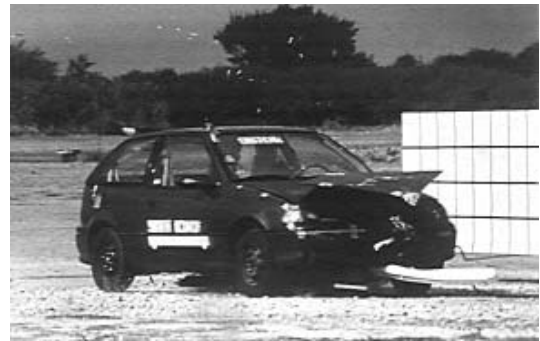
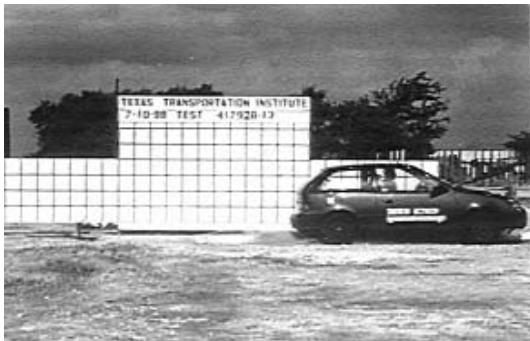
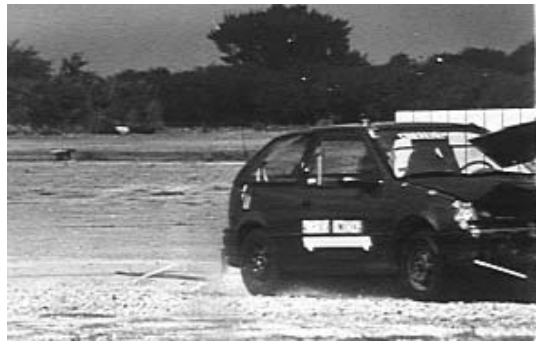
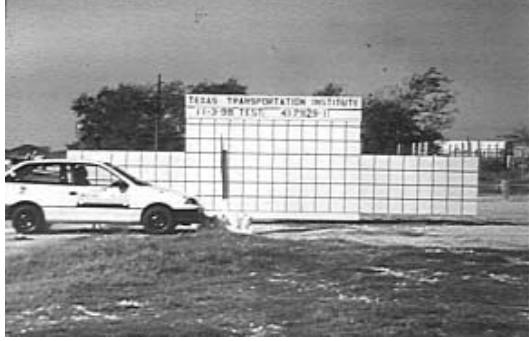
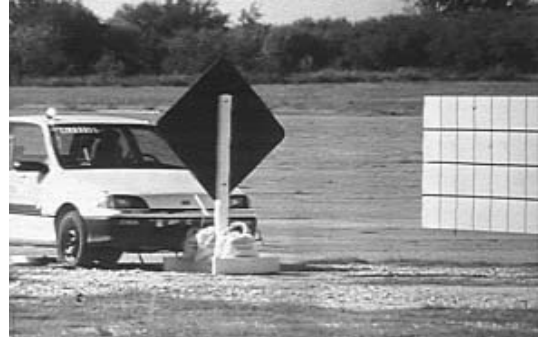
**Figure 242. Sequential Photographs for Test 417928-13
(Perpendicular and Oblique Views).**

vehicle and fell to the ground underneath the front vehicle bumper at 0.149 s. The vehicle was traveling at 92.4 km/h (57.4 mi/h) with the sign support still in contact, as the vehicle exited the test site. Brakes on the vehicle were applied as it exited the test site, and the vehicle came to rest 88.4 m (290.0 ft) from the impact point. Sequential photographs of the test can be found in [Appendix C, Figure 242](#).

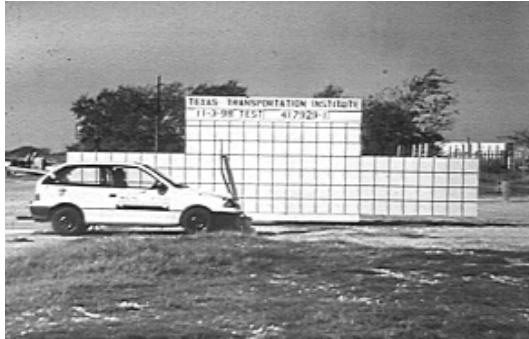
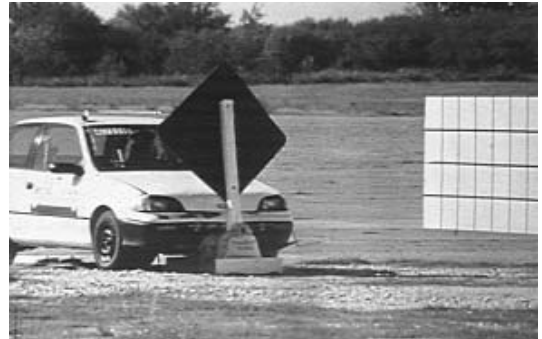
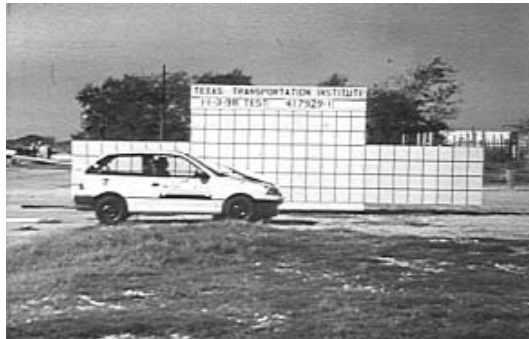
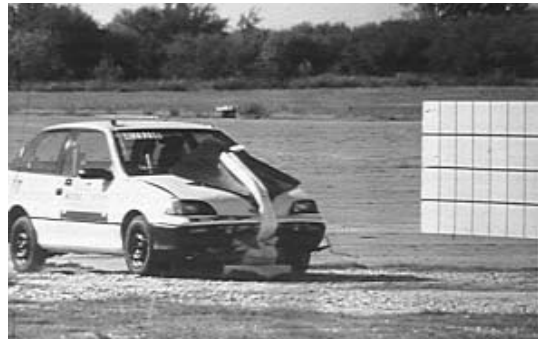
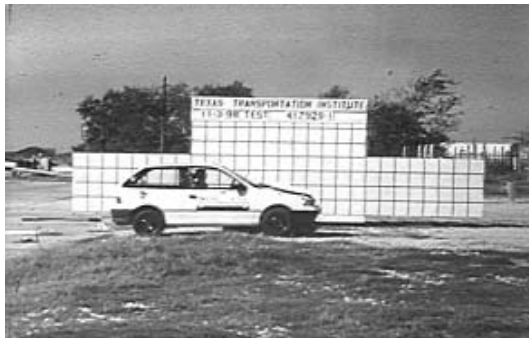
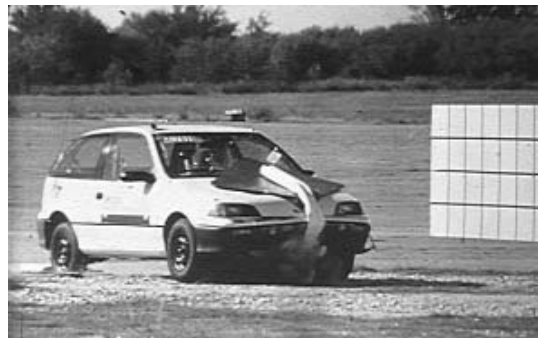
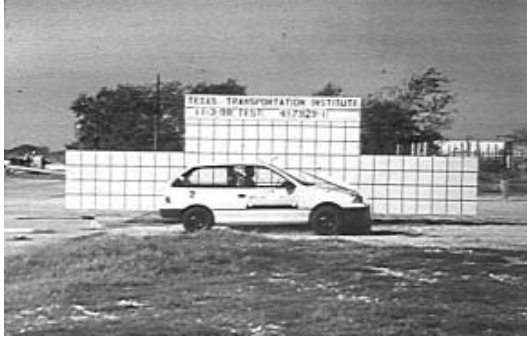
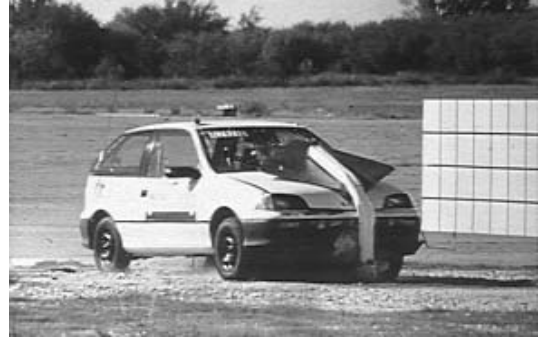
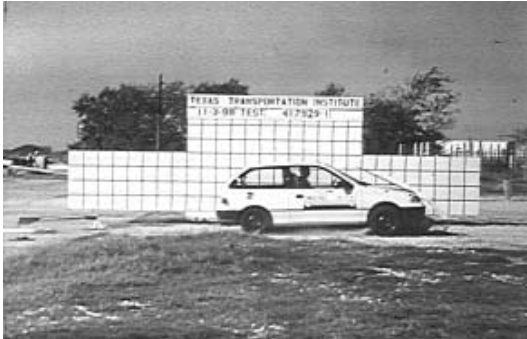
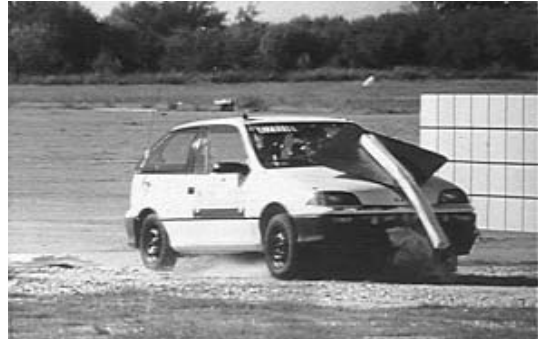
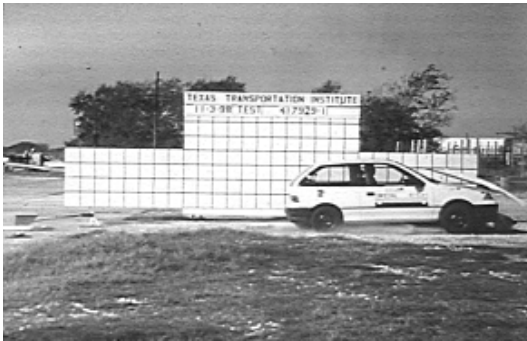
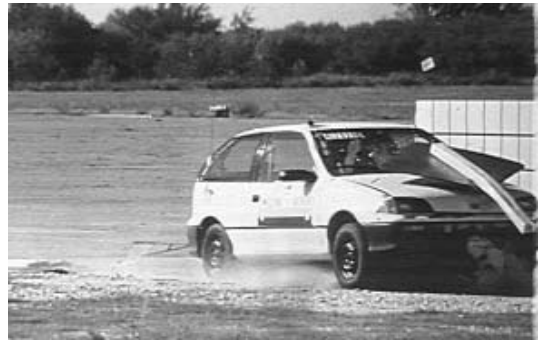
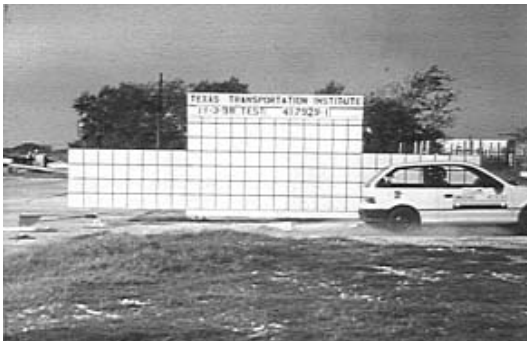
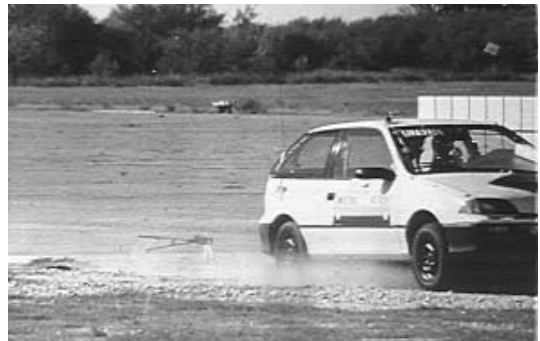
Figure 243. Sequential Photographs for Test 417929-1 (Perpendicular and Oblique Views).

Brakes on the vehicle were applied as it exited the test site, and the vehicle came to rest 102.1 m (335.0 ft) down and slightly yawed to the right of the impact point. Sequential photographs of the test can be found in [Appendix C, Figure 243](#).

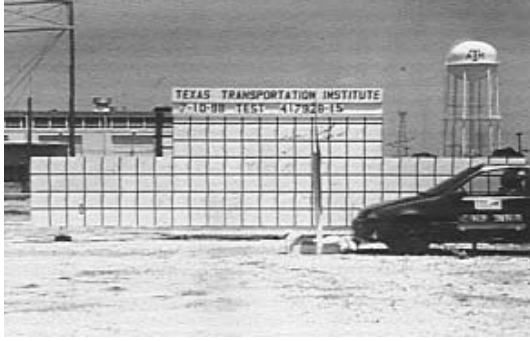
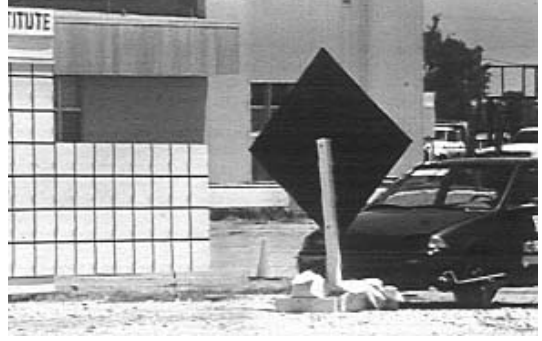
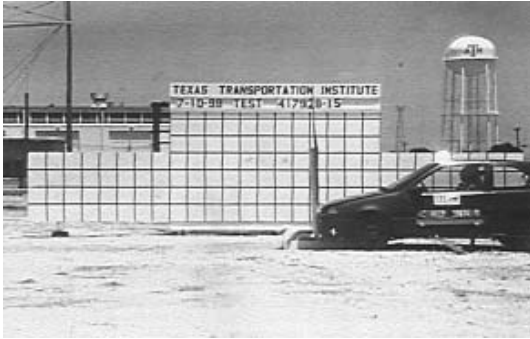
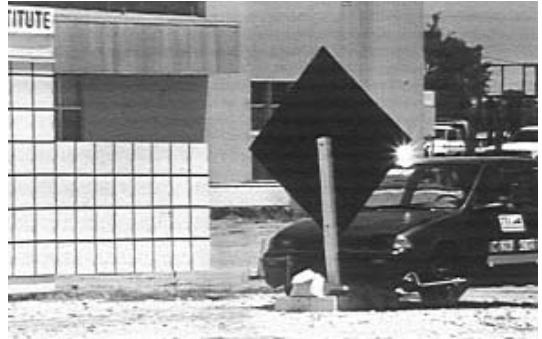
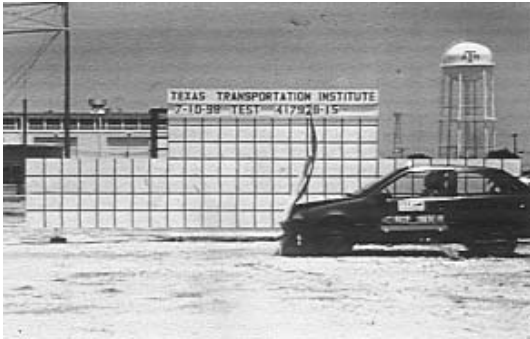
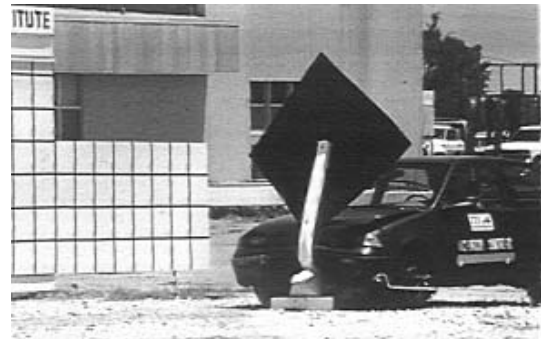
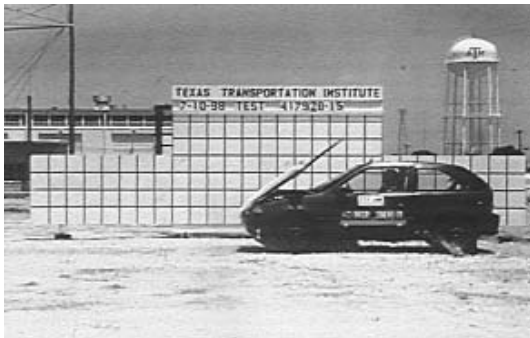
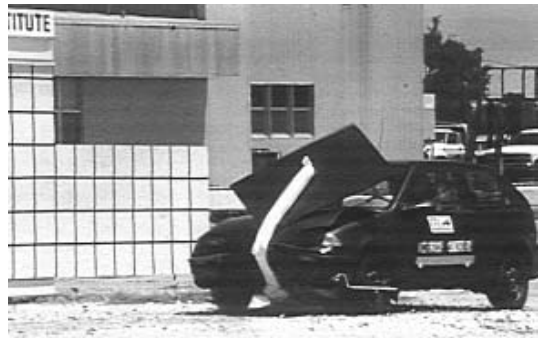
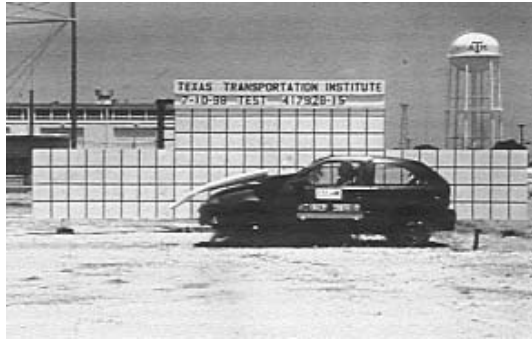
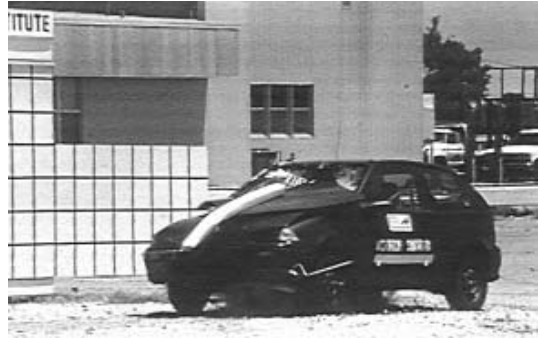
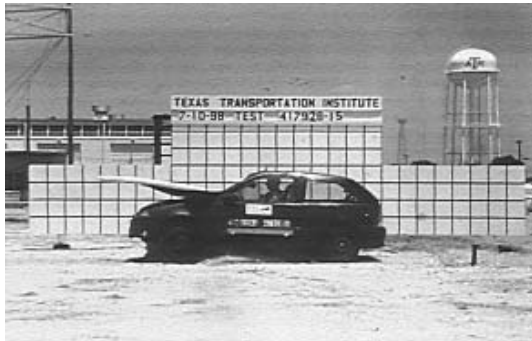
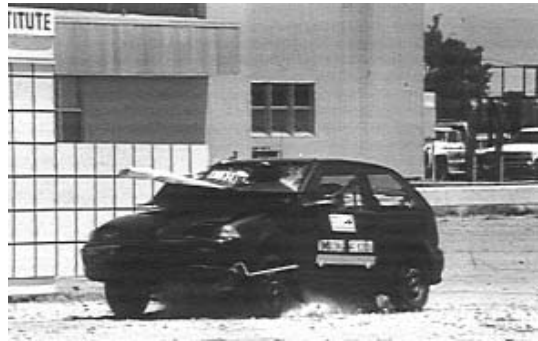
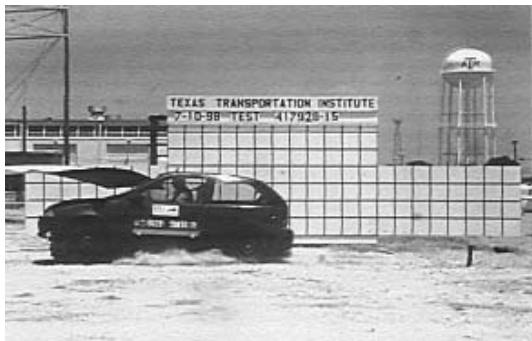
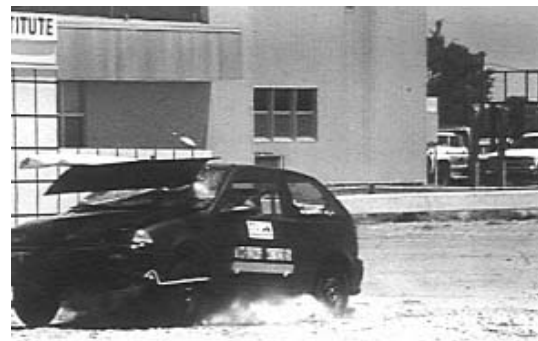
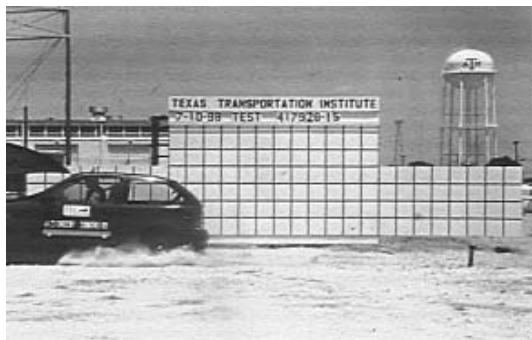
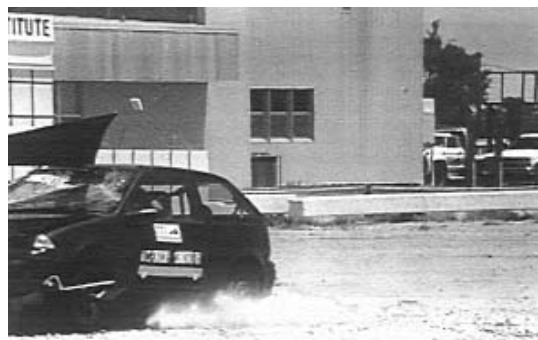
**Figure 244. Sequential Photographs for Test 417928-15
(Perpendicular and Oblique Views).**

0.119 s, and at 0.195 s the vehicle rode over the wooden base. The sign panel lost contact with the vehicle at 0.227 s. The vehicle was traveling at 92.5 km/h (57.5 mi/h) as the barricade panels lost contact with the vehicle. Brakes on the vehicle were applied as it exited the test site, and the vehicle came to rest 90.7 m (297.6 ft) down and 1.5 m (4.9 ft) to the left of the impact point. Sequential photographs of the test can be found in [Appendix C, Figure 244](#).

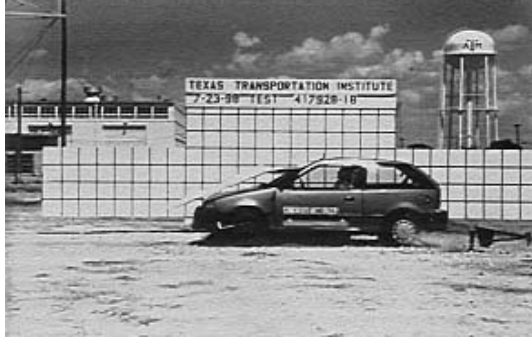
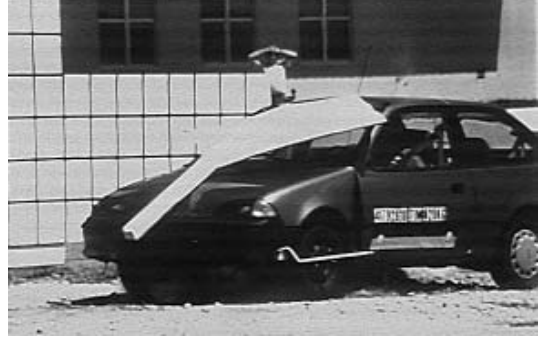
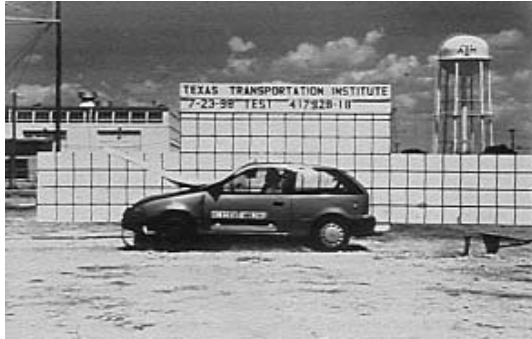
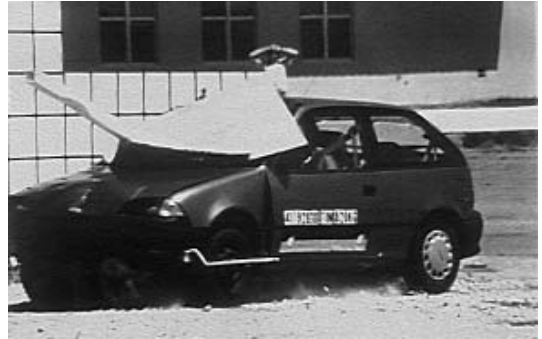
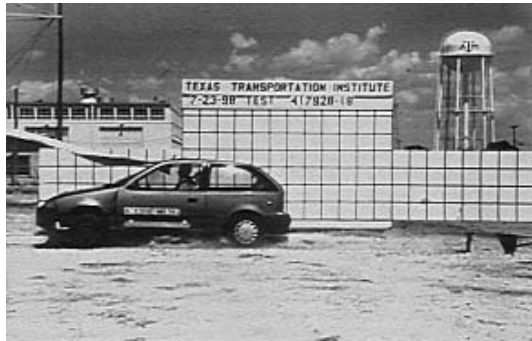
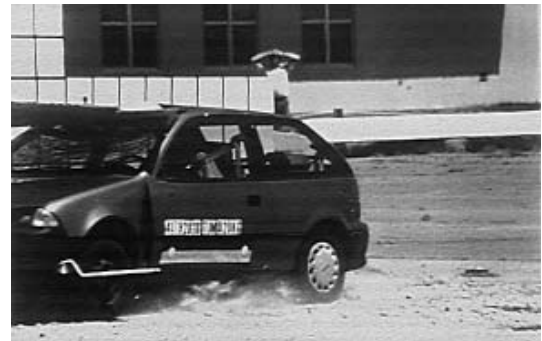
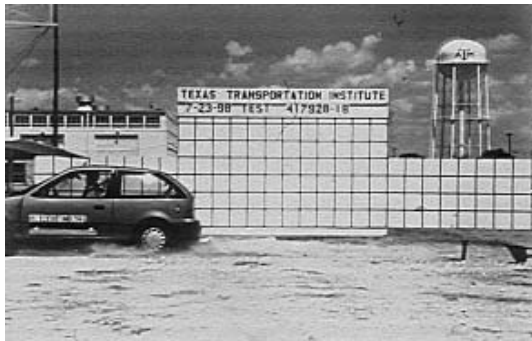
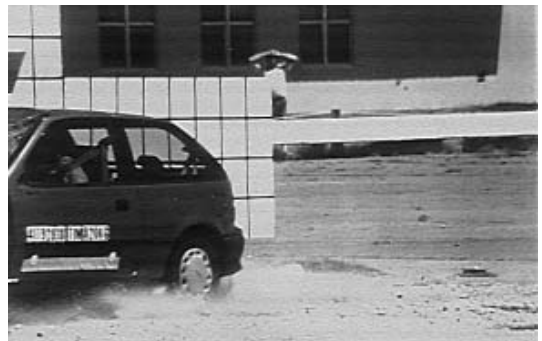
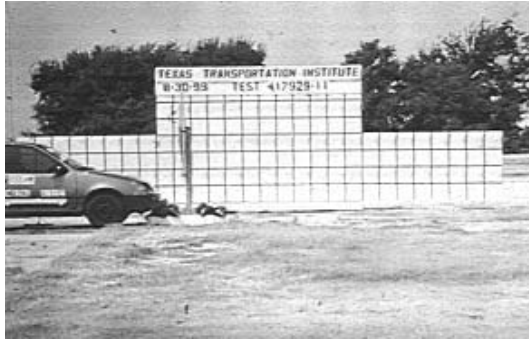
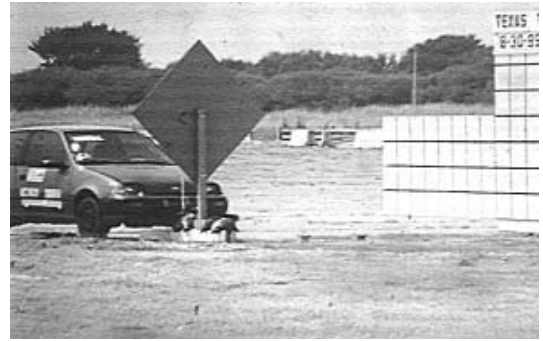
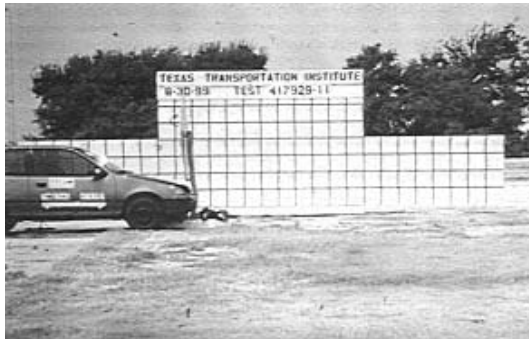
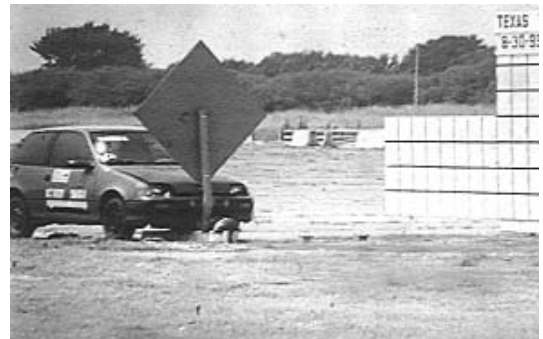
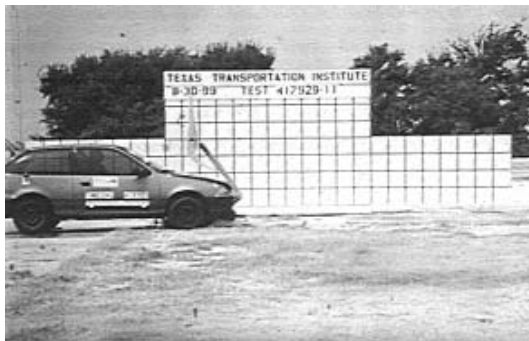
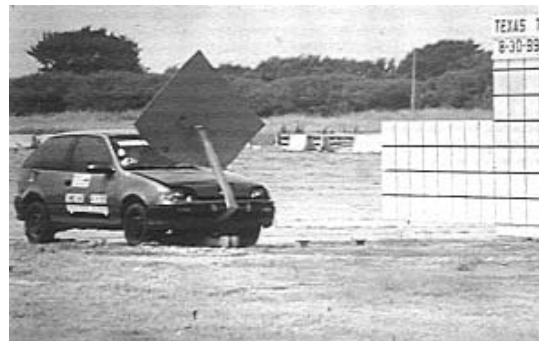
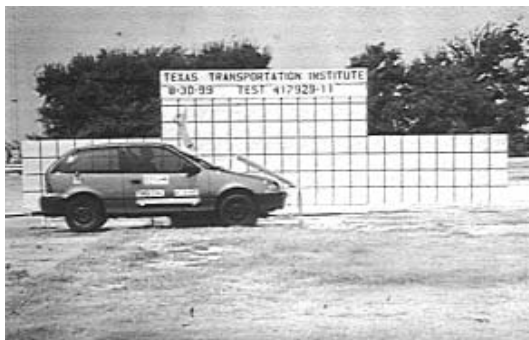
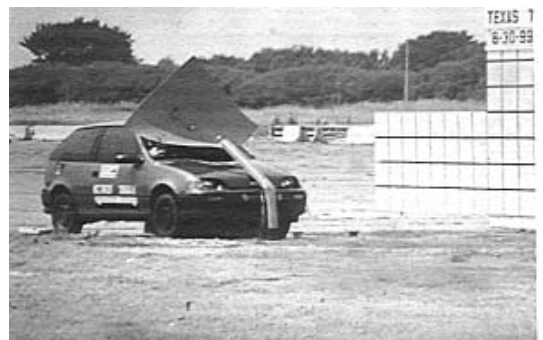
**Figure 245. Sequential Photographs for Test 417928-18
(Perpendicular and Oblique Views).**

inward. The sign panel lost contact with the roof of the vehicle at 0.205 s. At 0.207 s, the vehicle was traveling at 93.1 km/h (57.8 mi/h) as the barricade was still in contact with vehicle. The vehicle lost contact with the wooden base at 0.208 s. Brakes on the vehicle were applied as it exited the test site, and the vehicle came to rest 84.6 m (277.6 ft) from the impact point. Sequential photographs of the test can be found in [Appendix C, Figure 245](#).

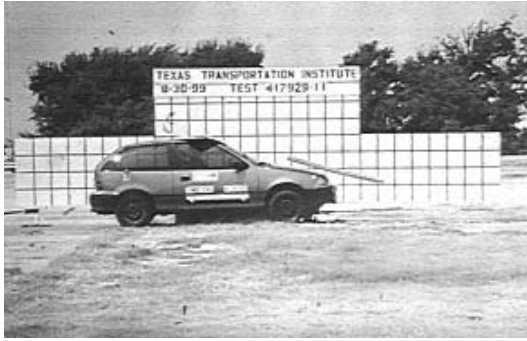
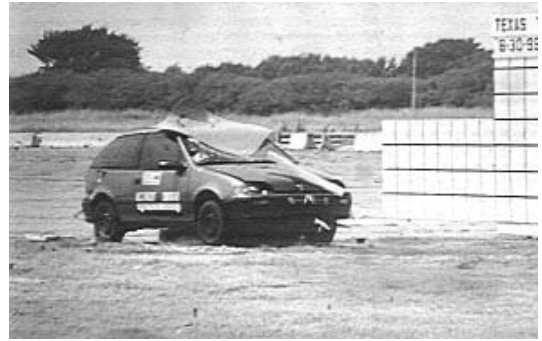
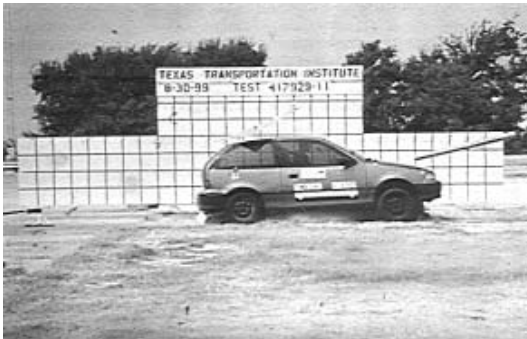
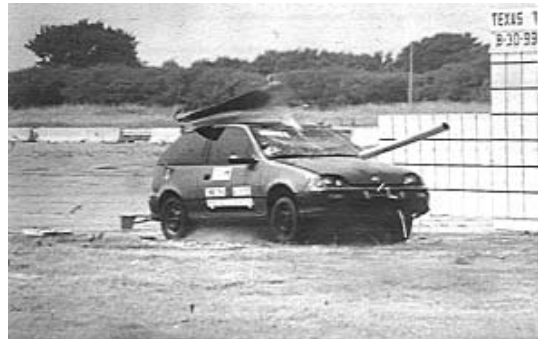
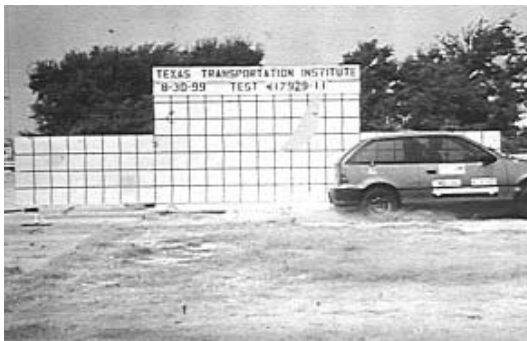
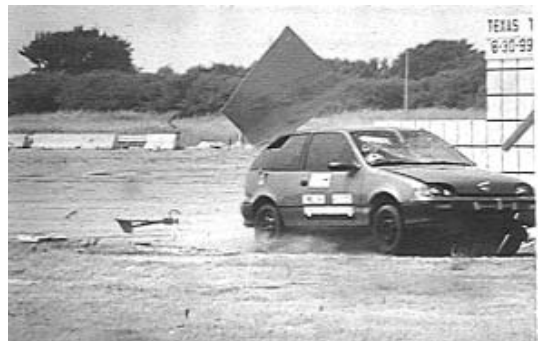
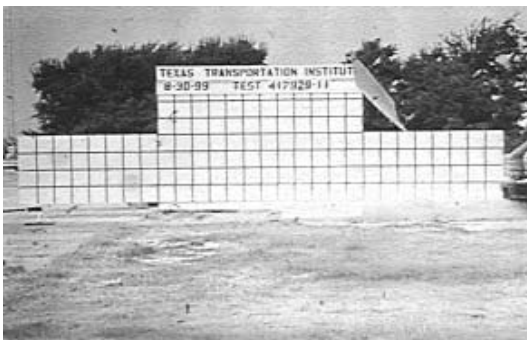
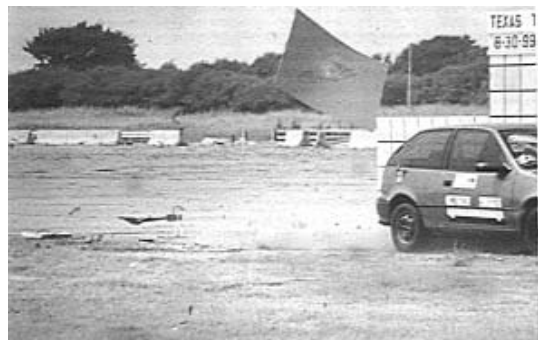
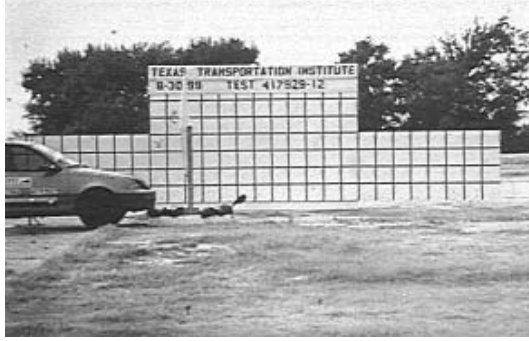
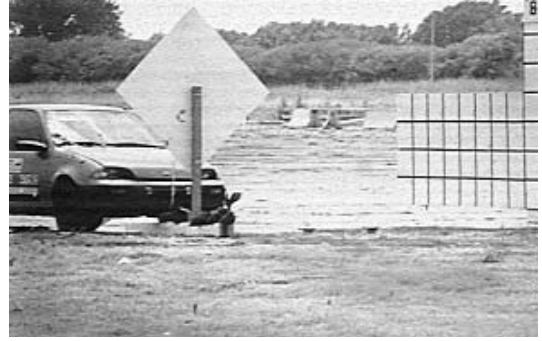
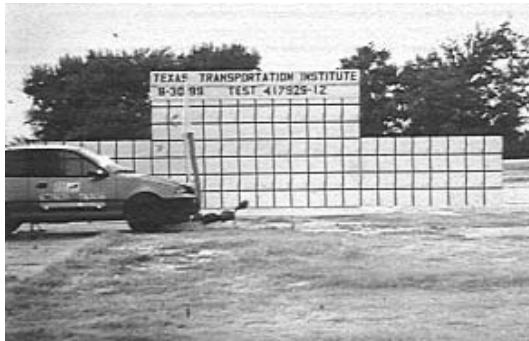
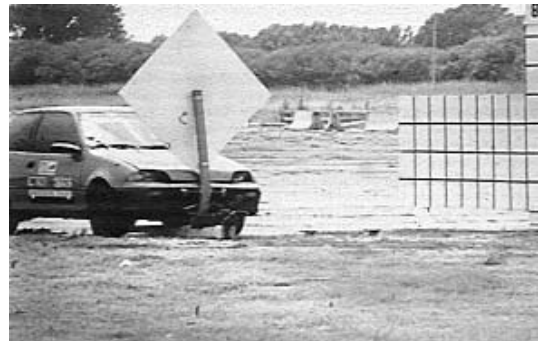
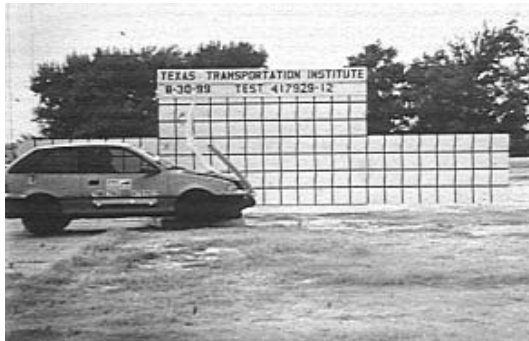
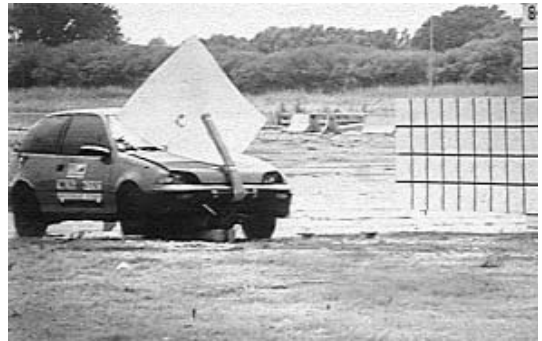
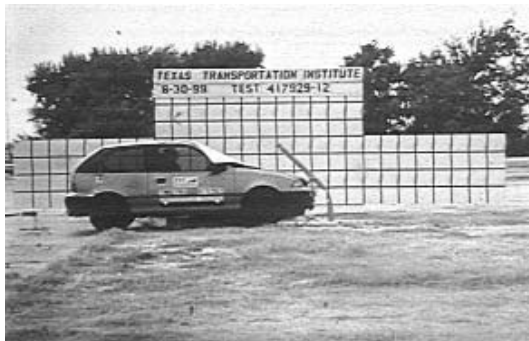
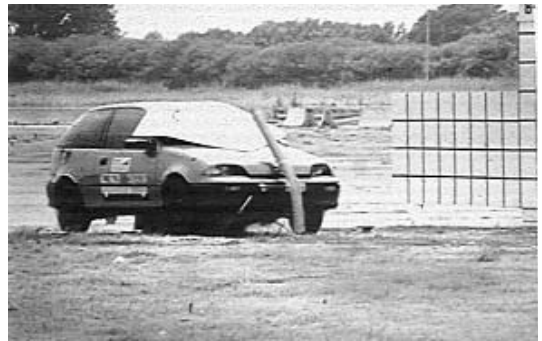
Figure 246. Sequential Photographs for Test 417929-11 (Perpendicular and Oblique Views).

The vehicle impacted the barricade head-on at a speed of 97.3 km/h (60.5 mi/h). At 0.028 s, the sign post was pulled out of the wooden base, and at 0.036 s, the bracket located at the top of the sign support slid off of the post. By 0.066 s, the post bounced off the front of the vehicle, and by 0.068 s, the bracket at the bottom of the sign support slid off of the post. The sign panel contacted the upper windshield, which shattered at 0.076 s, and at 0.128 s the sign panel lost contact with the vehicle. As the vehicle lost contact with the support, at 0.240 s, the vehicle was traveling at 91.8 km/h (57.0 mi/h). Brakes on the vehicle were applied as the vehicle exited the test site, and the vehicle came to rest 94.5 m (310.0 ft) down from the impact point. Sequential photographs of the test can be found in [Appendix C, Figure 246](#).

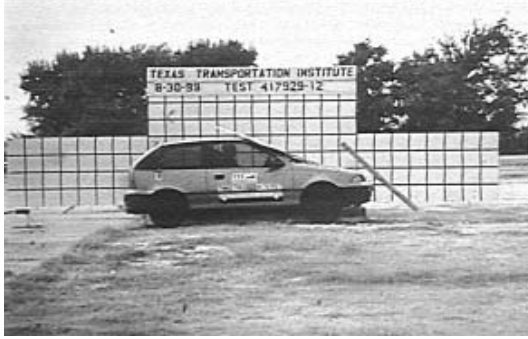
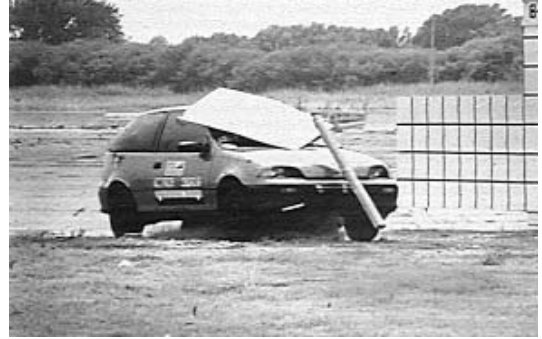
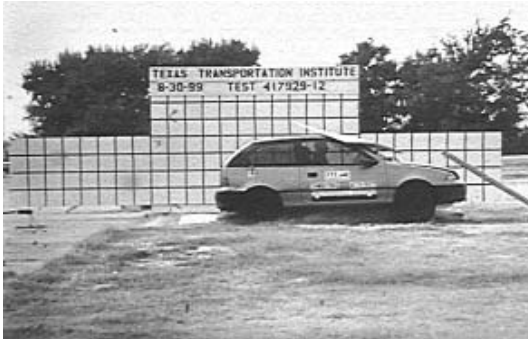
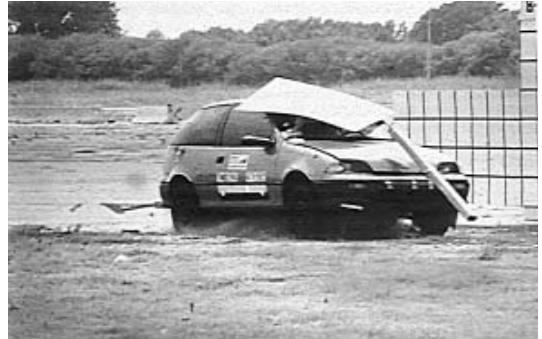
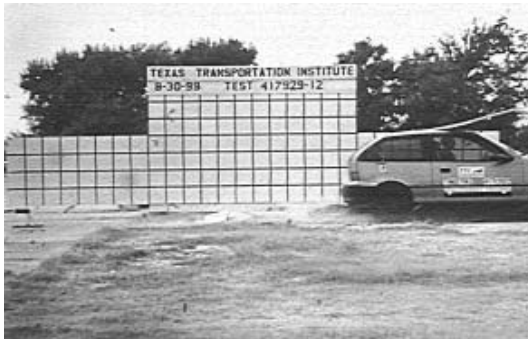
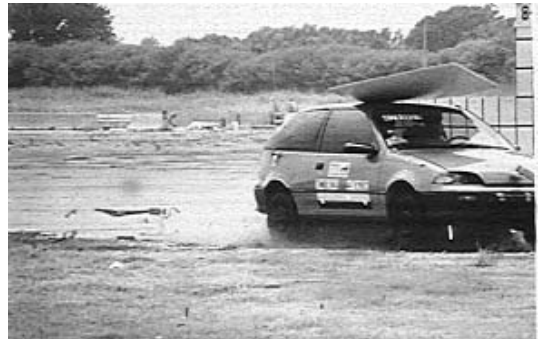
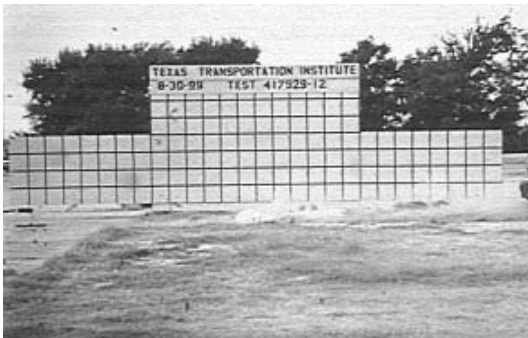
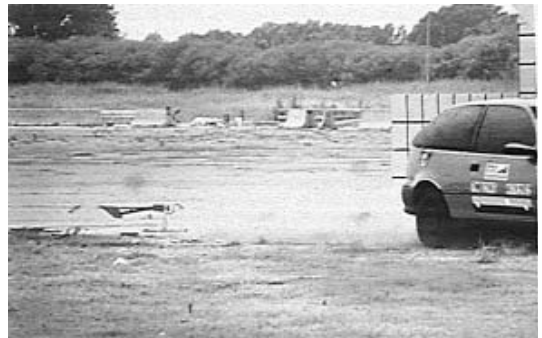
**Figure 247. Sequential Photographs for Test 417929-12
(Perpendicular and Oblique Views).**

The vehicle impacted the barricade head-on at a speed of 99.3 km/h (61.7 mi/h). At 0.020 s, the post moved, and at 0.032 s, the sign post was pulled out of the wooden base, and the bottom sign support bracket broke. By 0.036 s, the top sign support bracket broke, and by 0.038 s, the vehicle contacted the bottom of the sign panel. The post bounced off the front of the vehicle at 0.070 s, and at 0.072 s, the sign panel contacted the windshield. The top of the sign panel contacted the roof at 0.082 s. As the vehicle lost contact with the installation, at 0.297 s, the vehicle was traveling at 94.1 km/h (58.5 mi/h). Brakes on the vehicle were applied as the vehicle exited the test site, and the vehicle came to rest 109.7 m (359.9 ft) down from the impact point. Sequential photographs of the test can be found in [Appendix C, Figure 247](#).

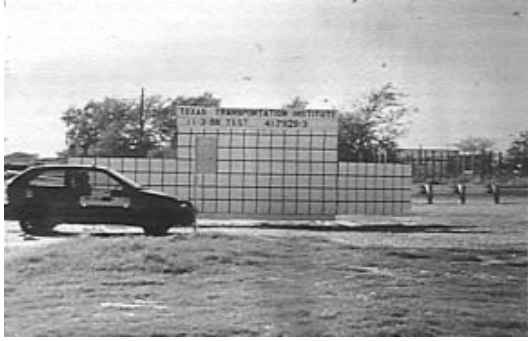
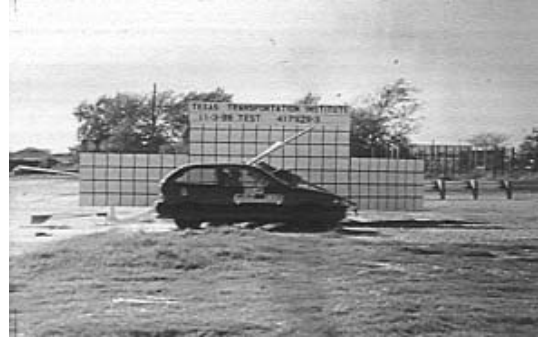
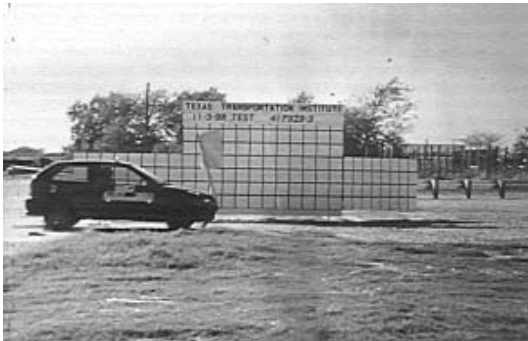
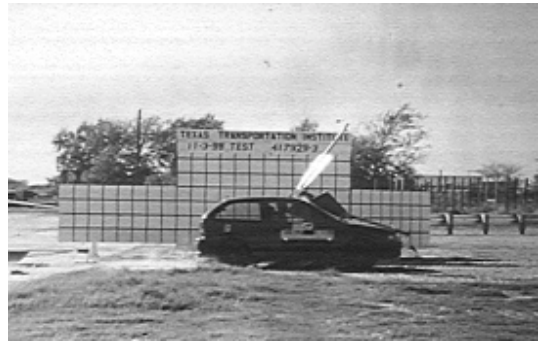
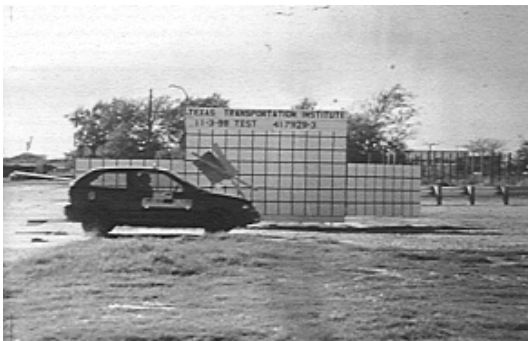
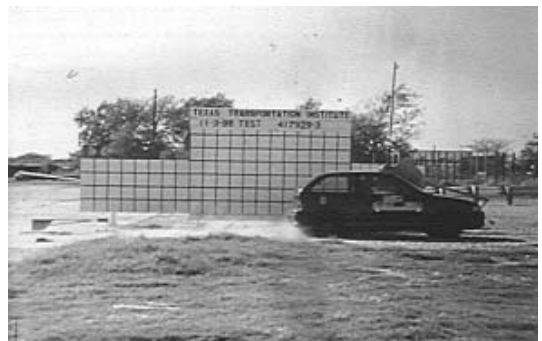
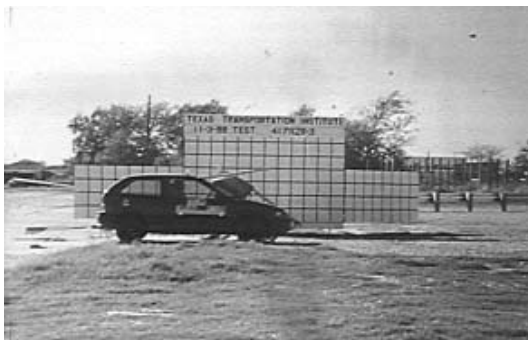
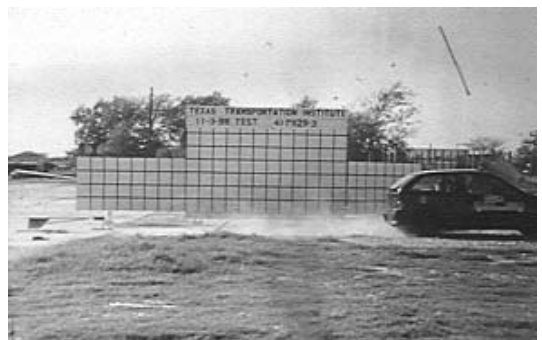
**Figure 248. Sequential Photographs for Test 417929-3
(Perpendicular View).**

deformed at bumper height and the base, and the post pulled out of the ground. By 0.029 s, the tube post pulled out of the ground. At 0.051 s, the tube post sign contacted the driver's side of the windshield and the door frame, and at 0.058 s, the U-channel sign contacted the roof at the windshield. By 0.064 s, the windshield shattered, and by 0.080 s, the tube post rear sign contacted the left side of the windshield at the frame of the vehicle. The U-channel sign lost contact with the vehicle at 0.102 s. At 0.255 s, the vehicle was traveling at 95.0 km/h (59.0 mi/h) as the vehicle exited the test site with the tube post sign. Brakes on the vehicle were applied as it exited the test site, and the vehicle came to rest 97.5 m (319.9 ft) downstream from impact. Sequential photographs of the test can be found in [Appendix C](#), Figures 248 and 249.
