1. Report No. FHWA/TX-01/1792-2		2. Government Accession No.		3. Recipient's Catalog No.	
4. Title and Subtitle IMPACT PERFORMANCE EVALUATION OF WORK ZONE TRAFFIC CONTROL DEVICES				5. Report Date December 2000

6. Performing Organization Code	
7. Author(s) Roger P. Bligh, D. Lance Bullard, Wanda L. Menges, and Sandra K. Schoeneman				8. Performing Organization Report No. Report 1792-2

IMPACT PERFORMANCE EVALUATION OF WORK ZONE TRAFFIC CONTROL DEVICES

December 2000

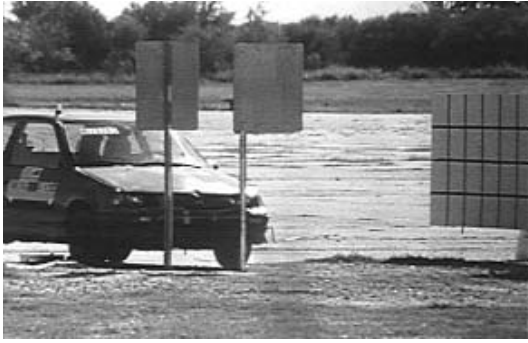
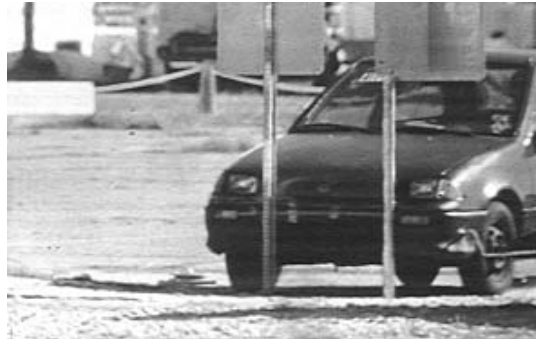
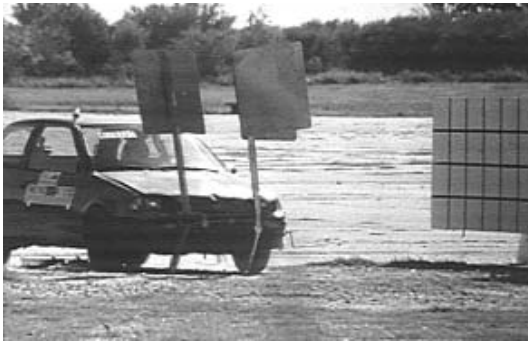
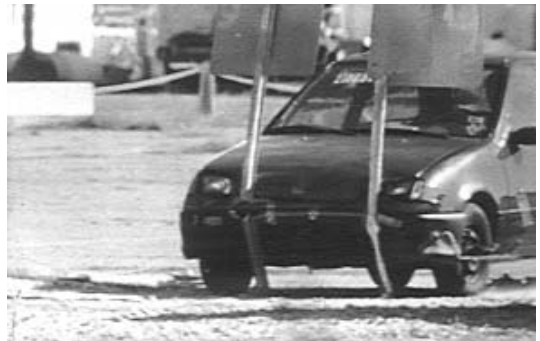
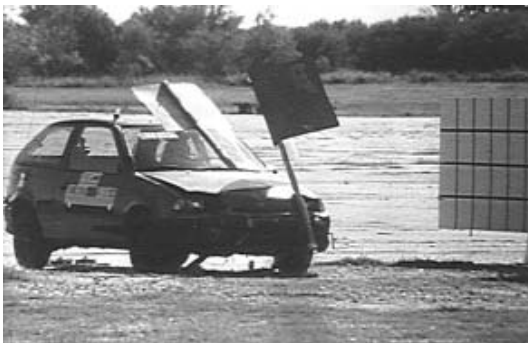
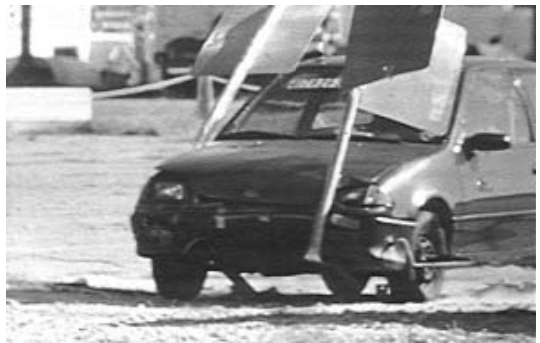
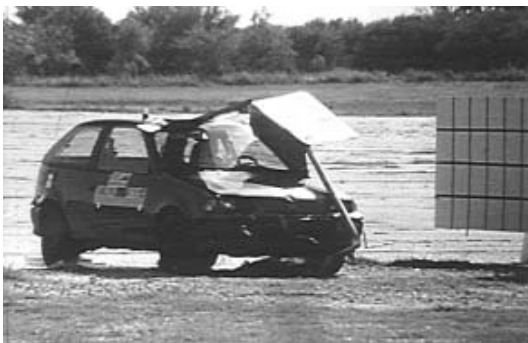
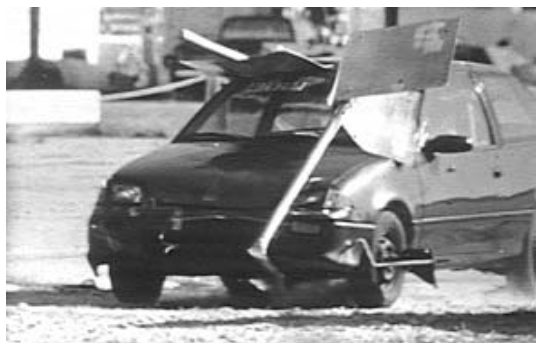
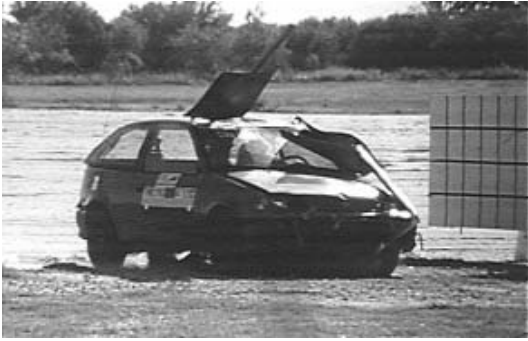
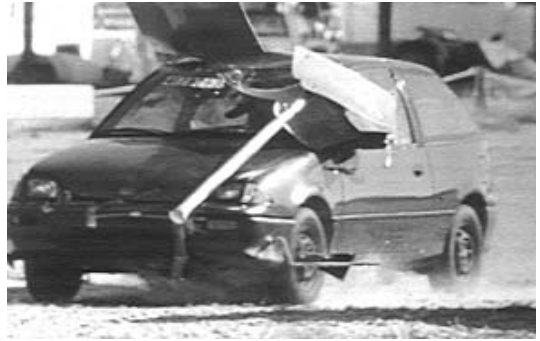
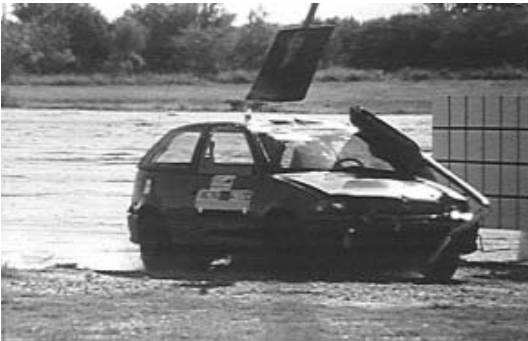
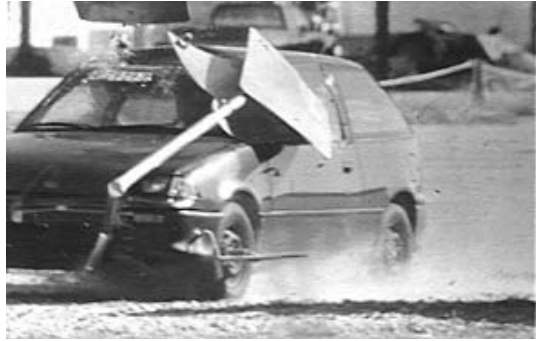
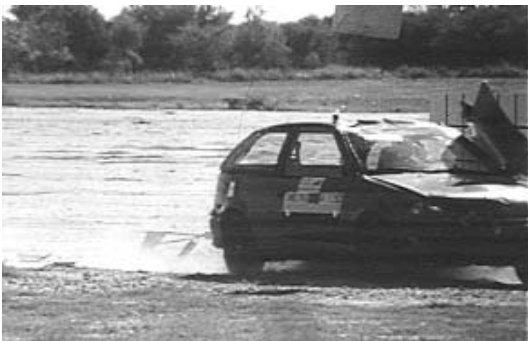
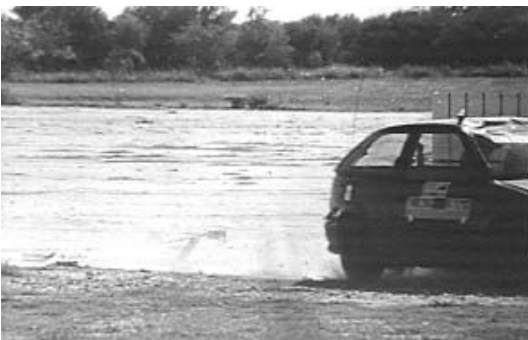
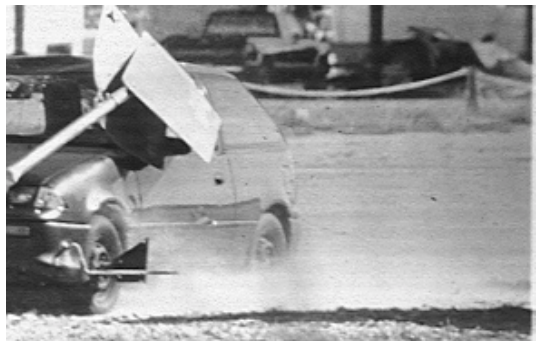
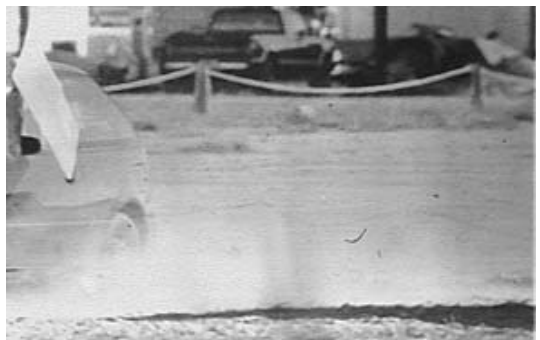
**Figure 249. Sequential Photographs for Test 417929-3
(Oblique Views).**

deformed at bumper height and the base, and the post pulled out of the ground. By 0.029 s, the tube post pulled out of the ground. At 0.051 s, the tube post sign contacted the driver's side of the windshield and the door frame, and at 0.058 s, the U-channel sign contacted the roof at the windshield. By 0.064 s, the windshield shattered, and by 0.080 s, the tube post rear sign contacted the left side of the windshield at the frame of the vehicle. The U-channel sign lost contact with the vehicle at 0.102 s. At 0.255 s, the vehicle was traveling at 95.0 km/h (59.0 mi/h) as the vehicle exited the test site with the tube post sign. Brakes on the vehicle were applied as it exited the test site, and the vehicle came to rest 97.5 m (319.9 ft) downstream from impact. Sequential photographs of the test can be found in [Appendix C](#), Figures 248 and 249.

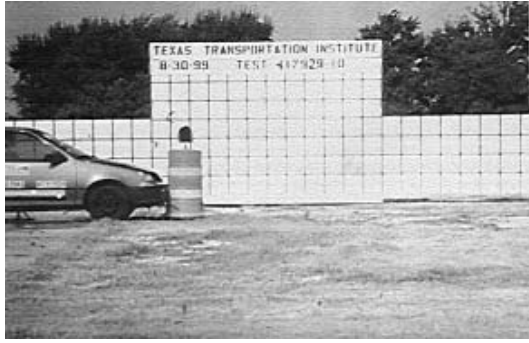
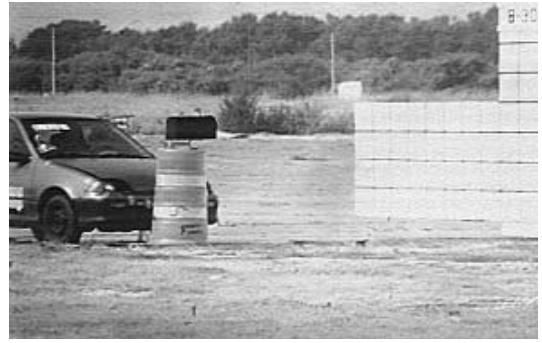
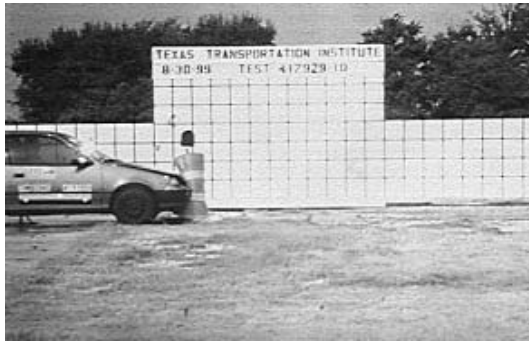
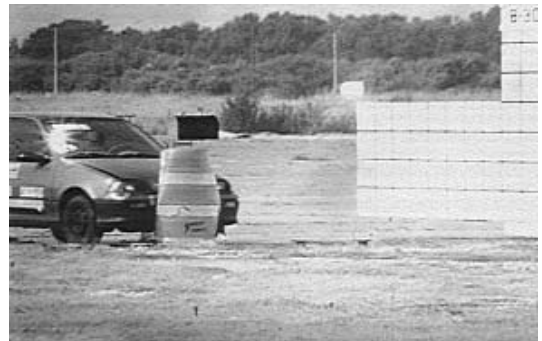
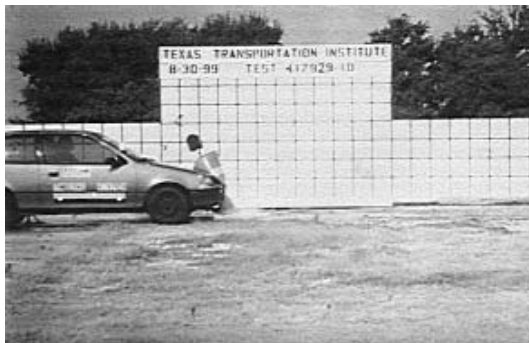
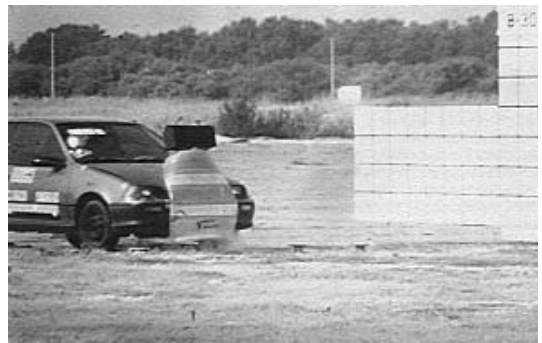
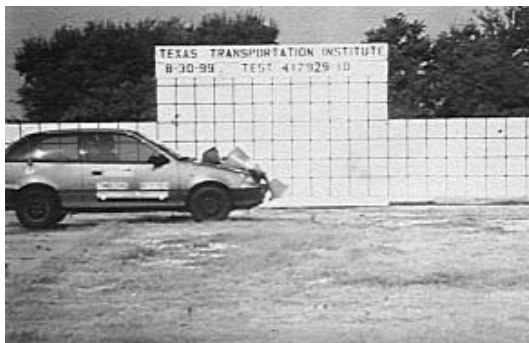
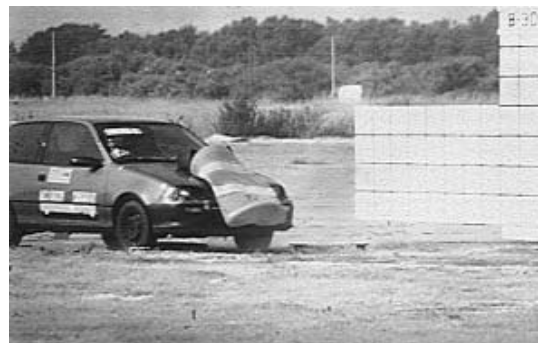
**Figure 250. Sequential Photographs for Test 417929-10
(Perpendicular and Oblique Views).**

The vehicle impacted the mailbox support head-on at a speed of 91.3 km/h (56.7 mi/h). Shortly after impact, the mailbox moved, and the drum lost contact with the ground. At 0.040 s, the mailbox contacted the hood of the vehicle, and at 0.054 s, the drum lost contact with the bumper of the vehicle. The drum lost contact with the front of the vehicle at 0.058 s, and at 0.078 s, the mailbox lost contact with the hood of the vehicle. As the vehicle lost contact with the installation, at 0.094 s, the vehicle was traveling at 90.3 km/h (56.1 mi/h). Brakes on the vehicle were applied as the vehicle exited the test site, and the vehicle came to rest 91.4 m (300.0 ft) down from the impact point. Sequential photographs of the test can be found in [Appendix C, Figure 250](#).
