1. Report No. FHWA/TX-01/1792-6		2. Government Accession No.		3. Recipient's Catalog No.	
4. Title and Subtitle TESTING AND EVALUATION OF MOLDED PLASTIC MAILBOXES				5. Report Date September 2001

# TESTING AND EVALUATION OF MOLDED PLASTIC MAILBOXES

Report 1792-6  
Project Number 0-1792  
Research Project Title: Roadside Safety Hardware  
for Traffic Control Devices

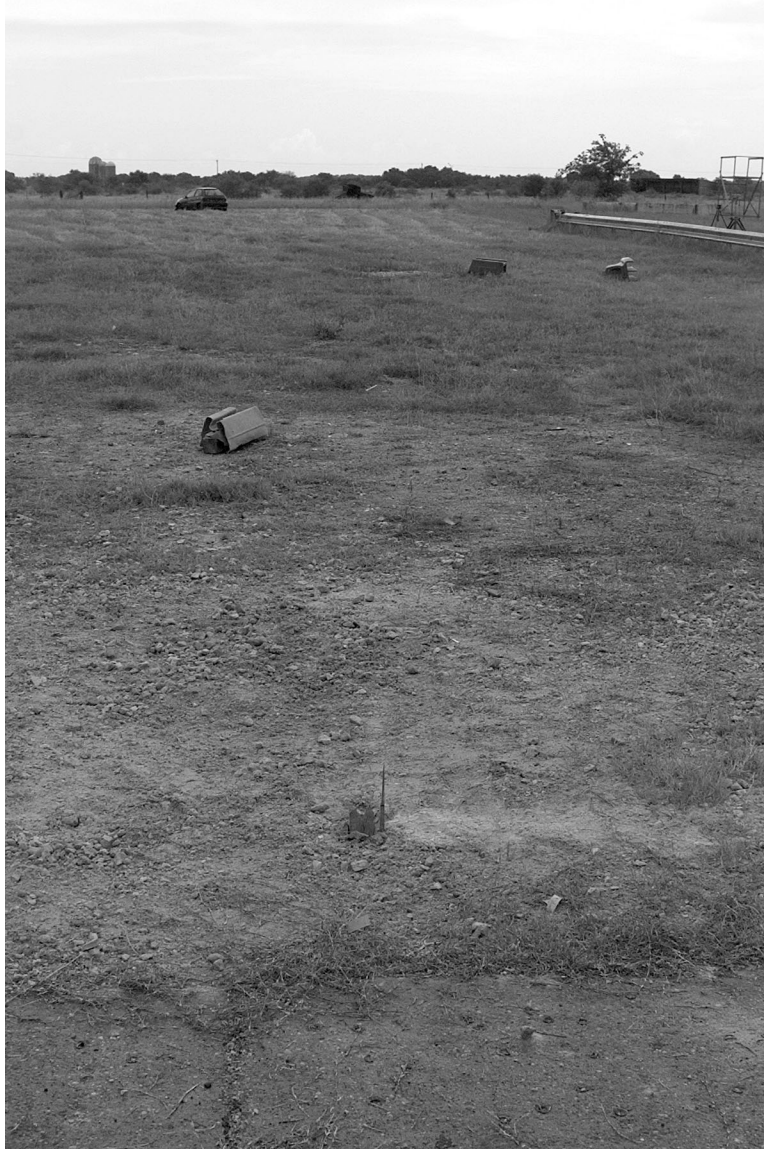
**Figure 9. After Impact Trajectory for Test 417921-2.**

Figures 9 and 10 show damage to the test installation. The 4x4 timber support pulled out of the ground 3.5 in. before fracturing flush with ground level. The mailbox separated into several pieces, the heaviest of which weighed 12 lb-2 oz. The debris pattern extended 77.5 ft downstream, 20.0 ft to the left, and 25 ft to the right of the point of impact.

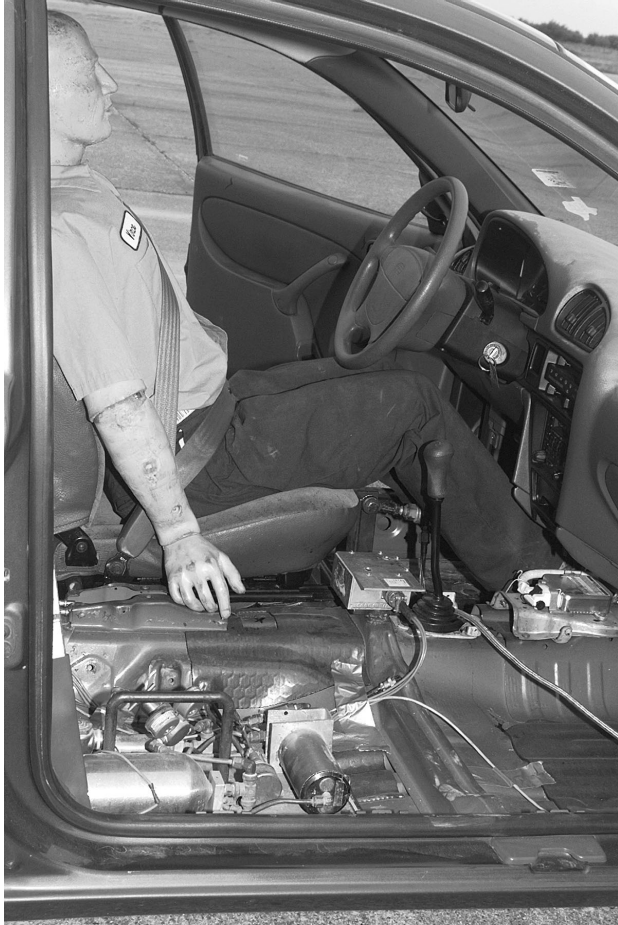
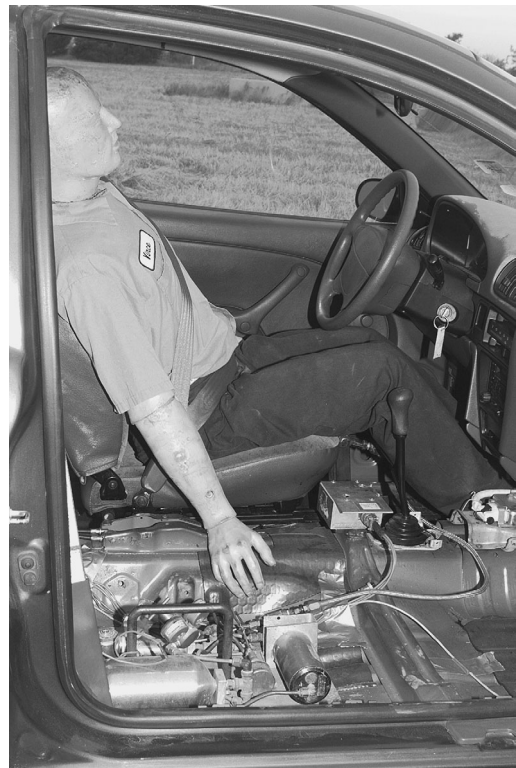
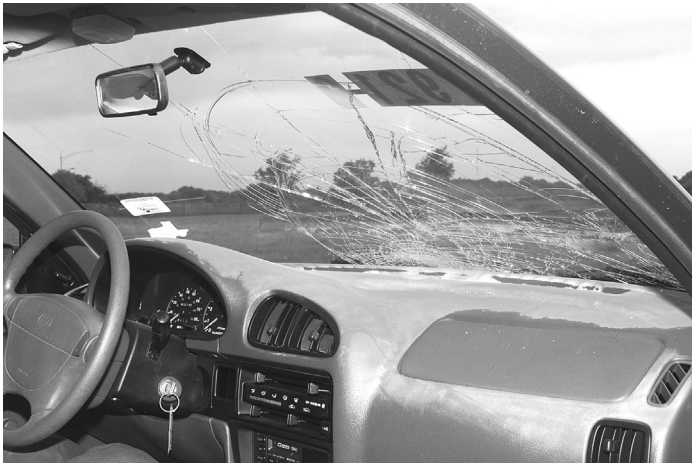
**Figure 12. Interior of Vehicle for Test 417921-2.**

As shown in [Figure 11](#), damage to the vehicle was minimal. The windshield was cracked (Case 4 of the Federal Highway Administration (FHWA) Windshield Damage Guidance) due to contact with the upper portion of the mailbox unit. However, there were no holes in the windshield nor any deformation of the windshield into the passenger compartment, and visibility was not restricted. No other occupant compartment deformation was noted. The hood was deformed over an area 16 in. long × 19.68 in. wide × 0.40 in. deep. Photographs of the interior of the vehicle are shown in [Figure 12](#). Exterior crush measurements and occupant compartment measurements are provided in [Appendix B, Tables 4 and 5](#).

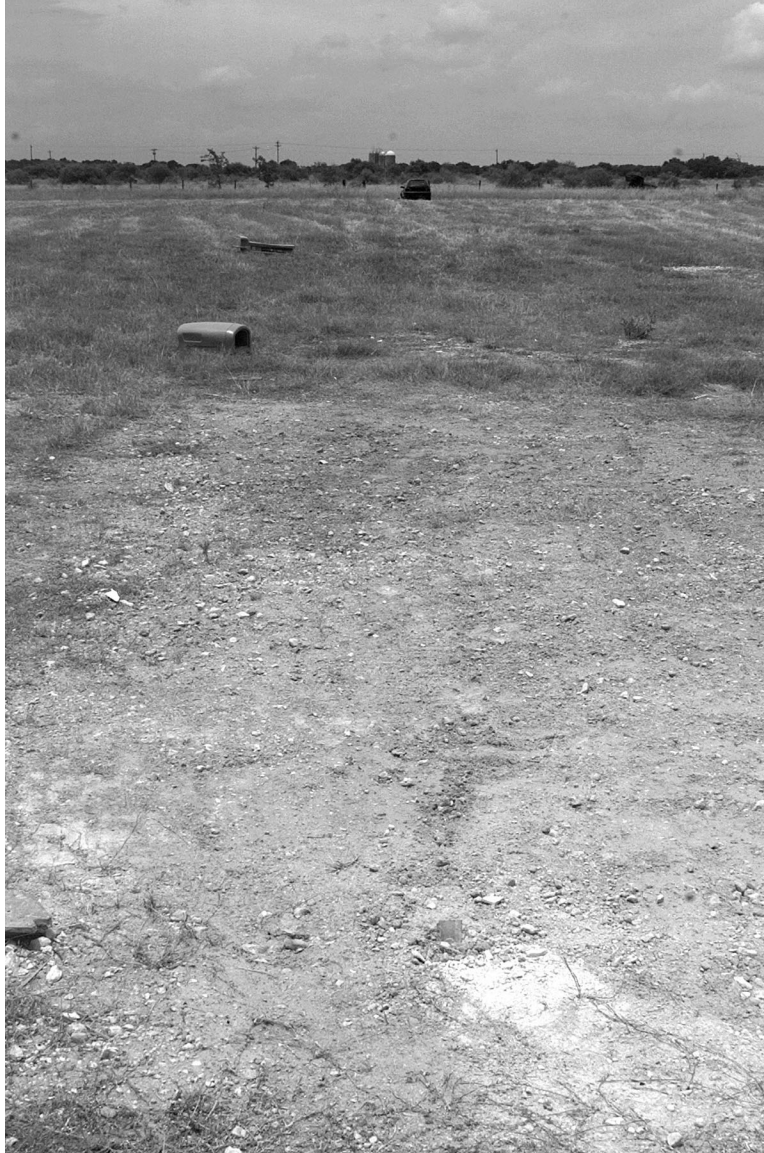
**Figure 16. After Impact Trajectory for Test 417921-3.**

Damage to the test installation is shown in Figures 16 and 17. The impact caused the upper portion of the mailbox unit to separate from the lower base portion. The steel U-channel fractured at ground level with the lower molded plastic base portion still attached. The ground stub remaining from the U-channel projected 1.75 in. above ground level. The molded plastic mailbox separated into several pieces, the heaviest of which weighed 13 lb-8 oz. The debris pattern extended 80.0 ft downstream and 15.0 ft to the left of the point of impact.

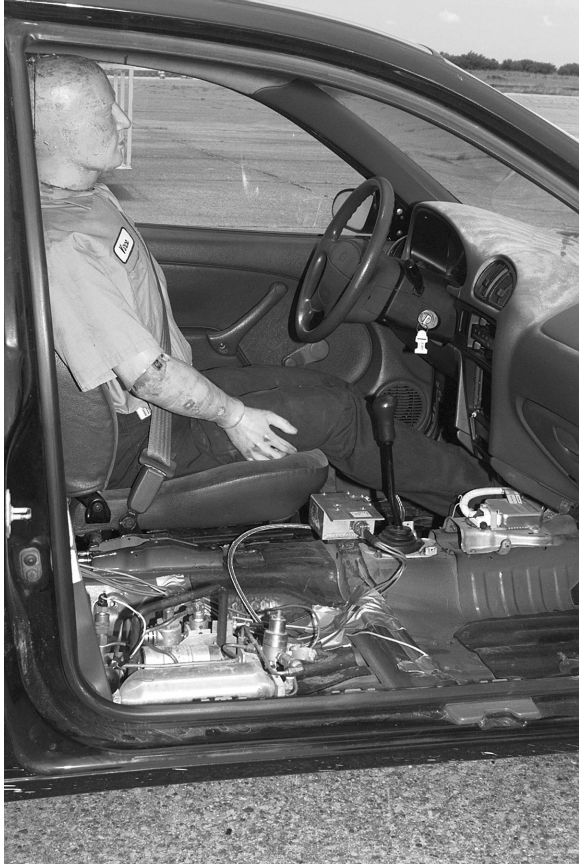
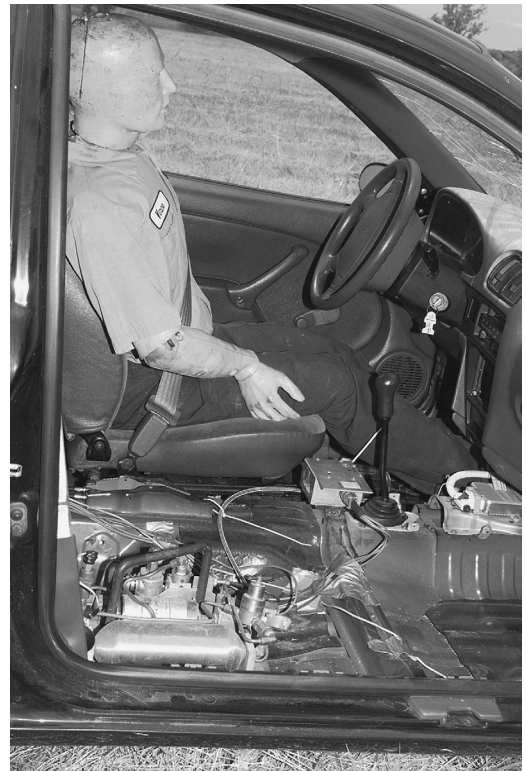
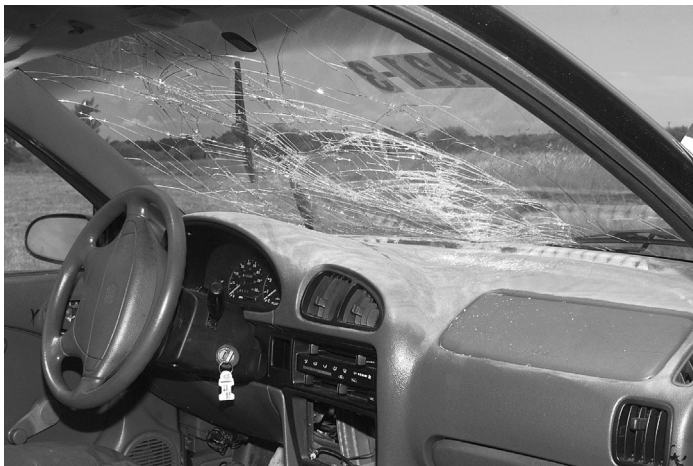
**Figure 19. Interior of Vehicle for Test 417921-3.**

As shown in [Figure 18](#), damage to the vehicle was minimal. The windshield was cracked and deformed inward 1.5 in. (Case 4 of the FHWA Windshield Damage Guidance), but there was no hole and visibility was not restricted. No other occupant compartment deformation was noted. The hood was deformed over an area 13.00 in. long × 20.87 in. wide × 0.20 in. deep. Photographs of the interior of the vehicle are shown in [Figure 19](#). Exterior crush measurements and occupant compartment measurements are detailed in [Appendix B](#), Tables 6 and 7.

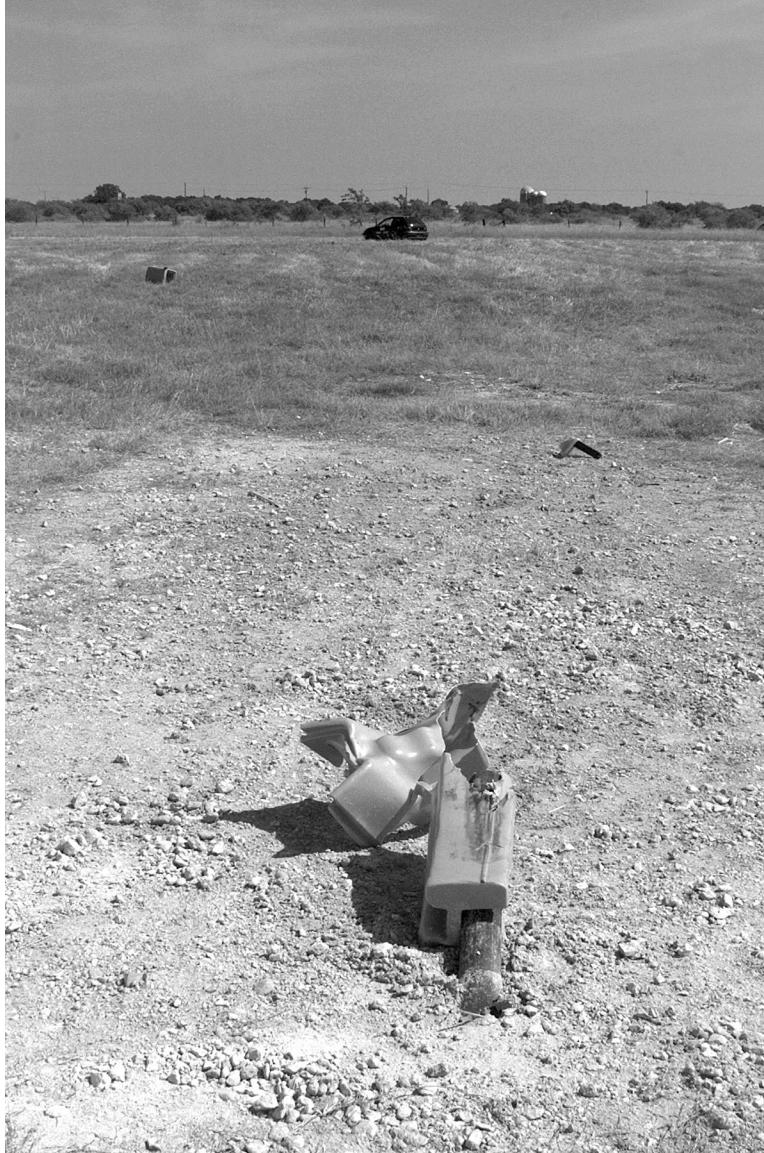
**Figure 23. After Impact Trajectory for Test 417921-4.**

Damage to the test installation is shown in [Figures 23 and 24](#). The steel pipe support yielded and bent near ground level. As the vehicle rode over the pipe support, most of the lower molded plastic base section of the mailbox was pulled off the support post. The upper portion of the deformed steel pipe had a maximum height of 5.1 in. above ground level. The mailbox separated into several pieces, none of which was considered heavy enough to cause physical threat. The debris pattern extended 45.0 ft downstream, 18 ft left, and 10 ft right of the point of impact.

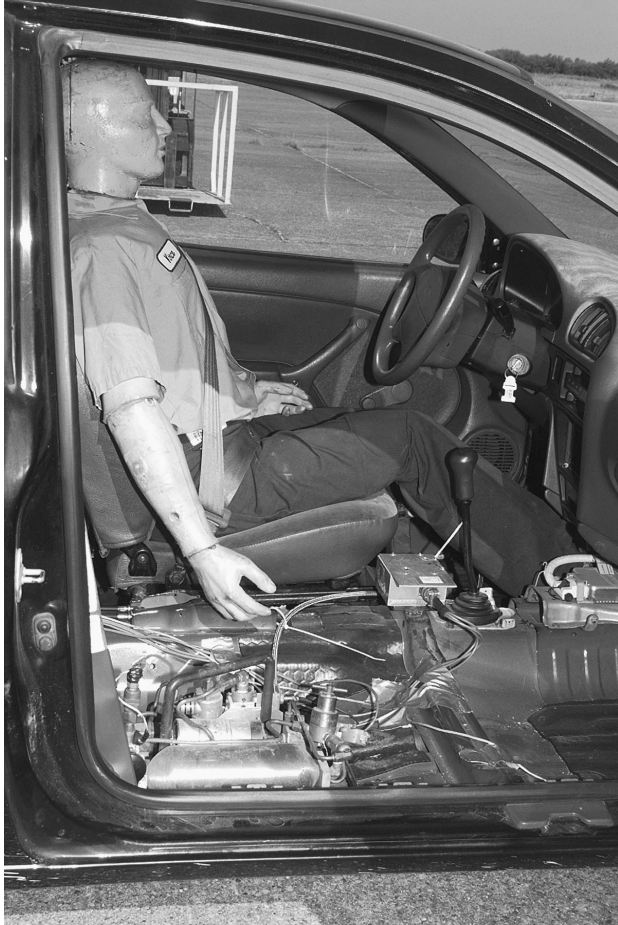
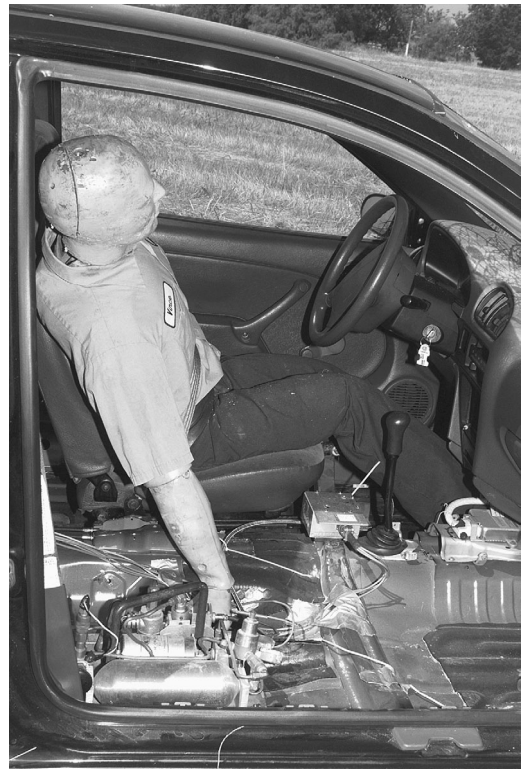
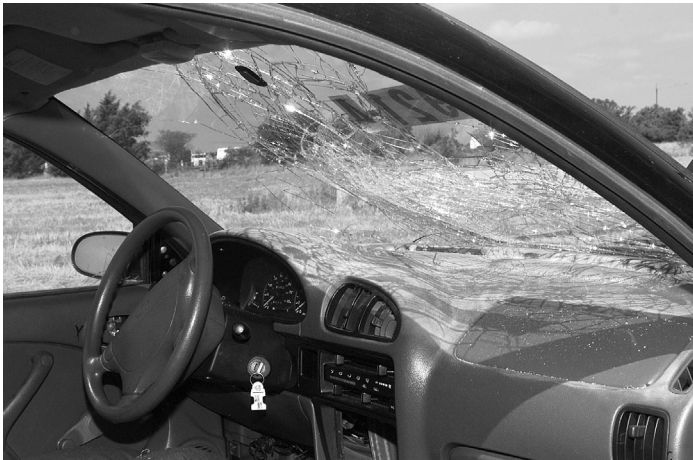
**Figure 26. Interior of Vehicle for Test 417921-4.**

Damage to the vehicle is shown in [Figure 25](#). A 0.5-in. long tear was noted in the windshield, and the windshield was deformed inward 2.75 in (Case 1 of the FHWA Windshield Damage Guidance). Visibility was not restricted. No other occupant compartment deformation was noted. The right motor mount and radiator support were damaged and there was a dent in the oil pan. Also damaged were the front bumper, hood, radiator, compressor, and condenser. Maximum exterior crush to the vehicle was 9.8 in. at the right front quarter point. Photographs of the interior of the vehicle are shown in [Figure 26](#). Exterior crush measurements and occupant compartment measurements are detailed in [Appendix B, Tables 7 and 8](#).

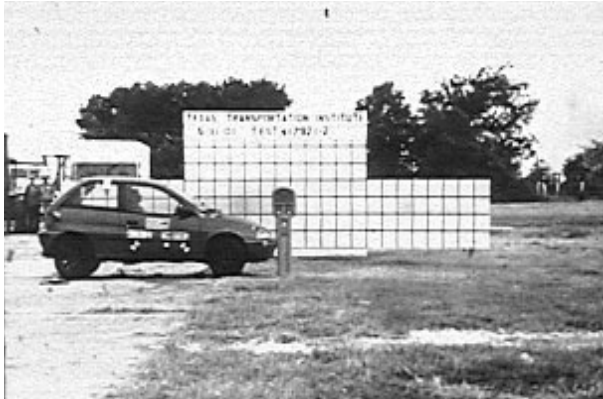
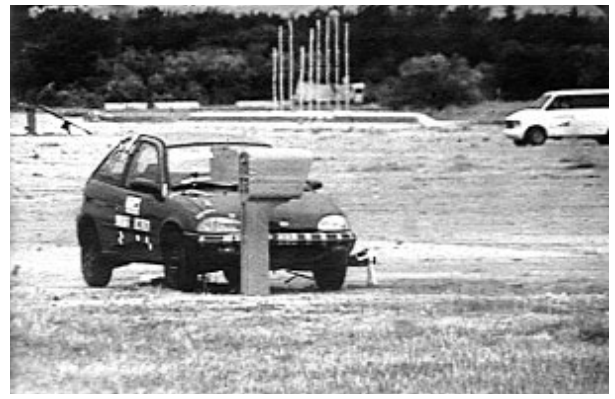
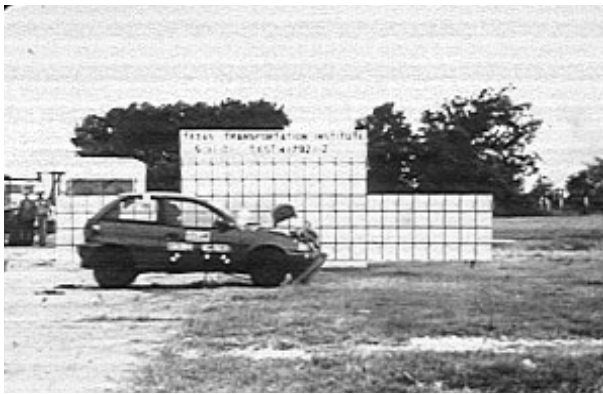
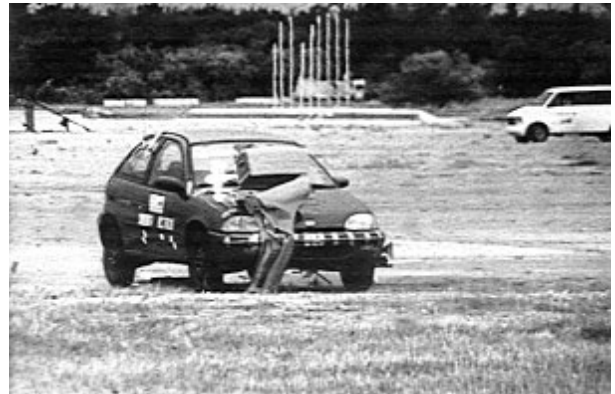
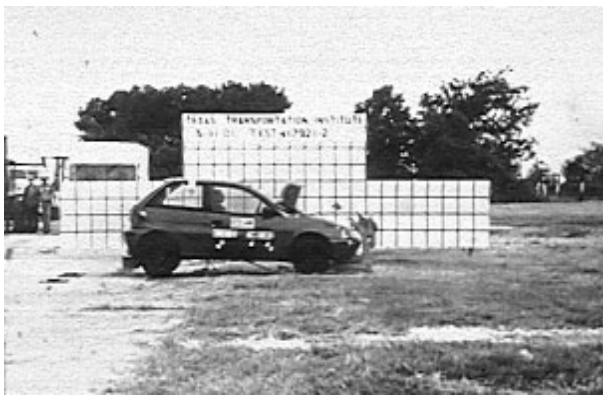
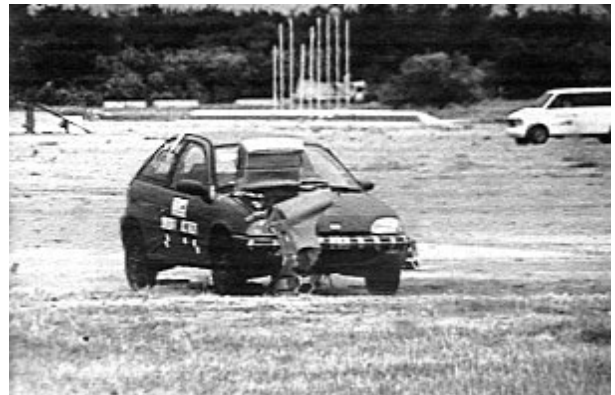
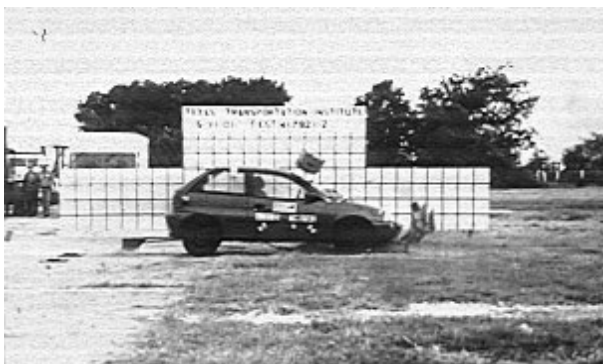
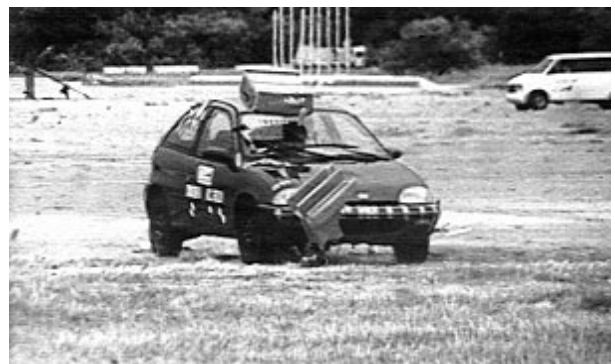
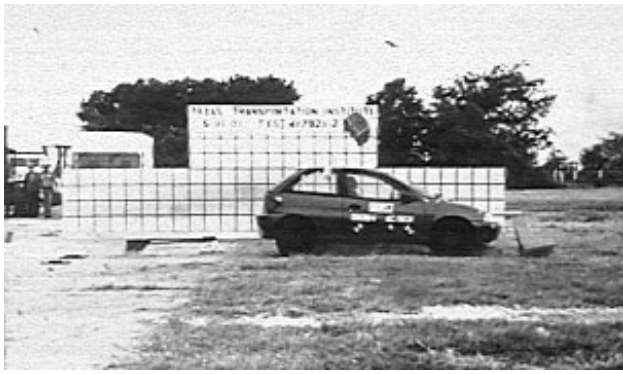
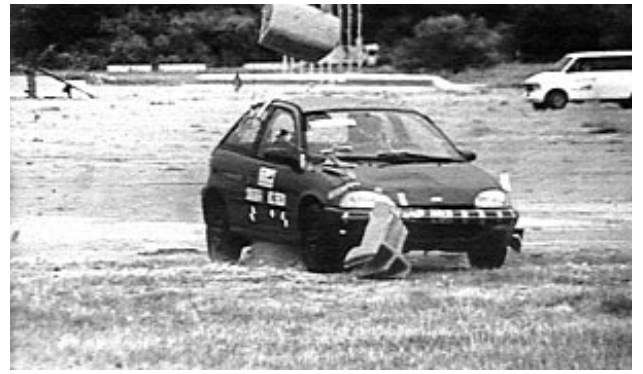
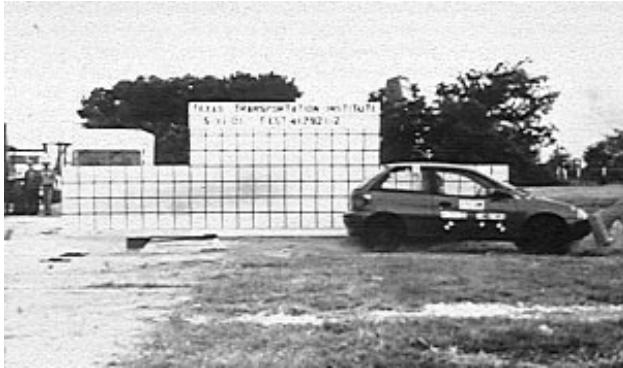
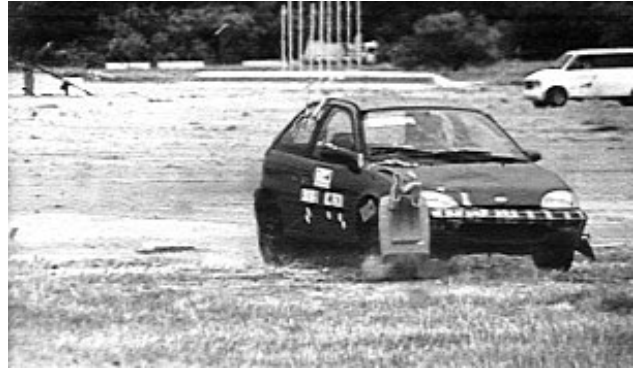
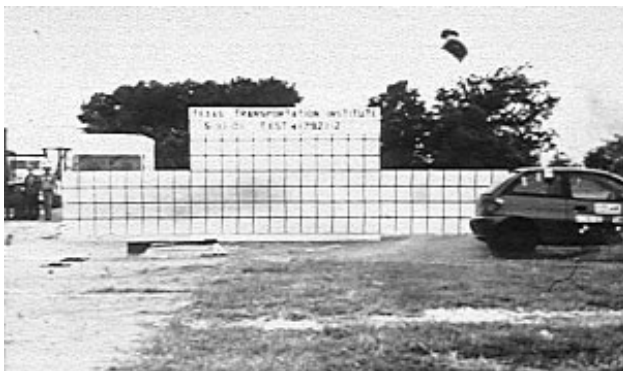
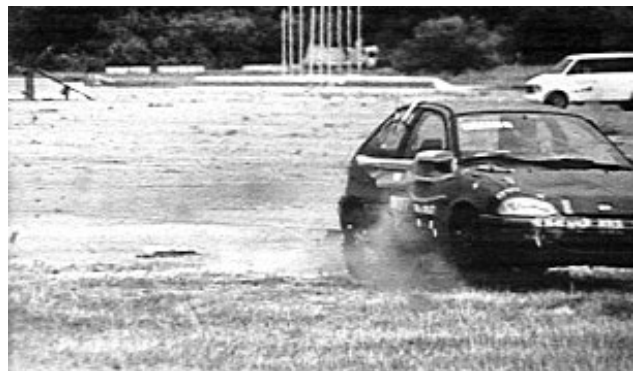
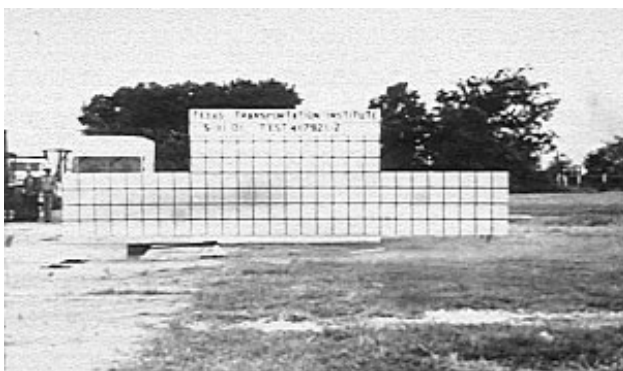
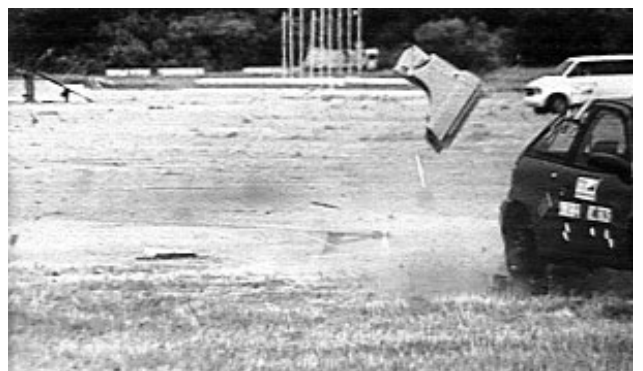
**Figure 30. Sequential Photographs for Test 417921-2 (Perpendicular and Oblique Views).**

mailbox began to separate from the lower base portion. At 0.010 s, the timber support post began to fracture at ground level. At 0.015 s, the upper end of the lower base portion of the mailbox contacted the hood of the vehicle. The upper molded portion containing the mailbox was completely separated from the lower base portion of the unit by 0.020 s. This upper section subsequently contacted the rear of the hood and lower part of the windshield at 0.032 s. The lower base portion and wood support post lost contact with the vehicle bumper at 0.052 s, and the upper section lost contact with the windshield at 0.077 s. Speed of the vehicle at loss of contact was 59.5 mi/h. The vehicle traveled forward in a straight path, and brakes were remotely applied at 1.3 s. The vehicle subsequently came to rest 263 ft downstream of impact. Sequential photographs of the test period are shown in [Appendix C, Figure 30](#).

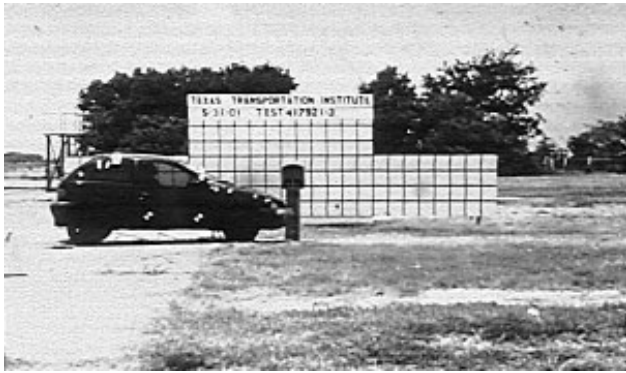
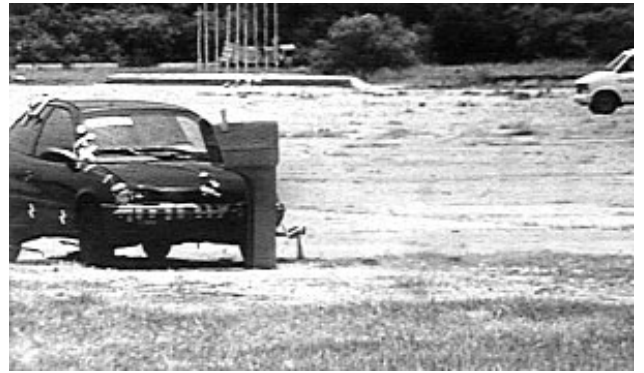
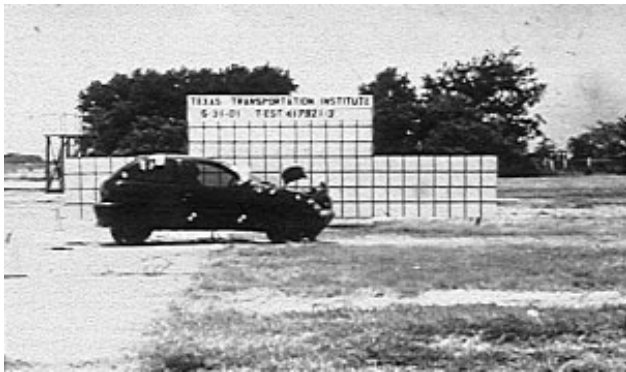
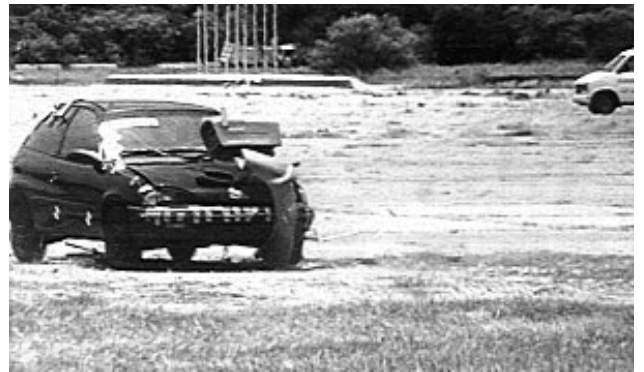
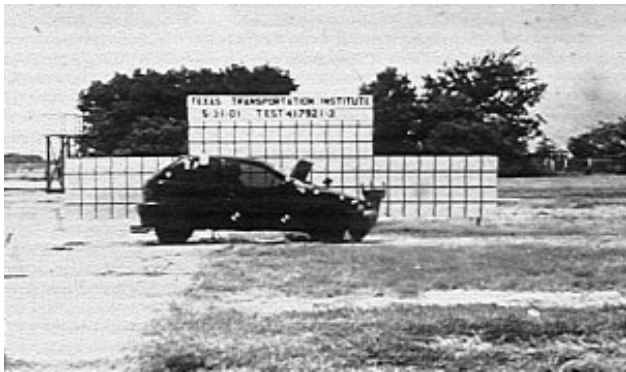
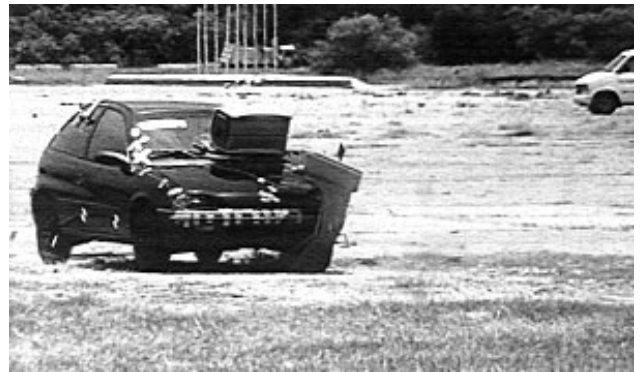
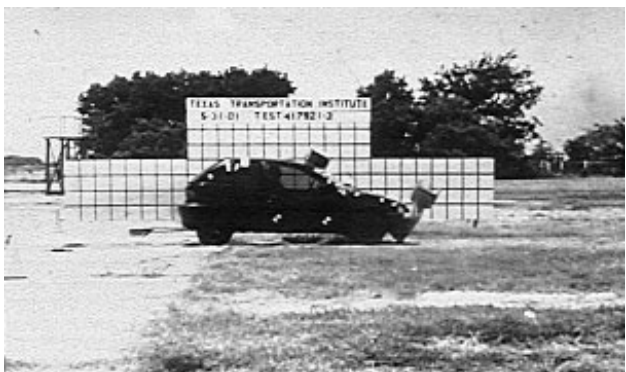
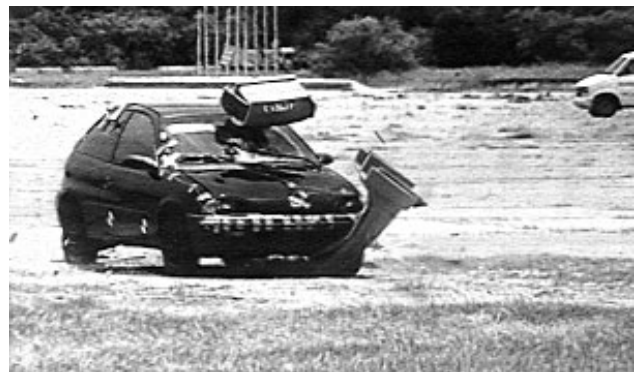
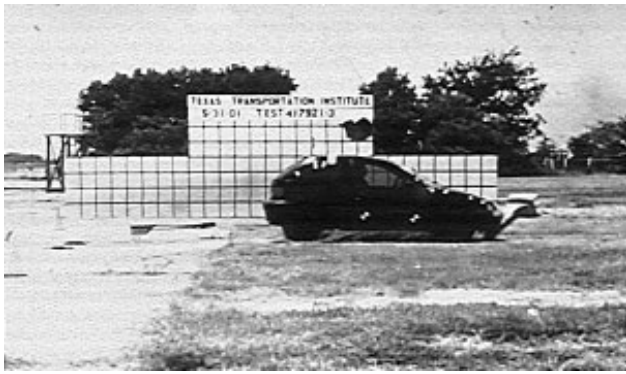
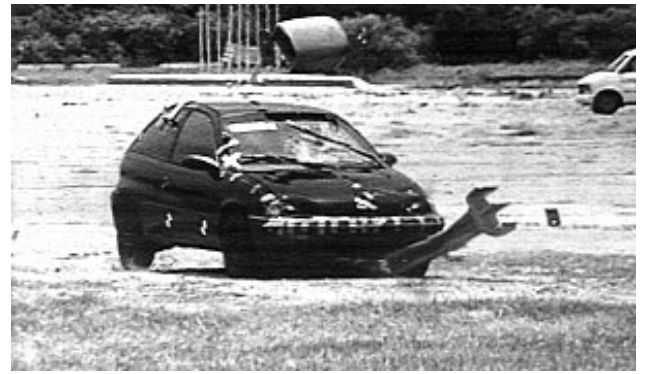
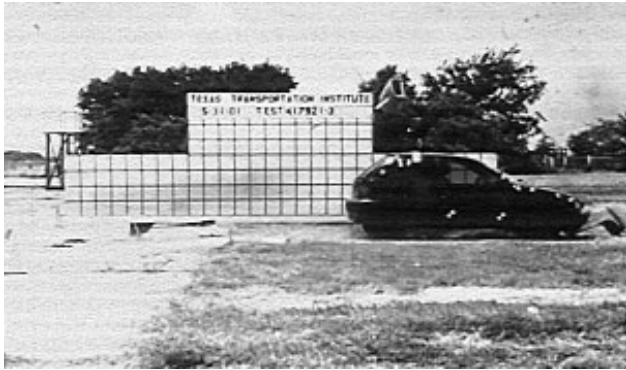
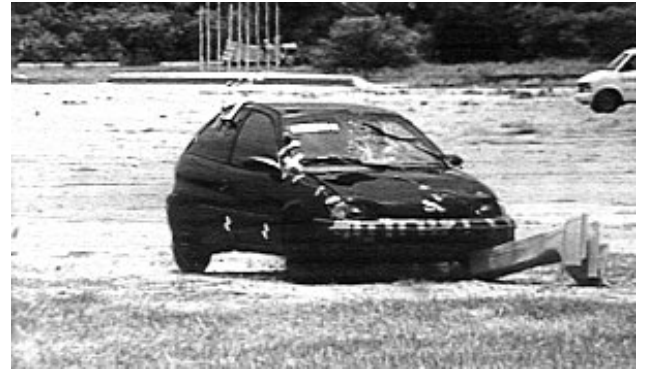
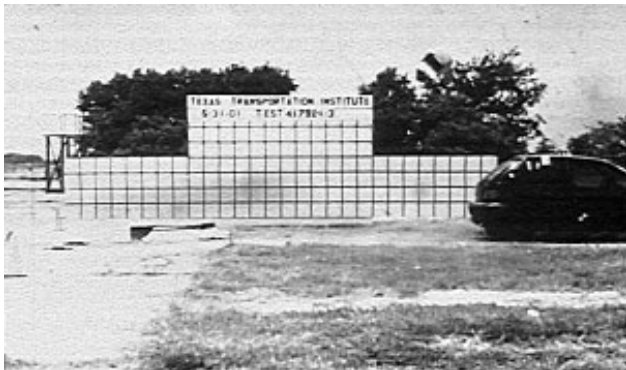
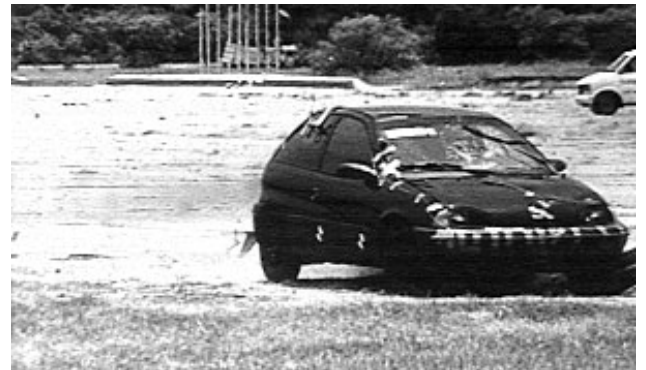
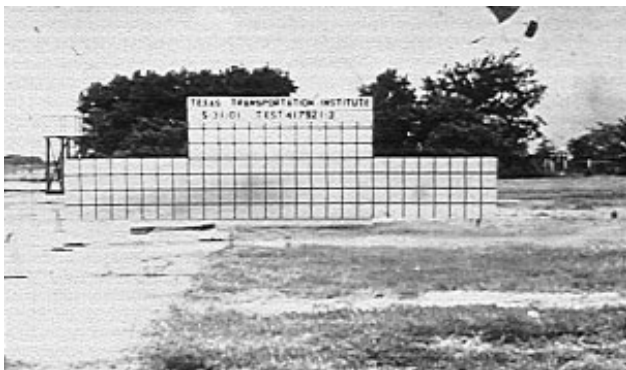
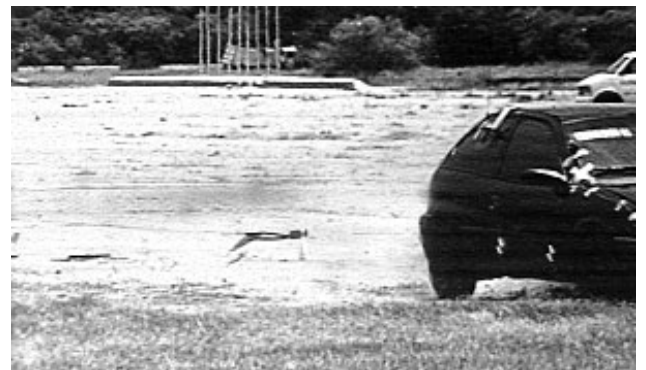
**Figure 31. Sequential Photographs for Test 417921-3  
(Perpendicular and Oblique Views).**

The vehicle, traveling at 60.7 mi/h, impacted the MailMaster Deluxe mailbox on a 2 lb-ft U-channel support post at 0 degree with the vehicle left quarter point aligned with the centerline of the mailbox support. Shortly after impact, the mailbox began to deflect, and at 0.017 s the upper section of the mailbox separated from the lower base section. The U-channel fractured at ground level at 0.025 s with the lower molded plastic base section attached. The upper section of the mailbox contacted the hood at 0.030 s and then contacted the windshield at 0.040 s. At 0.089 s the vehicle lost contact with the upper section of the mailbox, and at 0.149 s the vehicle lost contact with the U-channel support post. Speed of the vehicle at loss of contact was 59.0 mi/h. Brakes on the vehicle were remotely applied 1.8 s after impact. The vehicle traveled on a straight path through the test site and subsequently came to rest 272.5 ft downstream of the point of impact. Sequential photographs of the test period are shown in [Appendix C, Figure 31](#).
