**FIELD PERFORMANCE OF MAINTENANCE TREATMENTS
CONSTRUCTED WITH RECLAIMED ASPHALT PAVEMENT (RAP)**

Research Report 187-24
Research Study Number 0-187, Task 13
Research Study Title: Monitoring Reclaimed Asphalt Pavement
Test Sections (Follow-up to Research Study 1272)

November 1994

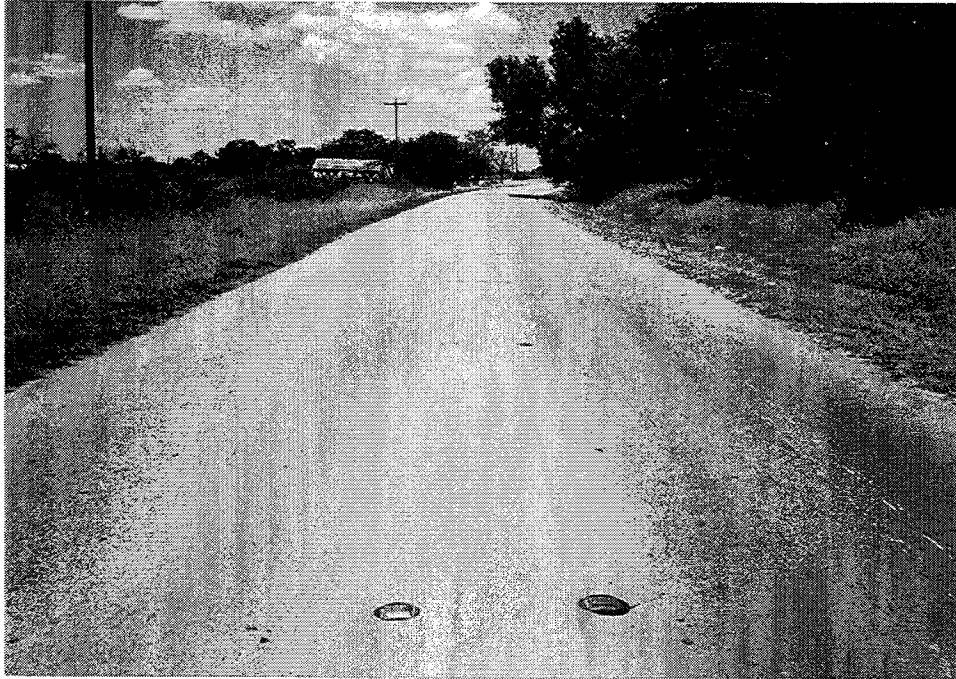
Figure 11. Cleburne Test Section 1: HMCL.

This section served as a control material and was constructed using 100% HMCL. It performed very well throughout the study and showed no signs of any distress. This test section performed better than any of the other four in this Cleburne experiment. A photo of this section is shown in Figure 11.

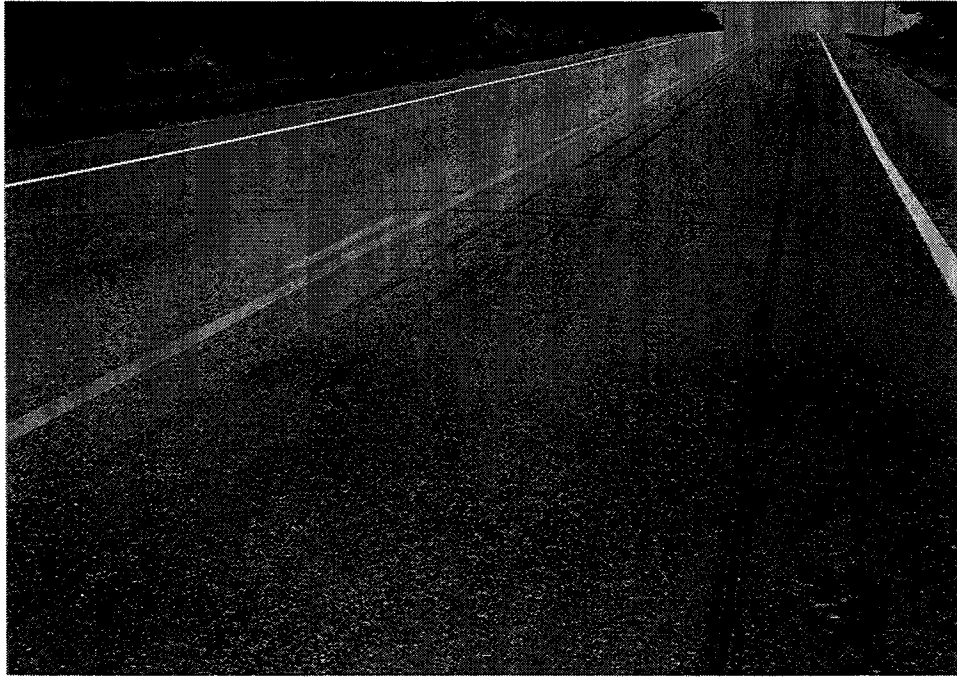
Figure 18. Pleasanton Test Section 2: HMCL.

Test section 2 was built as a control section and was constructed of 100% HMCL. It performed very well throughout the study and showed no signs of distress. See Figure 18.

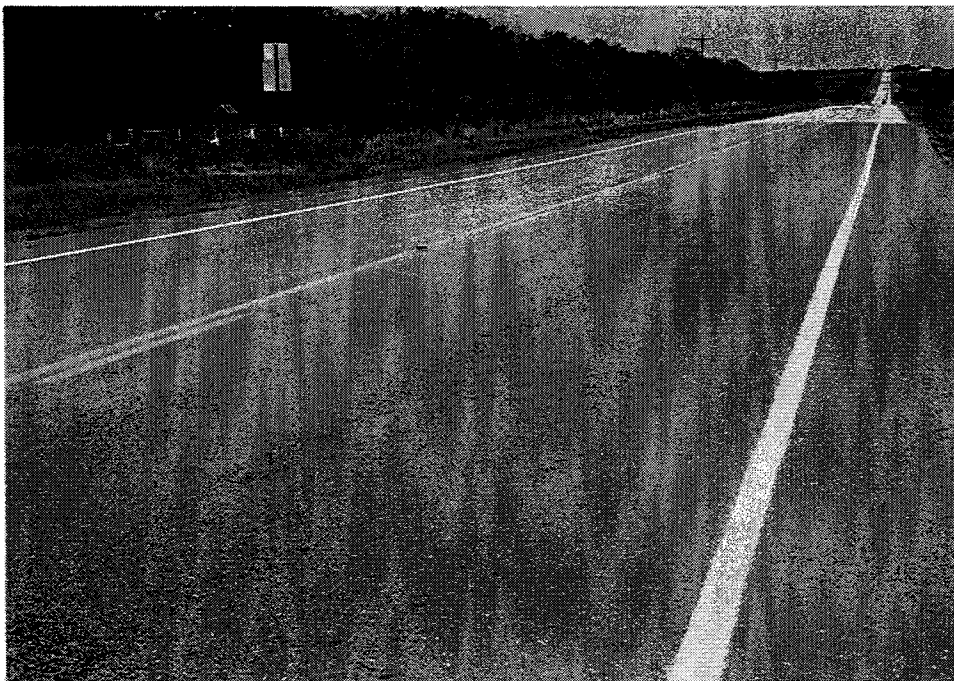
Figure 21. Pleasanton Test Section 5: HMCL/Treated RAP.

This section was constructed as a 50/50 blend of HMCL and treated RAP. This section performed very well with only minor signs of ravelling. See Figure 21.

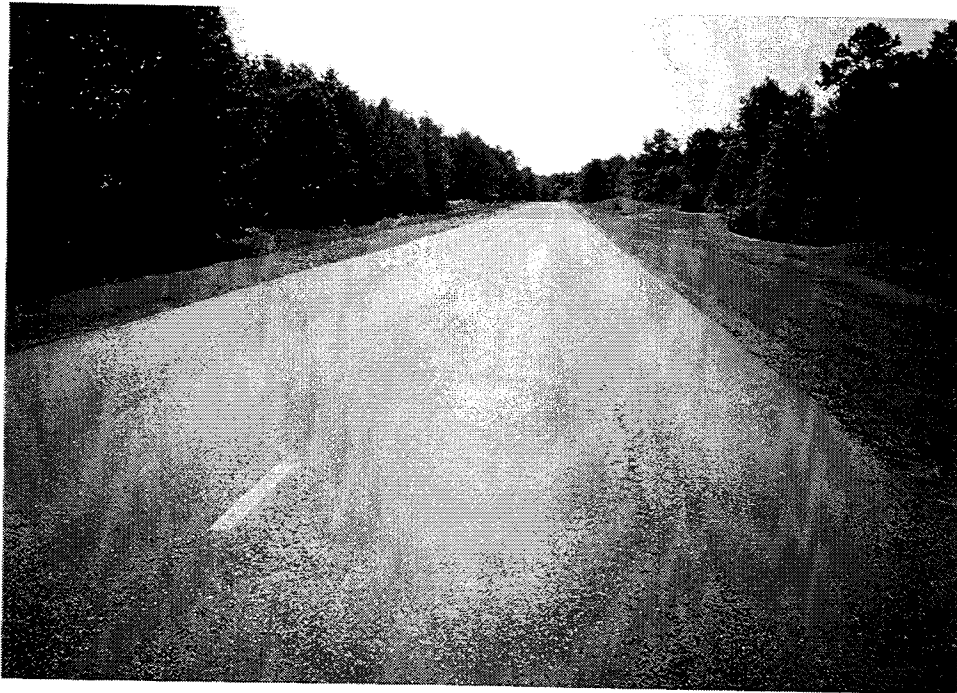
Figure 24. Kilgore Test Section 2: HMCL.

Test section 2 was constructed as a control using HMCL. This test section performed well except for some flushing in the wheelpaths of the eastbound lane as shown below in Figure 24.

In summary, the treated RAP test section performed poorly as might have been predicted by the extremely low Hveem stability laboratory values. The poor performance is attributed to excess binder added to the RAP. The HMCL test section performed acceptably despite some minor flushing.
