IMPROVED END TREATMENT
FOR METAL BEAM GUARDRAIL

Research Report 189-1(Final)

Research Study No. 2-10-76-189
Development of Effective Highway Safety Appurtenances

Texas Transportation Institute
Texas A&M University
College Station, Texas

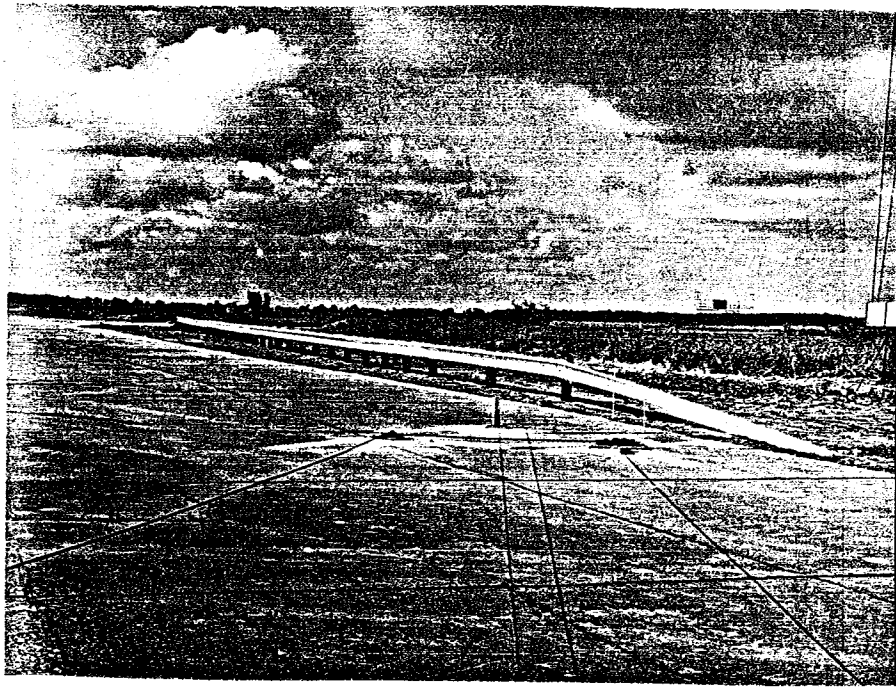
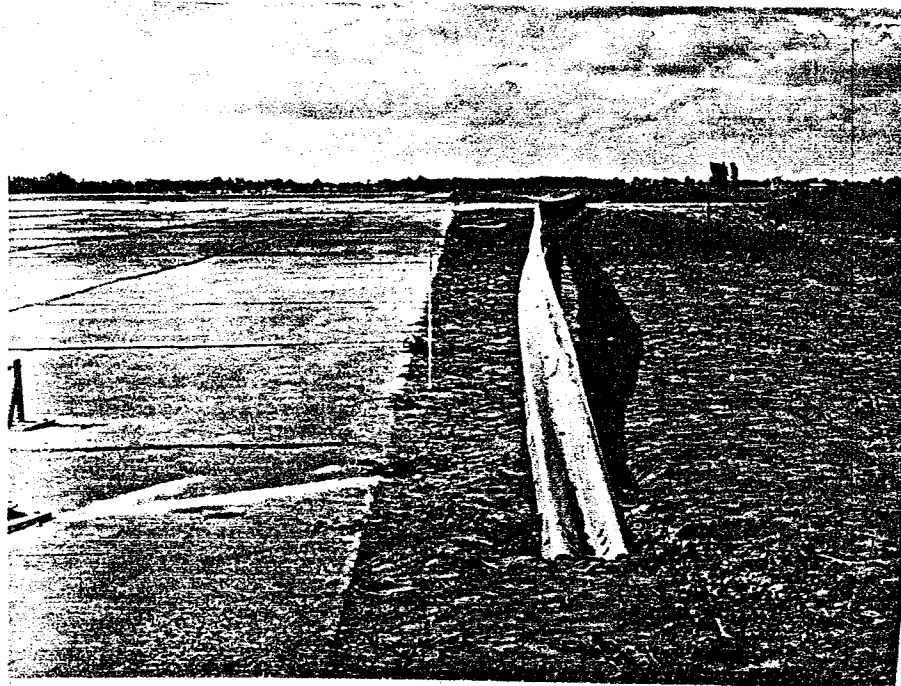
FIGURE 5. GUARDRAIL TEST SITE PRIOR TO TEST 1.

The guardrail installation evaluated in this test was a variation of the final proposed modified design described in the previous section. In this installation, posts number 2 and 4 (Figure 3) were omitted. Backup plates, 6 in. long in this installation, were used on posts number 1, 3, 5, 6 and 7. The remainder of the rail was installed in accordance with the standard drawings in Figure 1. This installation is shown in Figure 5.

In this test, a 2280 lb Vega (1971) impacted the turned down terminal section of the guardrail at 17.5 degrees and 63.2 mph (101.7 km/hr). The impact point was midway between the end anchor and beginning of length-of-need. Upon impact, the right front wheel of the test vehicle mounted the turned down section. As the vehicle continued forward, the W-section disengaged the backup plates and was pushed down. The vehicle rode over the rail, impacted the first post breaking it near ground level and continued upright on its path for several hundred feet behind the rail.

Right front bumper and wheel will engage terminal
midway between first post and terminal anchor.

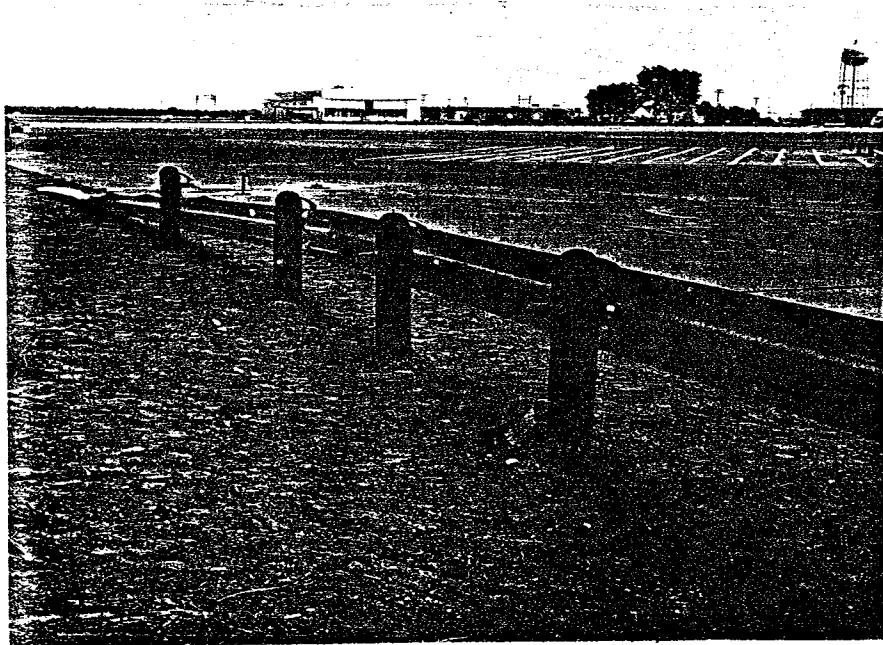
FIGURE 8. GUARDRAIL TEST SITE AFTER TEST 1.

After crossing the rail, the vehicle was airborne for a short distance then exhibited oscillatory roll displacement (see Appendix A). The maximum roll displacement was about 29 degrees. The vehicle did not roll over, and performance of the terminal and vehicle were considered good. The critical roll angle of such a Vega is about 53.4 degrees before rollover is possible. Results of this test are summarized in Table 1. Accelerometer traces obtained from vehicle mounted accelerometers and sequential photographs are presented in the Appendices. The TAD (1) vehicle damage classification was FC-2 (Figure 6). Photographs of the rail after the test are shown in Figures 7 and 8. One post and two 25 ft. pieces of W-section had to be replaced to repair the guardrail.

Posts shown are numbers 3, 5, 6, and 7. Post no. 1 was knocked out by vehicle.

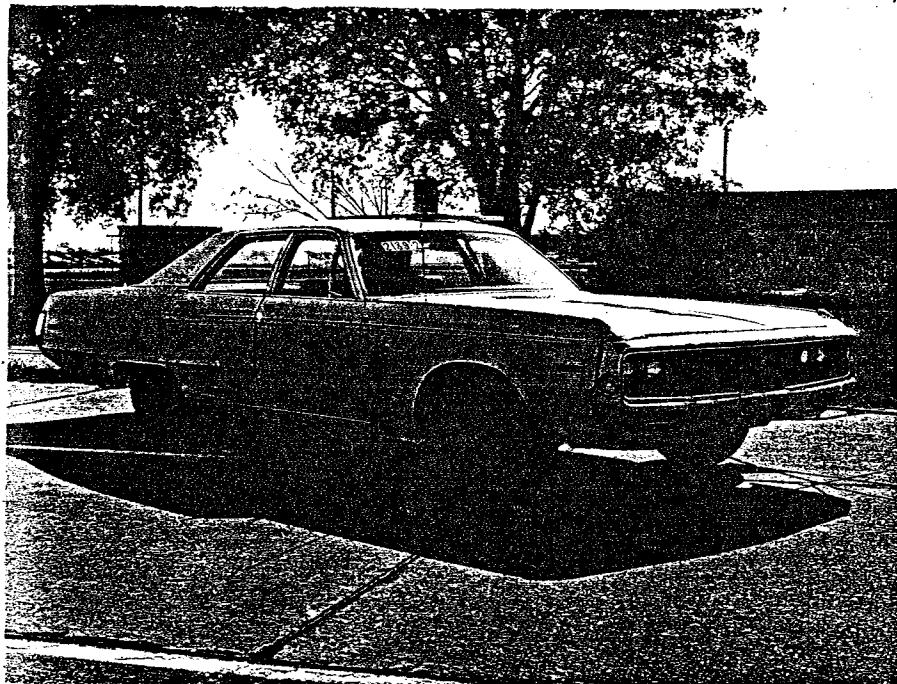
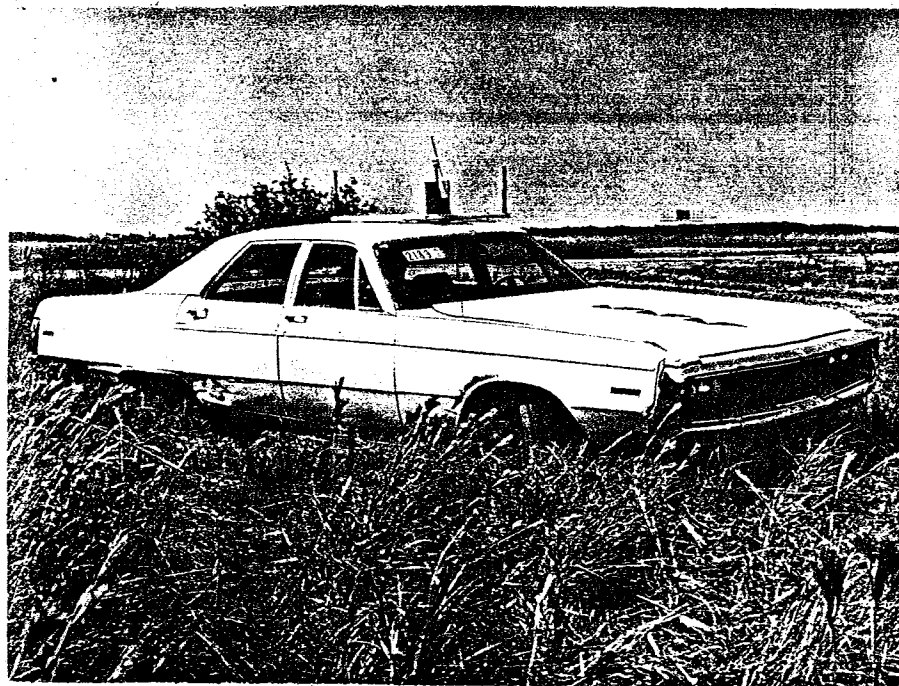
FIGURE 11. TEST VEHICLE BEFORE AND AFTER TEST 2 A.

of approximately 45 degrees. The critical roll angle for such a heavy car is about 60 degrees. The vehicle did not roll over, and performance was considered acceptable because the actual impact point was a foot upstream of the beginning of length-of-need. With this location of the impact point which was on the terminal, redirection is not a necessary requirement. Damage to the rail is shown in Figures 12 and 13. The first post was displaced laterally. The second post was displaced and fractured. It was necessary to replace two posts and two pieces of the W-section to repair the rail. Before and after test photographs of the test vehicle are shown in Figure 11.

The original objective of Test 2A was to impact the rail along the "length-of-need" and obtain a redirection of the vehicle. The vehicle, however, pushed down the rail and rode over it without rollover. This happened for several apparent reasons: (1) the vehicle's right front bumper actually impacted the rail 1 ft. upstream of post no. 1 on the terminal and not on the "length-of-need", and (2) the rail was only 24 in. high at post no. 1 as a result of repairs after Test 1 (see Figure 10), consequently the Chrysler bumper got on top of the terminal and pushed it down. Several modifications were made in the installation and in the conduct of Test 2B to eliminate these shortcomings. Test 2A was still considered a success in that the vehicle struck the terminal, pushed it down, and rode over it without experiencing rollover.

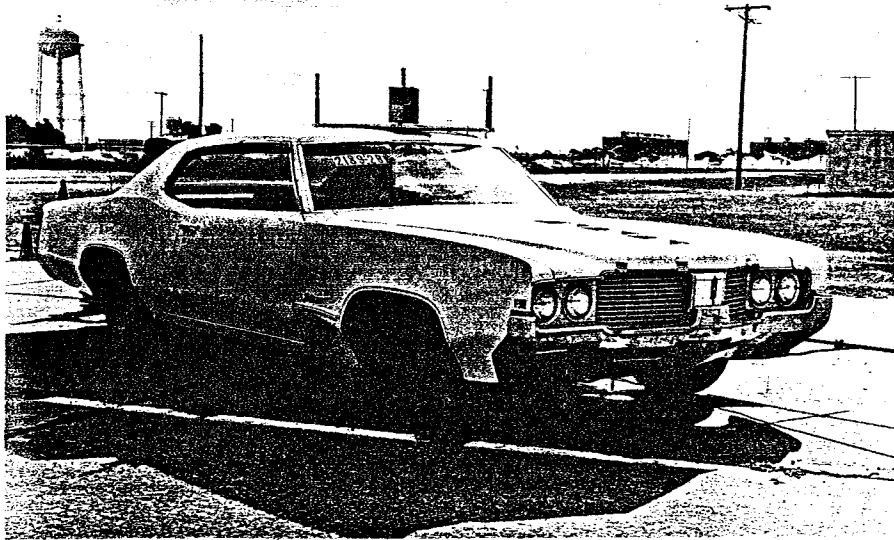
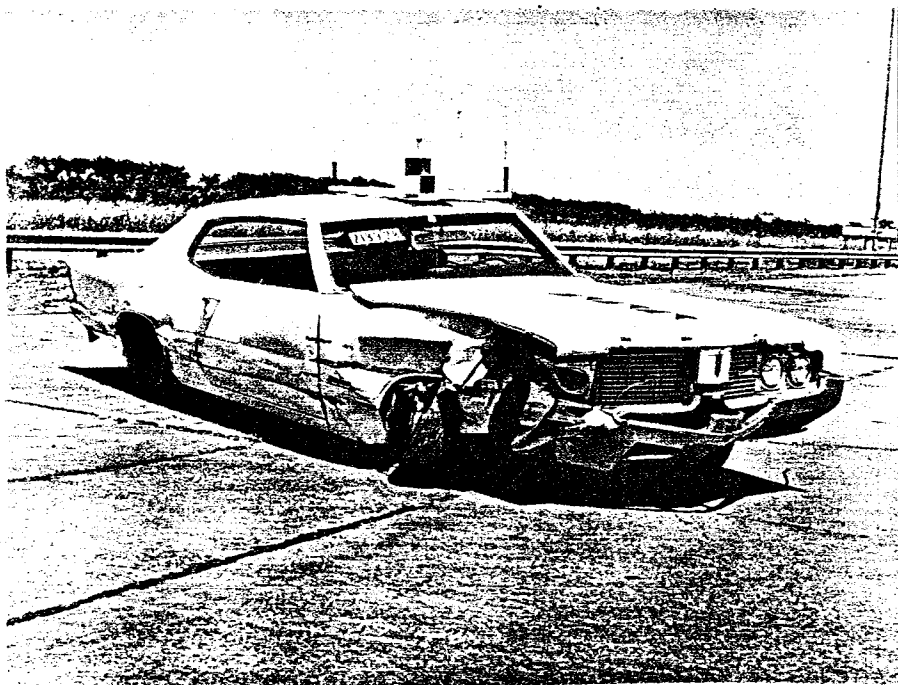
FIGURE 16. TEST VEHICLE BEFORE AND AFTER TEST 2B.

guardrail with another impact approximately 200 ft. downstream. During redirection, some interaction between the vehicle front wheel and the guardrail posts did occur but no snagging effect was evident. Damage to the vehicle (TAD classification, RFQ 5) is shown in Figure 16. Photographs of the guardrail after the test are shown in Figure 17. As evidenced by this figure, the rail remained nested in the backup plates and at the intended height. Post number 3 was broken off at ground level and posts number 2 and 4 were bent back considerably.

Repairs to the rail consisted of replacing one post and one 25 ft. section of flexbeam rail. This test at the beginning of length-of-need was considered very successful.

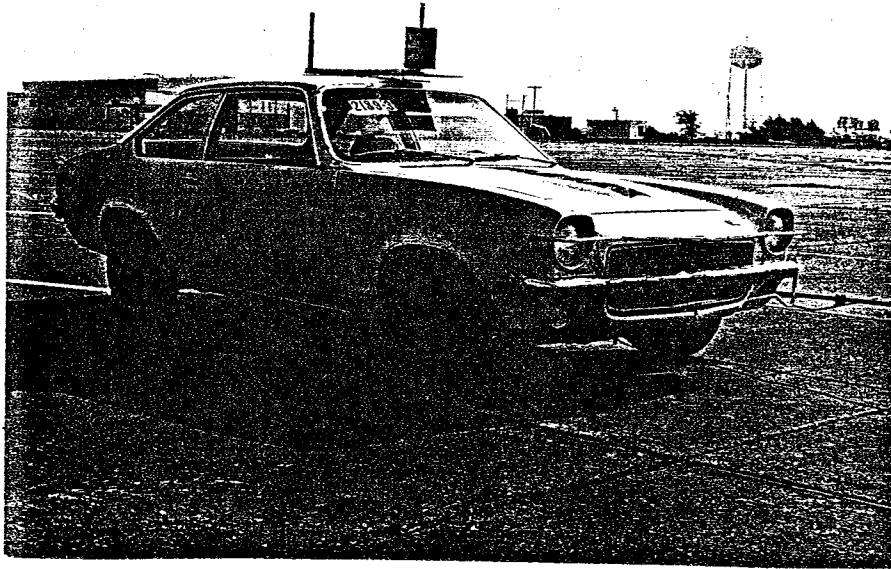
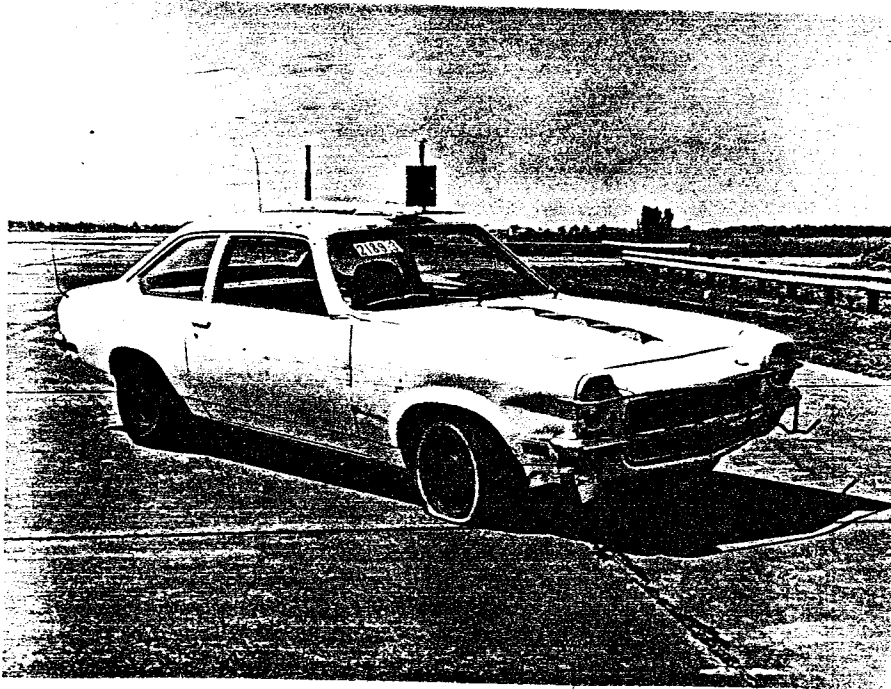
FIGURE 20. TEST VEHICLE BEFORE AND AFTER TEST 3.

Performance of the rail in this test was very good. The maximum .050 sec average longitudinal deceleration was less than 2.0 g's and all peak values were less than 5.0 g's. The TAD vehicle damage classification was RF-1 (Figure 20). Damage to the rail is shown in Figure 21. Repair of the rail necessitated replacement of one post and one backup plate.

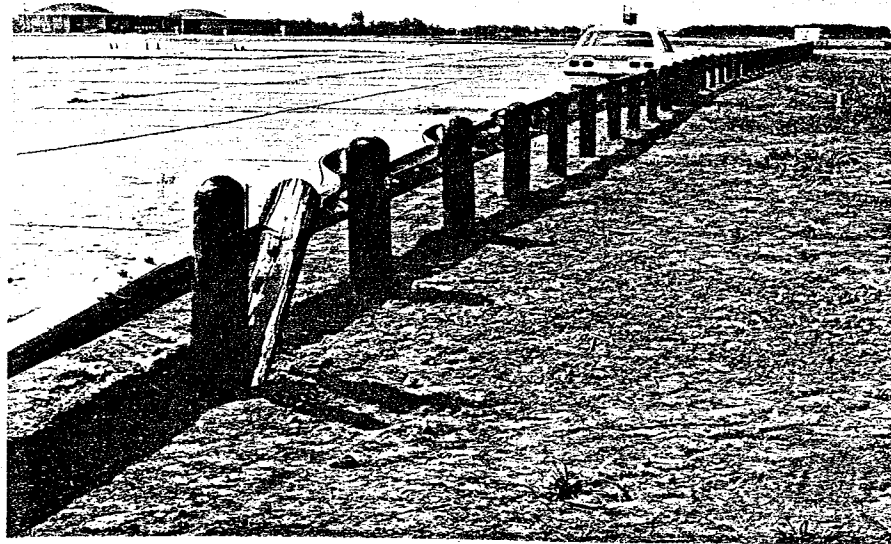
FIGURE 21. GUARDRAIL TEST SITE AFTER TEST 3.

Note that when the rail was depressed it rotated away from the posts and off the backup plates.

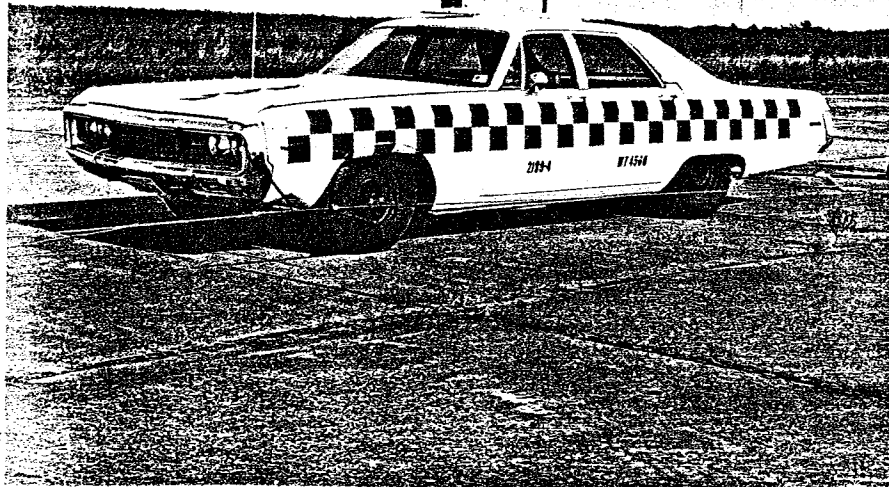
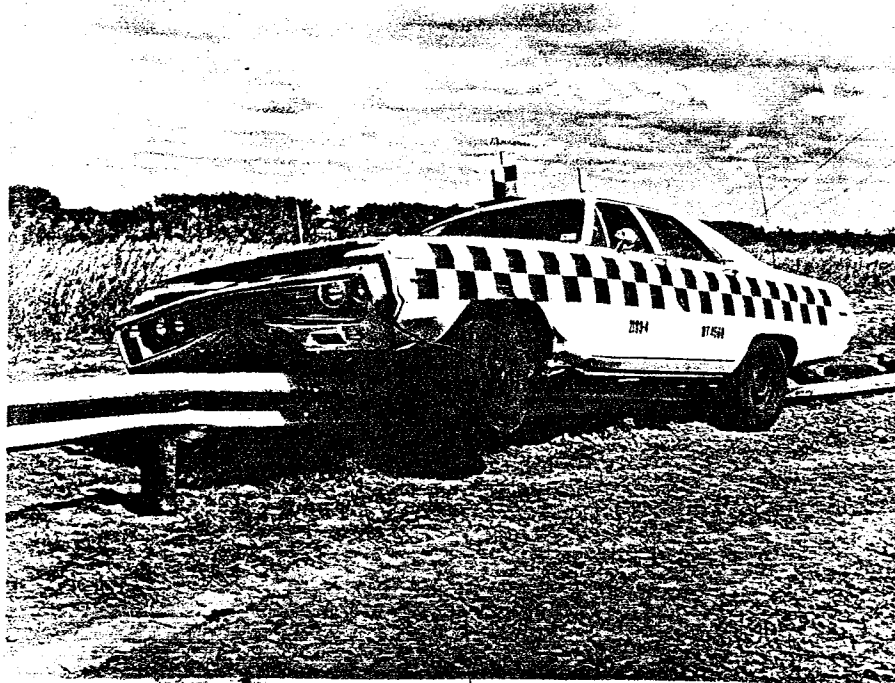
FIGURE 24. TEST VEHICLE BEFORE AND AFTER TEST 4.

the end anchor (Figure 23). Twenty-six posts were split, broken, or bent over by the vehicle. The average longitudinal deceleration was 0.54 g's over the stopping distance. The maximum .050 sec average longitudinal deceleration was approximately 3 g's and peak values were all below 6 g's (see Appendix B). Extensive damage to the undercarriage of the vehicle occurred (Figure 24). Repair of the guardrail required replacing twenty-six posts and eight 25 ft. sections of rail.

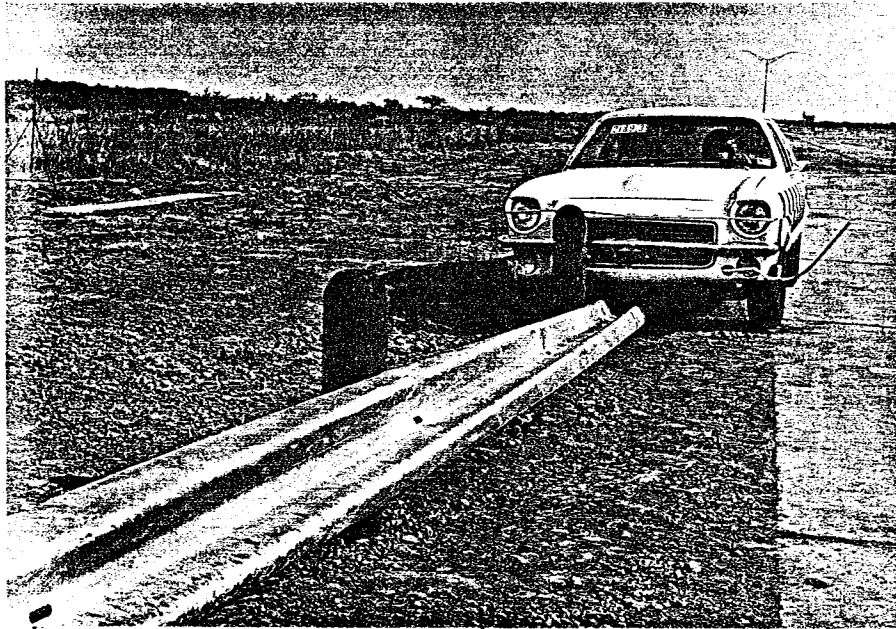
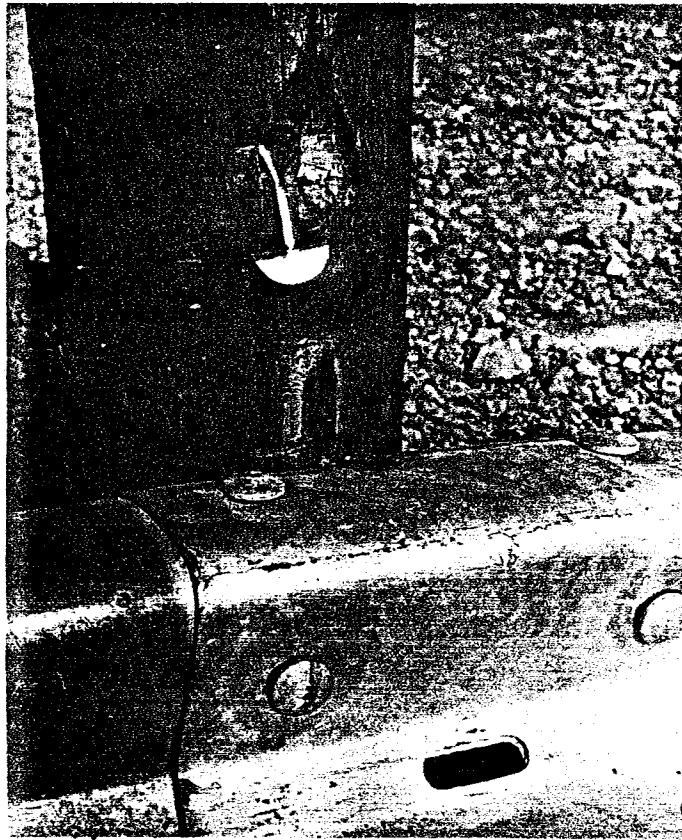
FIGURE 28. PHOTOGRAPHS OF DEPRESSED RAIL POSITION AFTER LOW-SPEED TRIAL TEST.

A small car (1971 Vega) was slowly driven onto the end of the rail to obtain some indication of the ease with which the terminal rail could be stripped off the bolt and washer and depressed. From this low speed trial, it appeared that performance in this respect might be satisfactory in a higher speed impact. (Figure 28)

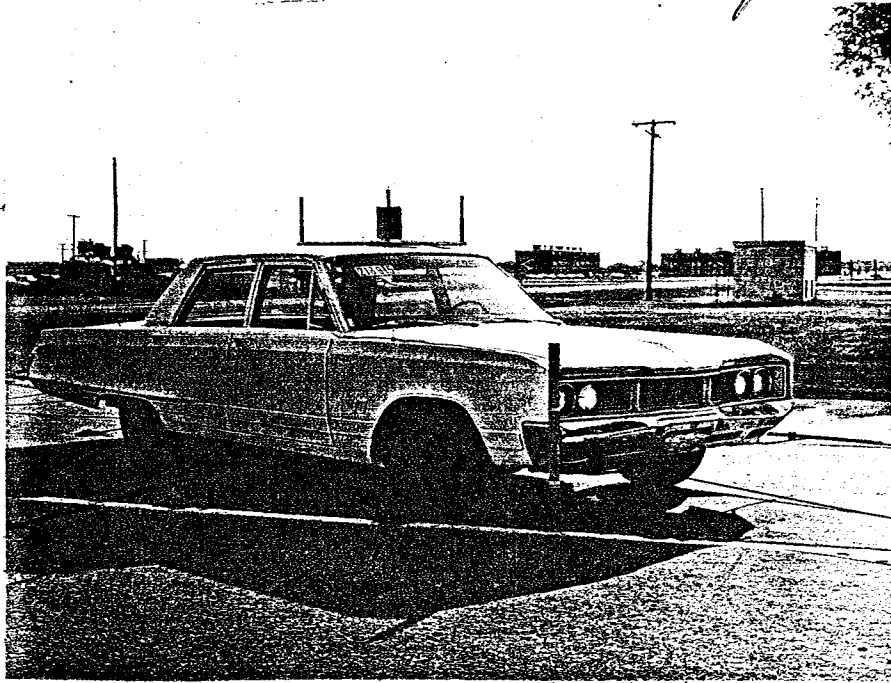
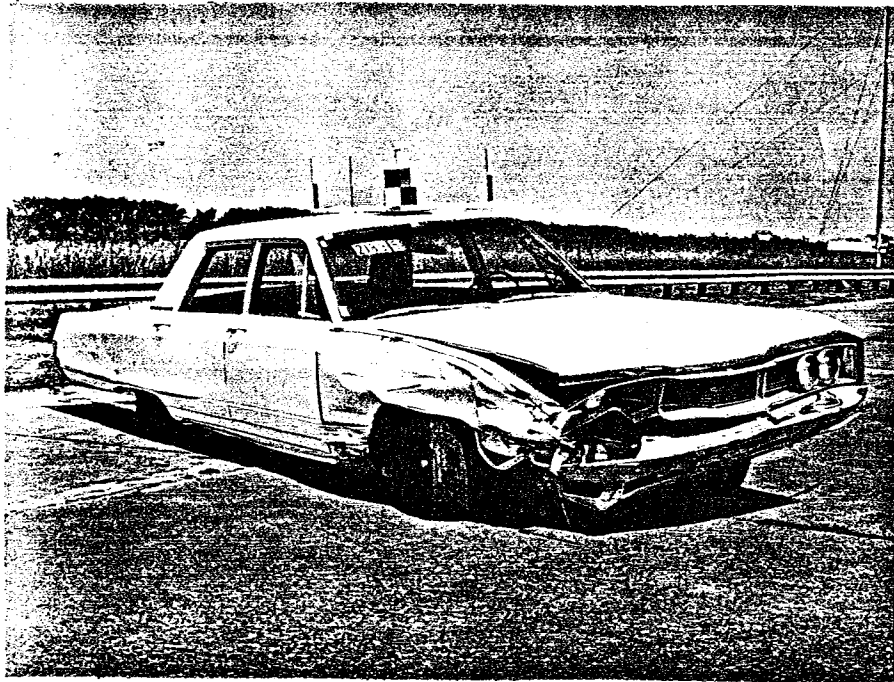
FIGURE 31. TEST VEHICLE BEFORE AND AFTER TEST 5.

Photographs showing the behavior of posts number 1 and 3 are given in Figure 30. Photographs of the test vehicle before and after the test are shown in Figure 31.

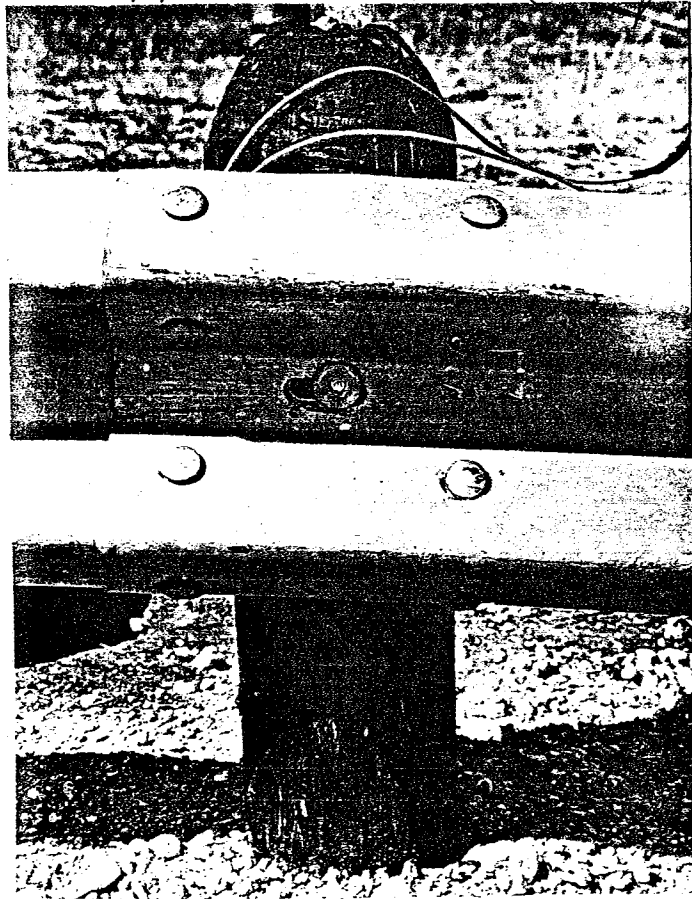
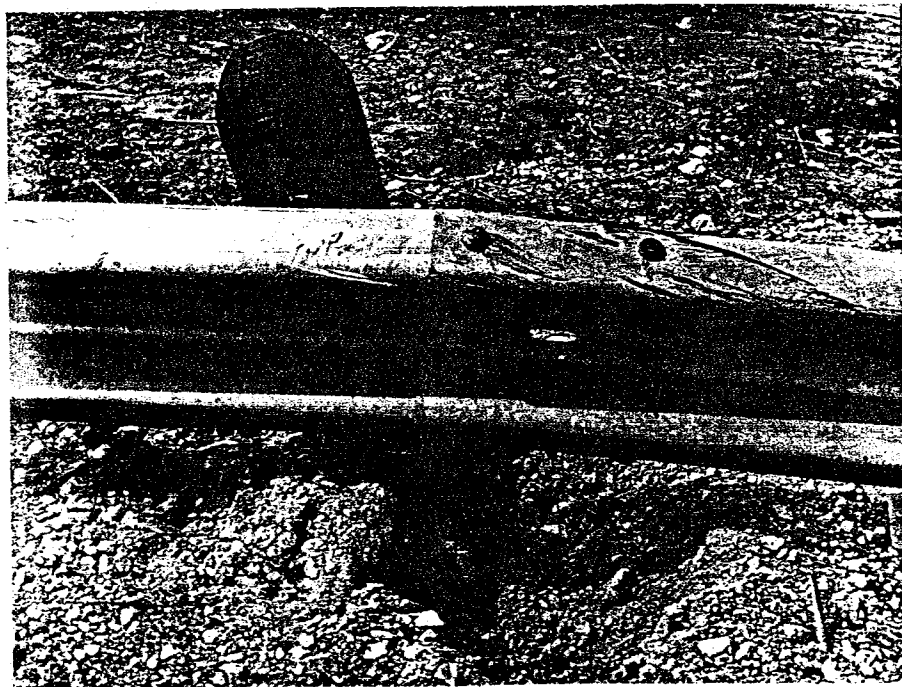
FIGURE 32. POST NO. 1 BEFORE AND AFTER TEST 6.

Test 6 was conducted on essentially the same modified terminal and rail as in Test 5 except althread bolts $\frac{3}{16}$ in. in diameter were used on the first five posts (see Figure 32). The first two post spaces at the beginning of length-of-need were 12 ft. 6 in. and all others were at 6 ft. 3 in. as shown in Figures 33 and 34.

Immediately after initial impact, the rail did not drop quickly to the ground as intended and this caused the vehicle to vault several feet into the air. While the vehicle ended up right side up, its maximum roll angle during the collision event was 76° . The critical roll angle of such a vehicle would be about 60° , however because of complex dynamic behavior, the vehicle did right itself after the 76° maximum roll angle.

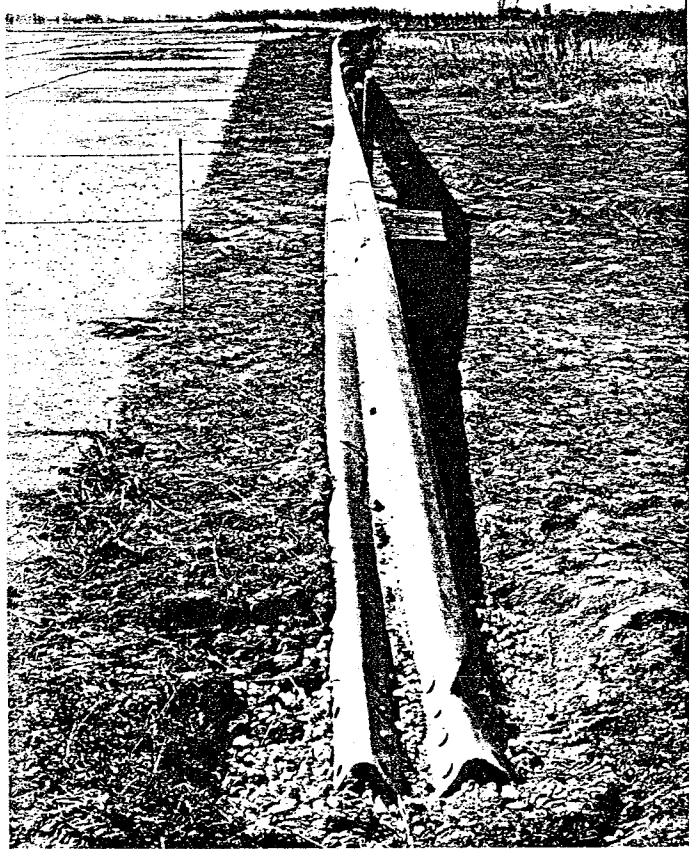
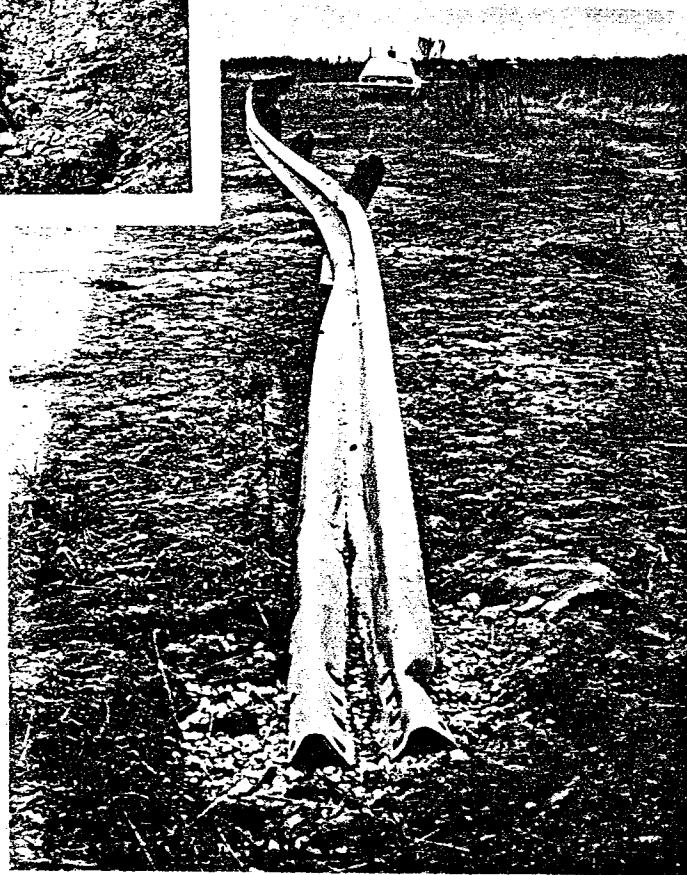
FIGURE 34. TURNED-DOWN END GUARDRAIL
BEFORE AND AFTER TEST 6.

Damage to the vehicle is shown by Figure 35. Damage to the guardrail and terminal is shown by Figures 33 and 34.
