**TESTING AND EVALUATION OF  
WORK ZONE TRAFFIC CONTROL DEVICES**

Research Report 1917-1F

Texas Department of Transportation

Texas Transportation Institute  
Texas A&M University System  
College Station, Texas 77843

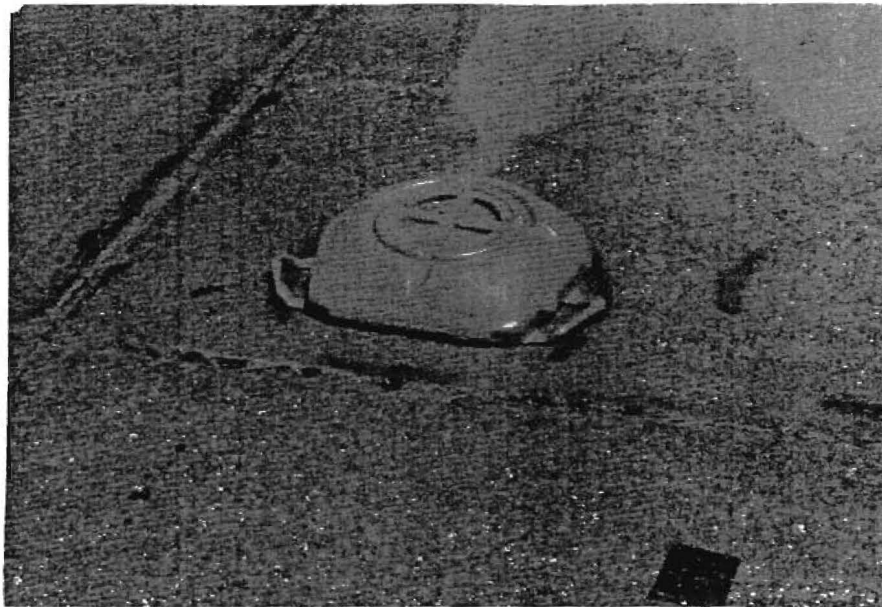
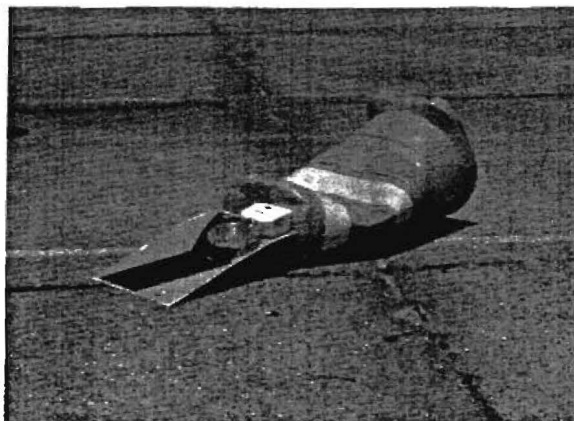
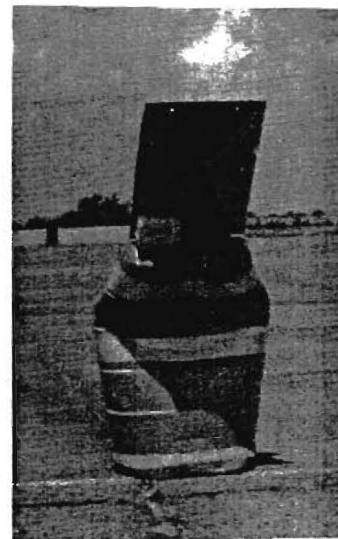
Figure 7. Damage to first device, test 1917-1

The base of the first device moved back 4 inches as shown in Figure 7, and the sandbag was found bursted 28 feet down and 10 inches to the left. The drum came to rest 150 feet down and 16 feet to the left of its original position. As shown in Figure 8, the second base moved back 2 inches and the sandbag was bursted 45 feet down and 10 inches to the left. The drum was found 158 feet down and 3 feet to the left of its original position. The third base moved back 2 inches (see Figure 9), and the sandbag was bursted 35 feet down and 18 inches to the right. The drum travelled down with the vehicle to its final rest. The base of the fourth device rotated slightly and moved back 10 inches as shown in Figure 10. The bursted sandbag was found 21 feet down and 12 inches to the right and the drum was 240 feet down and 15 feet to the left.

Base moved 4 in down

Drum 150 ft down, 16 ft left

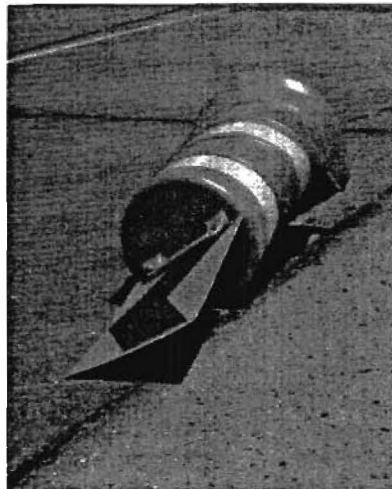
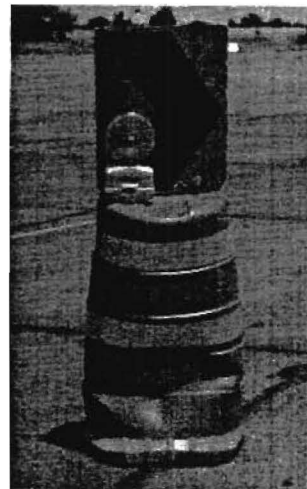
Figure 8. Damage to second device, test 1917-1

Base moved 2 in down

Drum 158 ft down, 3 ft left

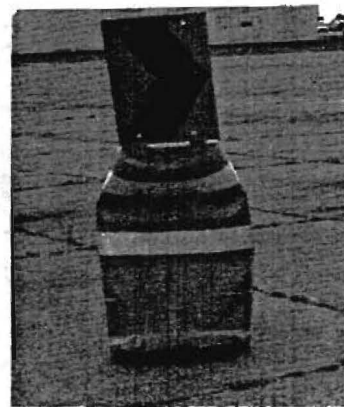
Figure 9. Damage to third device, test 1817-1

Base moved 2 in down

Drum stayed with vehicle

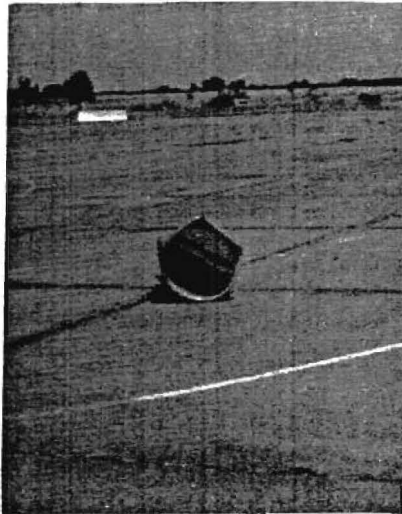
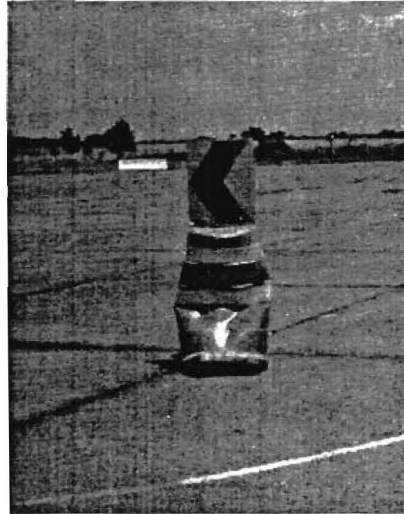
Figure 10. Damage to fourth device, test 1917-1

Base moved 10 in down, rotated slightly

Drum 240 ft down, 15 ft left

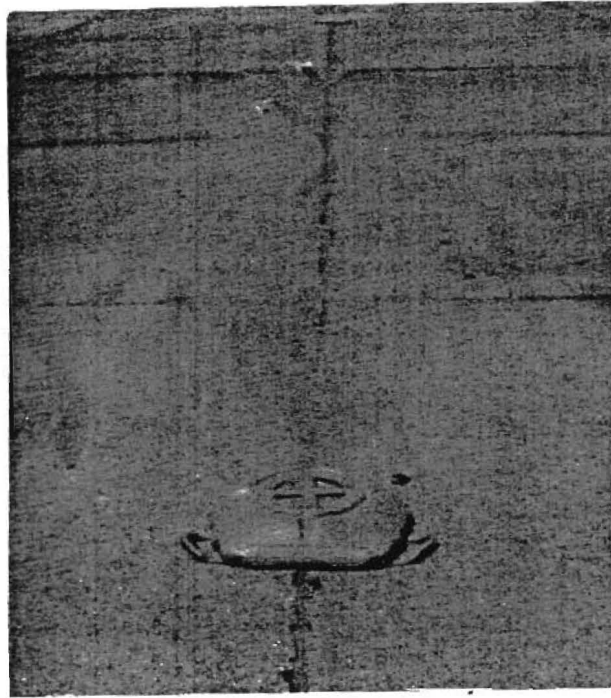
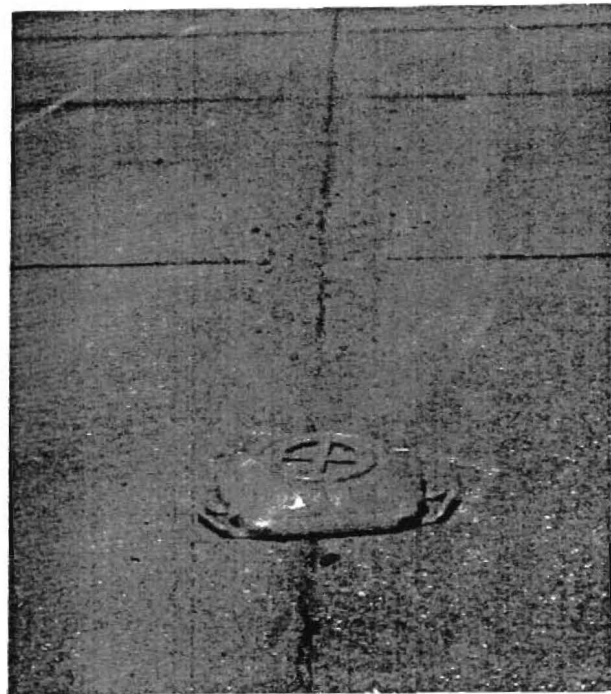
Figure 12. Base 1 and 2 after test 1917-2

The first base was not moved and the bursted sandbag was lying 32 feet from the base as shown in Figure 12. The drum was 173 feet down and 13 feet to the right of its original position. The second base was not moved either, but the sandbag was bursted and lying beside the third base (75 feet down). The second drum was 240 feet down and 13 feet to the right (shown in Figure 13). The third base moved 15 feet back and was on top of a sandbag. The drum was 65 feet down and 2 feet to the left of its original position. The positions of the base and drum after the test are shown in Figures 14 and 15. The fourth base did not move and as the drum snapped loose from the base, it threw the sandbag backwards

Base did not move

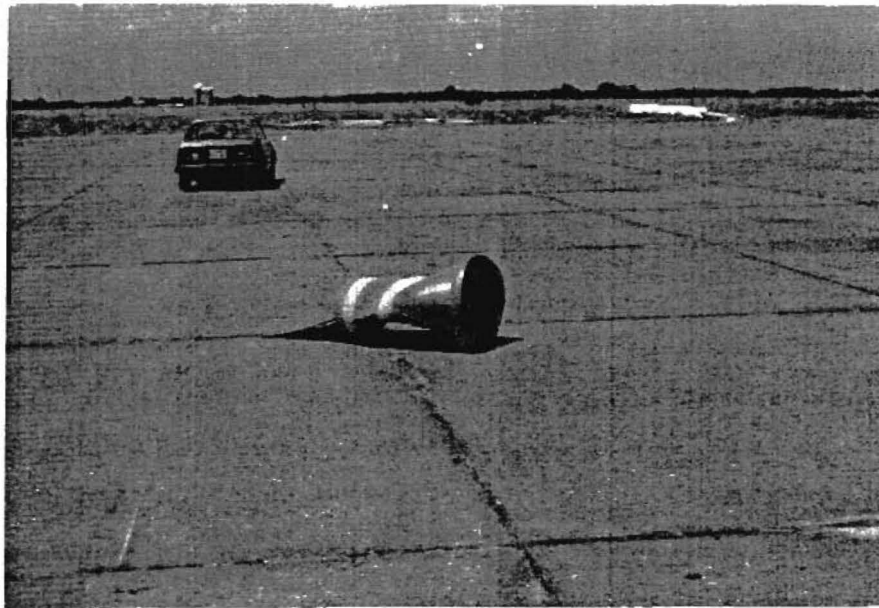
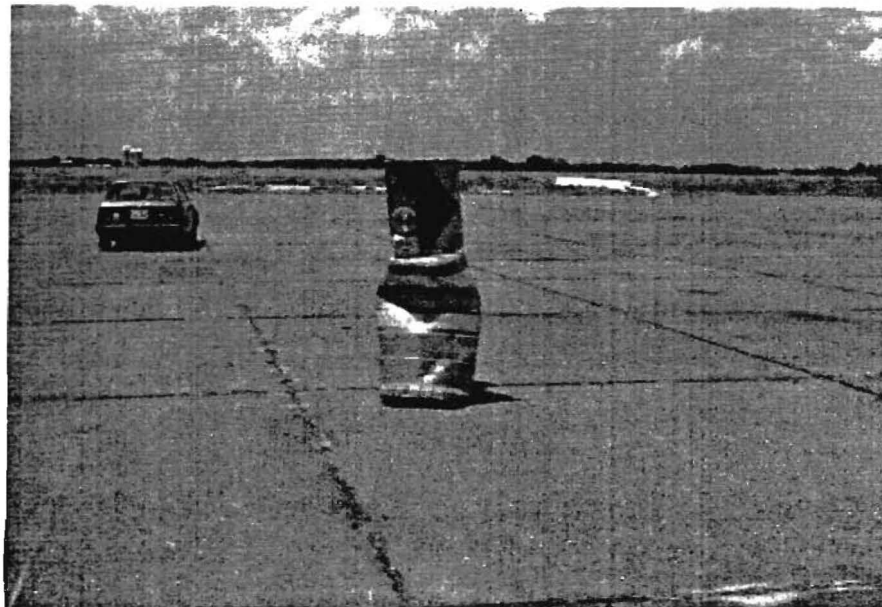
Figure 13. Second drum after test 1917-2

Drum 240 ft down, 13 ft right

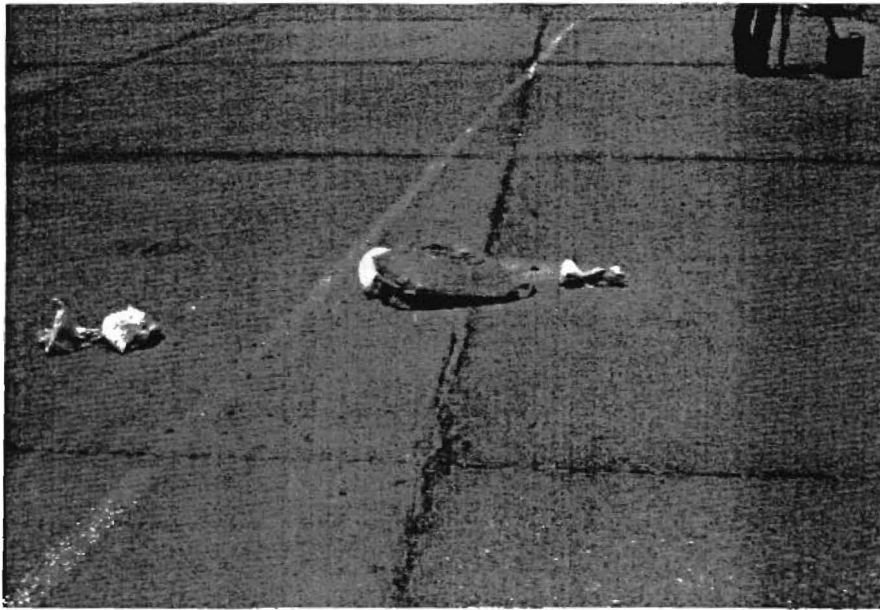
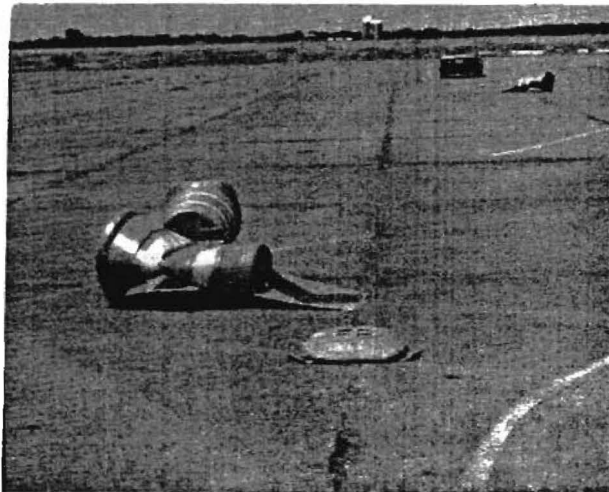
Figure 14. Base 3 and 4 after test 1917-2

Base moved down 15 ft

Base did not move

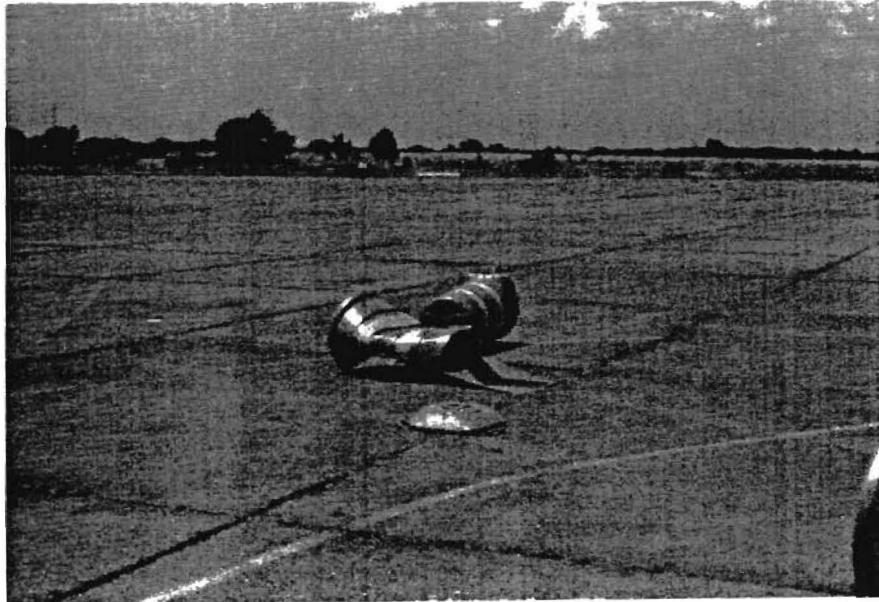
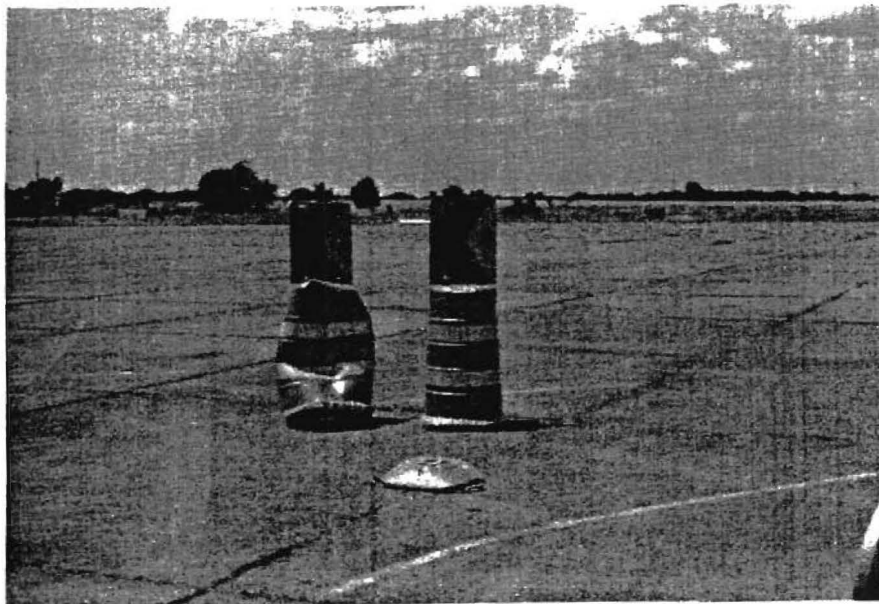
Figure 15. Third and fourth drums after test 1917-2

Drum #3 65 ft down, 2 ft left

Drum #4 8 ft down, 5 ft left

toward the third base where it bursted (see Figure 14). The drum landed next to the third drum, 8 feet down and 5 feet right of its original location (shown in Figure 15).

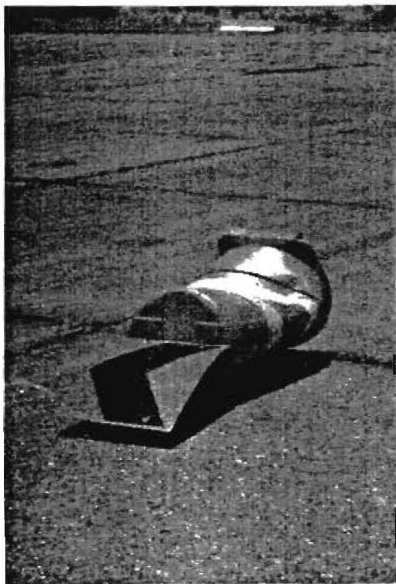
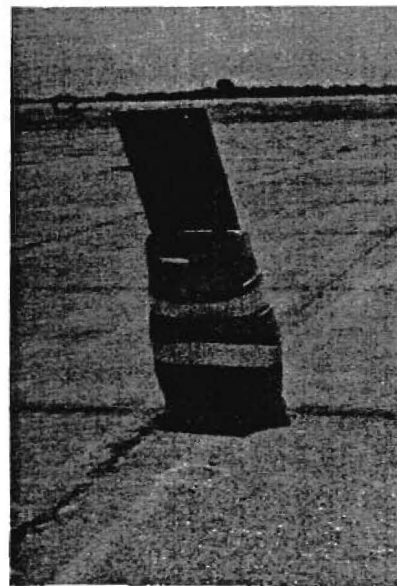
Figure 20. Damage to fourth device. test 1917-3

The fourth base was 11 feet down and 12 inches to the right and all three sandbags were bursted. One sandbag was lying 3 inches down and 12 inches to the left, another was 9 feet down and 12 inches to the left, and the last was 85 feet down and 2 feet to the right. The drum (shown in Figure 20) was found 120 feet down and 12 feet to the left of its original position.

Base moved 11 ft down, 1 ft right

Drum 120 ft down, 12 ft left

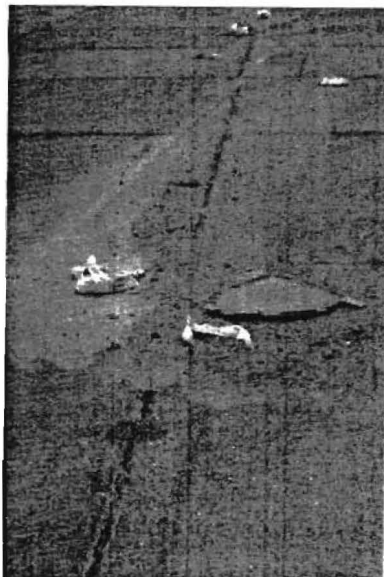
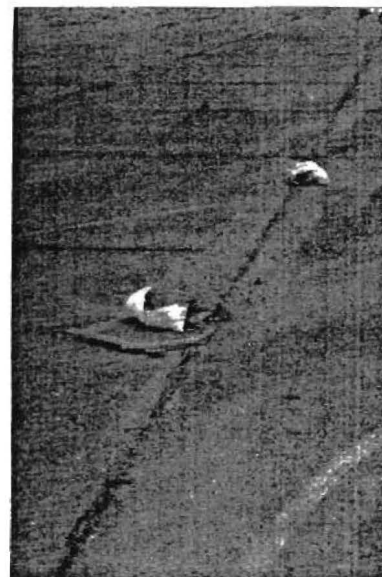
Figure 21. First, third and fourth bases after test 1917-4

The base of the first device was 6 feet back and 12 inches to the right. All three sandbags had bursted and one was found 4 feet down and 4 inches to the right, another was 5 feet down and 4 inches to the right, and the third was 60 feet down and 18 inches to the right. The drum travelled along the front of the vehicle. The base and drum are shown in Figures 21 and 22.

The third base (shown in Figure 21) was 6 feet back and 18 inches to the right. All three sandbags were split; the first was 3 feet down and 12 inches right, the second was 6 feet down and 12 inches left, and the third was 33 feet down and 3 feet right. The drum, shown in Figure 22, rode along the front of the vehicle.

The base of the fourth device was found 12 feet back and 12 inches to the left of its original position. One sandbag was 13 feet down and 12 inches left, another was 14 feet down and 10 inches left, the last was 29 feet down and 6 inches right, and all three were split. The drum stayed with the vehicle. The base and drum after the test are shown in Figures 21 and 22.

Base moved 6 ft down, 1 ft right

Base moved 6 ft down,  
18 in right

Base moved 12 ft down,  
1 ft left

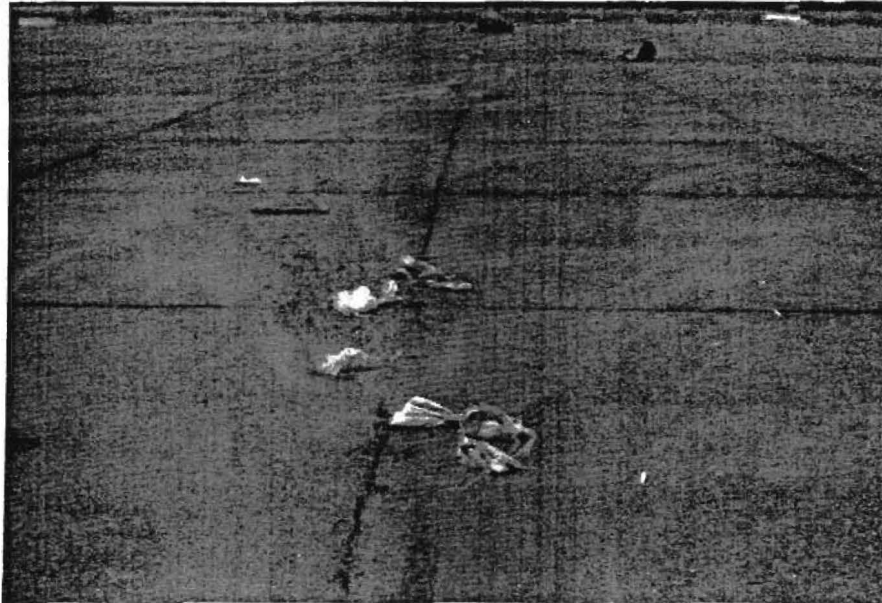
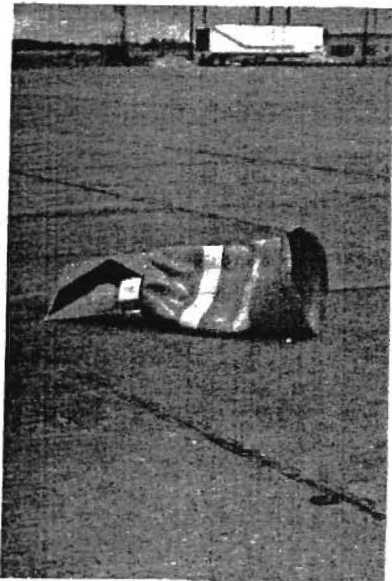
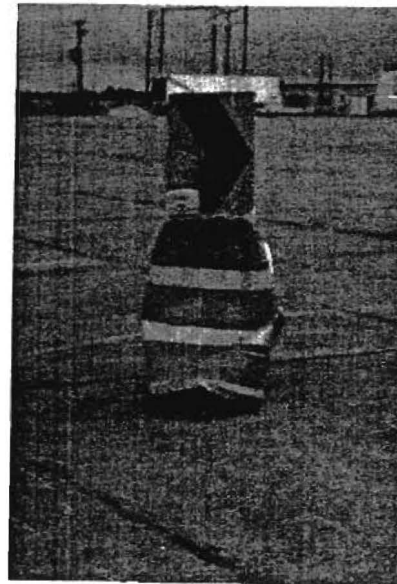
Figure 23. Damage to second device, test 1917-4

The second base was 18 feet down and 4 feet to the left, and all three sandbags were bursted as shown in Figure 23. One sandbag was lying 3 feet down and 10 inches to the left, a second was 8 feet down and 12 inches left, and the third was 11 feet down and 12 inches right. The drum was found 135 feet down and 18 feet to the right of its original location.

Base moved 18 ft down, 4 ft left

Drum 135 ft down, 18 ft right

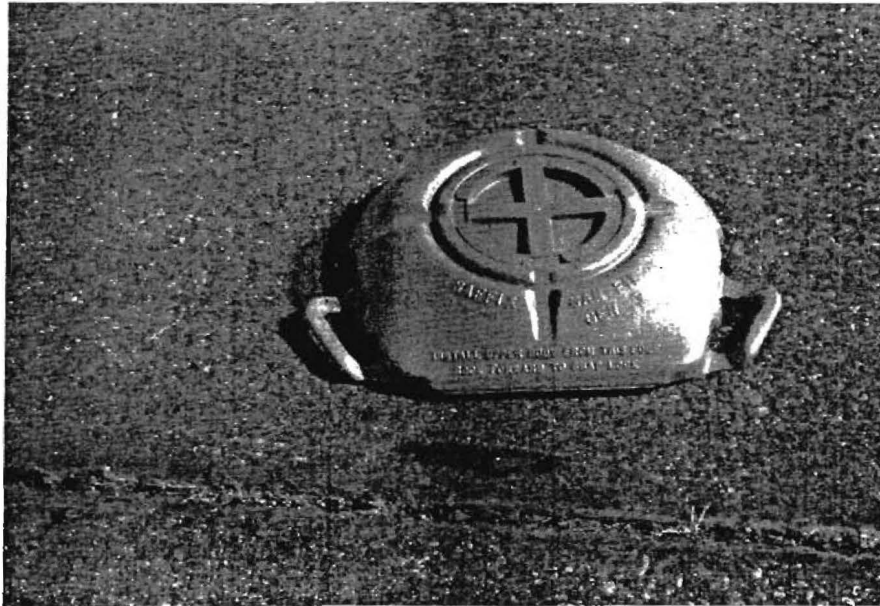
The vehicle contacted the device while travelling at a speed of 42.3 mi/h. The drum snapped loose from the base and flipped over to the right side of the vehicle but did not touch the vehicle. The San-fill base was not damaged and was moved back 4 inches and 2 inches to the left of its initial position. The drum landed 75 feet down and 8 feet to the right and was only dented and scraped slightly. The test site and damage to the device are shown in Figures 24 and 25. The vehicle was not damaged at all.

Base moved 4 in down, 2 in right

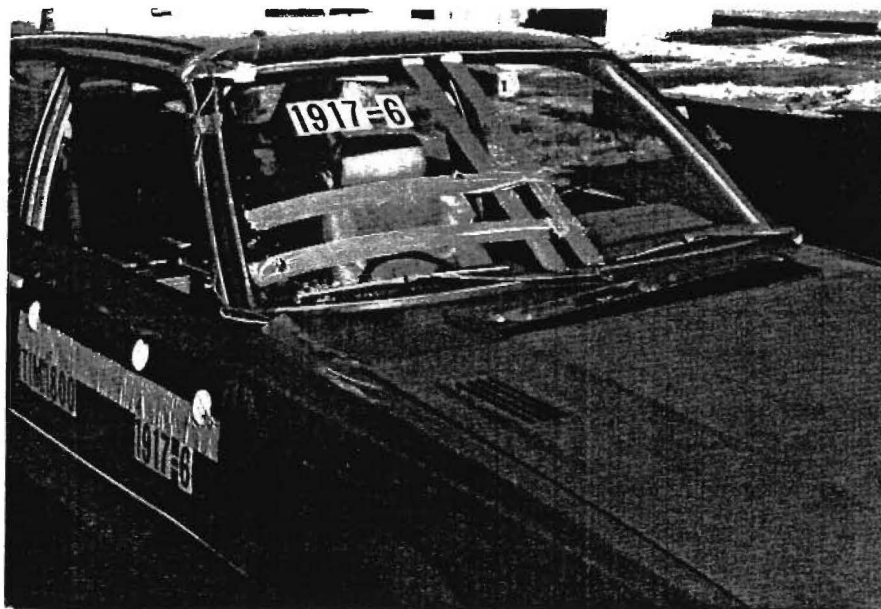
Figure 27. Vehicle after test 1917-6

The vehicle was travelling at a speed of 63.2 mi/h as it contacted the device. The drum snapped loose from the base and flipped hard to the right side of the vehicle. The chevron and light unit hit the lower right corner of the windshield and the hood, cracking the windshield and leaving a dent in the top of the hood as shown in Figure 27. The San-fill base was not damaged and was moved 18 inches back and 6 inches to the right of its original position (see Figure 28). The drum was dented and scraped slightly and was found 75 feet down and 14 feet to the right. The windshield of the vehicle had to be replaced and the hood repaired.

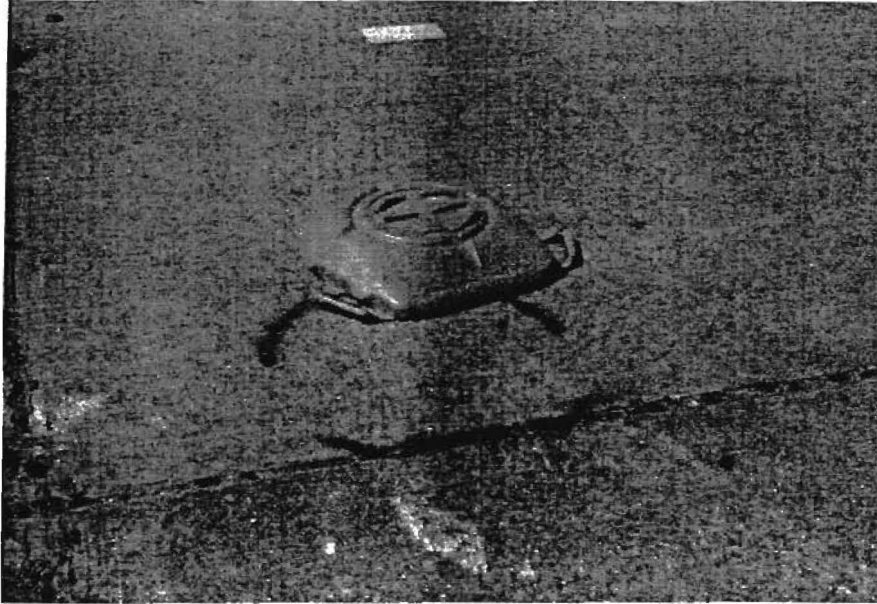
Figure 28. Damage to device, test 1917-6

Base moved 18 in down, 6 in right

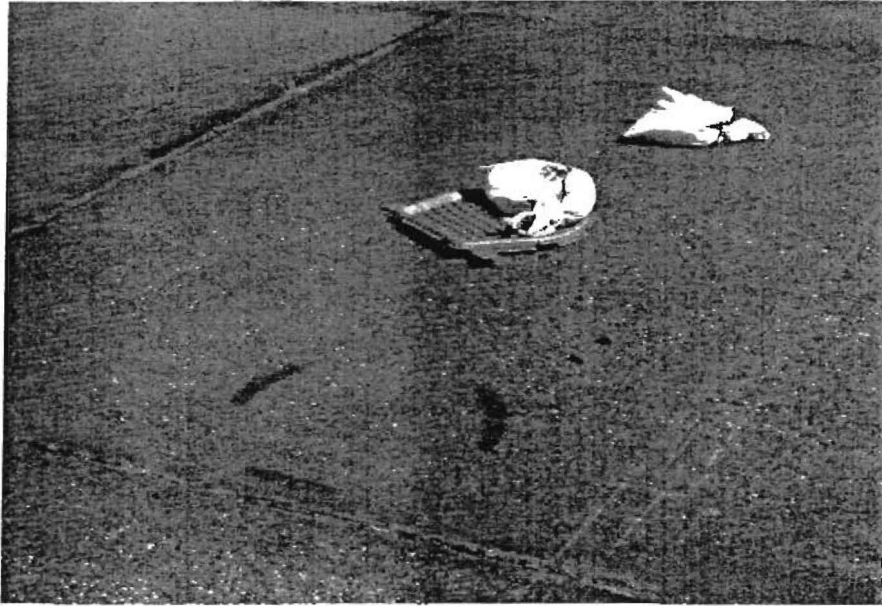
Figure 30. Damage to device, test 1917-7

other was 8 feet down. The drum was dented and scraped and was found 90 feet down and 3 feet to the right of its original position. The test site and device are shown in Figures 29 and 30. The chevron was slightly torn at one of the bolt connections. The vehicle was only scratched slightly on the right side.

Base moved 4 ft down, 6 in left

Drum 90 ft down, 3 ft right Chevron torn

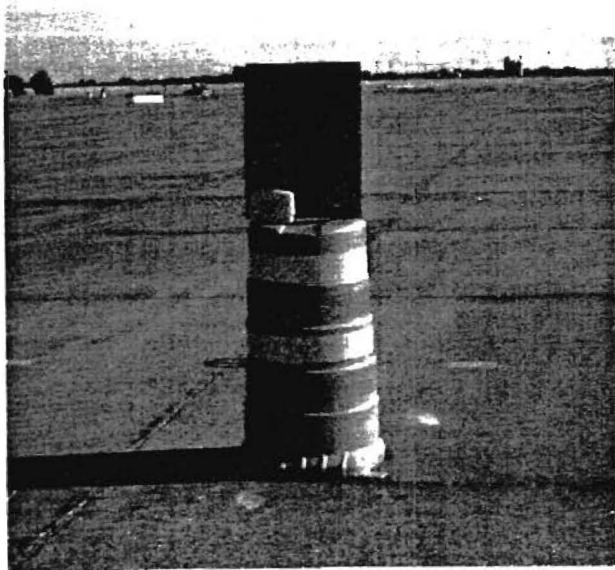
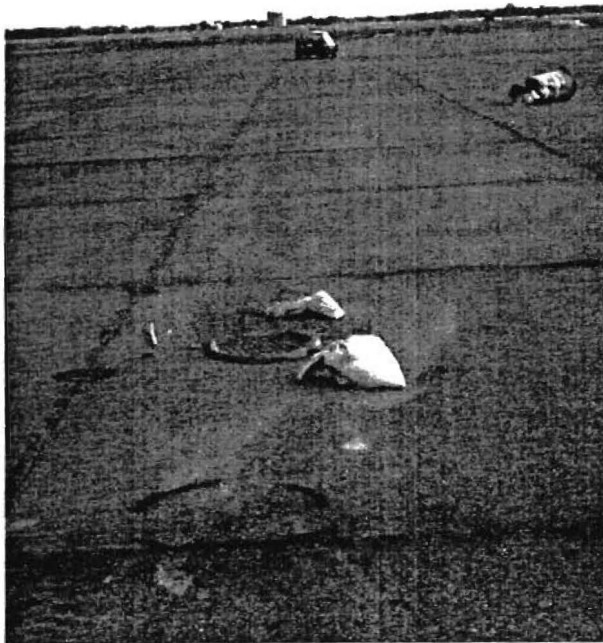
Figure 31. Test site before and after test 1917-8

As the vehicle impacted the device travelling at a speed of 62.0 mi/h, the plastic drum snapped free of the base. The drum flipped hard to the right side of the vehicle, making contact with the right front quarter panel and the right door. The flat base was not damaged and was moved 8 feet back and 6 inches to the right. The first sandbag was not damaged and was found 5 feet down and 3 feet to the right; however, the second sandbag was split and was lying 11 feet down and 1 foot to the right. The drum was found 69 feet down and 15 feet to the right of its initial position. The site and device after the test can be seen in Figures 31 and 32. As shown in Figure 33, the right front quarter panel and right door of the vehicle was scratched.

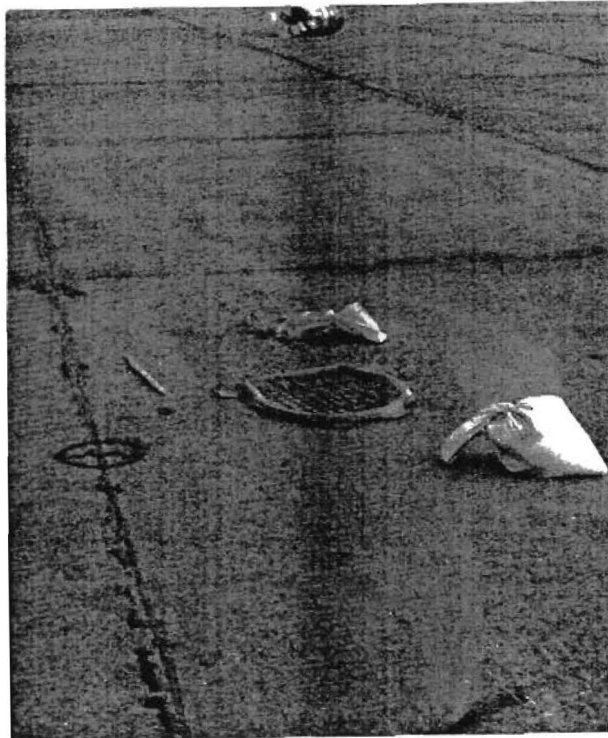
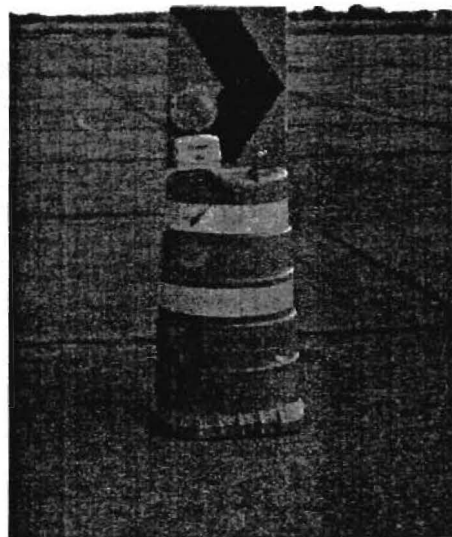
Figure 32. Damage to device, test 1917-8

Base moved 8 ft down, 6 in right

Drum 69 ft down, 15 ft right

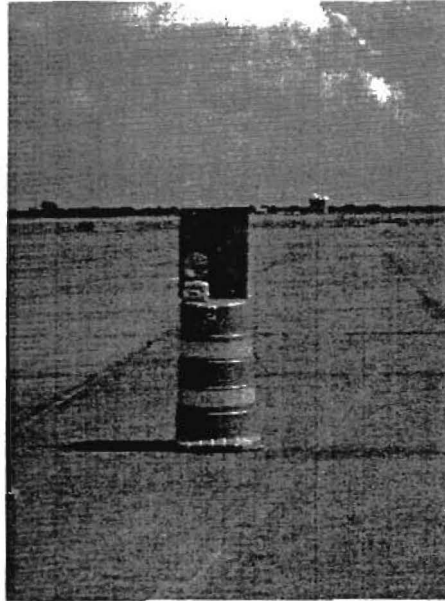
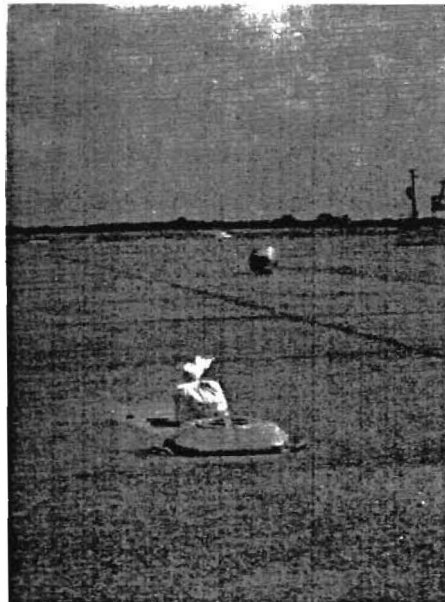
Figure 34. Test site before and after test 1917-9

The drum snapped free of the base as the vehicle, travelling at 47.0 mi/h, made contact with the device. The drum flipped over to the right side of the vehicle, but did not make contact with the side of the vehicle. The base was undamaged and was moved 8 inches back and 5 inches to the right. As can be seen in Figures 34 and 35, the sandbag was split and lying 3 feet down and 5 inches to the right. The slightly dented and scratched drum was found 78 feet down and 15 feet to the right of its original location. The vehicle was not damaged.

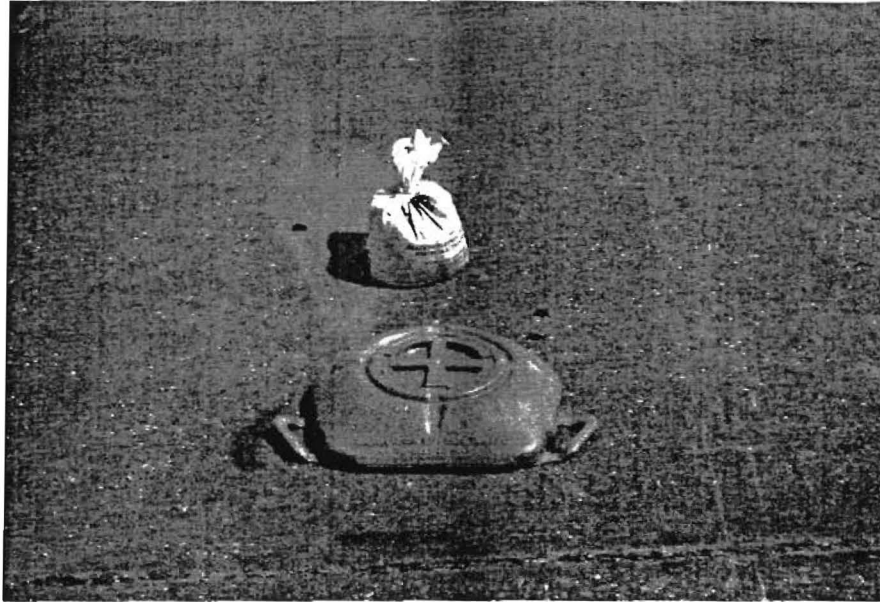
Figure 35. Damage to device, test 1917-9

Base moved 8 in down, 5 in right

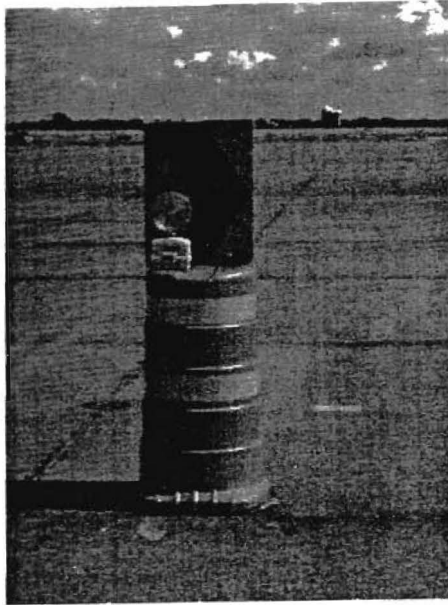
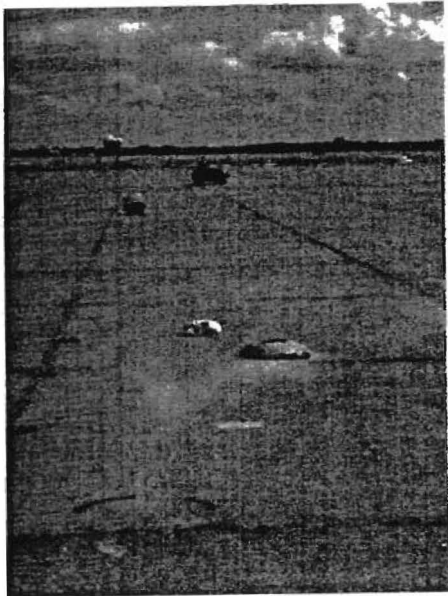
Figure 36. Test site before and after test 1917-10

of the vehicle and the top of the base was knocked off. The site and damage to the base and drum are shown in Figures 36 and 37. The base was moved back 16 feet and 3 feet to the right and the sandbag was bursted 19 feet down and 2 feet to the right. The drum was dented and scraped and came to rest 105 feet down and 12 inches to the left of its initial position. The hood of the vehicle was dented as shown in Figure 38, and the right front strut was damaged. The vehicle was not used for further tests.

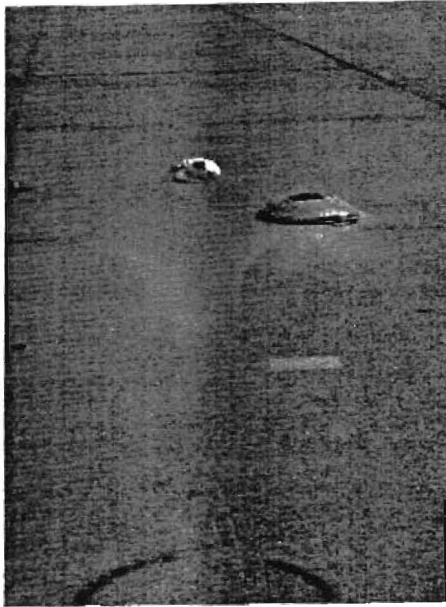
Figure 37. Damage to device, test 1917-10

Base moved 16 ft down, 3 ft right

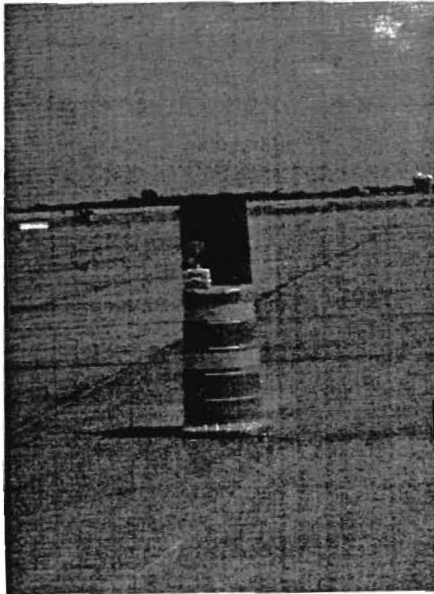
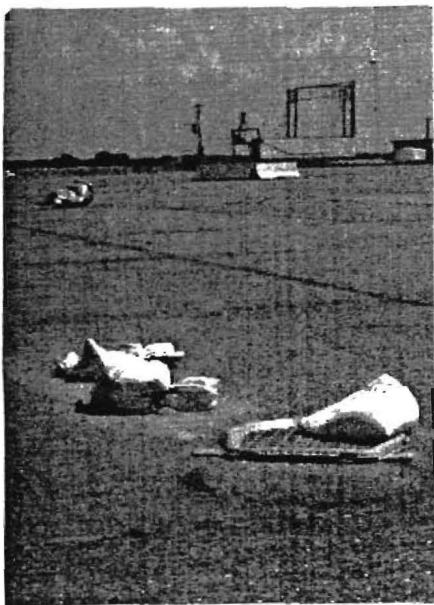
Figure 39. Test site before and after test 1917-11

The speed of the vehicle upon impact with the device was 45.7 mi/h. As the drum snapped free of the base, the chevron and light slapped the right side of the hood of the vehicle and then rode off the side of the vehicle. As shown in Figures 39 and 40, the flat base was undamaged and only moved back 16 inches and 8 inches to the right. The first two sandbags remained intact; one was 18 inches down and 14 inches to the right and the other was 4 feet down and 10 inches to the left. The third sandbag bursted 7 feet down and 10 inches to the left. The drum was dented and came to rest 85 feet down and 16 feet to the right of the point of impact. The hood of the vehicle was dented on the right corner, but repaired quickly.

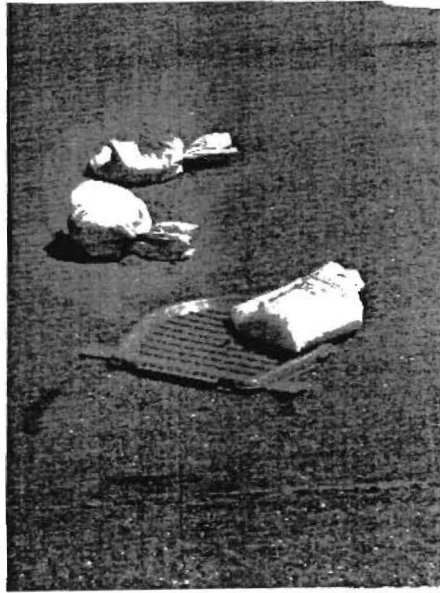
Figure 40. Damage to device, test 1917-11

Base moved 16 in down, 8 in right

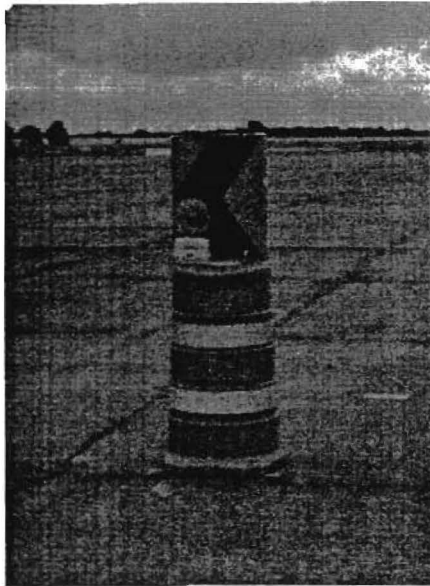
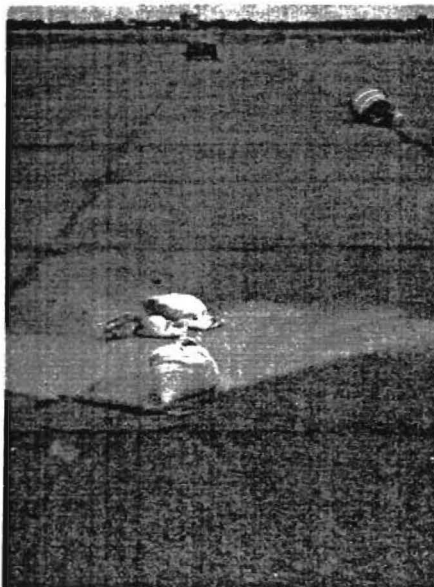
Figure 41. Test site before and after test 1817-12

The vehicle was travelling 60.7 mi/h as it impacted the device. As the drum snapped loose from the base, the chevron slapped the right side of the hood, and the drum flipped off to the right. The vehicle rose up and over slightly as it travelled through the site. The test site and damage to the device are shown in Figures 41 and 42. The flat base was not damaged and was 18 inches down and 6 inches to the right. Two of the sandbags remained intact; one 18 inches down and 12 inches to the right, and another 6 feet down and 8 inches to the right. The other sandbag bursted and was 5 feet down and 8 inches to the right. The drum was dented and was found 57 feet down and 9 feet to the right of its original position. The hood of the vehicle was scratched and there was a small dent in the upper right front quarter panel.

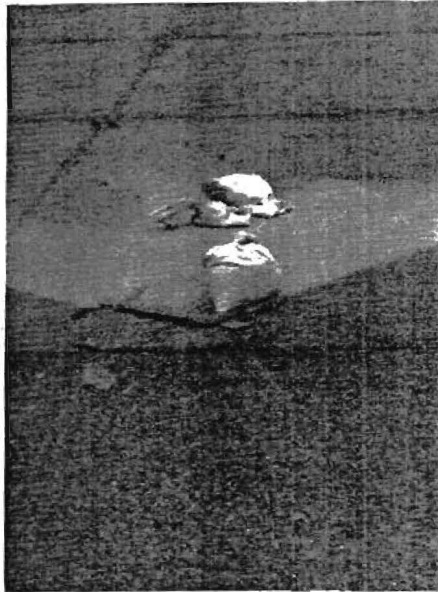
Figure 42. Damage to device after test 1917-12

Base moved 18 in down, 6 in right

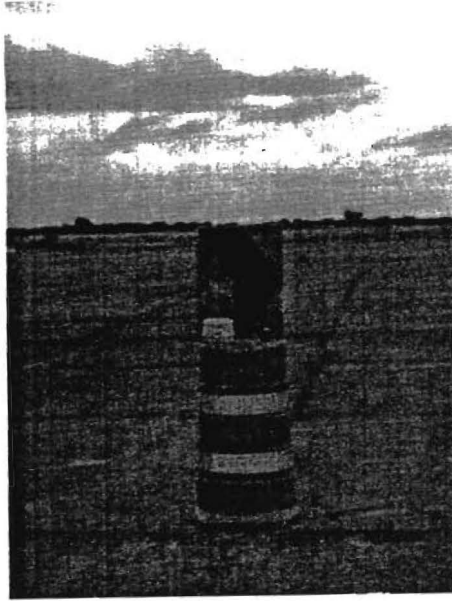
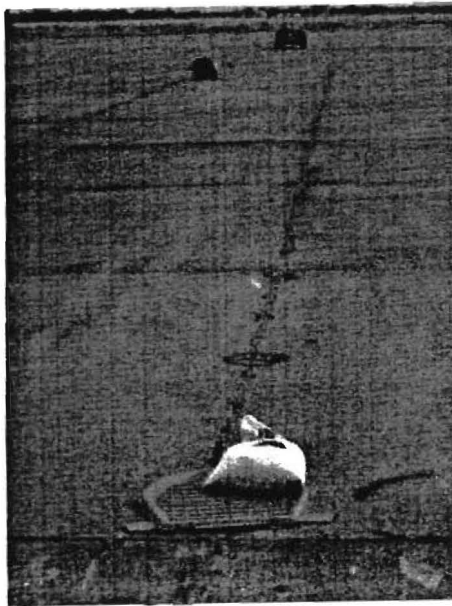
Figure 43. Test site before and after test 1917-13

The speed of the vehicle as it contacted the device was 61.0 mi/h. The drum snapped free of the base and rode up onto the hood of the vehicle. The drum continued to roll up the hood, skimmed the windshield and then went over the vehicle. As can be seen in Figure 43, the flat base was undamaged and had rotated and moved back only 2 inches. The sandbag remained intact and was lying on the base. The drum, shown in Figure 44, was dented and came to rest 110 feet down and 10 feet to the right. Other than a slight film of plastic where the drum skimmed the windshield (see Figure 45), there was no damage to the vehicle.

Base moved 2 in down

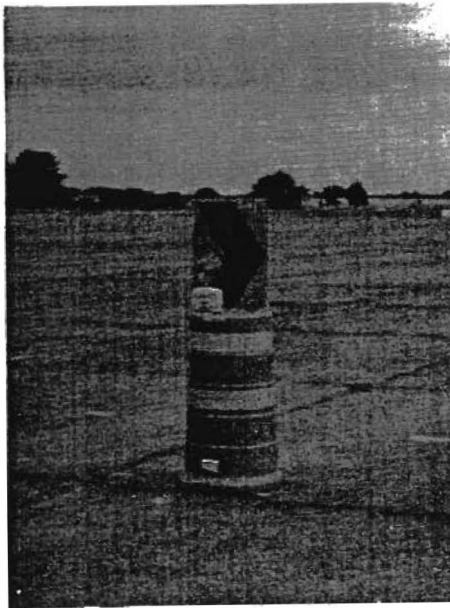
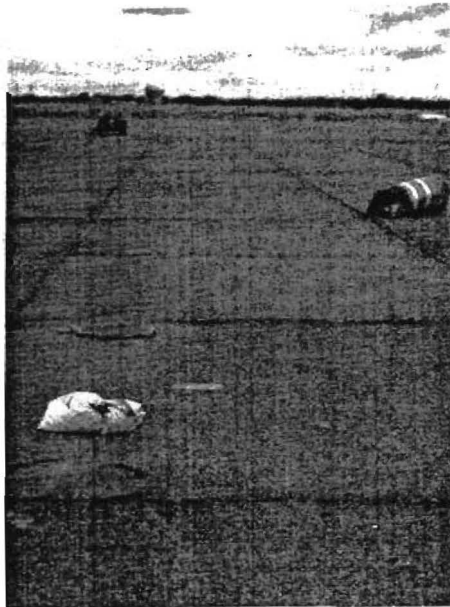
Figure 46. Test site before and after test 1917-14

As the vehicle, travelling at a speed of 60.4 mi/h, contacted the device, the drum snapped free of the base and flipped over to the right side of the vehicle, but no contact with the side of the vehicle. The flat base was not damaged and was moved 12 feet down. The sandbag remained intact and was lying 3 feet down. The drum was dented and was found 48 feet down and 12 feet to the right of its original location. The test site and damage to the device are shown in Figures 46 and 47. The vehicle was not damaged.

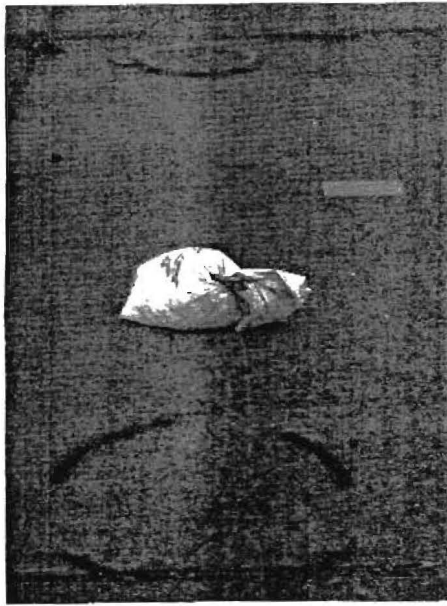
Base moved 12 ft down
