1. Report No. TX-94/1945-2F		2. Government Accession No.		3. Recipient's Catalog No.	
4. Title and Subtitle MAILBOX BRACKET CRASH TESTS				5. Report Date November 1993

MAILBOX BRACKET CRASH TESTS

Research Report 1945-2F
Research Study No. 7-1945
Study Title: Mailbox Bracket Crash Tests

TEXAS TRANSPORTATION INSTITUTE
The Texas A&M University System
College Station, Texas 77843-3135

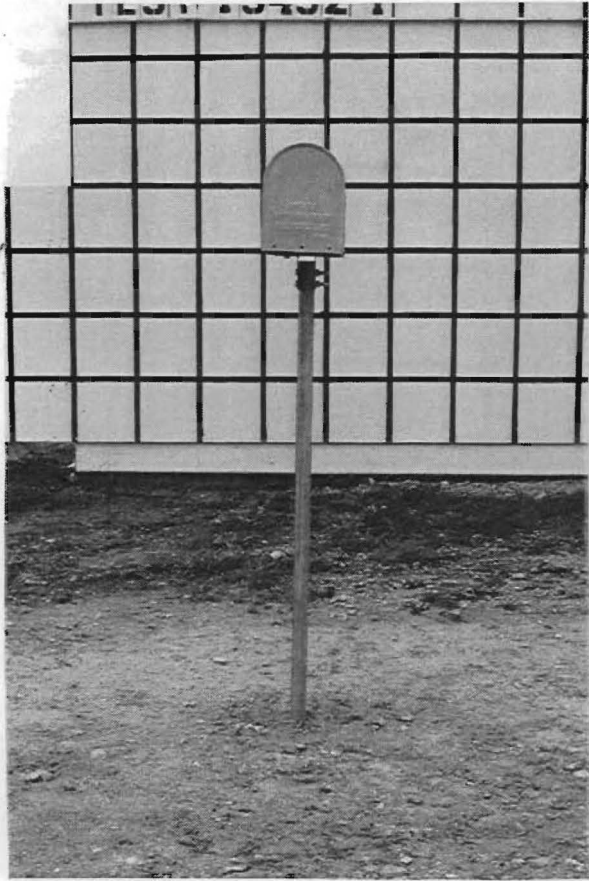
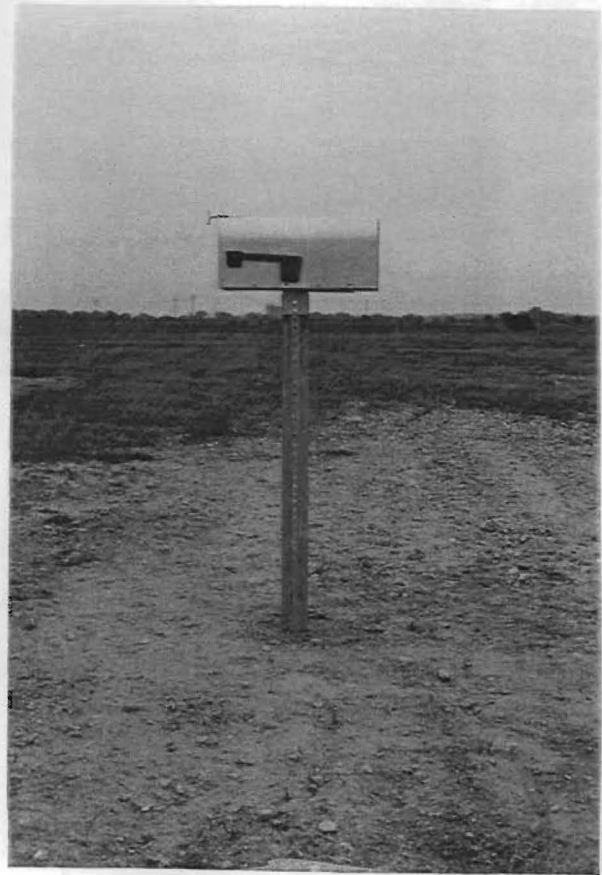
Figure C-1. Mailbox installation for test 19452-1.

Figures C-7 and C-8 show test article damage. As shown, the support bent at ground level and the mailbox attachment bracket remained attached to the support. The mailbox components came to rest approximately 72.5 ft (22.1 m) from the point of impact. The vehicle sustained only minor damage to the bumper and hood as shown in Figure C-9.

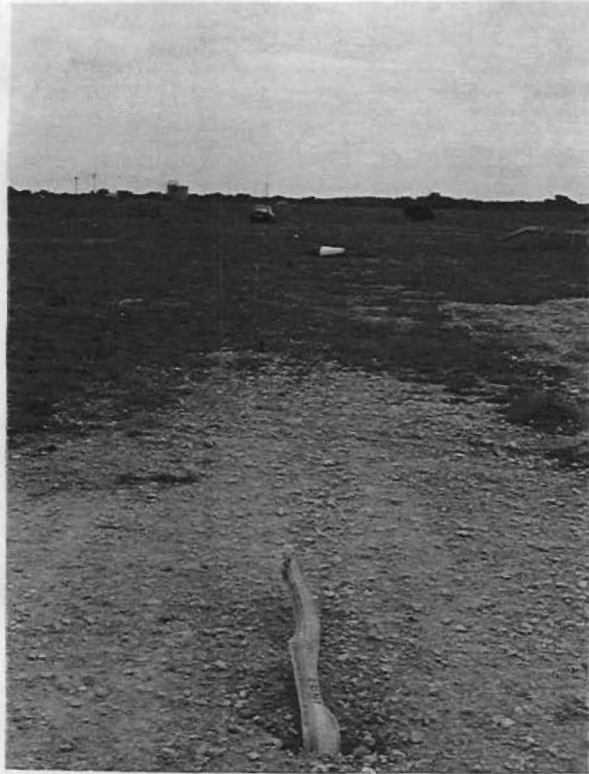
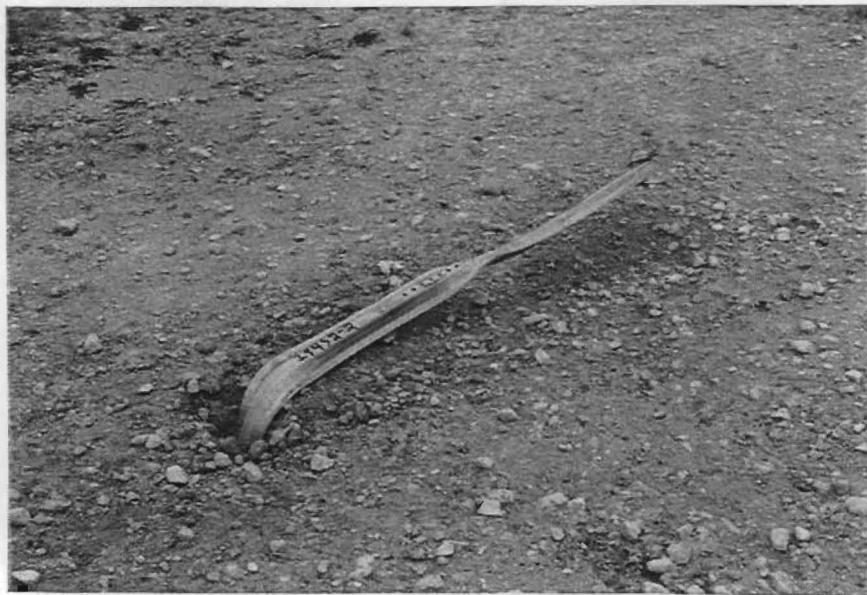
Figure D-6. Test installation after test 19452-2.

Figures D-6 and D-7 shows the test article damage. As shown, the support bent at ground level and the mailbox attachment bracket became detached from the support, coming to rest approximately 153 ft (46.6 m) from the impact point. Other mailbox components came to rest approximately 101.3 ft (30.9 m) from the impact point. Figure D-8 shows the vehicle sustained only minor damage to the bumper, hood, and windshield.

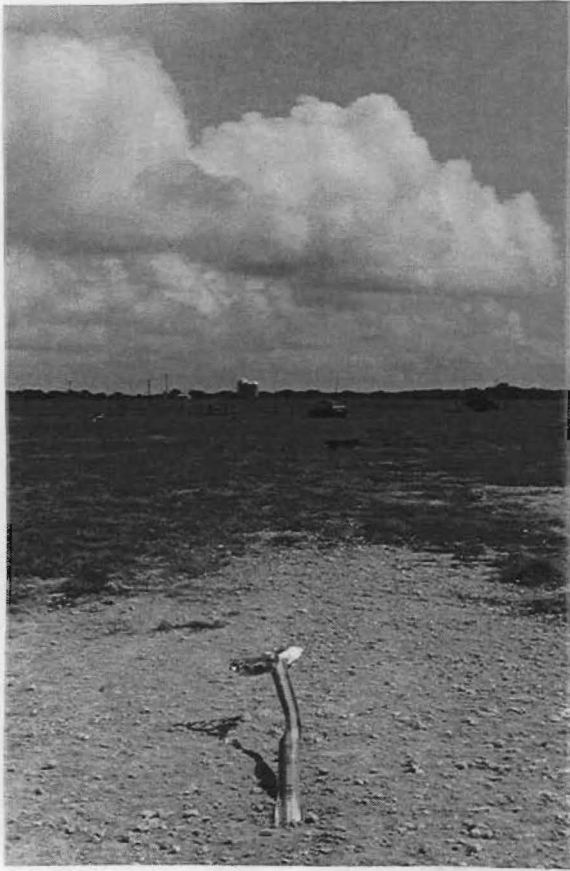
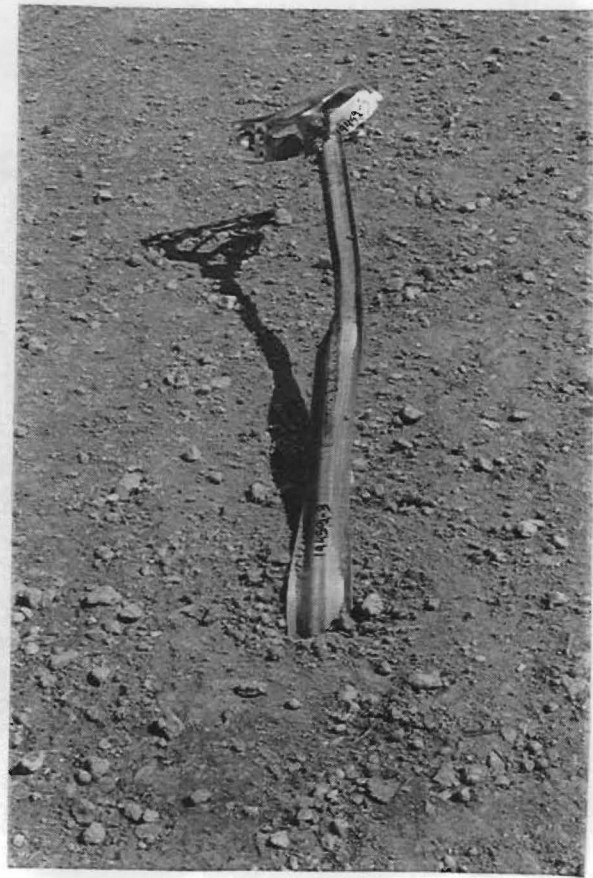
Figure E-7. Test installation after test 19452-3.

Figures E-7 and E-8 show test article damage. As shown, the support bent at ground level and the mailbox attachment bracket remained with the support, but the mailbox itself was torn from the attachment bracket. Other mailbox components came to rest approximately 96.3 ft (29.3 m) from the impact point. The vehicle sustained only minor damage to the bumper, hood, and windshield as shown in Figure E-9.

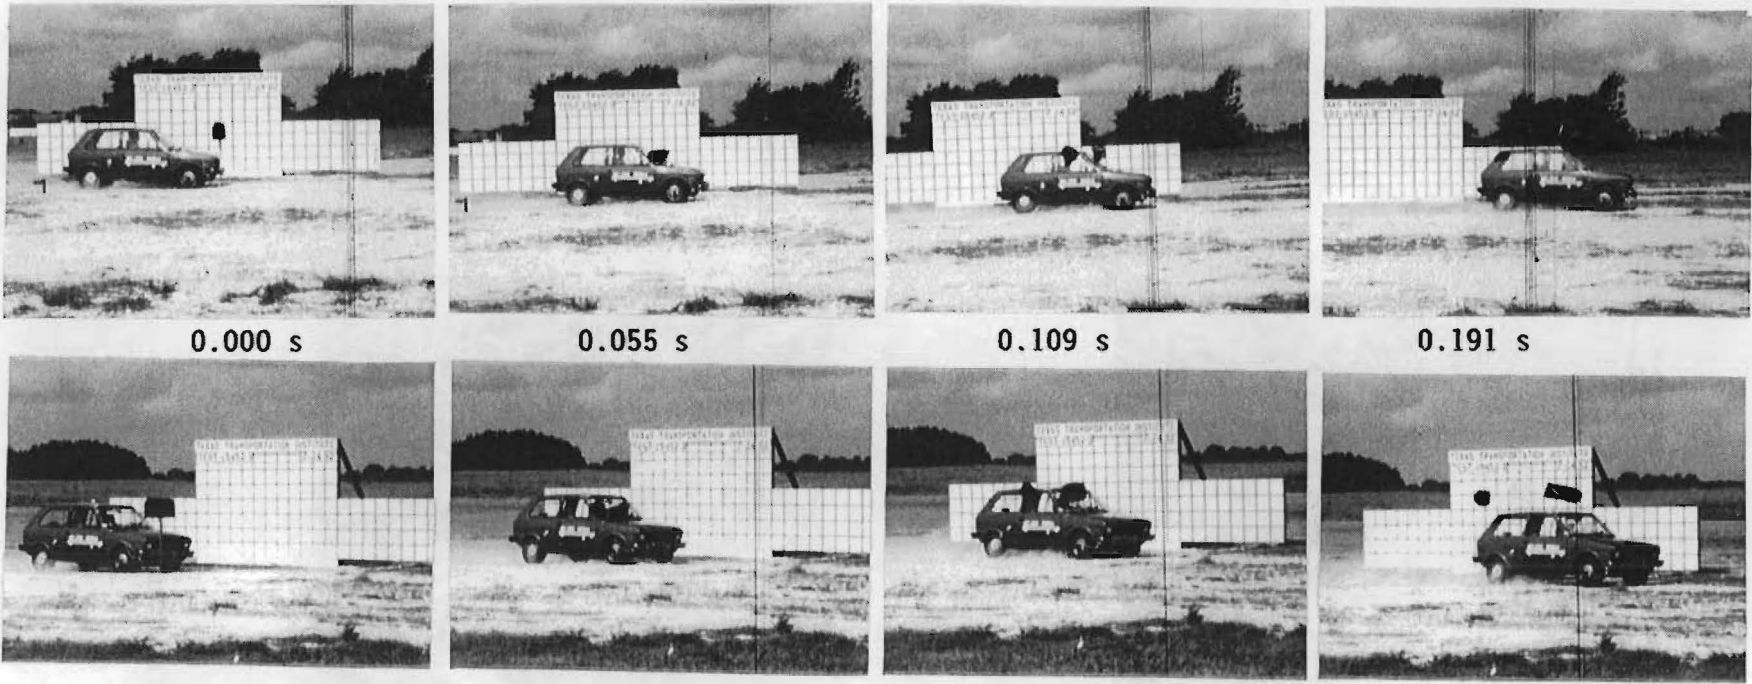
Figure E-10. Summary of results for test 19452-3.

In summary, the test was marginally acceptable. The only concern was that the windshield was broken and dished during impact. Researchers concluded that changes could and should be made in the design to eliminate this concern.

Test No	19452-3.	Impact Speed	61.2 mi/h (98.4 km/h)
Date	07/24/92.	Change in Velocity . . .	1.3 mi/h (2.1 km/h)
Test Article	Single mount, Type 2 Mailbox Installation.	Change in Momentum . . .	106.6 lb-s
Support	Type 4 (2 lb/ft winged channel post)	Vehicle Accelerations (Max. 0.050-sec Avg)	
Embedment	2'-0" driven (strong soil)	Longitudinal . . .	-1.2 g
Vehicle	1987 Yugo GV	Lateral	-0.3 g
Vehicle Weight		Occupant Impact Velocity	
Test Inertia	1800 lb (816 kg)	Longitudinal . . .	N/A
Gross Static	1968 lb (893 kg)	Lateral	N/A
Vehicle Damage Classification		Occupant Ridedown Accelerations	
TAD	12-FR-1	Longitudinal . . .	No contact
SAE	12FRAN1	Lateral	No contact

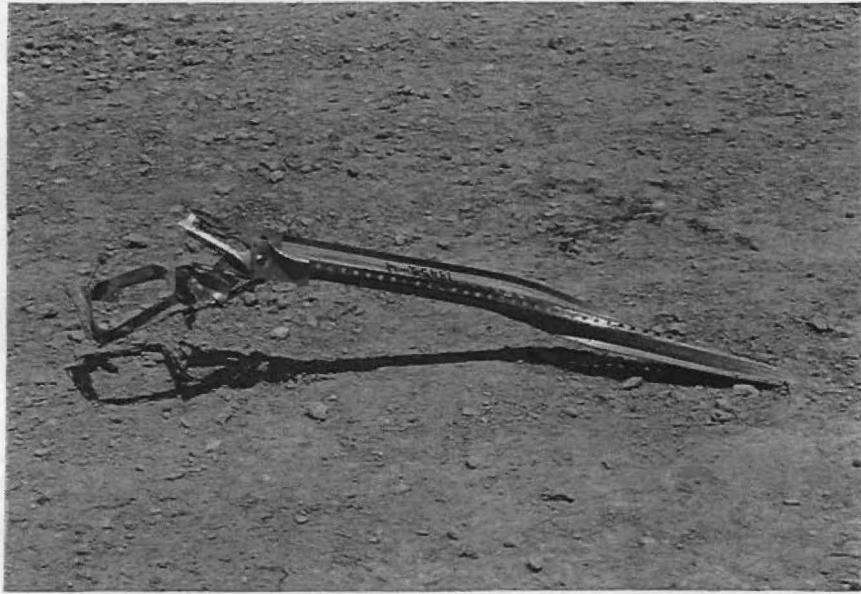
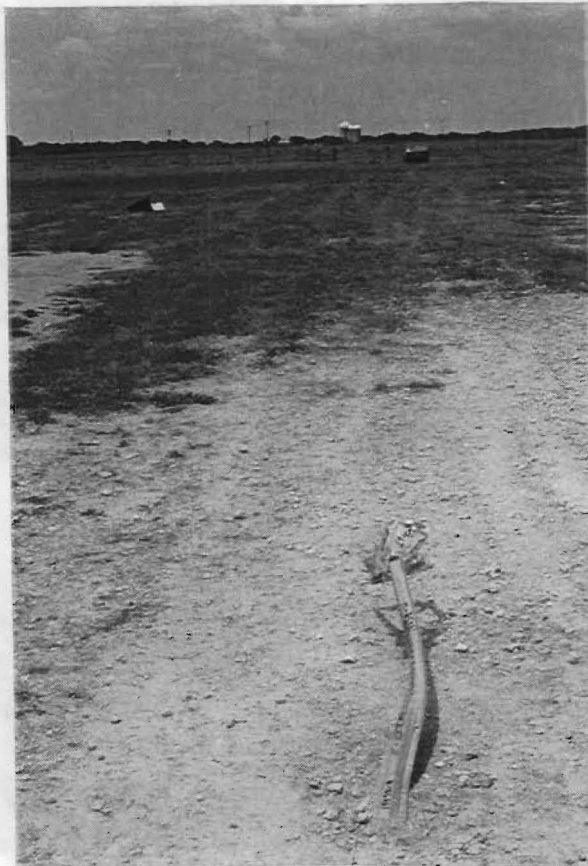
Figure F-6. Test installation after test 19452-4.

Figures F-6 and F-7 show the test article damage. As shown, the support bent at ground level and the mailbox attachment bracket remained with the support, but the mailbox itself was torn from the attachment bracket. Other mailbox components came to rest approximately 90 ft (27.4 m) from the impact point. The vehicle sustained only minor damage to the bumper and hood as shown in Figure F-8.

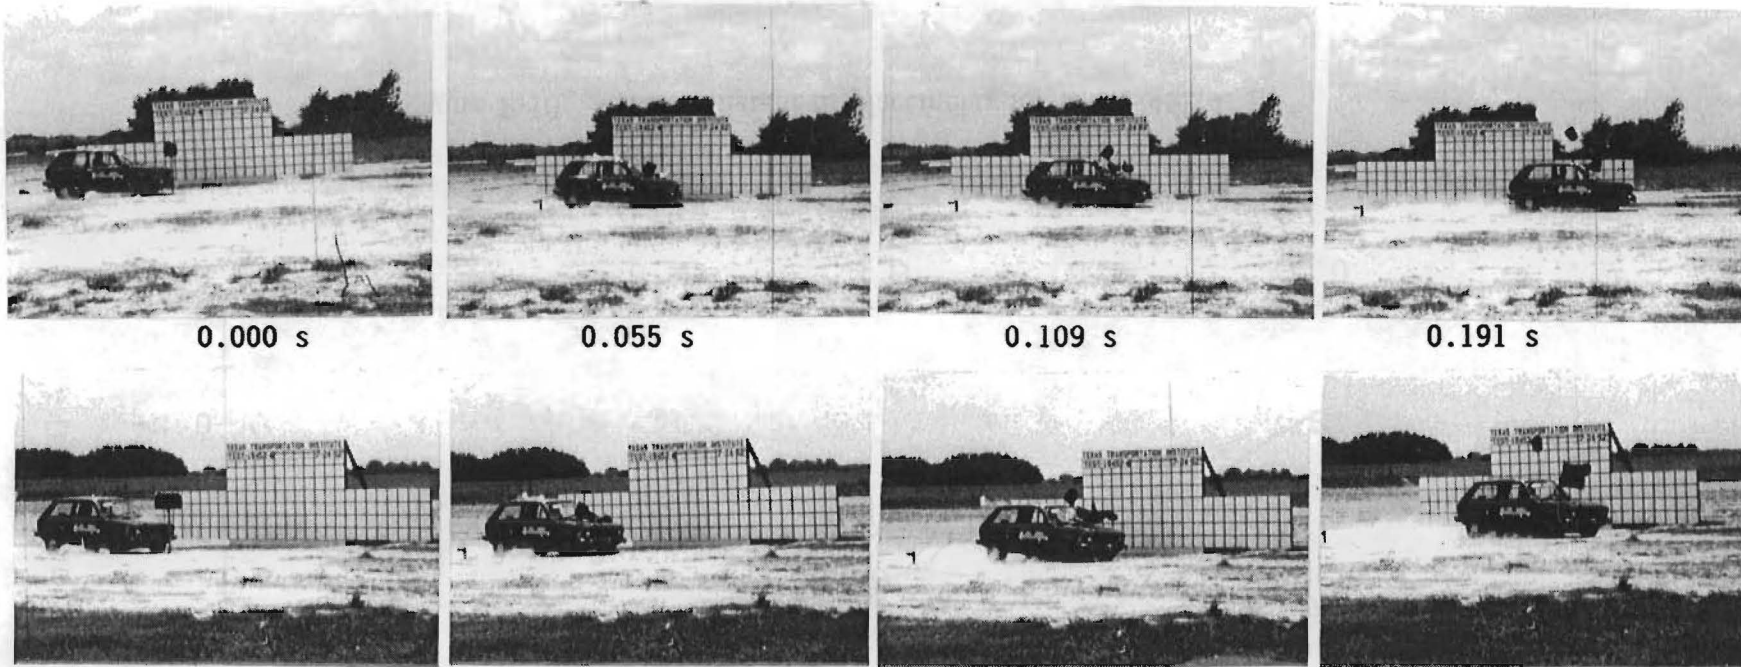
Figure F-9. Summary of results for test 19452-4.

A summary of test results and other pertinent information are given in Figure F-9. The maximum 0.050 second average acceleration experienced by the vehicle was -1.5 g in the longitudinal direction and 0.4 g in the lateral direction. No occupant contact occurred in the longitudinal or lateral direction. Angular displacements of the vehicle are plotted in Figure F-10 and vehicular accelerations are plotted in Figures F-11 through F-13. Change in the vehicle's velocity was 1.5 mph (2.3 km/h).

In summary, the test was successful and met all evaluation criteria.

Test No	19452-4.	Impact Speed.	61.2 mi/h (98.4 km/h)
Date	07/24/92.	Change in Velocity. . .	1.5 mi/h (2.3 km/h)
Test Article	Double mount, Type 1 1/2 Mailbox Installation.	Change in Momentum. . .	123.0 lb-s
Support	Type 4 (2 lb/ft winged channel post)	Vehicle Accelerations (Max. 0.050-sec Avg)	
Embedment.	2'-0" driven(strong soil)	Longitudinal. . .	-1.5 g
Vehicle	1987 Yugo GV	Lateral	0.4 g
Vehicle Weight		Occupant Impact Velocity	
Test Inertia	1800 lb (816 kg)	Longitudinal. . .	N/A
Gross Static	1968 lb (893 kg)	Lateral	N/A
Vehicle Damage Classification		Occupant Ridedown Accelerations	
TAD	12-FL-1	Longitudinal. . .	No contact
SAE	12FLEN1	Lateral	No contact

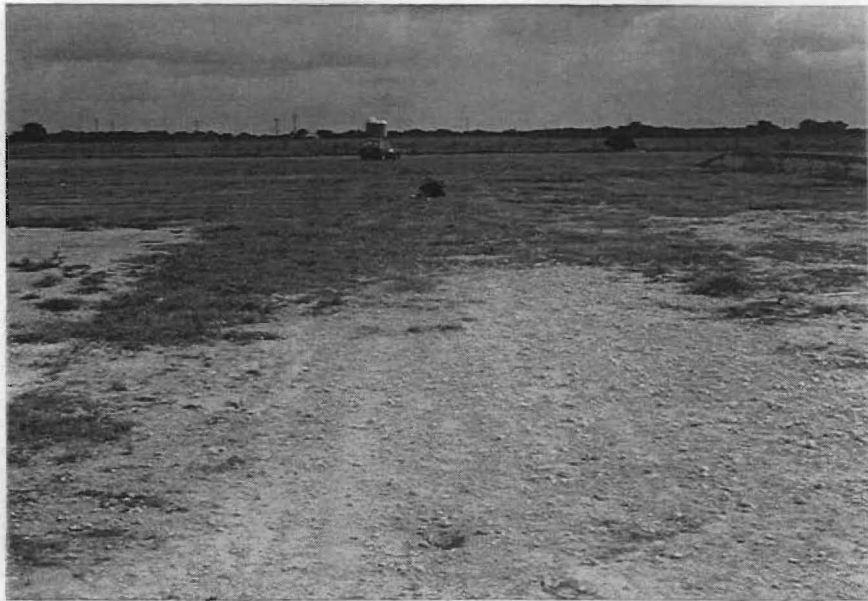
Figure G-7. Test installation after test 19452-5.

Figures G-7 and G-8 show test article damage. As shown, the support was pulled from the ground. The mailboxes remained attached to the support post. The mailboxes and support came to rest approximately 85 ft (25.9 m) from the impact point. Doors and back sides of the mailboxes were detached and distributed along the vehicle's path. The vehicle sustained only minor damage to the bumper and hood as shown in Figure G-9.

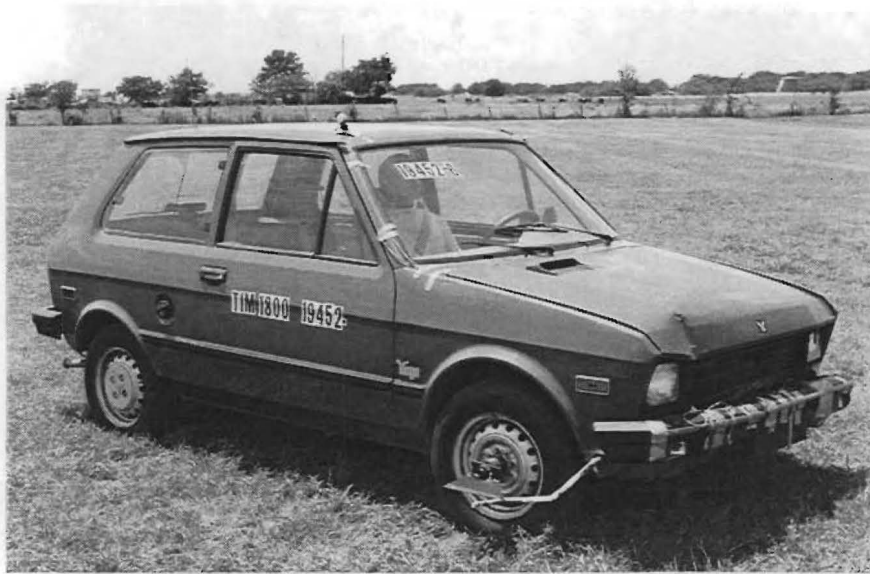
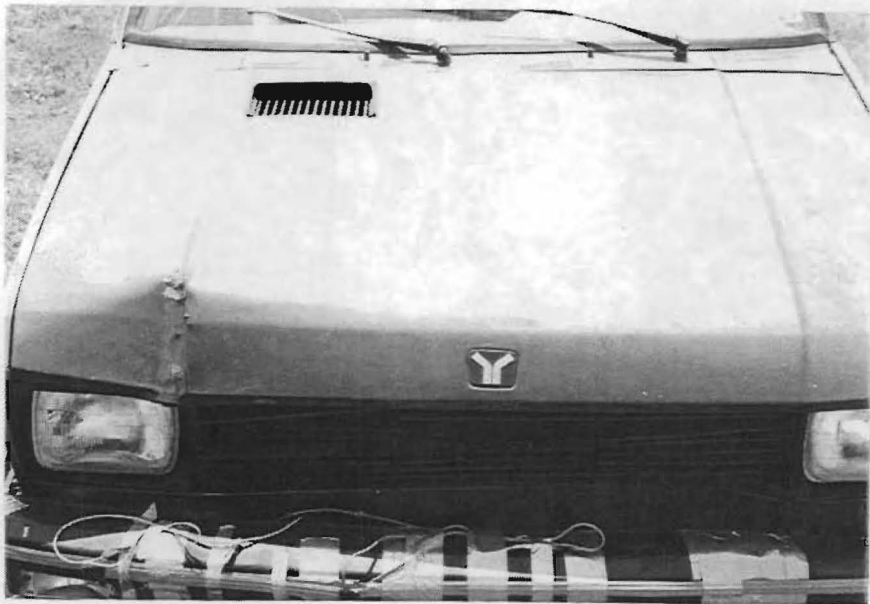
Figure H-10. Vehicle after test 19452-6.

Figures H-7 through H-9 shows the test article damage. As shown, the support was pulled from the ground socket and came to rest 20 ft (6.1 m) from the impact point. The mailbox came to rest approximately 108 ft (32.9 m) from the impact point. The vehicle sustained only minor damage to the bumper and hood as shown in Figure H-10.

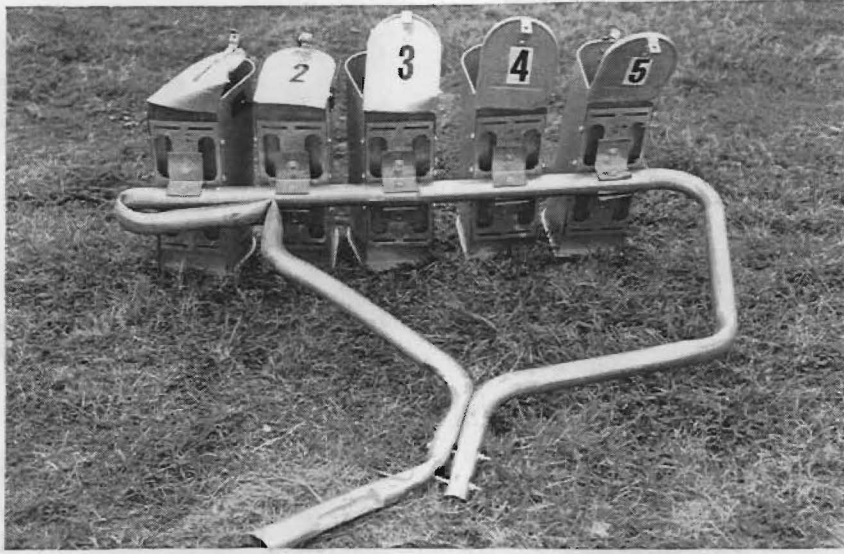
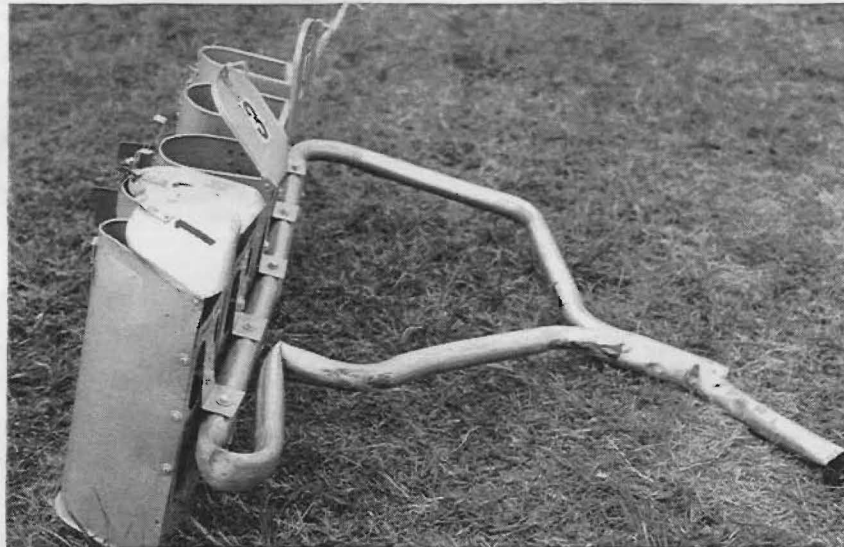
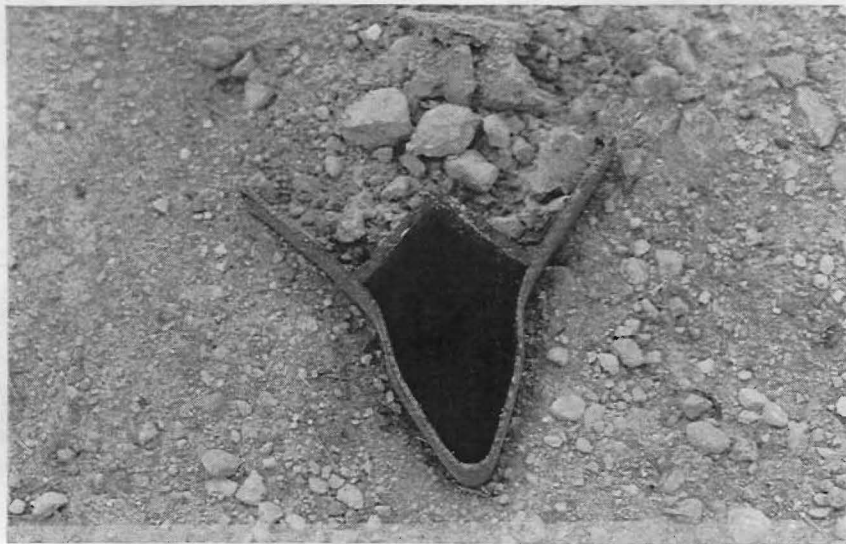
Figure I-7. Mailbox/support and base after test 19452-7.

Figure I-7 shows test article damage. As shown, the support was pulled from the ground socket and came to rest approximately 132 ft (40.2 m) from the impact point. All mailboxes remained attached to the support. The vehicle sustained only minor damage to the bumper and hood as shown in Figure I-8.

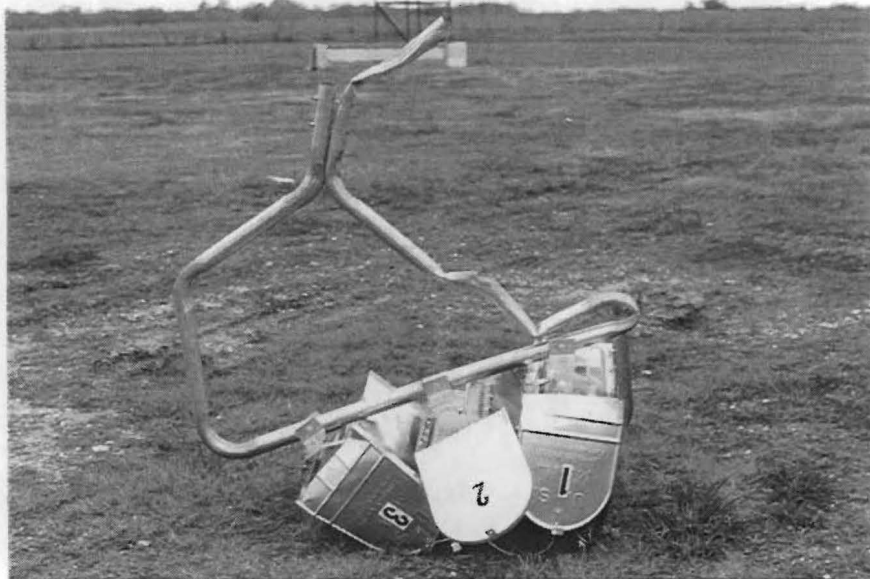
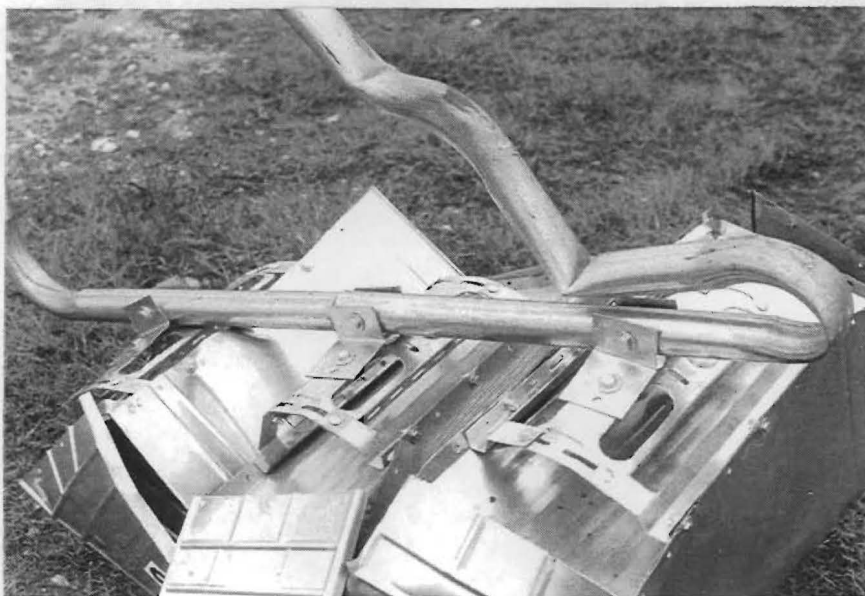
Figure J-7. Mailbox/support after test 19452-8.

Figures J-7 and J-8 show test article damage. As shown, the support was pulled from the ground anchor and came to rest approximately 102 ft (31.1 m) from the impact point. All mailboxes remained attached to the support. The vehicle sustained only minor damage to the bumper and hood as shown in Figure J-9.

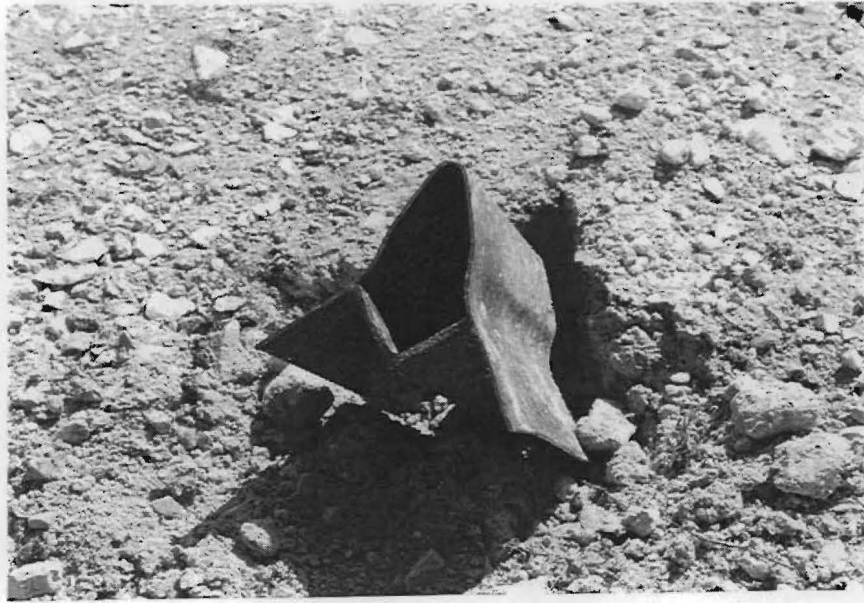
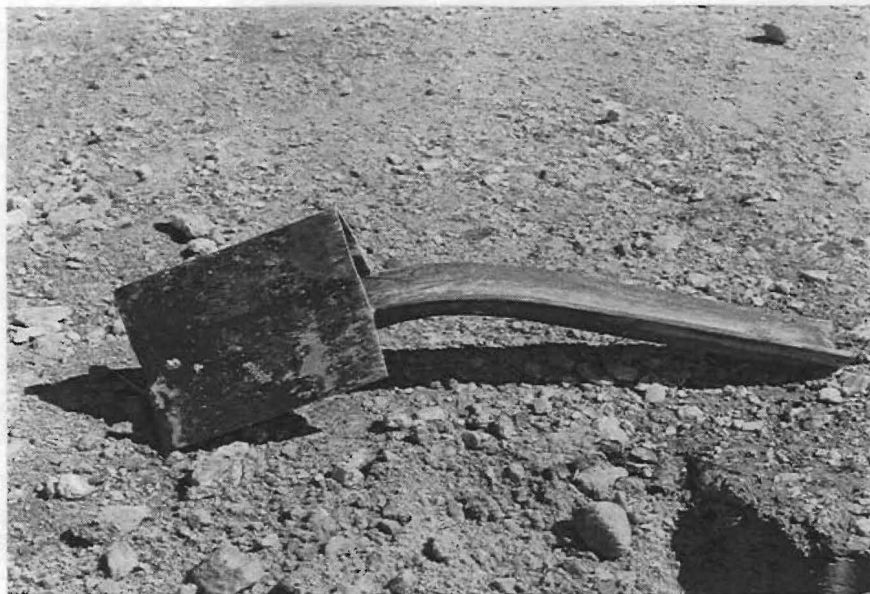
Figures K-7 and K-8 show test article damage. As shown, the support was pulled from the ground anchor and came to rest approximately 132 ft (40.2 m) from the impact point. All mailboxes remained attached to the support. The vehicle sustained moderate damage to the bumper, hood, grill, and windshield as shown in Figure K-9. The fan and radiator also sustained damage.

Figure K-7. Flush V-wing socket after test 19453-9.

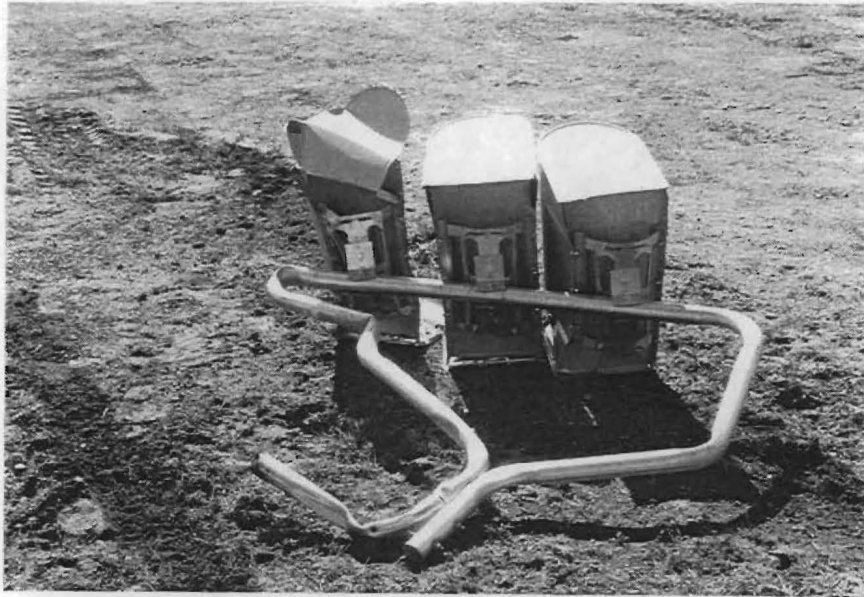
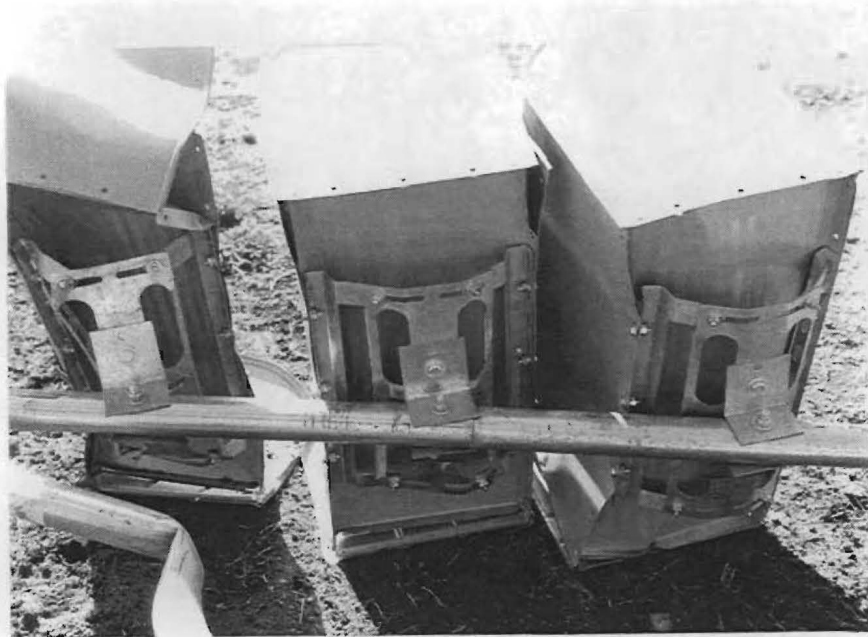
Figure K-8. Mailbox/support after test 19453-9.

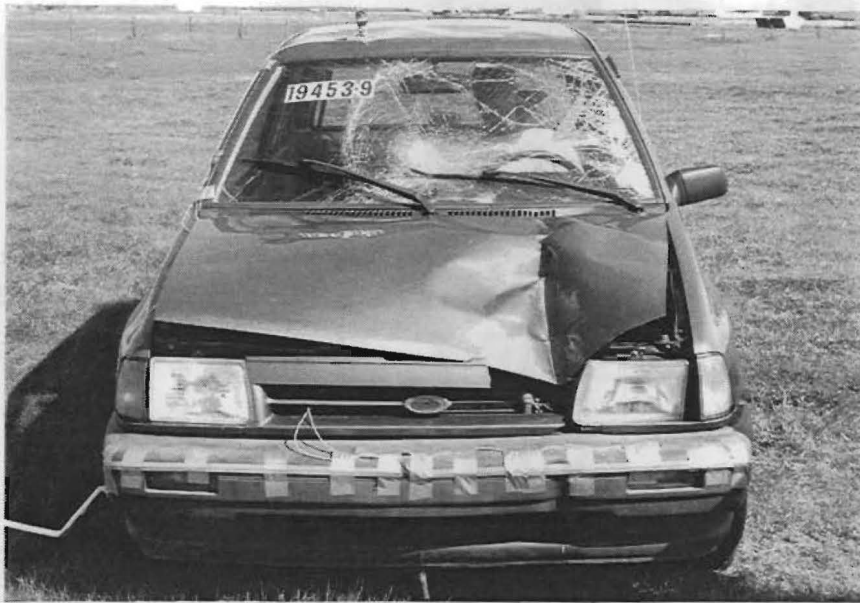
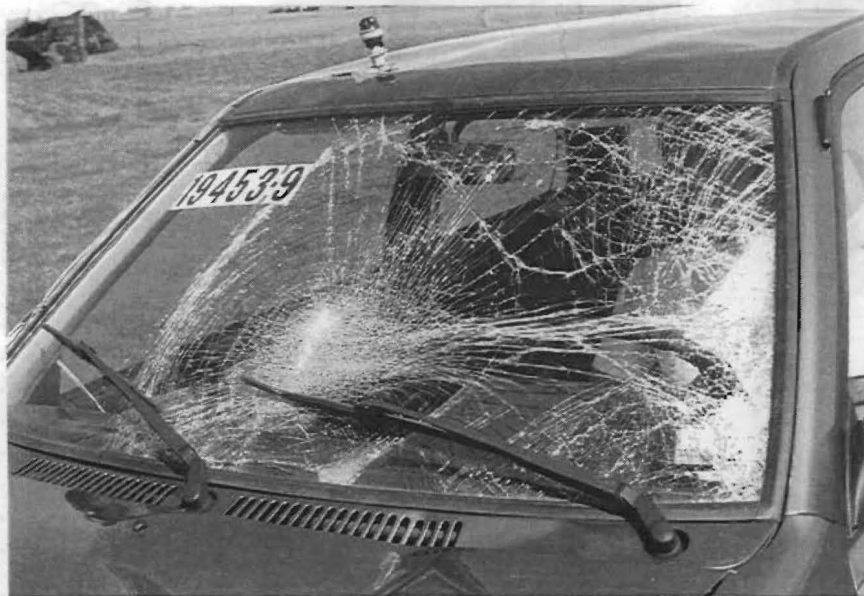
Figure K-9. Vehicle after test 19453-9.

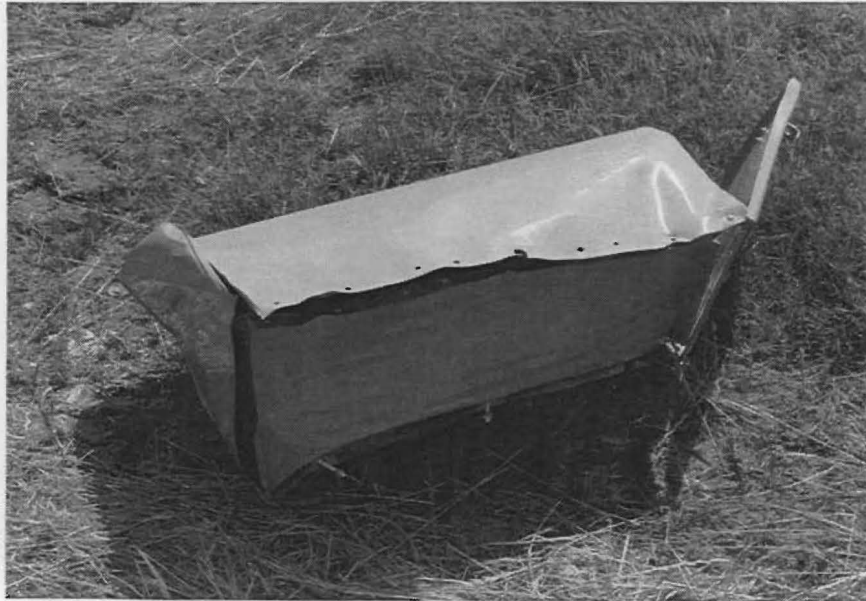
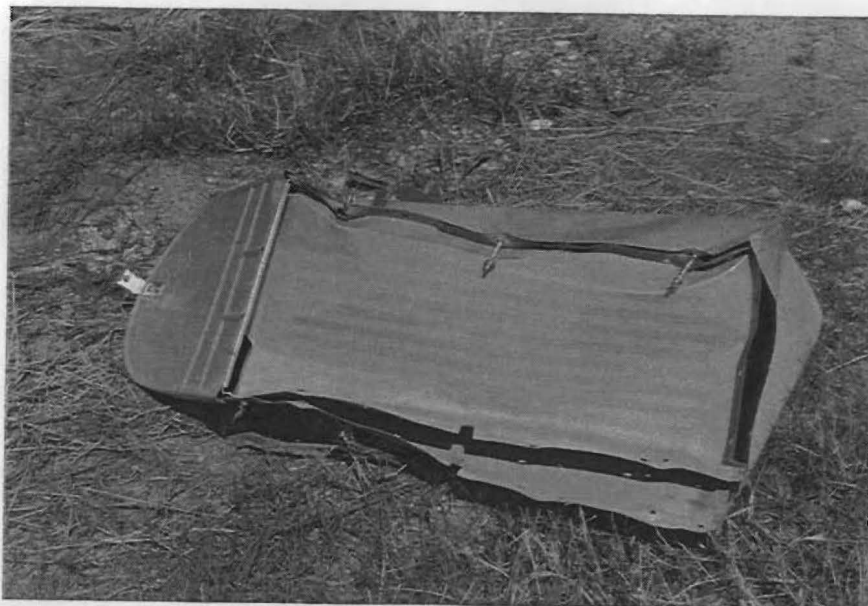
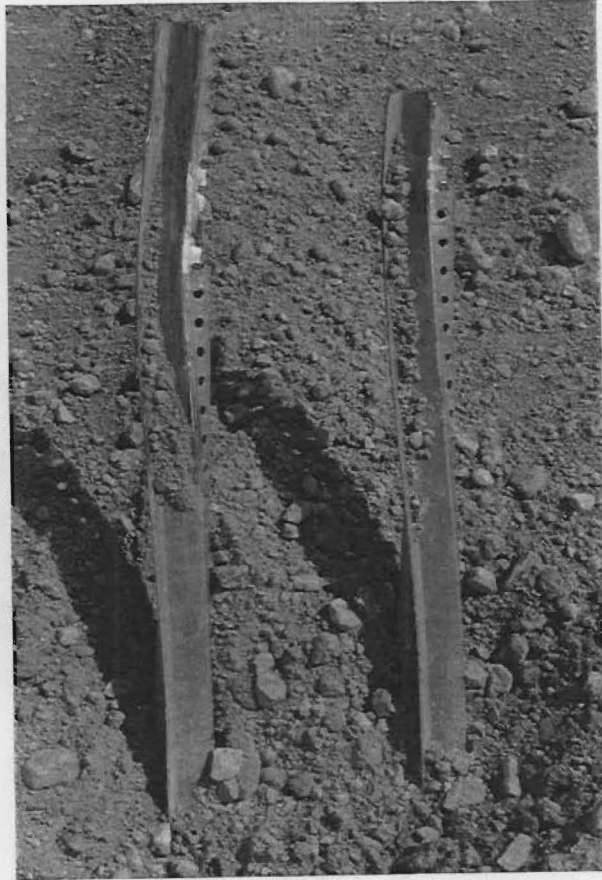
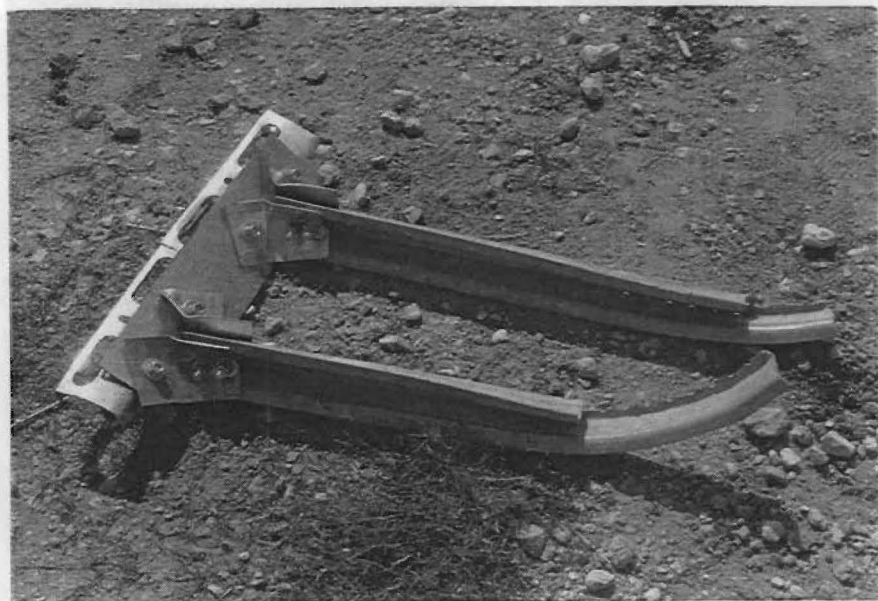
Figure L-6. Type II mailbox installation after test 19453-10.

Figures L-6 and L-7 show test article damage. As shown, the support was bent at ground line and fractured about 25 in. (63.5 cm) above ground. The upper portions of the support with mailbox attached came to rest 15.8 ft (4.8 m) from impact point. The vehicle sustained minor damage to the bumper and hood, as shown in Figure L-9.

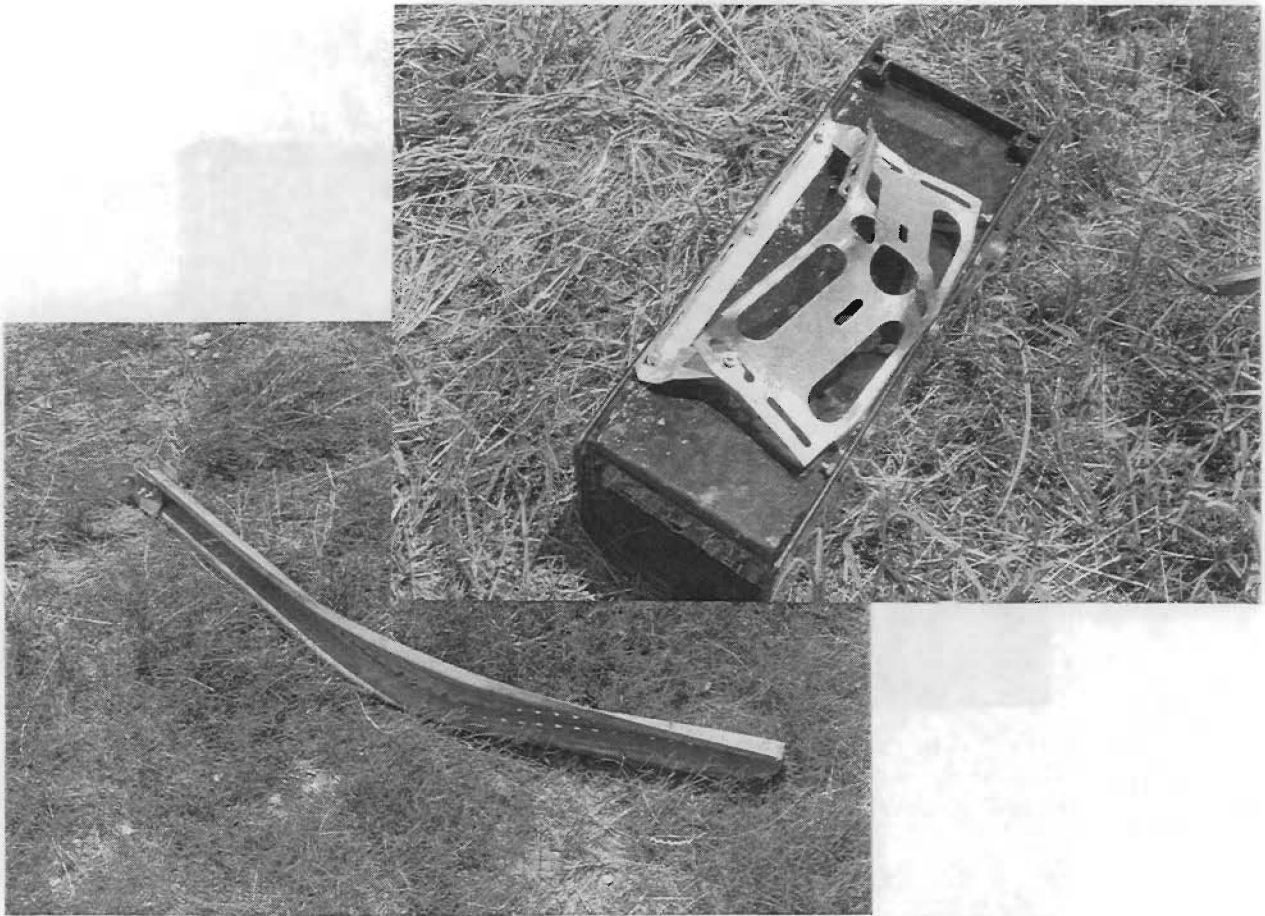
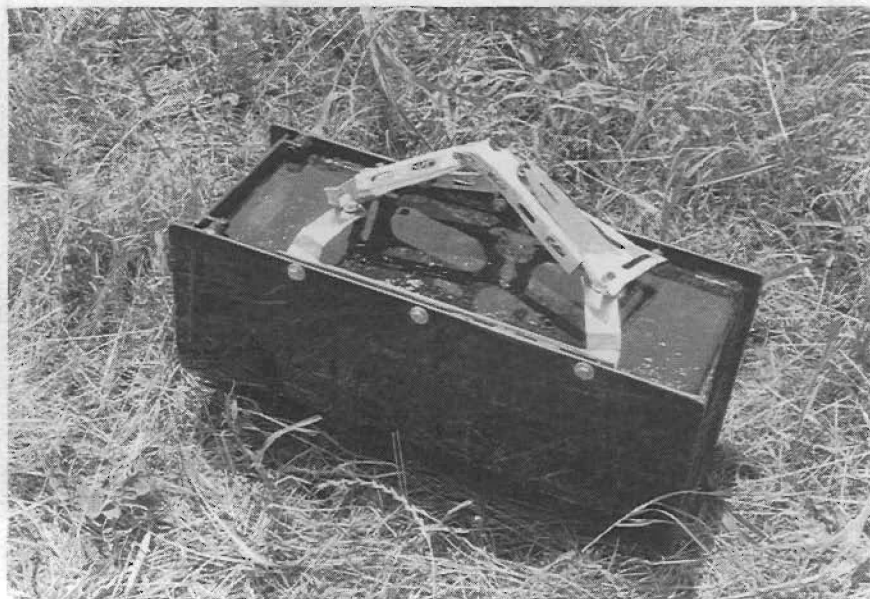
Figure M-7. Mailbox installation after test 19453-11.

Figure M-7 shows test article damage. Note that the mailbox itself was essentially undamaged. Remnants of the support came to rest 57 ft (17.4 m) from the impact point. The vehicle sustained damage to the bumper, hood, A-pillar, windshield, and steering wheel as shown in Figures M-8 and M-9.

Results of this test were unacceptable. Use of this box on high-speed roadways clearly should not be permitted. Its use on low-speed roadways is not recommended unless it can be demonstrated to be acceptable through crash testing.
