1. Report No. <b>TX-94/1959-1</b>		2. Government Accession No.		3. Recipient's Catalog No.	
4. Title and Subtitle <b>DEVELOPMENT OF A LIMITED-SLIP PORTABLE CONCRETE BARRIER CONNECTION</b>				5. Report Date <b>November 1993</b>

**DEVELOPMENT OF A LIMITED-SLIP PORTABLE  
CONCRETE BARRIER CONNECTION**

Research Report 1959-1  
Contract No. 7-1959, Task A

TEXAS TRANSPORTATION INSTITUTE  
The Texas A&M University System  
College Station, Texas 77843-3135

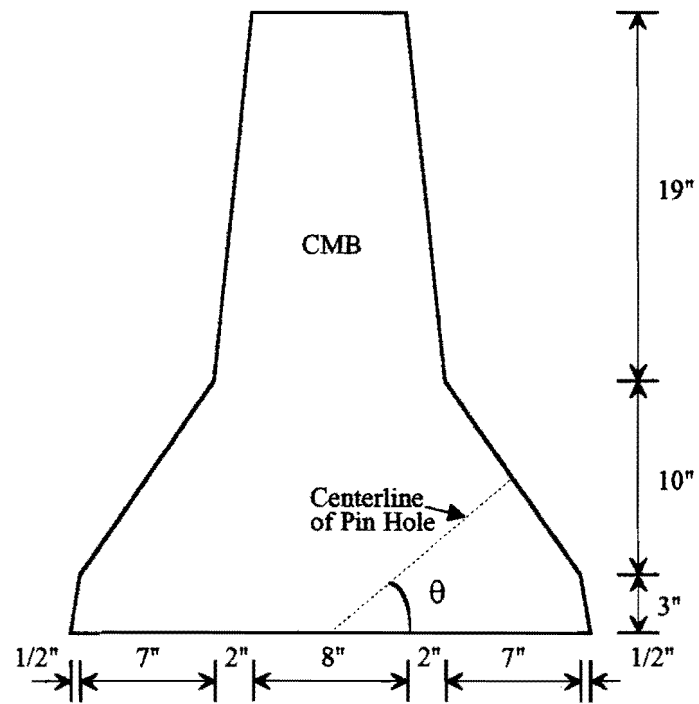
Figure 1. Schematic of steel pin location.

The 1 3/8-in. (3.49 cm) diameter holes were drilled through the barrier segment and into the concrete pavement at controlled angles as shown in Figure 1. The purpose of drilling the holes at an angle was to provide a vertical reaction between the pin and barrier so that the overturning moment associated with the impact force could be resisted more effectively than would be the case if the holes were drilled vertically. The smaller the angle of the hole with respect to the horizontal, the greater the resistance to overturning. In addition, the smaller the angle, the greater the area of PCB concrete available to resist the impact force. However, the smaller the pin angle, the less bridge deck or pavement concrete area was available to resist the impact force. Therefore, a strength trade-off had to be considered in determining the pin angle. Approximate analyses were used to select as large an angle as possible, given the stated performance requirements.

The entry point for each pin hole on the barrier face was selected to be 6 1/2 in. (16.5 cm) up from the first break of the impact face of the barrier as shown in Figure 1. In the first crash test discussed later in this report, the angle between the centerline of the hole and the horizontal plane was set at 53.1 degrees. This angle corresponds to a 3-4-5 slope. Based on a questionable outcome in the first test, the situation was re-evaluated, and the

angle of the pin holes was reduced to 40.1 degrees with respect to the horizontal axis. Based on crash test results discussed later in this report, it became clear that the reduction of the angle marginally improved the performance of the PCB system. However, in retrospect, we believe that minor variations in the angle of the pins which will be inherent in the fabrication process will not have a major influence on the performance of the barrier.

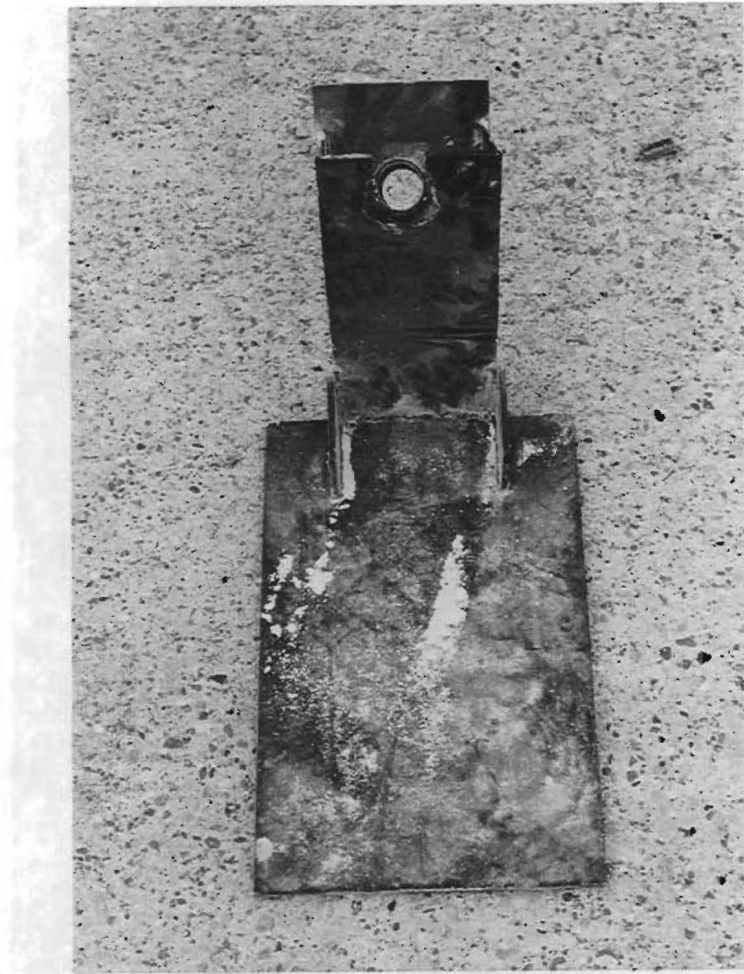
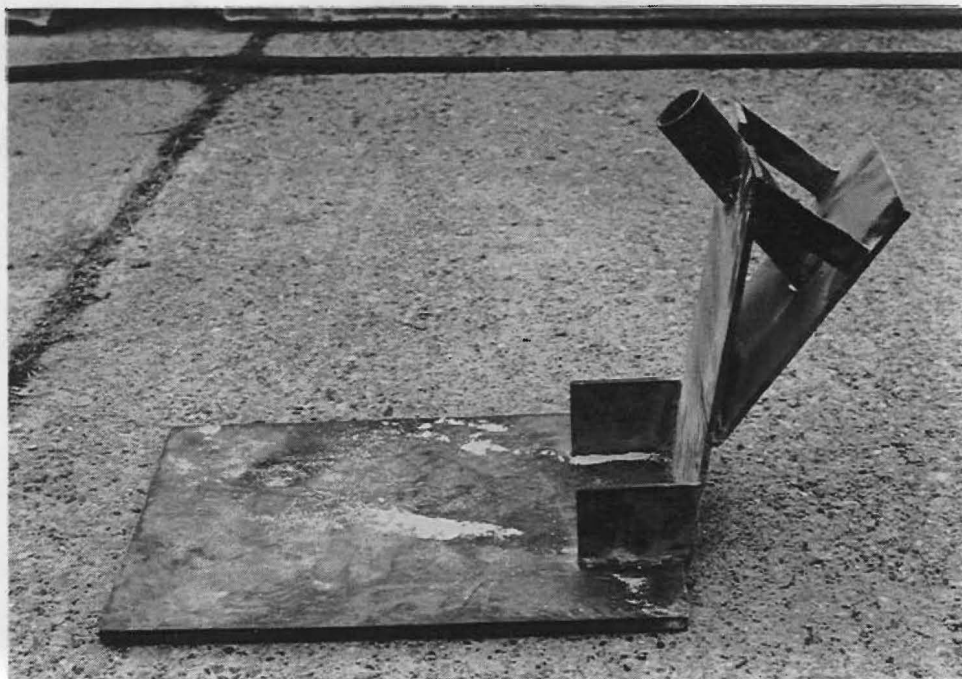
Figure 2. Steel drill guide.

The most difficult part of the modification procedure was drilling the holes through the PCB at the angles specified. To aid in this process, a specialized steel drill guide was fabricated. Figure 2 presents two photographs of the steel drill guide. As shown, the drill guide consists of a steel tube which is fixed into the proper position with a steel frame. The steel frame is welded to a horizontal foot plate which rests on the pavement. The procedure used was to place the steel drill guide against the barrier face and to secure it in place with the weight of the drill operator as shown in Figure 3. Then, the drill operator inserted the drill bit through the guide and drilled the hole as shown in Figure 3. Occasionally during

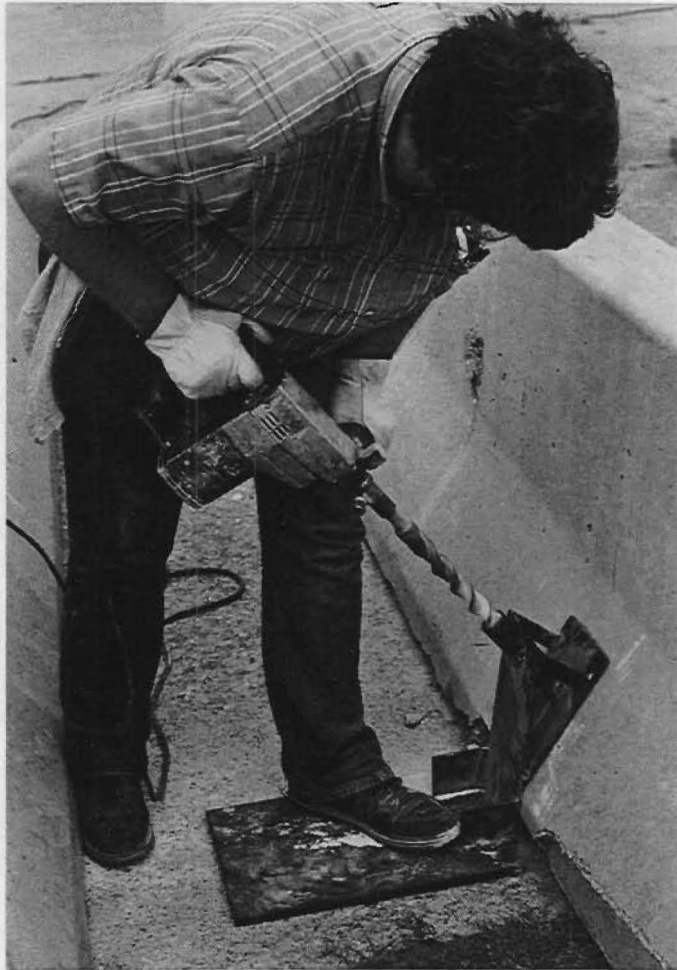
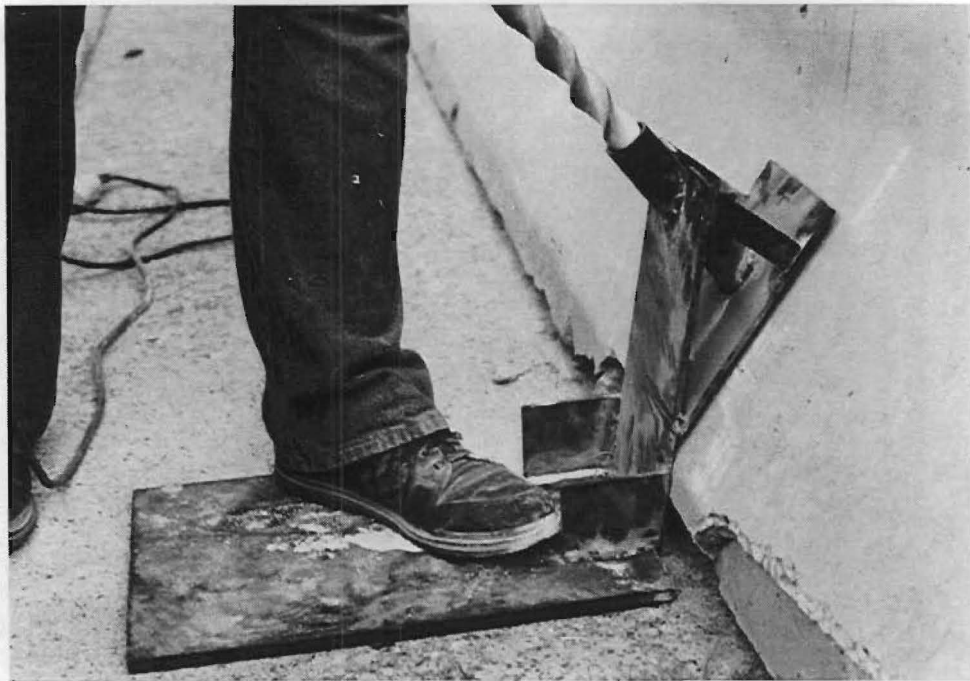
Figure 3. Drilling of PCB.

this process, the drill bit struck a reinforcing bar. When this happened, the hole was abandoned, and the drilling operation was moved about 6 in. (15.24 cm) to the left or right where a new hole was started.

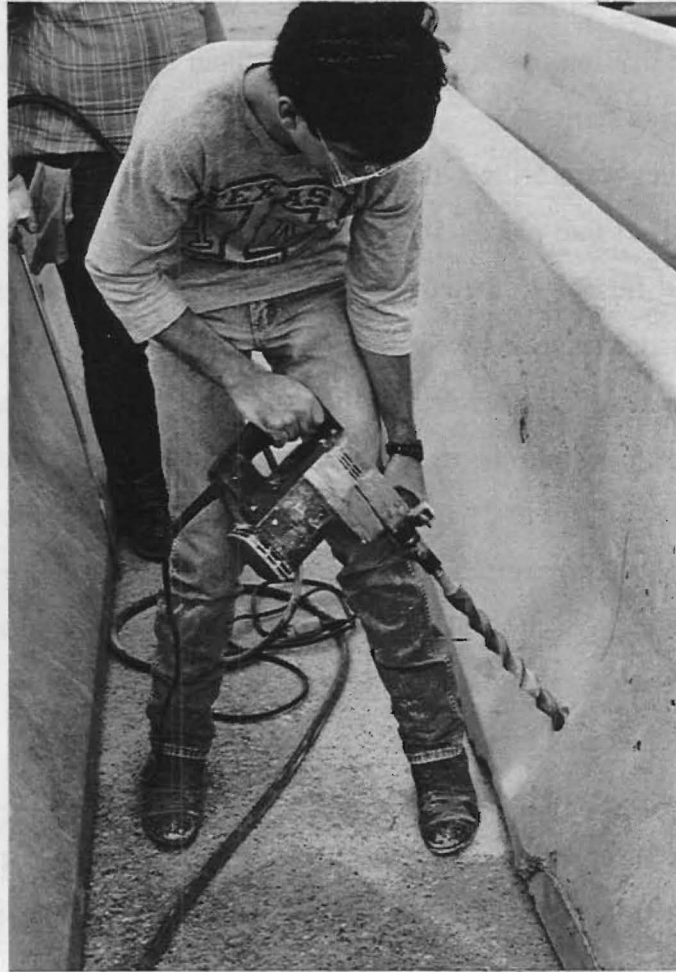
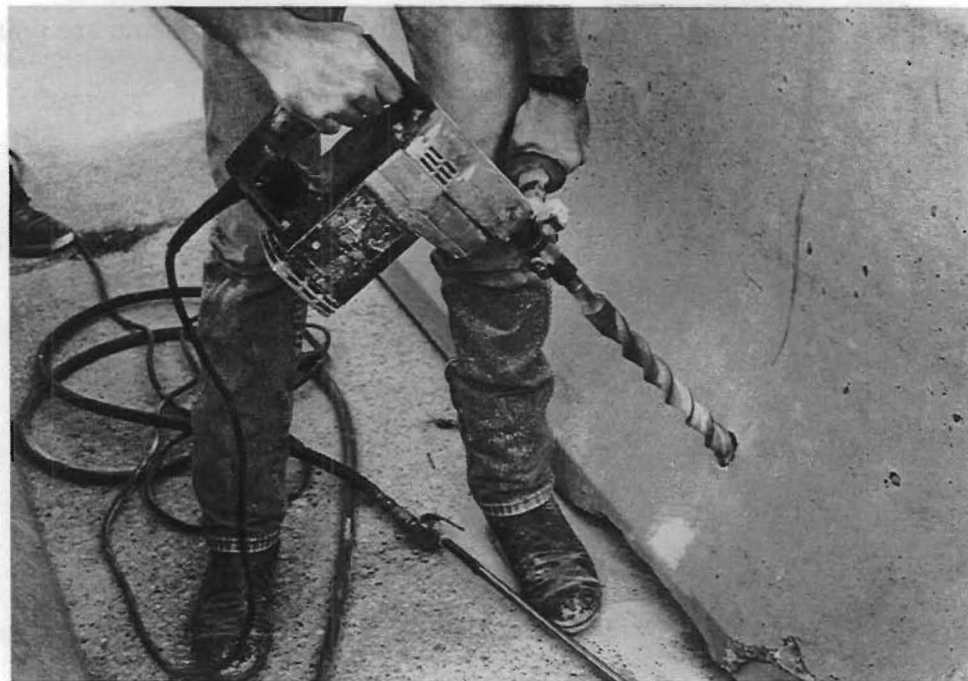
Figure 4. Drilling of pavement.

Once the barrier segments were set into place, the predrilled holes in the barrier segments were used as a guide for drilling holes into the underlying pavement. The depth of penetration of the drill bit into the underlying pavement was controlled by limiting the depth of penetration of the drill bit to 21 in. (53.3 cm). By limiting the depth of penetration of the drill bit to 21 in. (53.3 cm), vertical penetration into the underlying pavement was limited to a depth slightly in excess of 5 in. (12.7 cm), depending on the flatness of the pavement. Thus, typical bridge decks would not be penetrated by this operation. Figure 4 presents two photographs of a technician simulating the final drilling operation.

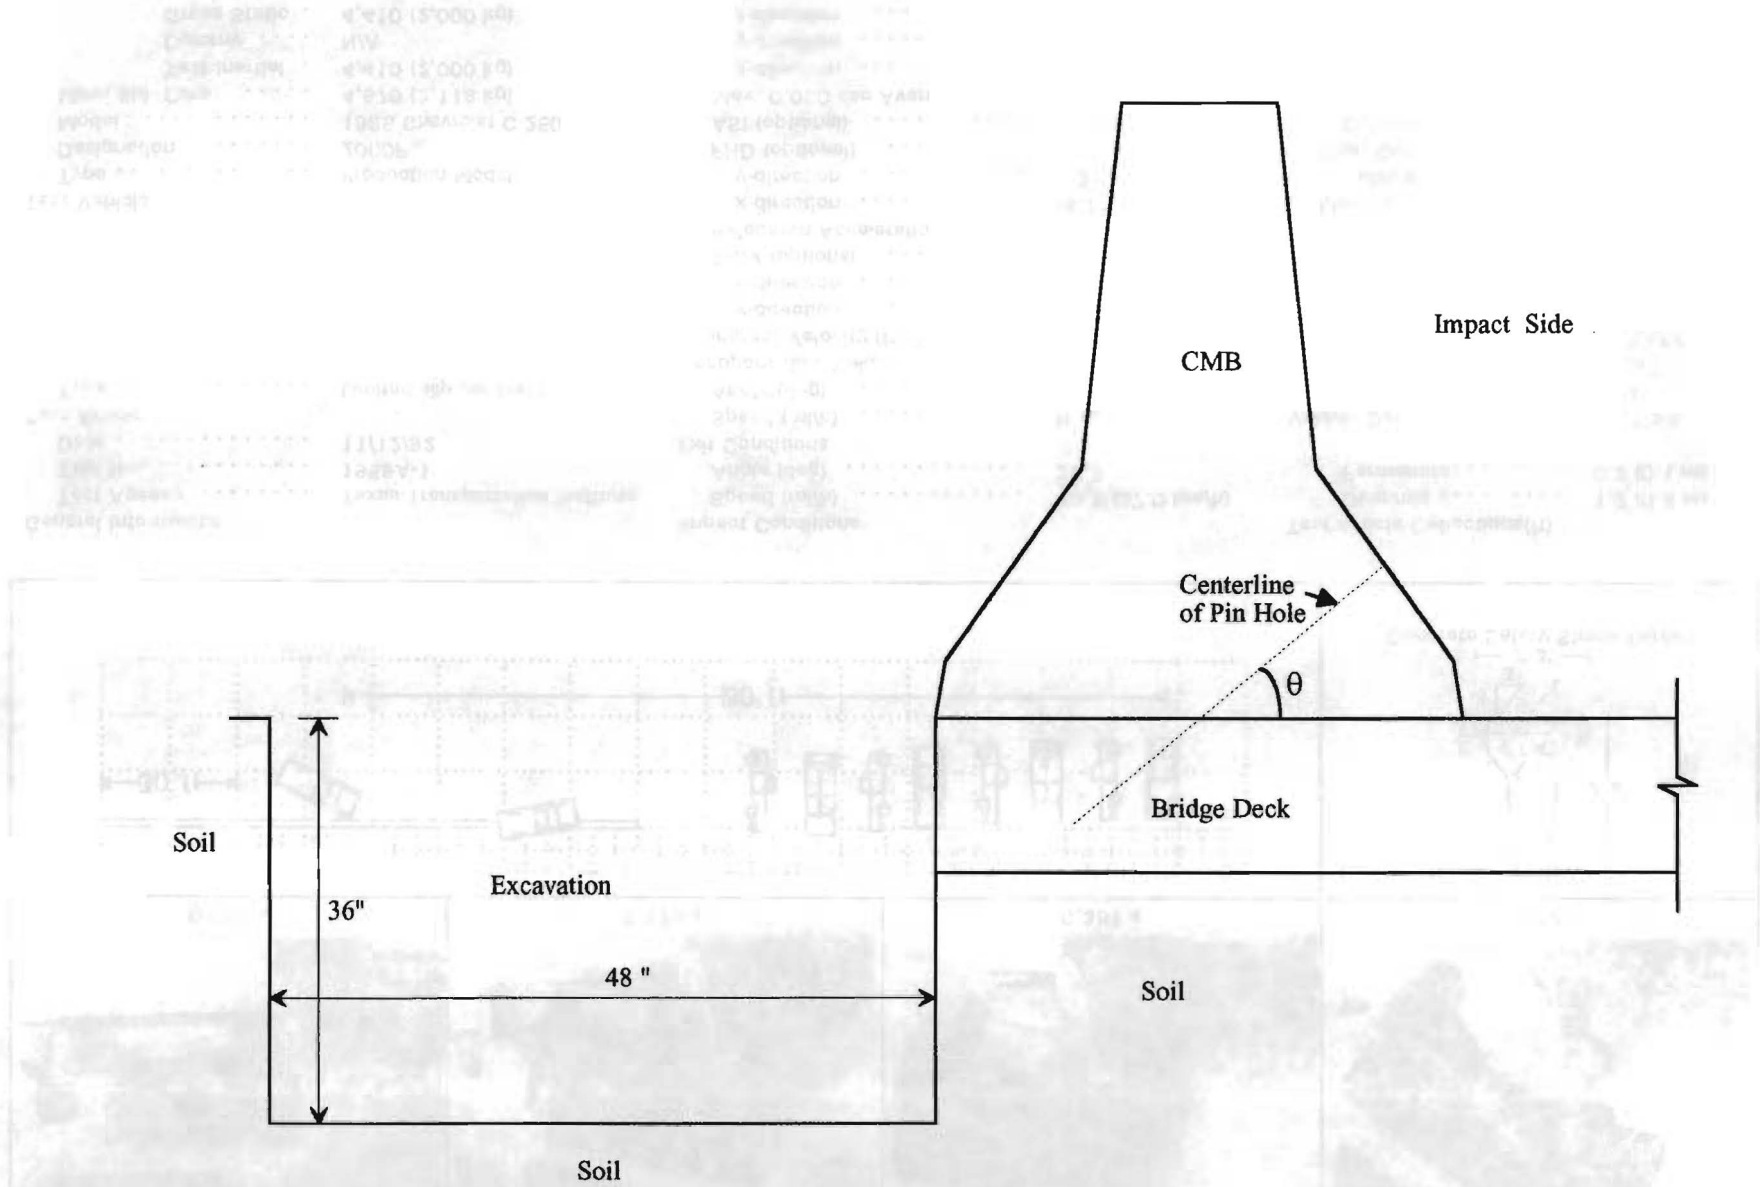
Figure 5. Schematic of test installation.

in Figure 5. This excavation was continued for the full length of the barrier installation so that the barrier would be completely free to drop-off of the edge of the pavement.

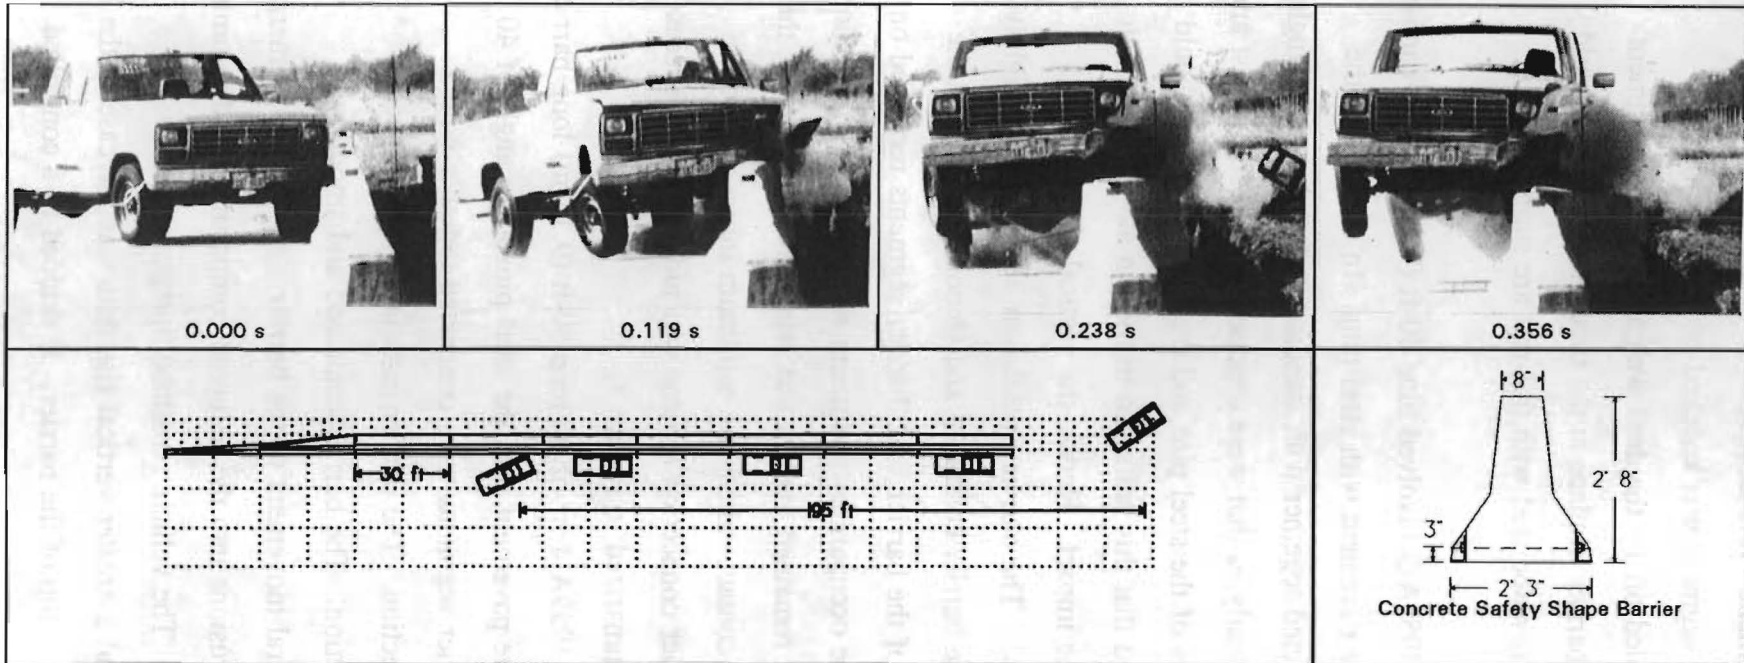
Figure 7. Summary sheet for test 1959A-2.

However, all of the downstream barrier segments were dislodged from the concrete pavement in a domino fashion. Once the first barrier segment was knocked off the edge of the pavement, the next barrier segment was pulled off by the dead weight of the first segment and so on. We believe that the amount of barrier in place at the time of the impact would have been knocked off the deck. The results associated with this test are summarized in Figure 7.

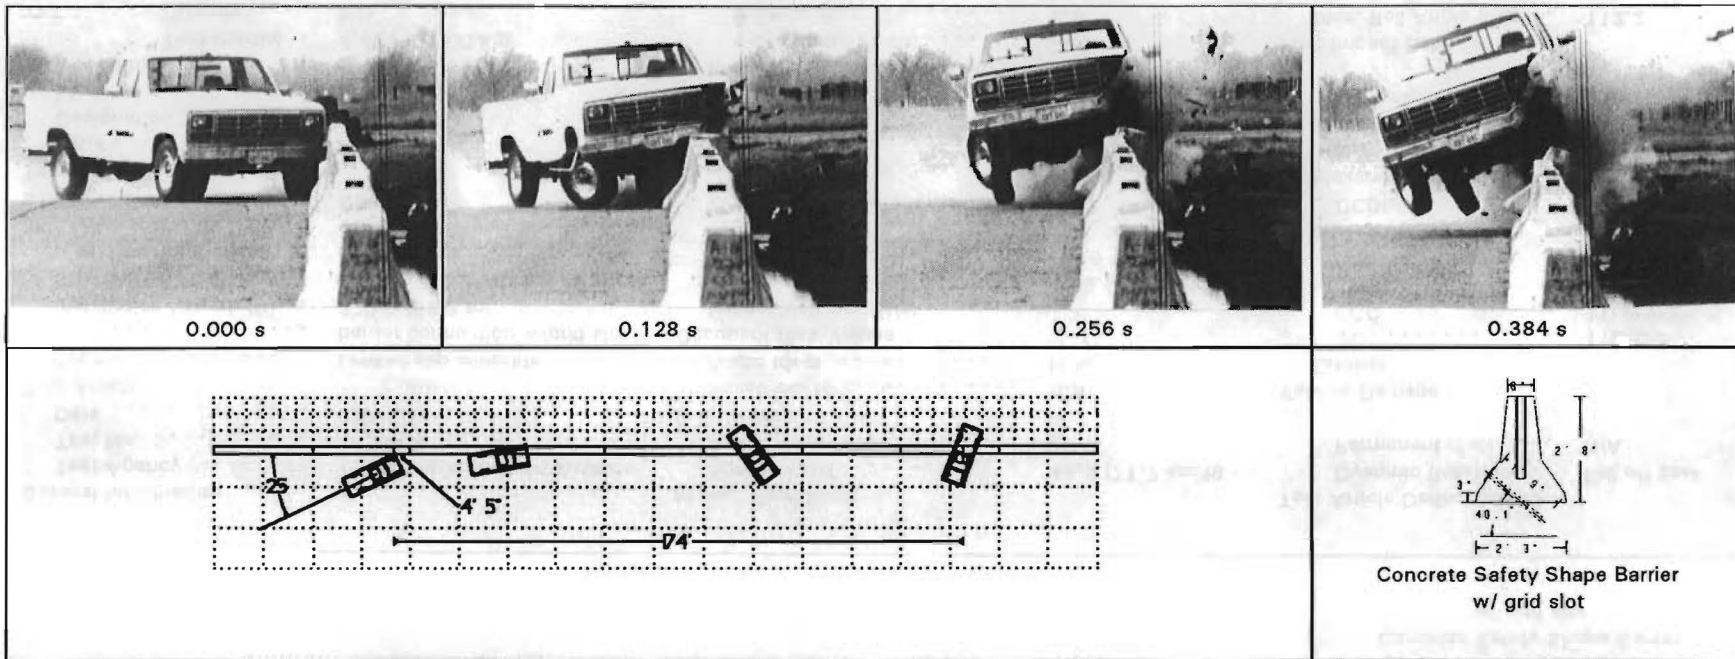
Figure 9. Summary sheet for test 1959A-4.

The barrier installation used in test 1959A-4 involved nine 30-ft (9.14 m) long barrier segments which were pinned to the concrete pavement with the steel pins at an angle of 40.1 degrees with the horizontal axis. The barrier segments were connected together with a standard ungrouted TxDOT grid-slot connection. The barrier installation was impacted slightly ahead of the second barrier connection. The barrier contained and smoothly redirected the test vehicle with limited lateral movement of the barrier. All barrier segments remained on the deck. There were no intrusions into the occupant compartment and minimal deformation of the occupant compartment. The vehicle remained upright and relatively stable during the collision. The vehicle had a greater vertical rise than was the case in the third test. As such, the vehicle ended up on top of the barrier. It skidded to a controlled

stop after traveling 174 ft (57.1 m) and remained on top of the barrier. Therefore, there was no intrusion into the adjacent traffic lanes. This barrier connection scheme was judged to be a success. The results associated with this test are summarized in Figure 9.

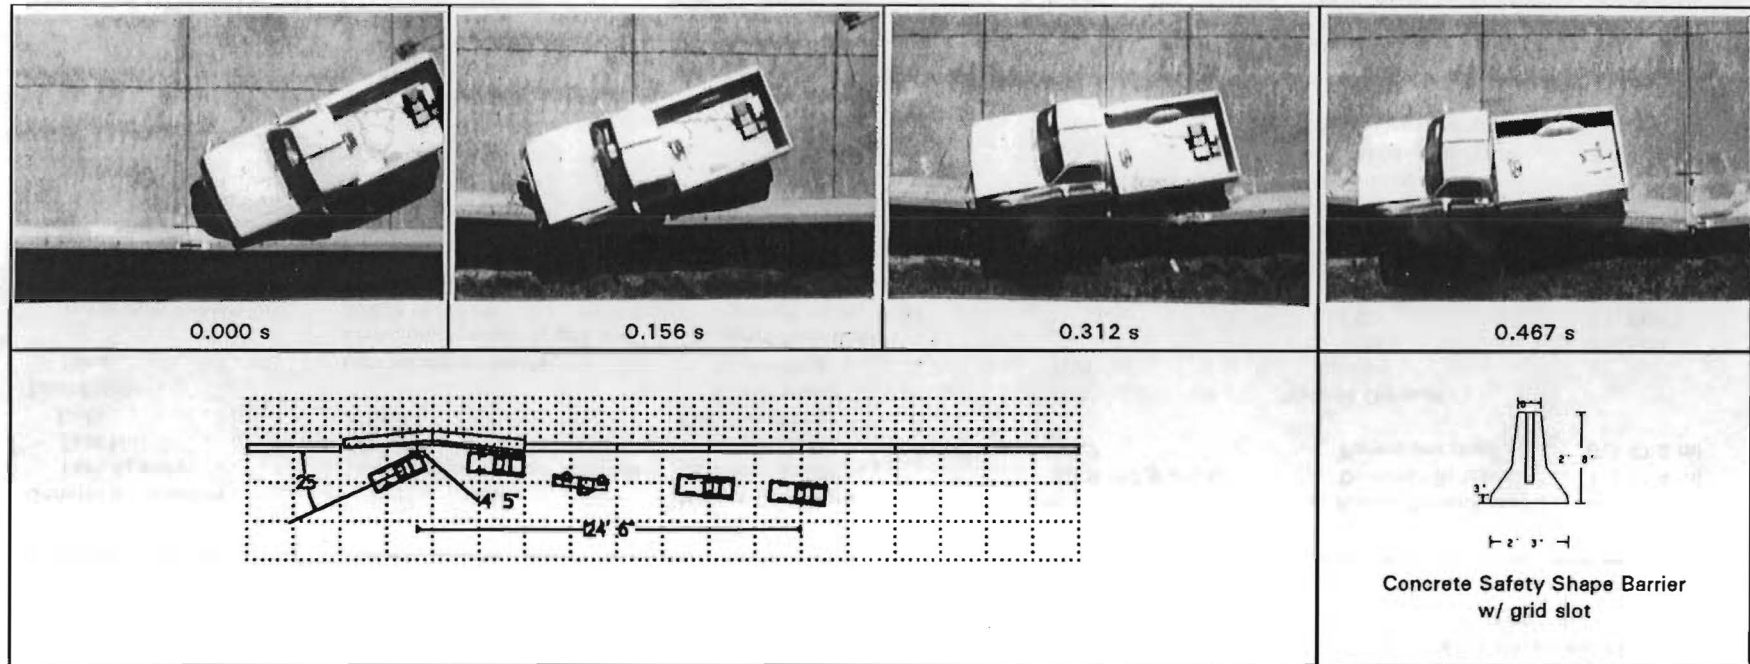
Figure 10. Summary sheet for test 1959A-5.

Test 1959A-5 was conducted to determine if an unpinned barrier installation employing a standard ungrouted TxDOT grid slot connection could successfully redirect a low speed [45 mph (72.5 km/h)] impact of a 4,500-lb (2043 kg) 3/4-ton pickup impacting with an angle of 25 degrees. Nine 30-ft (9.14 m) long segments were used in the barrier installation. The impact point was located just ahead of the second barrier joint. The impact knocked two barrier sections off of the edge of the concrete pavement. The vehicle was successfully redirected back onto the roadway. However, shortly after loss of contact with the barrier, the vehicle rolled completely over on its right side. It then skidded a short distance and rolled back to an upright position. While there were no intrusions into the occupant compartment and minimal deformation of the occupant compartment, the results were not judged to be acceptable because the vehicle rolled onto its side. In addition, it was not considered acceptable that two barrier segments were knocked off the concrete pavement. The results associated with this test are summarized in Figure 10.

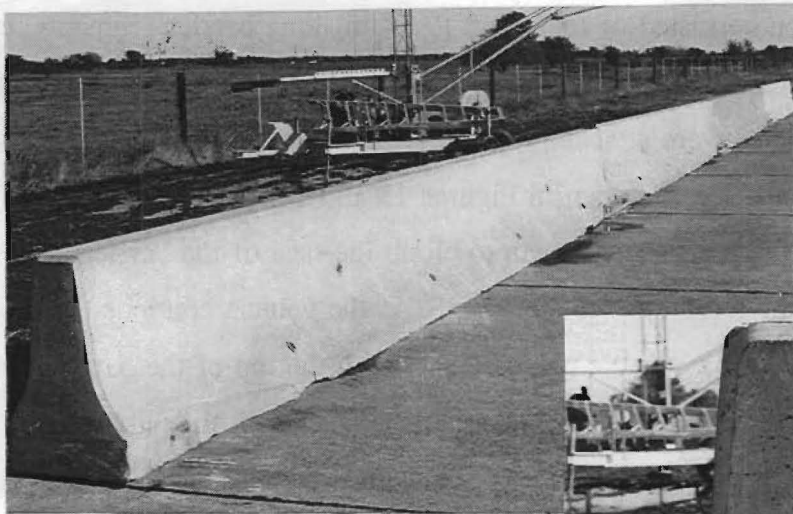
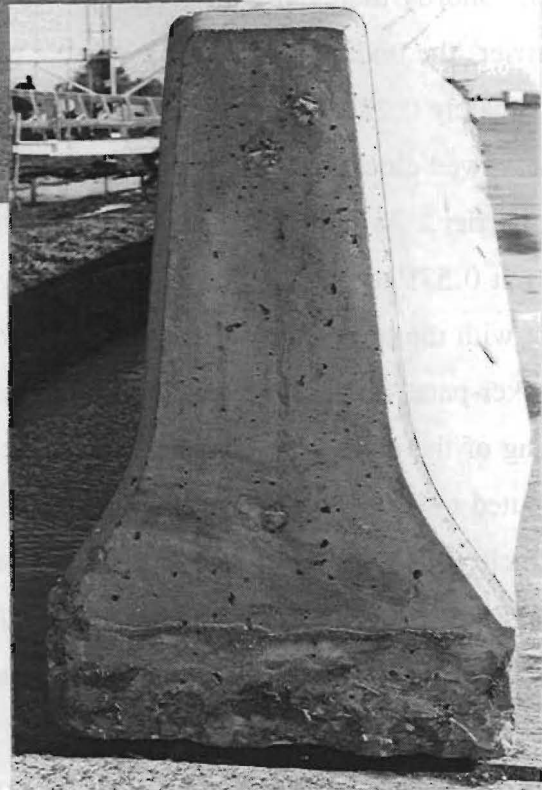
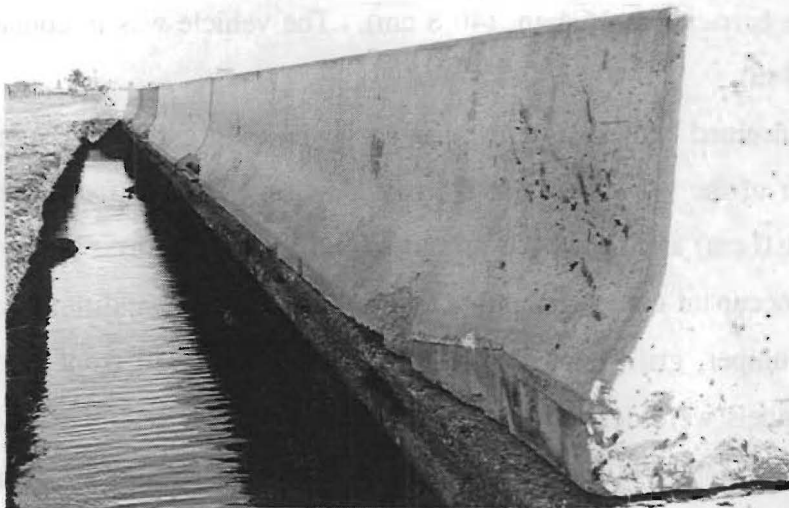
Figure 13. Limited-slip concrete barrier connection test 1959A-1 installation.

The barrier installation consisted of four 30-ft (9.14 m) long barrier segments, each connected to the concrete pavement with four steel pins oriented at an angle of 53.1 degrees. In addition, the barrier segments were attached together with a standard channel/angle splice connection. The barrier installation is shown in Figures 13 and 14.

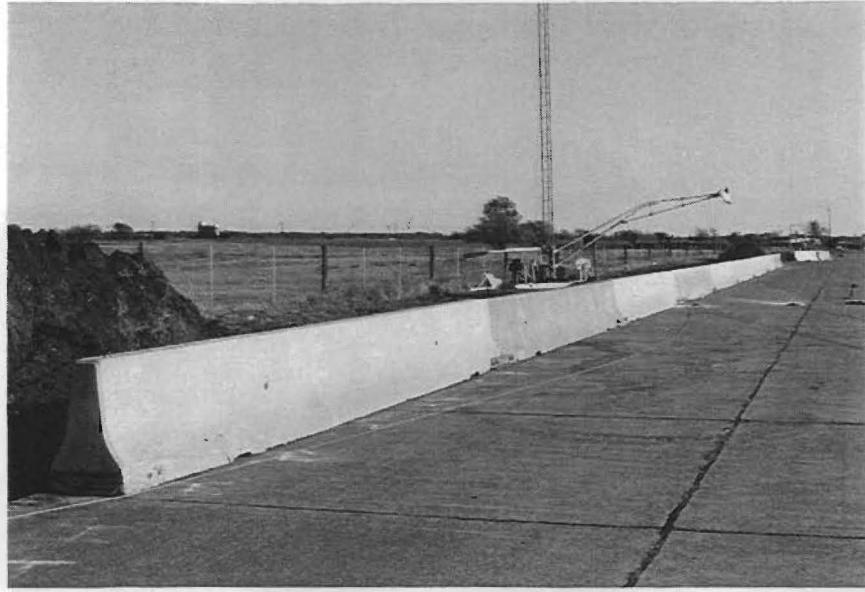
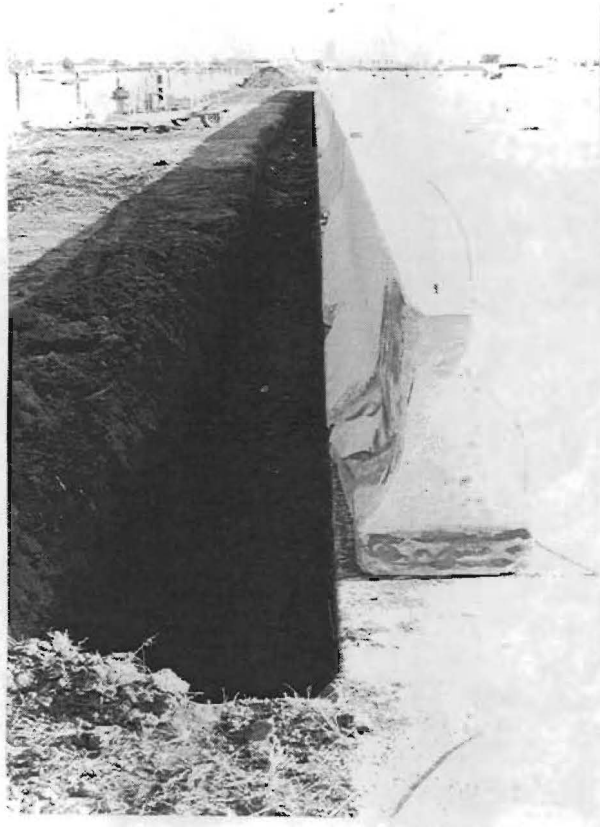
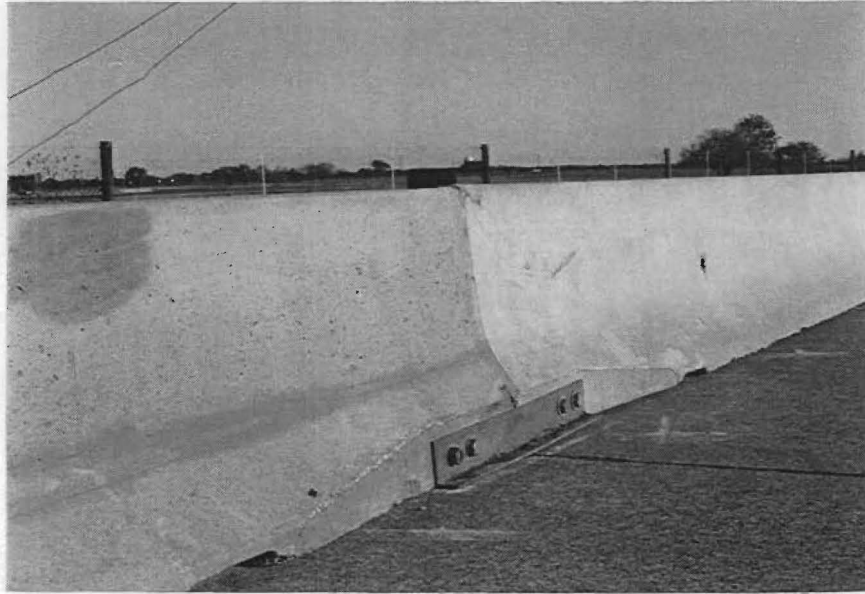
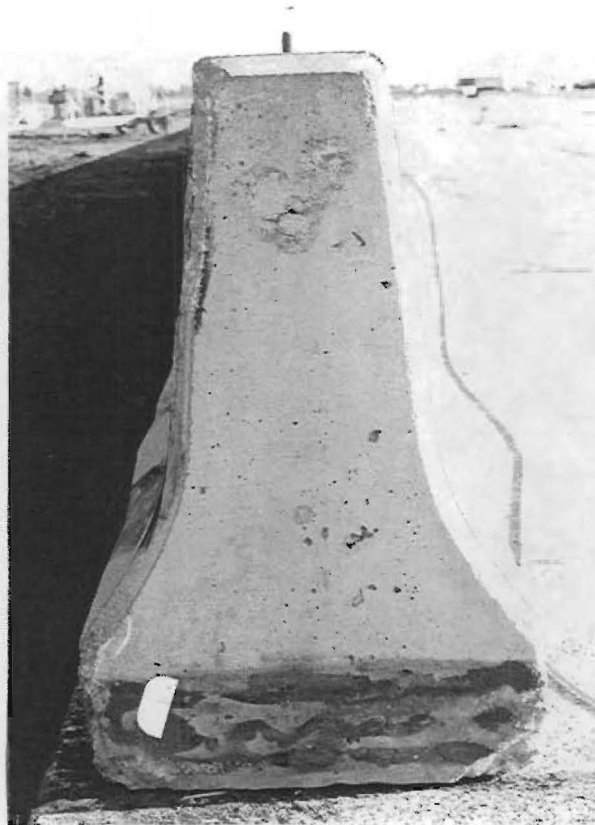
Figure 20. Limited-slip concrete barrier connection test 1959A-2 installation.

The barrier installation consisted of nine 30-ft (9.14 m) long barrier segments which were not connected to the concrete pavement. However, the barrier segments were attached together with a standard channel/angle splice connection. The barrier installation is shown in Figures 20.

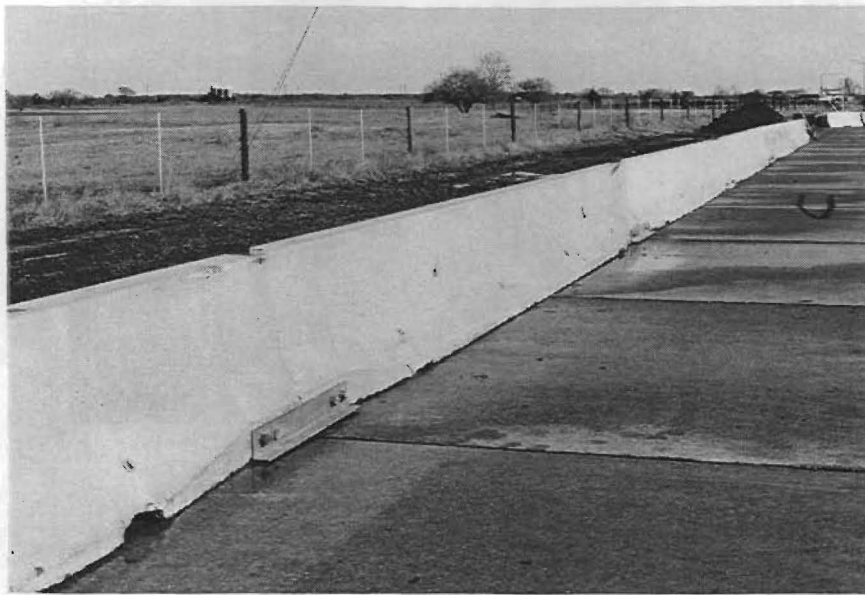
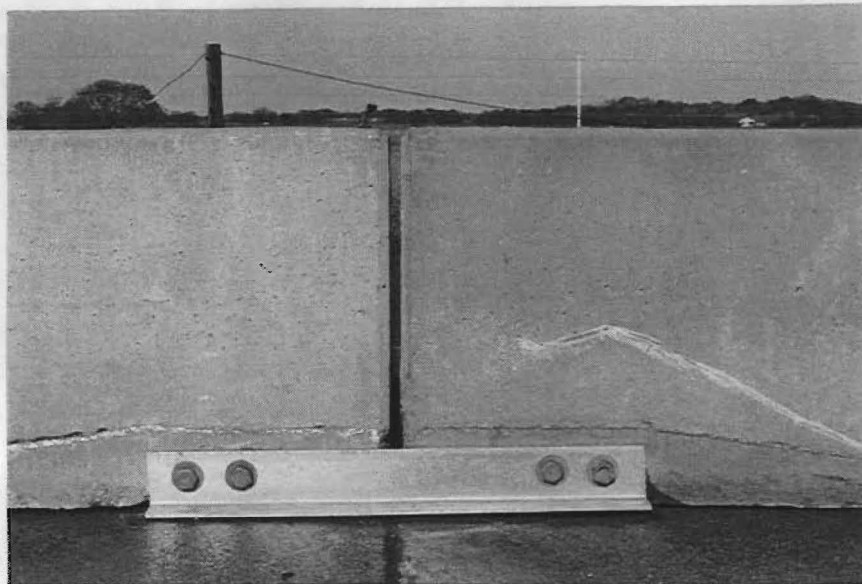
Figure 26. Limited slip concrete barrier connection test 1959A-3 installation.

The barrier installation consisted of nine 30-ft (9.14 m) long barrier segments, each connected to the concrete pavement with four steel pins oriented at an angle of 40.1 degrees. In addition, the barrier segments were attached together with a standard channel/angle splice connection. The barrier installation is shown in Figures 26 and 27.

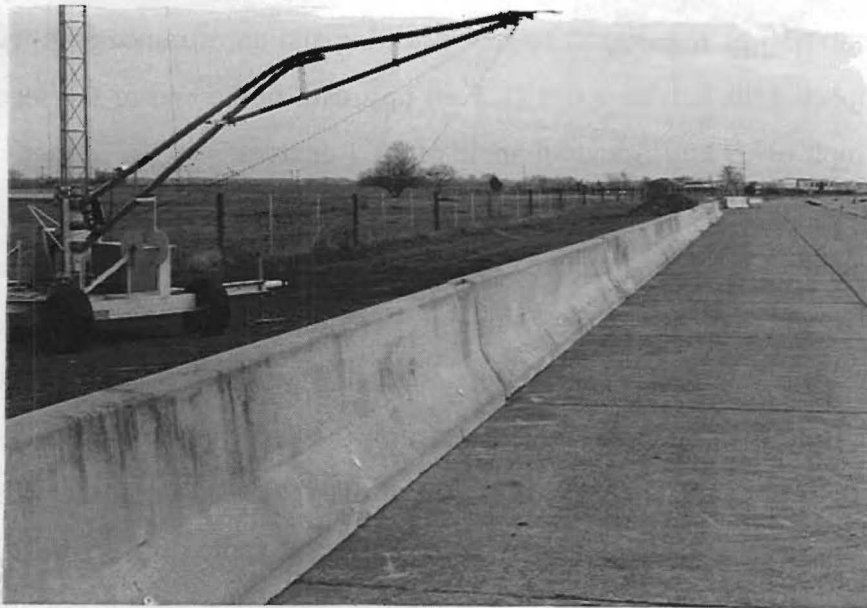
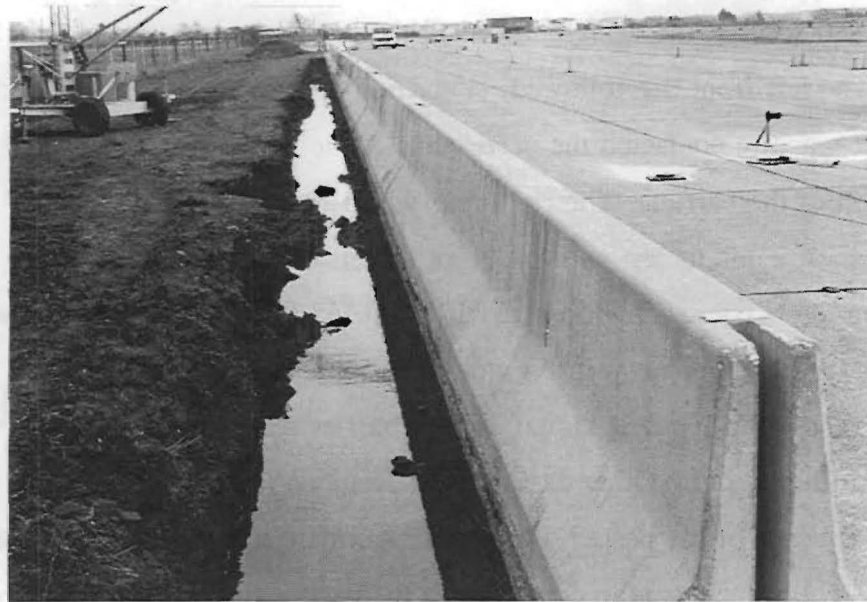
Figure 33. Limited slip concrete barrier with grid-slot connection (test installation 1959A-4).

The barrier installation consisted of nine 30-ft (9.14 m) long barrier segments which were each connected to the concrete pavement with four steel pins oriented at an angle of 40.1 degrees. In addition, the barrier segments were attached together with a standard ungrouted grid slot connection. The barrier installation is shown in Figures 33 and 34.

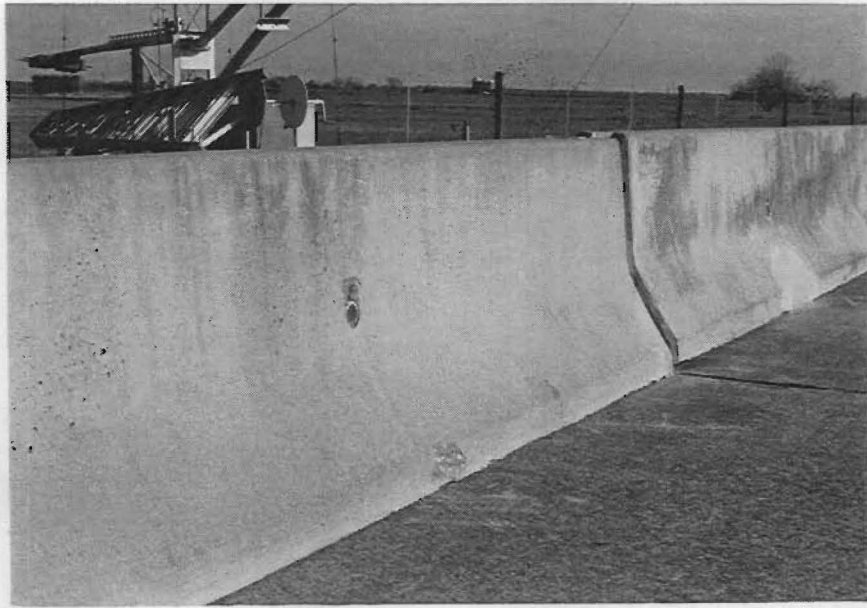
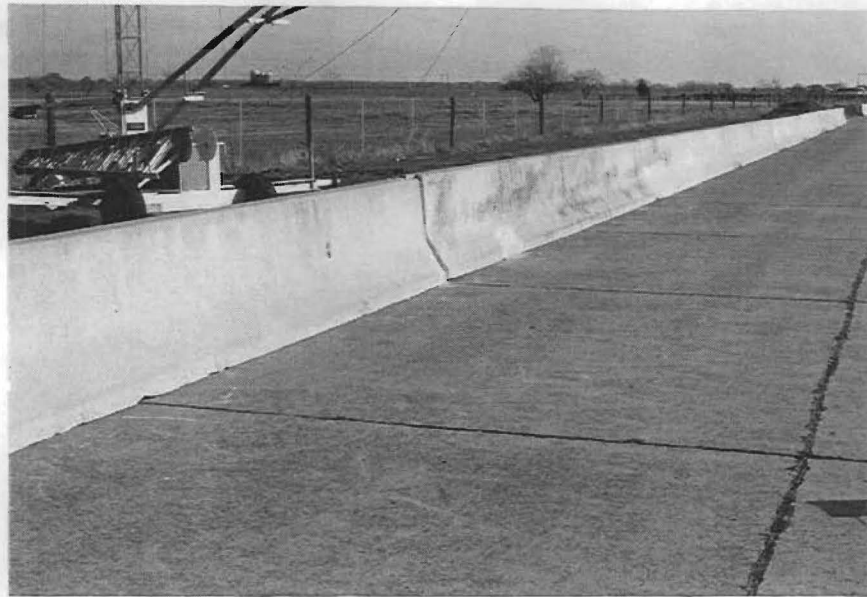
Figure 40. Limited slip concrete barrier with grid-slot connection (test installation 1959A-5).

The barrier installation consisted of nine 30-ft (9.14 m) long barrier segments which were not connected to the concrete pavement. The barrier segments were attached together with a standard, ungrouted grid-slot connection. The barrier installation is shown in Figures 40 and 41.
