EVALUATION OF FABRIC INTERLAYERS

Research Report 261-2

TEXAS TRANSPORTATION INSTITUTE

November, 1982

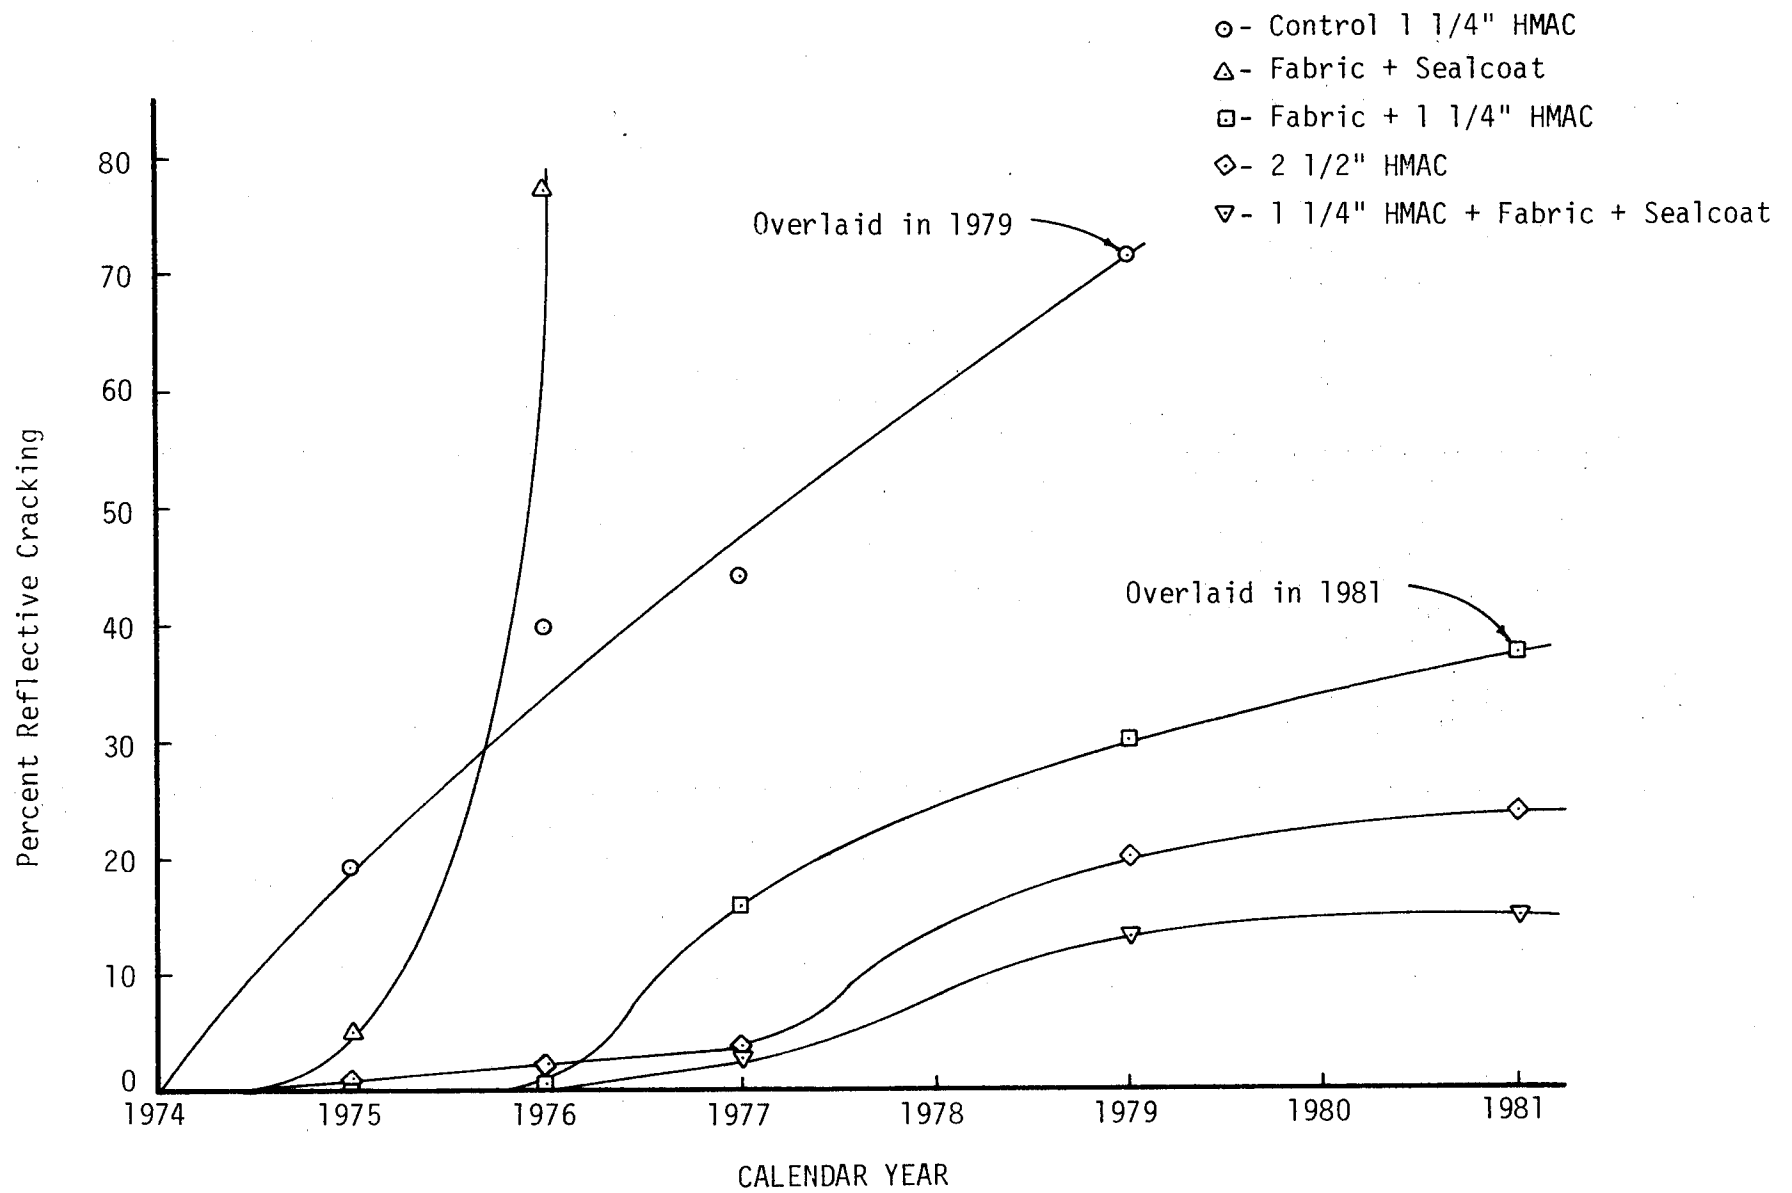
Figure 7. Reflection Cracking Progression for Selected Rehabilitative Treatments. (After Reference 7)

Chronological progression of reflection cracking for selected District 6 test sections is depicted in Figure 7. This plot illustrates the rapid progression of reflection cracks during the first year or two for the sealcoat plus fabric and the conventional thin (1 1/4-inch) overlay; whereas, the thicker overlay (2 1/2-inch) and those overlays reinforced and/or undersealed with a fabric and/or a sealcoat exhibited a delay of 2 to 3 years before significant reflection cracking was visible.
