DEVELOPMENT OF A SAFE END TREATMENT FOR W-BEAM-ON-BARRELS BARRIER

Research Report 262-6F

Research Study No. 2-18-79-262 Safety Devices for Highway Work Zones

November 1984

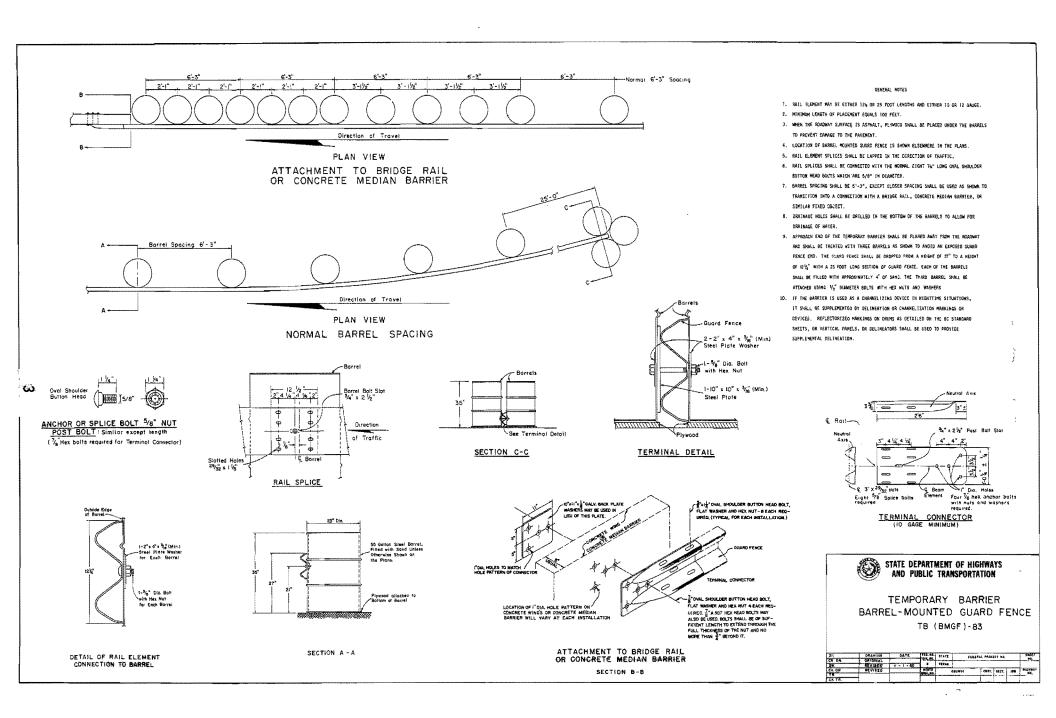
Figure 1. Existing W-Beam on Barrel Configuration

The WBBB end treatment currently used in Texas is essentially a tapered terminal where the end of the W-beam rail is bent down to the ground. In addition to the taper, the rail end is flared away from the travelway approximately 4 ft (1.2 m) over a distance of approximately 50 ft (15.1 m). The end of the W-beam is held in place by three steel drums at the nose containing 4 in. (10.2 cm) of sand. A 25 ft (7.7 m) section of unsupported rail separates the three steel drums at the nose of the treatment and the beginning of the length of need for the barrier. Figure 1 shows drawings of the existing WBBB terminal design and Figure 2 shows photographs of the constructed end treatment. Note that steel barrels at the beginning of the length of need of the barrier are full of sand as shown in Figure 3. Preliminary analysis of the impact performance of the existing end treatment for WBBB was inconclusive. Therefore, full-scale crash testing of the design was undertaken to accurately determine the crashworthiness of the terminal.

The W-beam-on-barrels barrier has been shown to be a cost beneficial, low service, temporary barrier and is used widely across Texas. No safe end treatment for the WBBB had been previously tested successfully. The end treatment currently used in Texas, shown in Figures 1, 2, and 3, utilized a bent-down guardrail element with a cluster of three steel drums at the end to hold the rail in place and cushion head-on impacts. This end treatment, although difficult to construct, was found to be installed correctly by most contractors using the WBBB, and it contains no obvious safety problems. Therefore, this end treatment was selected for full-scale crash test evaluation.

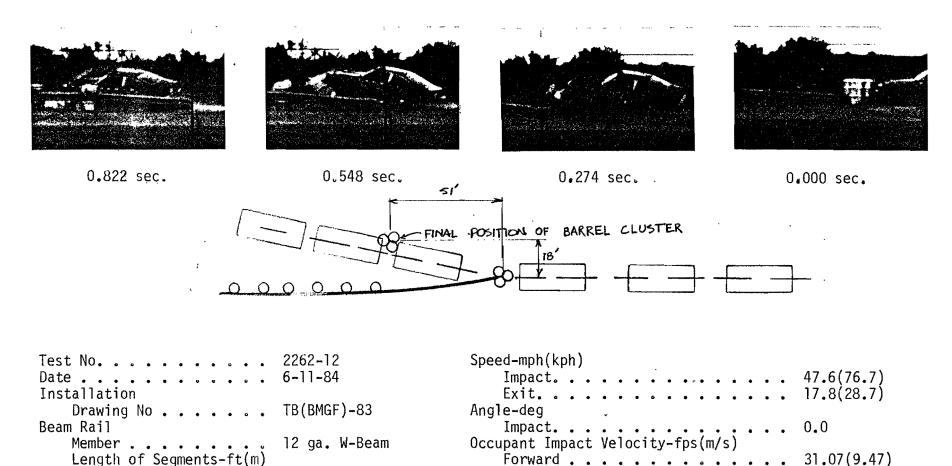
Figure 4. Summary of Test 12

Test 12*. In the first test a 2410 lb (1095 kg) vehicle impacted the three-barrel end cluster at 48 mph (77 km/h) and an impact angle of 0°. The centerline of the impacting vehicle was offset 15 in. (38 cm) from the center nose of the end treatment. Upon impact the 25 ft (7.7 m) section of unsupported W-beam buckled through the bolt holes midway between the end of the terminal and the beginning of the length of need. The vehicle then rode up onto the clustered barrels and dragged them along as the test vehicle continued to travel behind the barrier. The test vehicle came to rest approximately 55 ft (17 m) from the point of impact. Figure 4 summarizes the results of test 12.

The longitudinal occupant impact velocity measured during the test was $31 \, \text{ft/sec}$ (9.6 m/sec). This value is only slightly higher than the recommended maximum longitudinal impact velocity of $30 \, \text{ft/sec}$ (9.3 m/sec) and is much lower than the maximum allowable limit of $40 \, \text{ft/sec}$ (12.3 m/sec) (2). The measured lateral occupant impact velocity was $6 \, \text{ft/sec}$ (1.9 m/sec), which is much lower than the recommended limits (2). Longitudinal and lateral ridedown accelerations of $3.8 \, \text{and} \, 2.1 \, \text{g's}$, respectively, were also well below recommended limits (2). Figures $5 \, \text{and} \, 6 \, \text{show}$ the test vehicle before and after the test. Figure $7 \, \text{shows}$ the damage to the test

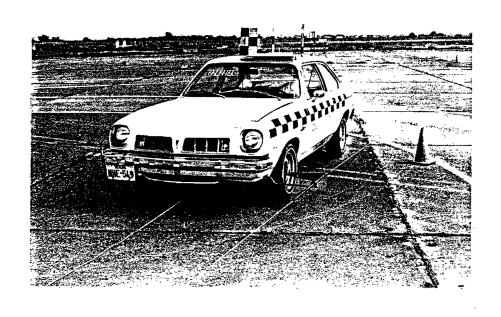
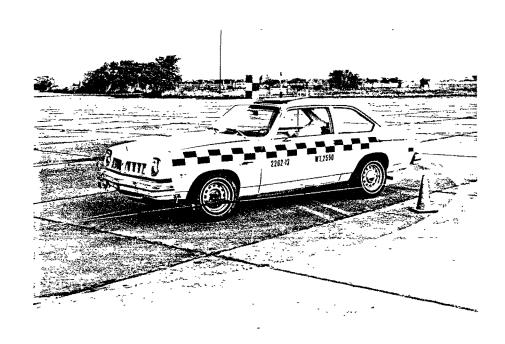
Figure 9. Test Vehicle Before Test 13

Figure 8 summarizes the results of test 13. Although, as shown in Figure 8, impact severity evaluation criteria were within recommended limits, the test was considered to be a failure since the vehicle rolled over. Figures 9 and 10 show the test vehicle before and after the test, and Figure 11 shows test installation damage.

Test 14. After review of the results of test 13, it was concluded that the WBBB end treatment must be modified to prevent impacting vehicles from mounting the bent down guardrail. The end treatment was then modified as shown in Figures 12 and 13. As shown in Figure 12 the bent down rail was raised to the normal height of the W-beam, and the cluster of barrels at the nose of the terminal was replaced with a single barrel. A standard W-beam

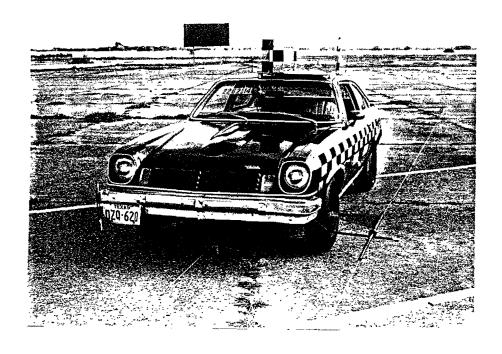
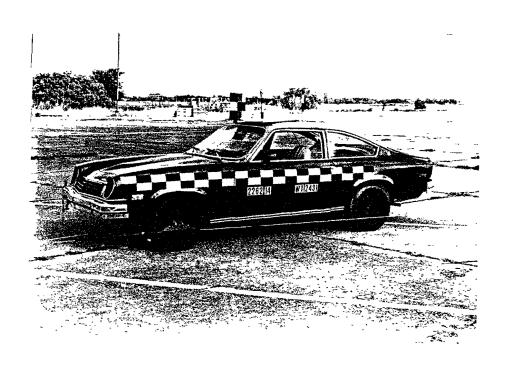
Figure 15. Test Vehicle Before Test 14

The forward and lateral occupant impact velocities were 16.7 and 8.4 ft/sec (5.2 and 2.6 m/sec), respectively, while the forward and lateral ridedown velocities were 11.4 and 9.2 g's, respectively. These values are well below the recommended values cited in NCHRP Report 230. Figures 15 and 16 show the test vehicle before and after testing. As illustrated, the

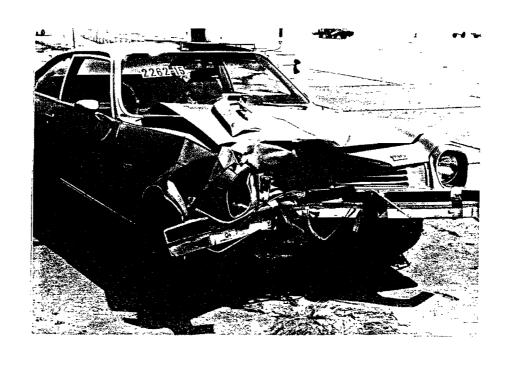
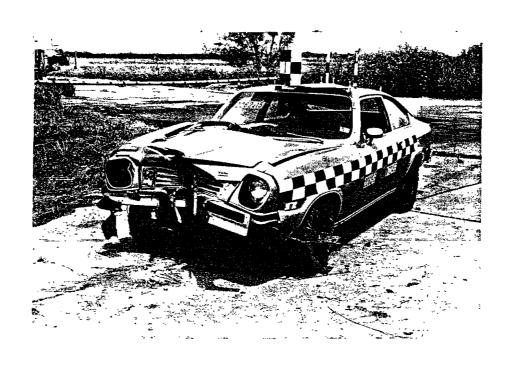
Figure 20. Test Vehicle After Test 15

Figure 18 shows a summary of test 15. As shown in this figure the longitudinal occupant impact velocity was 35 ft/sec (10.8 m/sec), which is above the recommended limit of 30 ft/sec (9.3 m/sec) but below the maximum allowable limit of 0 ft/sec (12.3 m/sec) ($\underline{2}$). All other measures of impact severity shown in Figure 18 were well below the recommended values. Figures 19 and 20 show the damage incurred by the test vehicle, and Figure 21 shows the damage sustained by the test installation. Although the longitudinal occupant impact velocity was above recommended limits for this test, the test was considered to be a success because the impact velocity was within maximum acceptable limits and the test passed all other methods of evaluation.
