BRIDGE SLAB CONCRETE PLACED ADJACENT
TO MOVING LIVE LOADS

Research Report Number 266-1F
Bridge Slab Concrete Placed Adjacent to
Moving Live Loads
Research Study Number 2-5-79-266

Texas Transportation Institute
The Texas A&M University System
College Station, Texas

January 1981

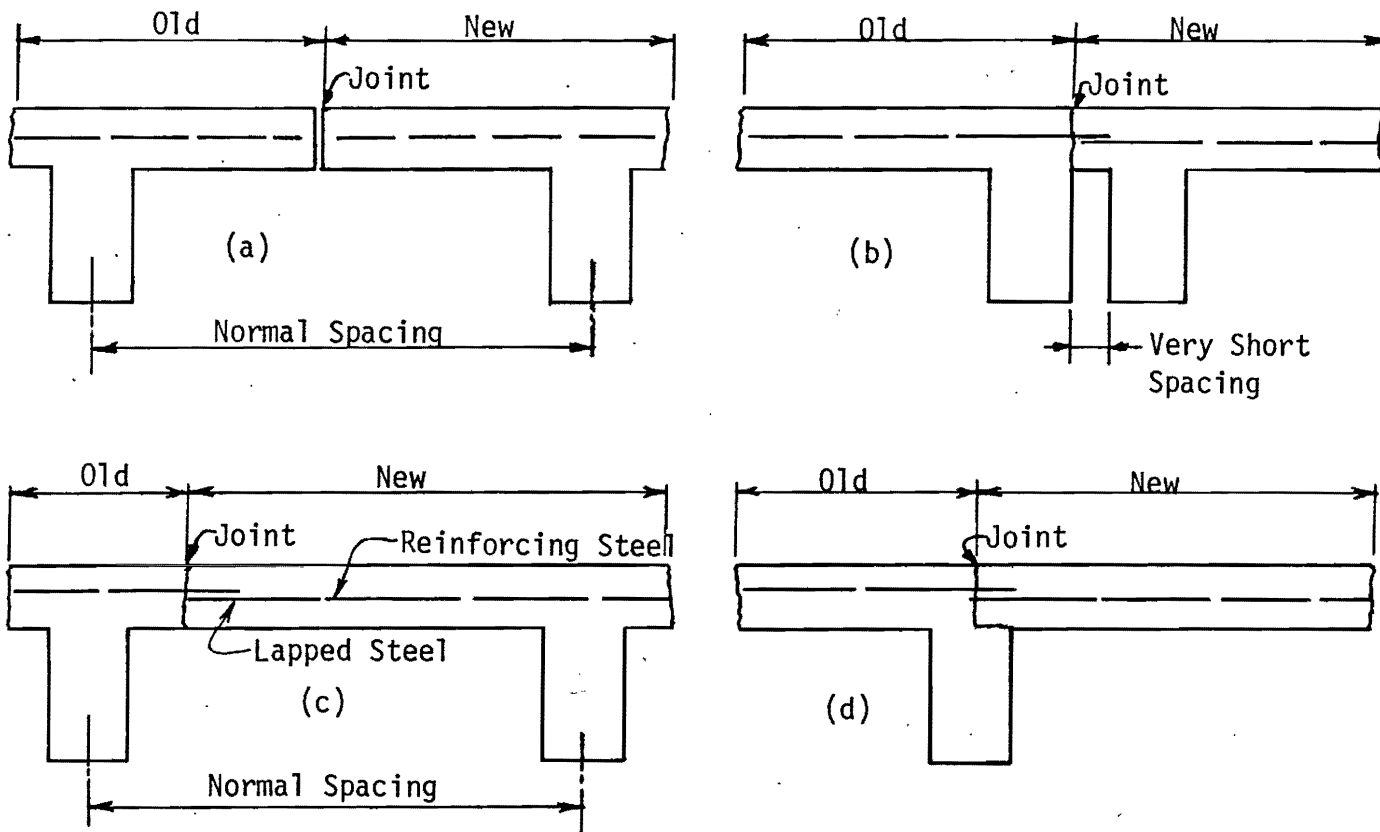
Figure 1. Types of Construction that Connect New Concrete to Existing Structure in Bridges Listed in Appendix A.

The joint between old and new material is sometimes made directly over a supporting beam, and sometimes between beams. SDHPT uses both methods, see Figure 1, whereas California preference is for forming the joint between beams. The survey of bridges listed in Appendix A found no problem that would indicate preference of one over the other.

The third type, shown in Figure 1(c), was used in most of the bridges. No evidence of problems in the deck that could be associated with this type of joint, nor that shown in Figure 1(d), was found.

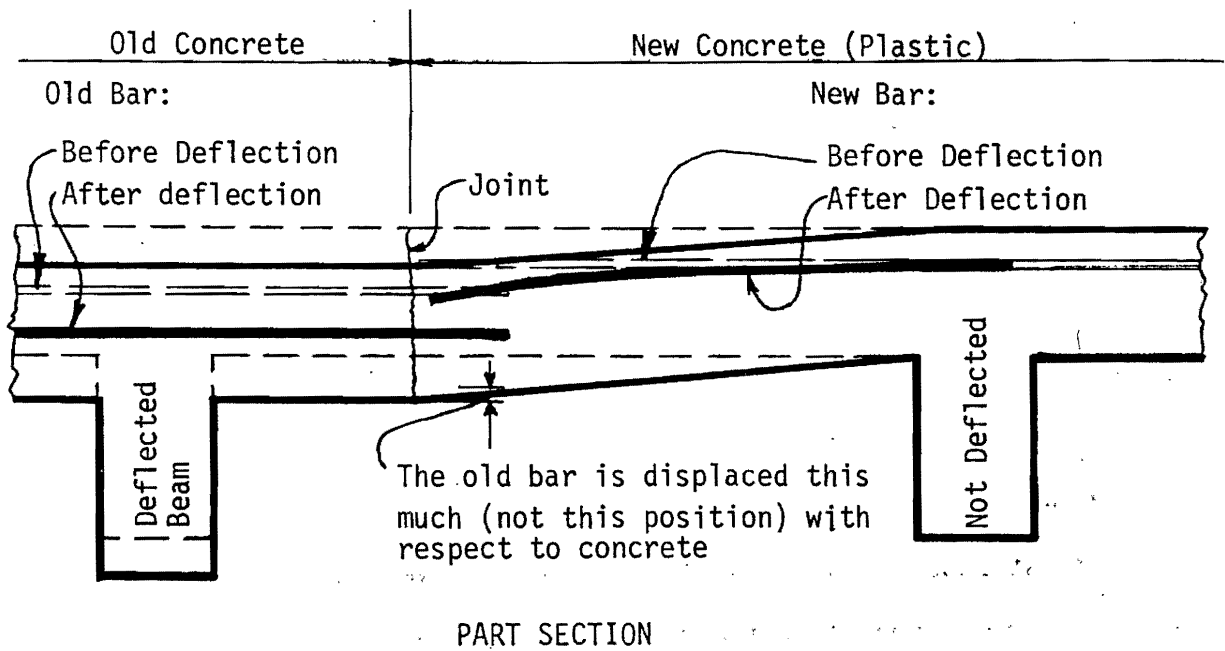
Figure 2. Relative Movements Between Old and New Concretes When Traffic Moves Across the Bridge.

Regardless of whether the joint is made over a beam or between beams, the deflection when traffic moves over the structure causes movement of the fresh concrete. If a closure pour is used, the movement would occur in the fresh material of the closure strip. Figure 2 illustrates this type of movement. The reinforcing steel crosses over from the joint and is embedded in concrete when the new portion of the deck is cast. This bar might be lap tied to reinforcement placed for the new slab, or it might simply cantilever out from the existing material. When a vehicle crosses the bridge it deflects the existing slab. The added part is deflected some, because of diaphragm action, but not nearly as much as the old deck. The deck forms between the old and new are supported on a stiff spanner between beams, and the deflection of that form is linear between the beams. If the form is stay-in-place steel, it behaves in a similar way.

The stub bar from the existing material moves down with the old slab; it has little or no bending between its cantilevered end and the joint. In the overall movement, the end of this bar moves closer to the bottom form, and in doing so it displaces plastic concrete. The same general behavior can be predicted for the transverse reinforcing, in the new deck, which very likely extends all the way to the joint, overlapping the stub bar.

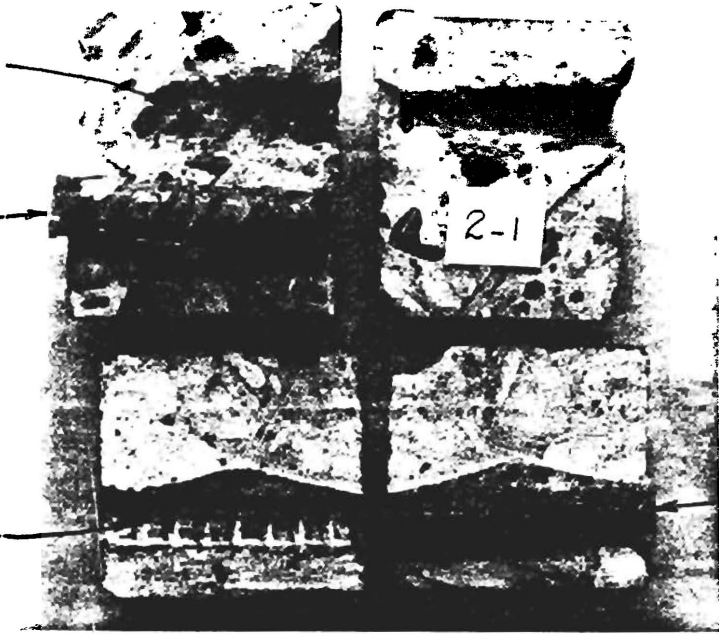
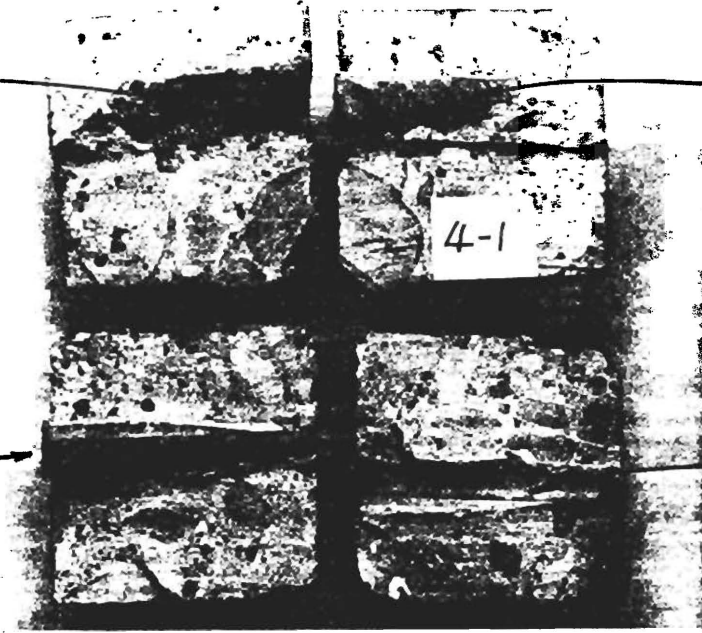
The study of the second set of five cores indicated that bonding of the dowel bars, connecting between the old and new decks of a bridge, or bars tied to them, may be somewhat deficient or imperfect. Cores 2-1, 3-1 and 4-1 were obtained from that portion of the beam which had a dowel bar as well as top and bottom steel. These cores were compared to core 5-2 which was obtained from the middle portion of the beam where relative movement between the steel and concrete is highly improbable. In all three cores, the dye penetrated through the ends of the dowel bar and the #5 top bar, completely soaking the whole embedment surface of the bar. Also, bar imprints were not sharp and well defined for at least one bar in each of the three cores. The undisturbed core, 5-2, did not display any bond problems, and dye penetration at the ends of the #5 top bar was 1/4 in. at most. These results indicate that some slight movement does in fact occur between the dowel bar and the fresh plastic concrete, and unfavorable bond might result from such action.

In cores 2-1 and 4-1, the condition of bonding of the dowel bar and #5 top bar were compared to that of the bottom #4 bar. The latter bar had very sharp and well defined imprints, and dye penetration was minimal. Figure 38 shows photographs of cores 2-1 and 4-1. The darker bar cavity of the dowel bars indicate that dye has penetrated through end of bar.

#5

Area Clear of Dye

#4

Area Darkened by Dye

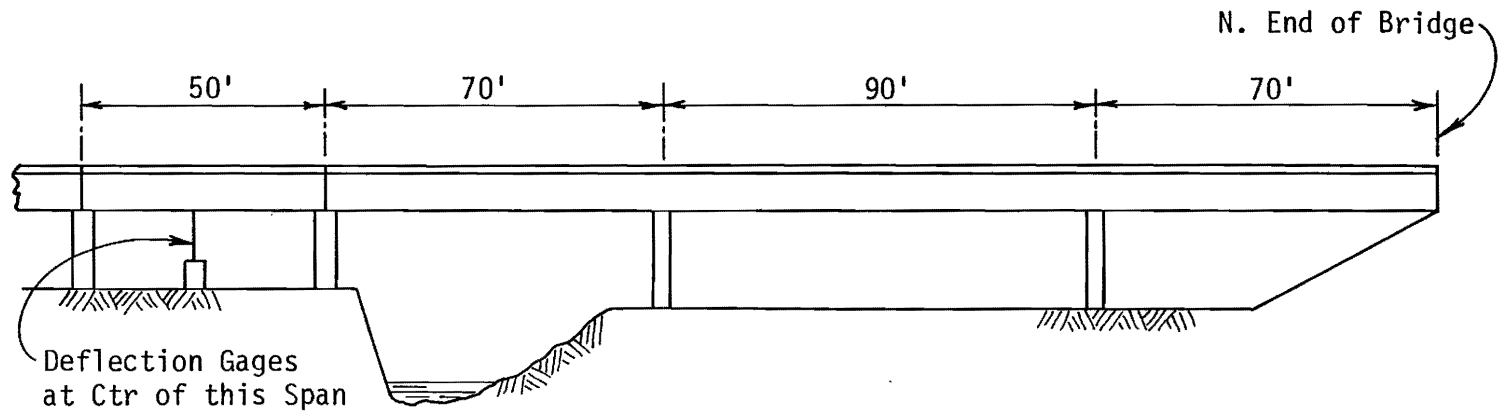
Figure B-6. US 75 & White Rock Creek, Southbound: Core Locations.

CORE MARK	LENGTH (in.)	TREATMENT	CONTINUOUS REINF.	REMARKS
Bridge: US 75 at White Rock Creek, Dallas, Texas Southbound traffic, 50 ft span except core WRD10F which comes from the 90 ft span (13 cores)				
WRDU1	6 1/4	TPF	None	Random hairline cracks.
WRDU2	6 3/4	TPF	Steel	No visible defects.
WRDU3	3	TPF	None	Random hairline cracks.
WRDD1F	8 1/2	TPF	Steel	Random hairline cracks.
WRDD2F	8 1/2	TPF US	Steel	Random hairline cracks; numerous large air bubbles.
WRDD3F	8 1/4	TPF Dye	Steel	The two top #5 bars, one perpendicular to traffic, the other parallel to traffic, have small crack-like voids on one exposed side of each bar. Random hairline cracks.
WRDD4F	8 1/4	TPF Dye	Steel	Random hairline cracks; many air bubbles.
WRDD5	8 1/4	TPF US	Steel	No visible defects.
WRDD6F	8 1/4	TPF	Steel	Random hairline cracks.
WRDD7	4 3/4	TPF Dye	Steel	No visible defects.
WRDD8	6	TPF	Steel	Random hairline cracks.
WRDD9	4 1/2	TPF	Steel	Random hairline cracks.

WRDD10F	8 1/4	None	Steel	Top of core is cracked parallel to traffic; concrete in upper part appears to have broken after set began. Core is separated horizontally at level of #5 new rebar (the end 3 in. is in the core), the #4 longitudinal bar tied to and just below the #5 new rebar, and the #5 rebar dowel from the old concrete (this bar is split by the core bit at its horizontal bend) which is just beneath the #4 bar. The two parts, separated in coring, leave an open crack, see photo to right, about 1/4 in. wide when they are carefully fitted together. The imprint of the #4 bar has no bar

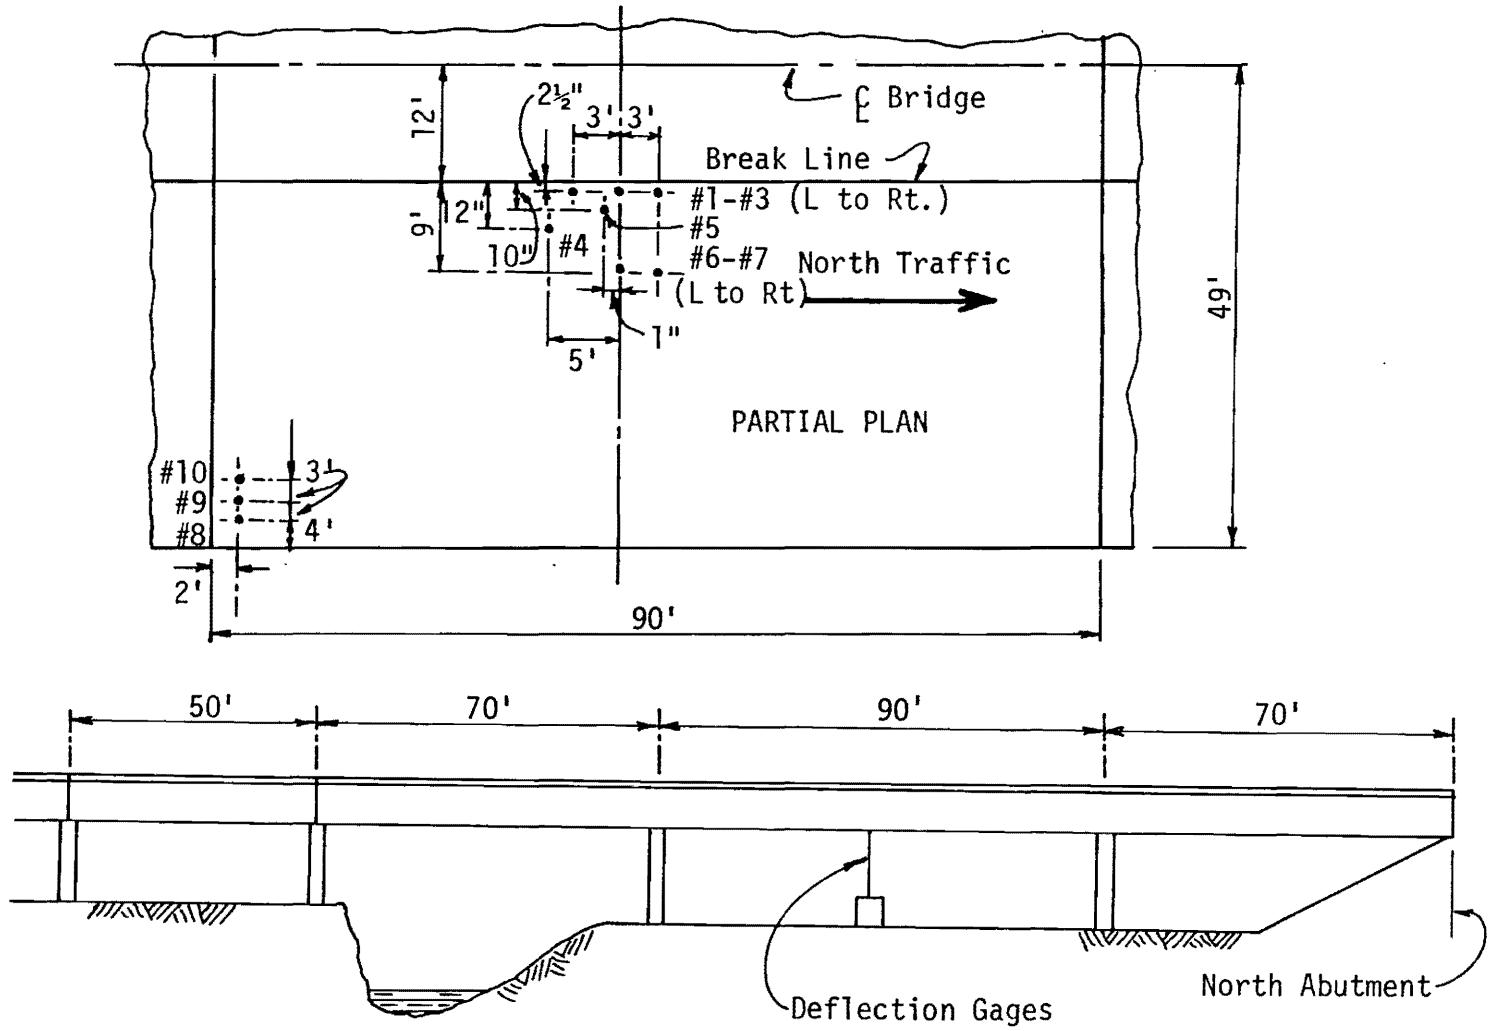
Figure B-7. US 75 & White Rock Creek, Northbound: Core Locations.

CORE MARK	LENGTH (in.)	TREATMENT	CONTINUOUS REINF.	REMARKS
				deformation marks, and its surface appears to have been puddled when the concrete was plastic. Clearly, the relative movements of the old and new decks caused this.
				Northbound traffic, 90 ft span (10 cores)
WRDLU1F	8 1/2	TPF	Steel	Random hairline cracks, top and bottom.
WRDLU2	6	None	Steel	No visible defects; bar impression contains mill scale indicating good bond.
WRDLU3F	8 3/4	TPF US	Steel	Random hairline cracks, bottom only.
WRDL1F	8 1/2	TPF	Steel	The #5 dowel bar from existing deck to new deck was cut in coring across the joint between new and old concrete. A definite void around the dowel in the new concrete exists. This indicates relative vertical movement between the dowel and the new concrete. No other distress is visible.
WRDL2F	8	TPF Dye	Steel	Cored across joint between new and existing deck cutting #5 dowel. A #4 longitudinal bar, and the end of a #5 transverse bar, are wired together in the core. The concrete around the bars is not compact; it contains voids and cracks which are probably caused by relative movement between the dowel (and the other steel wired to it), and the fresh concrete. Random hairline cracks, top and bottom.

WRDL3F	8 3/4	TPF	Steel	Top #5 bar perpendicular to traffic, and top #4 bar parallel to traffic have voids around them. The core broke at the level of these bars, revealing poor consolidation and evidence of relative movement between the steel and fresh concrete. Random hairline cracks, top and bottom.
