1. Report No. TX-96/2919-2		2. Government Accession No.		3. Recipient's Catalog No.	
4. Title and Subtitle FORENSIC EVALUATION OF THE CEMENT TREATED BASE FAILURE ON SH 36 IN HOUSTON				5. Report Date October 1995

**FORENSIC EVALUATION OF THE CEMENT TREATED
BASE FAILURE ON SH 36 IN HOUSTON**

Research Report 2919-2
Research Study Number 7-2919
Research Study Title: Spall Repair, Base and Subgrade Stabilization,
and Non Destructive Test Service (NDT) for the Houston District, Phase II

October 1995

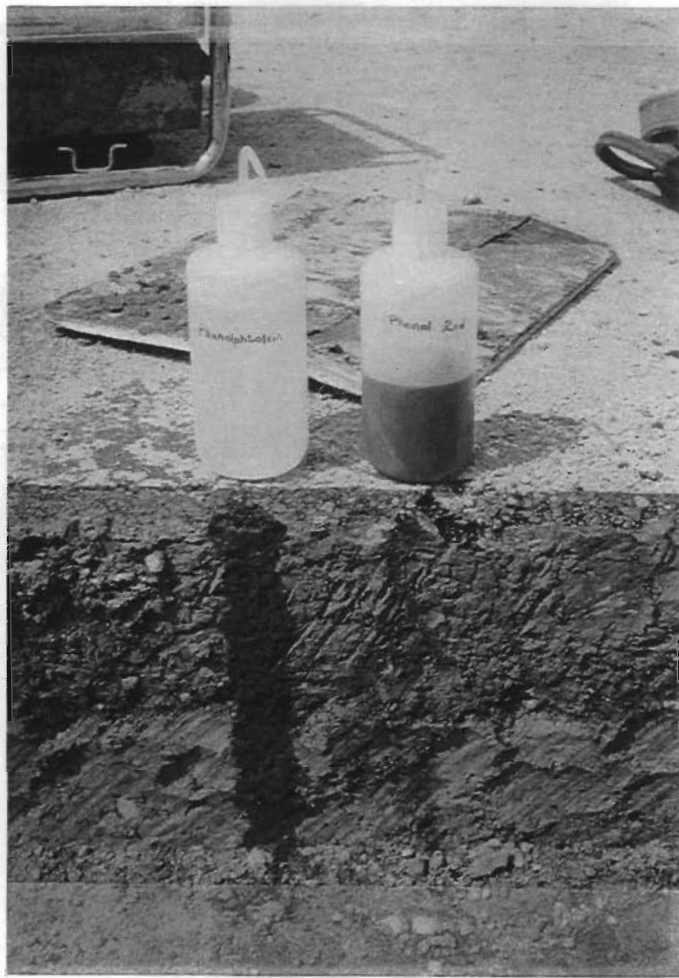
Figure 13. Carbonation Test Performed on a Newly Exposed CTB.

agents is shown in Figure 13. After spraying with the pH indicators, the surface is also sprayed with hydrochloric acid to test for the presence of carbonates. It is necessary to spray some of the untreated material with hydrochloric acid to determine whether carbonates are present in the material before stabilization. If it is found that carbonates were present in the parent material before stabilization, the hydrochloric acid test would not be valid to determine the presence of carbonates; however, the pH indicators should still be able to detect carbonation in most cases. The outcome of the test could be one of the following:

In all of the above cases, a yellow color with phenol red probably indicates that the stabilizer was never added or was not properly mixed through the material.
