1. Report No. TX-98/2919-3	2. Government Accession No.	3. Recipient's Catalog No.	
4. Title and Subtitle INVESTIGATION OF SPALL REPAIR FOR CONCRETE PAVEMENT		5. Report Date July 1996 Resubmitted: July 1997

**INVESTIGATION OF SPALL REPAIR
FOR CONCRETE PAVEMENT**

Research Report 2919-3
Research Study Number 7-2919
Study Title: Spall Repair, Base and Subgrade Stabilization, and
Non Destructive Test (NDT) Services for the Houston District, Phase II

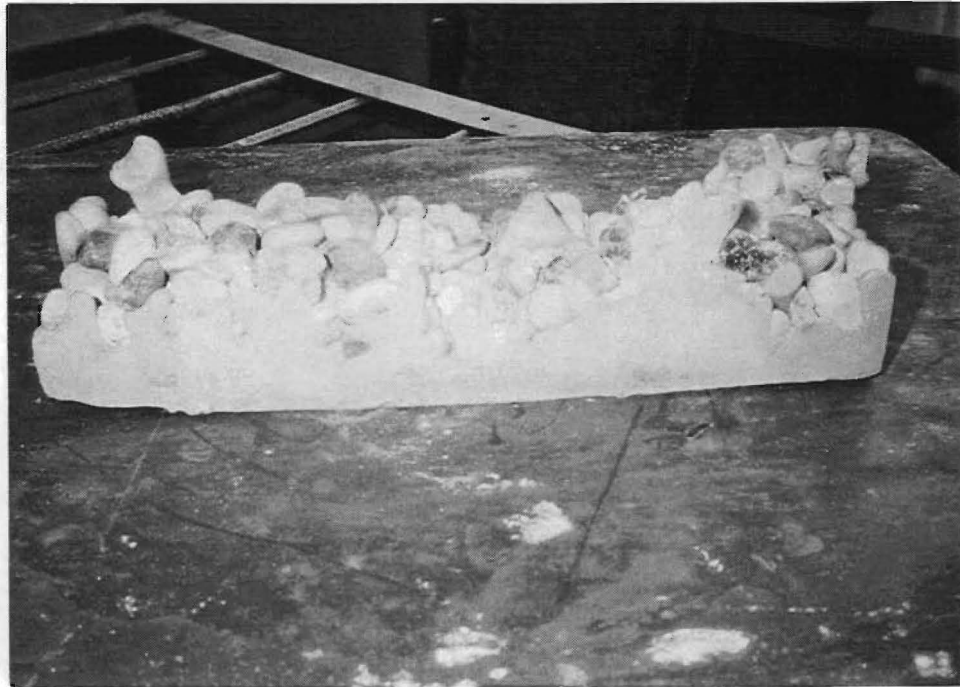
Penatron is a polymer composition of two monomers blended at a prescribed ratio. When used for repair, mineral aggregates are placed in the spalled area first. The monomers of Penatron are blended and then placed in the gaps between the aggregates, which are not disturbed. Penatron was used to make samples for bond strength tests and flexural strength tests and was observed to be set before it passed through the voids between the aggregates. A picture of an unfinished beam with Penatron is shown in Fig. 2.8. Mixing and pouring instructions in the producer's manual indicate that the polymer composition should be poured into the aggregates within 50 seconds after mixing. This timing was very critical. The high viscosity of Penatron composition and its rapid clotting characteristics reduced its ability to penetrate through the aggregate, especially when aggregate of smaller size (with the maximum size of 9.5 mm or 3/8 in.) was used. This indicates that care should be taken in repairing with Penatron in this regard.

Fig 2.8. Incomplete Beam Made of Penatron with its Bottom Up.

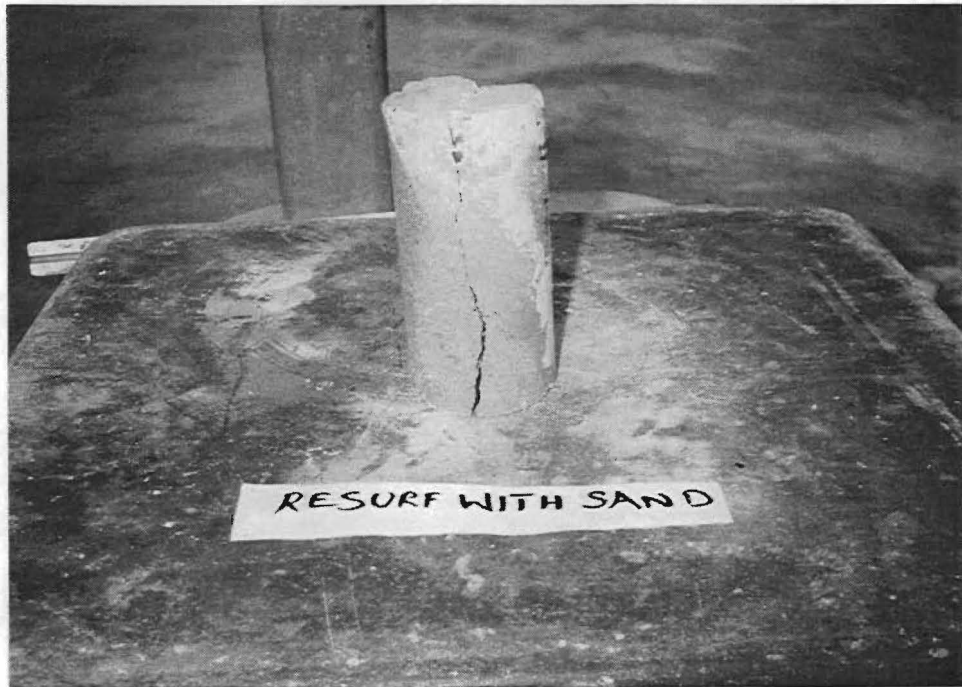
prescribed ratio and pouring into the mixer into which an aggregate has been poured. Resurf has been observed to be a very slow setting polymer composition. Resurf samples remained soft at the age of four hours but gained high strength in 24 hours. In bond strength tests using Resurf concrete, the failure plane occurred in the base material which was a regular concrete of 30 days old. A picture of a tested cylinder made of Resurf concrete and base concrete has been shown in Fig. 2.9. It can be seen in the figure that the bond between Resurf concrete and the base concrete was unaffected and the sample failed vertically through the base material. This material showed high strength but was very brittle.

Fig. 2.9. A Tested Slanting Shear Specimen of Resurf Blended with Sand as Repair Material.

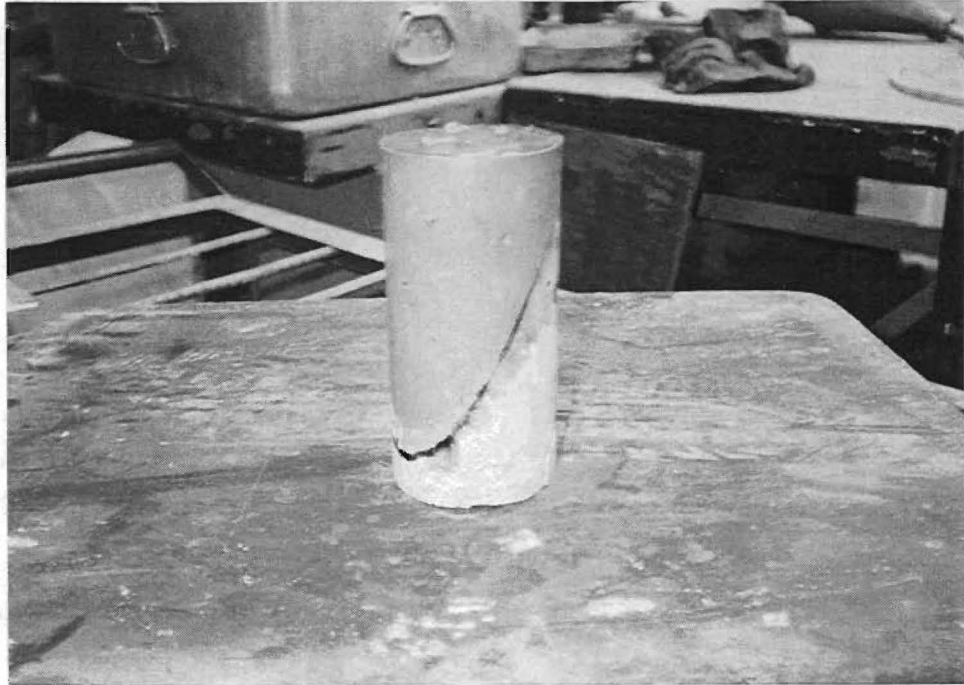
Pictures of a finished and tested slanting shear cylinder made of Sylcrete mender and river gravel on top of a base concrete piece are shown in Figs. 2.10 and 2.11. Both the Sylcrete products were tested for shear strength and fracture toughness.

Fig. 2.10. A Finished Slanting Shear Specimen of Sylcrete Mender Blended with Aggregates.

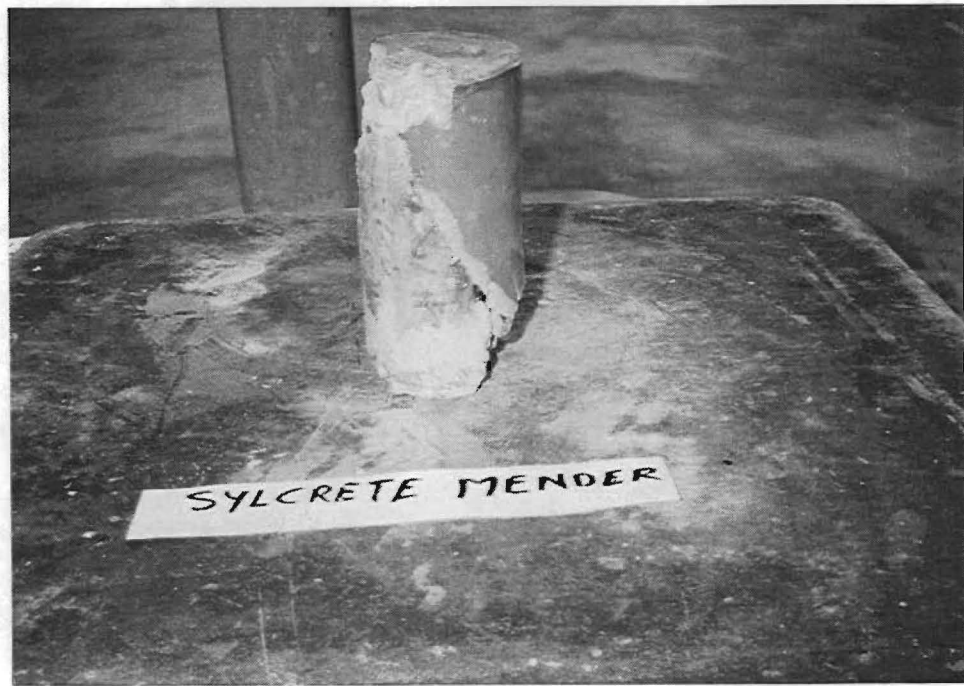
Fig. 2.11. A tested slanting shear specimen of Sylcrete mender blended with aggregates.

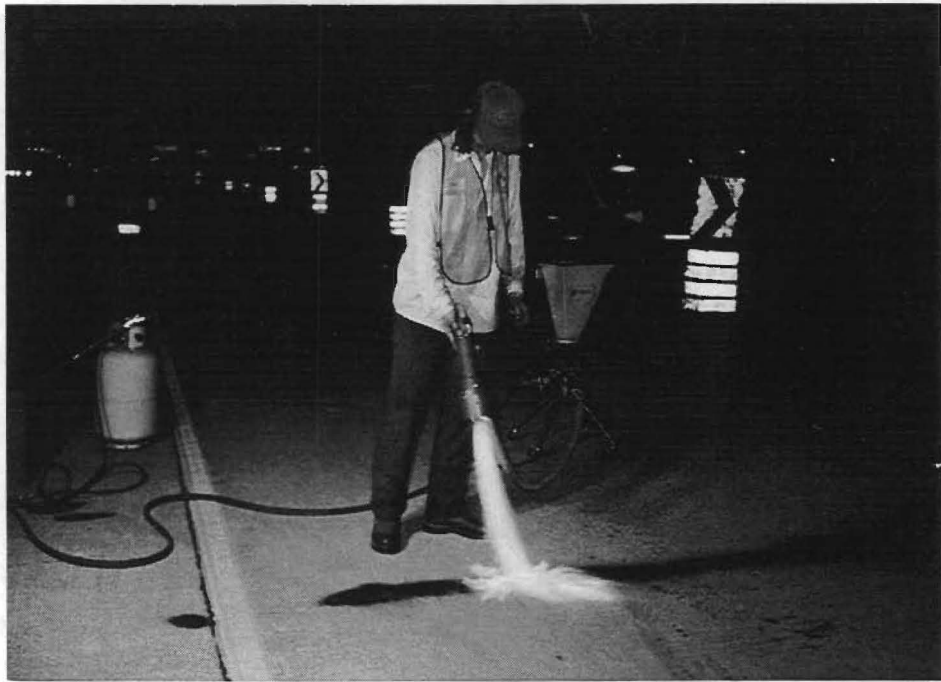
Fig. 3.2. Flame Spray Process in the Repair Section on BW 8 North.

All the repairs using Plastic Flamecoat products were made in the innermost lane. Three different Flamecoat product types were used. The repair information is recorded in Table A.2. Product PF113-H101 was a low viscosity material while product PR111-H101 was a high viscosity material. Product PH100 was made from recycled tires. The Flamecoat material was applied by using the flame spray method (Fig. 3.2). The polymer product was melted by a flame and thus flowed into pavement cracks and spalls. On three occasions (at patch series numbers 4, 5 and 8) patching was done by using Rapid Set Concrete after the

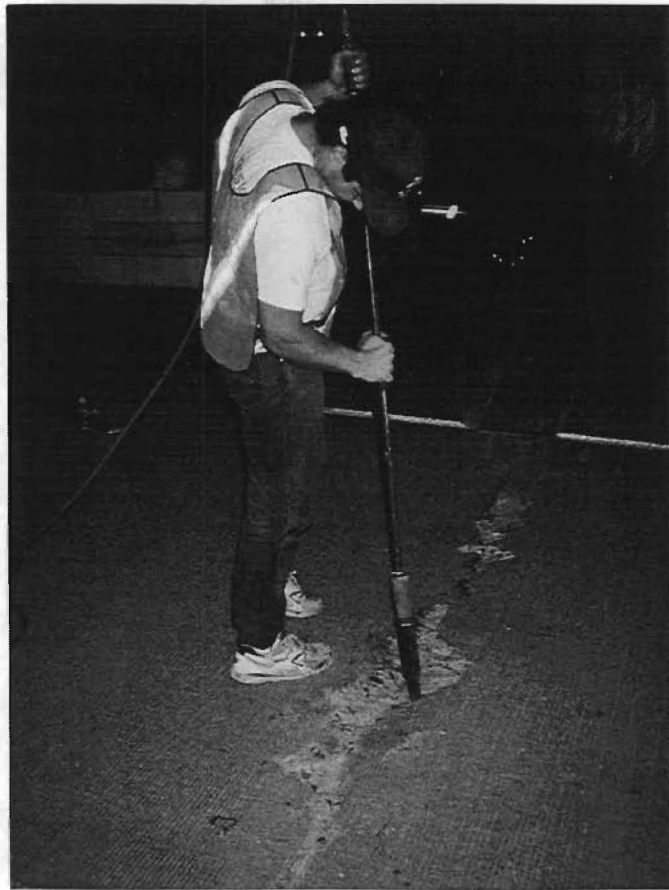
Fig. 3.4. Cleaning Operation Using a Wire-Brush Power Tool.

Before the repair material was applied, the spalls had been sandblasted and chipped. Loose concrete and dirt were removed with compressed air. The cracks were mechanically cleaned by using a wire-brush power tool and, in some instances, a hand operated pneumatic hammer (Fig. 3.4). Once the repair area was cleaned and dried, the mender was poured into the crack. After waiting a few seconds, the flexible cement was then poured over the repair area (Fig. 3.5). At places where spalling was extensive, crushed limestone was placed immediately after placement of the mender. After the flexible cement was applied, sand was sprinkled over it for better skid resistance on the surface. Nine repairs were made with the Sylcrete products and are listed in Table 3.1. Repair 1 resulted in a rough surface due to improper tooling.

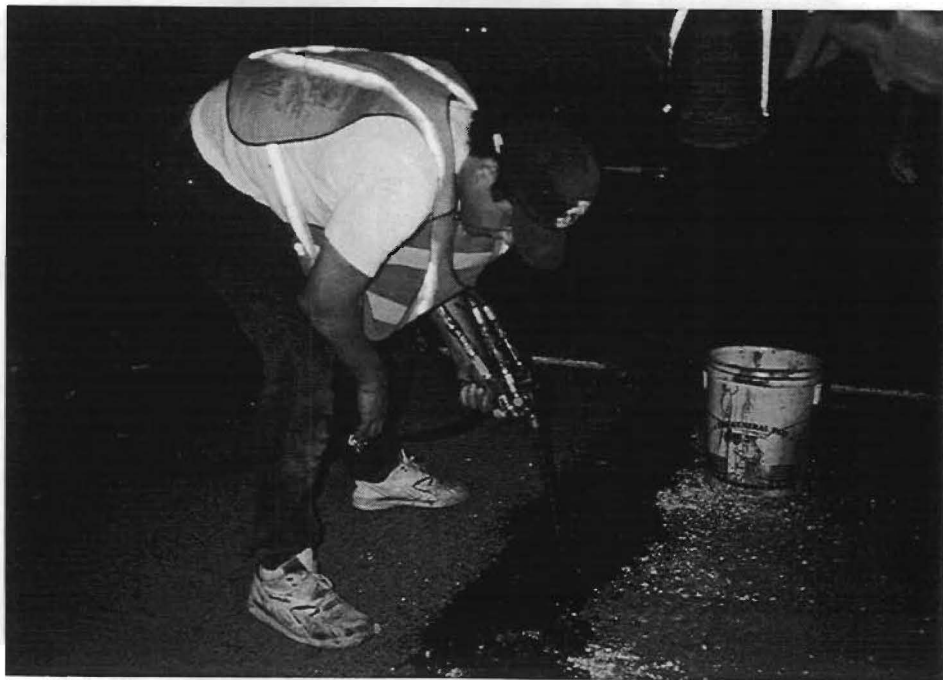
Fig. 3.5. Pouring of the Flexible Cement Over the Mender.

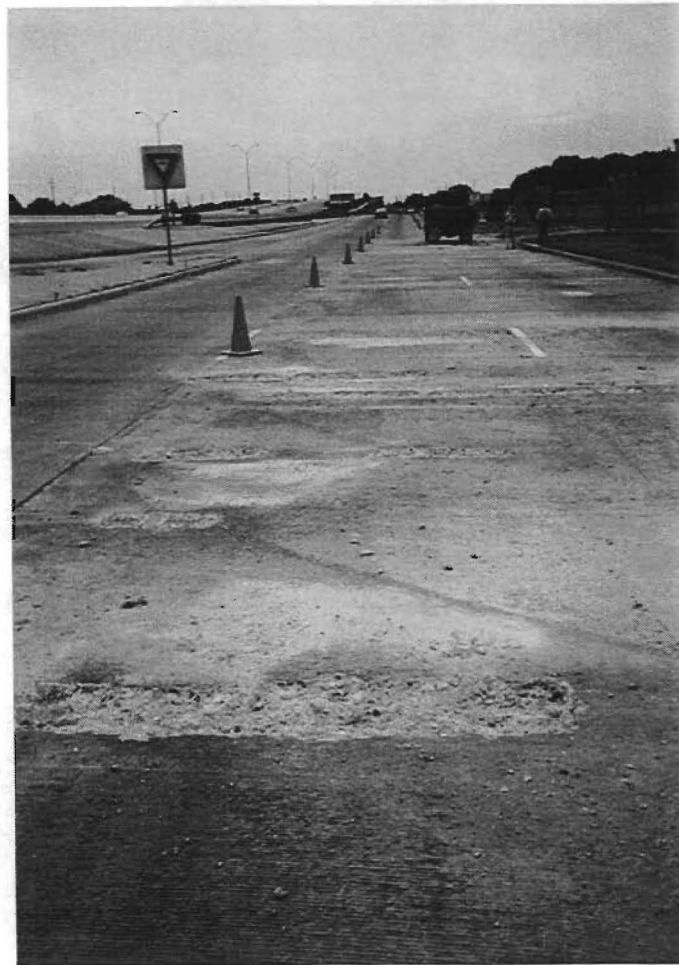
Fig. 4.2. A View of the Repair Section After the Spalls Were Cleaned.

with a jack hammer. Fig. 4.2 is a view of the repair section after the spalls are "cleaned." The repair material was immediately delivered to and poured to the spalls after mixing (Fig. 4.3). Then water was sprayed over all the repairs for curing. In some of the repairs, a cut was made about half an hour after material placing to induce a controlled crack. Different from the conventional method of saw cutting used in the repair section reported in Chapter 3, the saw cut in this section was made much earlier with the early-aged method of saw cutting, so that the saw blade did not need water cooling. The depth of the cut was 19 to 25 mm (3/4 to 1 in.). In order to observe the effect of saw cut, about half of the spall repair patches were cut while the remainder were not cut. Figs. 4.5 and 4.6 illustrate the same spalled area before the repair material was filled and after the repair was completed. The saw cut was oriented in the direction of the direction of the original transverse crack in the existing pavement (Fig. 4.7).

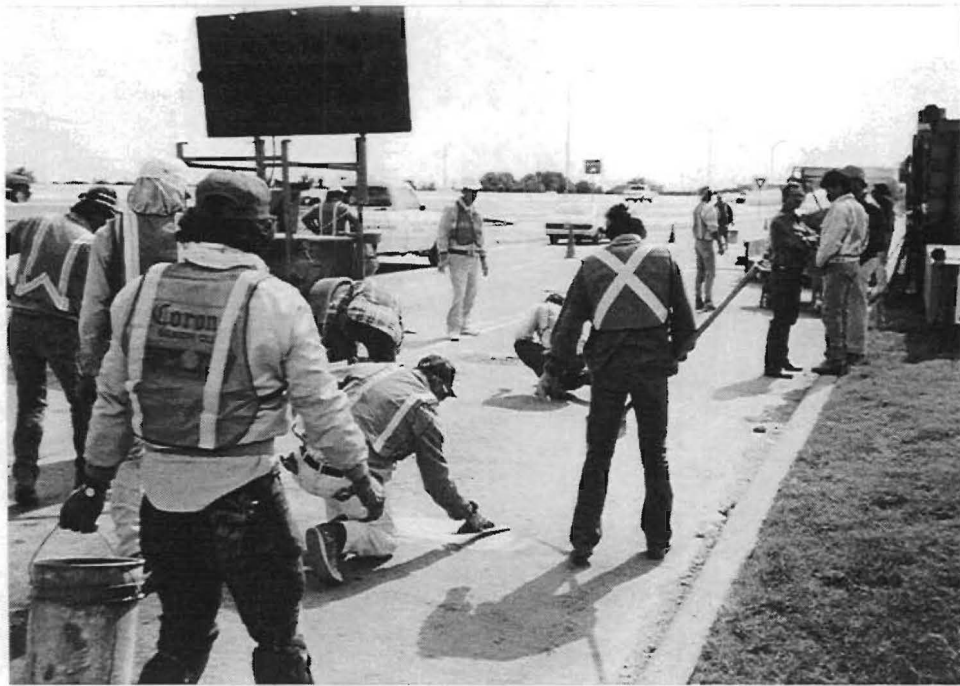
Fig. 4.3. Placing of Repair Mixture.

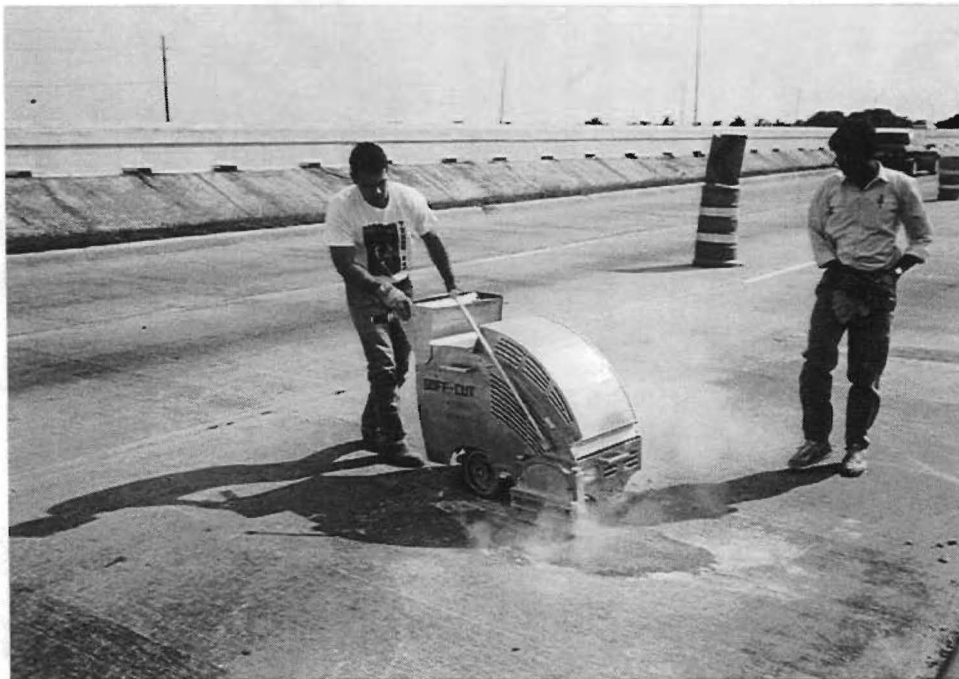
Fig. 4.4. Saw Cutting.

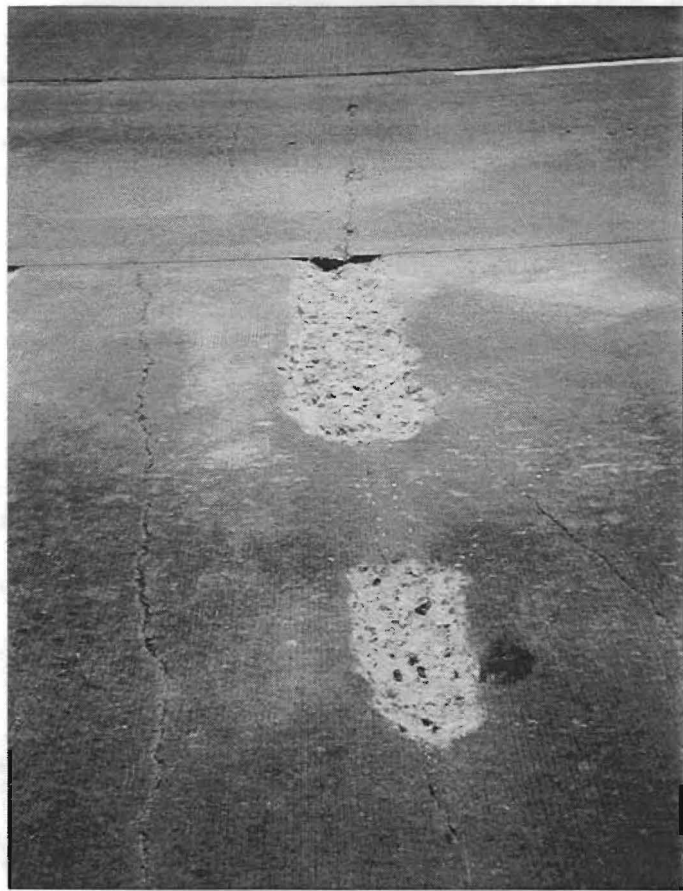
Fig. 4.5. Spalling Spots Before Filling of Repair Mixture.

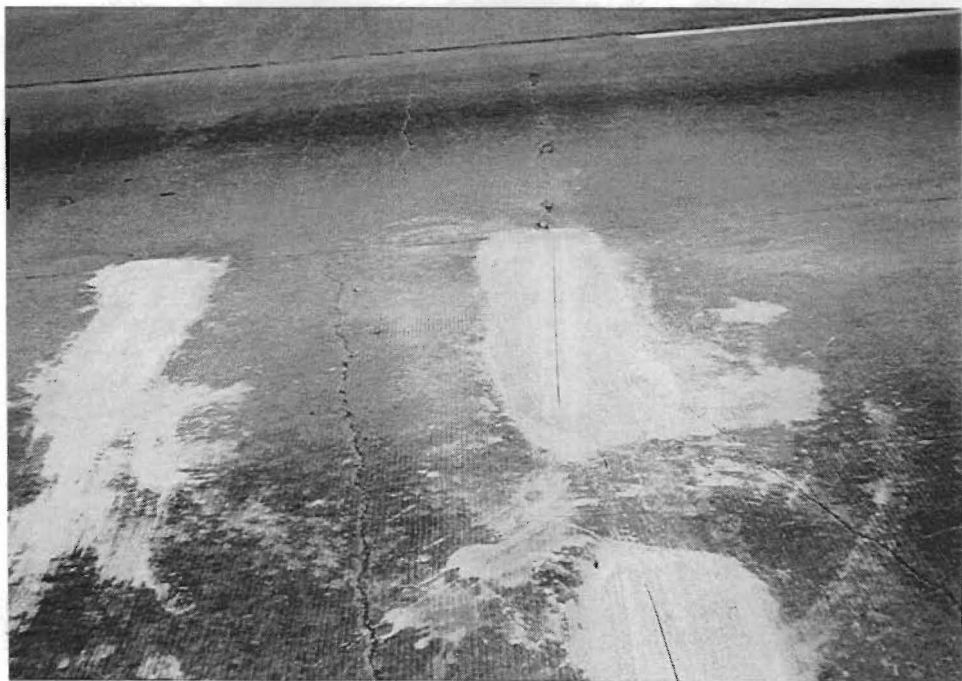
Fig. 4.6. Spalling Spots After Repairing and Saw Cutting.

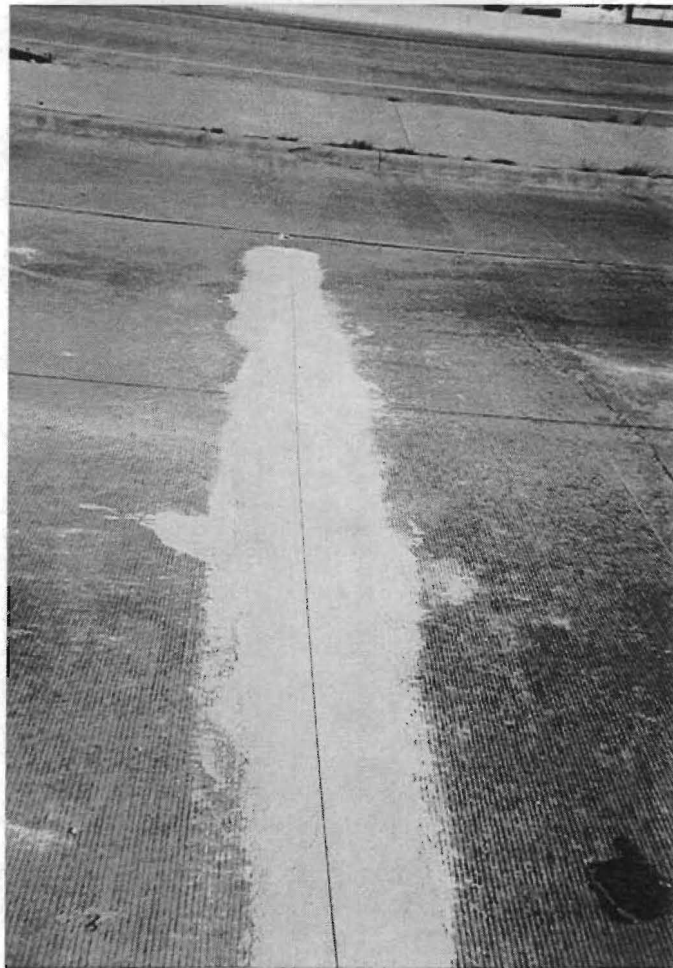
Fig. 4.7. An Extended Spall Repair with a Saw Cut.

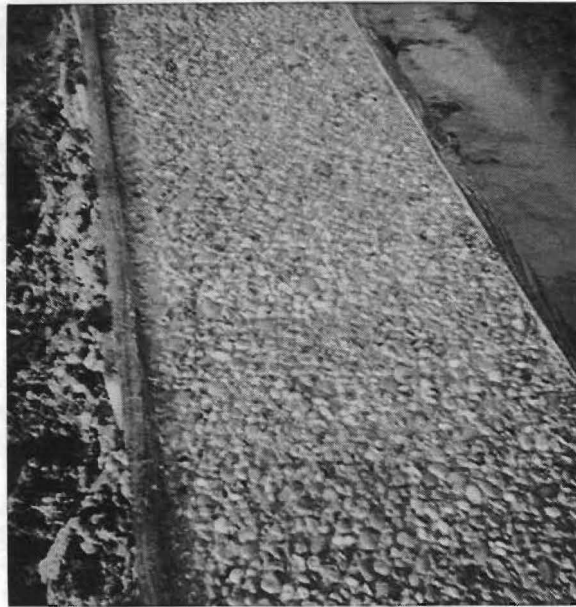
Fig. 5.3. Appearance of the pavement surface before placement of overlay.

rectangles represent the slabs that were used in this field test program. Fig. 5.2 shows a view of these slabs and Fig. 5.3 shows the appearance of the pavement surface ready to be overlaid.
