1. Report No. TX-98/2947-S		2. Government Accession No.		3. Recipient's Catalog No.	
4. Title and Subtitle APPLICATIONS OF GROUND-COUPLED GPR TO PAVEMENT EVALUATION				5. Report Date November 1997

APPLICATIONS OF GROUND-COUPLED GPR TO PAVEMENT EVALUATION

Research Report 2947-S
Research Study Number 7-2947
Research Study Title: Using Ground-Coupled and Air-Launched
Radar Systems for Pavement Evaluation

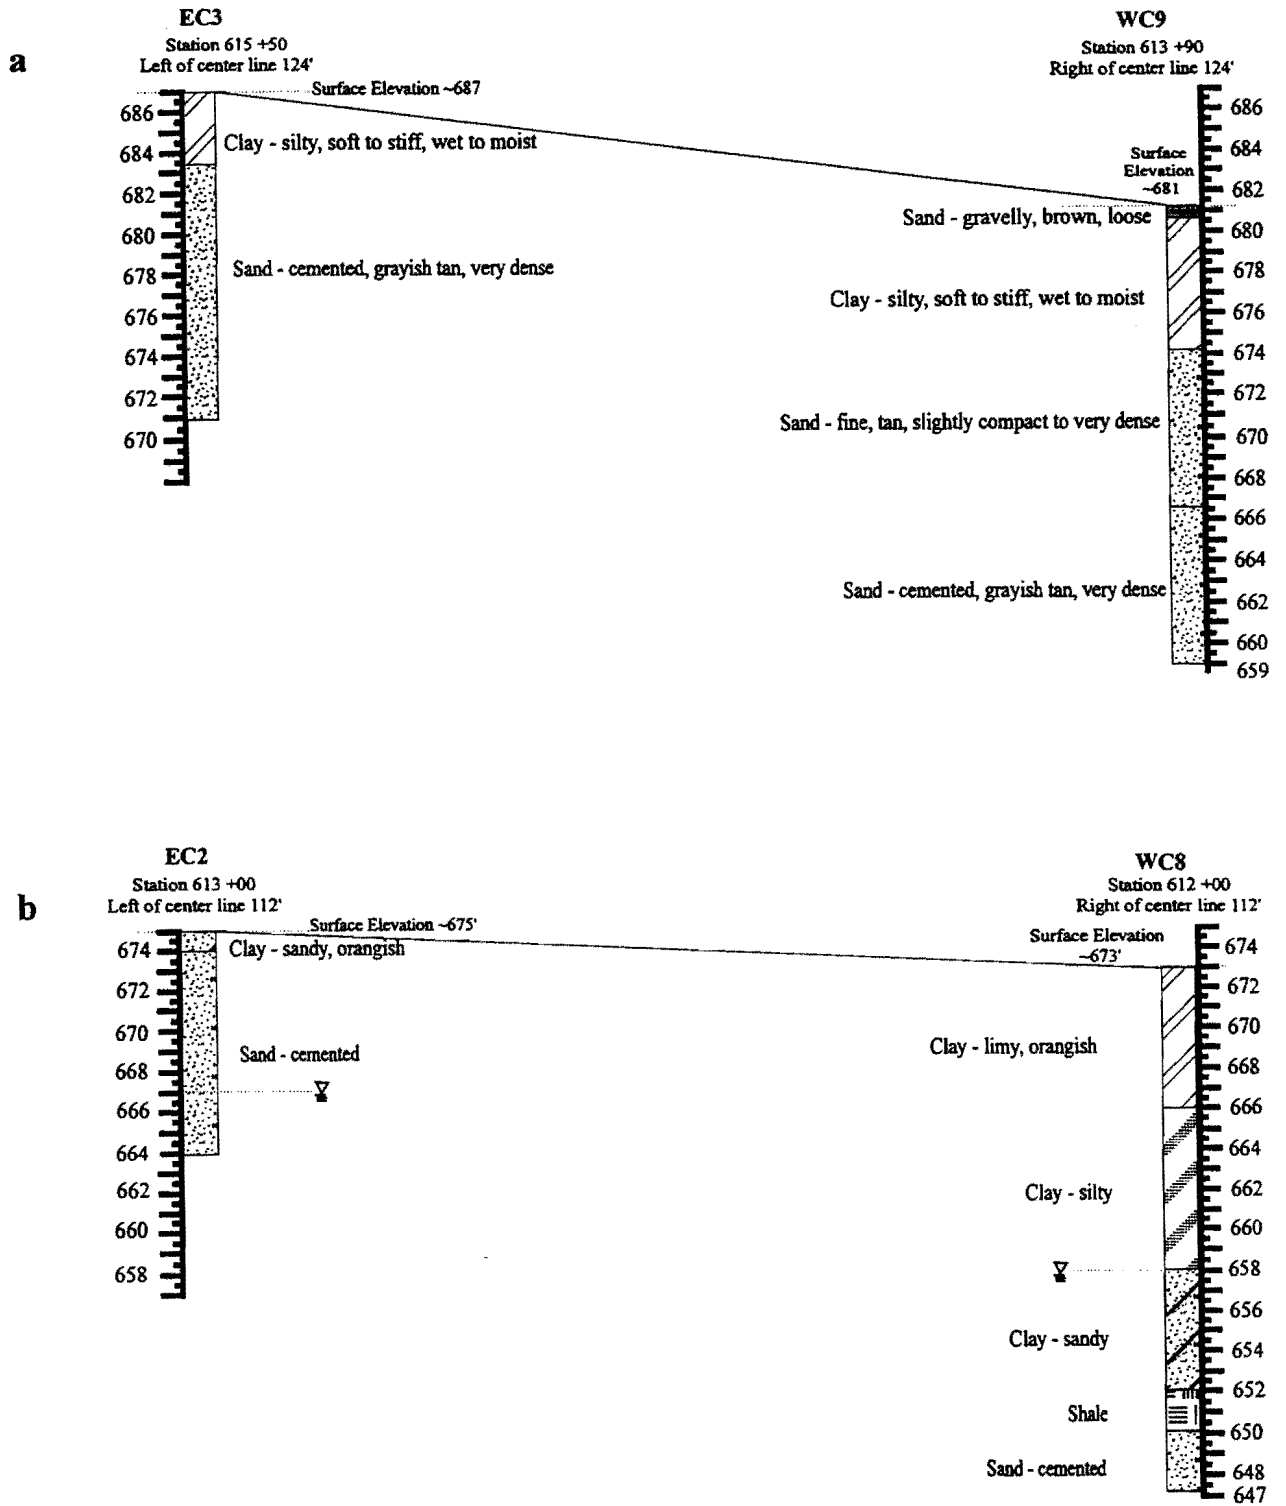
Figure 4. Cross-Sections Perpendicular to State Highway 199, Azle, Texas (East to West).

Observation of the cross-sections from east to west, began with EC1-WC9 (Figure 4a) (EC=east core; WC=west core). The surface appears to grade into a sandy soil to the west. The thickness of the clay increases to the west from 1.4 to 2.0 m (4.6 to 6.5 ft). Beneath the clay in both cores lies a dense, cemented sand. In observing cross-section EC2-WC8 (Figure 4b), 0.3 m (1 ft) of clay seen at the surface of EC2 and increasing in thickness and type towards WC8, overlies a cemented sand.

Cores EC4, MC5, WC6, run east to west across SH 199 near to Station 609 +50 (Figure 4c). Two meters of clay, either sandy or containing broken limestone, exist at the surface of these cores. Sand is only seen relatively near to the surface in core MC5.

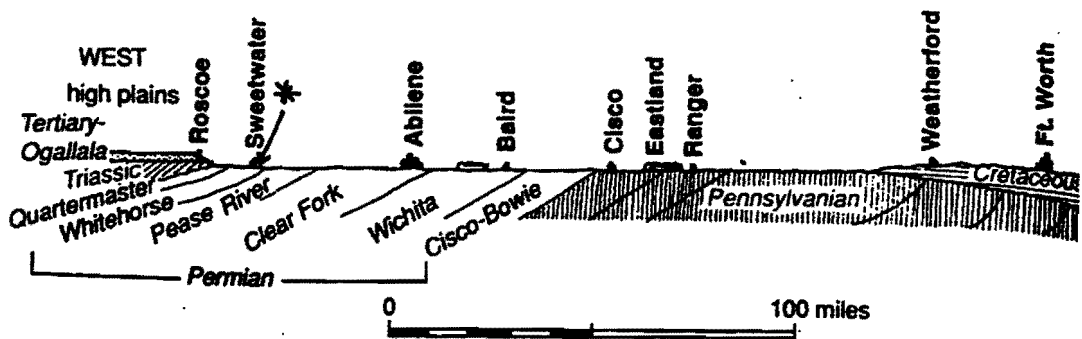
Figure 12. Cross-Section Along I-20 Between Ft. Worth, Abilene, and Roscoe. The Tilt of the Rocks is Greatly Exaggerated (From Texas Roadside Geology).

Sweetwater is located atop an outcropping of the Permian Whitehorse formation (Figure 12). The lower portion of the Whitehorse formation is comprised of gypsum rock (Figure 13). During the Permian period extensive flats acted as evaporation pans, laying down bed after bed of drying gypsum along with bright red, oxidized sand and mud layers. Gypsum, or calcium sulfate, occurs in three varieties, Alabaster is fine-grained and massive, Selenite is transparent, colorless, and crystal shape, and Satin Spar is fibrous with a silky luster. From observation and hearsay, Alabaster and Satin Spar can be found in the Sweetwater area.
