**FLY-ASH BASES IN THE ATLANTA DISTRICT:
EVALUATION OF SURFACE TREATMENT BOND
AND
YEAR-TWO FIELD PERFORMANCE EVALUATIONS**

Report 2966-2
Project Number 7-2966
Research Project:
Durability of Surface Treatments as the Wearing Course
Placed on Crushed Fly Ash and Long-Term Performance
of Crushed Fly Ash for Flexible Base

December 1998

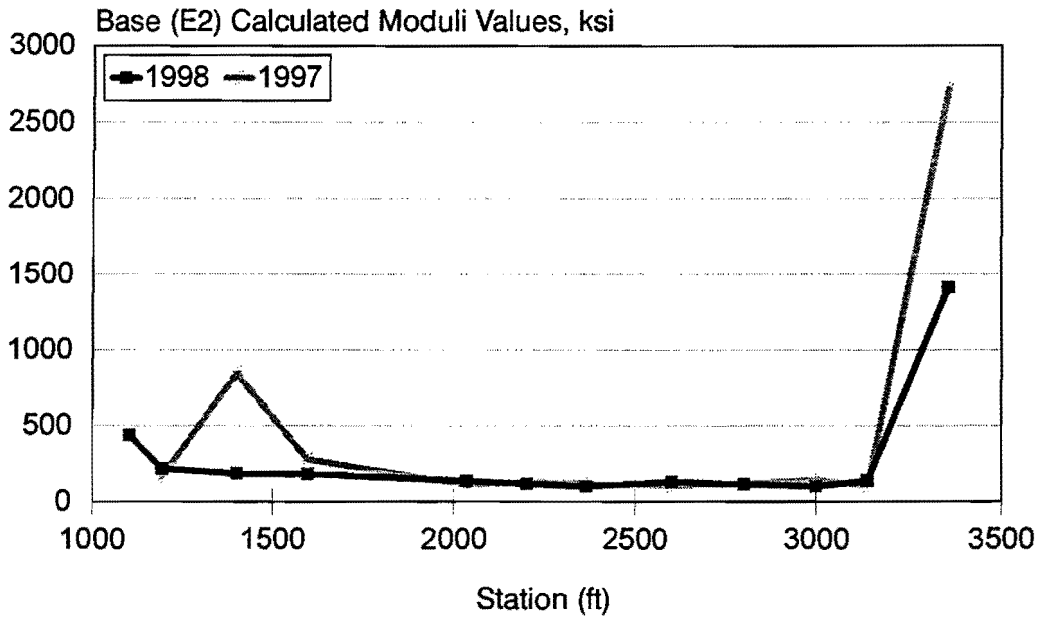
Figure 8. Base Moduli Values for IH 20 Frontage Road

Three cores were obtained from this pavement as shown in Figure 6. Last year, this pavement exhibited the highest compressive strength but there was a loss in strength as noted with the cores taken in 1998. However, there doesn't seem to be an appreciable difference in the base moduli values from 1997 to 1998 (Figure 8). Note in Figure 8, that the last data point may coincide with the beginning of a different type of pavement section.

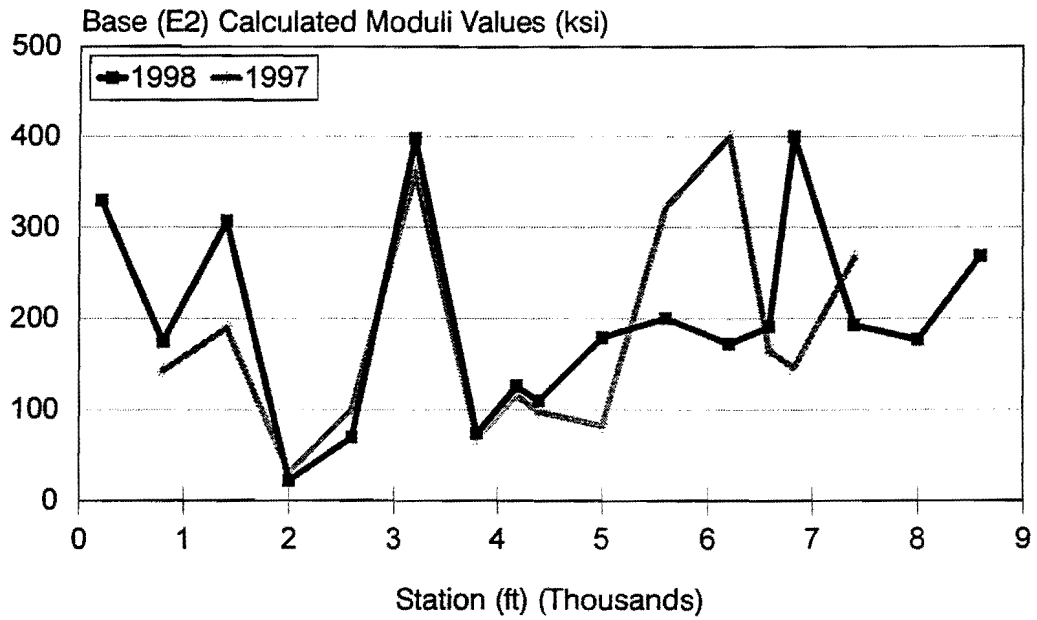
Figure 11. Base Moduli Values for FM 1520

Three cores were obtained from FM 1520 and two of the three cores showed a significantly greater compressive strength than the previous year. FWD data (Figure 11) on this pavement indicates that there is no significant change between 1997 and 1998.

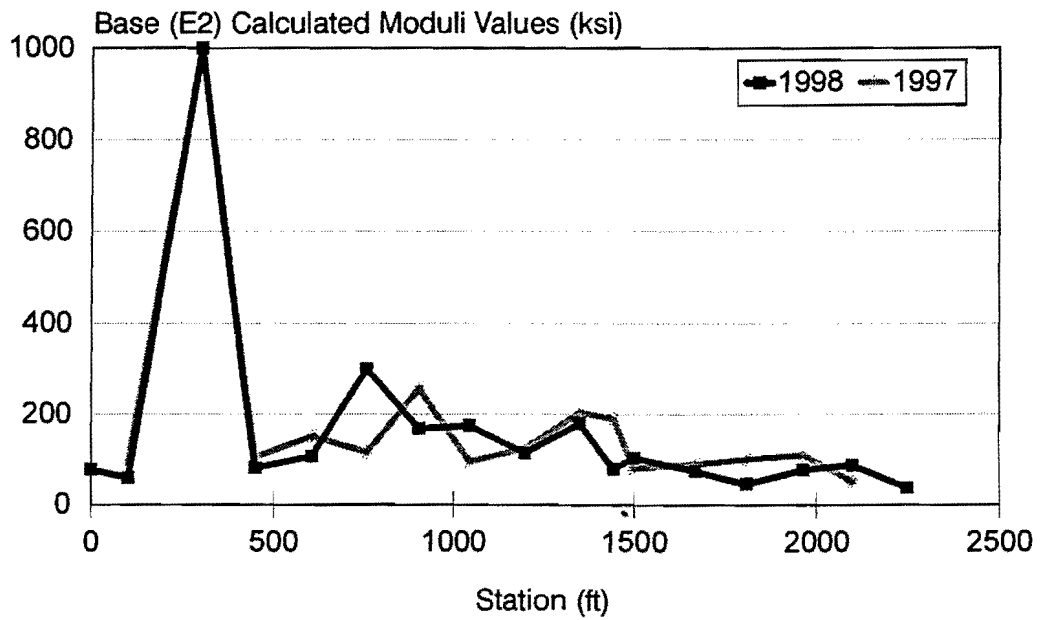
Figure 12. Base Moduli Values for FM 560.

All three cores obtained from FM 560 had a higher compressive strength than the cores obtained the previous year. The base on this pavement has two different thicknesses along its length: 9 inches and 16 inches. Because of the difference in thicknesses, two separate FWD analyses were performed as shown in Table 14. Results from both analyses, however, were combined for Figure 12. Moduli values for this pavement do not appear to be as variable as on some of the others; however, the values are lower than the desired minimum of 145,000 psi. Also, however, there seems to be little change in moduli values between 1997 and 1998.
