1. Report No. FHWA/TX-84/ 52 +343-2		2. Government Accession No.		3. Recipient's Catalog No.	
4. Title and Subtitle TEST AND EVALUATION OF NEIGHBORHOOD MAILBOX				5. Report Date March 1984

TEST AND EVALUATION OF NEIGHBORHOOD MAILBOX

Research Report No. 343-2

Improved Design of Lightpoles, Guardrails, and Other Appurtenances

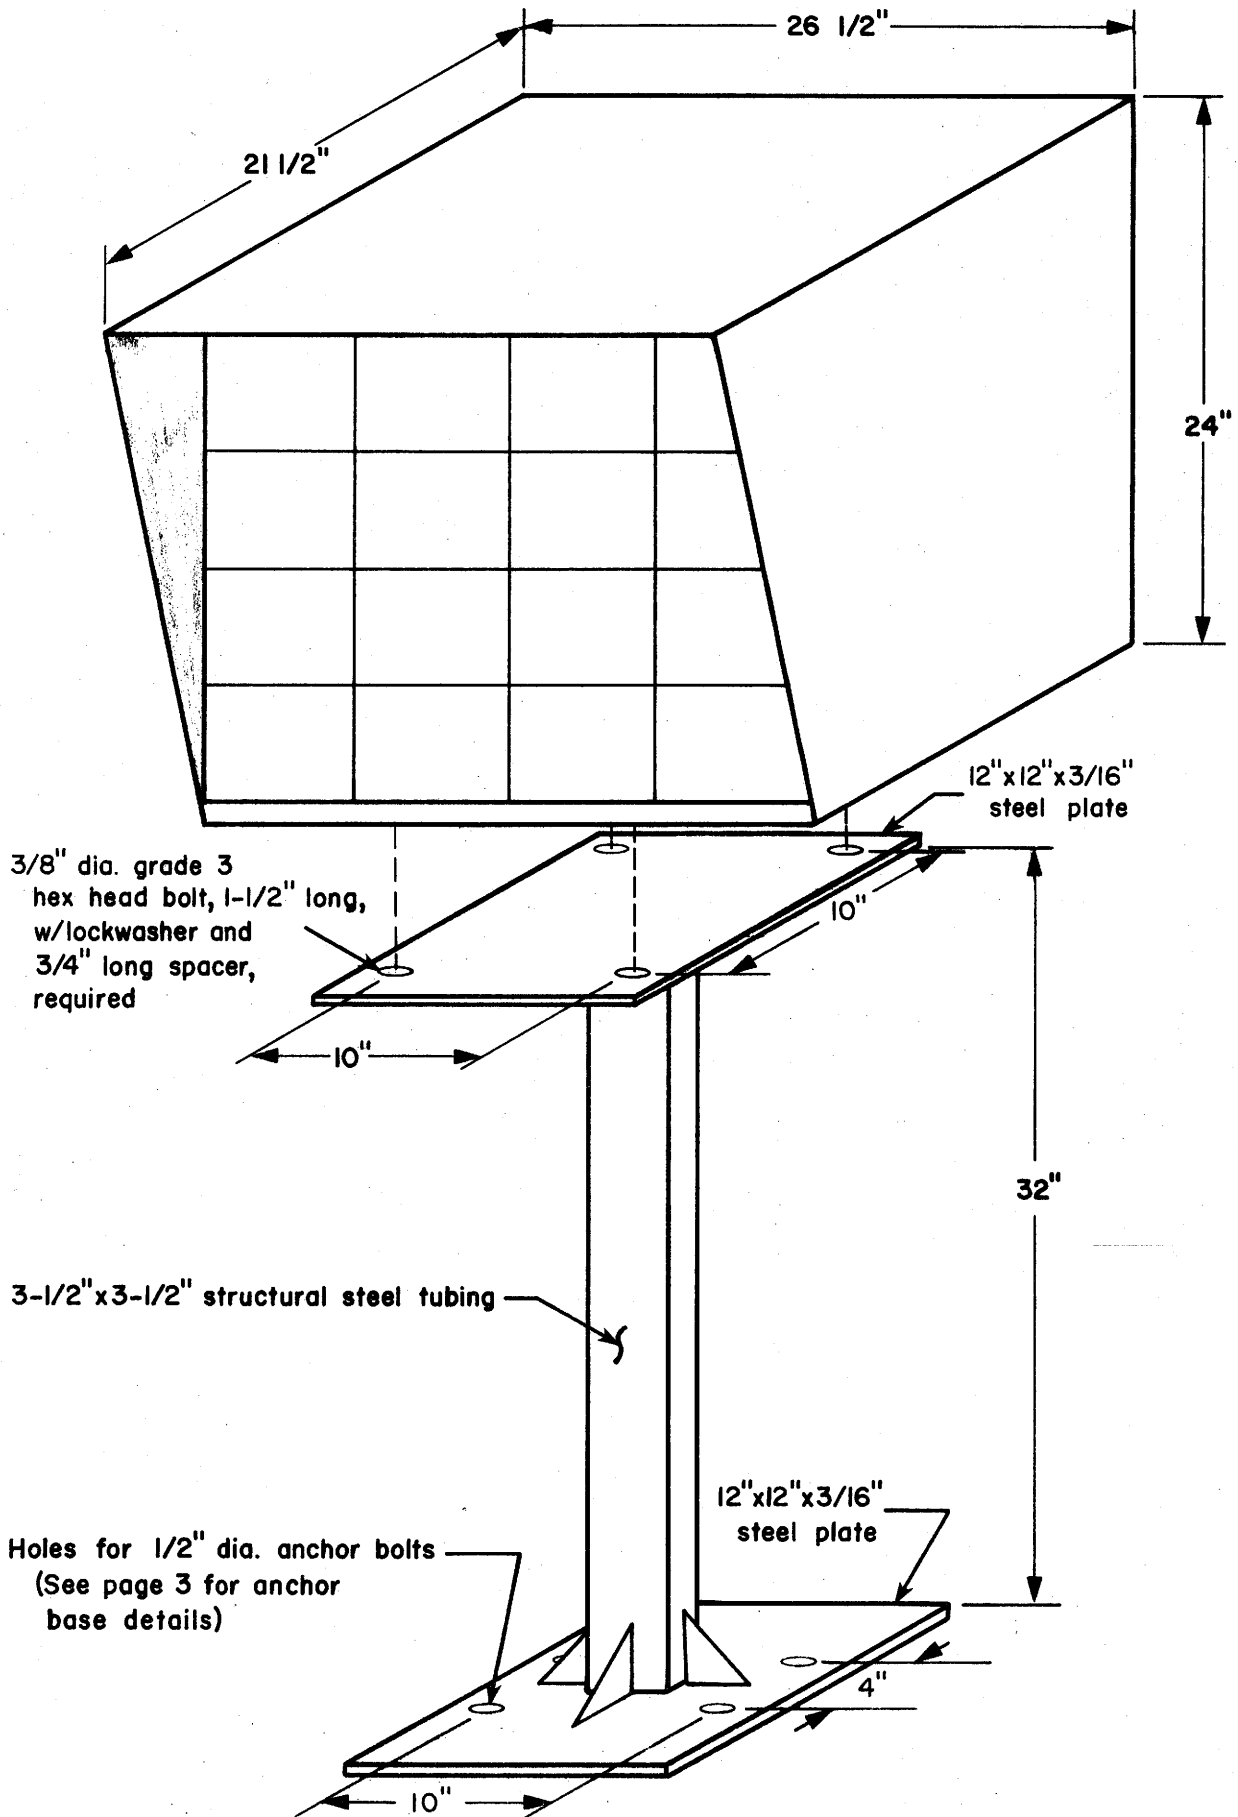
Figure 1. Details of Auth No. 452 Mailbox.

An Auth No. 452 neighborhood mailbox, manufactured by Auth Electric Co., Deer Park, N. Y., was set up for Test 2343-1 according to typical field installation procedures. The sixteen compartment mailbox unit was supported by a 3-1/2" x 3-1/2" structural steel tube. Steel plates, 12" x 12" x 3/16", welded to the tube at the top and bottom, were used to attach the boxes to the tube and to anchor the tube to the concrete foundation. The lower anchor plate was connected to the concrete foundation with four 1/2" diameter J-bolts. Details of the mailbox and base are shown in Figures 1 and 2. Photographs of the test installation before testing are presented in Figures 3 and 4. Two of the lower compartments were taped closed because the locks were missing.

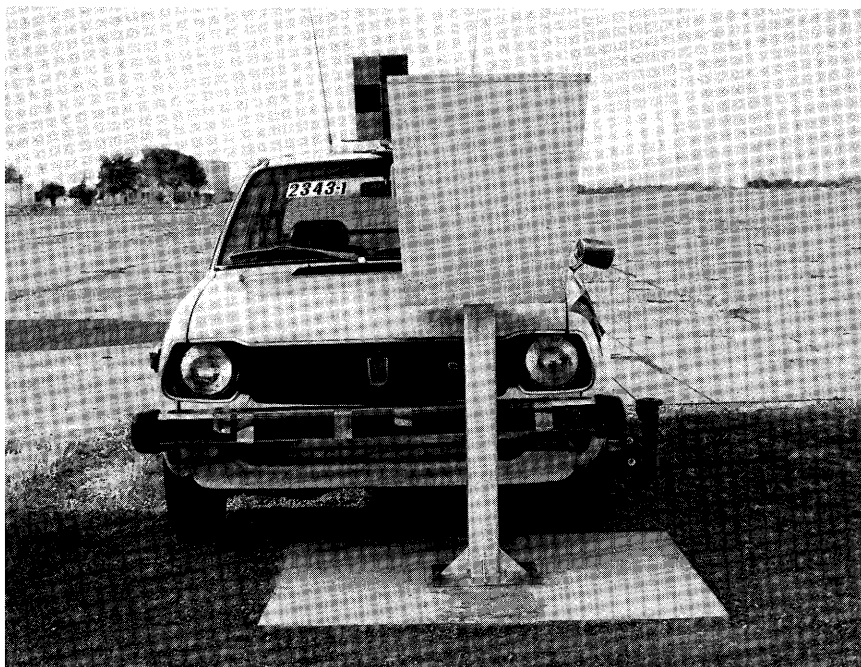
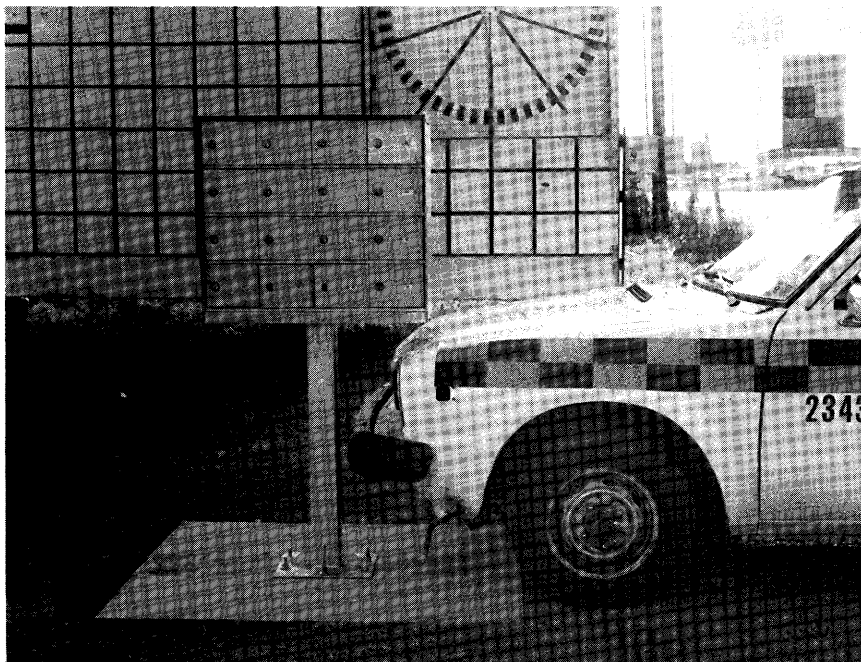
Figure 5 . Relative Position of Vehicle and Mailbox.

vehicle centerline. Relative positions of the vehicle and mailbox are shown in Figure 5.

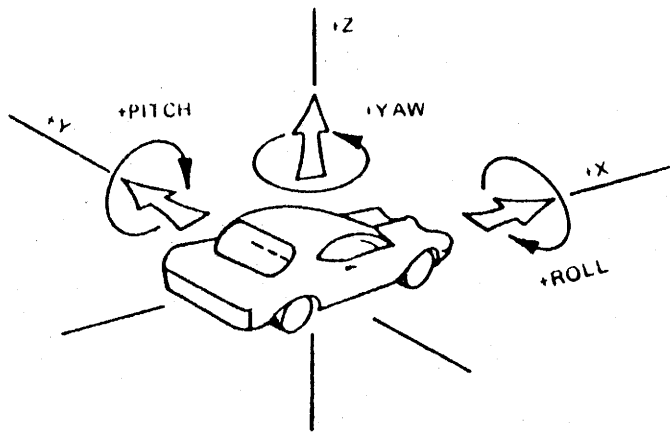
A summary of test data is provided in Figure 8. Sequential photographs are presented in Figure 9. Longitudinal vehicle acceleration is shown in Figure 10 and yaw, pitch and roll displacements are shown in Figure 11.

NCHRP Report 230 (5) contains recommended evaluation criteria for the impact performance of sign supports and places limits on these criteria for acceptable performance. It is generally felt that mailbox supports should meet these same criteria. In view of the violent multiple rollovers that occurred in the test, it is clear that the subject mailbox installation did

not meet the recommended performance criteria (5). It is therefore concluded that this mailbox installation and similar installations should not be permitted within the clear zone of high-speed roadways. Further testing and evaluation would be necessary to establish safe and acceptable operating conditions for the installation on other than high-speed roadways. Pending such investigation, these installations should also be considered undesirable within the clear zone of all roadways.
