1. Report No. TX-97/3910-S		2. Government Accession No.		3. Recipient's Catalog No.	
4. Title and Subtitle EVALUATION OF WORK ZONE BARRICADES				5. Report Date November 1997

# **EVALUATION OF WORK ZONE BARRICADES**

Research Report 3910-S  
Research Study Number 7-3910  
Research Study Title: Design, Evaluate, and Test  
Work Zone Sign Supports and Barricades

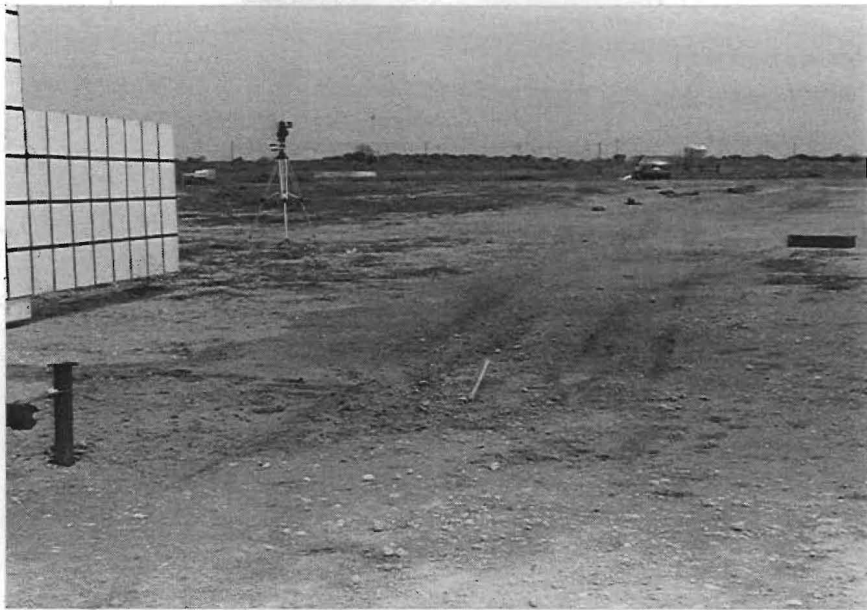
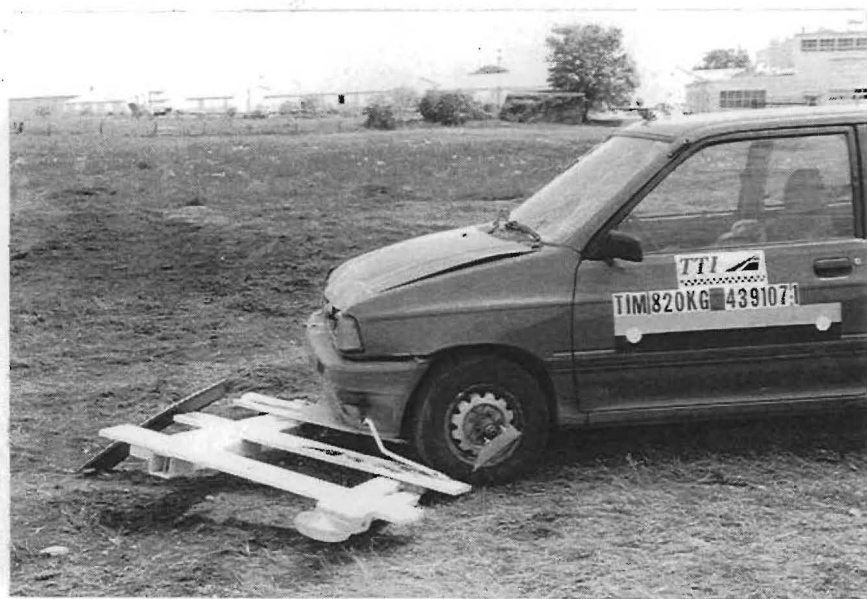
**Figure 14. After Impact Trajectory for Test 439107-1.**

The upright portion of the barricade remained in one piece and rode along with the vehicle as shown in Figures 14 and 15. The bases and braces separated from the upright and were scattered along the path of the vehicle. The debris scatter extended 4.9 m on both sides of the centerline of the path of the vehicle and 52.8 m downstream of impact.

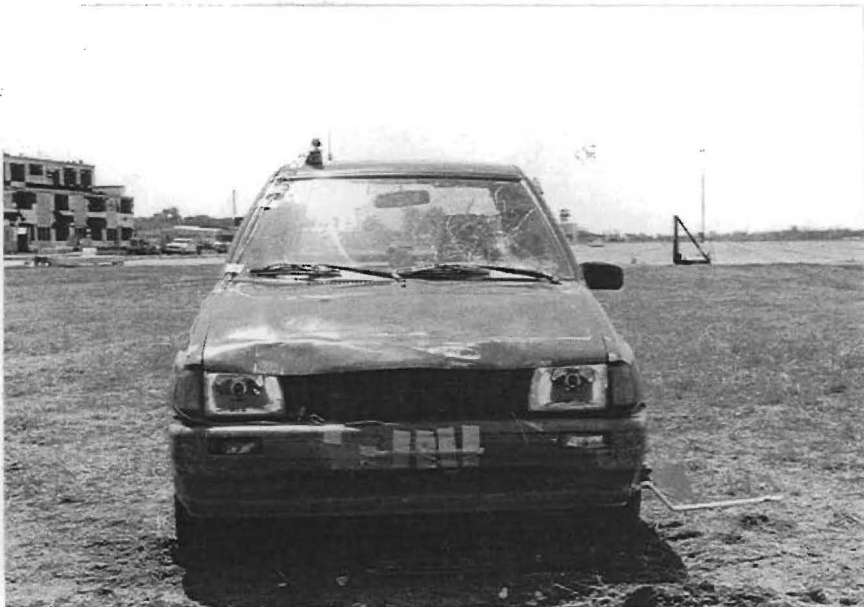
**Figure 16. Vehicle after test 439107-1.**

The vehicle received minor superficial damage as shown in Figure 16. The bumper, hood, and grill were dented and scraped, and the headlights were broken. The windshield was shattered on the driver's side from contact with the warning light.

A summary of the test results is shown in Figure 17. This test is judged to be unsatisfactory due to shattering of the windshield by the warning light attachment. Thus, it is recommended that warning lights should not be used with barricades. However, it is the opinion of the project staff that the barricade would have performed satisfactorily, meeting all evaluation criteria set forth in NCHRP Report 350, if there were no warning light attached to the barricade.

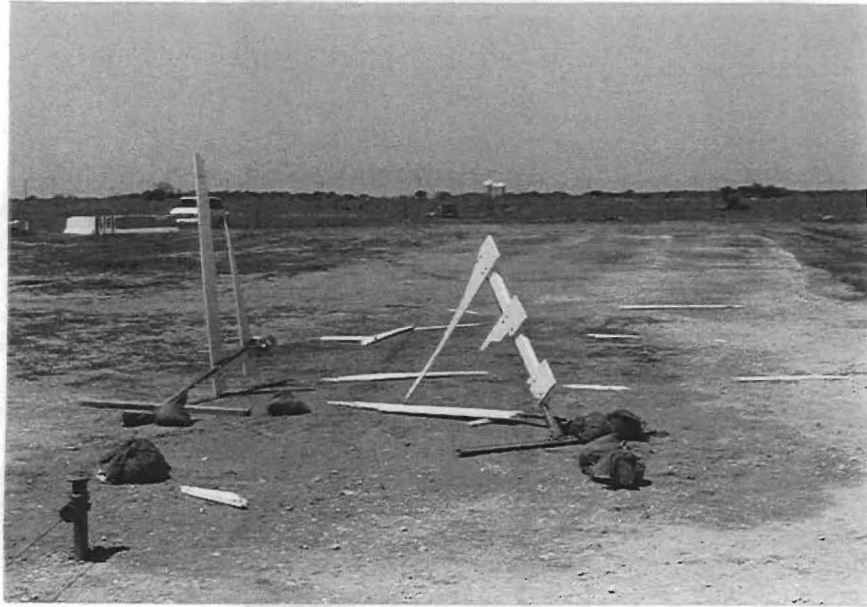
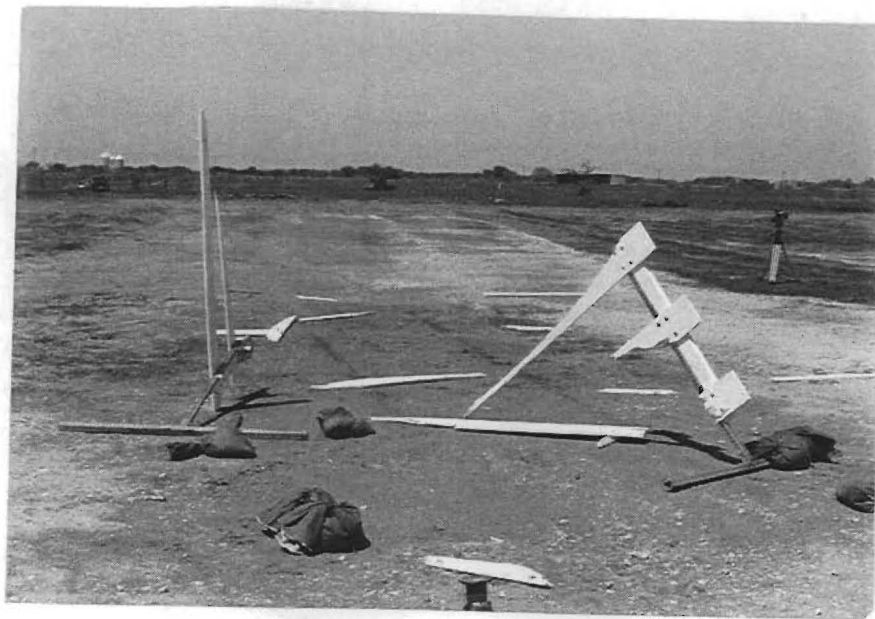
**Figure 20. After Impact Trajectory for Test 439107-2.**

The barricade shattered into several pieces as shown in Figures 20 and 21. The left vertical support was pulled inward 5 mm at the lower panel, and the base was bowed downward 5 mm. The right vertical support was pulled inward 8 mm at the lower panel and deformed back 7 mm. The right base was not deformed. The debris scatter extended 1.8 m to the left side, 4.9 m to the right side, and 12.2 m downstream of the impact point.

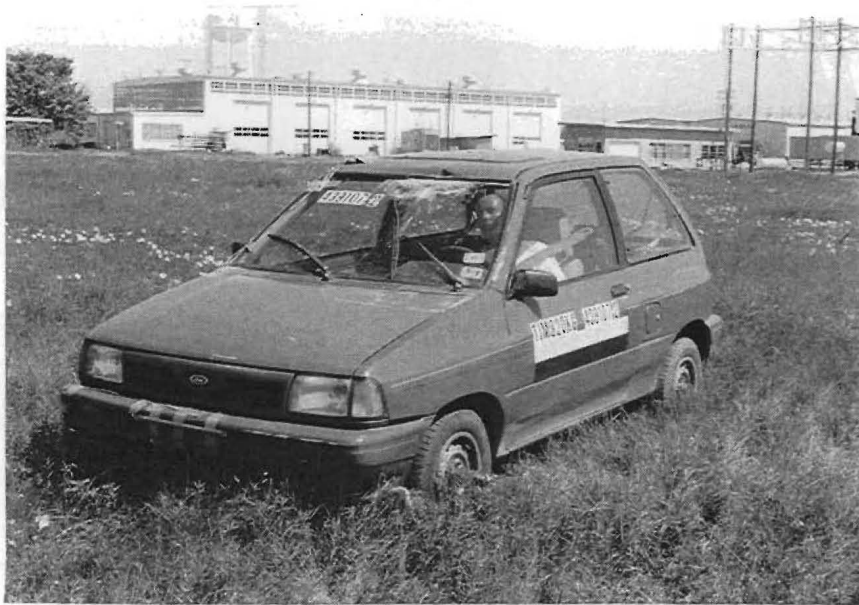
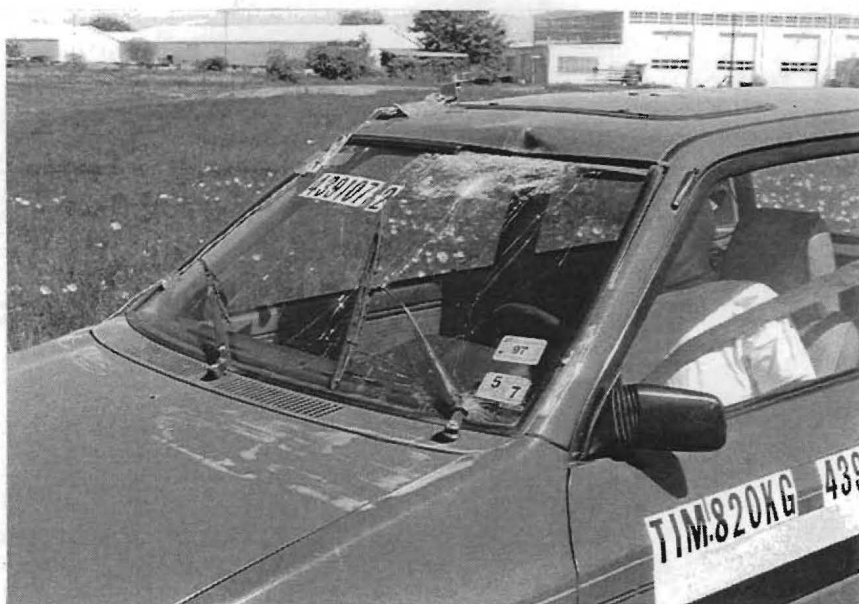
**Figure 22. Vehicle After Test 439107-2.**

As shown in Figure 22, the vehicle received minor damage. The hood was dented (not measurable), and the windshield was shattered near the roof edge at the center.

A summary of the test results is shown in Figure 23. This test is judged to be marginal. While the windshield was shattered near the roof edge at the center, there was no deformation or intrusion into the occupant compartment. The potential for such deformation or intrusion is judged to be minimal due to the large contact area between the separated section of the barricade and the windshield. Thus, the use of vertical braces for the horizontal rail elements is still considered acceptable. However, it is recommended that a smaller vertical brace be used at the center, e.g., a 25 mm × 102 mm instead of the 52 mm × 102 mm used in the test, to reduce the potential for any deformation or intrusion into the occupant compartment.

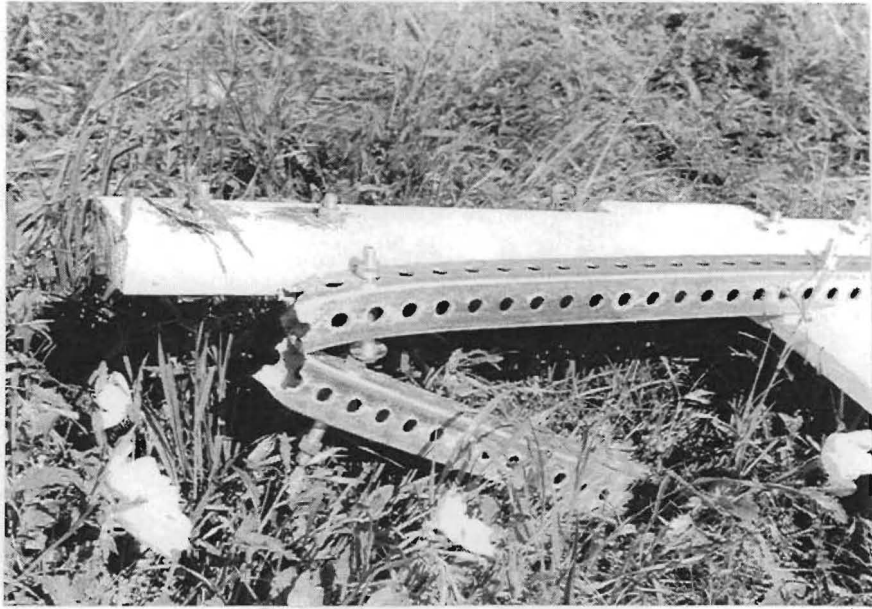
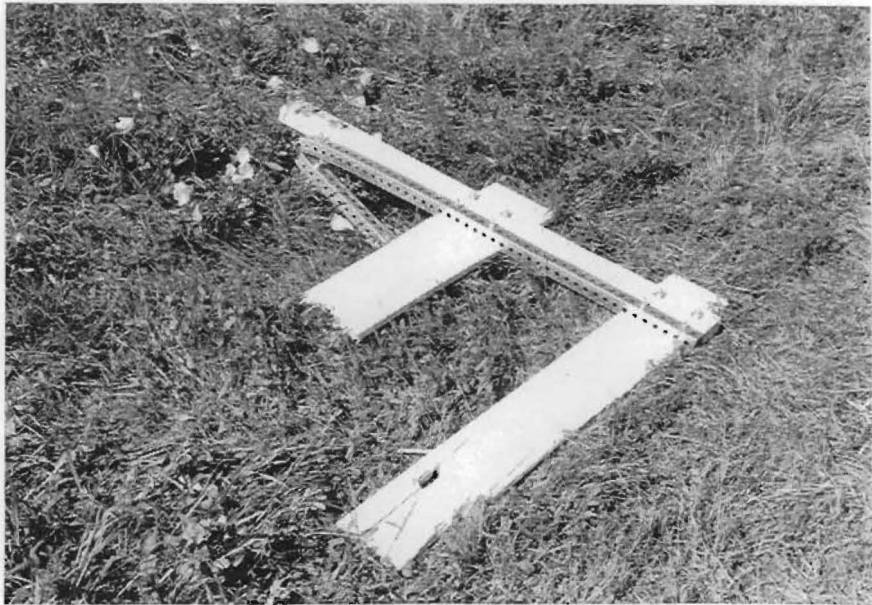
**Figure 26. After Impact Trajectory for Test 439107-3.**

The barricade separated into several pieces as shown in Figures 26 and 27. Both supports were torn at the rear side where the lower horizontal panel connected, on the left support at the lower bolt and on the right support at the upper bolt. The left base was bowed upward at the center 8 mm and the right base 3 mm. The debris scatter extended 6.9 m to the left, 5.0 m to the right, and 47.2 m down from impact.

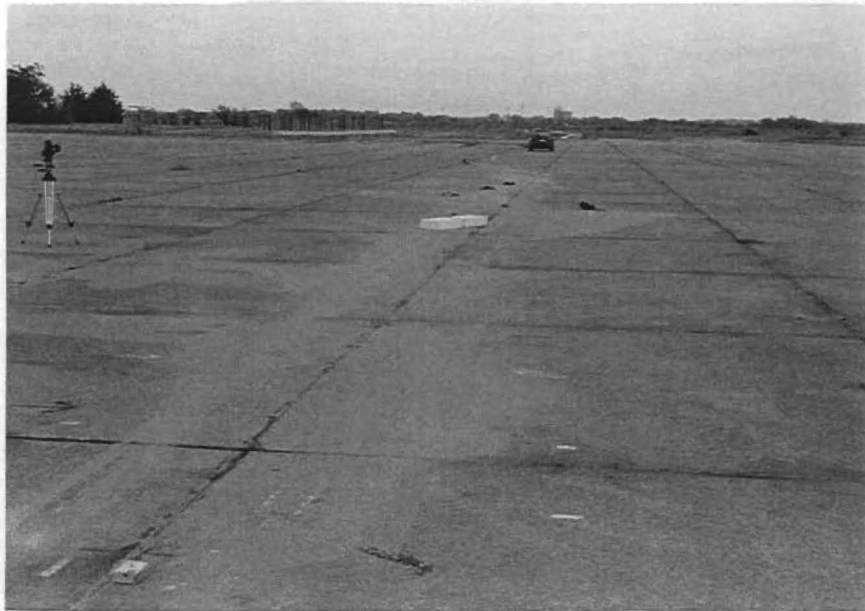
**Figure 32. After Impact Trajectory for Test 439107-5.**

The barricade separated from the bases, and the upper portion rode along with the vehicle as shown in Figures 32 and 33. The debris remained along the path of the vehicle with the upper portion at 95.1 m down from point of initial impact.

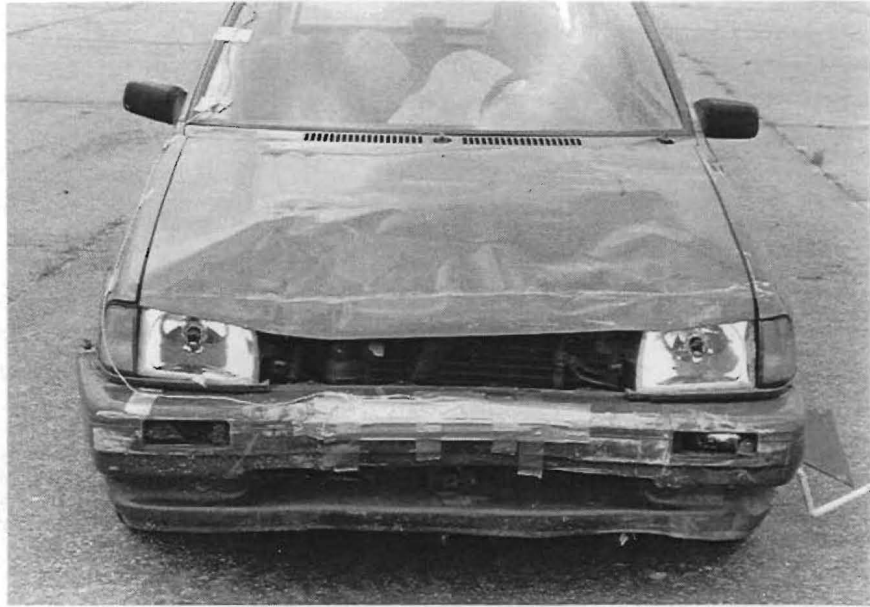
**Figure 34. Vehicle After Test 439107-5.**

The vehicle received minor scrapes and dents as shown in Figure 34. Only the bumper and hood were damaged.

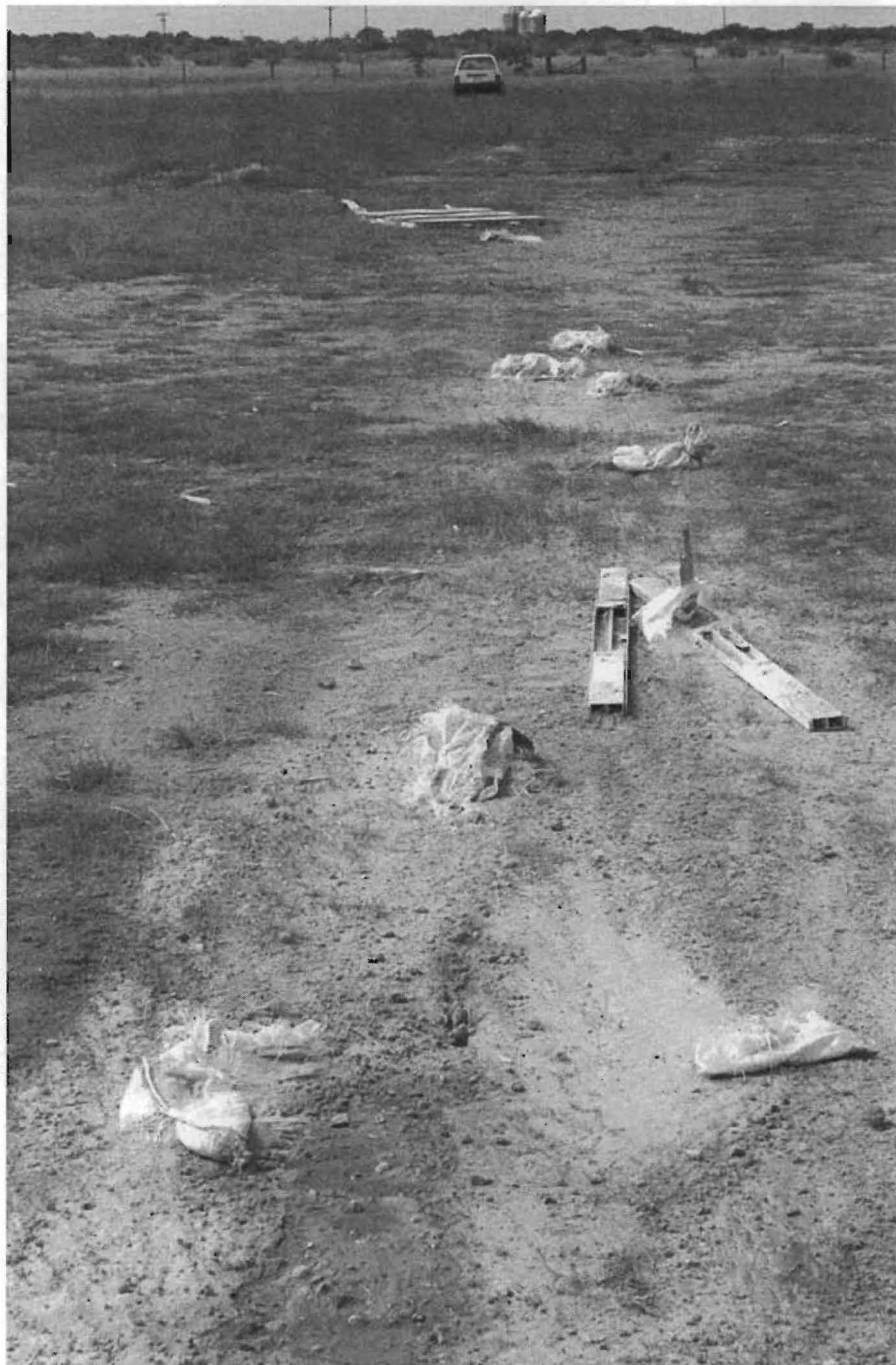
**Figure 38. After Impact Trajectory for Test 439107-12.**

The barricade separated into just a few pieces, as shown in Figures 38 and 39. The bases were 6.4 m down and 0.6 m to the right of impact point. The upper portion of the barricade was 22.3 m down and 2.6 m to the left of impact.

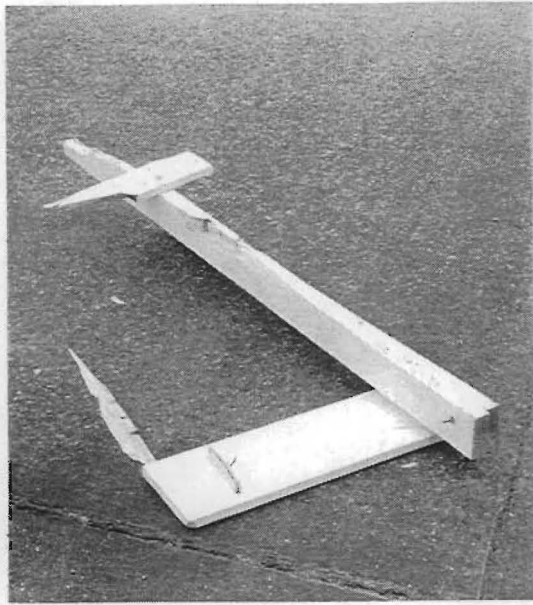
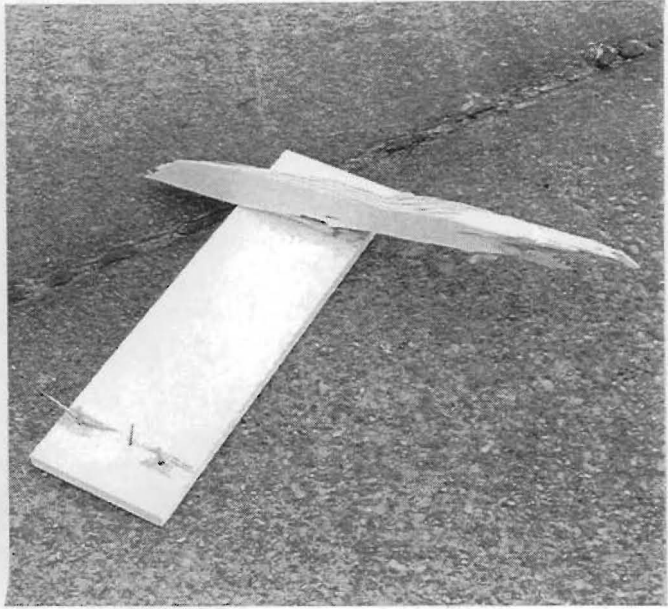
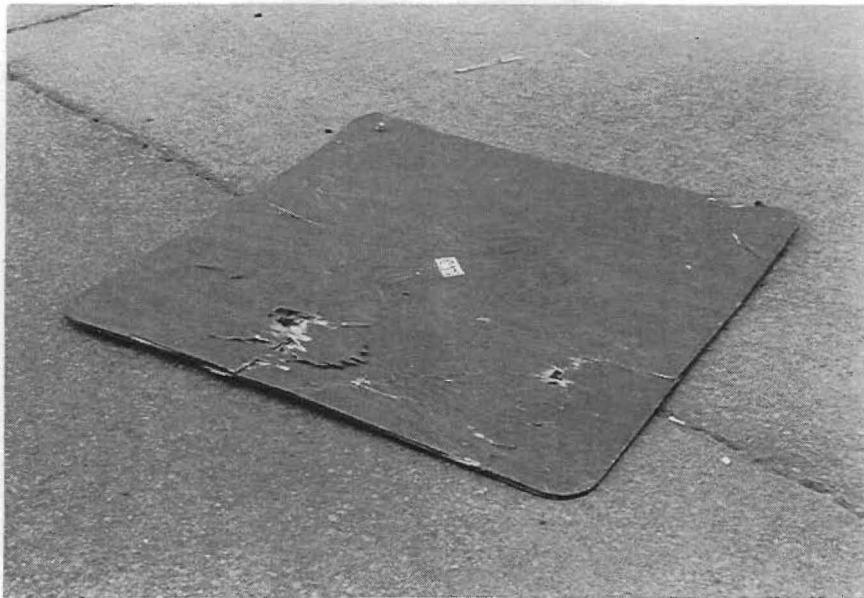
**Figure 44. Installation After Test 439107-4.**

The A-frame barricade separated into multiple pieces, as shown in Figure 44. The debris extended 7.3 m to the right, 17.7 m to the left, and 68.6 m down from impact.

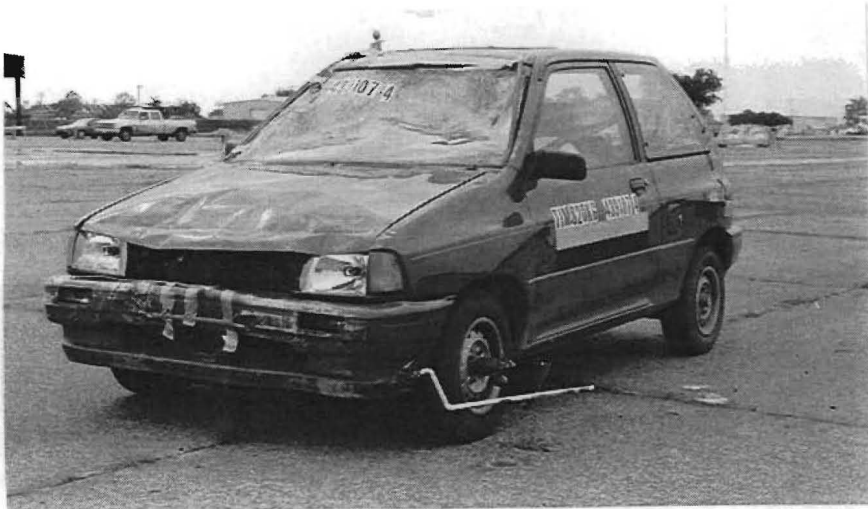
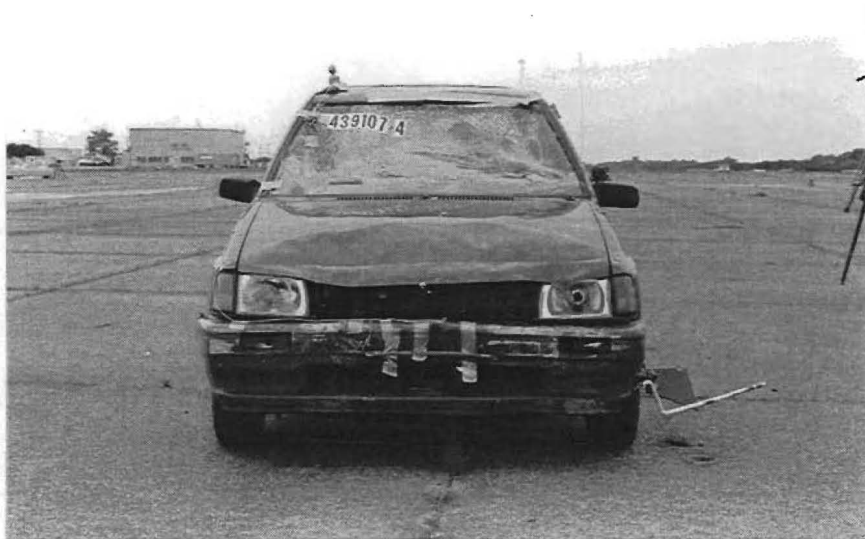
**Figure 45. Vehicle After Test 439107-4.**

The windshield of the vehicle was shattered and pushed inward, as shown in Figure 45. The bumper was dented and scraped.

A summary of the test results is shown in Figure 46. The test is judged to be unsatisfactory due to the shattering of the windshield and partial intrusion into the occupant compartment. It is anticipated that similar unsatisfactory performance would result even if the plywood sign panel is replaced with a lightweight fabric/plastic sign panel. Thus, the field implementation of wooden Type I barricade, with or without sign panel, is not recommended under test level 3 conditions.

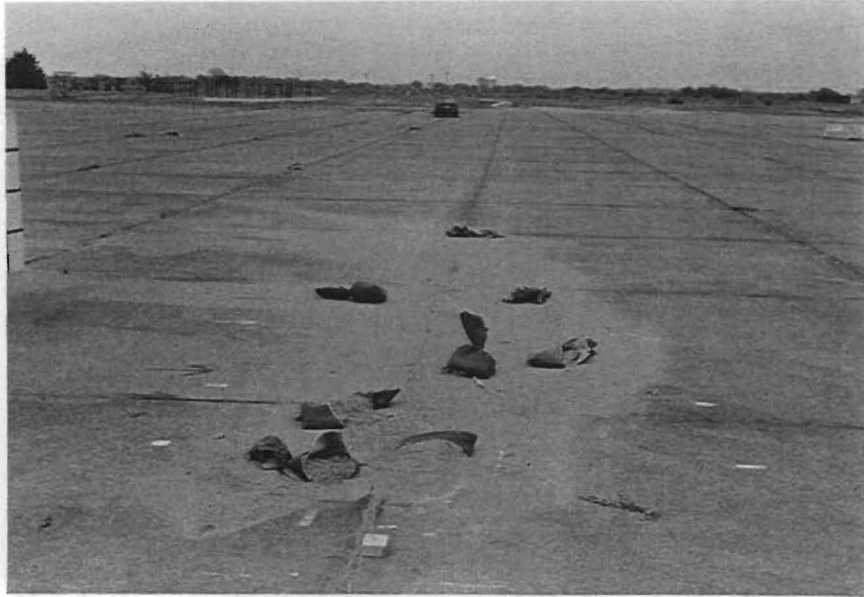
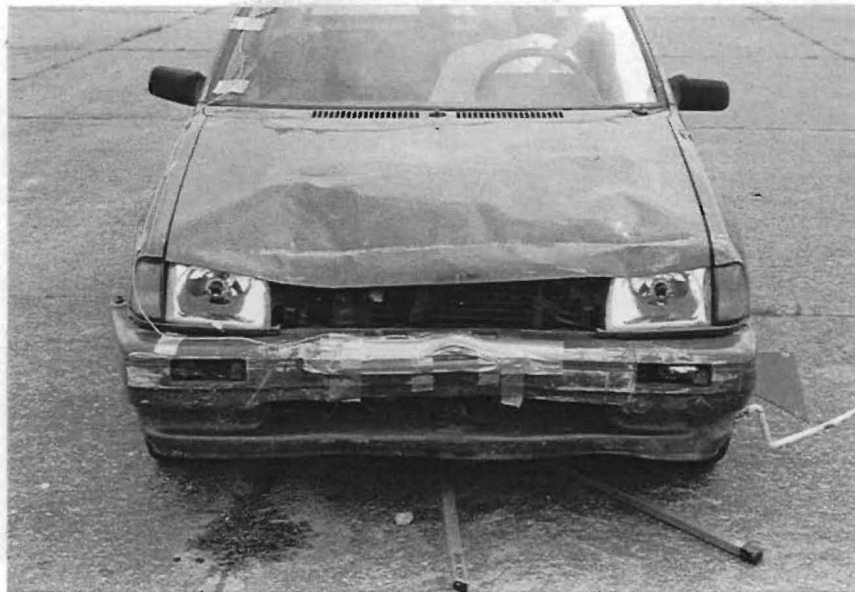
**Figure 49. After Impact Trajectory for Test 439107-6.**

The fabric/plastic sign panel and the upper tube separated from the spring-loaded sign support, as shown in Figures 49 and 50. The fabric/plastic sign panel and the upper tube support came to rest 31.2 m down and 10.6 m to the left of impact point. The base and lower tube support stayed with the vehicle.

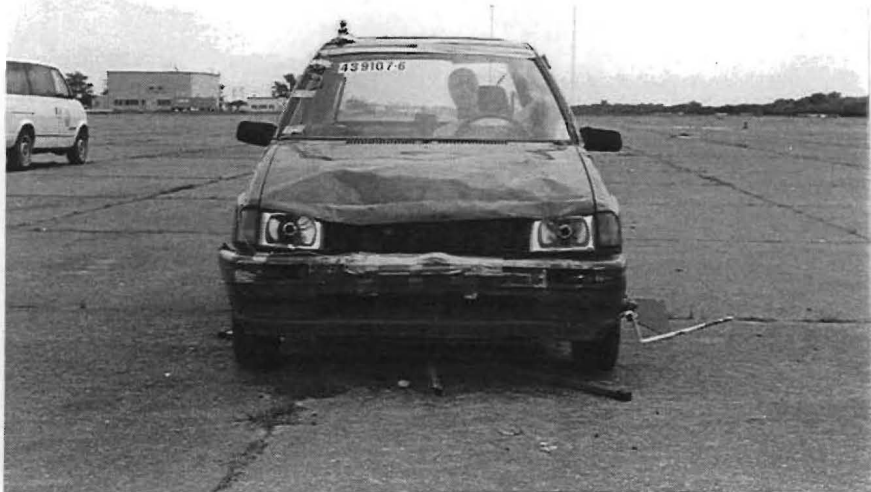
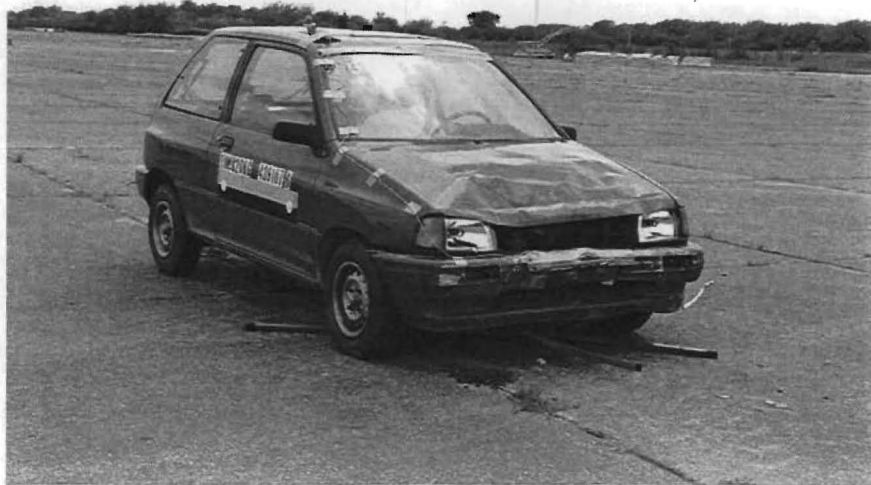
**Figure 51. Vehicle After Test 439107-6.**

The vehicle received damage to the front and the roof, as shown in Figure 51. The bumper, grill, and hood received scrapes. The roof was cut and dented.

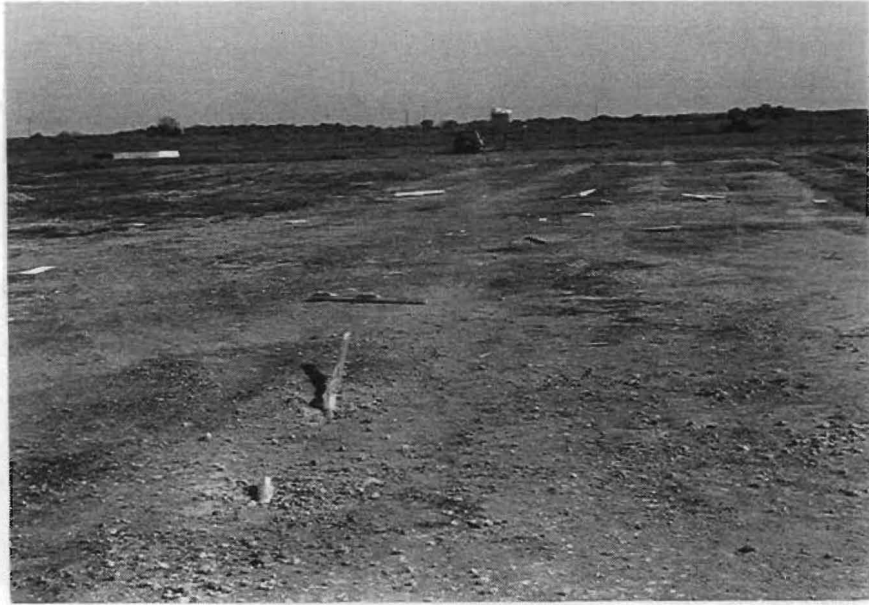
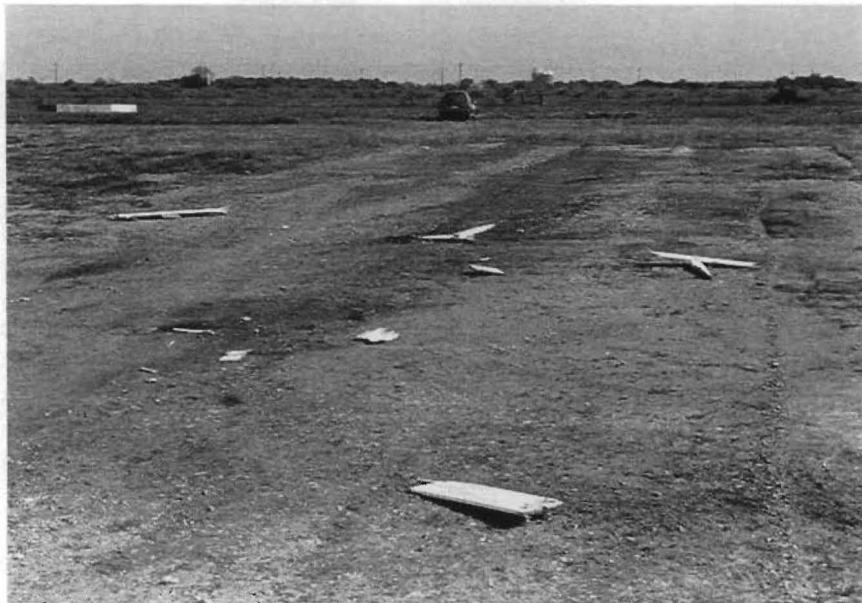
**Figure 55. After Impact Trajectory for Test 439107-7.**

The barricade separated into several pieces, as shown in Figures 55 and 56. The debris extended 42.1 m down, 8.5 m to the left, and 7.0 m to the right of the impact point. Sequential photographs of the test can be found in Appendix B, Figure 93.

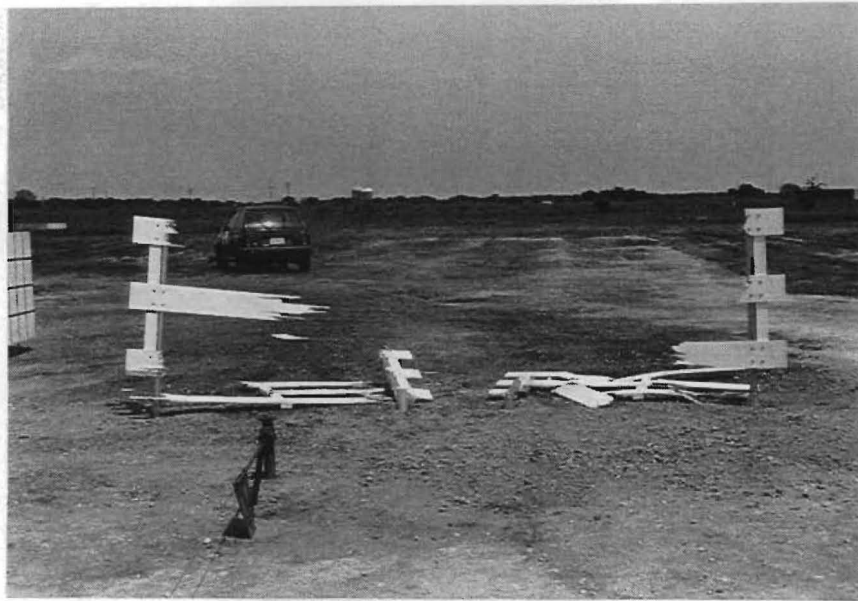
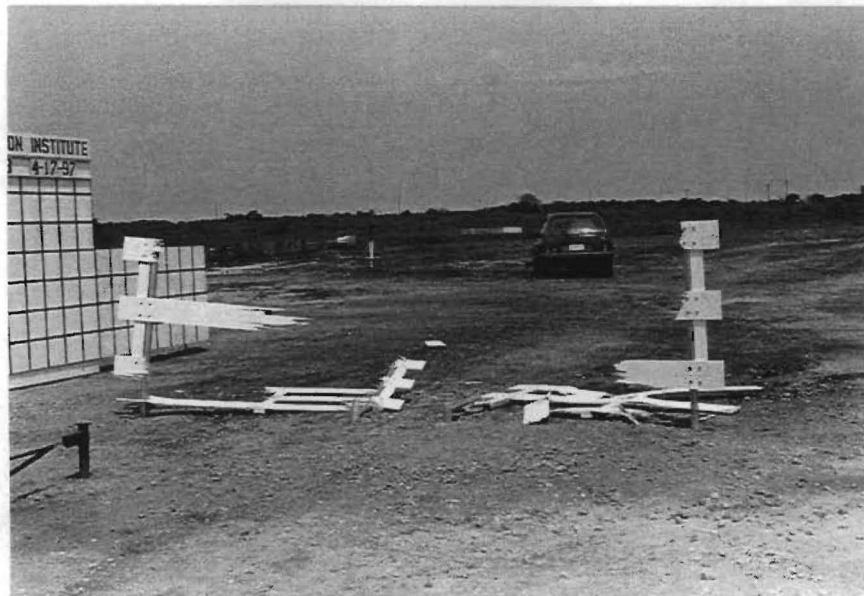
**Figure 61. After Impact Trajectory for Test 439107-8.**

Most of the debris remained at the impact point, as shown in Figures 61 and 62. The outer supports of the barricade remained upright, and the two supports impacted by the vehicle laid over on the ground. One small fragment of the support was 4.3 m down and 1.8 m to the left of the impact point. Sequential photographs of the test can be found in Appendix B, Figure 94.

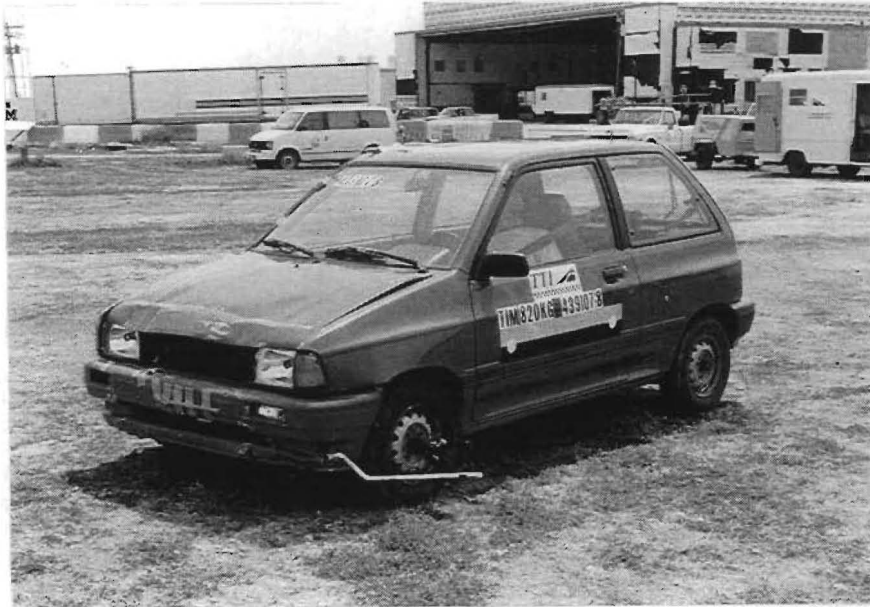
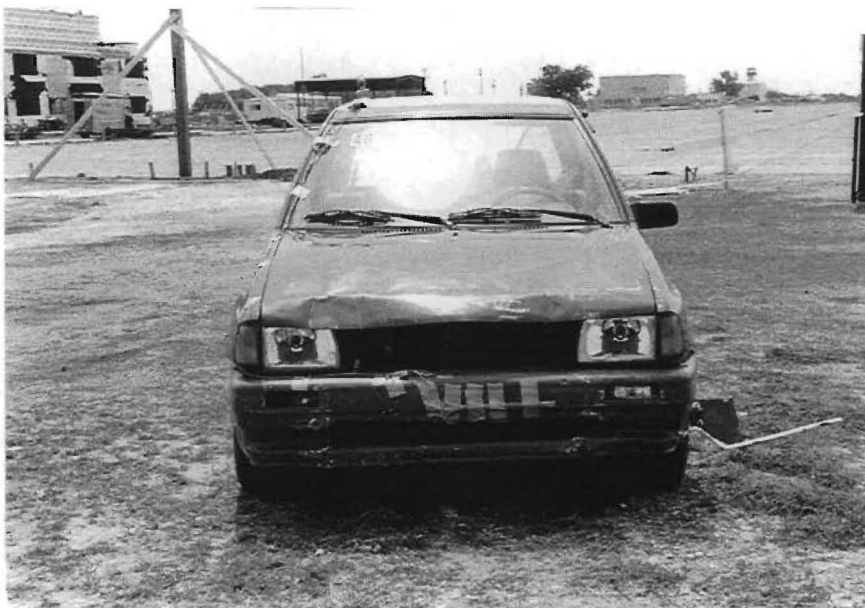
**Figure 63. Vehicle After Test 439107-8.**

The vehicle received minor dents and scrapes to the bumper and hood, as shown in Figure 63.

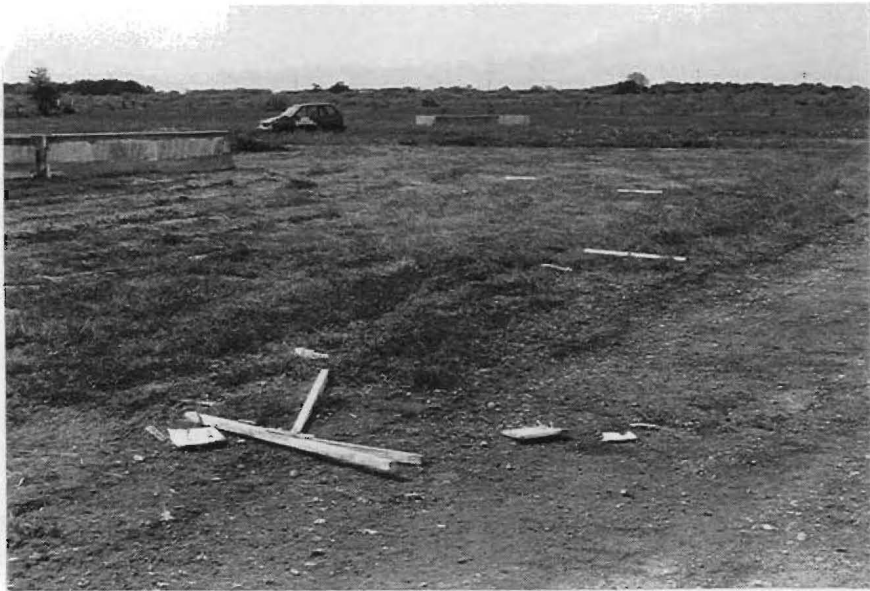
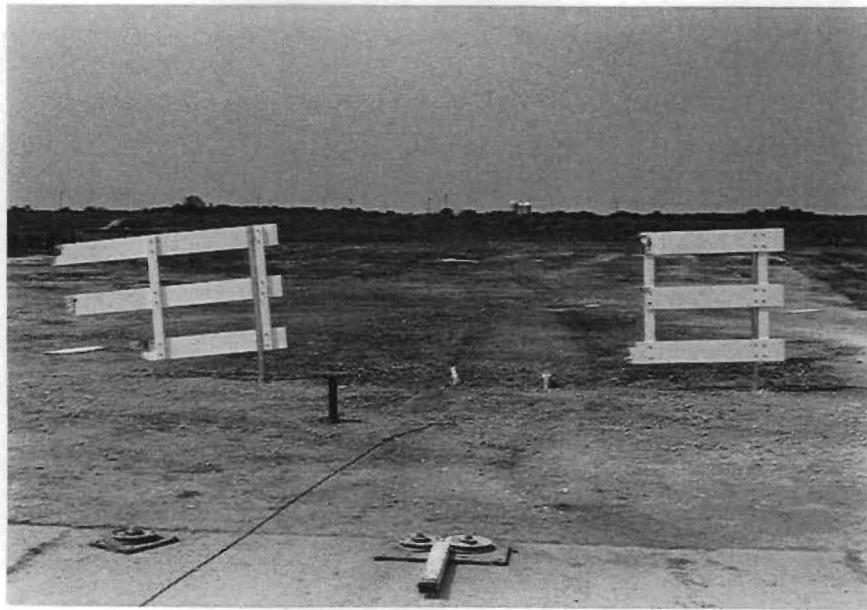
**Figure 67. After Impact Trajectory for Test 439107-9.**

About half of each barricade on the non-impact sides remained upright and in one piece, as shown in Figures 67 and 68. The impacted support of the right barricade fractured at bumper height, and the impacted support on the left barricade fractured near ground level. The remaining fragments were scattered 45.7 m down, 9.1 m to the right, and 5.4 m to the left of the impact point. Sequential photographs of the test can be found in Appendix B, Figure 95.

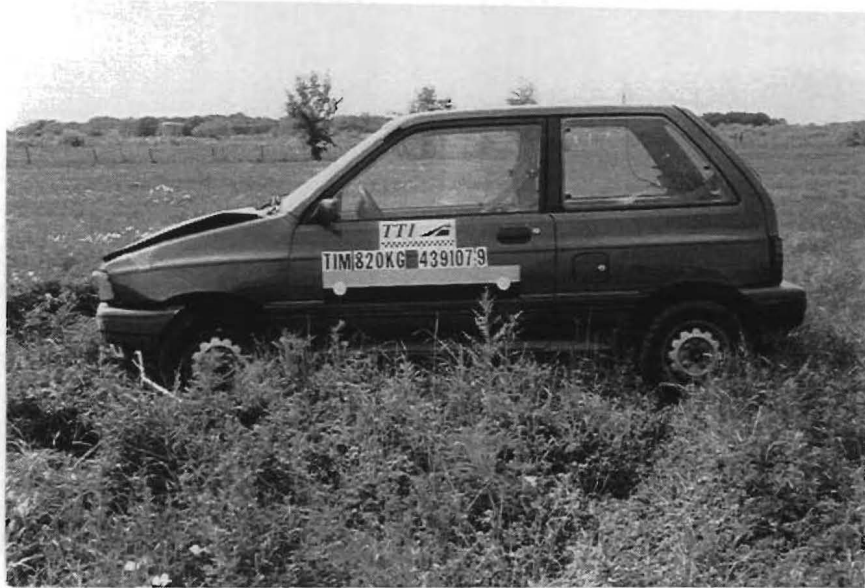
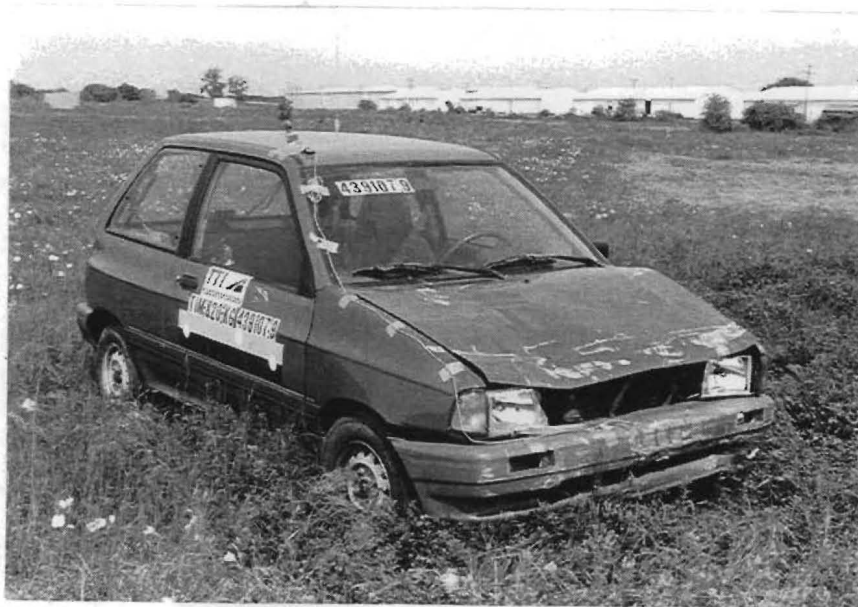
**Figure 69. Vehicle After Test 439107-9.**

The vehicle's hood and bumper received most of the damage, as shown in Figure 69. The left strut was also damaged, and there was a scratch on the passenger side door and door glass.

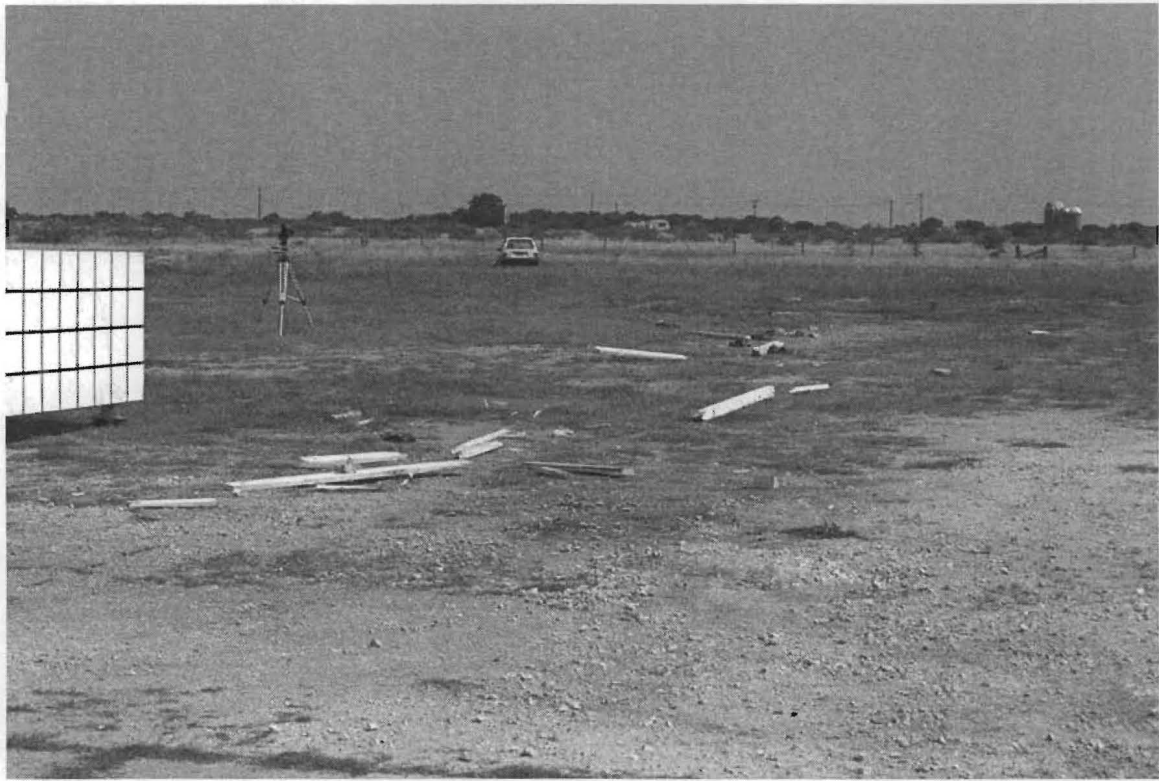
**Figure 73. After Impact Trajectory for Test 439107-10.**

The barricade separated into several pieces, as shown in Figures 73 and 74. The debris extended 33.8 m down and 1.8 m to either side of the impact point.

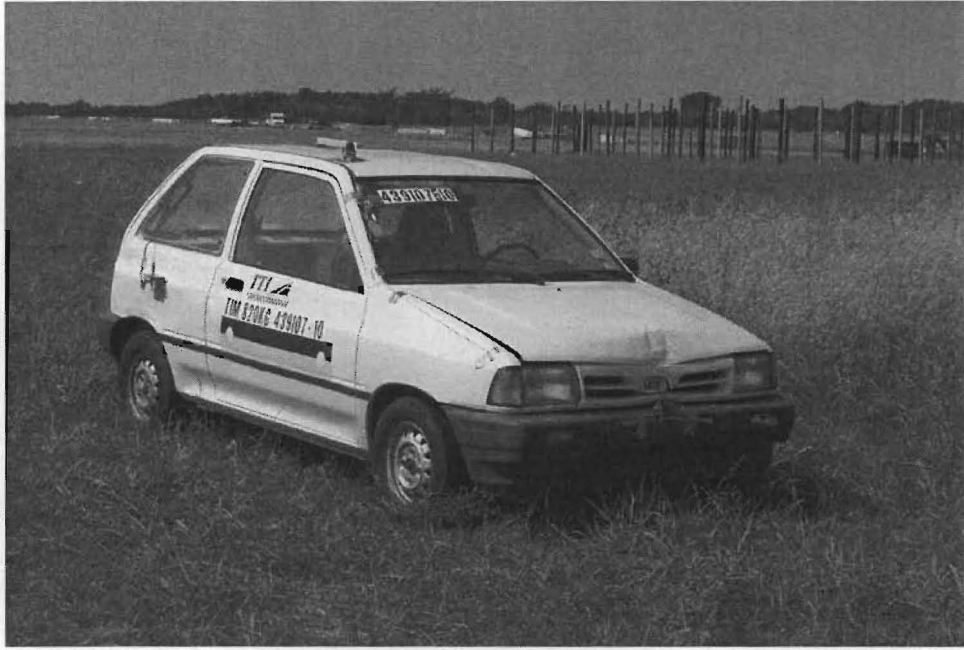
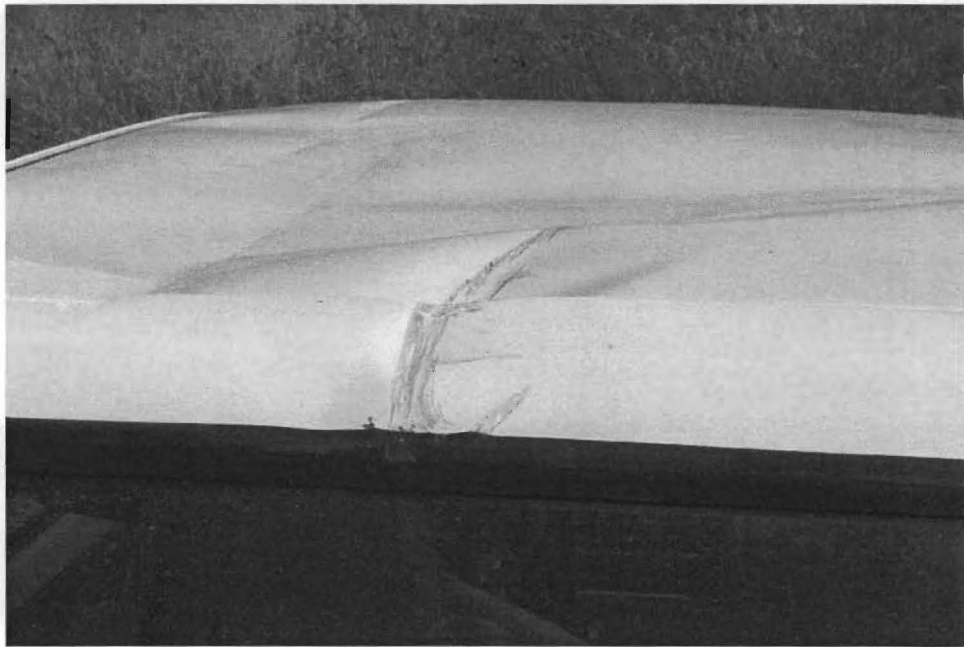
**Figure 75. Vehicle After Test 439107-10.**

The bumper and hood were damaged, and the roof was dented, as shown in Figure 75. The motor support was also bent. Maximum exterior crush to the center of the front bumper was 55 mm. Maximum occupant compartment deformation was 35 mm in the roof area over the left rear passenger position.

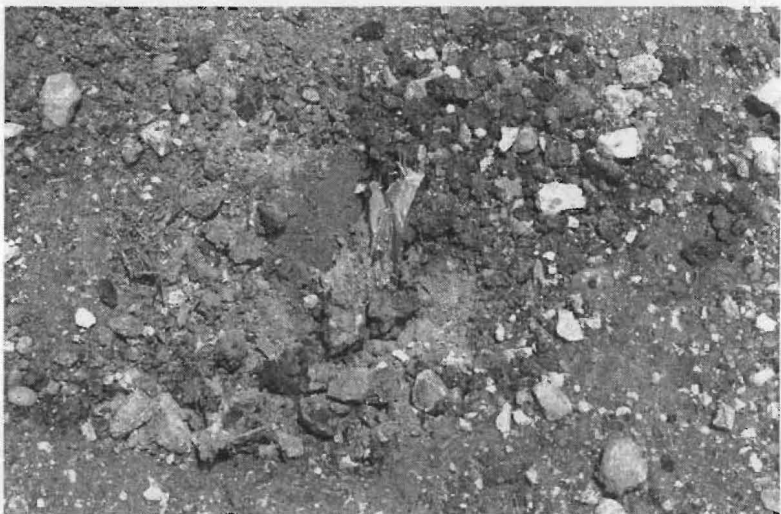
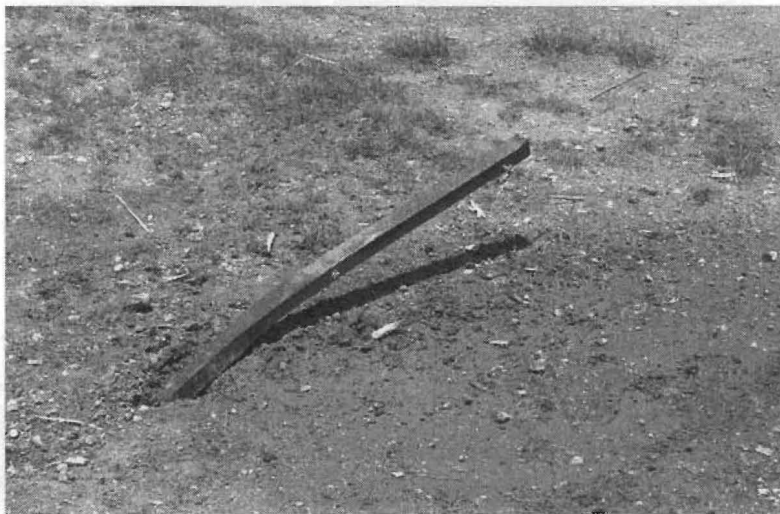
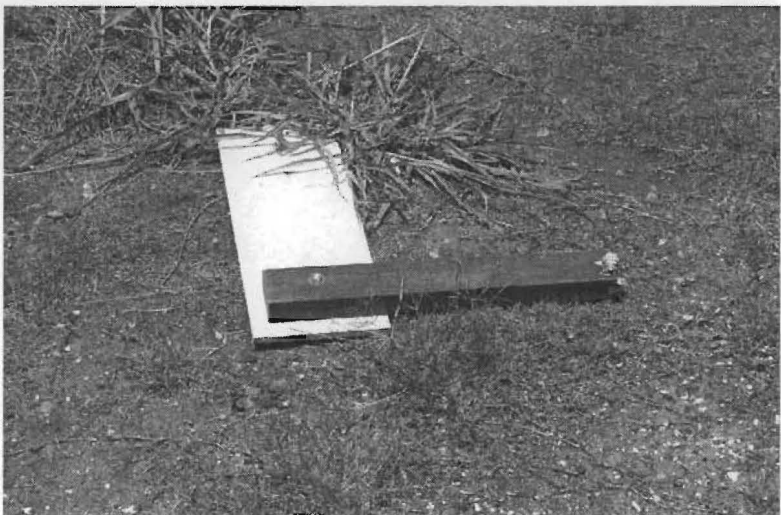
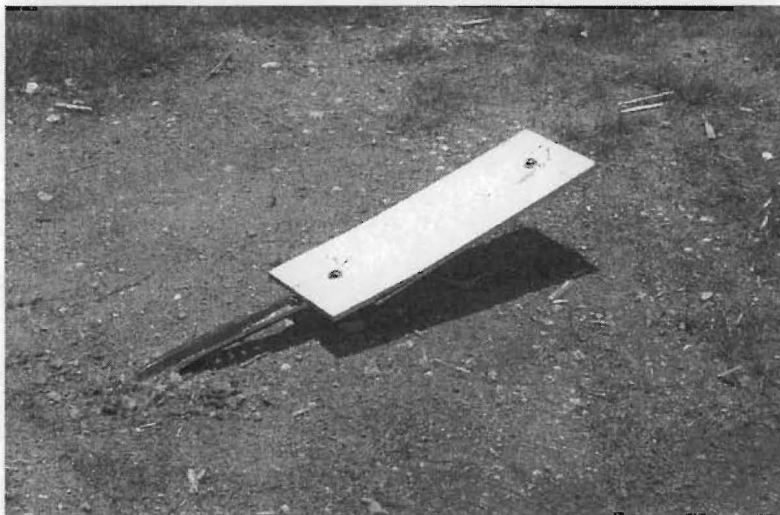
Figure 79. Installation After Test 439107-11.

The wooden support for the first vertical panel assembly broke off at ground level, and the steel angle and the supports for the remaining two vertical panel assemblies were bent over, as shown in Figures 78 and 79. The panel from the first vertical panel assembly came to

rest 36.7 m down and 3.7 m to the right of impact with pieces of the support 15.2 and 15.9 m down from impact. The panel for the second vertical panel assembly came to rest 1.8 m from its original position. The third vertical panel assembly was pushed back but remained intact.
