1. Report No. TX-97/3910-S		2. Government Accession No.		3. Recipient's Catalog No.	
4. Title and Subtitle EVALUATION OF WORK ZONE BARRICADES				5. Report Date November 1997

# **EVALUATION OF WORK ZONE BARRICADES**

Research Report 3910-S  
Research Study Number 7-3910  
Research Study Title: Design, Evaluate, and Test  
Work Zone Sign Supports and Barricades

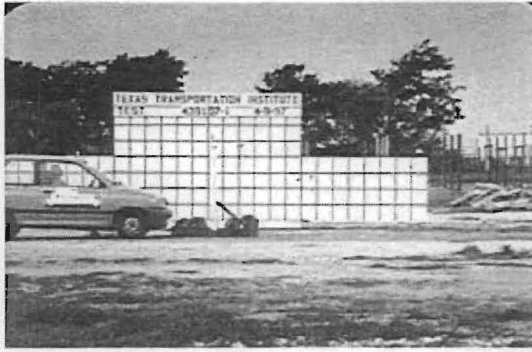
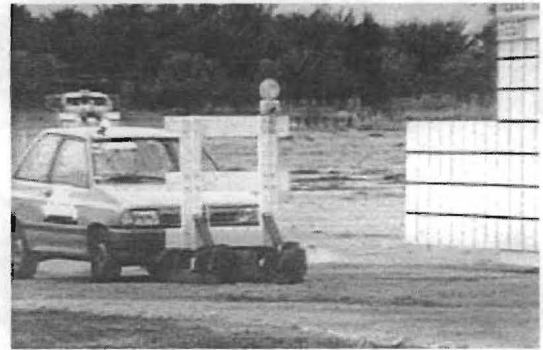
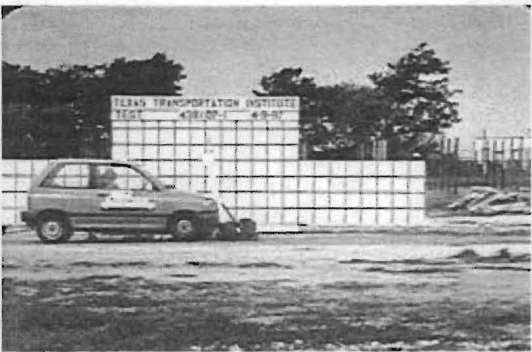
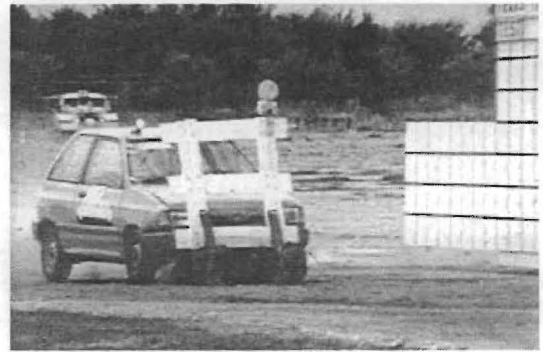
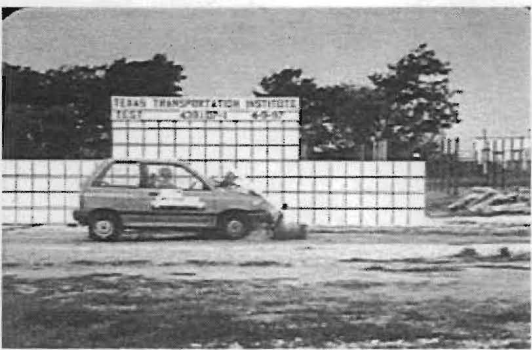
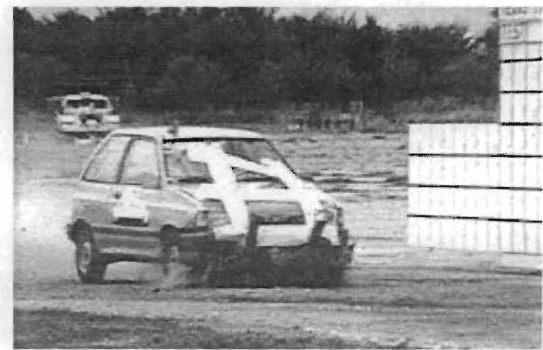
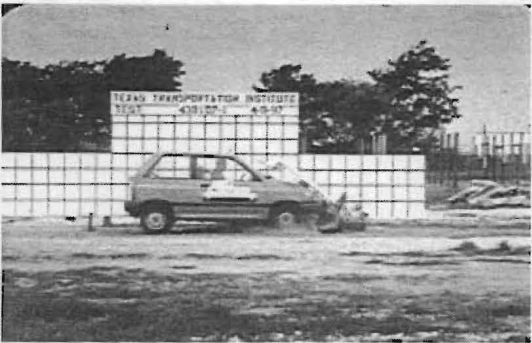
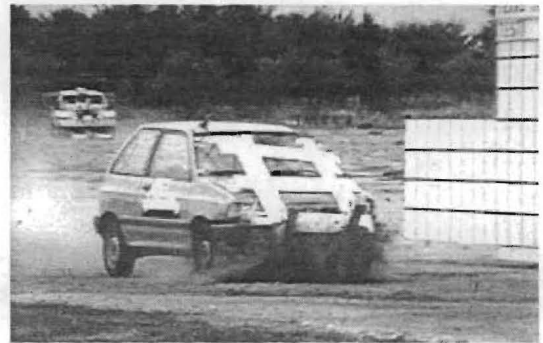
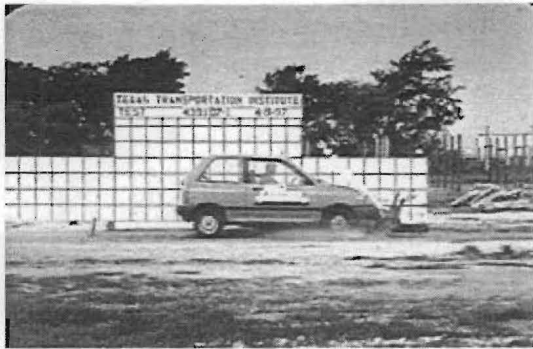
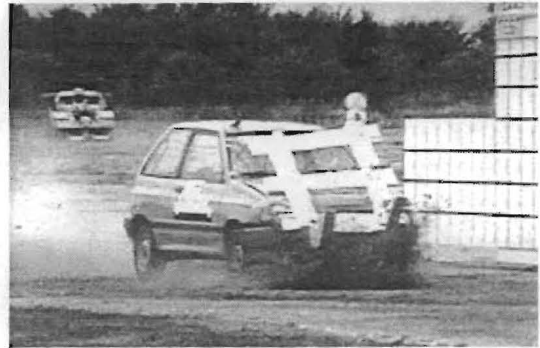
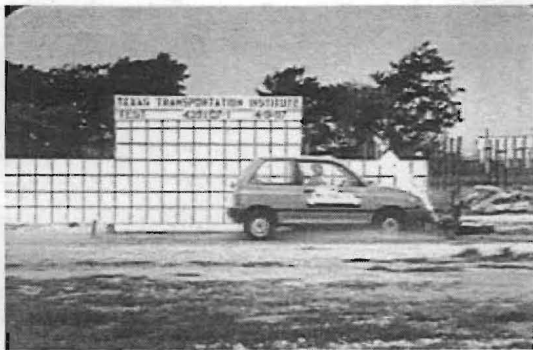
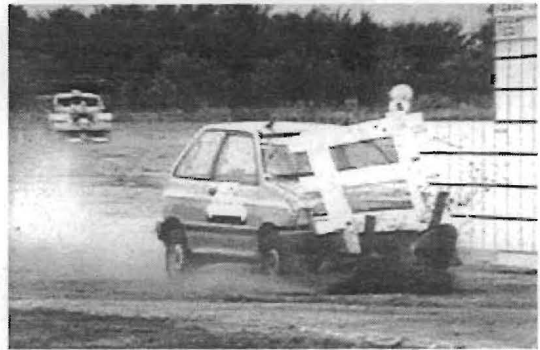
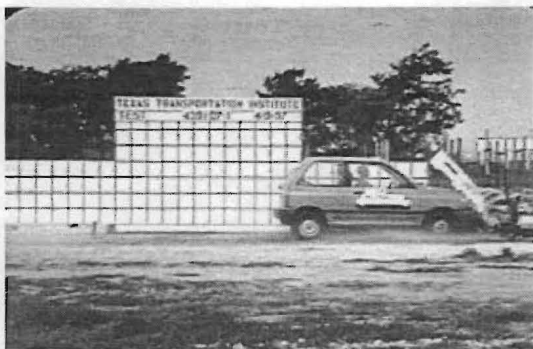
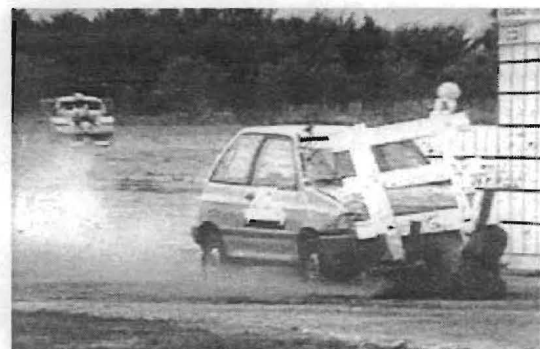
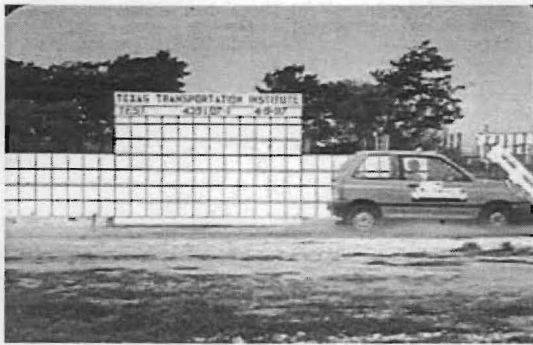
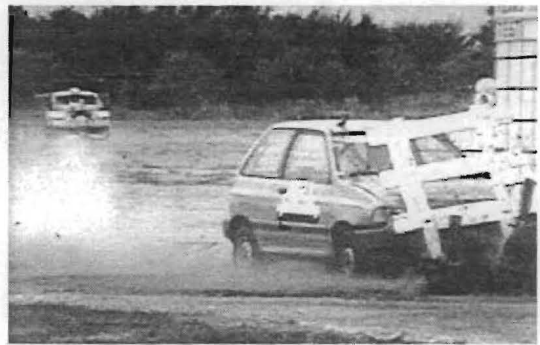
**Figure 86. Sequential Photographs for Test 439107-1  
(Perpendicular and Oblique Views).**

The vehicle impacted the barricade head-on with the centerline of the vehicle aligned with the centerline of the barricade at a speed of 99.5 km/h. At 0.042 s after impact, the rear brace on the right side of the barricade separated at the upper attachment to the upright. At 0.045 s, the rear brace on the left side separated at the upper attachment to the upright, and the left upright fractured just above the center horizontal panel. The upright made contact with the hood at 0.048 s, and the left upright fractured between the lower and center horizontal panels at 0.050 s. The warning light contacted the windshield at 0.072 s. The vehicle was traveling at 83.6 km/h as it lost contact with the warning light. Brakes on the vehicle were applied as the vehicle exited the test site, and the vehicle came to rest 51.6 m downstream and 2.8 m to the right of the impact point. Sequential photographs of the test can be found in Appendix B, Figure 86.

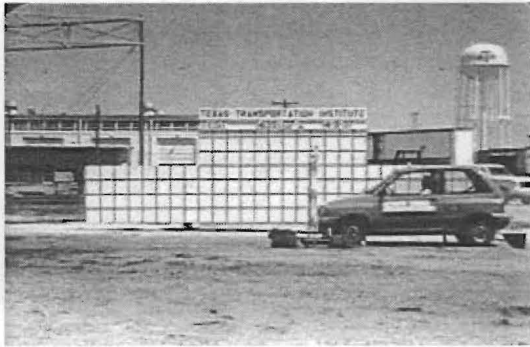
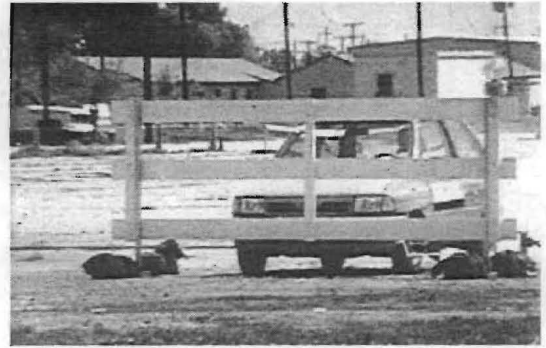
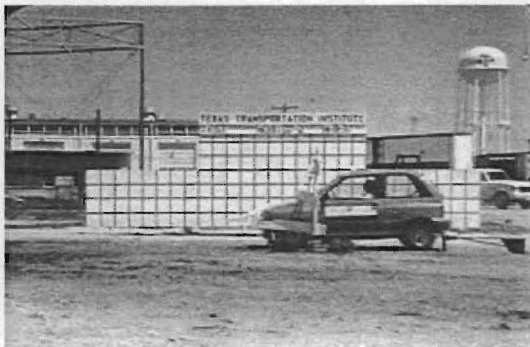
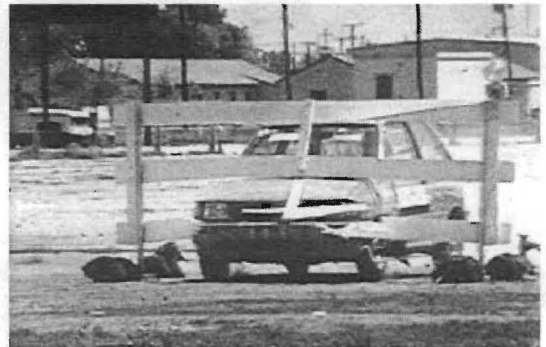
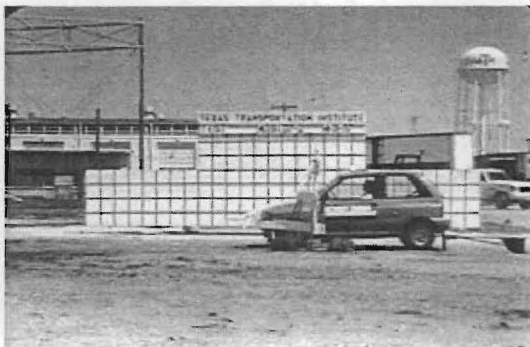
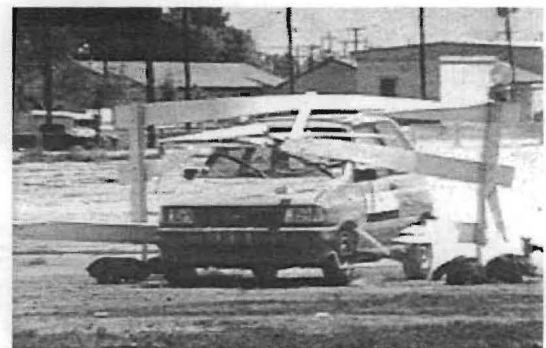
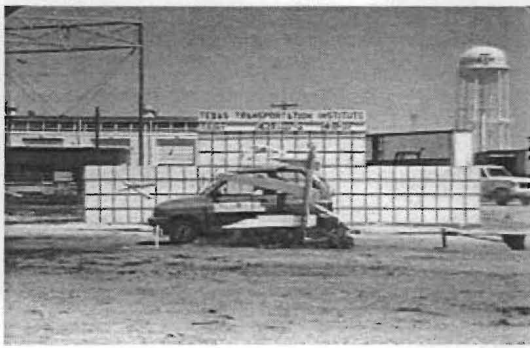
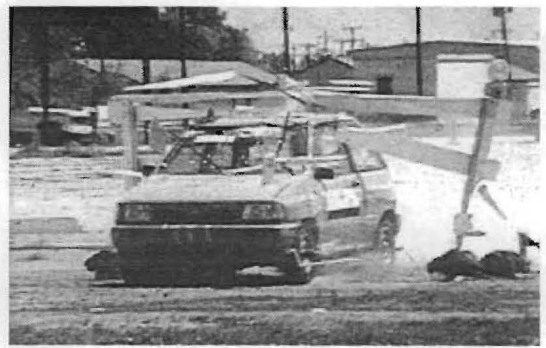
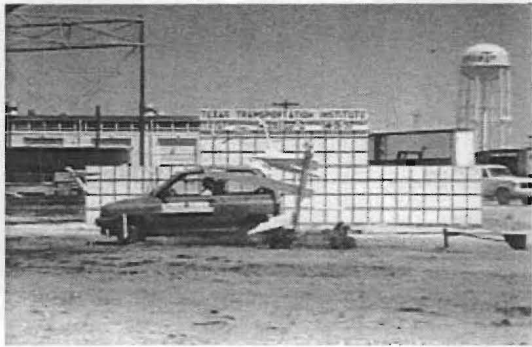
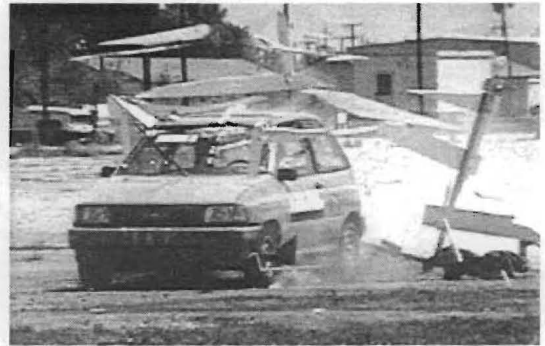
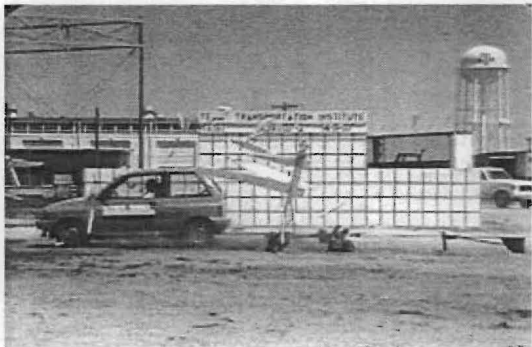
**Figure 87. Sequential Photographs for Test 439107-2  
(Perpendicular and Oblique Views).**

The vehicle impacted the barricade head-on at a speed of 98.04 km/h. At 0.011 s after impact, the lower and center horizontal panels fractured near the center vertical support. The center vertical support fractured near the center at 0.015 s, and a section of the center support contacted the windshield at 0.072 s. By 0.103 s, the barricade had shattered into multiple pieces. The vehicle was traveling at 94.52 km/h as it lost contact with the barricade. Brakes on the vehicle were applied as the vehicle exited the test site, and the vehicle came to rest 71.6 m down and 5.9 m to the right of the impact point. Sequential photographs can be found in Appendix B, Figure 87.

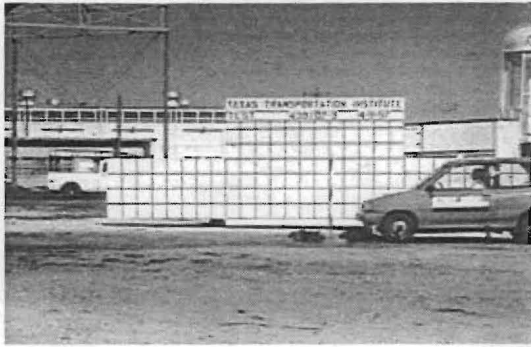
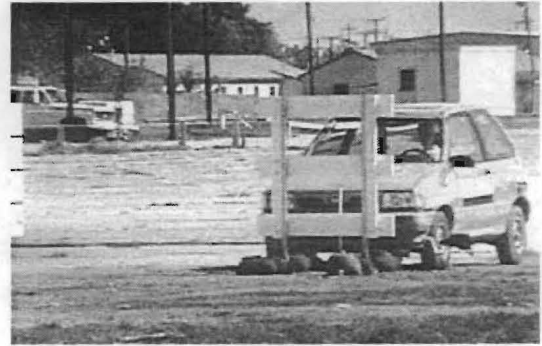
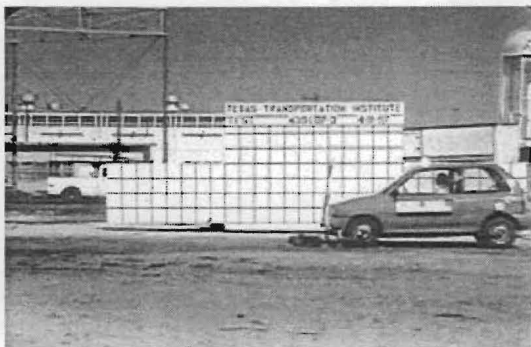
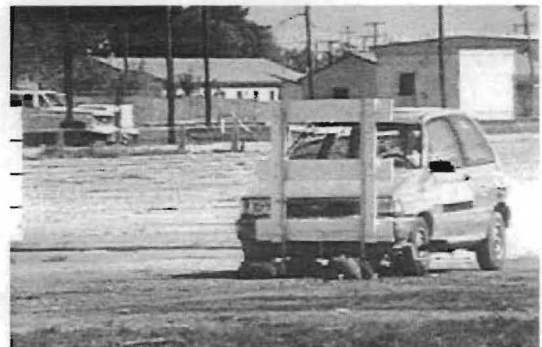
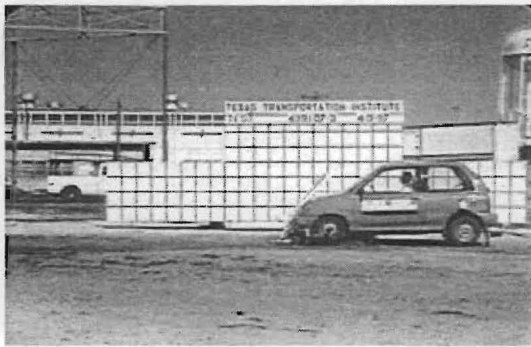
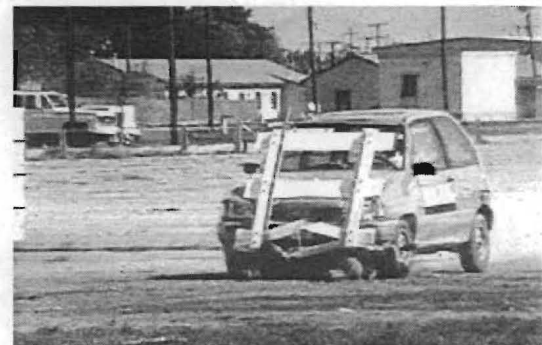
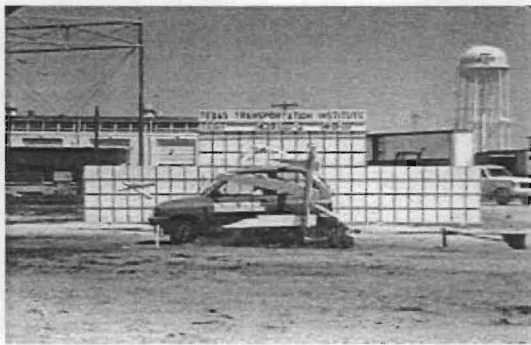
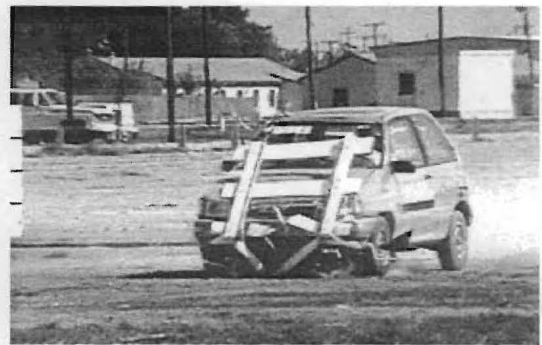
**Figure 88. Sequential Photographs for Test 439107-3  
(Perpendicular and Oblique Views).**

The vehicle impacted the barricade head-on at a speed of 98.05 km/h. At 0.022 s, the lower horizontal panel fractured, and at 0.026 s, the support post began to bend. The support post fractured at the bend at 0.030 s, and the center horizontal panel contacted the hood of the vehicle at 0.039 s. The vehicle was traveling at 89.99 km/h as it lost contact with the barricade. Brakes on the vehicle were applied as the vehicle exited the test site. The vehicle came to rest 50.3 m down and 5.7 m to the right of impact point. Sequential photographs of the test can be found in Appendix B, Figure 88.

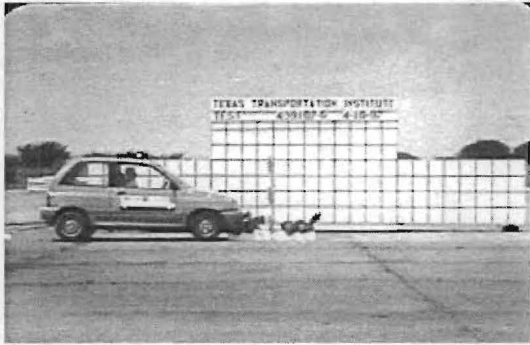
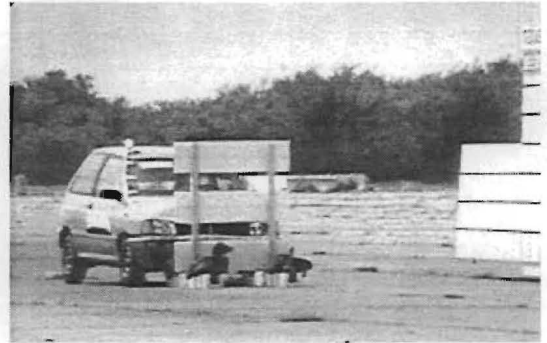
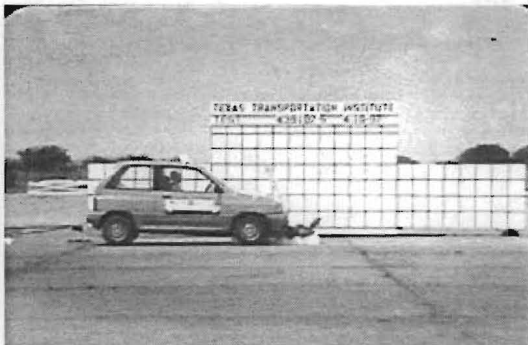
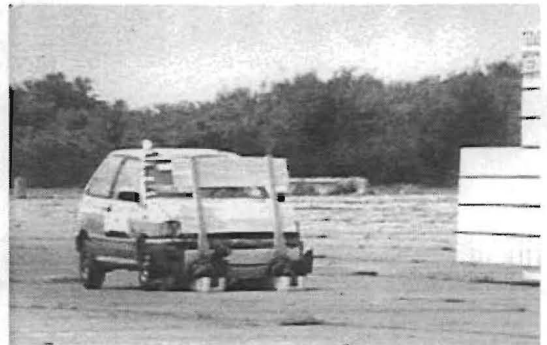
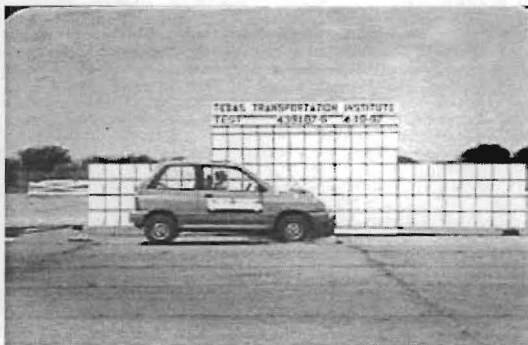
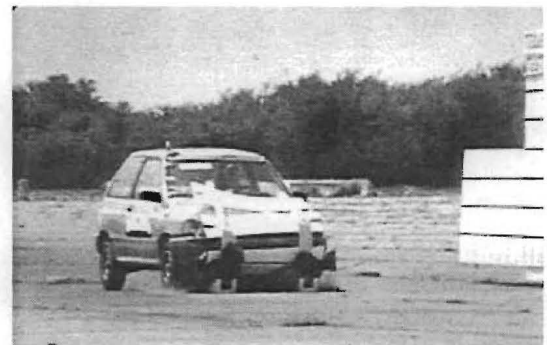
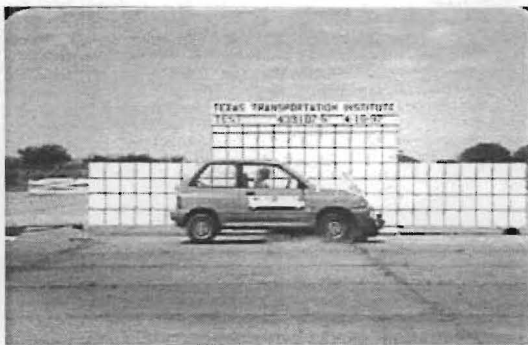
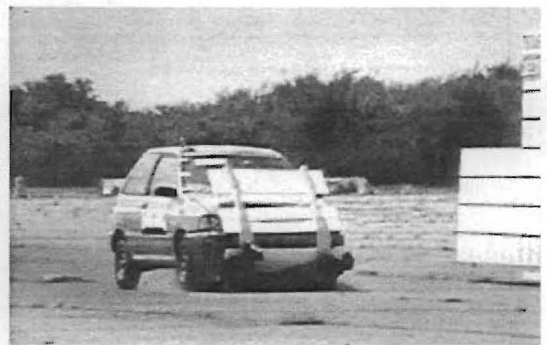
**Figure 89. Sequential Photographs for Test 439107-5 (Perpendicular and Oblique Views).**

0.235 s, the vehicle was traveling at 84.65 km/h. Brakes on the vehicle were applied as it exited the test site. The vehicle subsequently came to rest 90.6 m down from the impact point. Sequential photographs of the test can be found in Appendix B, Figure 89.

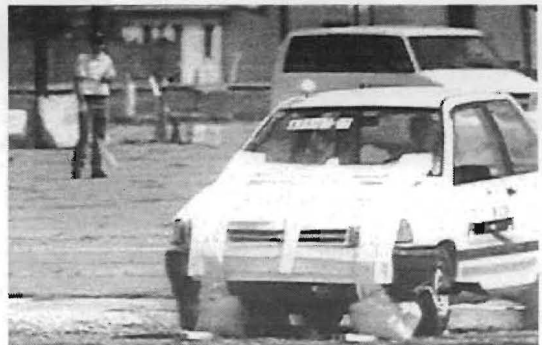
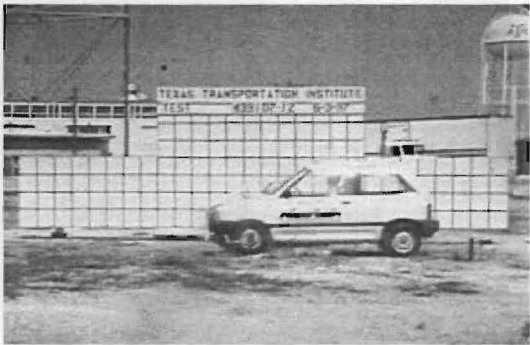
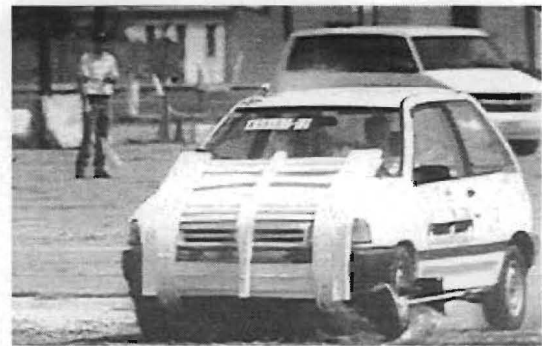
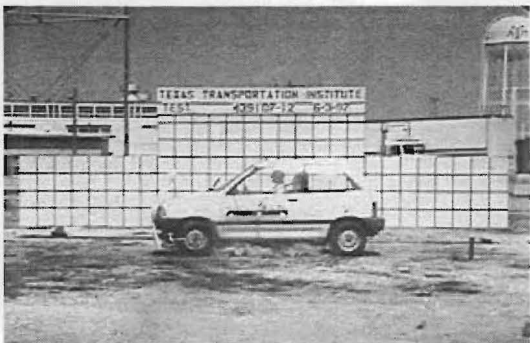
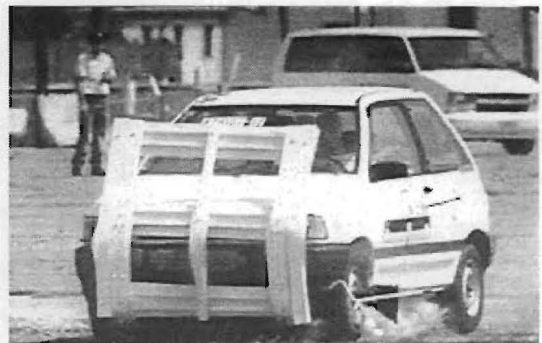
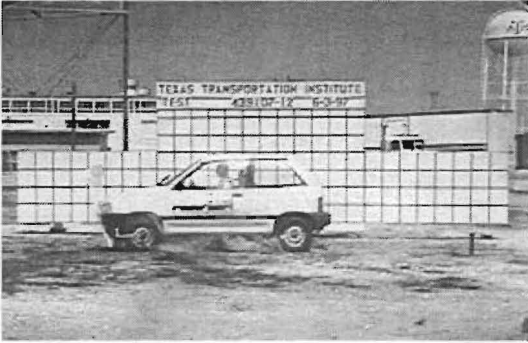
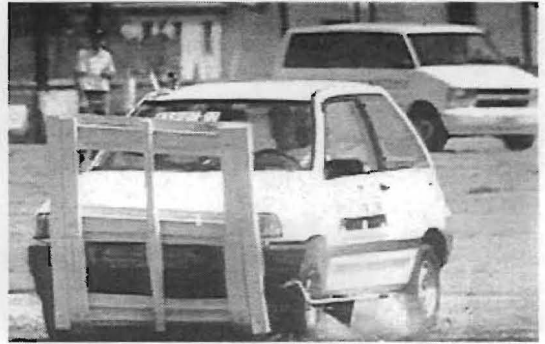
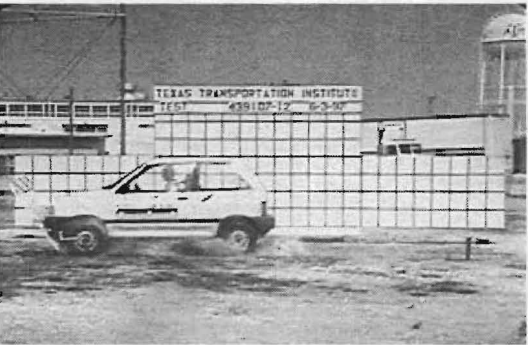
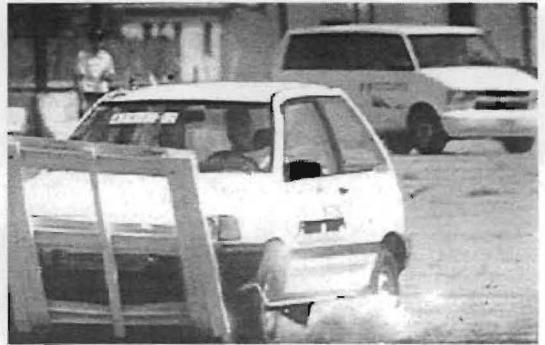
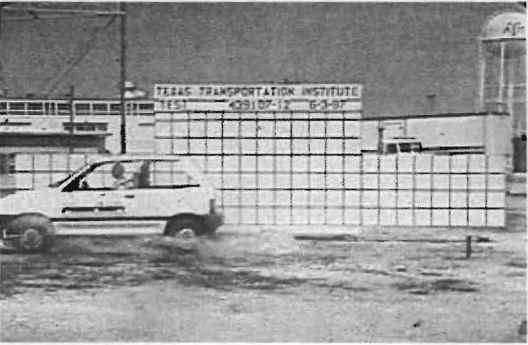
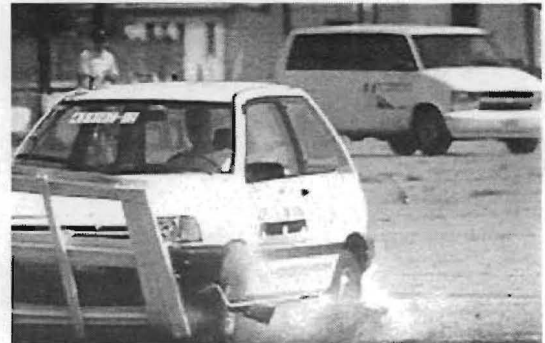
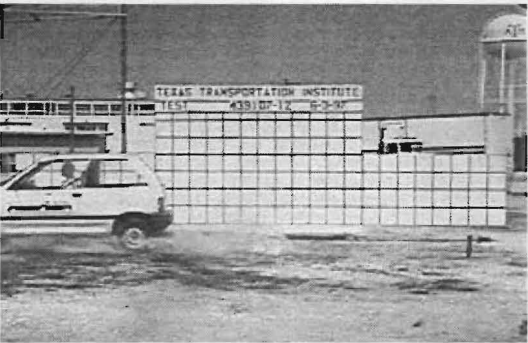
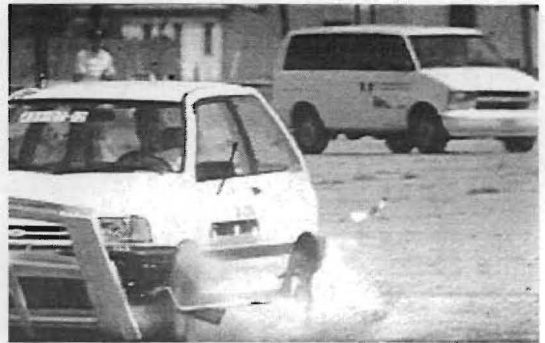
**Figure 90. Sequential Photographs for Test 439107-12  
(Perpendicular and Oblique Views).**

The vehicle impacted the barricade at a speed of 100.5 km/h. By 0.002 s after impact, the barricade showed movement and started to deform at bumper height. The barricade wrapped around the front of the vehicle, the top of the barricade, then impacted the rear of the hood near the windshield. At 0.041 s, the barricade lost contact with the hood. As the vehicle exited the test site, its speed was 88.5 km/h. The vehicle subsequently came to rest 109.7 m down and 6.4 m to the left of the impact point. Sequential photographs of the test can be found in Appendix B, Figure 90.

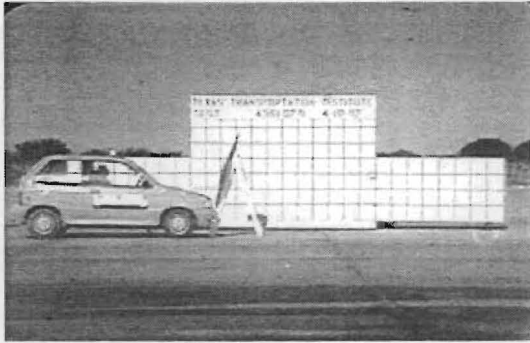
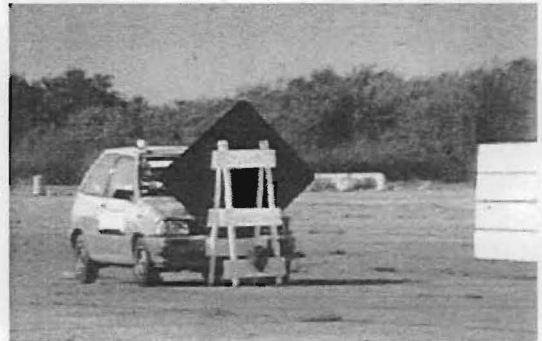
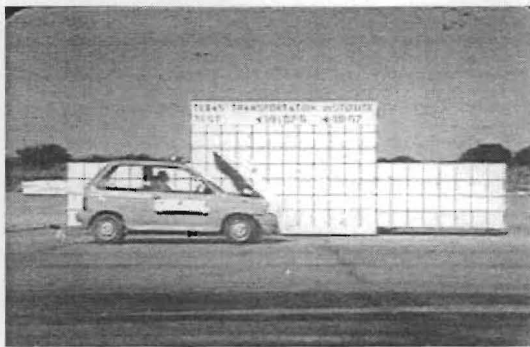
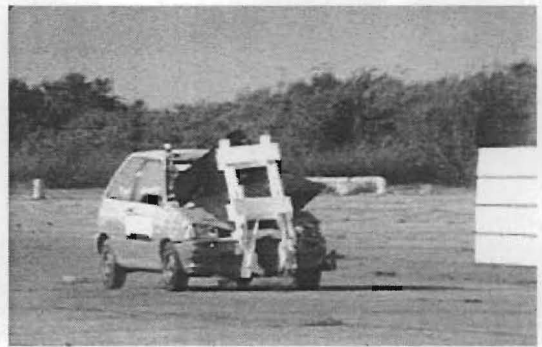
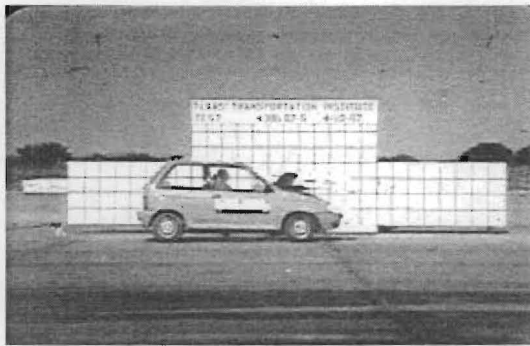
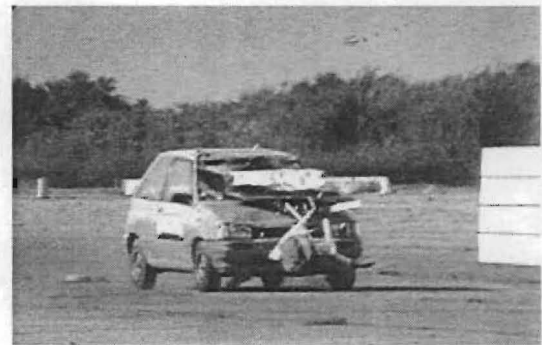
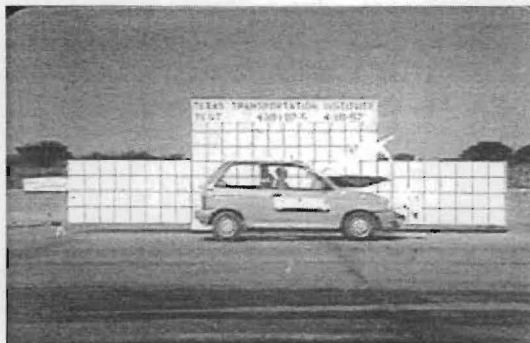
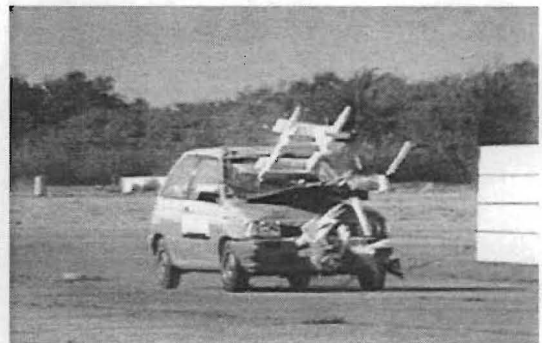
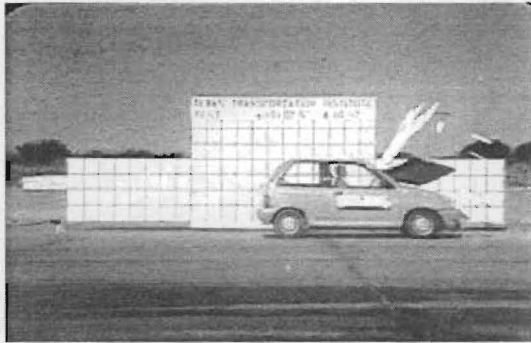
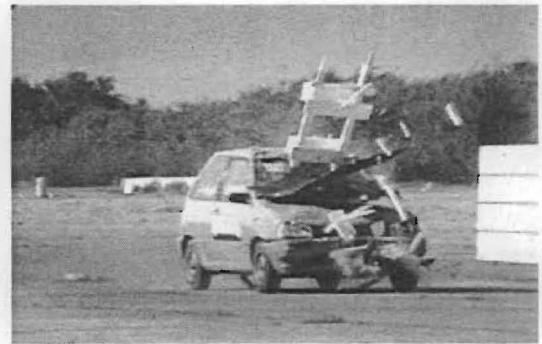
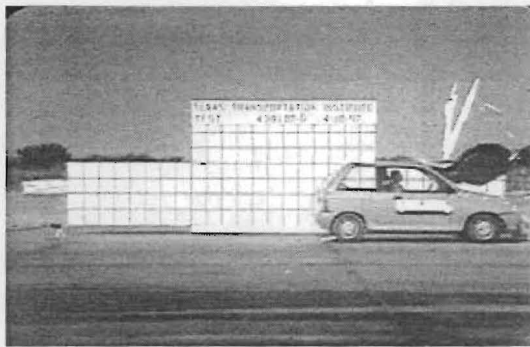
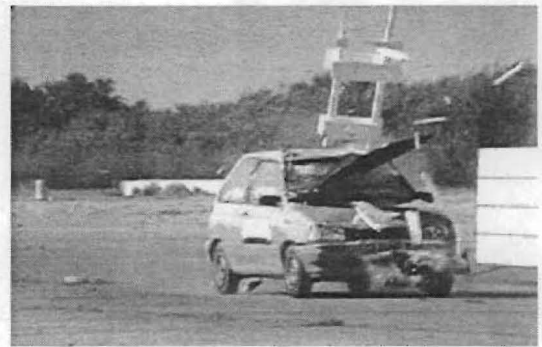
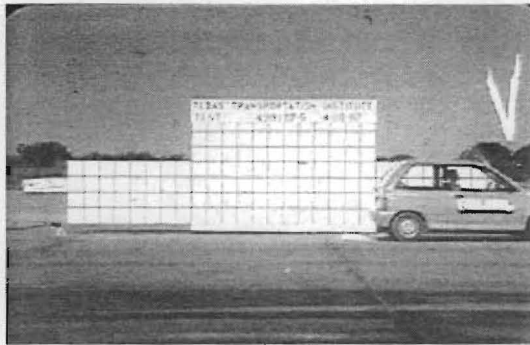
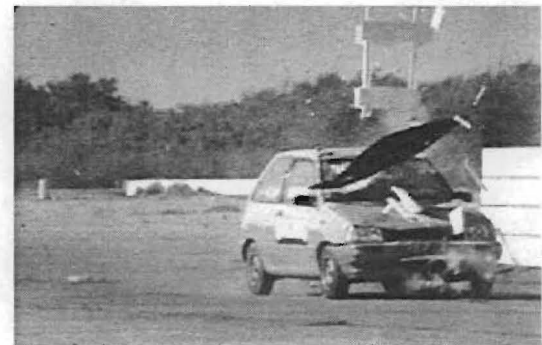
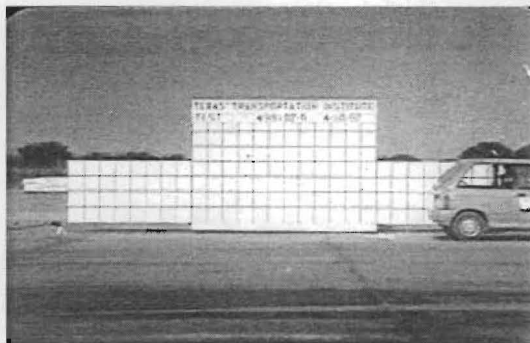
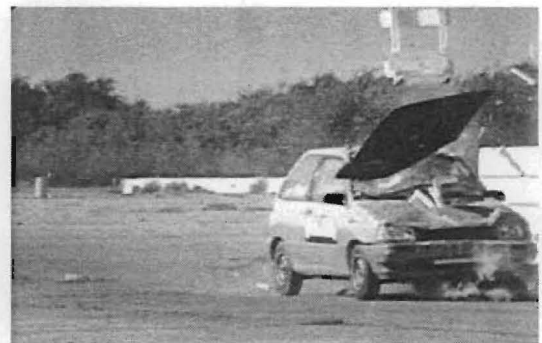
**Figure 91. Sequential Photographs for Test 439107-4  
(Perpendicular and Oblique Views).**

The vehicle impacted the barricade head-on at a speed of 98.12 km/h. At 0.005 s after impact, the right front support of the A-frame fractured at bumper height. The barricade folded up with the front and rear supports impacting each other at 0.023 s, causing three of the four supports to fracture. At 0.052 s, the top of the A-frame contacted and shattered the windshield. By 0.077 s, the barricade was parallel with the ground, just over the hood, and then rotated up and over the vehicle. As the vehicle lost contact with the A-frame, the vehicle was traveling at 92.79 km/h. Brakes on the vehicle were applied as the vehicle exited the test site, and subsequently came to rest 89.0 m down and 4.6 m to the left of impact point. Sequential photographs of the test can be found in Appendix B, Figure 91.

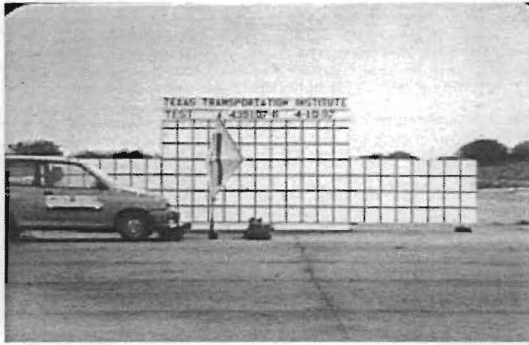
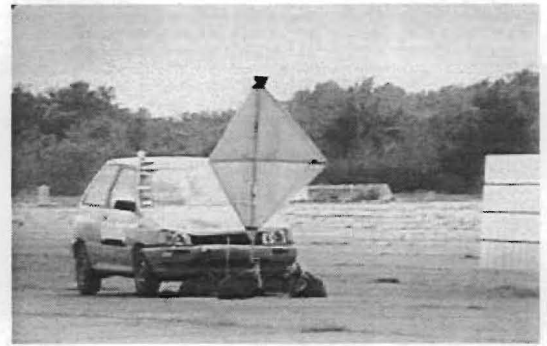
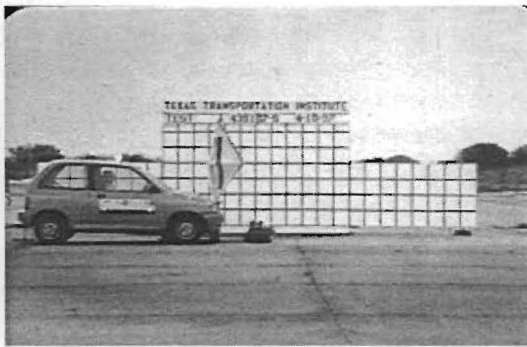
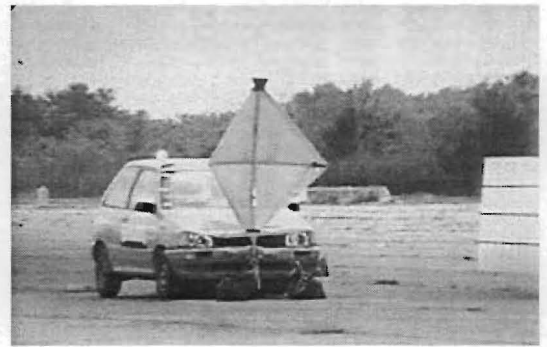
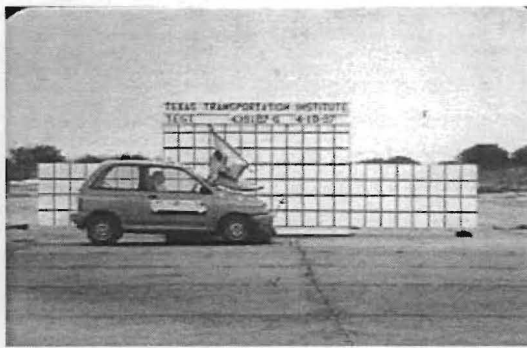
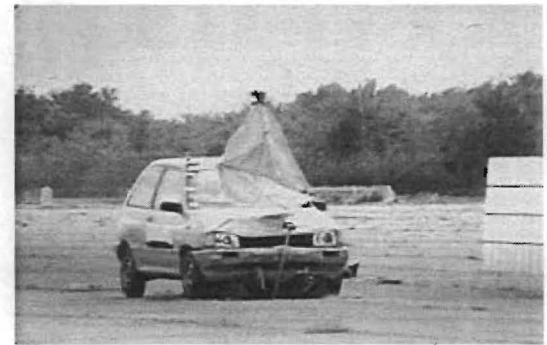
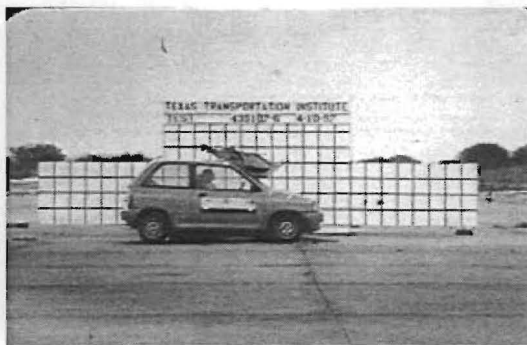
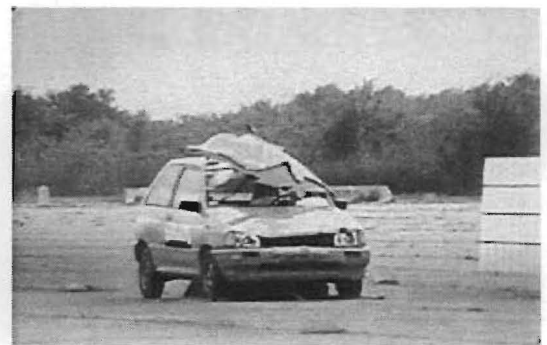
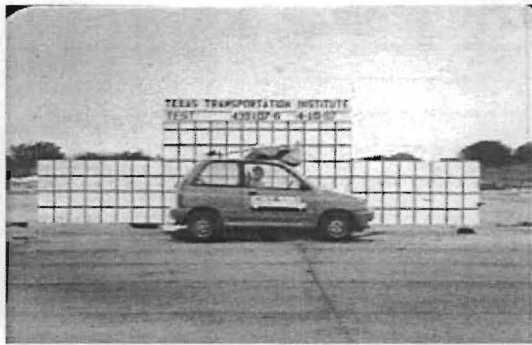
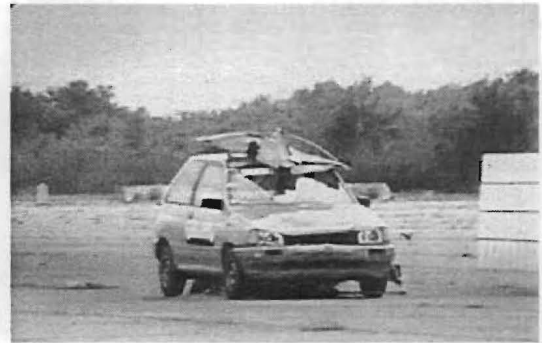
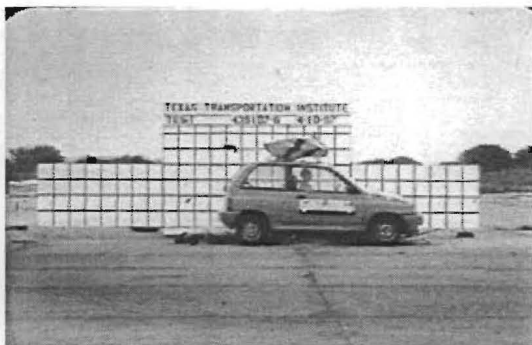
**Figure 92. Sequential Photographs for Test 439107-6  
(Perpendicular and Oblique Views).**

The fabric/plastic sign panel moved up over the windshield; the upper tube support contacted the roof, and then flew off the vehicle at 0.196 s. The vehicle was traveling at 92.35 km/h at this time. The base rode along with the vehicle and came to rest under the vehicle 93.9 m down from impact. Sequential photographs of the test can be found in Appendix B, Figure 92.

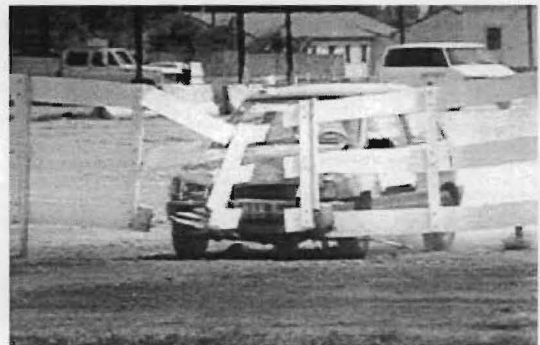
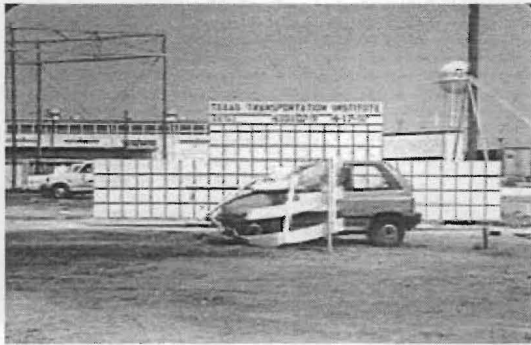
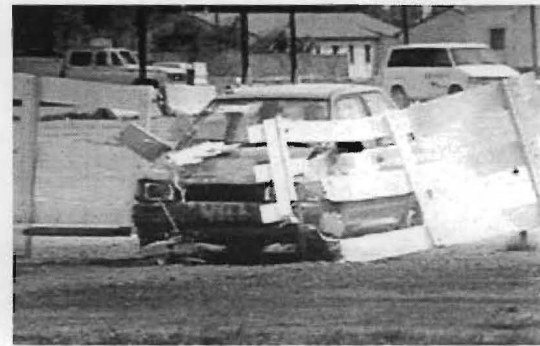
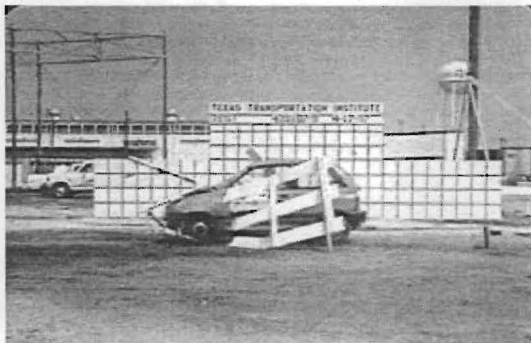
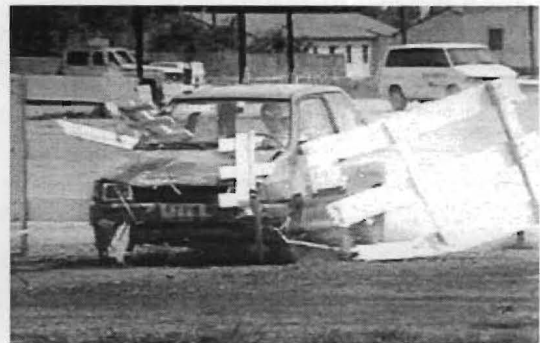
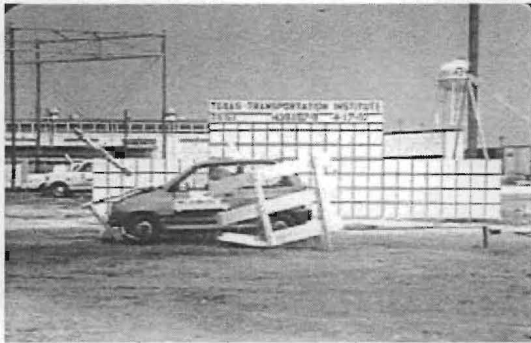
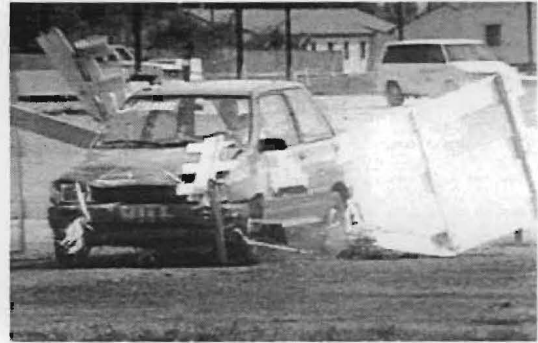
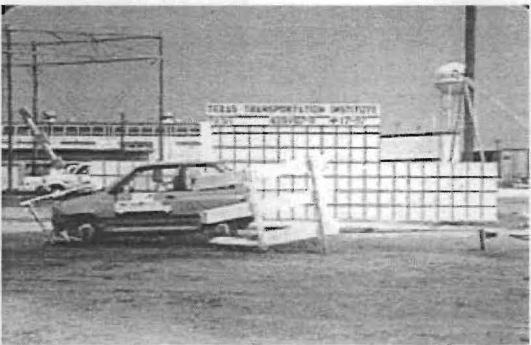
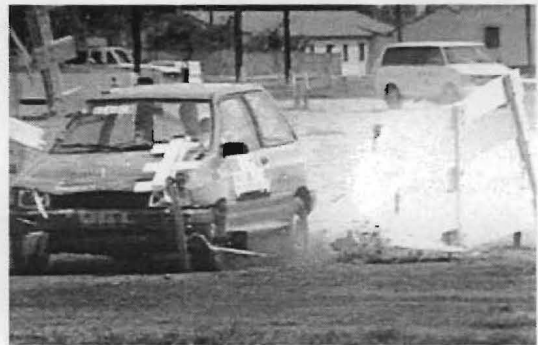
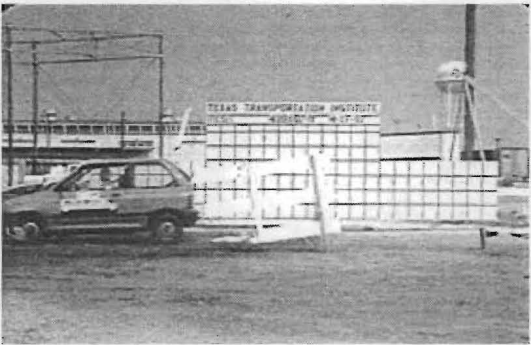
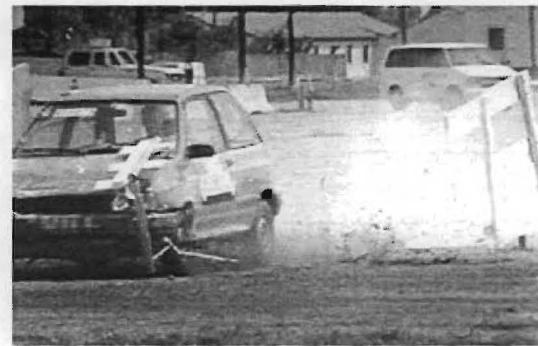
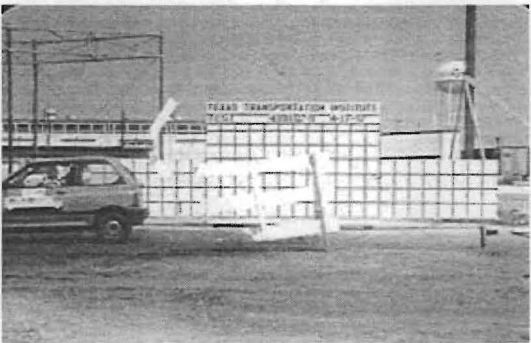
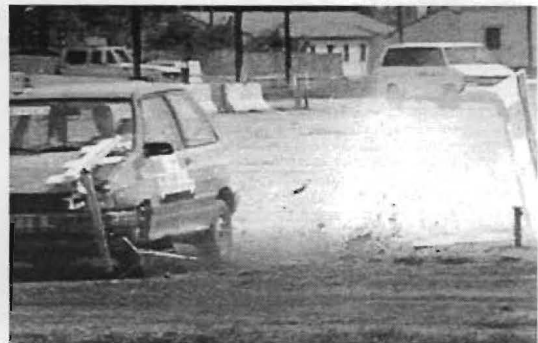
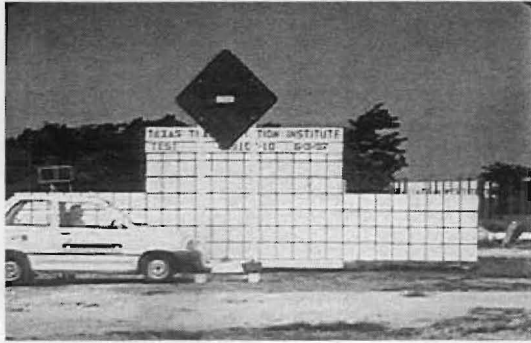
**Figure 95. Sequential Photographs for Test 439107-9  
(Perpendicular and Oblique Views).**

About half of each barricade on the non-impact sides remained upright and in one piece, as shown in Figures 67 and 68. The impacted support of the right barricade fractured at bumper height, and the impacted support on the left barricade fractured near ground level. The remaining fragments were scattered 45.7 m down, 9.1 m to the right, and 5.4 m to the left of the impact point. Sequential photographs of the test can be found in Appendix B, Figure 95.

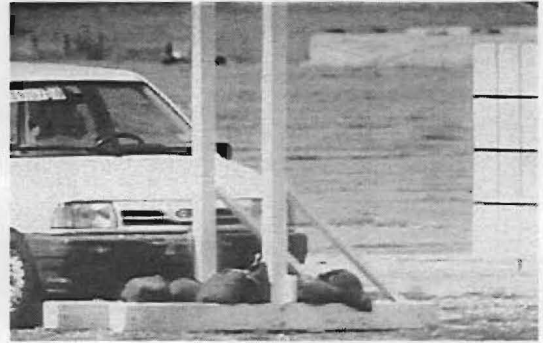
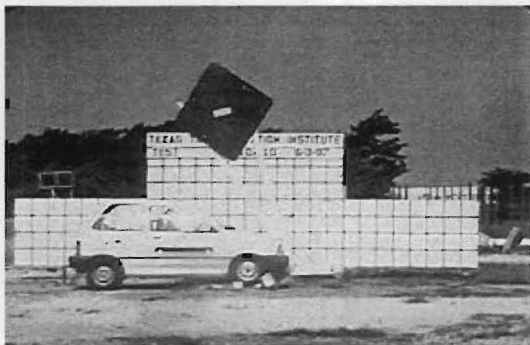
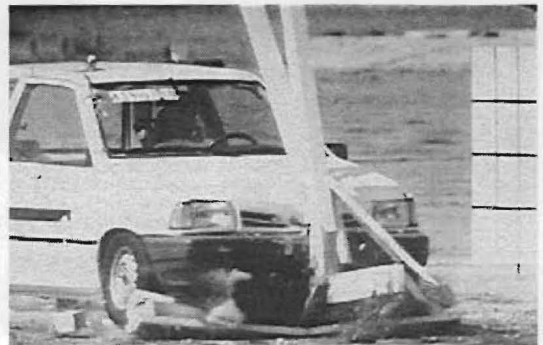
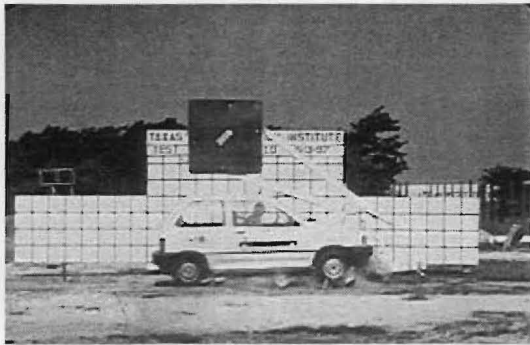
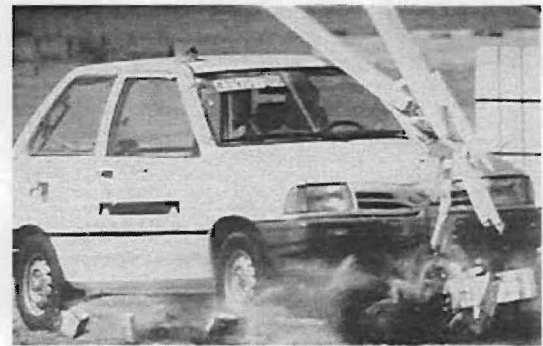
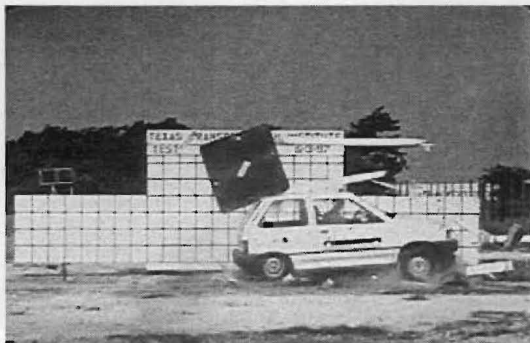
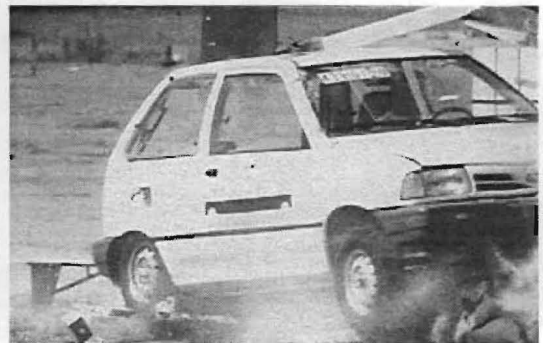
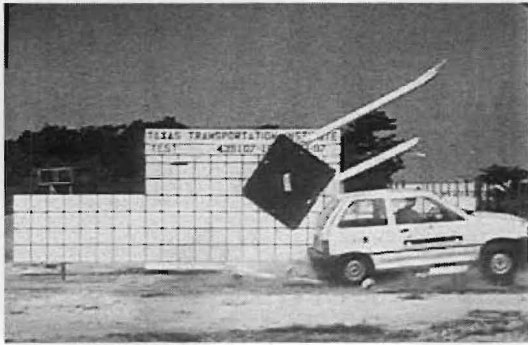
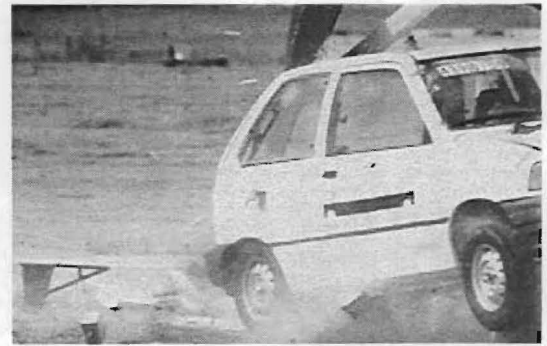
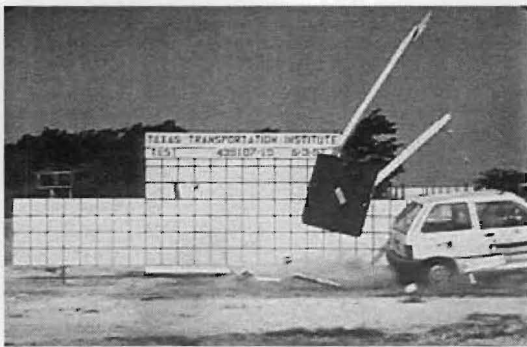
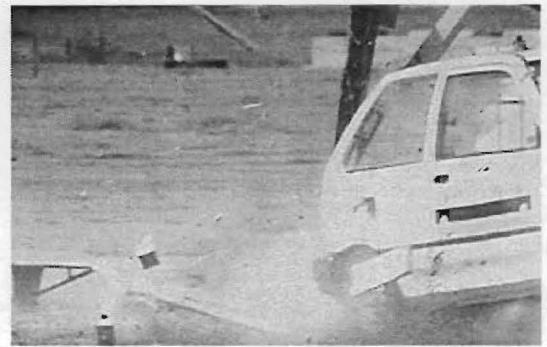
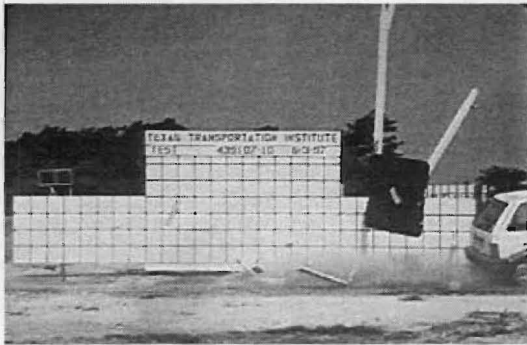
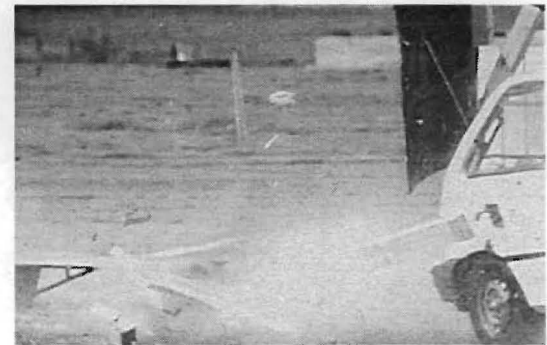
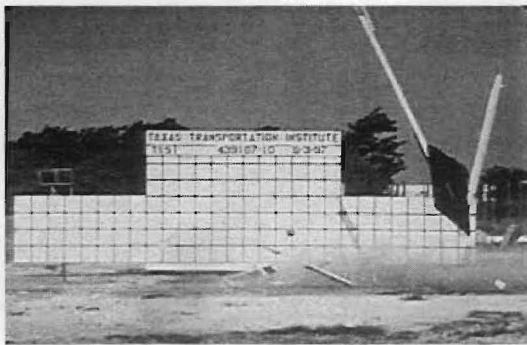
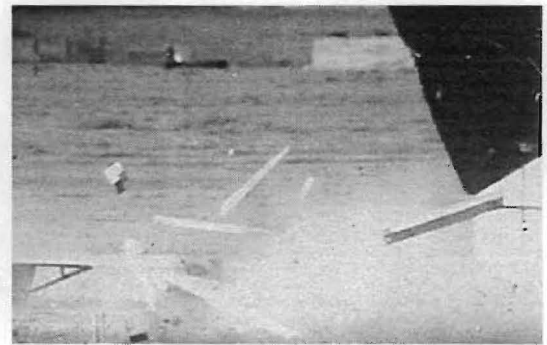
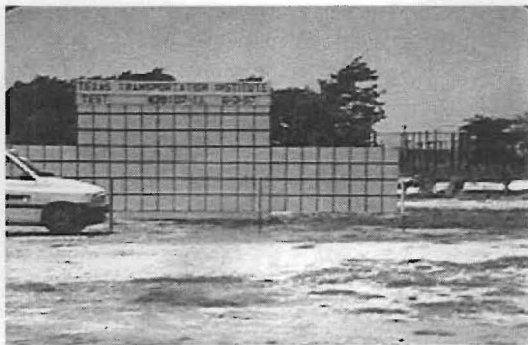
**Figure 96. Sequential Photographs for Test 439107-10 (Perpendicular and Oblique Views).**

The vehicle impacted the sign support end-on at a speed of 99.23 km/h. Shortly after impact, the vertical support on the impact side showed movement. At 0.005 s, the vertical support and the support brace on the non-impact side also started movement. The base for the vertical support on the impact side started to move at 0.008 s. At the same time, the support brace on the non-impact side broke away, causing pieces of wood from the vertical support to break away. At 0.026 s, the base of the vertical support on the impact side rolled over on its side and separated into pieces. The impact-side vertical support contacted the non-impact side vertical support at 0.032 s. The base of the vertical support on the non-impact side then rolled over and separated into pieces. Both supports contacted the vehicle with the support on the impact side, contacting the vehicle's roof just above the windshield. At 0.145 s, the support from the impact side was lying on the vehicle's roof. By 0.186 s, the sign panel and the vertical support from the impact side rotated off the back of the vehicle. The vehicle's speed at exit was 84.78 km/h. Asymmetrical brake actuation on the vehicle as it left the test site caused the vehicle to yaw and rotate to the left. The vehicle subsequently came to rest 88.7 m down and 27.4 m to the left of the impact point. Sequential photographs of the test can be found in Appendix B, Figure 96.

- A skid-mounted sign support with plywood sign panel was successfully crash tested in the end-on configuration. The skid-mounted sign support was found to perform satisfactorily in the head-on configuration in a previous crash test. The skid-mounted sign support is, therefore, recommended for field implementation.
