1. Report No. TX-97/3910-S		2. Government Accession No.		3. Recipient's Catalog No.	
4. Title and Subtitle EVALUATION OF WORK ZONE BARRICADES				5. Report Date November 1997

# **EVALUATION OF WORK ZONE BARRICADES**

Research Report 3910-S  
Research Study Number 7-3910  
Research Study Title: Design, Evaluate, and Test  
Work Zone Sign Supports and Barricades

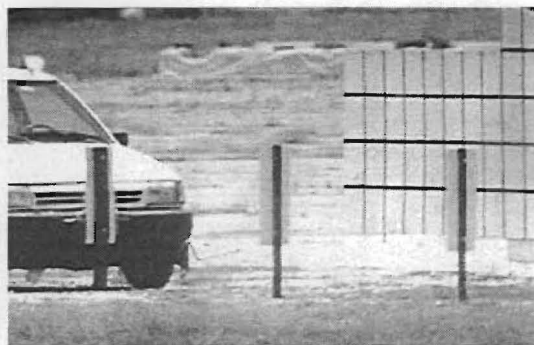
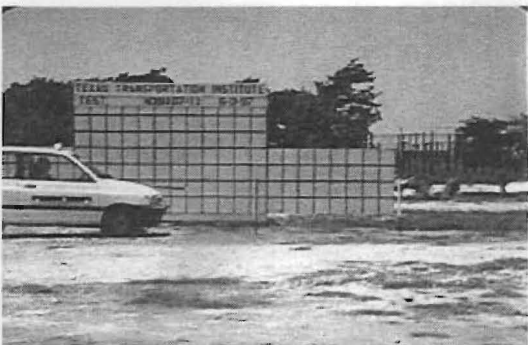
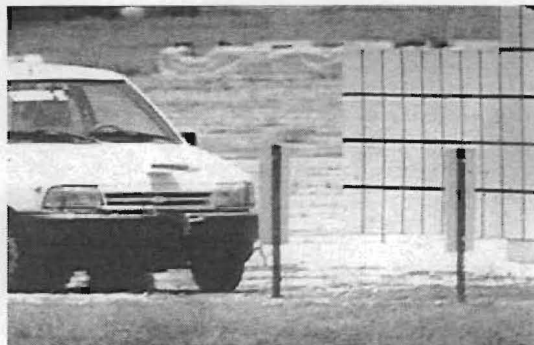
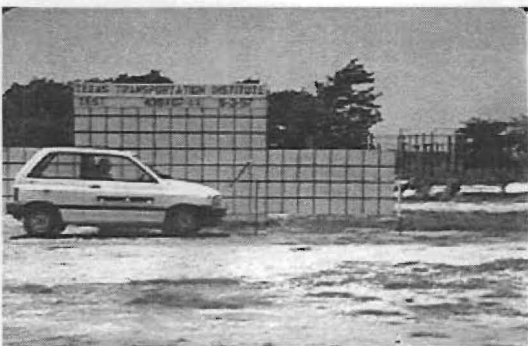
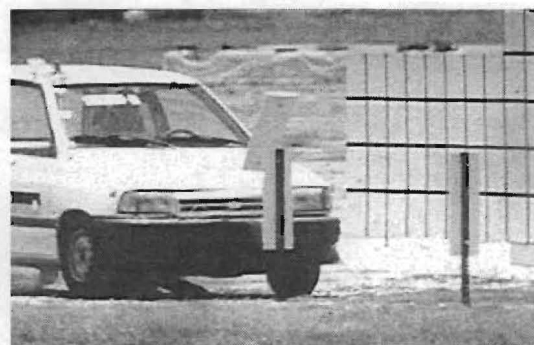
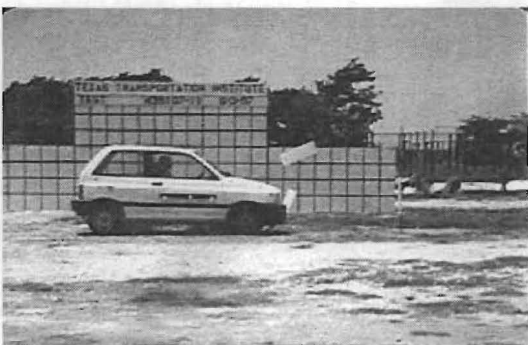
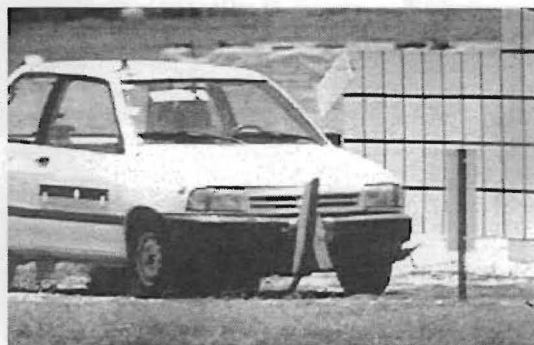
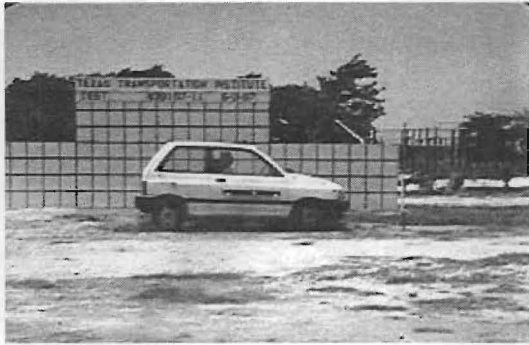
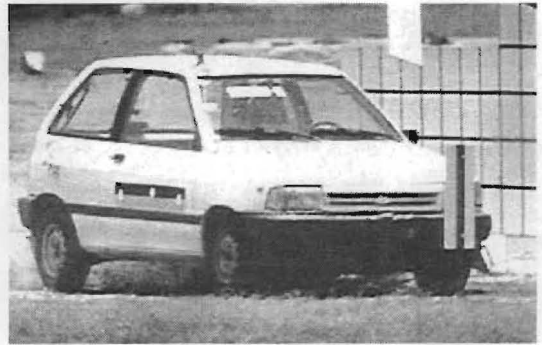
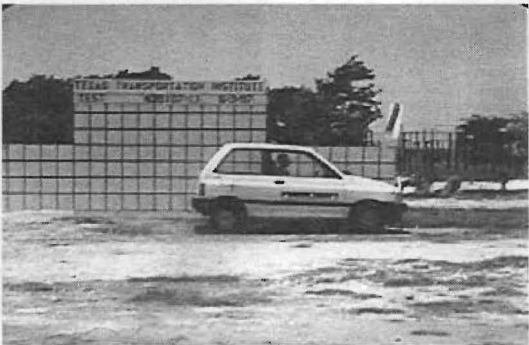
**Figure 97. Sequential Photographs for Test 439107-11  
(Perpendicular and Oblique Views).**

The vehicle impacted the first vertical panel mounted on a wooden post at a speed of 99.52 km/h. At 0.007 s, the support for the first vertical panel was fractured by the vehicle's bumper. The lower portion of the fractured support contacted the ground, followed by the upper section of the support and the attached panel contacting the vehicle. At 0.083 s, the separated upper portion of the support and attached panel from the first vertical panel assembly rotated around and impacted the top of the second vertical panel assembly. Sequential photographs of the test can be found in Appendix B, Figure 97.

- Three candidate support types for vertical panels: 51 mm × 102 mm wooden post, 12.7 mm × 12.7 mm × 6.4 mm steel angle, and 38 mm × 51 mm plastic C-channel, were crash tested and found to perform satisfactorily. Any of these support types would be acceptable for use with vertical panels.
