1. Report No. FHWA/TX-87/408-2	2. Government Accession No.	3. Recipient's Catalog No.	
4. Title and Subtitle Delineation of Urban Freeway Gore Area Crash Cushions		5. Report Date April 1988

DELINEATION OF URBAN FREEWAY GORE AREA CRASH CUSHIONS

Research Report 408-2
Research Study Number 2-18-86-408

TEXAS TRANSPORTATION INSTITUTE
The Texas A&M University System
College Station, Texas 77843

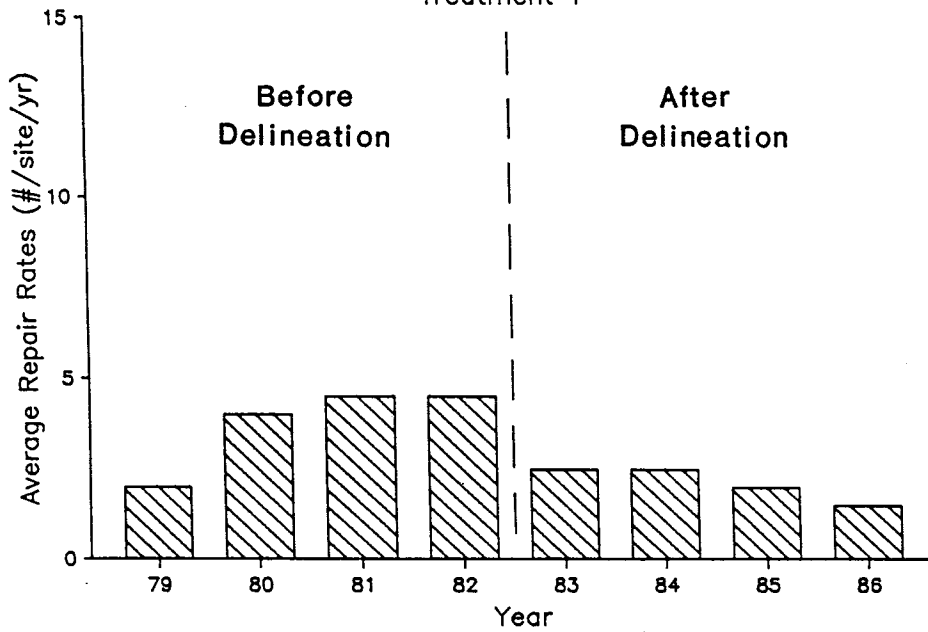
Figure 3-1. Average Crash Cushion Repair Rates at Treatment 1 Sites in Houston.

Average yearly repair rates (combining sites with identical treatments) for each treatment are shown graphically in Figures 3-1 through 3-4. Again, it is apparent that the treatments continued to be effective through the four-year period following installation of the delineation treatments. Some year-to-year variation is evident, but overall, crash cushion repair rates do not appear to have increased over time.

The earlier study suggested that repair rates were not affected by Treatments 1, 2, and 3 at the sites with moderate repair rates. This data was based on less than two years experience after the treatments were installed. Looking at the repair rates over a four-year period, though, it appears that these treatments were indeed effective in reducing crash cushion repairs to some degree.

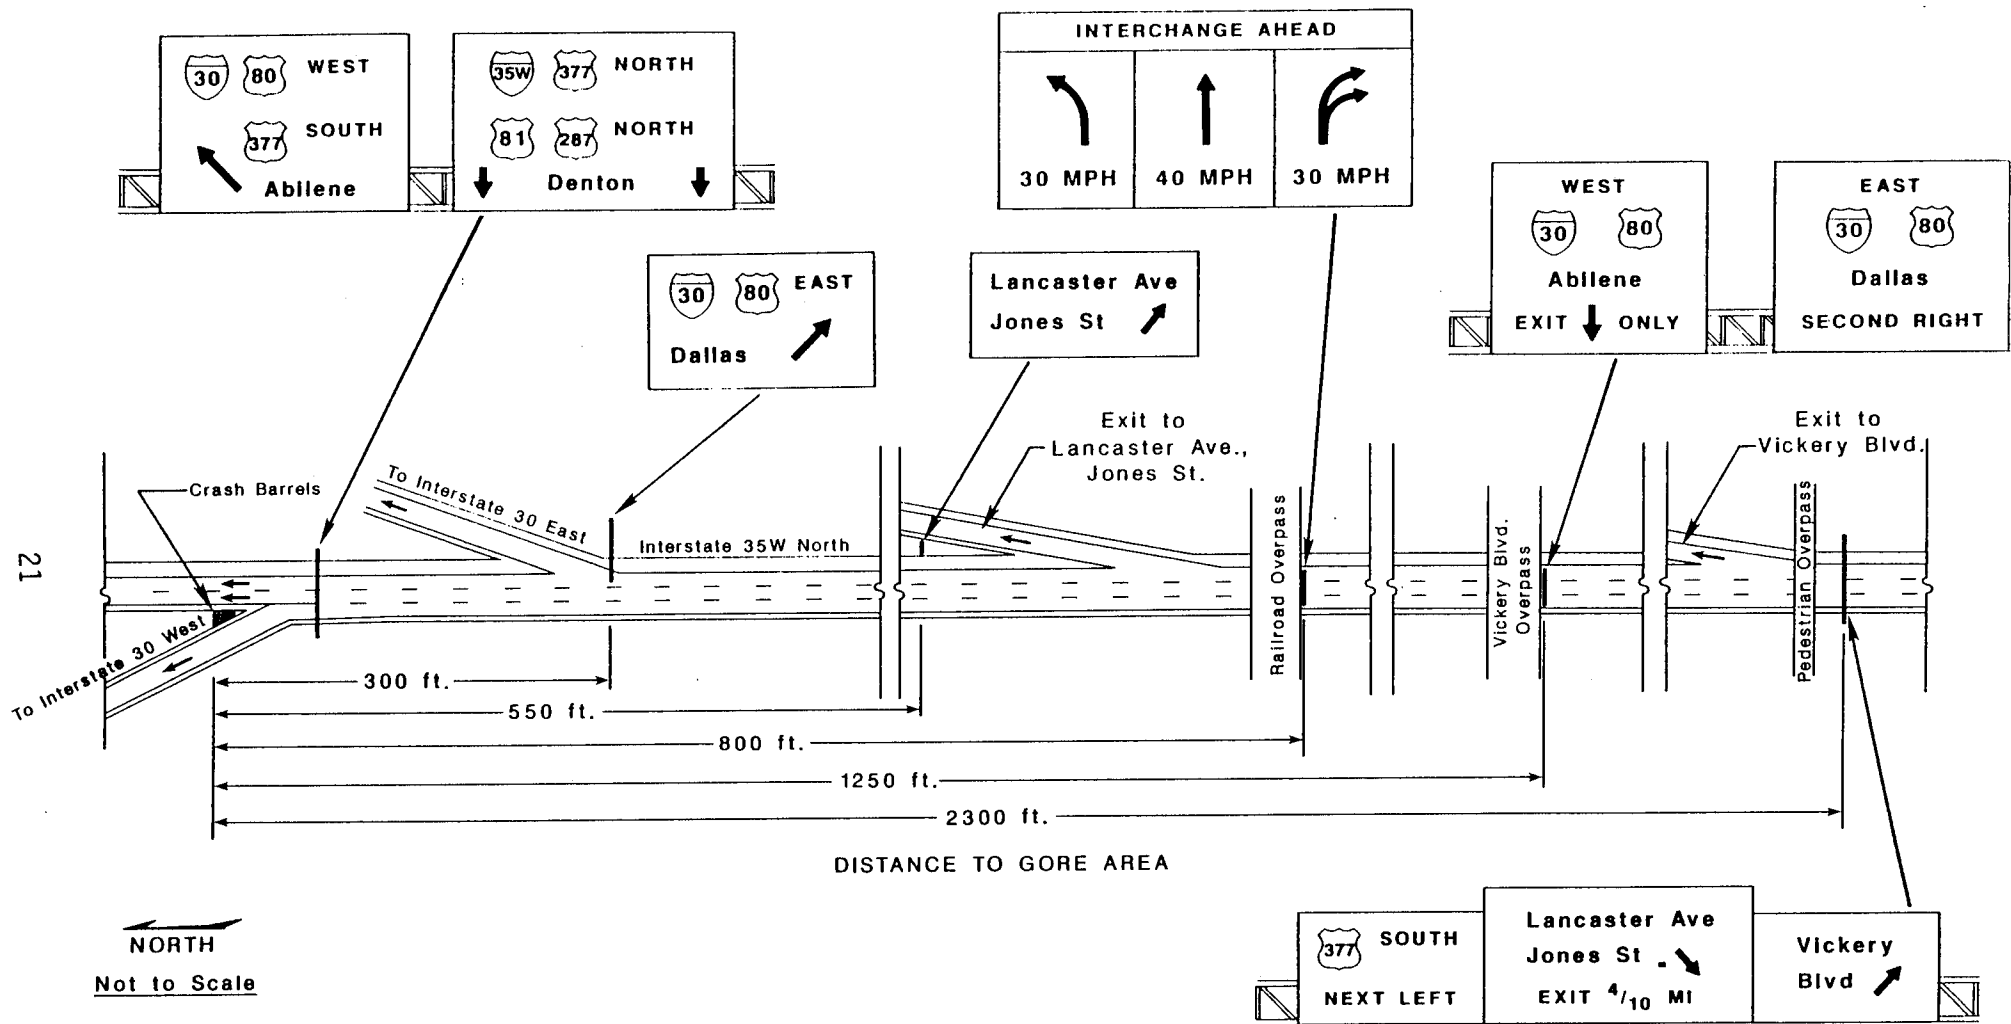
Figure 4-2. Site 1 Schematic Diagram, IH-35W Northbound to IH-30 (Fort Worth)

The study site gore, located at the Interstate (IH) 35W North -- IH-30 East-West Interchange in Ft. Worth, is the left-hand exit to IH-30 West. This is the site where long-term encroachment rate data (discussed previously) were collected. A schematic diagram of Site 1 and its sign locations with respect to the gore area is shown in Figure 4-2. Approaching the interchange are two through lanes and a left-hand exit lane. The crash cushions at the gore area are delineated with yellow and black chevron-patterned nose and back panels, supplemented by a pair of alternately flashing yellow beacons, vertically positioned on the back panel (see Figure 4-3). Because of vertical highway curvature and an overpass that limits the effective sight distance to the gore area, this site was classified as a Type IIa (left) Gore Area by the researchers.

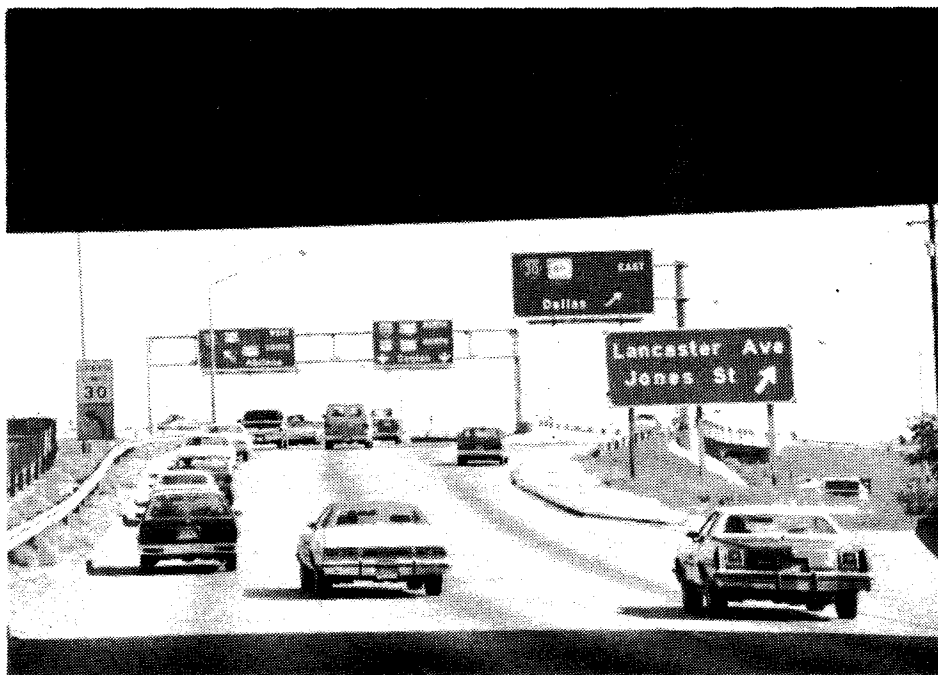
Figure 4-7. Lancaster Ave., Jones St. Exit Sign Location - Site 1
(300 Ft. From Gore Area).

there is a small sign on the right-hand shoulder at the gore area. This sign is located approximately 300 feet from the gore area and displays the message: "IH-30 -- US 80 EAST, DALLAS ↗" (Figure 4-7).

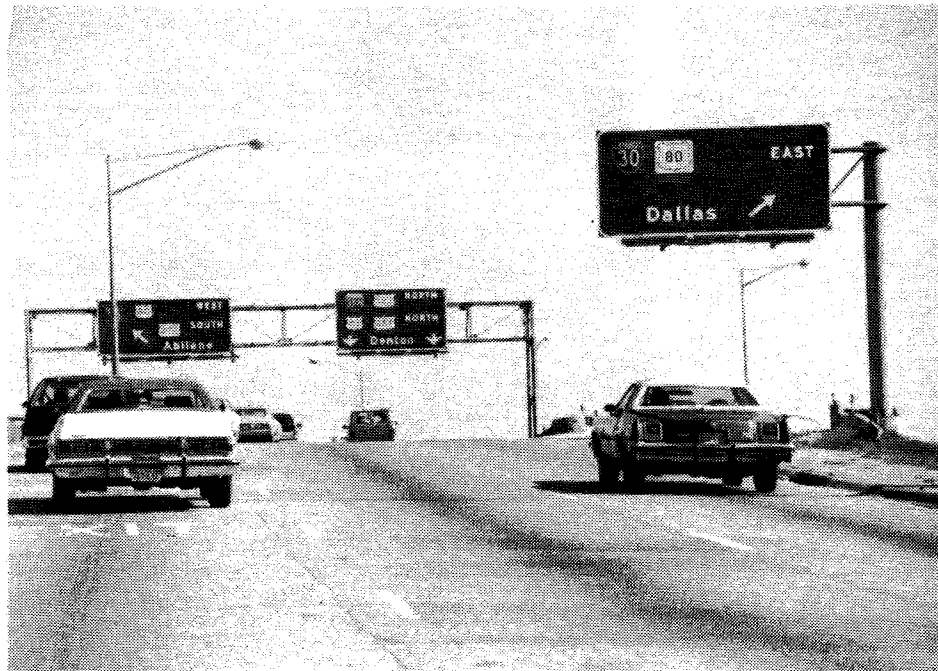
Figure 4-8. Gore Area Signs - Site 1.

An overhead sign bridge exists directly above the gore area and has two panels (Figure 4-8). On the left, the message "IH-30 -- US 80 WEST, US 377 SOUTH, ↙ ABILENE" points toward the left-hand exit to Abilene. On the right is a "pull-through" sign for motorists remaining on IH-35W NORTH. It contains the message "IH-35W -- US 377 NORTH, US 81 -- US 287 NORTH, ↓ DENTON ↓".
