Technical R	eport Documentation Page
1. Report No. FHWA/TX-03/4288-1	2. Government Accessio	n No.	3. Recipient's Catalog N	0.
4. Title and Subtitle		5. Report Date		
DESIGN AND EVALUATION OF THE TXDOT F41		1 AND 177	October 2002	
AESTHETIC BRIDGE RAILS			6. Performing Organizat	ion Code

DESIGN AND EVALUATION OF THE TXDOT F411 AND T77 AESTHETIC BRIDGE RAILS

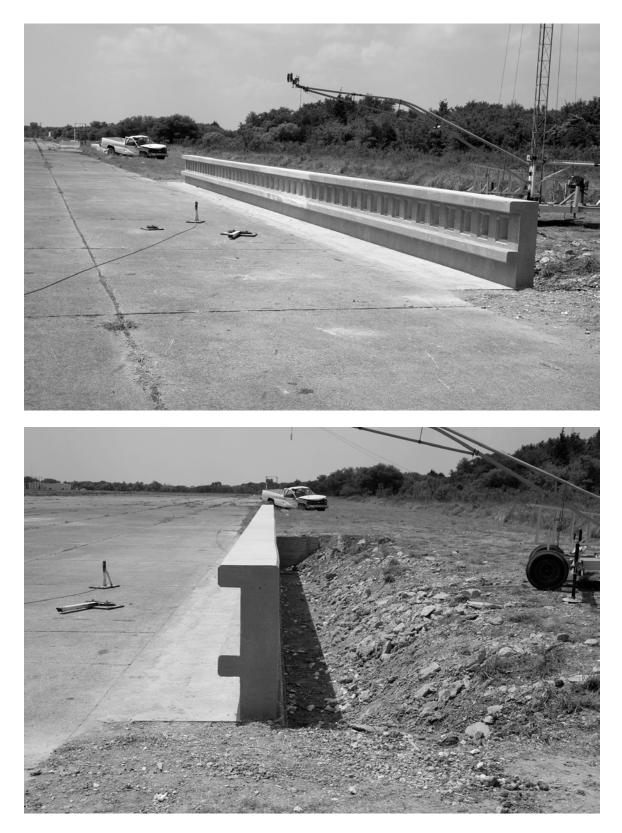
Figure 8. After Impact Trajectory for Test 442882-1.

The TxDOT F411 bridge rail sustained minimal cosmetic damage as shown in Figures 8 and 9. There were tire marks and scrapes along the face of the bridge rail for a distance of 11.4 ft (3.5 m). No cracks were noted in the beam rail, window frames, or deck. No measurable deformation occurred, and the working width was 1.4 ft. (0.4 m).

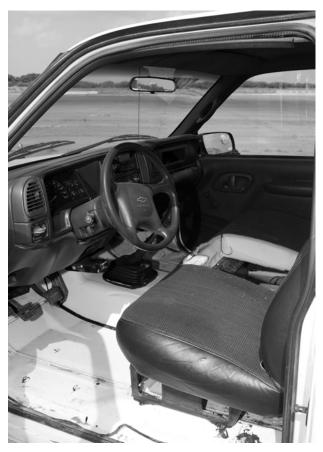
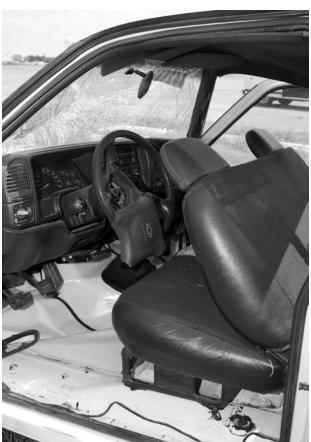
Figure 11. Interior of Vehicle for Test 442882-1.

- <u>Results</u>: No detached elements, fragments, or other debris were present to penetrate or to show potential for penetrating the occupant compartment, or to present undue hazard to others in the area. However, maximum deformation of the occupant compartment was 8.3 inches (210 mm) in the door area, 7.3 inches (186 mm) in the right floor pan area, and 6.9 inches (175 mm) in the right firewall area.

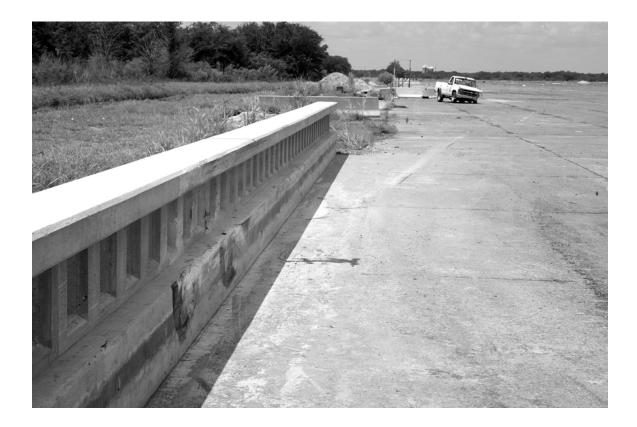
Figure 15. After Impact Trajectory for Test 442882-2.

The modified TxDOT F411 bridge rail sustained minimal cosmetic damage as shown in Figures 15 and 16. There were tire marks and scrapes along the face of the lower beam of the bridge rail for a distance of 9.8 ft (3.0 m). No cracks were noted in the beam rail, window frames, or deck. No measurable deformation occurred, and the working width was 1.7 ft (0.5 m).

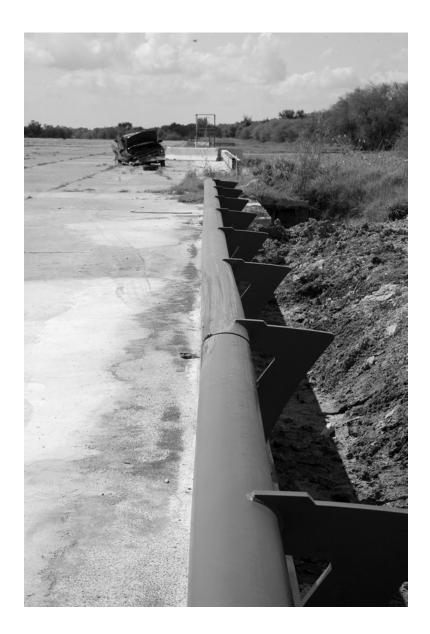
Figure 22. After Impact Trajectory for Test 442882-3.

Damage to the TxDOT T77 bridge rail is shown in Figures 22 and 23. The concrete curb was broken out around post 4, and the post and rail were deflected toward the rear side 0.4 inches

(10 mm). The pickup snagged on the lower rail splice just upstream of post 4 and expanded the joint 0.1 inch (3 mm). The lower rail element was also crushed 1.0 inch (25 mm). The pickup was in contact with the rail for 16.4 ft (5.0 m). Maximum deflection of the rail during the test was 1.8 inches (47 mm), and maximum permanent deformation was 0.4 inch (10 mm). Working width was 2.1 ft (0.6 m).

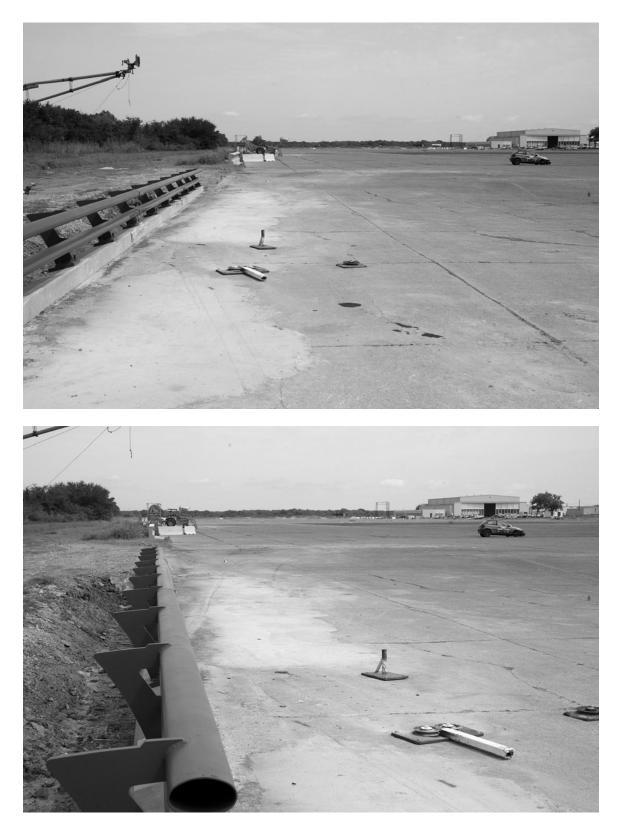
Figure 29. After Impact Trajectory for Test 442882-4.

The TxDOT T77 bridge rail sustained damage as shown in Figures 29 and 30. The edge of the concrete curb was chipped off in the area of initial contact. A hairline crack in the concrete curb radiated from the right rear bolt at post 7, and the post and rail were deflected toward the rear side 0.4 inches (10 mm). The small car snagged on the upper and lower rail splice just upstream of post 7. The small car was in contact with the rail 9.7 ft (3.0 m). There was no measurable deflection of the rail during the test, and maximum permanent deformation was 0.4 inches (10 mm). Working width was 1.9 ft (0.6 m).
