**MIX DESIGN, CONSTRUCTION, AND PERFORMANCE OF A THIN
HMA OVERLAY ON PUMPHREY DRIVE, FORT WORTH, TX**

Report 5-5123-01-2

Project Title: Implementation of Thin Lift Type F HMAC Mix Design

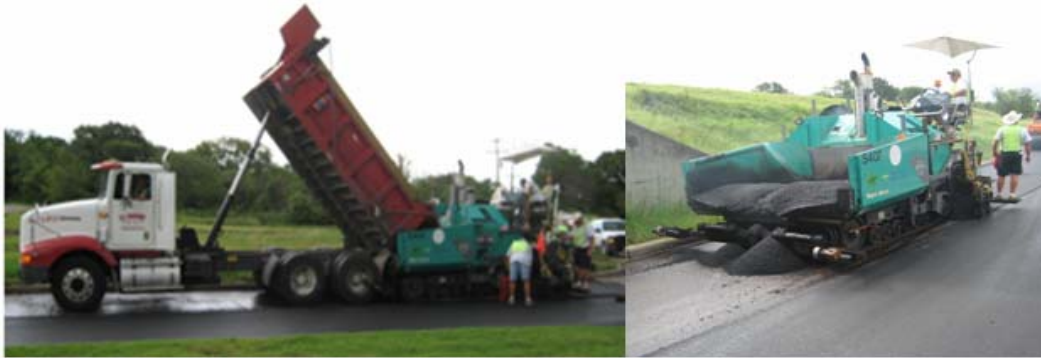
Figure 7. Paver Operation on the Pumphrey Drive, FTW.

The pavement surface temperature was about 106 °F which meets the CAM SS 3109 recommendations (TxDOT, 2004b). According to the Tarrant County construction crew, the air temperature should at least be 42 °F and rising for laydown operations such as the Pumphrey Drive project. The air temperature was about 78 °F at the start of the construction operation which satisfied the ≥ 42 °F recommendation. No material transfer device was engaged in this laydown operation. The trucks dumped the hot mix directly into the paver. This operation is shown in [Figure 7](#).

It is worth noting that two overlay mat thicknesses were used in this overlay project due to different traffic levels. The HMA overlay was 1.5 inch thick starting from the Naval Air Base Entrance to the middle of the overlay project where the traffic volume is much higher than the rest of the project in which only 1 inch thick mat was used.

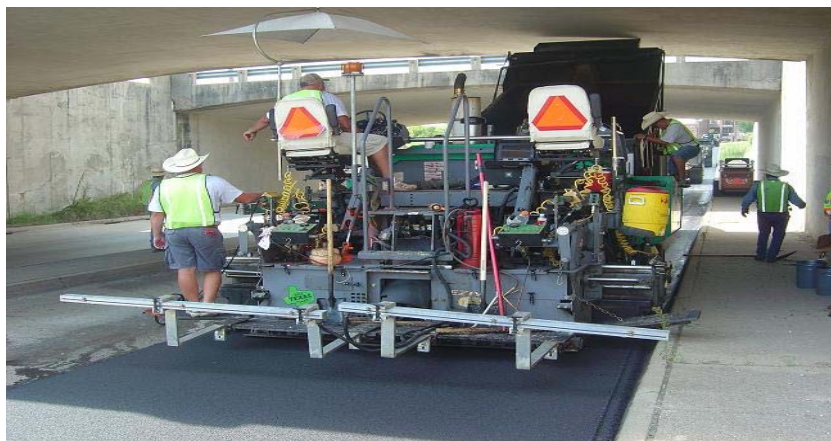
Figure 8. Temperature Measurement Using the Infra-Red Bar during Construction.

The Texas Transportation Institute (TTI) conducted Infra-Red (IR) temperature measurements on this project during placement of the crumb rubber mix on the outside lane starting at the Naval Air Station entrance and heading southbound toward SH 183. The IR set-up and measurement bar is shown in [Figure 8](#). This device was constructed and installed on the County's paver by TTI. The IR-measured mat surface temperature profiles are shown in [Figure 9](#).

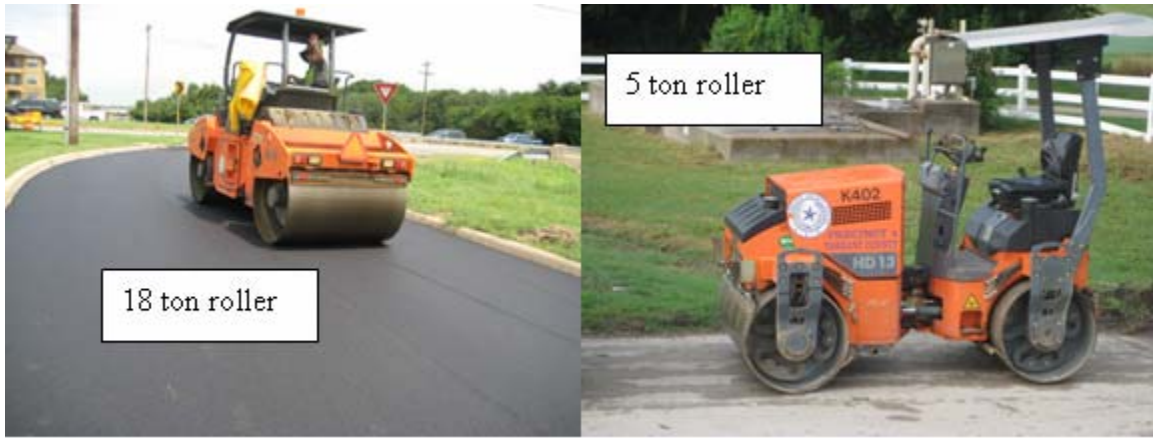
Figure 10. Rolling Compaction – Tarrant County 18- and 5-Ton Rollers.

Two steel rollers, an 18 ton and 5 ton as shown in [Figure 10](#), were used in the static mode for the compaction operation on the southbound outside lane. The 18-ton roller was used for the mix breakdown in two to four passes with the 5 ton roller used as the finishing roller at two to three passes. Rolling compaction in vibration mode was only conducted at the joints.

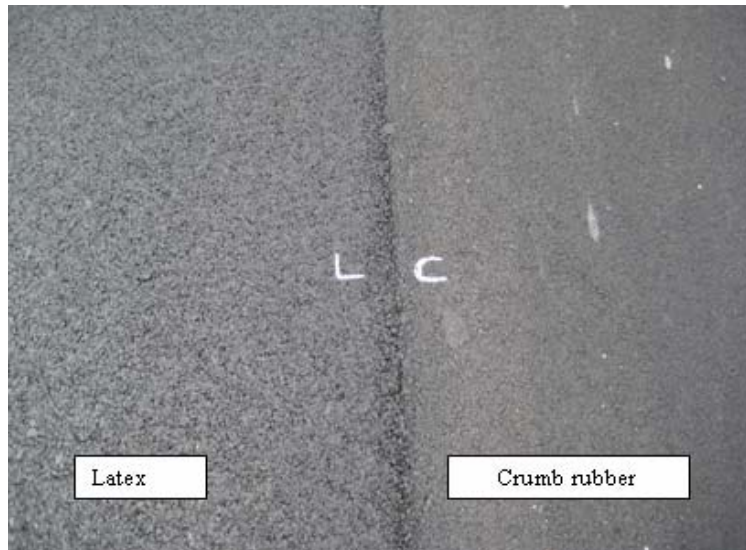
Figure 11. Finished HMA Surface – SBR Latex and Crumb Rubber Mixes.

[Figure 11](#) shows the completed surfaces for both the crumb rubber and SBR latex mixes. It is clear from [Figure 11](#) that the SBR latex mix had more open appearance than that of the crumb rubber mix. Nonetheless, the mixes' performance were monitored and compared.

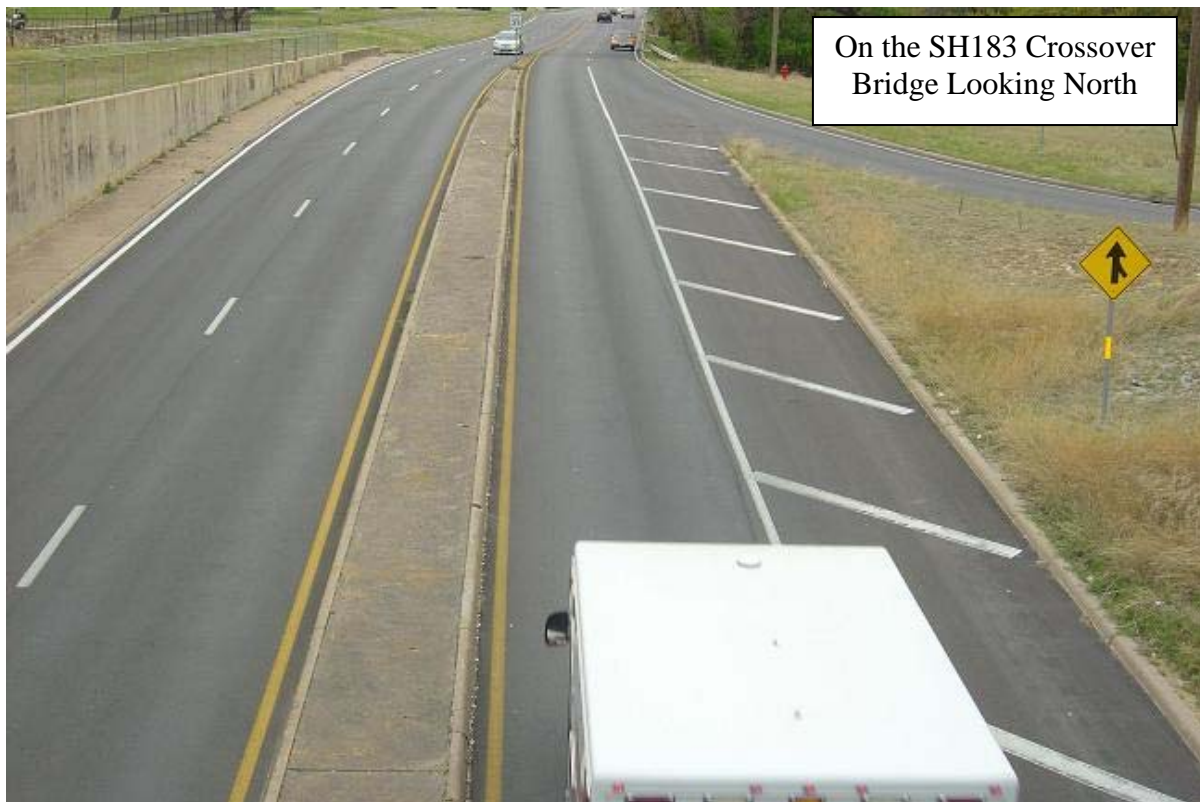
(14a). Overview of the Main Lanes between SH183 and the Naval Air Base Entrance.

As shown in all four views of [Figure 14](#), the overall performance of this experimental test section is very good. Almost no transverse reflective cracking was observed anytime during the first year's performance.

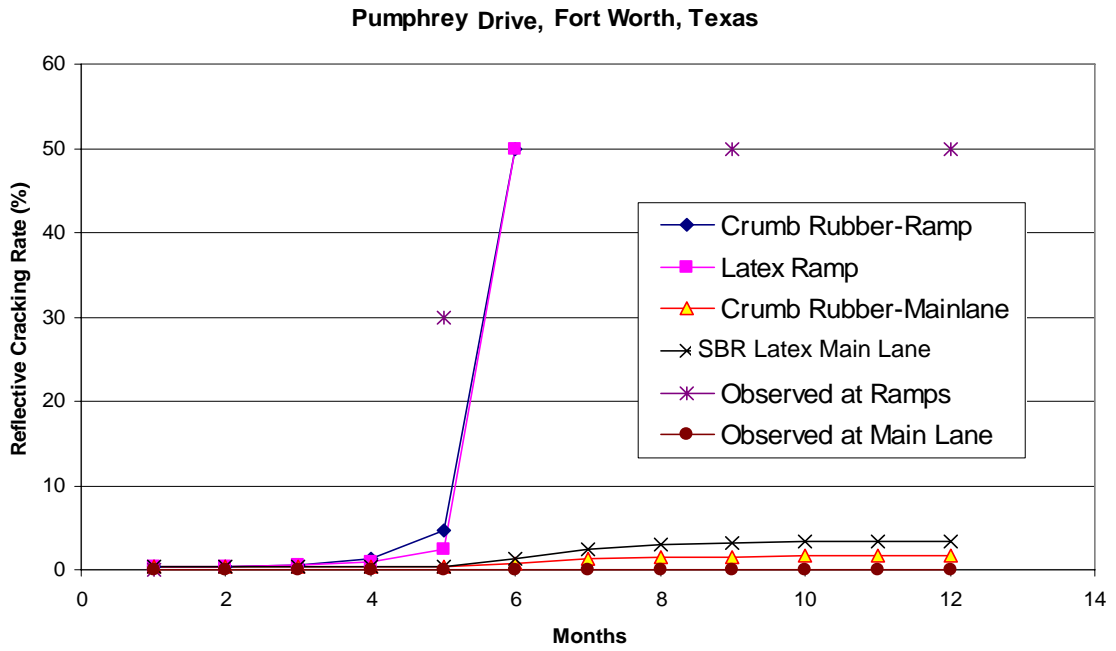
Figure 19. Pumphrey Drive: Reflective Cracking Prediction.

Figure 18 shows the dynamic modulus master curves of these two mixes. The fracture properties (A and n) measured at room temperature are also presented in Figure 18. With all this information plus the data from the Fort Worth, Texas weather station, the reflective cracking performance of these two test sections on both the main traffic lanes and the ramps were predicted by the asphalt overlay thickness design and analysis program developed under TxDOT's Research Project 0-5123. The results were compared to the observed reflective cracking and are shown in Figure 19. It can be seen that the prediction generally matches what has been observed in the field.
