**DESIGN, CONSTRUCTION, AND PERFORMANCE MONITORING OF
THE VERY THIN OVERLAY PLACED ON BUS 59 IN THE LUFKIN
DISTRICT**

Report 5-5598-01-2

Project Title: Implementation of Very Thin Overlay (<1 inch) in the Lufkin District

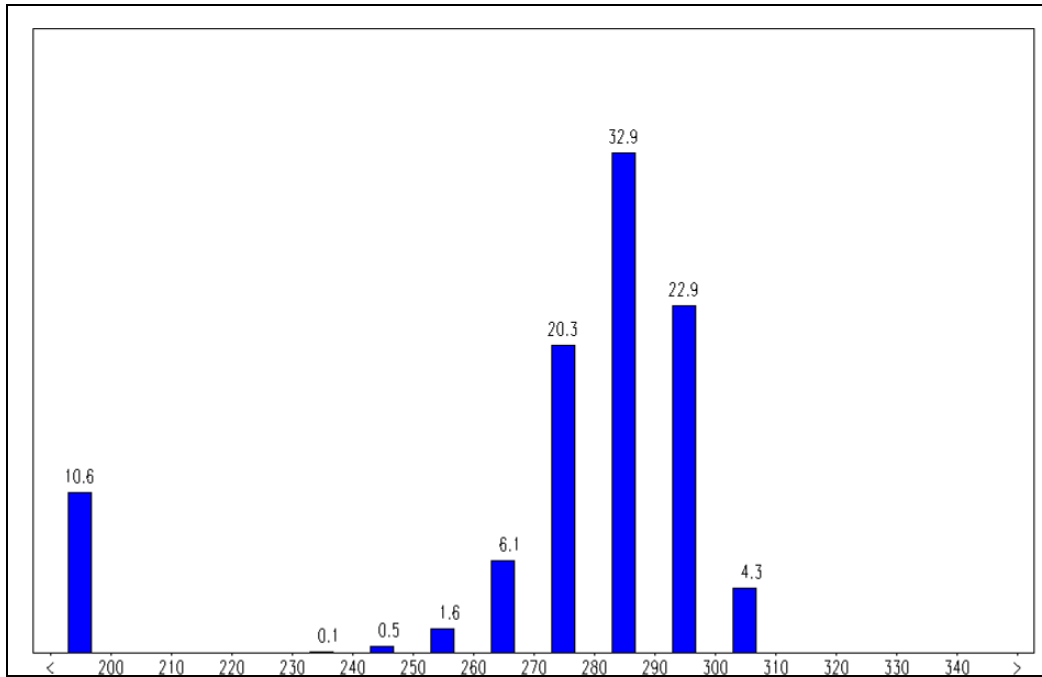
Figure 13. Temperature Histogram from CAM Turn Lane.

Figure 13 shows a histogram of the measured placement temperatures on the turning lane. The temperatures less than 200 °F resulted from sensor 1 being off the mat and should be ignored. The histogram shows approximately 97.5 percent of the placement temperatures fall within a 50 °F range from 260 to 310 °F.

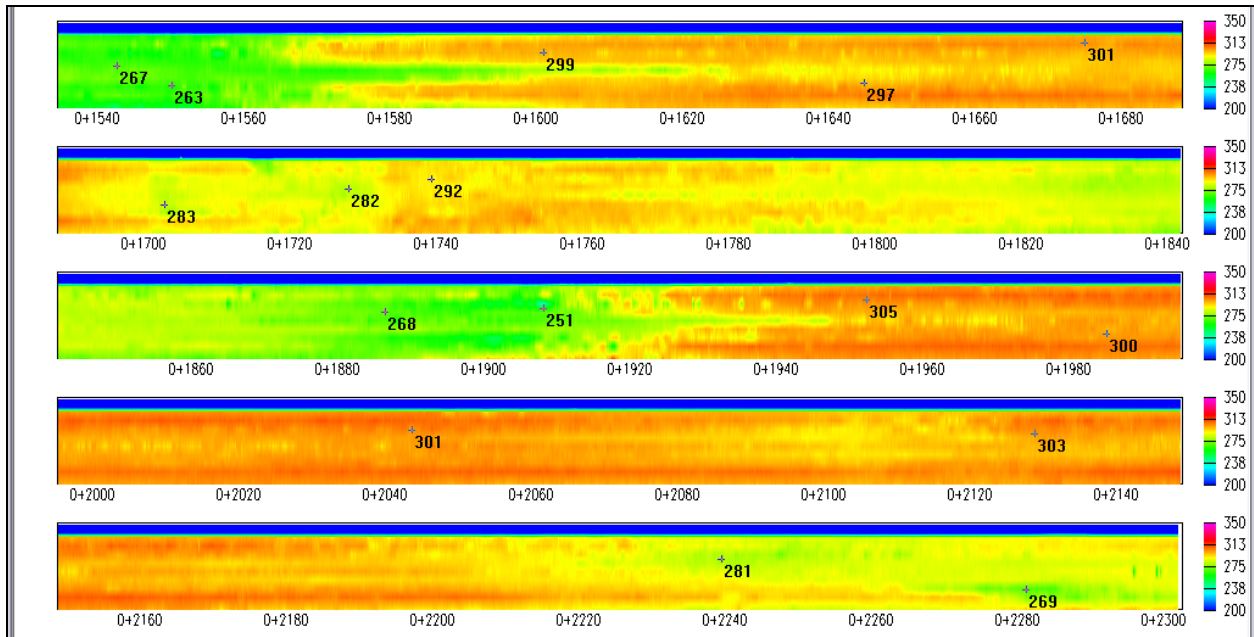
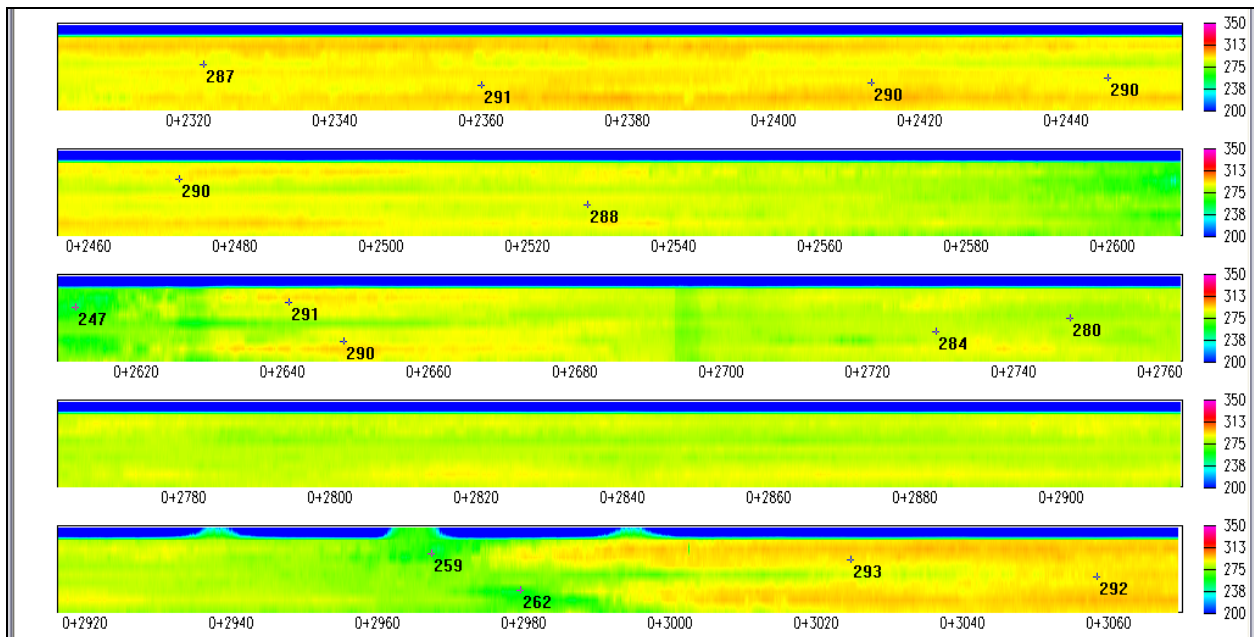
Figure 14. Thermal Profile of CAM Southbound Inside Lane.

Figure 14 shows excerpts from the thermal profile of the southbound inside lane. As before, the profile shows good uniformity within truckloads, some variations in the mean placement temperature from individual trucks, and some truck-end thermal differentials. The histogram from the temperatures recorded in the thermal profile, shown in Figure 15, reveals that approximately 95 percent of the placement temperatures fell within the 50 °F range from 260 to 310 °F.
