IMPLEMENTATION OF TRANSVERSE VARIABLE ASPHALT RATE SEAL COAT PRACTICES IN TEXAS

Report 5-5833-01-1
Project 5-5833-01
Project Title: Statewide Implementation of TVAR Seal Coat Methods

TEXAS TRANSPORTATION INSTITUTE
The Texas A&M University System
College Station, Texas 77843-3135

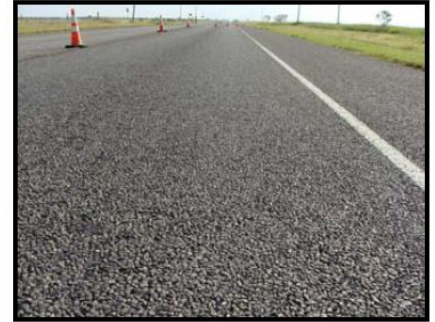
Eastbound View

US 190 (Location 1) – McCullough County Grade 3 Aggregate with Straight AC-20XP at 0.45 gal/SY

Sand Patch Mean Texture Depth, mm			
	Old Pavement in 2008	New Seal in 2009	New Seal in 2010
Wheel Path	1.70	2.72	2.45
Between WP	2.37	3.93	3.60
Difference	0.67	1.21	1.15

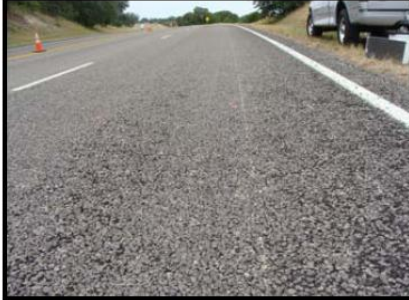
Westbound View

US 190 (Location 2) – McCullough County
Grade 3 Aggregate with Straight AC-20XP at 0.48 gal/SY

Sand Patch Mean Texture Depth, mm			
	Old Pavement in 2008	New Seal in 2009	New Seal in 2010
Wheel Path	2.09	2.78	3.00
Between WP	2.40	3.83	3.57
Difference	0.31	1.06	0.57

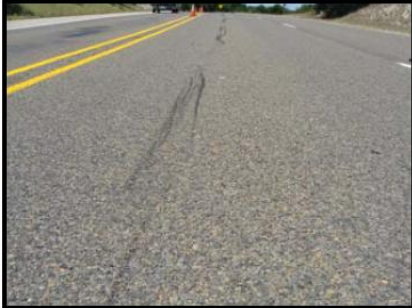
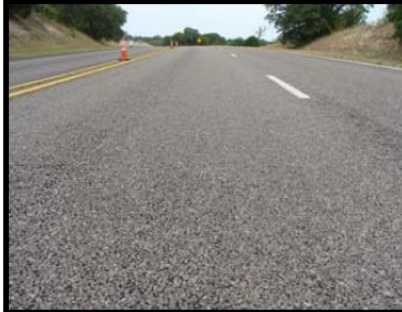
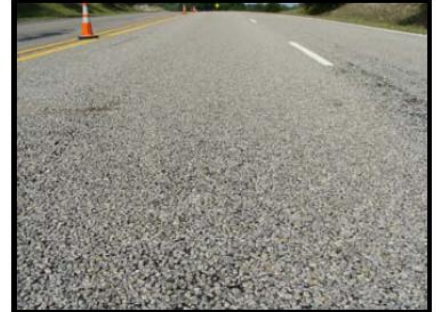
Westbound View

US 190 (Location 3) – McCullough County
 Grade 3 Aggregate with Straight AC-20XP at 0.50 gal/SY

Sand Patch Mean Texture Depth, mm			
	Old Pavement in 2008	New Seal in 2009	New Seal in 2010
Wheel Path	1.83	2.83	2.71
Between WP	2.45	4.22	3.78
Difference	0.62	1.39	1.07

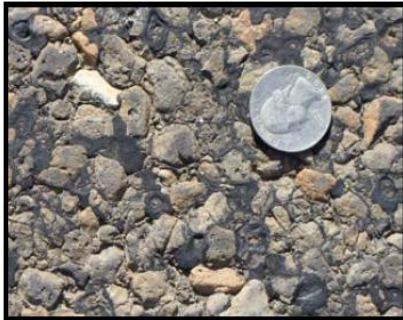
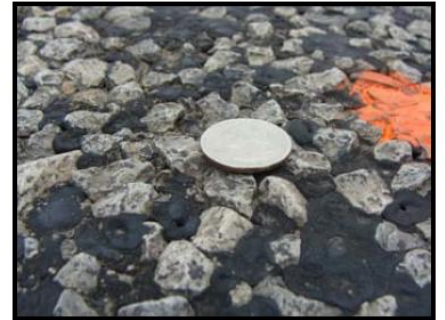
Sand Patch Mean Texture Depth, mm			
	Old Pavement in 2008	New Seal in 2009	New Seal in 2010
Wheel Path	1.02	1.94	1.59
Between WP	1.88	3.53	3.11
Difference	0.86	1.59	1.52

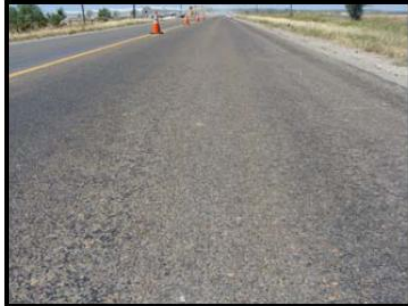
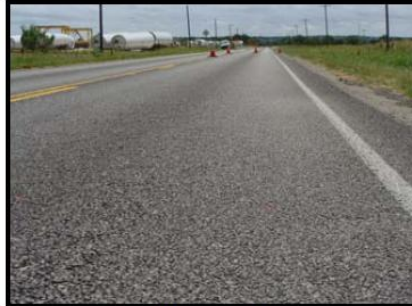
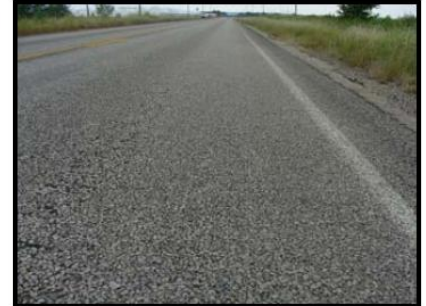
FM 3425 – Coleman County
Grade 3 Aggregate with Straight AC-20XP at 0.42 gal/SY

Sand Patch Mean Texture Depth, mm			
	Old Pavement in 2008	New Seal in 2009	New Seal in 2010
Wheel Path	1.07	3.16	2.81
Between WP	1.52	3.23	2.98
Difference	0.45	0.07	0.17

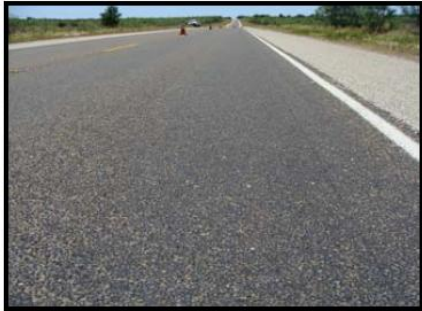
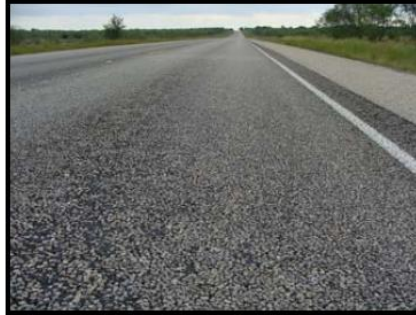
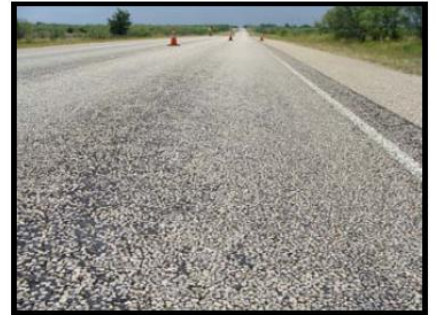
US 283 (Location 1) – Coleman County
 Grade 3 Aggregate with Straight AC-20XP at 0.47 gal/SY

Sand Patch Mean Texture Depth, mm			
	Old Pavement in 2008	New Seal in 2009	New Seal in 2010
Wheel Path	0.99	2.12	2.07
Between WP	1.65	2.86	2.32
Difference	0.66	0.74	0.25

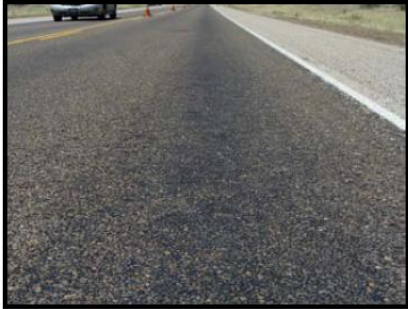
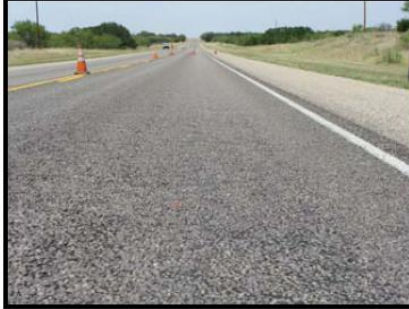
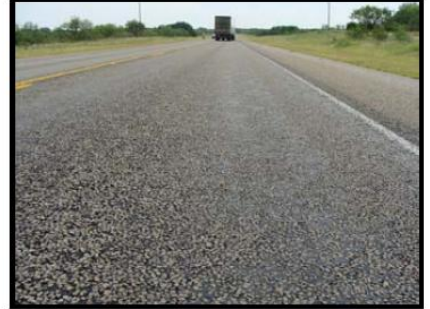
US 283 (Location 2) – Coleman County
 Grade 3 Aggregate with Straight AC-20XP at 0.47 gal/SY

Sand Patch Mean Texture Depth, mm			
	Old Pavement in 2008	New Seal in 2009	New Seal in 2010
Wheel Path	1.04	2.16	1.94
Between WP	1.91	3.51	3.19
Difference	0.87	1.35	1.25

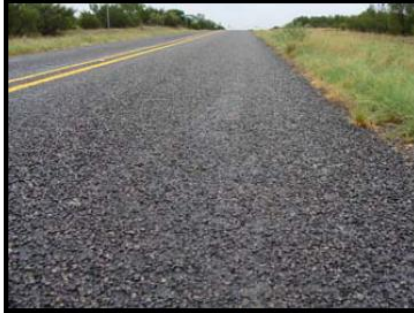
FM 2134 (Location 2) – Coleman County
 Grade 3 Aggregate with Straight AC-20XP at 0.52 gal/SY

Eastbound View

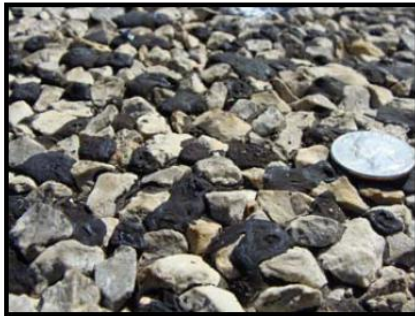
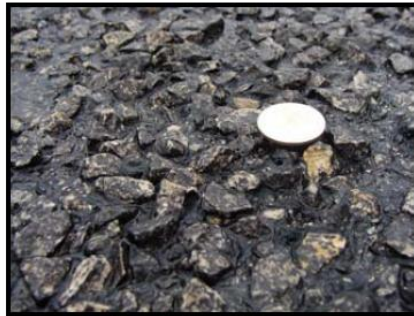
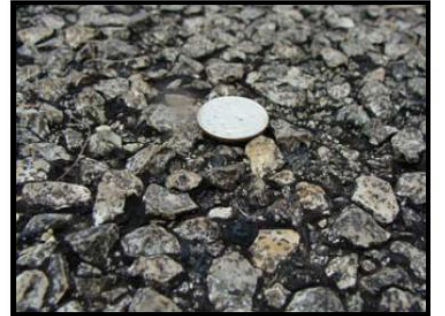
Sand Patch Mean Texture Depth, mm			
	Old Pavement in 2008	New Seal in 2009	New Seal in 2010
Wheel Path	2.39	4.00	4.10
Between WP	3.03	6.79	5.58
Difference	0.64	2.79	1.48

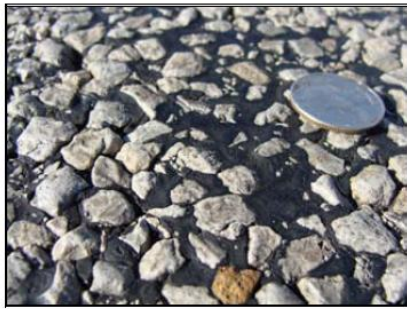
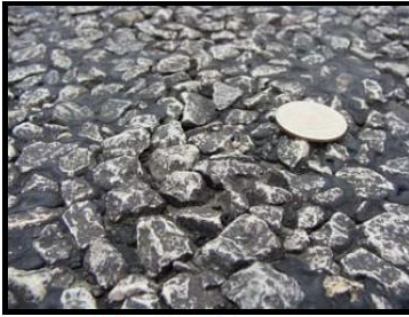
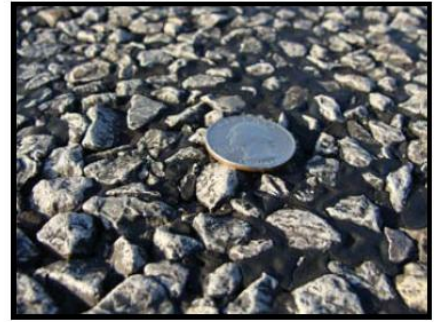
Southbound View

Sand Patch Mean Texture Depth, mm			
	Old Pavement in 2008	New Seal in 2009	New Seal in 2010
Wheel Path	1.27	1.62	1.55
Between WP	1.89	2.61	2.43
Difference	0.62	1.00	0.88

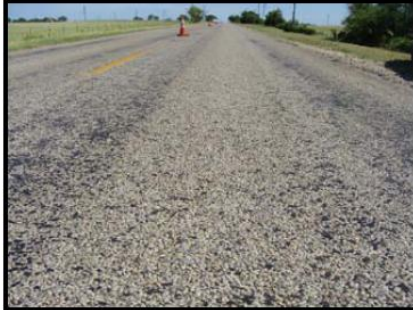
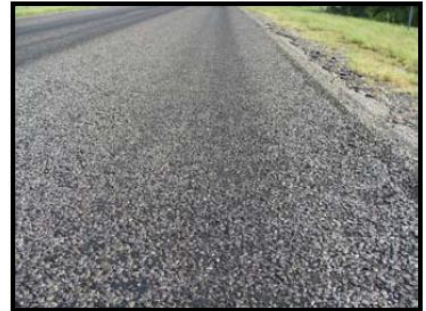
FM 2689 (Location 1) – Eastland County
 Grade 3 Aggregate with TVAR AC-20XP at 0.30/0.38 gal/SY

The second pair of pavement locations was on FM 2689 in Eastland County. They were located in the same lane, within approximately 600 ft of each other, and may be seen in [Figure 17](#). Yet, location 1 had limited pre-existing wheel path texture depth, 1.35 mm, compared to the pre-existing wheel path texture depth of 3.48 mm at location 2. These wheel path texture depths and those found after one year and two years of traffic are shown in [Table 12](#). Both locations received a TVAR seal coat, at asphalt application rates of 0.30 and 0.38 gal/SY, as the bulk of the pavement length called for a TVAR seal coat. Both locations have retained excellent textures over the two-year period of the study. Location 2, which did not require a TVAR method seal coat, has not lost aggregate from the wheel path even though a relatively low asphalt rate was applied.

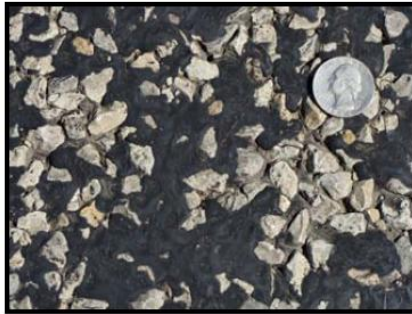
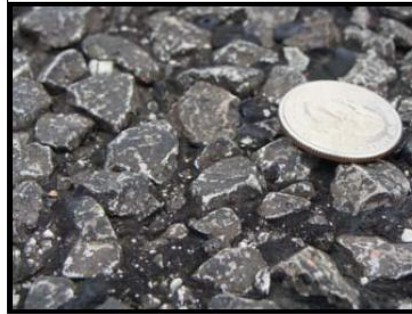
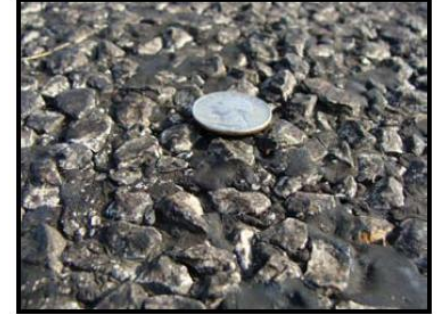
Northbound View

Sand Patch Mean Texture Depth, mm			
	Old Pavement in 2008	New Seal in 2009	New Seal in 2010
Wheel Path	1.35	3.05	2.74
Between WP	2.57	4.72	3.55
Difference	1.22	1.67	0.81

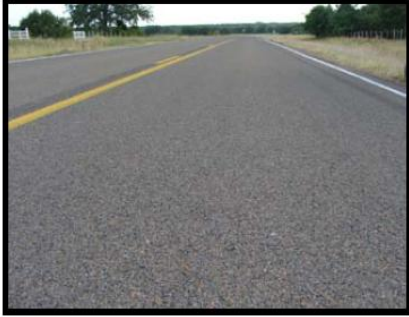
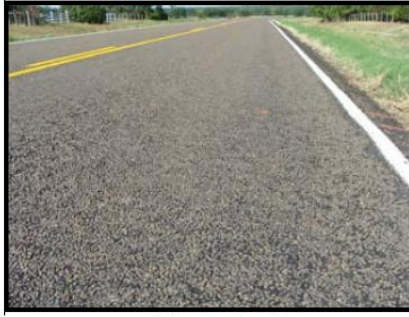
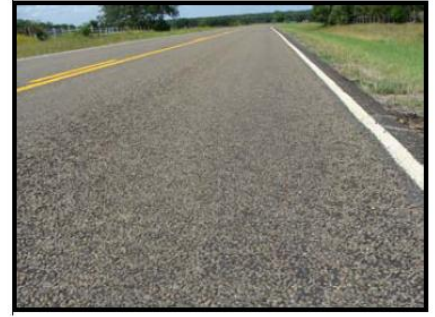
Northbound View

FM 696 (Location 1) – Burleson County
 Grade 4 Aggregate with Straight AC-20XP at 0.36 gal/SY

Sand Patch Mean Texture Depth, mm			
	Old Pavement in 2008	New Seal in 2009	New Seal in 2010
Wheel Path	2.16	1.82	1.28
Between WP	2.50	3.02	2.62
Difference	0.34	1.19	1.34

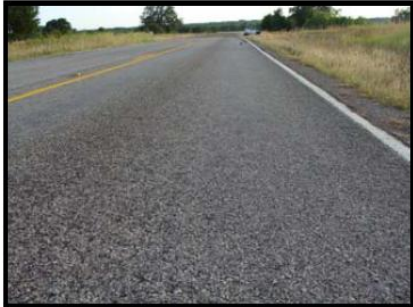
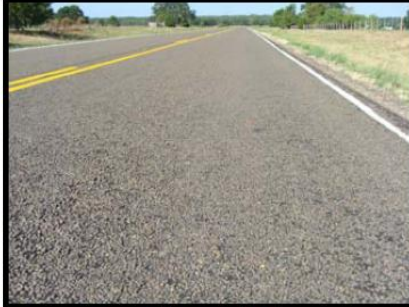
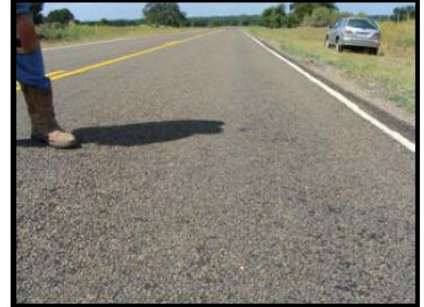
Northbound View

FM 696 (Location 2) – Burleson County
 Grade 4 Aggregate with Straight AC-20XP at 0.36 gal/SY

Sand Patch Mean Texture Depth, mm			
	Old Pavement in 2008	New Seal in 2009	New Seal in 2010
Wheel Path	0.93	2.33	1.67
Between WP	2.14	3.78	2.92
Difference	1.21	1.44	1.25

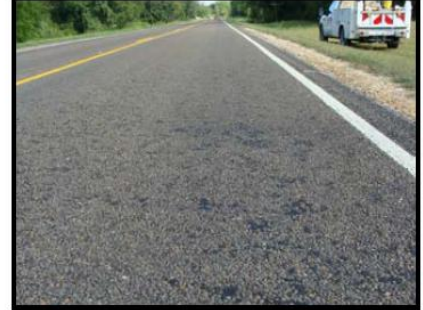
Northbound View

FM 908 (Location 1) – Burleson County
 Grade 4 Aggregate with TVAR AC-20XP at 0.32/0.38 gal/SY

Sand Patch Mean Texture Depth, mm			
	Old Pavement in 2008	New Seal in 2009	New Seal in 2010
Wheel Path	0.79	2.24	1.85
Between WP	2.14	3.55	3.07
Difference	1.35	1.32	1.22

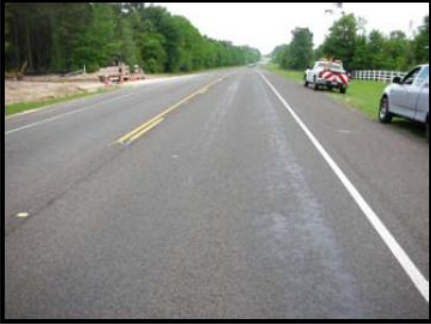
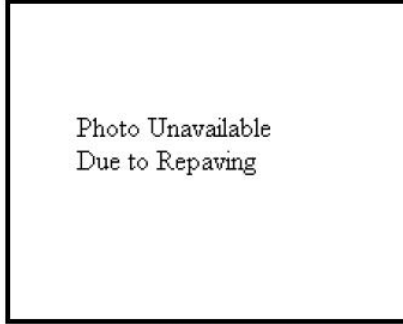
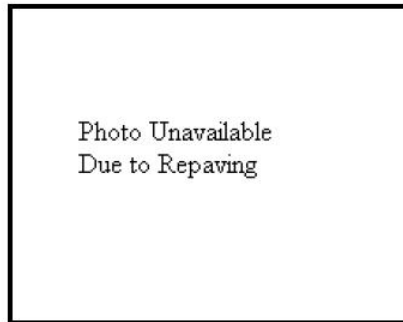
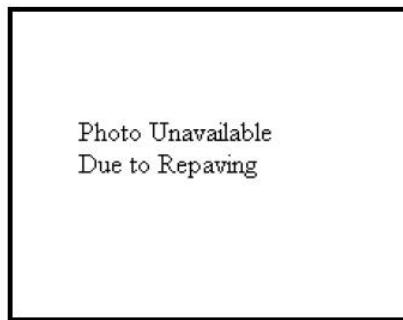
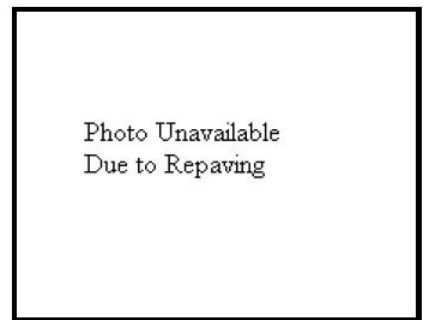
FM 819 (SB) – Angelina County
Grade 4 Aggregate with AC-20-5TR

Sand Patch Mean Texture Depth, mm			
	Old Pavement in 2008	New Seal in 2009	New Seal in 2010
Wheel Path	1.19	Data Unavailable Due to Repaving	
Between WP	1.97		
Difference	0.78

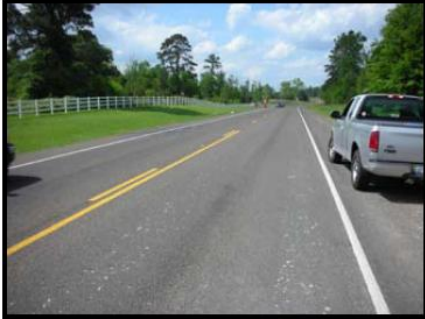
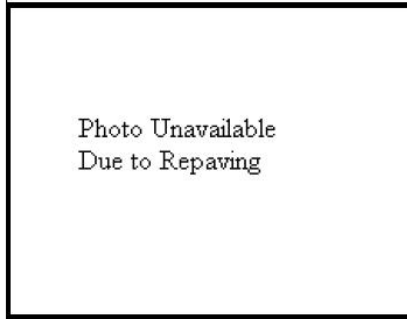
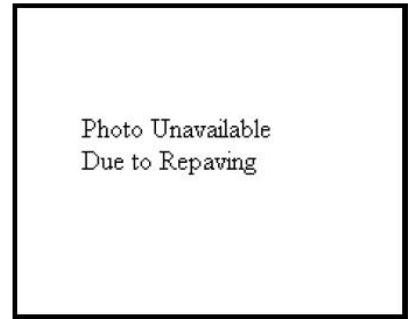
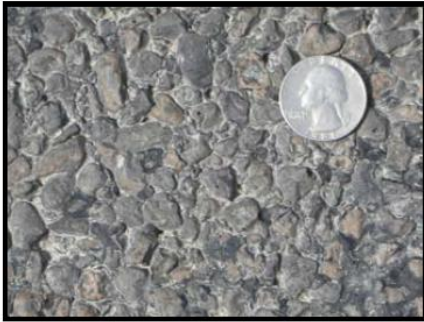
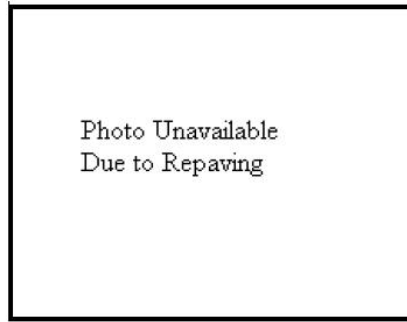
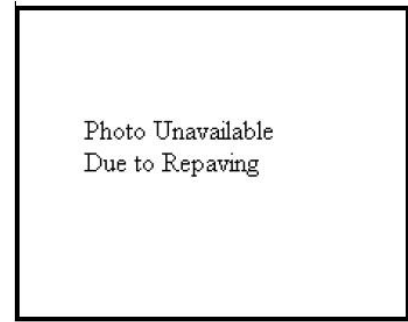
FM 819 (NB) – Angelina County
Grade 4 aggregate with AC-20-5TR asphalt

Sand Patch Mean Texture Depth, mm			
	Old Pavement in 2008	New Seal in 2009	New Seal in 2010
Wheel Path	1.49	Data Unavailable due to Repaving	
Between WP	2.51		
Difference	1.02

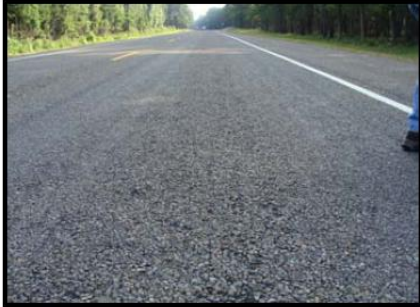
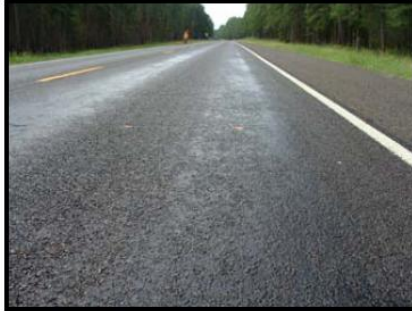
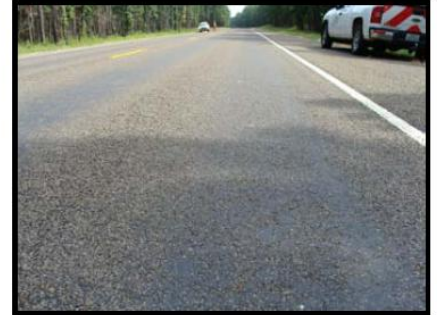
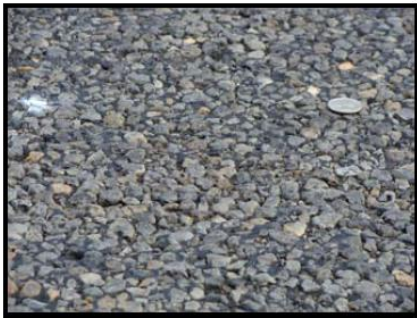
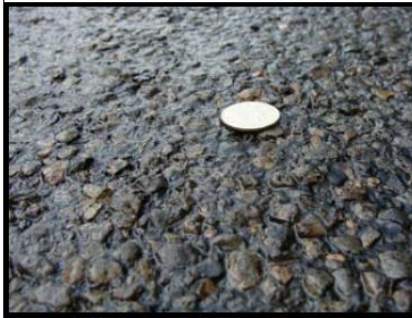
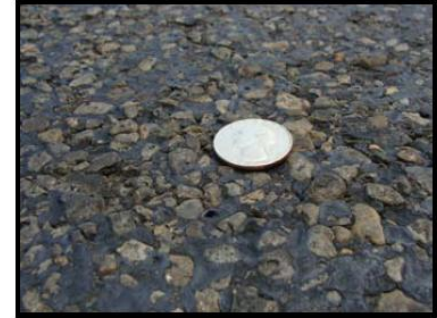
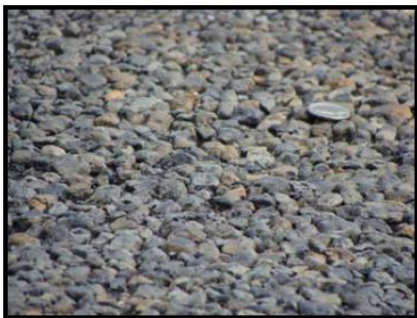
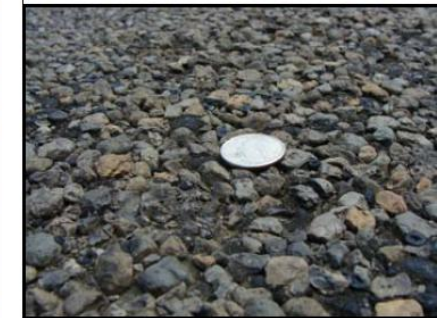
SH 147 (Location 1) – San Augustine County
 Grade 4 Aggregate with TVAR AC-15P at 0.32/0.38 gal/SY

The third pair of locations is on SH 147 in San Augustine County. Location 1 is in the northbound lane and location 3 is in the southbound lane, approximately three miles apart. Because of predominantly differing texture conditions around these test locations, location 1 with reasonably good pre-existing wheel path textures received a TVAR seal coat at 0.32 and 0.38 gal/SY and location 3, which was a considerably flushed wheel path location, received a uniform asphalt application at 0.34 gal/SY. The visual appearances of these locations may be seen in [Figure 18](#), and [Table 13](#) contains pre-existing and post-seal coat wheel path texture depths. Location 3 has lost virtually all texture improvement provided by the new seal coat within two years of construction. Location 1 now has *less* wheel path texture than existed prior to seal coat construction two years prior, although the texture depth is superior to that in location 3. The appearance is that both of these locations still have an excess of asphalt at the surface and both would have benefited from a lesser asphalt application in the wheel paths provided that the lesser asphalt amount would have held the aggregate over the first winter.

Sand Patch Mean Texture Depth, mm			
	Old Pavement in 2008	New Seal in 2009	New Seal in 2010
Wheel Path	1.93	1.77	1.20
Between WP	2.91	2.86	2.44
Difference	0.98	1.09	1.24

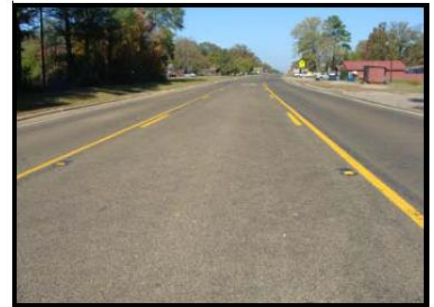
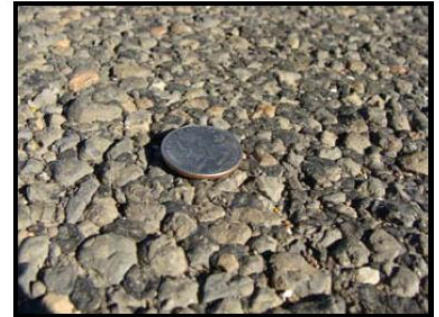
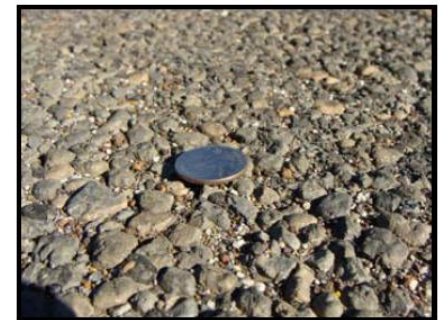
SH 147 (Location 2) – San Augustine County
 Grade 4 Aggregate with Straight AC-15P at 0.33 gal/SY

Sand Patch Mean Texture Depth, mm			
	Old Pavement in 2008	New Seal in 2009	New Seal in 2010
Wheel Path	1.34	2.38	1.86
Between WP	1.39	2.76	2.02
Difference	0.05	0.38	0.16

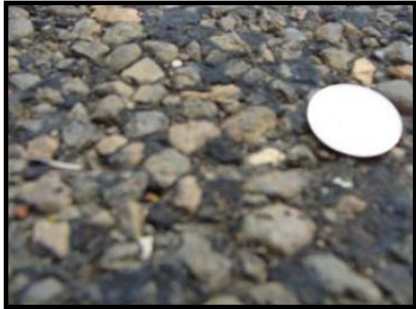
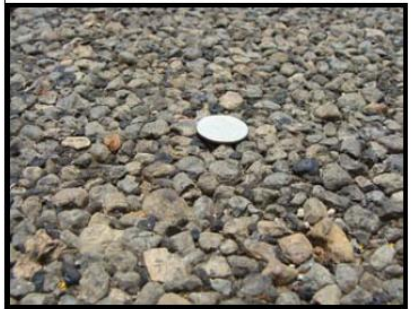
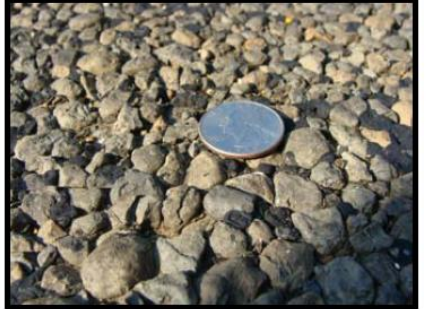
SH 147 (Location 4) – San Augustine County
Grade 4 Aggregate with Straight AC-15P at 0.38 gal/SY

Sand Patch Mean Texture Depth, mm			
	Old Pavement in 2008	New Seal in 2009	New Seal in 2010
Wheel Path	1.45	2.43	2.10
Between WP	1.79	2.86	2.36
Difference	0.34	0.42	0.26

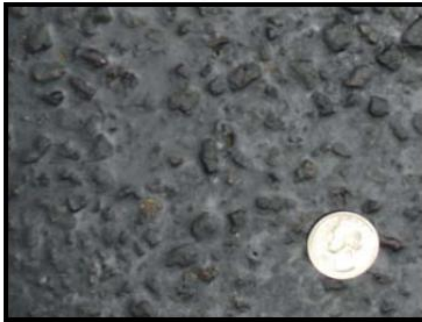
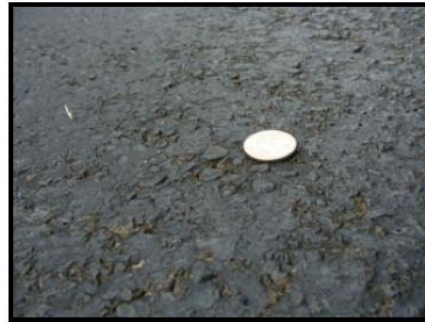
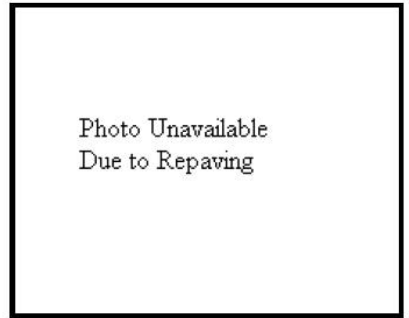
Westbound View

Sand Patch Mean Texture Depth, mm			
	Old Pavement in 2008	New Seal in 2009	New Seal in 2010
Wheel Path	0.79	1.04	N/A
Between WP	2.53	2.39	N/A
Difference	1.74	1.35	N/A

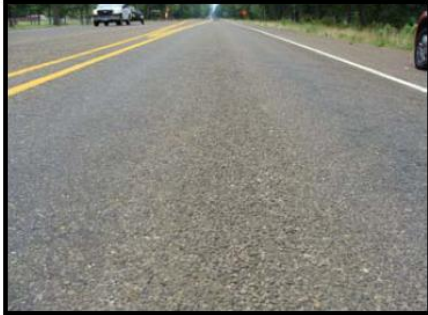
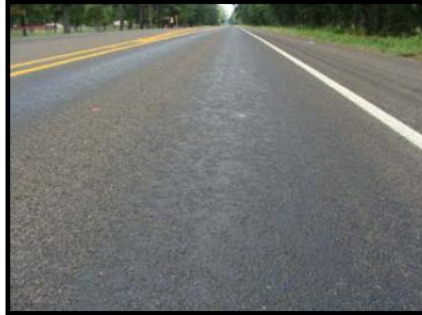
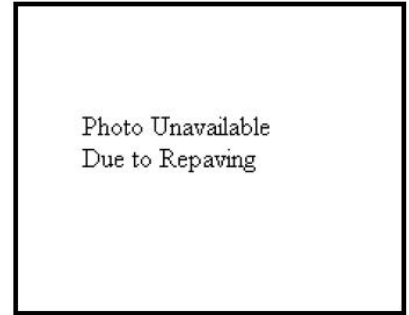
SH 103 (Location 2) – San Augustine County
 Grade 4 Aggregate with Straight AC-15P at 0.35 gal/SY

Sand Patch Mean Texture Depth, mm			
	Old Pavement in 2008	New Seal in 2009	New Seal in 2010
Wheel Path	1.34	1.14	N/A
Between WP	2.82	2.67	N/A
Difference	1.48	1.52	N/A

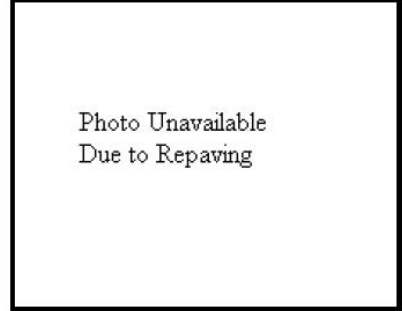
SH 103 (Location 3) – San Augustine County
 Grade 4 Aggregate with TVAR AC-15P at 0.30/0.38 gal/SY

Sand Patch Mean Texture Depth, mm			
	Old Pavement in 2008	New Seal in 2009	New Seal in 2010
Wheel Path	1.34	1.58	N/A
Between WP	2.80	2.99	N/A
Difference	1.46	1.41	N/A

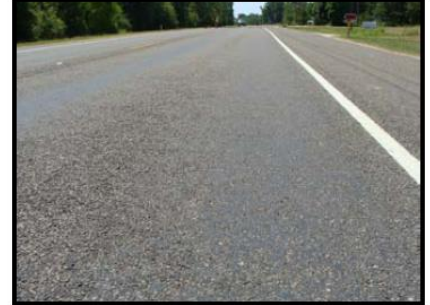
FM 2457 (Location 1) – Polk County
 Grade 4 Aggregate with TVAR AC-20-5TR at 0.24/0.33 gal/SY

Sand Patch Mean Texture Depth, mm			
	Old Pavement in 2008	New Seal in 2009	New Seal in 2010
Wheel Path	0.79	1.25	0.86
Between WP	2.29	2.63	2.15
Difference	1.50	1.38	1.29

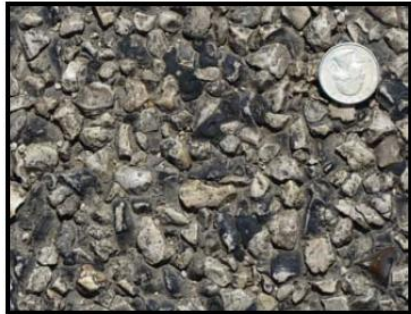
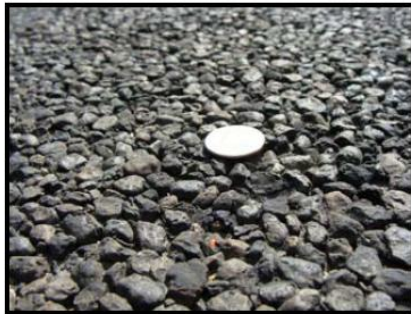
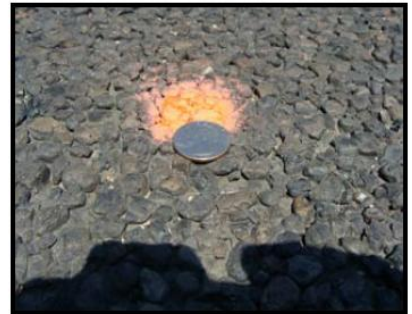
Wheel Path Texture

Between Wheel Path Texture

Sand Patch Mean Texture Depth, mm			
	Old Pavement in 2008	New Seal in 2009	New Seal in 2010
Wheel Path	0.41	0.90	0.68
Between WP	1.42	2.29	2.09
Difference	1.01	1.39	1.47
