1. Report No. FHWA/TX-12/5-9043-01-1		2. Government Accession No.		3. Recipient's Catalog No.	
4. Title and Subtitle HEATWURX PATCHING AT TWO LOCATIONS IN SAN ANTONIO				5. Report Date March 2012 Published: June 2012

HEATWURX PATCHING AT TWO LOCATIONS IN SAN ANTONIO

Project 5-9043-01
Report 5-9043-01-1
Project Title: Evaluation of Asphalt Pavement Patching Using Infrared Heat

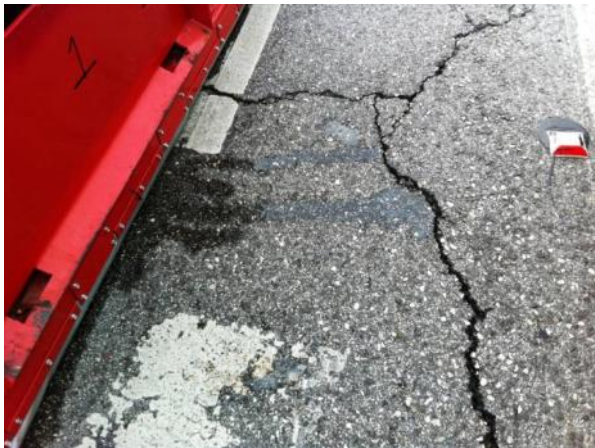
Figure 7. Condensed Water along Unit.

The pavement is heated until it meets or exceeds the temperature that the supervisor or operator selected. The unit can be lifted and the temperature tested with an infrared temperature device. If the temperature is still lower than preferred, the unit is replaced over the distressed area and heating is continued. As shown in [Figures 7](#) and [8](#), moisture in the pavement is evaporated forming steam, which can then condense along the sides of the heater unit.

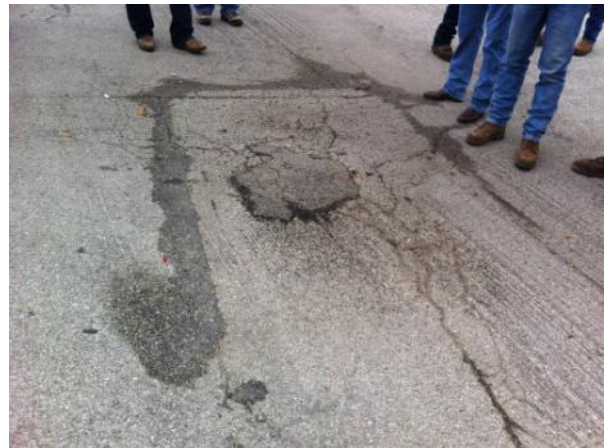
Figure 8. Water after Unit Removal.

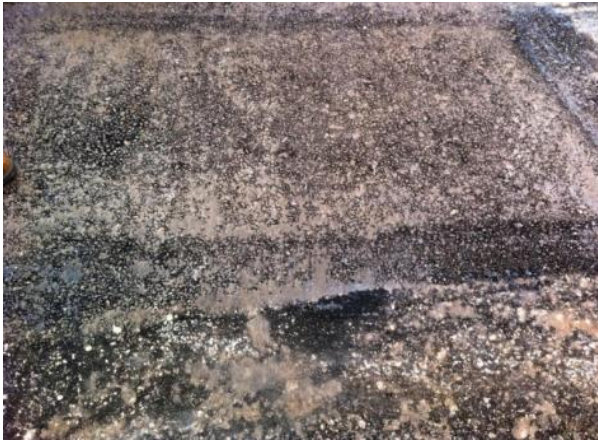
[Figures 22](#) and [23](#) show completed patches. The surface of the patch in [Figure 22](#) looks dirty because the water in the roller tracked mud onto the patch and not due to the HeatWurx system. The patch in [Figure 23](#) shows how multiple patches can be laid adjacent to previous patches.

Figure 22. Completed Patch

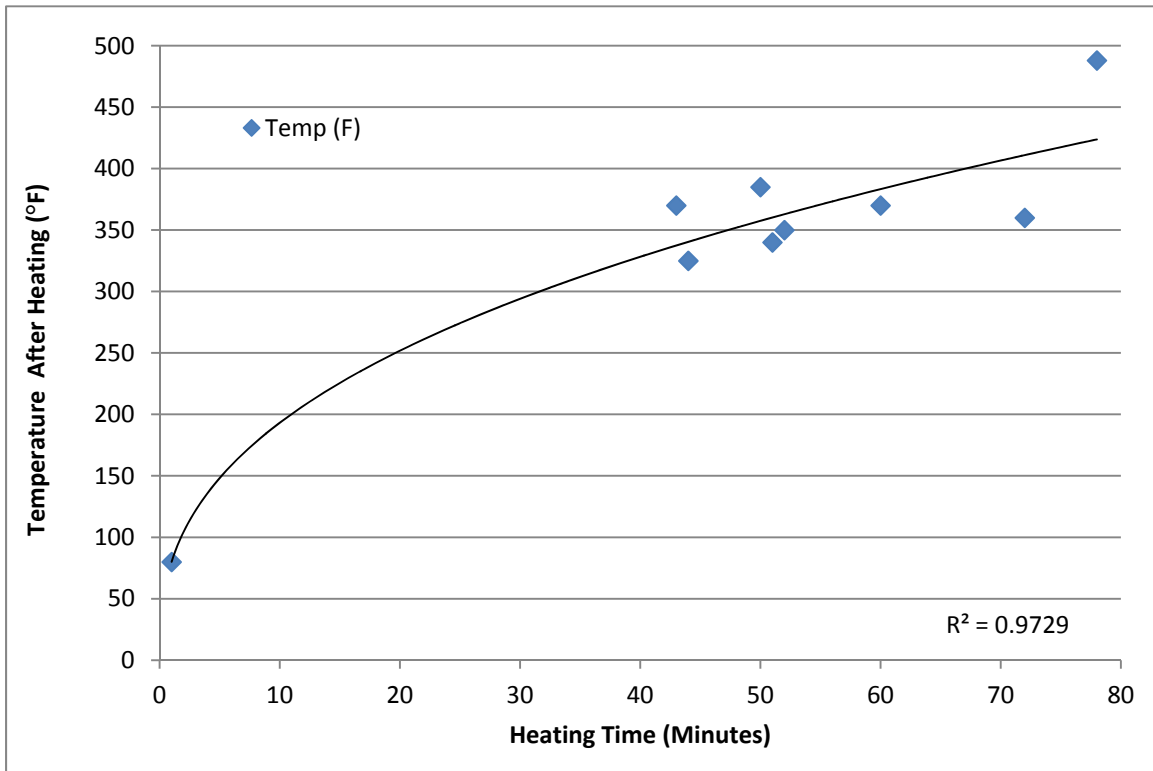
Table 2 lists the times and temperatures for the IH410Fr location. Data taken at the IH10 Frontage road site (IH10Fr) was lost before it could be transferred to the research team. However, the next section shows that infrared camera readings of temperature were available for IH10FR. Figure 33 illustrates the heating time versus pavement temperature curve for the IH410Fr-1 and -2 sites.

Figure 33. Pavement Temperature versus Heating Time (IH410-1 and -2).

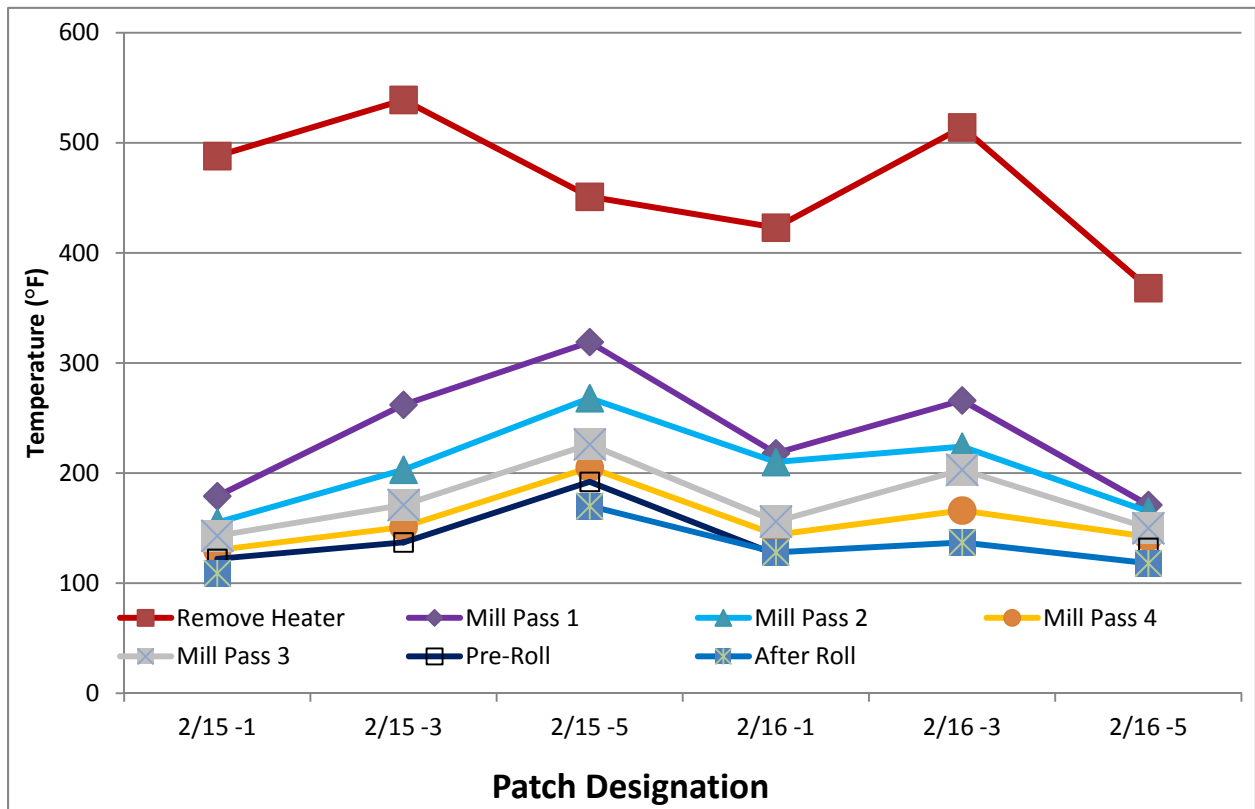
The temperatures after the removal of the heating unit varied from a low of 368°F to a high of 629°F. The lower temperatures for the last two patches were an attempt to see if the work could be done at a lower temperature with less heating time. Table 3 and Figure 34 illustrate the variability in temperature experienced in the HeatWurx process. Unfortunately, the recorded temperatures could not be tied to the performance of the patches, as this site was completely repatched about four months later. This is discussed in the section on performance.

Figure 34. Graph of Temperatures at IH10 Site.

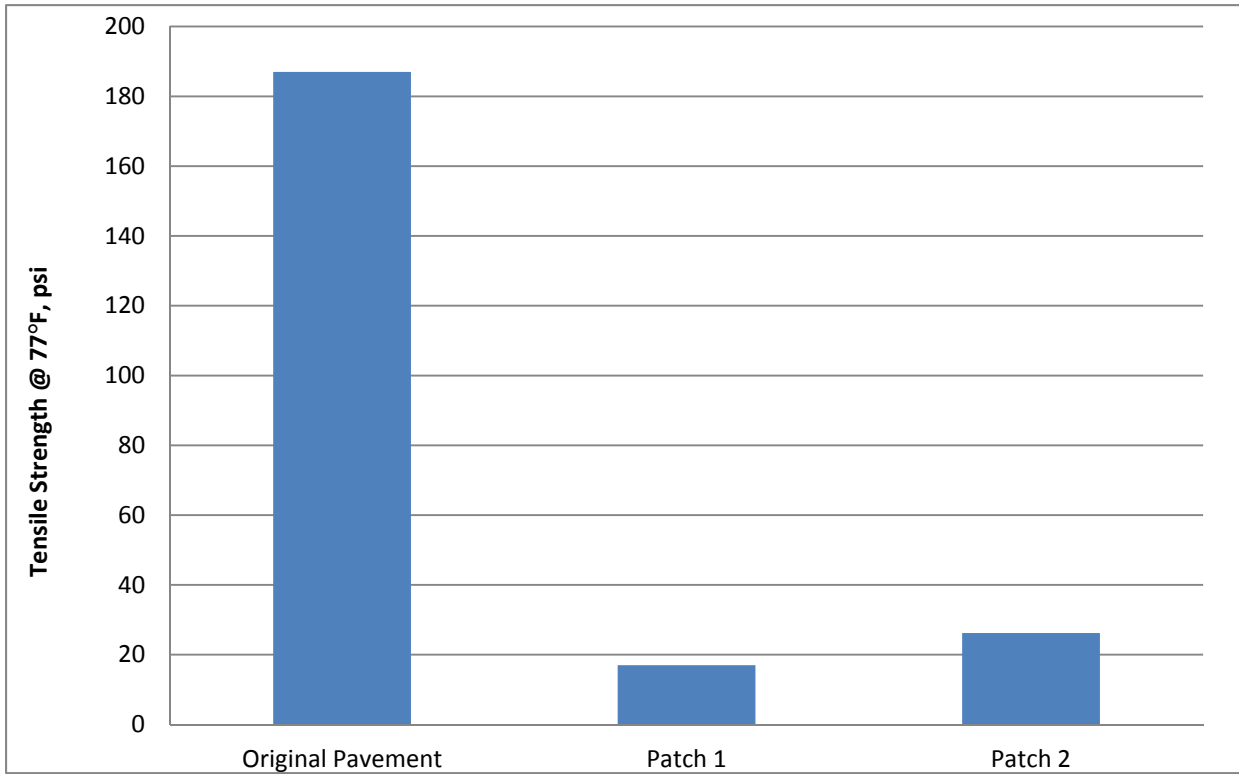
[Table 4](#) shows that the bulk density of the materials in the patches are lower than the bulk density of the original pavement by about 5 to 10 lbs/ft³, and that the air voids for the patch material are greater by 0.6 to 3.5 percent. The indirect tensile strength is almost 10 times lower for the patch materials than the original pavement (see [Figure 66](#)). The resilient modulus values of the patch materials for both 39.2° and 77°F are lower than the original pavement by about a factor of 5 to 10 ([Figure 67](#)). The reasons for the difference between the patching materials in terms of tensile strength and resilient modulus are most likely attributable to two primary factors:

Figure 66. Indirect Tensile Strength of the Original Pavement and Patches for IH410Fr.

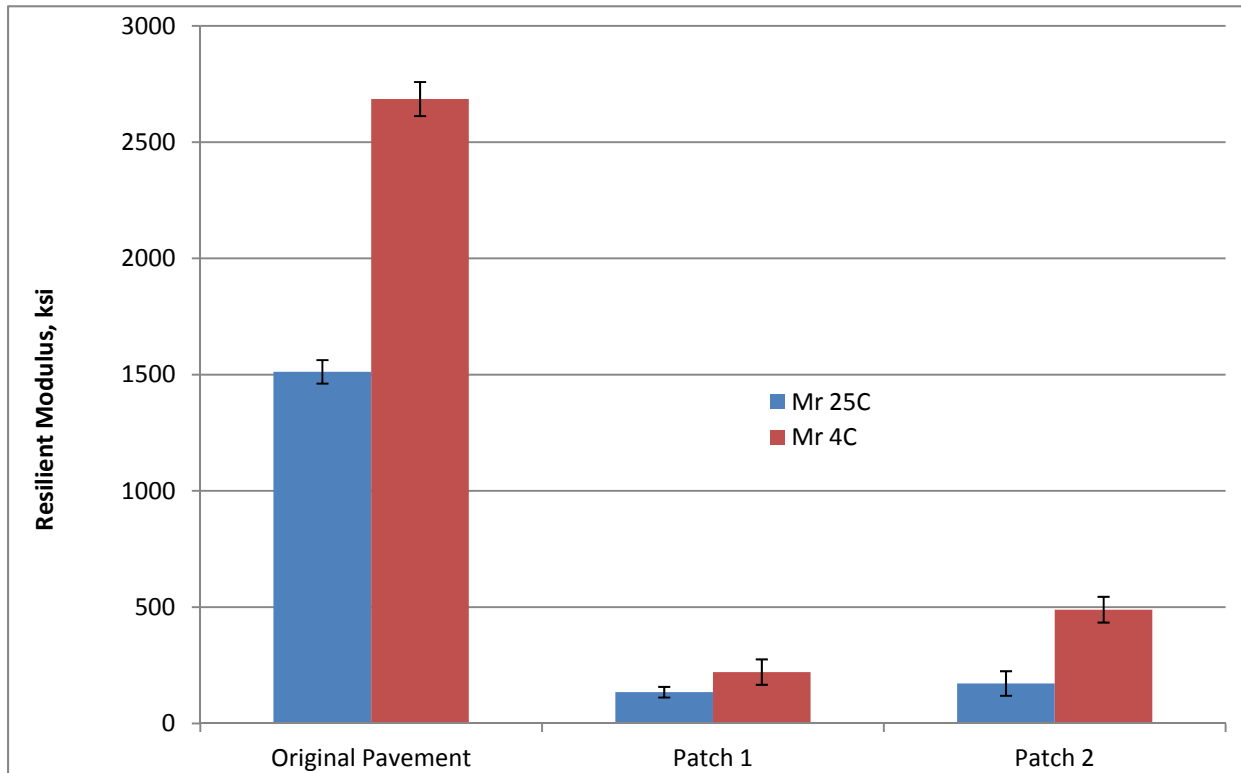
Figure 67. Resilient Modulus of the Original Pavement and Patches for IH410Fr.
