1. Report No. TX-96/5388-1F		2. Government Accession No.		3. Recipient's Catalog No.	
4. Title and Subtitle EVALUATION OF WORK ZONE BARRICADES AND TEMPORARY SIGN SUPPORTS				5. Report Date February 1996

EVALUATION OF WORK ZONE BARRICADES AND TEMPORARY SIGN SUPPORTS

Report No. 5388-1F
Research Study No. 585xxA3014
Research Study Title: Development of New Designs for Barricades
and Sign Supports in Work Zones

February 1996

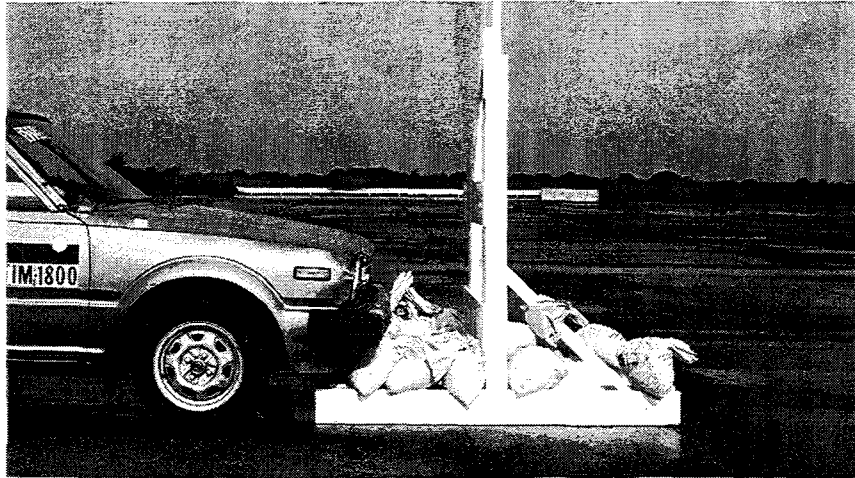
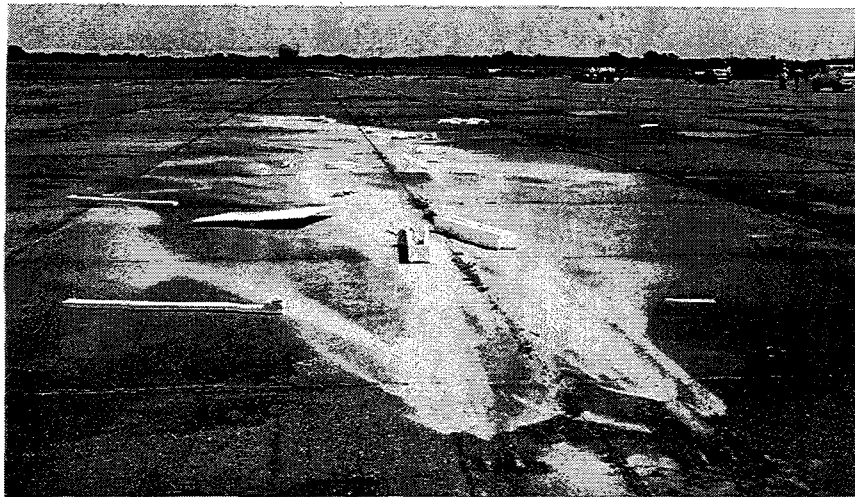
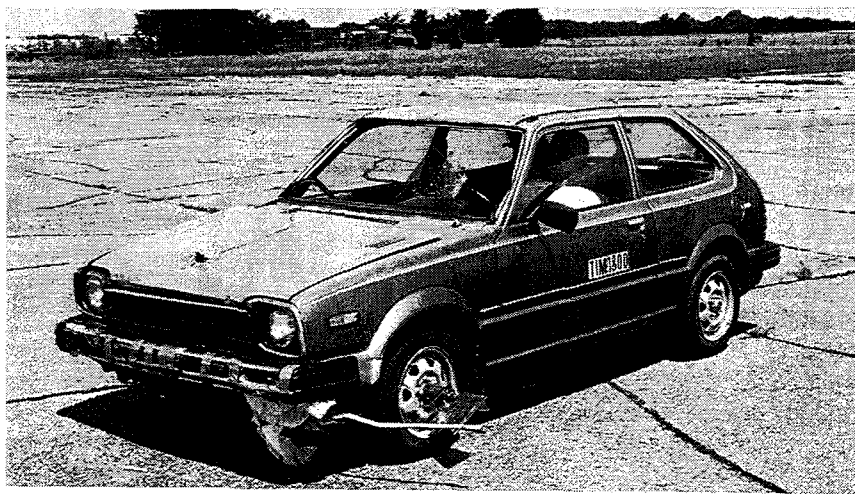
Figure 2. Vehicle and Barricade for Test No. 453360-1

As can be seen in Figure 2, the Type III Wood Barricade separated upon impact. Debris and sand were strewn along the path of the vehicle in an area 11 m wide by 37 m long. Figure 2 shows damage to the vehicle. There were two dents in the bumper, 38 mm and 19 mm from

impact with the vertical supports of the barricade. There was a 40 mm x 200 mm dent in the hood, the windshield was broken and had fallen into the occupant compartment, and there was a small dent in the rear roof near the hatch.

In summary, the performance of the barricade was judged to be unsatisfactory due to penetration of the windshield and the occupant compartment by the fractured vertical supports of the barricade.

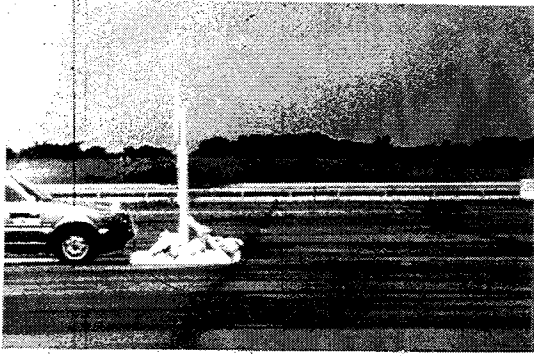
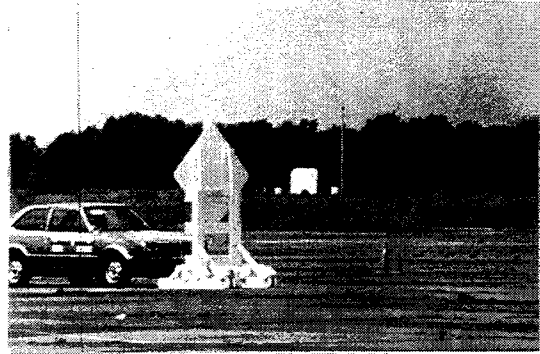
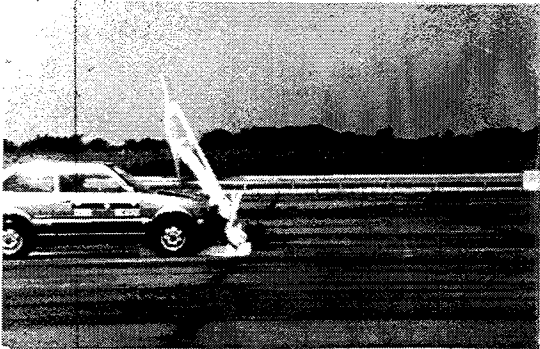
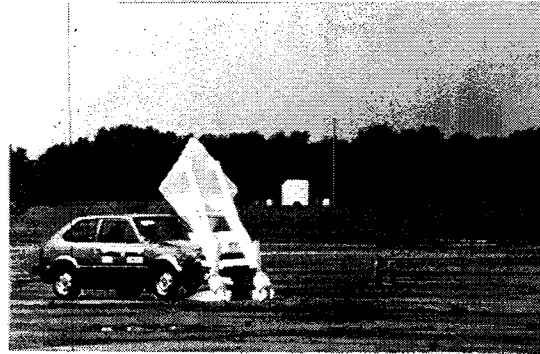
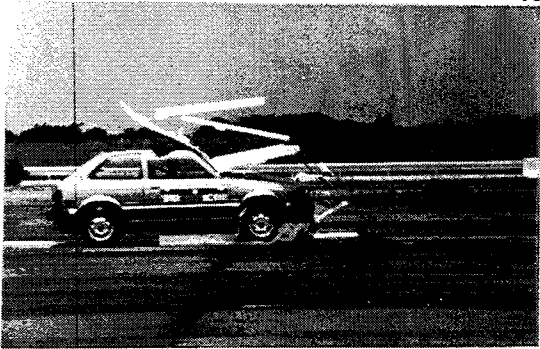
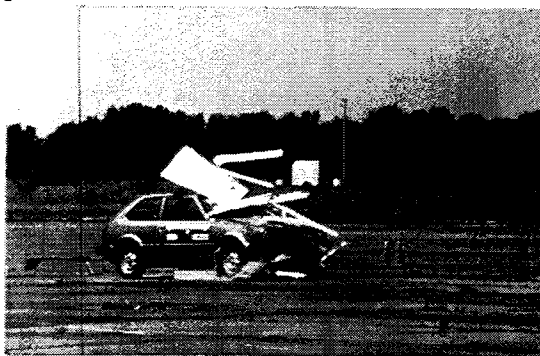
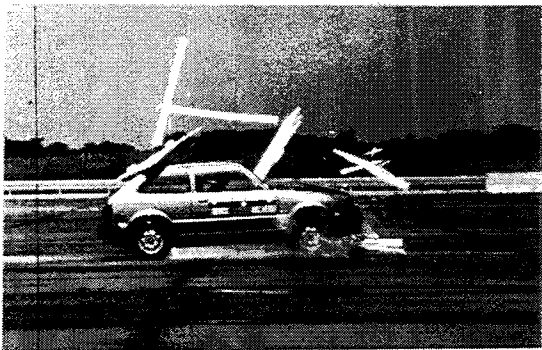
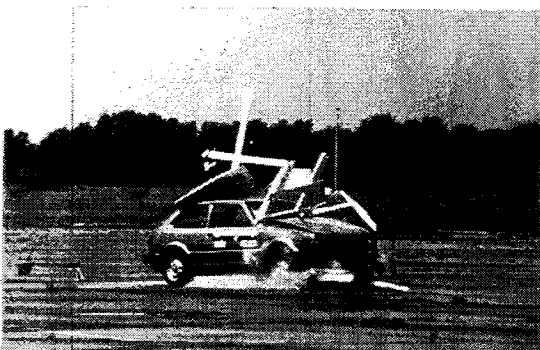
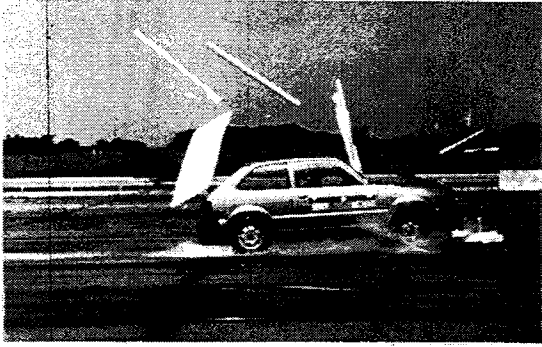
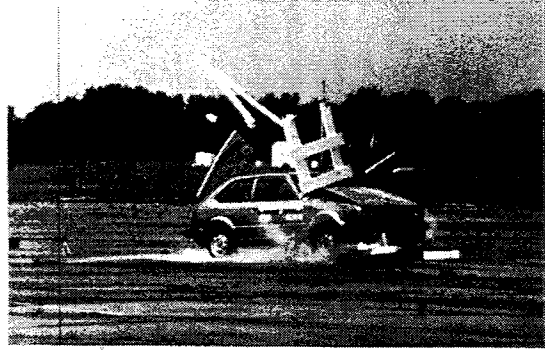
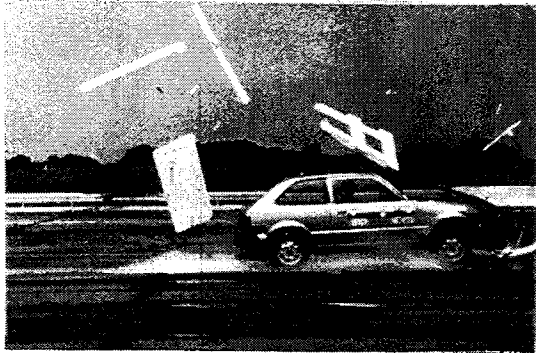
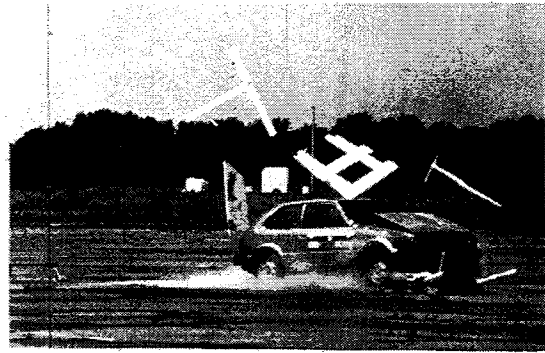
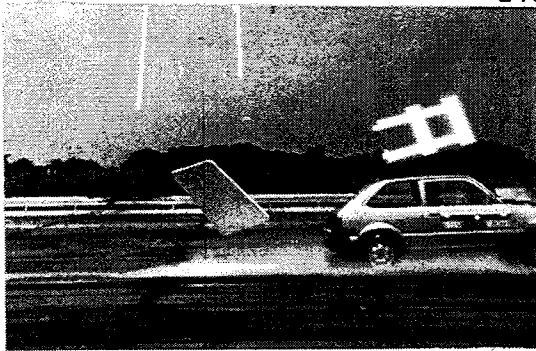
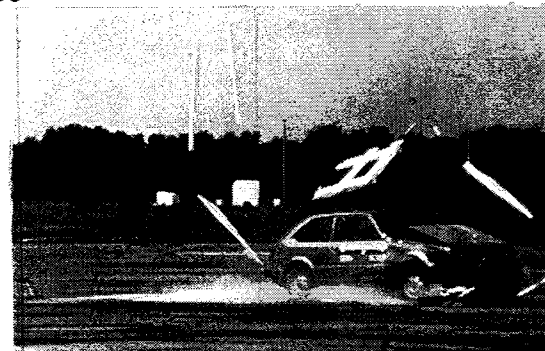
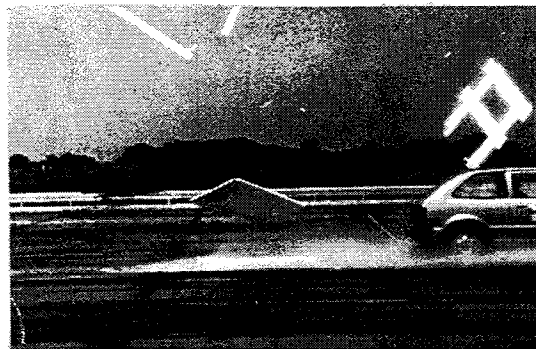
Figure 3. Sequential Photographs for Test No. 453360-1

At 10 msec after initial impact, the sign panel broke loose from the barricade, and the vertical supports began to break loose from the bases. The sign panel struck the roof just above the windshield at 62 msec. The top of the vertical supports, which had broken off at the base, impacted and penetrated the windshield at 74 msec. As the vehicle continued forward, the sign panel rotated up and over the vehicle, striking the telemetry antenna resulting in loss of data transmission at about 93 msec. The time at loss of contact with the barricade, i.e., when the support ended contact with the vehicle, was 209 msec and the vehicle had slowed to 84.5 km/h. The support rotated as it went over the vehicle, and one leg momentarily contacted the rear portion of the roof just above the rear hatch at about 307 msec. Brakes on the vehicle were applied at 1.05 seconds after impact, which was after the vehicle cleared the immediate test site. Prior to brake application, the test vehicle was traveling on a relatively straight-forward path. However, one brake did not actuate upon application, causing the vehicle to yaw in a clockwise rotation. The vehicle subsequently came to rest 137 m down and 37 m to the right of the point of impact. Figure 3 shows sequential photographs of the test period.

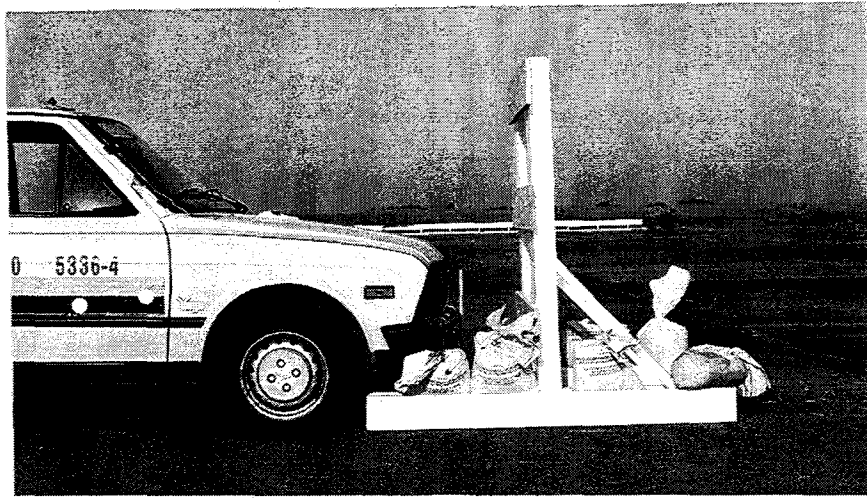
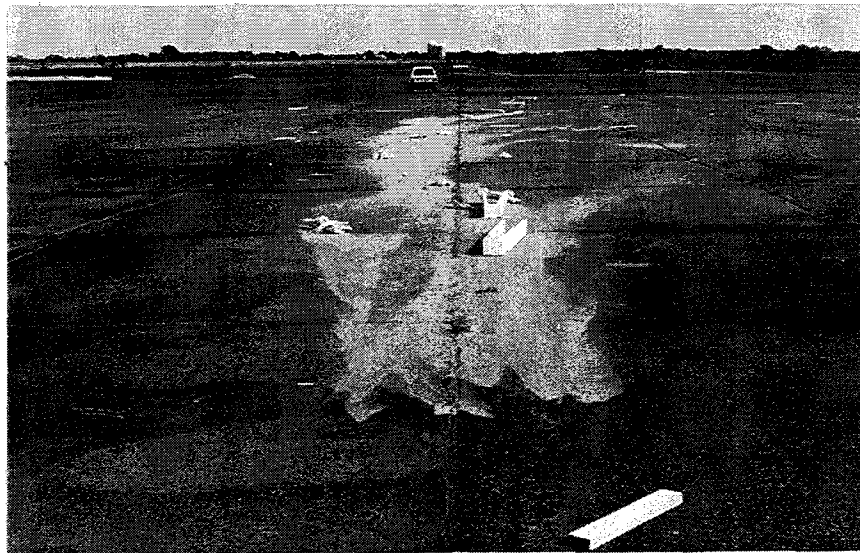
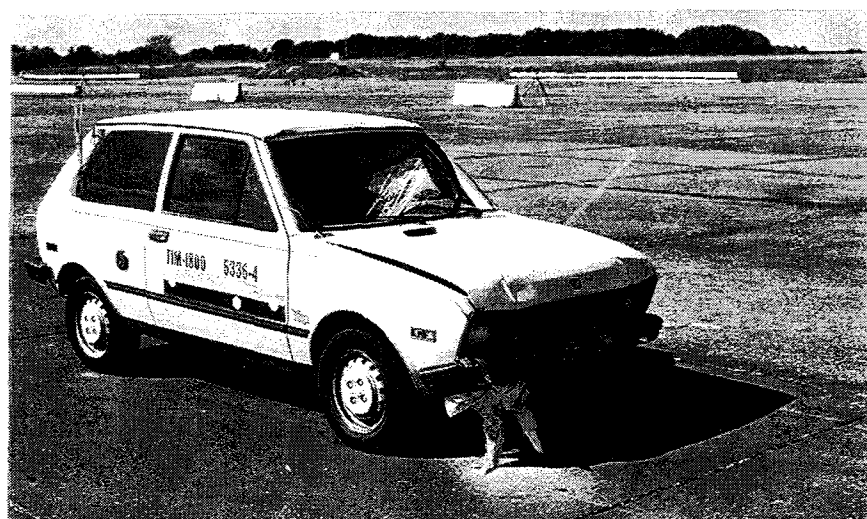
Figure 6. Vehicle and Barricade for Test No. 453360-4

The barricade shattered upon impact, as can be seen in Figure 6. Debris and sand were strewn along the path of the vehicle in an area 18 m wide by 56 m long. Figure 6 shows damage to the vehicle. There were two dents in the bumper, 89 mm and 64 mm from impact with the vertical supports. The windshield was broken and had fallen into the occupant compartment,

In summary, the performance of the barricade was judged to be unsatisfactory due to penetration of the windshield and the occupant compartment by the fractured vertical supports of the barricade.

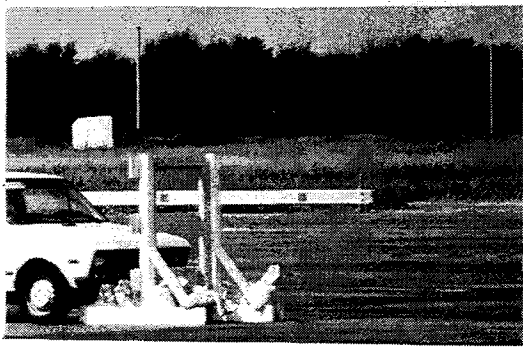
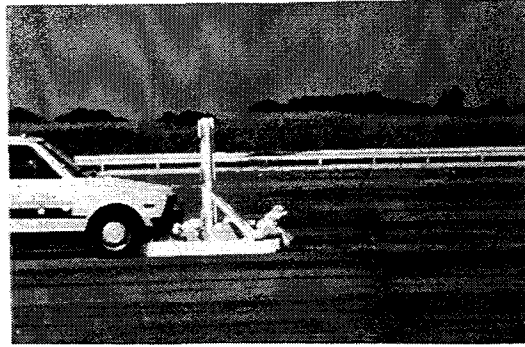
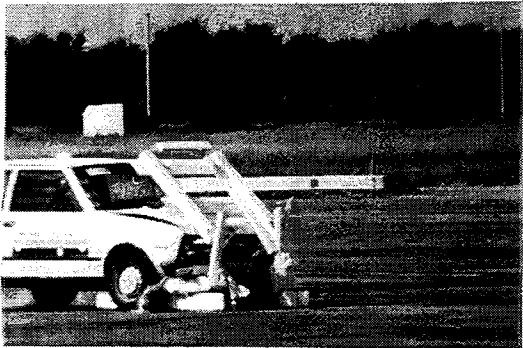
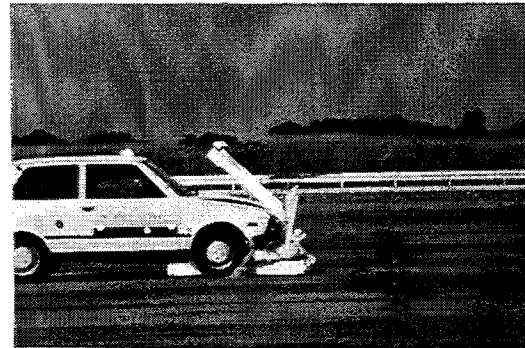
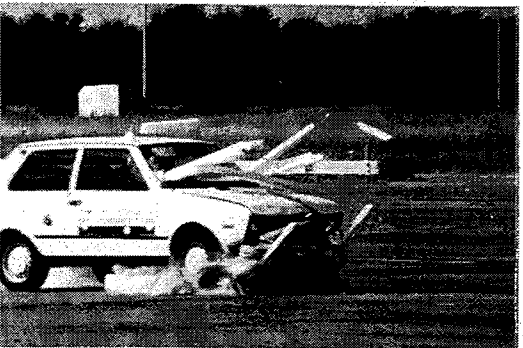
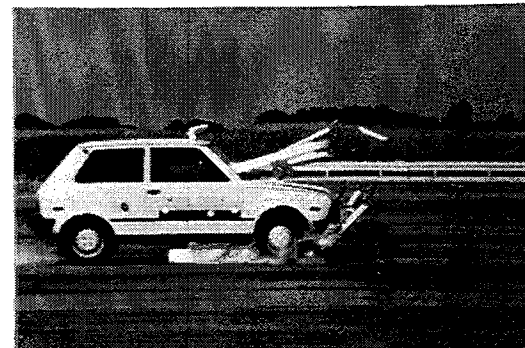
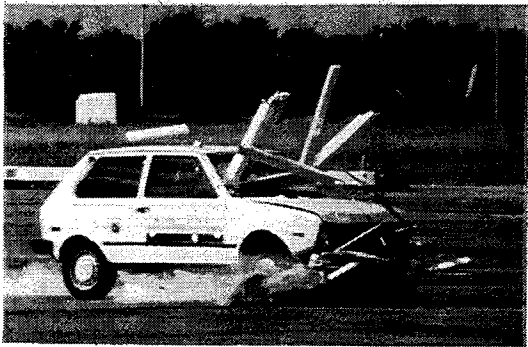
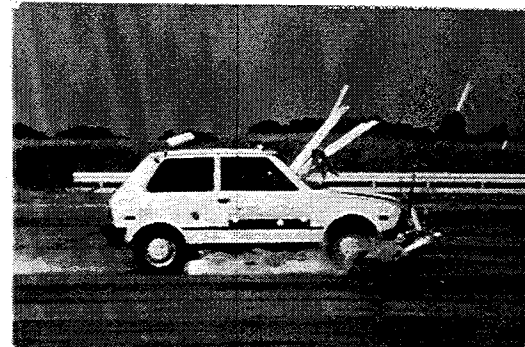
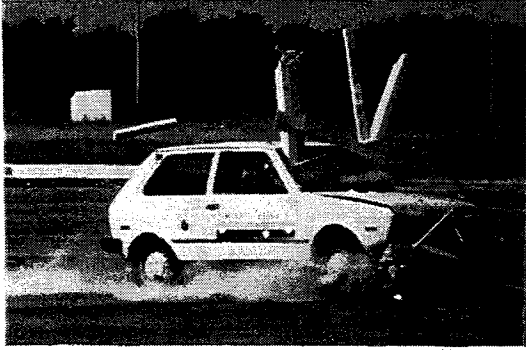
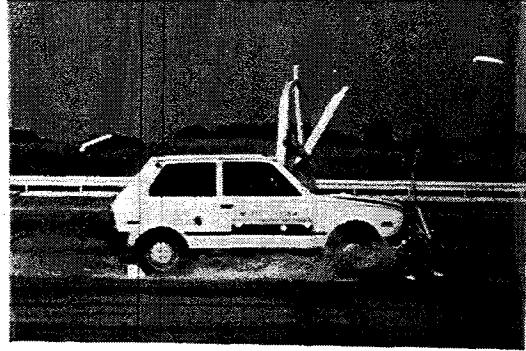
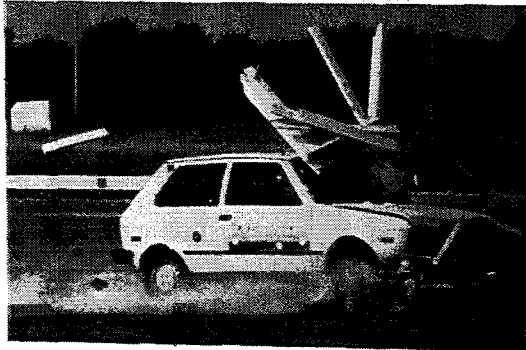
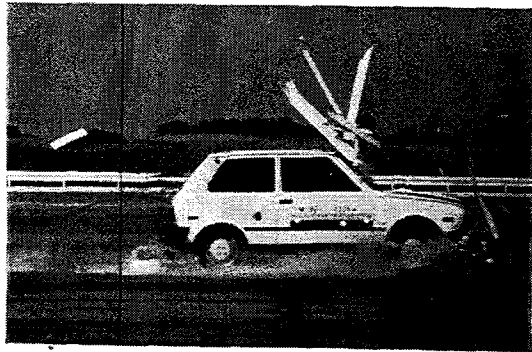
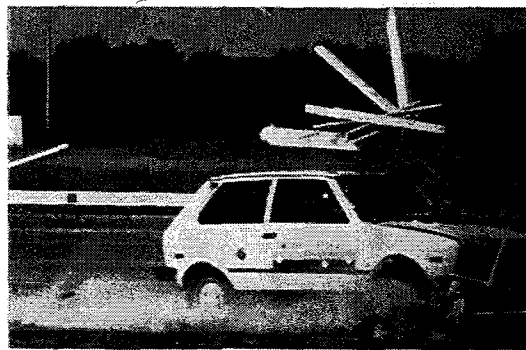
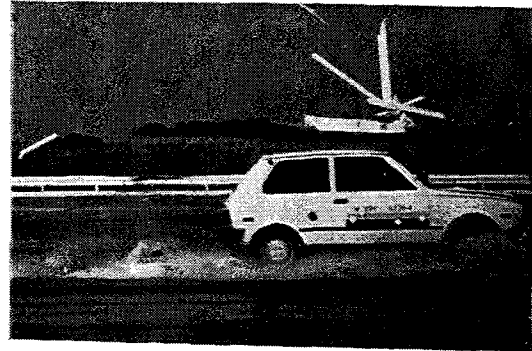
Figure 7. Sequential Photographs for Test No. 453360-4

Upon impact, the vertical supports fractured and contacted the hood of the vehicle while the vehicle traveled over the bases. The top rear section of the barricade separated at 17 msec and made contact with the windshield at 40 msec. The windshield broke at 45 msec, and a fragment of the barricade entered the occupant compartment at 72 msec. As the vehicle continued forward, the other fragments contacted the roof of the vehicle just above the windshield at 117 msec and then lost contact at 164 msec. At this time, the vehicle had slowed to 84.5 km/h. The fragments rotated as they went over the vehicle and momentarily contacted the left rear portion of the roof at about 226 msec. After the vehicle cleared the immediate test site, brakes on the vehicle were applied at 860 msec. Prior to brake application, the test vehicle was traveling on a relatively straight-forward path. The vehicle subsequently came to rest 71 m down from the point of impact. Figure 7 shows sequential photographs of the test period.

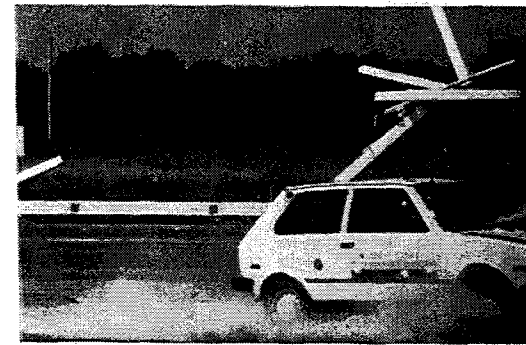
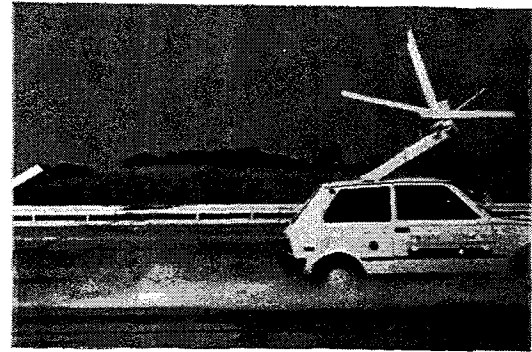
0.242 s

Figure 7. Sequential Photographs for Test No. 453360-4 (continued)

Figure 8 presents a brief summary of the results of this test. The barricade shattered upon impact, and a segment of the barricade impacted the windshield, penetrated and intruded into the occupant compartment. The 533 mm long fragment was found in the rear section of the occupant compartment, showing potential risk to occupants in the vehicle. Sand and many fragments of the barricade were scattered along an area 18 m wide by 56 m long. Some fragments were fairly large, which could pose potential hazard to oncoming traffic in adjacent lanes and to workers in the area. Sand was also scattered on the pavement, which could lead to loss of control of other vehicles. The vehicle sustained damage to the front bumper, hood, windshield and roof. The longitudinal occupant impact velocity was 2.8 m/s and the highest 10-msec average ridedown acceleration was -0.9 g. There was no lateral occupant contact during the test period. The 50-msec average accelerations were -4.8 g in the longitudinal direction and 0.7 g in the lateral direction. The vehicle exited the immediate test site in a relatively smooth, stable manner and showed no potential for intrusion into adjacent traffic lanes.

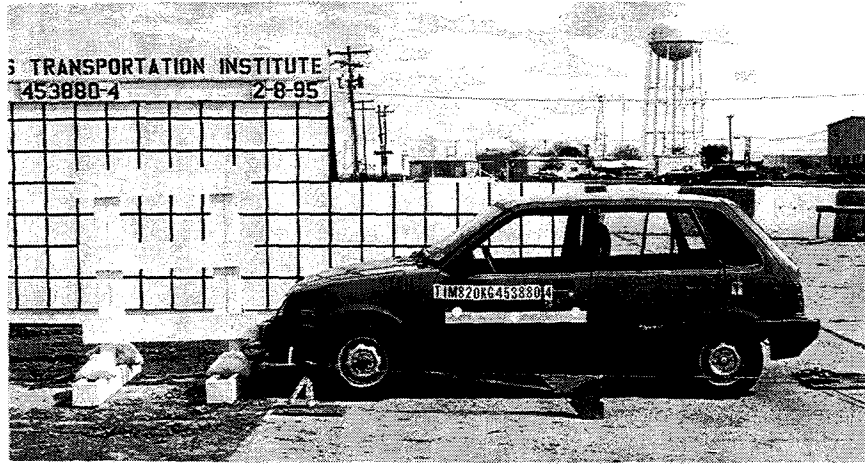
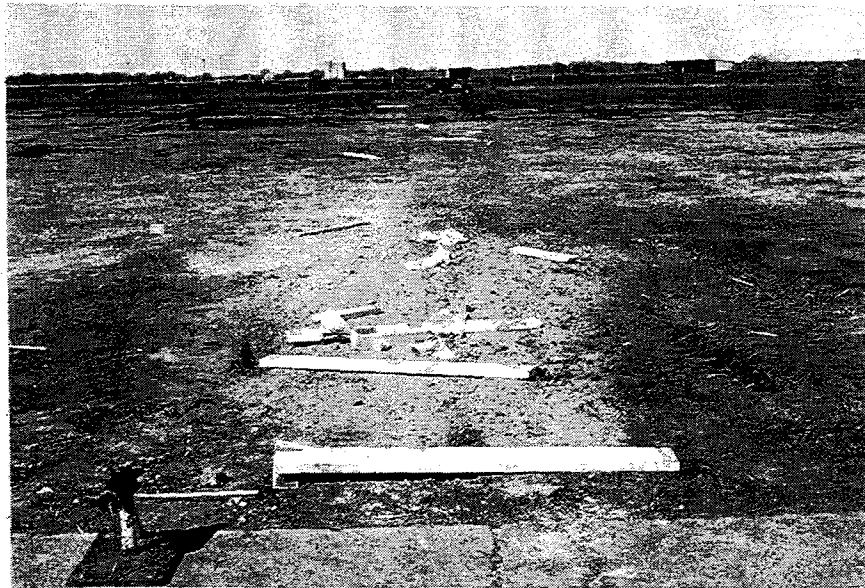
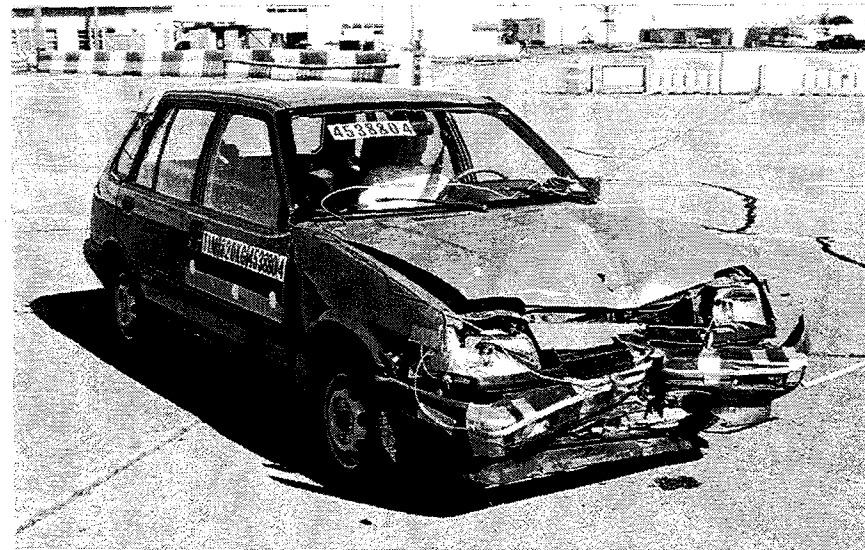
Figure 10. Vehicle and Barricade for Test No. 453880-4

The barricade separated from the base upon impact, as can be seen in Figure 10. Debris and sand were strewn along the path of the vehicle in an area 4.3 m wide by 58.8 m long. Figure 10 shows damage to the vehicle. Maximum crush to the exterior of the vehicle was 190 mm to the center front bumper. The right front door was jammed, and there was damage to the bumper, grill, and hood. The right front tire was flat.

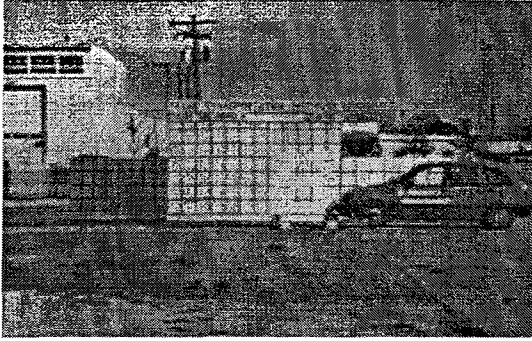
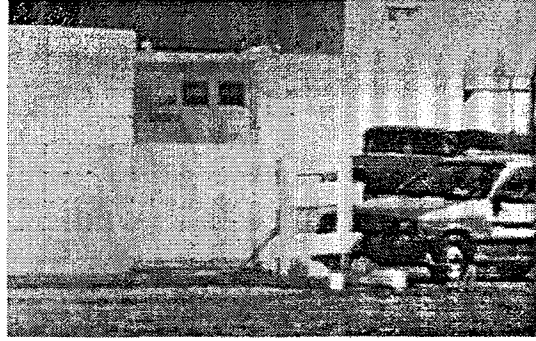
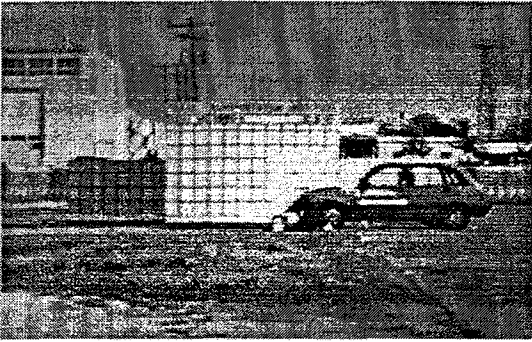
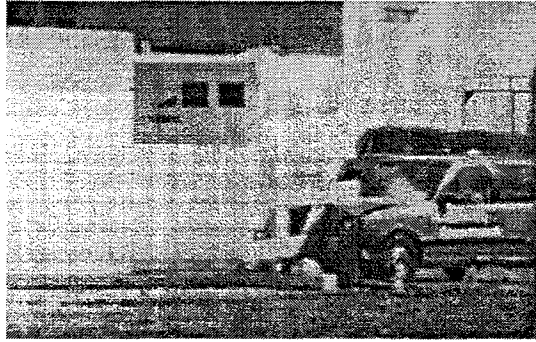
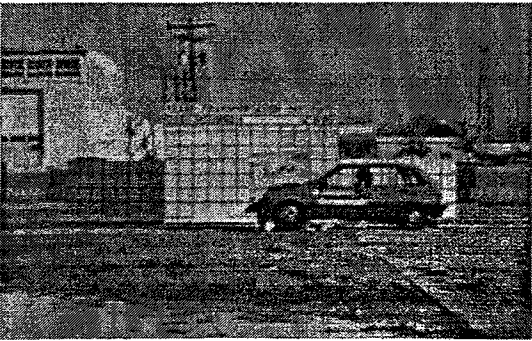
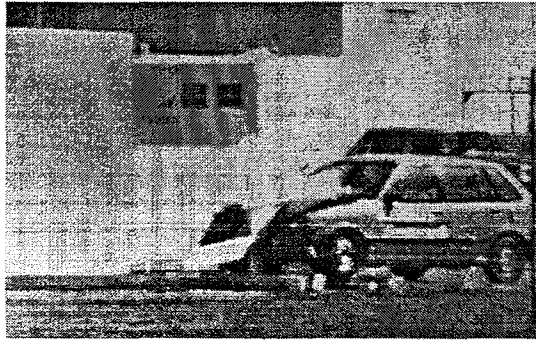
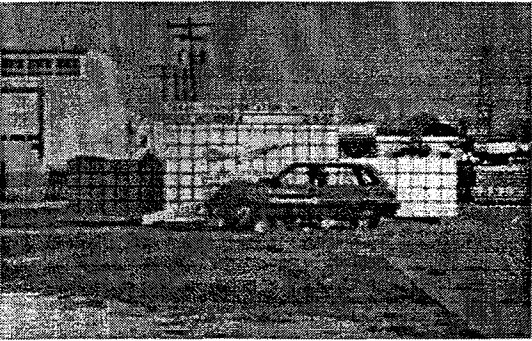
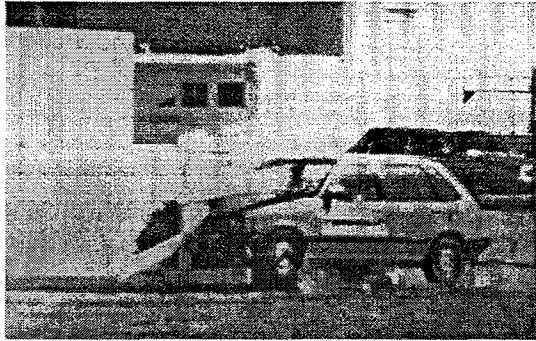
Figure 11. Sequential Photographs for Test No. 453880-4

As the vehicle impacted the end of the rail elements, the right vertical support separated from the base. The vehicle contacted the right vertical support at 7 msec. At 12 msec, the lower rail element separated from the vertical supports. At 17 msec, the middle rail element separated from the vertical support and contacted the hood of the vehicle at 20 msec. The front tires of the vehicle rode over the right base, which separated from the vertical support. The left vertical support separated at 48 msec, and the vehicle rode over the left base, carrying the remaining debris of the barricade with it. At 221 msec, the vehicle cleared the installation site traveling at a speed of 93.1 km/h. Prior to brake application, the vehicle was tracking straight forward. The vehicle subsequently came to rest 102.4 m down and 1.7 m to the right of the point of impact. Figure 11 shows sequential photographs of the test period.

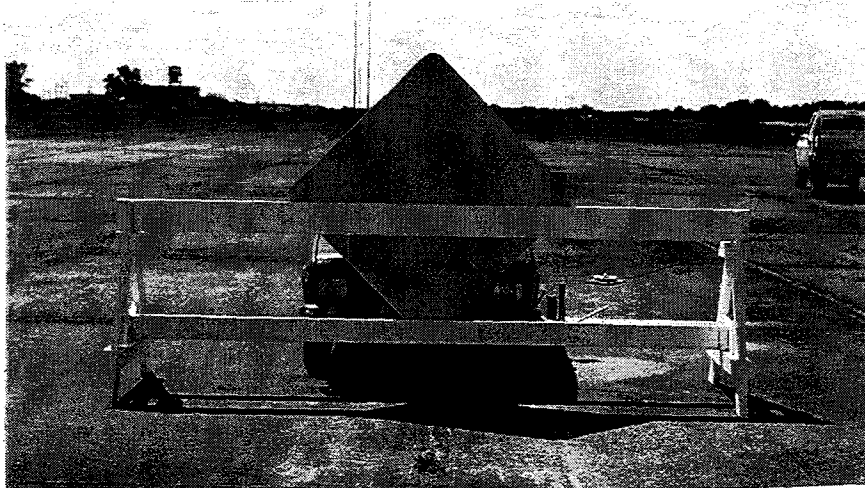
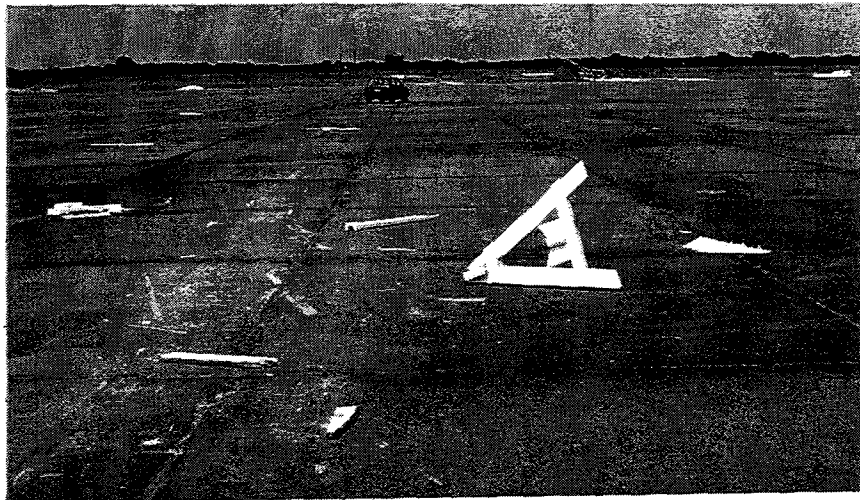
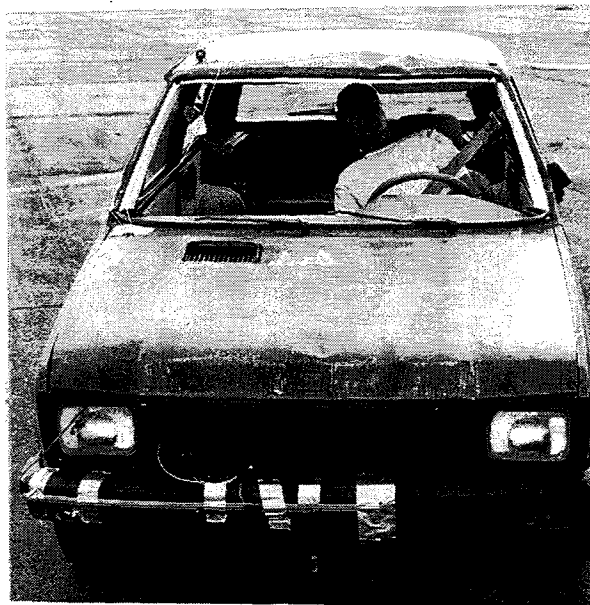
Figure 14. Vehicle and Barricade for Test No. 453360-5

The barricade shattered upon impact, as can be seen in Figure 14. Debris and sand were strewn along the path of the vehicle in an area 15 m wide by 53 m long. Figure 14 shows damage to the vehicle. There were two dents in the bumper, 38 mm and 19 mm from impact with the rail elements. There were scrapes in the hood leading up to the windshield, the windshield was broken and fallen into the occupant compartment, and there were dents on the A-pillars starting 152 mm above the bottom of the windshield frame and ending at the top edge of the roof.

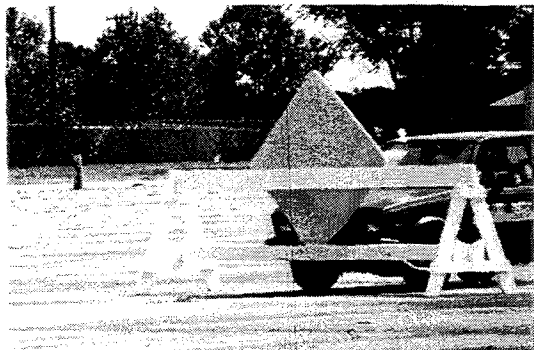
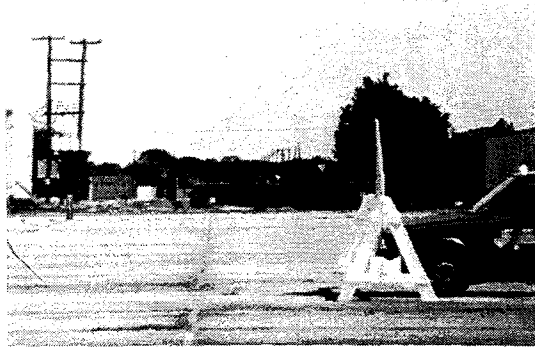
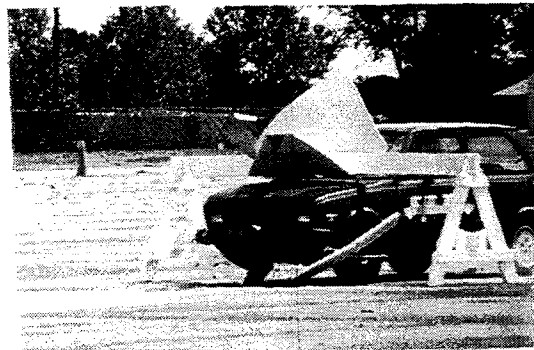
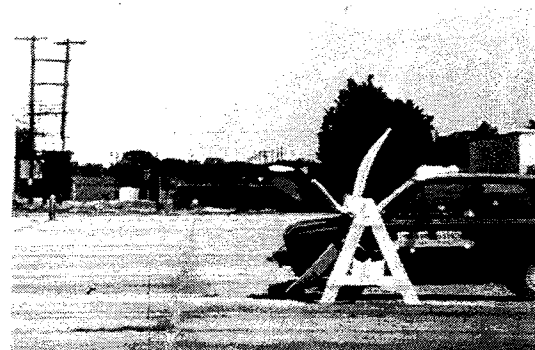
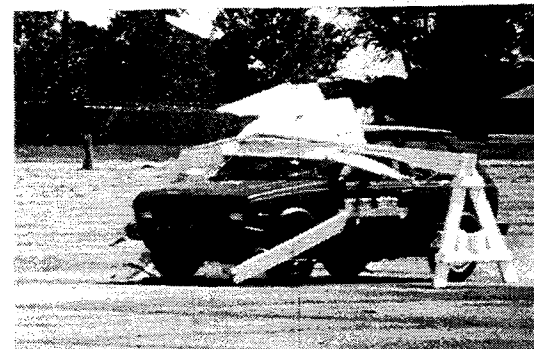
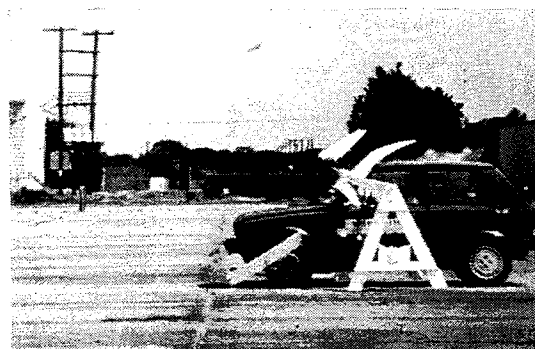
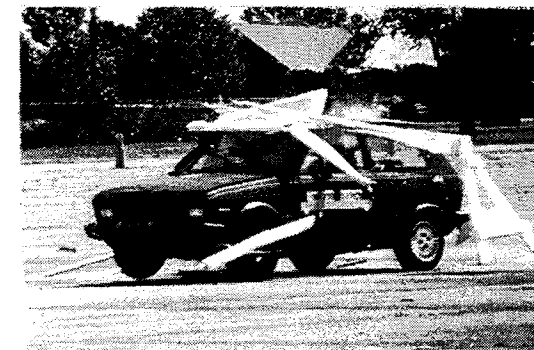
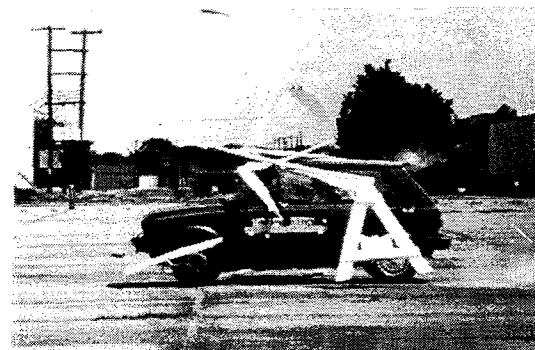
Figure 15. Sequential Photographs for Test No. 453360-5

Upon impact, the bottom rail element broke. At 15 msec after impact, the sign panel cracked. As the vehicle continued forward, the fragments rose and struck the windshield, which broke at 57 msec. At the same time, the top rail element of the barricade contacted the A-pillars of the vehicle. The sign panel continued to go up and lost contact with the vehicle at 122 msec, while the remaining fragments of the rail elements lost contact at 156 msec. The vehicle had slowed to 91.2 km/h by this time. After the vehicle cleared the immediate test site, brakes on the vehicle were applied at 960 msec after impact. Prior to brake application, the test vehicle was traveling on a relatively straightforward path. The vehicle subsequently came to rest 68 m down from the point of impact. Figure 15 shows sequential photographs of the test period.

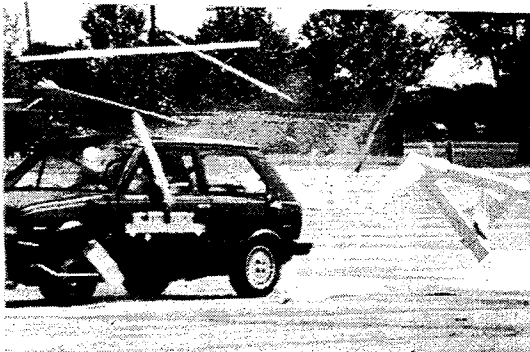
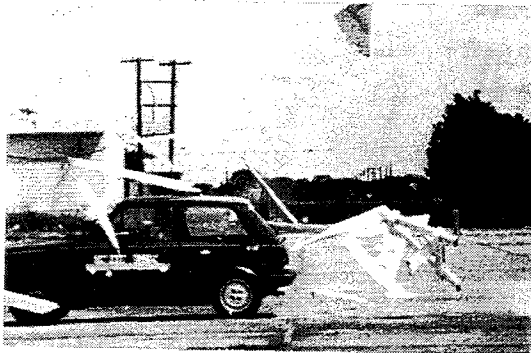
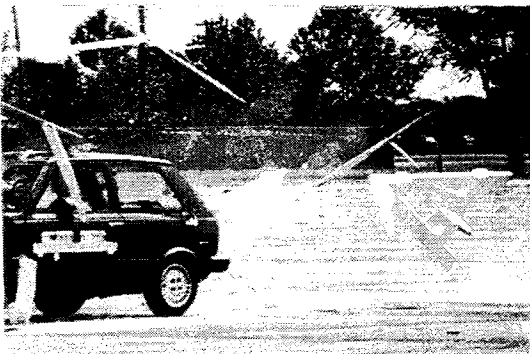
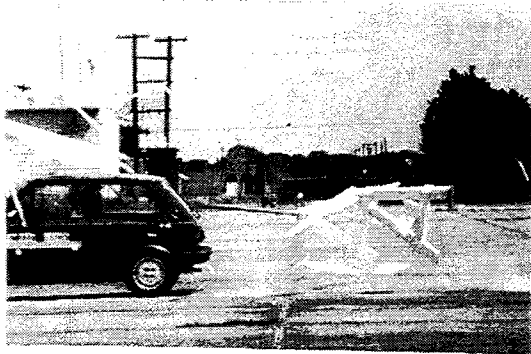
Figure 15. Sequential Photographs for Test No. 453360-5 (continued)

In summary, the performance of the barricade was judged to be unsatisfactory due to penetration of the windshield and the occupant compartment by the fractured vertical supports of the barricade.

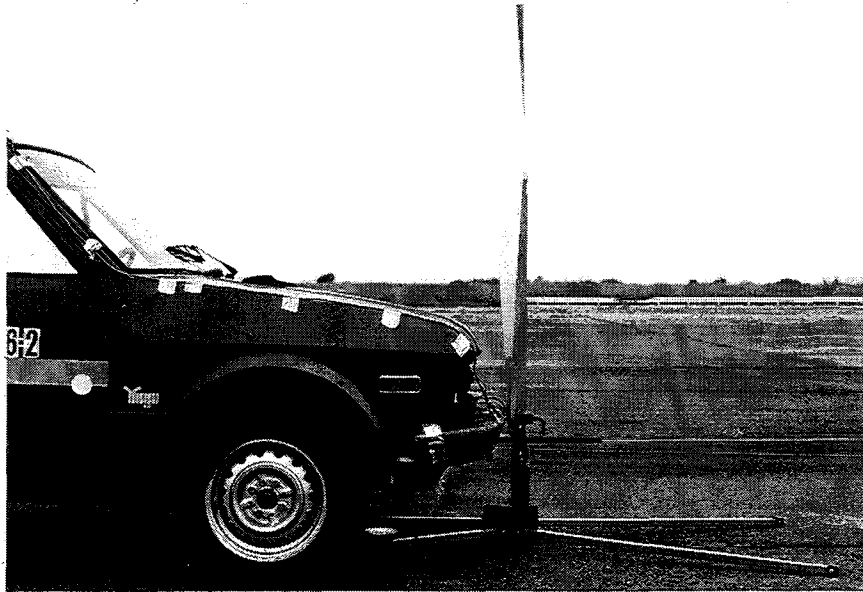
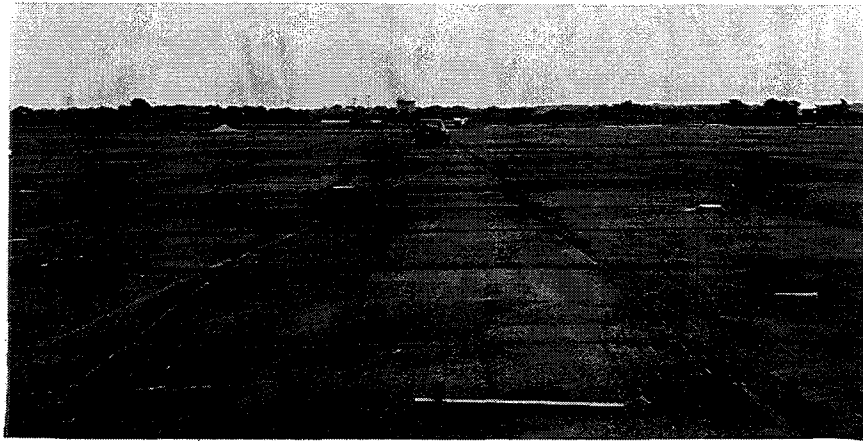
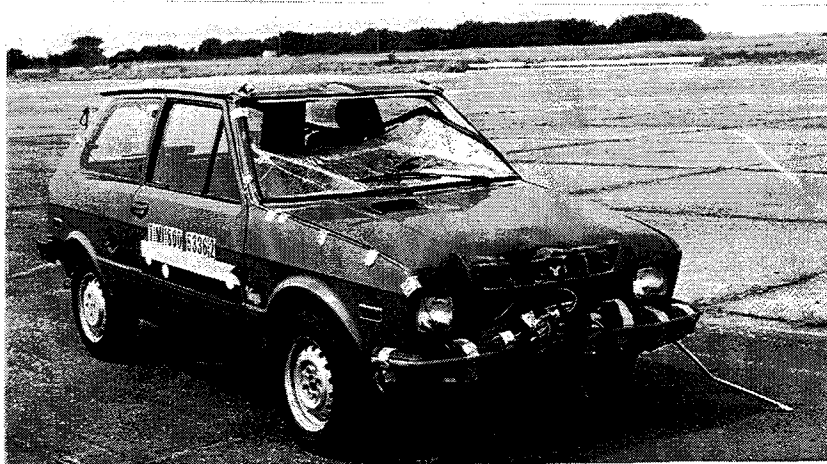
Figure 18. Vehicle and Sign Support for Test No. 453360-2

The spring-mounted portable sign support shattered upon impact, as can be seen in Figure 18. Debris were strewn along the path of the vehicle in an area 17 m wide by 21 m long. Figure 18 shows damage to the vehicle. There was a maximum crush of 89 mm in the bumper from impact with the sign support. There was a 25-mm deep dent in the roof just above the windshield, and the windshield was broken and had partially fallen into the occupant compartment.

In summary, the performance of the spring-mounted portable sign support with a wooden sign panel was judged to be unsatisfactory due to penetration of the windshield and the occupant compartment by the sign panel and a portion of the sign support.

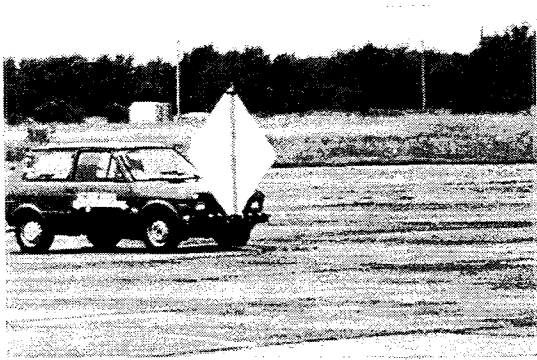
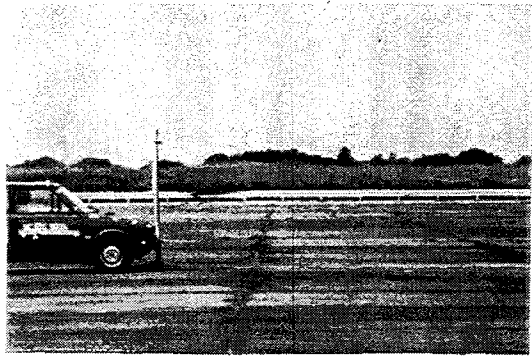
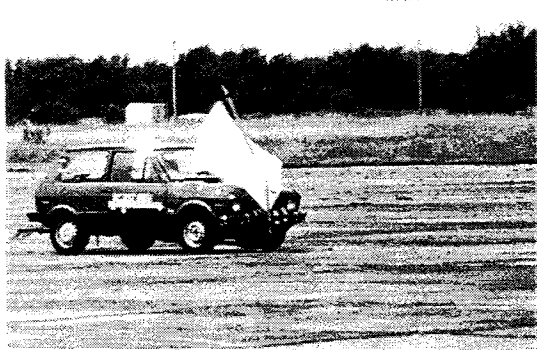
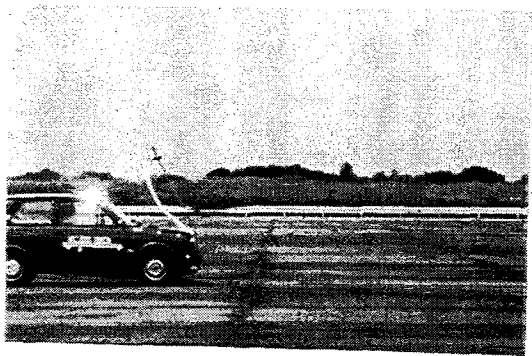
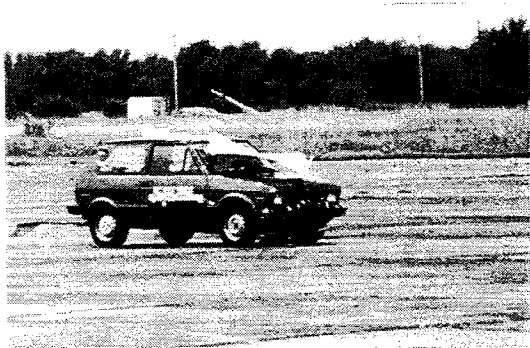
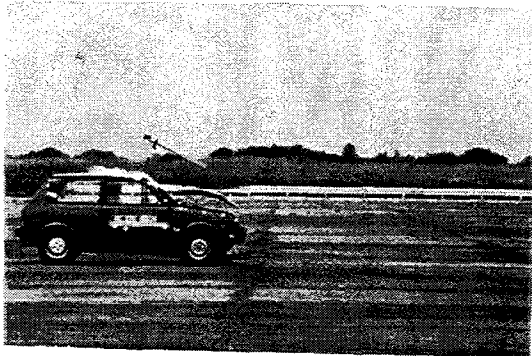
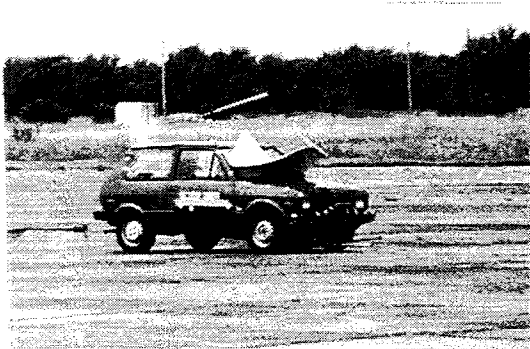
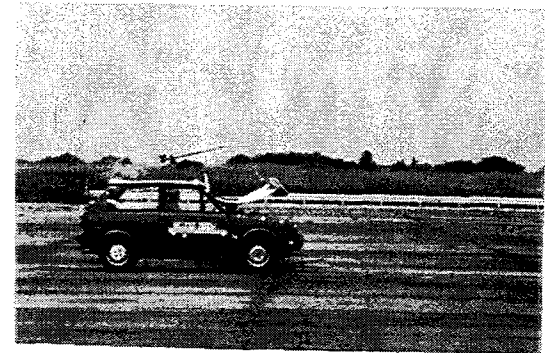
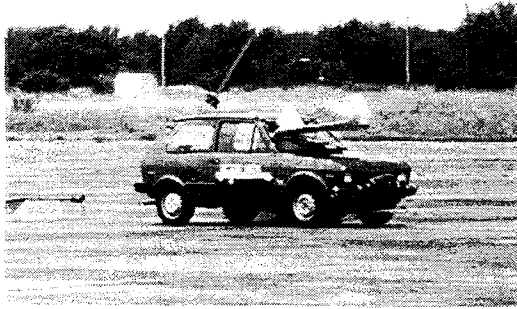
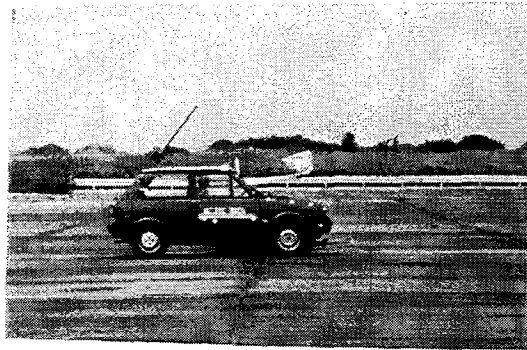
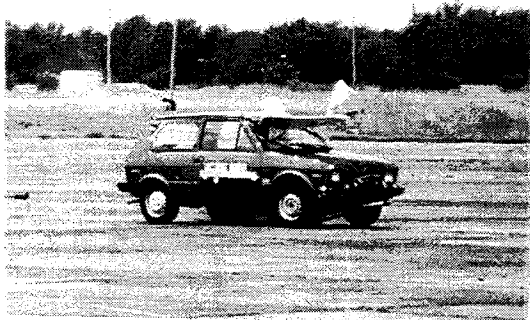
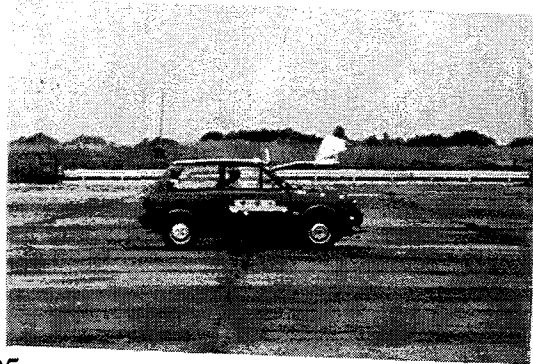
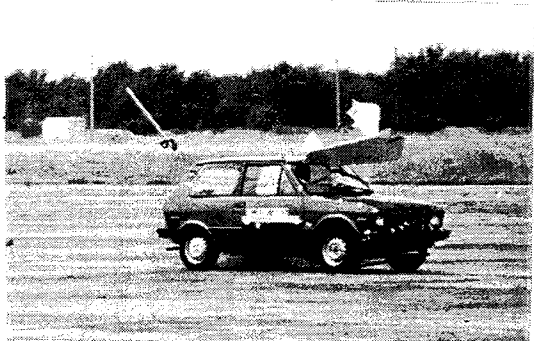
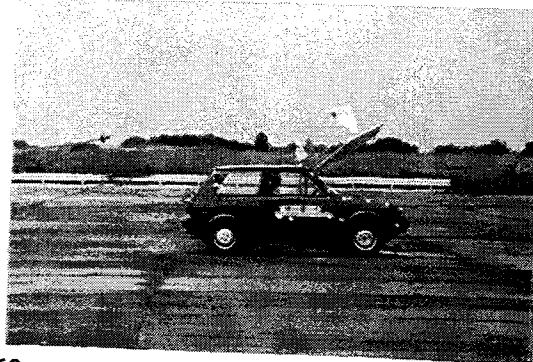
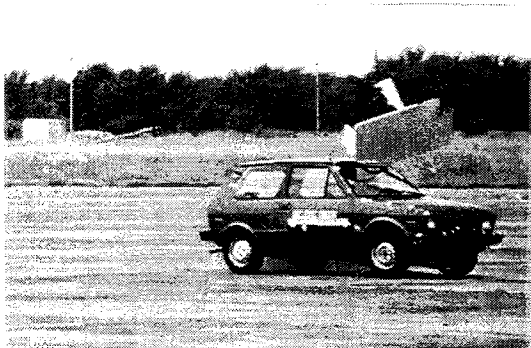
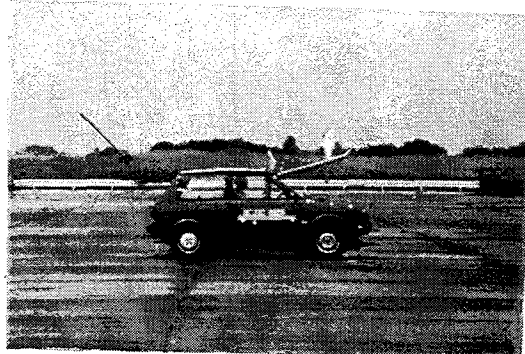
Figure 19. Sequential Photographs for Test No. 453360-2

At approximately 10 msec after impact, the sign panel began to crack. The bracket supporting the sign panel broke at 17 msec, and at 22 msec the sign panel slipped out of the bracket. The sign panel continued moving upward and contacted the edge of the roof of the vehicle just above the windshield. As the vehicle continued forward, the sign panel deformed, impacted and penetrated the windshield, the bracket went over the roof, and the base hung up on the undercarriage of the vehicle. The panel rotated up and over the vehicle and lost contact at 200 msec, at which time the vehicle had slowed to 91.4 km/h. After the vehicle cleared the immediate test site, brakes on the vehicle were applied at 937 msec after impact. Prior to brake application, the test vehicle was traveling on a relatively straight-forward path. The vehicle subsequently came to rest 59 m down and 6 m to the east of the point of impact. Figure 19 shows sequential photographs of the test period.
