1. Report No. TX-96/5388-1F		2. Government Accession No.		3. Recipient's Catalog No.	
4. Title and Subtitle EVALUATION OF WORK ZONE BARRICADES AND TEMPORARY SIGN SUPPORTS				5. Report Date February 1996

EVALUATION OF WORK ZONE BARRICADES AND TEMPORARY SIGN SUPPORTS

Report No. 5388-1F
Research Study No. 585xxA3014
Research Study Title: Development of New Designs for Barricades
and Sign Supports in Work Zones

February 1996

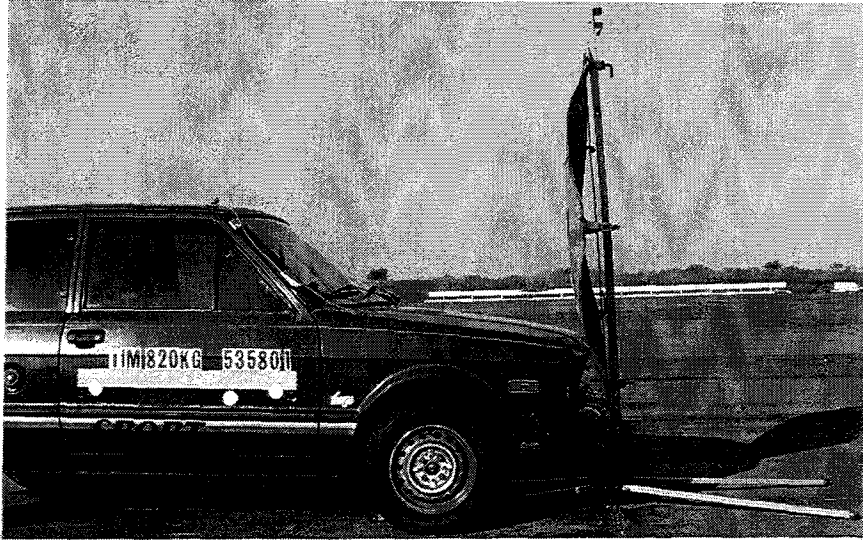
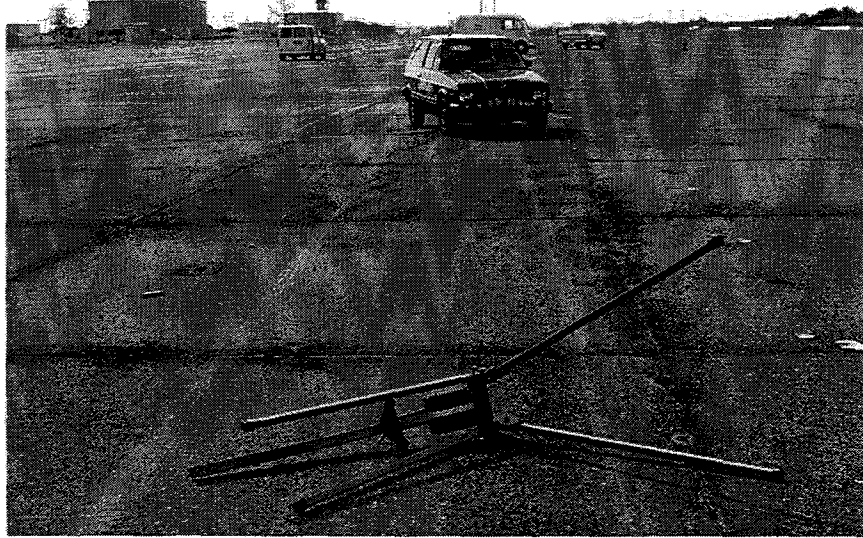
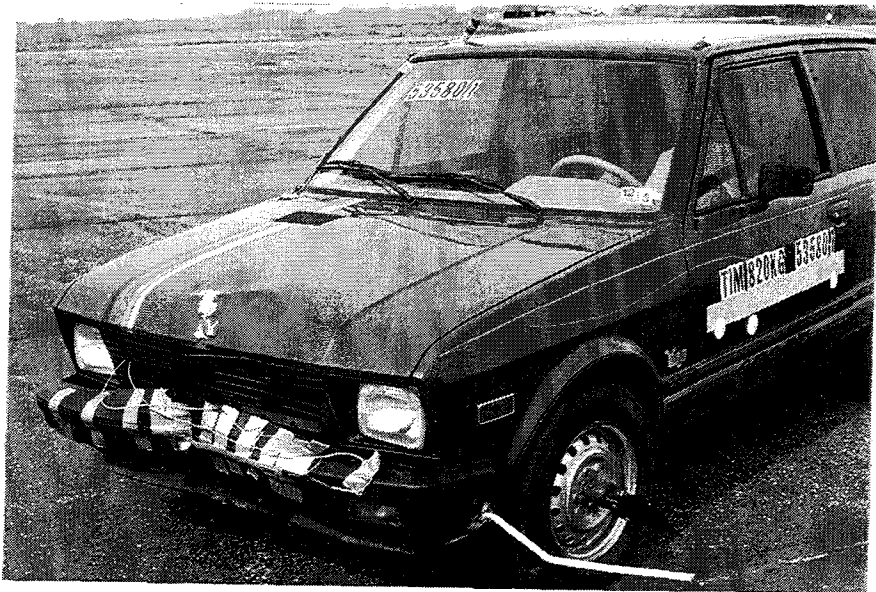
Figure 22. Vehicle and Sign Support for Test No. 453580-1

The spring-mounted portable sign support separated upon impact, as can be seen in Figure 22. Debris were strewn along the path of the vehicle in an area 3 m wide by 73 m long. Figure 22 shows damage to the vehicle. There was a maximum crush in the bumper of 70 mm from impact with the support. There was a 32 mm deep dent in the roof toward the rear, the windshield received a small chip, and the hood, bumper, and grill were dented and scratched.

In summary, the spring-mounted portable sign support with plastic/fabric sign panel was judged to have met all evaluation criteria set forth in NCHRP Report 350.

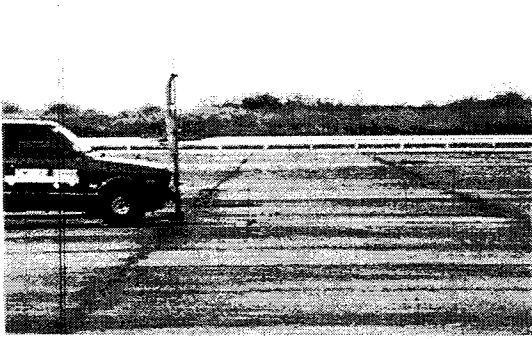
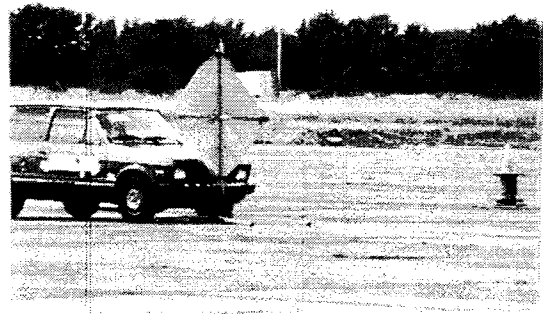
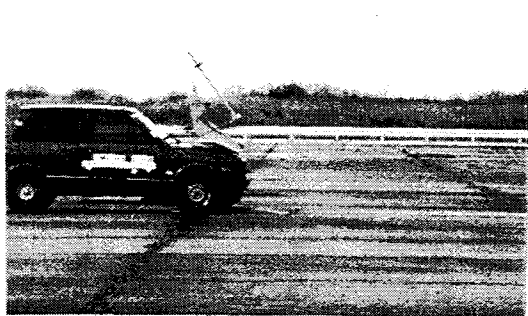
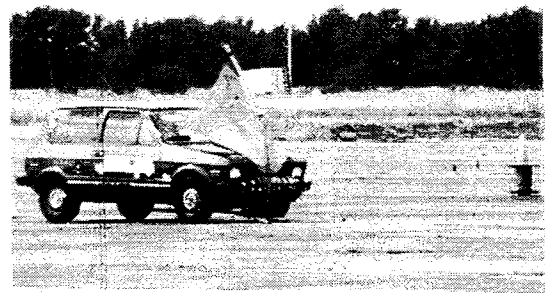
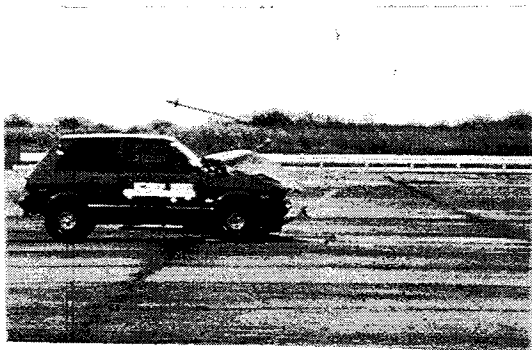
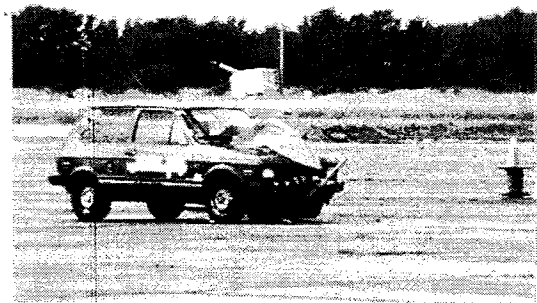
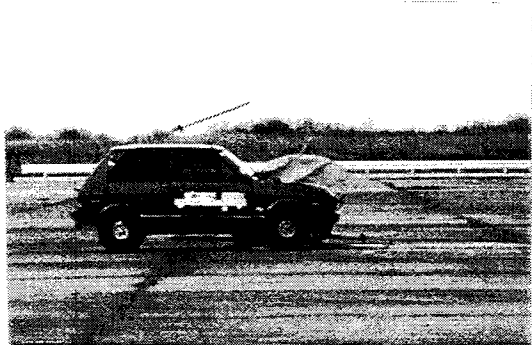
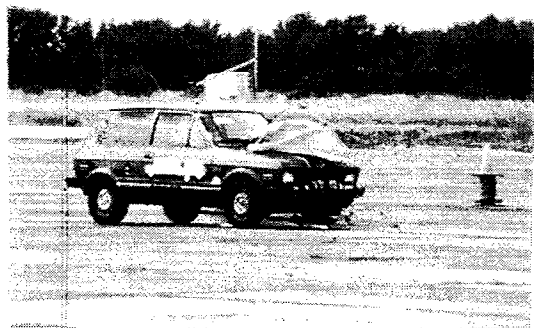
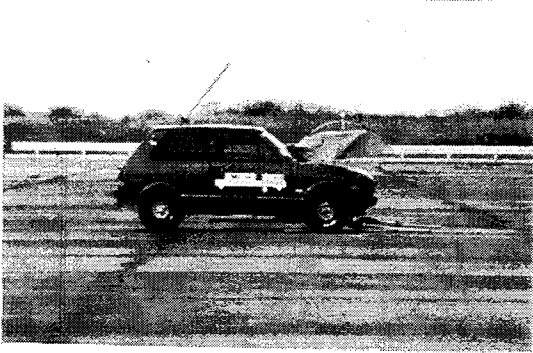
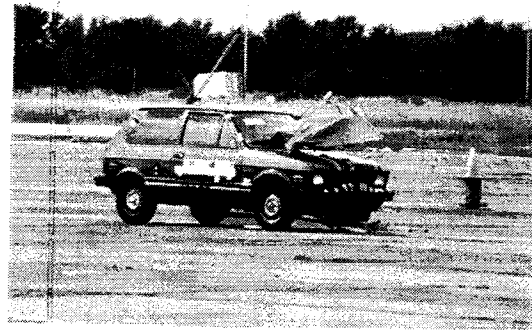
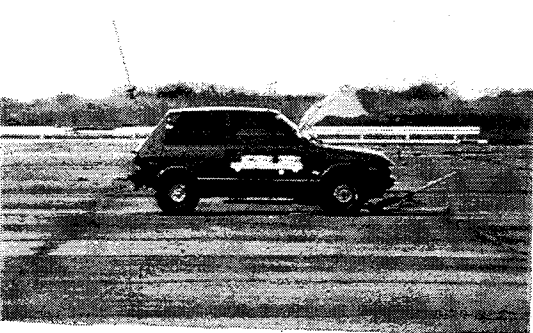
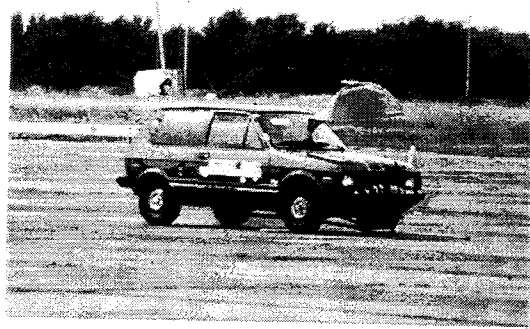
Figure 23. Sequential Photographs for Test No. 453580-1

Upon impact, the plastic/fabric sign panel and the upper support arm began to deform on the hood. At 20 msec after impact, the upper support arm separated from the lower support arm, and the upper corner of the sign panel released. The lower corner of the sign panel released at 39 msec. The upper support arm and sign panel flipped up and contacted the roof of the vehicle at 98 msec. The support and panel lost contact at 119 msec, as the vehicle was traveling at a speed of 93.6 km/h. The support base hung up on the undercarriage of the vehicle and rode along with the vehicle. After the vehicle cleared the immediate test site, brakes on the vehicle were applied at 500 msec after impact. Prior to brake application, the test vehicle was traveling on a relatively straightforward path. The vehicle subsequently came to rest 58 m down and 3 m to the west of the point of impact. The base support continued forward another 15 m after the vehicle had stopped. Figure 23 shows sequential photographs of the test period.

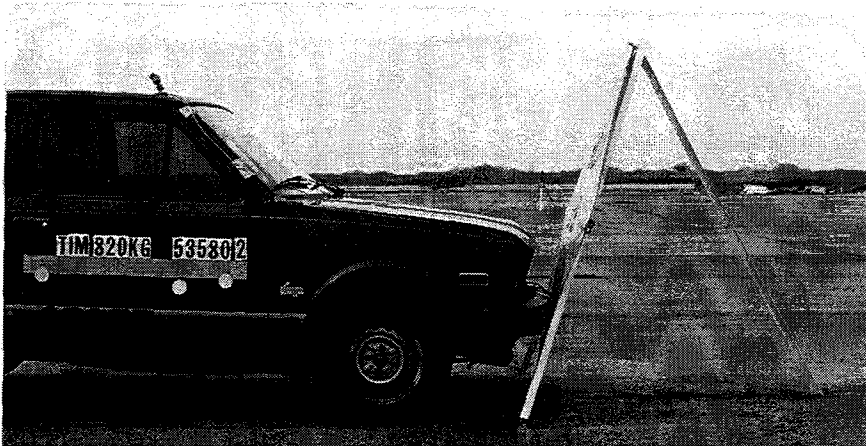
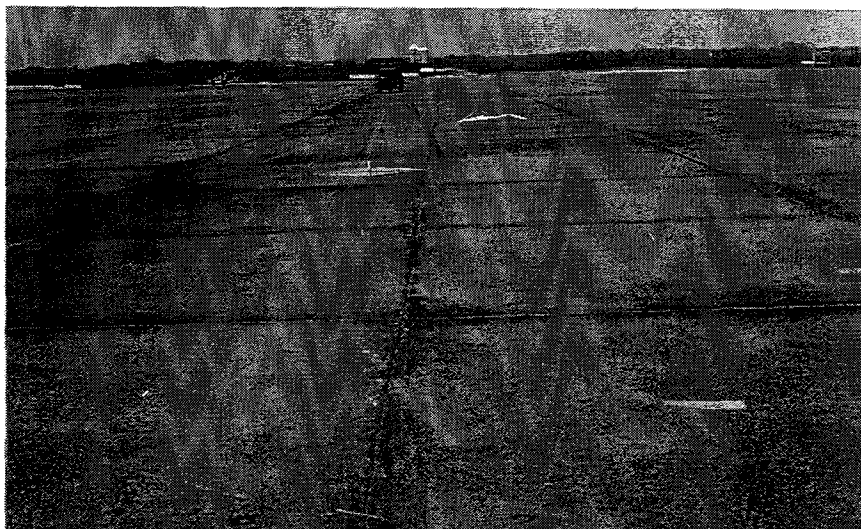
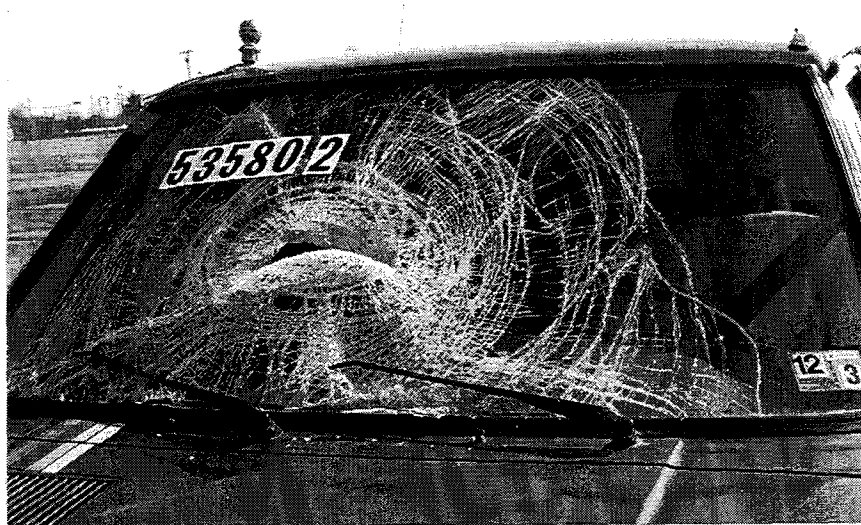
Figure 26. Vehicle and Sign Support for Test No. 453580-2

As Figure 26 shows, the sign panel of the easel sign support released, and the support came apart upon impact. Debris were strewn along the path of the vehicle in an area 4 m wide by 32 m long. Figure 26 shows damage to the vehicle. There was no measurable crush to the exterior of the vehicle. There was a small hole in the windshield caused by penetration of the top of the easel support and a small dent in the hood.

In summary, the easel portable sign support failed to meet the evaluation criteria set forth in NCHRP Report 350 and is not recommended for further field use.

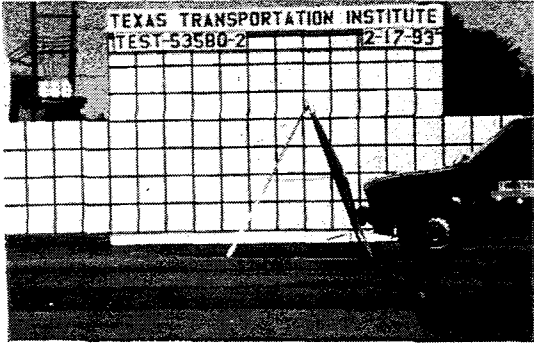
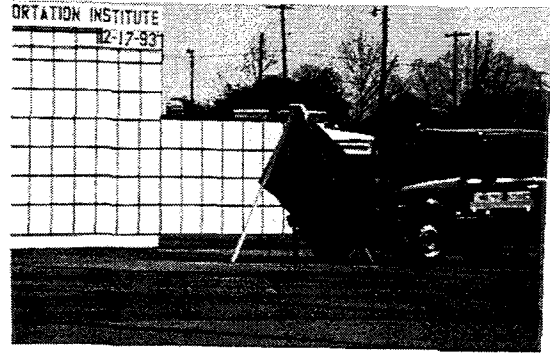
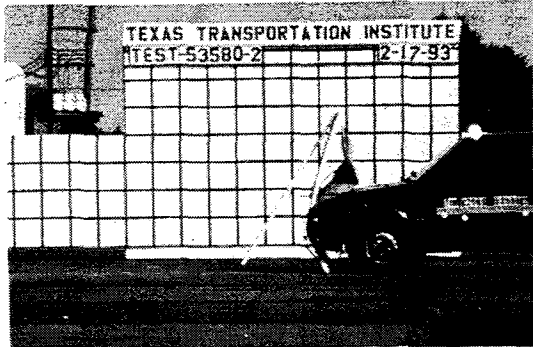
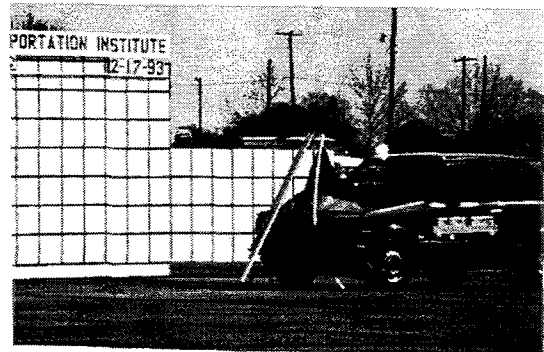
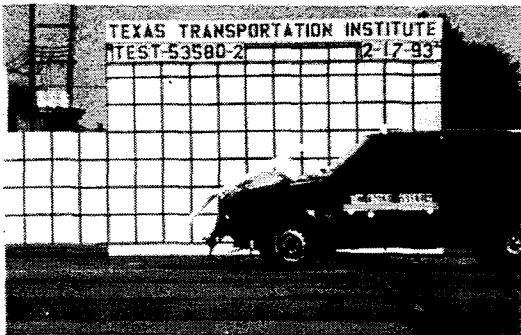
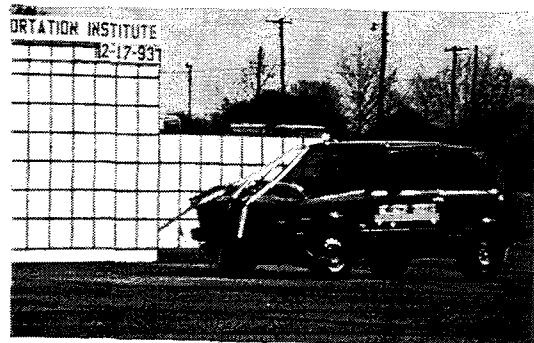
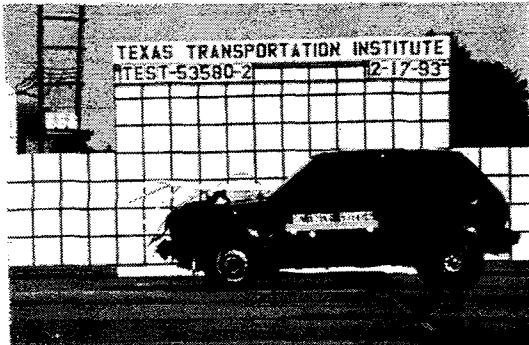
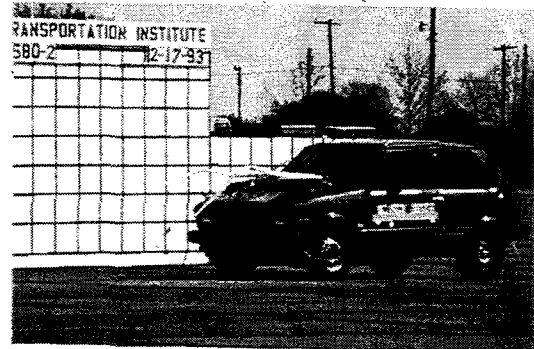
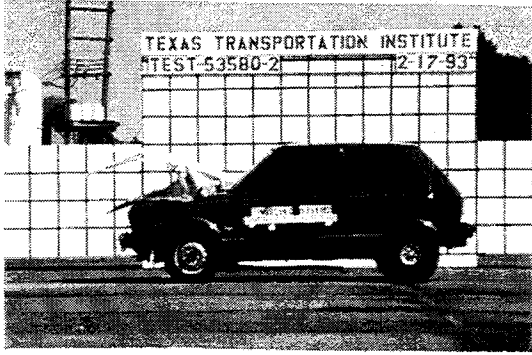
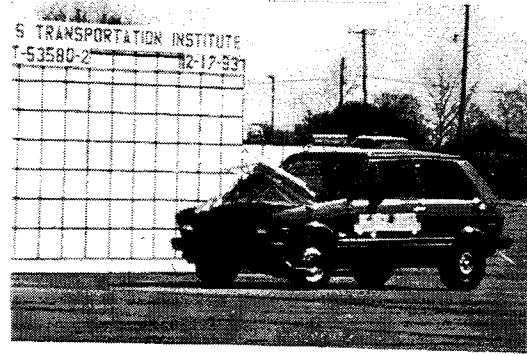
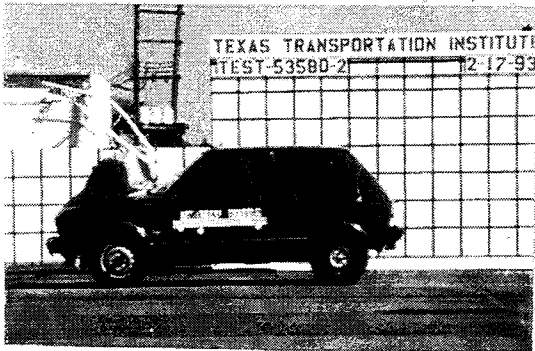
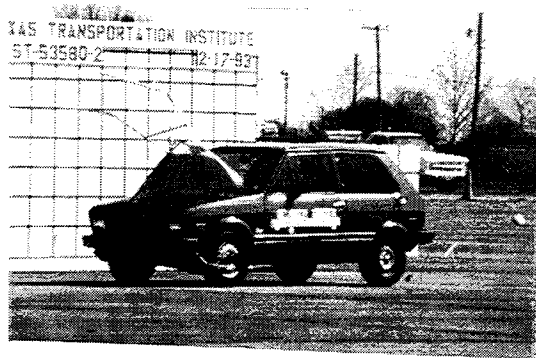
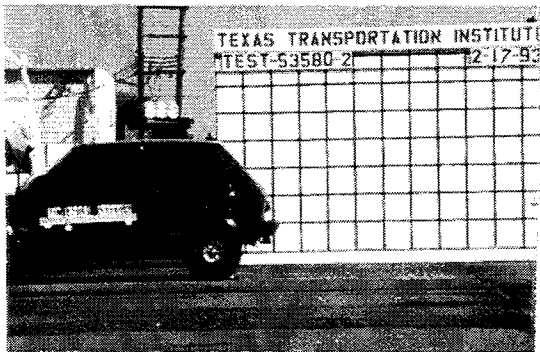
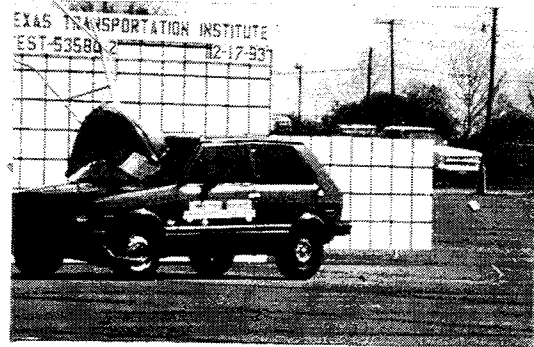
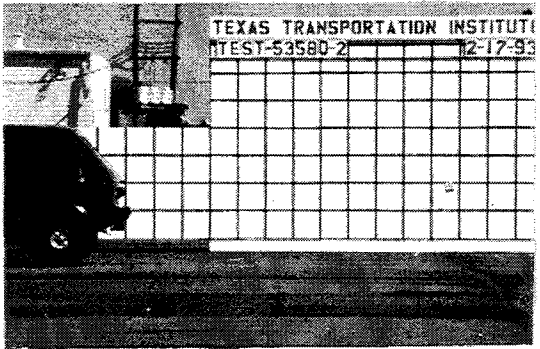
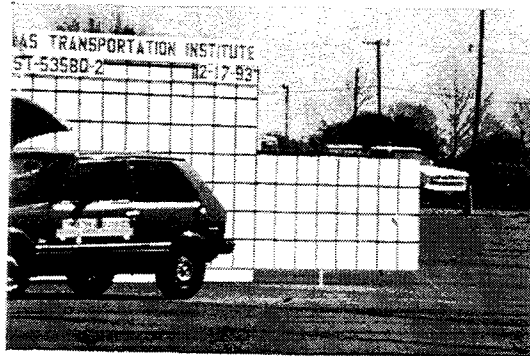
Figure 27. Sequential Photographs for Test No. 453580-2

Upon impact, the front legs of the support bent at bumper height. At 17 msec, the top of the sign panel released from the top of the support. The easel support flipped up and the top of the support contacted and penetrated the windshield at 60 msec. At 251 msec, the easel support lost contact with the vehicle and windshield. Speed of the vehicle at loss of contact was 95.1 km/h. After the vehicle cleared the immediate test site, brakes on the vehicle were applied at 1.3 seconds after impact. Prior to brake application, the test vehicle was traveling on a relatively straightforward path. The vehicle subsequently came to rest 71 m down and 3 m to the left of the point of impact. Sequential photographs of the test period are shown in Figure 27.

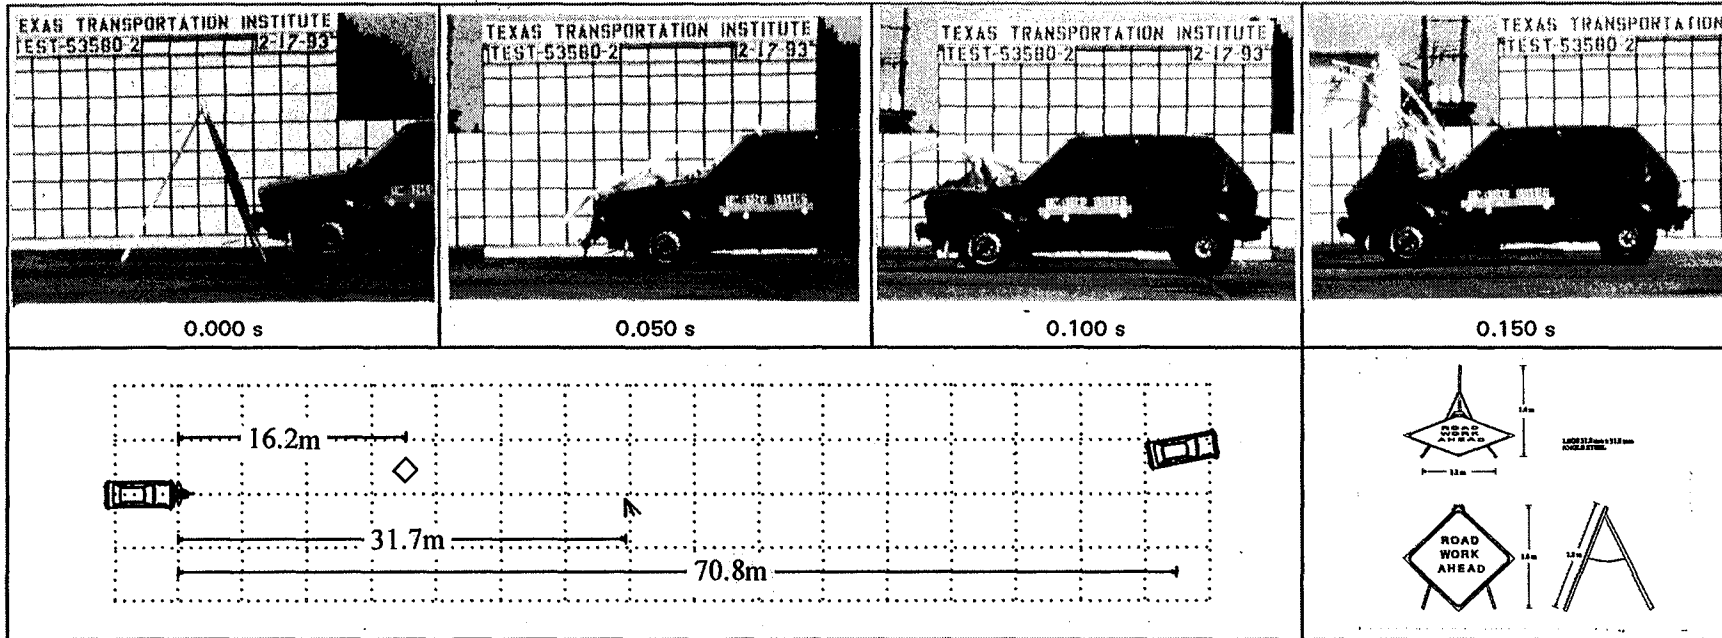
Figure 28. Summary of Results for Test No. 453580-2

Figure 28 shows a brief summary of the results of this test. The sign panel, upon release from the support, went up and contacted the windshield and then went over the top of the vehicle. The easel support rotated upon impact, and the top of the easel support impacted and penetrated the windshield, exhibiting potential risk of intrusion into the occupant compartment. Debris from the sign support remained along the path of the vehicle, posing only minor potential hazard to other traffic or workers in the area. Other than the penetration of the windshield by the top of the easel support, there was little damage to the vehicle. There was no occupant contact in the longitudinal or lateral direction during the test period. The maximum 50-msec average accelerations were -0.7 g in the longitudinal direction and -0.1 g in the lateral direction. The vehicle exited the immediate test site in a relatively smooth, stable manner and showed minimal intrusion into adjacent traffic lanes.

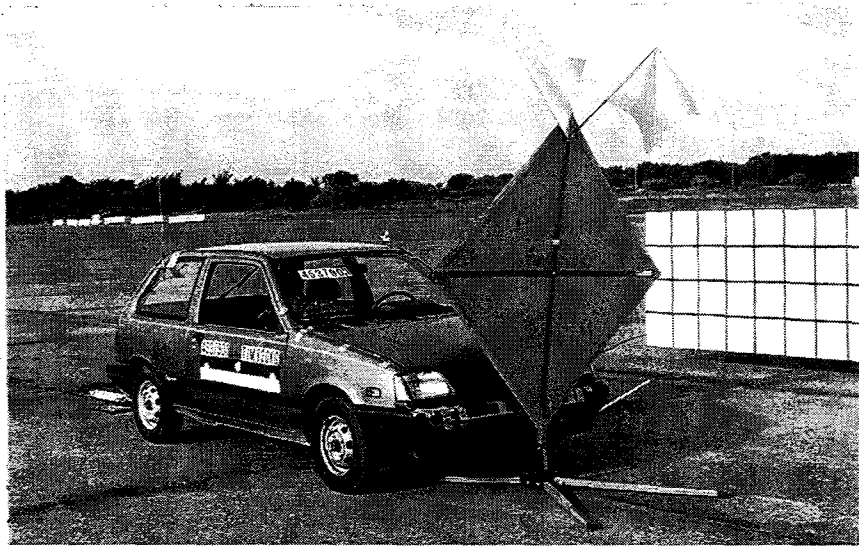
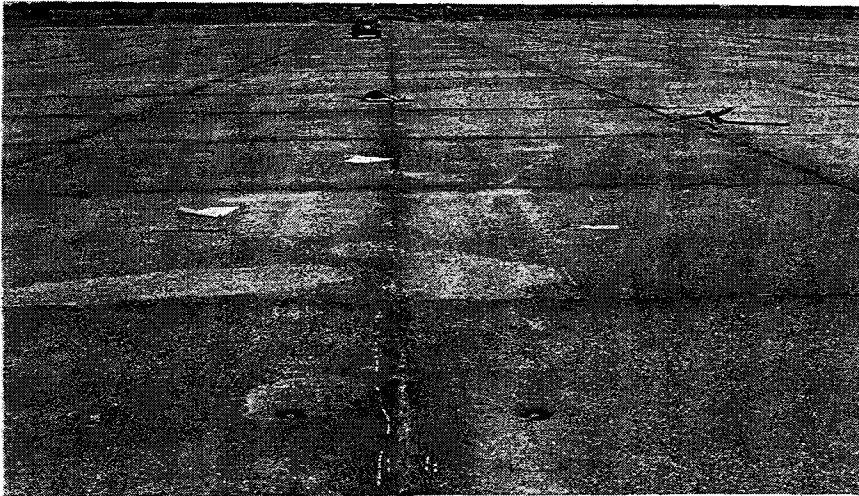
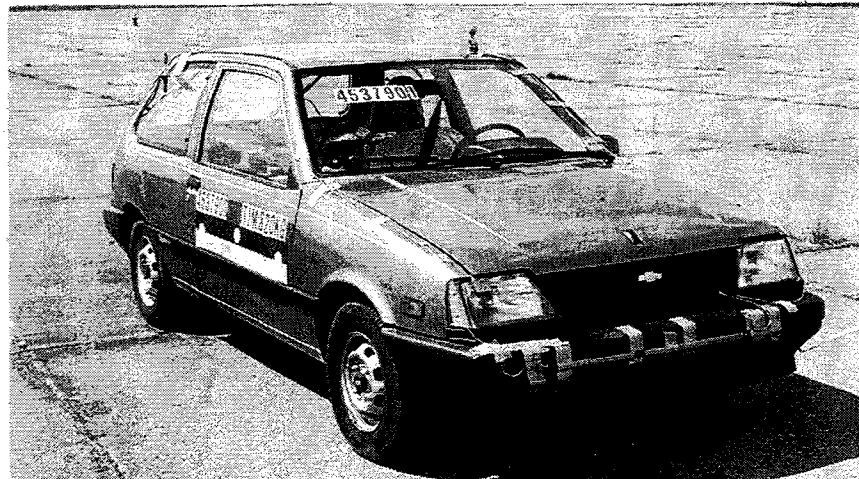
Figure 30. Vehicle and Sign Support for Test No. 453790-1

The portable sign support separated upon impact, as can be seen in Figure 30. Fragments of the sign were strewn along the path of the vehicle in an area 5.5 m wide by 19.3 m long. Figure 30 shows damage to the vehicle. There was no measurable crush to the exterior of the vehicle, only scratches on the hood and on the roof where the flags made contact.

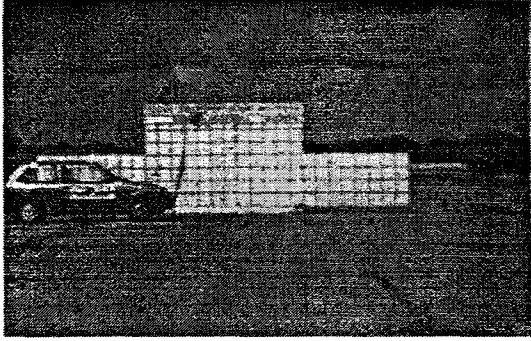
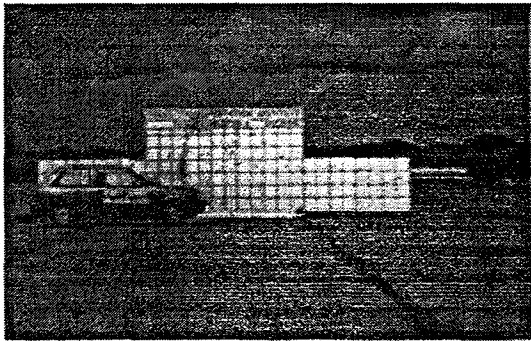
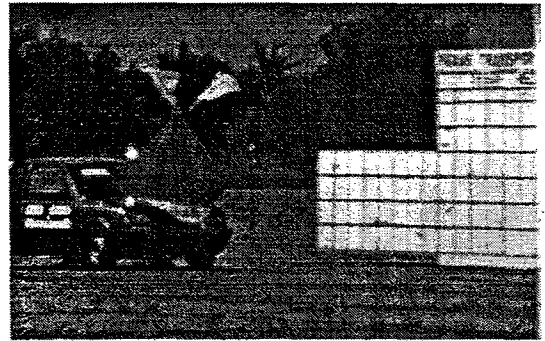
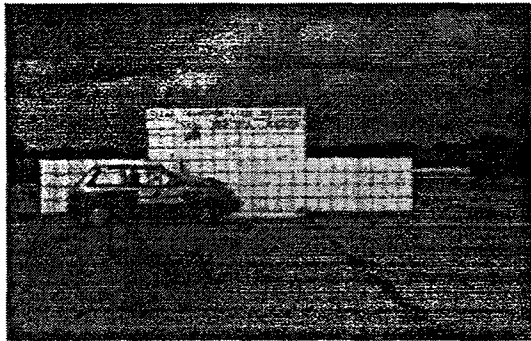
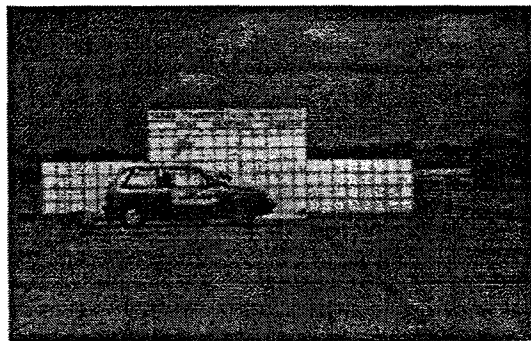
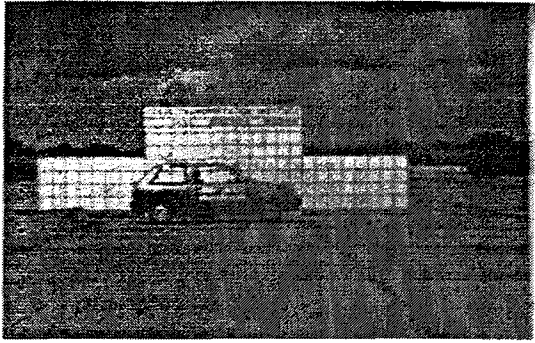
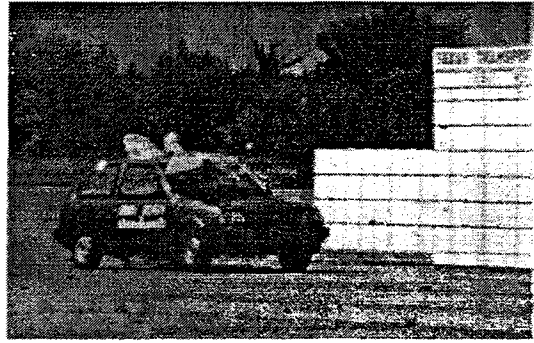
Figure 31. Sequential Photographs for Test No. 453790-1

As the vehicle impacted the portable sign support, the upper portion of the sign separated from the base, and the plastic/fabric sign panel formed to the front of the vehicle. The plastic/fabric sign panel and reinforcement strips contacted the windshield at 50 msec and 69 msec, respectively. At 100 msec, the flags contacted the roof of the vehicle and separated from the sign panel. At 221 msec, the vehicle cleared the installation site traveling at a speed of 95.8 km/h. Prior to brake application, the vehicle was tracking straightforward. The vehicle subsequently came to rest 102 m down and 1.7 m to the right of the point of impact. Figure 31 shows sequential photographs of the test period.

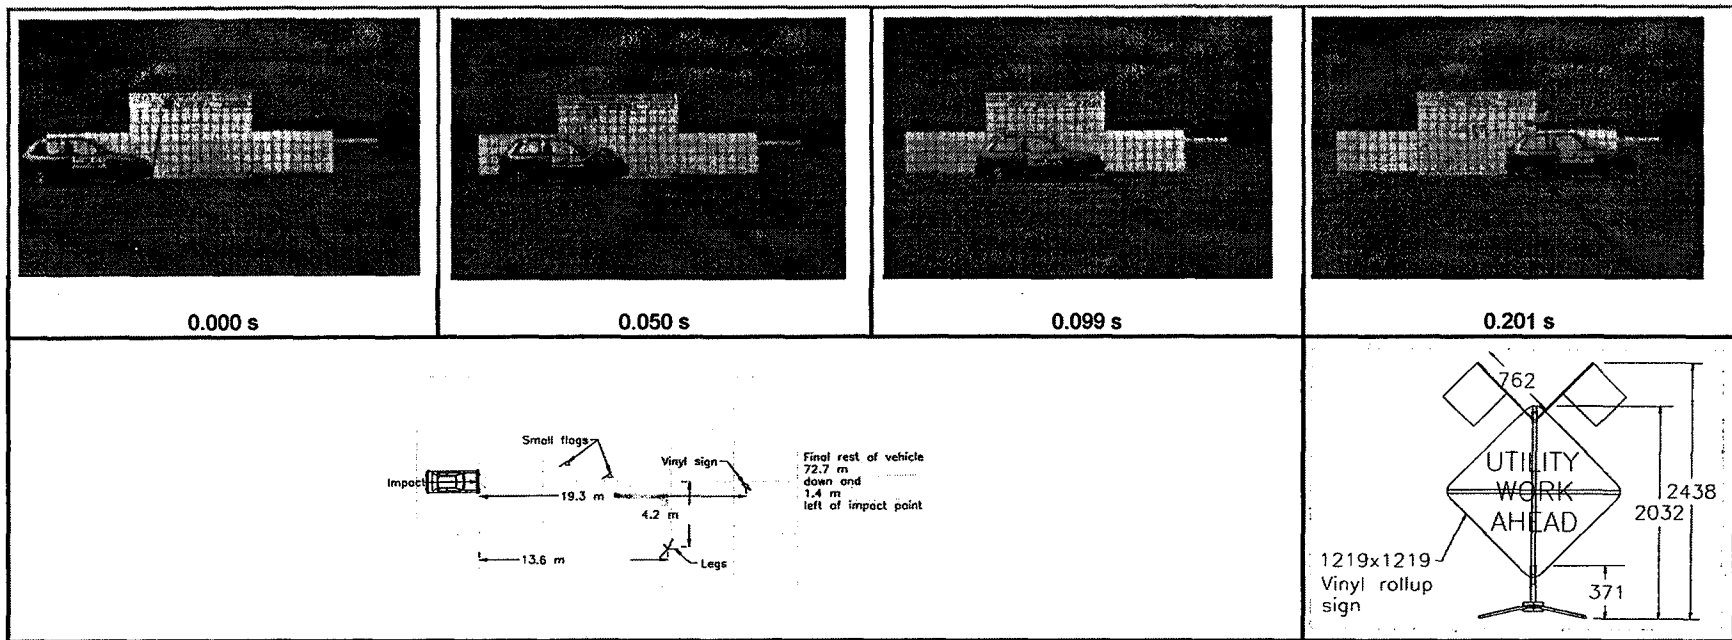
Figure 32. Summary of Results for Test No. 453790-1

Figure 32 presents a brief summary of the results of this test. The portable sign support shattered upon impact. Fragments of the plastic/fabric sign panel and the sign support made contact with the roof, but there was no penetration or intrusion into the occupant compartment. Debris from the sign was thrown along an area 5.5 m wide by 19.3 m long. The fragments were not large enough to pose potential hazard to oncoming traffic in adjacent lanes or to workers in the area. The vehicle sustained minor scratches to the hood and roof. There was no measurable crush to the exterior of the vehicle. There was no longitudinal or lateral occupant impact. The 50-msec average accelerations were -0.6 g in the longitudinal direction and -0.4 g in the lateral direction. The vehicle exited the immediate test site in a relatively smooth, stable manner and showed no potential for intrusion into adjacent traffic lanes.

General Information		Impact Conditions		Test Article Deflections (m)		
Test Agency	Texas Transportation Institute	Speed (km/h)	97.9 (60.9 mi/h)	Thrown Forward	19.3 (63.3 ft)	
Test No.	453790-1	Angle (deg)	0	Thrown Laterally	4.2 (13.8 ft)	
Date	08/23/94	Exit Conditions		Vehicle Damage		
Test Article		Speed (km/h)	95.8 (59.6 mi/h)	Exterior		
Type	Portable Traffic Sign	Angle (deg)	0	VDS	12FC1	
Name or Manufacturer	TrafFix-Sign	Occupant Risk Values		CDC	12FCEN1	
Installation Length (m)	1.2 (4.0 ft)	Impact Velocity (m/s)		Interior	OCDI	FS0000000
Size and/or dimension and material of key elements	Aluminum base with Vinyl rollup sign	x-direction	No Contact	Maximum Exterior	Vehicle Crush (mm)	Nil (scratched)
Soil Type and Condition	on Pavement, dry	y-direction	No Contact	Max. Occ. Compart. Deformation (mm)	0 (0 in)	
Test Vehicle		THIV (optional)		Post-Impact Behavior		
Type	Production	Ridedown Accelerations (g's)		Max. Roll Angle (deg)	0.7

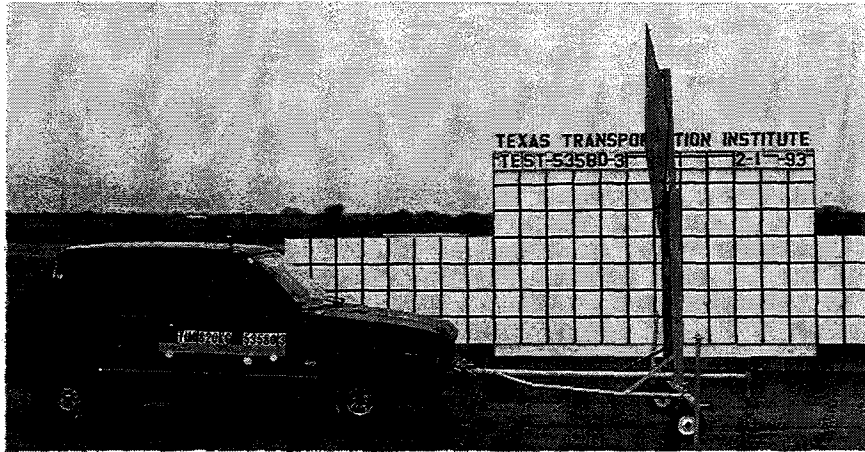
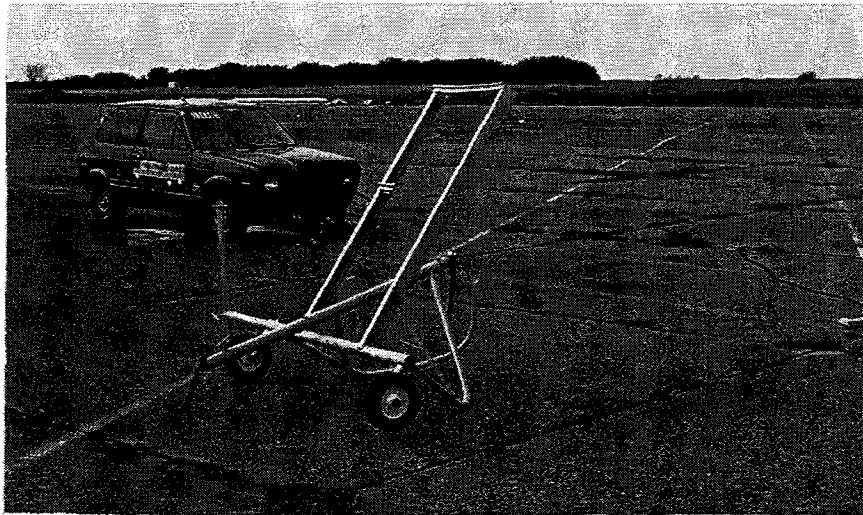
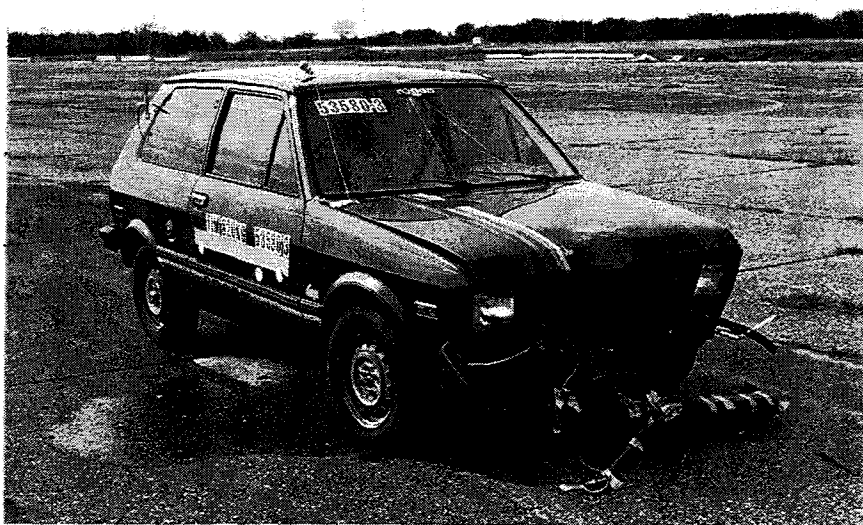
Figure 34. Vehicle and Sign Trailer for Test No. 453580-3

As Figure 34 shows, the sign panel and support separated from the trailer upon impact. The sign panel and upper support structure came to rest 2 m down and 4 m to the left side of the vehicle path. The sign support trailer came to rest 106 m down and 3 m to the right of the point of impact with a fragment 3.4 m west of the trailer. The trailer was deformed and some of the welds broken. As Figure 34 also shows, the vehicle sustained moderate damage to the front. The maximum crush at bumper height was 330 mm. The windshield was cracked starting at the edge of the roof near the center. There were also two dents in the roof, the deepest approximately 8 mm. There were dents and scratches on the hood and the bumper, and the grill and radiator were damaged.

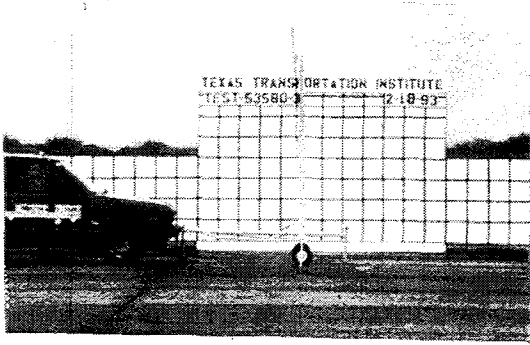
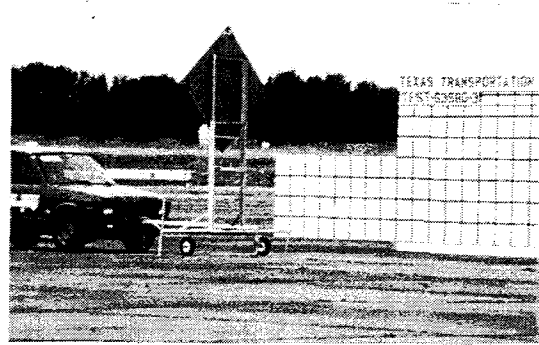
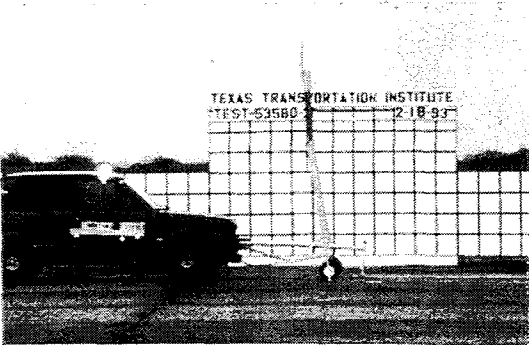
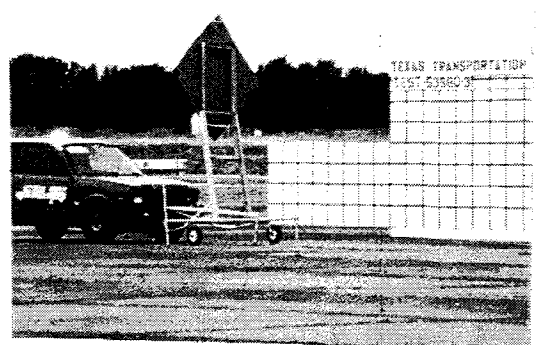
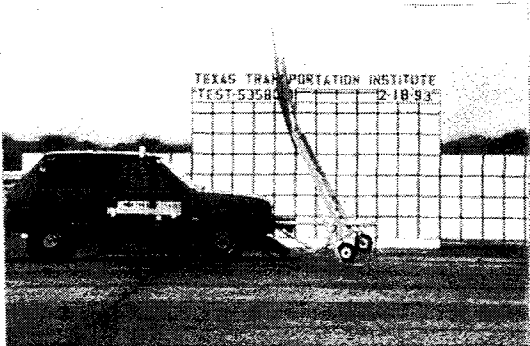
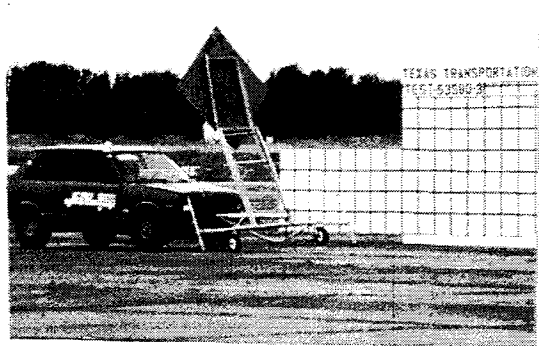
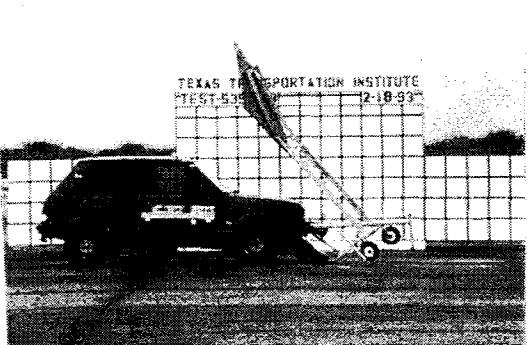
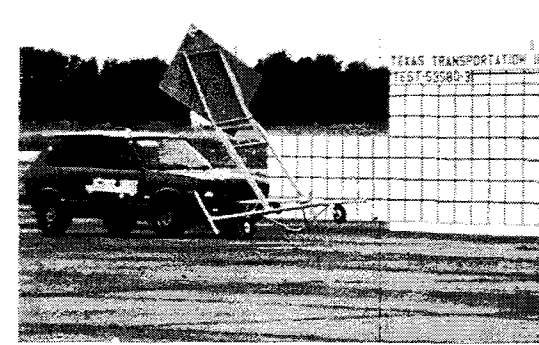
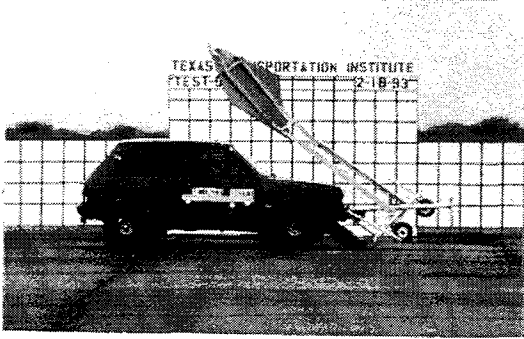
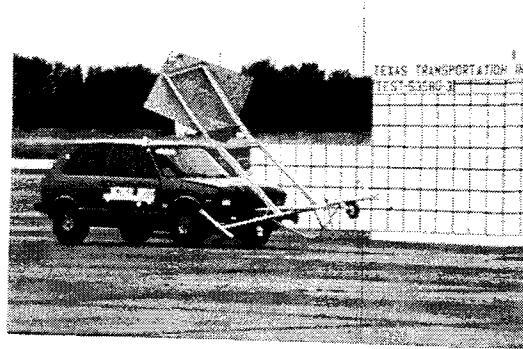
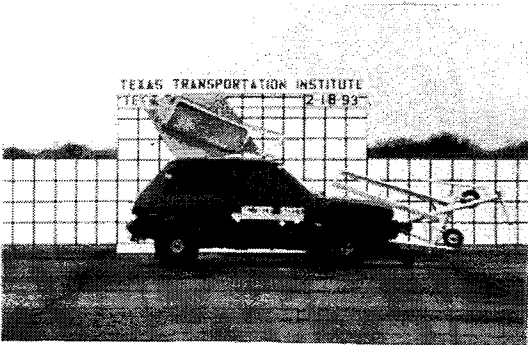
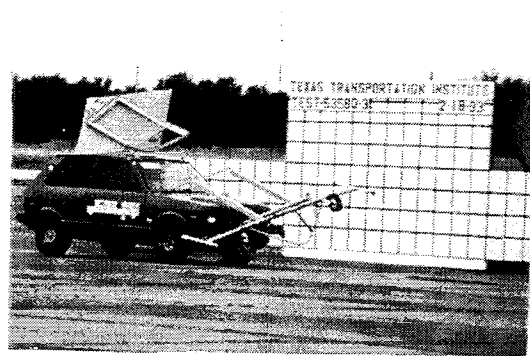
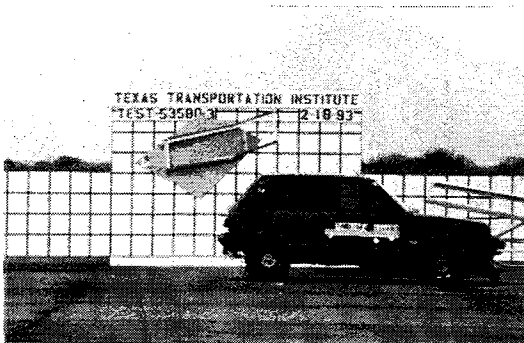
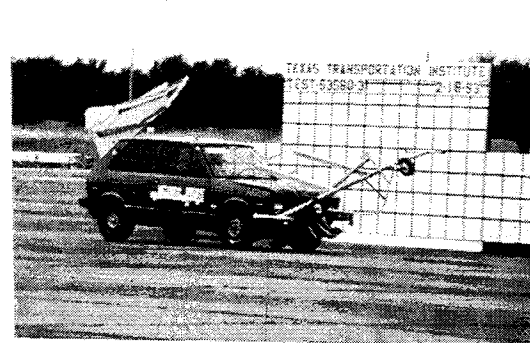
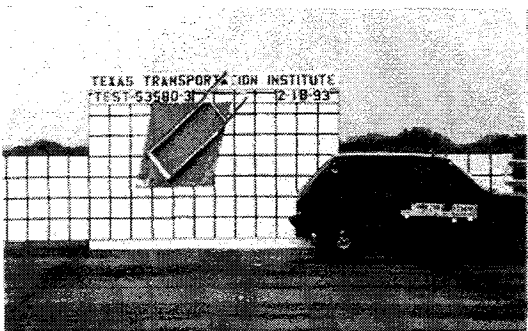
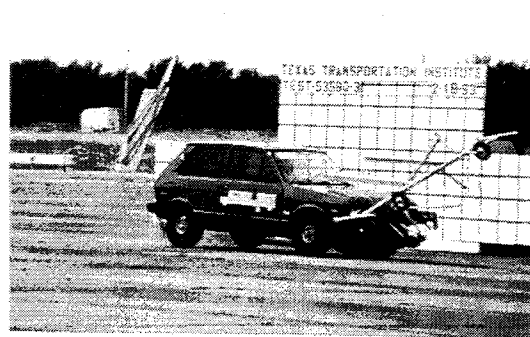
Figure 35. Sequential Photographs for Test No. 453580-3

m down and 2 m to the west of the point of impact. The trailer continued another 7 m forward before coming to rest. Figure 35 shows sequential photographs of the test period.

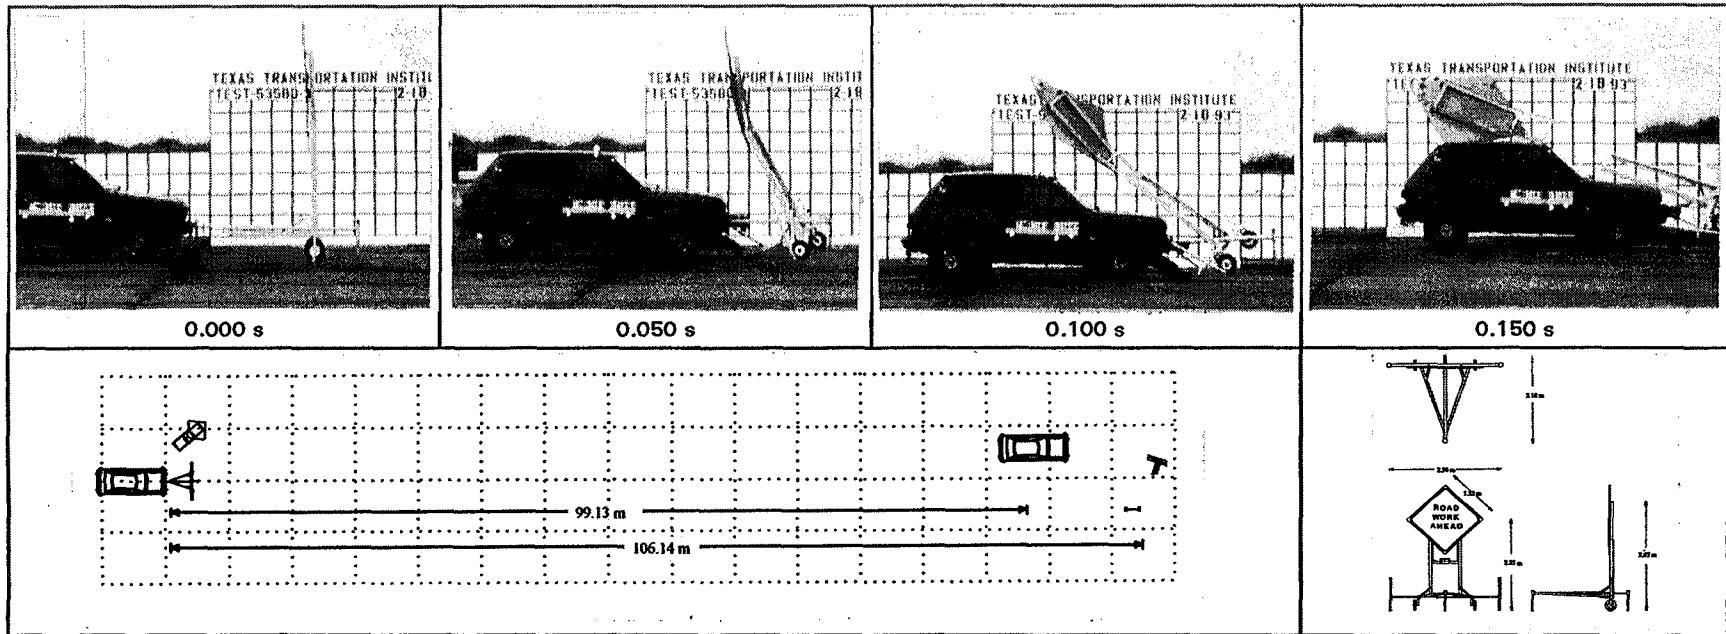
A brief summary of the results of this test is presented in Figure 36. The sign panel and upper support structure separated from the trailer upon impact and went up and over the vehicle, contacting the roof just above the windshield, causing a few stress cracks. There was no penetration of the passenger compartment, and the cracks did not impair driver vision. Debris from the sign support trailer remained along the path of the vehicle, posing minimal potential hazard to other traffic or workers. The trailer was deformed, and some of the welds on the frame had separated. The vehicle sustained a 330 mm crush to the center front at bumper height, and the bumper was partially detached from the vehicle. The hood was scratched and dented, the windshield was cracked, and the roof was deformed slightly. The longitudinal occupant impact velocity was 2.0 m/s, and the highest 10-msec ridedown acceleration was 0.4 g. There was no occupant contact in the lateral direction during the test period. The maximum 50-msec average accelerations were -3.2 g in the longitudinal direction and -0.3 g in the lateral direction. The vehicle exited the immediate test site in a relatively smooth, stable manner and showed no potential for intrusion into adjacent traffic lanes.

General Information		Impact Conditions		Test Article Deflections (ft)	
Test Agency	Texas Transportation Institute	Speed (mi/h)	61.3 (98.6 km/h)	Dyanmic	Broke apart
Test No.	53580-3	Angle (deg)	0	Permanent	Broke apart
Date	02/18/93	Exit Conditions		Vehicle Damage	
Test Article		Speed (mi/h)	N/A	Exterior	
Type	Traffic Control Device	Angle (deg)	0	VDS	12FC2
	Sign Support Trailer	Occupant Risk Values		CDC	12FCEN2 & 12FCGN7
Installation Length (ft)		Impact Velocity (ft/s)		Interior	
Size and/or dimension and material of key elements	8.75 (2.7 m) high	x-direction	6.6 (2.0 m/s)	OCDI	FS0000000
Soil Type and Condition	N/A	y-direction	No contact	Maximum Exterior	
Test Vehicle		THIV (optional)		Vehicle Crush (in)	13.0 (33 cm)
Type	Production Model	Ridedown Accelerations (g's)		Max. Occ. Compart.	
Designation	820 C	x-direction	0.4	Deformation (in)	Cracked windshield
Model	1987 Yugo GV	y-direction	N/A	Post-Impact Behavior

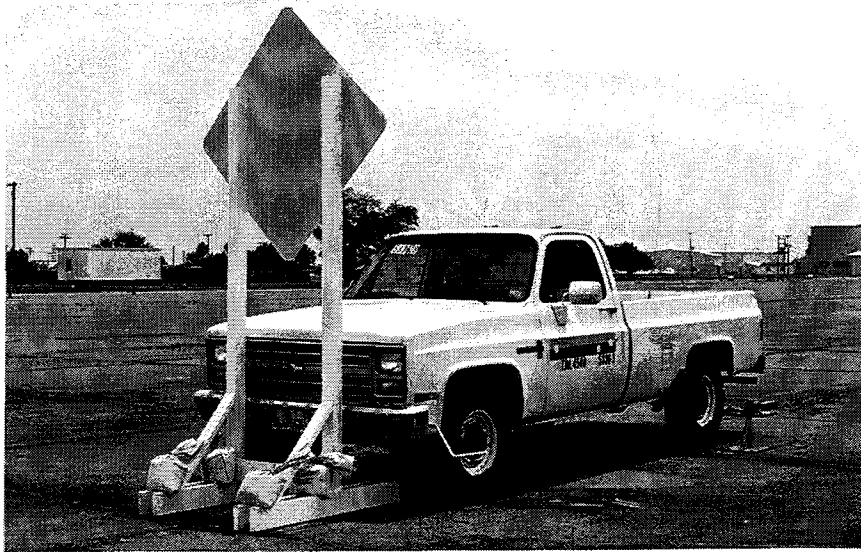
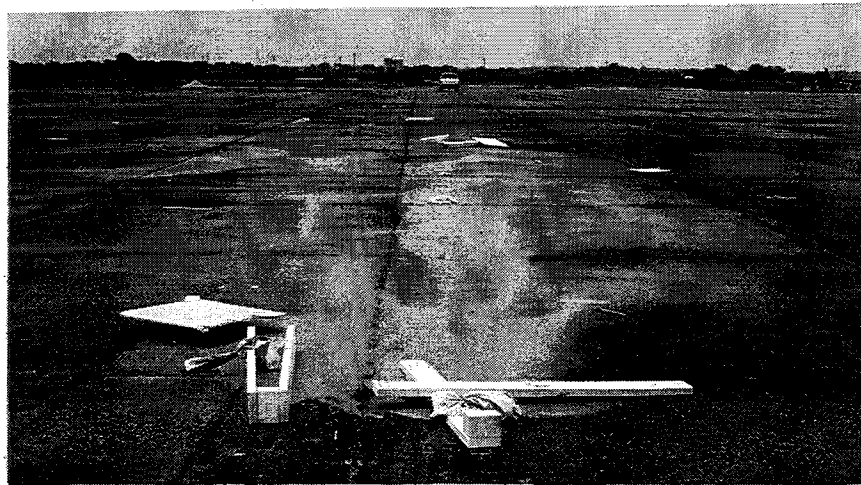
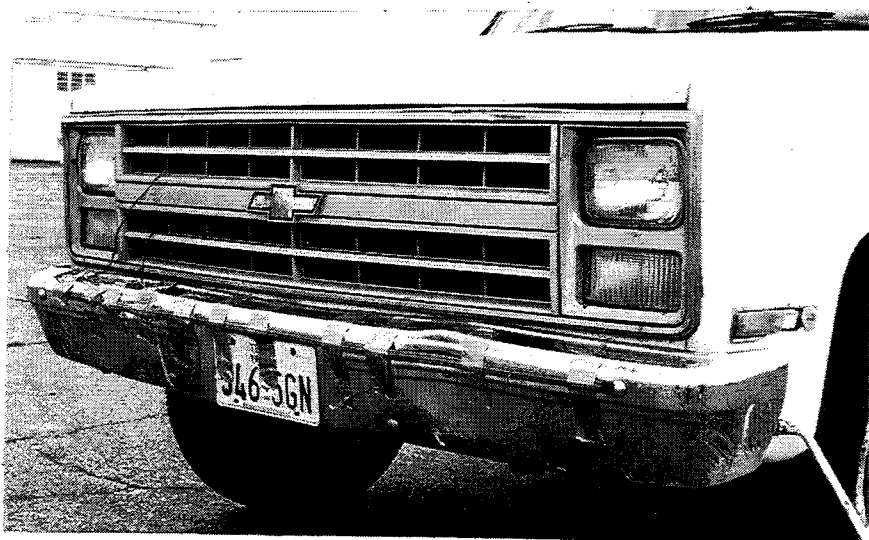
Figure 38. Vehicle and Sign Support for Test No. 453360-3

As Figure 38 shows, the skid-mounted sign support fractured upon impact. Debris and sand were strewn along the path of the vehicle in an area 9 m wide by 59 m long. Figure 38 also shows damage to the vehicle. There were two dents in the bumper, 13 mm and 19 mm, from impact with the supports. There was a small dent in the rear of the roof of the cab.
