1. Report No. TX-96/5388-1F		2. Government Accession No.		3. Recipient's Catalog No.	
4. Title and Subtitle EVALUATION OF WORK ZONE BARRICADES AND TEMPORARY SIGN SUPPORTS				5. Report Date February 1996

EVALUATION OF WORK ZONE BARRICADES AND TEMPORARY SIGN SUPPORTS

Report No. 5388-1F
Research Study No. 585xxA3014
Research Study Title: Development of New Designs for Barricades
and Sign Supports in Work Zones

February 1996

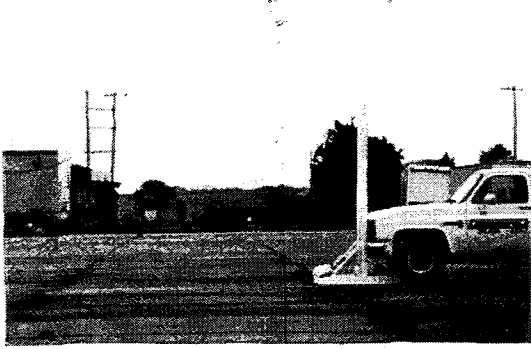
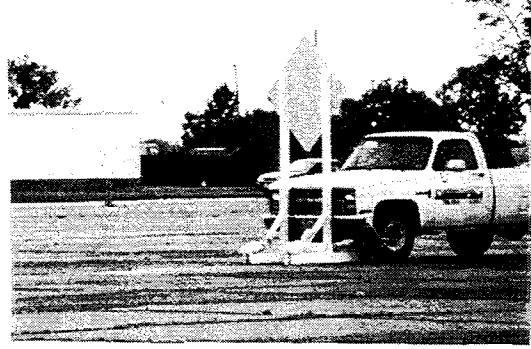
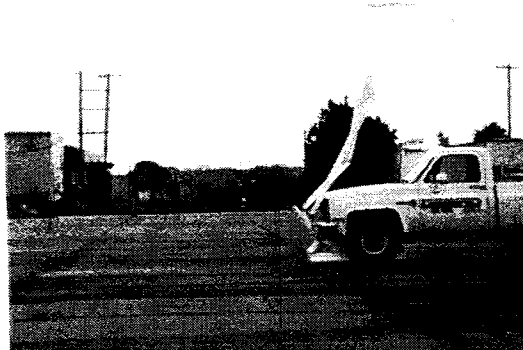
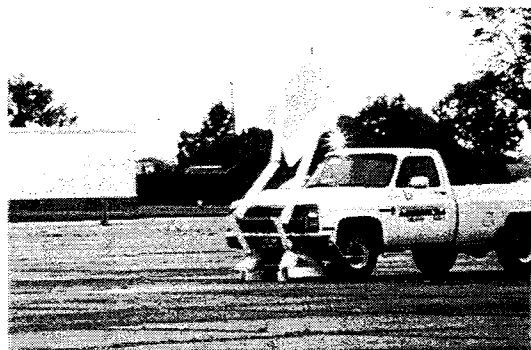
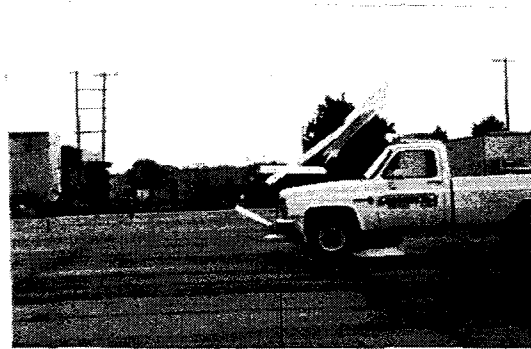
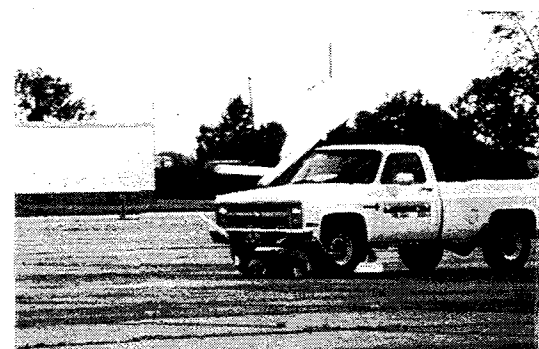
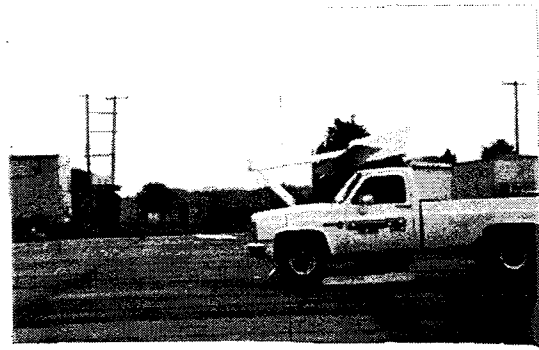
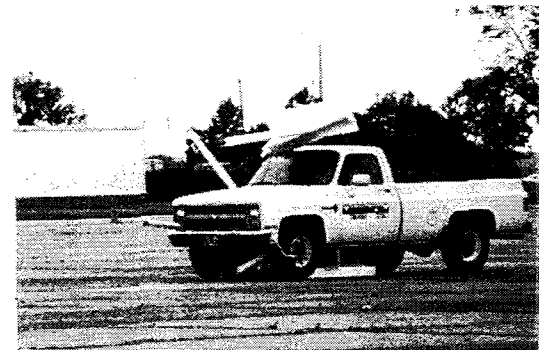
Figure 39. Sequential Photographs for Test No. 453360-3

Immediately upon impact, the vertical supports began to fracture at bumper height and approximately 1.8 m above ground level. The panel and pieces of the support rose up and over the hood of the pickup, while the pickup traveled over the bases. A broken segment of the support then struck the roof near the rear of the cab at 79 msec and bounced off at 126 msec. Pieces of the support continued over the pickup with several pieces landing in the bed of the pickup. The time at loss of contact with the sign support, i.e., when the fractured support ended contact with the vehicle, was 126 msec, and the vehicle had slowed to 91.4 km/h. After the vehicle cleared the immediate test site, brakes on the vehicle were applied at 950 msec after impact. Prior to brake application, the test vehicle was traveling on a relatively straightforward path. The vehicle subsequently came to rest 133 m down and 4 m to the left of the point of impact. Figure 39 shows sequential photographs of the test period.

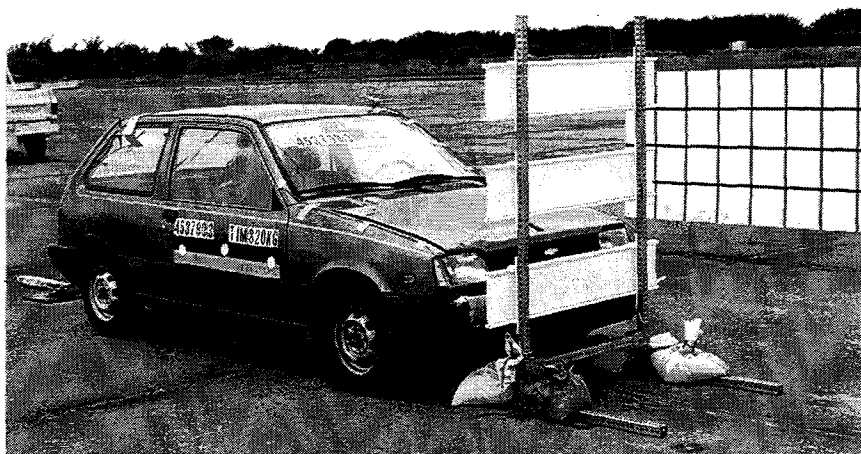
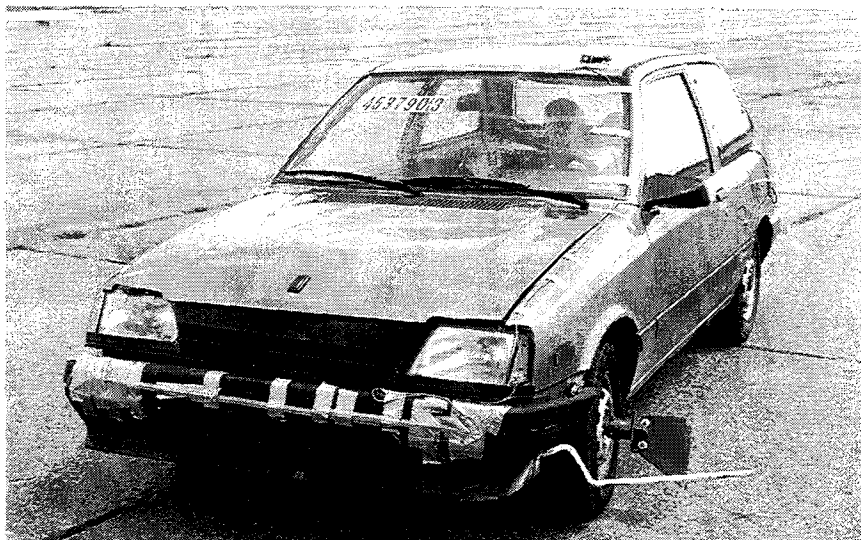
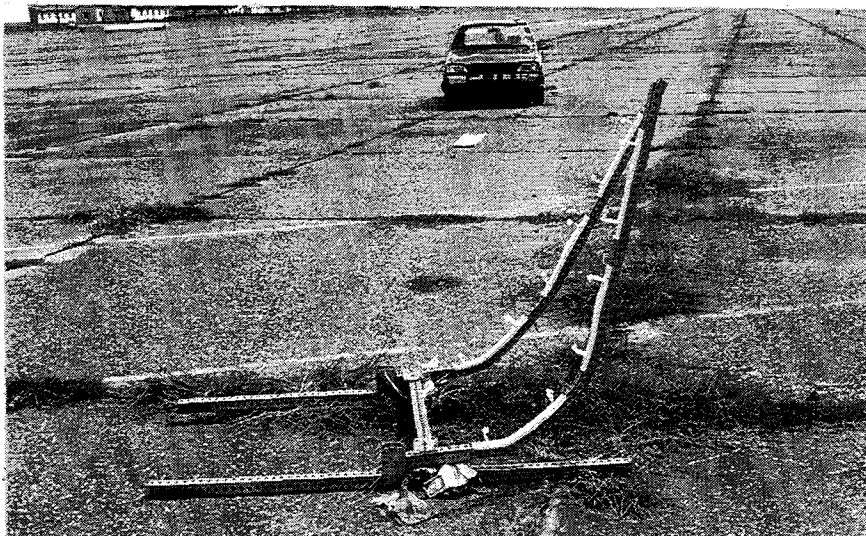
Figure 46. Vehicle and Barricade for Test No. 453790-3

As Figure 46 shows, the plastic rail elements separated from the vertical supports upon impact. The shear pins for the vertical supports sheared as designed, but the impact speed was too high for the vertical supports to fold down. Instead, the vertical supports wrapped around the front the vehicle and stayed with the vehicle until final rest. Debris and sand were strewn along the path of the vehicle in an area 11 m wide by 109 m long. Figure 46 shows damage to the vehicle. The bumper, grill, and hood were dented and scratched. The windshield was cracked; however, no penetration or intrusion of the occupant compartment occurred. Maximum crush to the exterior of the vehicle at the left front corner of the bumper was 70 mm.

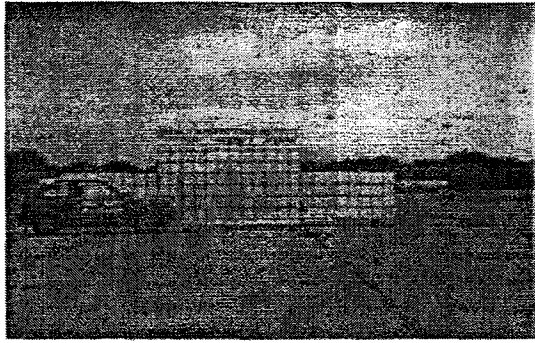
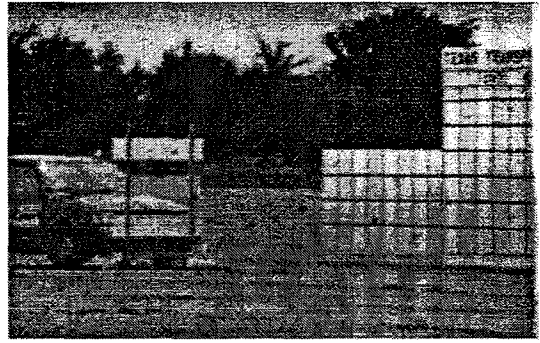
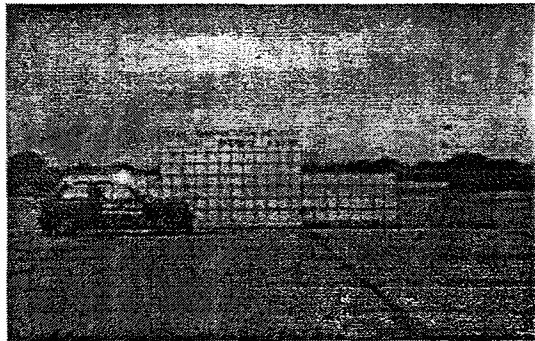
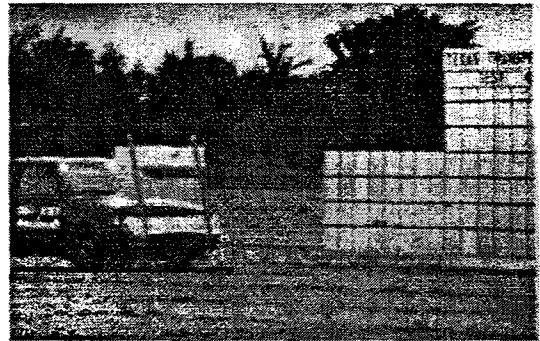
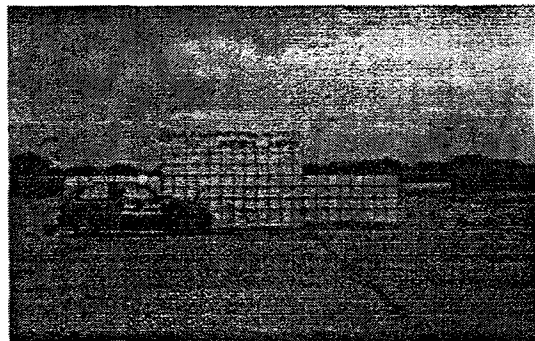
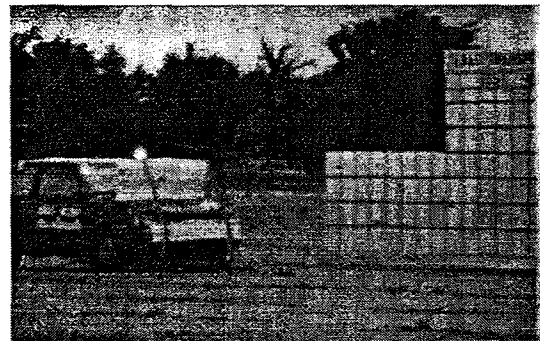
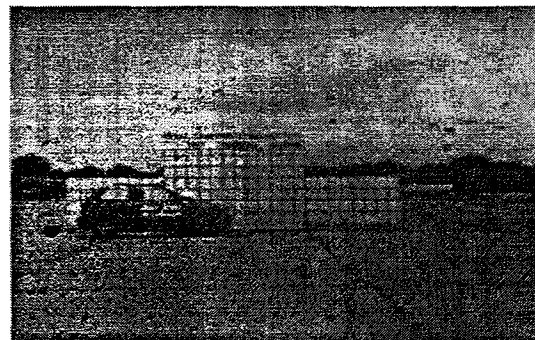
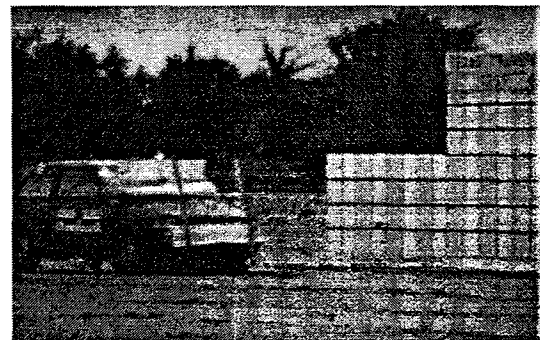
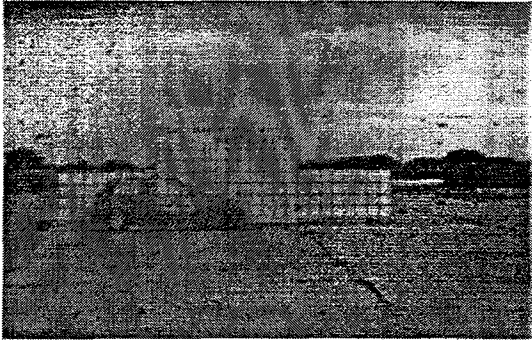
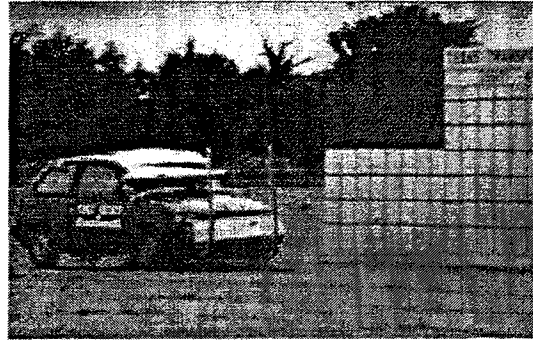
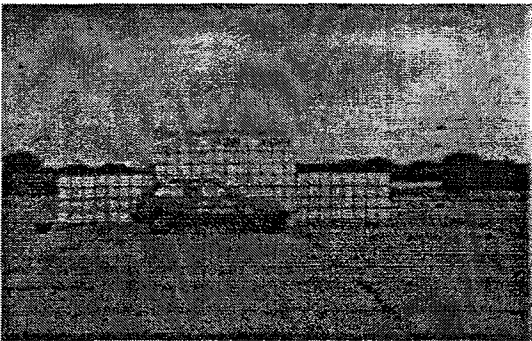
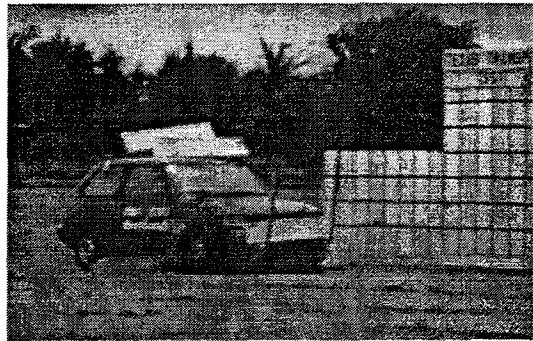
Figure 47. Sequential Photographs for Test No. 453790-3

As the vehicle impacted the vertical supports, the middle and upper plastic rail elements separated from the vertical supports. The lower plastic rail element and vertical supports deformed and wrapped around the front of the vehicle. Windshield contact by the middle plastic rail element occurred at 42 msec and with the upper rail element at 54 msec. The vehicle lost contact with the barricade at 69 msec, traveling at a speed of 95.2 km/h. Prior to brake application, the vehicle was tracking straightforward. The vehicle subsequently came to rest 91.7 m down and 7.9 m to the left of the point of impact. Figure 47 shows sequential photographs of the test period.

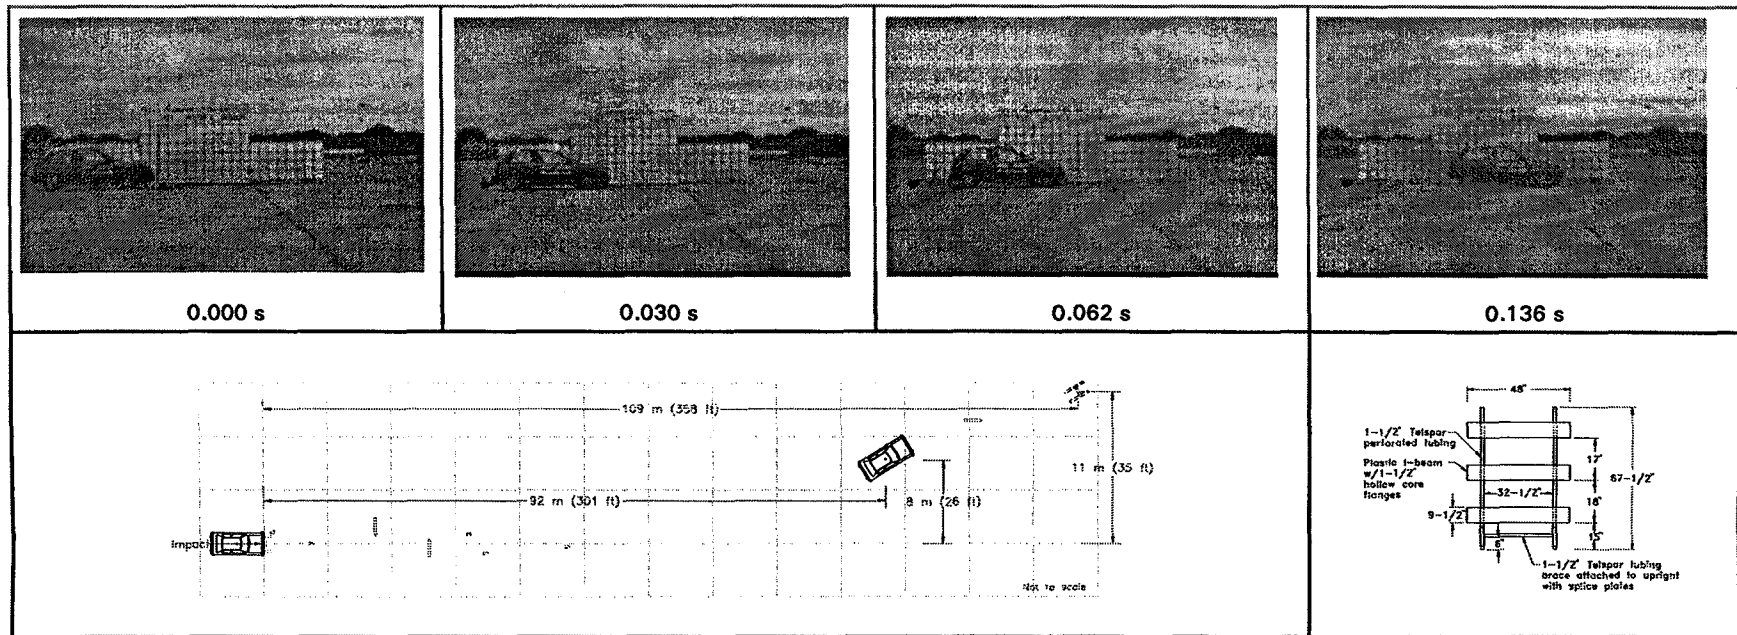
Figure 48. Summary of Results for Test No. 453790-3

Figure 48 presents a brief summary of the results of this test. The plastic rail elements separated from the vertical supports and made contact with the hood and windshield, but did not penetrate the occupant compartment. Debris from the barricade was thrown along an area 11 m wide by 109 m long. The metal supports and bases rode along in front of the vehicle, and most of the remaining fragments were not large or heavy enough to pose potential hazard to oncoming traffic in adjacent lanes or to workers in the area. Damage to the vehicle included dents and scratches to the bumper, grill, and hood. The windshield was cracked by contact with the plastic rail elements, but there was no penetration or intrusion into the occupant compartment. The longitudinal occupant impact velocity was 1.7 m/s and the highest 10-msec average ridedown acceleration was -0.3 g. There was no lateral occupant contact. The 50-msec average accelerations were -2.9 g in the longitudinal direction and -0.5 g in the lateral direction. The vehicle exited the immediate test site in a relatively smooth, stable manner and showed no potential for intrusion into adjacent traffic lanes.

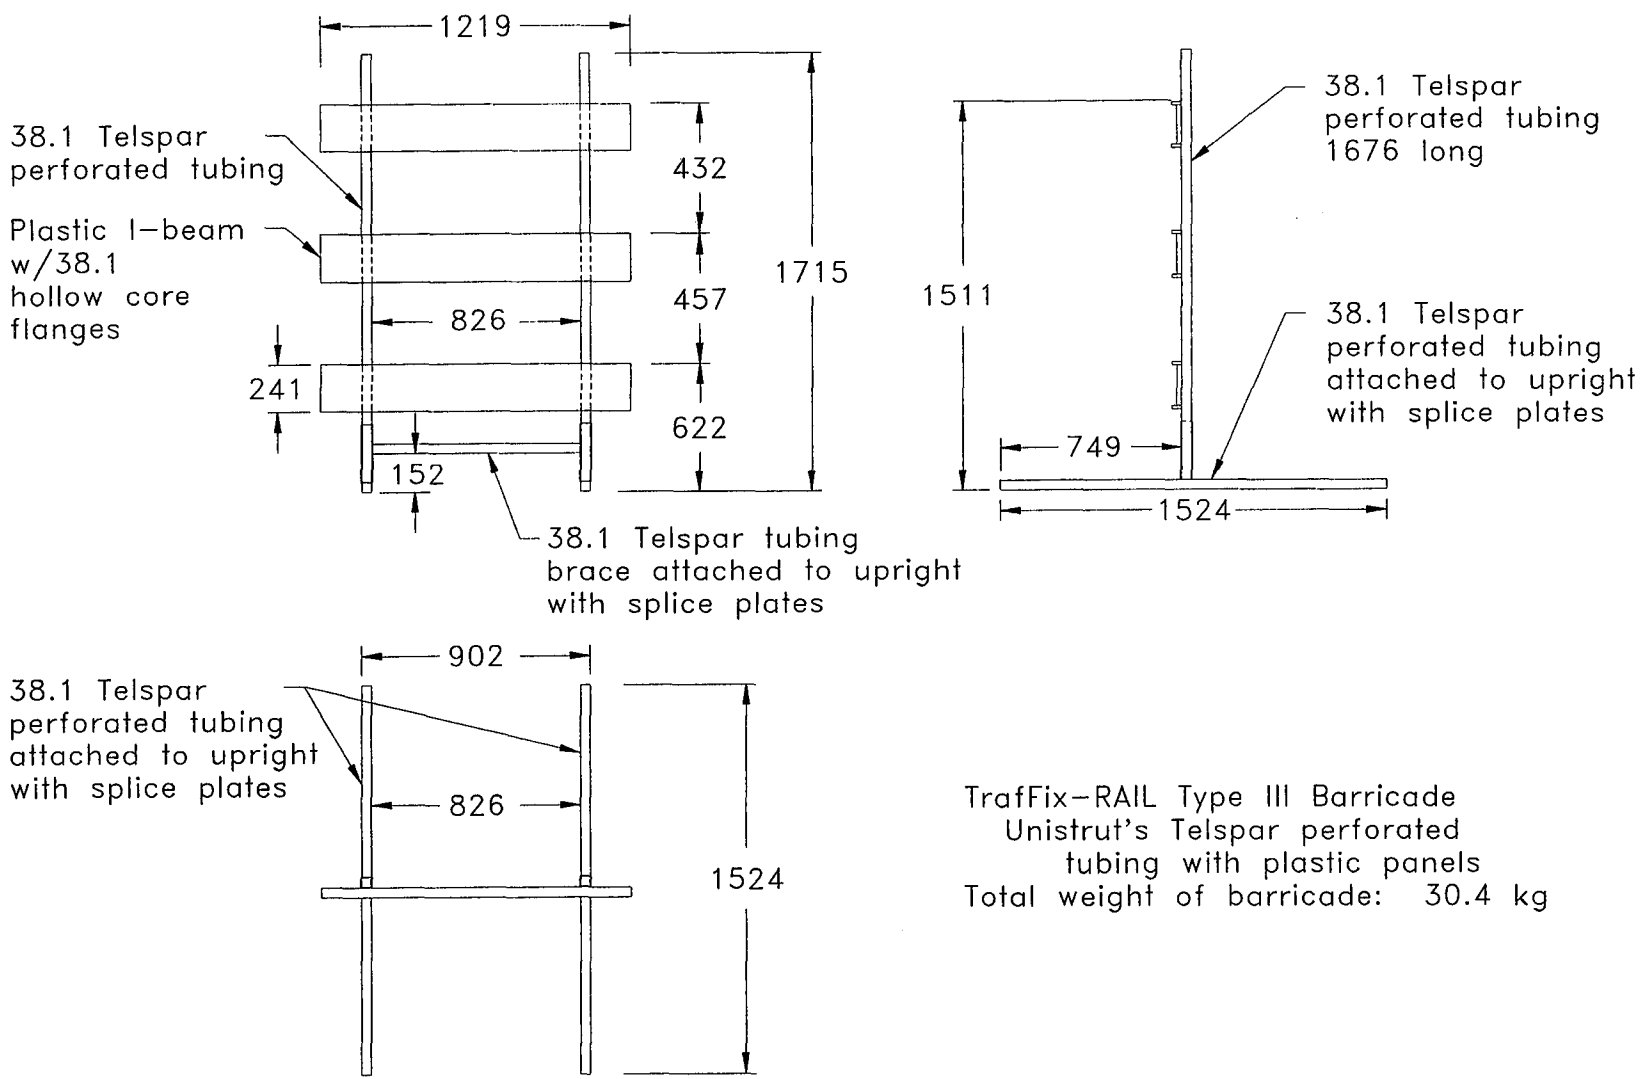
Figure 49. Schematic of Perforated Tubing Type III Barricade with Plastic Rail Elements (Test No. 453880-1)

A Type III barricade fabricated from perforated steel tubing with plastic rail elements, similar to that used in test no. 453790-3, was tested under wet soil condition, i.e., the barricade was placed on wet soil instead of a concrete pavement surface. Figure 49 shows a schematic of the barricade. The barricade was purchased from TraFix Devices, Inc. The test vehicle was a 1989 Chevrolet Sprint, as shown in Figure 50. Dimensions and information on the vehicle are given in Appendix Figure 90. The test vehicle impacted the plastic Type III barricade head-on with the centerline of the vehicle aligned with the centerline of the barricade, traveling at a speed of 100.5 km/h.

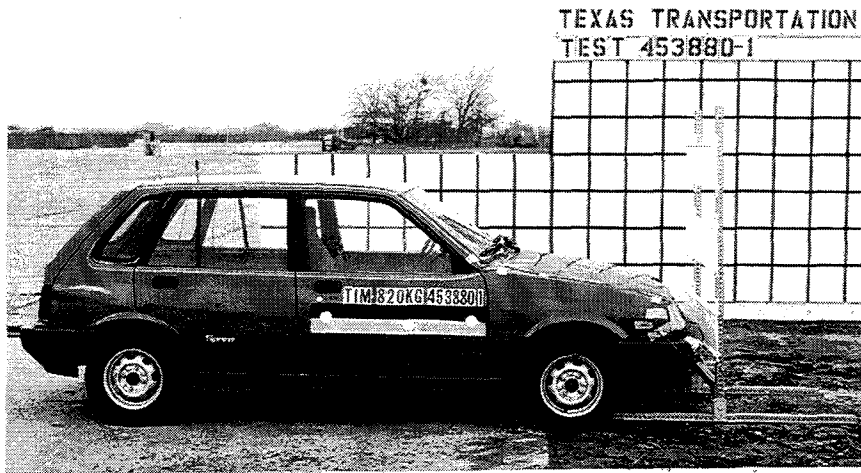
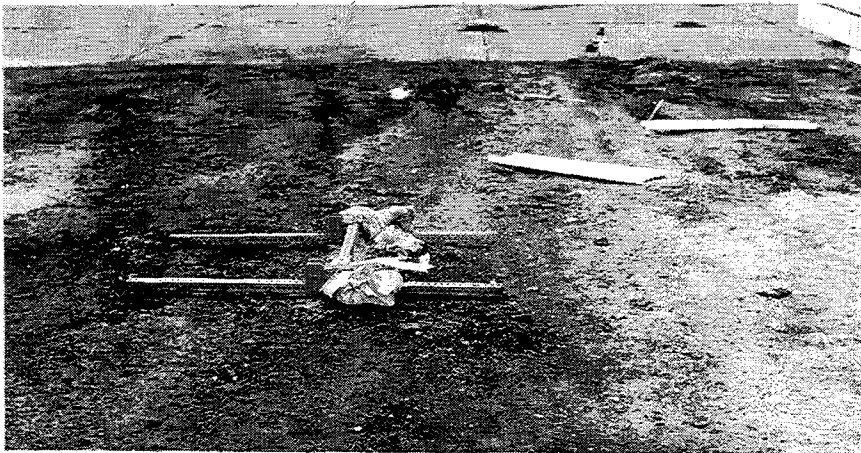
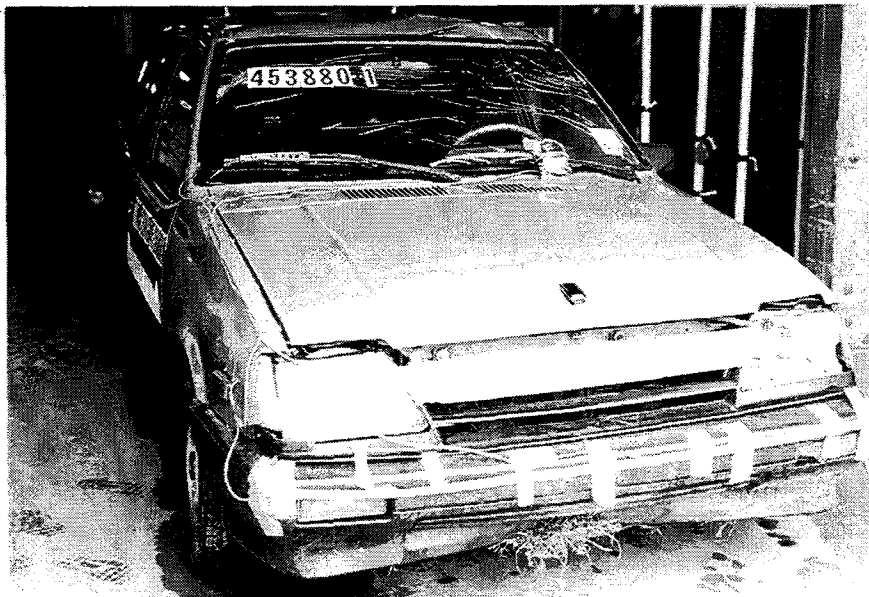
Figure 50. Vehicle and Barricade for Test No. 453880-1

As Figure 50 shows, the plastic rail elements separated from the barricade upon impact, and the barricade came apart subsequently. Debris and sand were strewn along the path of the vehicle in an area 12.6 m wide by 121 m long. Damage to the vehicle is also shown in Figure 50. There were three dents in the roof from impact with the plastic rail elements, and the windshield was cracked. A vertical support made a cut on the roof 15 mm deep and 55 mm long just above the windshield on the driver's side. There were scratches along the hood.

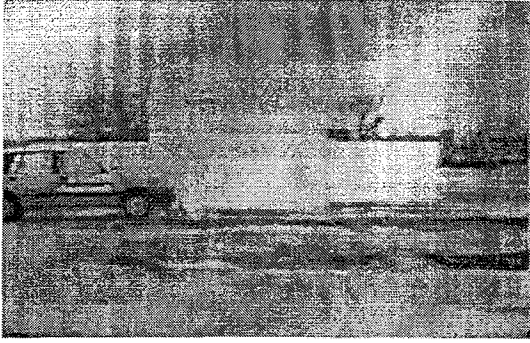
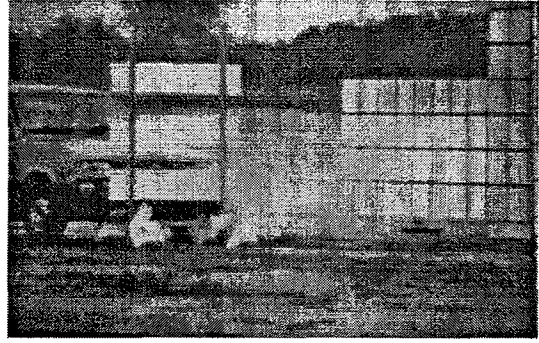
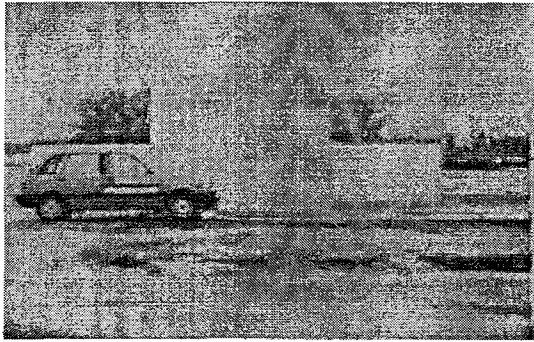
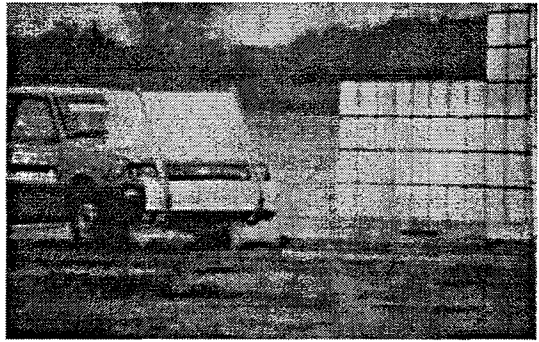
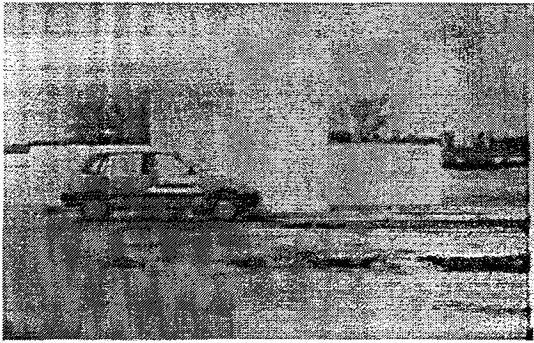
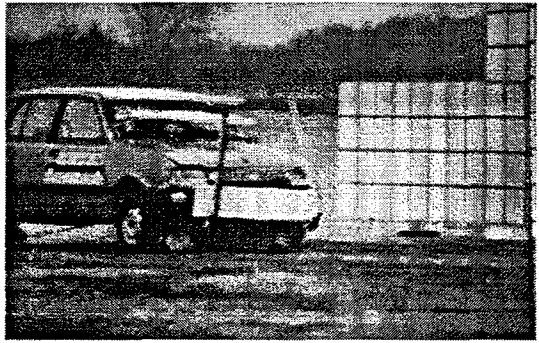
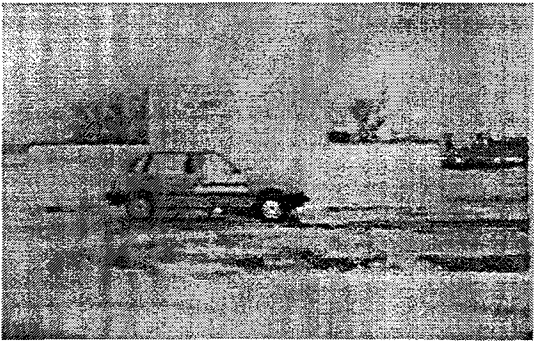
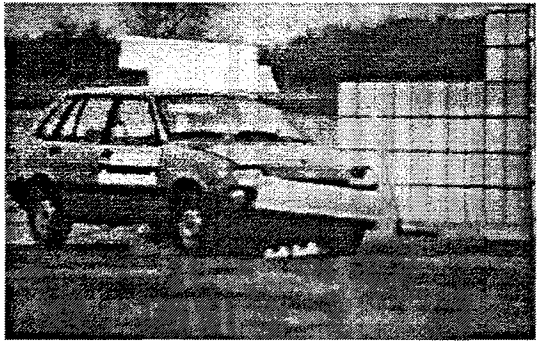
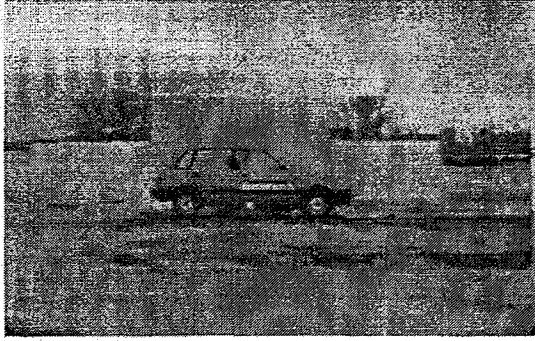
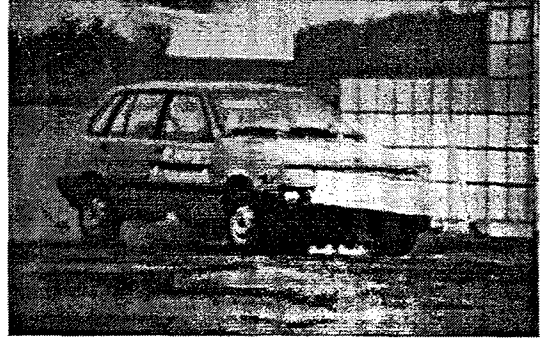
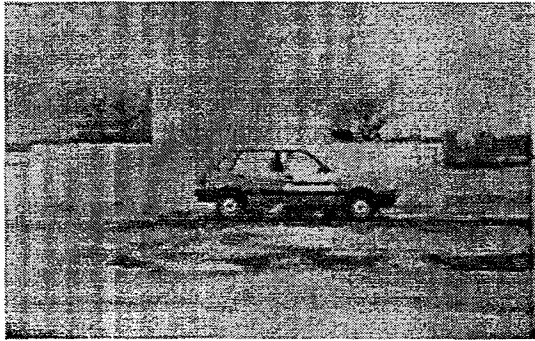
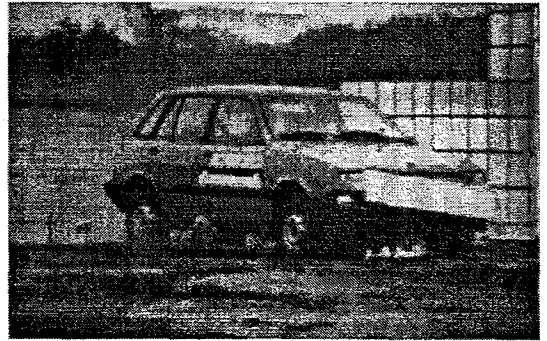
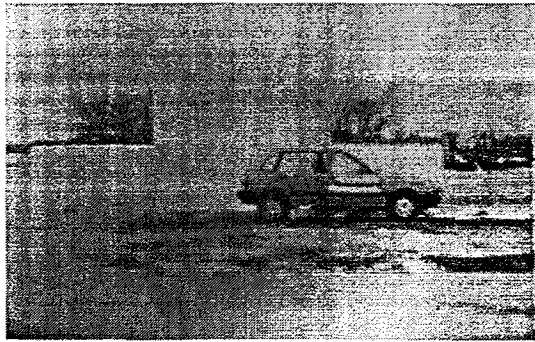
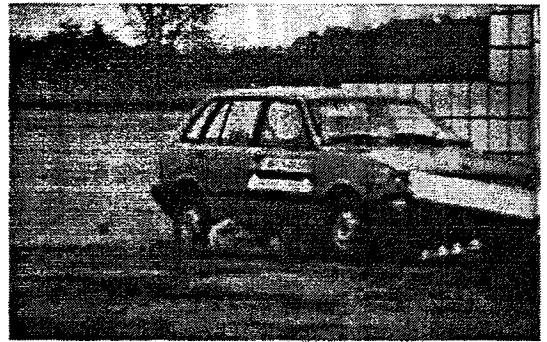
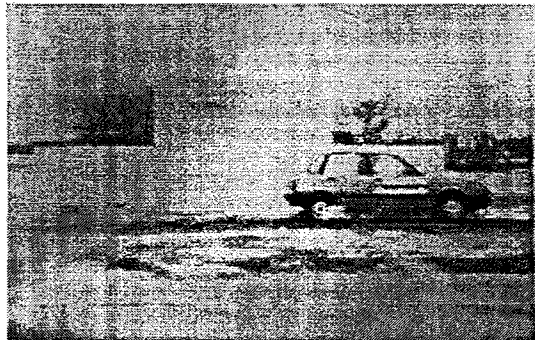
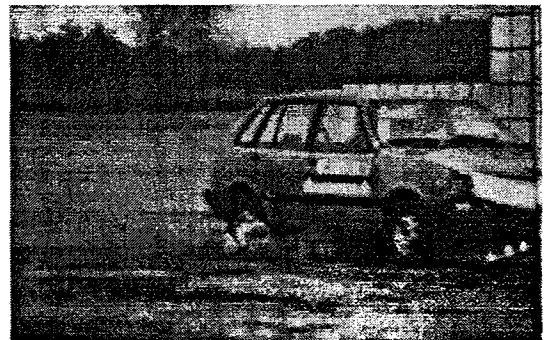
Figure 51. Sequential Photographs for Test No. 453880-1

Upon impact, the middle and top rail elements separated from the vertical supports while the vertical support uprights deformed and wrapped around the front of the vehicle. At 7 msec, the middle rail element contacted the hood of the vehicle. The vehicle lost contact with the left vertical support at 37 msec. The top rail element contacted the windshield at 47 msec, and the middle rail element contacted the windshield at 49 msec. However, the windshield remained intact. The vehicle lost contact with the right vertical support, which then rode underneath the vehicle, and the lower rail element rode along on the bumper. At 142 msec, the vehicle cleared

the installation site traveling at a speed of 92.2 km/h. Prior to brake application, the vehicle was tracking straightforward. The vehicle subsequently came to rest 123 m down and 7.6 m to the left of the point of impact. Figure 51 shows sequential photographs of the test period.

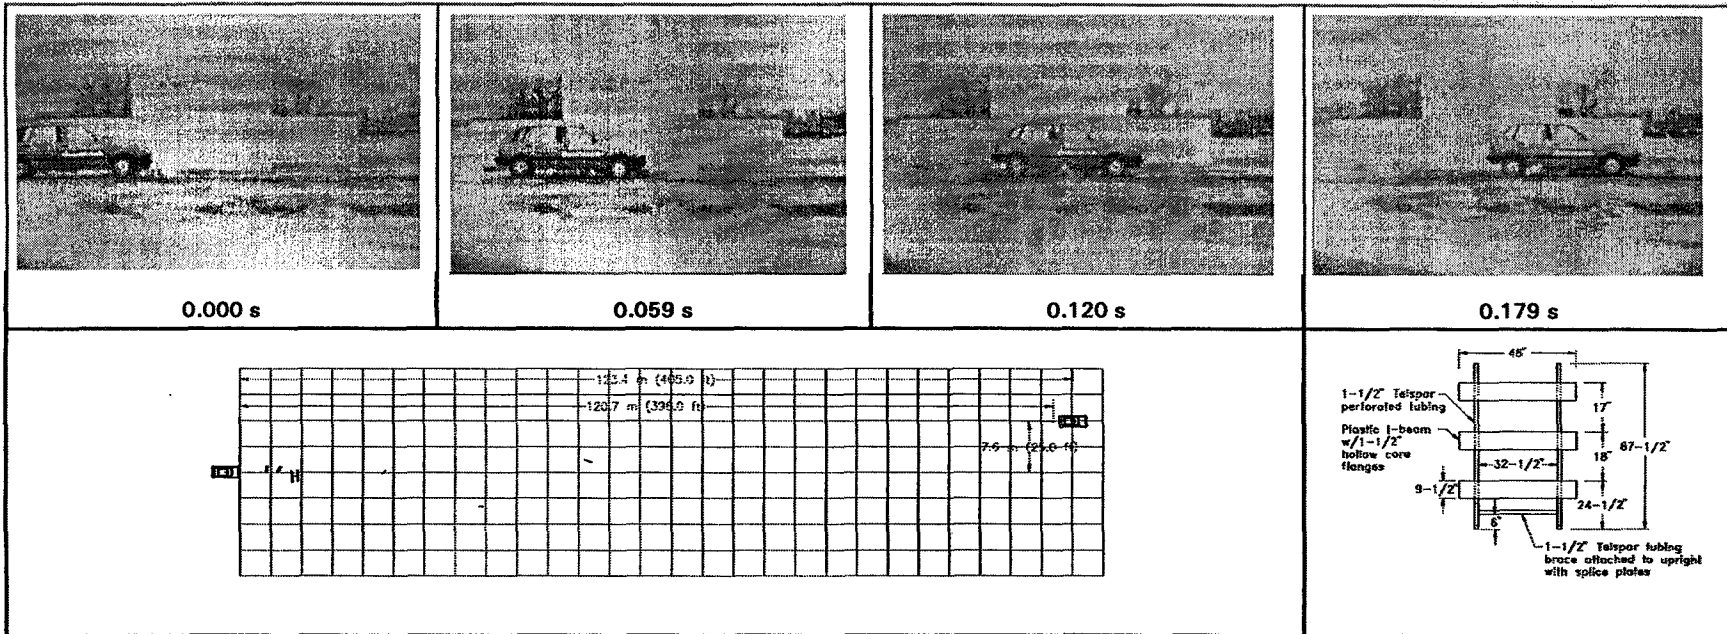
Figure 52. Summary of Results for Test No. 453880-1

Figure 52 presents a brief summary of the results of this test. The barricade came apart upon impact, and the broken segments contacted the hood, windshield, and roof of the vehicle. However, there was no penetration or intrusion into the occupant compartment. Sand and fragments of the barricade were scattered along an area 12.6 m wide by 121 m long. Most fragments were not large enough to pose potential hazard to oncoming traffic in adjacent lanes; however, the metal tubing from the vertical support could pose a hazard to workers in the area. The vehicle sustained minor damage to the hood and windshield, with a small cut in the roof. The longitudinal occupant impact velocity was 1.9 m/s and the highest 10-msec average ridedown acceleration was -2.7 g. The lateral occupant impact velocity was 1.0 m/s and the highest 10-msec average ridedown acceleration was -3.6 g. The 50-msec average accelerations were -3.3 g in the longitudinal direction and -0.8 g in the lateral direction. The vehicle exited the immediate test site in a relatively smooth, stable manner and showed no potential for intrusion into adjacent traffic lanes.

In summary, the Type III barricade fabricated from perforated tubing with plastic rail elements tested with wet soil condition was judged to have met all evaluation criteria set forth in NCHRP Report 350.

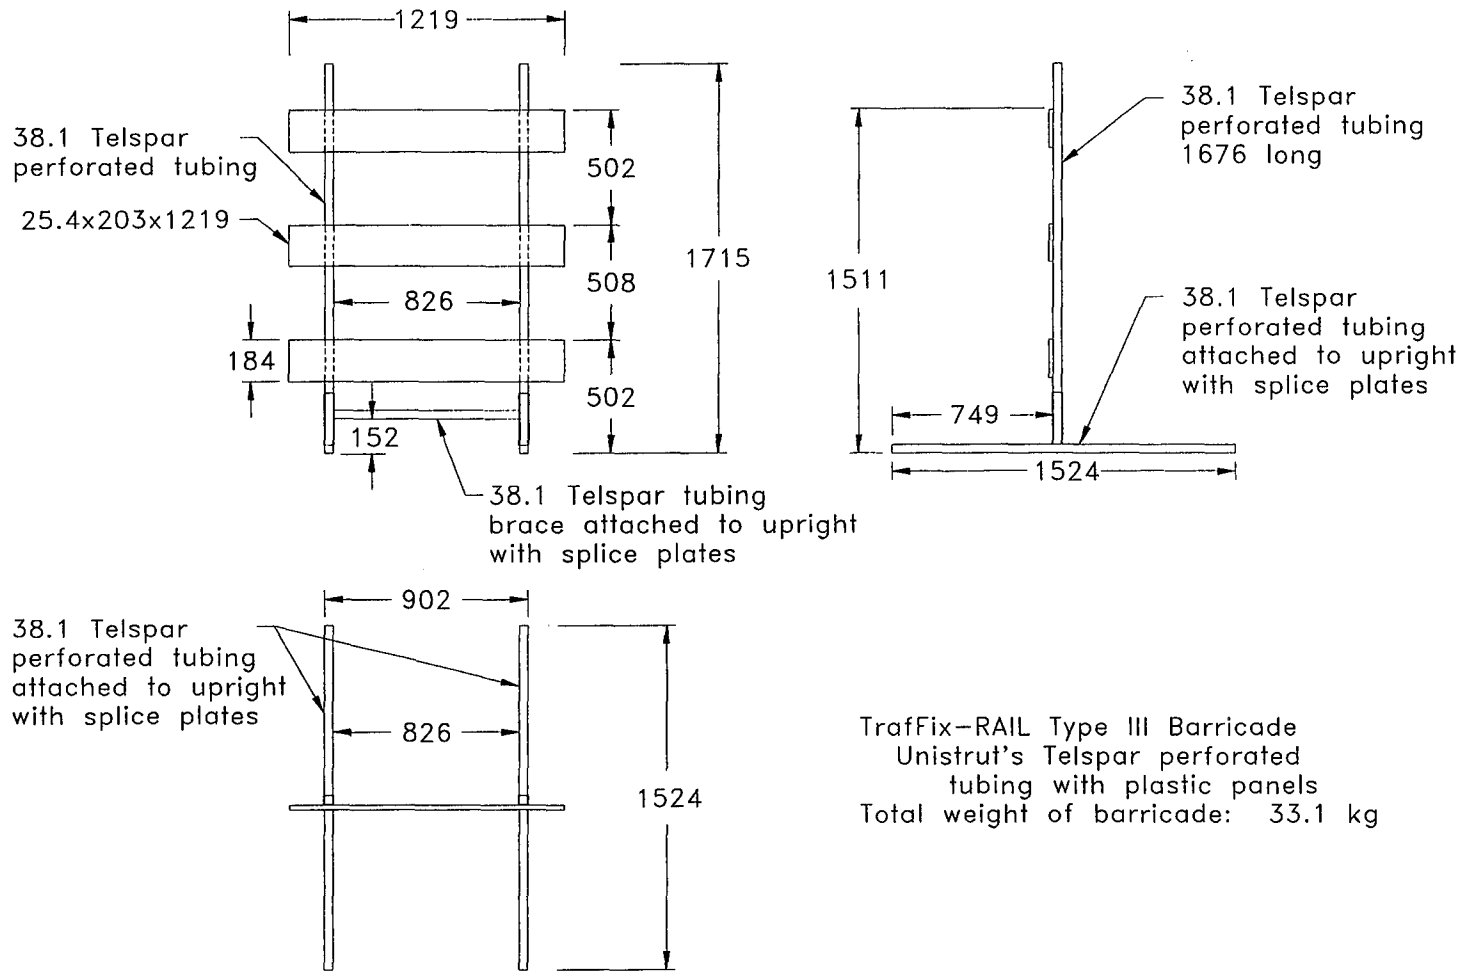
Figure 53. Schematic of Perforated Tubing Type III Barricade with Wooden Rail Elements (Test No. 453880-2)

A Type III barricade fabricated from perforated steel tubing with wooden rail elements, similar to that used in test nos. 453790-3 and 453880-1, was tested under wet soil condition, i.e., the barricade was placed on wet soil instead of a concrete pavement surface. Figure 53 shows a schematic of the barricade. The barricade was fabricated from perforated steel tubing and wooden panels. The test vehicle was a 1989 Chevrolet Sprint, as shown in Figure 54. Dimensions and information on the vehicle are given in Appendix Figure 90. The test vehicle impacted the plastic Type III barricade head-on with the centerline of the vehicle aligned with the centerline of the barricade, traveling at a speed of 102.7 km/h.

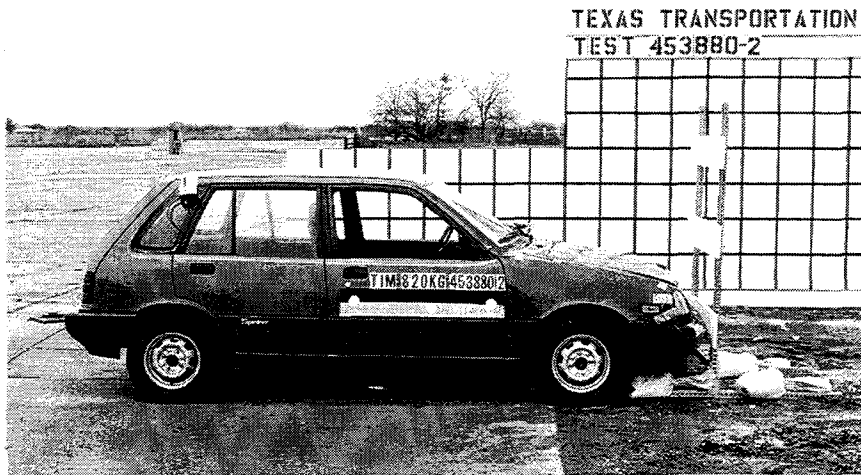
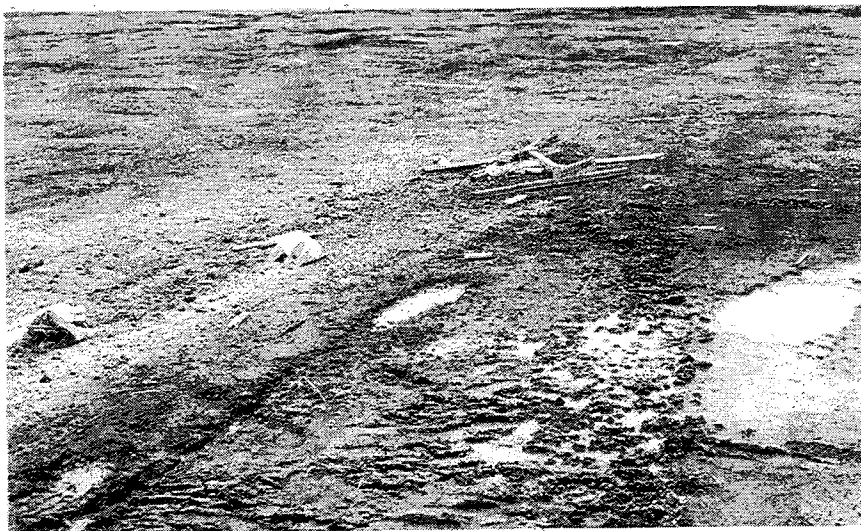
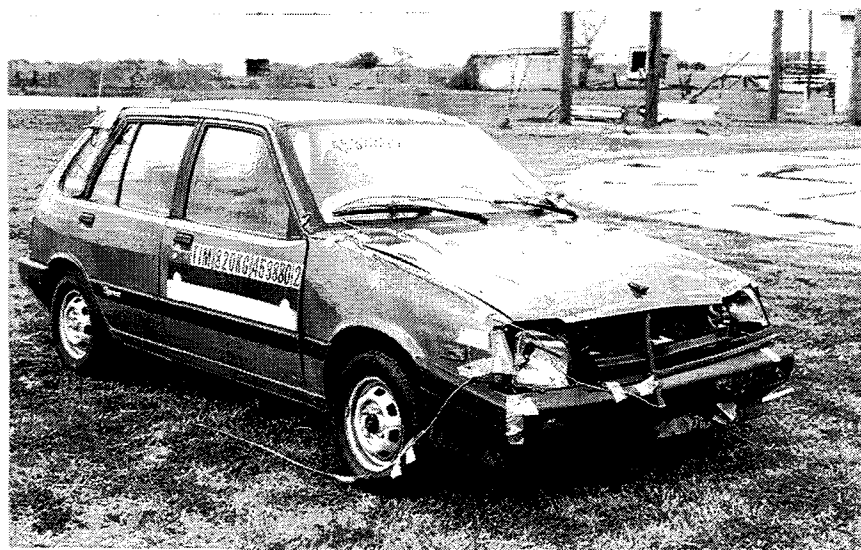
Figure 54. Vehicle and Barricade for Test No. 453880-2

As Figure 54 shows, the barricade shattered upon impact. Debris and sand were strewn along the path of the vehicle in an area 11 m wide by 46 m long. Figure 54 shows damage to the vehicle. There were dents and scratches along the bumper, grill, and hood, and the left rear tire was flat.

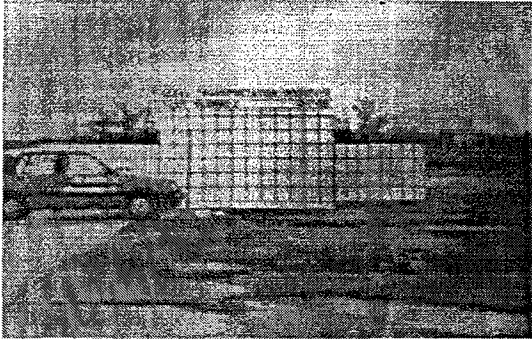
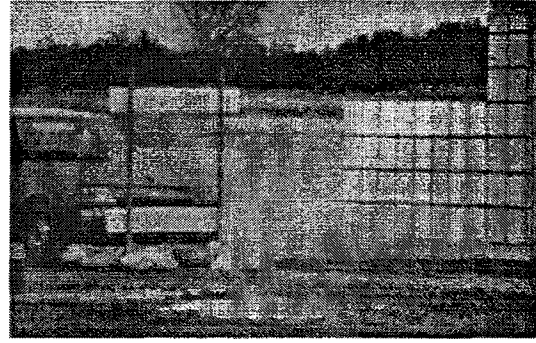
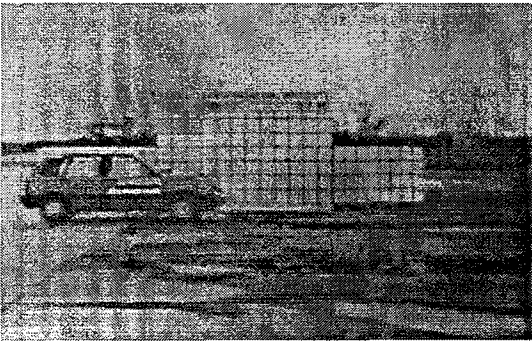
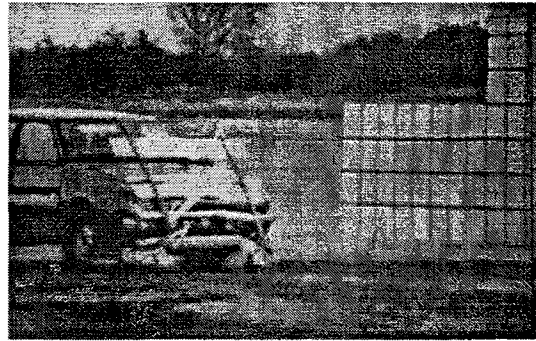
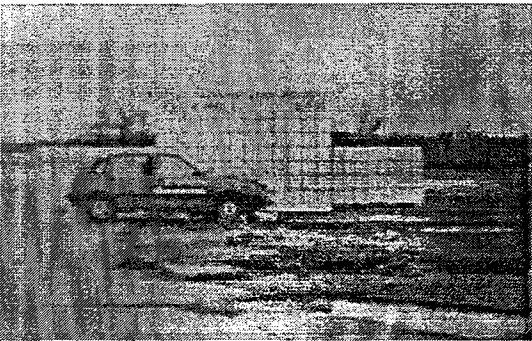
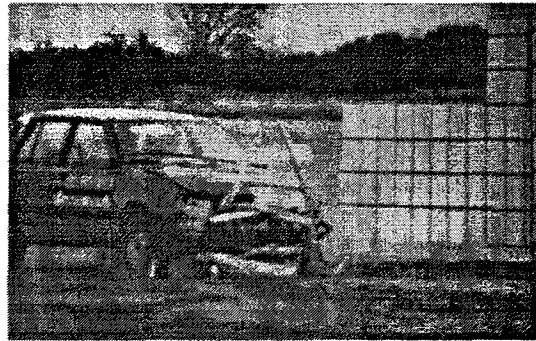
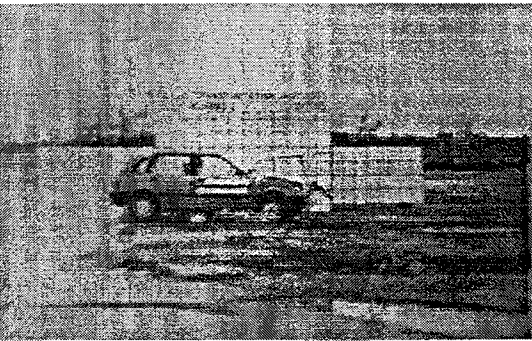
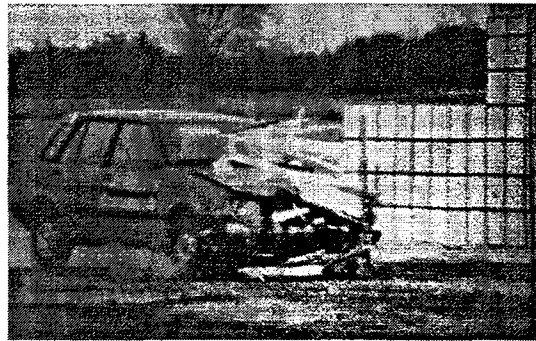
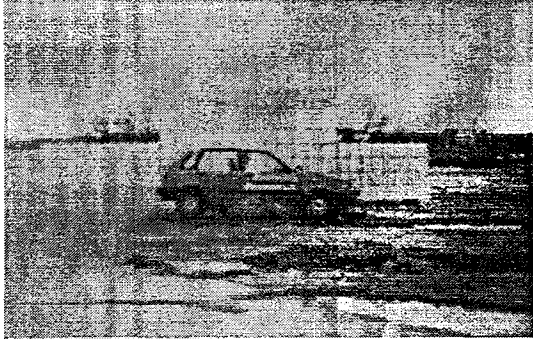
Figure 55. Sequential Photographs for Test No. 453880-2

As the vehicle impacted the lower rail element of the barricade, the wooden rail element split and then shattered. The vertical supports deformed and wrapped around the front of the vehicle. At 12 msec after impact, the middle wooden rail element split. At 14 msec, the right vertical support fractured at bumper height, and at 19 msec, the left vertical support also fractured

at bumper height. The top wooden rail element contacted the hood of the vehicle at 38 msec. At 46 msec, the right vertical support separated from the rail element and became airborne while the vehicle was traveling at a speed of 93.4 km/h. The left vertical support rode along the front of the vehicle and lost contact with the vehicle at 176 msec as the vehicle had slowed to 92.5 km/h. Prior to brake application, the vehicle was tracking straight-forward. The vehicle subsequently came to rest 116 m down and 6.7 m left of the point of impact. Figure 55 shows sequential photographs of the test period.

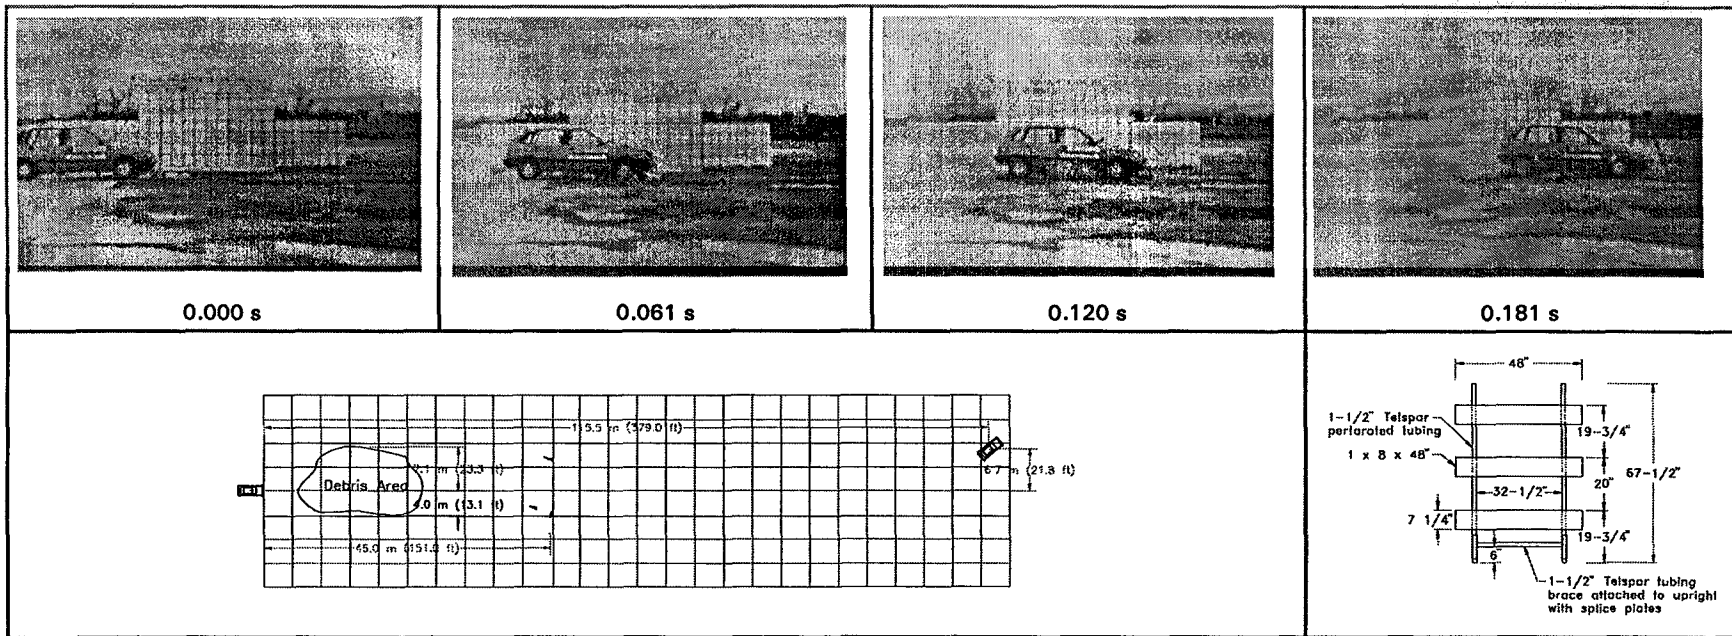
Figure 56. Summary of Results for Test No. 453880-2

A brief summary of the results of this test is presented in Figure 56. The barricade shattered upon impact and broken segments of the barricade made contact with the hood but did not penetrate the occupant compartment. Debris from the barricade was thrown along an area 11 m wide by 46 m long. Most fragments were not large enough to pose potential hazard to oncoming traffic in adjacent lanes. The fractured metal vertical supports could cause minor hazard to workers in the area. The vehicle sustained minor damage to the bumper, grill, and hood. There was no penetration or intrusion into the occupant compartment. The longitudinal occupant impact velocity was 2.3 m/s, and the highest 10-msec average ridedown acceleration was -1.8 g. There was no lateral occupant contact. The 50-msec average accelerations were -3.5 g in the longitudinal direction and 0.7 g in the lateral direction. The vehicle exited the immediate test site in a relatively smooth, stable manner and showed no potential for intrusion into adjacent traffic lanes.
