1. Report No. TX-96/5388-1F		2. Government Accession No.		3. Recipient's Catalog No.	
4. Title and Subtitle EVALUATION OF WORK ZONE BARRICADES AND TEMPORARY SIGN SUPPORTS				5. Report Date February 1996

EVALUATION OF WORK ZONE BARRICADES AND TEMPORARY SIGN SUPPORTS

Report No. 5388-1F
Research Study No. 585xxA3014
Research Study Title: Development of New Designs for Barricades
and Sign Supports in Work Zones

February 1996

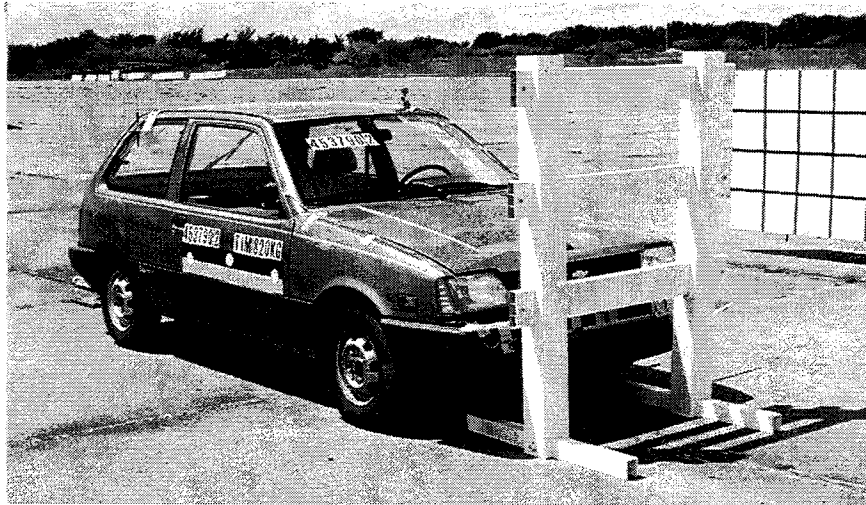
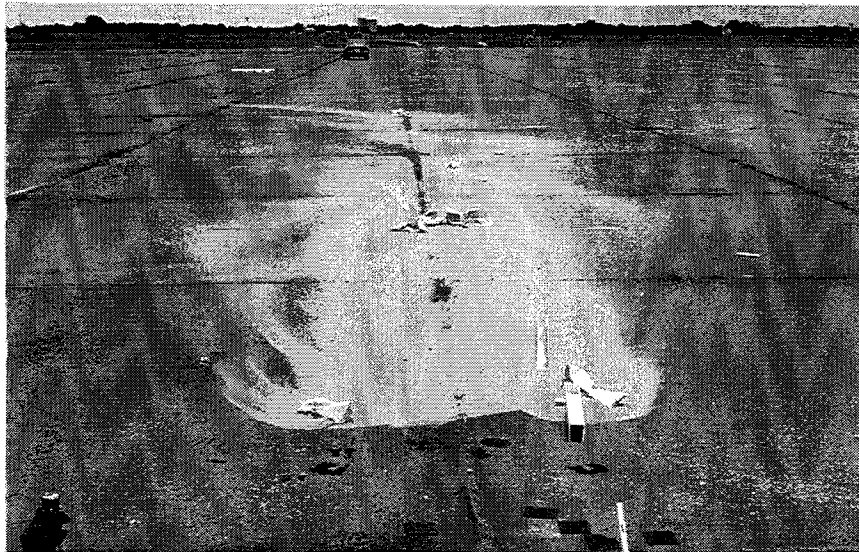
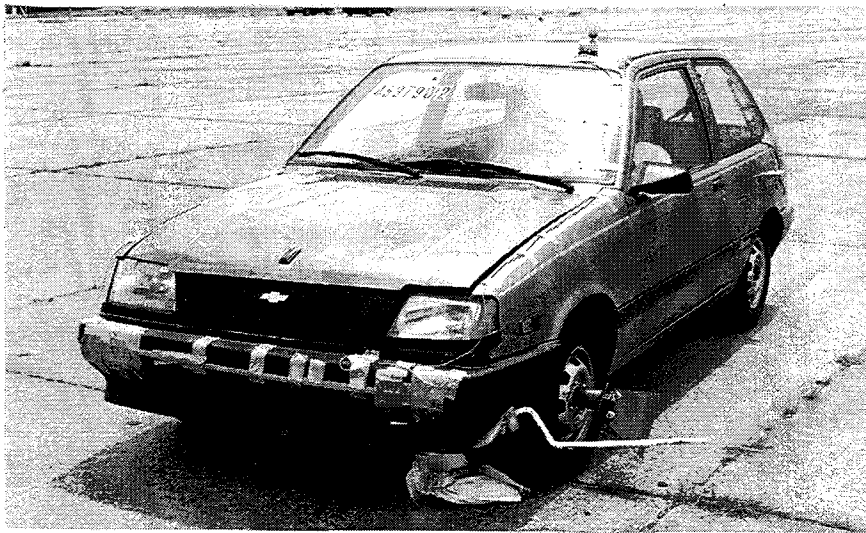
Figure 58. Vehicle and barricade for Test No. 453790-2

As Figure 58 shows, the barricade separated from the base upon impact. Debris and sand were strewn along the path of the vehicle in an area 6 m wide by 54 m long. Figure 58 also shows damage to the vehicle. The bumper was pushed up slightly, and the headlight on the driver's side was loose. The hood was dented on each corner, and there were three scratches along the hood.

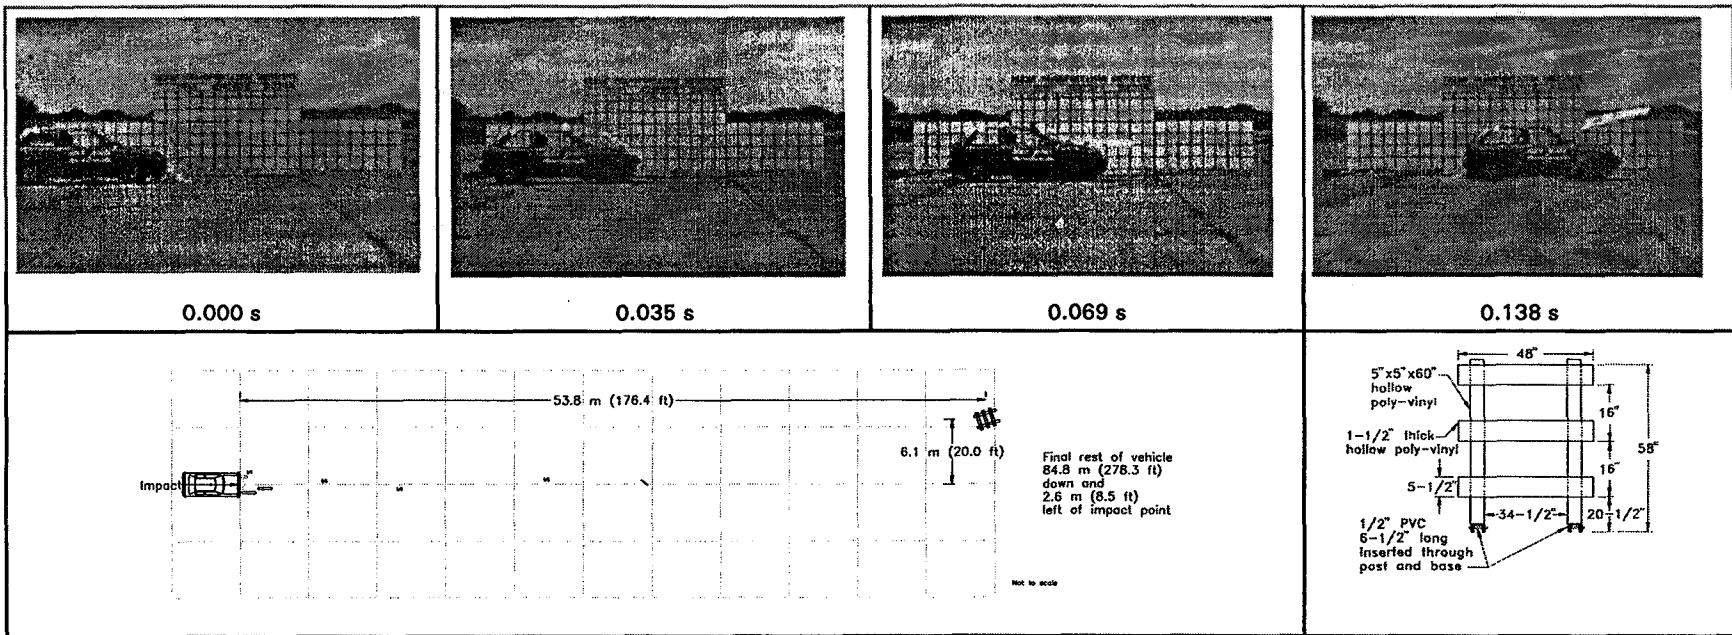
Figure 60. Summary of Results for Test No. 453790-2

A brief summary of the results of this test is presented in Figure 60. The vertical supports of the barricade separated from the base upon impact and made contact with the hood, but did not penetrate the occupant compartment. Debris from the barricade was thrown along an area 6 m wide by 54 m long. Most fragments were not large enough or heavy enough to pose potential hazard to oncoming traffic in adjacent lanes; however, the vertical supports may pose a slight hazard to workers in the area. The vehicle sustained minor damage to the bumper and hood. The longitudinal occupant impact velocity was 0.8 m/s, and the highest 10-msec average ridedown acceleration was -0.2 g. There was no lateral occupant contact. The 50-msec average accelerations were -1.9 g in the longitudinal direction and -0.3 g in the lateral direction. The vehicle exited the immediate test site in a relatively smooth, stable manner and showed no potential for intrusion into adjacent traffic lanes.

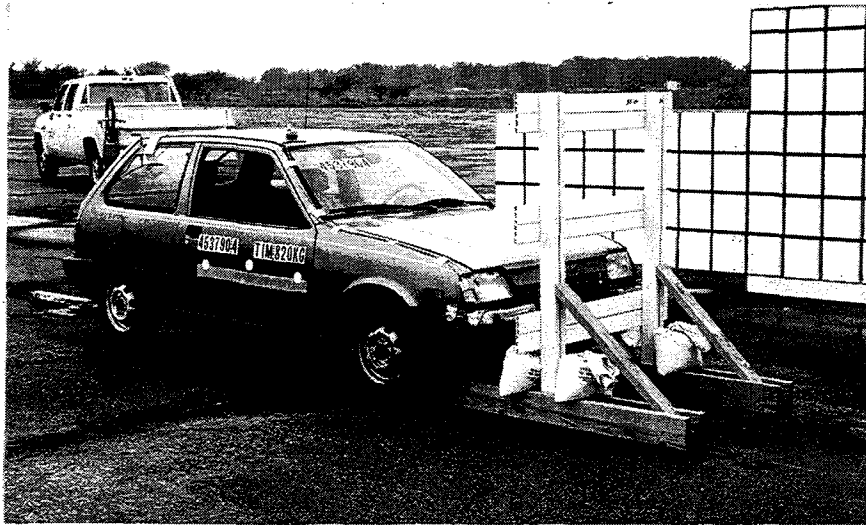
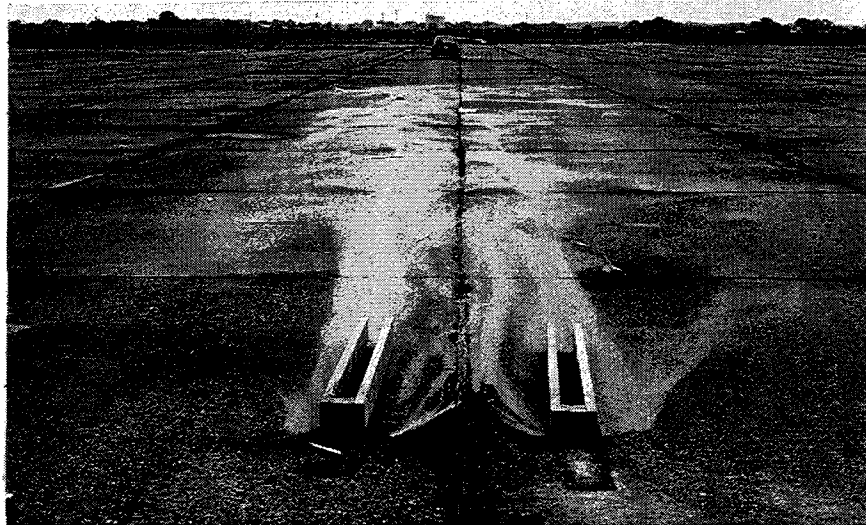
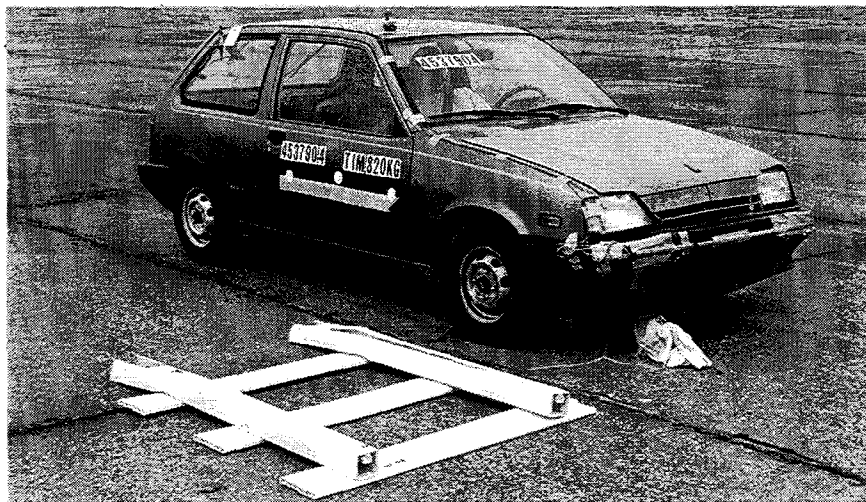
Figure 62. Vehicle and Barricade for Test No. 453790-4

As Figure 62 shows, the hollow core recycled plastic vertical supports and rail elements separated from the wooden base upon impact. Debris and sand were strewn along the path of the vehicle in an area 17 m wide by 77 m long. Figure 62 also shows damage to the vehicle. The bumper and hood of the vehicle were scratched. No penetration or intrusion of the occupant compartment occurred. There was no measurable crush to the exterior of the vehicle.

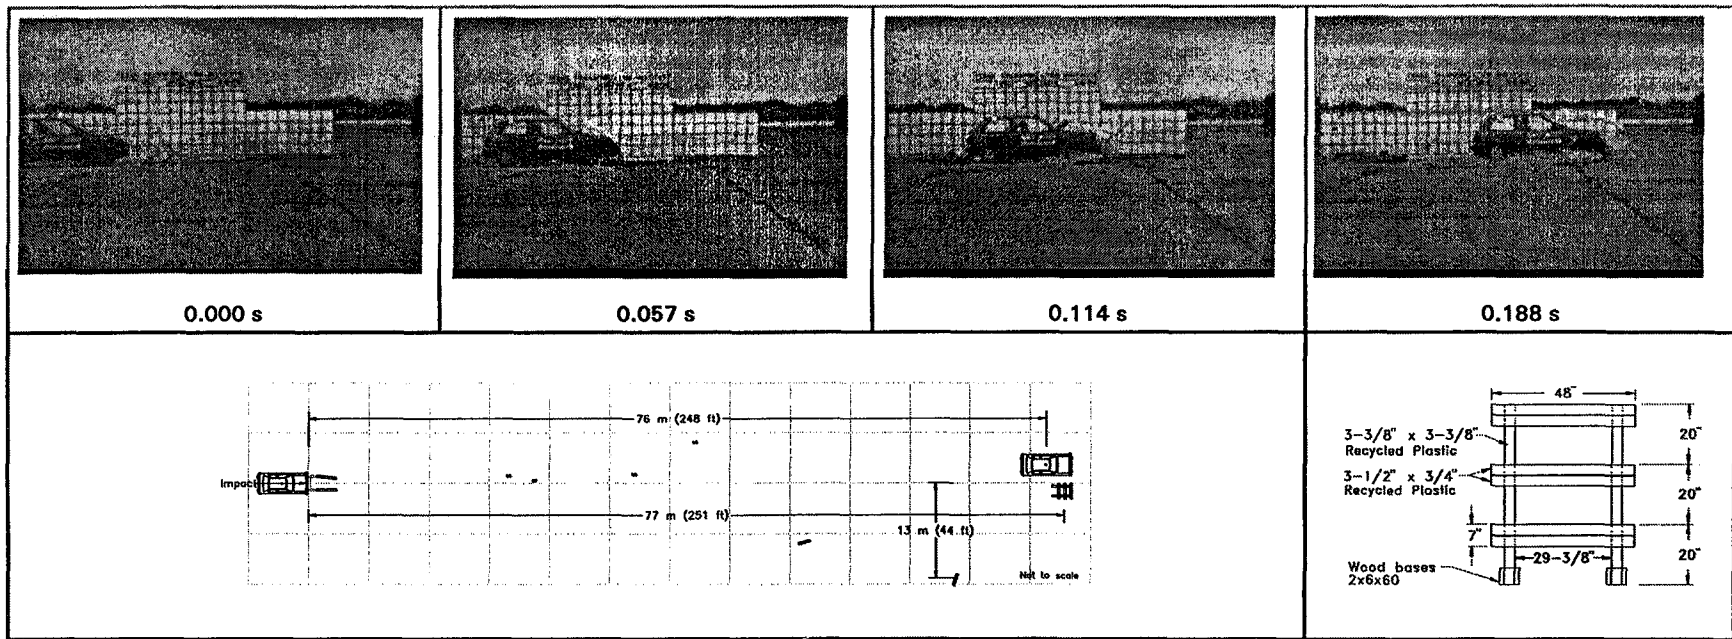
hood and windshield of the vehicle, but did not penetrate the occupant compartment. Debris from the barricade was thrown along an area 17 m wide by 77 m long. The plastic vertical supports and wooden braces rode along with the vehicle. The wooden base remained near the point of impact and most of the remaining fragments were not large enough to pose potential hazard to oncoming traffic in adjacent lanes or to workers in the area. Damage to the vehicle included scratches to the bumper and hood. The plastic vertical supports, which separated from the wooden base, contacted the windshield area, but there was no penetration or intrusion into the occupant compartment. The longitudinal occupant impact velocity was 1.6 m/s, and the highest 10-msec average ridedown acceleration was 0.4 g. There was no lateral occupant contact. The 50-msec average accelerations were -3.3 g in the longitudinal direction and -0.3 g in the lateral direction. The vehicle exited the immediate test site in a relatively smooth, stable manner and showed no potential for intrusion into adjacent traffic lanes.

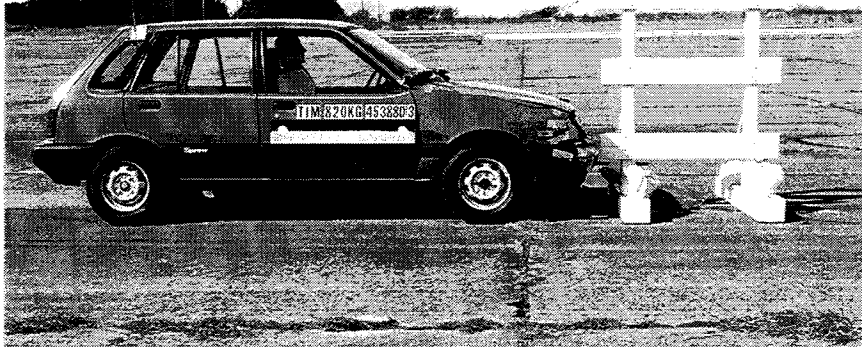
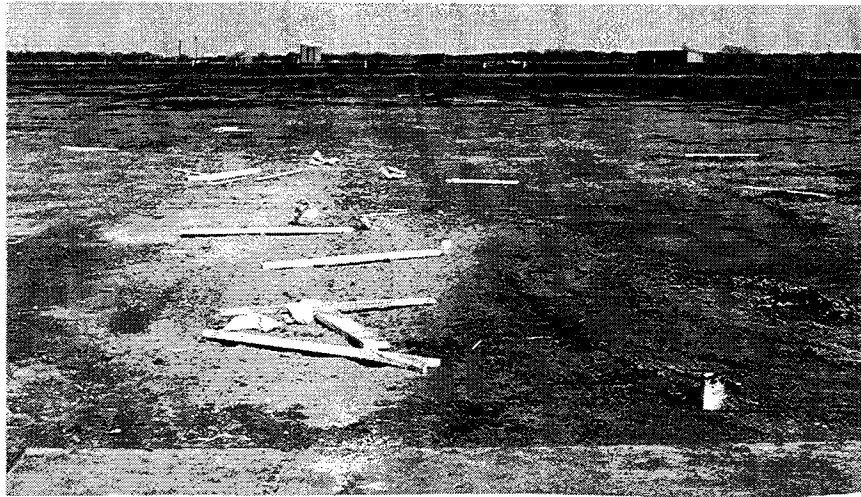
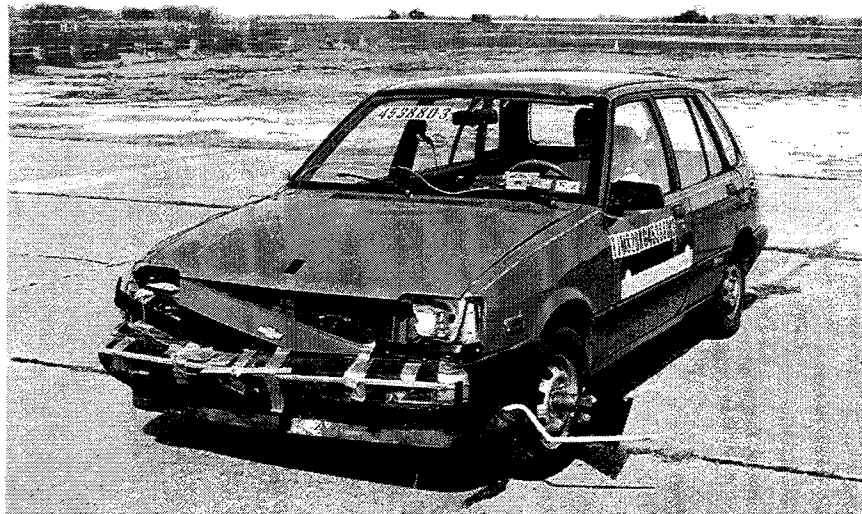
Figure 66. Vehicle and Barricade for Test No. 453880-3

As Figure 66 shows, the hollow core recycled plastic vertical supports and rail elements separated from the base fabricated from solid recycled plastic upon impact and subsequently shattered. Debris and sand were strewn along the path of the vehicle in an area 9.9 m wide by

48 m long. Figure 66 shows damage to the vehicle. The damage to the vehicle included the bumper, grill, and scratches on the hood. The right rear tire was flat.

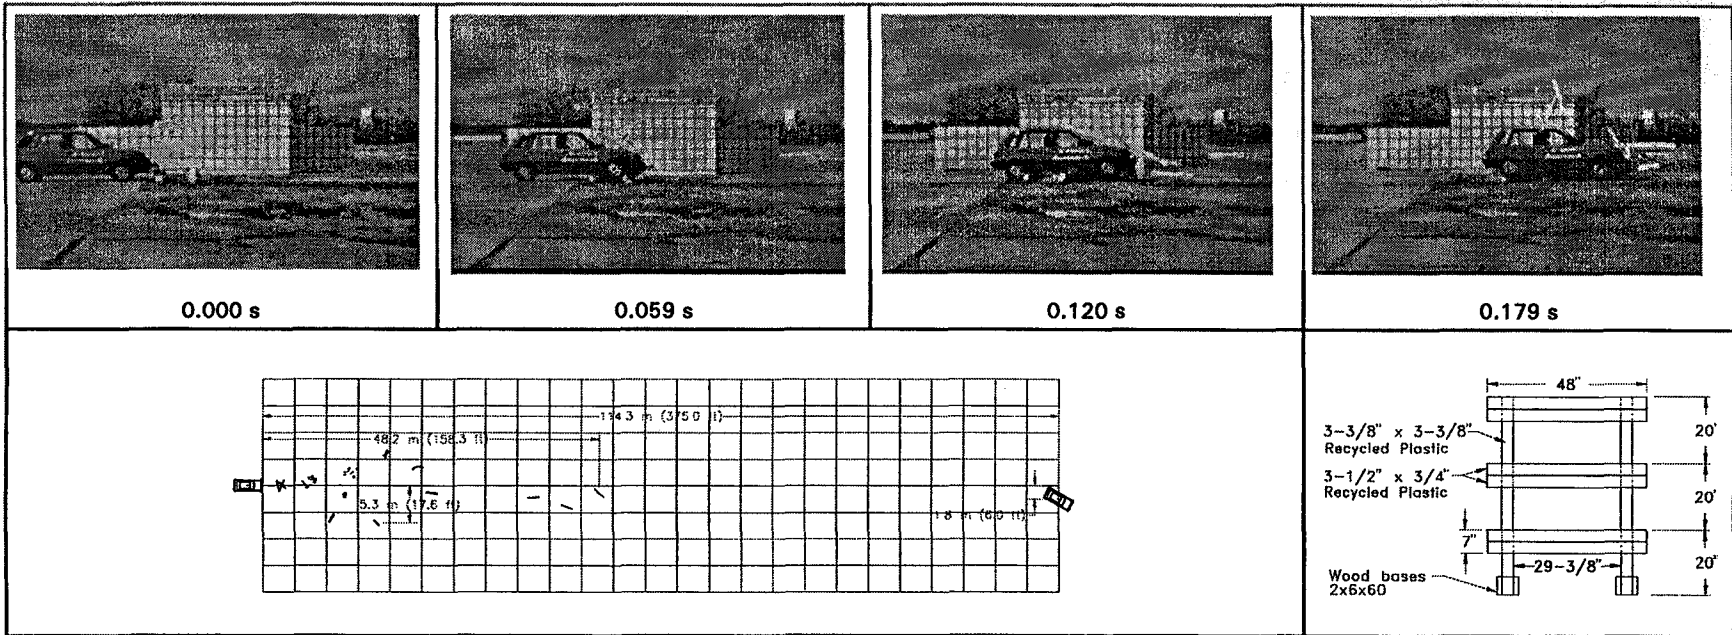
Figure 68. Summary of Results for Test No. 453880-3

A brief summary of the results of this test is presented in Figure 68. The hollow core recycled plastic vertical supports and rail elements separated from the solid recycled plastic base upon impact. The broken segments made contact with the hood and the windshield, but did not penetrate the occupant compartment. Sand and fragments of the barricade were scattered along an area 9.9 m wide by 48 m long. Most fragments were not large enough to pose potential hazard to oncoming traffic in adjacent lanes or to workers in the area. The vehicle sustained minor damage to the bumper, grill and hood. The longitudinal occupant impact velocity was 1.7 m/s and the highest 10-msec average ridedown acceleration was 3.4 g. There was no lateral occupant contact. The 50-msec average accelerations were -2.6 g in the longitudinal direction and -0.6 g in the lateral direction. The vehicle exited the immediate test site in a relatively smooth, stable manner and showed no potential for intrusion into adjacent traffic lanes.

In summary, the Type III barricade fabricated from hollow core recycled plastic material with a base constructed of solid recycled plastic material tested with wet soil condition was also judged to have met all evaluation criteria set forth in NCHRP Report 350.

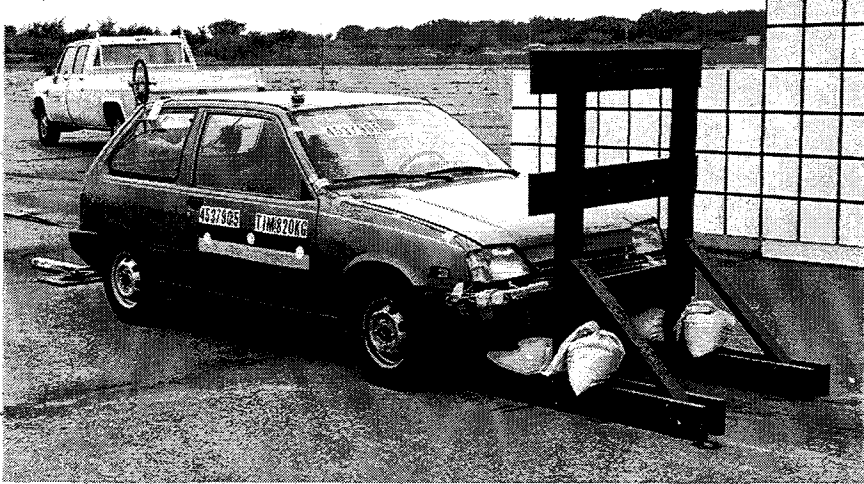
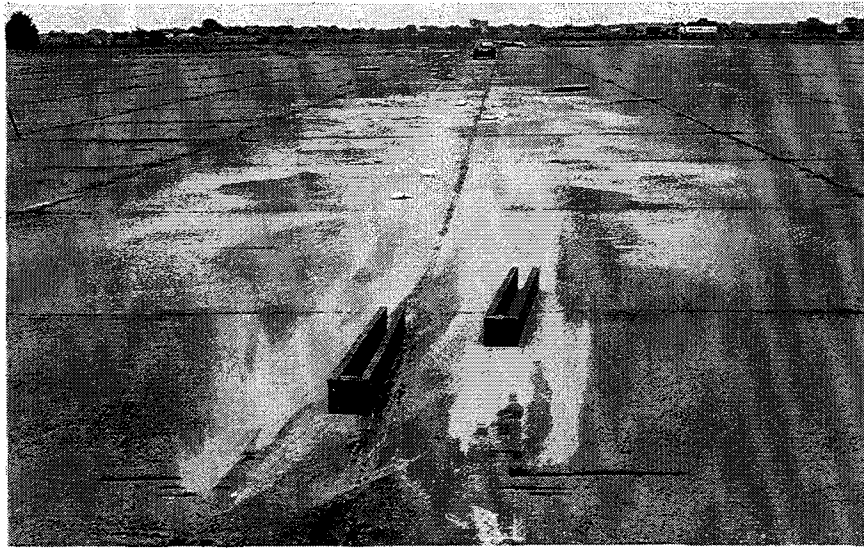
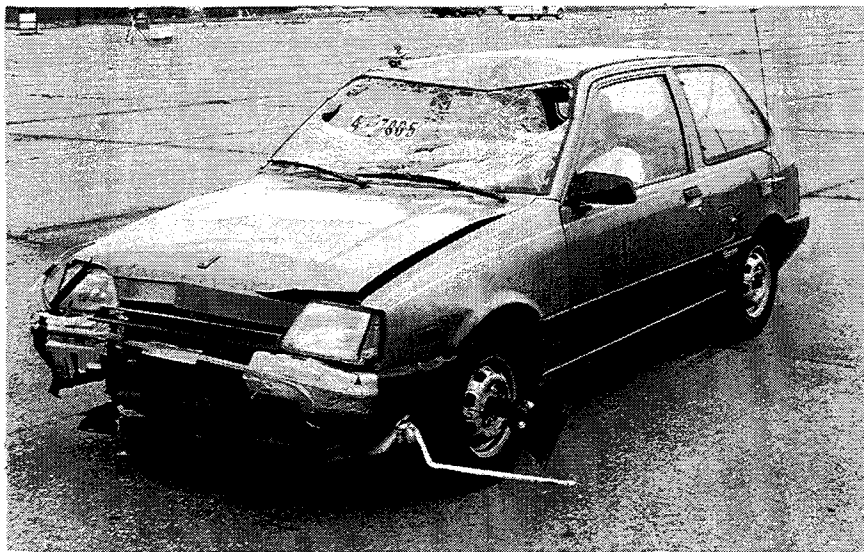
Figure 70. Vehicle and Barricade for Test No. 453790-5

As Figure 70 shows, the solid recycled plastic barricade shattered upon impact. Debris and sand were strewn along the path of the vehicle in an area 14.5 m wide by 63 m long. Figure 70 also shows damage to the vehicle. The bumper, grill, and hood of the vehicle were dented and scratched. The left side A-post was dented, the windshield was broken, and the roof was dented. Maximum exterior crush to the front of the vehicle at bumper height was 80 mm. Maximum intrusion into the occupant compartment (measured from high-speed film) was 259 mm near the head area of the driver. The maximum residual deformation into the occupant compartment was 61 mm.

In summary, the performance of the Type III barricade fabricated from solid recycled plastic material was judged to be unsatisfactory due to penetration of the windshield and the occupant compartment by a segment of the fractured vertical support.

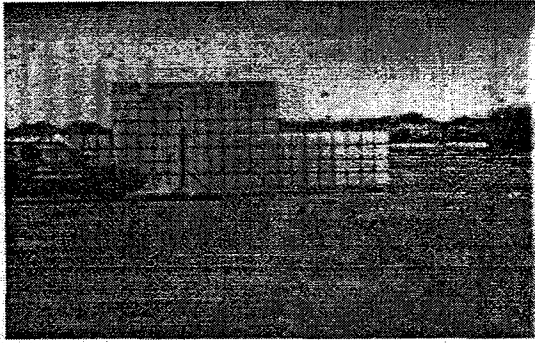
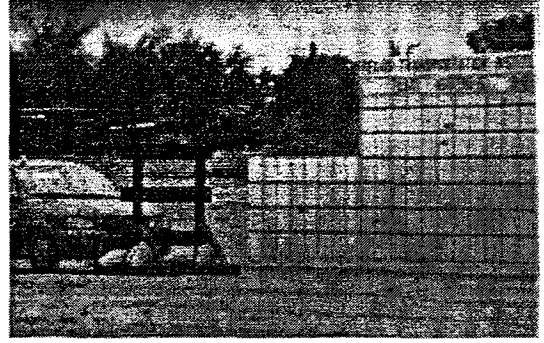
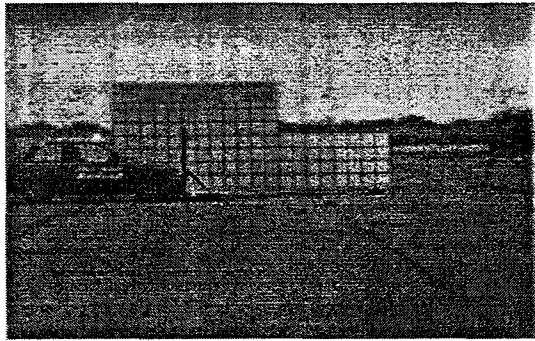
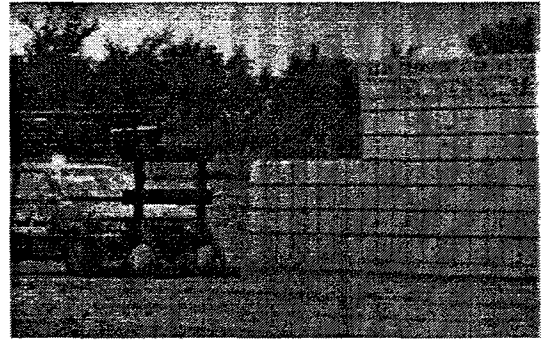
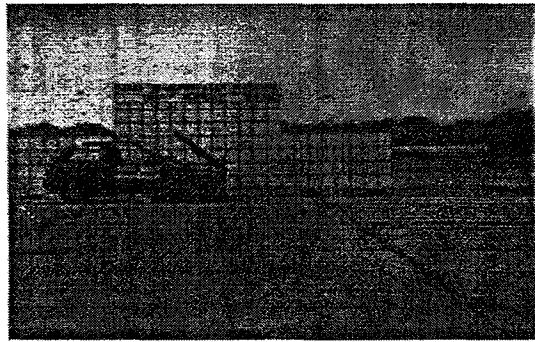
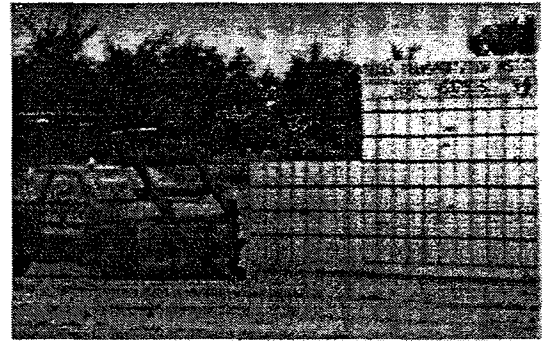
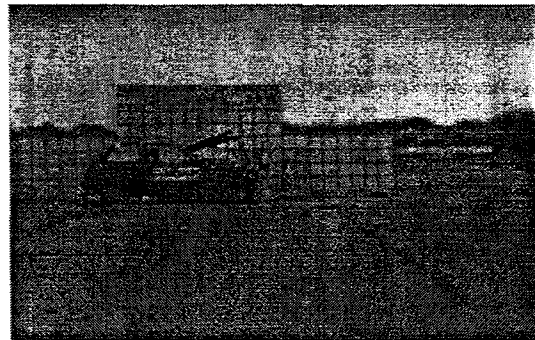
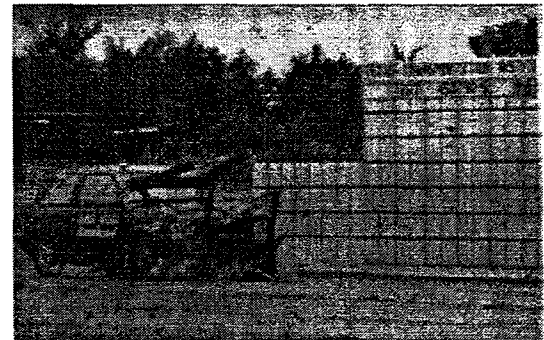
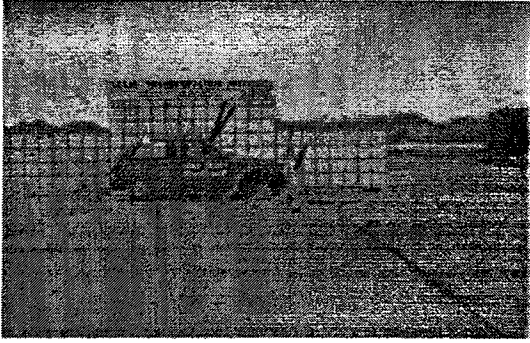
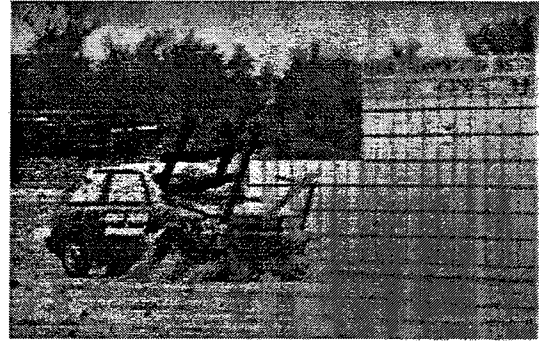
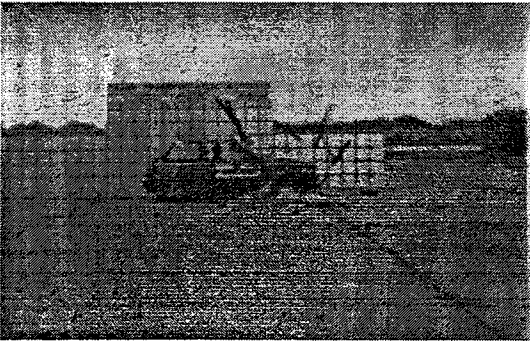
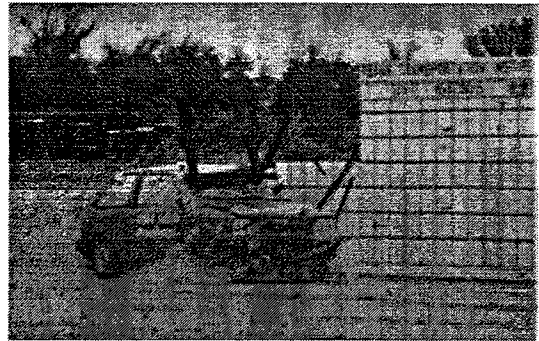
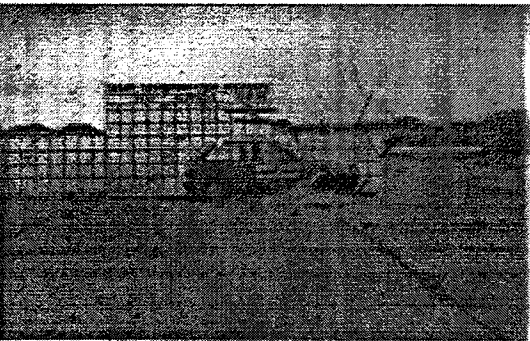
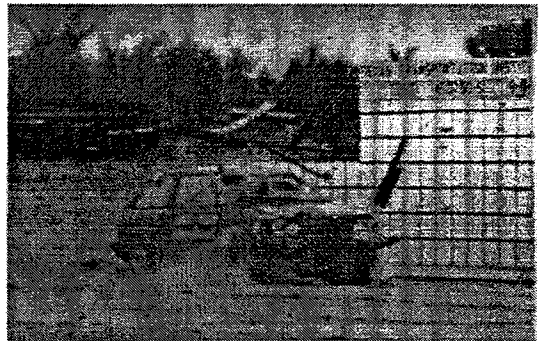
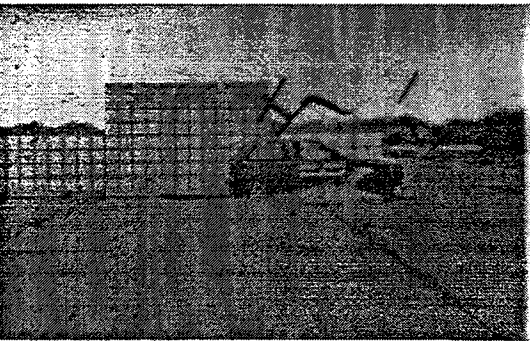
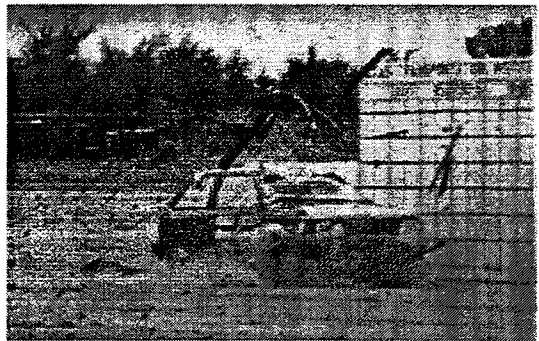
Figure 71. Sequential Photographs for Test No. 453790-5

At 5 msec after impact, the barricade shattered. At 47 msec, the fractured vertical support impacted and penetrated the windshield. The segment then went up over the vehicle and touched the roof. The vehicle lost contact with the barricade at 176 msec, traveling at a speed of 93.6 km/h. Prior to brake application, the vehicle was tracking straightforward. The vehicle subsequently came to rest 93 m down and 1.2 m to the left of the point of impact. Figure 71 shows sequential photographs of the test period.

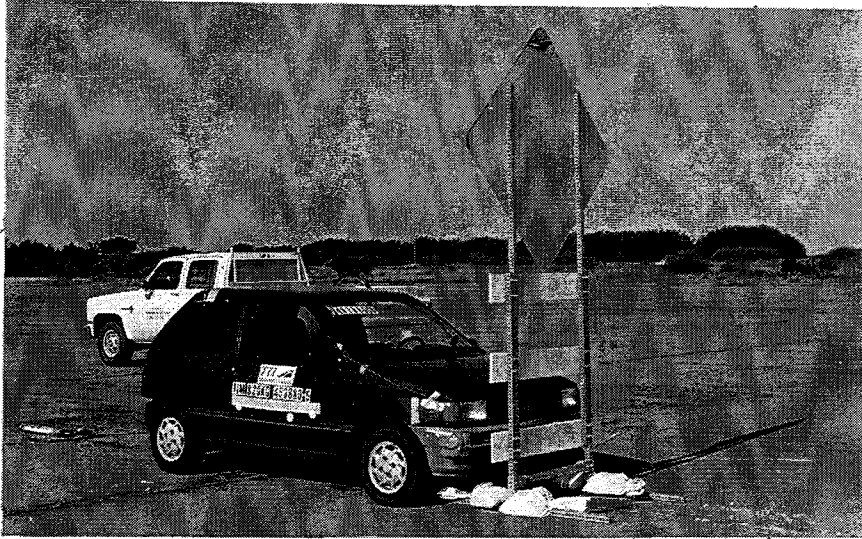
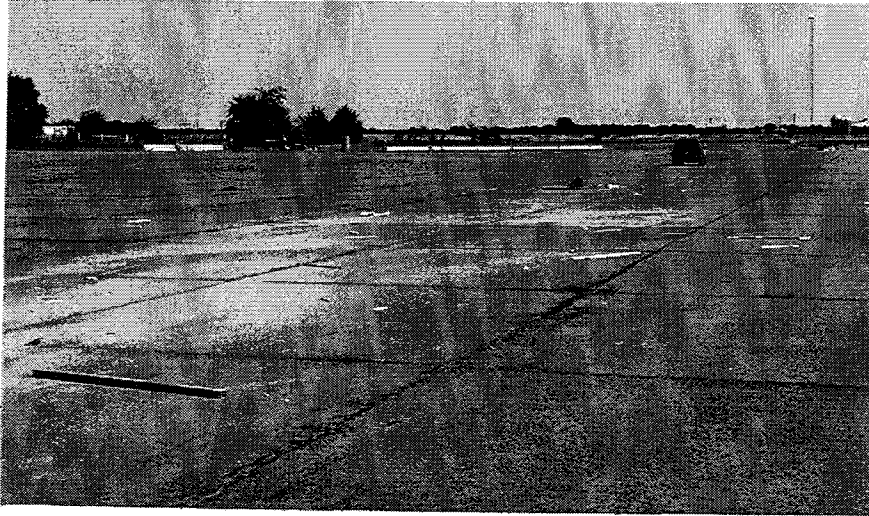
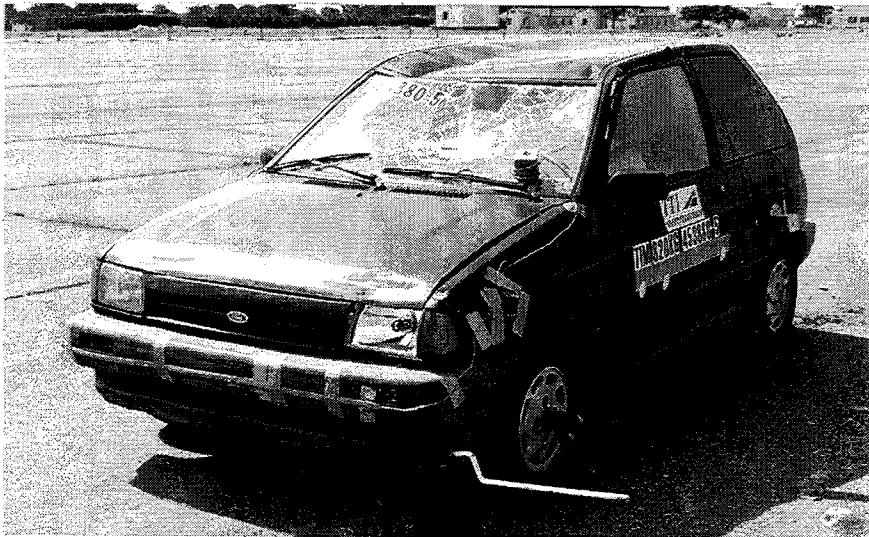
Figure 77. Vehicle and Barricade for Test No. 453880-5

As Figure 77 shows, the barricade and the sign attachment shattered upon impact. Debris and sand were strewn along the path of the vehicle in an area 14.6 m wide and 90.5 m long. Figure 77 also shows damage to the vehicle. There was damage to the hood, roof, and left headlight, but the damage was limited to minor scrapes. The windshield was shattered and deformed into the occupant compartment 51 mm.

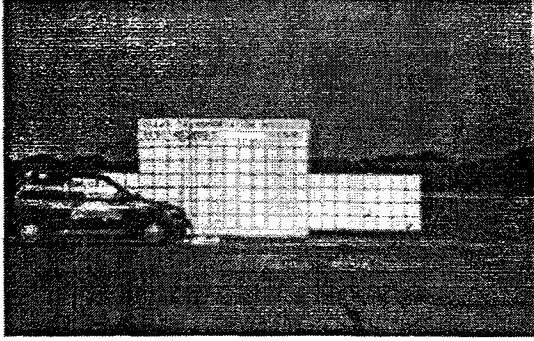
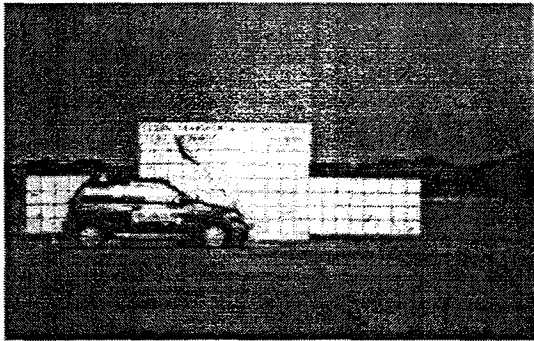
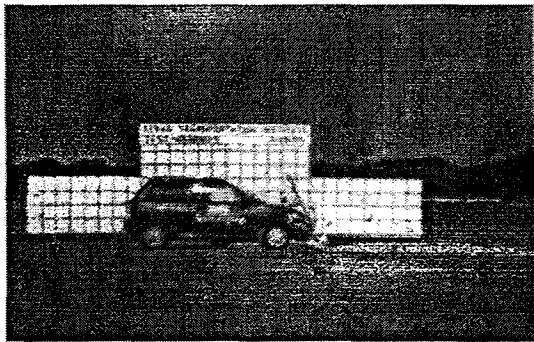
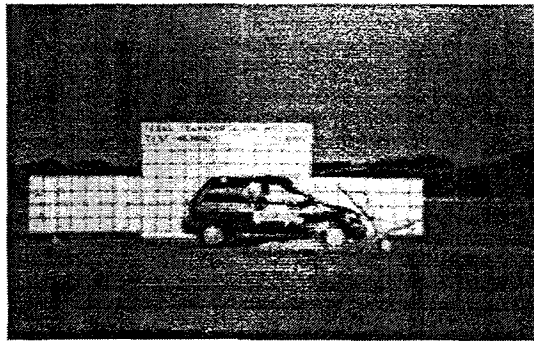
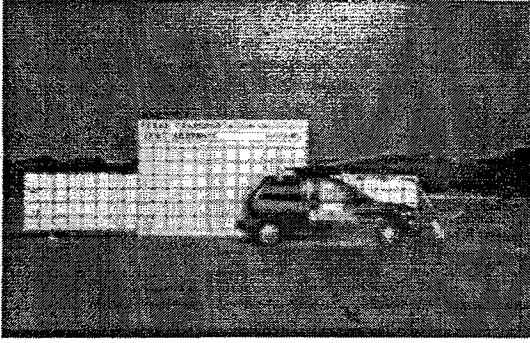
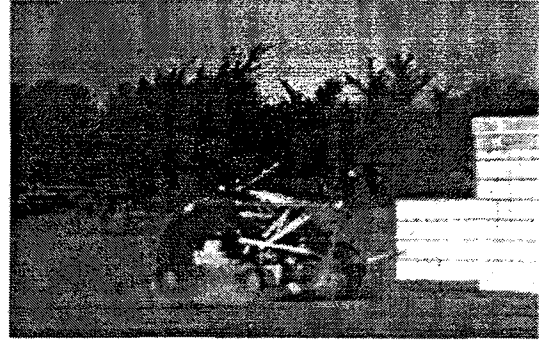
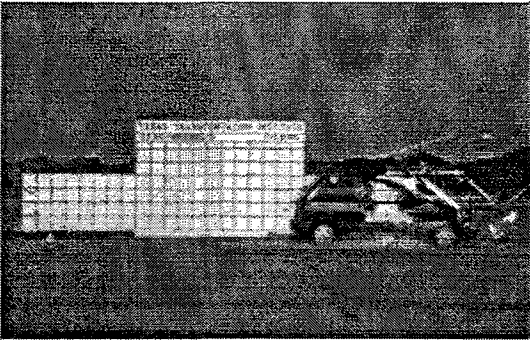
Figure 78. Sequential Photographs for Test No. 453880-5

As the vehicle impacted the barricade, the bottom rail element began to break and the vertical supports for the barricade began to bend. At 11 msec, the top and center rail elements began to break. At 24 msec, the right vertical support for the sign panel started to separate from the barricade. The right vertical support for the sign panel cleared the bumper and hood at 39 msec, and the left vertical supports for the sign panel and the barricade began to rise at 48 msec. The top of the sign panel contacted the roof at 71 msec. The bottom of the sign panel folded forward and subsequently contacted and penetrated the windshield at 97 msec. At 103 msec, the supports lost contact with the vehicle as it traveled at 86.9 km/h; however, the sign panel remained in contact with the roof. The left vertical support for the sign panel began to separate from the left vertical support of the barricade at 116 msec. At 258 msec, the right vertical support for the barricade began to separate from the base. Prior to brake application, the vehicle was tracking straightforward. The vehicle subsequently came to rest 78 m down and 3.2 m to the right of the point of impact. Figure 78 shows sequential photographs of the test period.

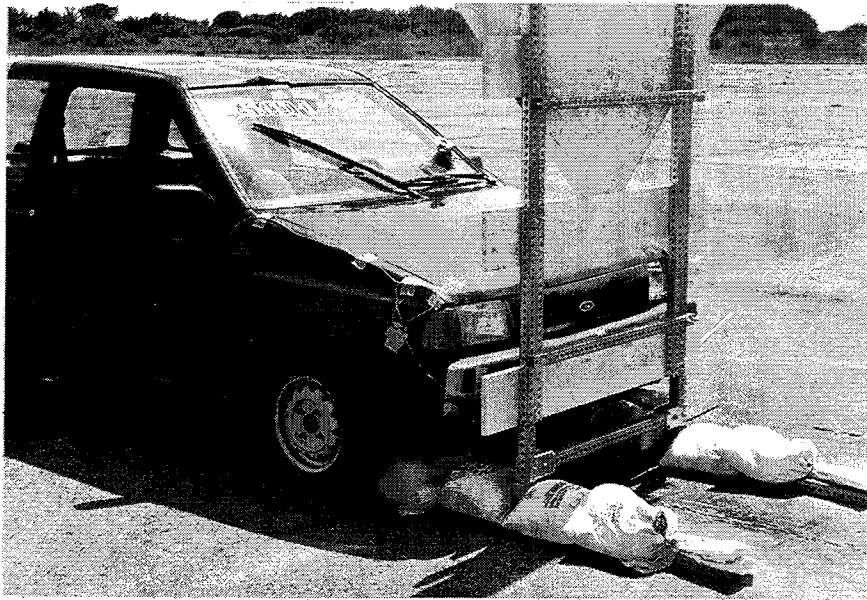
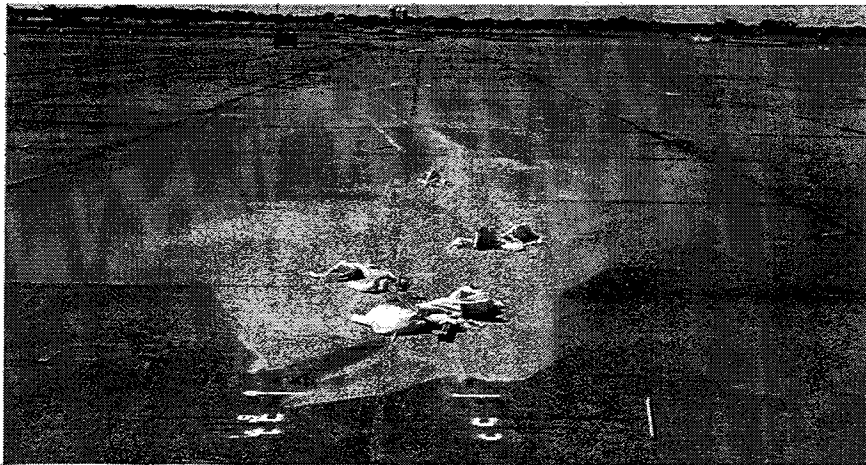
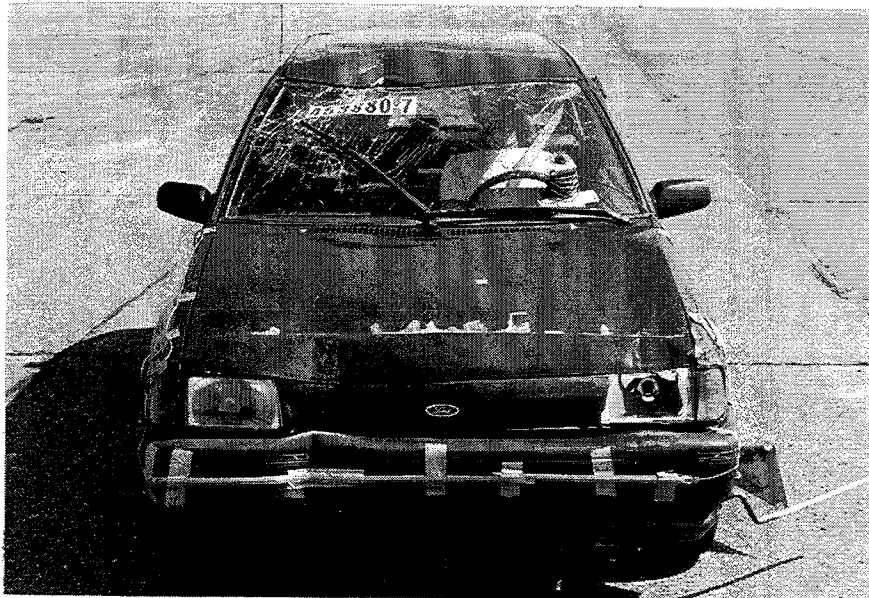
Figure 81. Vehicle and Barricade for Test No. 453880-7

As Figure 81 shows, the vertical supports and the sign attachment separated from the barricade upon impact. Debris and sand were strewn along the path of the vehicle in an area 15.2 m wide and 87.8 m long. Damage to the vehicle is also shown in Figure 81. Maximum crush to the front exterior of the vehicle was not measurable (scrapes only). There was damage to the hood and roof. The windshield was shattered, and the roof was deformed 41mm into the occupant compartment.

Figure 83 presents a brief summary of the results of this test. The vertical supports and the sign panel attachment separated from the barricade upon impact. Broken segments of the barricade made contact with the hood and shattered the windshield and deformed the roof into the occupant compartment by 41 mm, but there was no penetration into the occupant compartment. Debris from the barricade was thrown along an area 15.2 m wide and 87.8 m long. The barricade vertical supports and the sign panel attachment were carried forward by the vehicle as a single unit, and it could pose potential hazard to oncoming traffic in adjacent lanes or to workers in the area, although it remained mostly in the path of the vehicle. The vehicle sustained minor damage to the hood and roof; however, the windshield was shattered. Crush to the center front bumper was not measurable. The longitudinal occupant impact velocity was 2.2 m/s, and the highest 10-msec average ridedown acceleration was 0.3 g. There was no contact in the lateral direction. The 50-msec average accelerations were -3.7 g in the longitudinal direction and 1.7 g in the lateral direction. The vehicle exited the immediate test site in a relatively smooth, stable manner and showed no potential for intrusion into adjacent traffic lanes. This crash test was judged to be successful; however, due to the potential hazard associated with the barricade vertical supports and sign panel attachment being carried forward as a single unit by the impacting vehicle, this sign panel attachment mechanism is not recommended for implementation.

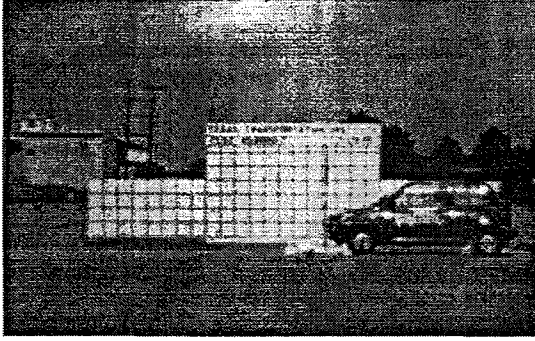
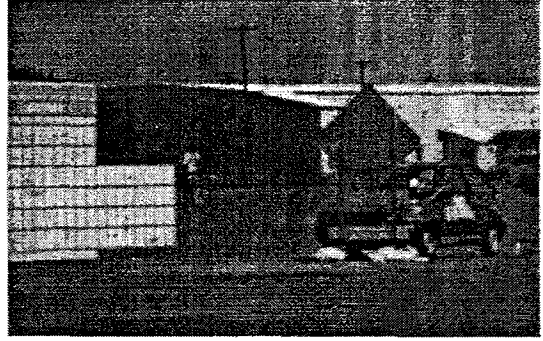
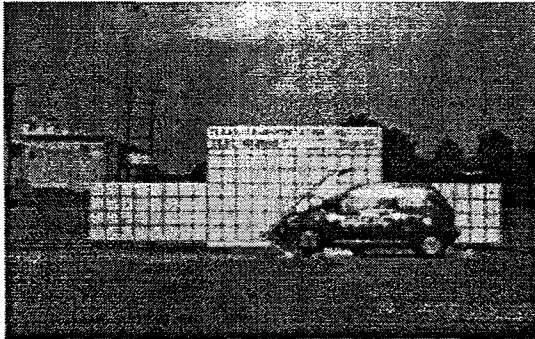
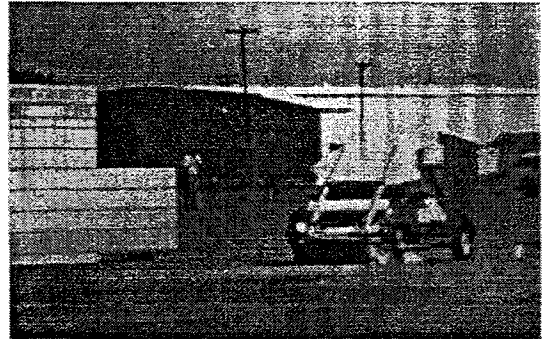
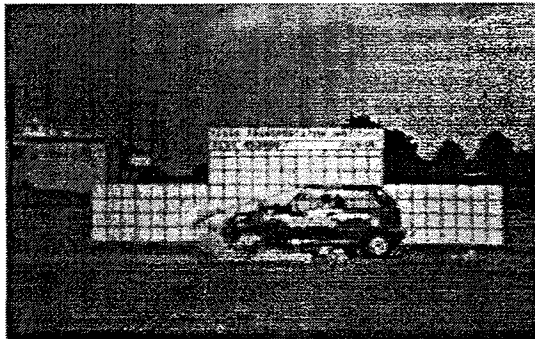
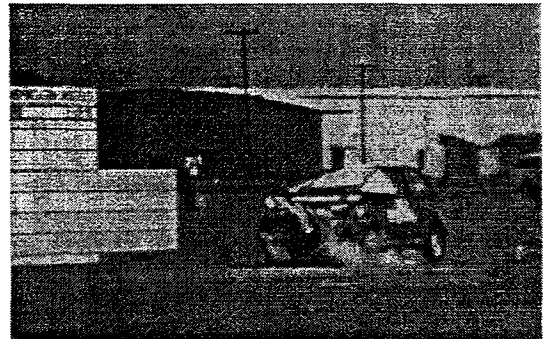
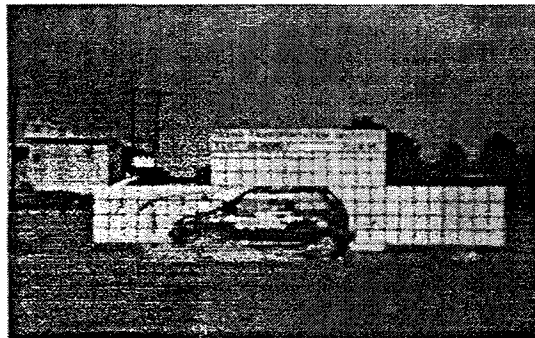
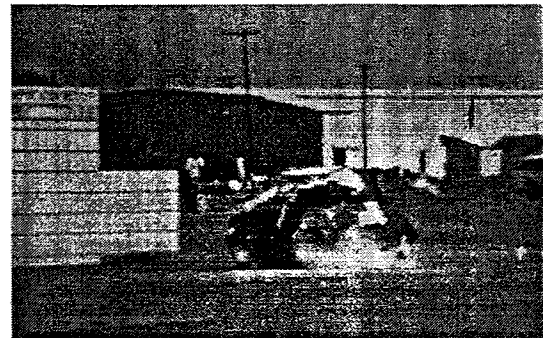
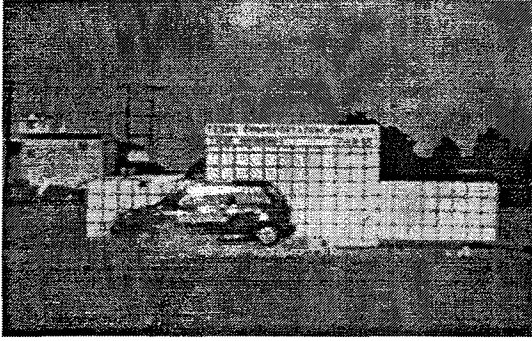
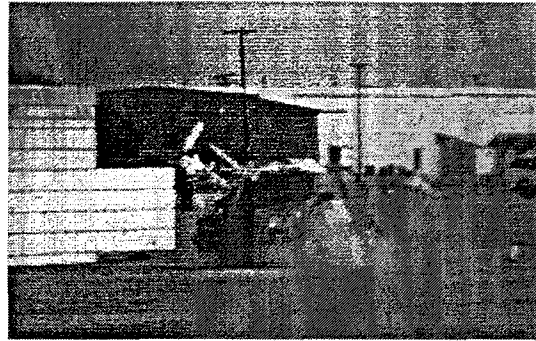
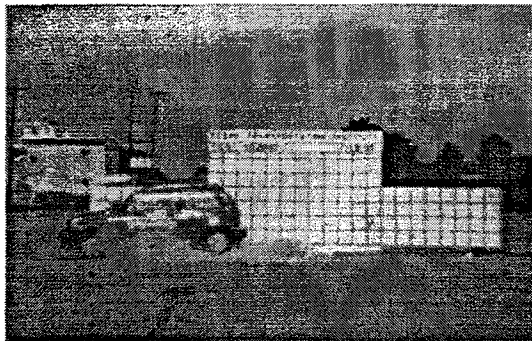
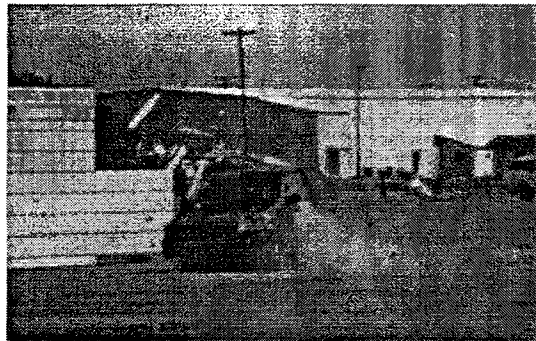
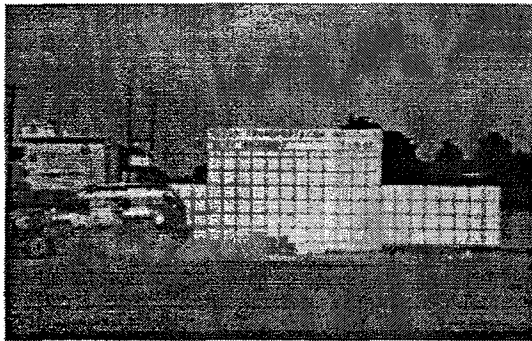
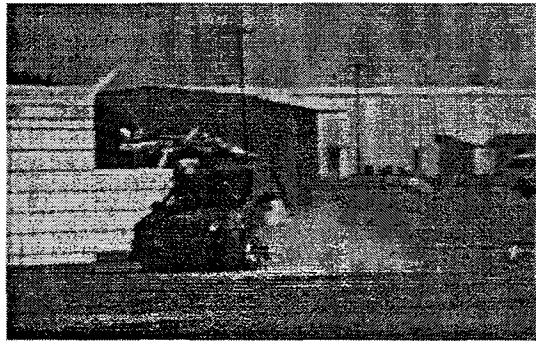
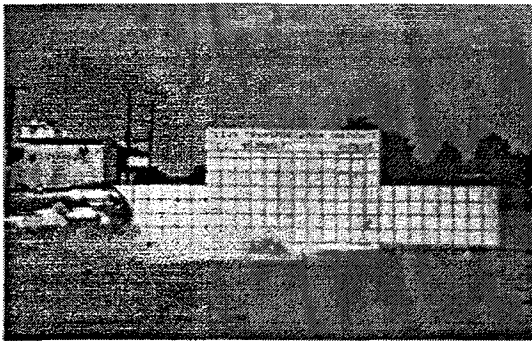
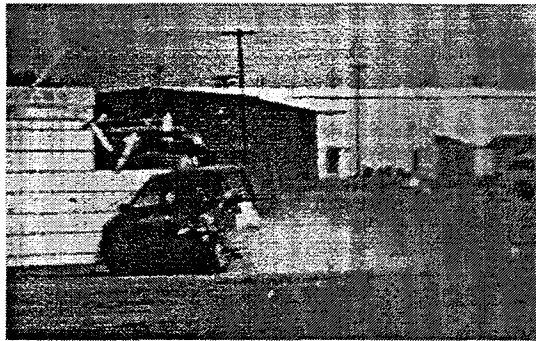
Figure 82. Sequential Photographs for Test No. 453880-7

As the vehicle impacted the barricade, the bottom panel began to break, and the vertical supports began to bend. At 39 msec, the bottom of the sign panel contacted the hood near the windshield. The supports lost contact with the bumper at 47 msec, and the sign panel contacted the windshield at 56 msec. At 130 msec, the sign panel lost contact with the windshield as the vehicle was traveling at 87.0 km/h, and the panel continued to travel in front of the vehicle. Prior to brake application, the vehicle was tracking straightforward. The vehicle subsequently came to rest 91 m down and 9.1 m to the right of the point of impact. Figure 82 shows sequential photographs of the test period.
