1. Report No. TX-96/5388-1F		2. Government Accession No.		3. Recipient's Catalog No.	
4. Title and Subtitle EVALUATION OF WORK ZONE BARRICADES AND TEMPORARY SIGN SUPPORTS				5. Report Date February 1996

EVALUATION OF WORK ZONE BARRICADES AND TEMPORARY SIGN SUPPORTS

Report No. 5388-1F
Research Study No. 585xxA3014
Research Study Title: Development of New Designs for Barricades
and Sign Supports in Work Zones

February 1996

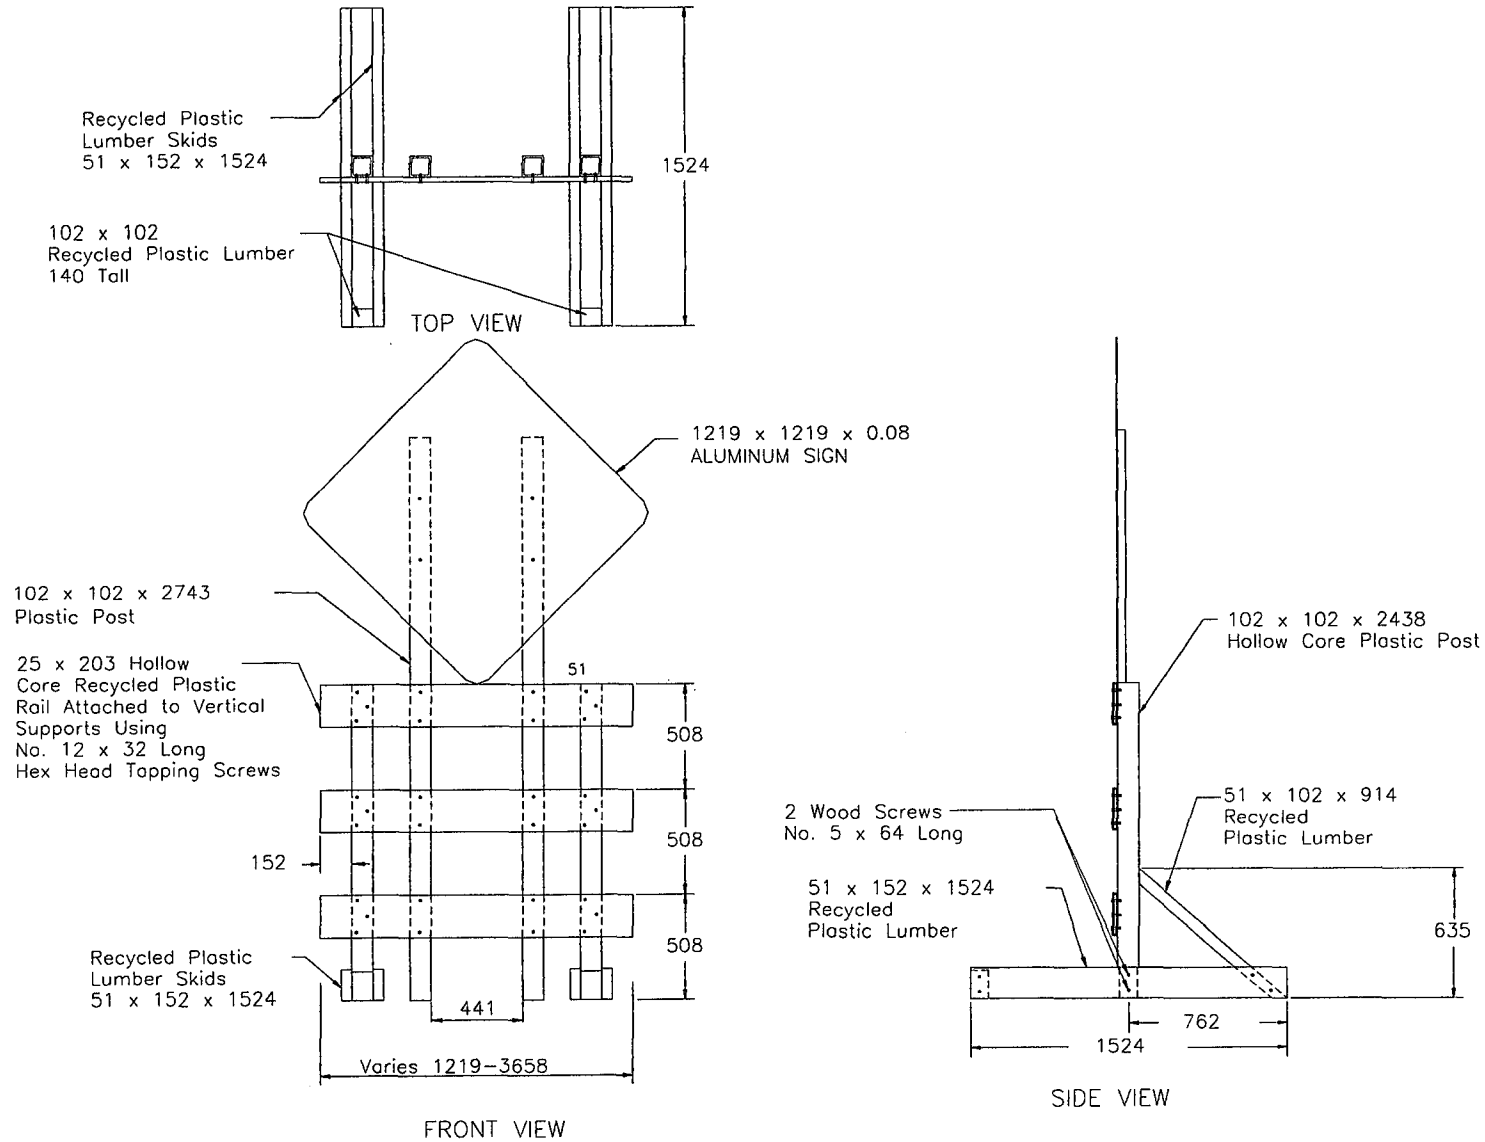
Figure 84. Schematic of Type III Barricade Fabricated from Hollow Core Recycled Plastic Material with Solid Recycled Base and Sign Panel (Test No. 453880-6)

It was observed in the high-speed film that the bottom corner of the aluminum sign panel bent and folded in a manner similar to that observed in a previous test with the perforated tubing using the same 1.52-m mounting height (test no. 453880-5). Therefore, although no intrusion into the occupant compartment was observed in this test, it is the opinion of the researchers that the potential for the corner of the sign panel shattering and penetrating the windshield should be addressed. As with the perforated tubing design, two options are available for eliminating this behavior:

The simpler and more economical of the two modifications is to lower the mounting height by 51 mm and to attach it to the horizontal cross member, as shown in Figure 84. In the opinion of the researchers, modification of the existing hollow core recycled plastic barricade design is not necessary for a 2.13-m mounting height, since the sign panel should not contact the windshield of the impacting vehicle.

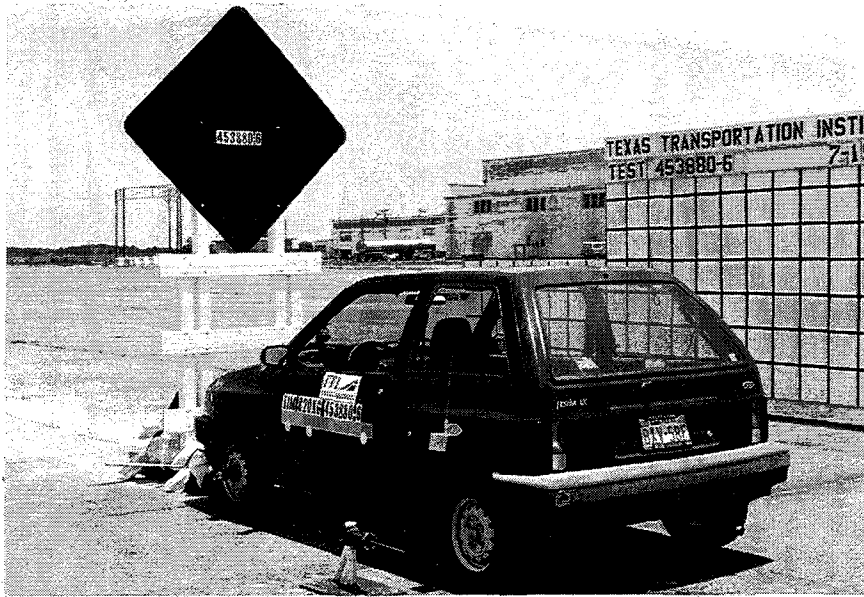
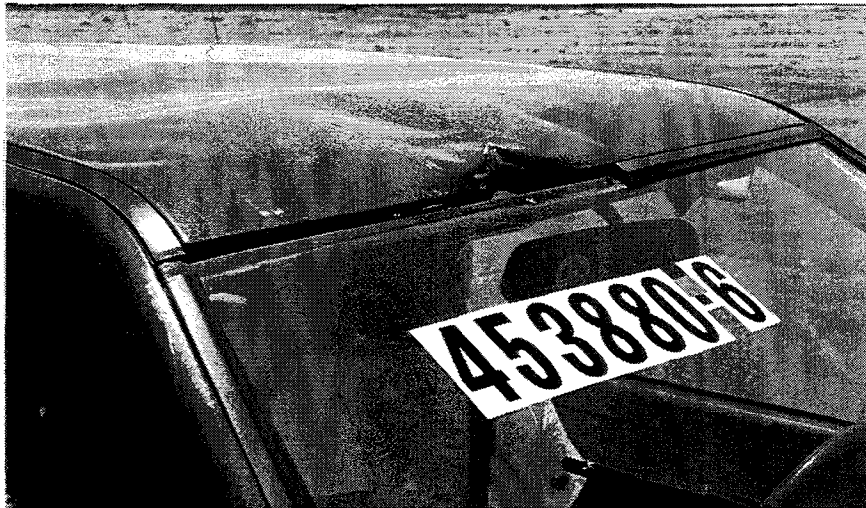
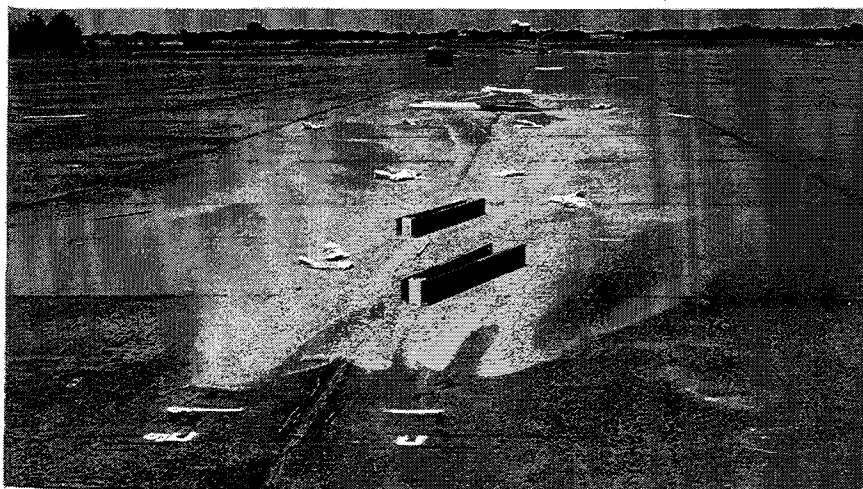
Figure 85. Vehicle and Barricade for Test No. 453880-6

As Figure 85 shows, the barricade shattered upon impact. Debris and sand were strewn along the path of the vehicle in an area 13.0 m wide and 83.2 m long. Figure 85 shows damage to the vehicle. Maximum crush to the exterior of the vehicle was 70 mm on the passenger side just above the windshield. There was scrapes on the hood and roof. There was no deformation or intrusion into the occupant compartment.

A brief summary of the results of this test is presented in Figure 87. The barricade shattered upon impact, and broken segments of the barricade made contact with the hood and roof. However, the fragments neither penetrated nor intruded into the occupant compartment. Debris from the barricade was thrown along an area 13.0 m wide and 83.2 m long. Most fragments were not large enough to pose a potential hazard to oncoming traffic in adjacent lanes or to workers in the area. The vehicle sustained minor damage to the hood and roof. Maximum crush was 70 mm. The longitudinal occupant impact velocity was 2.6 m/s, and the highest 10-msec average ridedown acceleration was -3.8 g. There was no contact in the lateral direction. The 50-msec average accelerations were -5.0 g in the longitudinal direction and -2.8 g in the lateral direction. The vehicle exited the immediate test site in a relatively smooth, stable manner and showed no potential for intrusion into adjacent traffic lanes. This crash test was considered satisfactory.

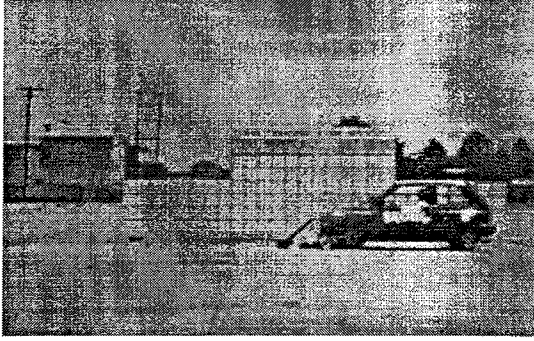
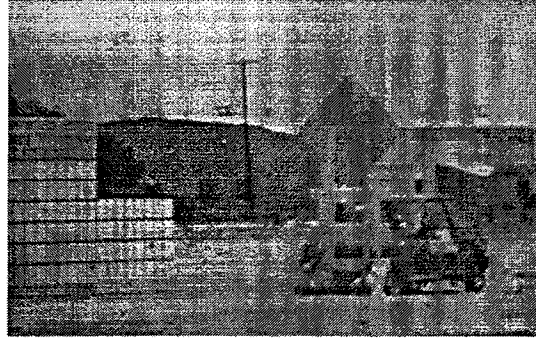
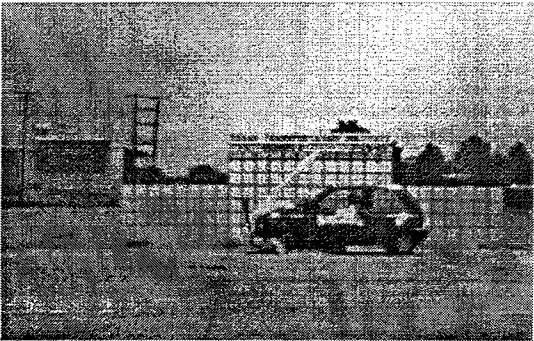
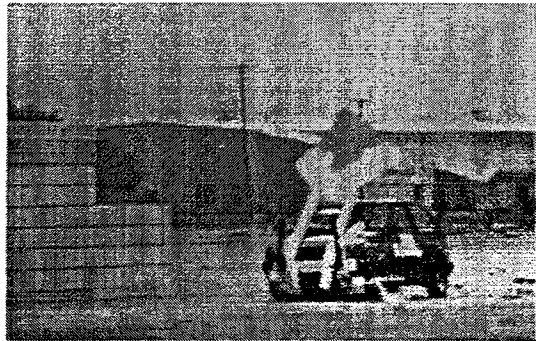
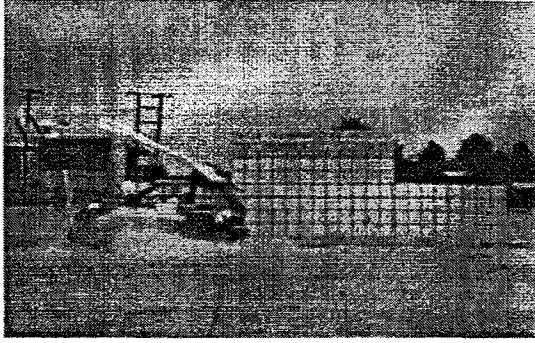
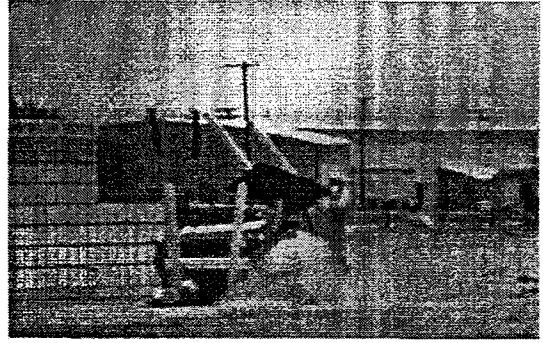
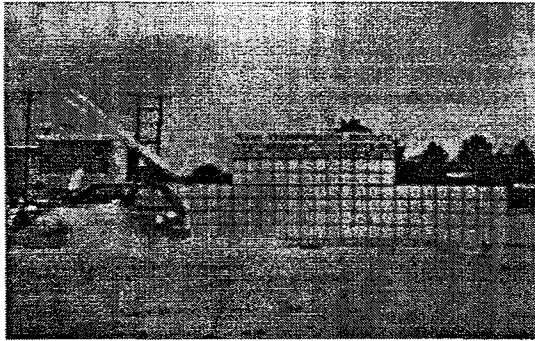
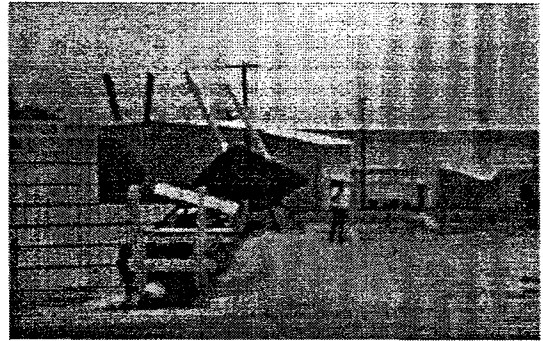
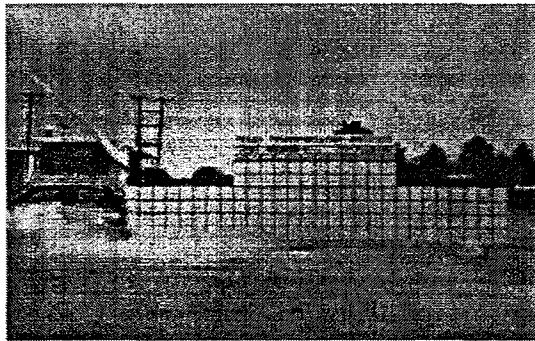
Figure 86. Sequential Photographs for Test No. 453880-6

separated from the base at 152 msec. The vehicle lost contact with the barricade at 199 msec, traveling at a speed of 87.2 km/h. Prior to brake application, the vehicle was tracking straight-forward. The vehicle subsequently came to rest 80 m down and 5.7 m to the right of the point of impact. Figure 86 shows sequential photographs of the test period.
