IMPACT BEHAVIOR OF SIGN SUPPORTS

A PROGRESS REPORT

Research Report Number 68-1

Sign Support Structures
Research Project Number 2-5-63-68

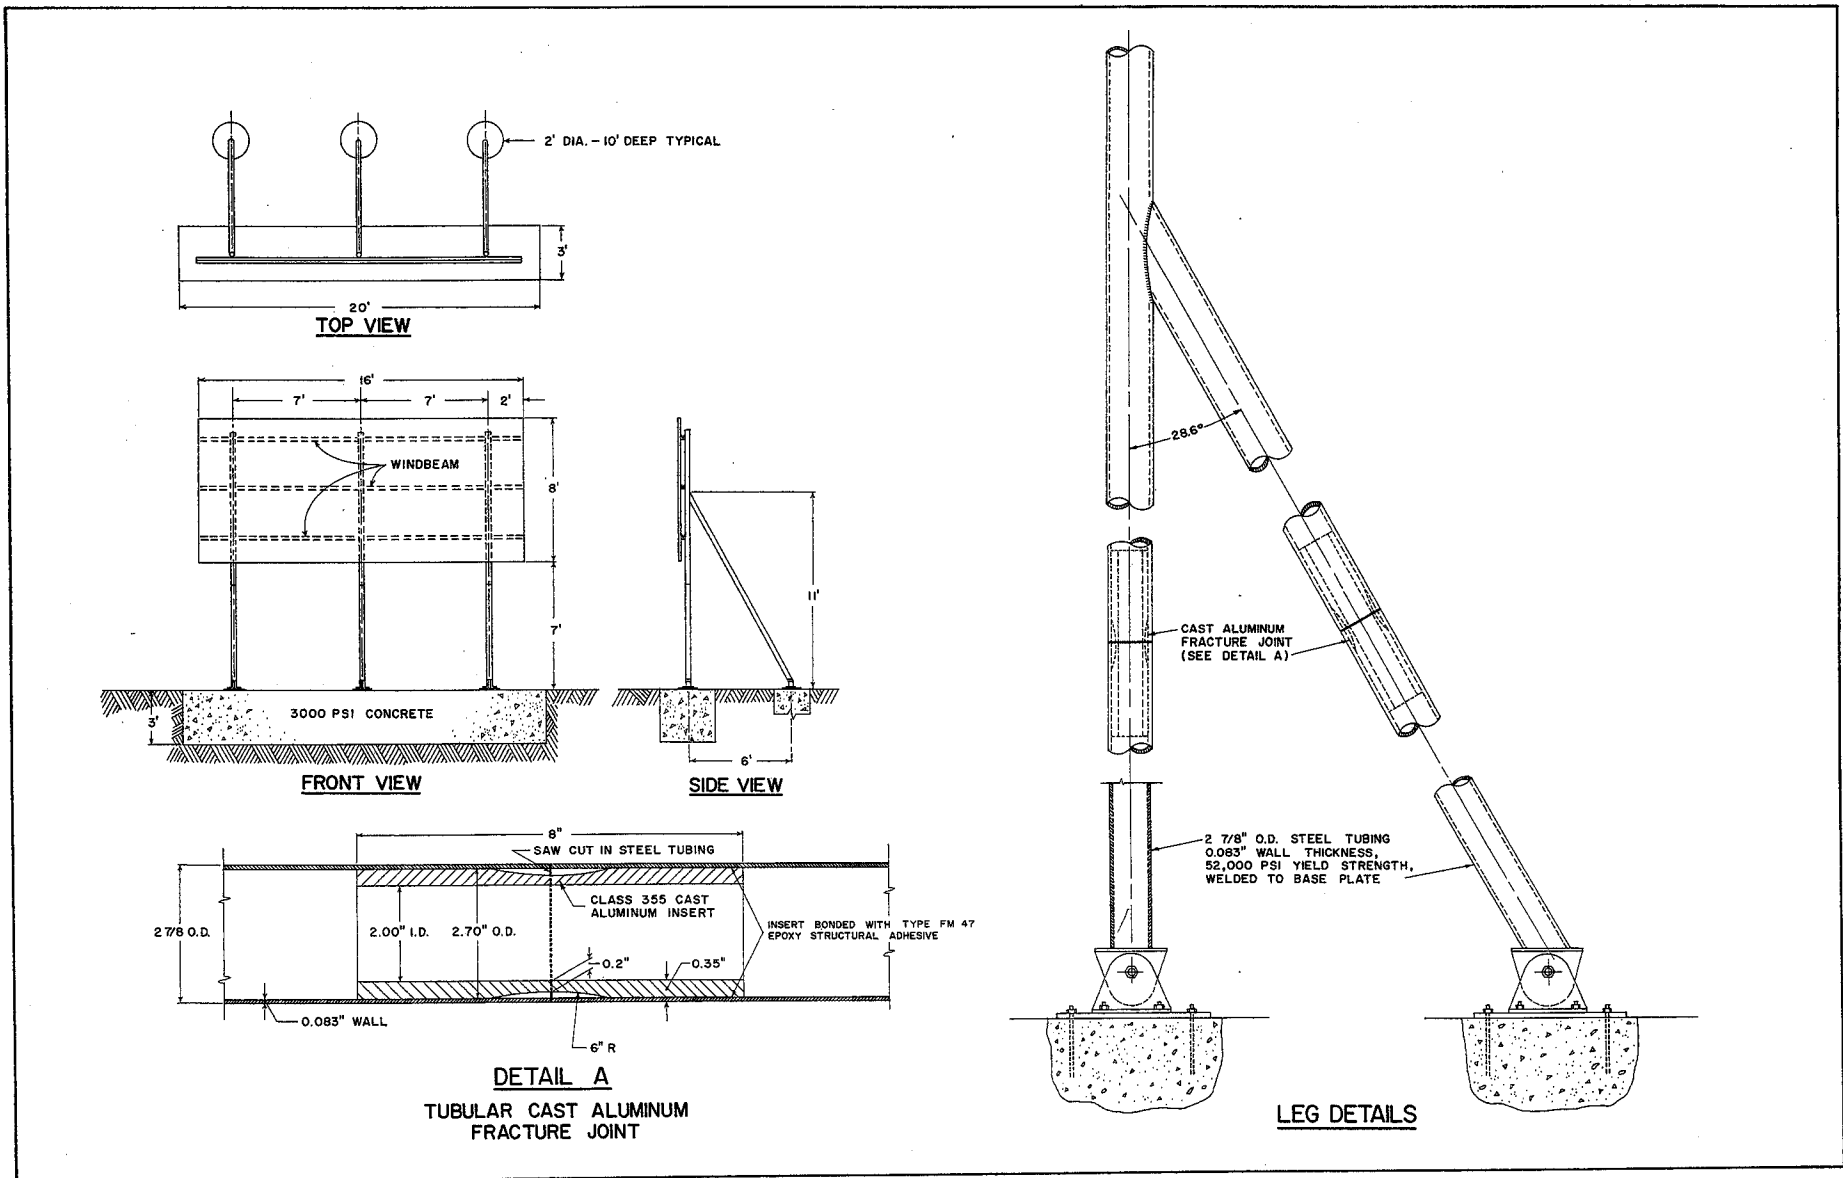
FIGURE 2

As indicated above, the first crash test was conducted by striking a braced-leg type support. The support was designed in accordance with AASHQ specifications to withstand a 100 mph wind. Both the leg and the brace were made of steel tubing having an outside diameter of 2-7/8 inches, a wall thickness of 0.083 inches, and a yield strength of 52,000 psi. Details of the design are shown in Figure 2. The objective in this design was to reduce the mass and rigidity required by a single vertical support. It was understandable that the thin wall tubing employed in the design should buckle under the force of the impact, and a cast aluminum fracture joint was placed in each leg and brace at 6-1/2 feet above the foundation to produce impact failure.

A careful study of the high-speed motion picture film of the crash indicated that the vertical leg failed first due to excessive deformation. Next the tubular leg was torn from its base plate, and finally failure occurred at the fracture joint. When failure of the fracture joint occurred it appeared that energy stored in the leg and in the sheet metal of the automobile caused the lower portion of the leg to proceed ahead of the automobile, striking the brace member causing a failure at the fracture joint of the brace prior to impact by the vehicle with the brace. When the vehicle made contact with the brace, the tubing failed due to excessive deformation, and there was a slight tendency for the tube to wrap around the bumper of the vehicle which, in turn, caused a failure at the weld holding the base plate to the lower end of the brace. Both pieces of the support removed by the vehicle were thrown forward in front of the vehicle some distance and were then struck repeatedly by the vehicle. They finally came to rest approximately 250 feet beyond the sign. Sequence photographs of this crash are shown in Figure 3.

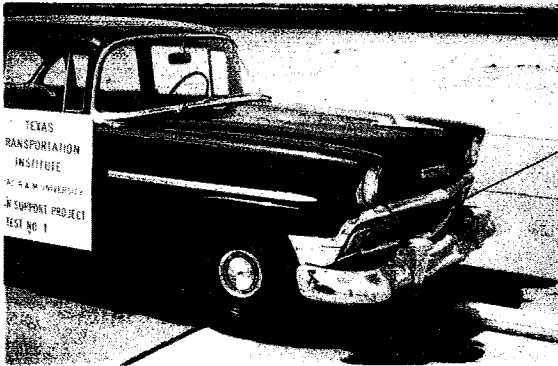
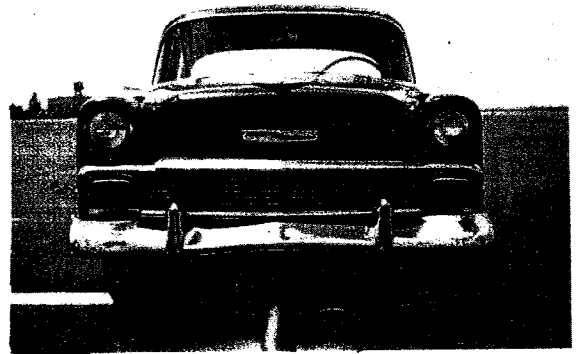
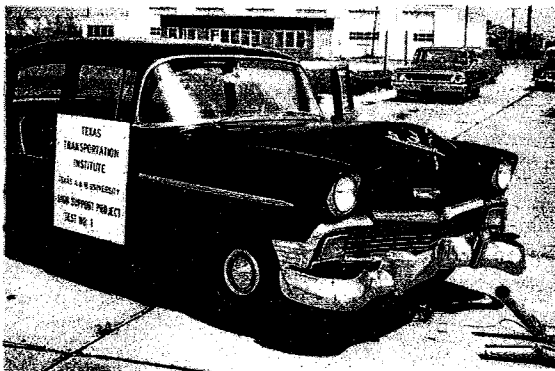
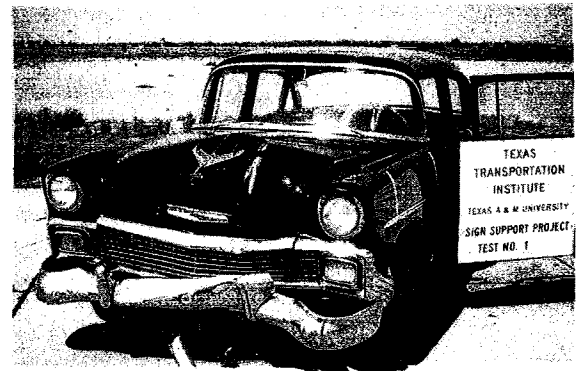
FIGURE 4 — VIEWS OF VEHICLE TEST NO. 1

was negligible, especially when considered in terms of personal injury. There was no detectable deceleration of the vehicle due to the impact. Damage was limited to the bumper, gravel shield, grill and hood. The radiator was not damaged nor was it displaced in its harness. It was the general opinion of those observing the crash and the films that the driver possibly could have regained control of the automobile after the crash occurred. The vehicle traveled more than 350 feet following impact.

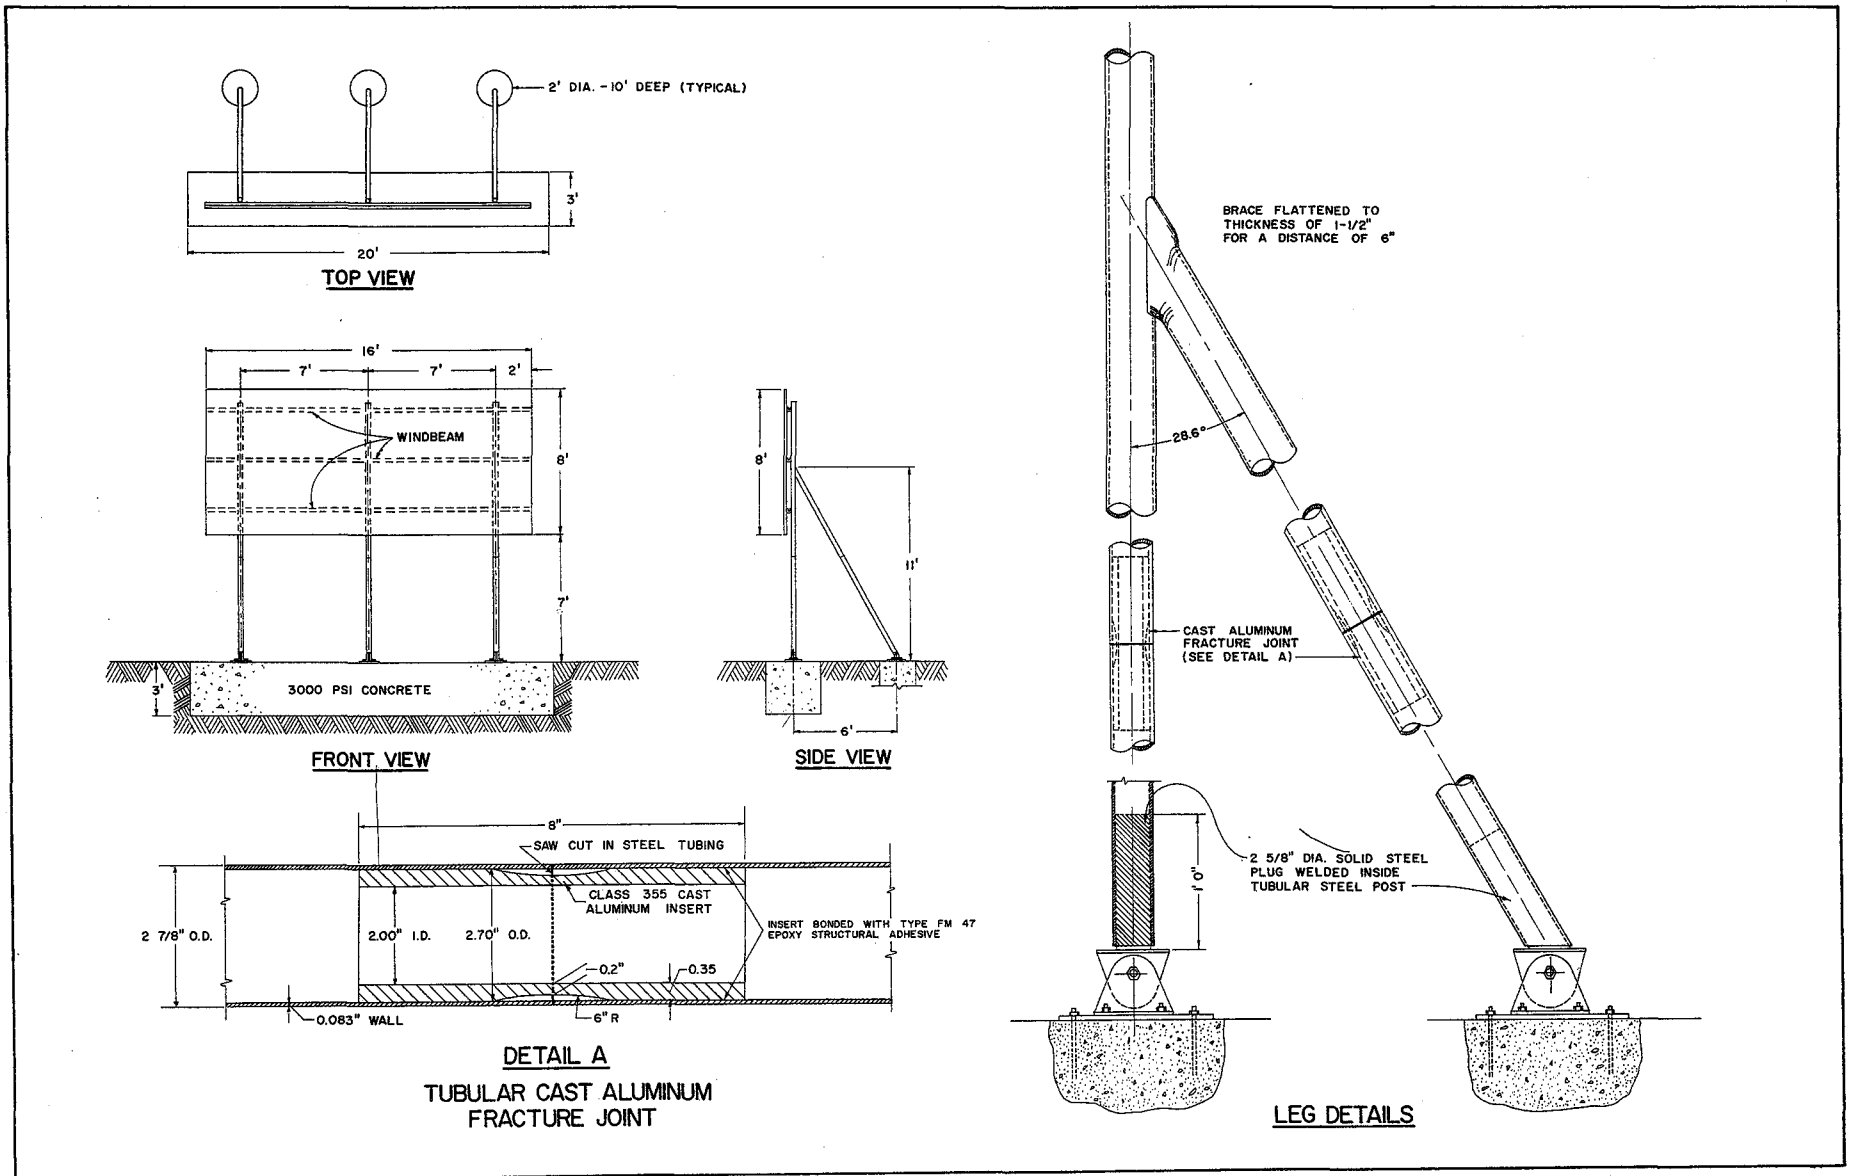
FIGURE 5

The type of sign support used in this test differed from the braced-leg structure in the first test in that the lower section of the legs and the brace were "plugged" with a round steel bar 2-5/8 inches in diameter and 12 inches in length, details of which are shown in Figure 5. This variation in the braced-leg structure was devised in an effort to contain the portion of the support below the fracture joint and prevent it from being thrown through the air like a projectile. The steel plug was inserted in order to strengthen and add mass to the leg and brace at the base plate where failure had occurred in the previous test. This mass below the bumper level would conceivably retain the lower portion of the leg until failure had occurred at the fracture joint and then the vehicle would pass over the lower portions of the support leaving them attached to the foundation.

A study of the high speed motion picture film of this test revealed that the vertical leg failed by excessive deformation due to impact. (Sequence photographs of the crash are shown in Figure 6.) As this failure progressed the aluminum fracture joint insert was pulled out of the upper portion of the vertical leg. There was evidence that the cast aluminum insert used to form the fracture joint was not completely bonded to the inside wall of the tubing. Apparently the amount of epoxy used in bonding the insert was not sufficient to completely fill the space between the cast insert and the inside wall of the tubing. Finally, the brace was torn loose from the foundation due to shearing of the bolt which pinned the brace to the foundation.

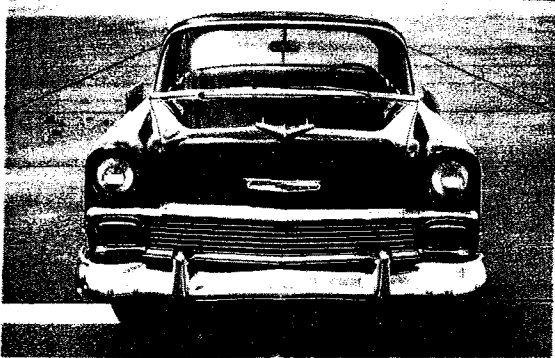
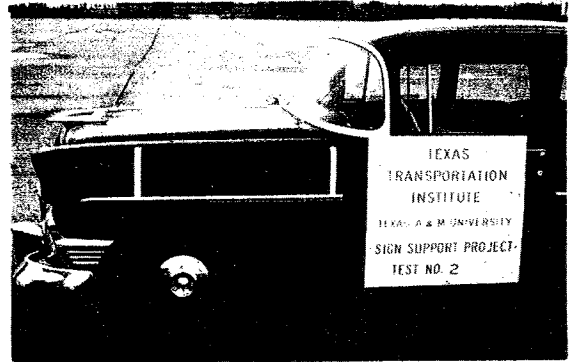
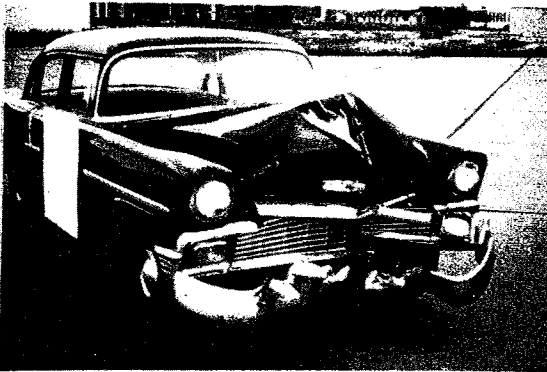
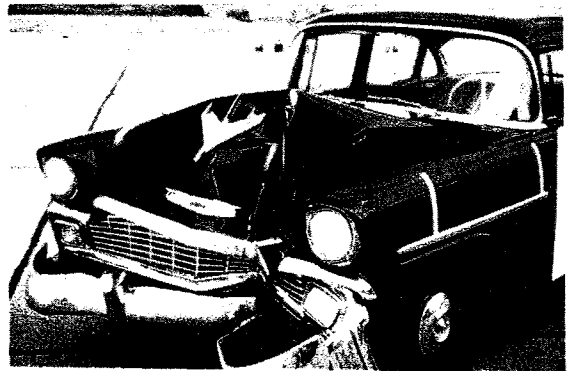
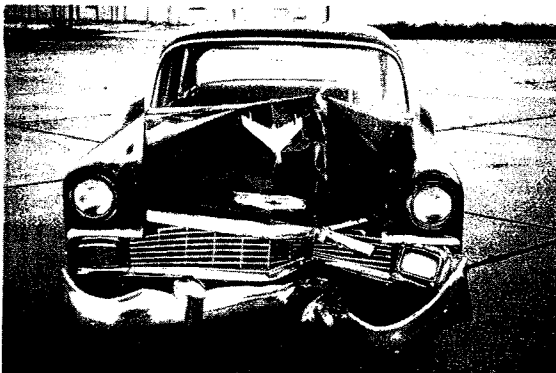
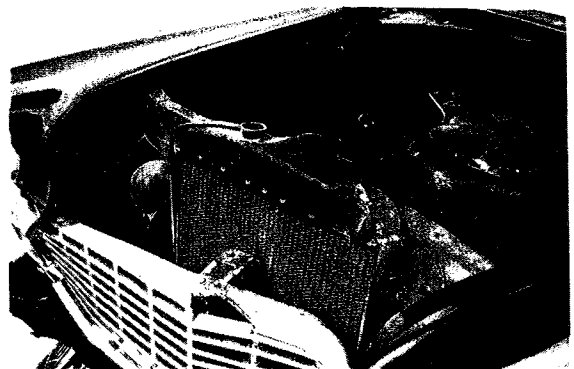
FIGURE 7 — VIEWS OF VEHICLE TEST NO. 2

vehicle due to the impact. As the photographs in Figure 7 will indicate the bumper, gravel shield, grill, and hood were damaged more extensively, and the radiator was slightly displaced in its harness. The film showed that this interior damage was caused primarily by the brace rather than the leg of the support. The vehicle traveled more than 350 feet following impact.

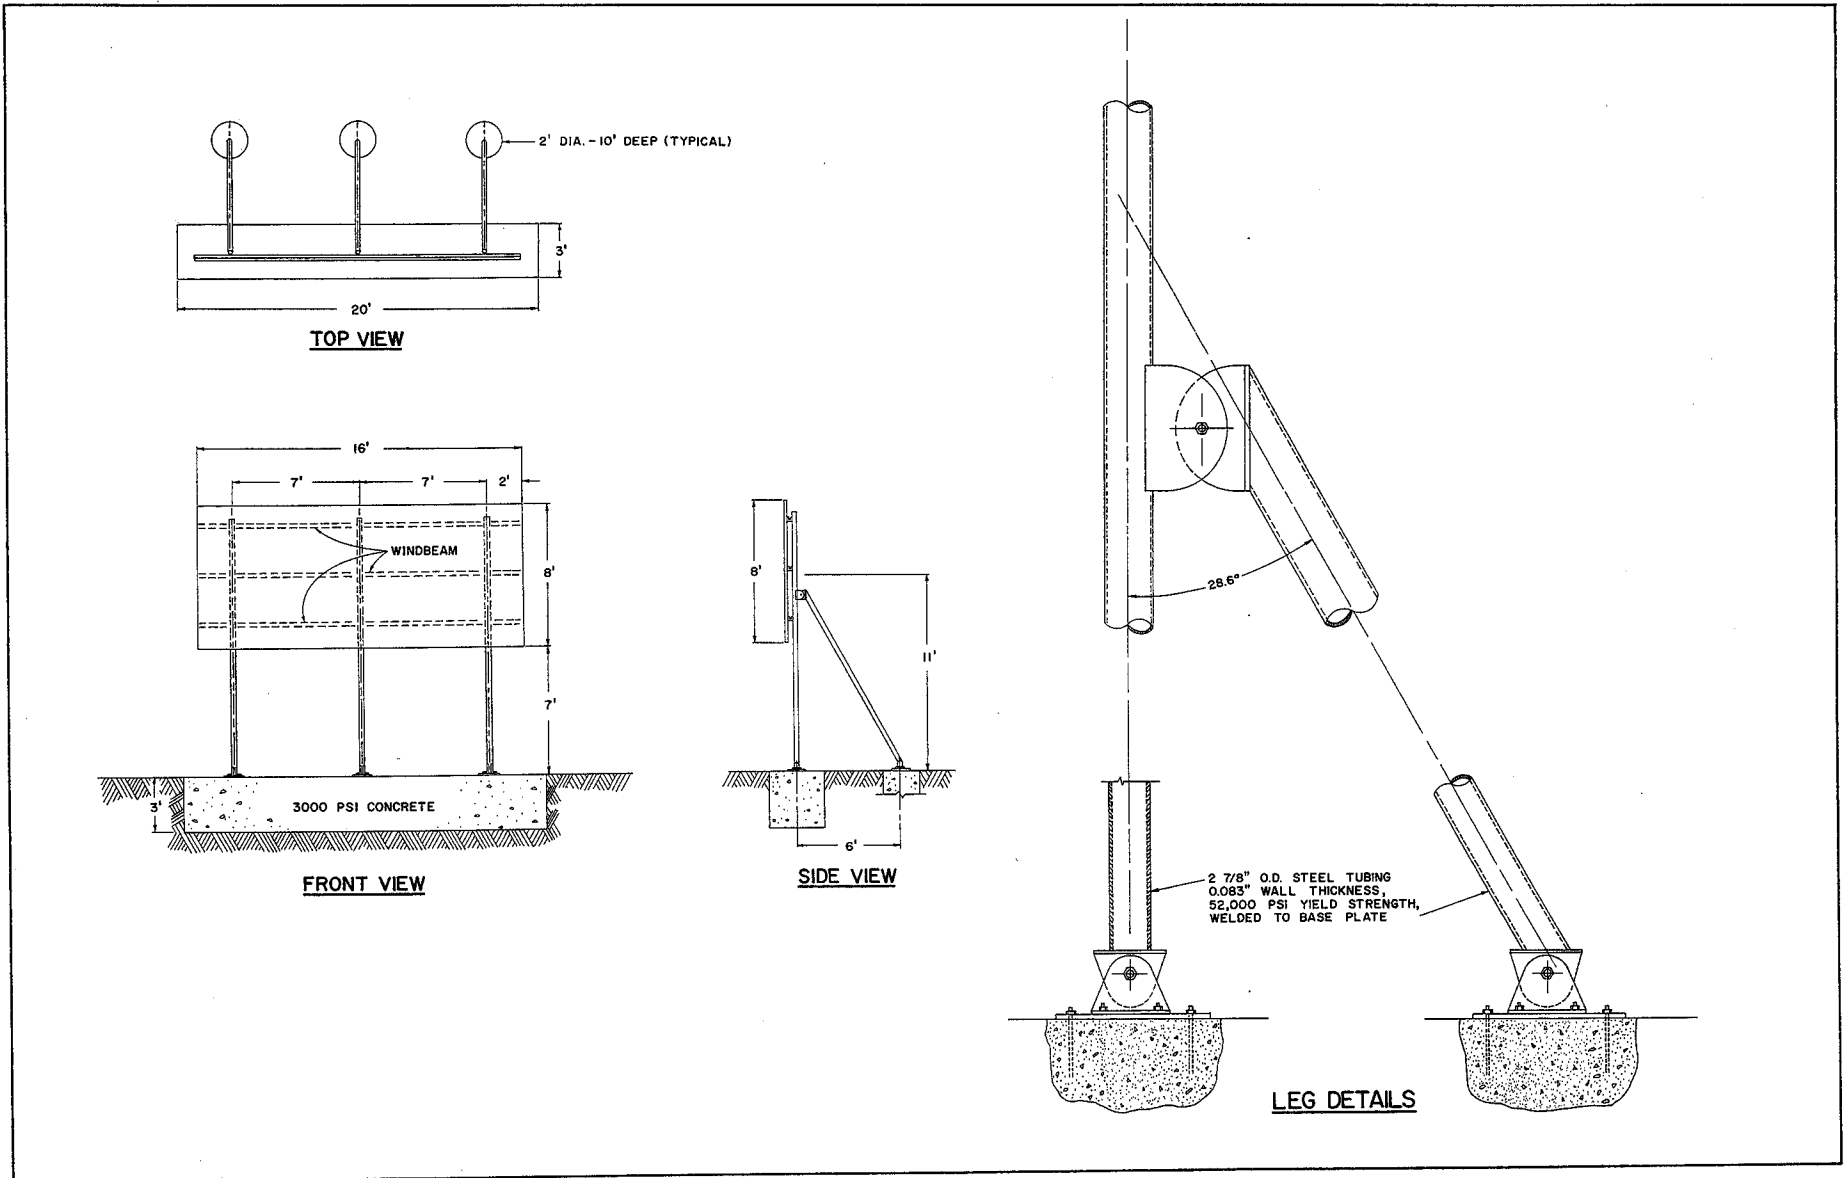
FIGURE 8

Although this was the third in the series of the tests on braced-leg supports, it was a test of the original design concept of the braced-leg structure recommended by the design engineers of the Houston Urban Office.

Observations of the high-speed film showed that the initial impact of the crash vehicle caused excessive deformation in the leg at bumper level. Sequence photographs of this test are shown in Figure 9. As the vehicle continued on through the support the front leg was pulled down causing failure of the bolt connecting the leg and the brace at the top. As the leg was pulled down the two lower cross beams were torn loose from the sign. The lower cross beam struck the windshield of the vehicle shattering the glass, but it did not break through the plastic lamination in the windshield. The front leg separated approximately six feet above ground level as it was being dragged under the vehicle. The brace member which had been freed at the top during the impact was torn loose at the base, and it and the upper portion of the front leg were carried along in front of the vehicle for a considerable distance. There was no perceptible deceleration of the automobile due to impact.

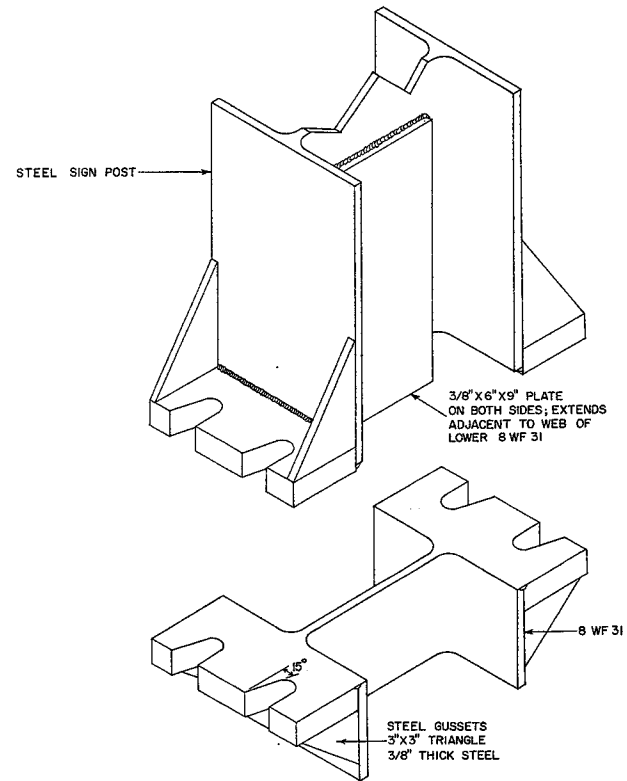
FIGURE 11

This particular design, which was proposed by engineers of the Bridge Division of the Texas Highway Department, makes use of a release mechanism at the base of the post replacing the rigid connection currently used in practice. It must be emphasized that the 8WF31 steel beam section employed in this test was larger than would normally be required for an 8'x18' sign installed in the field. This particular size was selected as representative of the large sign supports currently used in practice. The release mechanism is termed a "slip joint" and is shown in detail in Figure 11. Upon impact the post was intended to be released due to sliding action permitted by the slots in the foundation and the base plate of the post. As shown in Figure 11, a steel plate was welded to the web of the post and permitted to extend alongside but not attached to the web of the foundation. This extended plate was intended to cause the sign post to rotate forward so the vehicle would pass over it.

When impact occurred the slip joint behaved as expected but the plate extending alongside the web of the base served as a secondary restraint. The crash vehicle traveled 9 inches between initial impact and the time slippage occurred at the base. However, the vehicle traveled an additional 27 inches before the extension plate on the web of the post was raised above the foundation fitting. The inertia effects of the large mass above the bumper level and ambient air resistance on the sign were too great to allow forward rotation prior to movement of the extension plate. The upper portion of the post penetrated inside the left frame member of the vehicle to the left of the engine for a distance of approximately 3 feet. While this destruction was occurring the vehicle was decelerating rapidly and beginning to pitch and skid to the right. (Sequence photographs are shown in Figure 12). Finally the extension plate on the post was lifted above the foundation and the vehicle passed on under the post a distance of 63 feet beyond the sign. The front wheels were damaged to the extent that the left front wheel was restrained and the vehicle skidded to a stop. It should also be noted that the base plate of the foundation was not precisely horizontal and had to

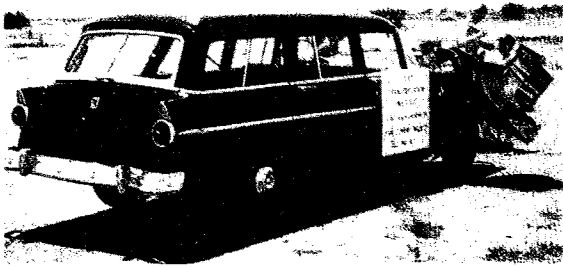
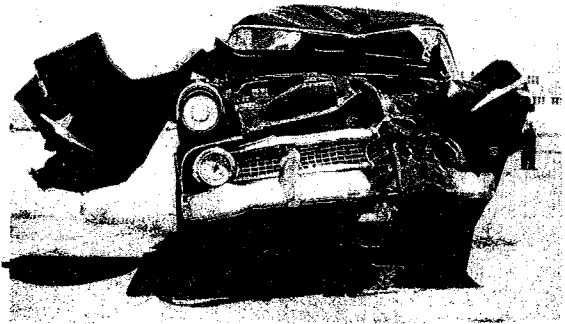
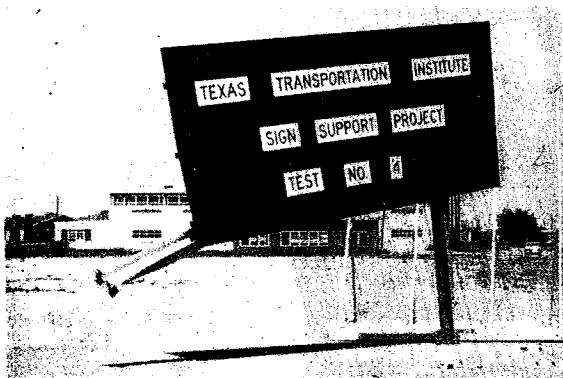
FIGURE 13 — VIEWS OF VEHICLE AND SIGN TEST NO. 4

be altered for a subsequent test. As the vehicle passed under the post, the base plate of the post tore the hood loose, penetrated the windshield in front of the driver's seat, and caused considerable damage to the front portion of the top of the vehicle. This particular variation was by no means satisfactory, and further modifications were proposed by engineers of the Bridge Division. Most observers conjectured that the severity of the impact and the damage due to the post striking the windshield and passenger area would probably have resulted in serious injury or possibly a fatality. Before and after views of the sign and the test vehicle are shown in Figure 13.

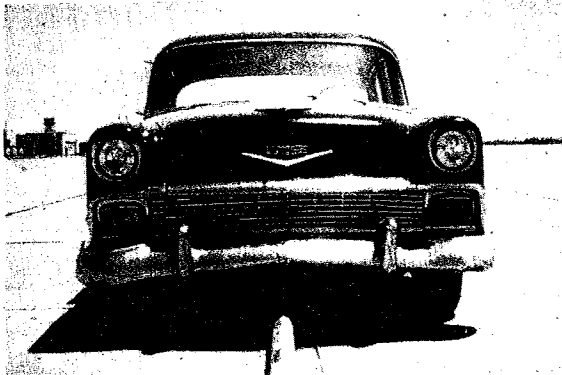
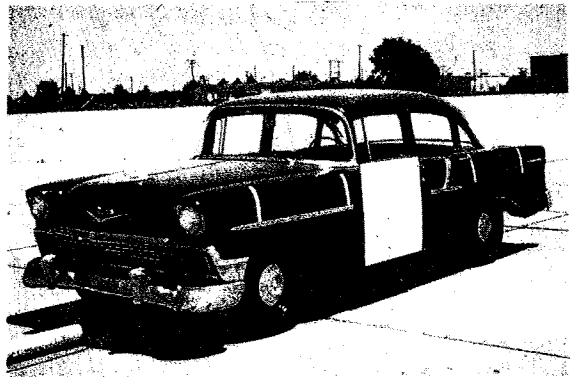
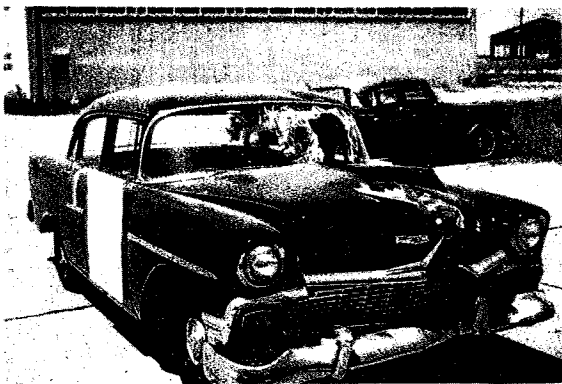
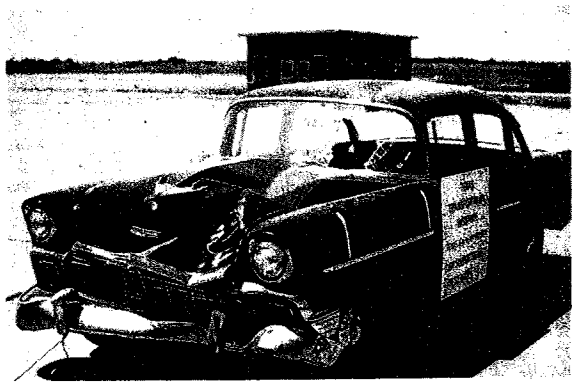
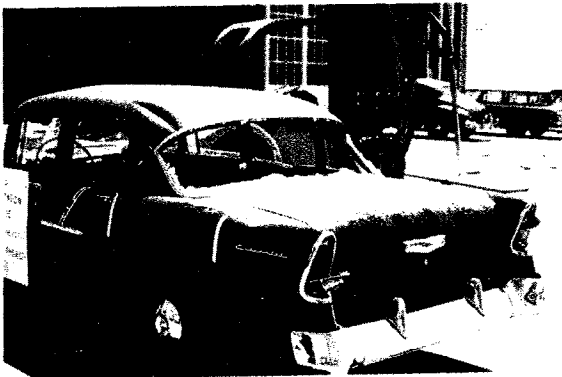
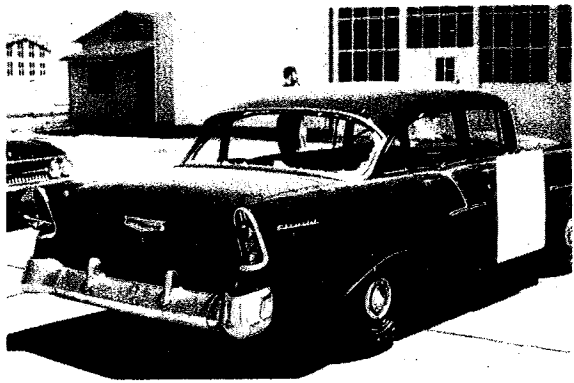
FIGURE 15 — VIEWS OF VEHICLE TEST NO. 5

Test 5 was conducted to evaluate the inertial effects of a section of the unbraced post support which could conceivably be removed by the impact of collision. To facilitate this test a 227-pound, seven-foot section of the same post used in Test 4 was erected in a free-standing position on its foundation. It was not bolted or fastened to the foundation in any way. The sequence photographs in Figure 14 show the results of this test. As shown in Figure 15 the damage of the vehicle due to initial impact was limited mainly to sheet metal parts. The major damage to the vehicle was caused by the behavior of the free-standing beam which rotated end over end, striking the hood and windshield first, and then striking the rear of the vehicle, breaking the rear windshield. (See Figure 14). Observation of the behavior of this free-standing beam suggested that the effect of the mass of this type of support is sufficiently small to permit the accomplishment of an effective break-away design. The vehicle traveled more than 350 feet following impact.

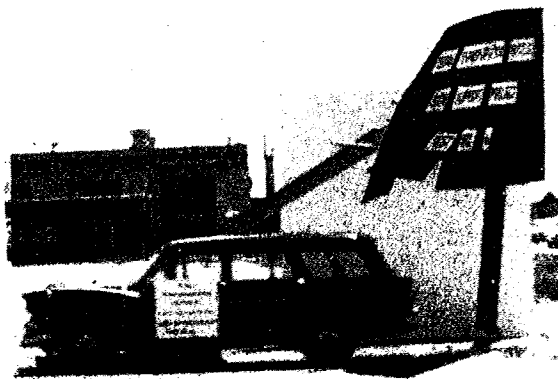
FIGURE 17 — SEQUENCE PHOTOGRAPH TEST NO. 6

When the vehicle struck the post (see Figure 17) the slip joint at the base functioned as expected and the post rotated upward clearing the vehicle. Several of the aluminum welds failed and the sign completely collapsed. It was apparent that the welds were of poor quality and observations drawn from the test could not be considered reliable. Before and after views of the impact, post, and vehicle are shown in Figure 18.

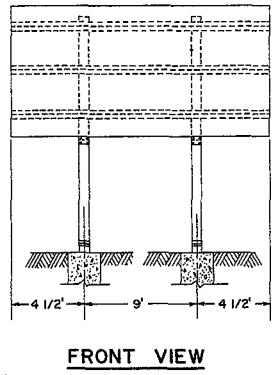
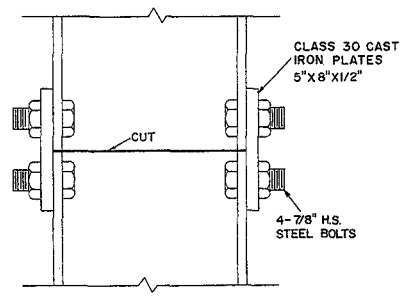
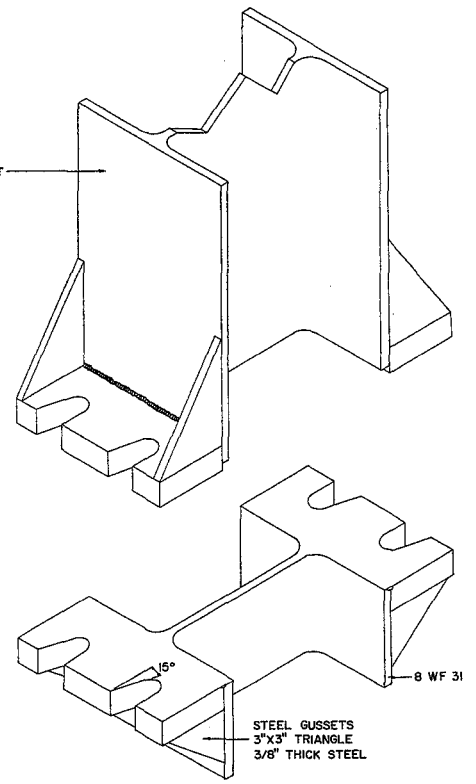
FIGURE 19

In Test 8 steps were taken to correct the undesirable characteristics of the unbraced post support noted in Test 4. The details of this design are shown in Figure 19. It should be noted that the slip joint at the base was improved by removing extension plates from the web of the post, and a "fracture joint" was introduced in the post at a point 7 feet above the ground level. This fracture joint was formed by cutting the post completely through and rejoining the abutting portions with two cast iron plates bolted to the front and back flanges. This feature was introduced in an effort to eliminate the possibility of the base of the post striking the windshield and passenger space as described in Test 4.

FRACTURE JOINT
 POST CUT COMPLETELY THROUGH
 AND REJOINED WITH CAST IRON PLATES

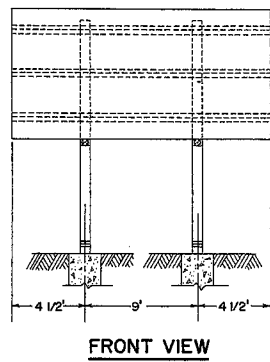
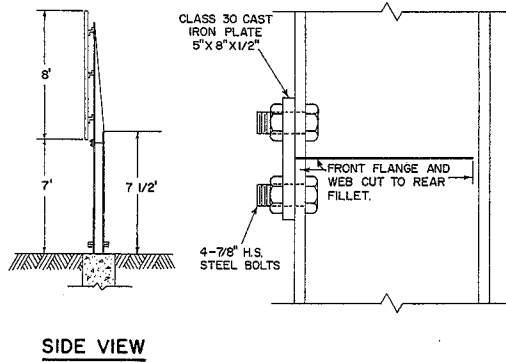
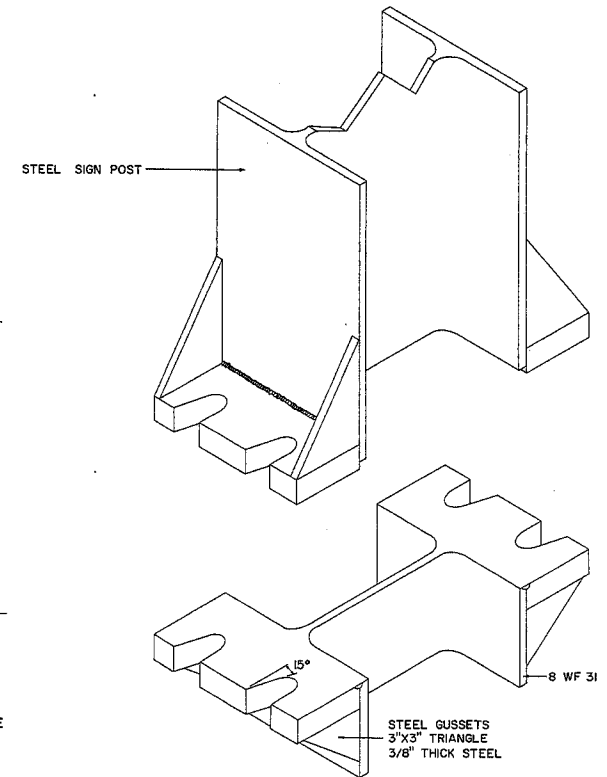
FIGURE 21

The problem encountered with the unbraced post support in Test 8 suggested devising some means of controlling the lower section of the post after its release at the base due to impact. To correct this problem a "hinge" joint was introduced in the place of the fracture joint described in Test 8. As shown in Figure 21 this hinge was formed by cutting the front flange and the web of the post at a height of 7 feet above the ground level. The front flange was then rejoined across the cut using a cast iron plate bolted to the flange. The back flange was left intact to serve as the "hinge".

When the base had slipped free the post rotated through an angle of approximately 45 degrees before the fracture plate failed. At that point the plate failed across the bolt holes and the lower section of the beam rotated upward through an angle of roughly 120 degrees from its original position and completely cleared the top of the automobile.

"PLASTIC HINGE" JOINT
POST CUT AS SHOWN AND REJOINED WITH CAST IRON PLATE. BACK FLANGE PROVIDES "PLASTIC HINGE".

BASE DETAIL AT
JUNCTURE WITH POST
