IMPACT BEHAVIOR OF SIGN SUPPORTS-II

A STAFF PROGRESS REPORT

Research Report Number 68-2

Sign Support Structures  
Research Project Number 2-5-63-68

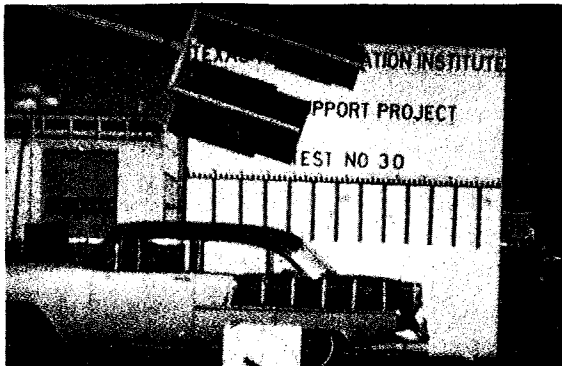
4" PIPE  
BASE INCLINED 20°

In view of these complexities, an alternative was sought. In earlier work, the rotational pattern of the sign and sign supports was altered appreciably by inclining the slip base. For the single pipe mounts the slip base was inclined 20 degrees as shown in Figure 10 to give the sign a quick vertical lift immediately after slippage occurred at the base. This design and modification would not necessarily reduce the angular velocity of the support as it rotates over the top of the vehicle but it was hoped that the additional lift would be sufficient to keep the sign clear of the automobile until it had passed on under the sign.

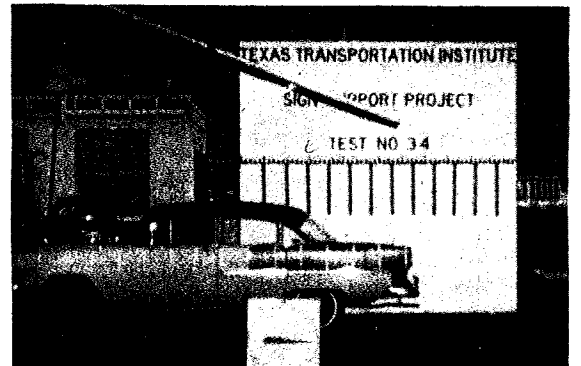
3" PIPE  
BASE INCLINED 20°

In a later test the angle of incline at the base was reduced to 10 degrees. This modification was made on the 3-inch pipe support and other test conditions were the same as in the earlier tests. A study of the films showed that the sign pitched vertically upon release from the foundation and rotated over the top of the automobile. The top of the support struck the extreme rear of the vehicle but caused very little damage.
