IMPACT BEHAVIOR OF LUMINAIRE SUPPORTS

Research Report Number 75-8

Supplementary Studies in Highway Illumination

TEXAS TRANSPORTATION INSTITUTE  
Texas A&M University  
College Station, Texas

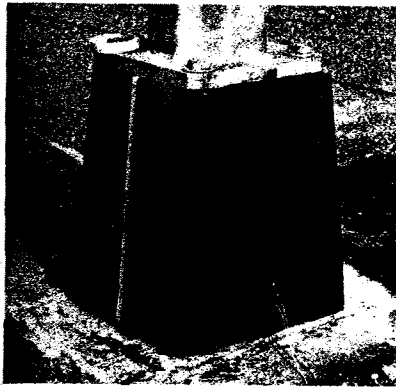
STEEL POLE - STEEL  
TRANSFORMER BASE

The fact that the steel pole with steel transformer base completely stopped the vehicle from an impact of 39.4 miles per hour is sufficient evidence that the design is unsatisfactory from the standpoint of safety. The front of the crash vehicle was deformed approximately 30 inches and the force of the impact actually caused the vehicle to bounce back approximately 24 inches. The severity of the collision is illustrated in the series of photographs in Figure 4. The pole remained in an upright position after the impact but considerable damage was done to the anchor bolts. This test is considered sufficient evidence to completely rule out this design.

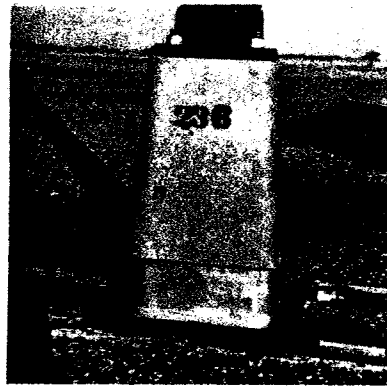
STEEL POLE - STEEL TRANSFORMER  
BASE WITH ALUMINUM INSERT

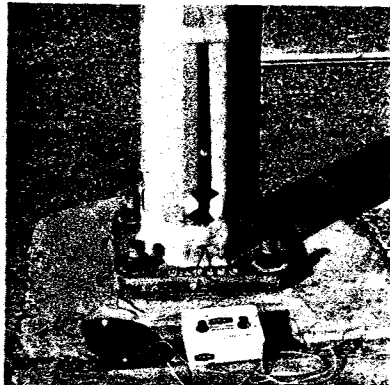
FLANGE MOUNTED STEEL POLE

The flange-mounted steel pole produced less severity than the steel-transformer base mounting, but it was still considered quite hazardous. The failure mechanism was the shaft itself. As the crash progressed (see Figure 5), the shaft crushed in the vehicle contact area and sheared across the weld at the flange. The impact force was sufficient to cause 27 inches of deformation before failure occurred. This particular pole was constructed of eleven gauge steel plate; some poles are made of thicker steel plate and they would naturally offer much greater resistance to impact.

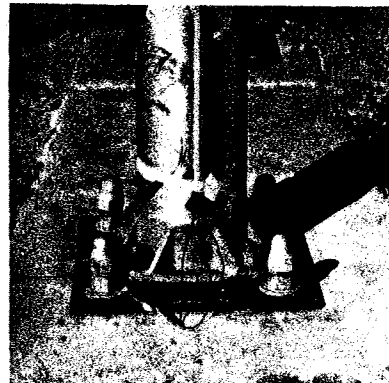
FLANGE MOUNTED ALUMINUM POLE

The flange-mounted aluminum pole offered almost as much resistance to impact as did the flange-mounted steel pole, based on observations of the physical damage to the automobile (see Figure 6). This is evidenced by the fact that the deformation of the frontal area of the automobile was 23 inches when the pole finally failed. Failure occurred by the vehicle crushing the impact side of the pole and breaking the cast aluminum flange on the pole. Since the pole was crimped or crushed, a hook was formed and caught on the front bumper of the vehicle momentarily as in the case of the steel pole. This gave the pole an appreciable forward and downward acceleration so that the pole struck the top of the automobile. The pole stayed in contact with the front of the automobile for approximately 45 feet beyond the point of impact. After striking the ground, the pole skidded forward until the top of the pole was approximately 40 feet from the foundation.

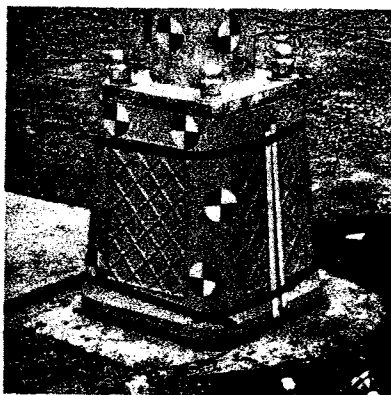
STEEL POLE - ALUMINUM  
TRANSFORMER BASE

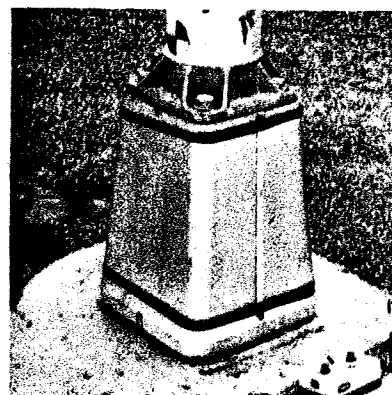
ALUMINUM POLE - ALUMINUM  
TRANSFORMER BASE

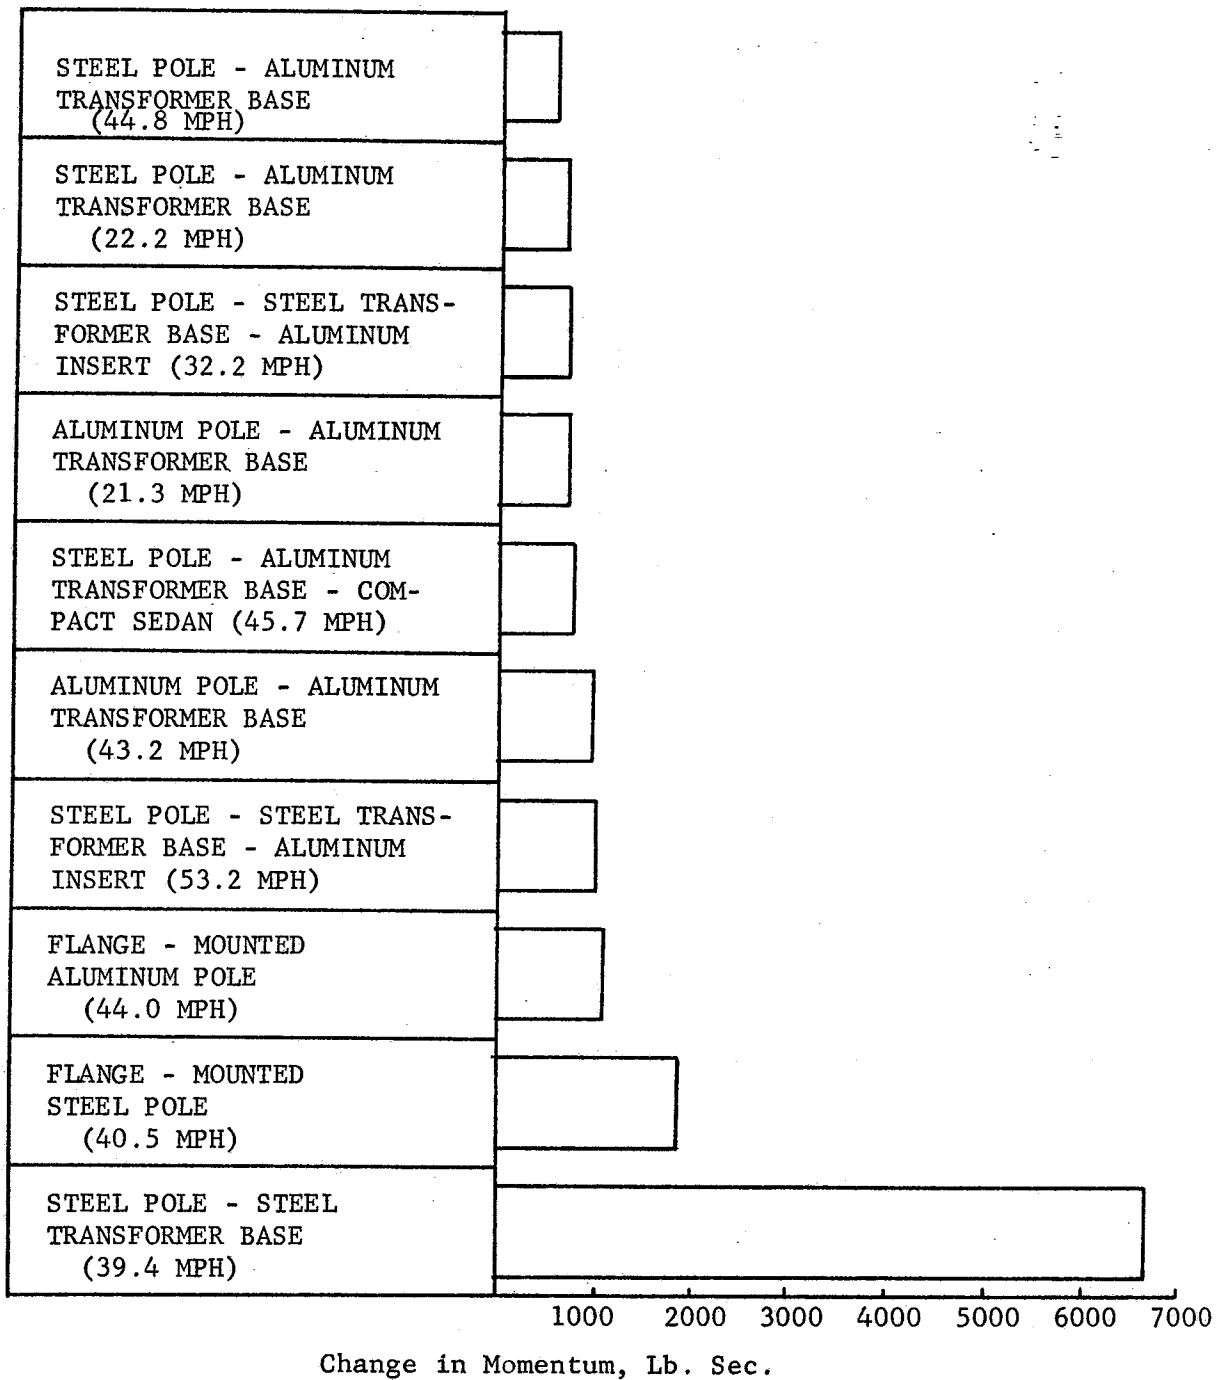
FIGURE 2

A comparison of the various designs tested made on the basis of change in momentum is illustrated in Figure 2. This comparison shows that there are only small differences in the change in momentum with the exception of the flange-mounted steel pole and the steel pole on the steel transformer base. On the basis of this comparison it would appear that the frangible base such as the cast aluminum transformer base or the cast aluminum insert produces satisfactory impact behavior of lighting poles.

COMPARISON OF POLE AND BASE COMBINATIONS ON THE BASIS OF CHANGE IN MOMENTUM

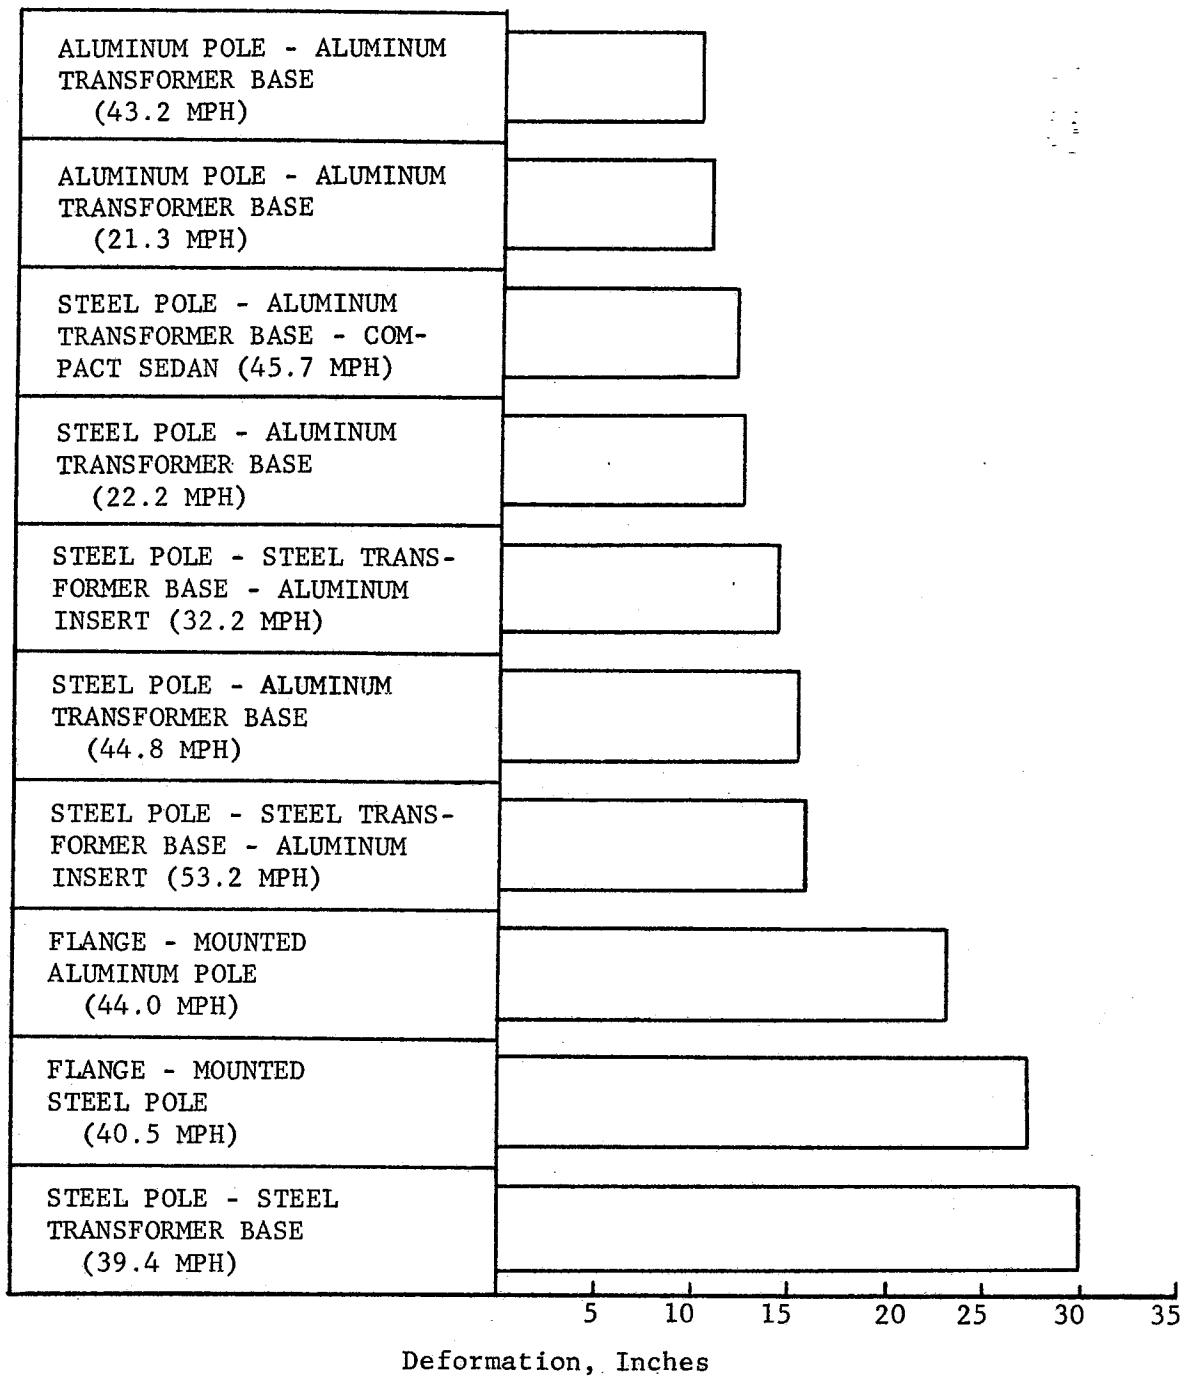
FIGURE 3

For another means of comparison, the deformation or penetration of the vehicle due to the impact was plotted as shown in Figure 3. This comparison shows essentially the same results as indicated by the comparison of the change in momentum except for the flange-mounted aluminum pole. In comparison, the aluminum pole does not show a great advantage over the steel pole. In both cases the deformation of the front of the vehicle was on the order of 2 feet. From experience, such severity may not cause a fatality but would likely result in personal injury to the vehicle occupants.

COMPARISON OF POLE AND BASE COMBINATIONS ON THE BASIS  
 OF DEFORMATION OF FRONTAL AREA OF VEHICLE
