**Development and *MASH* Full-Scale Crash  
Testing of a High-Mounting-Height  
Temporary Single Sign Support with  
Aluminum Sign**

**Test Report No. 9-1002-12-5**

**TEXAS A&M TRANSPORTATION INSTITUTE  
THE TEXAS A&M UNIVERSITY SYSTEM  
COLLEGE STATION, TEXAS**

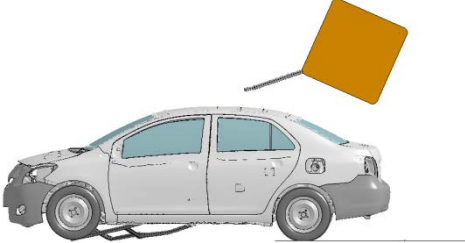
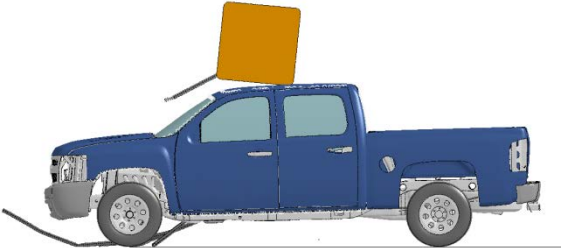
**Figure 5.22. Predicted Outcomes of Finite Element Simulations with (a and b) *MASH* 1100C and (c and d) *MASH* 2270P Vehicles (Design Modification #2).**

The FE simulation did not predict any second impact between the released sign support assembly and the 1100C vehicle (see Figure 5.22 (a and b)). However, although contact with the windshield was avoided, secondary contact between the sign support assembly and the roof was predicted in the simulation with the 2270P vehicle (see Figure 5.22 (c and d)). Figures 5.23 and 5.24 show the energy balance for the 1100C and 2270P simulations, respectively. Hourglass and sliding interface energy values remained under 5 percent for both simulations. Table 5.4 compares the sign support trajectory for the 1100C and 2270P vehicle simulations.

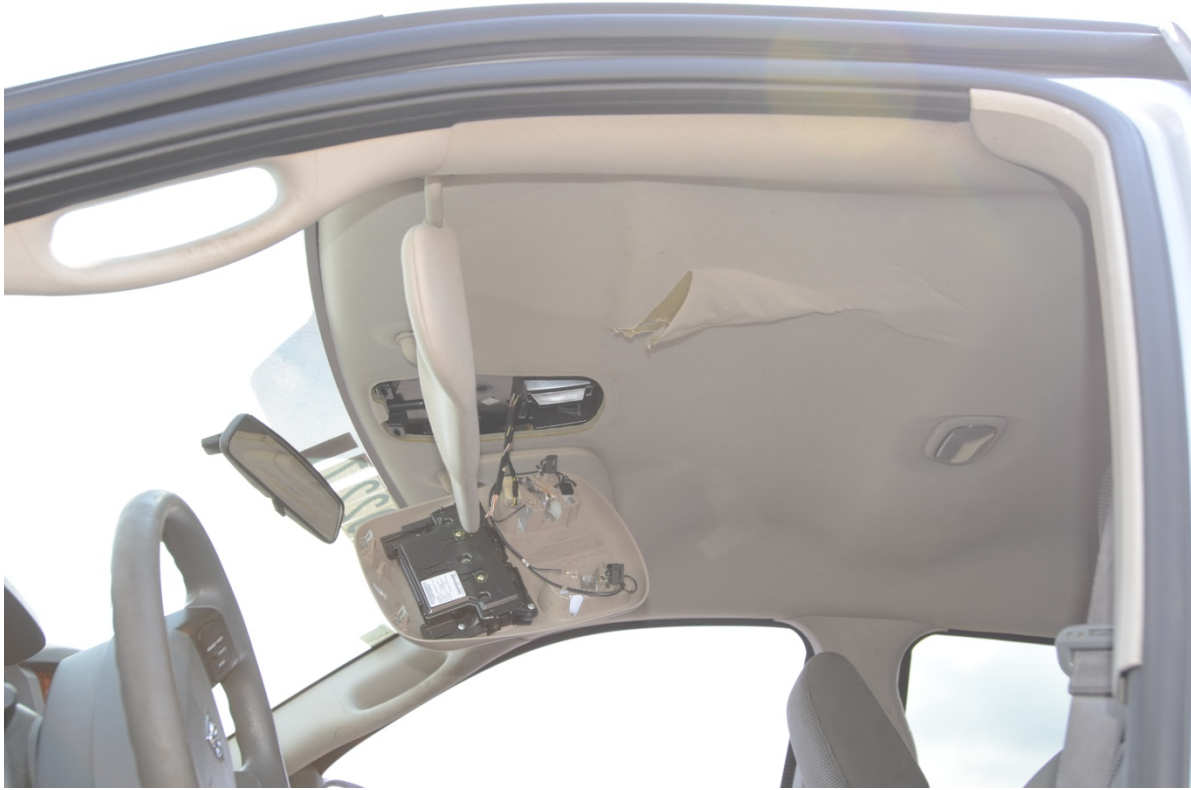
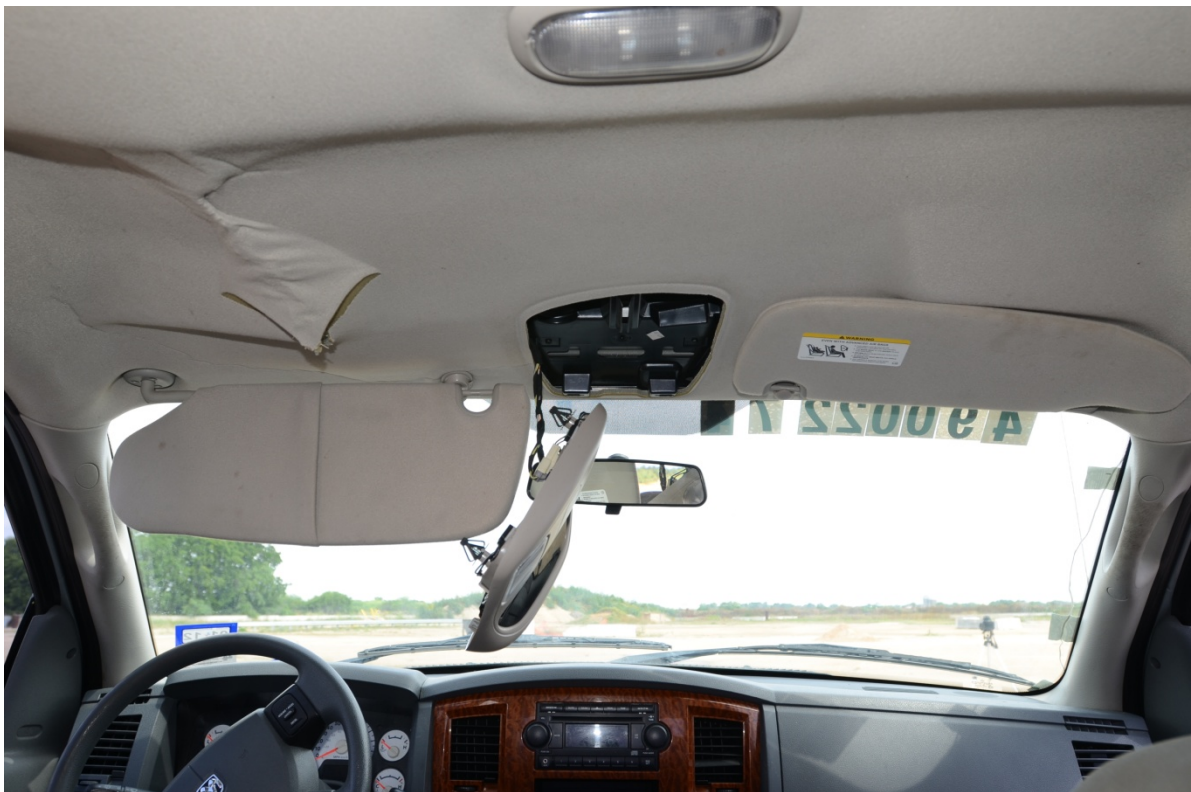
**Figure 6.9. Occupant Compartment Interior of Vehicle after Test No. 490022-7-4.**

The 2270P vehicle sustained a small dent in the bumper, hood, and grill, due to the initial impact with the 90-degree oriented sign support. A secondary impact of the edge of the aluminum sign panel caused a 29-inch long cut in the roof of the pickup truck. Additionally, the roof was deformed over an area measuring 51 inches in length and 40 inches in width.

Results: The secondary impact of the edge of the sign with the roof of the vehicle in the 90-degree orientation caused a 29-inch long cut in the roof and the sign panel penetrated into the occupant compartment before subsequently exiting from the vehicle. (FAIL)

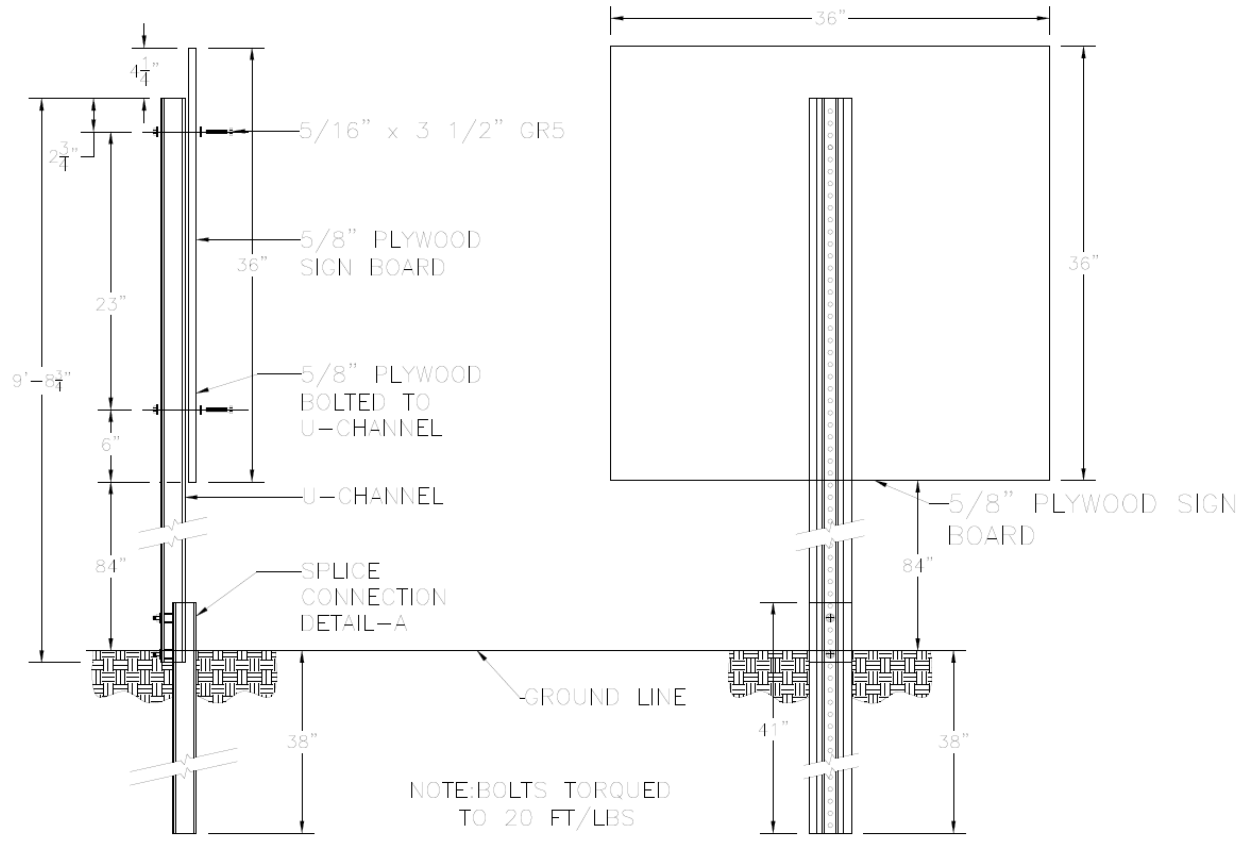
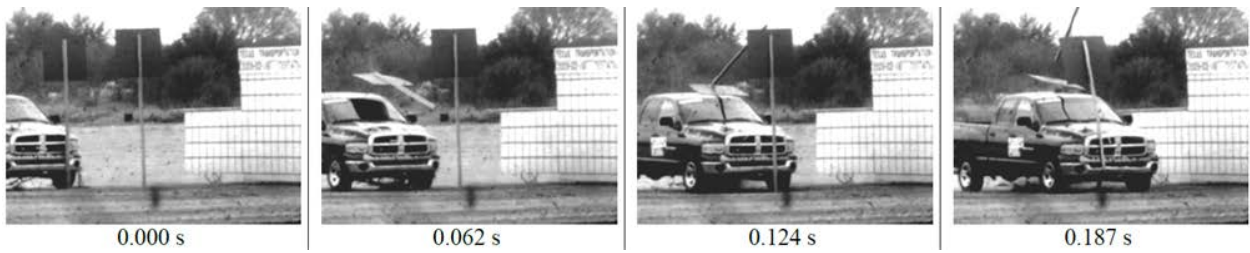
### 4 lb/ft U-channel Sign Support, 7 ft MH

The 4 lb/ft U-channel sign support readily activated upon impact by the 2270P vehicle by fracturing at the ground stub and bumper height. The upper portion of the fractured sign support traveled with the vehicle. Contact of the U-channel support with the windshield and roof was minimal and the support did not penetrate or show potential for penetrating the occupant compartment. The largest piece of this support weighed 33.6 lb, but the trajectory was relatively low and should not cause undue hazard to others in the area.

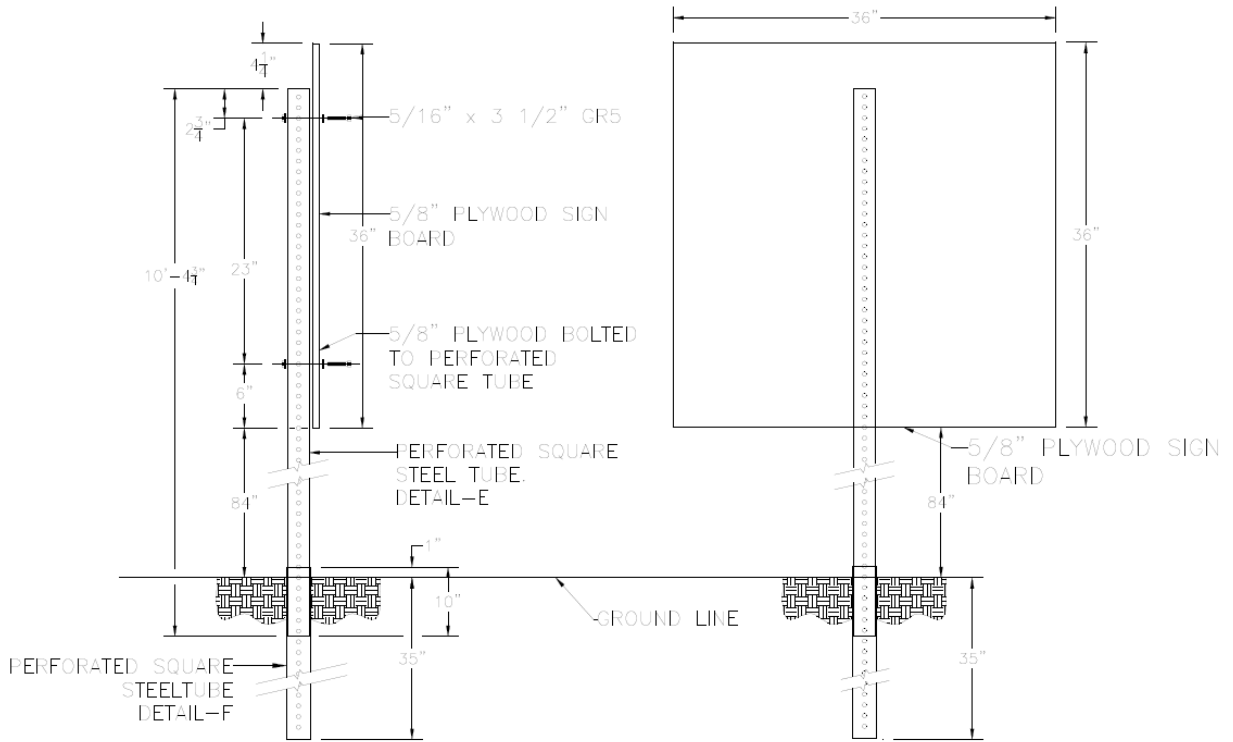
## Perforated Square Steel Tube Support, 7 ft MH

The Perforated Square Steel Tubing sign support readily activated upon impact by the 2270P vehicle by fracturing at the ground stub and at bumper height. The upper portion of the sign support traveled with the vehicle. The upper section of the support and sign panel contacted the windshield near the roof line. No tear of the plastic lining of the windshield occurred, however, the windshield was deformed inward 3.5 inches. MASH Section 5.3 and Appendix E limits deformation of the windshield to 3 inches.

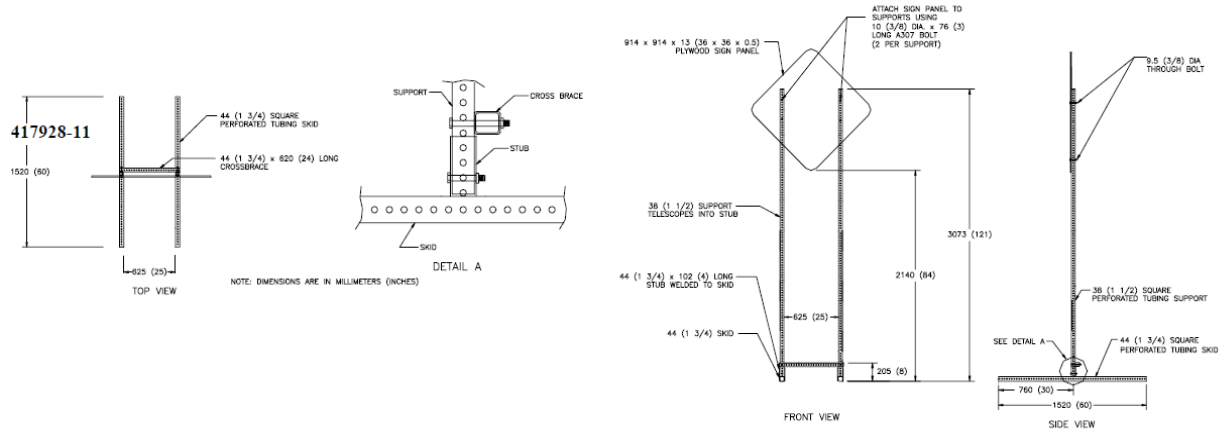
# Dual Perforated Steel Tube Skid Mounted Sign Support, 7 ft MH

Speed: 93.8 km/hr
Angle: 0 deg
NCHRP Report 350: Failed
<p>Upon impact, the left steel post fractured at the steel base, and the sign panel contacted the roof of the vehicle. The windshield shattered. The steel sign support penetrated the occupant compartment in the windshield area and deformed the roof. Maximum deformation into the occupant compartment was 99 mm (3.9 inch) (11 percent reduction of space) in the floor pan near the transmission tunnel.</p>

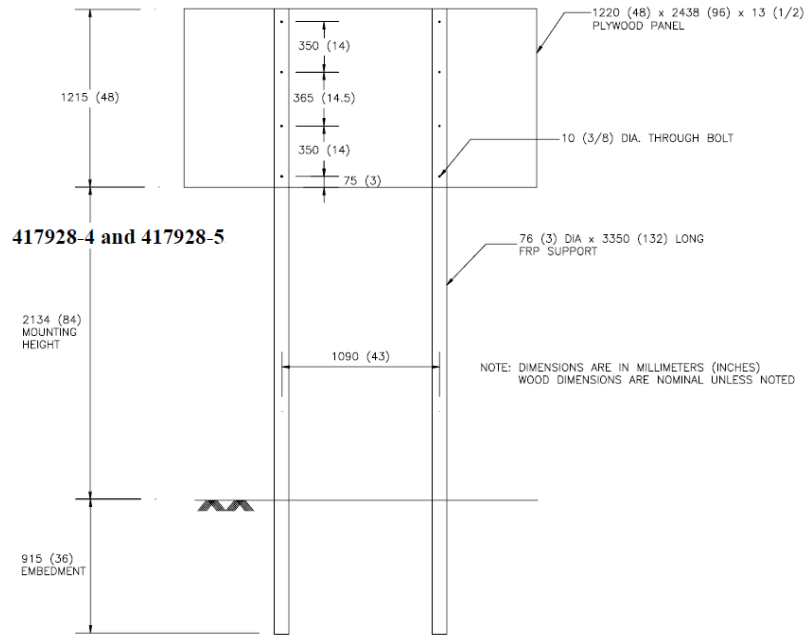
## Dual FRP Sign Support, 7 ft MH

The sign posts deformed around the front bumper. The plywood sign panel contacted the hood of the vehicle. The cover of the front right of the bumper of the vehicle separated from the vehicle. The hood received two scrapes, and there was minor damage to the bumper cover. The sign panel shattered the windshield, but it did not penetrate or show potential to penetrate the occupant compartment, or present undue hazard to others in the area. No deformation or intrusion of the occupant compartment occurred.

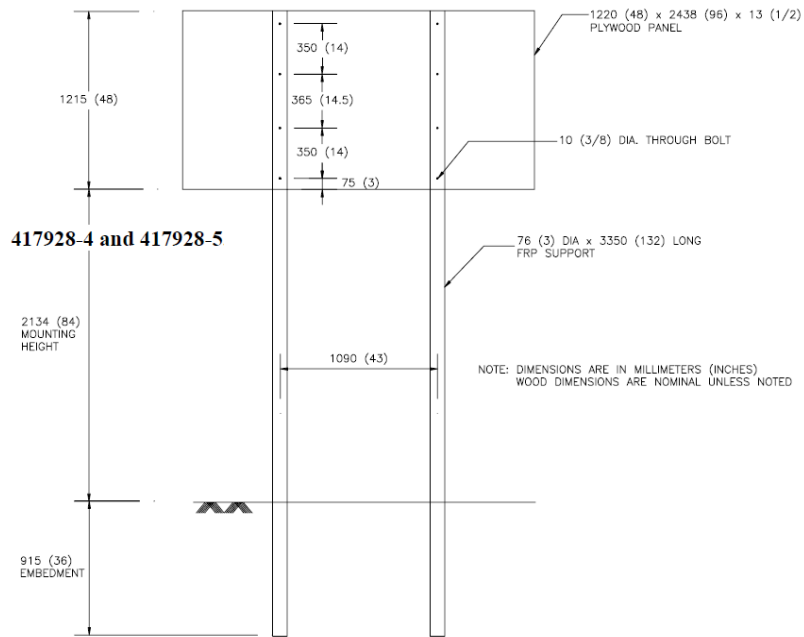
## Dual FRP Sign Support, 7 ft MH

The sign posts deformed around the front of the bumper and were pulled out of the ground. The plywood sign panel contacted the roof of the vehicle. The sign panel contacted the roof and cracked the windshield, but it did not penetrate or show potential to penetrate the occupant compartment, or present undue hazard to others in the area. No deformation or intrusion of the occupant compartment occurred.

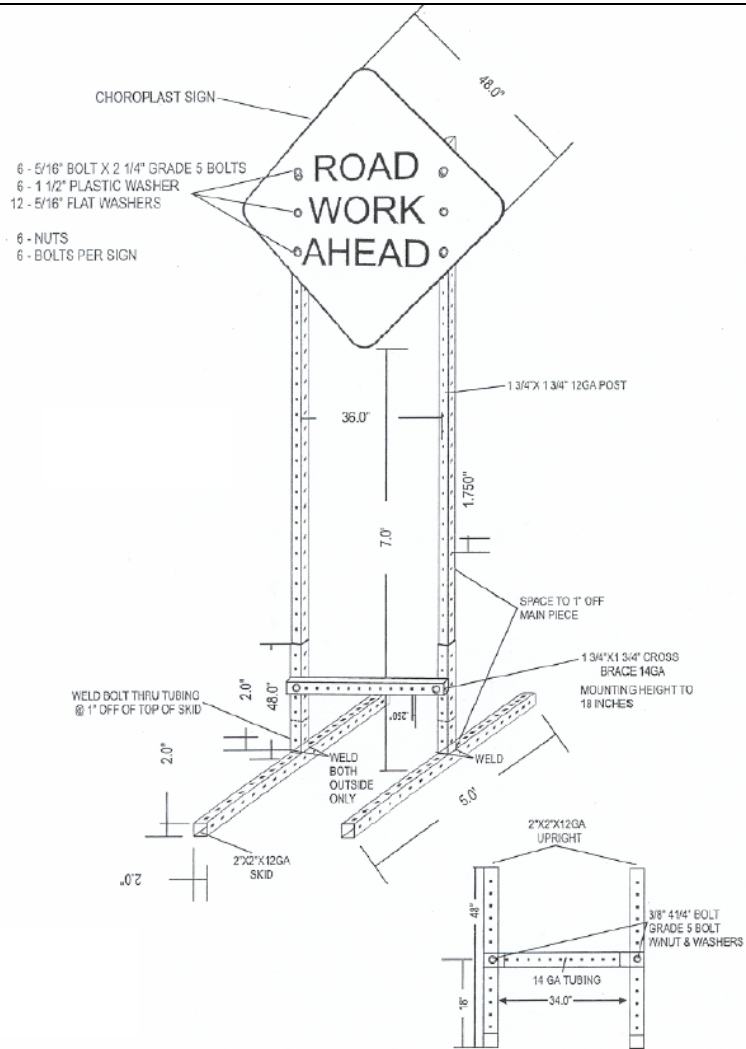
## Dual-Leg Perforated Square Steel Tube, 7 ft MH

The Allied Tube & Conduit dual-leg perforated square steel tube temporary sign support system activated as designed by yielding to the small car and fracturing. There were detached elements, fragments, and debris resulting from the test. However, the debris was primarily strewn along the path of the vehicle and was not considered to present undue hazard to others in the area. Further, none of the detached elements, fragments, and debris penetrated or showed potential for penetrating the occupant compartment. There was no deformation of or intrusion into the occupant compartment.

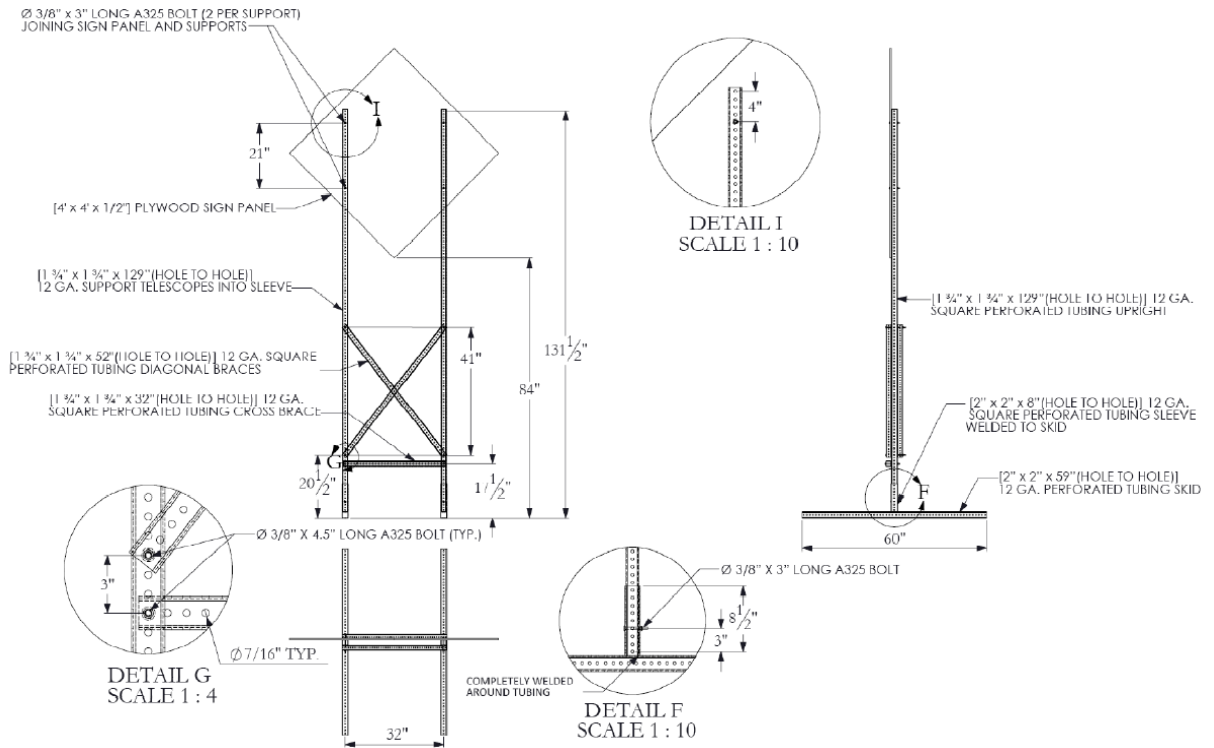
# Dual-Support Temporary Sign Support, 7 ft MH

Debris remained scattered along the vehicle path. The roof of the vehicle was deformed inward 200 mm (7.9 inch). The windshield was torn and separated from its frame (FHWA Case 1 and 2). During the test, the sign panel reached a maximum penetration of 302 mm (11.9 inch). There was no other measurable occupant compartment deformation.

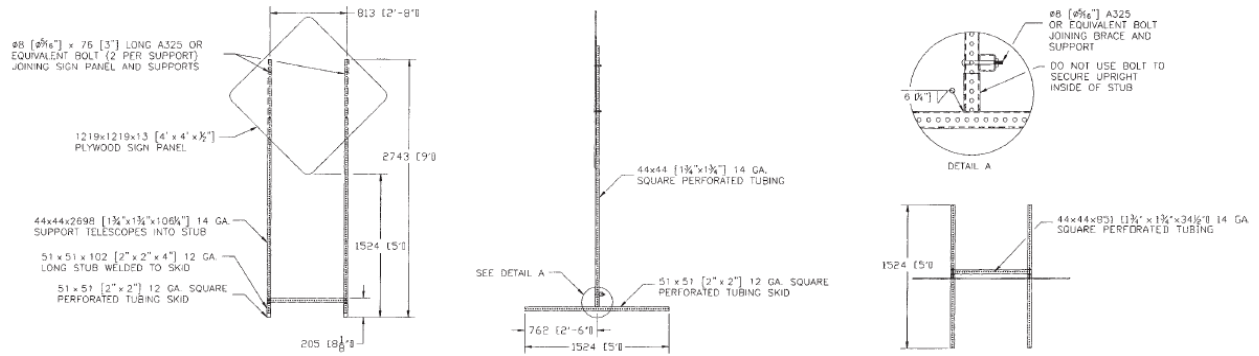
## Dual Uprights with Slip Connection, 7 ft MH

Both tall, dual-leg sign supports readily activated as designed by yielding and fracturing. Debris remained scattered along the vehicle path. The roof was deformed inward 25 mm (1.0 inch). The windshield was not damaged (no holes or tears), nor was the windshield separated from its frame. There was no other measurable occupant compartment deformation.

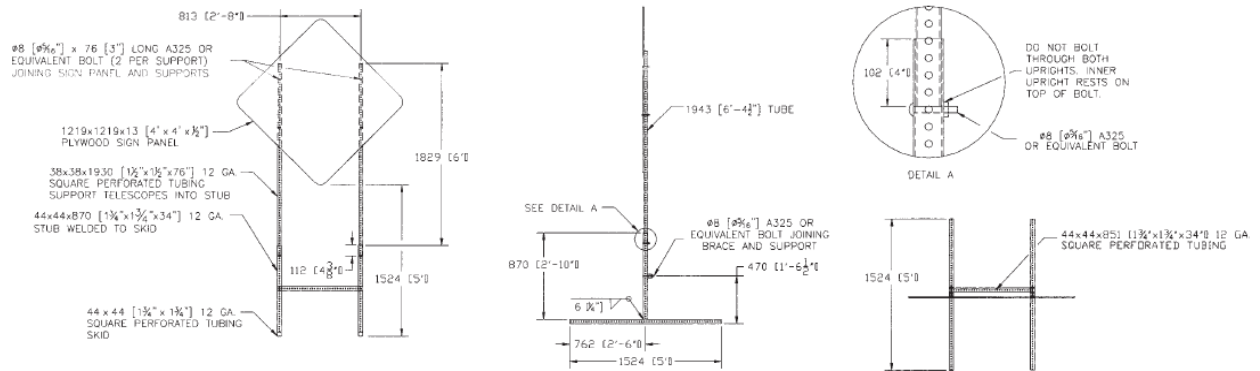
## Dual Uprights with Raised Slip Joint, 7 ft MH

Debris remained scattered along the vehicle path. The roof of the vehicle was deformed inward 62 mm (2.4 inch) near the windshield, and 40 mm (1.6 inch) near the center. The windshield was shattered and deformed inward 92 mm (3.6 inch) with a small hole (FHWA Case 1). The windshield was not separated from its frame. There was no other measurable occupant compartment deformation.
